Facility Condition Assessment Summary Report

Kenderton School

School District of Philadelphia
S431001;Kenderton
Final
Site Assessment Report
January 30, 2017

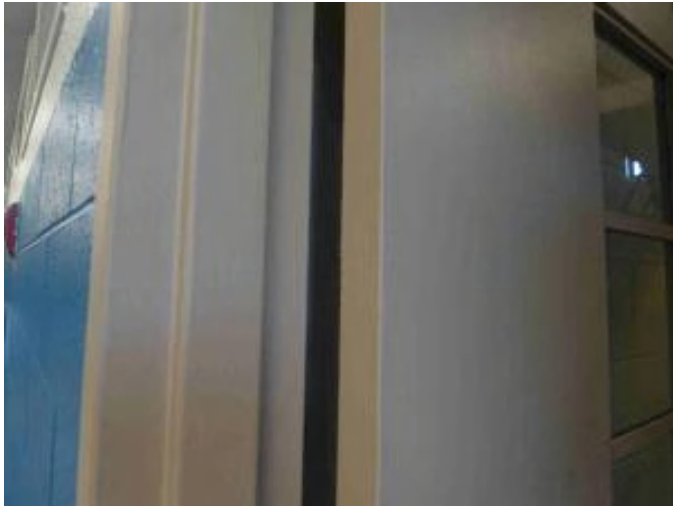
System: C1010 - Partitions

Location: Stairs

Distress: Damaged

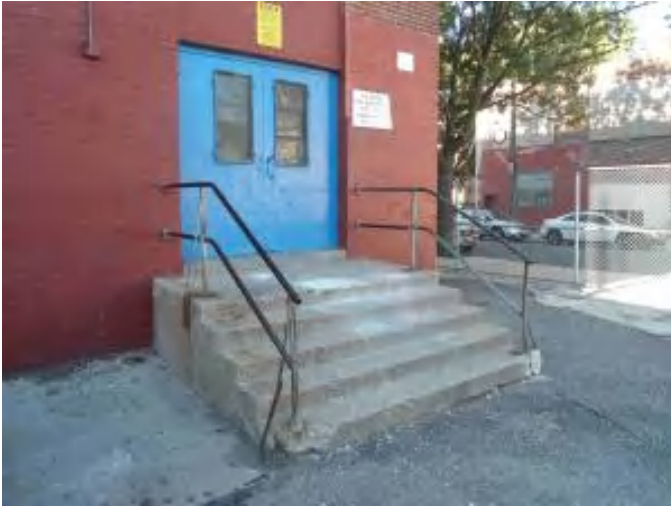
System: B2030 - Exterior Doors

Location: Exterior Elevation

Distress: Damaged

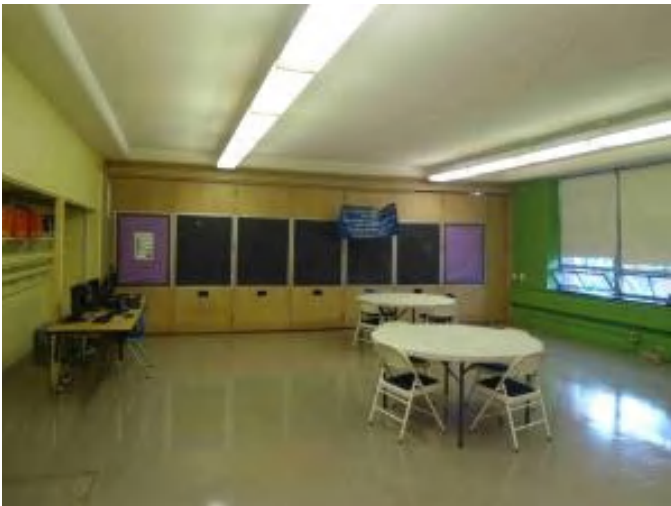
System: C1010 - Partitions

Location: Classrooms

Distress: Damaged

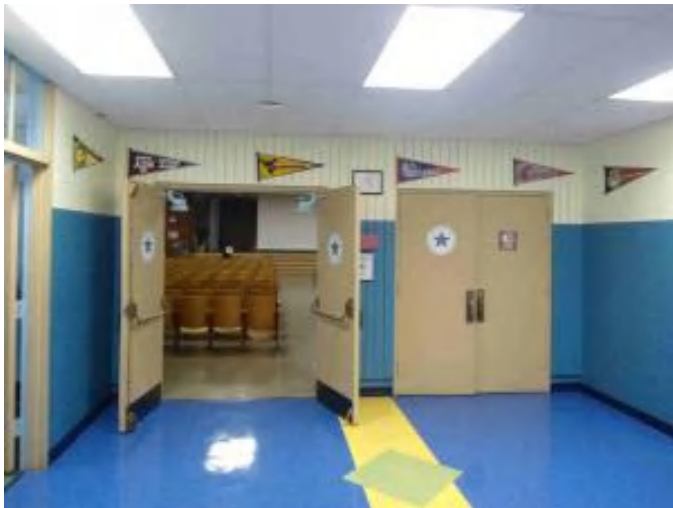
System: C1020 - Interior Doors

Location: Classrooms
Distress: Damaged
Category: 3 - Operations / Maint.
Priority: 3 - Response Time (3-4 yrs)
Correction: Remove and replace interior doors - wood doors with hollow metal frames - per leaf
Qty: 120.00
Unit of Measure: Ea.
Estimate: \$572,470.45
Assessor Name: System
Date Created: 12/14/2015

Notes: Interior doors are a mix of wood in metal frames with glass glazing or metal doors in metal frames. Other interior doors include wooden glass pane doors with original wooden pane frames, hollow metal in hollow metal frames. Doors are generally in good condition considering the age of the application however, several doors are hard to open and in some cases have been re-hung to prevent door jam issues. Universal upgrades are required for the interior door systems, it is recommended that the interior doors system be removed and replaced with a new modern metal framed wooden door system with consideration for ADA compliance.

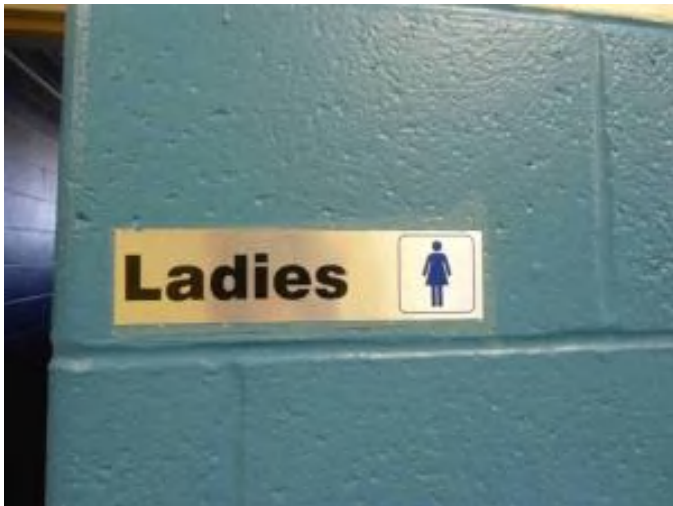
System: C1030 - Fittings

Location: Building Wide
Distress: Damaged
Category: 3 - Operations / Maint.
Priority: 3 - Response Time (3-4 yrs)
Correction: Replace missing or damaged signage - insert the number of rooms
Qty: 180.00
Unit of Measure: Ea.
Estimate: \$48,764.25
Assessor Name: System
Date Created: 12/14/2015

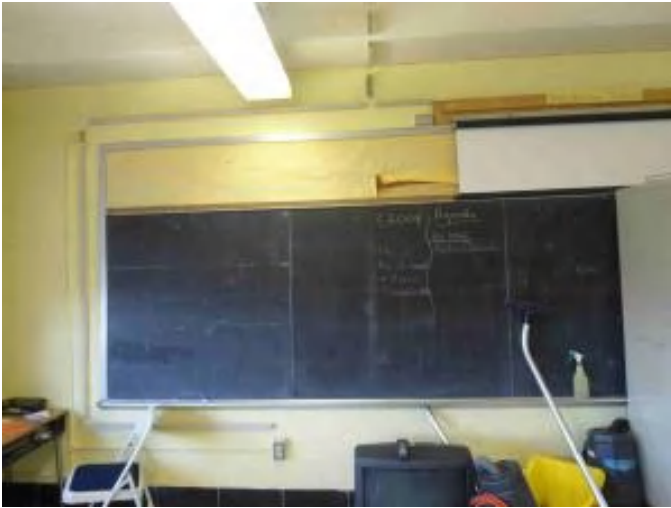
System: C1030 - Fittings

Location: Classroom

Distress: Damaged

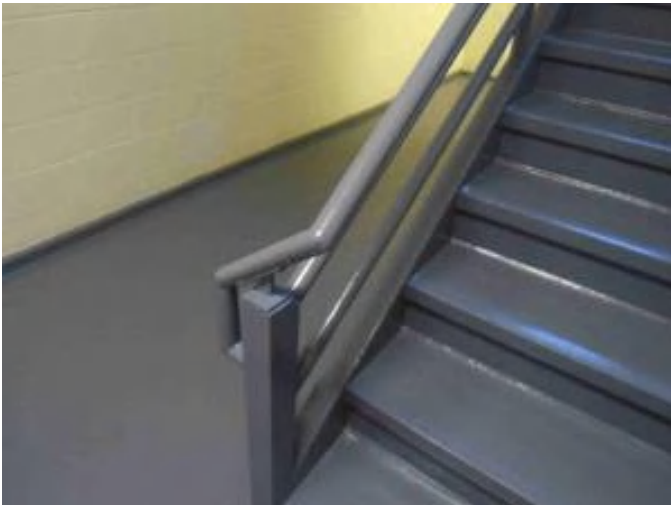
System: C2010 - Stair Construction

Location: Stairs

Distress: Life Safety / NFPA / PFD

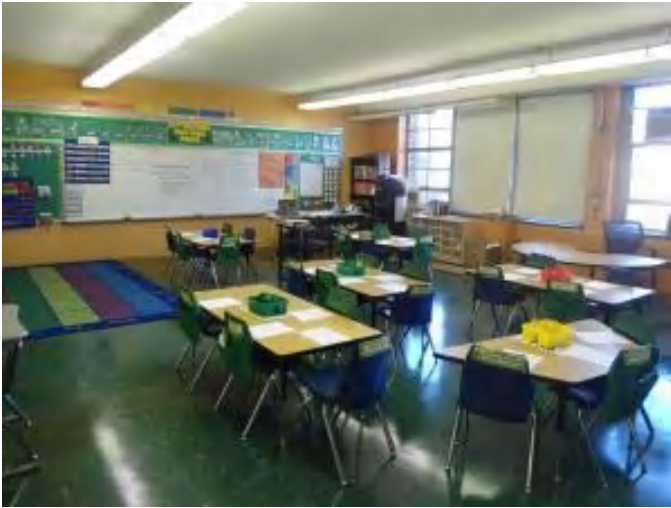
System: C3020413 - Vinyl Flooring

Location: Building Wide

Distress: Health Hazard / Risk

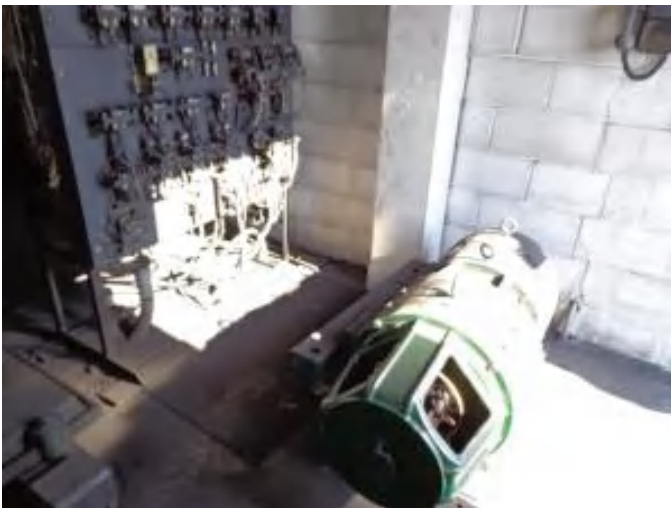
System: D1010 - Elevators and Lifts

Location: Elevator Machine Room

Distress: Beyond Service Life

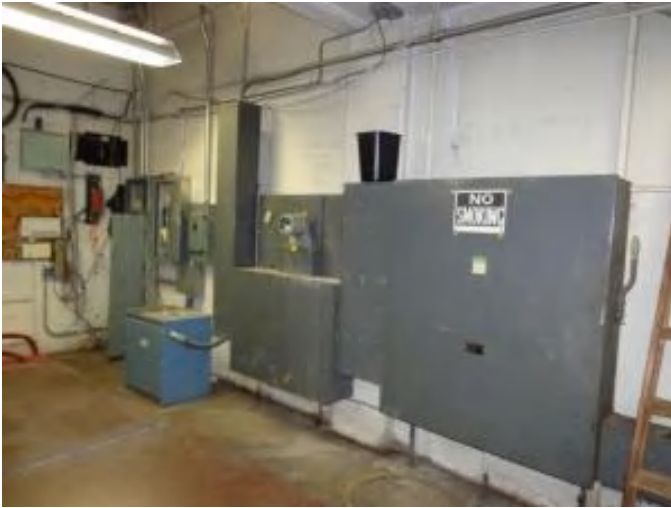
System: D5010 - Electrical Service/Distribution

Location: Main Electrical Room
Distress: Beyond Service Life
Category: 3 - Operations / Maint.
Priority: 3 - Response Time (3-4 yrs)
Correction: Replace Electrical Distribution System (U)
Qty: 1.00
Unit of Measure: Ea.
Estimate: \$975,323.67
Assessor Name: System
Date Created: 10/20/2015

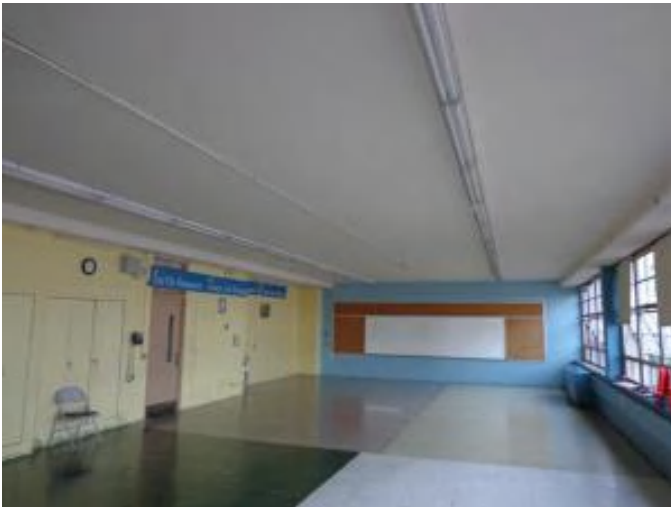
System: D5020 - Lighting and Branch Wiring

Location: Main Office, PE Office and Room 407
Distress: Beyond Service Life
Category: 3 - Operations / Maint.
Priority: 3 - Response Time (3-4 yrs)
Correction: Replace lighting fixtures
Qty: 53.00
Unit of Measure: Ea.
Estimate: \$46,632.88
Assessor Name: System
Date Created: 10/20/2015

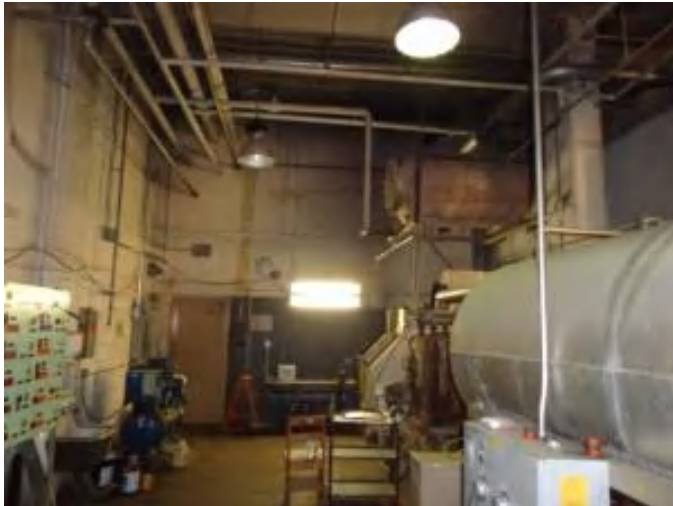
System: D5020 - Lighting and Branch Wiring

Location: Boiler Room and Basement
Distress: Beyond Service Life
Category: 3 - Operations / Maint.
Priority: 3 - Response Time (3-4 yrs)
Correction: Replace lighting fixtures
Qty: 46.00
Unit of Measure: Ea.
Estimate: \$39,183.64
Assessor Name: System
Date Created: 10/20/2015

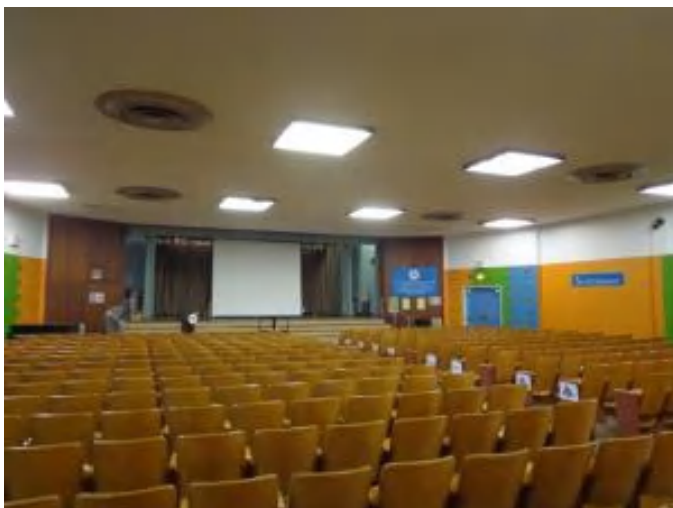
System: D5020 - Lighting and Branch Wiring

Location: Auditorium and platform
Distress: Beyond Service Life
Category: 3 - Operations / Maint.
Priority: 3 - Response Time (3-4 yrs)
Correction: Replace lighting fixtures
Qty: 15.00
Unit of Measure: Ea.
Estimate: \$30,850.52
Assessor Name: System
Date Created: 10/20/2015

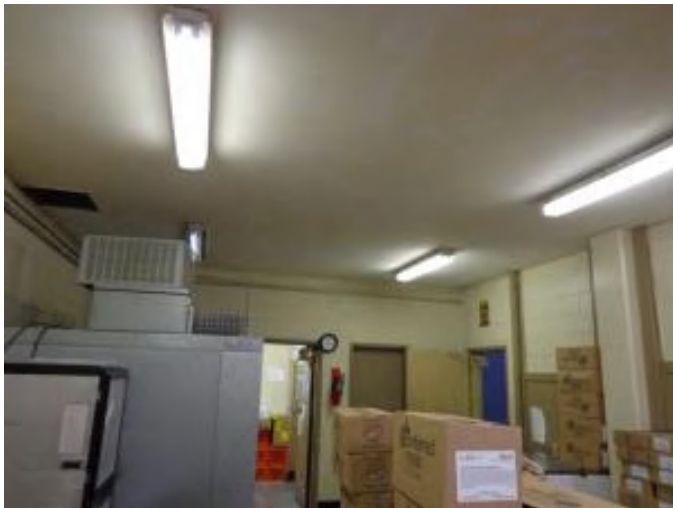
System: D5020 - Lighting and Branch Wiring

Location: Kitchen
Distress: Beyond Service Life
Category: 3 - Operations / Maint.
Priority: 3 - Response Time (3-4 yrs)
Correction: Replace lighting fixtures
Qty: 6.00
Unit of Measure: Ea.
Estimate: \$6,983.95
Assessor Name: System
Date Created: 10/20/2015

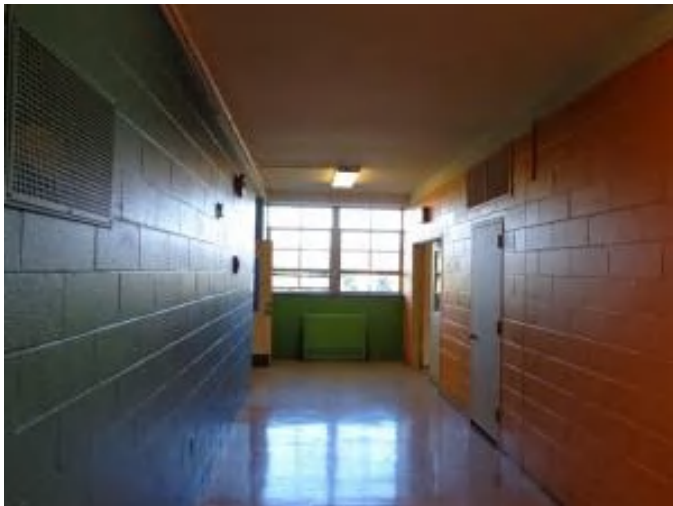
System: D5020 - Lighting and Branch Wiring

Location: Floor 4 west corridor
Distress: Failing
Category: 3 - Operations / Maint.
Priority: 3 - Response Time (3-4 yrs)
Correction: Replace lighting fixtures
Qty: 5.00
Unit of Measure: Ea.
Estimate: \$4,292.74
Assessor Name: System
Date Created: 10/20/2015

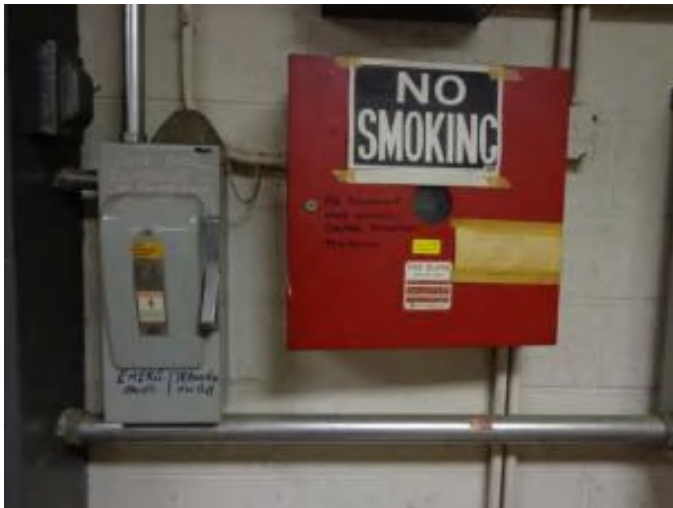
System: D5030 - Communications and Security

Location: Building wide
Distress: Beyond Service Life
Category: 3 - Operations / Maint.
Priority: 3 - Response Time (3-4 yrs)
Correction: Replace fire alarm system
Qty: 91,008.00
Unit of Measure: S.F.
Estimate: \$307,812.85
Assessor Name: System
Date Created: 10/20/2015

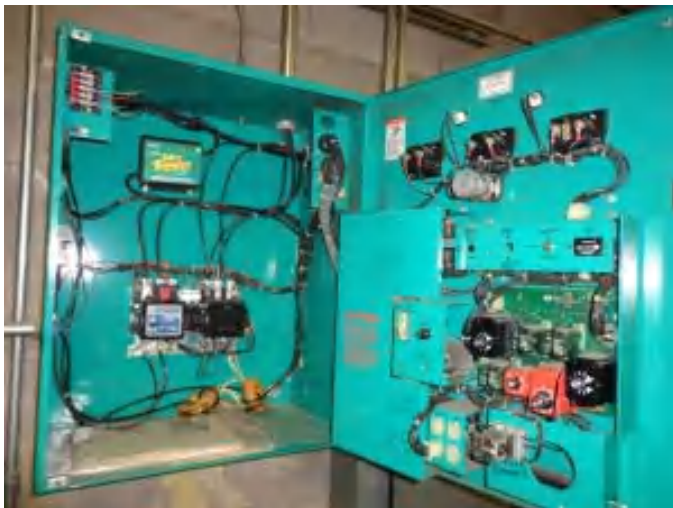
System: D5090 - Other Electrical Systems

Location: Existing generator room
Distress: Inadequate
Category: 4 - Capital Improvement
Priority: 3 - Response Time (3-4 yrs)
Correction: Replace standby generator system
Qty: 1.00
Unit of Measure: Ea.
Estimate: \$403,280.89
Assessor Name: System
Date Created: 10/20/2015

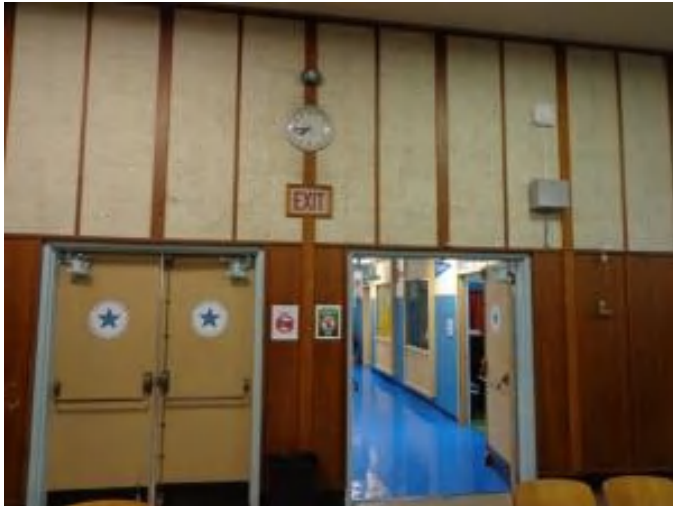
System: D5090 - Other Electrical Systems

Location: Building wide
Distress: Failing
Category: 3 - Operations / Maint.
Priority: 3 - Response Time (3-4 yrs)
Correction: Replace Emergency/Exit Lighting
Qty: 25.00
Unit of Measure: Ea.
Estimate: \$21,195.48
Assessor Name: System
Date Created: 10/20/2015

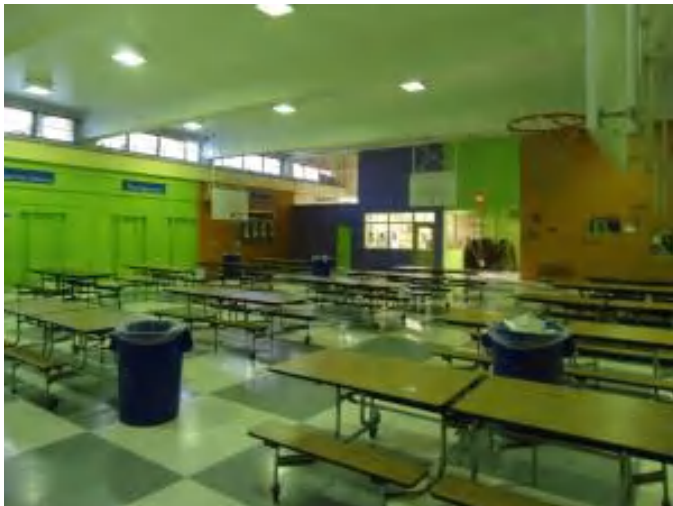
System: E1020 - Institutional Equipment

Location: Gym
Distress: Damaged
Category: 3 - Operations / Maint.
Priority: 3 - Response Time (3-4 yrs)
Correction: Remove and replace or install basketball backstop and hoop - pick the appropriate style of backstop
Qty: 2.00
Unit of Measure: Ea.
Estimate: \$19,273.29
Assessor Name: System
Date Created: 12/14/2015

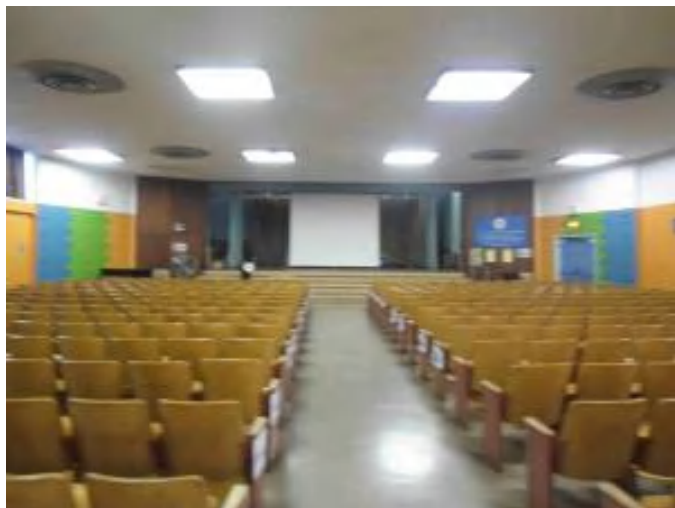
System: E2010 - Fixed Furnishings

Location: Stage

Distress: Life Safety / NFPA / PFD

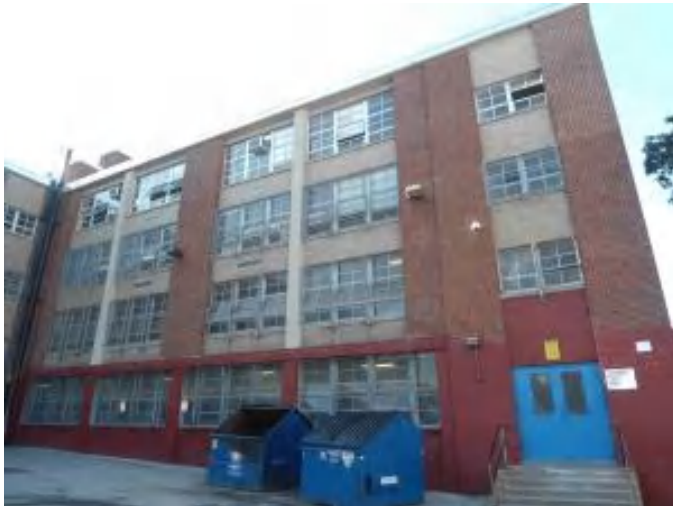
System: B2020 - Exterior Windows

Location: Building Wide

Distress: Damaged

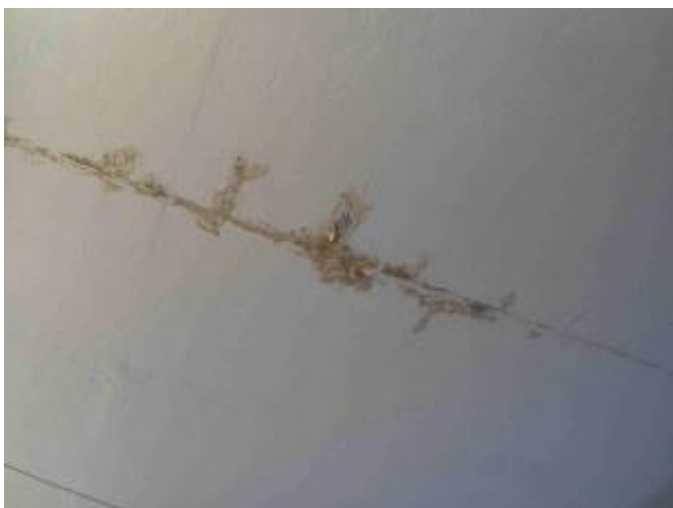
System: B3010105 - Built-Up

Location: Roof

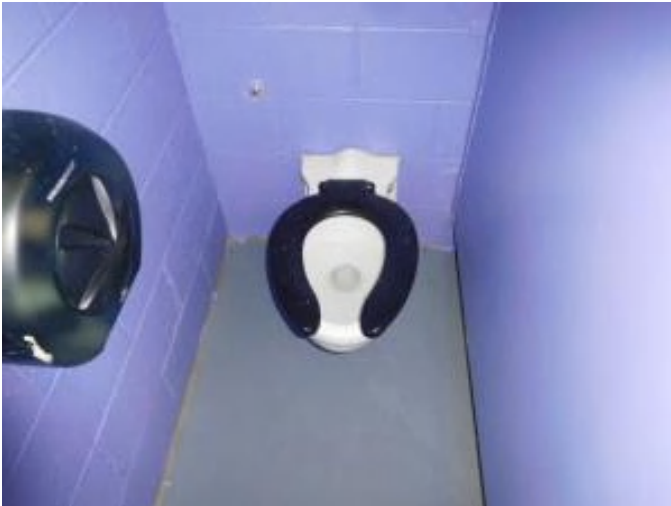
System: D2010 - Plumbing Fixtures

Location: toilet rooms

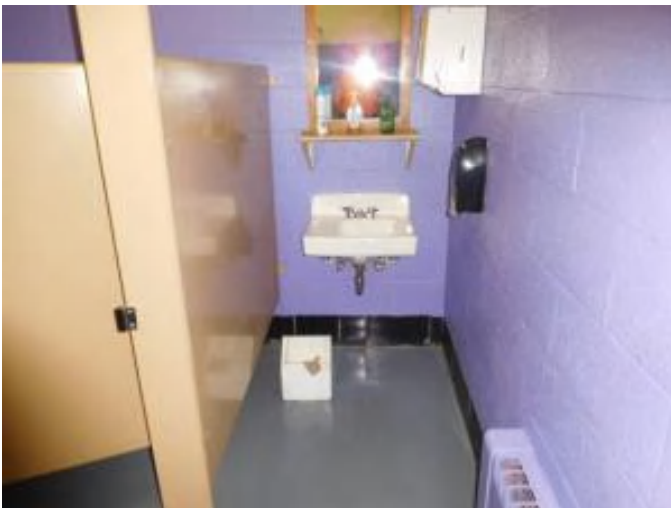
System: D2010 - Plumbing Fixtures

Location: toilet rooms

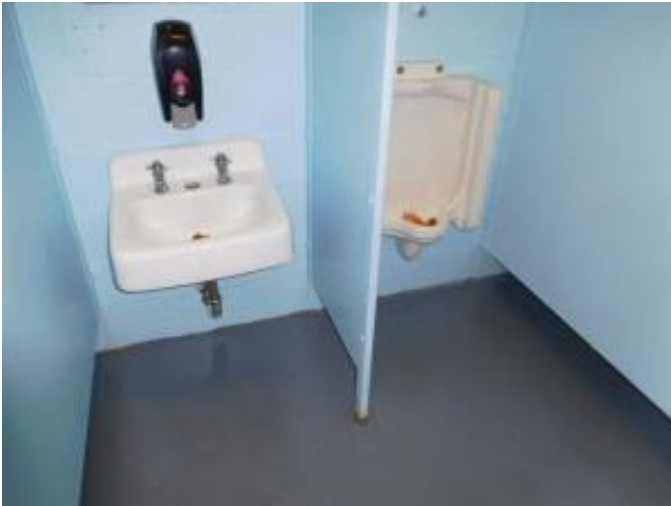
System: D2010 - Plumbing Fixtures

Location: toilet rooms
Distress: Beyond Service Life
Category: 3 - Operations / Maint.
Priority: 4 - Response Time (4-5 yrs)
Correction: Remove and replace or replace wall hung urinals
Qty: 12.00
Unit of Measure: Ea.
Estimate: \$41,199.11
Assessor Name: System
Date Created: 11/09/2015

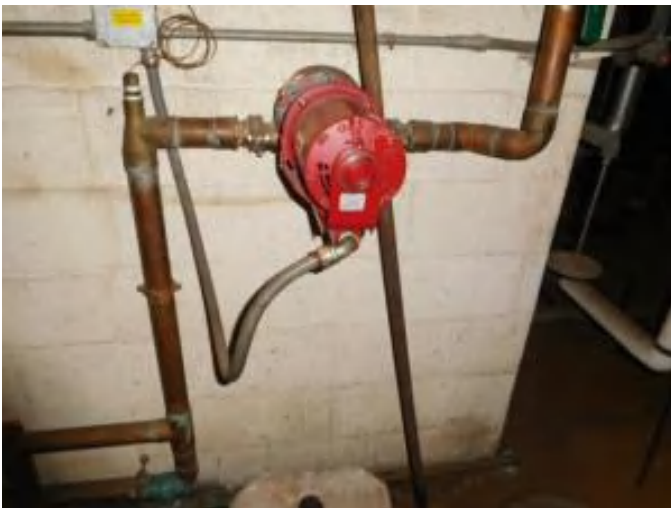
System: D2020 - Domestic Water Distribution

Location: entire building
Distress: Beyond Service Life
Category: 3 - Operations / Maint.
Priority: 4 - Response Time (4-5 yrs)
Correction: Replace domestic water piping (75 KSF)
Qty: 91,008.00
Unit of Measure: S.F.
Estimate: \$461,169.77
Assessor Name: System
Date Created: 11/09/2015

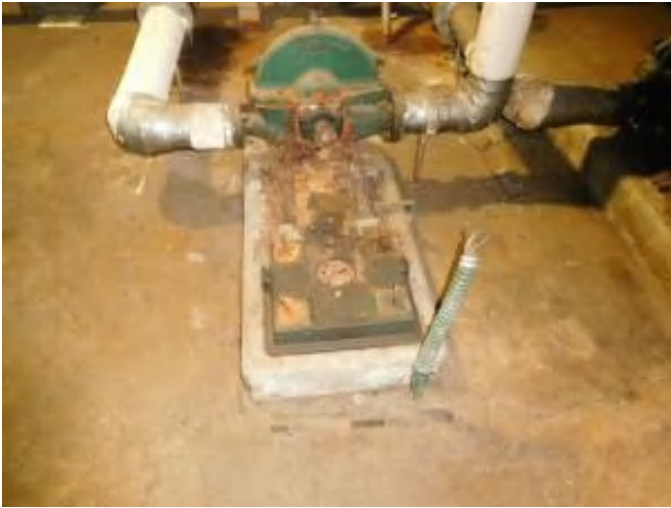
System: D2020 - Domestic Water Distribution

Location: mechanical room
Distress: Beyond Service Life
Category: 3 - Operations / Maint.
Priority: 4 - Response Time (4-5 yrs)
Correction: Replace duplex domestic booster pump set (5 HP)
Qty: 1.00
Unit of Measure: Ea.
Estimate: \$50,533.86
Assessor Name: System
Date Created: 11/09/2015

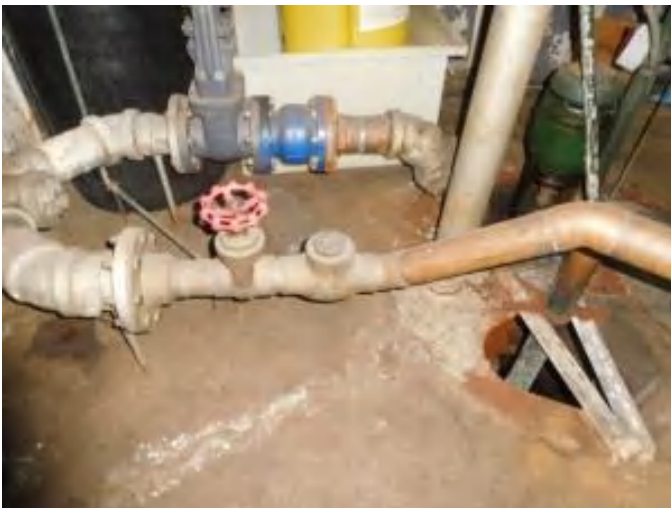
System: D2030 - Sanitary Waste

Location: entire building
Distress: Beyond Service Life
Category: 3 - Operations / Maint.
Priority: 4 - Response Time (4-5 yrs)
Correction: Inspect sanitary waste piping and replace damaged sections. (+100KSF)
Qty: 91,008.00
Unit of Measure: S.F.
Estimate: \$386,475.24
Assessor Name: System
Date Created: 11/09/2015

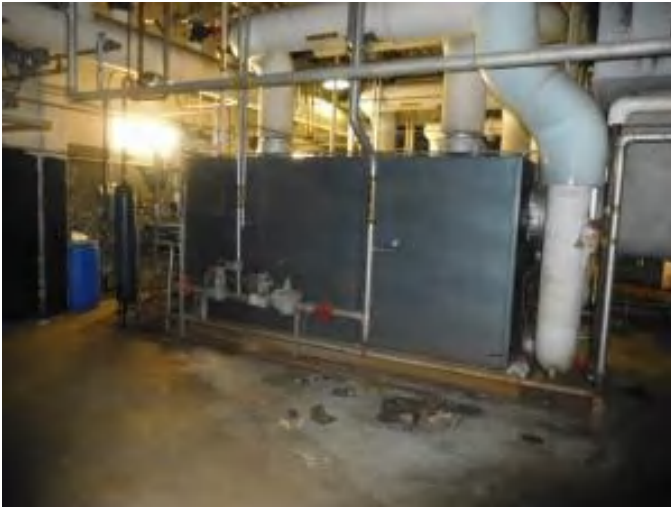
System: D3020 - Heat Generating Systems

Location: mechanical room
Distress: Beyond Service Life
Category: 3 - Operations / Maint.
Priority: 4 - Response Time (4-5 yrs)
Correction: Replace boiler, cast iron sectional (150 HP)
Qty: 3.00
Unit of Measure: Ea.
Estimate: \$1,518,307.89
Assessor Name: System
Date Created: 11/09/2015

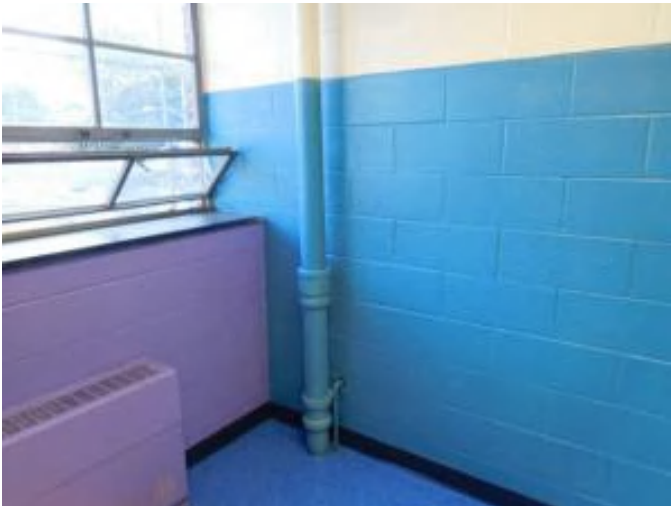
System: D3040 - Distribution Systems

Location: entire building
Distress: Building / MEP Codes
Category: 2 - Code Compliance
Priority: 4 - Response Time (4-5 yrs)
Correction: Replace the existing unit ventilators with new units designed to provide adequate ventilation per ASHRAE Std 62 - insert the SF of bldg. in the qty.
Qty: 91,008.00
Unit of Measure: S.F.
Estimate: \$4,390,151.79
Assessor Name: System
Date Created: 11/09/2015

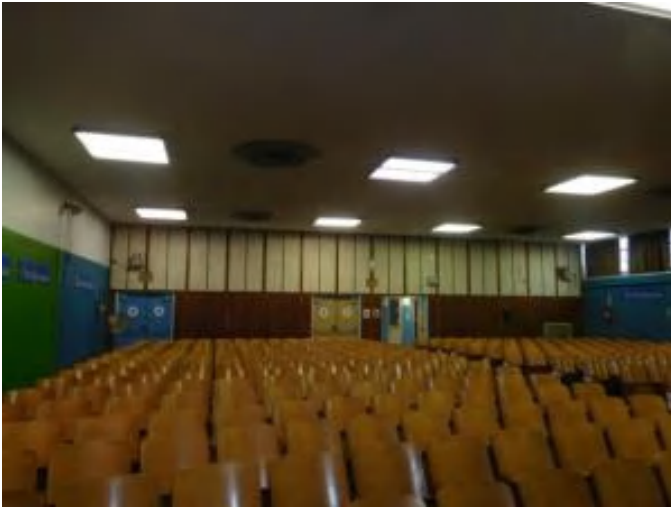
System: D3040 - Distribution Systems

Location: auditorium

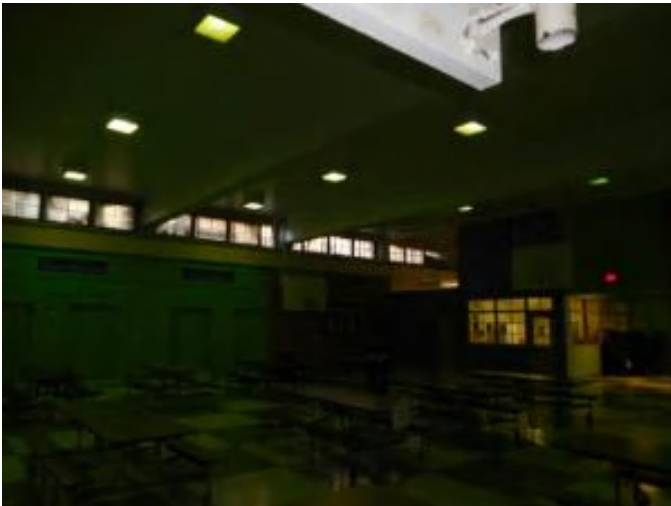
System: D3040 - Distribution Systems

Location: cafeteria/gymnasium

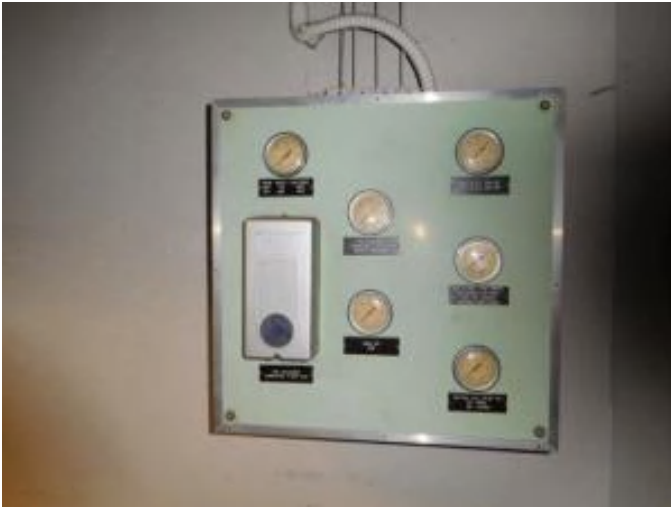
System: D3060 - Controls & Instrumentation

Location: entire building
Distress: Inadequate
Category: 4 - Capital Improvement
Priority: 4 - Response Time (4-5 yrs)
Correction: Replace pneumatic controls with DDC (150KSF)
Qty: 91,008.00
Unit of Measure: S.F.
Estimate: \$1,630,079.43
Assessor Name: System
Date Created: 11/09/2015

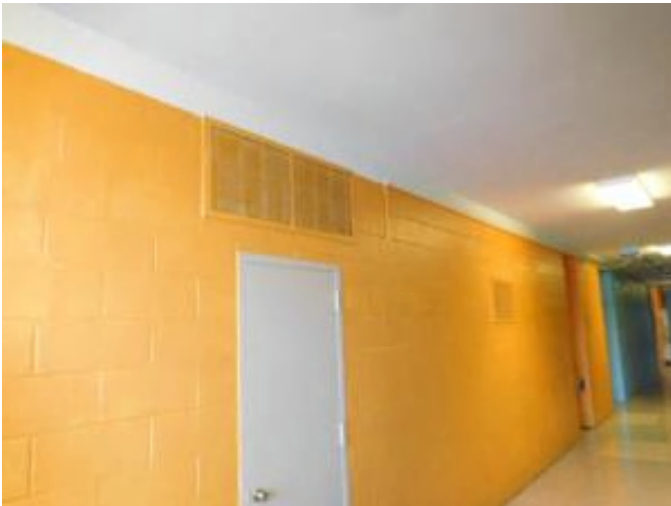
System: D4010 - Sprinklers

Location: entire building
Distress: Life Safety / NFPA / PFD
Category: 1 - Health & Safety
Priority: 4 - Response Time (4-5 yrs)
Correction: Install a fire protection sprinkler system
Qty: 91,008.00
Unit of Measure: S.F.
Estimate: \$1,301,910.03
Assessor Name: System
Date Created: 11/09/2015

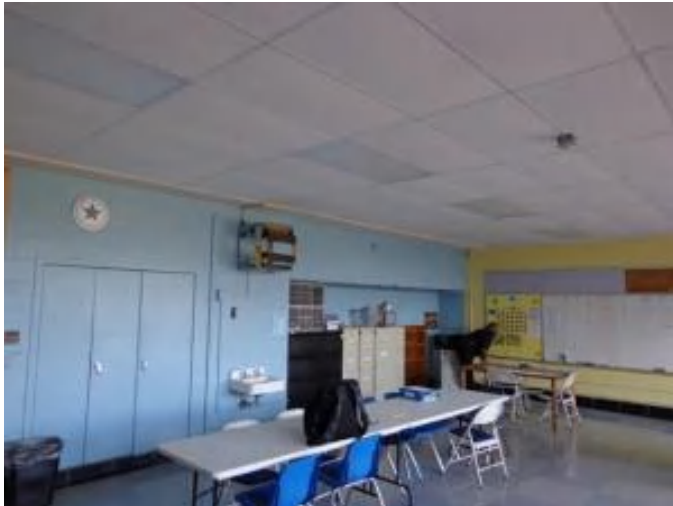
System: D5020 - Lighting and Branch Wiring

Location: Classrooms

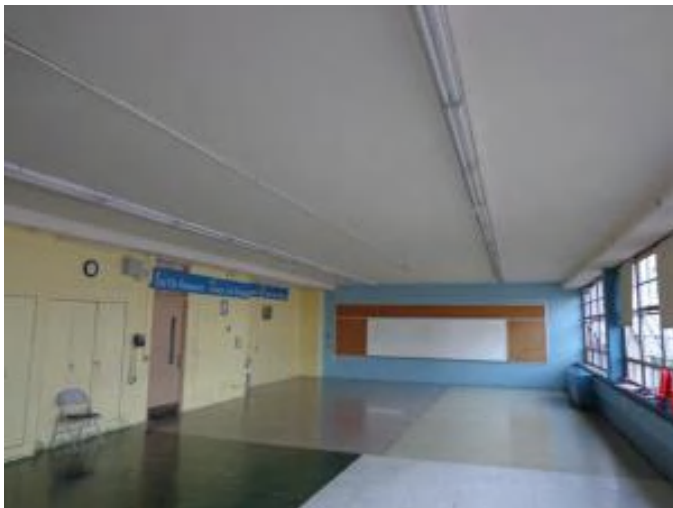
System: D5030 - Communications and Security

Location: Building wide

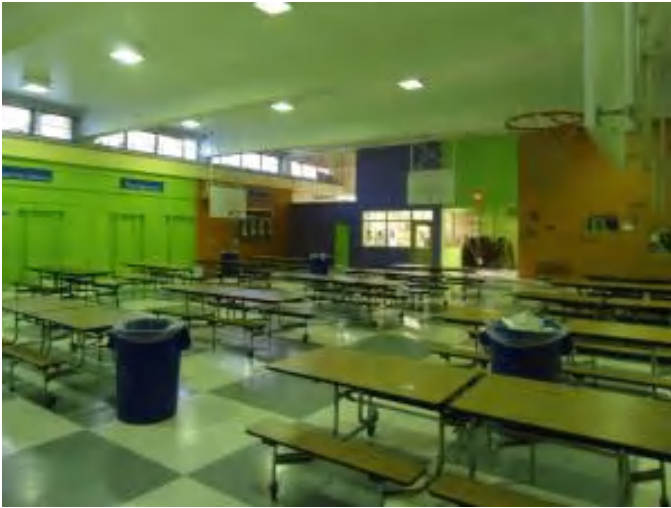
System: E1020 - Institutional Equipment

Location: Gym

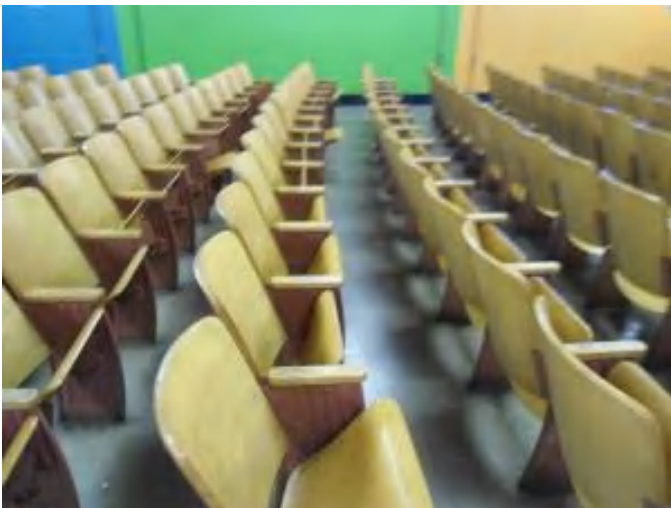
System: E2010 - Fixed Furnishings

Location: Auditorium

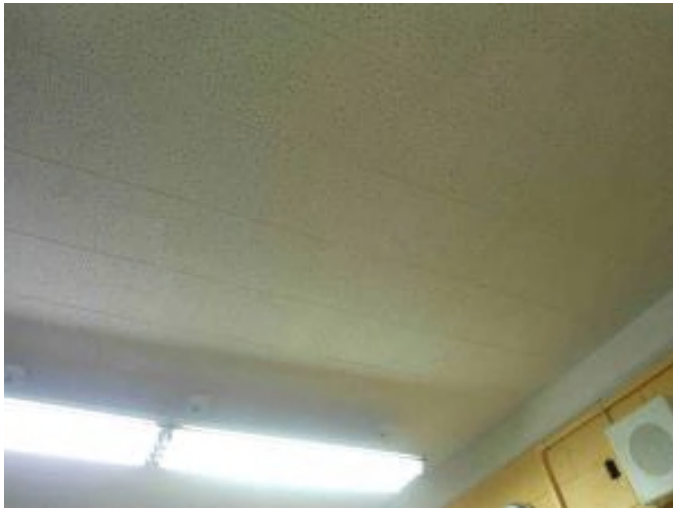
System: C3030 - Ceiling Finishes

Location: Building Wide

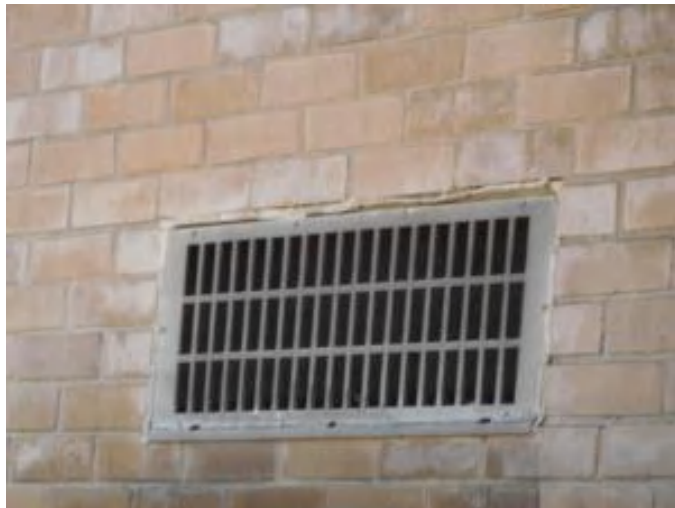
System: D3030 - Cooling Generating Systems

Location: roof, mechanical room

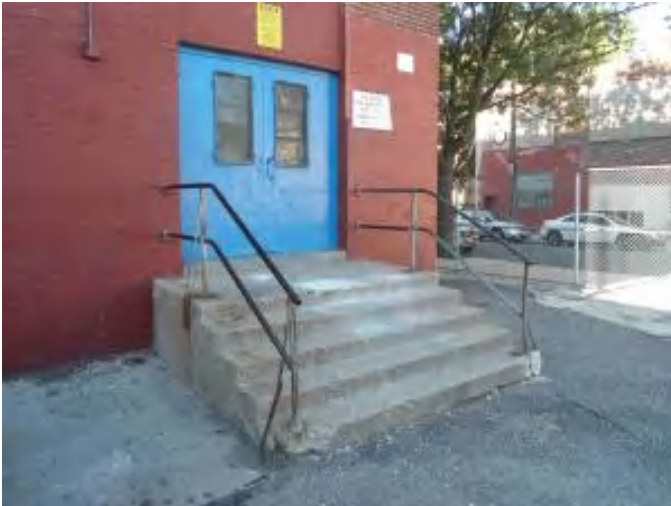
System: G2030 - Pedestrian Paving

Location: Exterior Stair

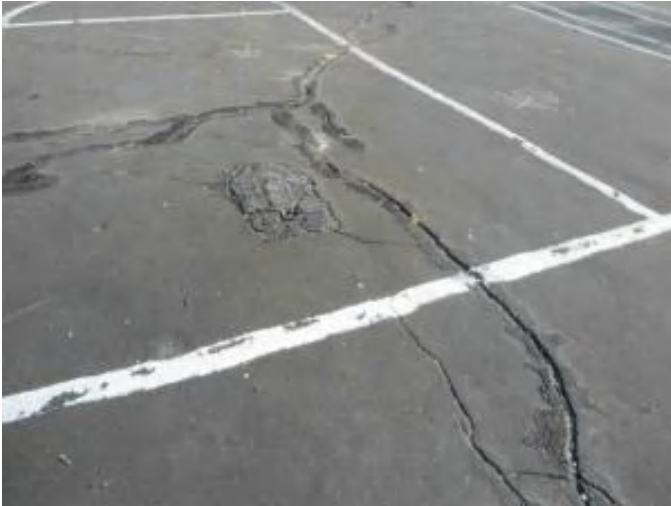
System: G2020 - Parking Lots

Location: Site

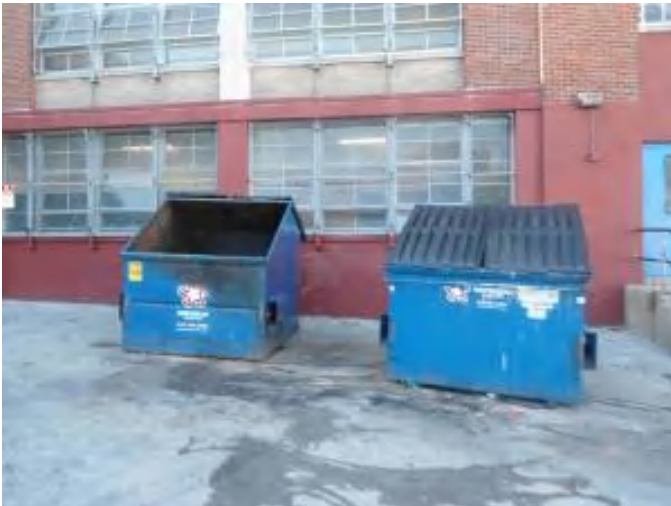
System: G2040 - Site Development

Location: Site

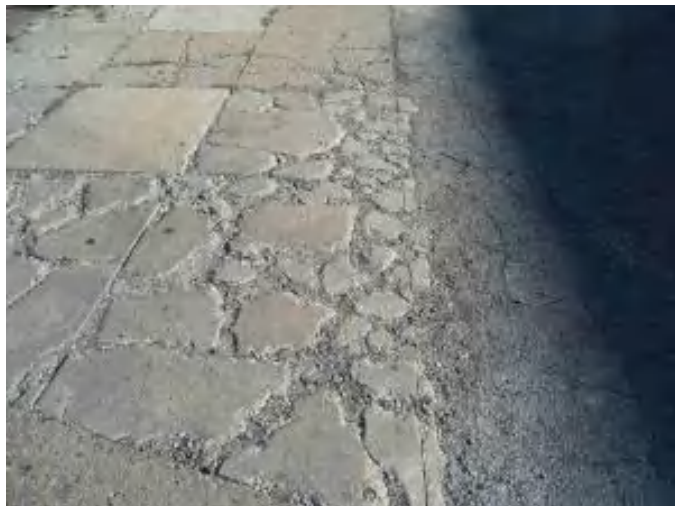
System: G2030 - Pedestrian Paving

Location: Site
