## Facility Condition Assessment Summary Report

### Kensington CAPA High School

School District of Philadelphia  
**S552001;Kensington CAPA**  
Final  
**Site Assessment Report**  
January 31, 2017

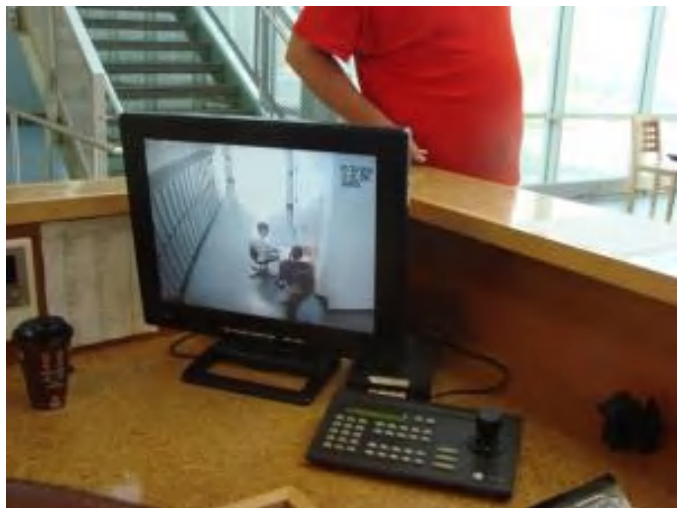
#### System: D5030 - Communications and Security

**Location:** Interiors (corridors)

**Distress:** Inadequate

**Correction:** Add/Replace Video Surveillance System
