Facility Condition Assessment Summary Report

Kensington HS School

S501001;Kensington HS

Site Assessment Report

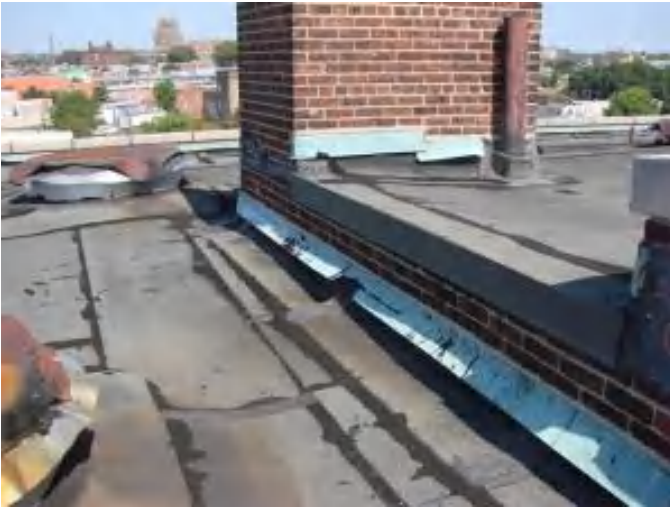
System: B3010105 - Built-Up

Roofing is typically built-up. All roofing and flashing is typically in poor condition with deterioration of the built-up system that allows water to pond leading to soft spots and reports of leaks.

Location: Exterior

Distress: Building Envelope Integrity

Notes: Install all new roofing system including insulation; tear-down existing roofing; install flashing, counter flashing and reglets

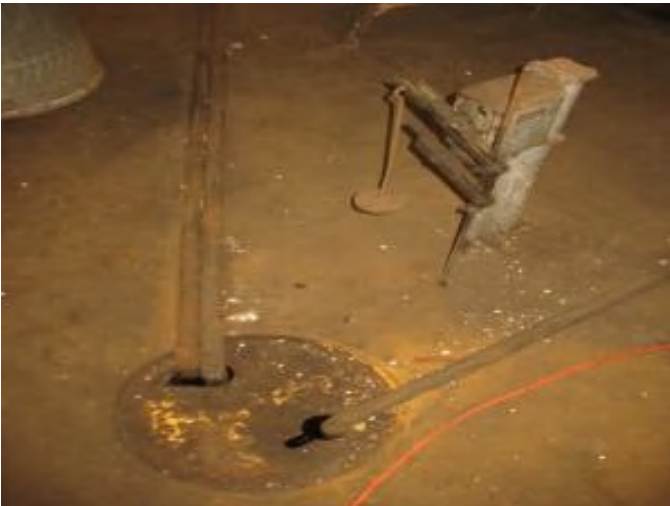
System: D2030 - Sanitary Waste

A sewage ejector pit located in the basement boiler room receives sewage from the basement area and condensate return pit. It has a single pump that is beyond its service life and was not operational at the time of the site visit. The pump system should be replaced to prevent flooding of the basement. The pit is not sealed, but should be.

Location: Boiler room

Distress: Beyond Service Life

Notes: Replace existing sewage ejector pump system and piping in the basement as it is beyond its service life and was not functional during the site visit.

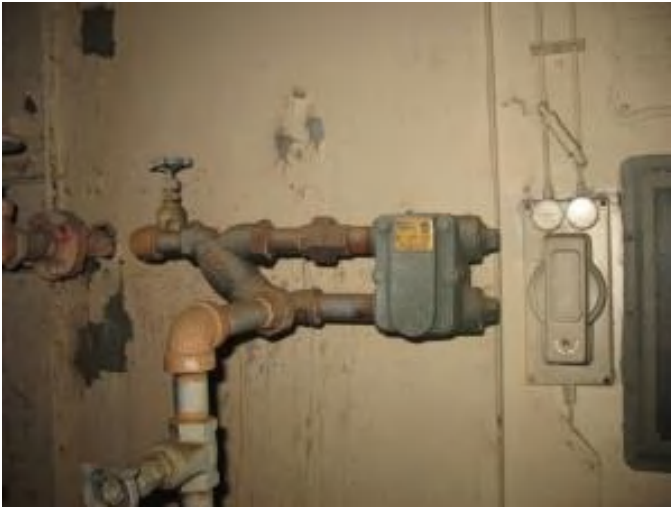
System: D3040 - Distribution Systems

The condensate receiver, boiler feed pumps and tank assemblies are installed in the boiler room. A serious problem was reported with failed steam traps. Live steam passes into the condensate piping system from the failed traps and then vents from the condensate handling equipment. Make-up water treatment is provided by a Marlo brine tank system and chemical treatment for the boiler feed water. The boiler feed tank and pumps appear to be in good condition. The District has not conducted a steam trap survey for this building and traps are not serviced on a regular schedule.

Location: Throughout building

Distress: Damaged

Notes: Conduct a steam trap survey to identify and replace failed traps passing live steam into the condensate piping system.

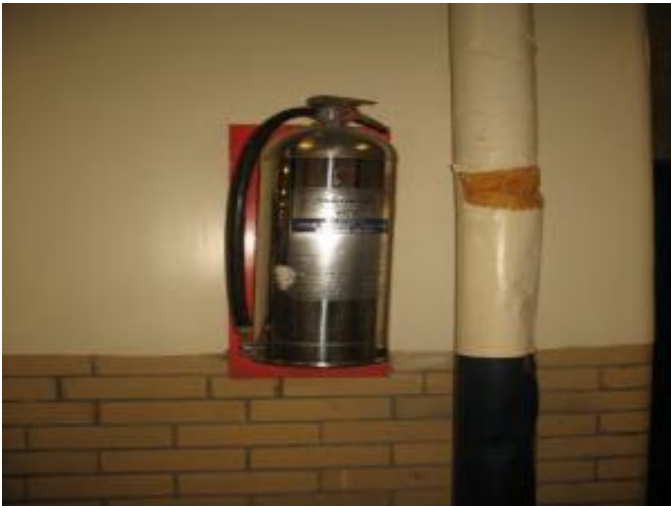
System: D4010 - Sprinklers

Location: Throughout building

Distress: Life Safety / NFPA / PFD

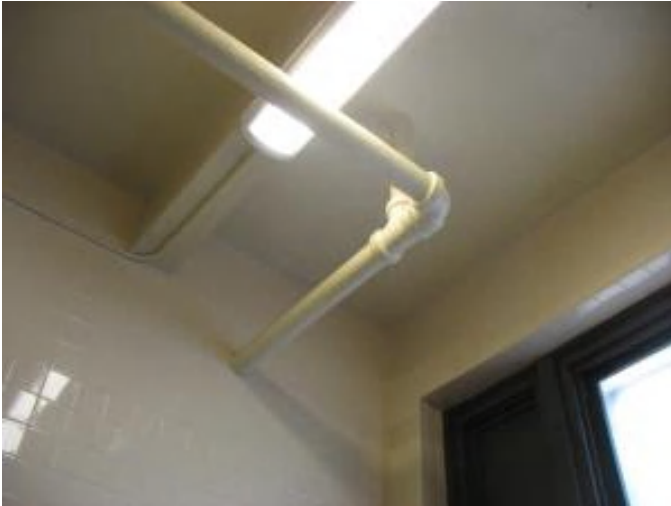
System: D2030 - Sanitary Waste

The maintenance staff reported mostly minor problems with the sanitary waste piping systems. The original sewer piping has been in service for almost 100 years and will require more frequent attention from the maintenance staff as time passes. The District should hire a qualified contractor to examine the sanitary waste piping using video cameras to locate and replace any damaged piping and to further quantify the extent of potential failures.

Location: Throughout building

Distress: Beyond Service Life

Notes: Hire a qualified contractor to perform a detailed examination of the sanitary waste piping using visual inspection and video cameras to locate and replace any damaged piping and to further quantify the extent of potential failures.

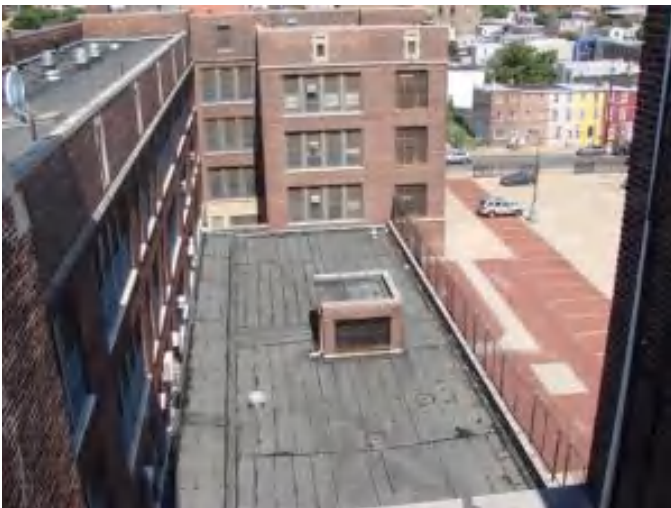
System: D2040 - Rain Water Drainage

Rain Water Drainage - Rain water drains from the roof are routed through mechanical chases in the building and appear to be original. Some of the original galvanized piping has been repaired with HDPE piping and no-hub fittings. The drain piping should be inspected by a qualified contractor and repaired as necessary.

Location: Throughout building

Distress: Beyond Service Life

Notes: Hire a qualified contractor to perform a detailed examination of the rain water drainage piping using visual inspection and video cameras to locate and replace any damaged piping and to further quantify the extent of potential failures.

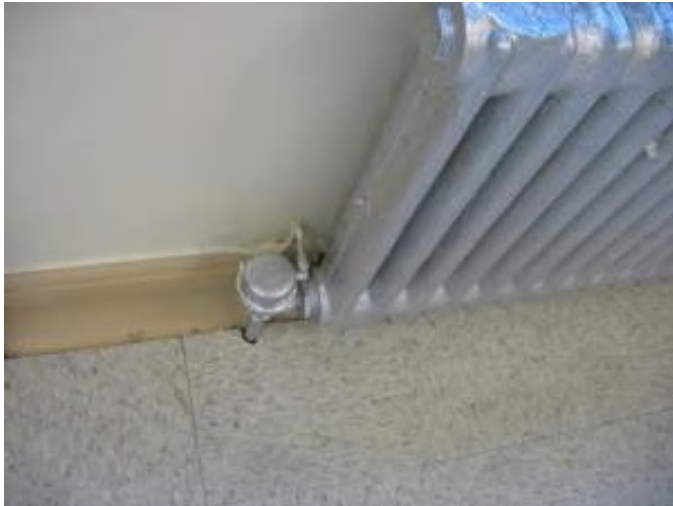
System: D3040 - Distribution Systems

Distribution Systems - Steam piping is black steel with welded fittings. The condensate piping is black steel with threaded fittings. Steam and condensate piping mains from the basement level run up through the building to the radiators on all four floors. The distribution piping has been in use well beyond its service life and will require more frequent attention from the maintenance staff to address pipe/valve failures as time passes. The District should hire a qualified contractor to examine the steam and condensate piping and perform additional testing to locate and replace any damaged piping and to further quantify the extent of potential failures. The District should budget for replacing this piping over the next 10 years.

Location: Throughout building

Distress: Beyond Service Life

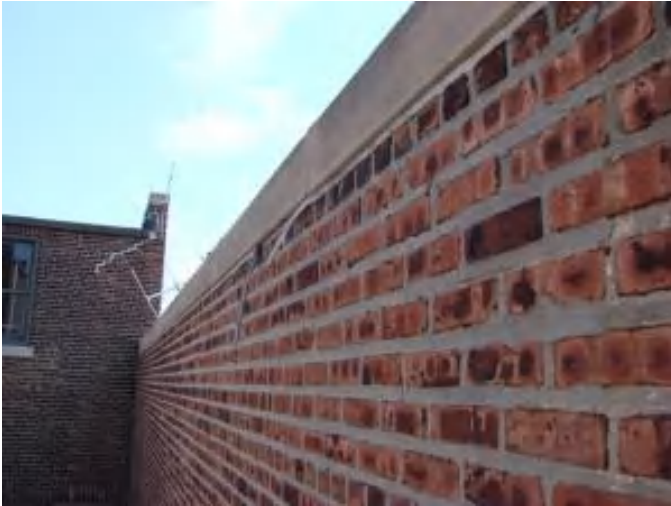
System: B2010 - Exterior Walls

The building envelope is typically masonry with face brick with decorative stone friezes and quoining at main entrances doors. In general, masonry is in fair to poor condition with deteriorated and missing mortar from joints; the chimney shows cracks below steel banding reinforcing its top portion.

Location: Exterior

Distress: Building Envelope Integrity

Notes: Repair cracks in masonry including chimney, tuck-point all walls

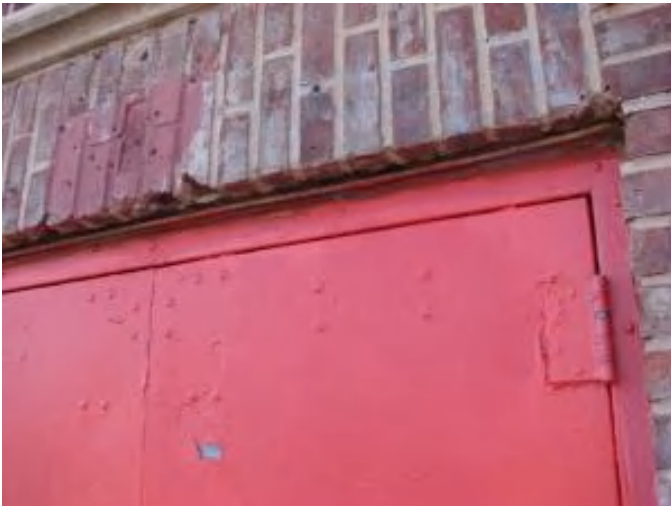
System: B2010 - Exterior Walls

Location: Exterior

Distress: Building Envelope Integrity

Notes: Replace rusting lintels above window/door openings

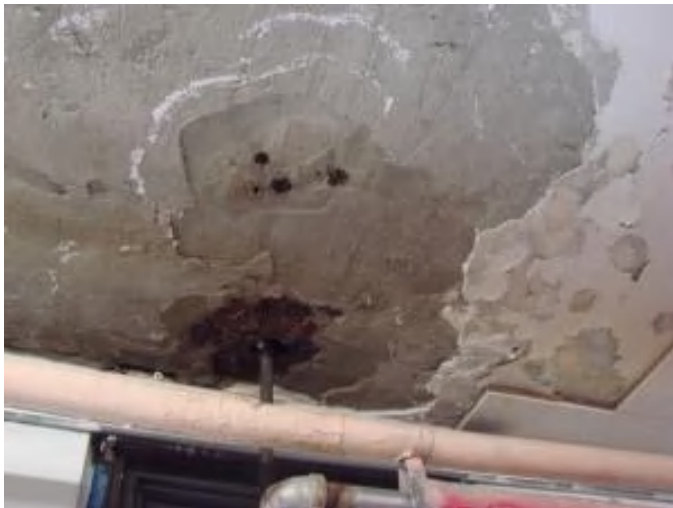
System: C3030 - Ceiling Finishes

Location: Interior

Distress: Beyond Service Life

Notes: Repair and repaint all ceilings

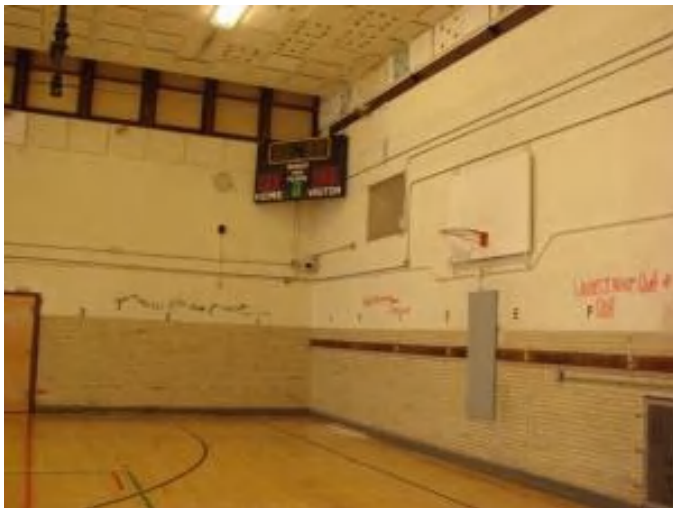
System: C3030 - Ceiling Finishes

Location: Interior/gym

Distress: Beyond Service Life

Notes: Replace acoustic panels in gym

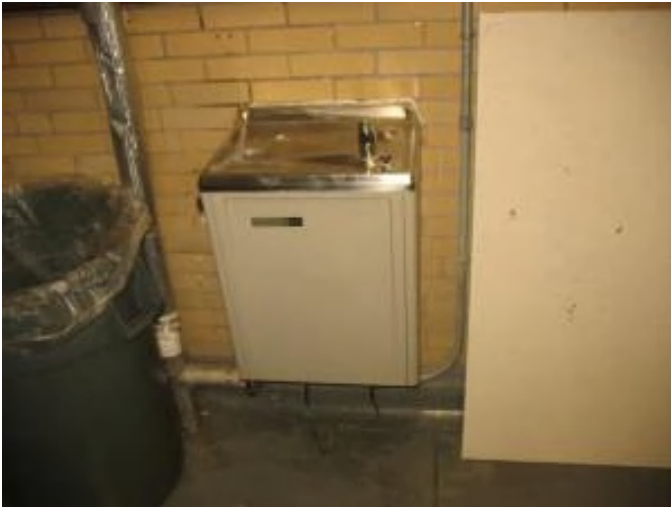
System: D2010 - Plumbing Fixtures

Drinking fountains in the corridors and at the restrooms are wall hung with integral refrigerated coolers. They are well beyond their service life and should be replaced; most are NOT accessible type.

Location: Corridors

Distress: Beyond Service Life

Notes: Replace sixteen (16) wall hung drinking fountains and integral refrigerated coolers in the corridors and at the restrooms. These units are well beyond their service life and most are NOT accessible type.

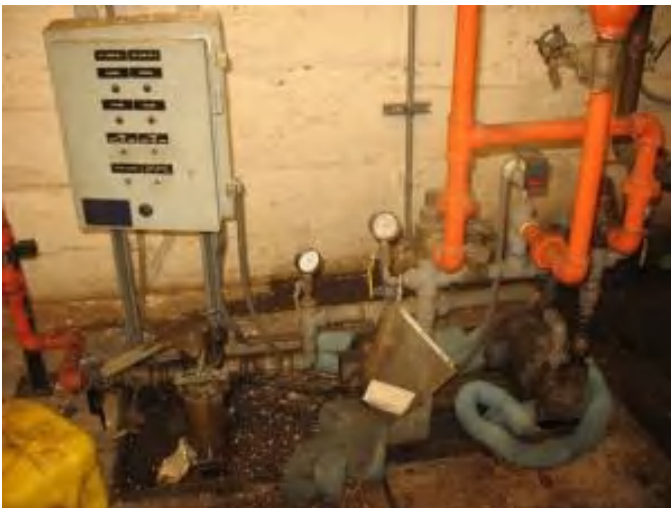
System: D3020 - Heat Generating Systems

The oil supply is stored in a 12,000 gallon underground storage tank (UST). Oil is the primary fuel for the boilers. Duplex pumps located in the basement circulate oil through the system. The fuel oil pumping system is beyond its service life and should be replaced. USTs have an anticipated service life of 20 years. The actual condition of the fuel side is unknown.

Location: Boiler room

Distress: Beyond Service Life

Notes: Inspect and replace current fuel oil pumping system, which is beyond its service life, with new system and control scheme.

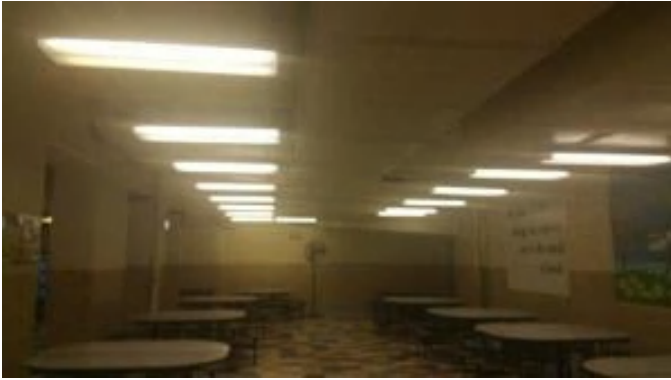
System: D5020 - Lighting and Branch Wiring

Location: Throughout the building

Distress: Beyond Service Life

Notes: Install new a lighting system for the entire building.

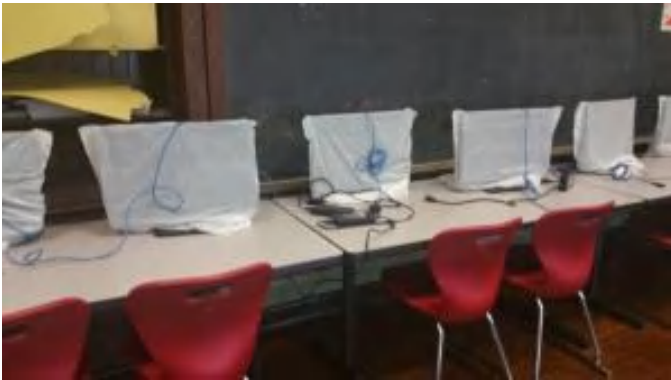
System: D5020 - Lighting and Branch Wiring

Location: Throughout the building

Distress: Building / MEP Codes

Notes: Install new receptacles in all classrooms and other areas (minimum two receptacles on each wall).

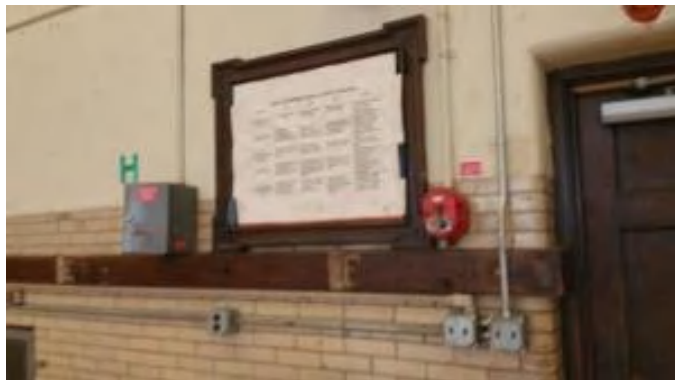
System: D5030 - Communications and Security

Location: Throughout the building

Distress: Life Safety / NFPA / PFD

Note: A multiplier of 3.4 was used to cover the large SF of the building plus other related construction cost.

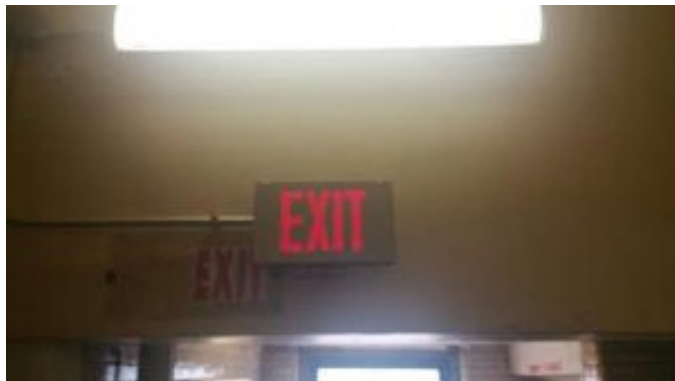
System: D5090 - Other Electrical Systems

Location: Throughout the building

Distress: Health Hazard / Risk

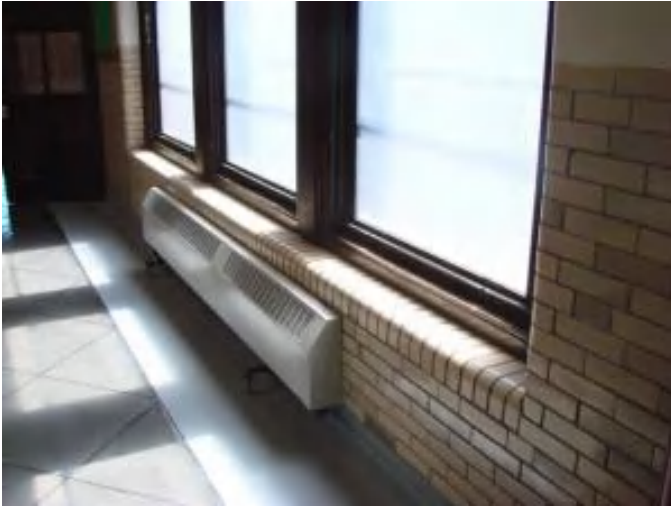
System: B2020 - Exterior Windows

The original building windows were retrofitted in late 1980's or early 1990's with extruded aluminum double hung windows single glazed with acrylic glazing; original wood frames are left in place and deteriorating. Basement and first floor windows are fitted with galvanized steel security screens. All windows are generally in fair to poor condition and not energy efficient.

Location: Exterior

Distress: Beyond Service Life

Notes: Replace all windows

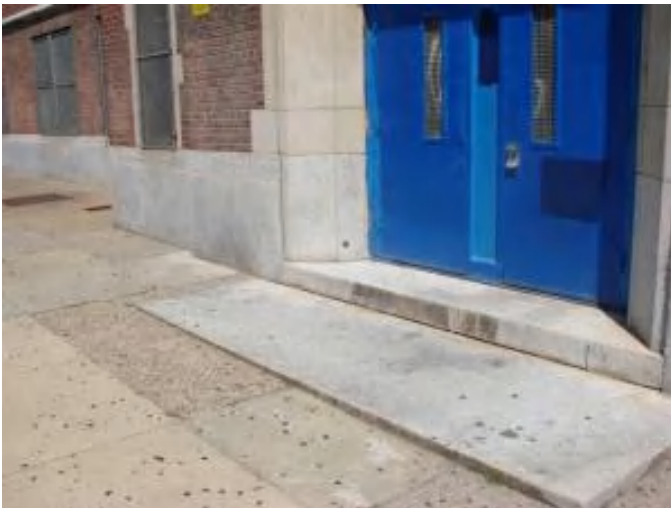
System: B2030 - Exterior Doors

Exterior doors are typically hollow metal in fair to poor condition with peeling paint and rusting. They are beyond their service life.

Location: Exterior

Distress: Beyond Service Life

Notes: Replace exterior doors

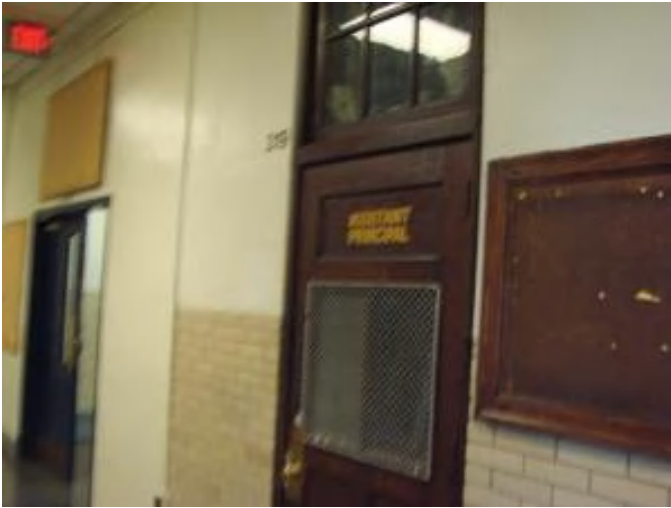
System: C1030 - Fittings

Fittings include original chalk boards, generally in poor condition. Toilet partitions and accessories in are in very good condition, installed in 2012 and ADA compliant; handrails, generally in good condition. Interior identifying signage is typically directly painted on wall or door surfaces generally in poor condition.

Location: Interior

Distress: Beyond Service Life

Notes: Install new signage throughout

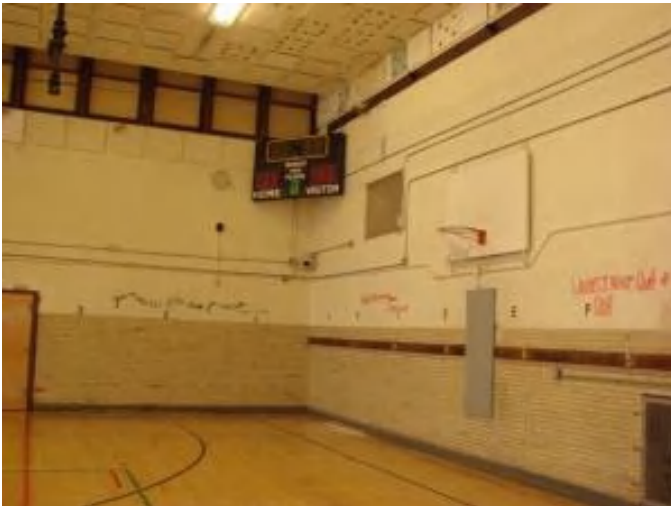
System: C3010230 - Paint & Covering

The interior wall finishes are generally painted plaster or CMU and some painted brick. Walls in toilets are covered with ceramic tile installed in 2012. Generally, paint is in fair condition with some deterioration in stairways and other spaces. Most ceilings are 2x4 suspended acoustical panels; gym/cafeteria has acoustic baffles adhered directly to underside of floor slab and top portions of walls; lot of acoustic baffles are missing, suspended ceilings are typically old and beyond their service life.

Location: Interior

Distress: Beyond Service Life

Notes: Repair (15%) and repaint all walls

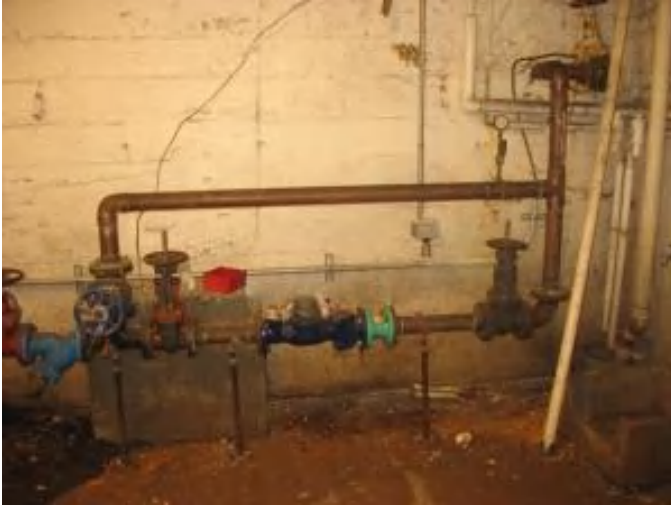
System: D2020 - Domestic Water Distribution

Domestic Water Distribution - A 3" city water service enters the building from parking lot behind the school. The 3" meter and valves are located in the basement boiler room. A reduced pressure backflow preventer is installed. Duplex domestic pressure booster pumps are installed on the domestic water line to ensure adequate pressure throughout the system. The original domestic hot and cold water distribution piping was replaced with copper piping and sweat fittings. The maintenance staff reports no significant problems with scale build up in the domestic piping and the supply is adequate to the fixtures, but the piping has been in use for an unknown amount of time and should be inspected and replaced by a qualified contractor.

Location: Throughout building

Distress: Beyond Service Life

Notes: Hire a qualified contractor to perform a detailed inspection of the domestic water piping, in use for an unknown amount of time, and replace any damaged piping.

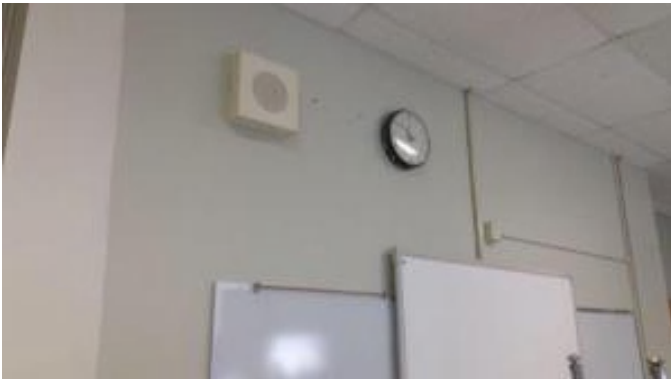
System: D5030 - Communications and Security

Location: Throughout the building

Distress: Beyond Service Life

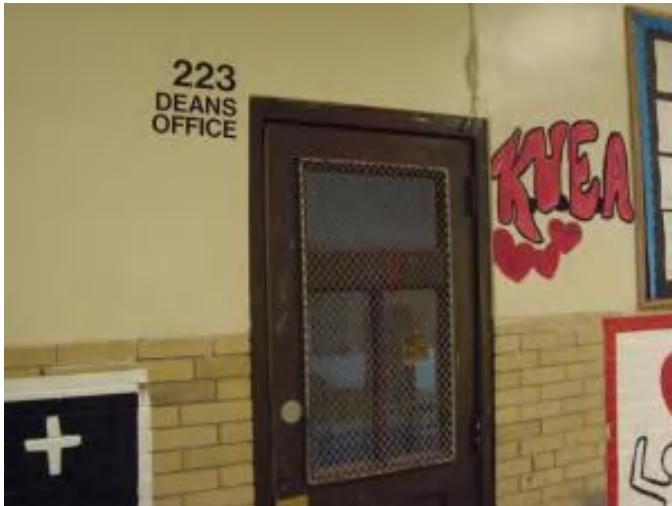
System: C1020 - Interior Doors

Location: Interior

Distress: Beyond Service Life

Notes: Replace interior doors

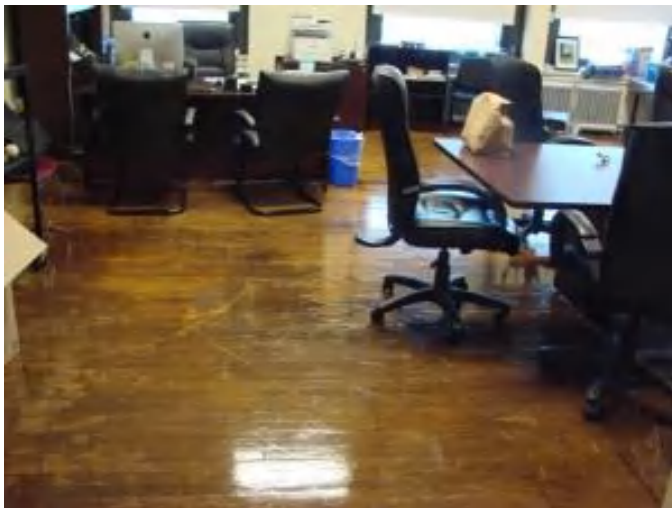
System: C3020414 - Wood Flooring

Flooring in classrooms, and auditorium and gym is generally hardwood, (50% requires refinishing); and patterned concrete in most corridors. Some classrooms have VCT installed in mid 2000's. Floor in toilets is typically ceramic tile installed in 2012. Main entrance hallway floor has a combination of terrazzo and marble finish in good condition.

Location: Interior

Distress: Appearance

Notes: Repair (10%) refinish hardwood flooring (50%)

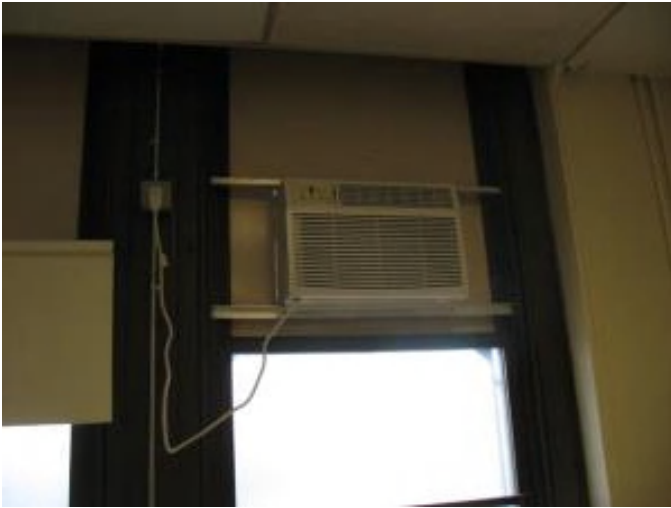
System: D3030 - Cooling Generating Systems

Terminal & Package Units - Several of the classrooms in the school building have window air conditioning units that have an anticipated service life of only 10 years. Installing a 275 ton air-cooled chiller with pumps located in a mechanical room and chilled water distribution piping would supply more reliable air conditioning for the building with a much longer service life.

Location: Throughout building

Distress: Inadequate

Notes: Remove the window air conditioning units and install a 275 ton air-cooled chiller with chilled water distribution piping and pumps located in a mechanical room to supply more reliable air conditioning for the building with a much longer service life.

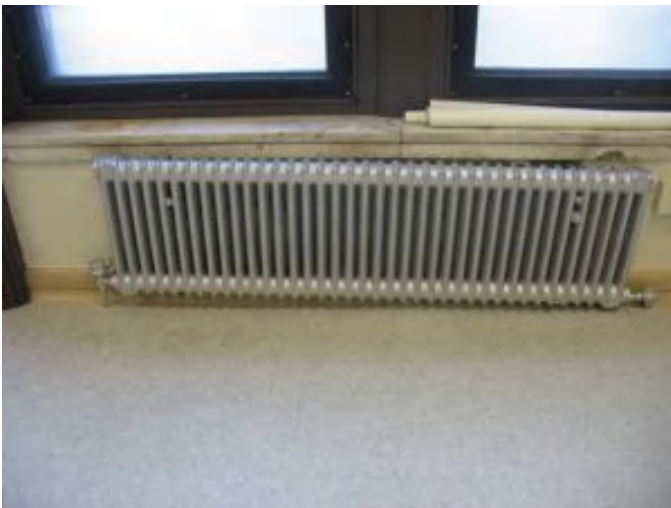
System: D3040 - Distribution Systems

Location: Throughout building

Distress: Building / MEP Codes

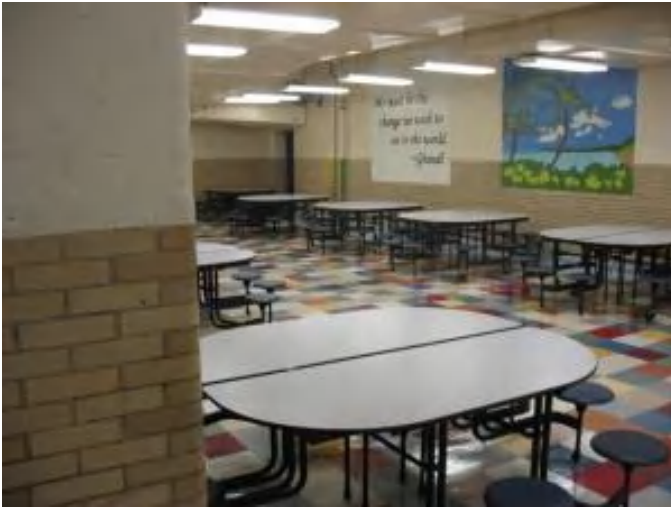
System: D3040 - Distribution Systems

Location: Cafeteria

Distress: Building / MEP Codes

Notes: Provide ventilation for the Cafeteria by installing a constant volume air handling unit with distribution ductwork and registers.

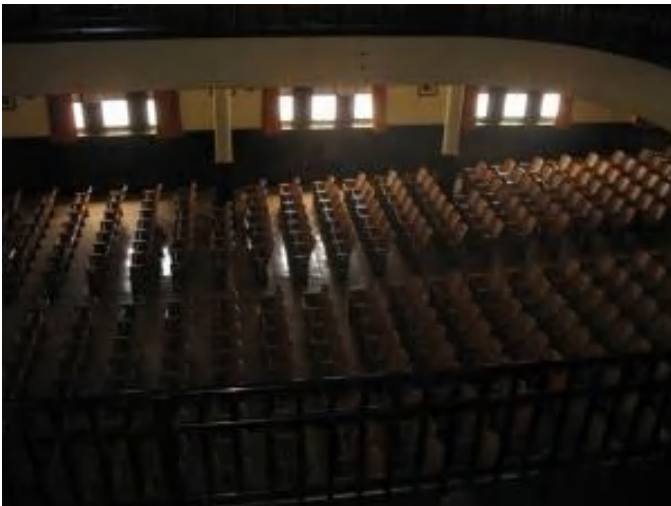
System: D3040 - Distribution Systems

Location: Auditorium

Distress: Building / MEP Codes

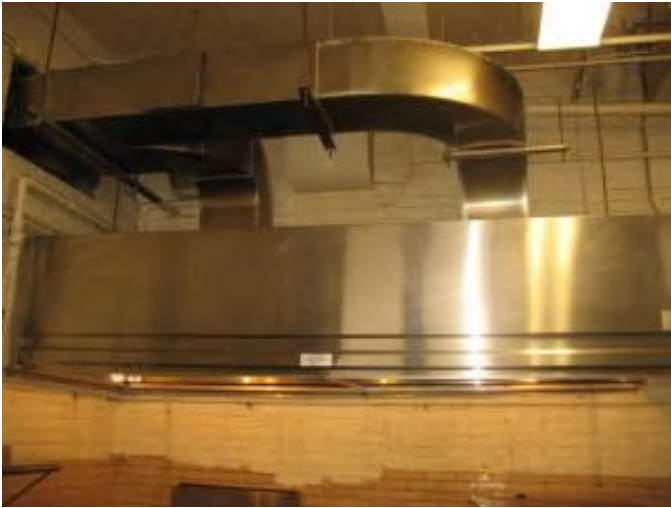
System: D3040 - Distribution Systems

Location: Kitchen

Distress: Building / MEP Codes

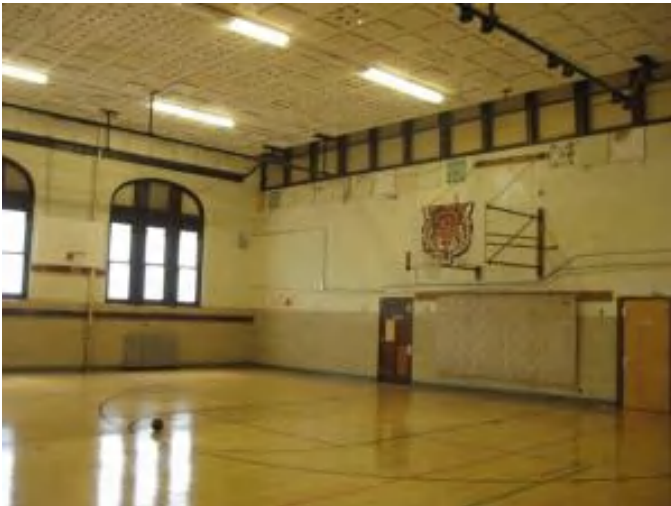
System: D3040 - Distribution Systems

Location: Gymnasium

Distress: Building / MEP Codes

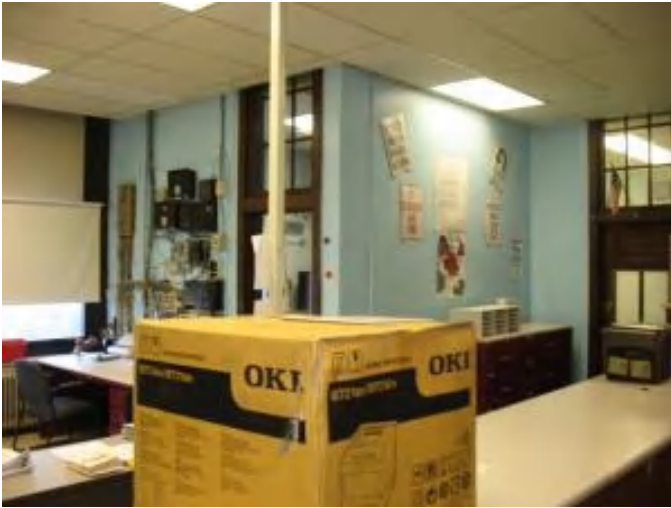
System: D3040 - Distribution Systems

Location: Administration

Distress: Building / MEP Codes

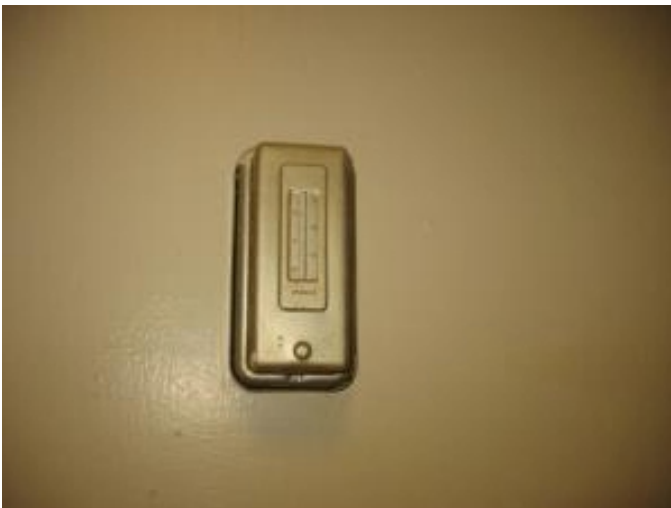
System: D3060 - Controls & Instrumentation

Controls & Instrumentation - The original pneumatic systems provide no control functions. Pneumatic room thermostats are intended to control the steam radiator control valves. In reality the radiator control valves are wide open and heating control is achieved via the boilers. Pneumatic control air is supplied from a compressor. The pneumatic systems are beyond their service life and require too much attention from the maintenance staff. The original control valves and pneumatic actuators are beyond their service life and should be rebuilt or replaced. These controls should be converted to DDC.

Location: Throughout building

Distress: Inadequate

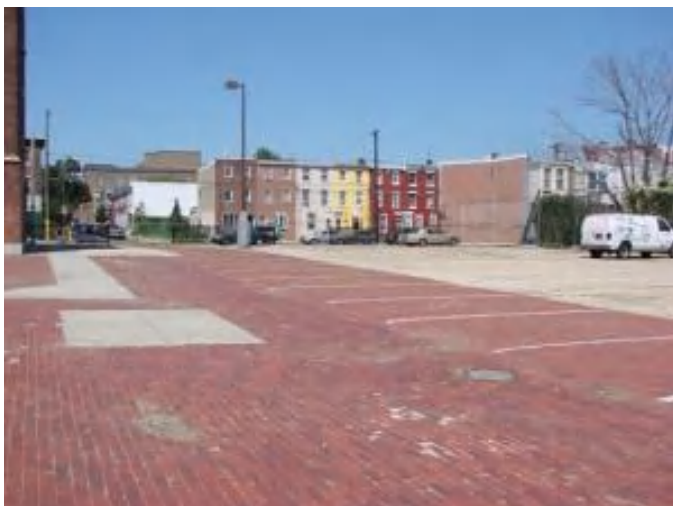
System: G4020 - Site Lighting

Location: Grounds

Distress: Health Hazard / Risk

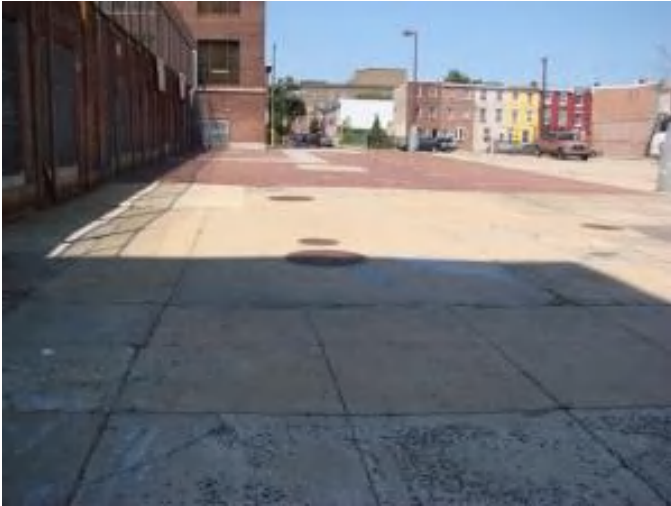
System: G2020 - Parking Lots

Location: Grounds/ site

Distress: Beyond Service Life

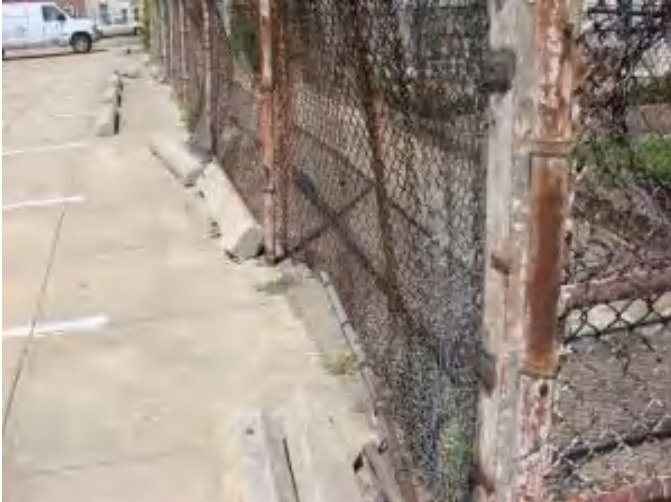
System: G2020 - Parking Lots

There is a small parking lot at the site; however, a large portion of the playground is designated for staff parking. The parking is partially striped with accessible (5) stalls and aisles; some wheel stops are damaged or displaced.

Location: Grounds/ site

Distress: Damaged

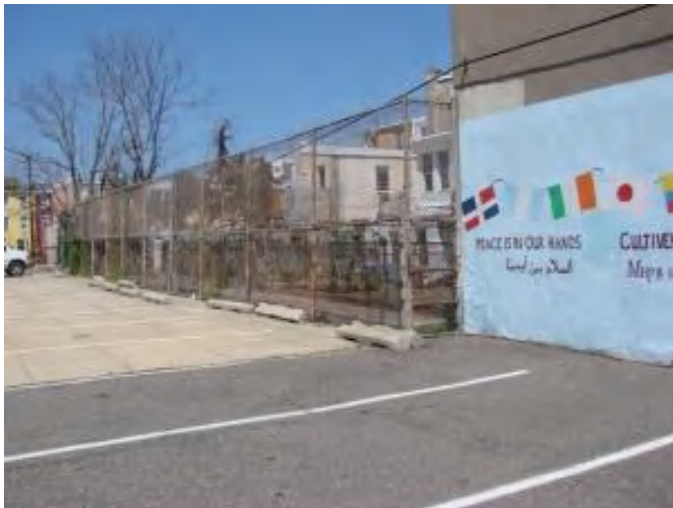
System: G2040 - Site Development

Location: Grounds/ site

Notes: Replace chain link fence

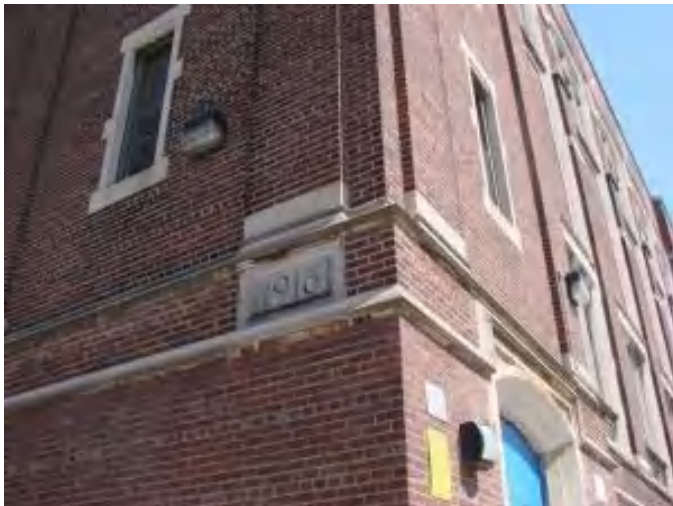
System: G4030 - Site Communications & Security

Location: grounds

Notes: Install additional exterior speakers for site paging
