Facility Condition Assessment Summary Report

Kensington Health Sciences School

School District of Philadelphia
S555001;Kensington Culinary
Final
Site Assessment Report
January 31, 2017

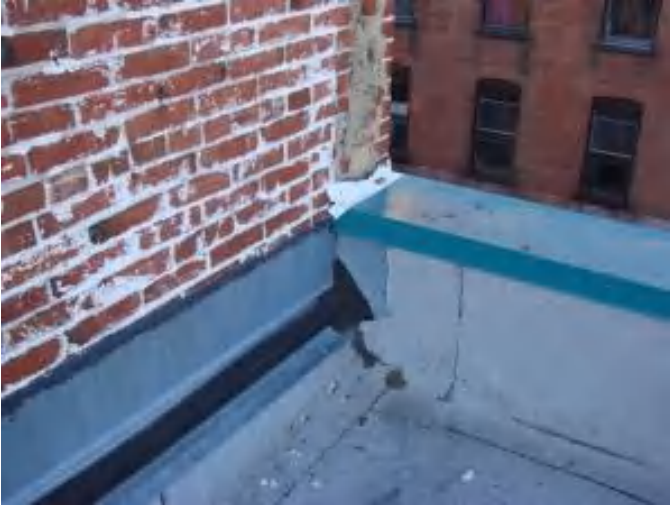
System: B3010105 - Built-Up

Roofing is built-up with crushed rock topping over rigid insulation, in good condition, except the lower roof over the Gym corridor which is damaged and leaking. Counter-flashing along adjacent building is damaged and pulls away from substrate.

Location: Exterior

Distress: Damaged

Correction: Repair or replace flashing where it connects to masonry parapet - choose proper material

Notes: Replace counter-flashing along adjacent building

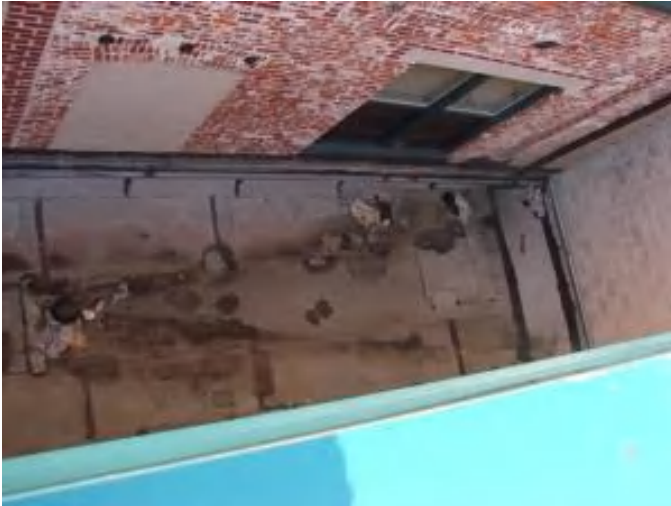
System: B3010105 - Built-Up

Location: Exterior

Distress: Building Envelope Integrity

Correction: Remove and Replace Built Up Roof

Notes: Replace built-up roof on lower roof (above Gym corridor).

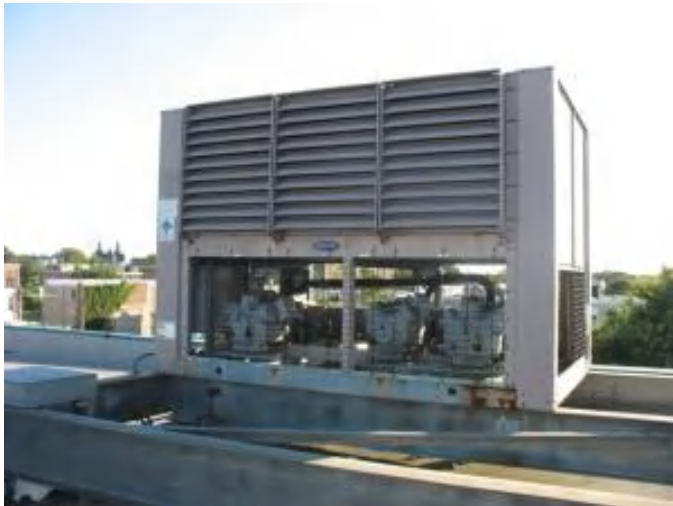
System: D3060 - Controls & Instrumentation

Controls & Instrumentation - A building management system (BMS) with DDC modules and communications network is installed in this building. The BMS is not operational and the ventilator control valves are wide open and heating and cooling control is achieved via the boilers or chiller for many classrooms. This system needs to be replaced with a new control system to ensure it is functioning properly.

Location: Throughout building

Distress: Failing

Correction: Replace pneumatic controls with DDC (75KSF)

Notes: Replace the existing, non functioning, DDC controls for the HVAC systems with modern DDC modules, valves and actuators to improve reliability and energy efficiency. Provide a new building automation system (BAS) with communication interface to the preferred system in use throughout the District.

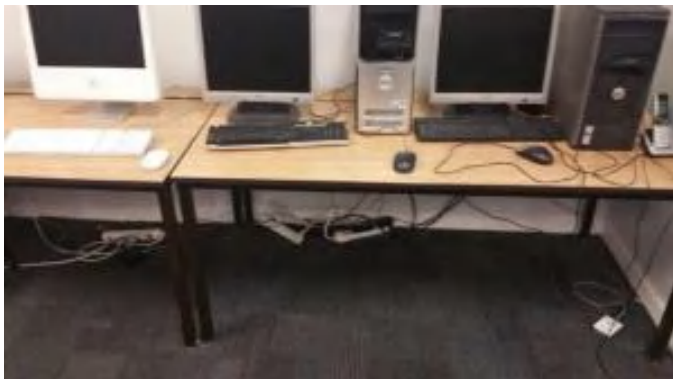
System: D5020 - Lighting and Branch Wiring

Receptacles - There are at least two receptacles on each wall of the classrooms, multi-purpose room, etc. However, the computer rooms has inadequate outlets for power and data.

Location: Computer Room (1st floor)

Distress: Building / MEP Codes

Notes: Install a wire-mold system with receptacles on every 3' for the computer room.

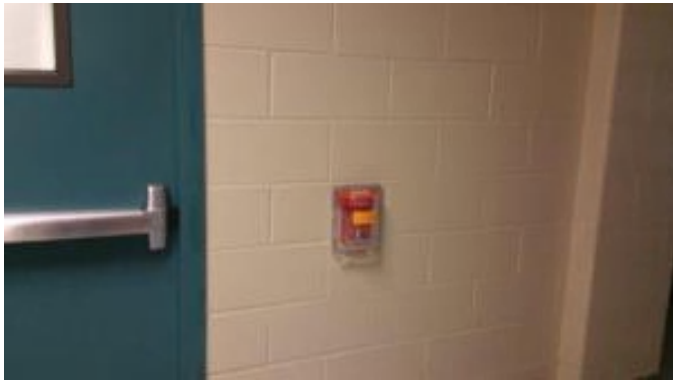
System: D5030 - Communications and Security

Location: Electrical Room (1st Floor)

Distress: Building / MEP Codes

Correction: Replace fire alarm system

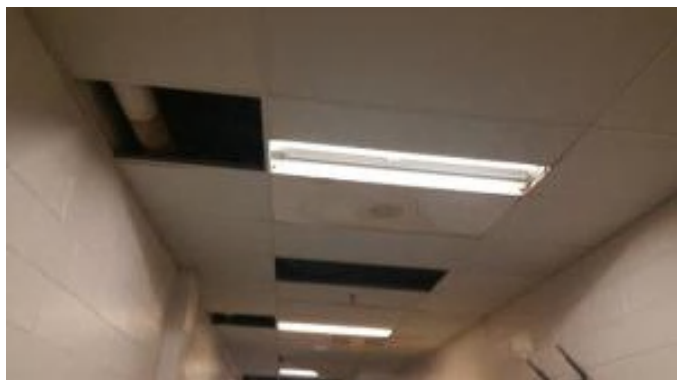
System: D5090 - Other Electrical Systems

Location: Throughout the building

Distress: Life Safety / NFPA / PFD

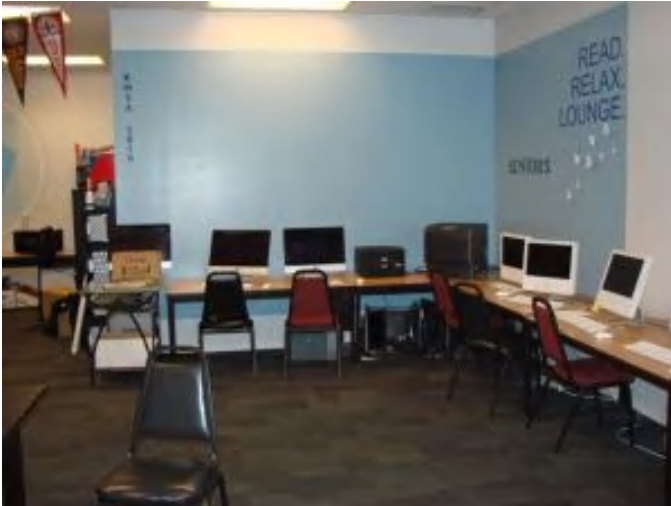
System: C3020411 - Carpet

Flooring in most areas is generally vinyl composition tile, in good condition. Flooring in library and principal's office is carpet, installed in 2012 and in poor condition. Gym has resilient sheet flooring in very good condition. Flooring in toilets is typically 2x2 ceramic tiles in good condition.

Location: Interior

Distress: Beyond Service Life

Correction: Remove and replace carpet

Notes: Replace carpet in Library and office spaces

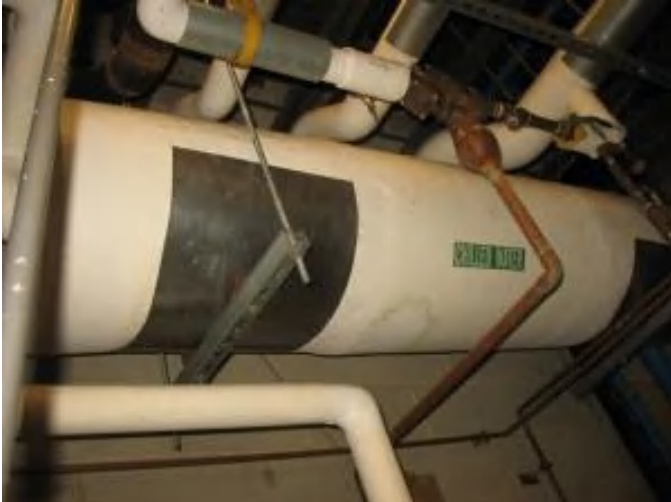
System: D3040 - Distribution Systems

Location: Boiler room

Distress: Damaged

Correction: Replace hydronic distribution piping insulation - 100 LF of piping

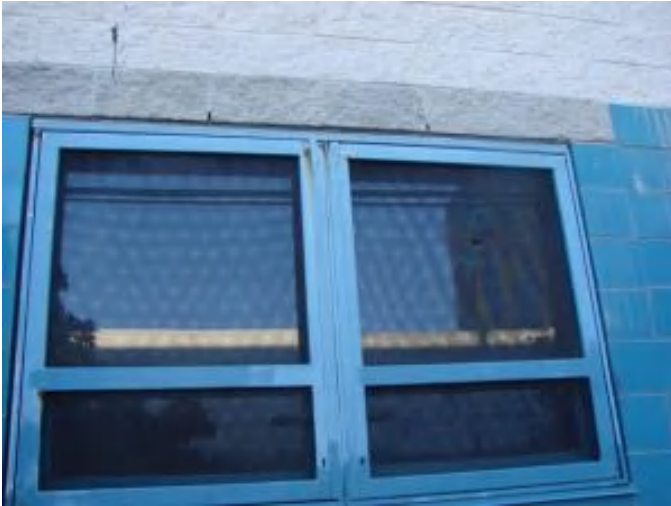
System: B2020 - Exterior Windows

Exterior windows are typically aluminum, double insulated units with tilt-in operating sections, in good condition. First floor windows are fitted with steel framed security screens, some rusting and finish deterioration was observed.

Location: Exterior
Distress: Appearance
Category: 3 - Operations / Maint.
Priority: 5 - Response Time (> 5 yrs)
Correction: Replace security screens
Qty: 900.00
Unit of Measure: S.F.
Estimate: \$138,155.72
Assessor Name: Ben Nixon
Date Created: 09/22/2015

Notes: Replace window screens

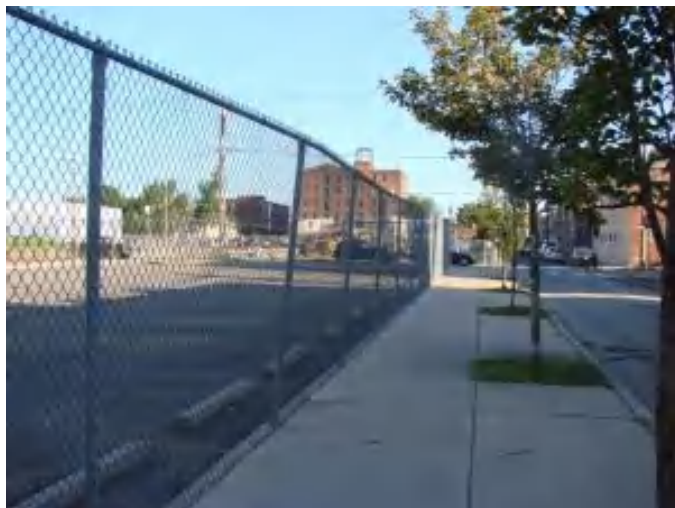
System: G2040 - Site Development

There is no playground at the site. Original perimeter chain link fences are generally in poor condition and damaged. There is no landscaping.

Location: Grounds/ site

Distress: Damaged
