Facility Condition Assessment Summary Report

Key School

S254001;Key

Site Assessment Report

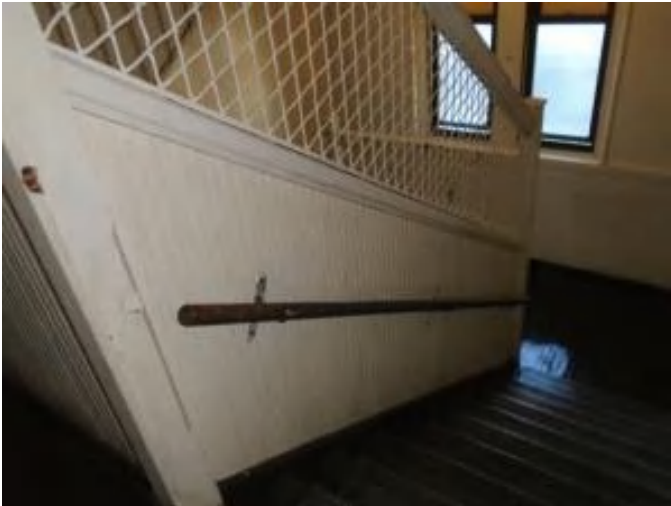
System: C2010 - Stair Construction

Location: Stairs

Distress: Building / MEP Codes

Notes: Replace stair railing to meet building codes

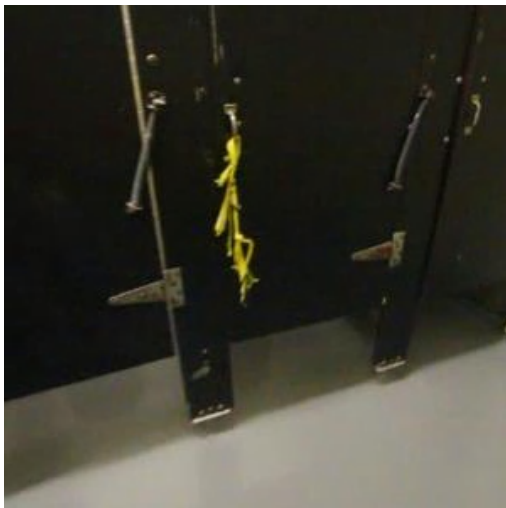
System: D2010 - Plumbing Fixtures

Location: Toilet rooms

Distress: Beyond Service Life

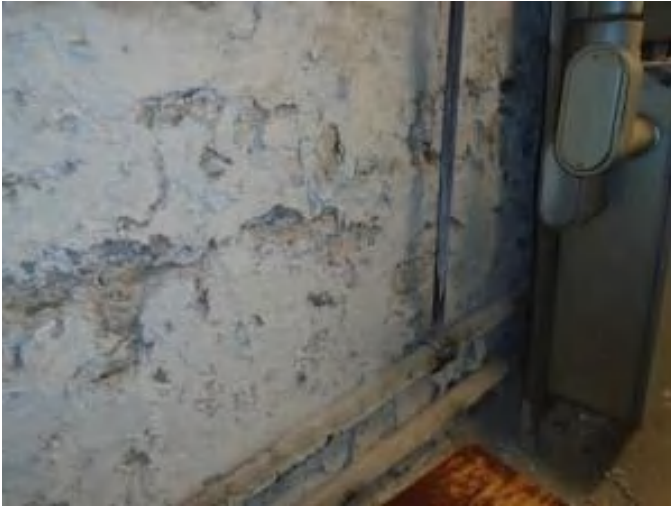
System: A2020 - Basement Walls

The building typically rests on concrete and stacked stone foundations and bearing walls that are not showing signs of settlement damage. Basement walls are a combination of brick, stacked stone, and concrete in fair to poor condition with deteriorating areas due to water intrusion and age. The main structure consists of masonry, steel and cast-in-place concrete columns, beams, and both brick and one way ribbed slab. The main roof structures consist of both wood and steel truss supported by main structural frame. Main roofing is built up application over center of original building and hallway or addition in good condition and pitched asphalt shingle roof in other areas in fair condition with missing shingles. The building envelope is typically masonry and concrete with face brick over structural stone in fair condition. Elevations are enhanced with decorative stonework around entrances and windows with some deterioration of the stonework. The windows were replaced in the early 1990s with extruded aluminum, double hung, Lexan Plexiglas sliding windows with insect/security screens in poor condition with heavy hazing and energy inefficient. Exterior doors are typically hollow metal in fair condition. Public access doors have concrete stoops and stairs in poor condition with heavy spalling. The building is not accessible per ADA requirements due to first floor grade separation with no access ramp.

Location: Basement

Distress: Damaged

Notes: Repair damaged basement walls

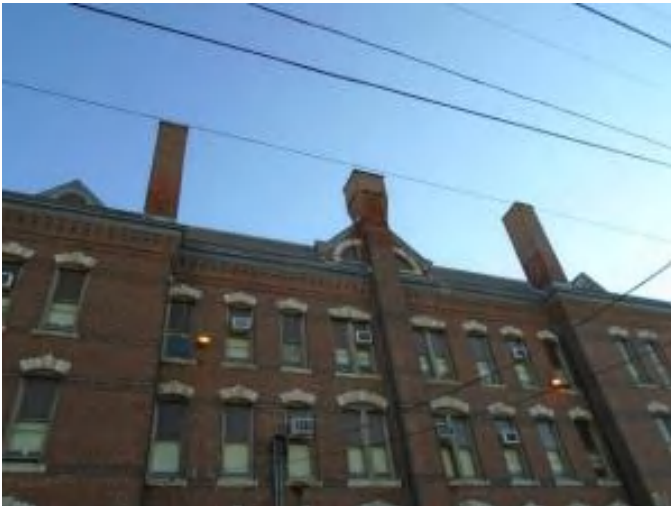
System: B2010 - Exterior Walls

Location: Windows

Distress: Failing

Notes: Repair and seal window lintels and sills – damaged stonework

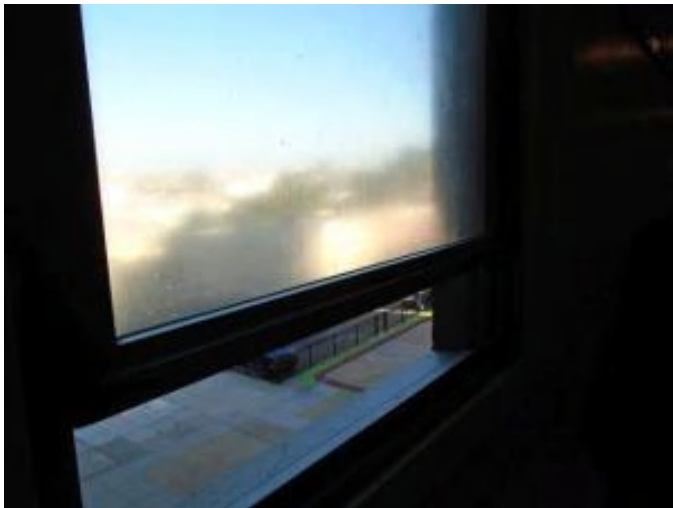
System: B2020 - Exterior Windows

Location: Entire building

Distress: Energy Efficiency

Notes: Replace Plexiglas windows – hazed and inefficient

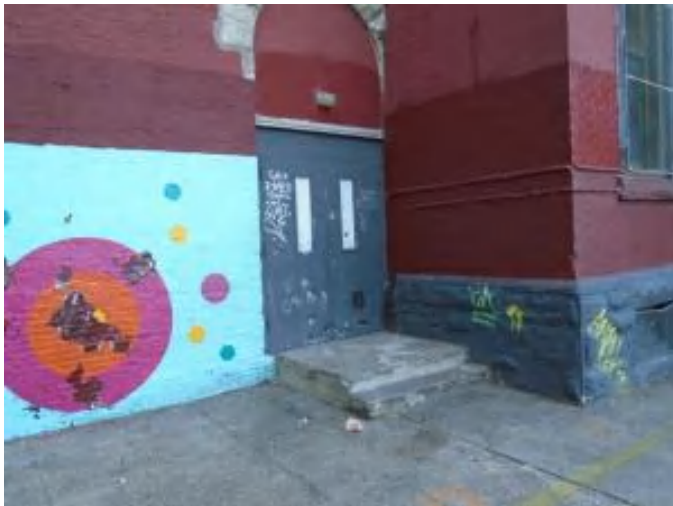
System: B2030 - Exterior Doors

Location: Entrance

Distress: Accessibility

Notes: Install accessible door hardware on at least one entrance door

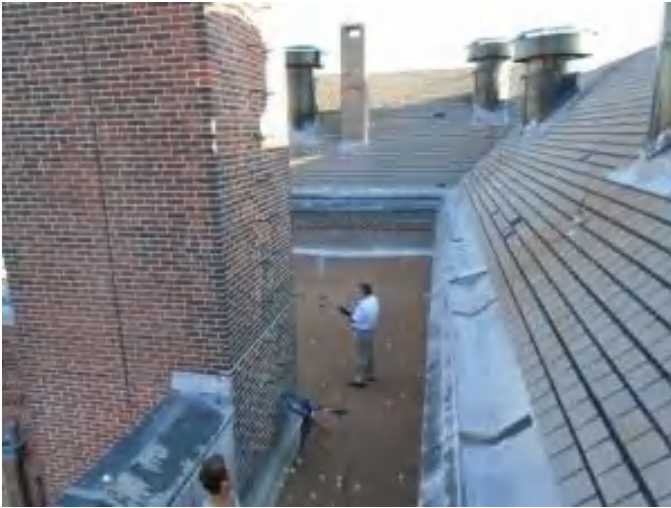
System: B3010140 - Shingle & Tile

Location: Roof

Distress: Maintenance Required

Notes: Repair roof – missing shingles (5% of shingle roof area)

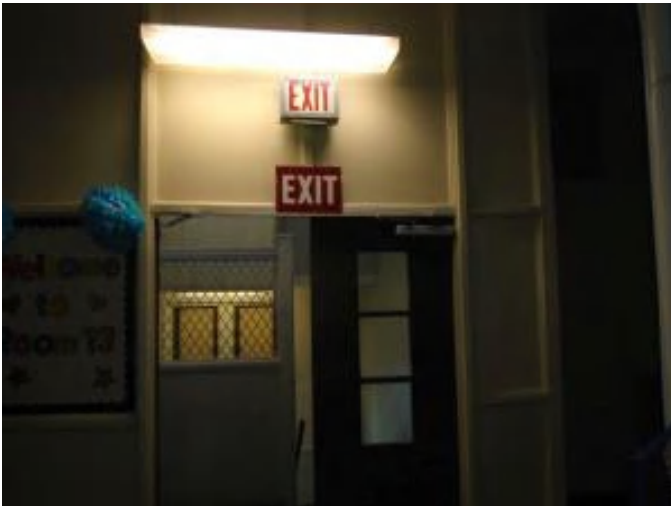
System: C1020 - Interior Doors

Location: Exit stairs

Distress: Building / MEP Codes

Notes: Replace exit stairway doors – do not meet fire code

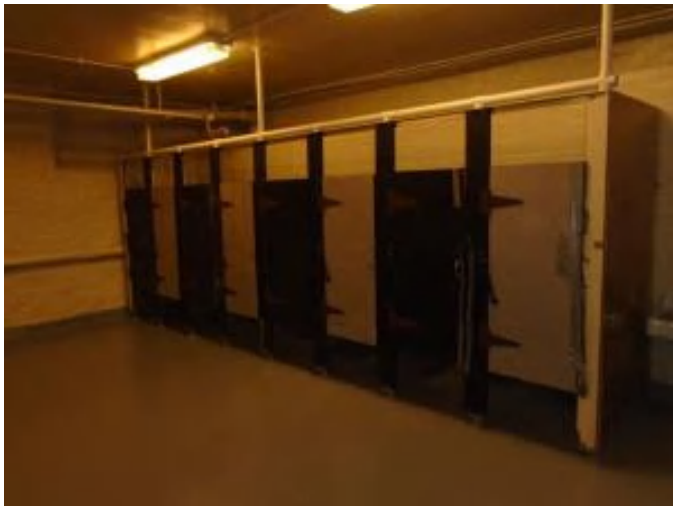
System: C1030 - Fittings

Location: Toilets

Distress: Beyond Service Life

Notes: Replace toilet partitions – beyond service life

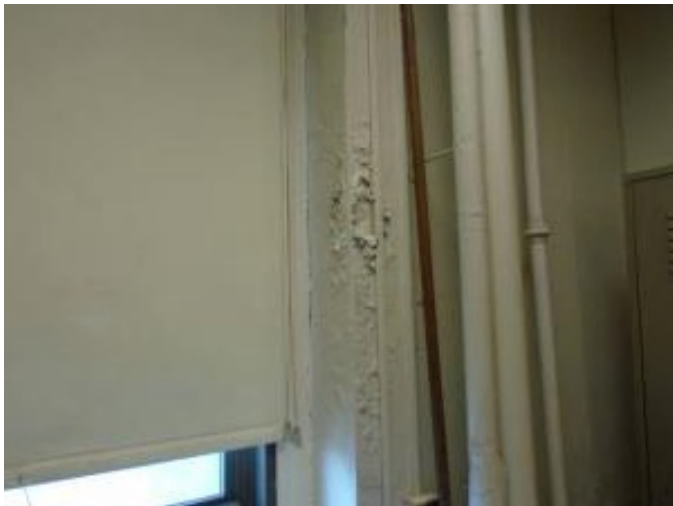
System: C3010230 - Paint & Covering

Location: Various

Distress: Damaged

Notes: Repair and paint interior plaster walls – damaged (10% of plaster wall area)

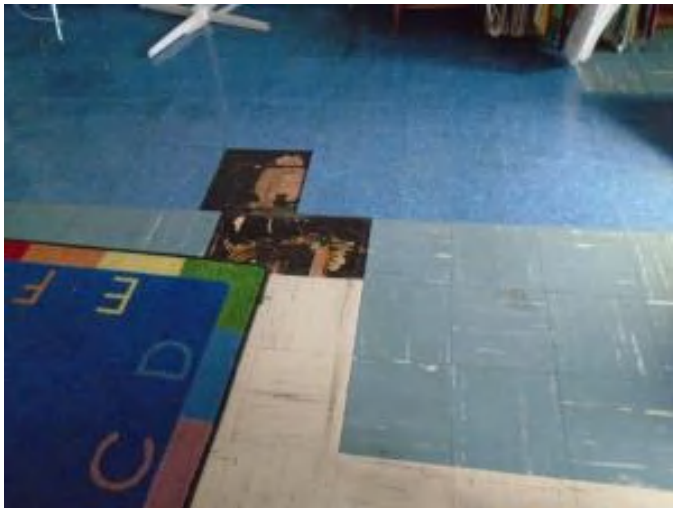
System: C3020413 - Vinyl Flooring

Location: Various

Distress: Damaged

Notes: Replace damaged VAT with VCT (40% of vinyl flooring area)

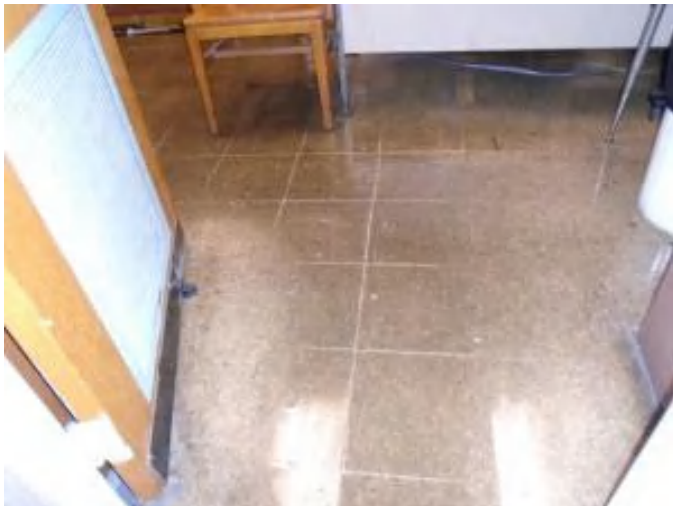
System: C3020413 - Vinyl Flooring

Location: Various

Distress: Damaged

Notes: Replace damaged VCT (40% of vinyl flooring area)

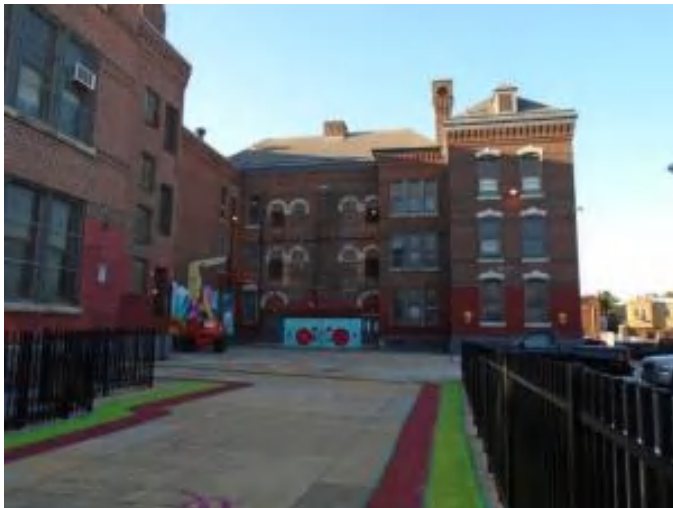
System: D1010 - Elevators and Lifts

Location: TBD

Distress: Accessibility

Notes: Install elevator for accessibility

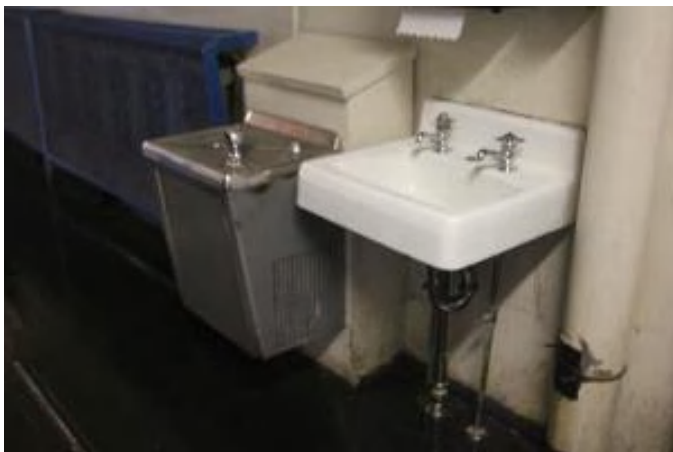
System: D2010 - Plumbing Fixtures

Drinking fountains are painted sheet metal and stainless steel located in hallways on each floor. They are beyond their service life and not ADA compliant. Fountains throughout the building should be replaced with accessible fountains with integral coolers.

Location: Hallways

Distress: Accessibility

Notes: Replace drinking fountains with ADA compliant fountains including integral coolers, 4 pairs.

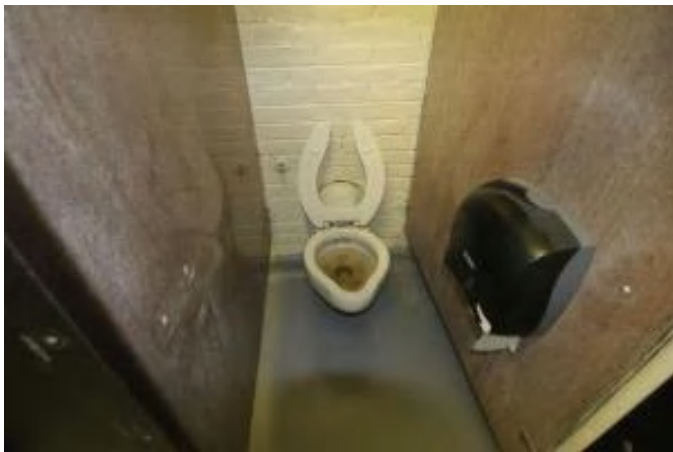
System: D2010 - Plumbing Fixtures

Location: Toilet rooms

Distress: Beyond Service Life

Notes: Replace water closets due to age and staining.

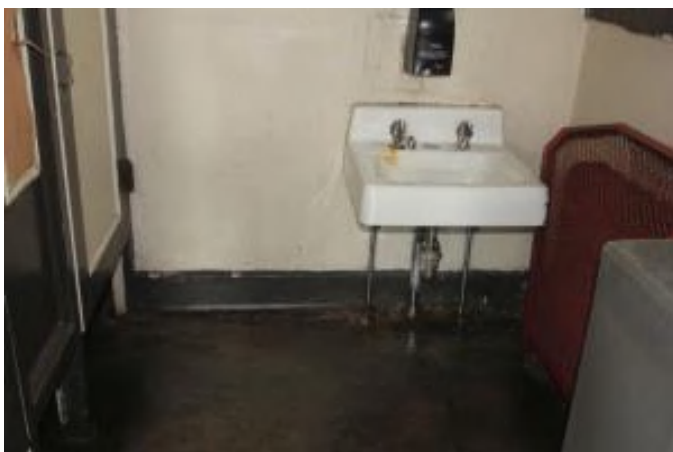
System: D2010 - Plumbing Fixtures

Location: Toilet rooms

Distress: Beyond Service Life

Notes: Replace lavatories due to age and staining.

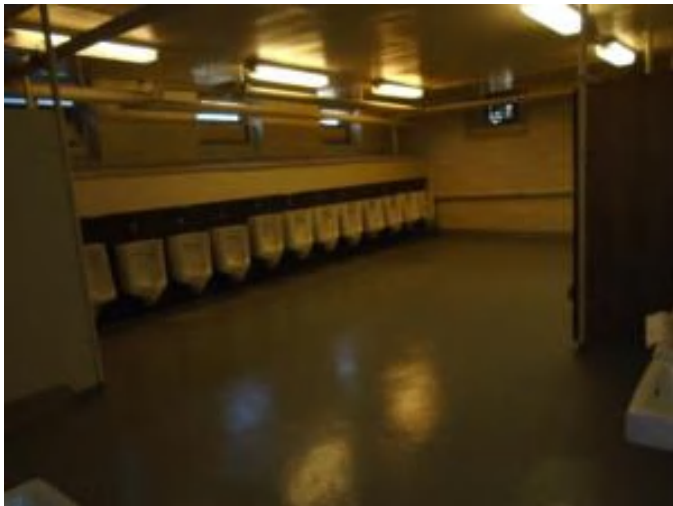
System: D2010 - Plumbing Fixtures

Location: Toilet rooms

Distress: Beyond Service Life

Notes: Replace urinals due to age and staining.

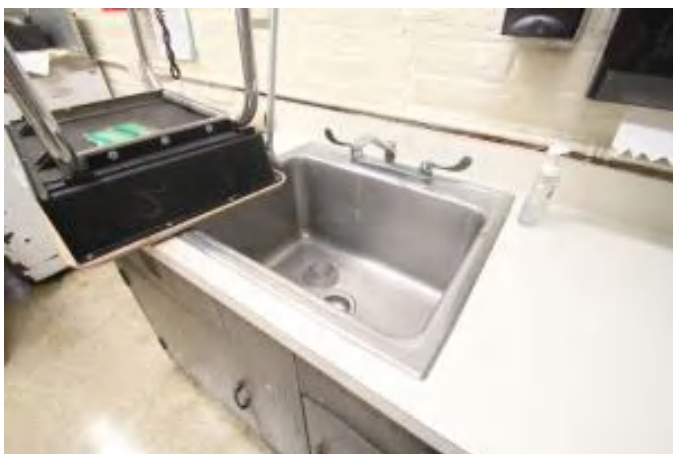
System: D2010 - Plumbing Fixtures

grease trap or chemical sanitation system installed in a 1960s vintage sheet metal cabinet. Its faucets leaks steadily. The sink is beyond its service life and not suitable for an institutional setting and should be replaced.

Location: Cafeteria

Distress: Beyond Service Life

Notes: Replace cafeteria kitchen sink including cabinet due to age.

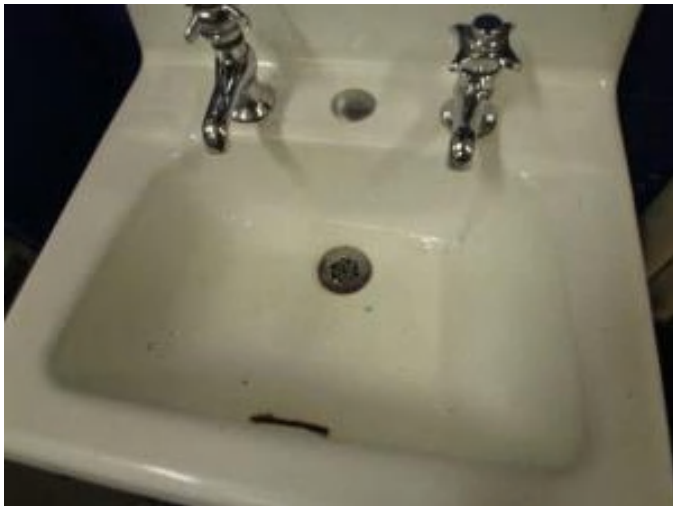
System: D2010 - Plumbing Fixtures

Location: Toilet rooms

Distress: Beyond Service Life

Notes: Replace faucet valves due to age and failure.

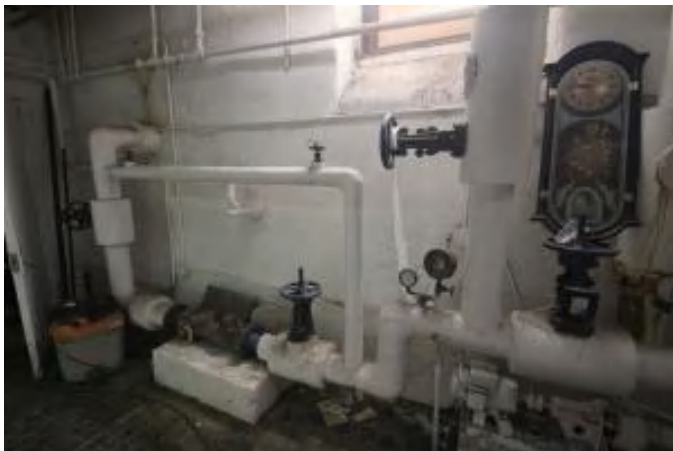
System: D2020 - Domestic Water Distribution

Location: Boiler room

Distress: Building / MEP Codes

Notes: Install double back flow prevention valve on water entry for code compliance.

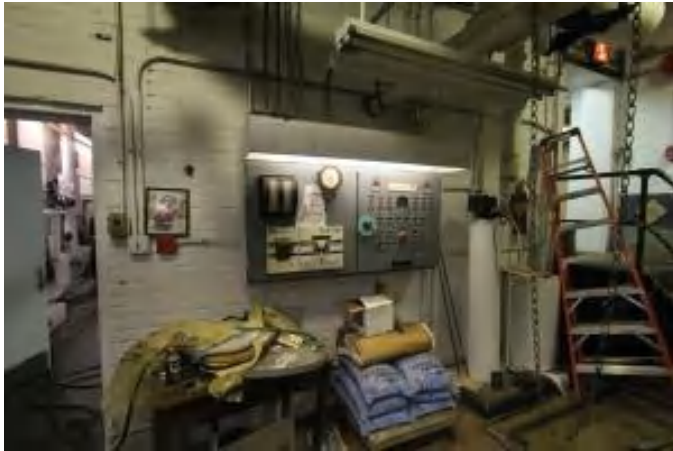
System: D2020 - Domestic Water Distribution

Location: Boiler room

Distress: Building / MEP Codes

Notes: Install double back flow prevention valve on boiler make up connection for code compliance.

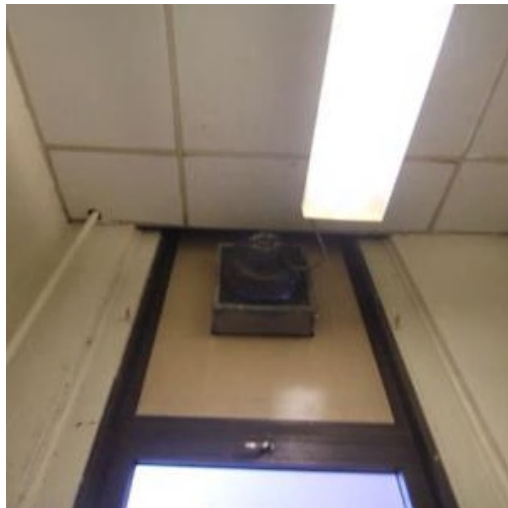
System: D3040 - Distribution Systems

The cafeteria kitchen does not have any fuel burning appliances and does not have a fume hood exhaust fan system. Toilet rooms have exhaust fans installed through windows, but there is still a problem with odor. Exhaust fans should be upgraded and makeup air supplied.

Location: Toilet rooms

Distress: Inadequate

Notes: Upgrade toilet room exhaust fans to abate odor problem.

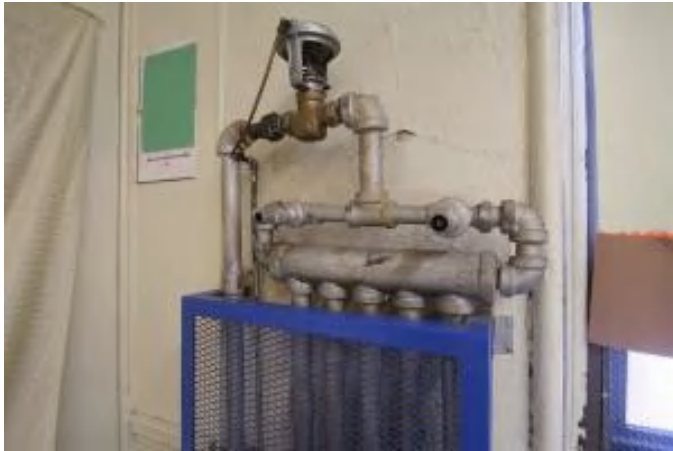
System: D3060 - Controls & Instrumentation

Location: Entire building

Distress: Failing

Notes: Replace pneumatic control with digital and provide a new building automation system (BAS).

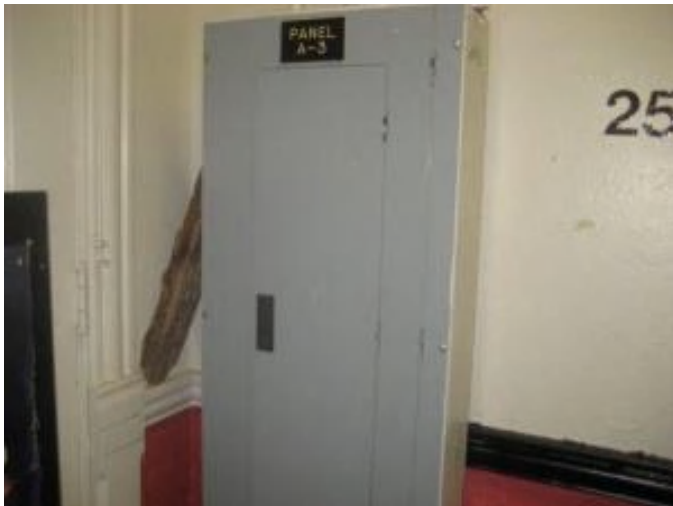
System: D5010 - Electrical Service/Distribution

Location: Corridors

Distress: Inadequate

Notes: Provide additional panel boards per floor. Total (8) 208/120V panel boards.

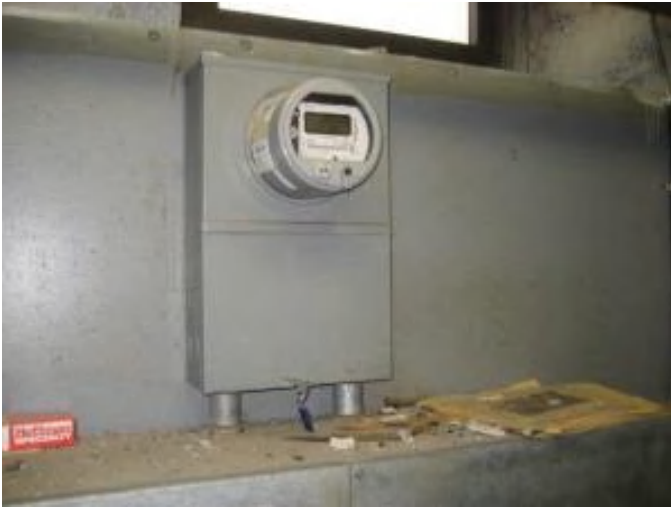
System: D5010 - Electrical Service/Distribution

Location: Basement electrical room

Distress: Inadequate

Notes: Provide a new electrical service 480V/277V, 3 phase power, approximate 800 Amperes and will be located in the vicinity of the existing electrical service.

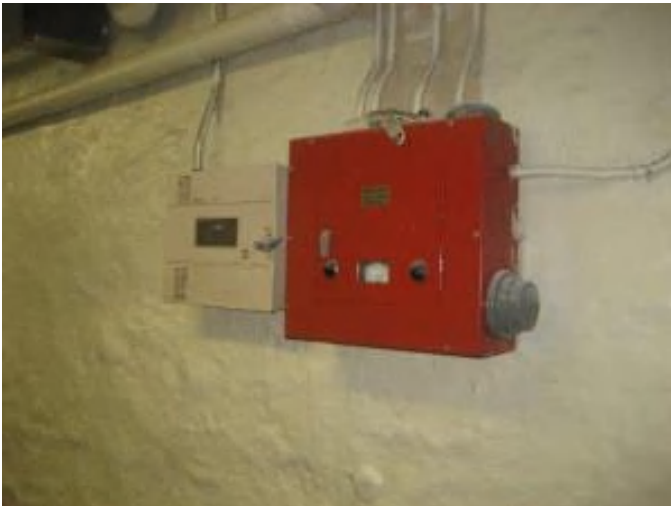
System: D5030 - Communications and Security

The Fire Alarm system is manufactured by Simplex 4001. The present Fire Alarm system does not meet current code and needs to be replaced. Fire alarm system is tested every day in the morning.

Location: Entire Building

Distress: Life Safety / NFPA / PFD

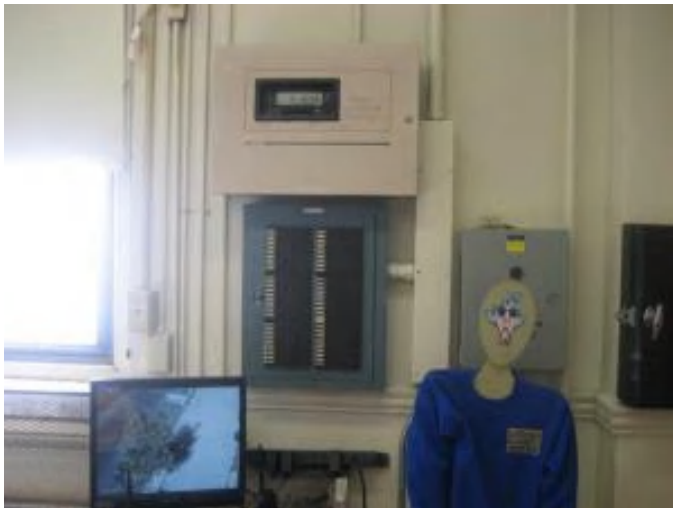
System: D5030 - Communications and Security

Location: Entire Building

Distress: Obsolete

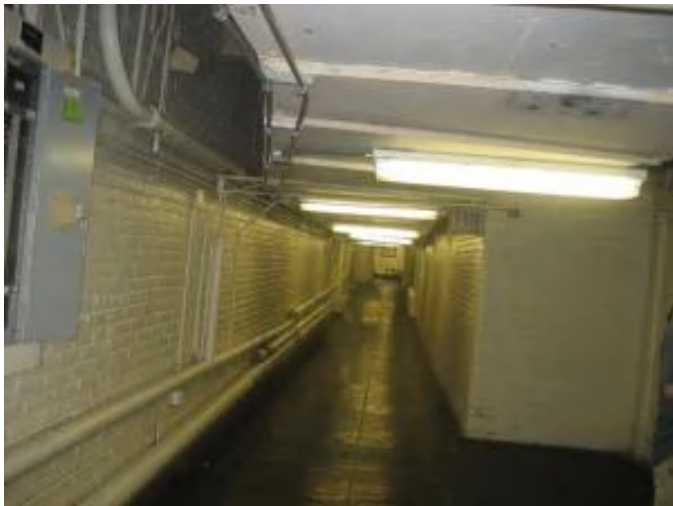
System: D5030 - Communications and Security

Location: Interior corridors and stair ways

Distress: Security Issue

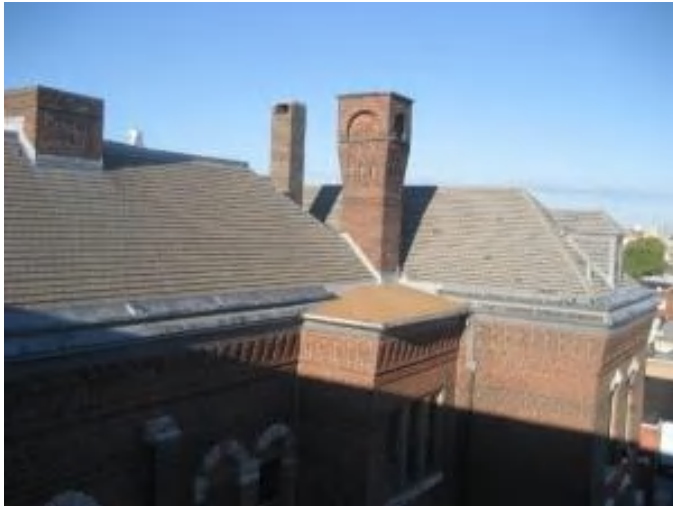
System: D5090 - Other Electrical Systems

Location: Roof

Distress: Building / MEP Codes

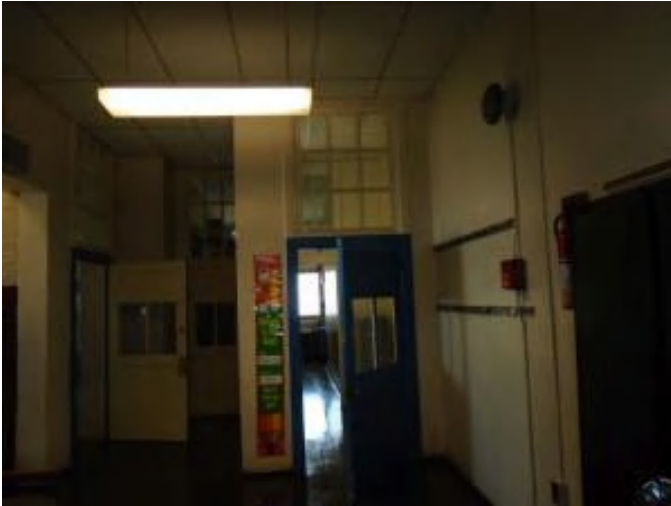
System: C1020 - Interior Doors

Location: Throughout

Distress: Beyond Service Life

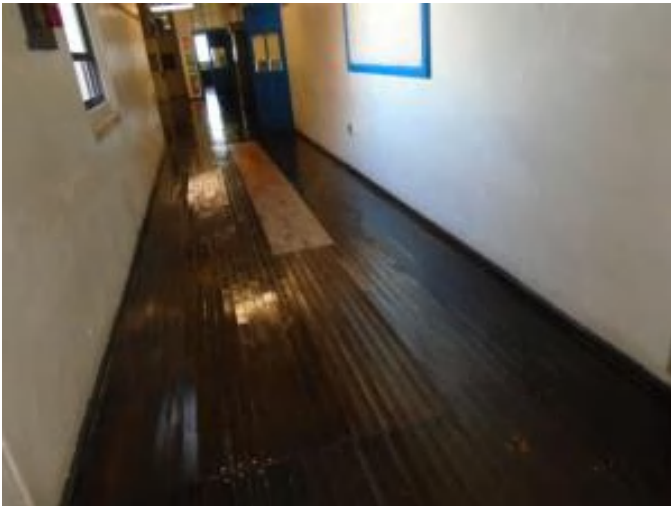
System: C3020414 - Wood Flooring

Location: Various

Distress: Damaged

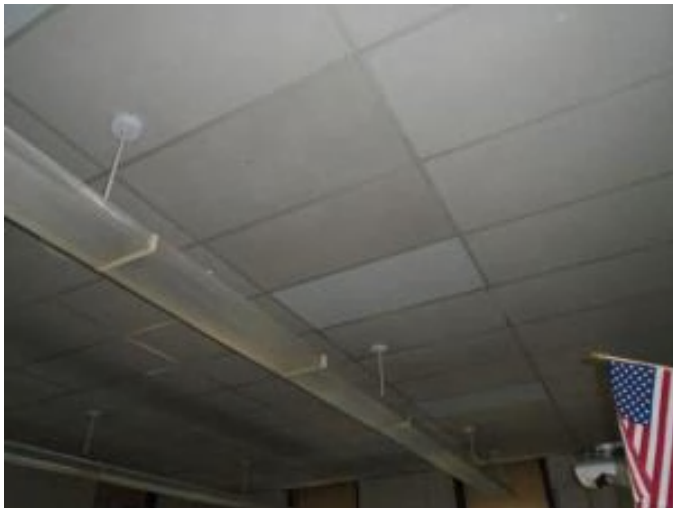
System: C3030 - Ceiling Finishes

Location: Various

Distress: Beyond Service Life

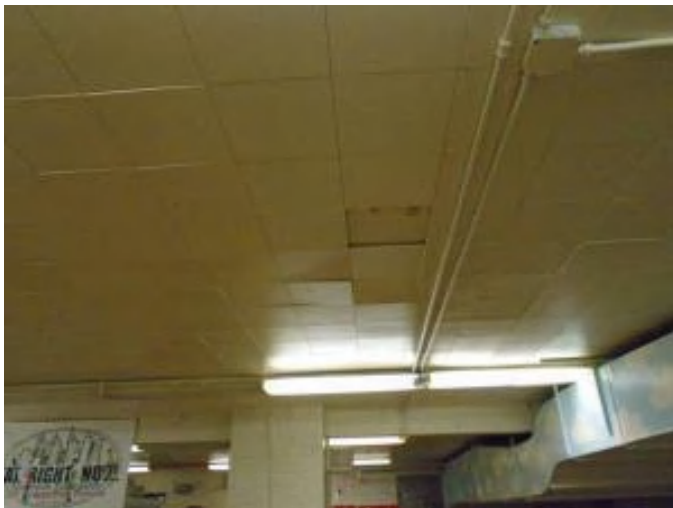
System: C3030 - Ceiling Finishes

Location: Cafeteria

Distress: Failing

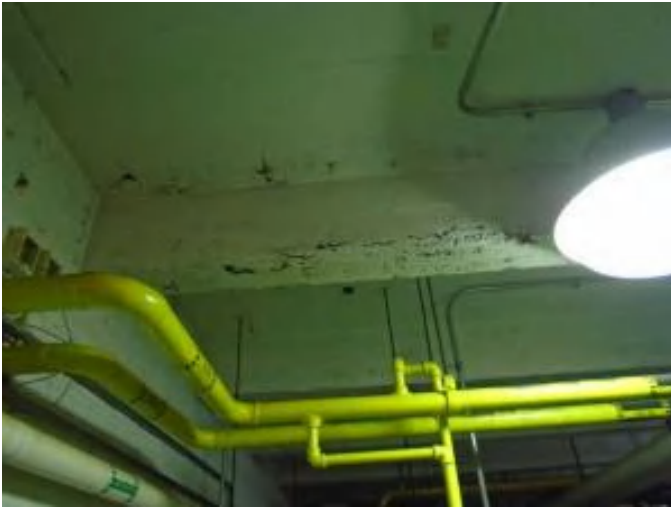
System: C3030 - Ceiling Finishes

Location: Various

Distress: Maintenance Required

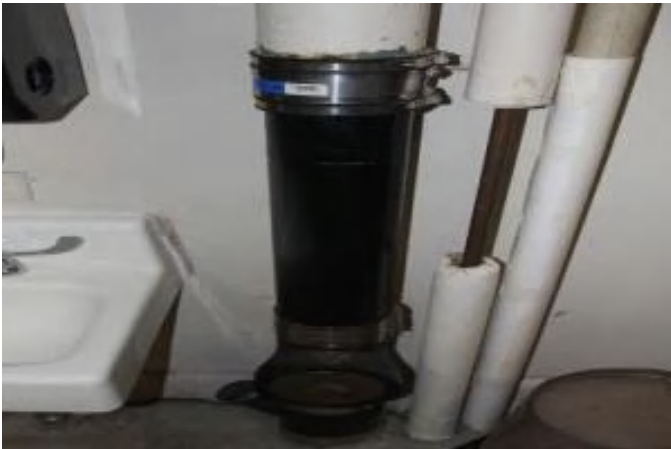
System: D2030 - Sanitary Waste

Sanitary waste piping is hub and spigot cast iron, threaded galvanized steel pipe, and hub less cast iron with banded connections for repairs. The principal stated there was a problem with slow drains. The sanitary drain pipes should be inspected and repaired as needed due to age and reported problems. The building does not have a sewage ejector.

Location: Entire building

Distress: Failing

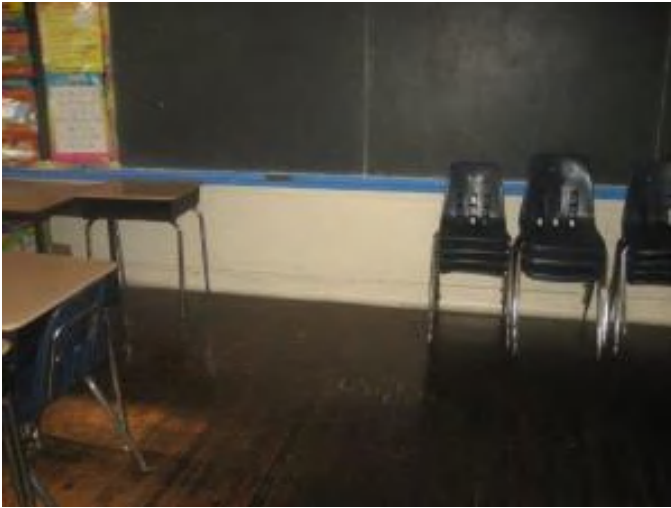
System: D5020 - Lighting and Branch Wiring

The number of receptacles in 50% of the classrooms is inadequate. Teachers use extension cords. The teacher's whiteboard wall and the opposite of it need to be provided with double compartment surface raceways, the other two walls with minimum two duplex outlets each, when feasible.

Location: Classrooms

Distress: Inadequate

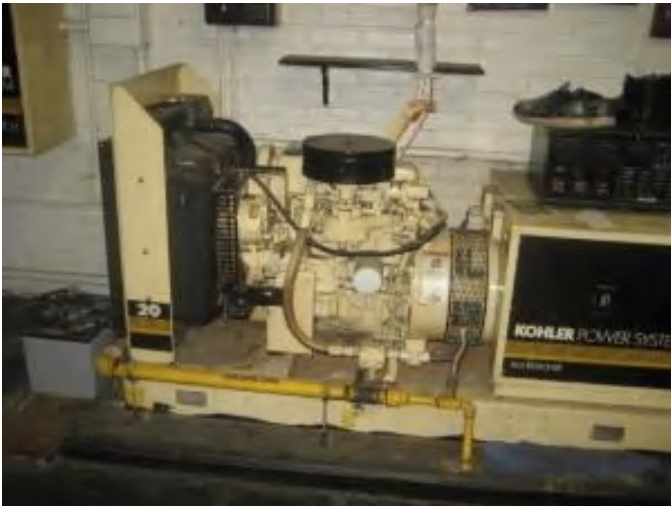
System: D5090 - Other Electrical Systems

Location: Outdoor

Distress: Inadequate

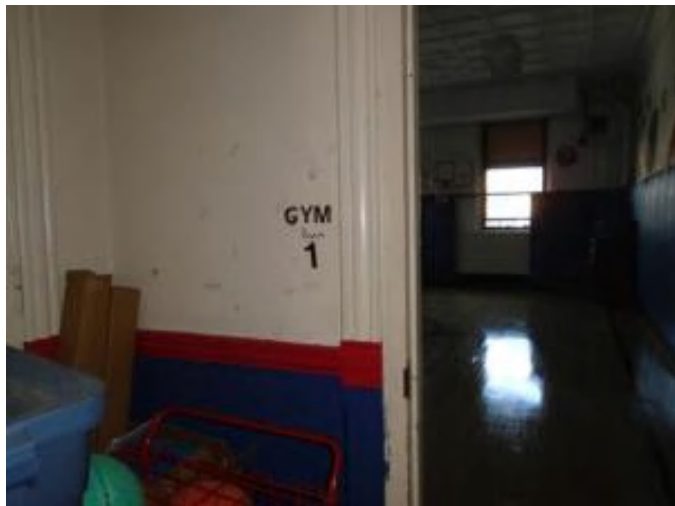
System: C1030 - Fittings

Location: Throughout

Distress: Inadequate

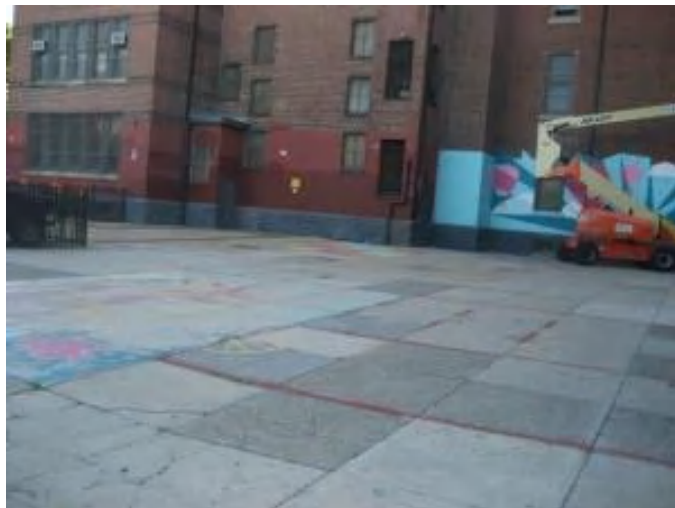
System: D5030 - Communications and Security

Location: Building exterior

Distress: Inadequate

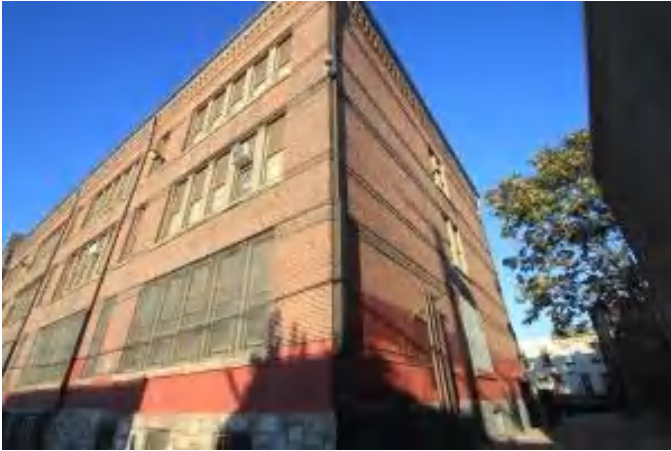
System: D3030 - Cooling Generating Systems

The building does not have any central cooling generation. There are 11 window unit air-conditioners for offices, IMC, and some classrooms. One mini-split systems provide cooling for the computer network equipment room. In total, the building currently has approximately 24 tons cooling capacity. A chiller system should be installed with 100 ton capacity for the entire building.

Location: Entire building

Distress: Inadequate

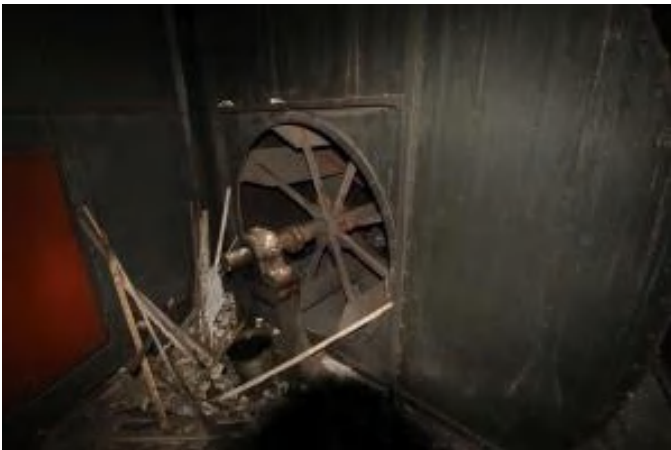
System: D3040 - Distribution Systems

Location: Mechanical room

Distress: Beyond Service Life

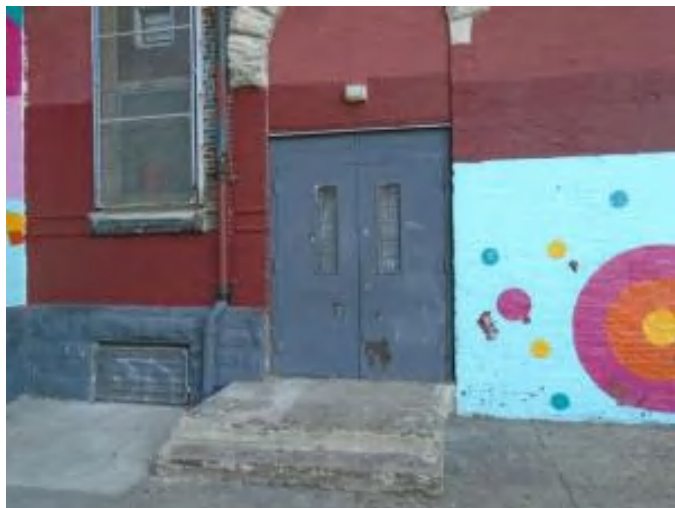
System: G2030 - Pedestrian Paving

Location: Entrance

Distress: Accessibility

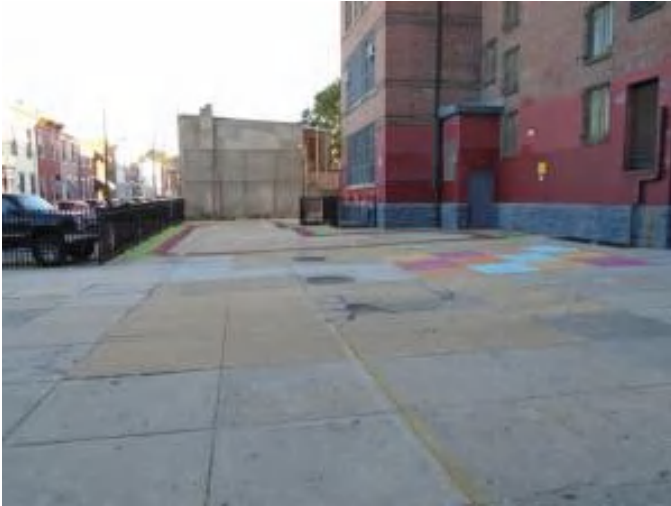
System: G2030 - Pedestrian Paving

The site surrounds the building on all four sides which is set back from the street. Play yard area on west side is concrete paving in poor condition with spalling, cracks, and depressions at manholes. Metal fence and gates surrounding site is in good condition. There is no landscaping at this site.

Location: Yard

Distress: Damaged
