Facility Condition Assessment Summary Report

Kipp (Turner) School

S116001;Turner

Site Assessment Report

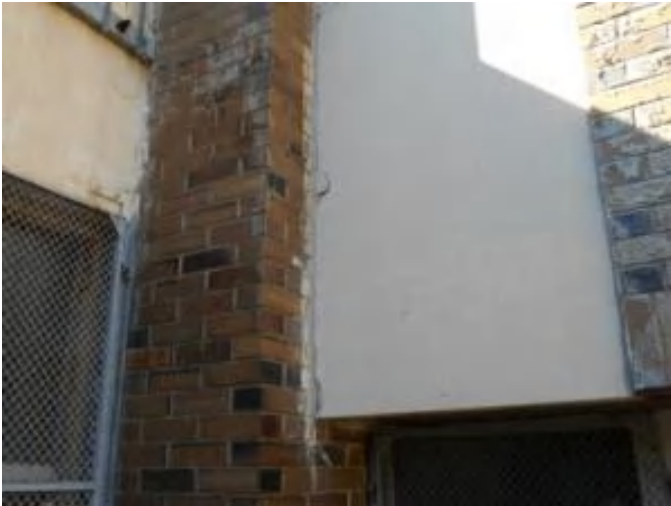
System: B2010 - Exterior Walls

Location: Exterior walls.

Distress: Beyond Service Life

Notes: Re-caulk joints in exterior walls.

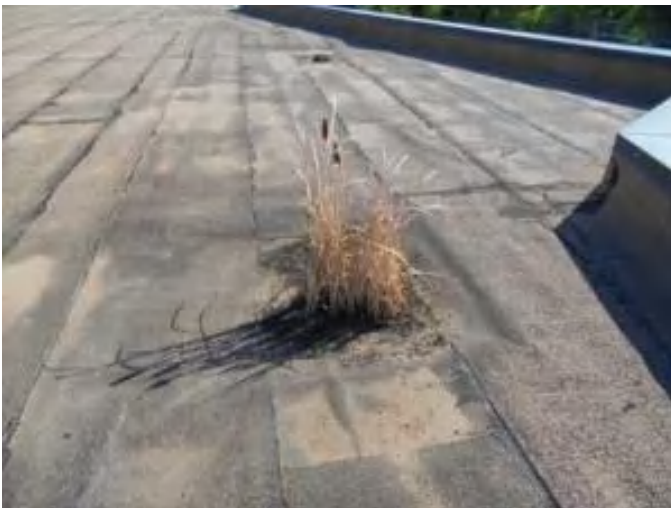
System: B3010105 - Built-Up

Location: Roofs

Distress: Beyond Service Life

Notes: Replace all roofs, flashing, etc.

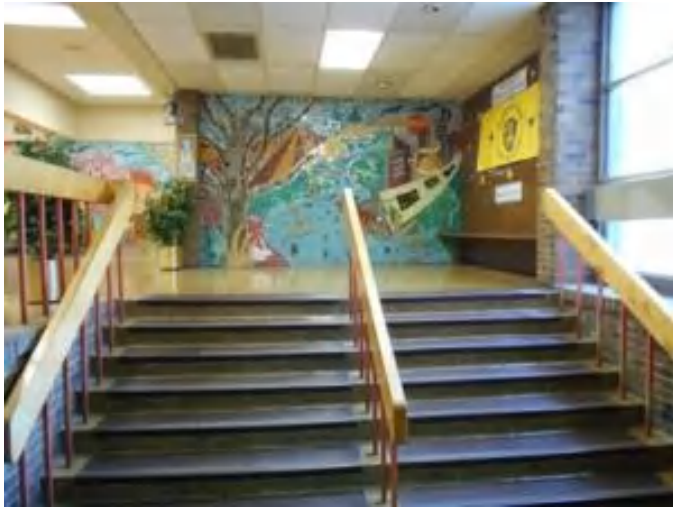
System: C2010 - Stair Construction

Location: Stairs

Distress: Building / MEP Codes

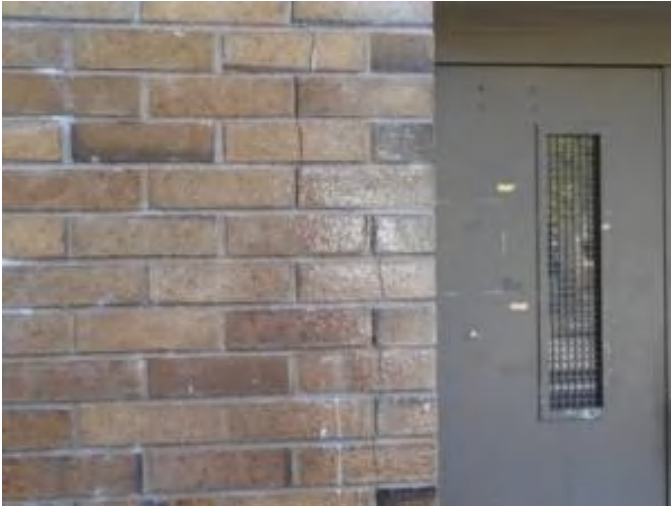
System: B2010 - Exterior Walls

Location: Exterior walls

Distress: Building Envelope Integrity

Notes: Brick walls are in need of re-pointing mortar joints. Some bricks are cracked and should be replaced.

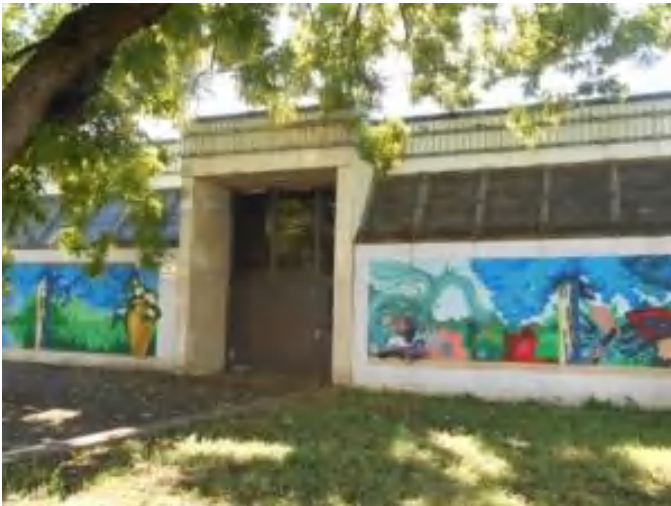
System: B2020 - Exterior Windows

Location: Exterior windows

Distress: Beyond Service Life

Notes: Replace exterior windows. Operable windows do not operate smoothly. All windows are energy inefficient.

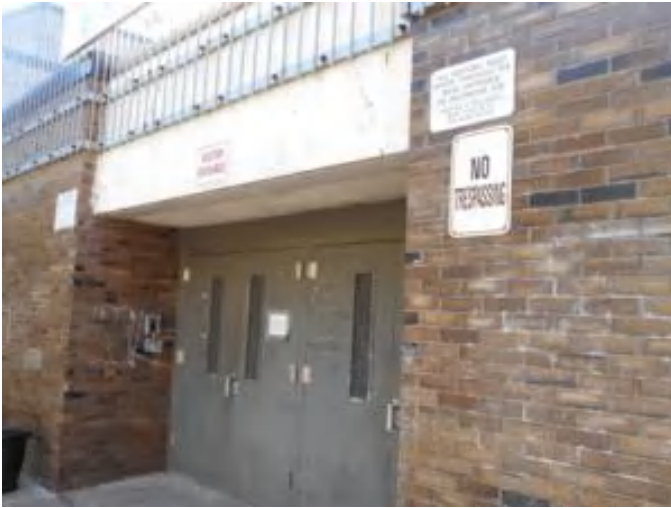
System: B2030 - Exterior Doors

Location: Exterior doors

Distress: Accessibility

Notes: Paint exterior doors and install handicap accessible hardware at three main entrances

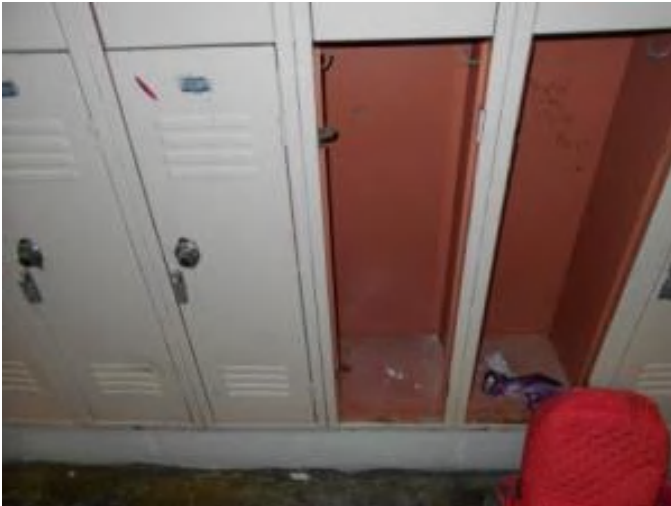
System: C1010 - Partitions

Location: Gym and pool locker rooms.

Distress: Maintenance Required

Notes: Remodel shower rooms, 60 shower heads. Existing shower heads are at elementary school height. Current enrolment is middle school and high school. Locker rooms are in poor condition. Repair ceilings and walls. (door replacement is addressed elsewhere in this assessment). Replace lockers and benches.

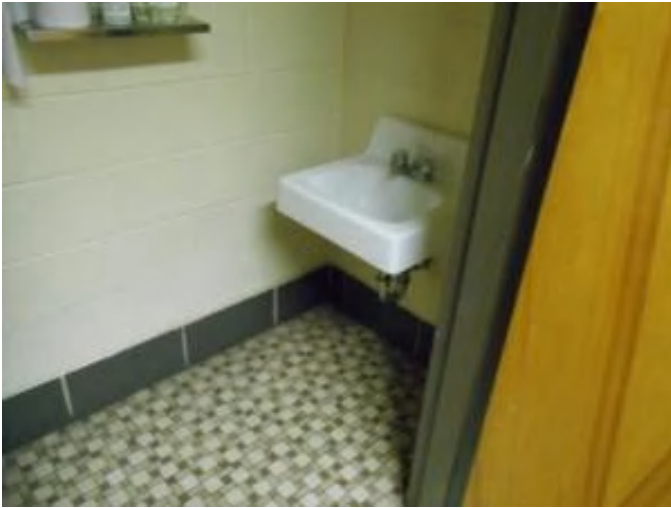
System: C1010 - Partitions

Location: Each floor

Distress: Accessibility

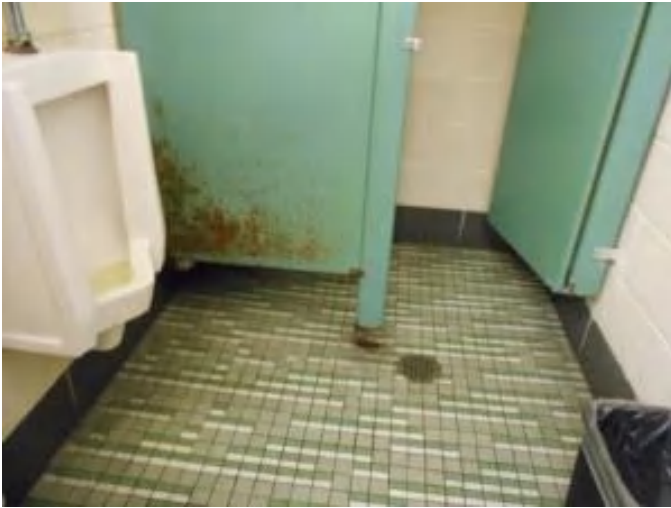
System: C1030 - Fittings

Location: 1st and 3rd Floor Toilet Rms.

Distress: Damaged

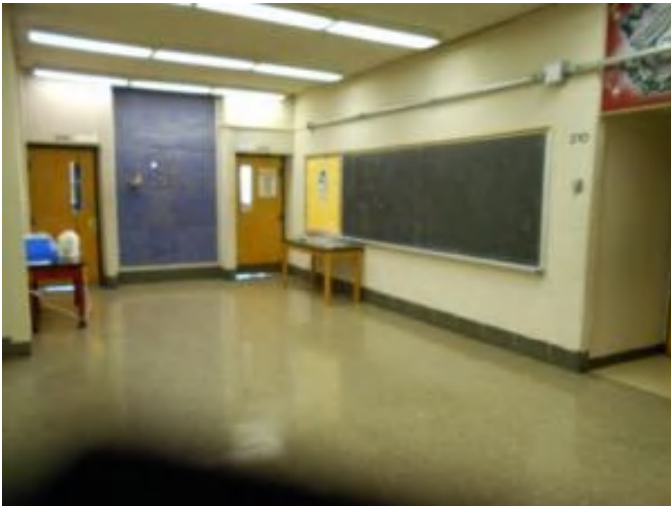
System: C1030 - Fittings

Location: Classrooms

Distress: Obsolete

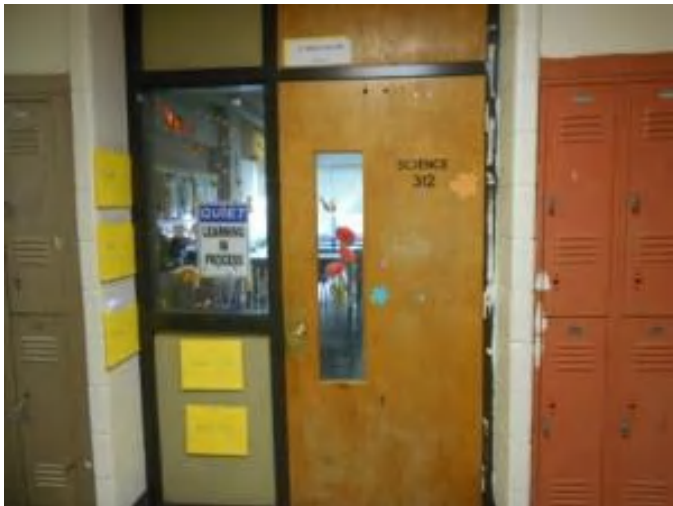
System: C1030 - Fittings

Location: Building wide

Distress: Building / MEP Codes

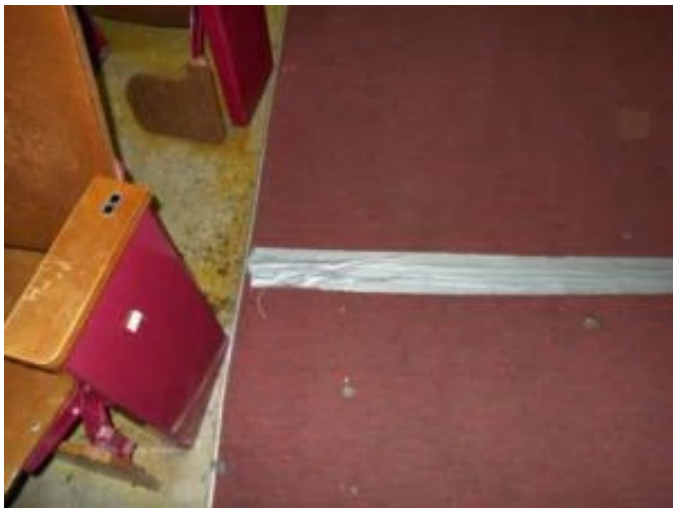
System: C3020411 - Carpet

Location: Auditorium

Distress: Beyond Service Life

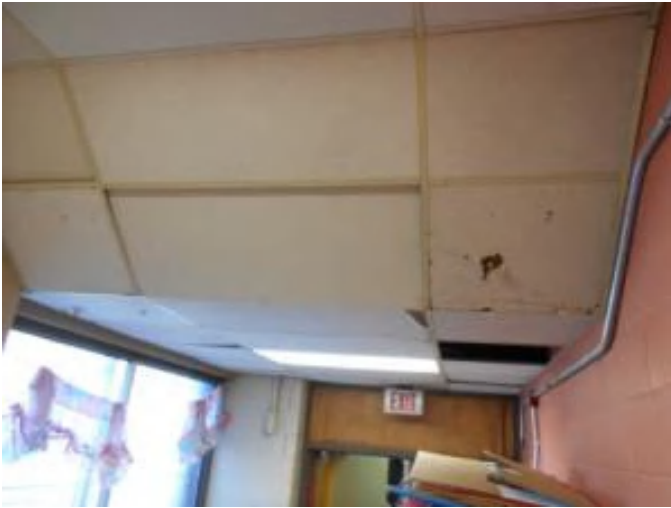
System: C3030 - Ceiling Finishes

Location: Corridors, offices, lecture halls, misc. areas

Distress: Beyond Service Life

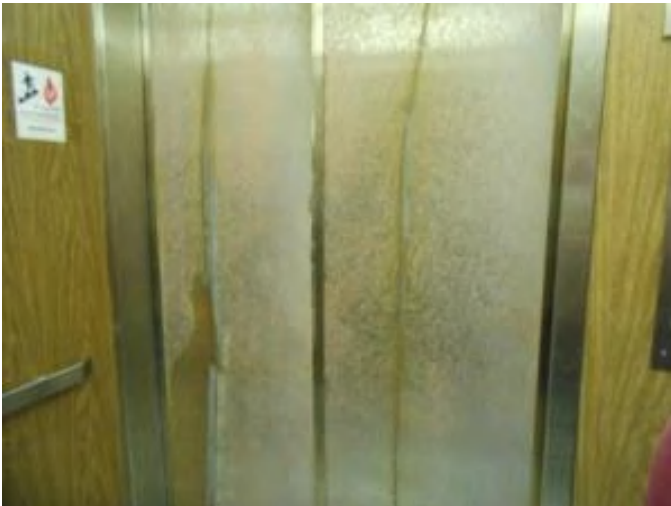
System: D1010 - Elevators and Lifts

Location: First Floor elevator machine room

Distress: Beyond Service Life

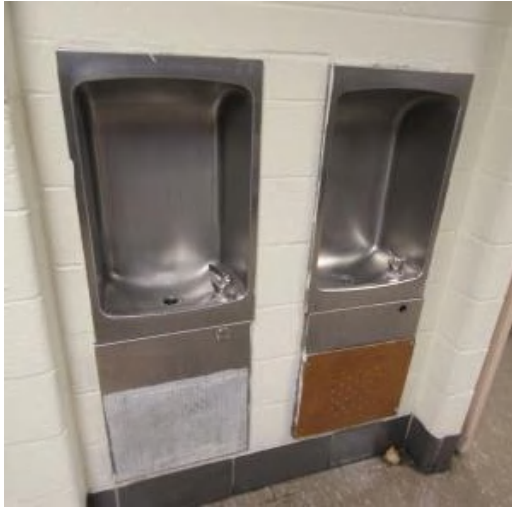
System: D2010 - Plumbing Fixtures

Drinking fountains throughout the building are a mixture of various type and age. They are not ADA compliant, generally beyond their expected lifespan, and some are out of order. Fountains should be replaced with refrigerated, accessible fountains.

Location: Entire building

Distress: Accessibility

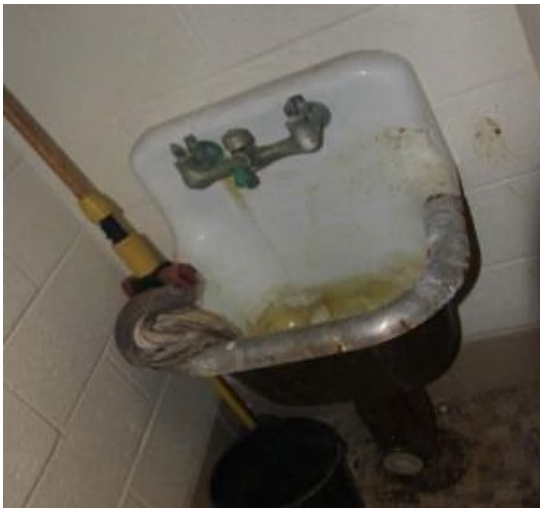
System: D2010 - Plumbing Fixtures

Service sinks in janitor closets are floor mounted cast iron with stainless steel rims and integral backsplash and trap. They have short neck mixing faucets with vacuum breakers. They are beyond their service life, stained and rusted, with corroded faucets, and they should be replaced.

Location: Janitor closets

Distress: Beyond Service Life

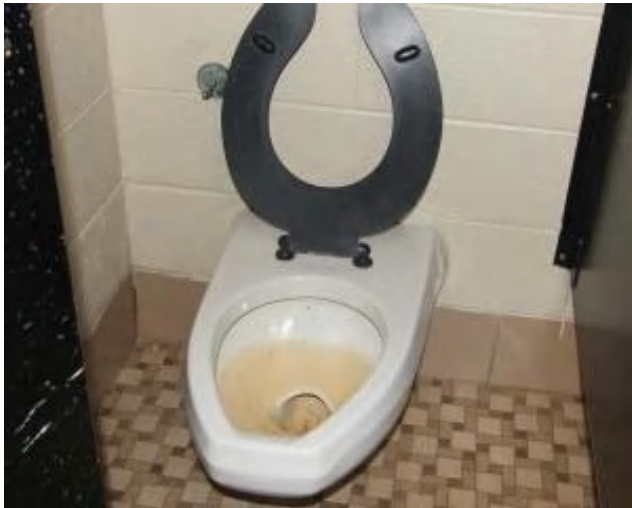
System: D2010 - Plumbing Fixtures

Location: Toilet rooms

Distress: Appearance

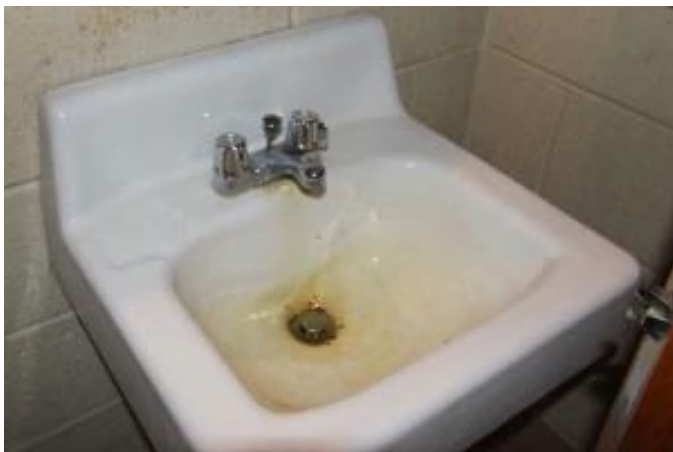
System: D2010 - Plumbing Fixtures

Location: Toilet rooms, classrooms

Distress: Appearance

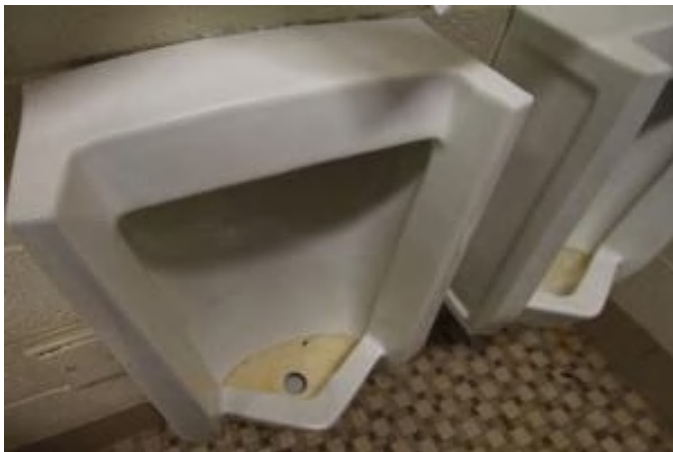
System: D2010 - Plumbing Fixtures

Location: Toilet rooms

Distress: Appearance

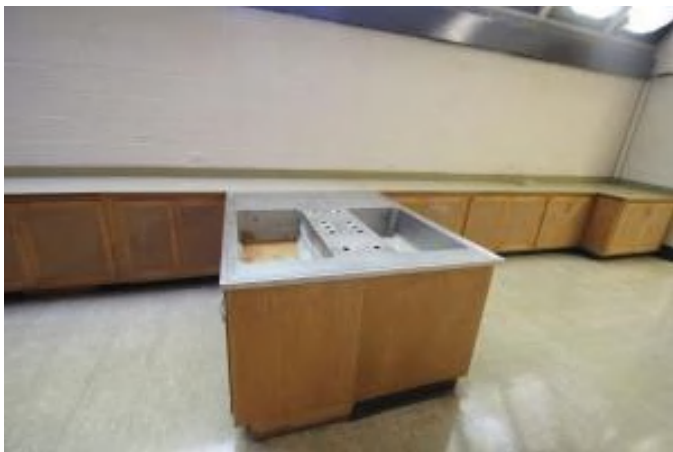
System: D2010 - Plumbing Fixtures

Location: Toilet rooms, classrooms

Distress: Damaged

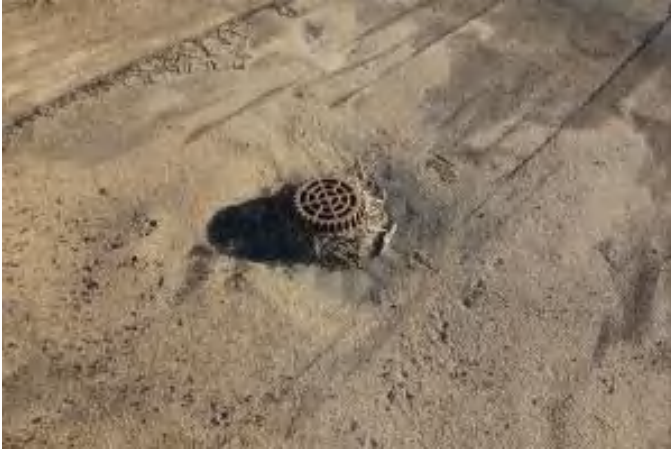
System: D2040 - Rain Water Drainage

Location: Entire building

Distress: Beyond Service Life

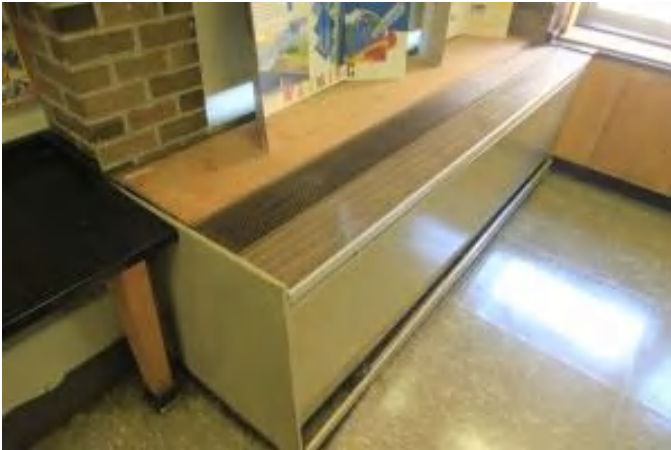
System: D3040 - Distribution Systems

Location: Classrooms

Distress: Failing

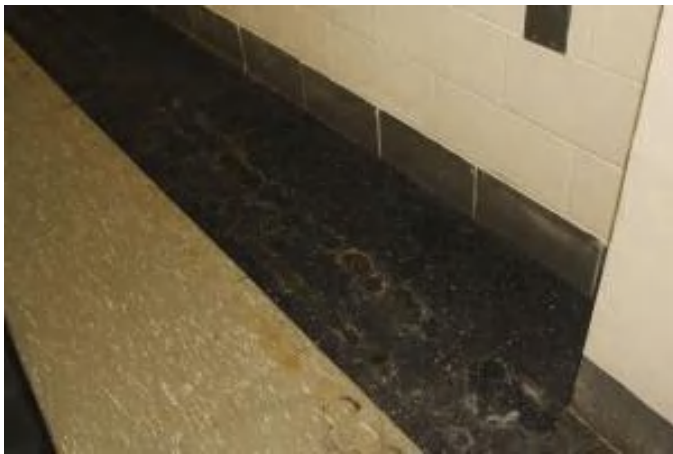
System: D3040 - Distribution Systems

Location: Entire building

Distress: Maintenance Required

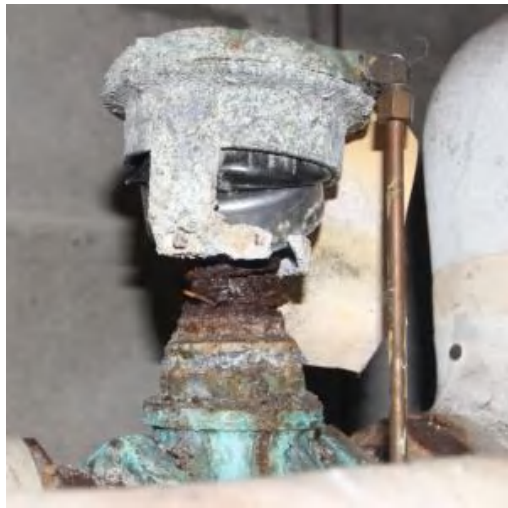
System: D3060 - Controls & Instrumentation

Location: Entire building

Distress: Failing

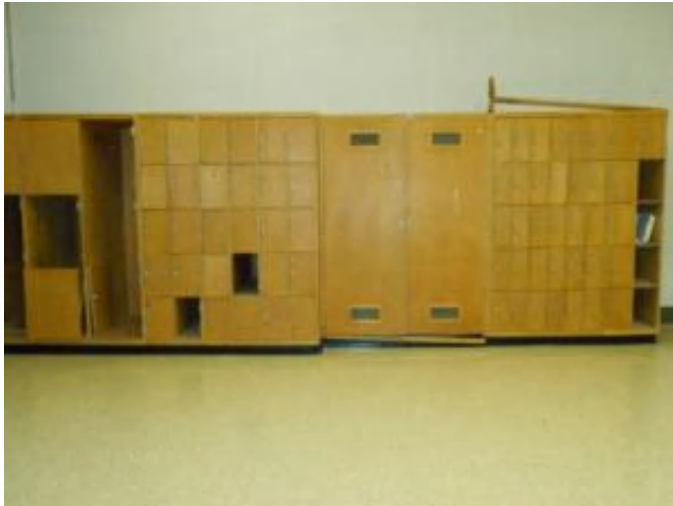
System: E2010 - Fixed Furnishings

Location: Music area

Distress: Security Issue

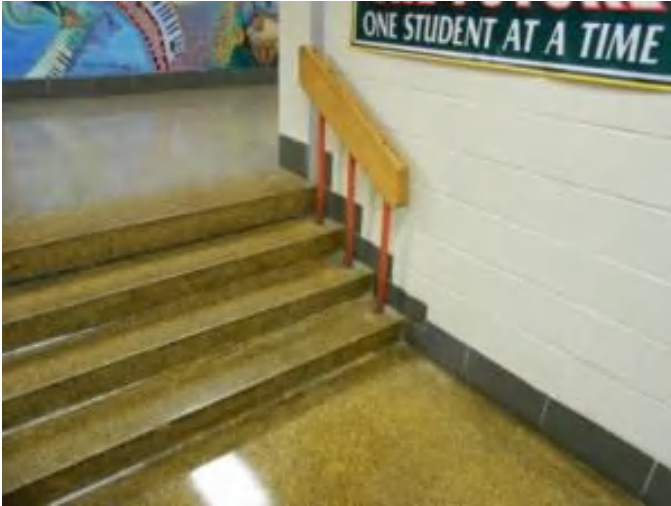
System: A1030 - Slab on Grade

Location: Connecting corridors between building blocks

Distress: Accessibility

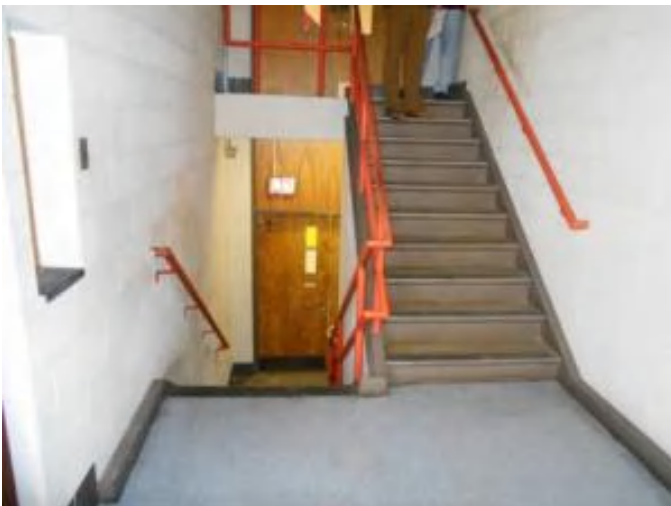
System: B1010 - Floor Construction

Location: 3rd Floor to IMC, 2nd Floor to IMC

Distress: Accessibility

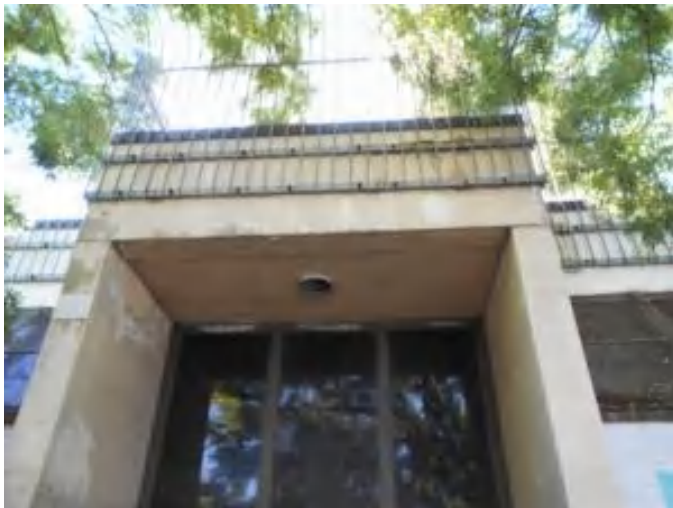
System: B2010 - Exterior Walls

Location: Exterior walls

Distress: Appearance

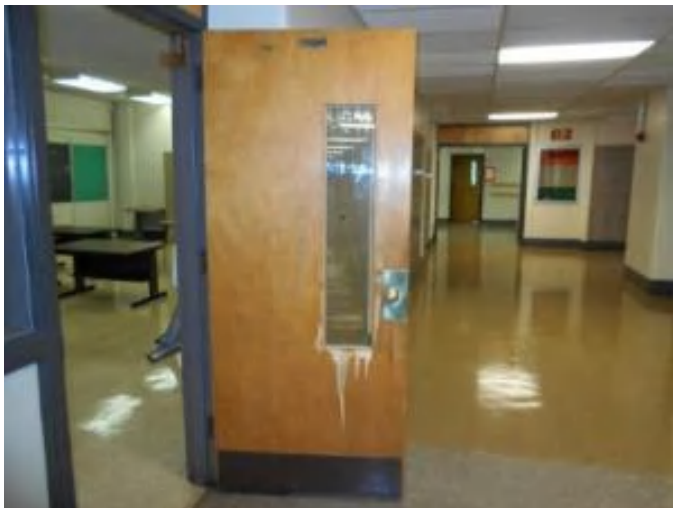
System: C1020 - Interior Doors

Location: Throughout the building

Distress: Beyond Service Life

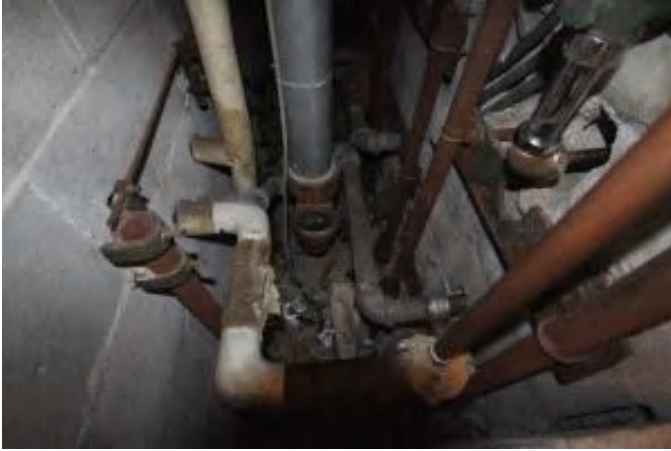
System: D2030 - Sanitary Waste

The sanitary sewer piping is threaded galvanized steel pipe and hub and spigot cast iron pipe. The pipe appears original to the building. First floor toilets back up during heavy rains, according to the principal. The sanitary drain piping should be entirely inspected and repaired where needed based on age, material, and reported failures. There is no sewage ejector.

Location: Entire building

Distress: Failing

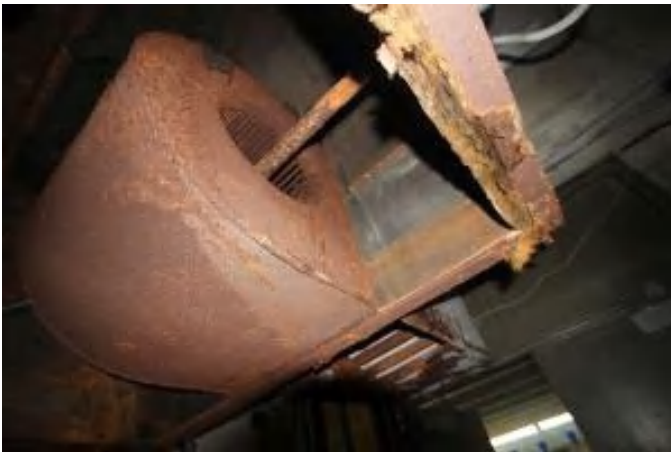
System: D3040 - Distribution Systems

Location: Gym and pool

Distress: Inadequate

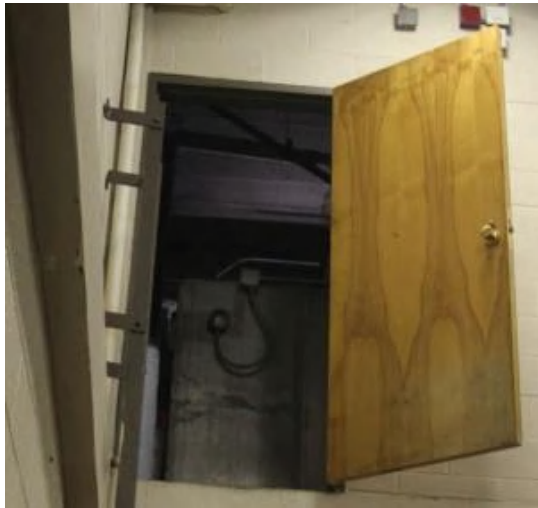
System: D3040 - Distribution Systems

Location: Auditorium

Distress: Beyond Service Life

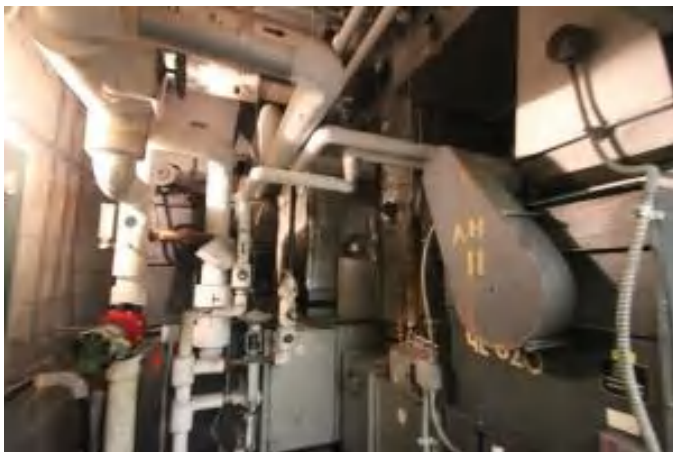
System: D3040 - Distribution Systems

Location: Cafeteria

Distress: Beyond Service Life

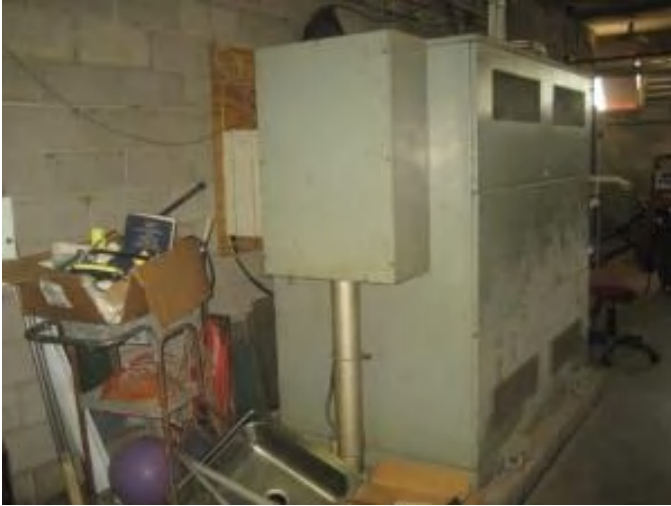
System: D5010 - Electrical Service/Distribution

Location: First Floor electrical room

Distress: Inadequate

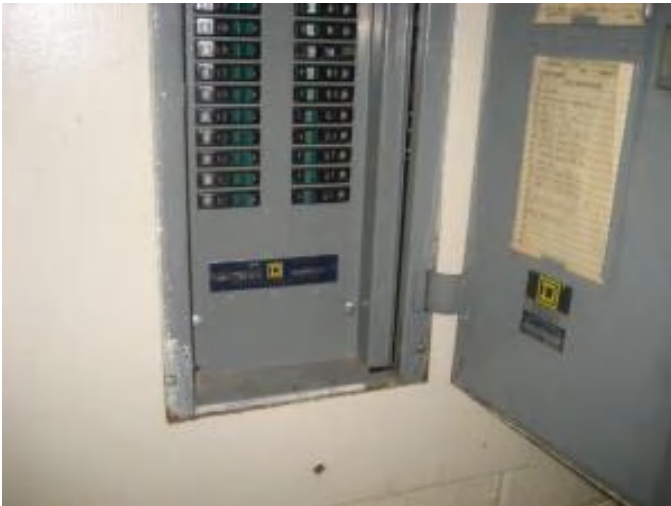
System: D5010 - Electrical Service/Distribution

Location: Entire Building

Distress: Beyond Service Life

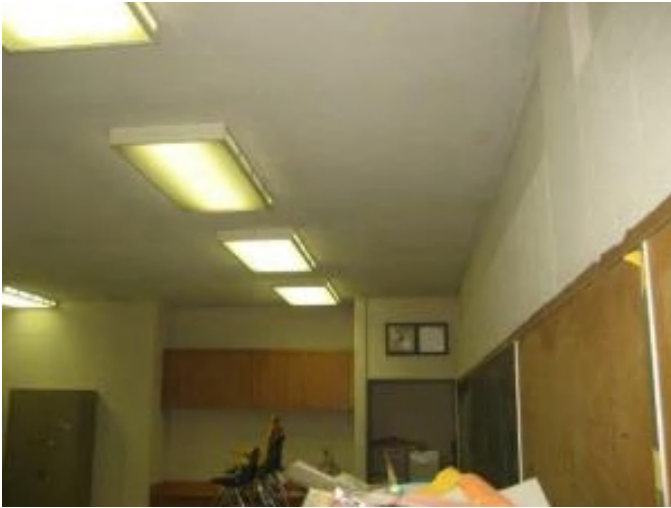
System: D5020 - Lighting and Branch Wiring

Location: Entire Building

Distress: Obsolete

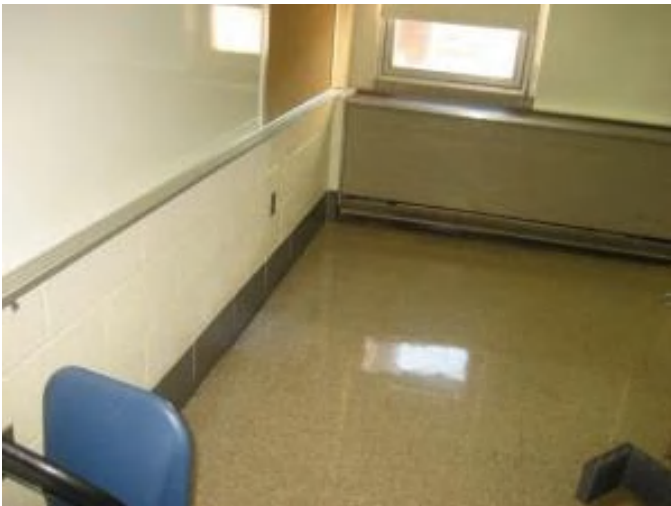
System: D5020 - Lighting and Branch Wiring

Location: Entire Building

Distress: Inadequate

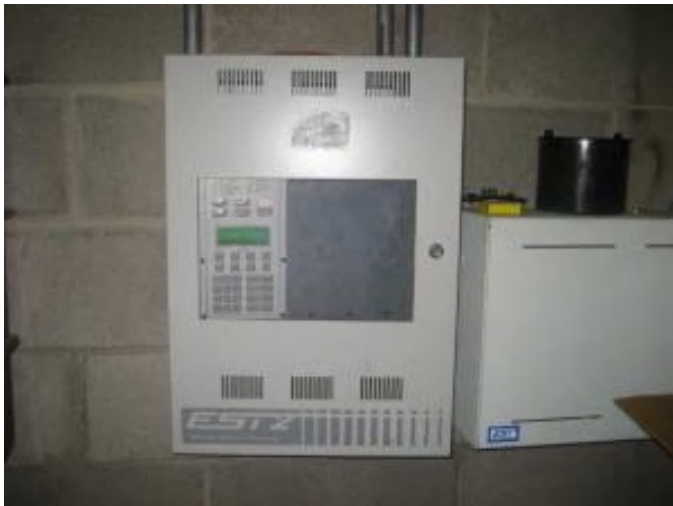
System: D5030 - Communications and Security

Location: Entire Building

Distress: Life Safety / NFPA / PFD

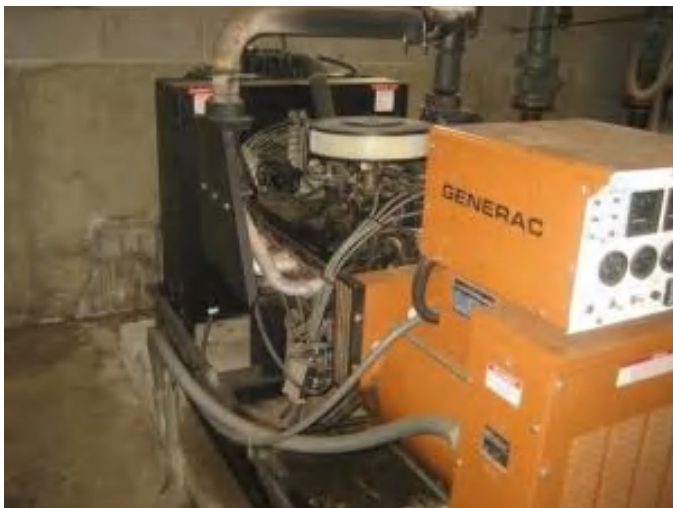
System: D5090 - Other Electrical Systems

Location: Outdoor

Distress: Inadequate

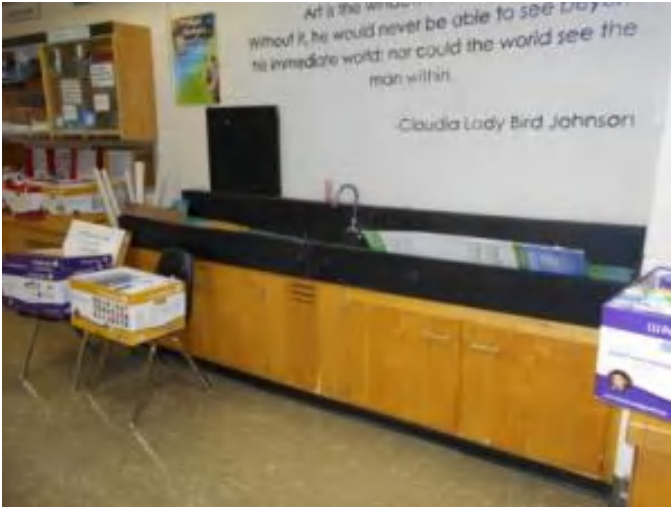
System: E1020 - Institutional Equipment

Location: Science classrooms

Distress: Beyond Service Life

- Replace laboratory equipment and casework

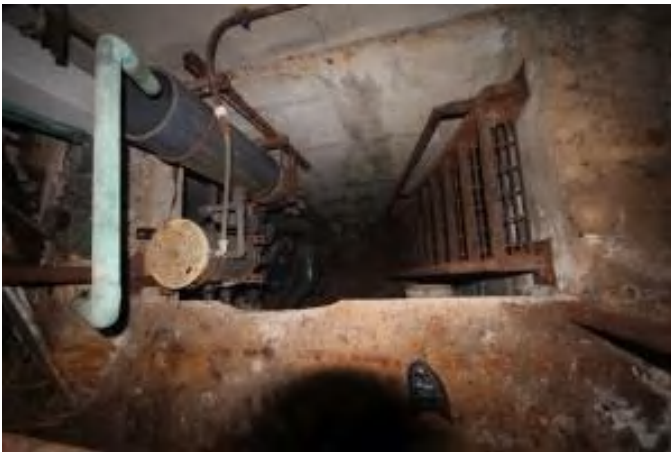
System: E1090 - Other Equipment

The swimming pool is completely inoperable. The pump room equipment is entirely rusted. The pool is 100 feet long and 60 feet wide, estimated 225,000 gallons. The principal would like the pool renovated.

Location: Pool

Distress: Failing

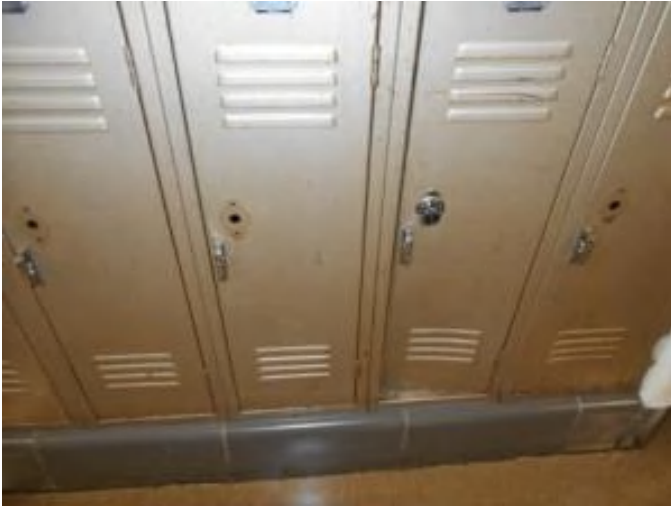
System: C1030 - Fittings

Location: Corridors

Distress: Beyond Service Life

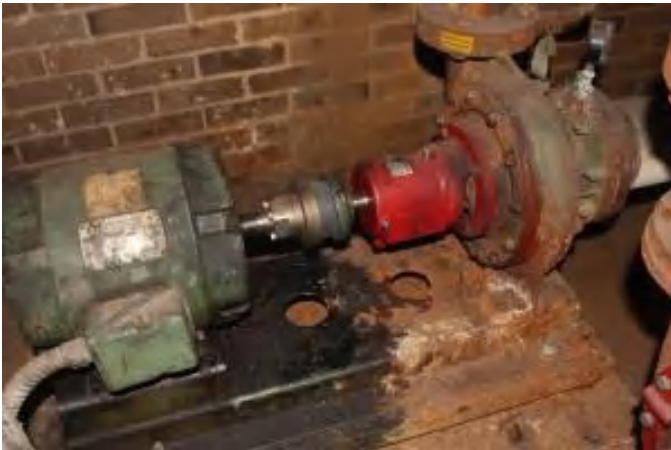
System: D3030 - Cooling Generating Systems

Location: Boiler room

Distress: Beyond Service Life

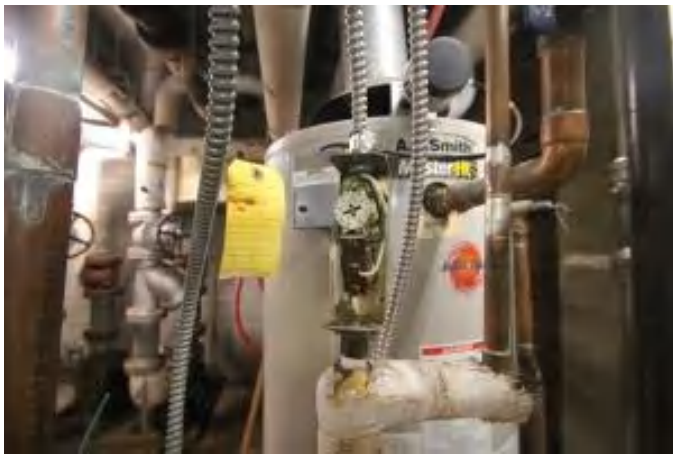
System: D3060 - Controls & Instrumentation

Location: Boiler room

Distress: Damaged

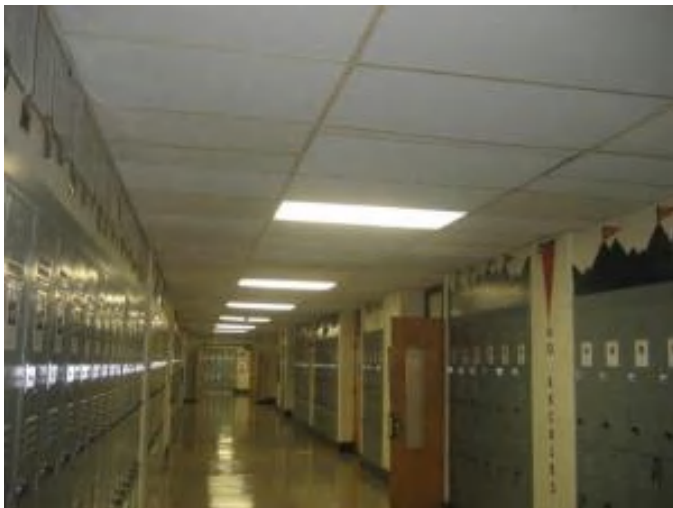
System: D5030 - Communications and Security

Location: Entire Building

Distress: Security Issue

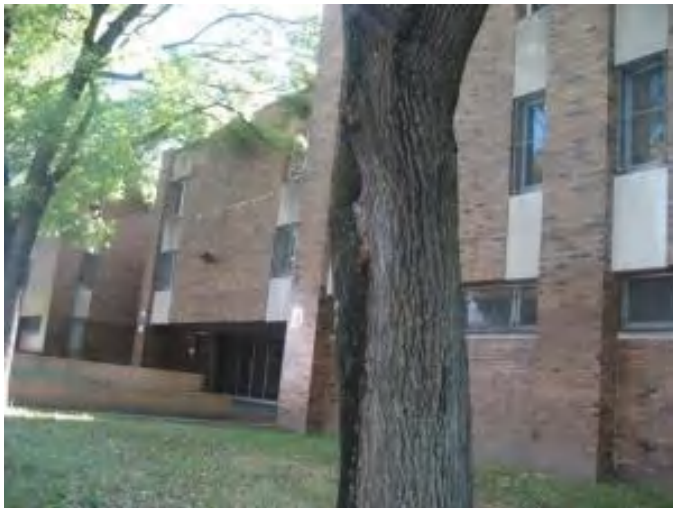
System: D5030 - Communications and Security

Location: Building perimeter

Distress: Security Issue

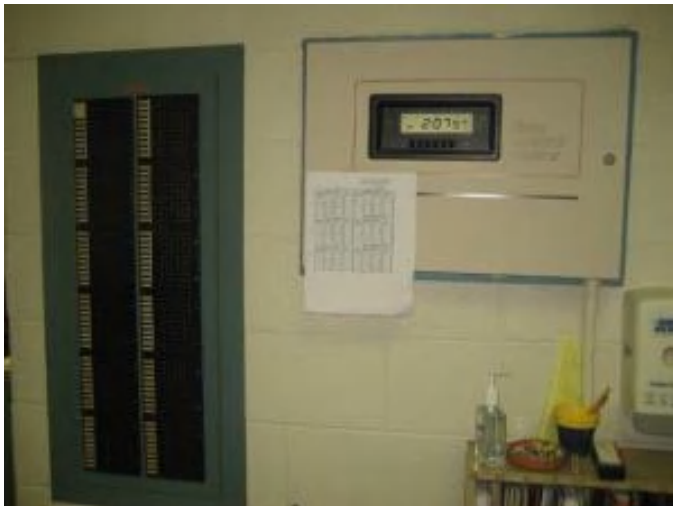
System: D5030 - Communications and Security

Location: Entire Building

Distress: Obsolete

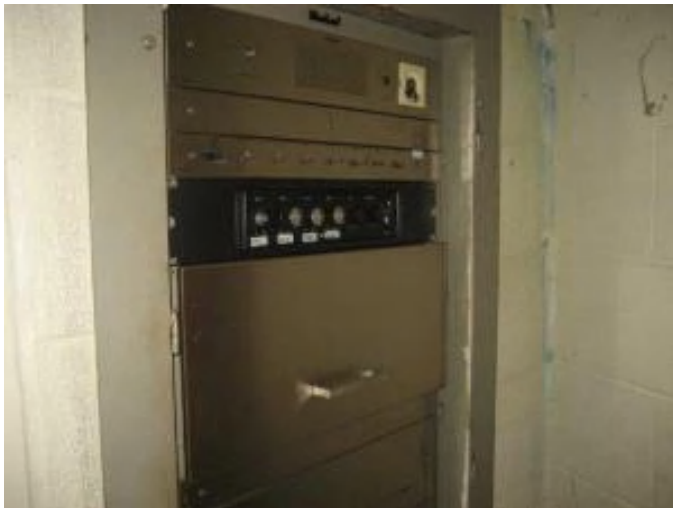
System: D5030 - Communications and Security

Location: Auditorium

Distress: Obsolete

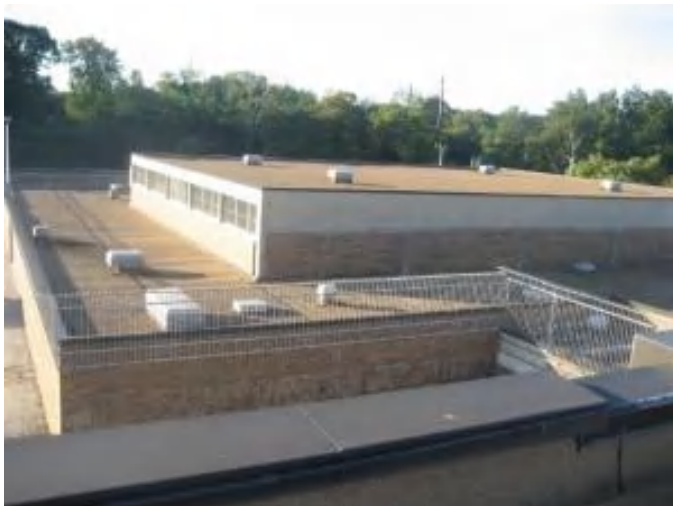
System: D5090 - Other Electrical Systems

Location: Roof

Distress: Life Safety / NFPA / PFD

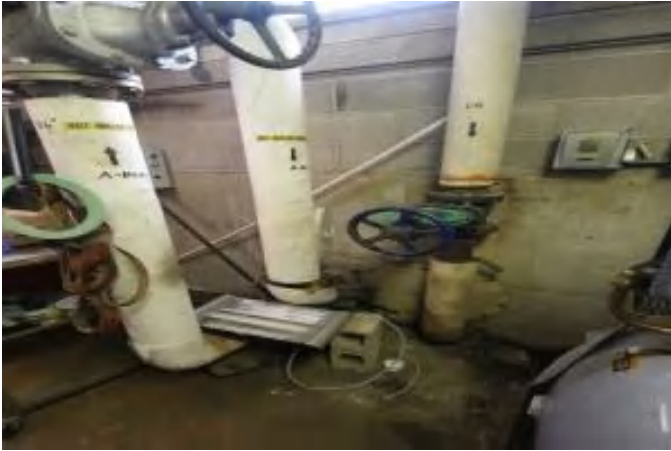
System: D3030 - Cooling Generating Systems

Location: Gym block

Distress: Inadequate

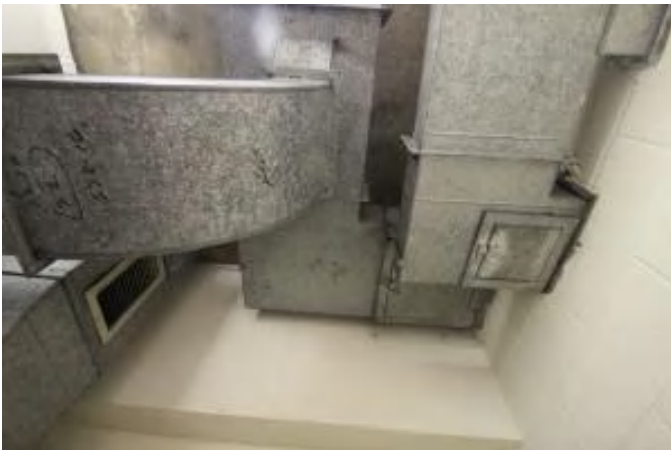
System: D3040 - Distribution Systems

Location: IMC

Distress: Beyond Service Life

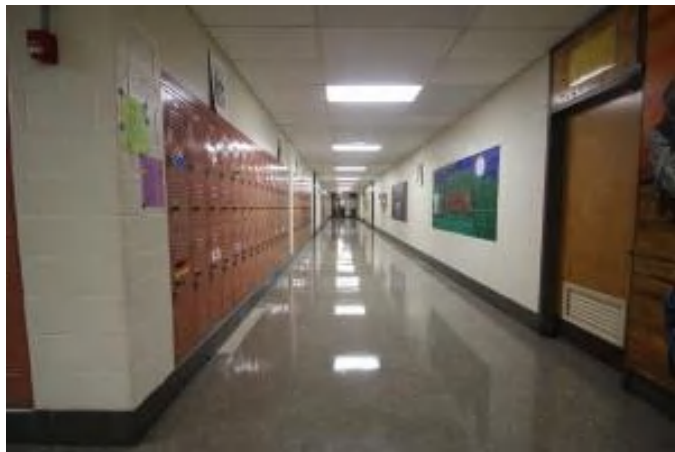
System: D4010 - Sprinklers

Location: Entire building

Distress: Life Safety / NFPA / PFD

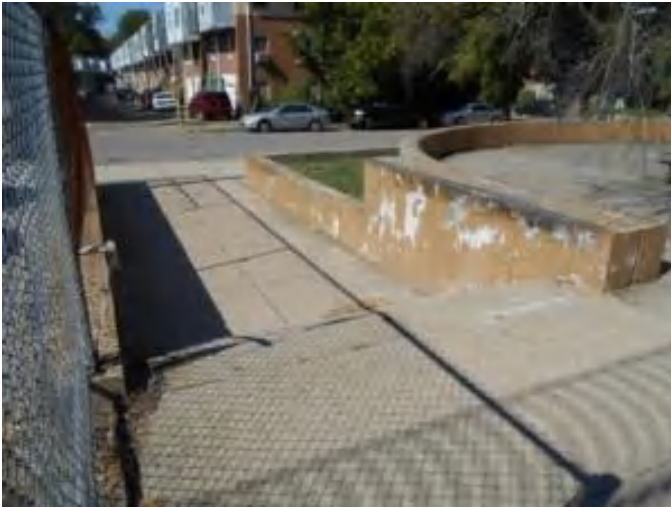
System: G2030 - Pedestrian Paving

Location: Entrances to KIPP and Head Start

Distress: Accessibility

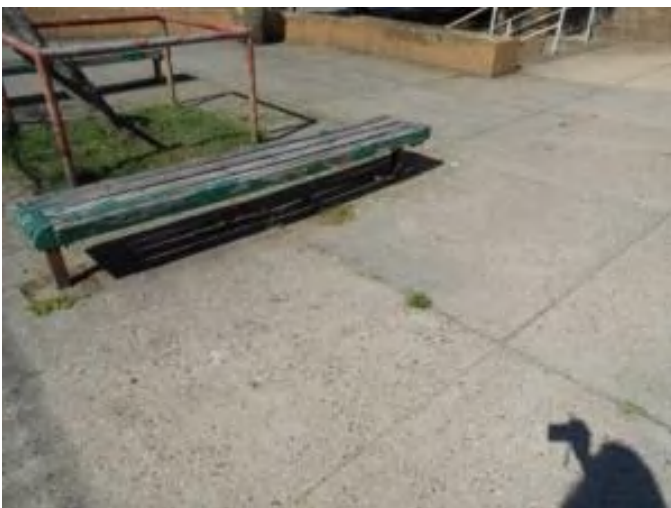
System: G2040 - Site Development

Location: Courtyards

Distress: Health Hazard / Risk

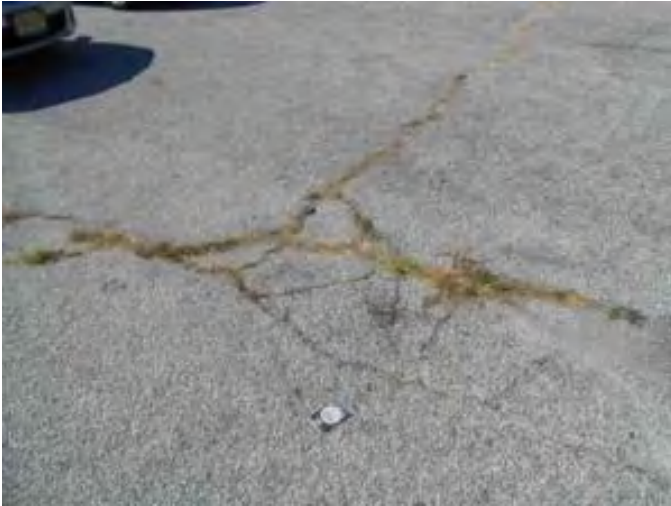
System: G2030 - Pedestrian Paving

Location: Parking Lots/Play Areas

Distress: Damaged

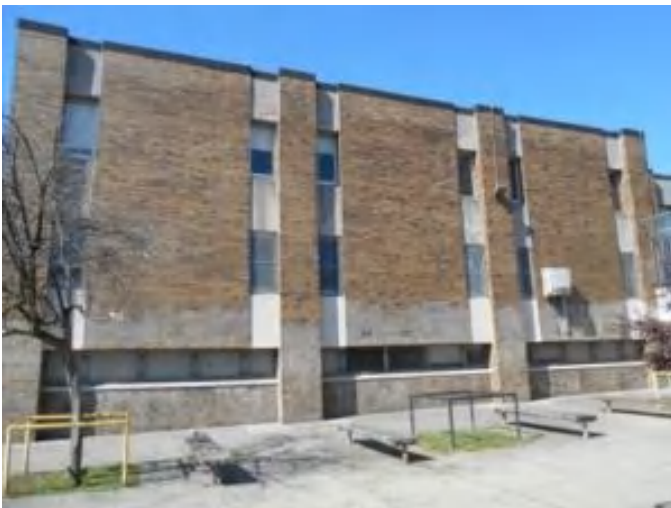
System: G2050 - Landscaping & Irrigation

Location: Exterior

Distress: Failing
