## Facility Condition Assessment Summary Report

### Kirkbride School

School District of Philadelphia  
**S258001;Kirkbride**  
Final  
**Site Assessment Report**  
January 31, 2017

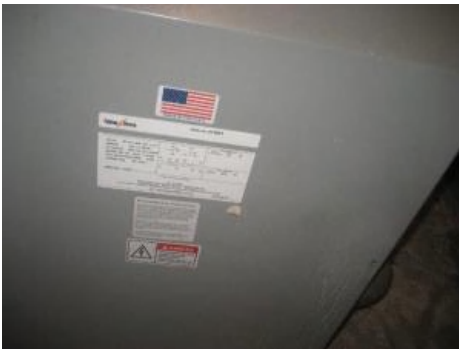
**System:** D5010 - Electrical Service/Distribution

**Note:** Phase converters (2) 50KVA and (1)37.5KVA

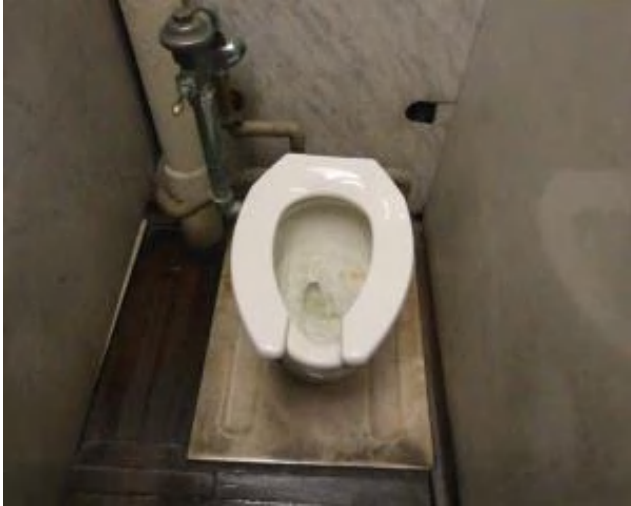
**Location:** Toilet room

#### System: D2010 - Plumbing Fixtures

**Distress:** Failing

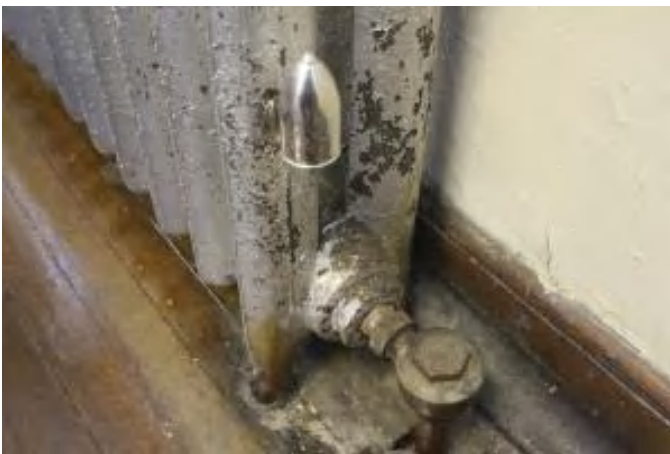
**Location:** Entire building

#### System: D3040 - Distribution Systems

**Distress:** Maintenance Required

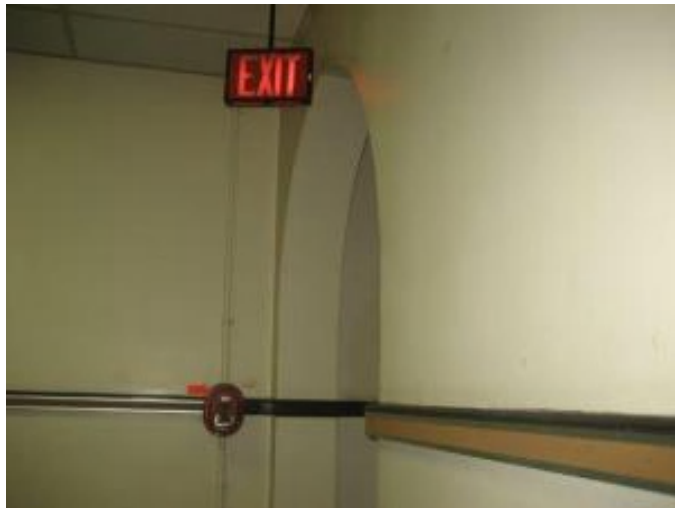
**Location:** corridors and stairways

**System: D5020 - Lighting and Branch Wiring**

**Distress:** Building / MEP Codes

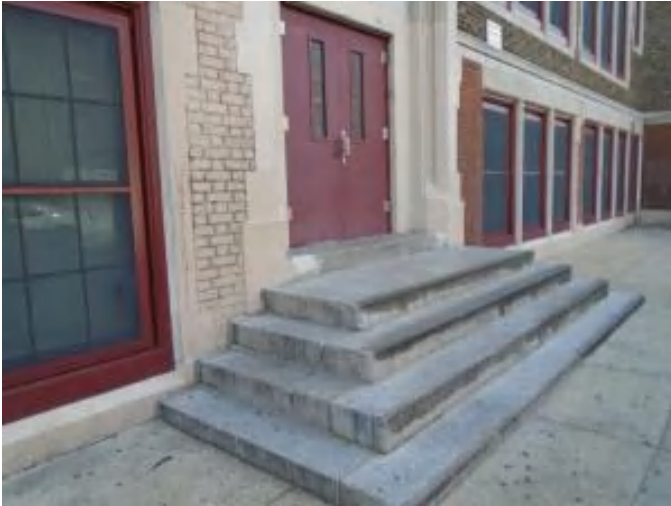
**Location:** Entrance

**System: B2030 - Exterior Doors**

**Distress:** Accessibility

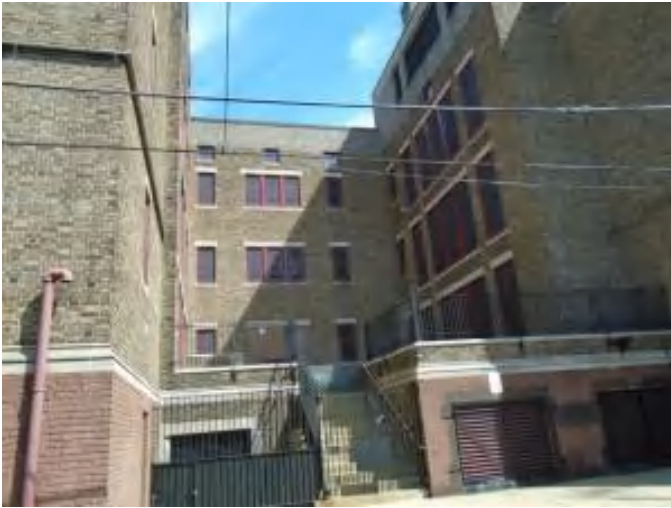
**Location:** TBD

**System: D1010 - Elevators and Lifts**

**Distress:** Accessibility

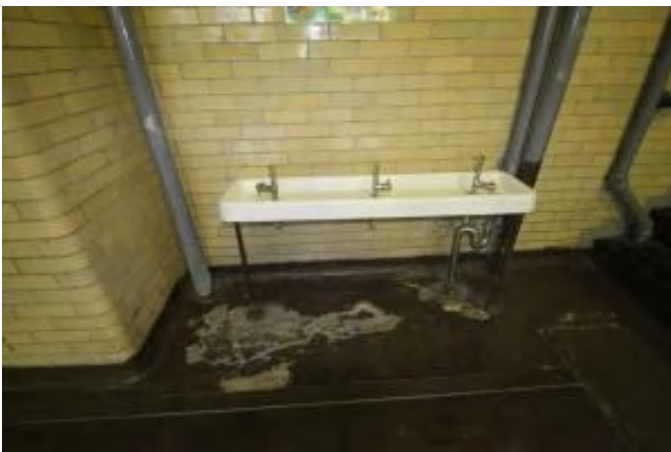
**Location:** Hallways

**System: D2010 - Plumbing Fixtures**

**Distress:** Accessibility

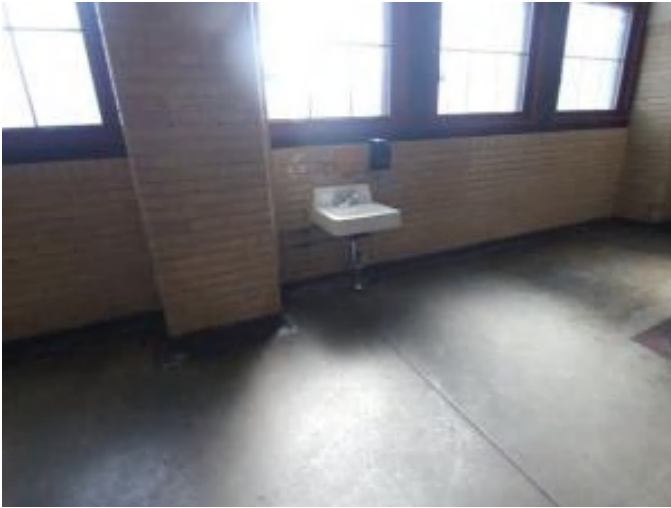
**System: D2010 - Plumbing Fixtures**

**Location:** Toilet rooms  
**Distress:** Inadequate  
**Category:** 4 - Capital Improvement  
**Priority:** 2 - Response Time (2-3 yrs)  
**Correction:** Remove and replace or replace lavatory - quantify accessible if required  
**Qty:** 15.00  
**Unit of Measure:** Ea.  
**Estimate:** \$57,864.77  
**Assessor Name:** System  
**Date Created:** 11/30/2015

**Notes:** Install 10 new lavatories due to lack of capacity and replace 5 lavatories due to stains.

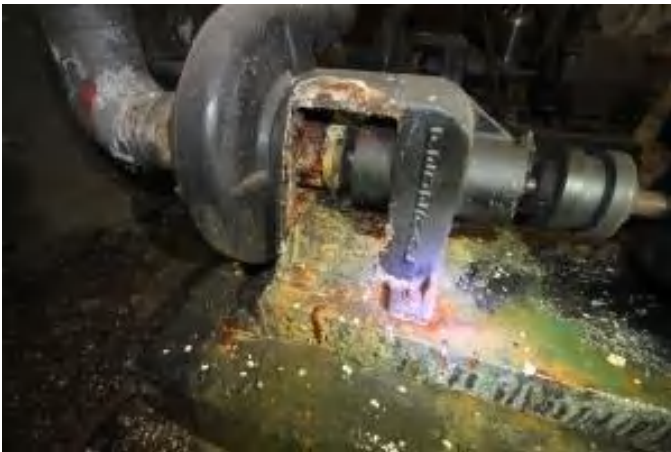
**System: D2020 - Domestic Water Distribution**

**Location:** Boiler room  
**Distress:** Failing  
**Category:** 3 - Operations / Maint.  
**Priority:** 2 - Response Time (2-3 yrs)  
**Correction:** Replace duplex domestic booster pump set (5 HP)  
**Qty:** 1.00  
**Unit of Measure:** Ea.  
**Estimate:** \$50,533.86  
**Assessor Name:** System  
**Date Created:** 11/30/2015

**Notes:** Replace failing domestic water pressure booster pumps with new packaged system including hydro-pneumatic storage tank.

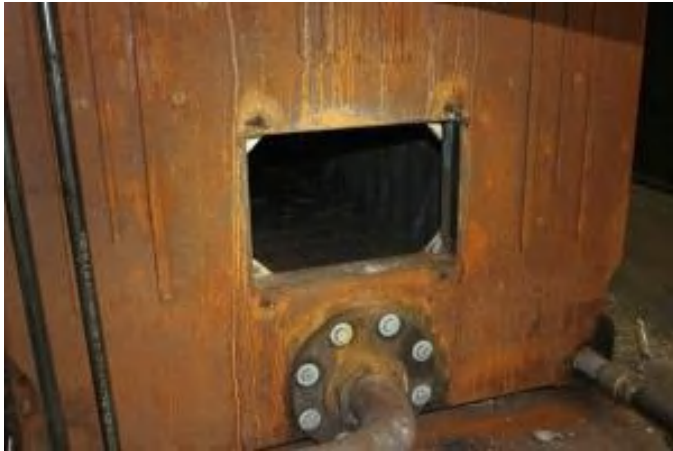
**Location:** Boiler room

**System: D3020 - Heat Generating Systems**

**Distress:** Beyond Service Life

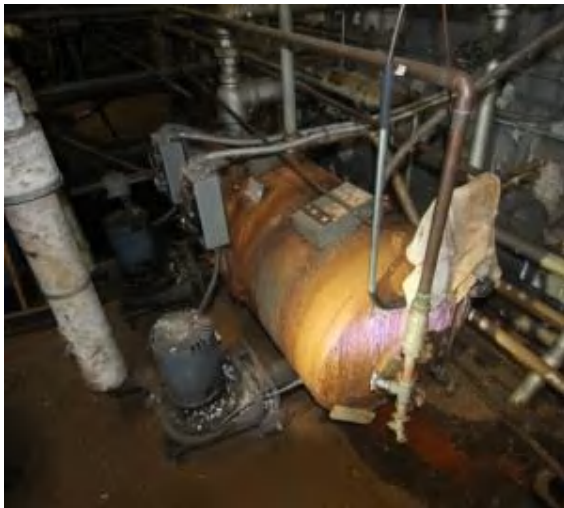
**Location:** Boiler room

**System: D3020 - Heat Generating Systems**

**Distress:** Failing

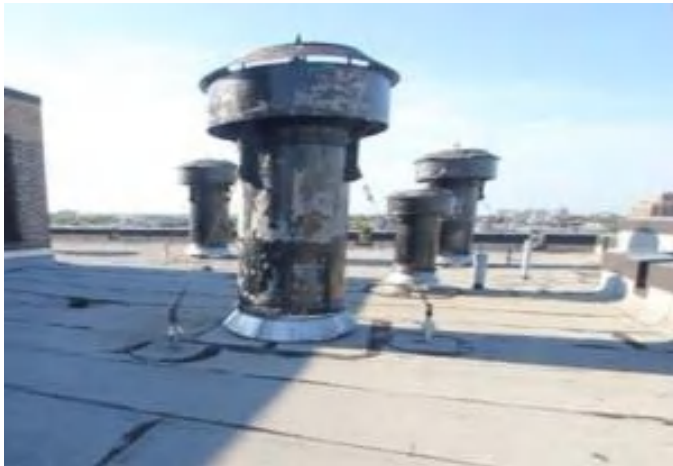
**System: D3040 - Distribution Systems**

**Location:** Roof top  
**Distress:** Failing  
**Category:** 3 - Operations / Maint.  
**Priority:** 2 - Response Time (2-3 yrs)  
**Correction:** Replace rooftop gravity ventilator units - select the proper type and size  
**Qty:** 12.00  
**Unit of Measure:** Ea.  
**Estimate:** \$28,424.01  
**Assessor Name:** System  
**Date Created:** 11/30/2015

**Notes:** Replace rooftop gravity vents due to age and reported leaks.

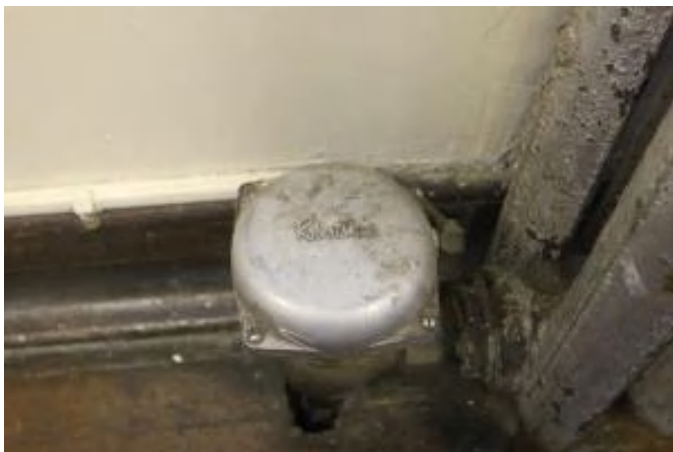
**System: D3060 - Controls & Instrumentation**

**Location:** Entire building  
**Distress:** Failing  
**Category:** 3 - Operations / Maint.  
**Priority:** 2 - Response Time (2-3 yrs)  
**Correction:** Replace pneumatic controls with DDC (75KSF)  
**Qty:** 57,000.00  
**Unit of Measure:** S.F.  
**Estimate:** \$1,222,769.19  
**Assessor Name:** System  
**Date Created:** 11/30/2015

**Notes:** Replace obsolete pneumatic controls with DDC.

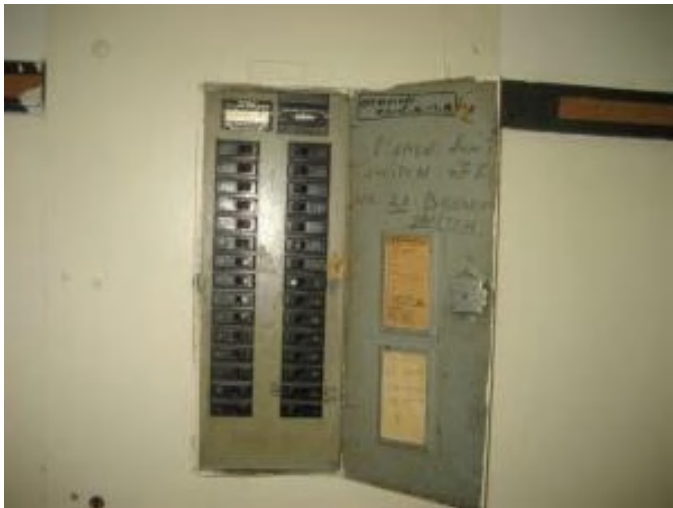
**System: D5010 - Electrical Service/Distribution**

**Location:** Corridors  
**Distress:** Inadequate  
**Category:** 4 - Capital Improvement  
**Priority:** 2 - Response Time (2-3 yrs)  
**Correction:** Replace Panelboard  
**Qty:** 12.00  
**Unit of Measure:** Ea.  
**Estimate:** \$539,706.19  
**Assessor Name:** System  
**Date Created:** 10/14/2015

**Notes:** Replace the entire distribution system with new panels and new wiring/conduits. Approximate (12) 208/120V panel boards.

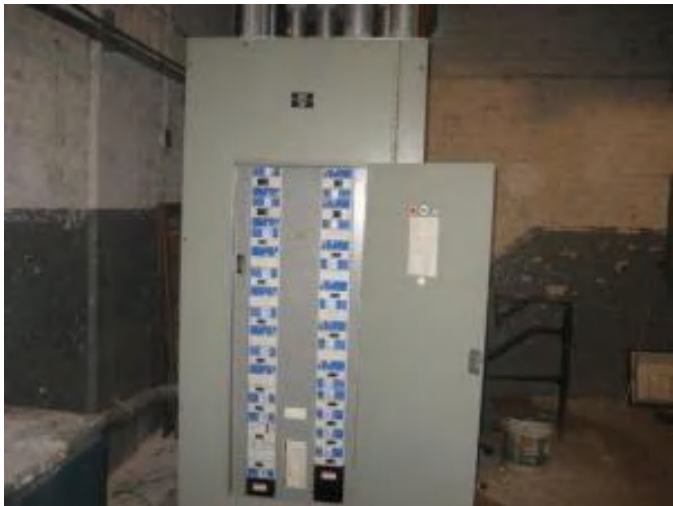
**System: D5010 - Electrical Service/Distribution**

**Location:** Basement electrical room  
**Distress:** Inadequate  
**Category:** 4 - Capital Improvement  
**Priority:** 2 - Response Time (2-3 yrs)  
**Correction:** Replace Switchboard  
**Qty:** 1.00  
**Unit of Measure:** Ea.  
**Estimate:** \$351,752.54  
**Assessor Name:** System  
**Date Created:** 10/14/2015

**Notes:** Provide a new electrical service 480V/277V, 3 phase power, approximate 1000 Amperes and will be located in the vicinity of the existing electrical service.

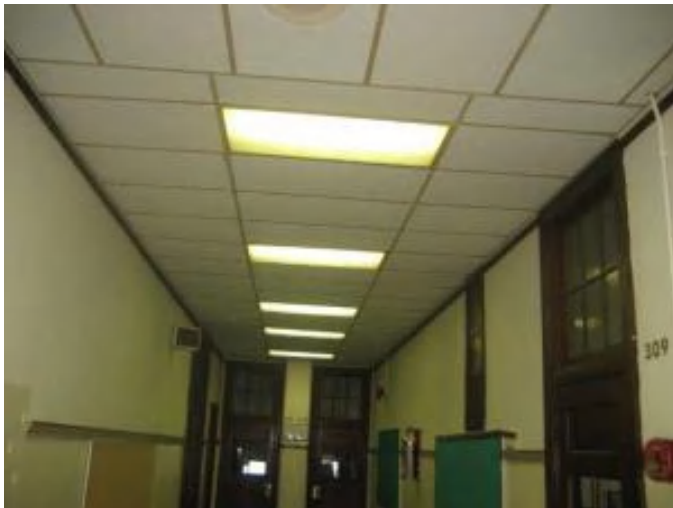
**System: D5020 - Lighting and Branch Wiring**

**Location:** Entire Building  
**Distress:** Obsolete  
**Category:** 3 - Operations / Maint.  
**Priority:** 2 - Response Time (2-3 yrs)  
**Correction:** Add Lighting Fixtures  
**Qty:** 530.00  
**Unit of Measure:** Ea.  
**Estimate:** \$456,774.84  
**Assessor Name:** System  
**Date Created:** 10/14/2015

**Notes:** Replace 70% of the existing lighting fixtures with up/down, recessed fluorescent fixtures with T8 lamps. Approximate 530 fixtures

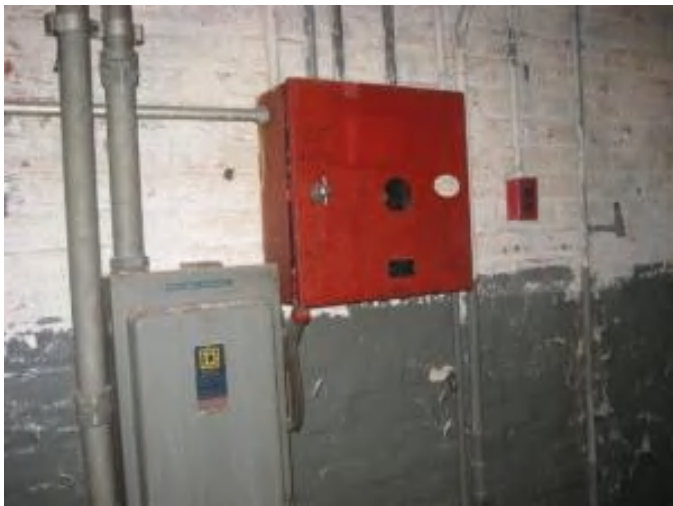
**System: D5030 - Communications and Security**

**Location:** Entire Building  
**Distress:** Life Safety / NFPA / PFD  
**Category:** 1 - Health & Safety  
**Priority:** 2 - Response Time (2-3 yrs)  
**Correction:** Replace fire alarm system  
**Qty:** 76.00  
**Unit of Measure:** S.F.  
**Estimate:** \$198,770.30  
**Assessor Name:** System  
**Date Created:** 10/14/2015

**Notes:** Replace old fire alarm system with addressable type with audio/visual devices at corridors and classrooms. Approximate 76 devices

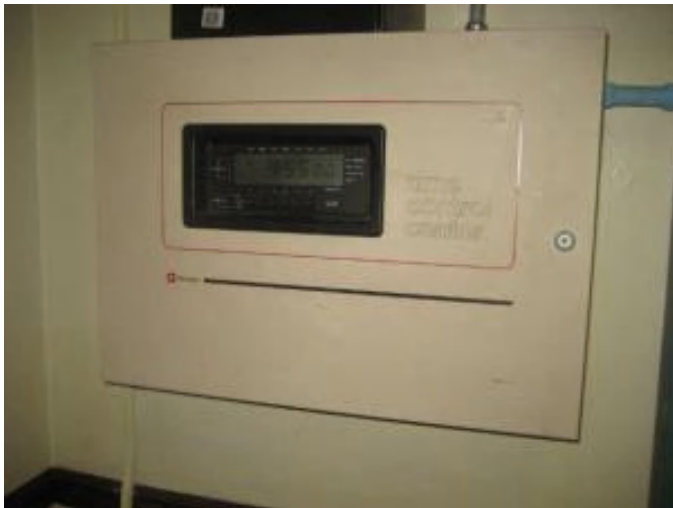
**System: D5030 - Communications and Security**

**Location:** Entire Building  
**Distress:** Obsolete  
**Category:** 3 - Operations / Maint.  
**Priority:** 2 - Response Time (2-3 yrs)  
**Correction:** Add/Replace Clock System or Components  
**Qty:** 53.00  
**Unit of Measure:** Ea.  
**Estimate:** \$112,560.22  
**Assessor Name:** System  
**Date Created:** 10/14/2015

**Notes:** Replace clock and bell system with wireless, battery operated, atomic clock system. Approximate 53

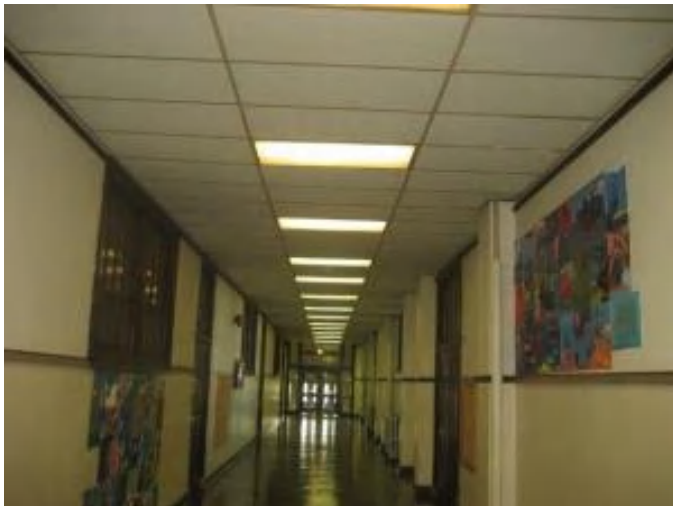
**System: D5030 - Communications and Security**

**Location:** Third Floor corridor  
**Distress:** Security Issue  
**Category:** 1 - Health & Safety  
**Priority:** 2 - Response Time (2-3 yrs)  
**Correction:** Add/Replace Video Surveillance System  
**Qty:** 6.00  
**Unit of Measure:** Ea.  
**Estimate:** \$49,329.72  
**Assessor Name:** System  
**Date Created:** 10/14/2015

**Notes:** Provide CCTV cameras to the third floor for a complete coverage of the school interior. Approximate 6 CCTV cameras

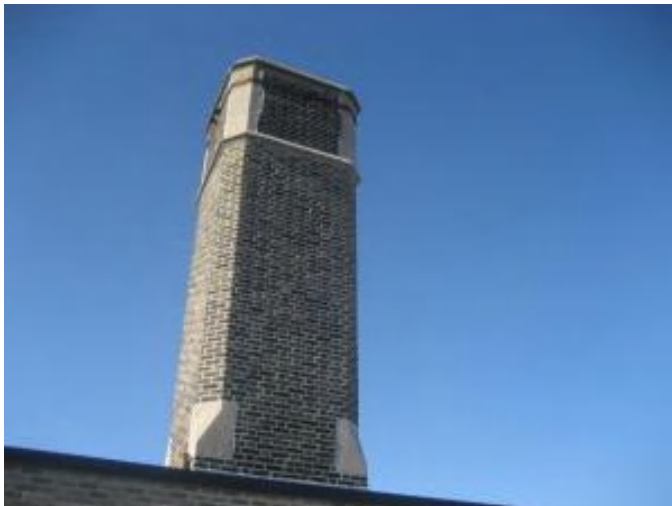
**Location:** Roof

**System: D5090 - Other Electrical Systems**

**Distress:** Building / MEP Codes

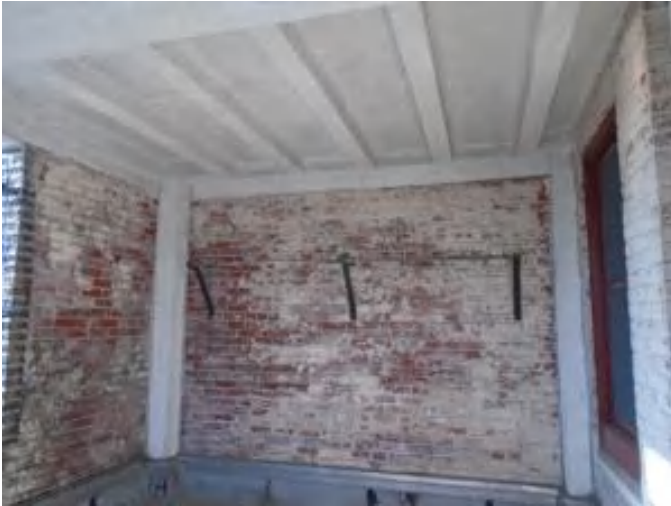
**Location:** Rooftop

**System: B1010 - Floor Construction**

**Distress:** Inadequate

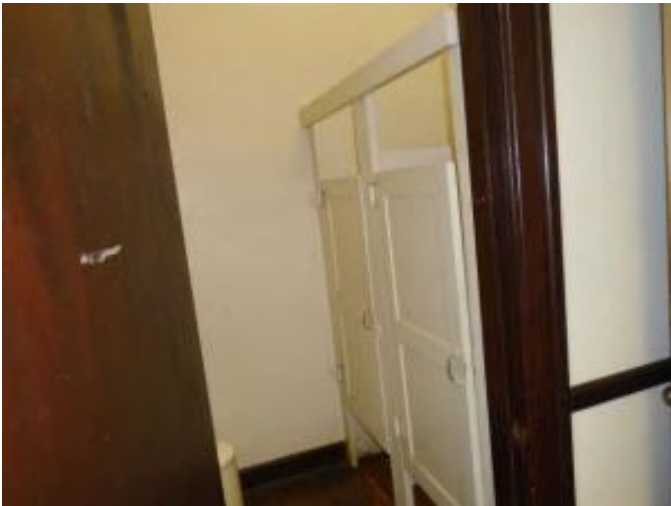
**Location:** Toilets

**System: C1030 - Fittings**

**Distress:** Beyond Service Life

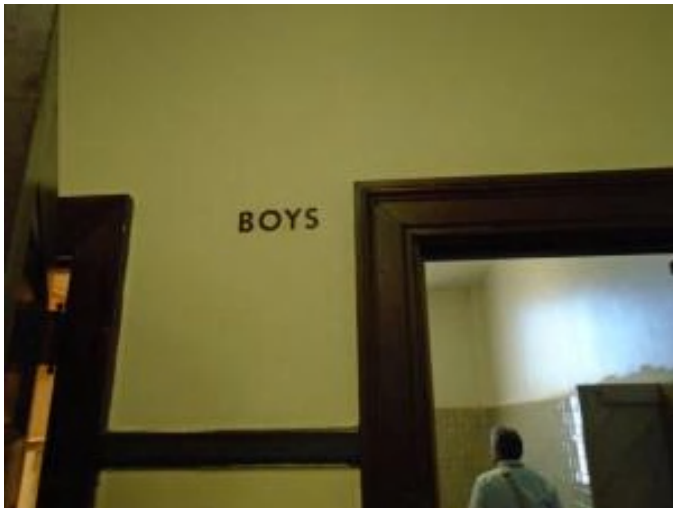
**Location:** Throughout

**System: C1030 - Fittings**

**Distress:** Inadequate

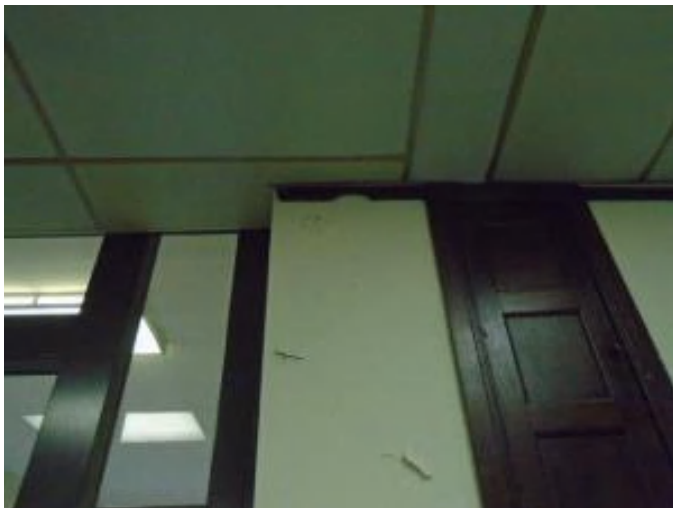
**Location:** Corridors

**System: C3030 - Ceiling Finishes**

**Distress:** Beyond Service Life

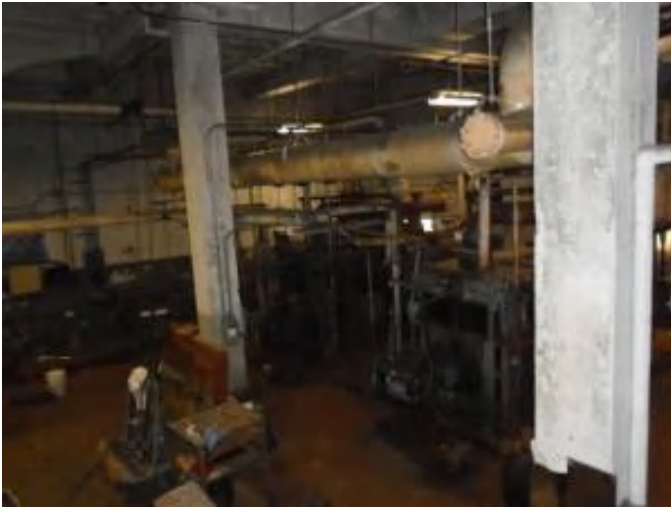
**System: C3030 - Ceiling Finishes**

**Location:** Basement, gym  
**Distress:** Appearance  
**Category:** 3 - Operations / Maint.  
**Priority:** 3 - Response Time (3-4 yrs)  
**Correction:** Re-paint ceilings - SF of ceilings  
**Qty:** 7,500.00  
**Unit of Measure:** S.F.  
**Estimate:** \$35,902.71  
**Assessor Name:** System  
**Date Created:** 10/23/2015

**Notes:** Strip and paint basement and gym ceilings – beyond service life

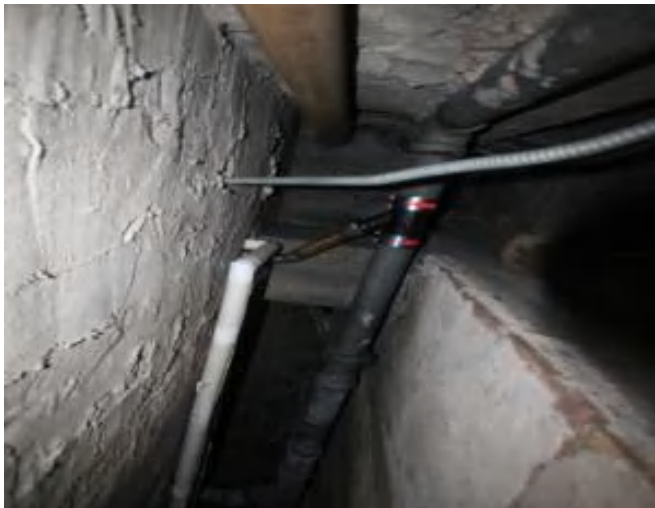
**System: D2030 - Sanitary Waste**

**Location:** Entire building  
**Distress:** Failing  
**Category:** 3 - Operations / Maint.  
**Priority:** 3 - Response Time (3-4 yrs)  
**Correction:** Inspect sanitary waste piping and replace damaged sections. (+50KSF)  
**Qty:** 57,000.00  
**Unit of Measure:** S.F.  
**Estimate:** \$279,627.81  
**Assessor Name:** System  
**Date Created:** 11/30/2015

**Notes:** Inspect and repair sanitary waste pipe due to age, reports of problems, and slow drains.

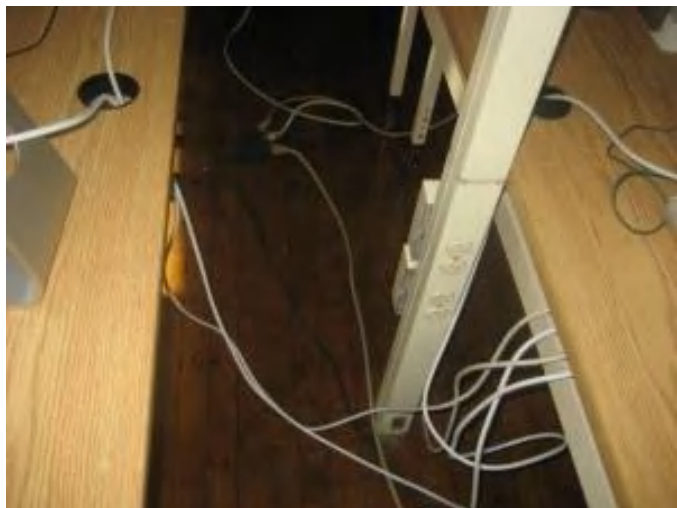
**System: D5020 - Lighting and Branch Wiring**

**Location:** Classrooms  
**Distress:** Inadequate  
**Category:** 4 - Capital Improvement  
**Priority:** 3 - Response Time (3-4 yrs)

**Correction:** Add wiring device

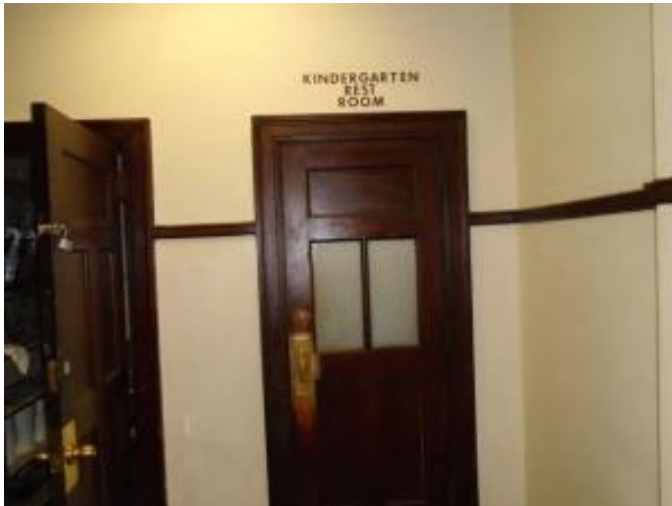
**Location:** Throughout

**System: C1020 - Interior Doors**

**Distress:** Beyond Service Life

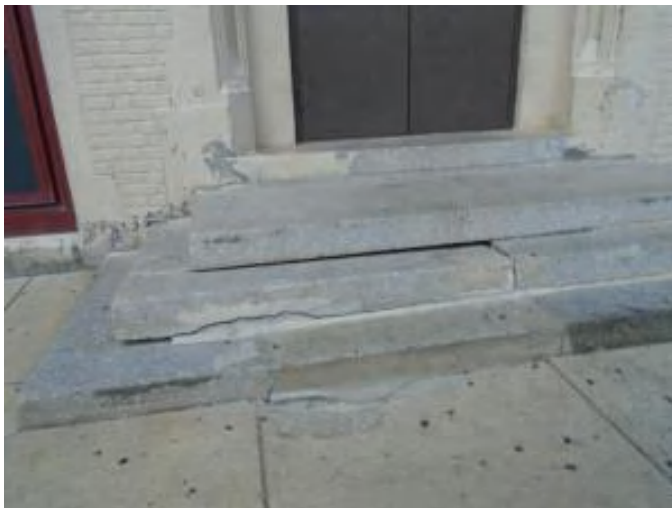
**Location:** Entrances

**System: C2010 - Stair Construction**

**Distress:** Failing

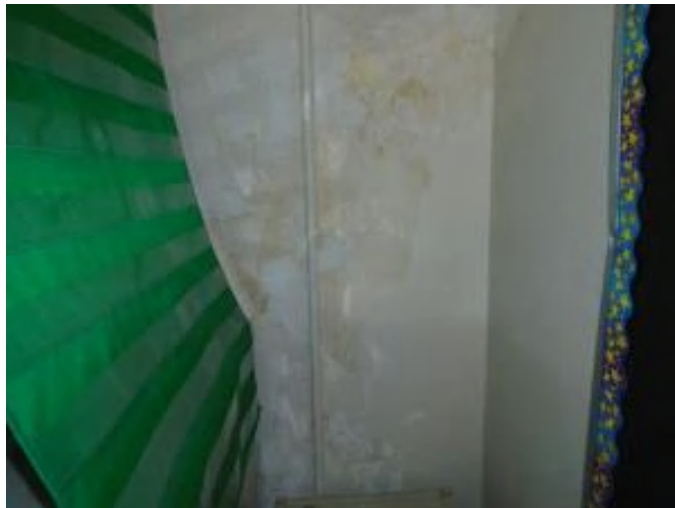
**Location:** Various

**System: C3010230 - Paint & Covering**

**Distress:** Damaged

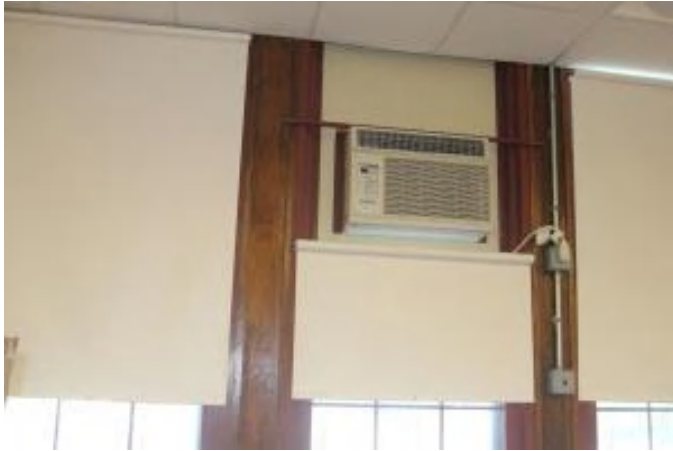
**Location:** Entire building

**System: D3030 - Cooling Generating Systems**

**Distress:** Inadequate

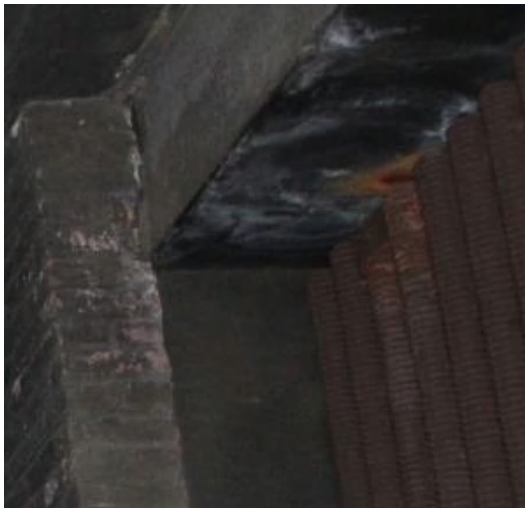
**Location:** Basement

**System: D3040 - Distribution Systems**

**Distress:** Beyond Service Life

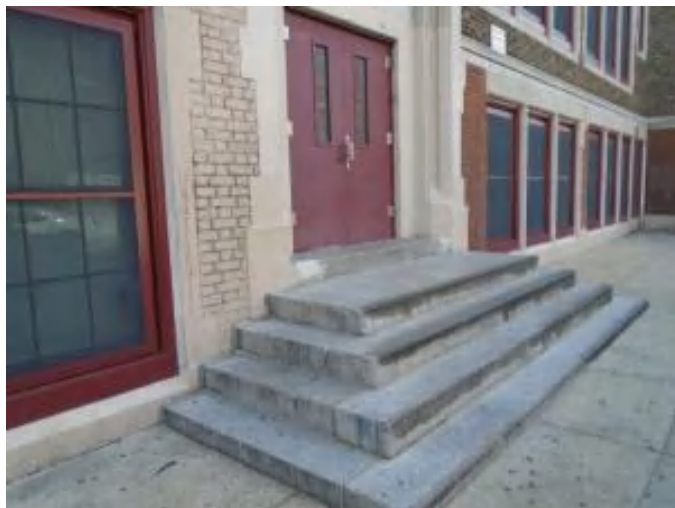
**Location:** Entrance

#### System: G2030 - Pedestrian Paving

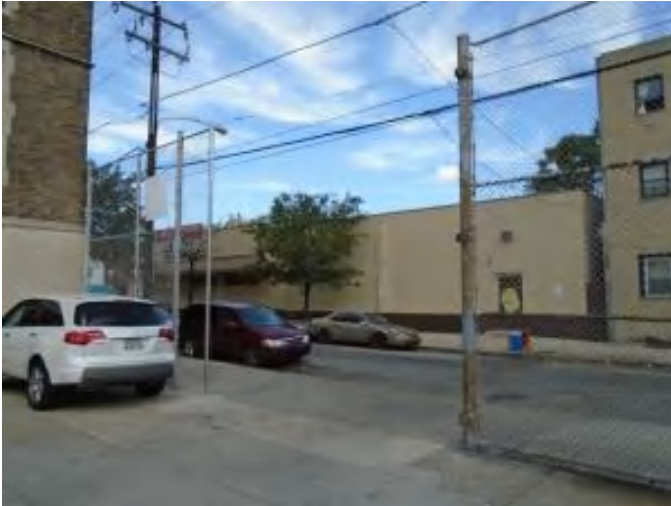
**Location:** Site

**System: G2040 - Site Development**
