Facility Condition Assessment Summary Report

Lankenau School

School District of Philadelphia
S654001;Lankenau
Final
Site Assessment Report
February 2, 2017

Site Assessment Report

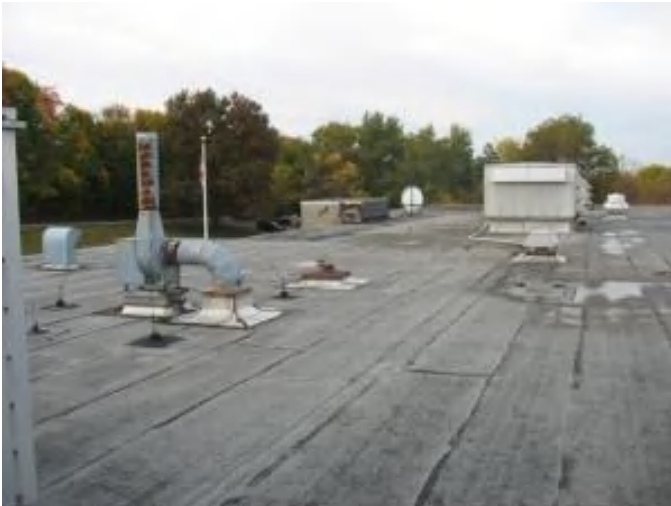
System: D3040 - Distribution Systems

Location: Roof

Distress: Beyond Service Life

Notes: Replace three (3) roof mounted power ventilators allowing relief air to escape from the building which are beyond their service lives.

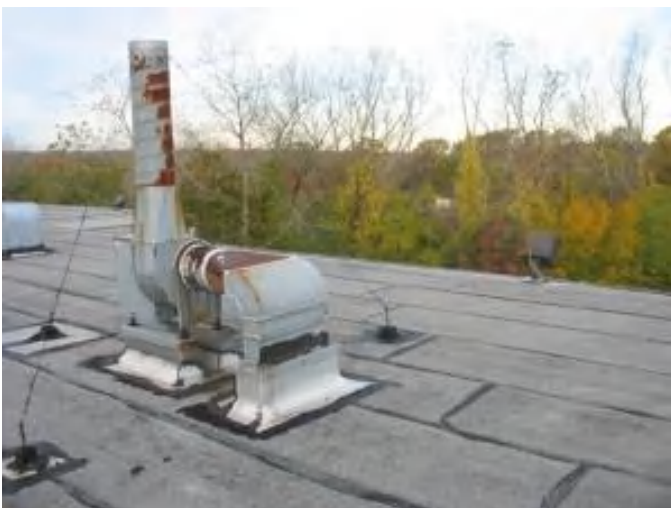
System: D3040 - Distribution Systems

Exhaust for the restrooms and Kitchen is provided by three (3) roof mounted exhaust fans. The two (2) fans serving the restrooms are beyond their service lives, no longer operational, and should be replaced. The one (1) fan serving the Kitchen is operational and within its service life. Three (3) roof mounted power ventilators allow relief air to escape from the building. These units are beyond their service life and should be replaced.

Location: Roof

Distress: Failing

Notes: Replace two (2) roof mounted exhaust fans serving the restrooms on the east and west sides of the building which are no longer operational.

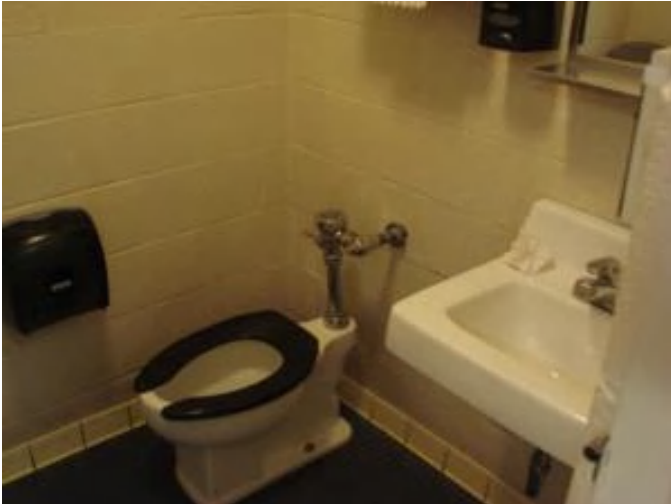
System: C1010 - Partitions

Location: Restrooms

Distress: Accessibility

Notes: Replace non-ADA compliant toilet partitions; reconfigure remaining toilet partitions

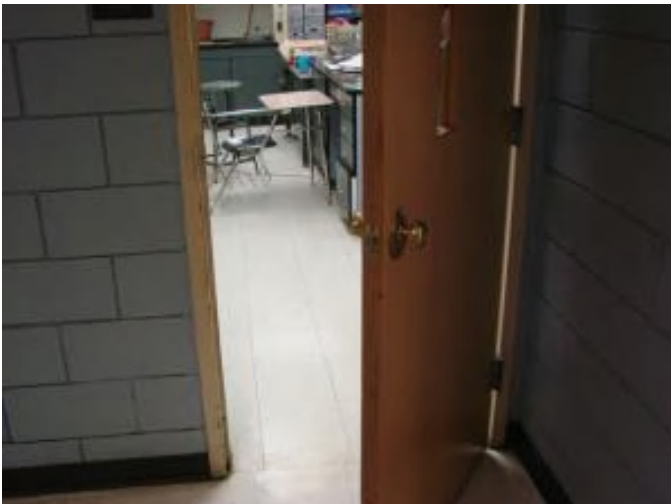
System: C1020 - Interior Doors

Interior doors are in fair condition; but are missing ADA compliant hardware. The doors leading to exits stairways are hollow metal doors and frames in good condition.

Location: Throughout building

Distress: Accessibility

Notes: Replace interior doors hardware for ADA accessibility

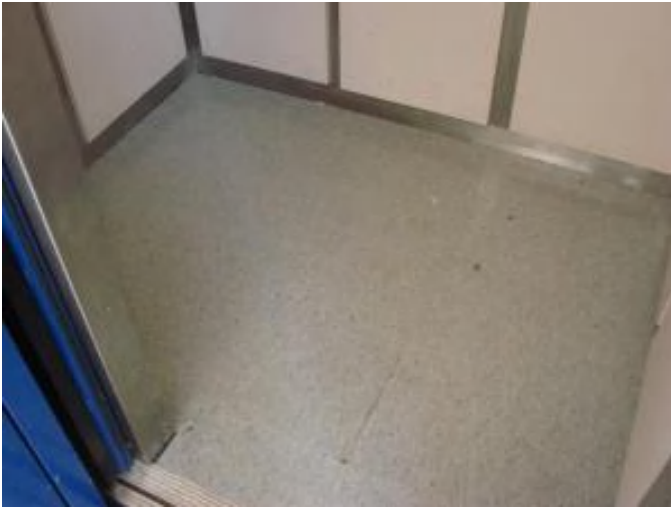
System: D1010 - Elevators and Lifts

The building has 2100 lb hydraulic elevator, original to the building. Cabin size does not conform to ADA requirement and its finishes are old and deteriorating.

Location: Main lobby area

Distress: Accessibility

Notes: Replace existing elevator with an ADA compliant 2500 lb elevator serving all floors

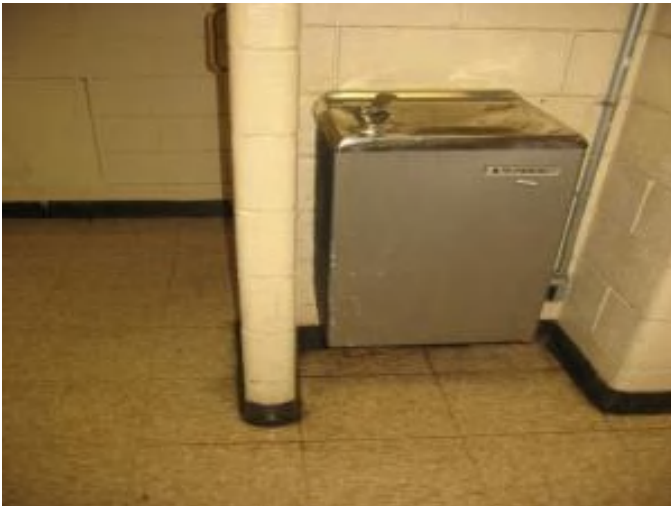
System: D2010 - Plumbing Fixtures

Drinking fountains in the corridors and at the restrooms are wall hung with integral refrigerated coolers. Many are beyond their service life, several have been replaced, and should be replaced; most are NOT accessible type.

Location: Throughout building

Distress: Beyond Service Life

Notes: Replace six (6) wall hung drinking fountains and integral refrigerated coolers in the corridors. These units are well beyond their service life and are NOT accessible type.

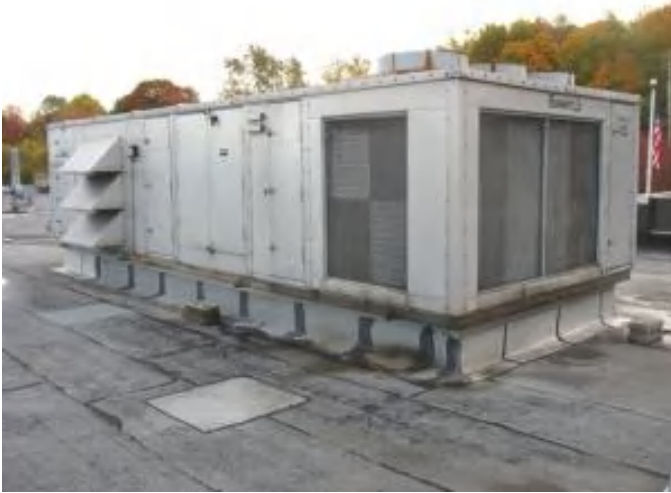
System: D3040 - Distribution Systems

The school is heated and cooled by three (3) Governair model TL20 roof mounted packaged air handling units. Each unit is custom designed to have integral direct expansion (DX) condensers for air conditioning, hot water coils for heating, and integral outdoor air intake. Conditioned air is provided to the spaces within the building by these units and associated variable air volume (VAV) boxes and distribution ductwork within the building. Each unit serves approximately 1/3 of the building with HVAC-1 serving the North side of the building, HVAC-2 serving the central part of the building, and HVAC-3 serving the South side of the building. Each unit has a 15HP supply fan, a three or five horsepower return fan, two (2) compressors, and utilizes R-22 refrigerant which is being phased out of use. These three (3) units were installed in 1993, are approaching the end of their service lives, and should be replaced within the next 1-3 years.

Location: Roof

Distress: Beyond Service Life

Notes: Replace the three (3) approximately 60 ton roof mounted air handling units, associated ductwork, and VAV boxes which are all approaching the end of their service lives.

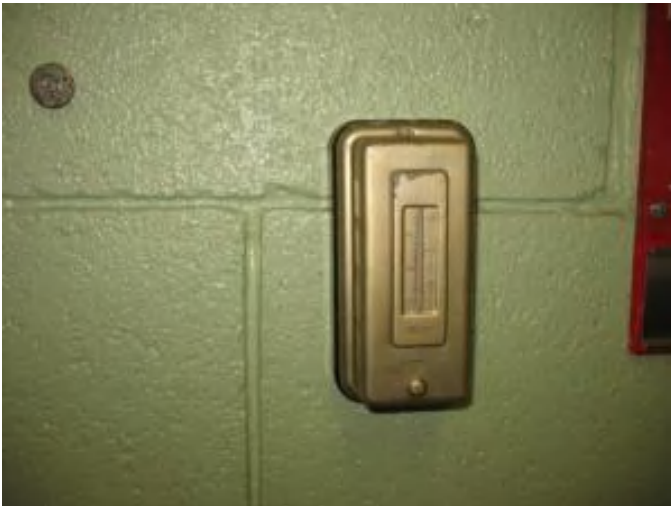
System: D3060 - Controls & Instrumentation

Location: Throughout building

Distress: Beyond Service Life

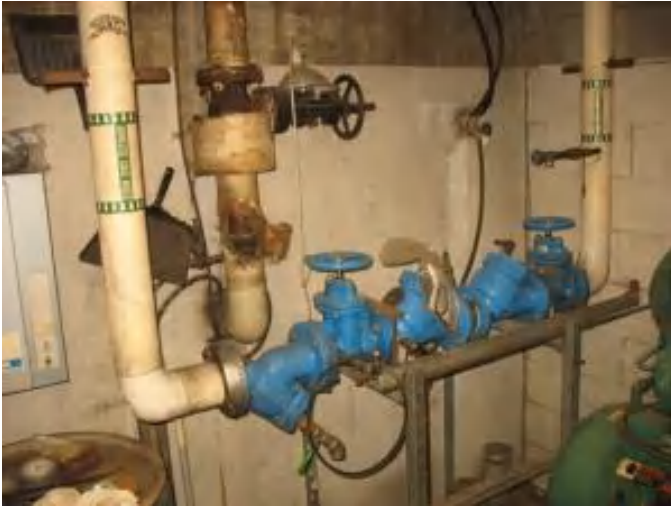
System: D2020 - Domestic Water Distribution

Location: Throughout building

Distress: Beyond Service Life

Notes: Hire a qualified contractor to perform a detailed inspection of the domestic water piping, in use for 45 years, and replace any damaged piping.

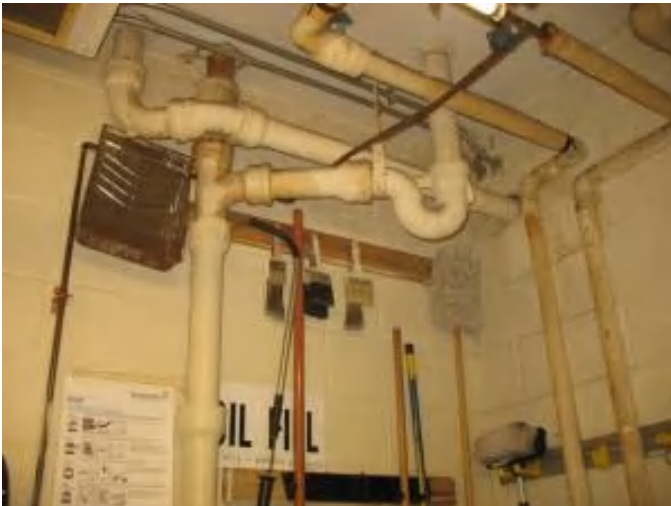
System: D2030 - Sanitary Waste

Location: Throughout building

Distress: Beyond Service Life

Notes: Hire a qualified contractor to perform a detailed examination of the sanitary waste piping using visual inspection and video cameras to locate and replace any damaged piping and to further quantify the extent of potential failures.

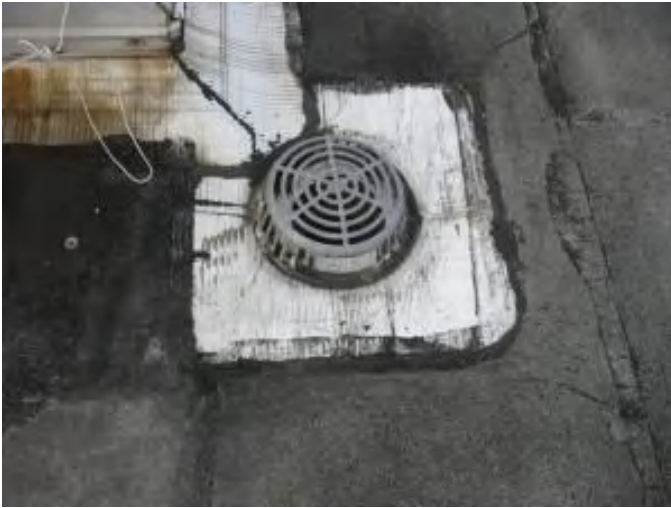
System: D2040 - Rain Water Drainage

Location: Throughout building

Distress: Beyond Service Life

Notes: Hire a qualified contractor to perform a detailed examination of the rain water drainage piping using visual inspection and video cameras to locate and replace any damaged piping and to further quantify the extent of potential failures.

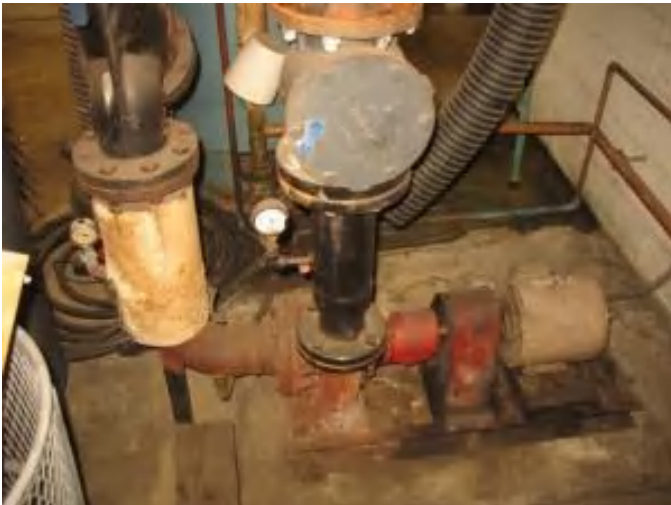
System: D3020 - Heat Generating Systems

Location: Boiler room

Distress: Beyond Service Life

Notes: Replace one (1) 3HP end-suction hot water supply pump in the boiler room which is beyond its service life.

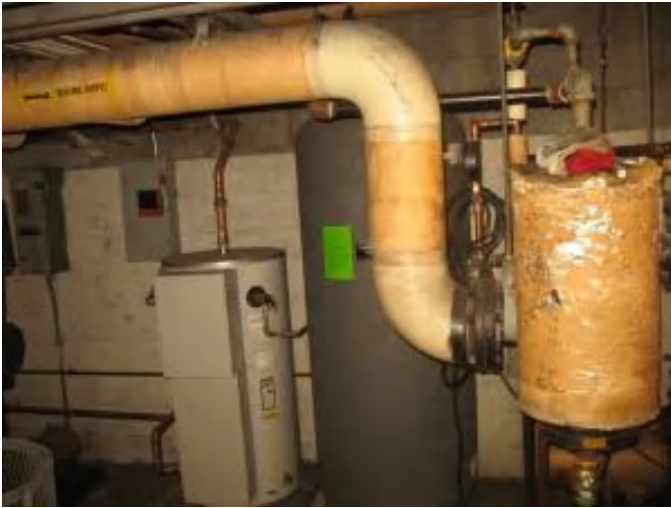
System: D3040 - Distribution Systems

Location: Throughout building

Distress: Beyond Service Life

Notes: Hire a qualified contractor to examine the distribution piping, in service for 45 years, and replace any damaged piping and to further quantify the extent of potential failures.

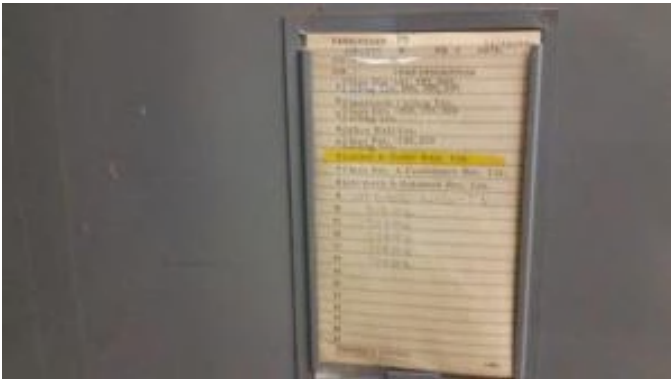
System: D5010 - Electrical Service/Distribution

Distribution system- The electrical distribution is accomplished with a 120V distribution switchboard, located in the electrical room, feeding several panels throughout the building (two panels in each floor). These panels are not in good condition. They have reached the end of their service life.

Location: throughout the building

Distress: Beyond Service Life

Notes: Install new 120V panel boards throughout the building for lighting, and receptacles loads.

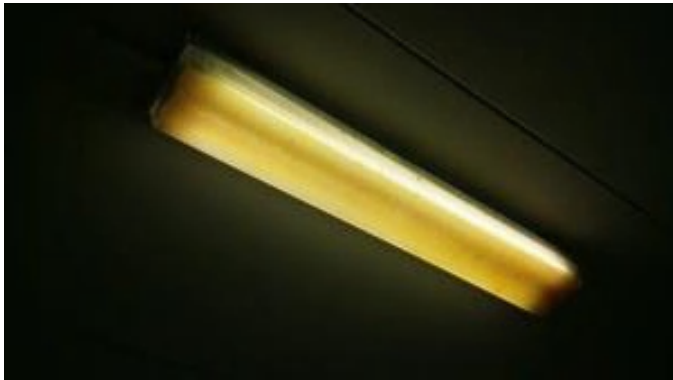
System: D5020 - Lighting and Branch Wiring

Lighting- Interior building is illuminated by various types of fixtures. They include fluorescent lighting (T-8 and some T-12) in majority of the areas, including; classrooms, corridor, offices and Kitchen. Surface or pendant mounted industrial fluorescent fixtures are used in mechanical and electrical rooms. Gymnasium and cafeteria and multi-purpose rooms are also illuminated by Fluorescent fixtures. The majority of interior lighting fixtures are in a poor condition and have reached the end of their service life.

Location: throughout the building

Distress: Beyond Service Life

Notes: Install new a lighting system for the entire building.

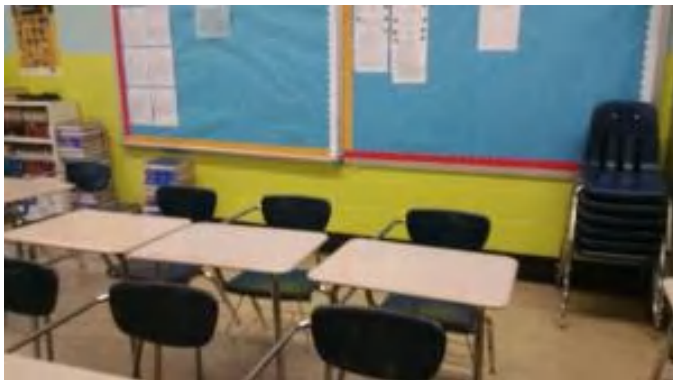
System: D5020 - Lighting and Branch Wiring

Location: throughout the building

Distress: Beyond Service Life

Notes: Install new receptacles in all classrooms and other areas (minimum two receptacles on each wall).

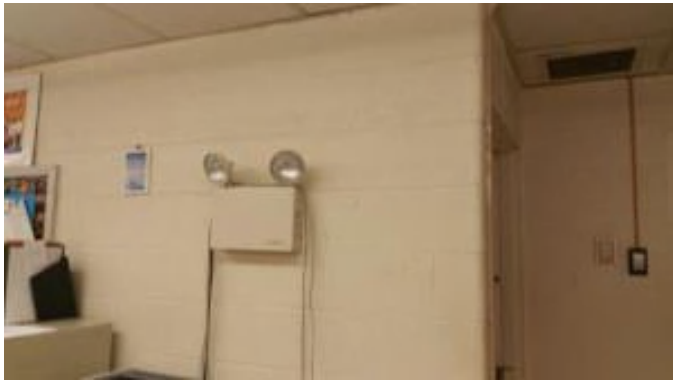
System: D5090 - Other Electrical Systems

Location: throughout the building
Distress: Beyond Service Life
Category: 3 - Operations / Maint.
Priority: 3 - Response Time (3-4 yrs)
Correction: Replace Emergency/Exit Lighting
Qty: 1.00
Unit of Measure: Ea.
Estimate: \$311,513.14
Assessor Name: Craig Anding
Date Created: 01/20/2016

Notes: Install new emergency exit signs emergency lights.

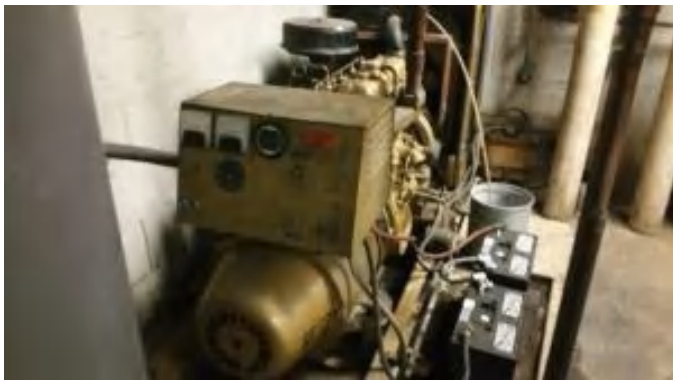
System: D5090 - Other Electrical Systems

Location: electrical room
Distress: Inadequate
Category: 4 - Capital Improvement
Priority: 3 - Response Time (3-4 yrs)
Correction: Replace standby generator system
Qty: 1.00
Unit of Measure: Ea.
Estimate: \$168,251.18
Assessor Name: Craig Anding
Date Created: 01/21/2016

Notes: Install a new 100KW Emergency Generator.

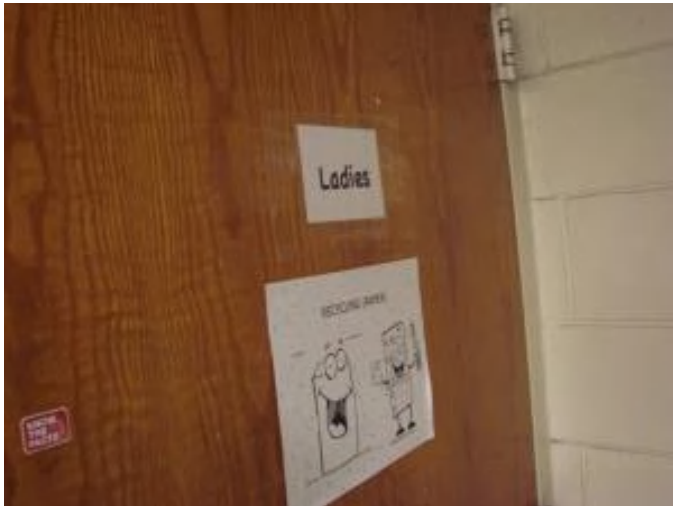
System: C1030 - Fittings

Location: Throughout building

Distress: Inadequate

Notes: Install new signage throughout

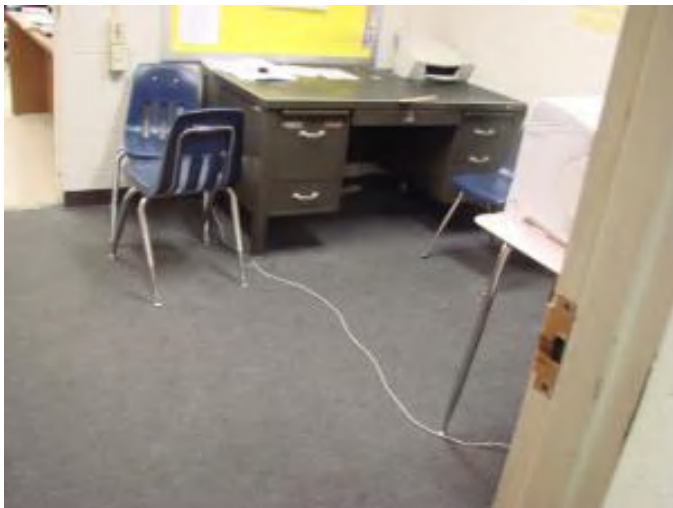
System: C3020411 - Carpet

Location: Office areas

Distress: Beyond Service Life

Notes: Replace all carpeting

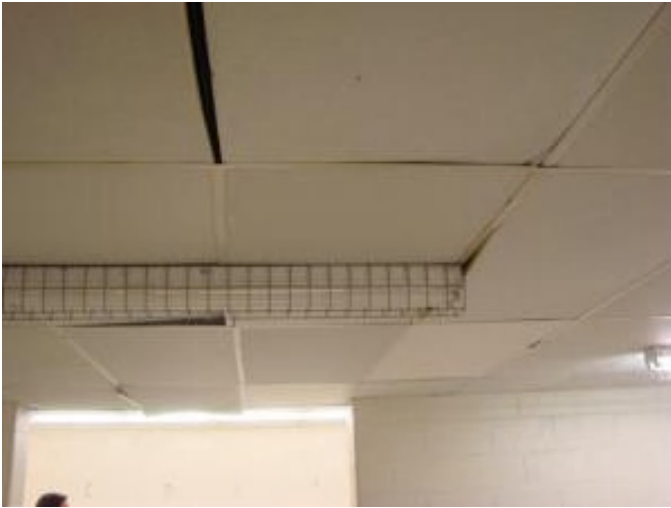
System: C3030 - Ceiling Finishes

Location: Corridors
Distress: Beyond Service Life
Category: 3 - Operations / Maint.
Priority: 4 - Response Time (4-5 yrs)
Correction: Remove and replace suspended acoustic ceilings - lighting not included
Qty: 48,000.00
Unit of Measure: S.F.
Estimate: \$723,956.65
Assessor Name: Craig Anding
Date Created: 02/19/2016

Notes: Replace acoustical ceilings in corridors

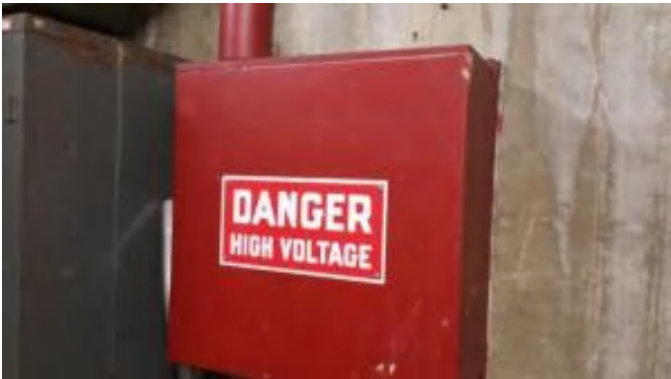
System: D5010 - Electrical Service/Distribution

Location: electrical room
Distress: Beyond Service Life
Category: 3 - Operations / Maint.
Priority: 4 - Response Time (4-5 yrs)
Correction: Replace Service Transformer, Add Switchboard
Qty: 0.00
Unit of Measure: Ea.
Estimate: \$400,048.73
Assessor Name: Craig Anding
Date Created: 01/20/2016

Notes: Install new Site electrical service 1500KVA, 480V, 3 Phase to feed the HVAC, lighting and receptacle loads.
Install a new 480V, 3 phase switchgear.
Install a new 120V/208V, 3 phase switchgear.

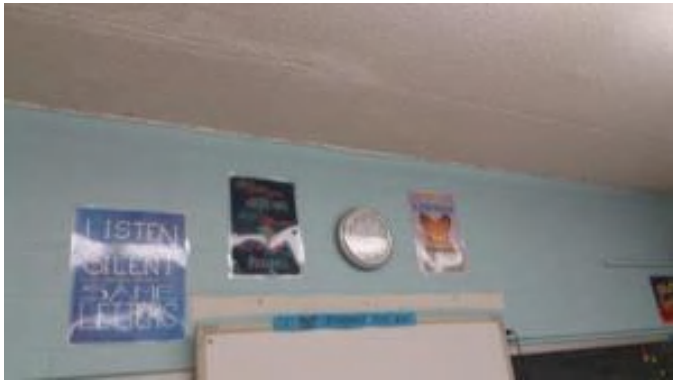
System: D5030 - Communications and Security

Location: throughout the building

Distress: Beyond Service Life

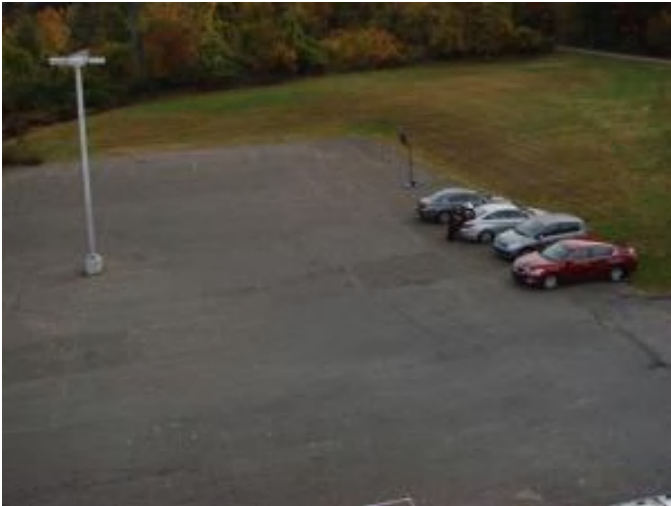
System: G2020 - Parking Lots

There is a parking lot at the northeast side of the site; pavement in the parking area is in fair condition, but striping is deteriorated with no accessible stalls or signage. The paving on the entry drive from Spring Lane is in very poor condition,

Location: Parking area

Distress: Accessibility

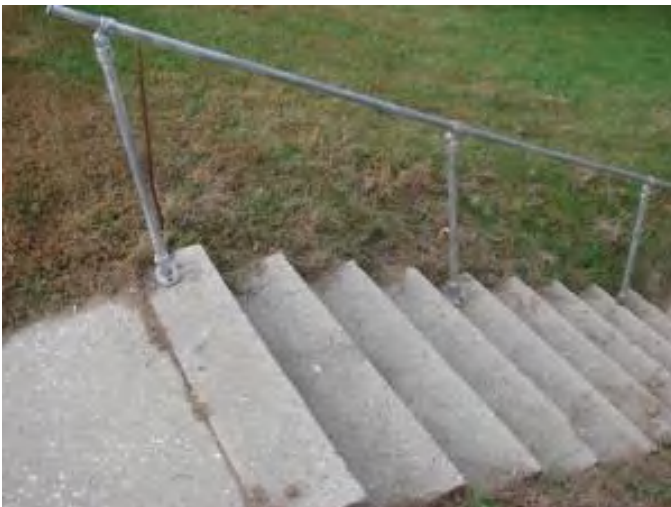
System: G2040 - Site Development

The handrails on the concrete stairs leading from front drop off area to the open lawn play area are in poor condition.

Location: Exterior stairs on southwest side

Distress: Accessibility

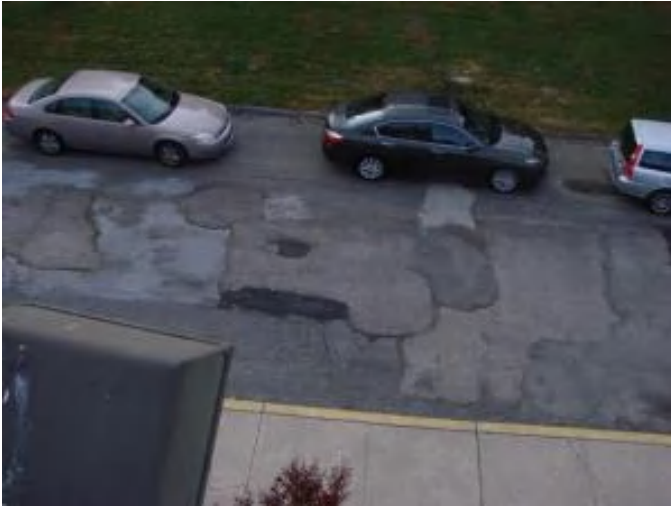
System: G2010 - Roadways

Location: Entry road way

Distress: Beyond Service Life

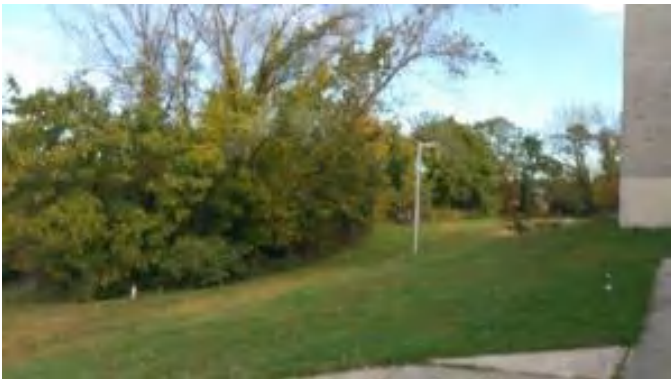
System: G4020 - Site Lighting

Site Lighting – There are several lighting poles on the grounds, however the majority of them are damaged and not working. Overall, the grounds are not adequately lighted for safety of the people and security of property.

Location: grounds

Distress: Health Hazard / Risk

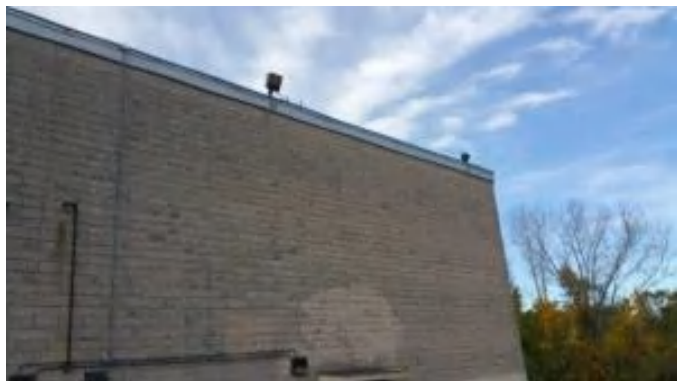
System: G4030 - Site Communications & Security

Location: grounds

Distress: Inadequate
