Facility Condition Assessment Summary Report

Lawton School

School District of Philadelphia
S733001;Lawton
Final
Site Assessment Report

January 31, 2017

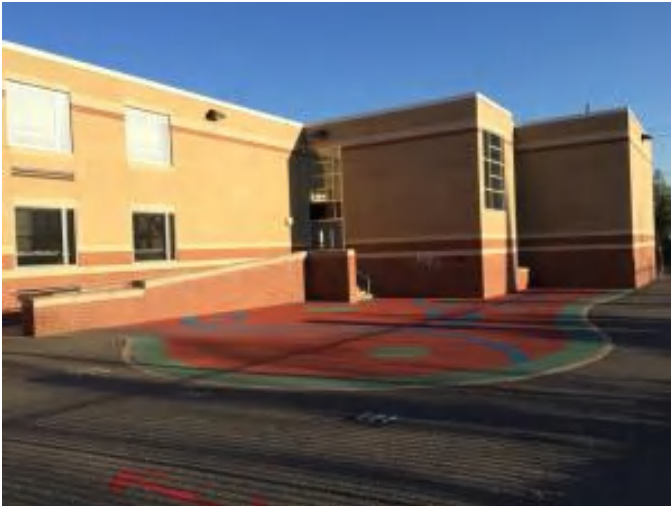
Location: original building - loading dock

System: B2010 - Exterior Walls

Distress: Damaged

Notes: Remove graffiti from Loading Dock area (1000sf)

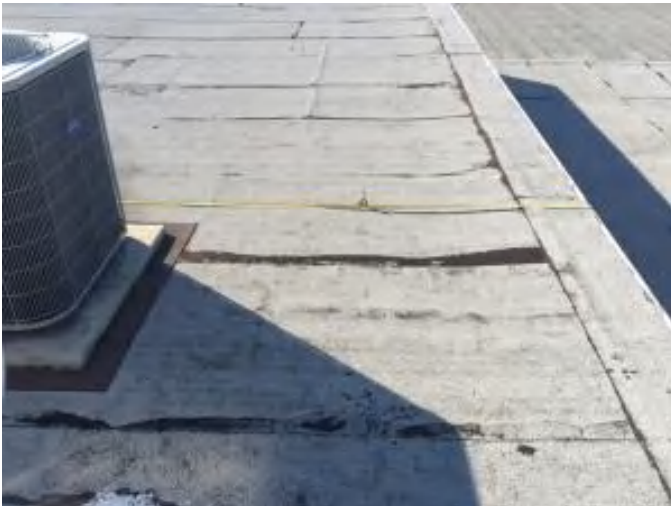
Location: new building - roof

10 years old. There were no soft areas and only 2 small areas of ponding at the time of inspection. The overall pitch of the roof appears to be less than the code required 2% slope, however no leaks were reported or seen that could be attributed to the roof. (Leaks seen were known to be caused by excessive air conditioning condensation.) An expansion joint across the Element 1-2 roof appeared to have been recently repaired, but looked to be water tight. It appears as if roof drains are periodically inspected and cleaned to minimize clogging. There were mechanical equipment clearance code violations observed. Some of the new condensing units located on new roof #1 are less than 10 feet away from the drop down to the gymnasium roof and some are too close to the edge of the roof #2 near the playground. A guard rail 42" tall or mechanical connectors for use of safety straps need to be provided to eliminate this dangerous condition.

System: B3020 - Roof Openings

Distress: Building / MEP Codes

Notes: Install guard rails on roof to provide edge protection near rooftop HVAC equipment (60ft length 42" h)

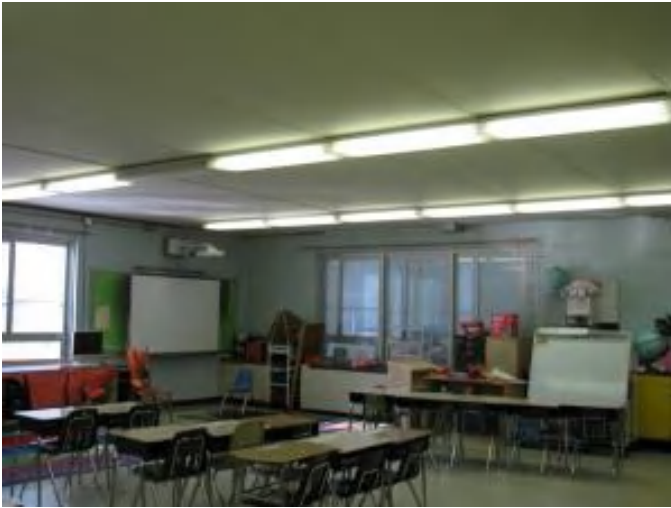
Location: Original Building classrooms

Interior building spaces are illuminated by various types of fluorescent lighting fixtures. 2x4 lay in grid fluorescent with parabolic lens and T8 lamps are used for the classrooms and offices in newer building. Original building utilized with 1x4 surface mounted fluorescent with outdated T12 lamps in the classrooms and 1x4 surface mounted fluorescent with T8 lamps in the corridors. Cafeteria is provided by linear surface fluorescent lighting fixtures with parabolic lenses and T8 lamp. These lighting fixtures are still in good conditions and no need for replacement. Gymnasium provided with pendent mounted metal halide fixtures which have high energy consumption and are difficult to re-lamp. Fluorescent fixtures with outdated T12 lamps should be replaced with similar type fluorescent but with T8 lamps. All existing pendent mounted metal halide fixtures in gymnasium should also be replaced with high bay LED lighting fixtures.

System: D5020 - Lighting and Branch Wiring

Distress: Beyond Service Life

Notes: Replace all lighting fixtures in classrooms of original building. Estimated 1000 fluorescent fixtures.

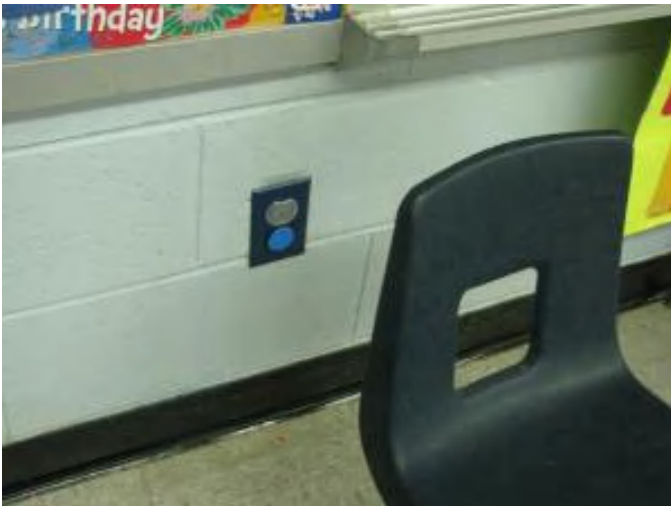
Location: Entire Building

Classrooms, corridors, offices, and other areas typically provided with adequate number of duplex receptacles. No major deficiencies were observed except those receptacles in kindergarten classrooms in the original building which are not of tamper-resistant type. This is in violation of the electrical codes that receptacles that are subject to child access be of either tamper proof or GFCI.

System: D5020 - Lighting and Branch Wiring

Distress: Inadequate

Notes: Replace all existing receptacles with GFCI type receptacle in areas subject to kid access. Estimated 10 each.

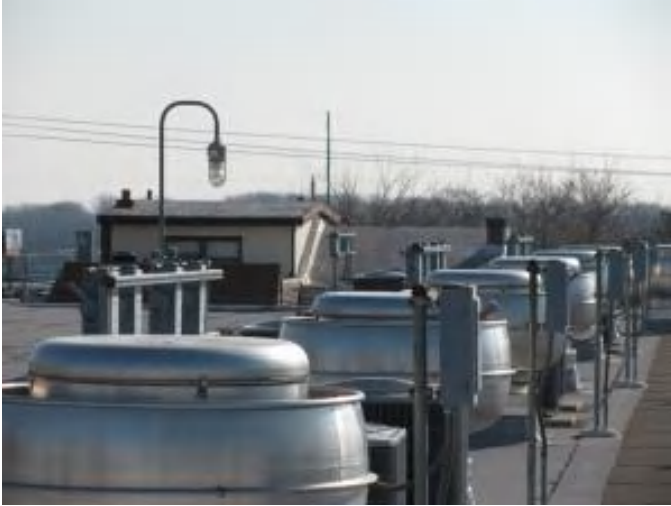
Location: Roof

System: D5090 - Other Electrical Systems

Distress: Life Safety / NFPA / PFD

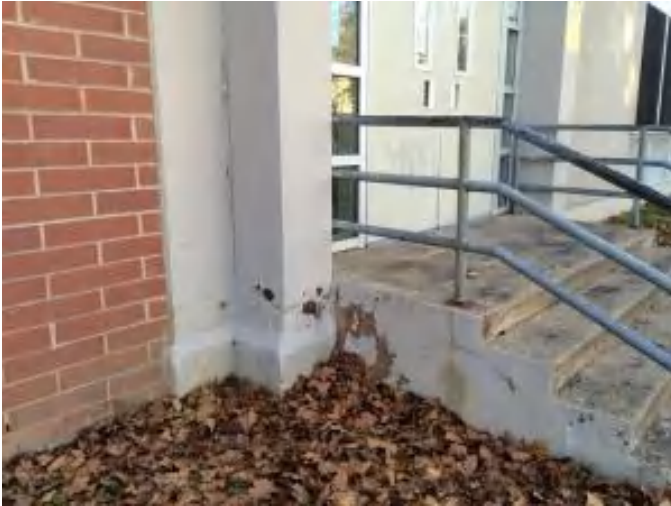
Location: original building - walls

System: B2010 - Exterior Walls

Distress: Failing

Notes: Repair spalling precast concrete column and beam (200sf)

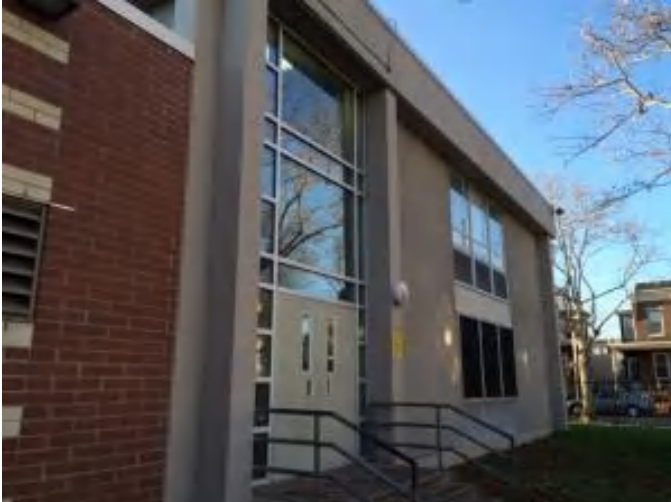
Location: all exterior doors

Most exterior doors used as stairway, toilet room or mechanical area exits are constructed of painted steel frames and flush hollow metal door units. They are in good condition with minimal dents and scratches; paint is worn and should be reapplied. Entrance doors are glass and stainless steel framed units with two sidelites. Door hardware was replaced in 2008 with the construction of the new addition; all seemed to be in good operation.

System: B2030 - Exterior Doors

Distress: Failing

Notes: Repaint all exterior doors and provide weatherstripping (20 3'x7')

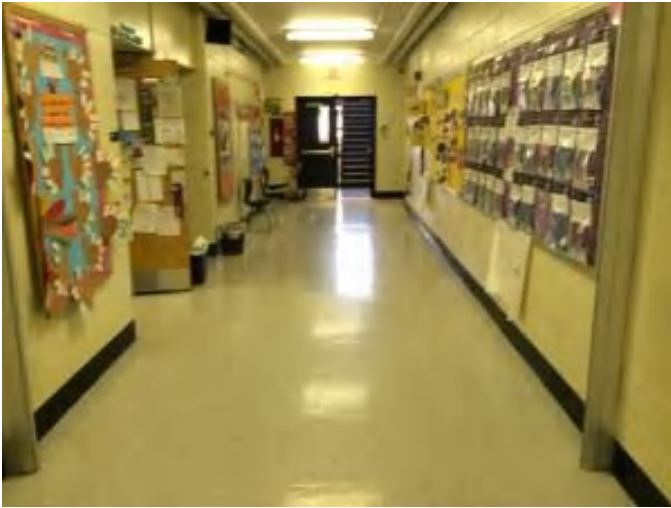
Location: original building - interior doors

Interior classroom and office doors in the original building are the original solid core wood with hollow metal door frames. They have narrow lite wired glass and closers as required of a fire rated door and lever locksets that can be locked from the inside to provide security lockdown. Doors are damaged and worn and should be properly prepared and painted with a sold paint to improve their appearance. Stairway doors are newer (not original) flush steel doors and frames with panic hardware and closers. Most doors frames are in good condition as they were probably installed when the addition was constructed, but could use a new coat of paint. Interior doors in mechanical rooms are the same type of wood doors in steel frames as the classroom doors in and are similarly worn; they should be replaced with hollow metal doors or repainted like the classroom doors. Doors in the new addition are solid oak doors with full height wired glass divided sidelites in hollow metal frames. These code-compliant doors have closers and lever handle security locksets. Frames are scratched on edges in many rooms and should be repainted. Stairway doors are solid wood with narrow lite vision panels, closers, panic hardware on push sides and lever handles on pull sides.

System: C1020 - Interior Doors

Distress: Damaged

Notes: Remove and replace all wood interior doors, frames in classrooms and offices in old building (66)

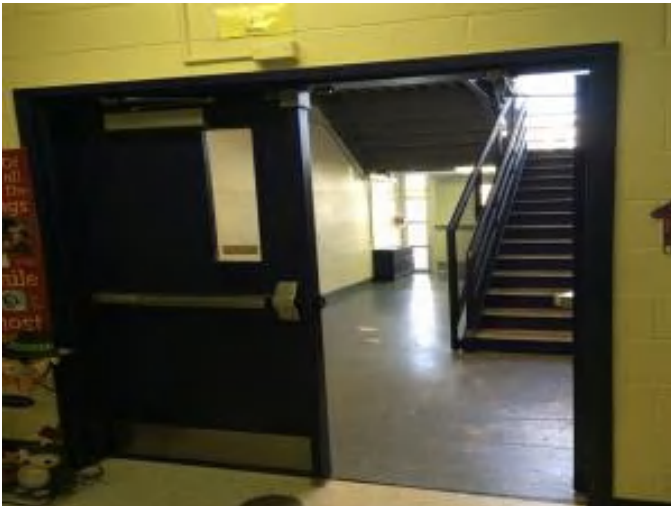
Location: original building - stairway doors

System: C1020 - Interior Doors

Distress: Appearance

Notes: Repaint interior steel doors, frames, in stairways in old building (8)

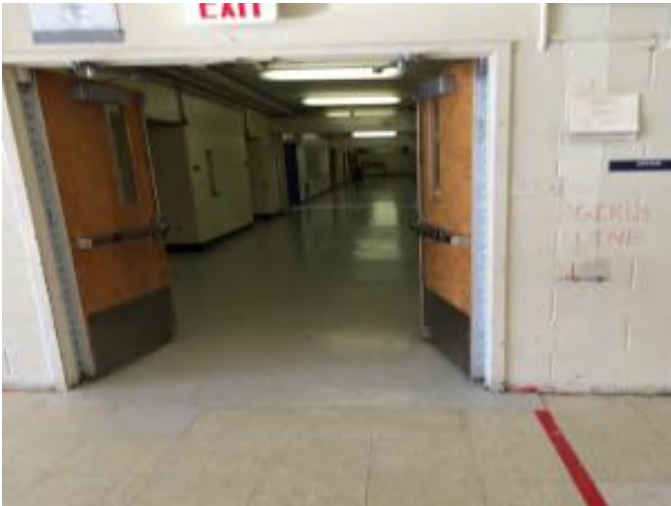
Location: original building - interior walls

Wall finishes in the old building classrooms, cafetorium, gymnasium, and stairways are painted concrete block interior walls and painted interior surface of precast concrete panels on the exterior walls. Many walls have stains and marks; some exterior walls have been caulked but have not been painted, leaving the caulking exposed and unsightly. All walls in the old building classrooms, gymnasium, and cafetorium need to be repainted. Toilet room walls and corridor walls are painted block in fair condition. There is no entrance vestibule at the main front visitor and student entry doors into the old building on Jackson Street. The doors open up into the main school lobby and corridor, which admits large amounts of cold air into the building during winter. There seems to be enough space in the entrance area to allow for the creation of a vestibule, which would trap the cold air blast admitted to the building when doors are opened during winter. Construction of a lobby vestibule is recommended. Wall finishes in the new addition are painted block in all rooms and corridors, in good condition.

System: C3010230 - Paint & Covering

Distress: Appearance

Notes: Repaint interior classroom, cafeteria, and gymnasium walls in old building (20,000sf)

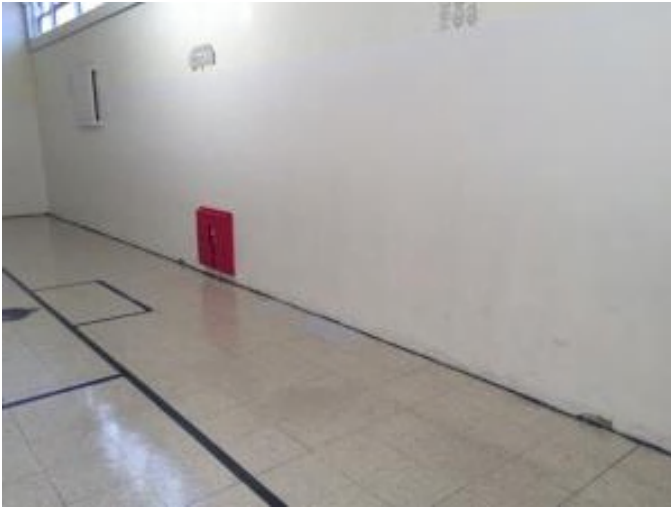
Location: original building - floors

concrete slab; this finish is in good condition. VCT is also used in all classrooms and corridors in the old building. The VCT in the old building classrooms is worn, dirty and damaged; corridors are in better condition with some dirt accumulation in corners and at doors. The entrance lobby in the old building has newer VCT in good condition, protected with loose entrance mats. The cafetorium (in the old building) has terrazzo in very good condition and the kitchen (part of the new addition) has highly quarry tile, also in good condition. The gymnasium (in the old building) has VCT which is worn and damaged and should be refinished. Stair walking surfaces in both buildings are painted or sealed concrete which appears to have been refinished with the construction of the addition. Toilet rooms in both buildings have ceramic mosaic floors which are dirty and in need of cleaning, but in good condition. In the old building classrooms, sections of VCT need to be added where old unit ventilators were replaced with newer smaller units, exposing sections of bare concrete floor.

System: C3020413 - Vinyl Flooring

Distress: Failing

Notes: Remove and replace damaged, old 12"x12" VCT floors in all old building classrooms (also at univents), offices, nurse, and gymnasium (40,000sf)

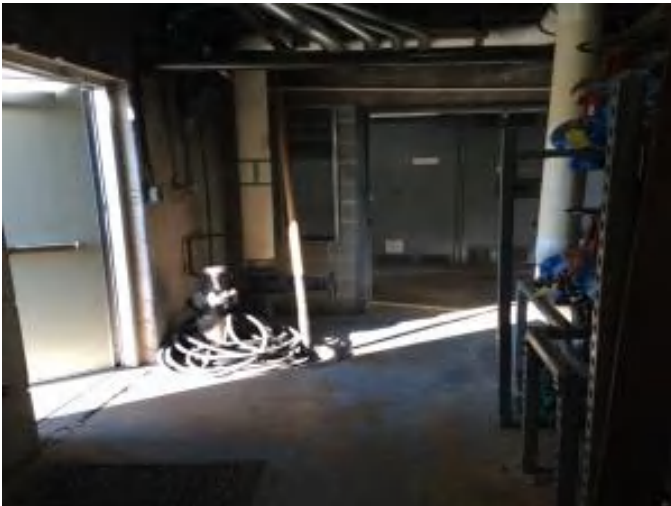
Location: original building - first floor - concrete floors

Ground floor slabs are good condition, with some minor floor tile cracks and joint separation observed. Unfinished slabs in the mechanical area and loading door area need to be cleaned and resealed. Upper floor slabs are constructed of precast concrete planks, exposed to view as first floor ceilings in most locations. There were a few locations where small cracks were observed in corridors across vinyl tile flooring in ground floor slabs. In the area of the Kindergartens in the new addition, the concrete slab is buckling slightly causing a slight lump across the corridor.

System: C3020415 - Concrete Floor Finishes

Distress: Appearance

Notes: Strip, clean and reseal concrete floors mechanical room (1,500sf)

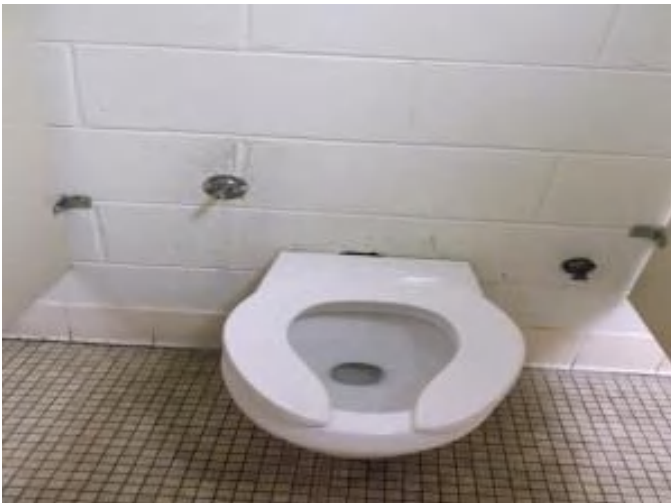
Location: Throughout the building

Plumbing Fixtures – The building is equipped with wall hung urinals (flush valve type), a combination of wall hung and floor set water closets (flush valve type), and wall hung lavatories with wheel handle faucets. Many of the original plumbing fixtures remain in service, however, these fixtures have reached the end of their service life and should be replaced. New fixtures will provide lower water consumption and provide savings on water heating costs. The bathrooms are also equipped with floor drains.

System: D2010 - Plumbing Fixtures

Distress: Beyond Service Life

Notes: Replace all water closets in the building with lower flow fixtures, as the fixtures are original.

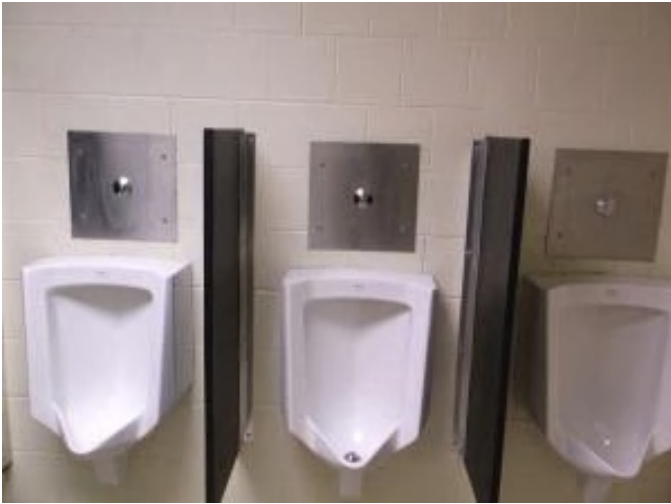
Location: Throughout the building

System: D2010 - Plumbing Fixtures

Distress: Beyond Service Life

Notes: Replace all urinals in the building with lower flow fixtures, as the fixtures are original.

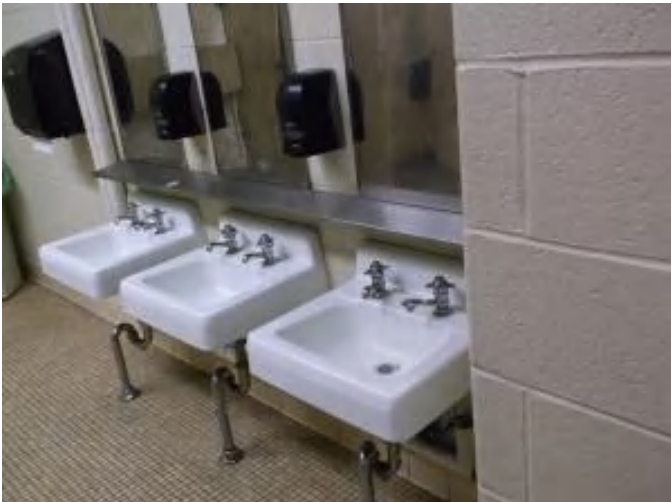
Location: Throughout the building

System: D2010 - Plumbing Fixtures

Distress: Beyond Service Life

Notes: Replace all lavatories in the building with lower flow fixtures, as the fixtures are original.

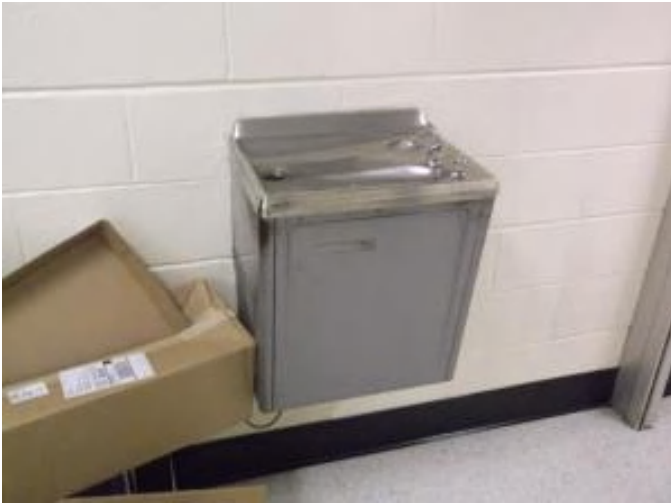
Location: Throughout the building

Electric water coolers in the corridors are located near the restrooms in general. These EWCs are wall hung fountains. There are also recessed style drinking fountains located in the gymnasium. Most appear to be the original installed equipment. The replacement of all original drinking fountains is recommended as the equipment is approximately 43 years old and beyond its service life. In the 2007 – 2008 addition, the electric water coolers are ten years old, are high/low ADA compliant and do not need to be replaced.

System: D2010 - Plumbing Fixtures

Distress: Beyond Service Life

Notes: Replace the wall hung drinking fountains and integral refrigerated coolers in the corridors and at the restrooms. These units are well beyond their service life and most are NOT accessible type.

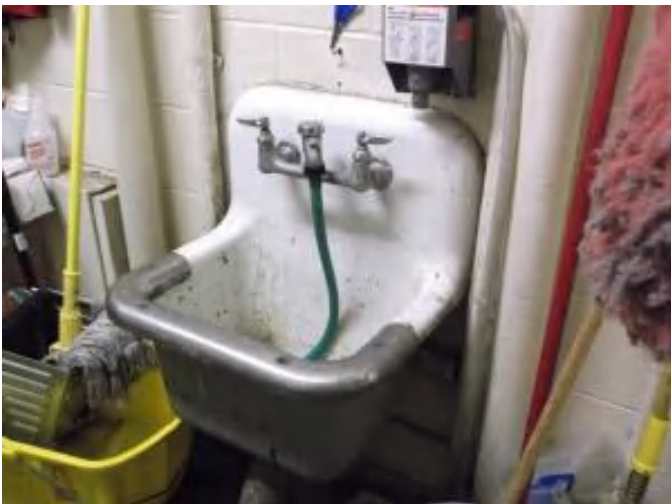
Location: Throughout the building

Wall hung service sinks are original and are available within the building for use by the janitorial staff. The Cafeteria's food prep/kitchen is equipped with one, three compartment stainless steel sink with blade handle operated faucets. The grease trap could not be located during the survey. The kitchen is also equipped with a hand sink. The triple wash sink and hand sink show signs of normal usage. Some fixtures are discharge to indirect connections to floor sinks in the kitchen while others are hard connections to the sanitary system. Chemicals are injected manually into the sanitizing basin.

System: D2010 - Plumbing Fixtures

Distress: Beyond Service Life

Notes: Replace service sinks (janitor sinks) in the building.

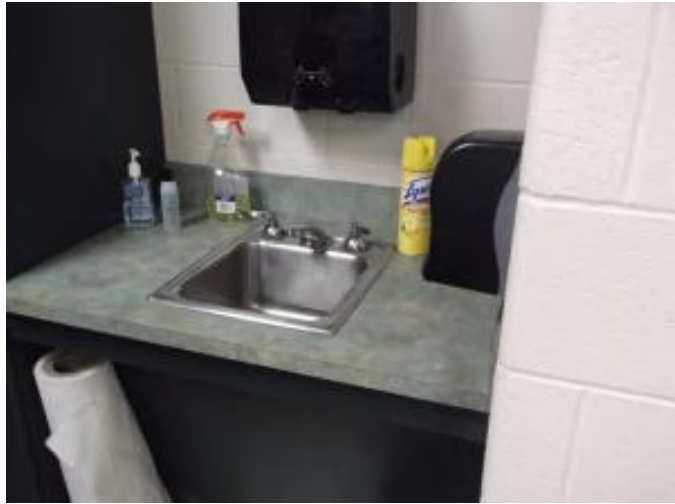
Location: Throughout the building

System: D2010 - Plumbing Fixtures

Distress: Beyond Service Life

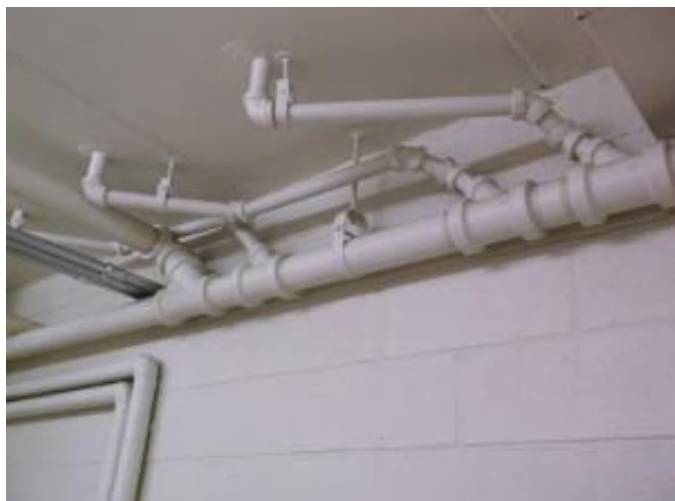
Location: Throughout the building

Sanitary Waste - The sanitary waste piping system in the original building is galvanized with threaded fittings and joints and appears to be the original piping installed in the building. It is therefore recommended to inspect this piping and repair or replace sections as needed. The sanitary system leaves the building by gravity flow.

System: D2030 - Sanitary Waste

Distress: Beyond Service Life

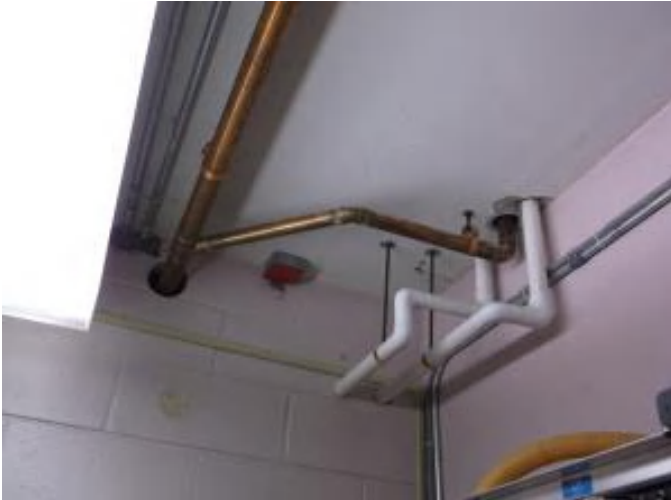
Location: Throughout the building

Domestic Water Distribution – It appears that the 4" domestic water service piping is mostly soldered copper. Water service enters the building on the first floor, with a double check backflow preventer (RPZA – reduced pressure zone assembly) and bypass assembly, however there is water meter on the main line located in a vault prior to entering the building. The domestic water piping is copper with soldered joints. The distribution piping appears to be original and is at the end of its service life and is recommended to be inspected and repaired as needed.

System: D2020 - Domestic Water Distribution

Distress: Beyond Service Life

Notes: Inspect and replace the original as needed the domestic water piping in the building

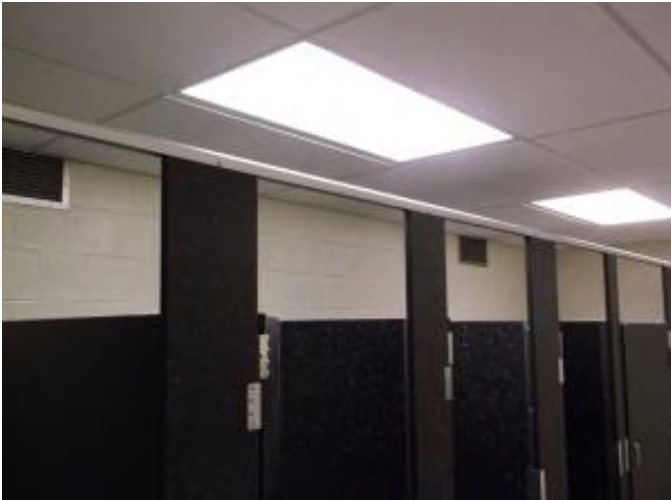
Location: Throughout the building

System: D4010 - Sprinklers

Distress: Beyond Service Life

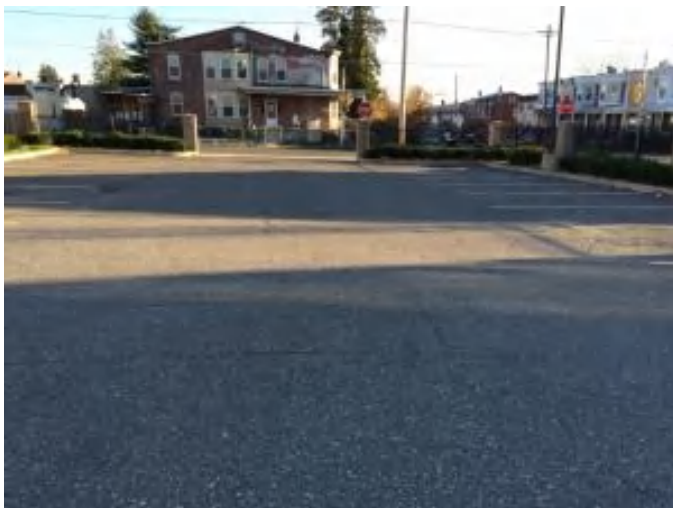
Location: faculty parking lot

Paving for parking consists of asphalt paving. Asphalt is less than 10 years old and in fair condition with some cracks and broken areas forming. The number of required parking spaces for school staff is unknown, but the lot was full at the time of inspection indicating that some staff and probably visitors may need to park on the street. There is a ramp providing accessibility to the new addition. Handicap parking spaces may have been provided. Handrails and guards at ramps and stairs are adequate in design, but need a new coat of paint.

System: G2020 - Parking Lots

Distress: Failing

- Crackfill faculty parking lot (500 lf)
