## Facility Condition Assessment Summary Report

### Lincoln High School

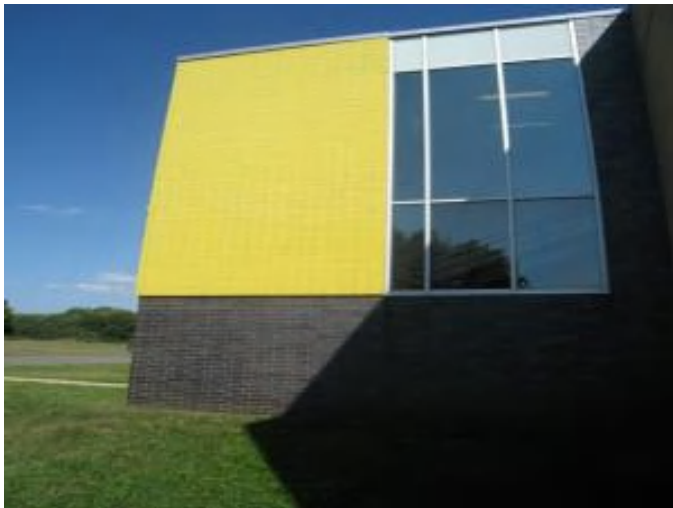
**Location:** Lincoln - Main Building - stair 1 window

have full height glass without screens. The outside pane of one of the glazing units in Stairway 1 was observed to be broken; the inside pane still seemed to be intact. Also, in Stairway 4, one of the inside covers of the aluminum tube system frames was missing. Gaskets in all units appeared to be intact and windows appeared to be in good condition. Building entrances are all constructed of full height clear glass letting in copious amounts of light into the atrium corridors inside. The main entrance vestibule is a tall element that terminates into the 2<sup>nd</sup> floor roof, calling attention to the main entrance. There is a glass greenhouse the size of a double classroom in the front of the building on the left side; it is actively utilized by students for project work. The corridor across from the cafeteria has full height windows facing the courtyard. Aluminum tube frame corners do not seal properly, at the tops of the entrance vestibules where those elements meet the roof coping; there are gaps and openings where rain and snow can enter the wall cavity below. These areas need to

**System: B2020 - Exterior Windows**

**Distress:** Damaged

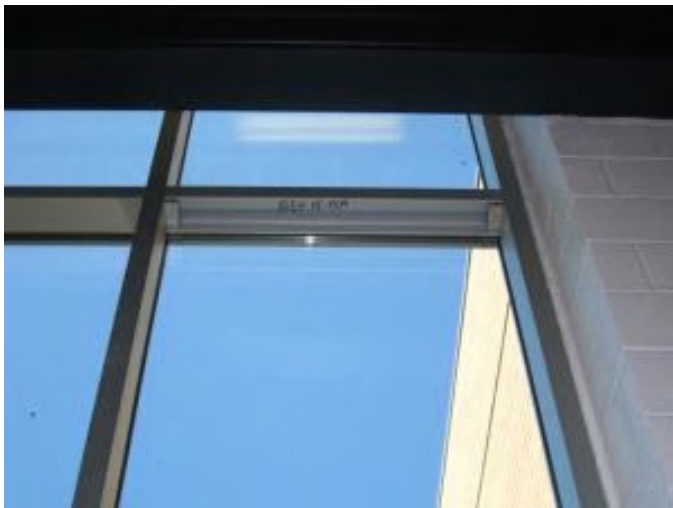
**Location:** Lincoln - Main Building - stair 4 mullion

**System: B2020 - Exterior Windows**

**Distress:** Damaged

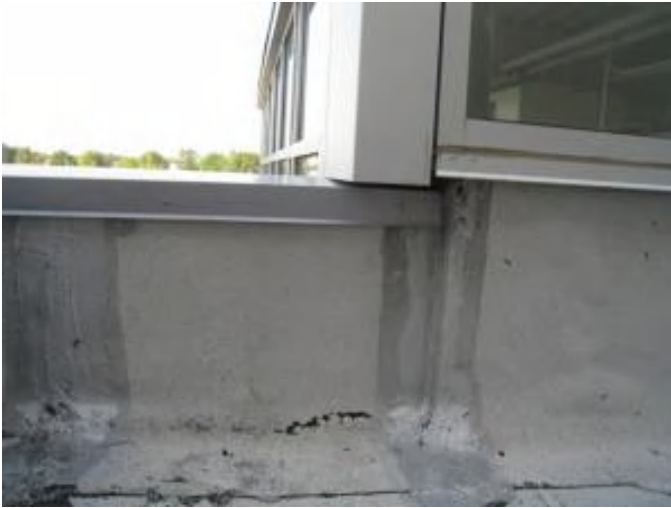
**Location:** Lincoln - Main Building - mullions @ roof coping

**System: B3010120 - Single Ply Membrane**

**Distress:** Failing

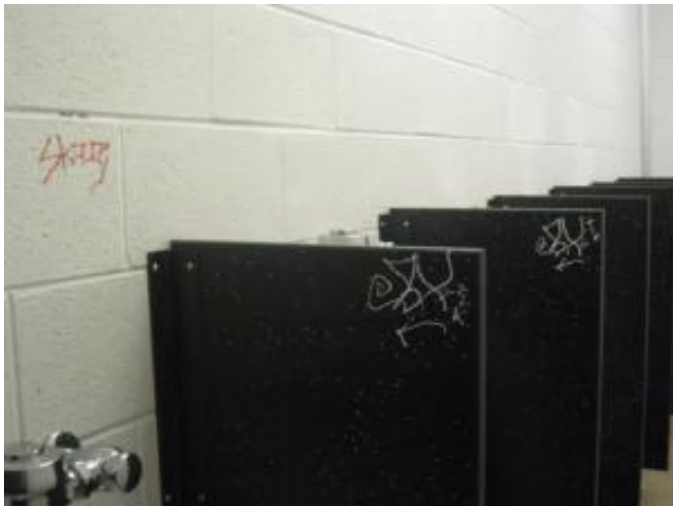
**Location:** Lincoln - Main Building - toilet rooms

**System: C1030 - Fittings**

**Distress:** Damaged

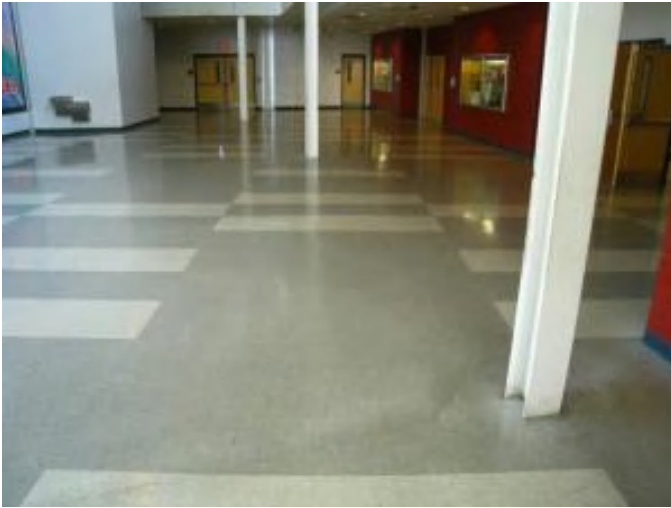
**Location:** Lincoln - Main Building - corridors

**System: C3020413 - Vinyl Flooring**

**Distress:** Damaged

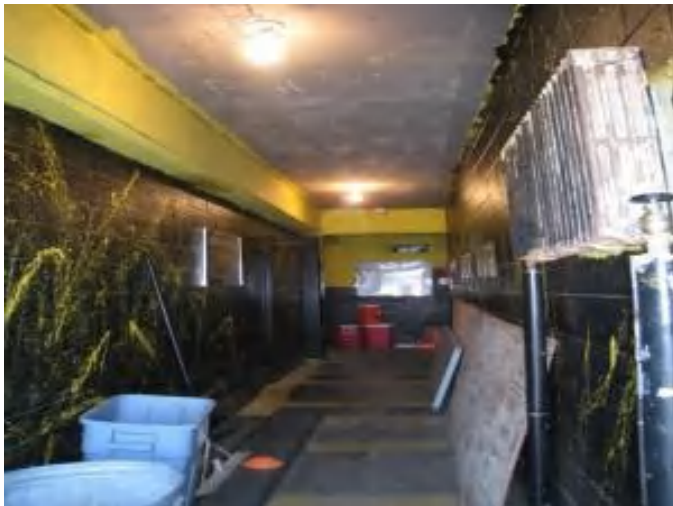
**Location:** Lincoln - Locker Facility - interior doors

### **System: C1020 - Interior Doors**

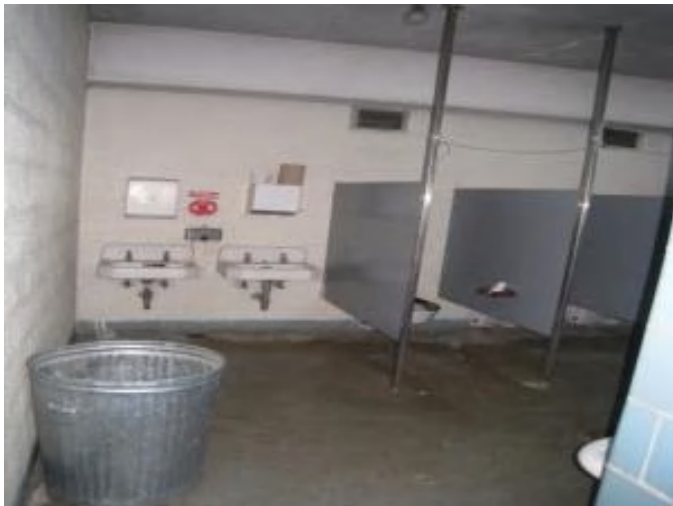
**Location:** Lincoln - Locker Facility - toilets

### **System: C1030 - Fittings**

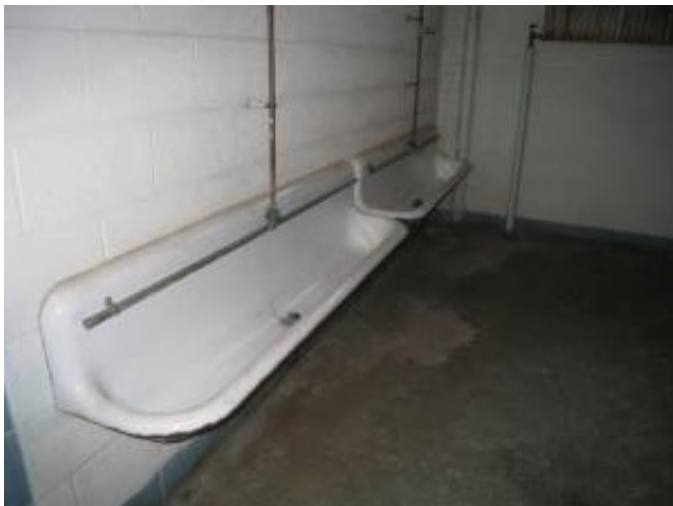
**Location:** Lincoln - Locker Facility - toilets

**System: C1030 - Fittings**

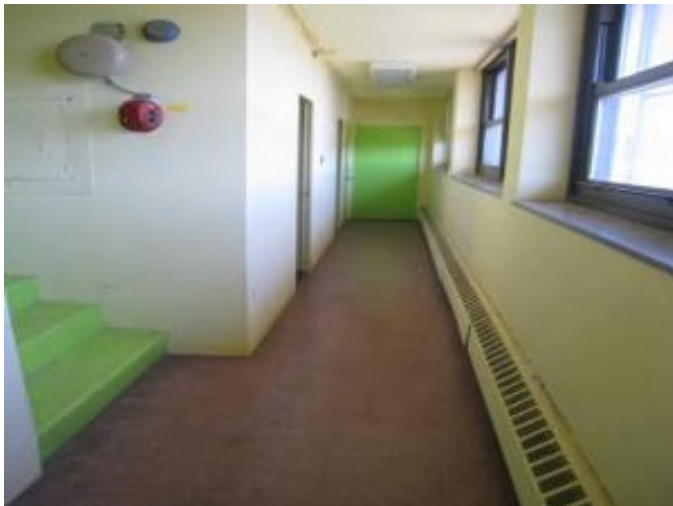
**Location:** Lincoln - Locker Facility - apartment

### **System: C3020413 - Vinyl Flooring**

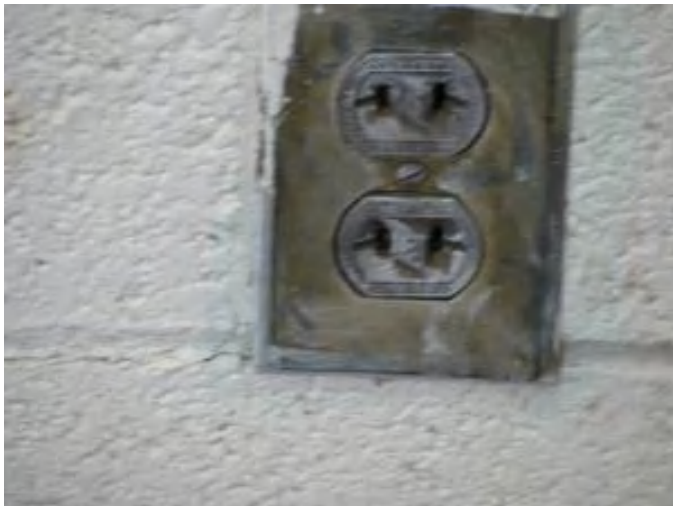
**Location:** Entire Building

**System: D5020 - Lighting and Branch Wiring**

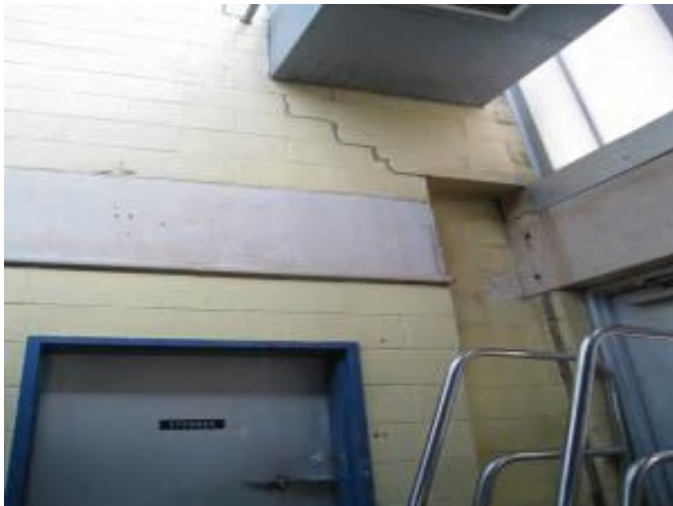
**Location:** Lincoln - Pool House - interior doors

### **System: C1020 - Interior Doors**

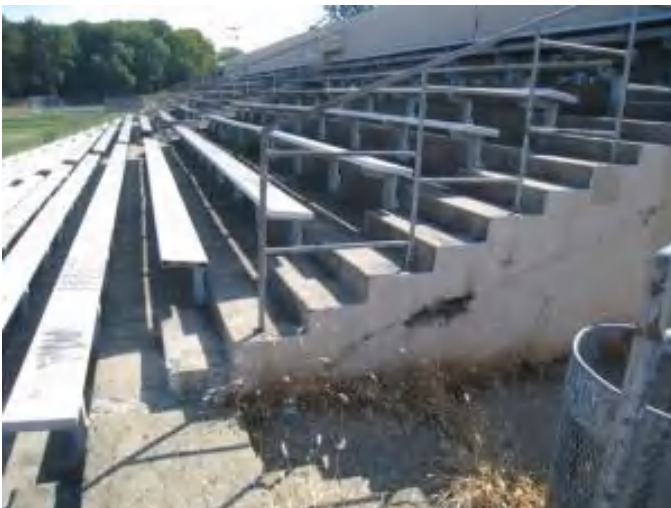
**Location:** Lincoln - Stands and Toilet Facilities

**System: B2010 - Exterior Walls**

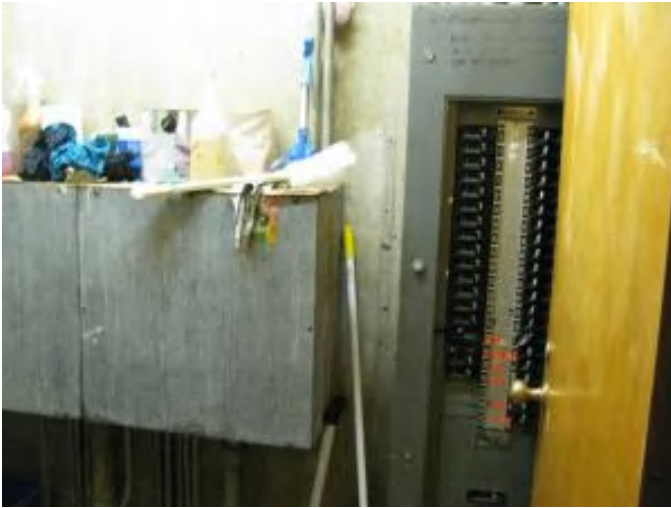
**Location:** Meehan-Entire Building

**System: D5010 - Electrical Service/Distribution**

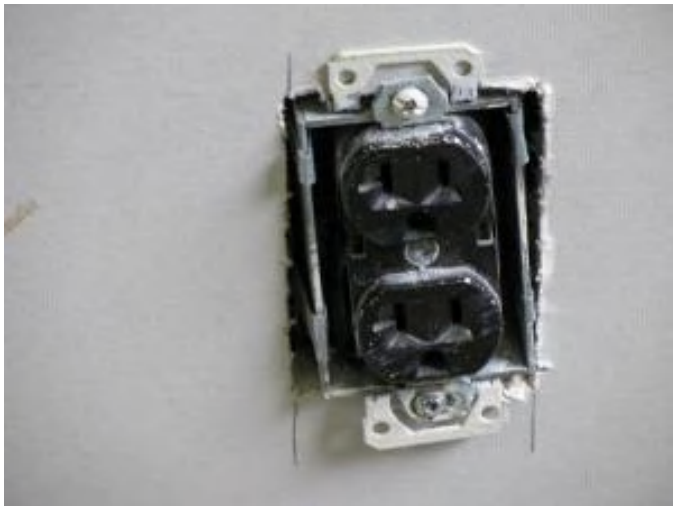
**Location:** Meehan-Entire Building

**System: D5020 - Lighting and Branch Wiring**

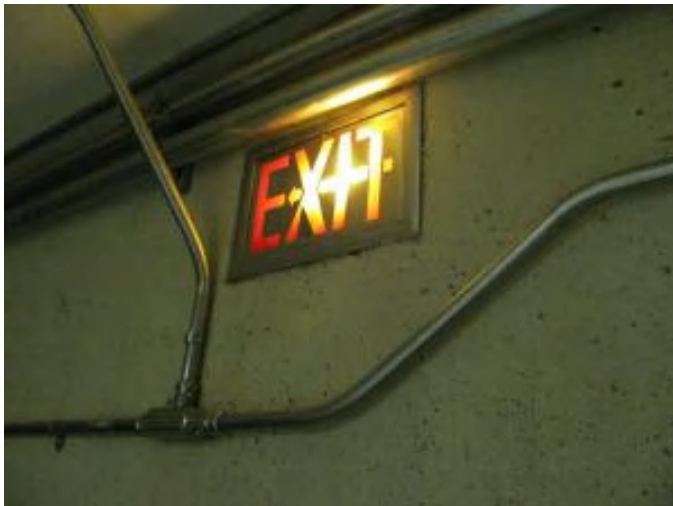
**Location:** Meehan- Entire Building

**System: D5020 - Lighting and Branch Wiring**

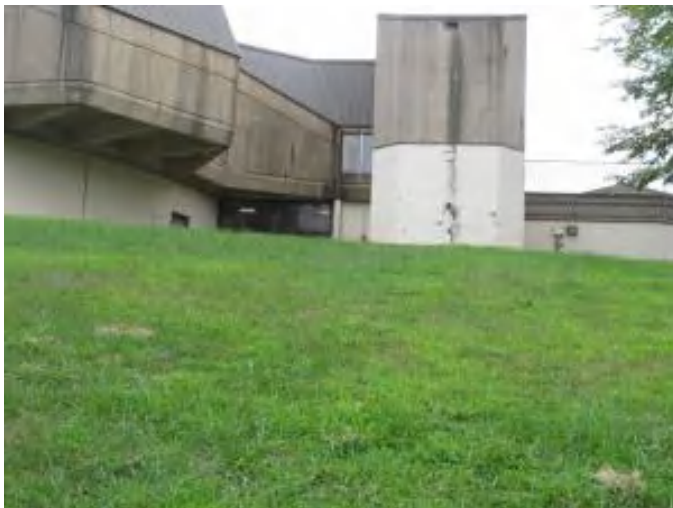
**Location:** Meehan- Exterior Building

**System: D5030 - Communications and Security**

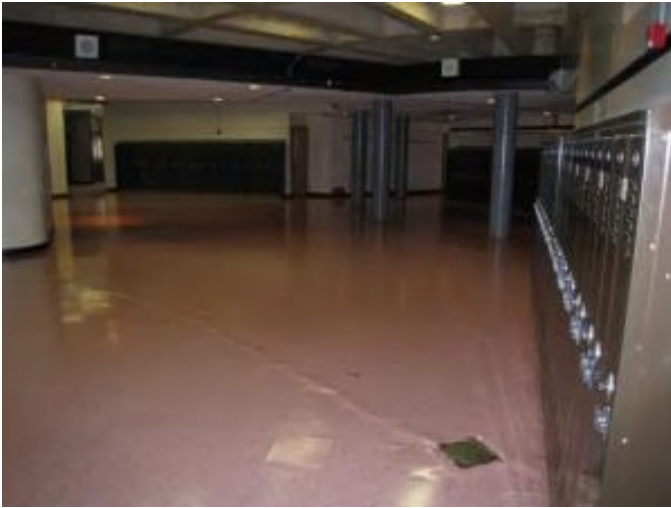
**Location:** Meehan - conc floors

**System: B1010 - Floor Construction**

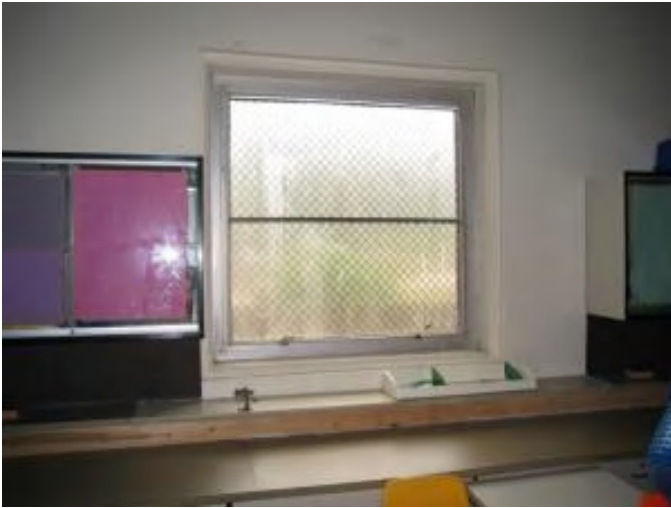
**Location:** Meehan - windows

**System: B2020 - Exterior Windows**

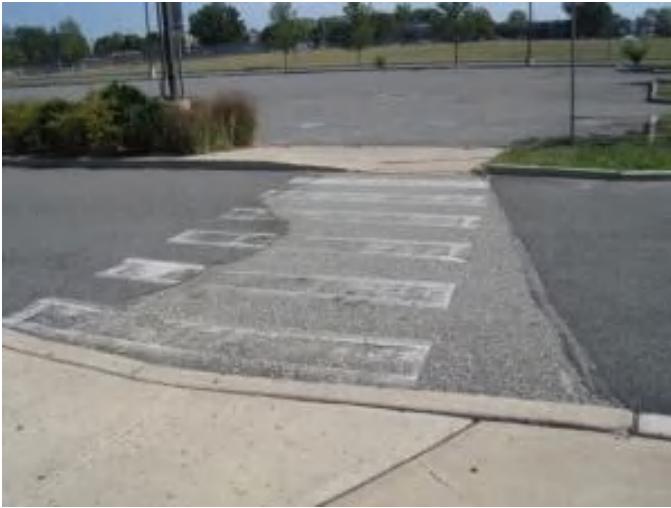
**Location:** Lincoln - Main Building front

**System: G2030 - Pedestrian Paving**

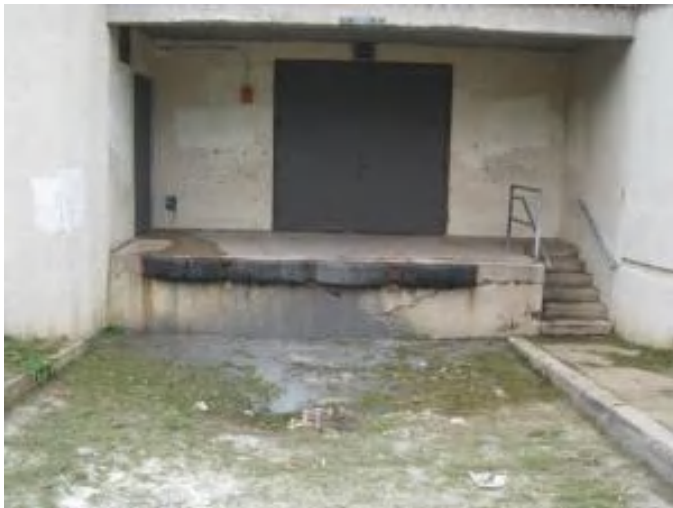
**Location:** Meehan - loading dock

**System: G2040 - Site Development**
