Facility Condition Assessment Summary Report

Locke School

S147001;Locke

Site Assessment Report

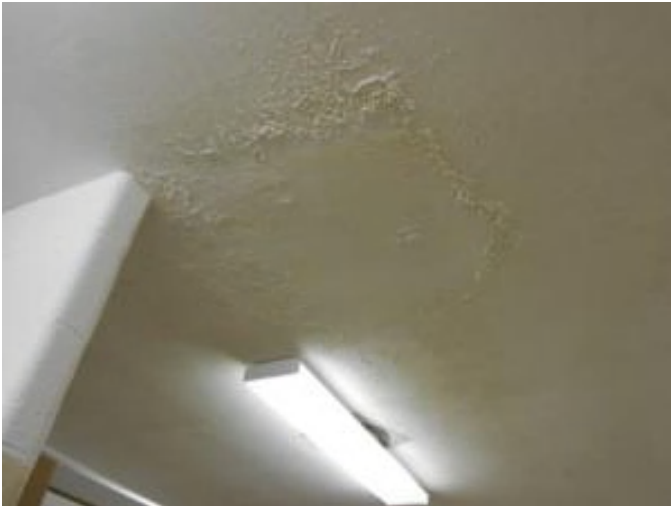
System: B3010105 - Built-Up

Location: Roof

Distress: Failing

Notes: Replace failing roofing system including insulation, flashing, counter flashing, reglets and coping

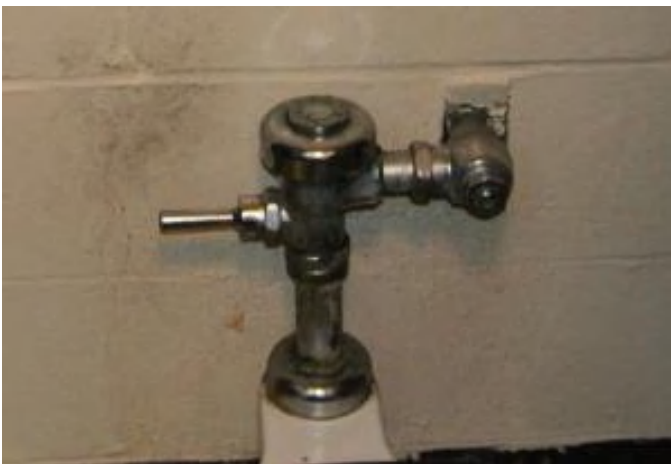
System: D2010 - Plumbing Fixtures

Location: Toilet rooms

Distress: Failing

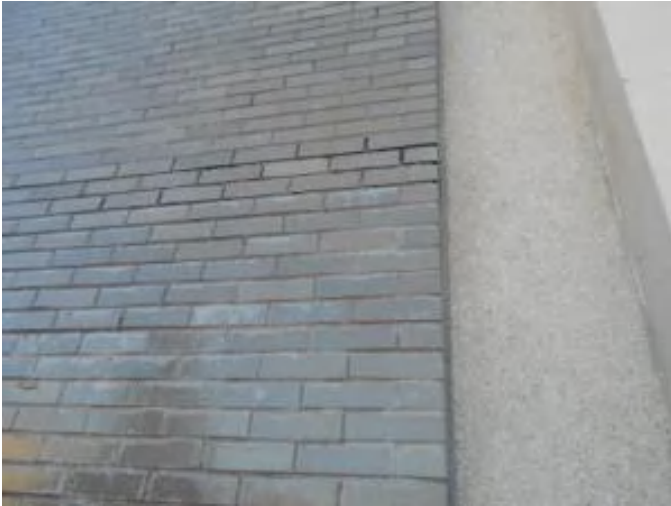
System: B2010 - Exterior Walls

Location: Exterior walls

Distress: Failing

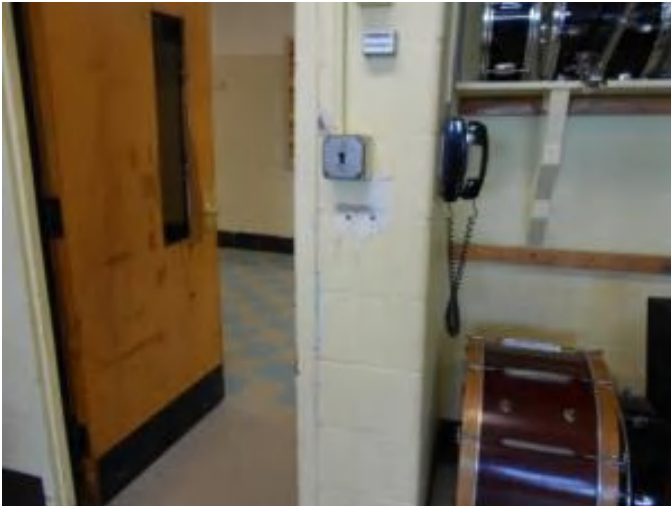
System: C1020 - Interior Doors

Location: Throughout the building

Distress: Accessibility

Notes: Replace interior classroom doors and provide recess to minimize swing into corridor.

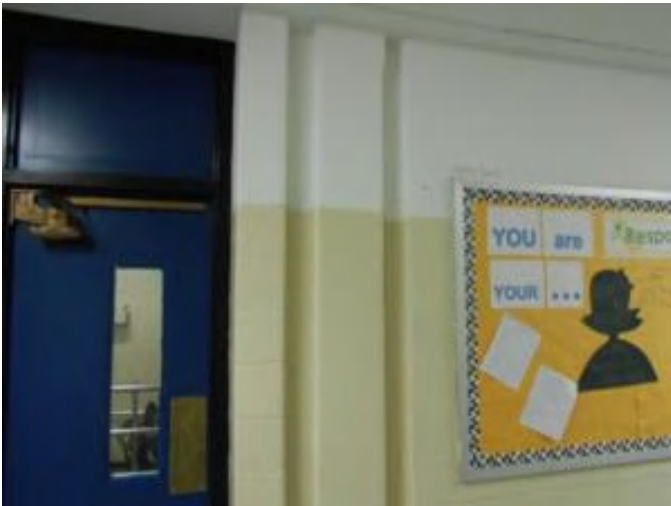
System: C1020 - Interior Doors

Location: Interior doors

Distress: Accessibility

Notes: Replace the hollow metal doors to the exit stairs with new units that have panic hardware.

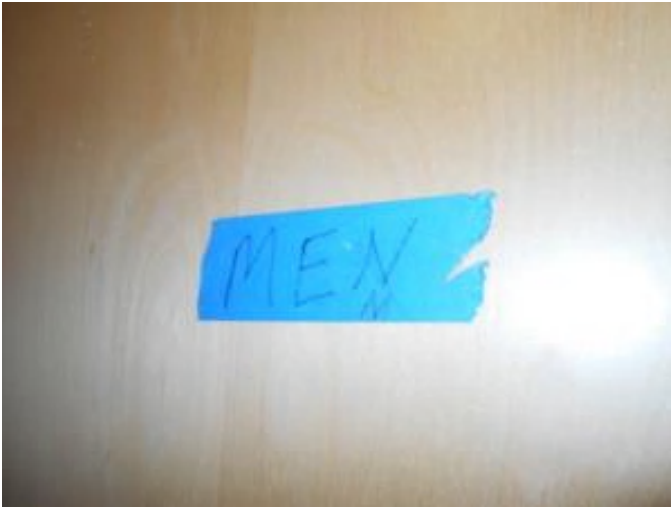
System: C1030 - Fittings

Location: Throughout the building

Distress: Inadequate

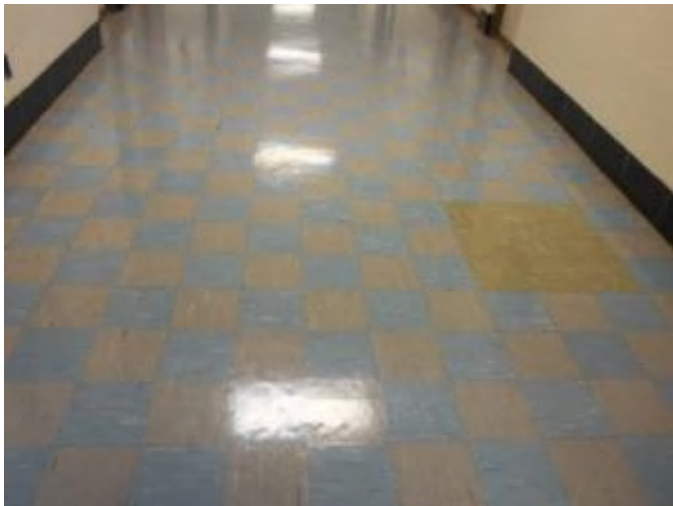
System: C3020413 - Vinyl Flooring

Location: Throughout the building

Distress: Failing

Notes: Remove the VAT floors throughout the building.

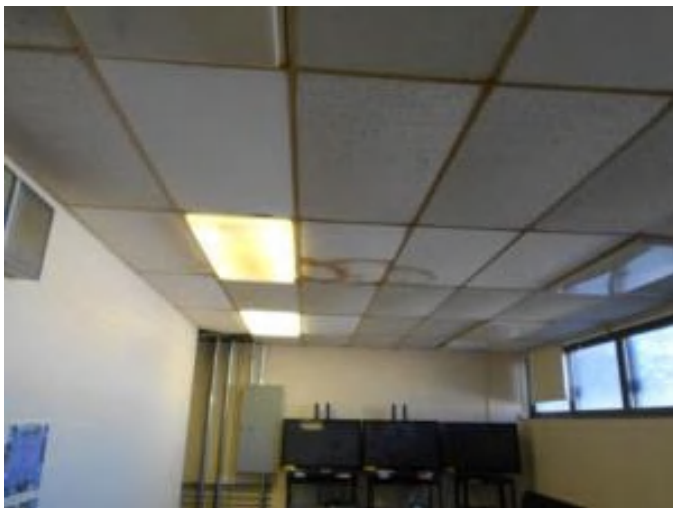
System: C3030 - Ceiling Finishes

Location: Throughout the building

Distress: Damaged

Notes: Replace damaged acoustical ceiling panels occurring throughout the building. Clean or paint existing grid.

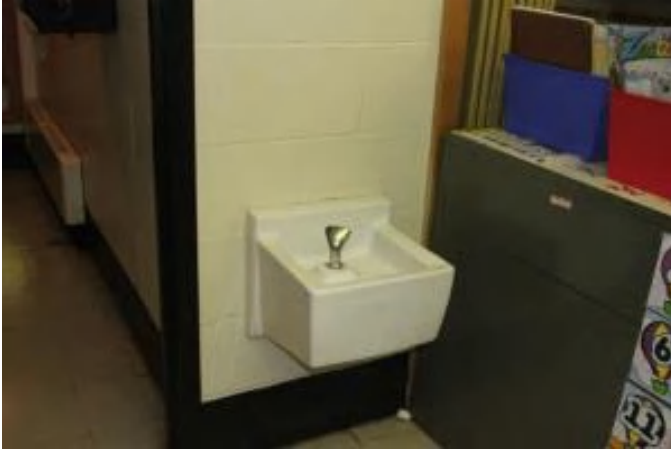
System: D2010 - Plumbing Fixtures

Location: Entire school

Distress: Accessibility

Notes: Replace water fountains due to age and lack of accessibility

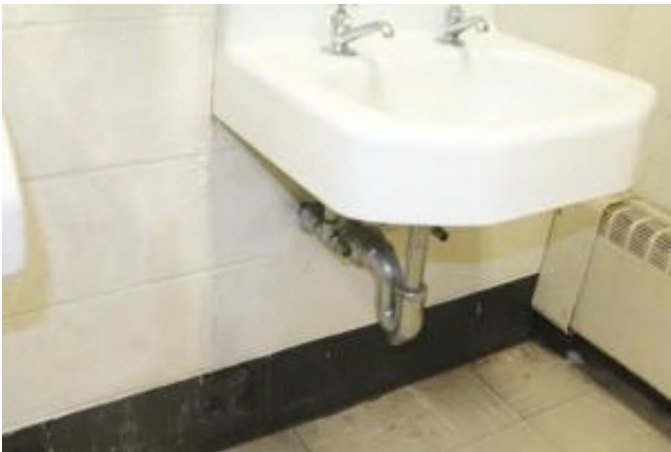
System: D2010 - Plumbing Fixtures

Location: Toilet rooms

Distress: Beyond Service Life

Notes: Replace lavatories due to age

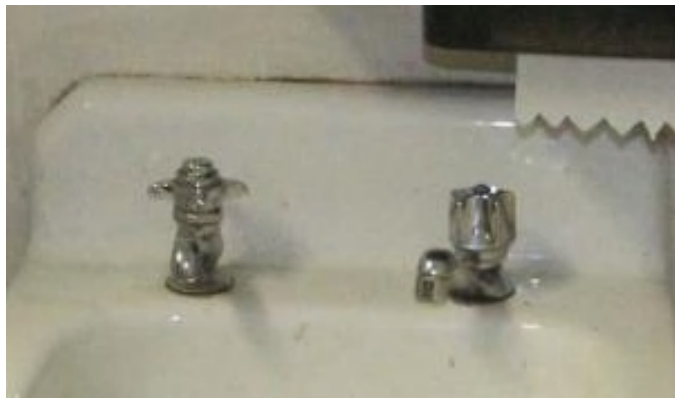
System: D2010 - Plumbing Fixtures

Location: Toilet rooms

Distress: Failing

Notes: Replace leaking faucets

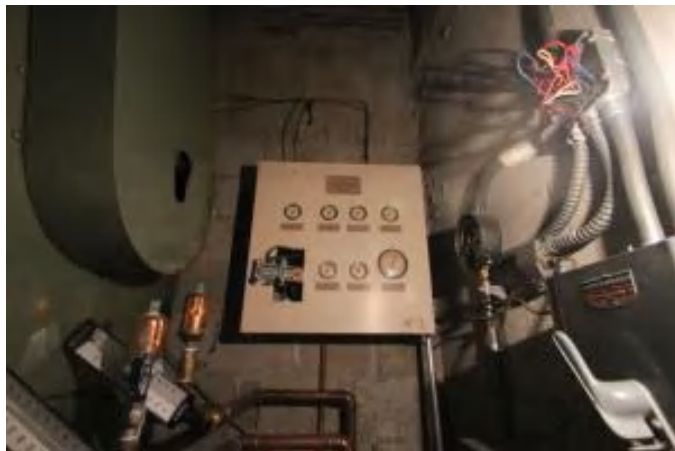
System: D3060 - Controls & Instrumentation

Location: Entire building

Distress: Obsolete

Notes: Replace pneumatic HVAC control with digital

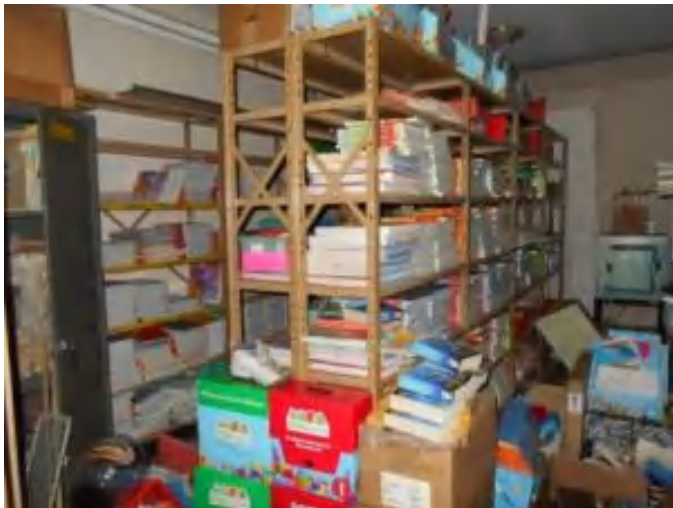
System: E1020 - Institutional Equipment

Location: Room 301A

Distress: Inadequate

Notes: Provide shelving in storage room 301A on the 3rd Floor to eliminate clutter and improve safety.

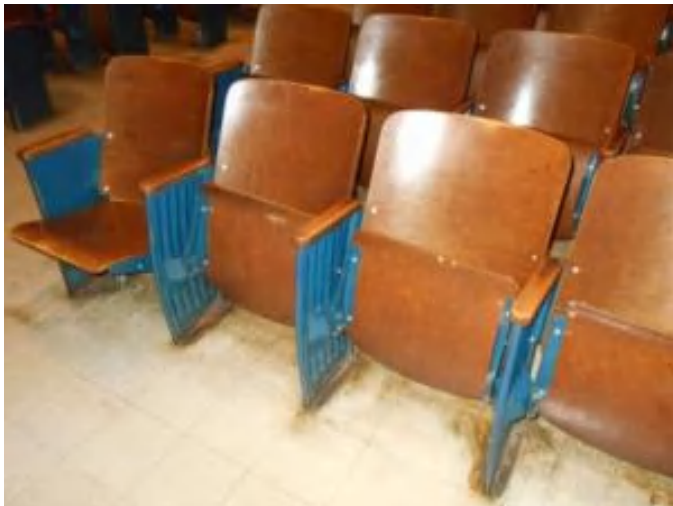
System: E2010 - Fixed Furnishings

Location: Auditorium

Distress: Damaged

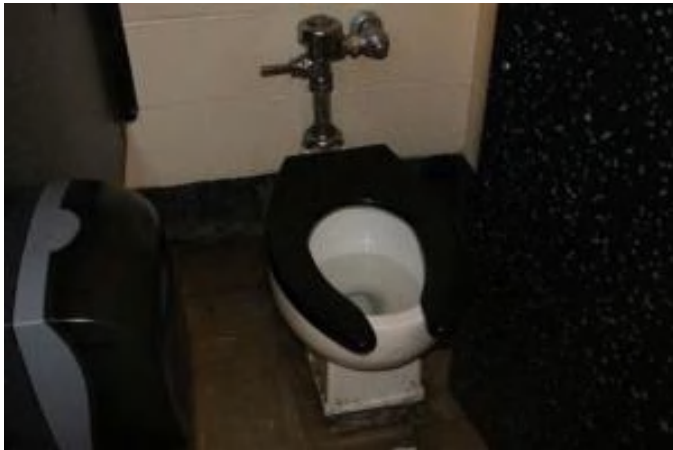
System: D2010 - Plumbing Fixtures

Location: Toilet rooms

Distress: Beyond Service Life

Notes: Replace water closets due to age

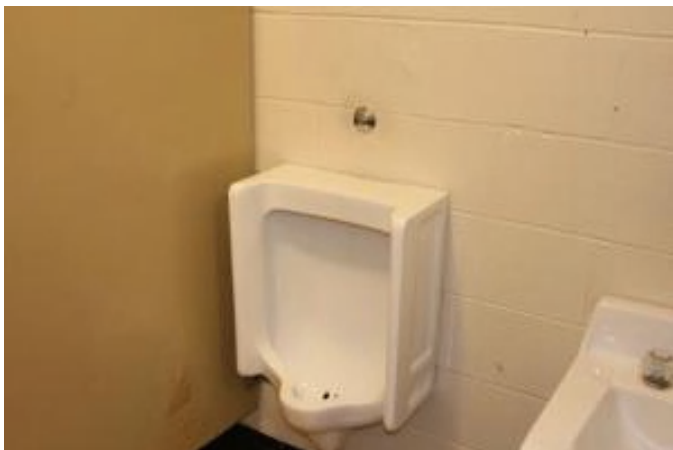
System: D2010 - Plumbing Fixtures

Location: Toilet rooms

Distress: Beyond Service Life

Notes: Replace urinals due to age

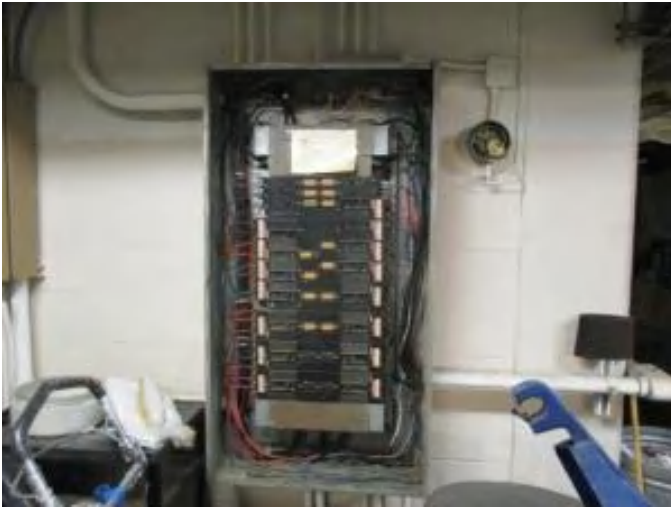
System: D5010 - Electrical Service/Distribution

Location: Entire Building

Distress: Beyond Service Life

Notes: Replace the entire distribution system with new panels and new wiring/conduits. Approximate (15) 208/120V panel boards.

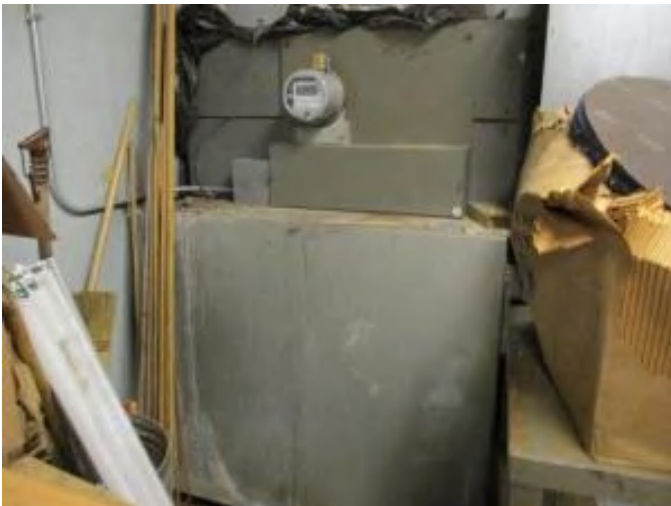
System: D5010 - Electrical Service/Distribution

Location: Basement

Distress: Inadequate

Notes: Provide a new electrical service 480V/277V, 3 phase power, approximate 500 Amperes and will be located in the vicinity of the existing electrical service.

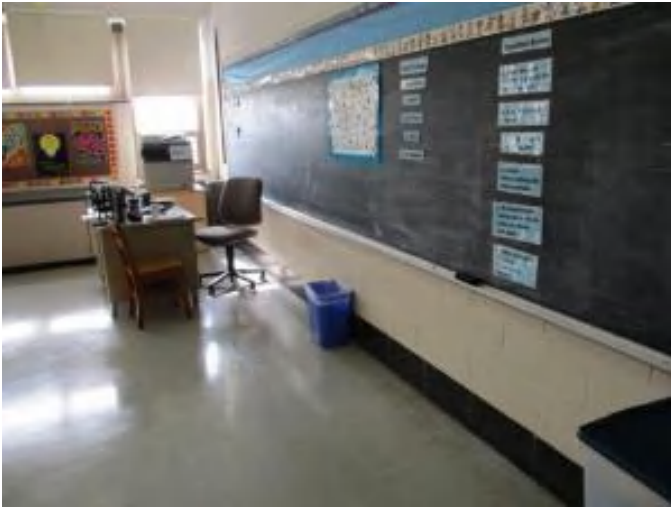
System: D5020 - Lighting and Branch Wiring

Location: Entire Building

Distress: Inadequate

Notes: Provide (2)25FT of surface raceways with 24" receptacles on center and two-duplex wall mount receptacles. Approximate 205

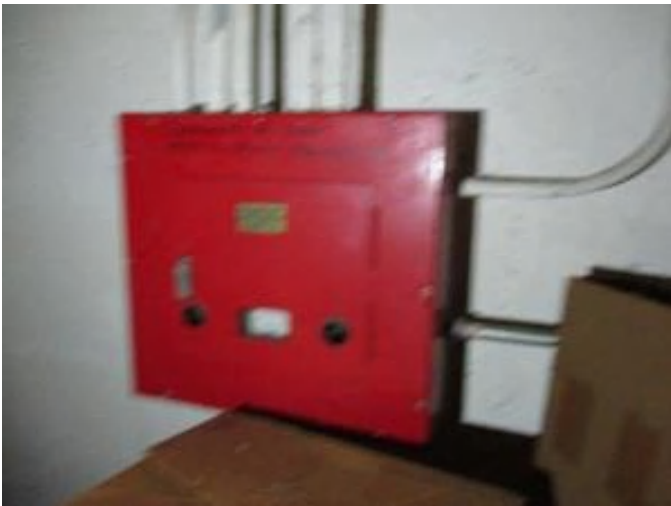
System: D5030 - Communications and Security

Location: Entire Building

Distress: Life Safety / NFPA / PFD

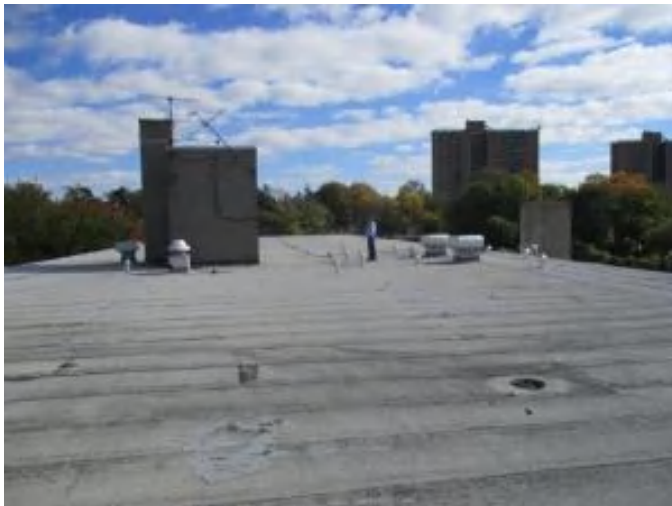
System: D5090 - Other Electrical Systems

Location: Roof

Distress: Building / MEP Codes

Notes: Prepare a study to determine if the air terminals on the chimney provide the proper protection to the school building

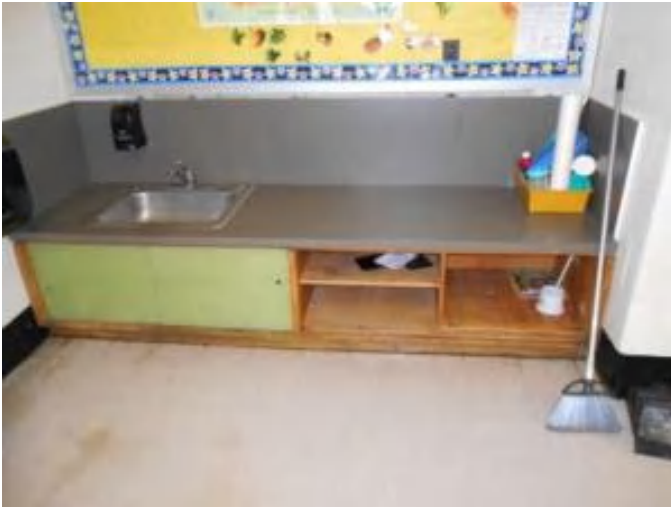
System: E1020 - Institutional Equipment

Location: Kindergarten rooms

Distress: Damaged

Notes: Replace the damaged base cabinets and counter tops in Kindergarten classrooms 115 and 117.

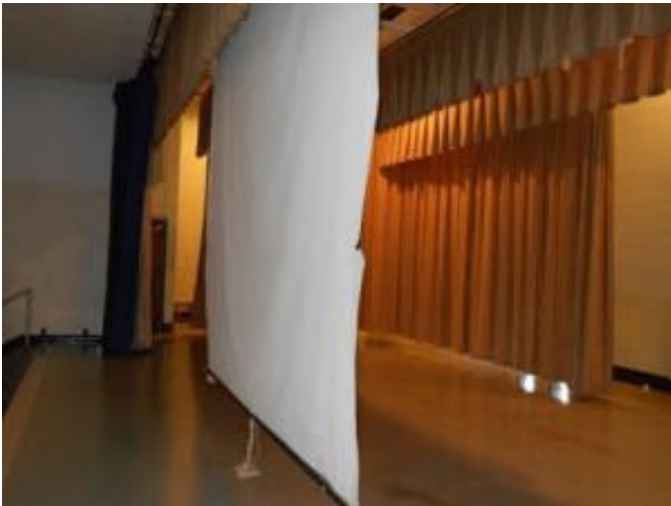
System: E1020 - Institutional Equipment

Location: Auditorium

Distress: Damaged

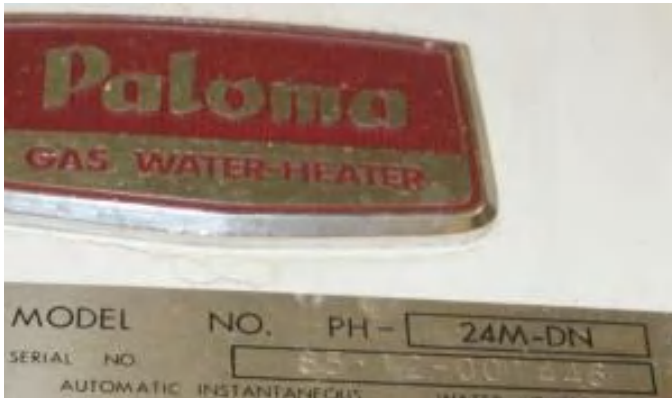
System: D2020 - Domestic Water Distribution

Location: Boiler room

Distress: Beyond Service Life

Notes: Replace tankless water heaters

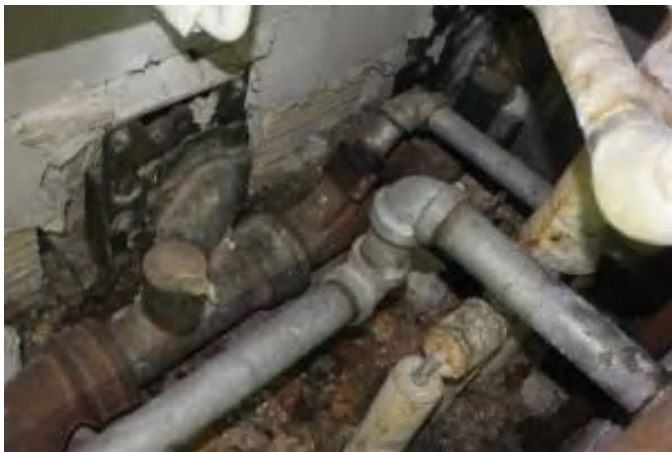
System: D2030 - Sanitary Waste

Location: Entire building

Distress: Beyond Service Life

Notes: Inspect and repair sanitary drain pipe due to age

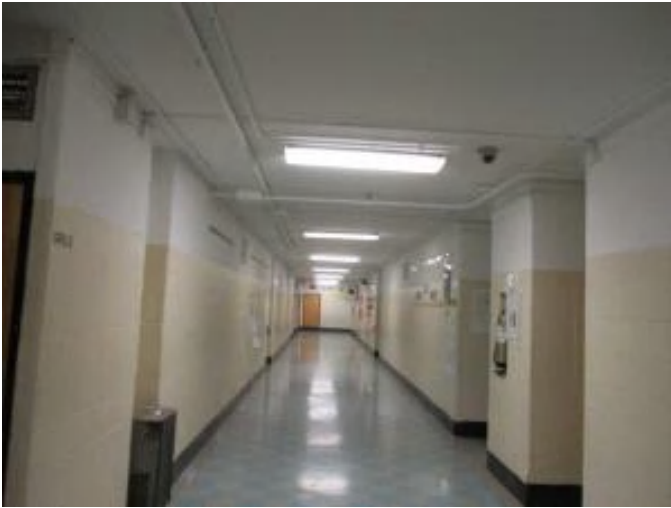
System: D5020 - Lighting and Branch Wiring

Location: Entire Building

Distress: Obsolete

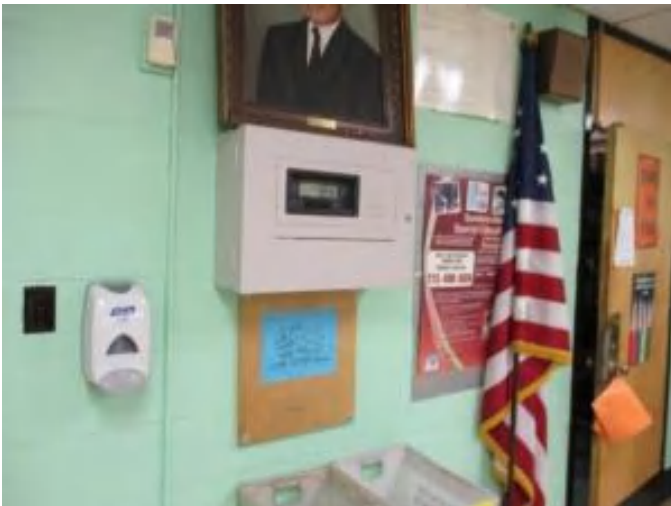
System: D5030 - Communications and Security

Location: Entire Building

Distress: Beyond Service Life

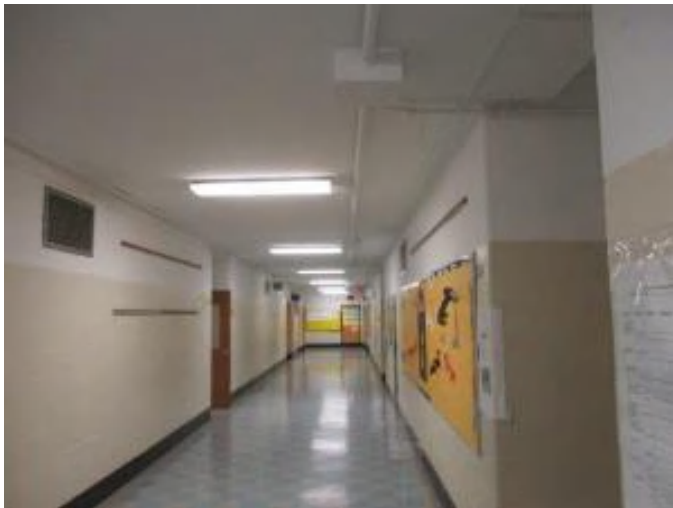
System: D5030 - Communications and Security

Location: Entire Building

Distress: Security Issue

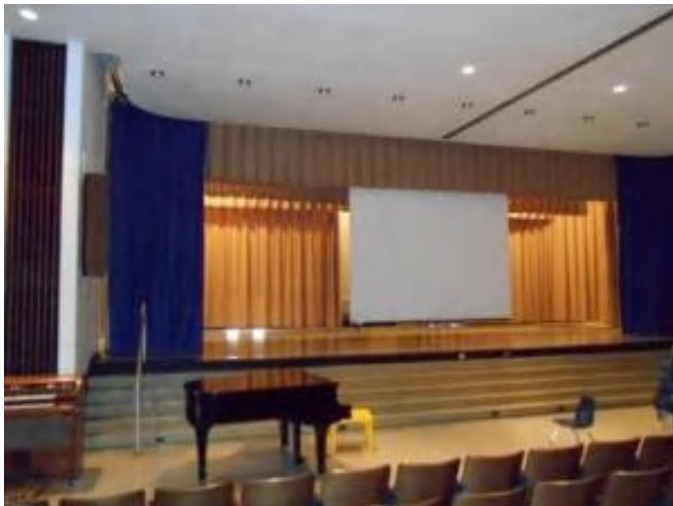
System: D5030 - Communications and Security

Location: Auditorium

Distress: Inadequate

Notes: Provide the auditorium with a permanent installed sound system.

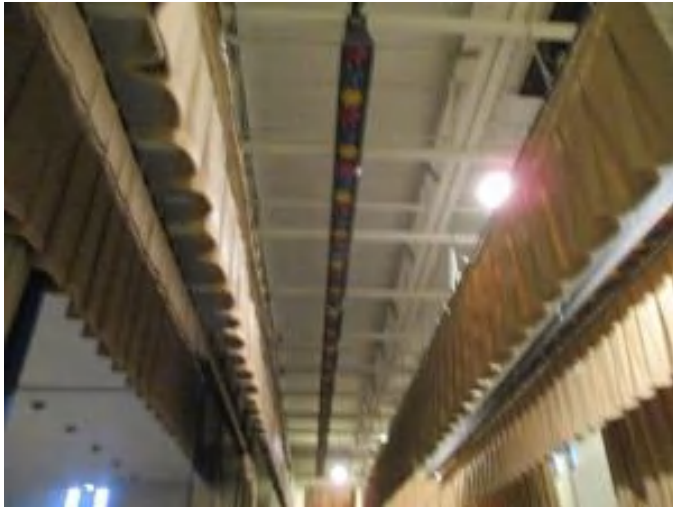
System: E1020 - Institutional Equipment

Location: Auditorium

Distress: Obsolete

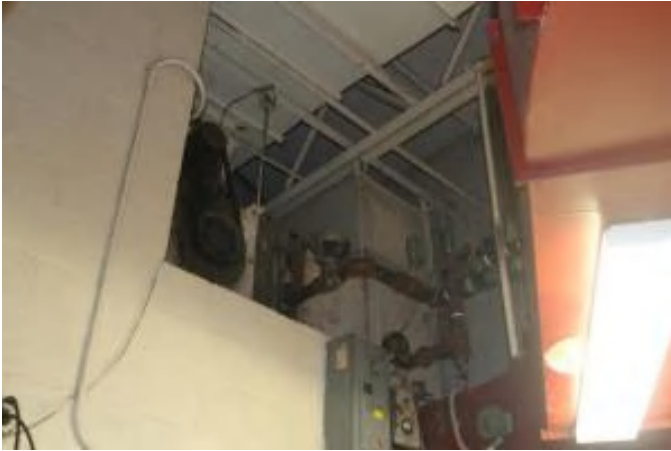
System: D3040 - Distribution Systems

Location: Gym and auditorium

Distress: Inadequate

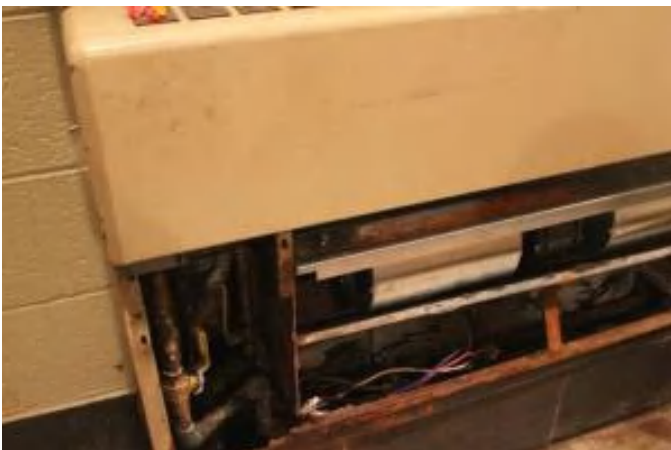
System: D3040 - Distribution Systems

Location: Offices, toilets, corridors

Distress: Beyond Service Life

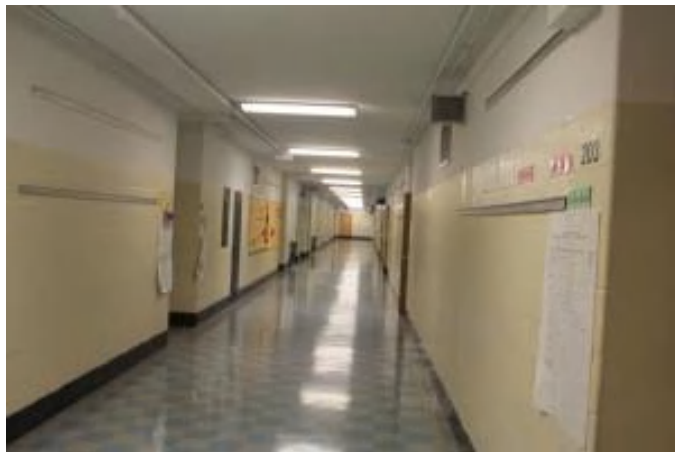
System: D4010 - Sprinklers

Location: Entire building

Distress: Life Safety / NFPA / PFD

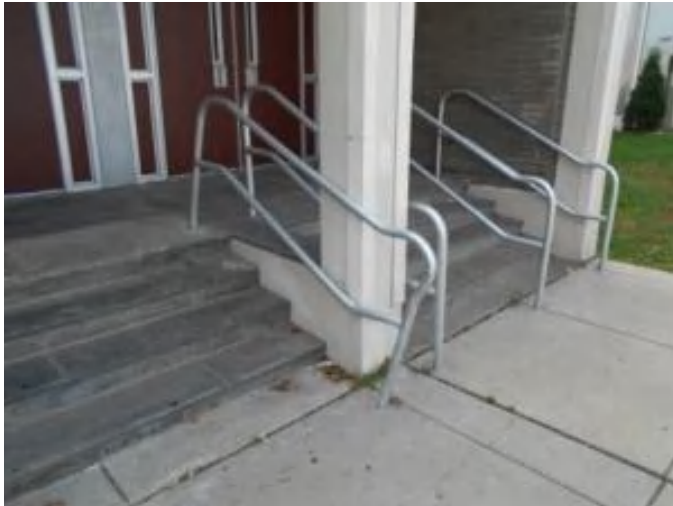
System: G2040 - Site Development

Location: Main entry

Distress: Damaged

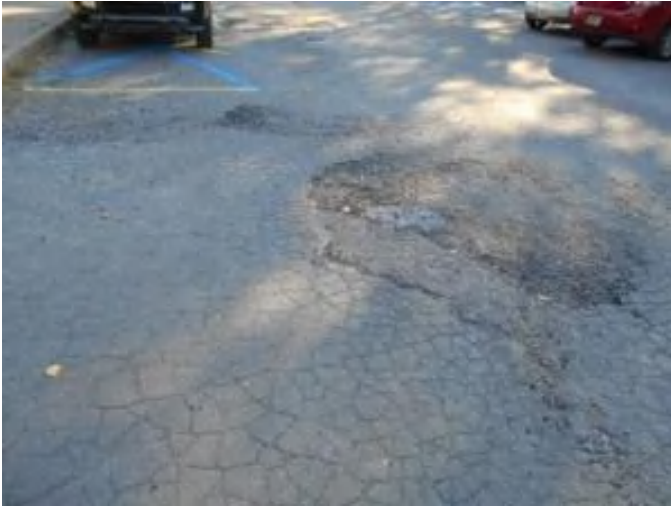
System: G2020 - Parking Lots

Location: Parking lot

Distress: Beyond Service Life

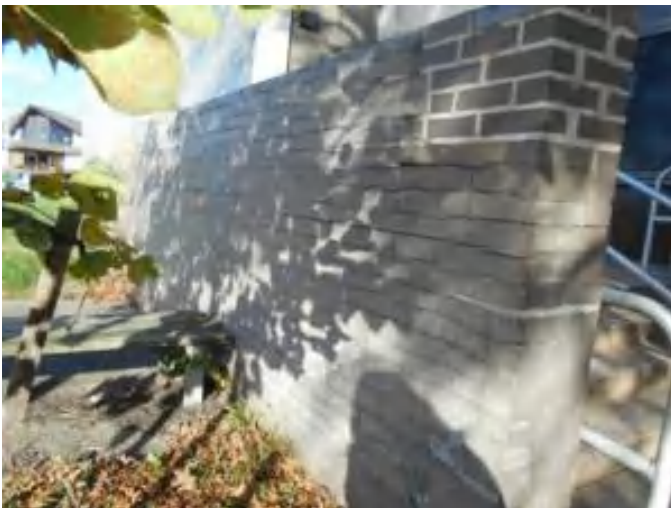
System: G2040 - Site Development

Location: Site

Distress: Damaged

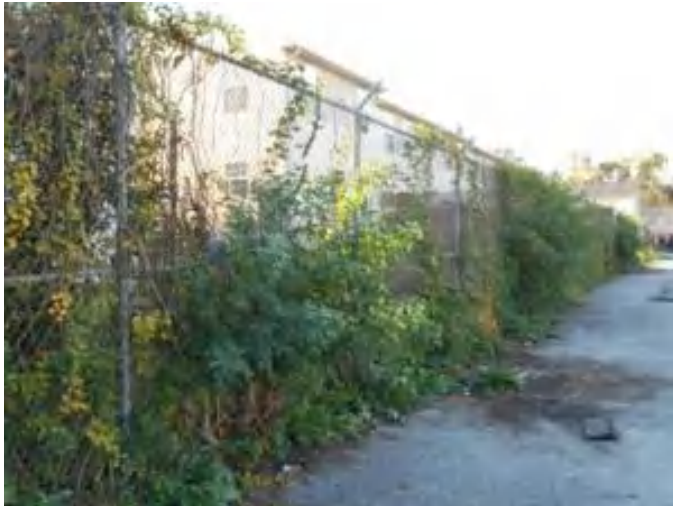
System: G2040 - Site Development

Location: South property line

Distress: Failing

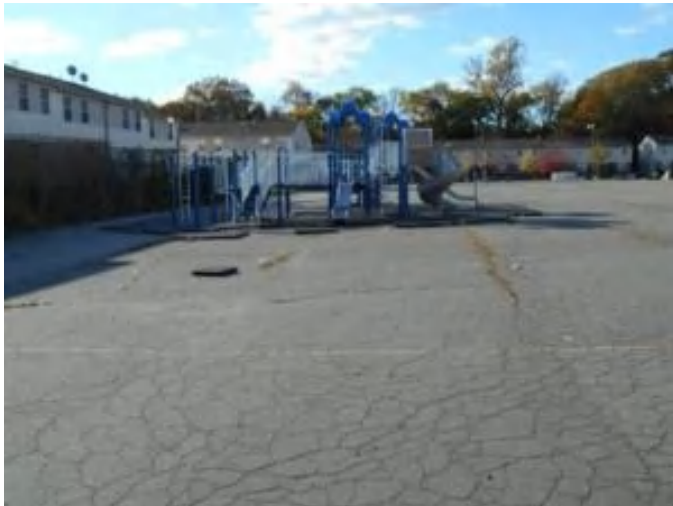
System: G2030 - Pedestrian Paving

Location: Playground

Distress: Failing

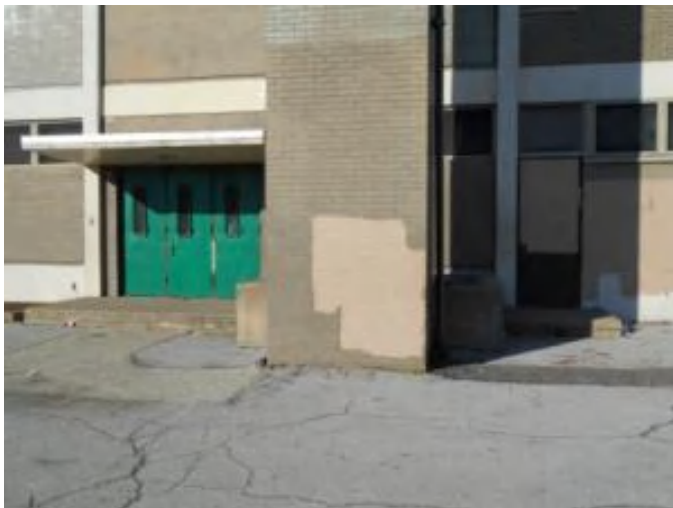
System: G2040 - Site Development

Location: Site

Distress: Accessibility

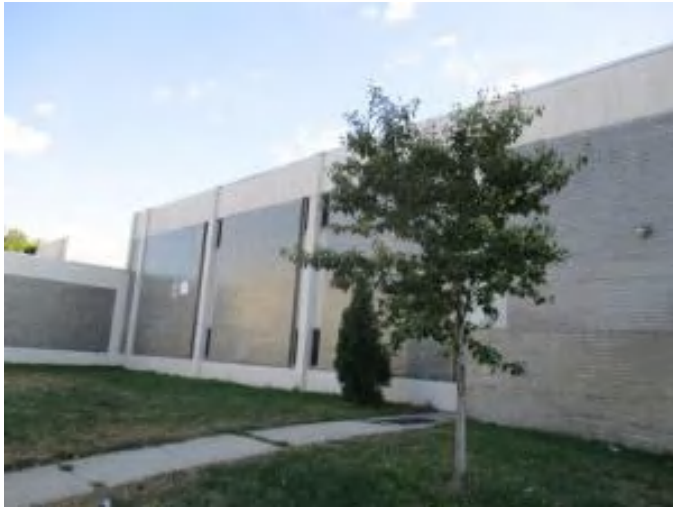
System: G4030 - Site Communications & Security

Location: Building Perimeter

Distress: Security Issue

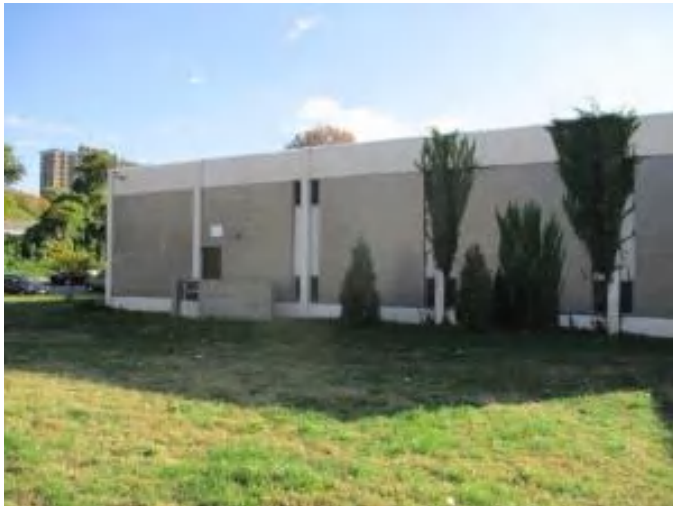
System: G4020 - Site Lighting

Location: Building Perimeter

Distress: Security Issue
