## Facility Condition Assessment Summary Report

### Loesche School

School District of Philadelphia  
**S844001;Loesche**  
Final  
**Site Assessment Report**  
January 31, 2017

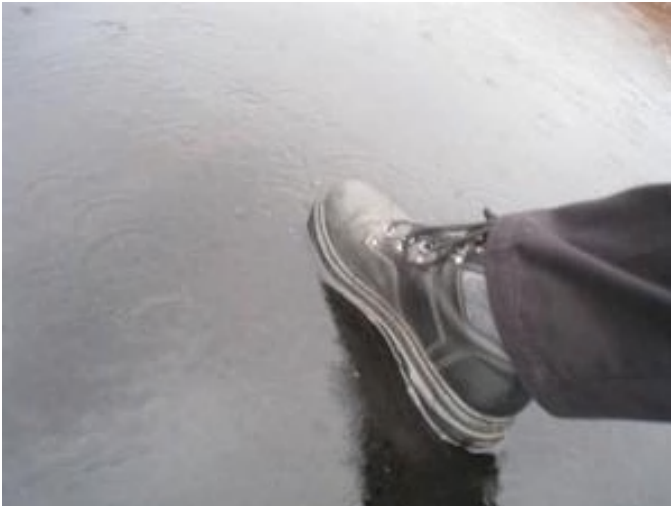
#### System: B3010105 - Built-Up

**Location:** roof

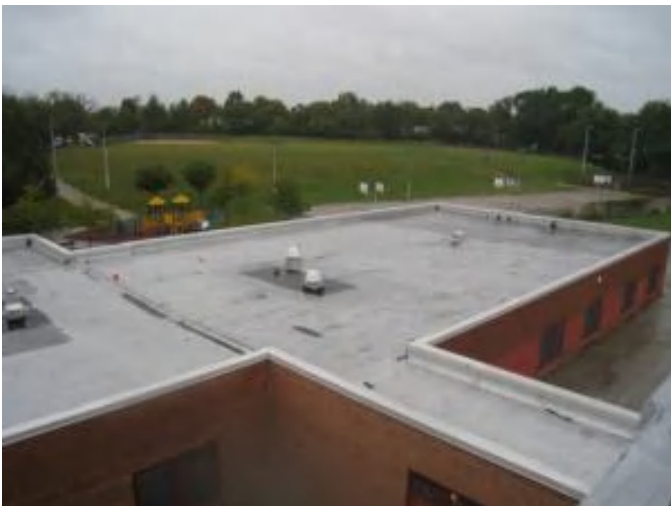
#### System: B3010105 - Built-Up

**Location:** roof gravel stop

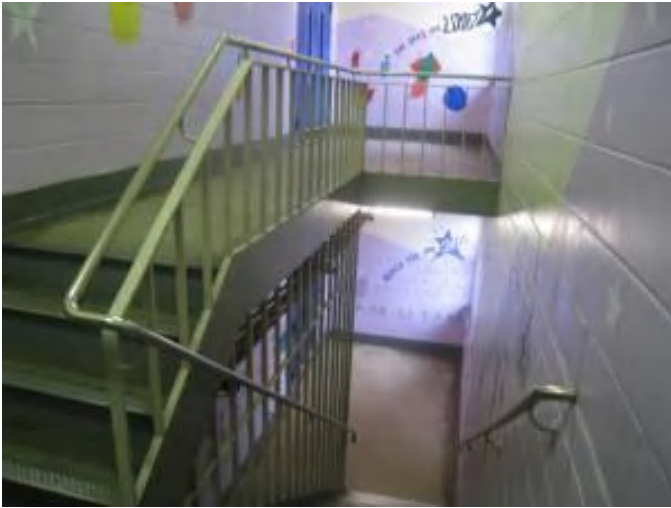
**System: C2010 - Stair Construction**

**Location:** stairways

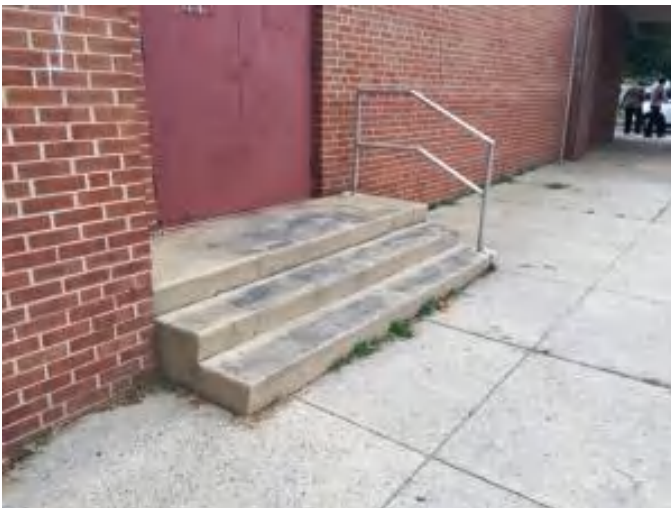
**System: C2010 - Stair Construction**

**Location:** exterior stairs

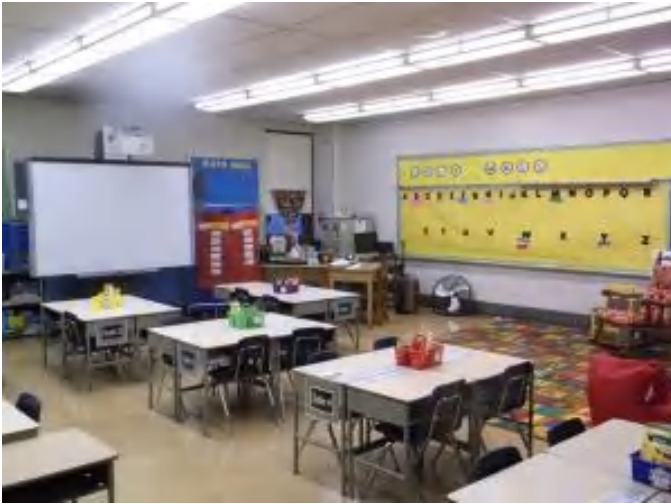
**System: D3040 - Distribution Systems**

**Location:** Classrooms

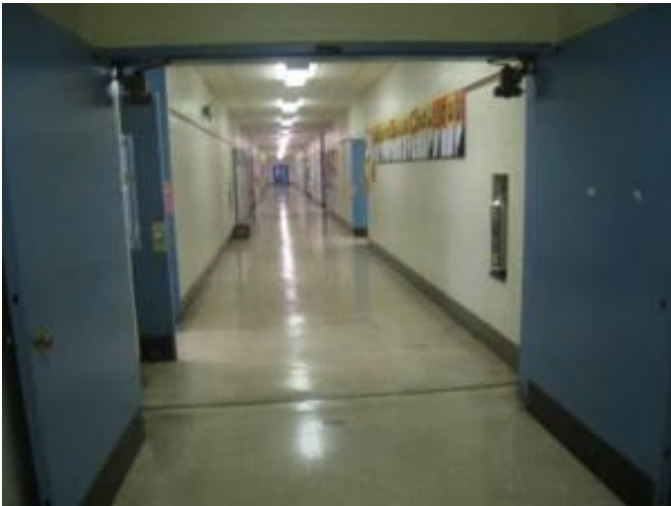
**System: D3040 - Distribution Systems**

**Location:** Throughout Building

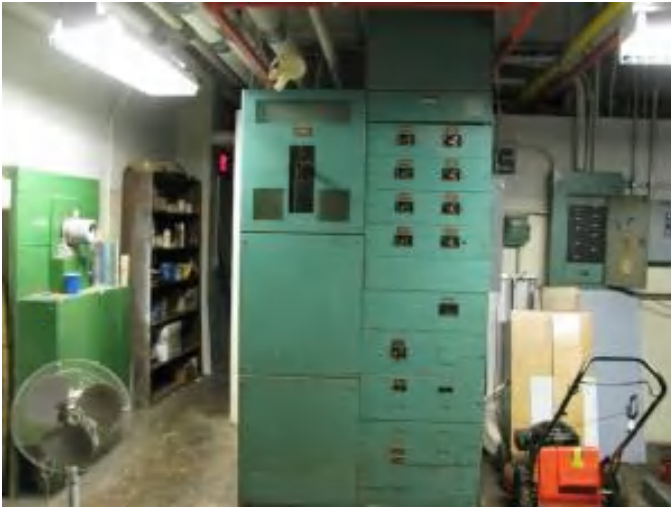
**System: D5010 - Electrical Service/Distribution**

**Location:** Utility Room  
**Distress:** Beyond Service Life  
**Category:** 3 - Operations / Maint.  
**Priority:** 1 - Response Time (< 2 yr)  
**Correction:** Replace Switchboard  
**Qty:** 1.00  
**Unit of Measure:** Ea.  
**Estimate:** \$518,394.56  
**Assessor Name:** Craig Anding  
**Date Created:** 11/10/2015

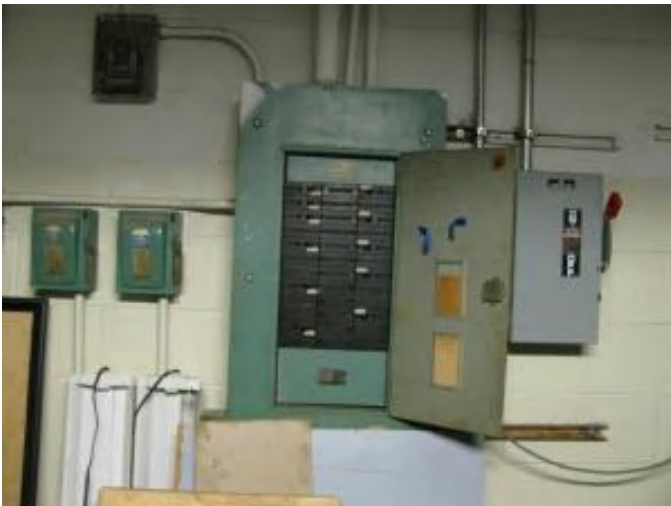
**System: D5010 - Electrical Service/Distribution**

**Location:** Entire Building  
**Distress:** Beyond Service Life  
**Category:** 3 - Operations / Maint.  
**Priority:** 1 - Response Time (< 2 yr)  
**Correction:** Replace Electrical Distribution System (U)  
**Qty:** 1.00  
**Unit of Measure:** Ea.  
**Estimate:** \$405,399.54  
**Assessor Name:** Craig Anding  
**Date Created:** 11/11/2015

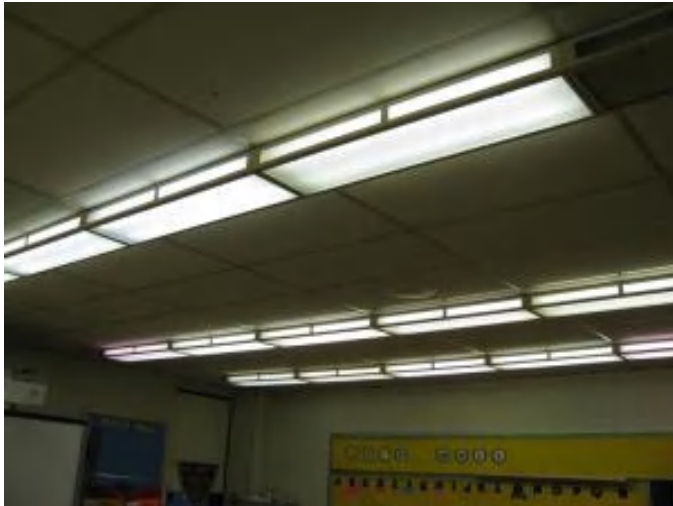
**System: D5020 - Lighting and Branch Wiring**

**Location:** Entire Building  
**Distress:** Beyond Service Life  
**Category:** 3 - Operations / Maint.  
**Priority:** 1 - Response Time (< 2 yr)  
**Correction:** Replace Lighting Fixtures (SF)  
**Qty:** 1.00  
**Unit of Measure:** S.F.  
**Estimate:** \$2,516,644.42  
**Assessor Name:** Craig Anding  
**Date Created:** 11/11/2015

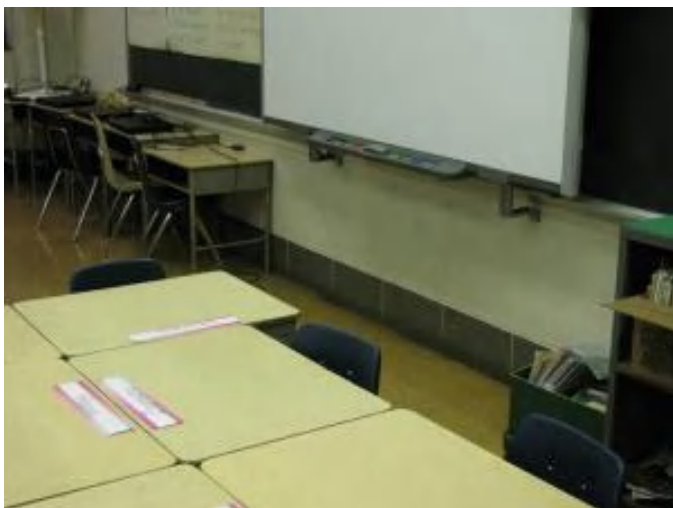
**System: D5020 - Lighting and Branch Wiring**

**Location:** Entire Building  
**Distress:** Inadequate  
**Category:** 4 - Capital Improvement  
**Priority:** 1 - Response Time (< 2 yr)  
**Correction:** Add wiring device  
**Qty:** 1.00  
**Unit of Measure:** Ea.  
**Estimate:** \$52,046.92  
**Assessor Name:** Craig Anding  
**Date Created:** 11/11/2015

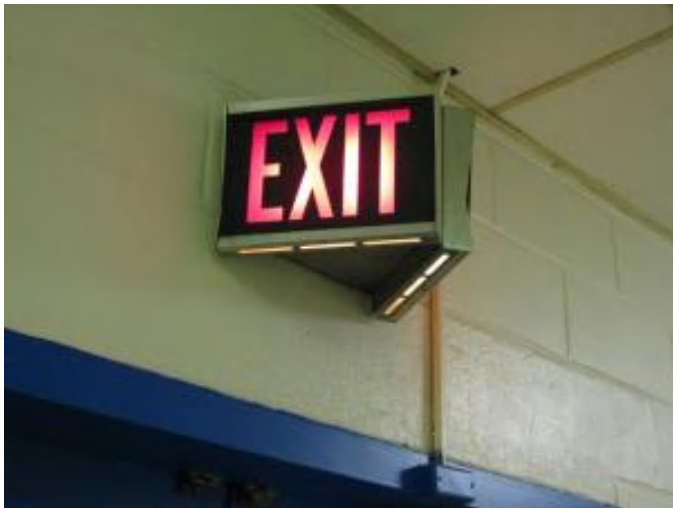
**System: D5020 - Lighting and Branch Wiring**

**Location:** Entire Building  
**Distress:** Inadequate  
**Category:** 4 - Capital Improvement  
**Priority:** 1 - Response Time (< 2 yr)  
**Correction:** Replace lighting fixtures  
**Qty:** 1.00  
**Unit of Measure:** Ea.  
**Estimate:** \$40,406.23  
**Assessor Name:** Craig Anding  
**Date Created:** 11/11/2015

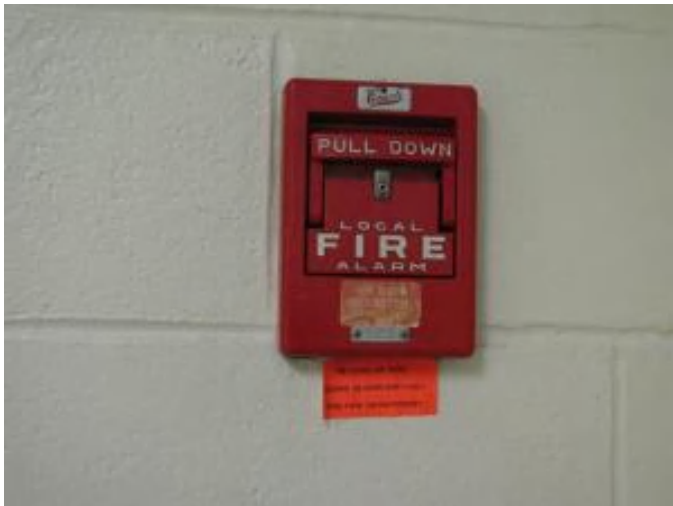
**System: D5030 - Communications and Security**

**Location:** Entire Building  
**Distress:** Beyond Service Life  
**Category:** 3 - Operations / Maint.  
**Priority:** 1 - Response Time (< 2 yr)  
**Correction:** Replace fire alarm system  
**Qty:** 1.00  
**Unit of Measure:** S.F.  
**Estimate:** \$506,538.67  
**Assessor Name:** Craig Anding  
**Date Created:** 11/11/2015

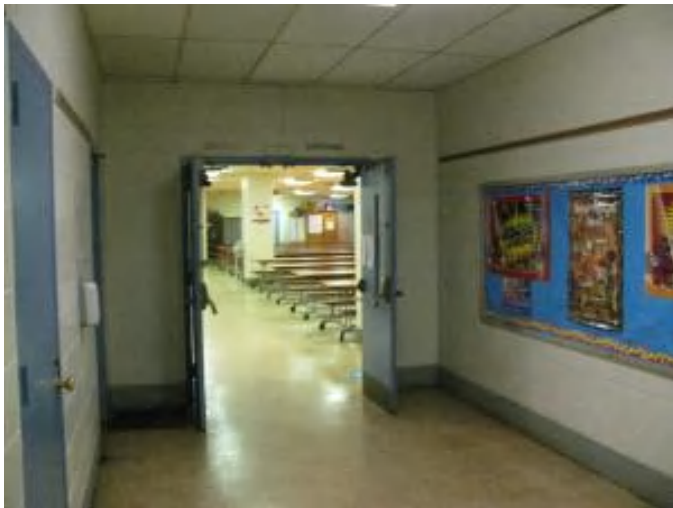
**System: D5030 - Communications and Security**

**Location:** Entire Building  
**Distress:** Security Issue  
**Category:** 1 - Health & Safety  
**Priority:** 1 - Response Time (< 2 yr)  
**Correction:** Add/Replace Video Surveillance System  
**Qty:** 1.00  
**Unit of Measure:** Ea.  
**Estimate:** \$268,117.14  
**Assessor Name:** Craig Anding  
**Date Created:** 11/11/2015

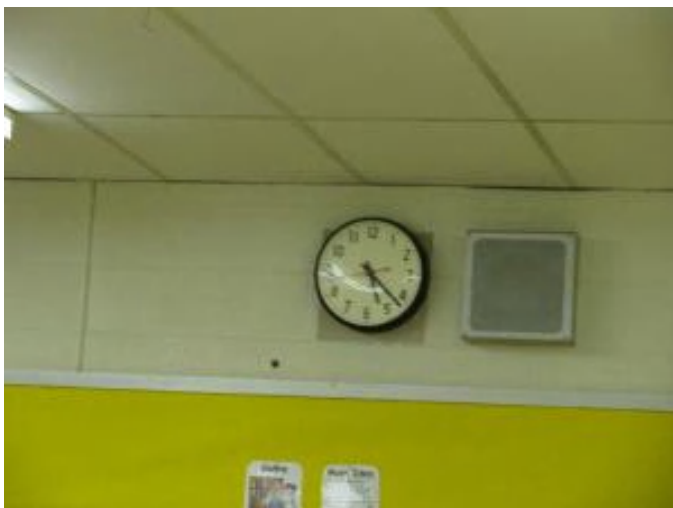
**System: D5030 - Communications and Security**

**Location:** Entire Building  
**Distress:** Inadequate  
**Category:** 4 - Capital Improvement  
**Priority:** 1 - Response Time (< 2 yr)  
**Correction:** Add/Replace Clock System or Components  
**Qty:** 1.00  
**Unit of Measure:** Ea.  
**Estimate:** \$60,863.23  
**Assessor Name:** Craig Anding  
**Date Created:** 11/11/2015

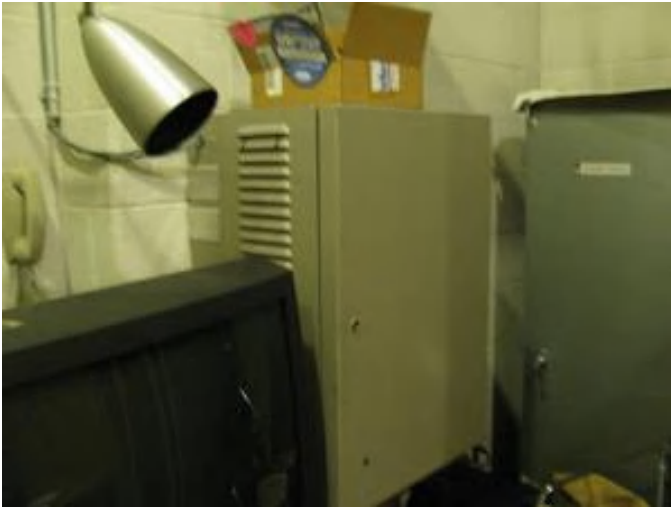
**System: D5030 - Communications and Security**

**Location:** Auditorium  
**Distress:** Beyond Service Life  
**Category:** 3 - Operations / Maint.  
**Priority:** 1 - Response Time (< 2 yr)  
**Correction:** Add/Replace Sound System  
**Qty:** 1.00  
**Unit of Measure:** LS  
**Estimate:** \$38,400.80  
**Assessor Name:** Craig Anding  
**Date Created:** 11/11/2015

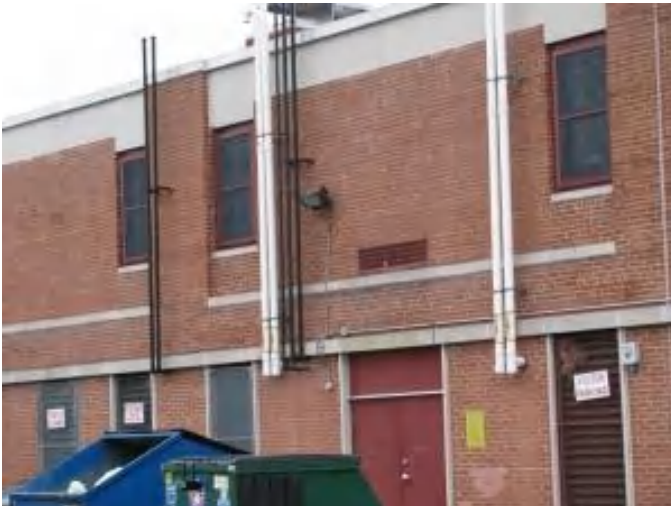
**System: D5030 - Communications and Security**

**Location:** Exterior Building  
**Distress:** Inadequate  
**Category:** 4 - Capital Improvement  
**Priority:** 1 - Response Time (< 2 yr)  
**Correction:** Add/Replace Paging System  
**Qty:** 1.00  
**Unit of Measure:** Ea.  
**Estimate:** \$32,865.79  
**Assessor Name:** Craig Anding  
**Date Created:** 11/11/2015

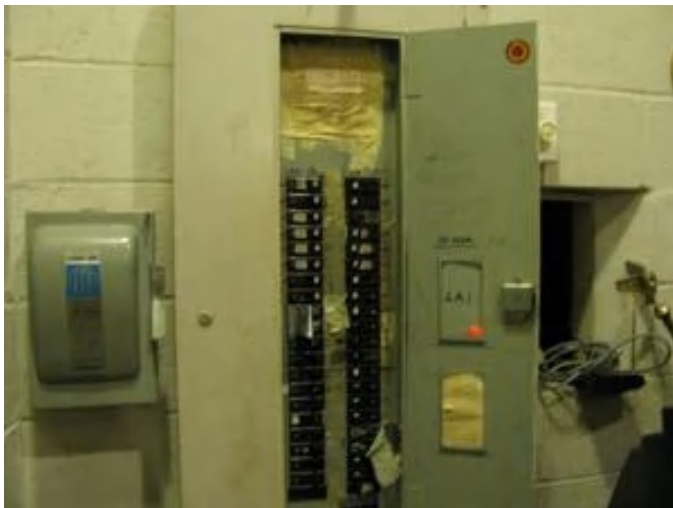
**System: F1020 - Institutional Equipment**

**Location:** Auditorium

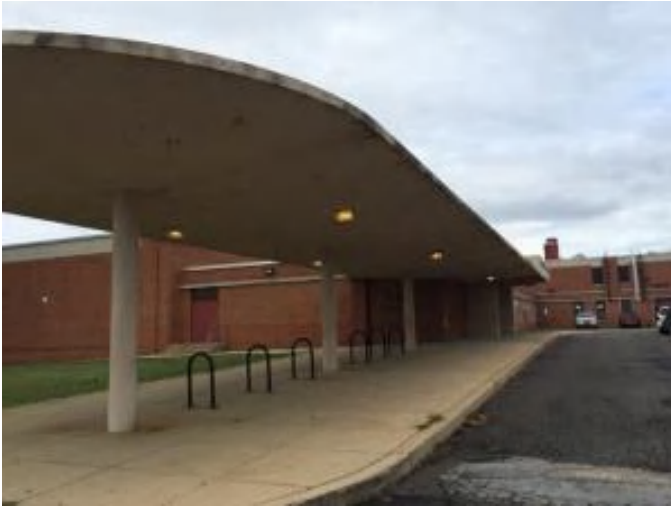
**System: A2020 - Basement Walls**

**Location:** concrete canopy

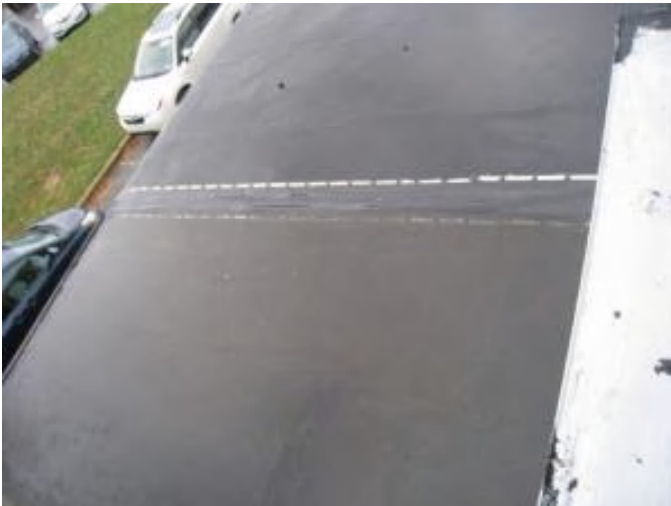
**System: B1010 - Floor Construction**

**Location:** concrete canopy

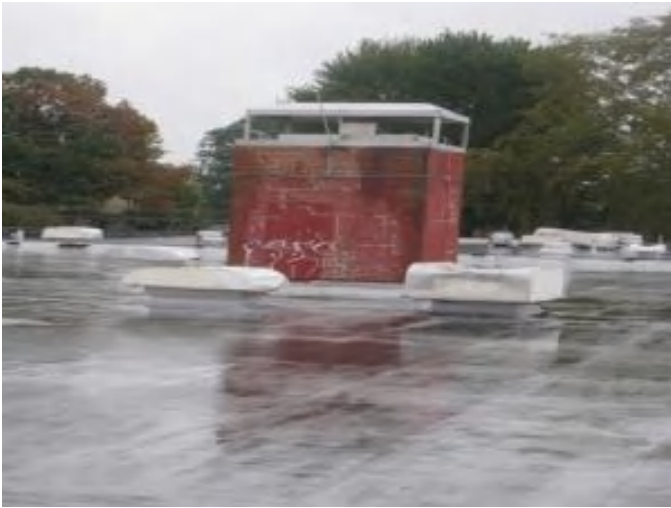
**System: B2010 - Exterior Walls**

**Location:** exterior walls  
**Distress:** Failing  
**Category:** 3 - Operations / Maint.  
**Priority:** 2 - Response Time (2-3 yrs)  
**Correction:** Repair cracks in masonry - replace missing mortar and repoint - SF of wall area  
**Qty:** 2,000.00  
**Unit of Measure:** S.F.  
**Estimate:** \$64,578.94  
**Assessor Name:** Craig Anding  
**Date Created:** 12/17/2015

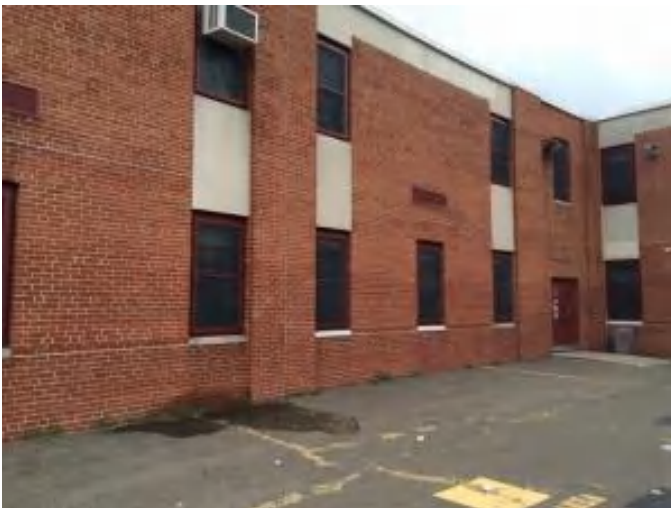
**System: B2010 - Exterior Walls**

**Location:** exterior walls  
**Distress:** Damaged  
**Category:** 3 - Operations / Maint.  
**Priority:** 2 - Response Time (2-3 yrs)  
**Correction:** Remove and replace exterior wall louvers - pick the closest size and insert the number of louvers  
**Qty:** 12.00  
**Unit of Measure:** Ea.  
**Estimate:** \$32,386.34  
**Assessor Name:** Craig Anding  
**Date Created:** 12/17/2015

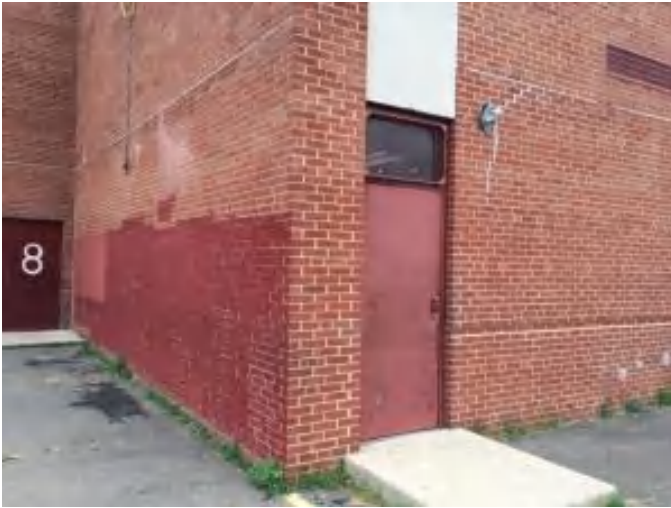
**System: B2010 - Exterior Walls**

**Location:** exterior brick walls

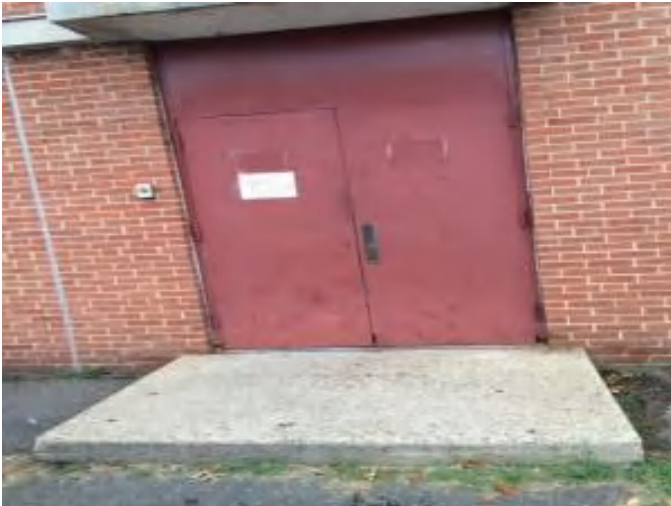
**System: B2030 - Exterior Doors**

**Location:** exterior doors

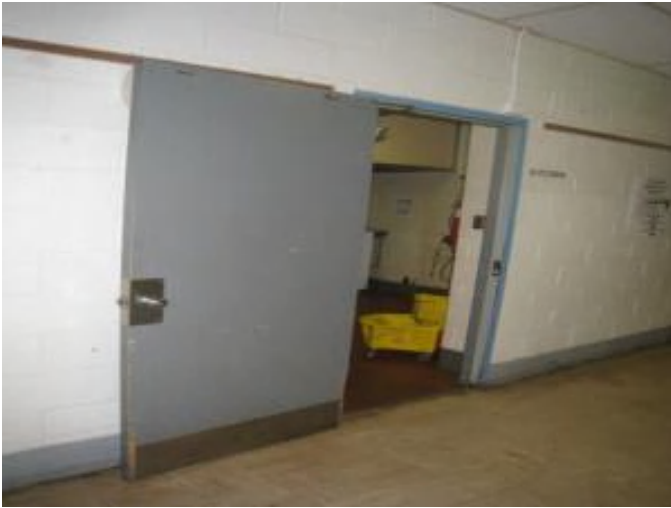
**System: C1020 - Interior Doors**

**Location:** interior doors  
**Distress:** Damaged  
**Category:** 3 - Operations / Maint.  
**Priority:** 2 - Response Time (2-3 yrs)  
**Correction:** Remove and replace hollow metal frames and doors  
**Qty:** 30.00  
**Unit of Measure:** Ea.  
**Estimate:** \$152,339.61  
**Assessor Name:** Craig Anding  
**Date Created:** 12/17/2015

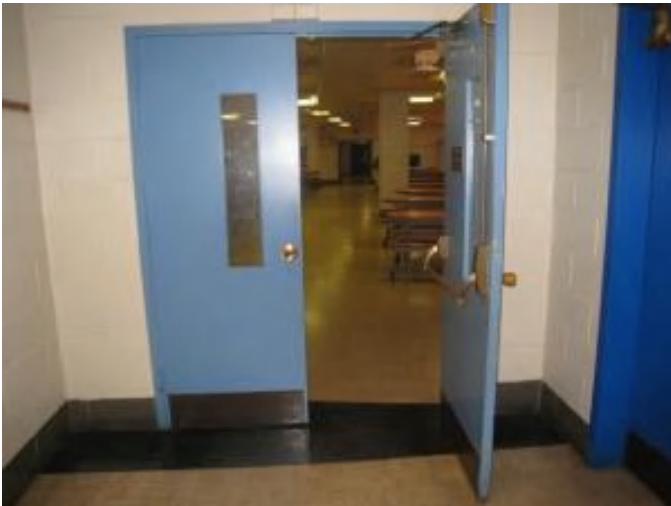
**System: C1020 - Interior Doors**

**Location:** interior doors  
**Distress:** Damaged  
**Category:** 3 - Operations / Maint.  
**Priority:** 2 - Response Time (2-3 yrs)  
**Correction:** Refinish interior doors  
**Qty:** 130.00  
**Unit of Measure:** Ea.  
**Estimate:** \$107,663.78  
**Assessor Name:** Craig Anding  
**Date Created:** 12/17/2015

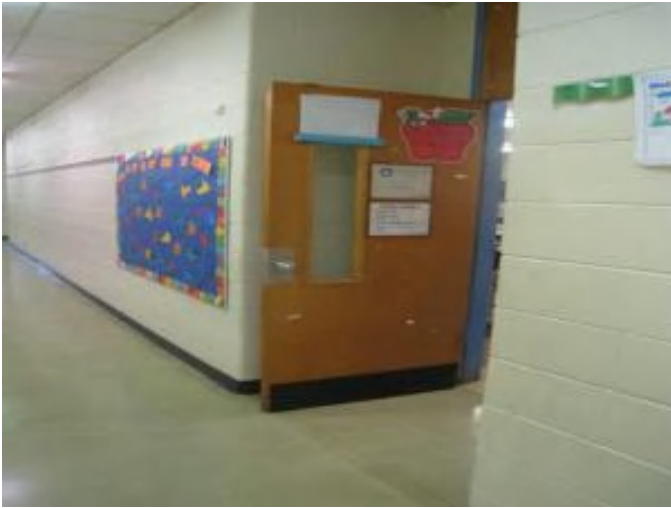
**System: C1020 - Interior Doors**

**Location:** classroom and office doors

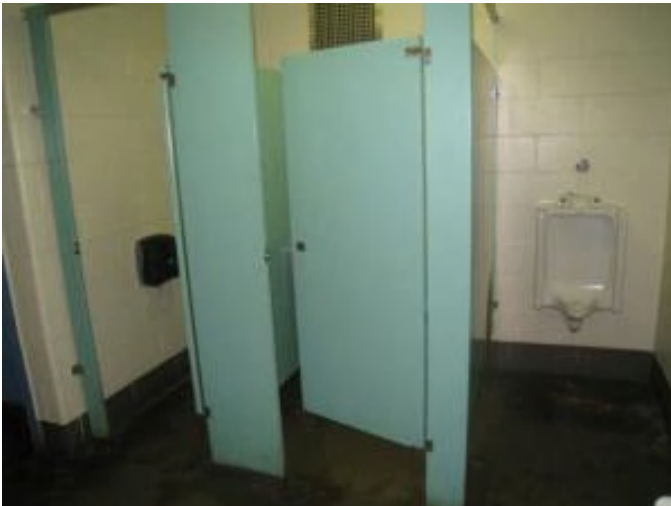
**System: C1030 - Fittings**

**Location:** toilet rooms

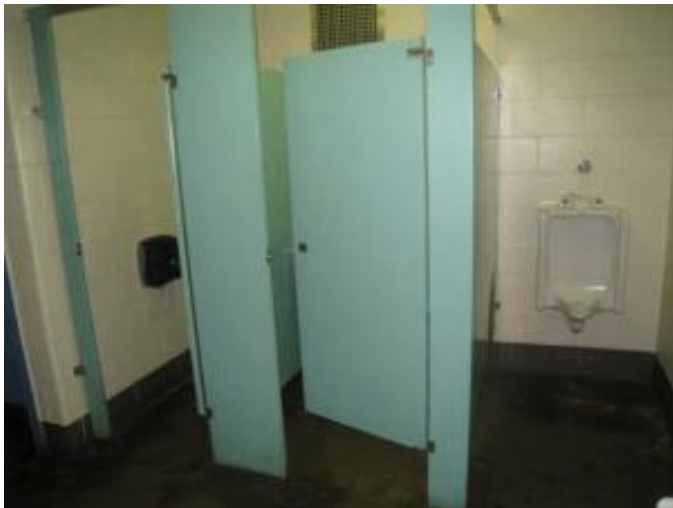
**System: C1030 - Fittings**

**Location:** toilet rooms

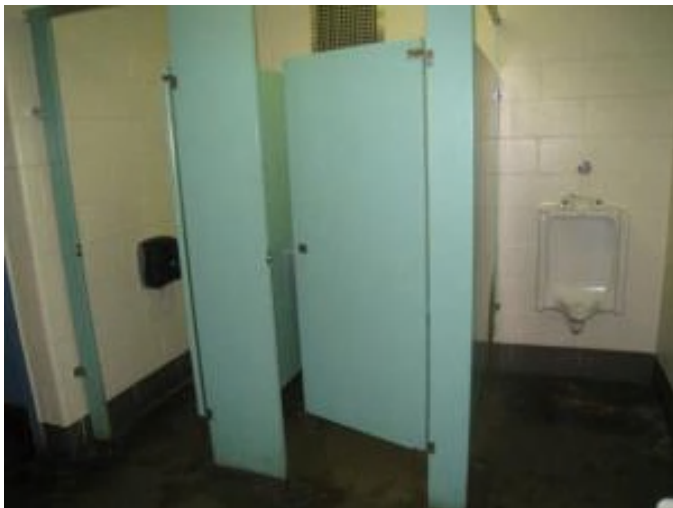
**System: C1030 - Fittings**

**Location:** toilet rooms

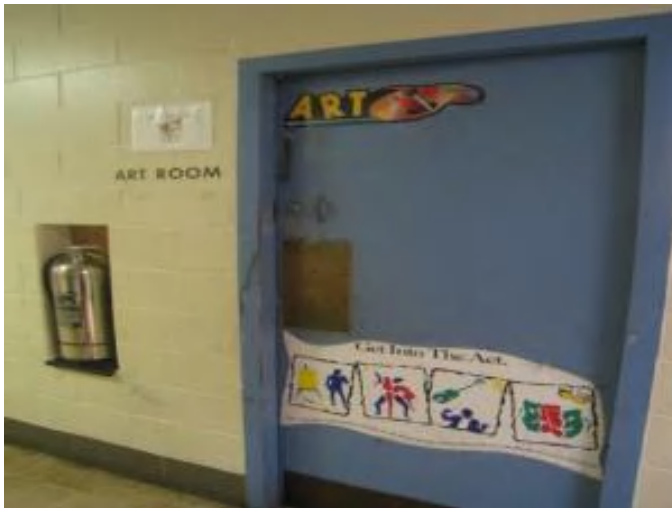
**System: C3010230 - Paint & Covering**

**Location:** interior walls

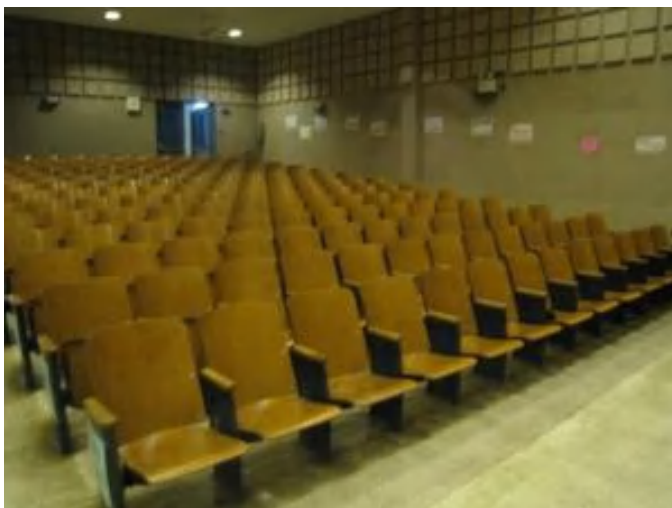
**System: C3020413 - Vinyl Flooring**

**Location:** interior floors

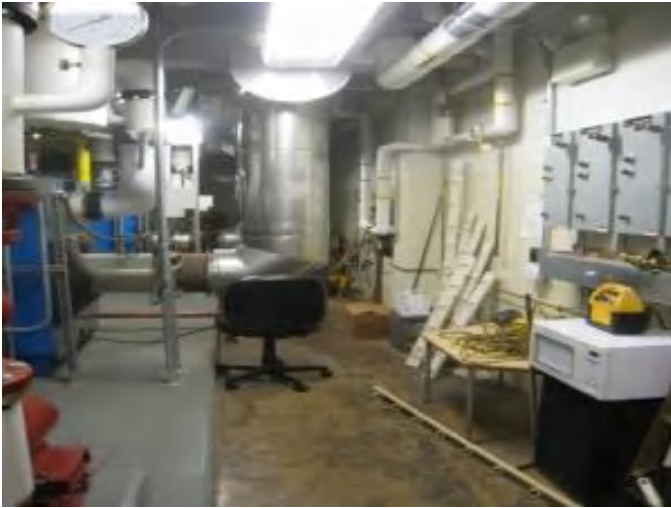
**System: C3020415 - Concrete Floor Finishes**

**Location:** stairways, toilet rooms, mechanical rooms  
**Distress:** Appearance  
**Category:** 3 - Operations / Maint.  
**Priority:** 2 - Response Time (2-3 yrs)  
**Correction:** Clean and reseal concrete floors  
**Qty:** 5,100.00  
**Unit of Measure:** S.F.  
**Estimate:** \$19,607.12  
**Assessor Name:** Craig Anding  
**Date Created:** 12/17/2015

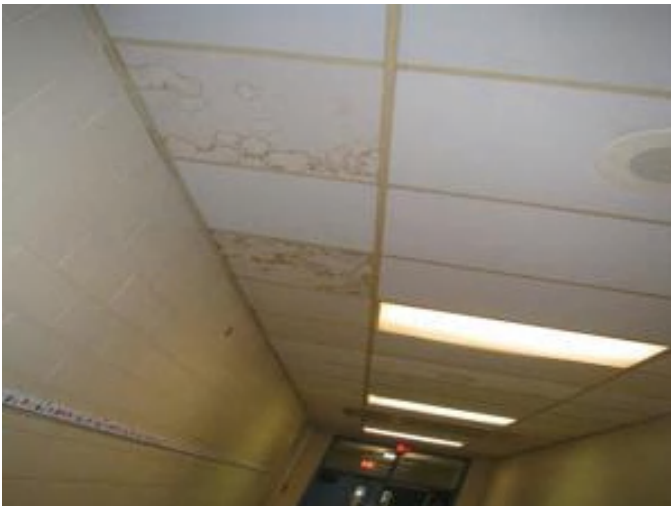
**System: C3030 - Ceiling Finishes**

**Location:** ceilings  
**Distress:** Appearance  
**Category:** 3 - Operations / Maint.  
**Priority:** 2 - Response Time (2-3 yrs)  
**Correction:** Remove and replace suspended acoustic ceilings - lighting not included  
**Qty:** 74,000.00  
**Unit of Measure:** S.F.  
**Estimate:** \$1,116,099.84  
**Assessor Name:** Craig Anding  
**Date Created:** 12/17/2015

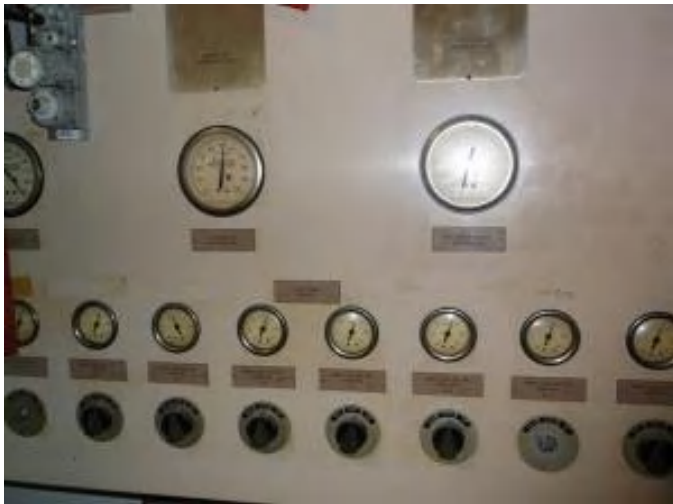
**System: D3060 - Controls & Instrumentation**

**Location:** Throughout Building

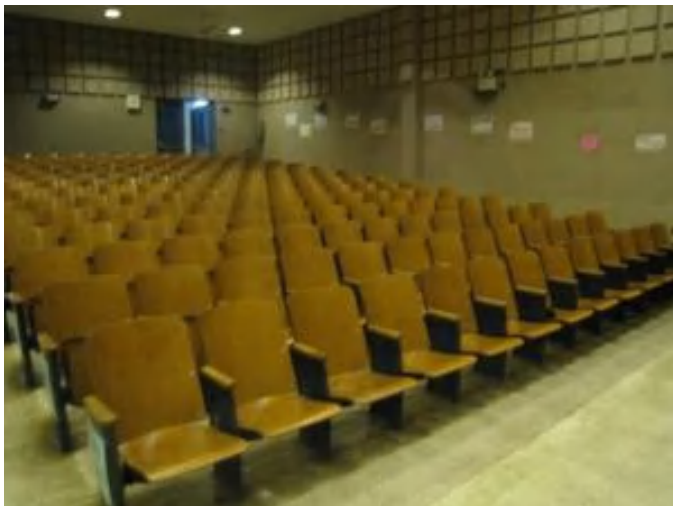
**System: E2010 - Fixed Furnishings**

**Location:** auditorium

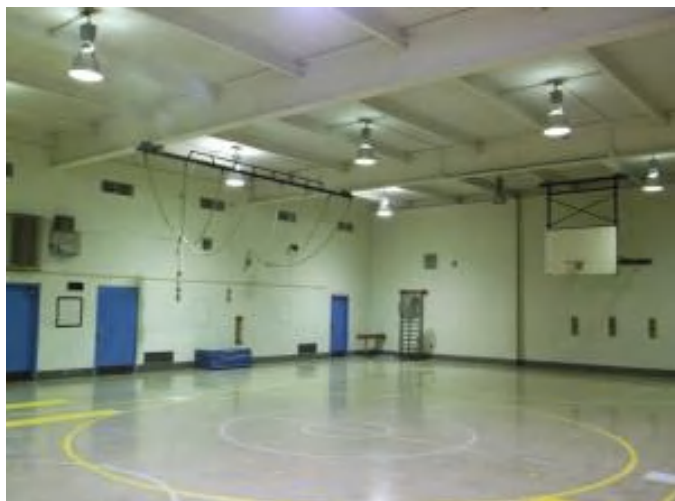
**System: D3040 - Distribution Systems**

**Location:** Gymnasium

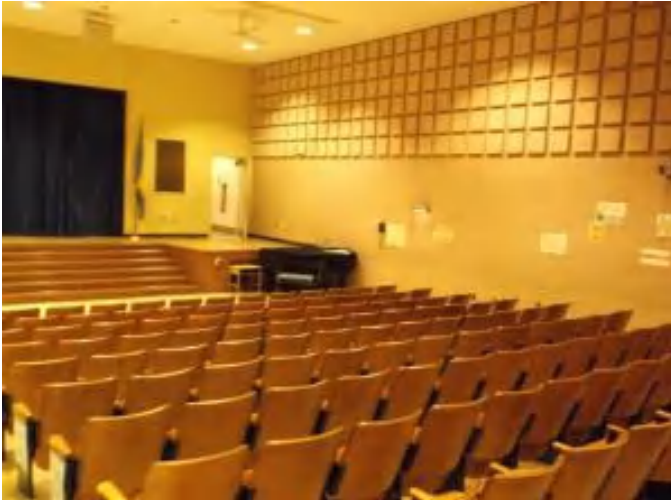
**System: D3040 - Distribution Systems**

**Location:** Auditorium

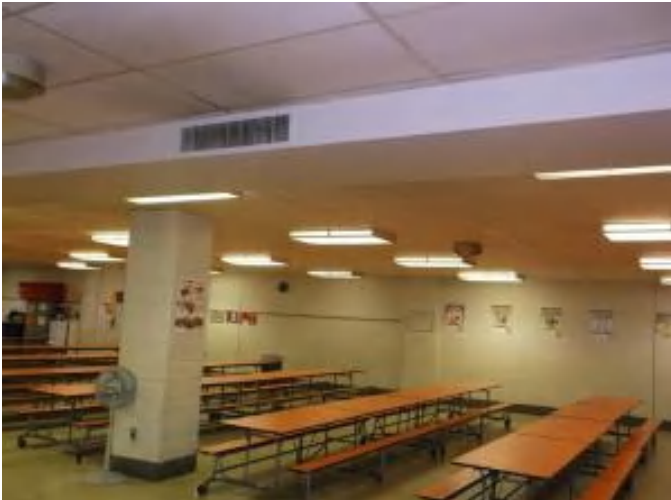
**System: D3040 - Distribution Systems**

**Location:** Cafeteria

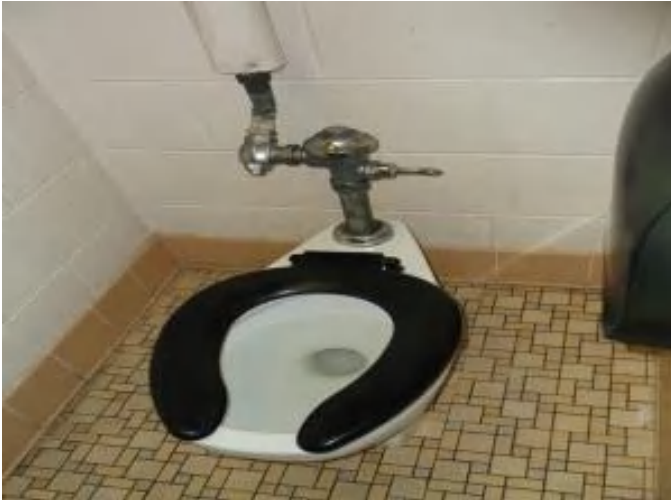
**System: D2010 - Plumbing Fixtures**

**Location:** Restrooms

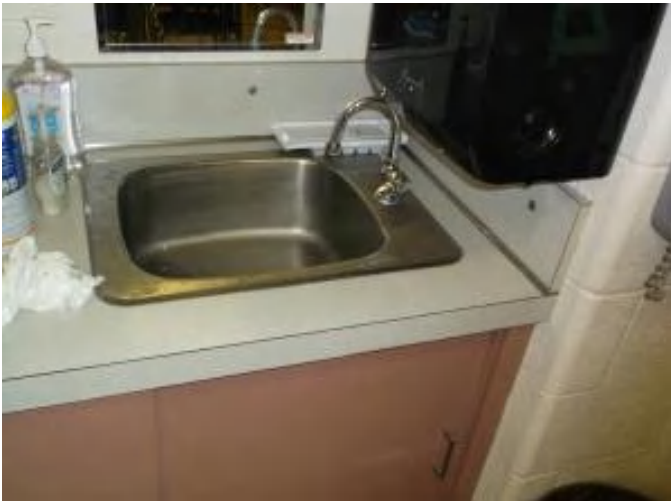
**System: D2010 - Plumbing Fixtures**

**Location:** Classrooms

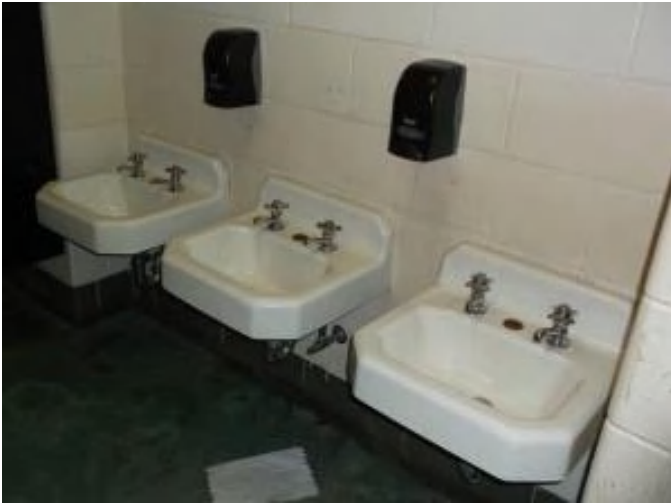
**System: D2010 - Plumbing Fixtures**

**Location:** Restrooms

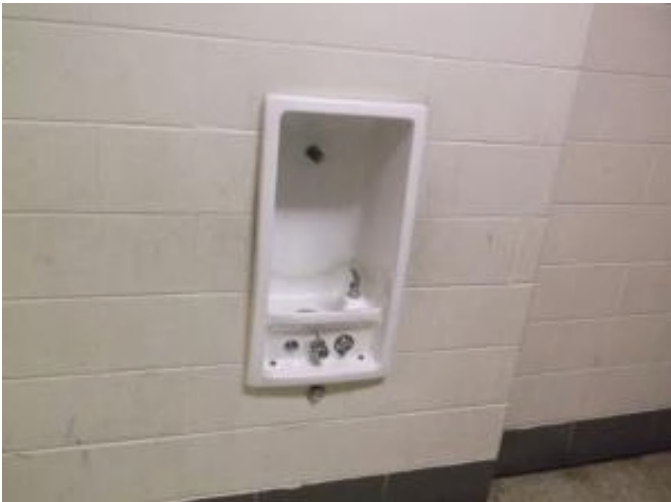
**System: D2010 - Plumbing Fixtures**

**Location:** Corridors

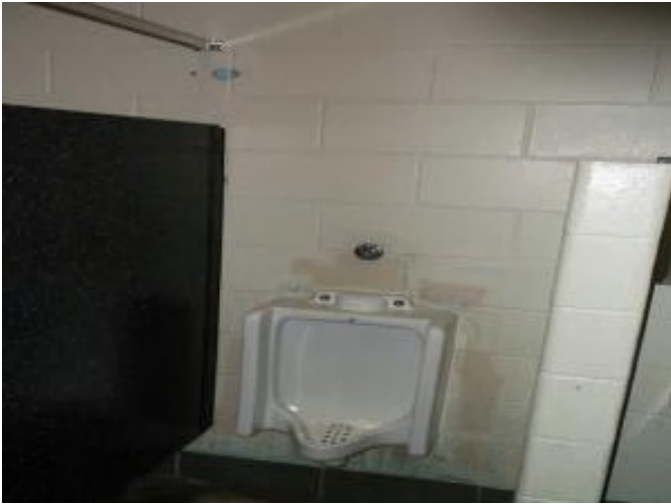
**System: D2010 - Plumbing Fixtures**

**Location:** Restrooms  
**Distress:** Beyond Service Life  
**Category:** 3 - Operations / Maint.  
**Priority:** 5 - Response Time (> 5 yrs)  
**Correction:** Remove and replace or replace wall hung urinals  
**Qty:** 17.00  
**Unit of Measure:** Ea.  
**Estimate:** \$63,002.92  
**Assessor Name:** Craig Anding  
**Date Created:** 02/08/2016

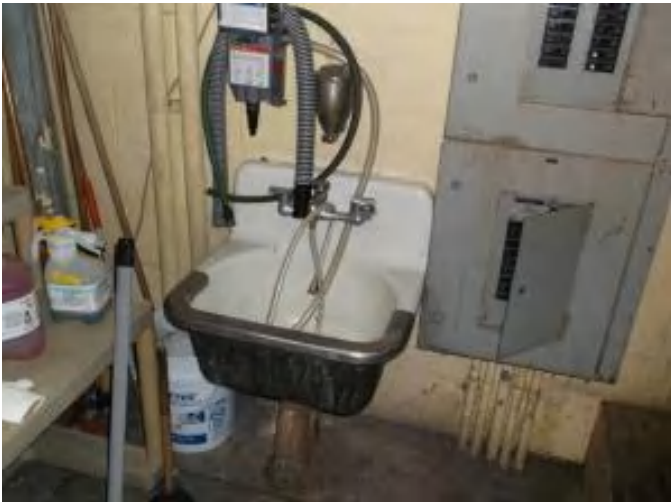
**System: D2010 - Plumbing Fixtures**

**Location:** Janitor Closets  
**Distress:** Beyond Service Life  
**Category:** 3 - Operations / Maint.  
**Priority:** 5 - Response Time (> 5 yrs)  
**Correction:** Remove and replace wall janitor or mop sink - insert the quantity  
**Qty:** 7.00  
**Unit of Measure:** Ea.  
**Estimate:** \$55,052.95  
**Assessor Name:** Craig Anding  
**Date Created:** 02/08/2016

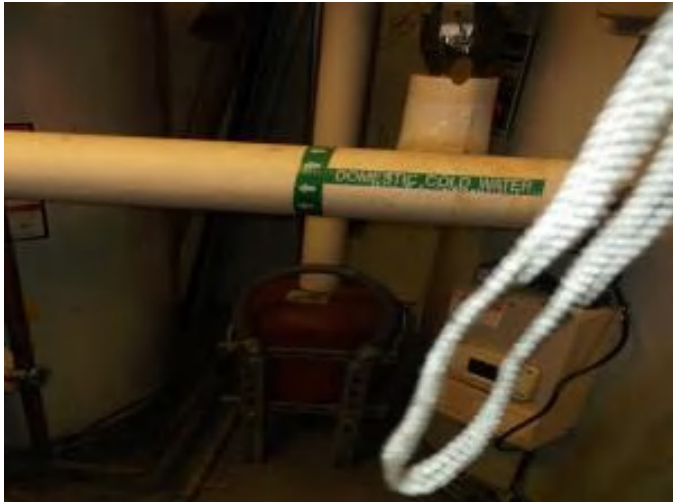
**System: D2020 - Domestic Water Distribution**

**Location:** Throughout Building  
**Distress:** Beyond Service Life  
**Category:** 3 - Operations / Maint.  
**Priority:** 5 - Response Time (> 5 yrs)  
**Correction:** Replace domestic water piping (75 KSF)  
**Qty:** 88,000.00  
**Unit of Measure:** S.F.  
**Estimate:** \$445,927.27  
**Assessor Name:** Craig Anding  
**Date Created:** 02/08/2016

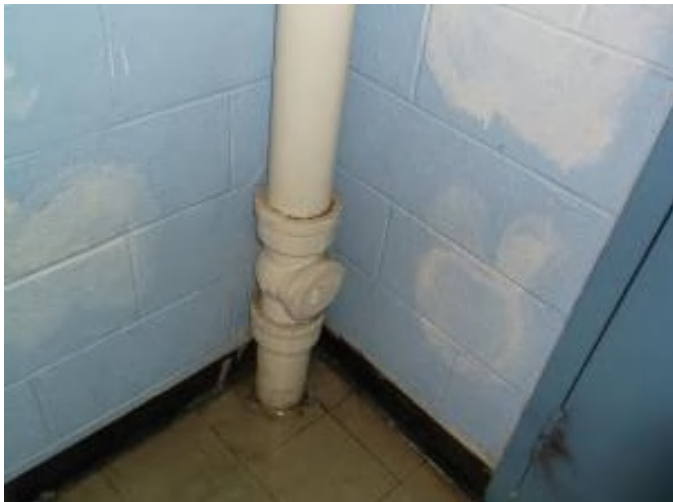
**System: D2030 - Sanitary Waste**

**Location:** Throughout Building  
**Distress:** Beyond Service Life  
**Category:** 3 - Operations / Maint.  
**Priority:** 5 - Response Time (> 5 yrs)  
**Correction:** Inspect sanitary waste piping and replace damaged sections. (+100KSF)  
**Qty:** 88,000.00  
**Unit of Measure:** S.F.  
**Estimate:** \$373,701.41  
**Assessor Name:** Craig Anding  
**Date Created:** 02/08/2016

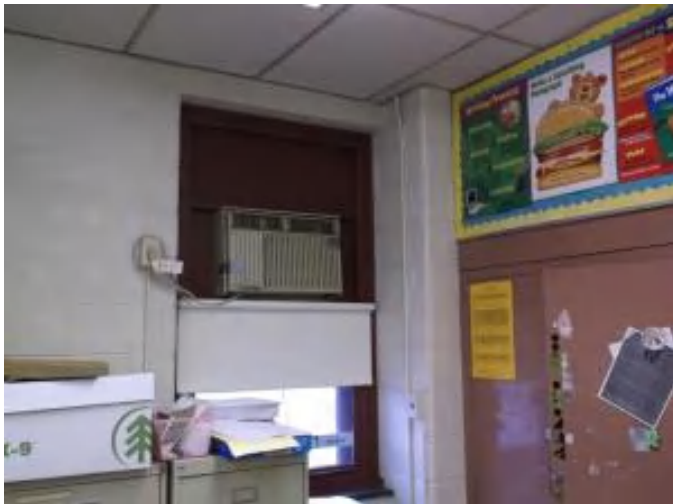
**System: D3030 - Cooling Generating Systems**

**Location:** Throughout Building  
**Distress:** Inadequate  
**Category:** 4 - Capital Improvement  
**Priority:** 5 - Response Time (> 5 yrs)  
**Correction:** Install chilled water system with distribution piping and pumps. (+75KSF)  
**Qty:** 88,000.00  
**Unit of Measure:** S.F.  
**Estimate:** \$1,413,212.91  
**Assessor Name:** Craig Anding  
**Date Created:** 02/08/2016

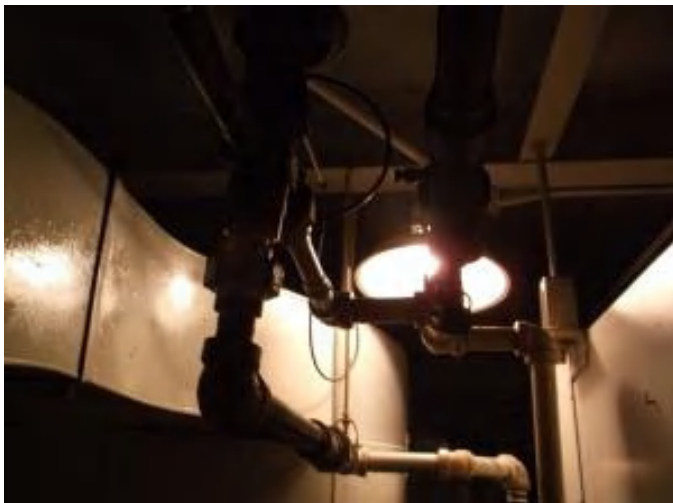
**System: D3040 - Distribution Systems**

**Location:** Throughout Building  
**Distress:** Beyond Service Life  
**Category:** 3 - Operations / Maint.  
**Priority:** 5 - Response Time (> 5 yrs)  
**Correction:** Replace hydronic heating piping (75KSF)  
**Qty:** 88,000.00  
**Unit of Measure:** S.F.  
**Estimate:** \$866,308.21  
**Assessor Name:** Craig Anding  
**Date Created:** 02/08/2016

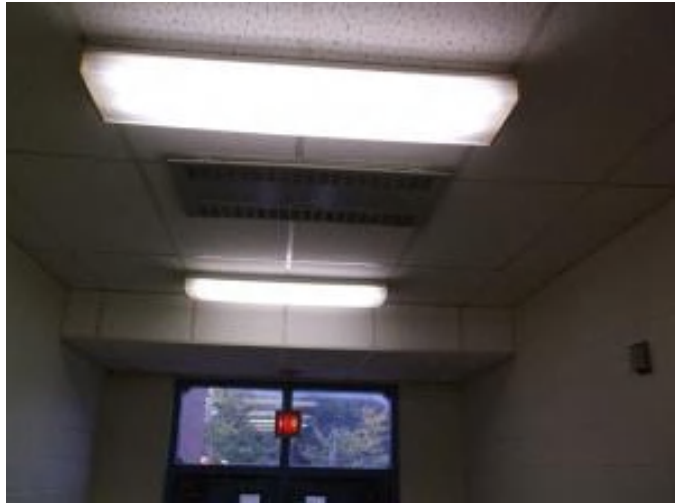
**System: D4010 - Sprinklers**

**Location:** Throughout Building

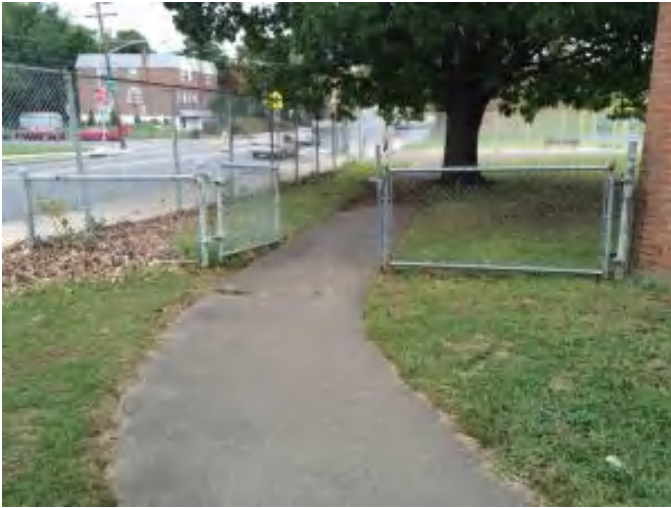
**Location:** site fence

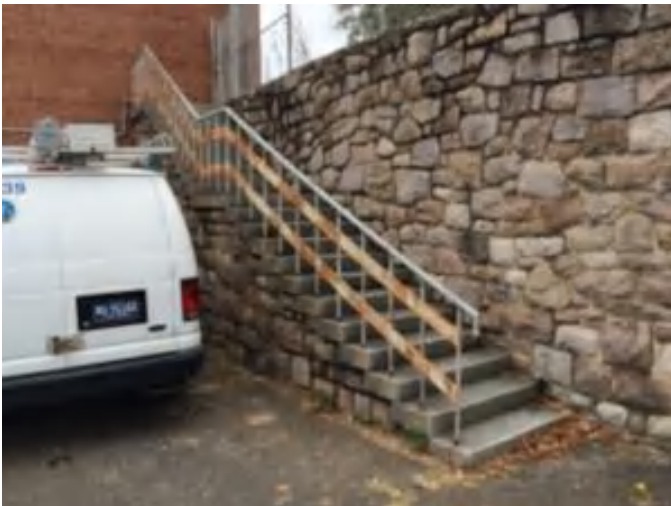
**Location:** site retaining wall

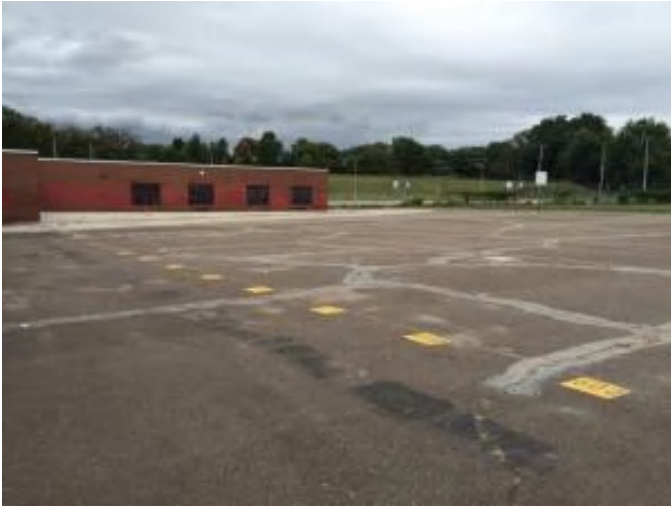
**Location:** asphalt parking lots and play areas

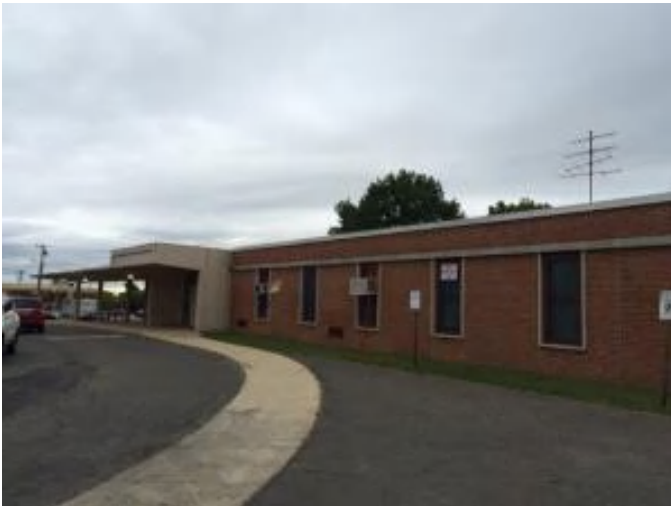
**Location:** handicapped parking
