### Lowell School

**S735001;Lowell**

**Site Assessment Report**

**January 31, 2017**

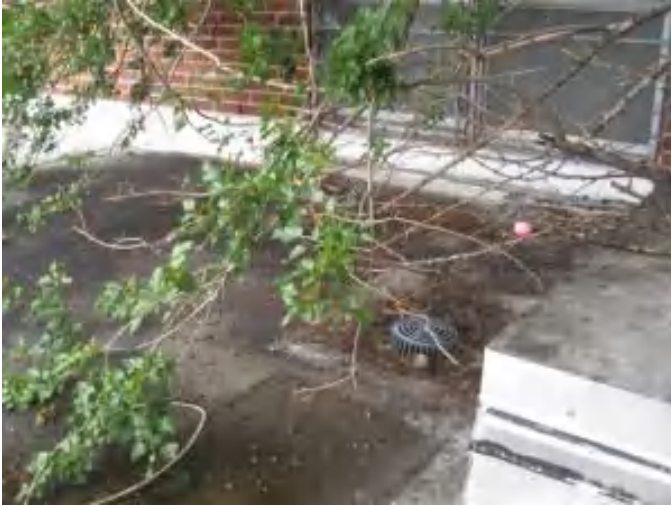
#### System: B3010105 - Built-Up

**Location:** all roofs

**Distress:** Beyond Service Life

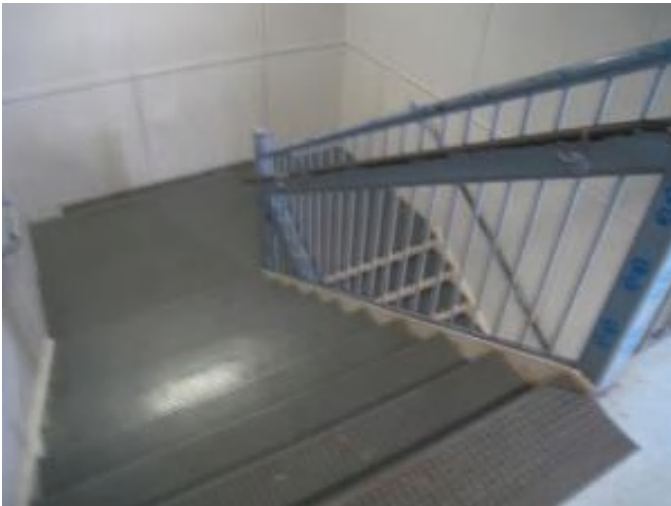
#### System: C2010 - Stair Construction

**Location:** stairways

**Distress:** Building / MEP Codes

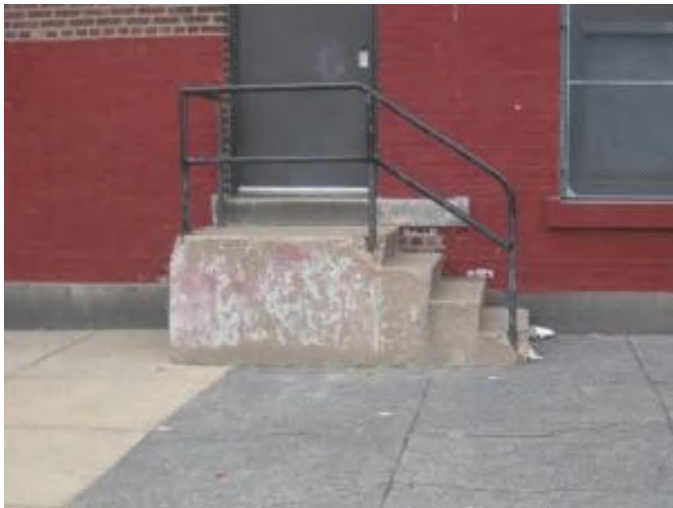
**System: C2010 - Stair Construction**

**Location:** exterior stairs

**Distress:** Damaged

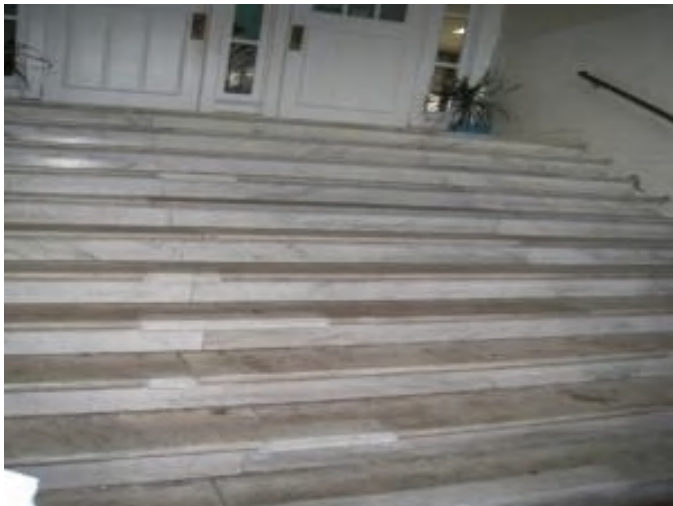
**System: C2010 - Stair Construction**

**Location:** old building entrance stairway

**Distress:** Building / MEP Codes

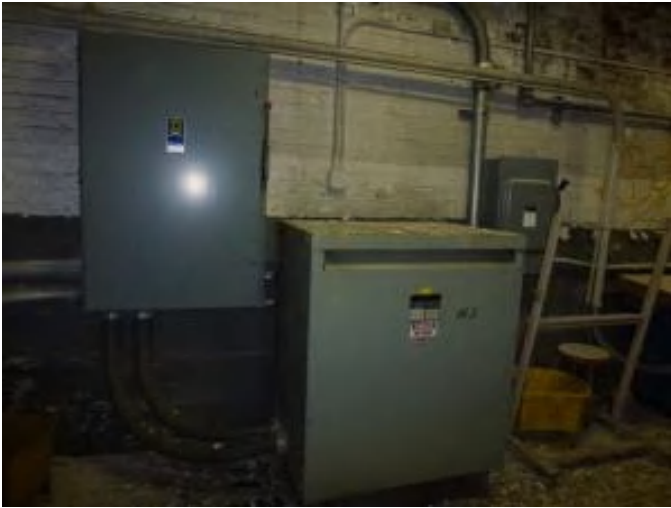
**System: D5010 - Electrical Service/Distribution**

**Location:** main electrical room in Sherman Annex

**Distress:** Beyond Service Life

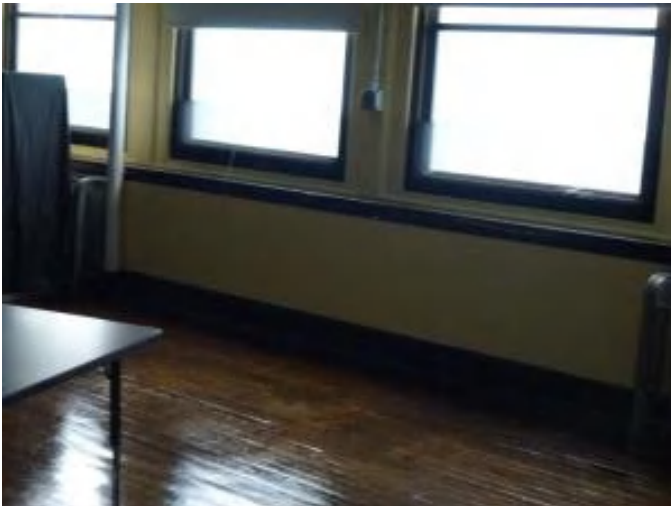
**System: D5020 - Lighting and Branch Wiring**

**Location:** Entire Building

**Distress:** Inadequate

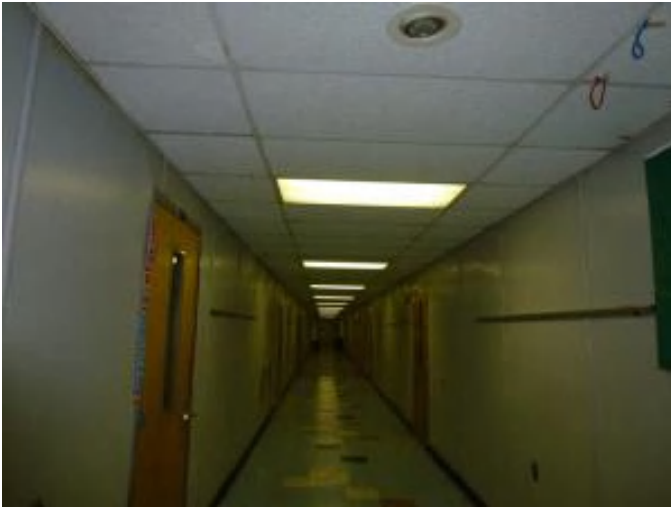
**System: D5020 - Lighting and Branch Wiring**

**Location:** Entire Building

**Distress:** Life Safety / NFPA / PFD

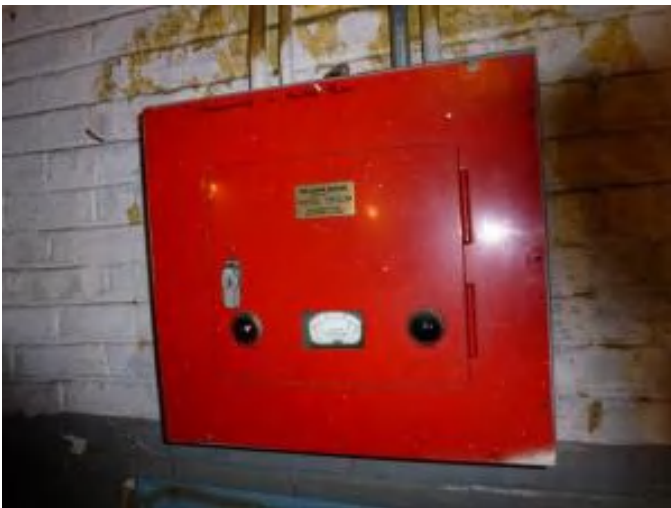
**System: D5030 - Communications and Security**

**Location:** Entire Building

**Distress:** Beyond Service Life

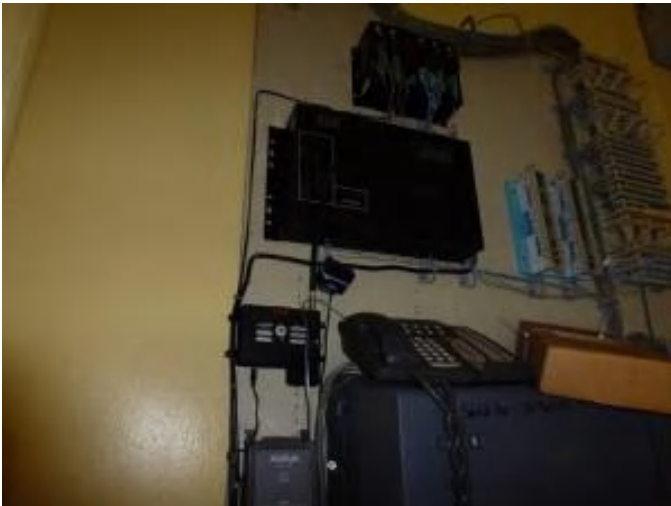
**System: D5030 - Communications and Security**

**Location:** school office

**Distress:** Inadequate

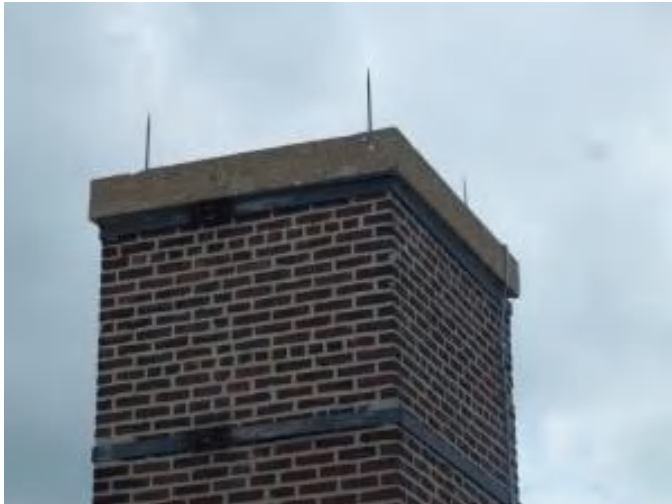
**System: D5090 - Other Electrical Systems**

**Location:** Roof

**Distress:** Life Safety / NFPA / PFD

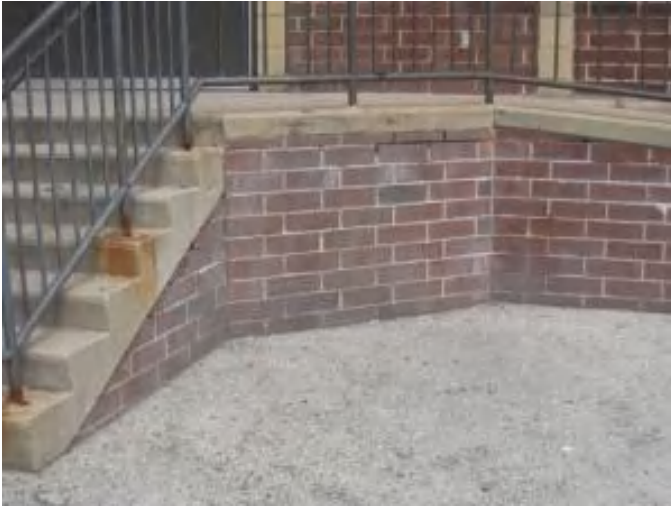
**System: B2010 - Exterior Walls**

Exterior walls in all buildings are generally in good condition, however lintels above most basement windows, some upper windows, and some doors in the old building are rusted with brick joint cracks extending from the lintels into the brick joints in the walls. Some efflorescence is present on the Marcase Addition near the roof gravel stop and in the interior courtyard play area and the masonry of the Sherman Annex has either been repaired or is experiencing some efflorescence. All brick masonry on the playground/parking area side and any other isolated locations should be powerwashed to achieve a uniform appearance. The brickwork by the playground stairs of the Sherman Annex needs to be repointed.

**Location:** exterior masonry elements

**Distress:** Damaged

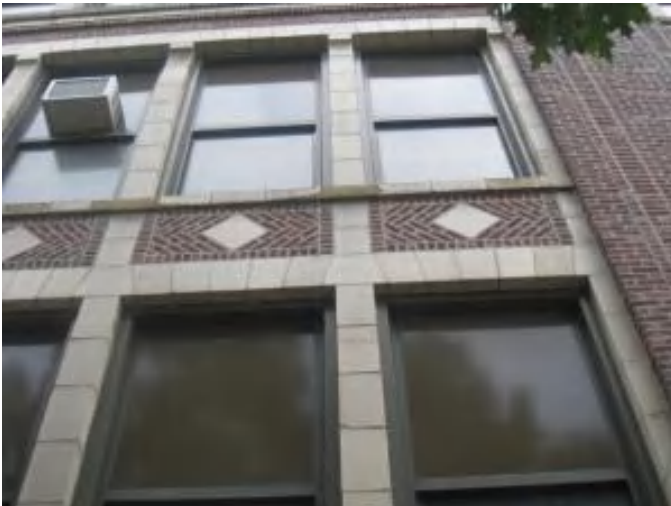
**System: B2020 - Exterior Windows**

Exterior windows in the old building were replaced in the 1990's with bronze anodized aluminum frame operable single hung units with single thickness clear plexiglass acrylic vision panel glazing. Windows are in poor condition with oxidized frames and severely scratched single-pane plexiglass vision panels. Operable units are difficult to operate up and down or do not stay open due to broken internal counterbalance weights, accidentally slamming closed in some cases – a potential safety hazard. Single pane plexiglas units do not meet today's energy code requirements and are large sources of heat loss. Windows in both additions are more modern single hung, dark bronze anodized aluminum frame window units containing 1" insulated glass and window screens on all windows, and exterior security screens on first floor windows. There are some broken window panes in the clerestory units above the gym in the Marcase addition and there are some damage window screens in some of the second floor windows in the Sherman addition.

**Location:** windows - all buildings

**Distress:** Damaged

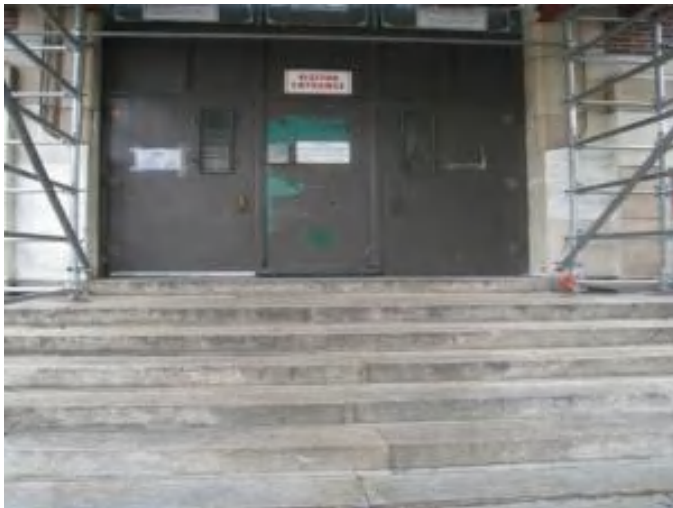
**System: B2030 - Exterior Doors**

Exterior doors throughout the complex are painted steel framed flush hollow metal units with steel frames. Some doors have small, glazed vision panels. Doors are generally in poor condition, have broken or non-functioning panic hardware, rusted dented panels and frames, and are not ADA compliant. There is one handicap accessible entrance on the south end of the Sherman Addition with an accessible ramp and ADA compliant guardrail/handrail. All exterior steel doors, frames, and hardware systems in the old building and the Marcase Addition have exceeded their useful lifespan and need to be replaced. Exterior doors, frames, and hardware in the Sherman Annex are also in very poor condition and should also be replaced.

**Location:** exterior doors

**Distress:** Failing

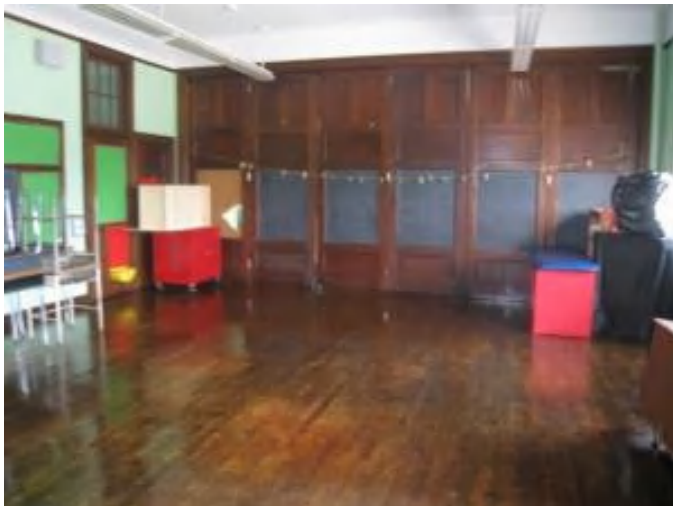
**System: C1010 - Partitions**

**Location:** classrooms

**Distress:** Damaged

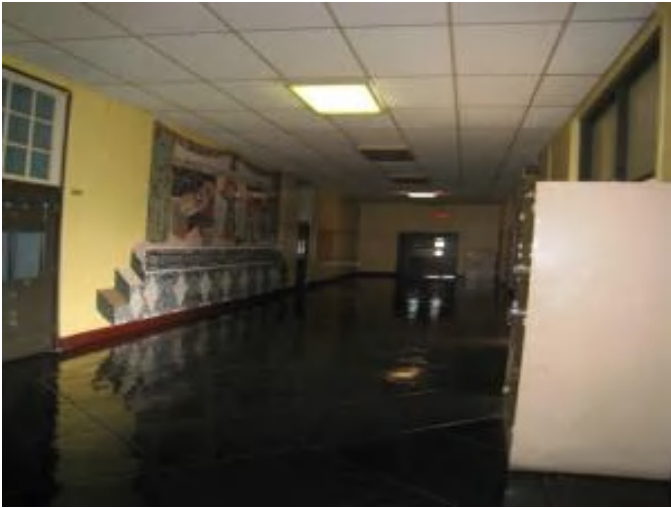
**System: C1010 - Partitions**

**Location:** old building corridors

**Distress:** Building / MEP Codes

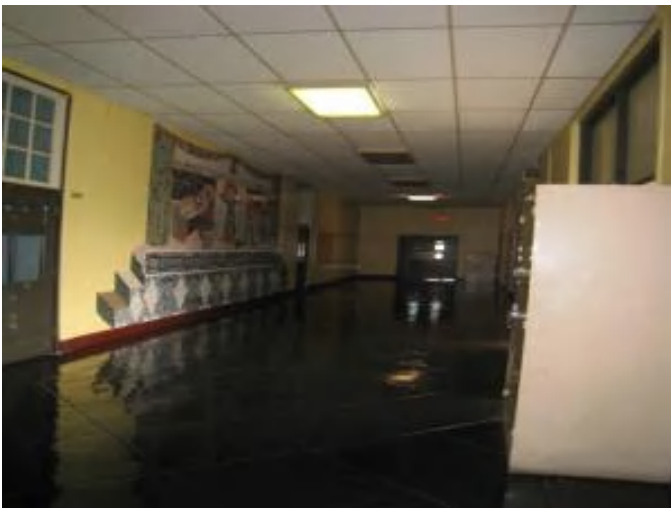
**System: C1020 - Interior Doors**

**Location:** old building classrooms, offices

**Distress:** Damaged

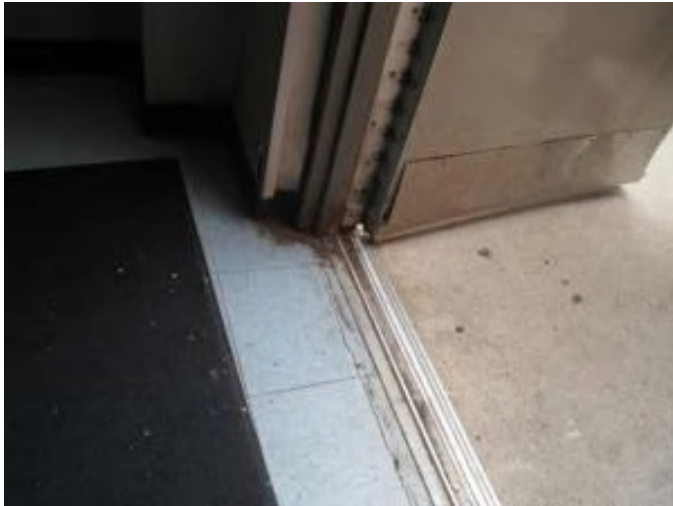
**System: C1020 - Interior Doors**

**Location:** mechanical rooms; basement

**Distress:** Damaged

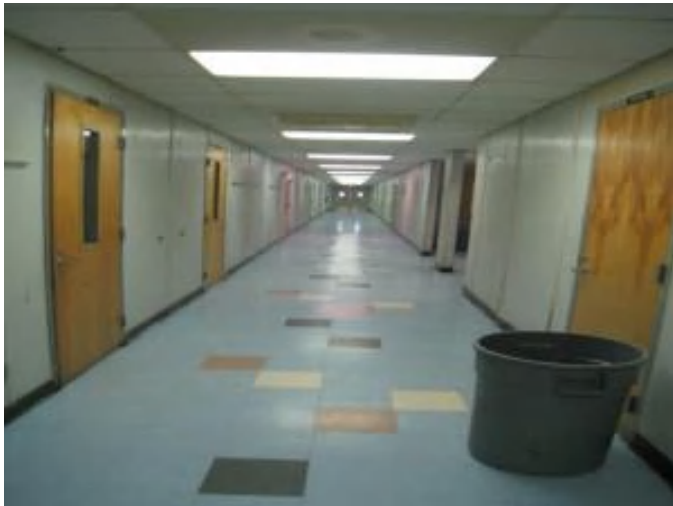
**System: C1020 - Interior Doors**

**Location:** Sherman Annex and Marcase Addition

**Distress:** Damaged

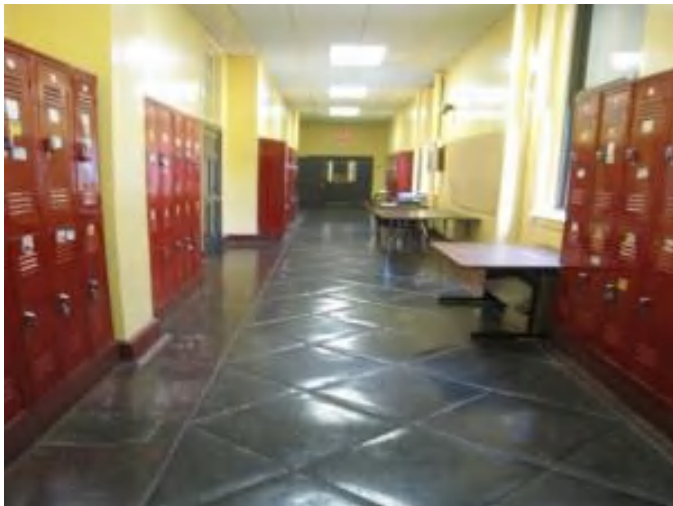
**System: C1020 - Interior Doors**

**Location:** classrooms and offices

**Distress:** Building / MEP Codes

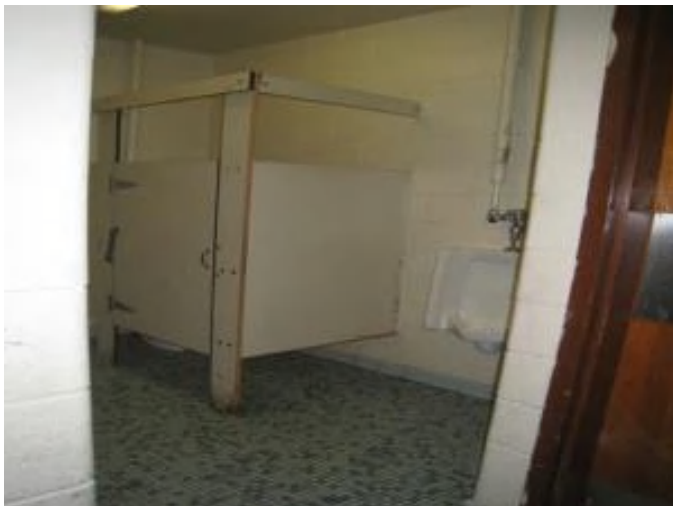
**System: C1030 - Fittings**

**Location:** toilet rooms

**Distress:** Damaged

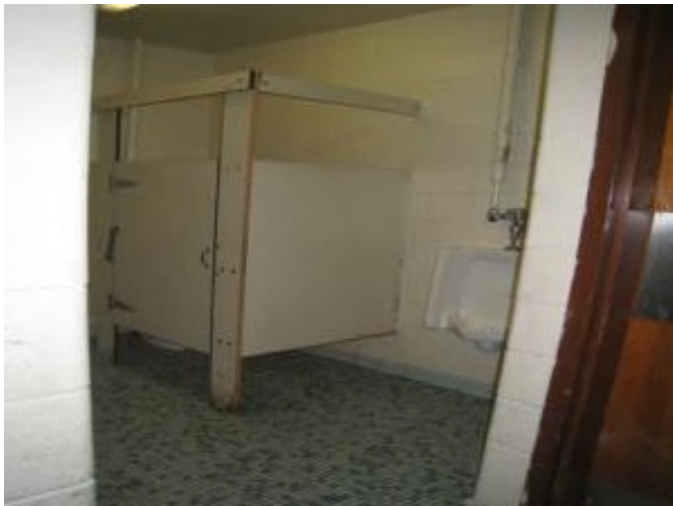
**System: C1030 - Fittings**

**Location:** toilet rooms

**Distress:** Damaged

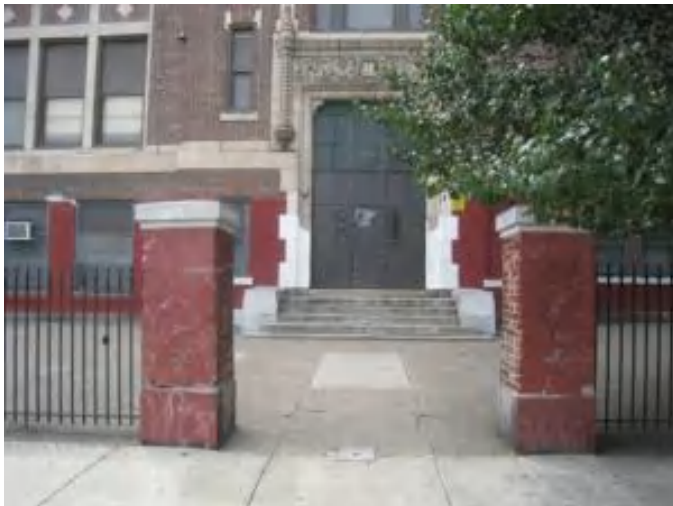
**System: C2010 - Stair Construction**

**Location:** exterior stairs

**Distress:** Damaged

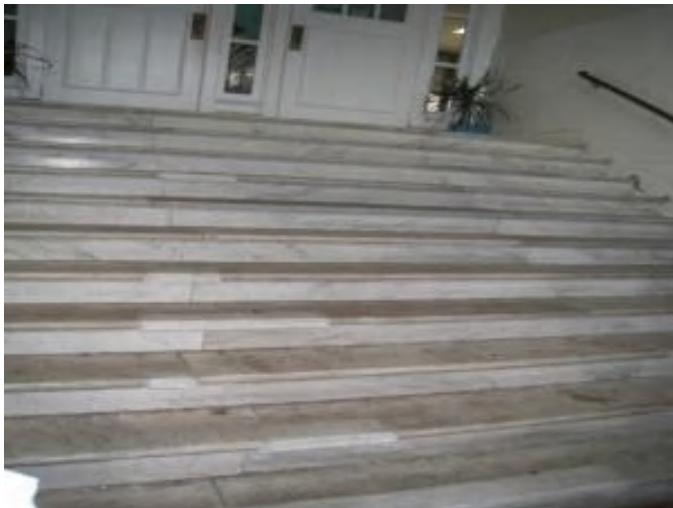
**System: C2010 - Stair Construction**

**Location:** old building entrance stairway

**Distress:** Damaged

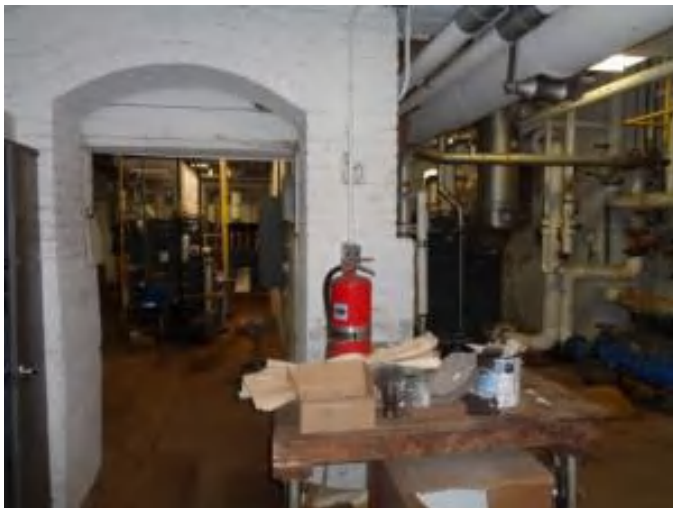
**System: C3010230 - Paint & Covering**

**Location:** mechanical rooms

**Distress:** Appearance

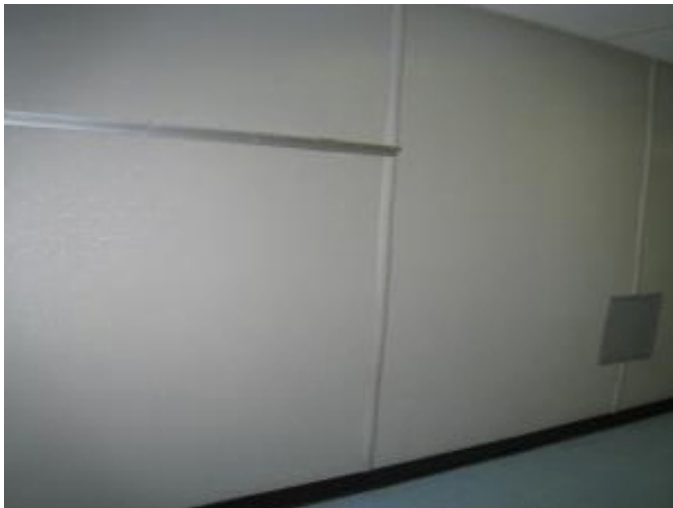
**System: C3010230 - Paint & Covering**

**Location:** Sherman Annex

**Distress:** Damaged

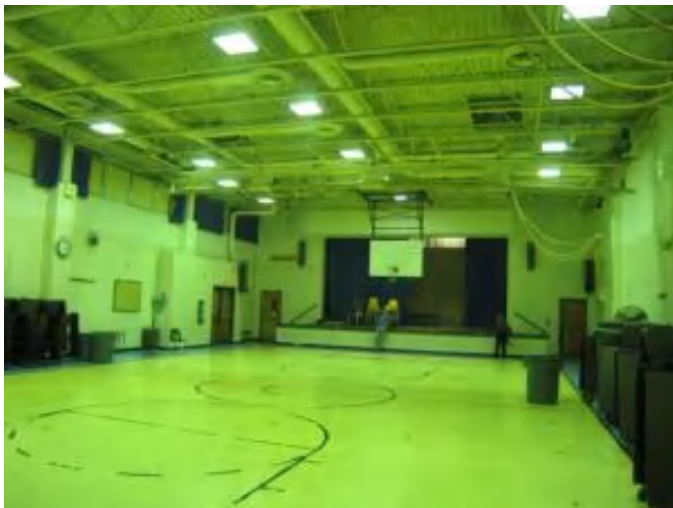
**System: C3020413 - Vinyl Flooring**

**Location:** Sherman Annex corridors and classrooms; gym

**Distress:** Damaged

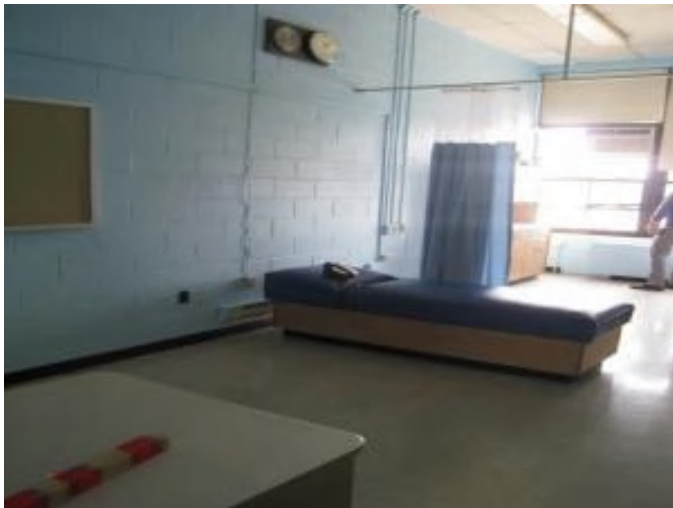
**System: C3020413 - Vinyl Flooring**

**Location:** old building 1st fl (kindergarten)

**Distress:** Life Safety / NFPA / PFD

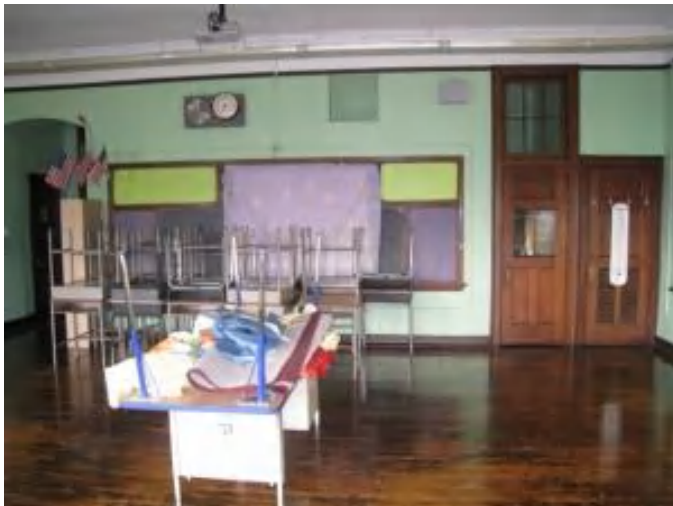
**System: C3020414 - Wood Flooring**

**Location:** classrooms - old building

**Distress:** Appearance

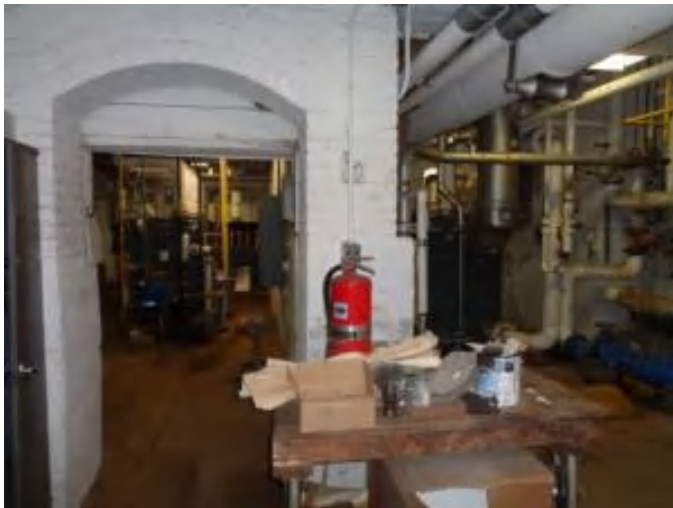
**System: C3020415 - Concrete Floor Finishes**

**Location:** hallways, stairways, mechanical room

**Distress:** Appearance

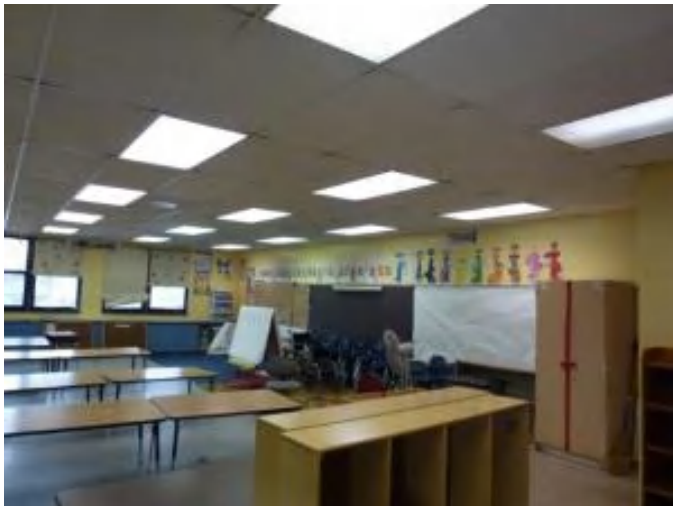
**System: C3030 - Ceiling Finishes**

**Location:** ceilings

**Distress:** Beyond Service Life

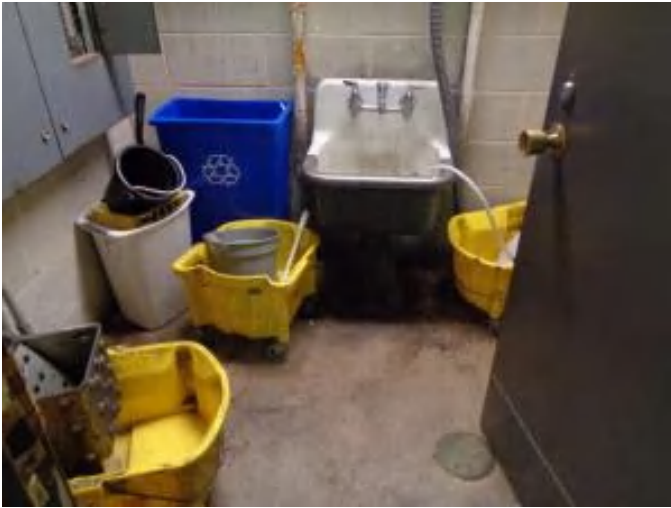
**System: D2010 - Plumbing Fixtures**

**Location:** Throughout the building

**Distress:** Beyond Service Life

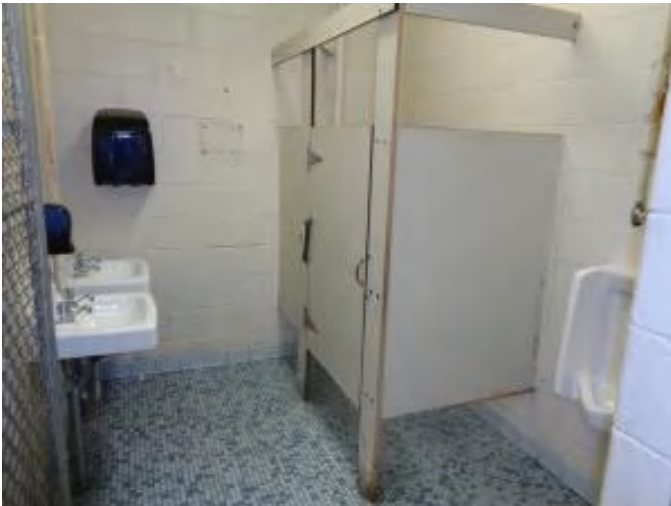
**System: D2010 - Plumbing Fixtures**

**Location:** Throughout the building

**Distress:** Beyond Service Life

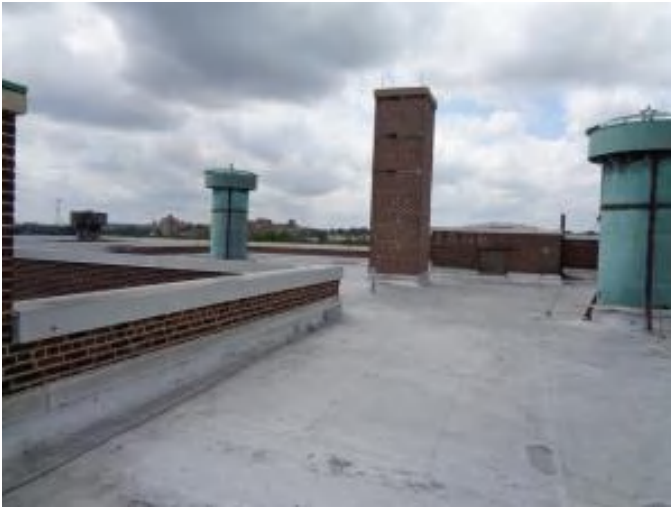
**System: D2040 - Rain Water Drainage**

**Location:** Roof

**Distress:** Building / MEP Codes

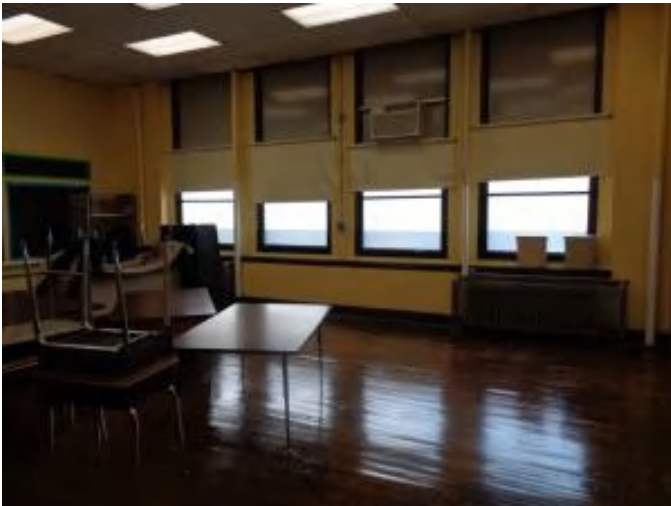
**System: D3040 - Distribution Systems**

**Location:** Throughout the building

**Distress:** Beyond Service Life

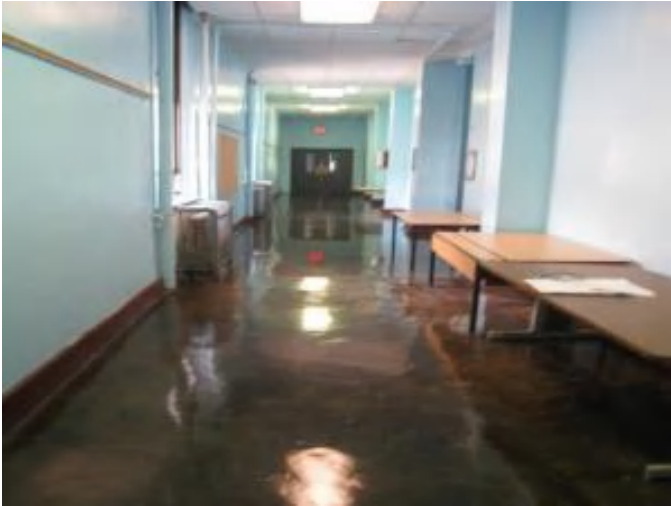
**System: C3010230 - Paint & Covering**

**Location:** old building

**Distress:** Appearance

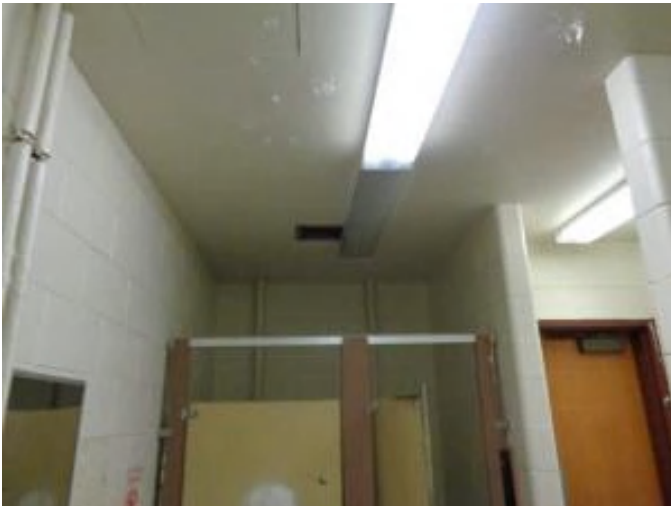
**System: C3030 - Ceiling Finishes**

**Location:** ceilings - toilet rooms and mech areas

**Distress:** Appearance

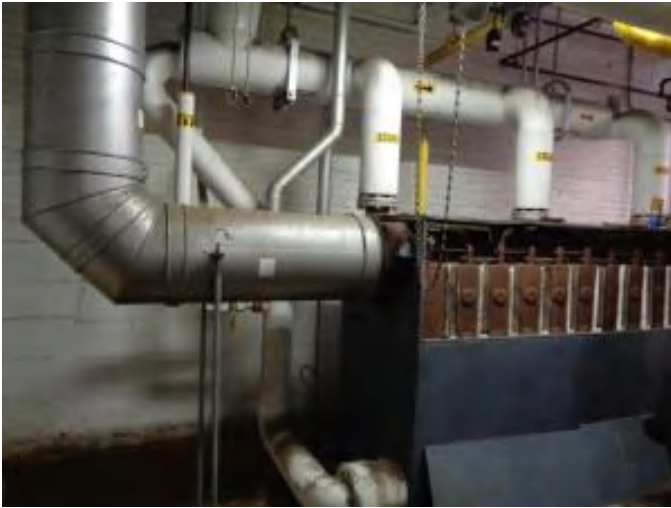
**System: D3020 - Heat Generating Systems**

**Heat Generating Systems** - Steam is generated in the main building by three 2,539 MBH Weil McLain 88 series dual fuel steam boilers. All boilers were equipped with Power Flame dual fuel burners. There is significant rust and signs of water damage in the basement, indicative of frequent leaks or moisture problems. The boilers are nearing the end of their service life and will most likely need replacement within the next 5-10 years. Additionally, there are three coal fired boilers that were abandoned in place in a large area of

**Location:** Boiler Mechanical Equipment Room

**Distress:** Beyond Service Life

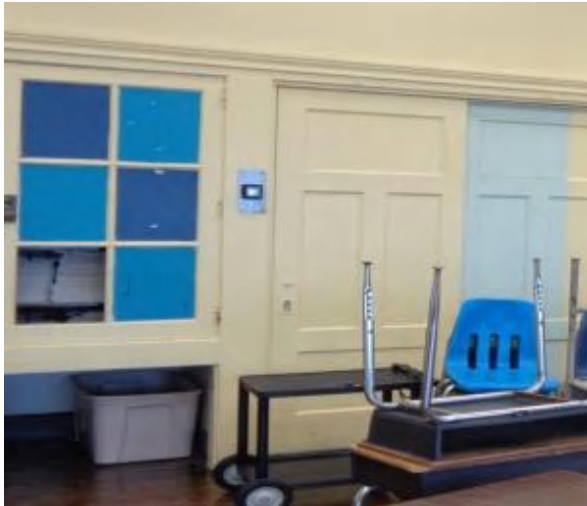
**System: D3060 - Controls & Instrumentation**

**Location:** Throughout the building

**Distress:** Failing

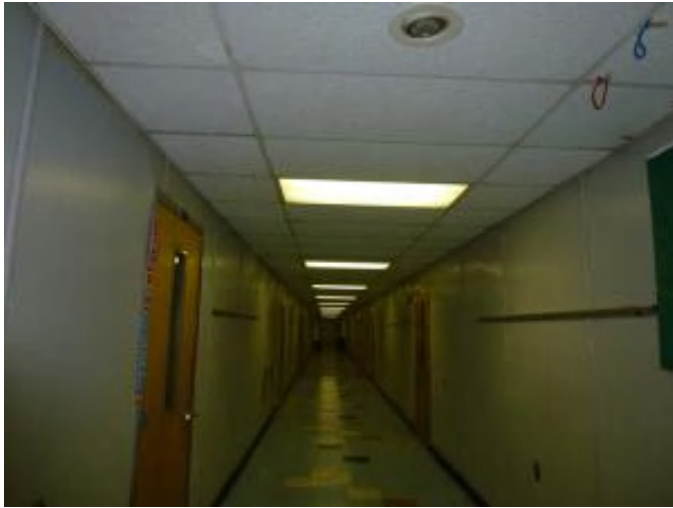
**System: D5020 - Lighting and Branch Wiring**

**Location:** Entire Building

**Distress:** Beyond Service Life

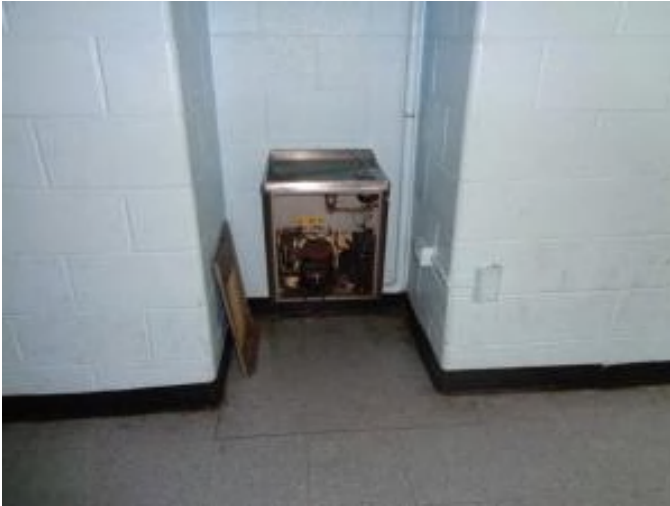
**System: D2010 - Plumbing Fixtures**

**Location:** Throughout the building

**Distress:** Beyond Service Life

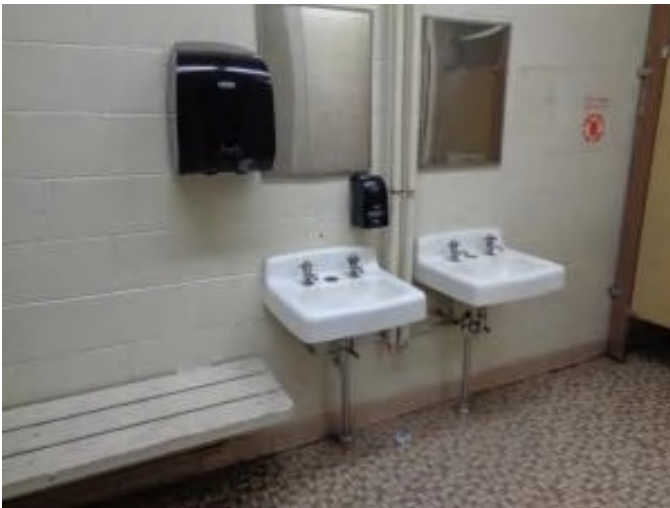
**System: D2010 - Plumbing Fixtures**

**Location:** Throughout the building

**Distress:** Beyond Service Life

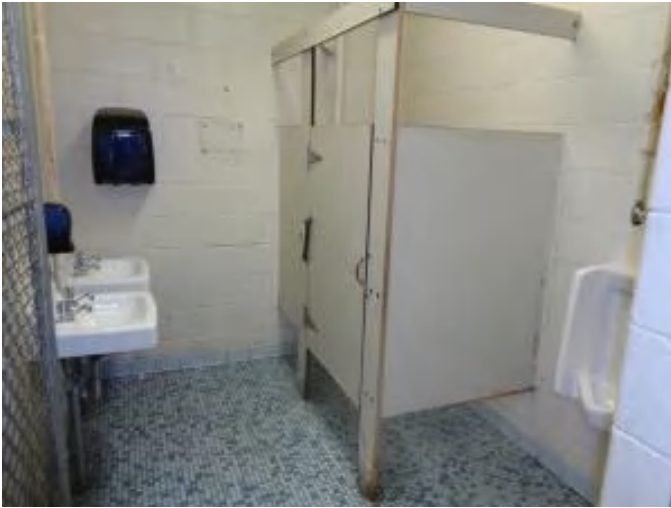
**System: D2010 - Plumbing Fixtures**

**Location:** Throughout the building

**Distress:** Beyond Service Life

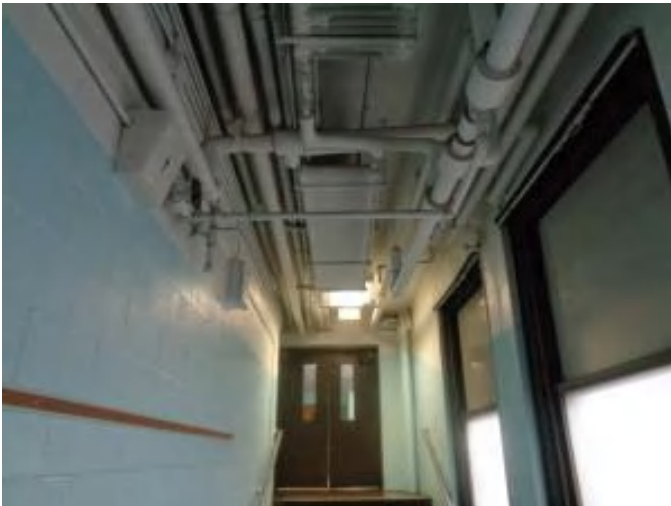
**System: D2030 - Sanitary Waste**

**Sanitary Waste** - The sanitary waste piping system in the original building is cast iron with lead and oakum seals and appears to be the original equipment installed in the building. It is therefore recommended to inspect this piping and repair or replace sections as needed. The sanitary waste piping in the Marcase addition appears to be the original equipment and is nearing the end of its service life. An inspection of the sanitary piping in the Marcase addition is recommended. The sanitary piping in the Sherman addition is in satisfactory condition and should not need repairs or replacement for the next 10 years.

**Location:** Throughout the building

**Distress:** Beyond Service Life

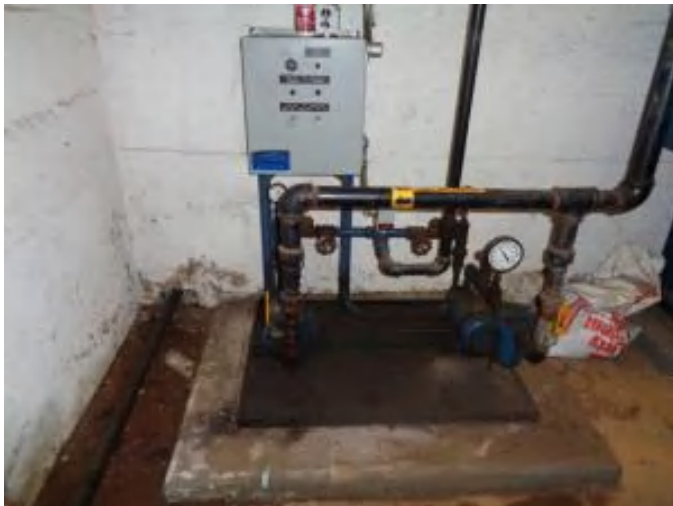
**System: D3020 - Heat Generating Systems**

**Location:** Boiler Mechanical Equipment Room

**Distress:** Beyond Service Life

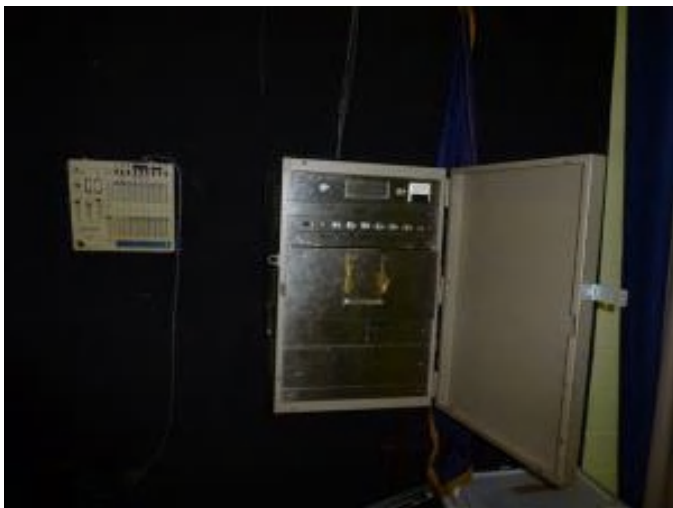
**System: E1020 - Institutional Equipment**

**Location:** backstage

**Distress:** Beyond Service Life

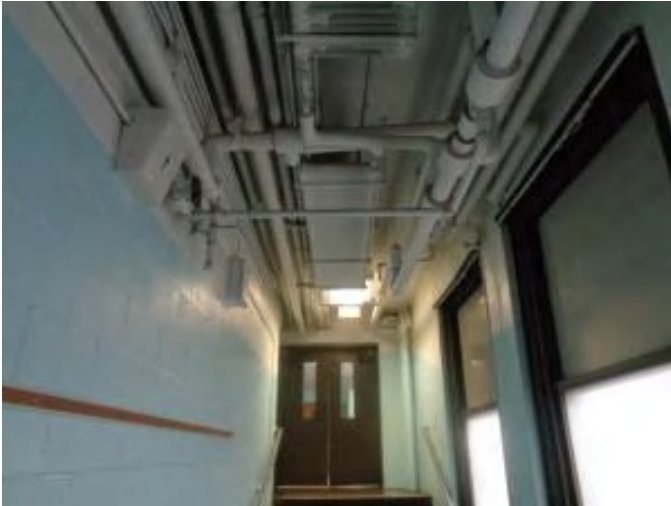
**System: D2020 - Domestic Water Distribution**

**Location:** Throughout the building

**Distress:** Beyond Service Life

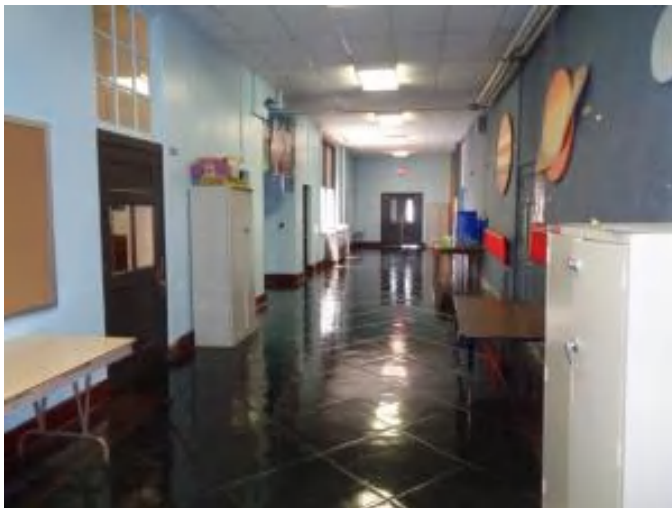
**System: D4010 - Sprinklers**

**Location:** Throughout the building

**Distress:** Life Safety / NFPA / PFD

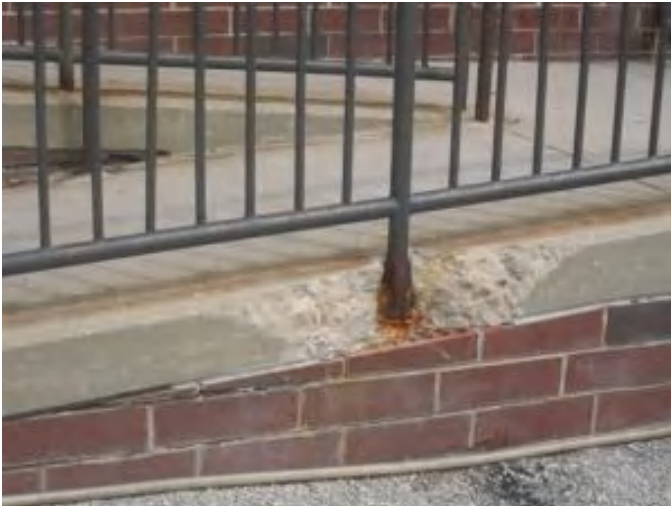
#### System: G2040 - Site Development

**Location:** handicap ramp - play area

**Distress:** Failing

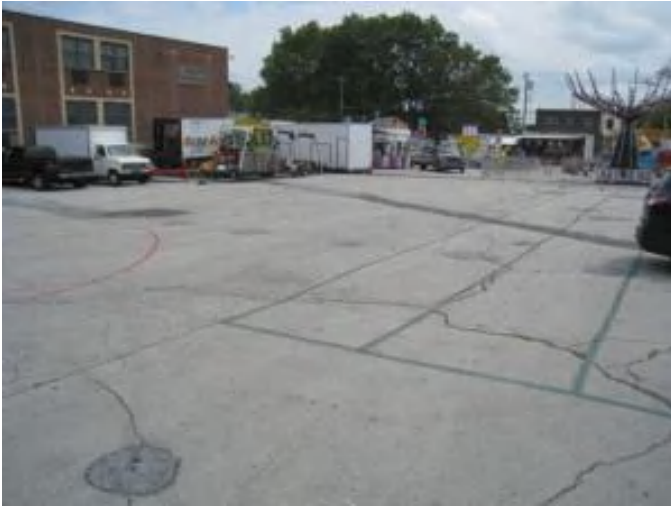
**System: G2020 - Parking Lots**

**Location:** parking lot / play area

**Distress:** Beyond Service Life

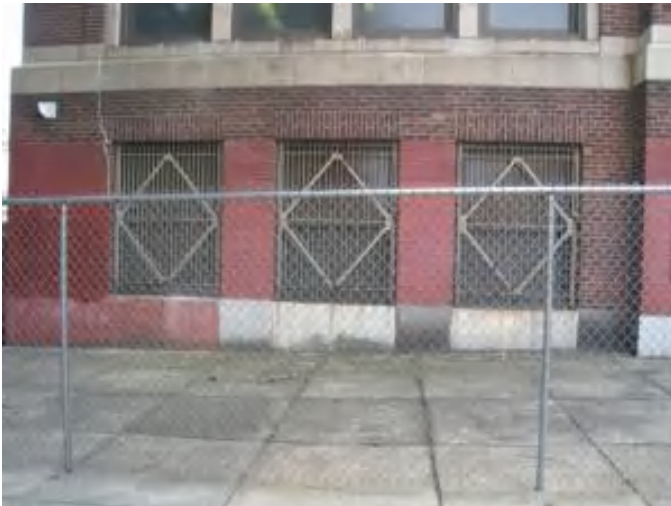
**System: G2030 - Pedestrian Paving**

**Location:** site - entrance doors

**Distress:** Damaged

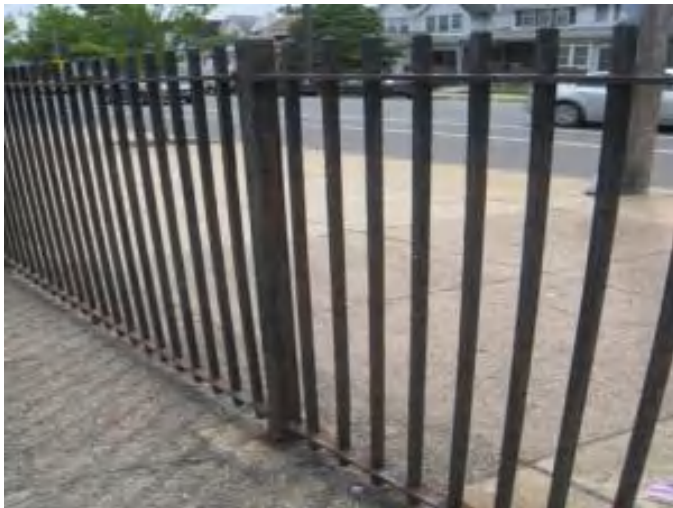
**System: G2040 - Site Development**

**Location:** site

**Notes:** Repaint rusted sections of steel fence

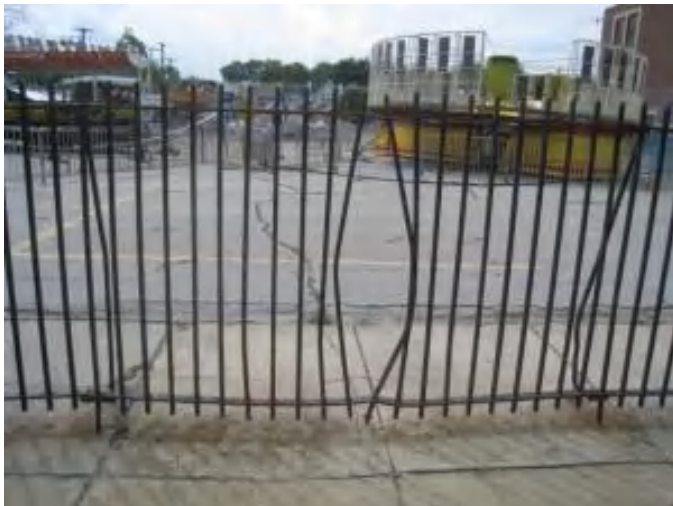
**System: G2040 - Site Development**

**Location:** site

**Notes:** Replace bent and broken sections of steel post fencing
