## Facility Condition Assessment Summary Report

### Ludlow School

School District of Philadelphia  
**S534001;Ludlow**  
Final  
**Site Assessment Report**  
January 31, 2017

Gross Area (SF):	70,230
Year Built:	1927
Last Renovation:	
Replacement Value:	\$35,073,521
Repair Cost:	\$17,140,258.19
Total FCI:	48.87 %
Total RSLI:	81.90 %

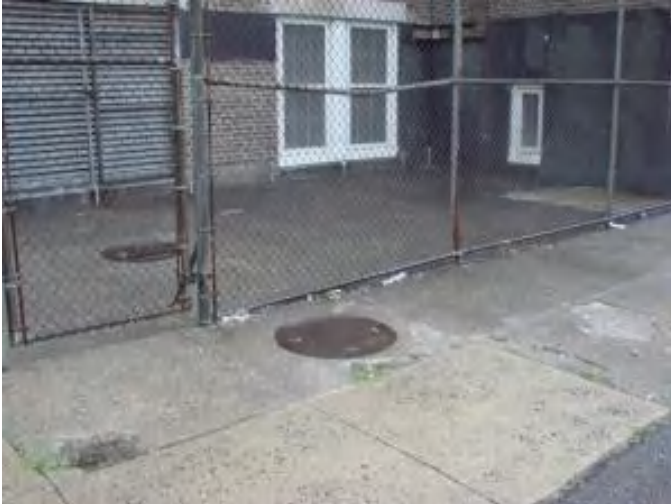
**Location:** Basement/ Exterior

**Distress:** Building Envelope Integrity

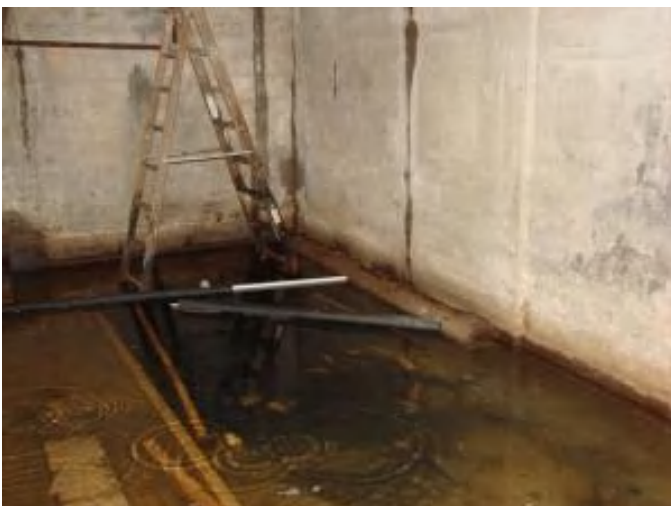
**Location:** Basement

**Distress:** Building Envelope Integrity

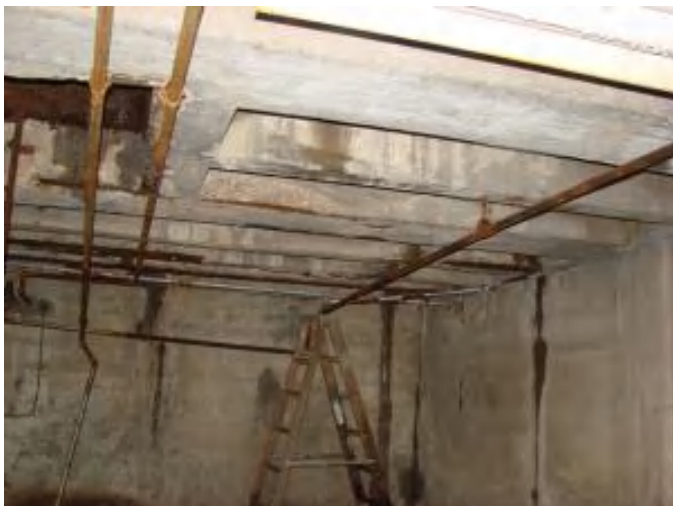
**Location:** Basement

**Distress:** Failing

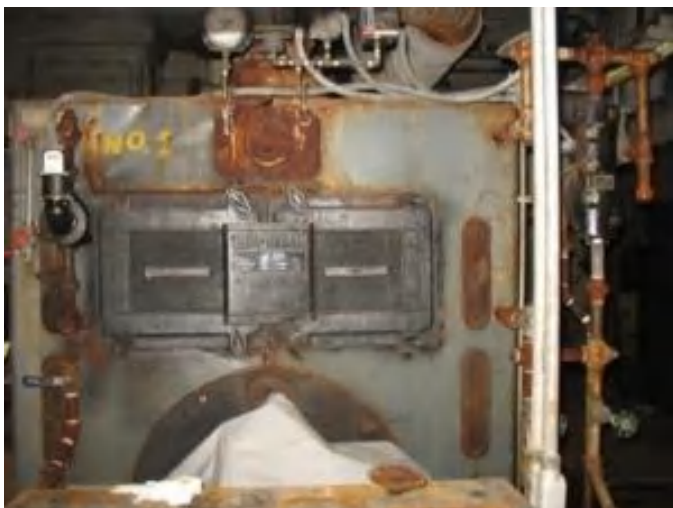
**Location:** Boiler Room

**Distress:** Beyond Service Life

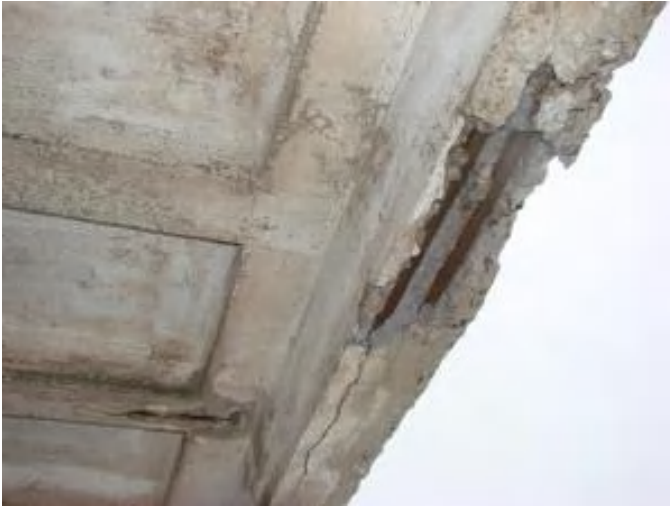
**Location:** Roof

**Distress:** Damaged

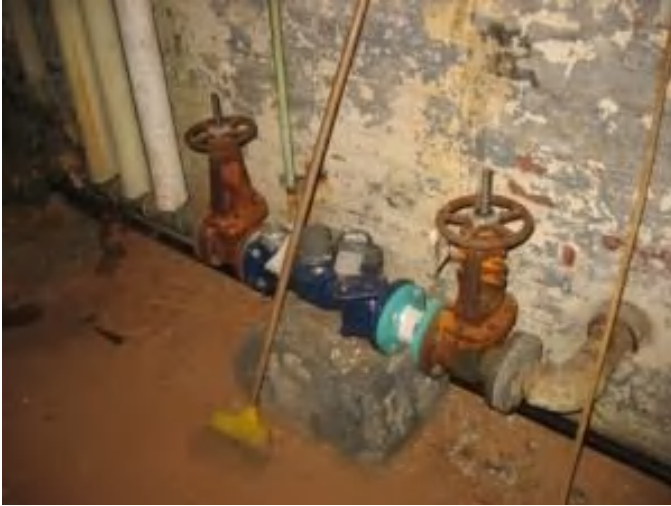
**Location:** Boiler Room

**Distress:** Inadequate

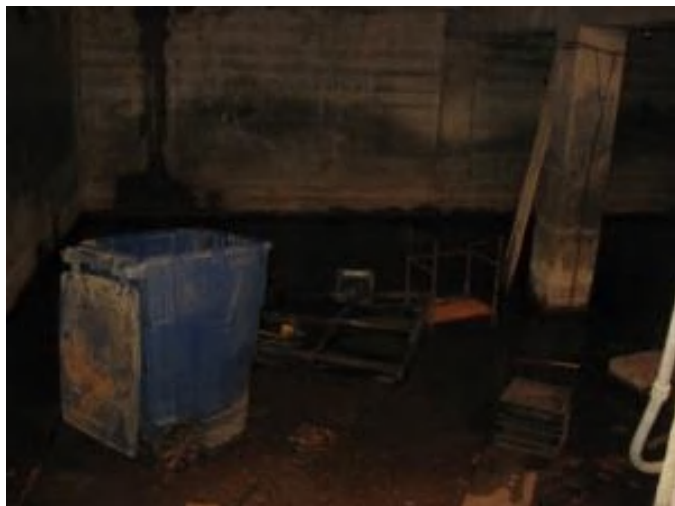
**Location:** Boiler Room

**Distress:** Beyond Service Life

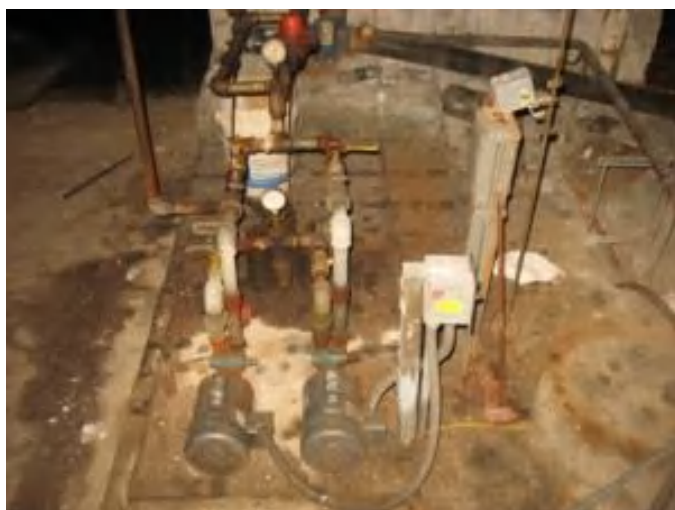
**Location:** Boiler Room

**Distress:** Beyond Service Life

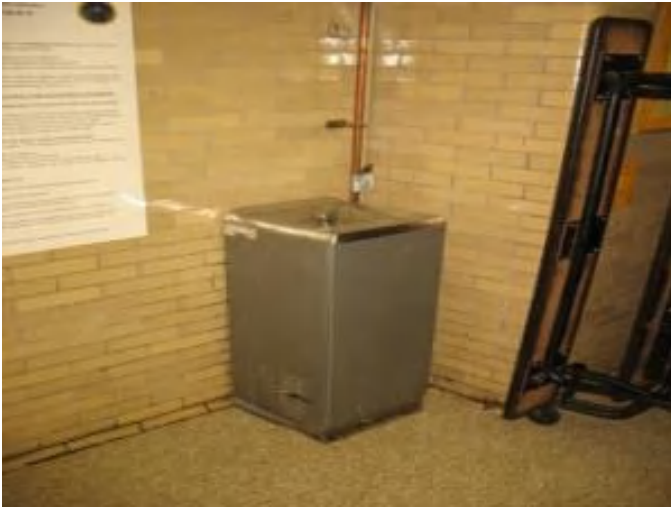
**Location:** Throughout building

**Distress:** Beyond Service Life

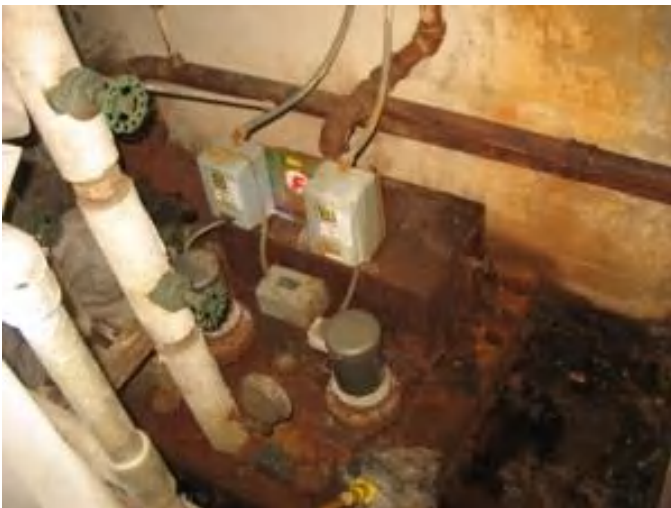
**Location:** Throughout building

**Distress:** Maintenance Required

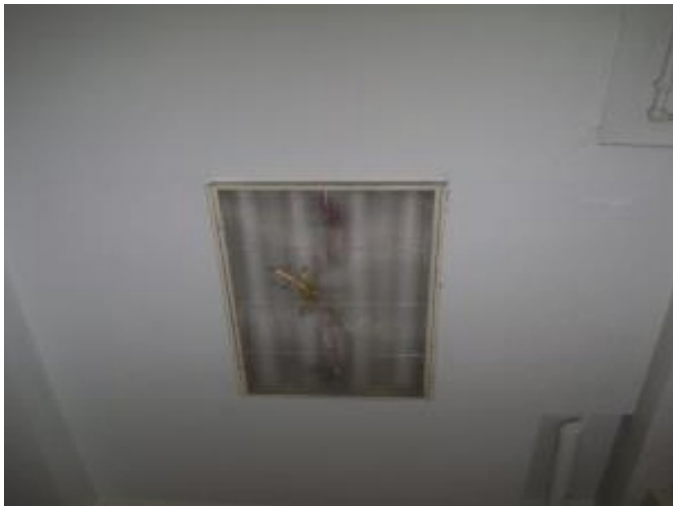
**Location:** Throughout Building

**Distress:** Energy Efficiency

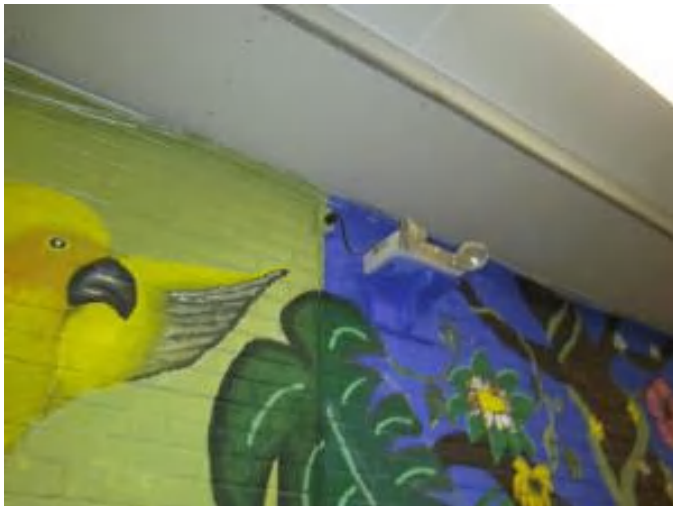
**Location:** Throughout Building

**Distress:** Life Safety / NFPA / PFD

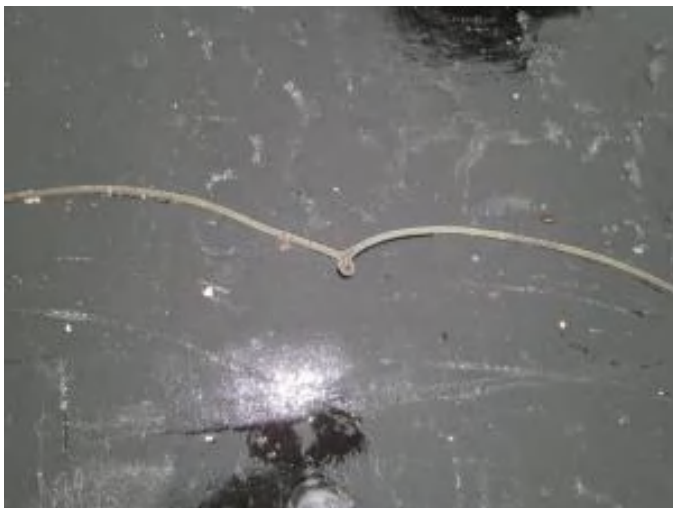
**Location:** Roof

**Distress:** Damaged

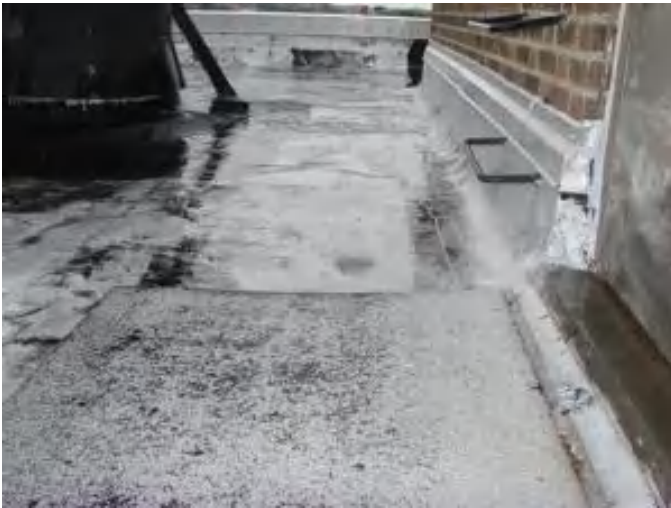
**Location:** Roof

**Distress:** Building Envelope Integrity

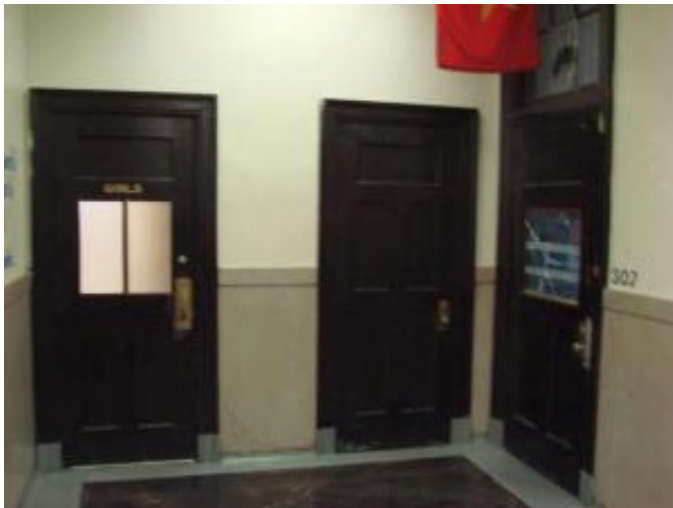
**Location:** Interiors

**Distress:** Damaged

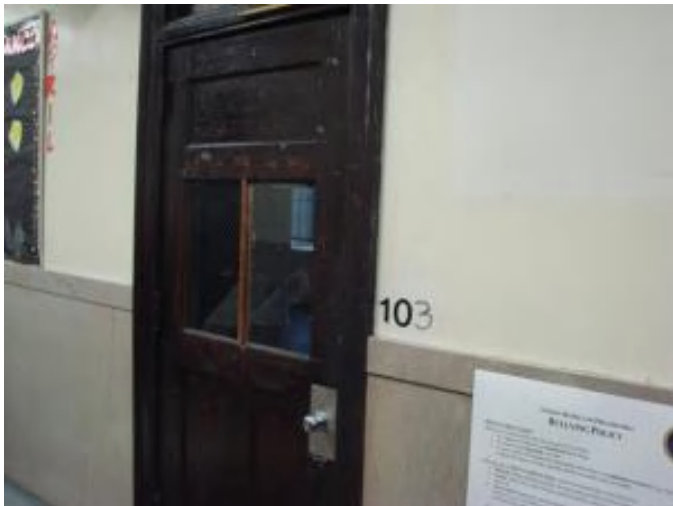
**Location:** Interiors

**Distress:** Building / MEP Codes

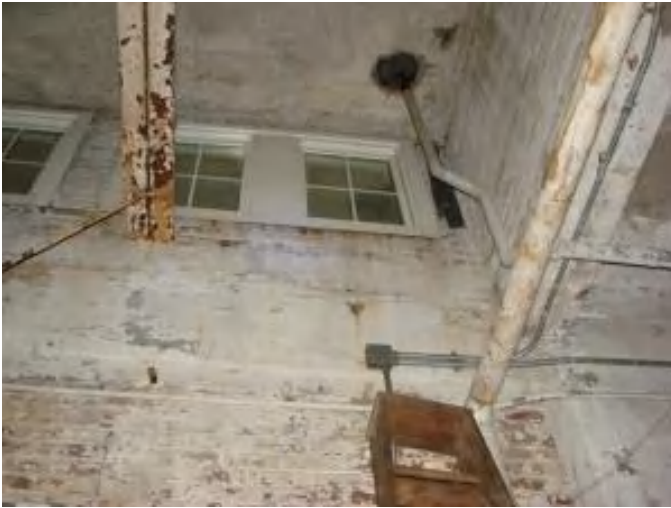
**Location:** Interiors

**Distress:** Beyond Service Life

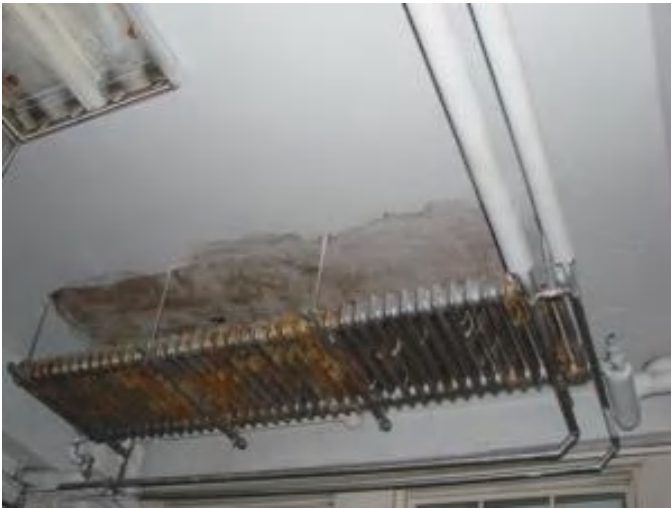
**Location:** Interiors

**Distress:** Beyond Service Life

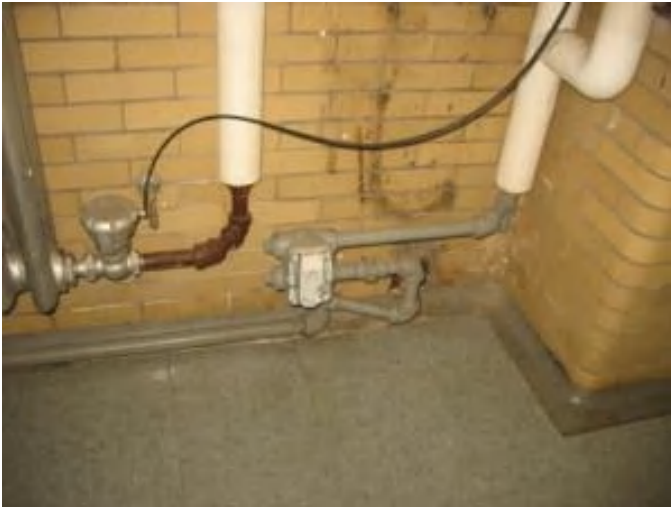
**Location:** Throughout building

**Distress:** Failing

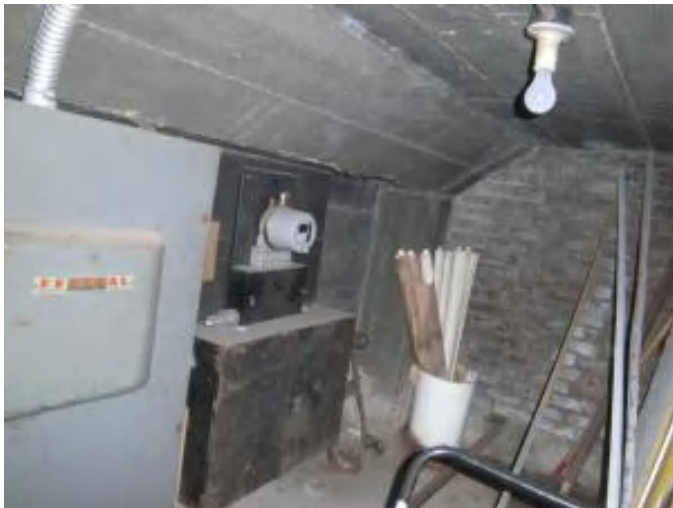
**Location:** Basement

**Distress:** Beyond Service Life

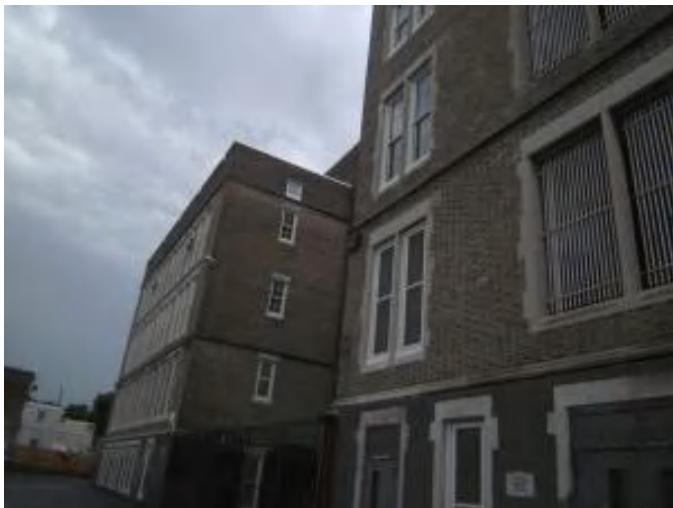
**Location:** Exterior at Play areas

**Distress:** Inadequate

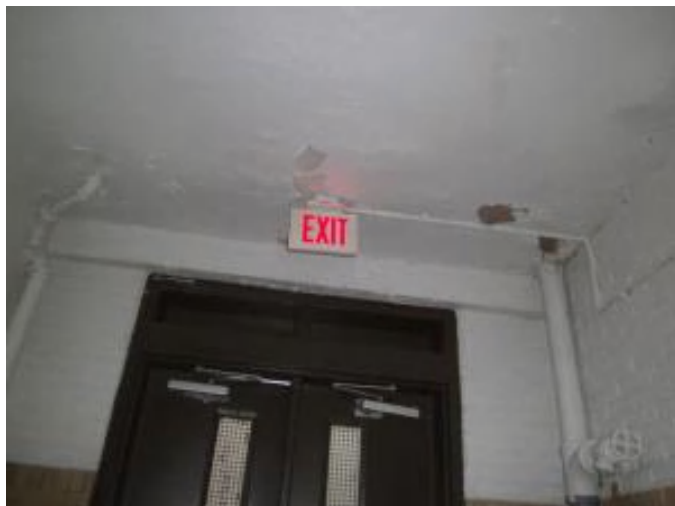
**Location:** 1st Floor

**Distress:** Security Issue

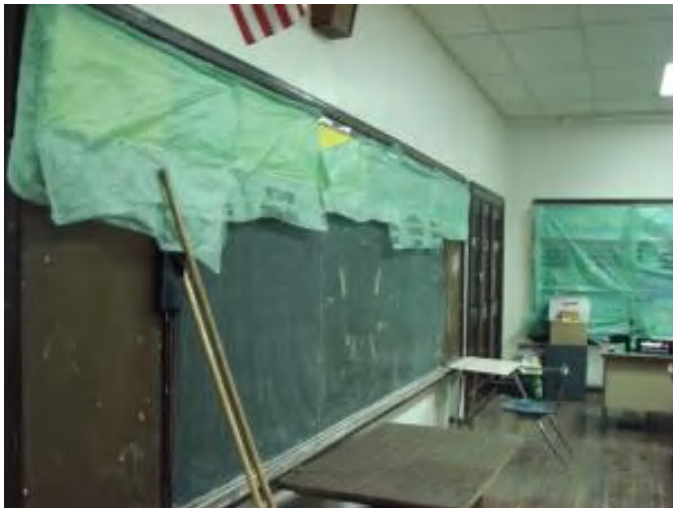
**Location:** Interiors/ Classrooms

**Distress:** Inadequate

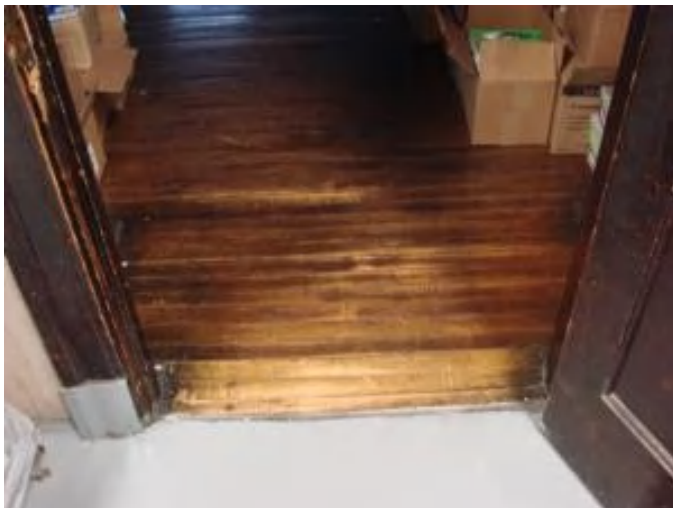
**Location:** Interiors

**Distress:** Beyond Service Life

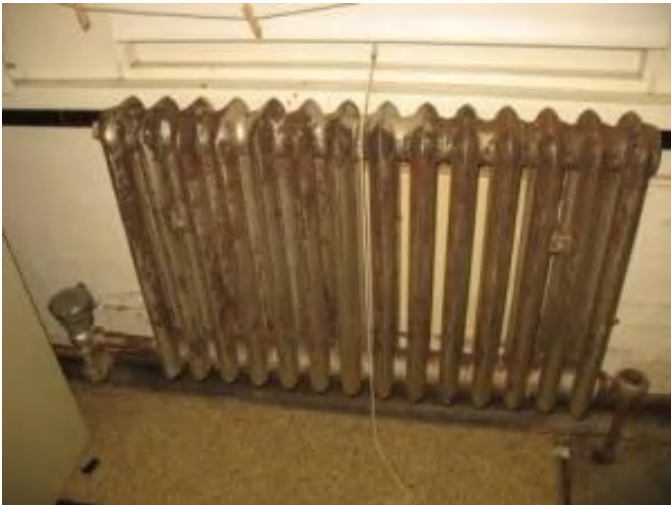
**Location:** Throughout building

**Distress:** Health Hazard / Risk

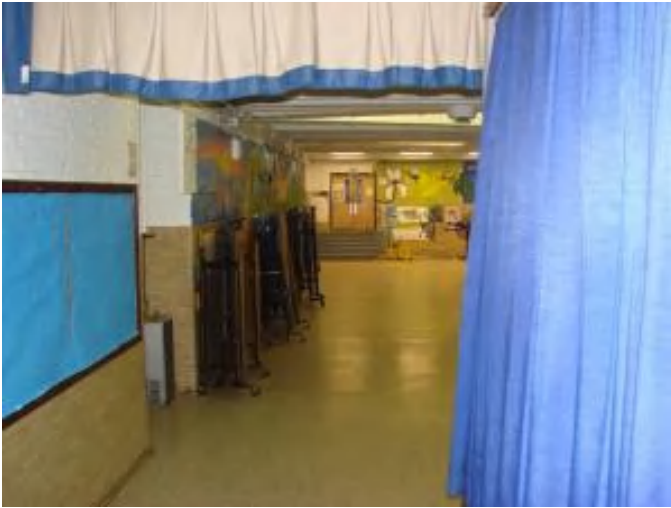
**Location:** Auditorium

**Distress:** Building / MEP Codes

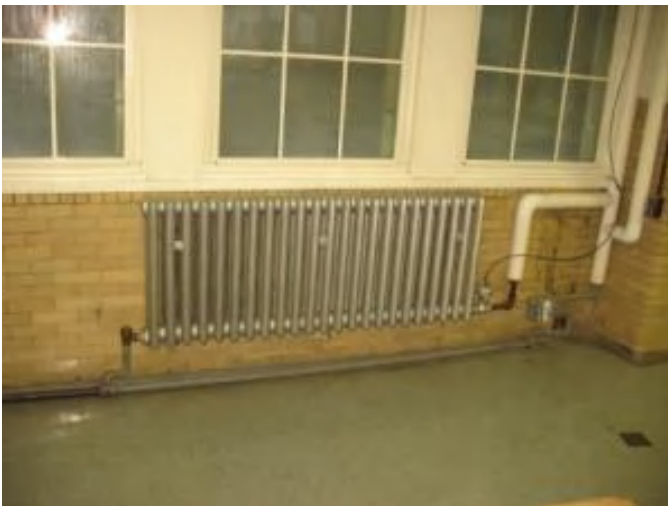
**Location:** Throughout building

**Distress:** Inadequate

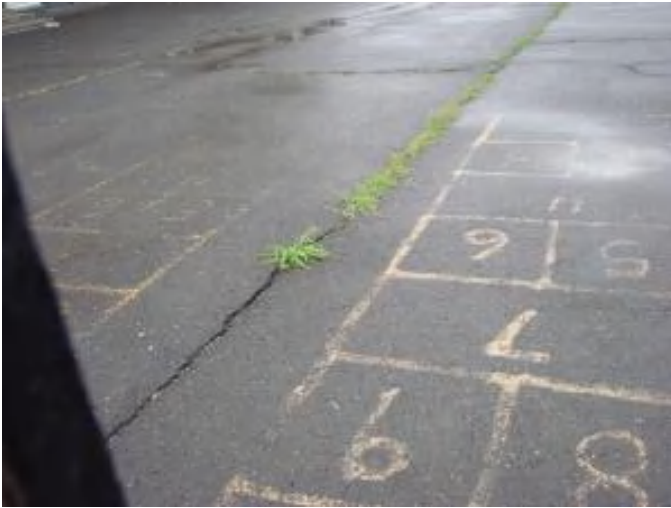
**Location:** Gorunds/ Site

**Distress:** Beyond Service Life

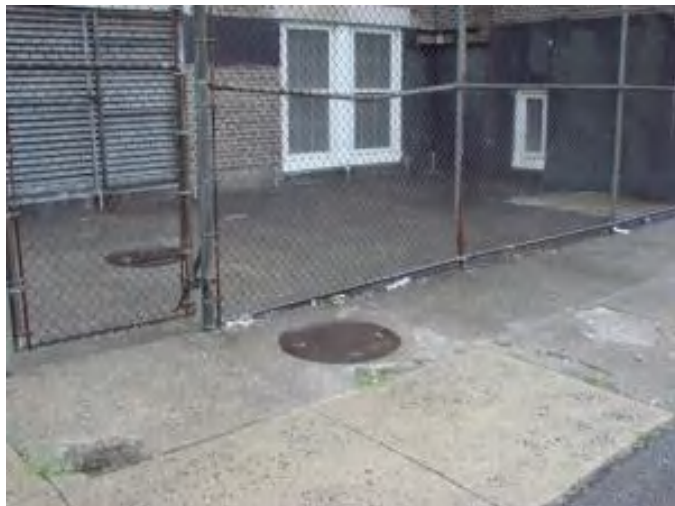
**Location:** Grounds/ Site

**Distress:** Beyond Service Life
