## Facility Condition Assessment Summary Report

### MLK High School

School District of Philadelphia  
**S606001; King HS and Field**  
Final  
**Site Assessment Report**  
February 1, 2017

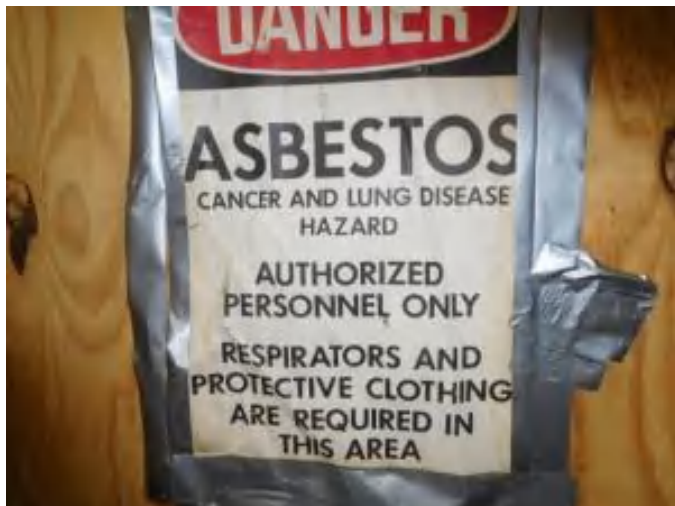
#### System: D3020 - Heat Generating Systems

**Location:** mechanical room

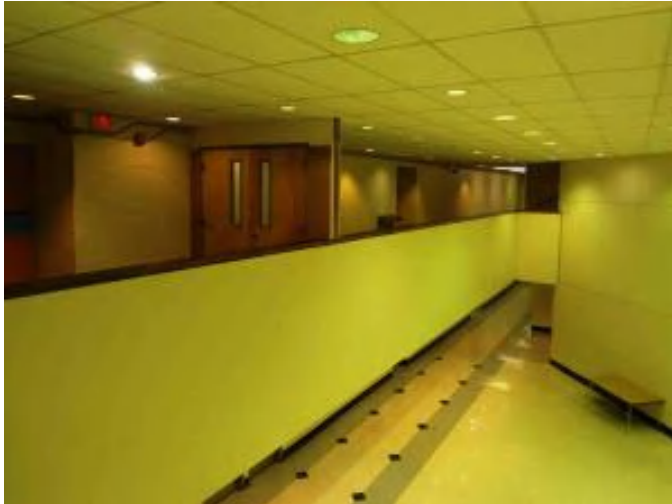
**System: C1010 - Partitions**

**Location:** Stairs and Corridors

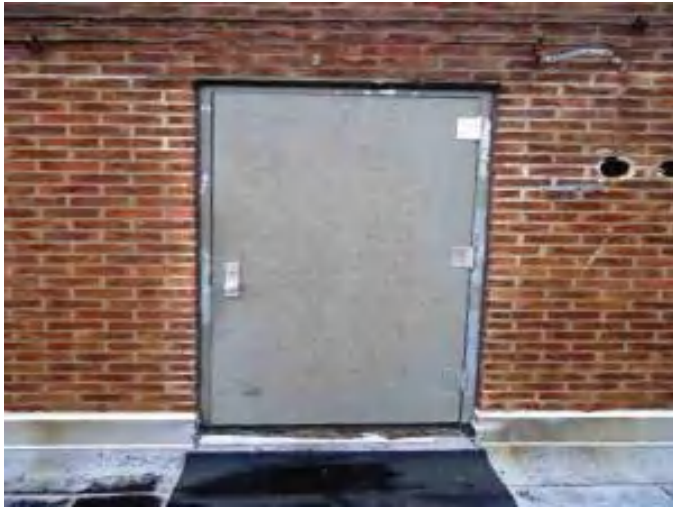
**System: C1010 - Partitions**

**Location:** Mechanical Spaces  
**Distress:** Damaged  
**Category:** 3 - Operations / Maint.  
**Priority:** 2 - Response Time (2-3 yrs)  
**Correction:** Add firestopping - per penetration - pick the type of penetration and insert the quantities in the estimate including finish restoration  
**Qty:** 1.00  
**Unit of Measure:** Ea.  
**Estimate:** \$15,965.67  
**Assessor Name:** System  
**Date Created:** 10/29/2015

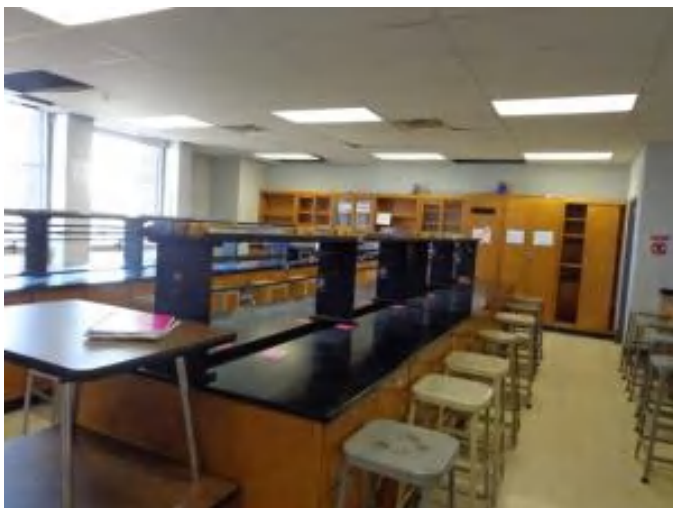
**System: D5020 - Lighting and Branch Wiring**

**Location:** Kitchens, wet locations  
**Distress:** Life Safety / NFPA / PFD  
**Category:** 1 - Health & Safety  
**Priority:** 2 - Response Time (2-3 yrs)  
**Correction:** Replace Wiring Device  
**Qty:** 60.00  
**Unit of Measure:** Ea.  
**Estimate:** \$20,548.20  
**Assessor Name:** System  
**Date Created:** 01/19/2016

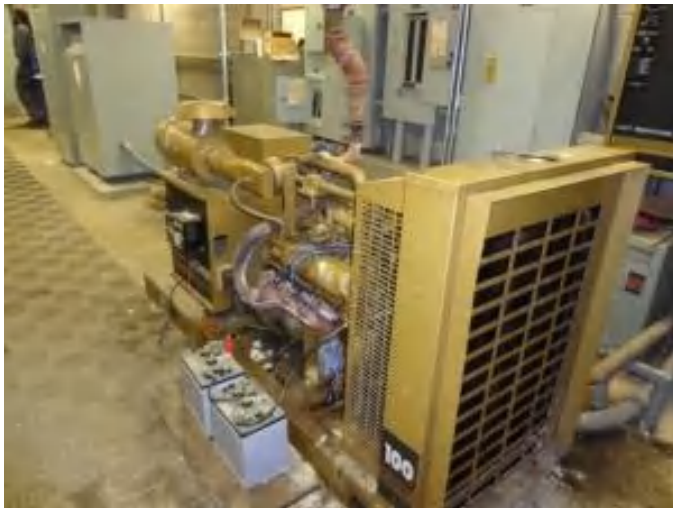
**System: D5090 - Other Electrical Systems**

**Location:** Main Electrical Room M127B  
**Distress:** Beyond Service Life  
**Category:** 3 - Operations / Maint.  
**Priority:** 2 - Response Time (2-3 yrs)  
**Correction:** Replace standby generator system  
**Qty:** 1.00  
**Unit of Measure:** Ea.  
**Estimate:** \$269,754.62  
**Assessor Name:** System  
**Date Created:** 01/19/2016

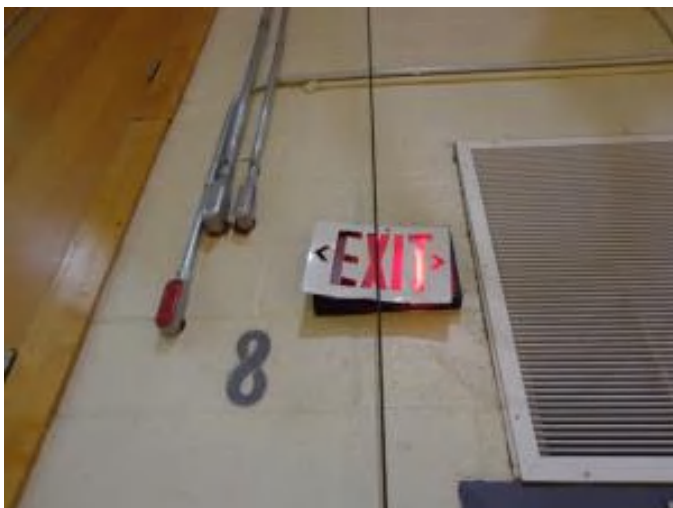
**System: D5090 - Other Electrical Systems**

**Location:** Building wide  
**Distress:** Life Safety / NFPA / PFD  
**Category:** 1 - Health & Safety  
**Priority:** 2 - Response Time (2-3 yrs)  
**Correction:** Replace Emergency/Exit Lighting  
**Qty:** 230.00  
**Unit of Measure:** Ea.  
**Estimate:** \$234,455.83  
**Assessor Name:** System  
**Date Created:** 01/19/2016

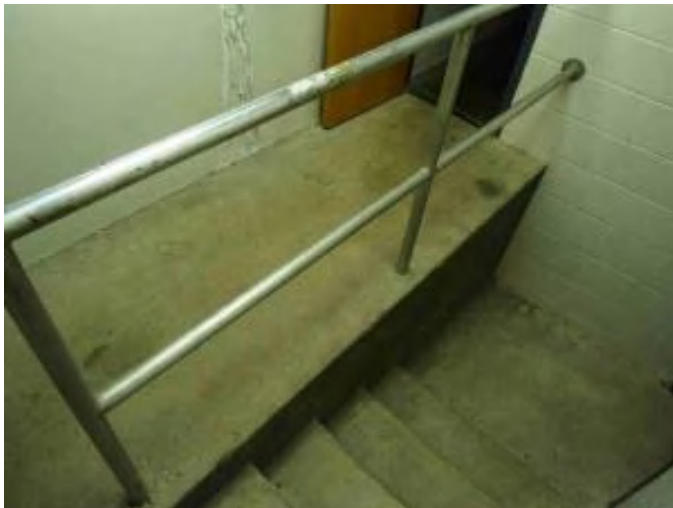
**System: C2010 - Stair Construction**

**Location:** Stairs  
**Distress:** Life Safety / NFPA / PFD  
**Category:** 1 - Health & Safety  
**Priority:** 3 - Response Time (3-4 yrs)  
**Correction:** Replace inadequate or install proper stair railing - select appropriate material  
**Qty:** 2,500.00  
**Unit of Measure:** L.F.  
**Estimate:** \$452,366.40  
**Assessor Name:** System  
**Date Created:** 10/29/2015

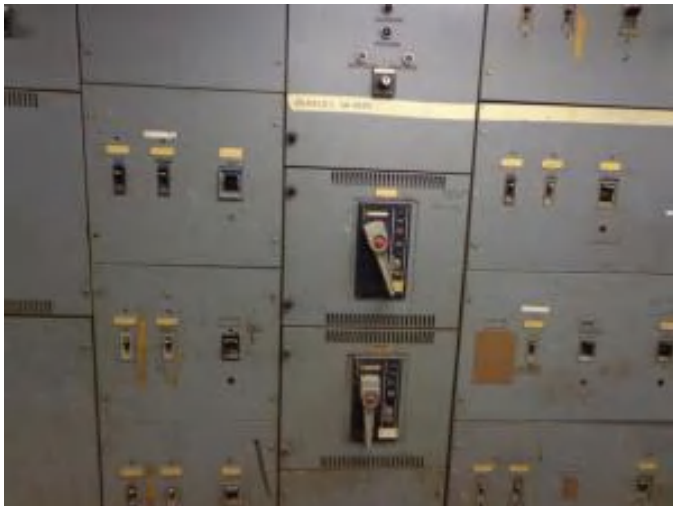
**System: D5010 - Electrical Service/Distribution**

**Location:** Main Electrical Room 127B  
**Distress:** Beyond Service Life  
**Category:** 3 - Operations / Maint.  
**Priority:** 3 - Response Time (3-4 yrs)  
**Correction:** Replace unit substation  
**Qty:** 1.00  
**Unit of Measure:** Ea.  
**Estimate:** \$1,613,042.55  
**Assessor Name:** System  
**Date Created:** 01/19/2016

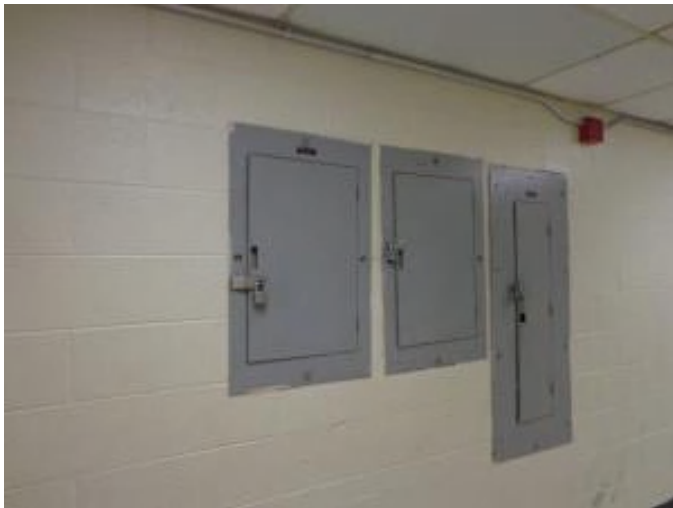
**System: D5010 - Electrical Service/Distribution**

**Location:** Building wide  
**Distress:** Beyond Service Life  
**Category:** 3 - Operations / Maint.  
**Priority:** 3 - Response Time (3-4 yrs)  
**Correction:** Replace Panelboard  
**Qty:** 30.00  
**Unit of Measure:** Ea.  
**Estimate:** \$1,048,543.87  
**Assessor Name:** System  
**Date Created:** 01/19/2016

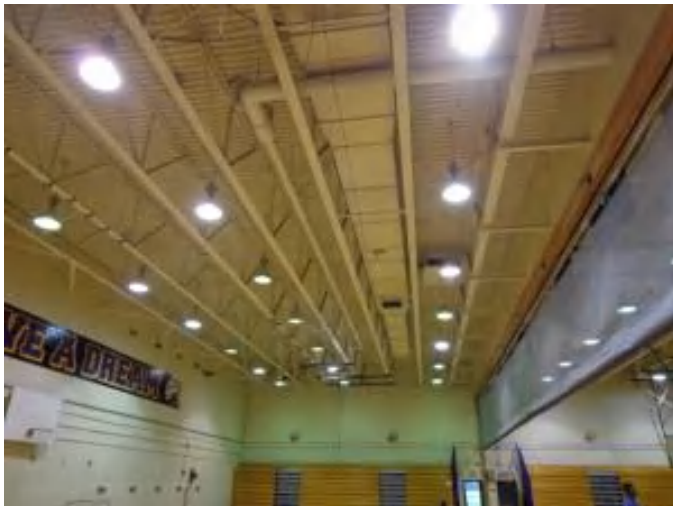
**System: D5020 - Lighting and Branch Wiring**

The four section divided gymnasium has a total of 96 industrial fixtures, a combination of 400W metal halide and mercury vapor, that are nearing the end of their useful life. Replacement is recommended.

**Location:** Gymnasium  
**Distress:** Beyond Service Life  
**Category:** 3 - Operations / Maint.  
**Priority:** 3 - Response Time (3-4 yrs)  
**Correction:** Replace lighting fixtures  
**Qty:** 96.00  
**Unit of Measure:** Ea.  
**Estimate:** \$330,832.20  
**Assessor Name:** System  
**Date Created:** 01/19/2016

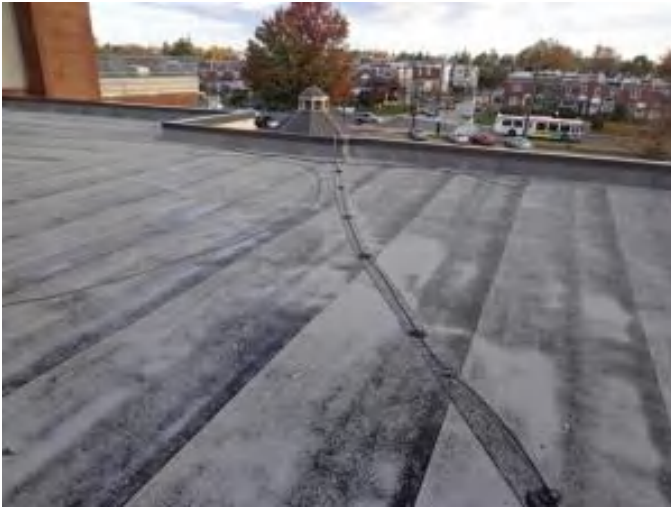
**System: D5090 - Other Electrical Systems**

**Location:** Roof  
**Distress:** Damaged  
**Category:** 3 - Operations / Maint.  
**Priority:** 3 - Response Time (3-4 yrs)  
**Correction:** Repair Lightning Protection System  
**Qty:** 1.00  
**Unit of Measure:** Job  
**Estimate:** \$8,333.07  
**Assessor Name:** System  
**Date Created:** 01/19/2016

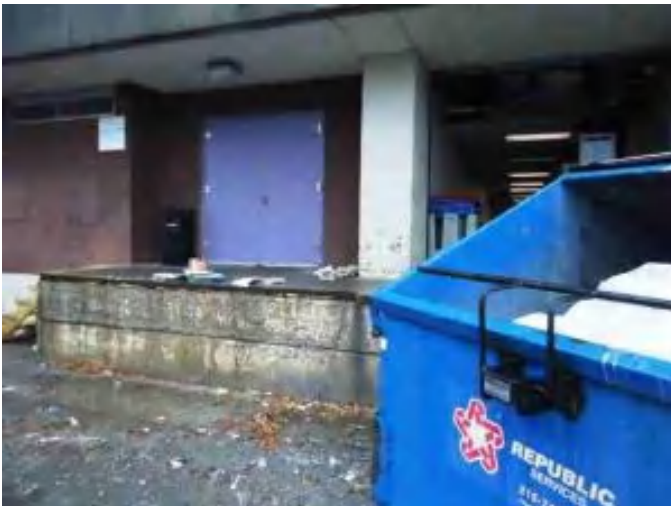
**System: E1090 - Other Equipment**

**Location:** Loading Dock  
**Distress:** Damaged  
**Category:** 3 - Operations / Maint.  
**Priority:** 3 - Response Time (3-4 yrs)  
**Correction:** Remove and replace dock bumpers  
**Qty:** 4.00  
**Unit of Measure:** Ea.  
**Estimate:** \$1,484.83  
**Assessor Name:** System  
**Date Created:** 10/29/2015

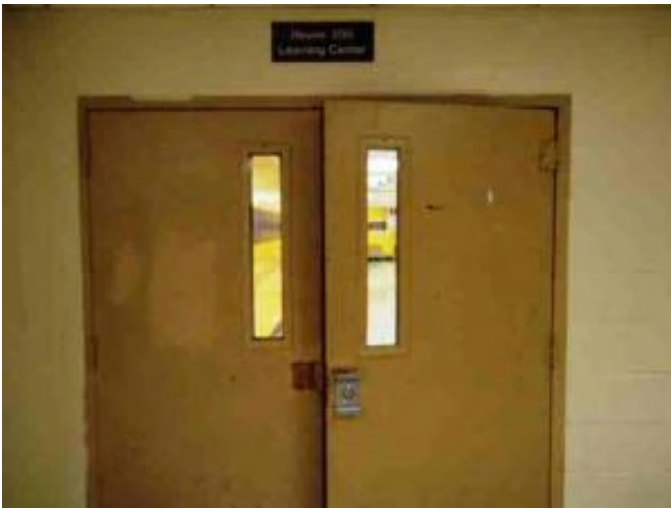
**System: C1020 - Interior Doors**

**Location:** Classrooms  
**Distress:** Damaged  
**Category:** 3 - Operations / Maint.  
**Priority:** 4 - Response Time (4-5 yrs)  
**Correction:** Remove and replace interior doors - wood doors with hollow metal frames - per leaf  
**Qty:** 300.00  
**Unit of Measure:** Ea.  
**Estimate:** \$1,431,176.13  
**Assessor Name:** System  
**Date Created:** 10/29/2015

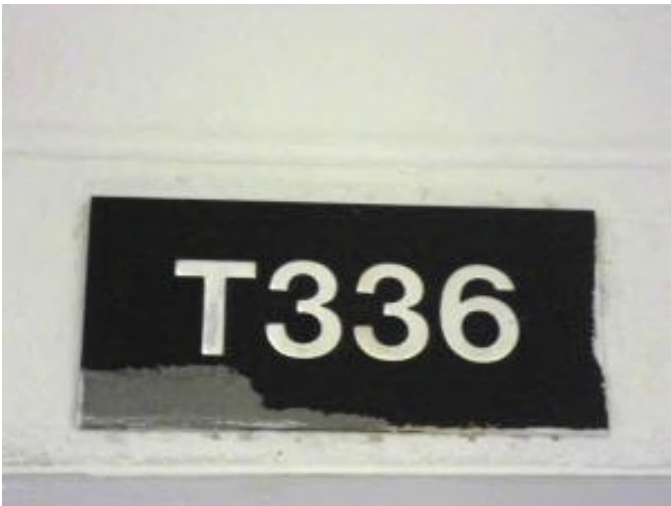
**System: C1030 - Fittings**

**Location:** Building Wide  
**Distress:** Damaged  
**Category:** 3 - Operations / Maint.  
**Priority:** 4 - Response Time (4-5 yrs)  
**Correction:** Replace missing or damaged signage - insert the number of rooms  
**Qty:** 300.00  
**Unit of Measure:** Ea.  
**Estimate:** \$81,273.74  
**Assessor Name:** System  
**Date Created:** 10/29/2015

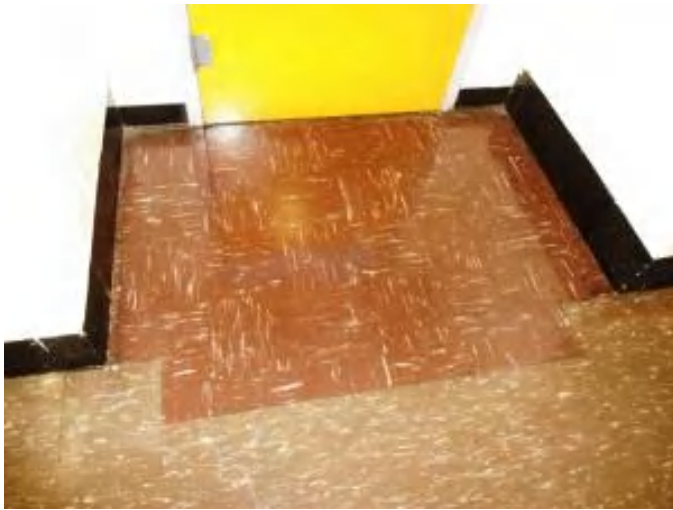
**Location:** Building Wide  
**Distress:** Damaged  
**Category:** 3 - Operations / Maint.  
**Priority:** 4 - Response Time (4-5 yrs)  
**Correction:** Remove VAT and replace with VCT - SF of area  
**Qty:** 30,000.00  
**Unit of Measure:** S.F.  
**Estimate:** \$455,000.04  
**Assessor Name:** System  
**Date Created:** 10/29/2015

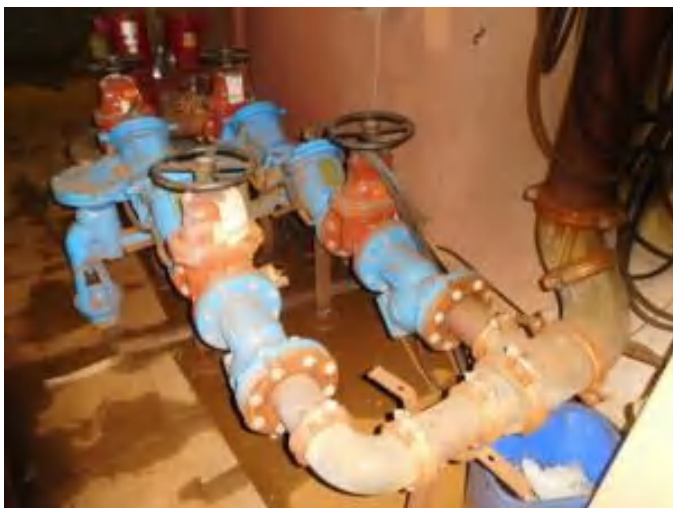
**Location:** entire building  
**Distress:** Beyond Service Life  
**Category:** 3 - Operations / Maint.  
**Priority:** 4 - Response Time (4-5 yrs)  
**Correction:** Replace domestic water piping (350 KSF)  
**Qty:** 370,000.00  
**Unit of Measure:** S.F.  
**Estimate:** \$1,824,306.66  
**Assessor Name:** System  
**Date Created:** 01/22/2016

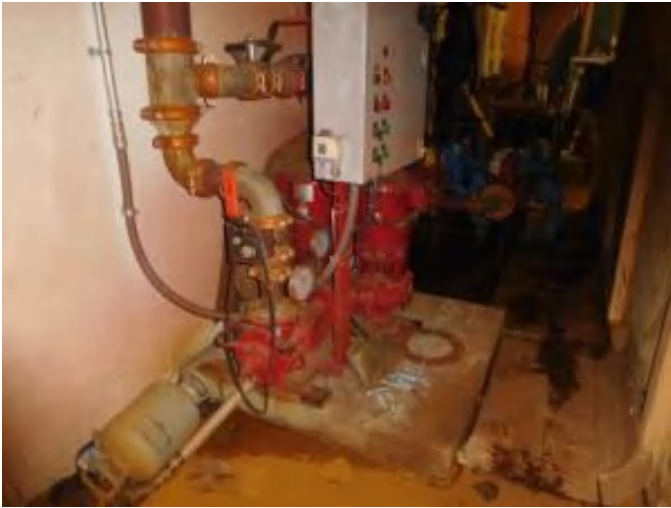
**Location:** mechanical room  
**Distress:** Beyond Service Life  
**Category:** 3 - Operations / Maint.  
**Priority:** 4 - Response Time (4-5 yrs)  
**Correction:** Replace duplex domestic booster pump set (5 HP)  
**Qty:** 1.00  
**Unit of Measure:** Ea.  
**Estimate:** \$50,533.86  
**Assessor Name:** System  
**Date Created:** 01/22/2016

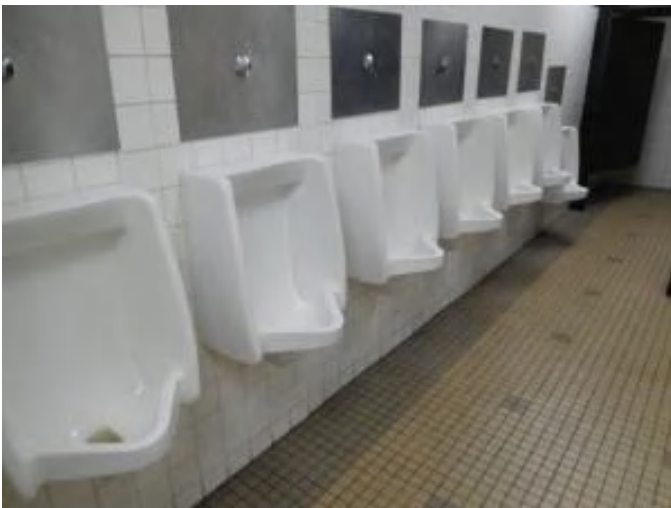
**Location:** entire building  
**Distress:** Beyond Service Life  
**Category:** 3 - Operations / Maint.  
**Priority:** 4 - Response Time (4-5 yrs)  
**Correction:** Inspect sanitary waste piping and replace damaged sections. (+300KSF)  
**Qty:** 370,000.00  
**Unit of Measure:** S.F.  
**Estimate:** \$1,625,721.73  
**Assessor Name:** System  
**Date Created:** 01/22/2016

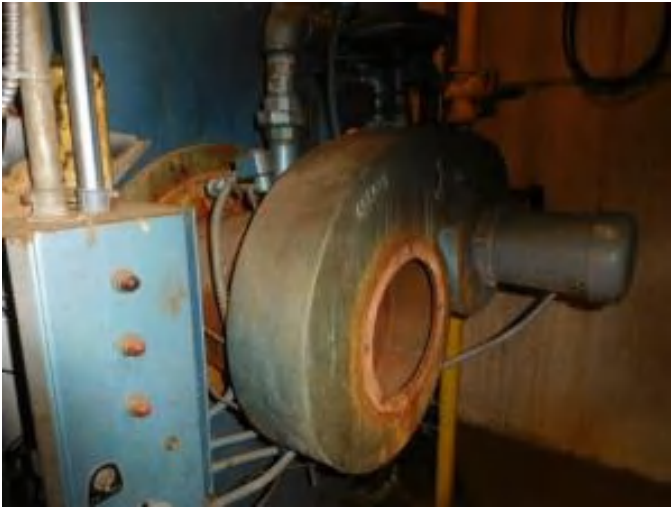
**Location:** mechanical room  
**Distress:** Beyond Service Life  
**Category:** 3 - Operations / Maint.  
**Priority:** 4 - Response Time (4-5 yrs)  
**Correction:** Replace boiler feed pump (duplex) and surge tank  
**Qty:** 1.00  
**Unit of Measure:** Ea.  
**Estimate:** \$101,394.17  
**Assessor Name:** System  
**Date Created:** 01/22/2016

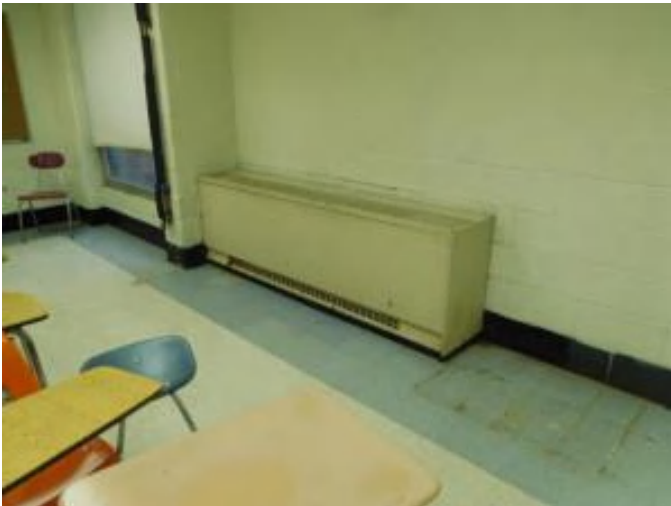
**Location:** entire building  
**Distress:** Building / MEP Codes  
**Category:** 2 - Code Compliance  
**Priority:** 4 - Response Time (4-5 yrs)  
**Correction:** Replace the existing unit ventilators with new units designed to provide adequate ventilation per ASHRAE Std 62 - insert the SF of bldg. in the qty.  
**Qty:** 370,000.00  
**Unit of Measure:** S.F.  
**Estimate:** \$17,848,494.55  
**Assessor Name:** System  
**Date Created:** 01/22/2016

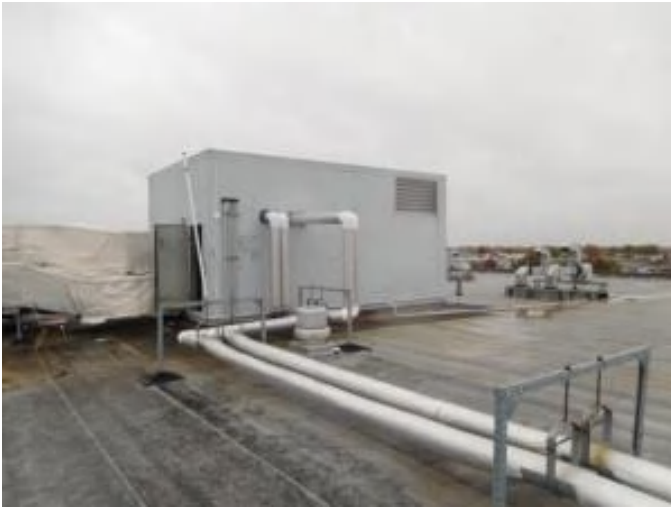
**Location:** roof  
**Distress:** Building / MEP Codes  
**Category:** 2 - Code Compliance  
**Priority:** 4 - Response Time (4-5 yrs)  
**Correction:** Replace Rooftop Unit (50T) and air terminals  
**Qty:** 25,000.00  
**Unit of Measure:** S.F.  
**Estimate:** \$1,840,712.32  
**Assessor Name:** System  
**Date Created:** 01/27/2016

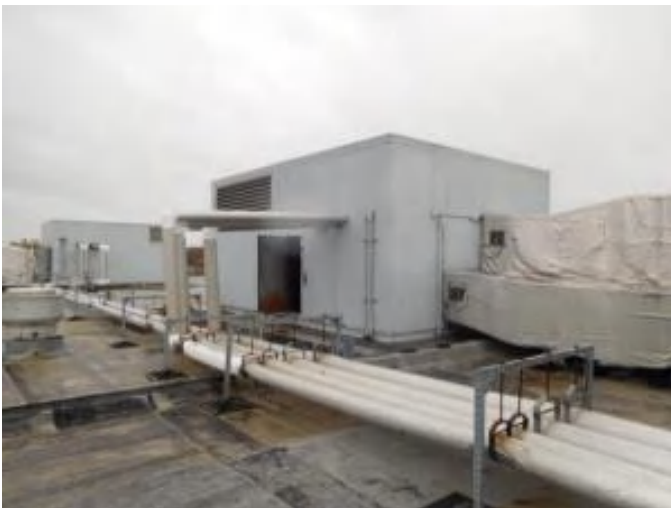
**Location:** roof  
**Distress:** Building / MEP Codes  
**Category:** 2 - Code Compliance  
**Priority:** 4 - Response Time (4-5 yrs)  
**Correction:** Replace Rooftop Unit (50T) and air terminals  
**Qty:** 25,000.00  
**Unit of Measure:** S.F.  
**Estimate:** \$1,840,712.32  
**Assessor Name:** System  
**Date Created:** 01/27/2016

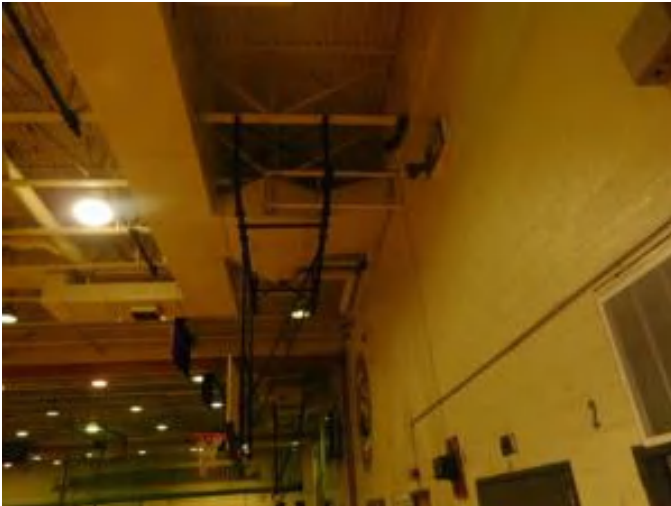
**Location:** gymnasium  
**Distress:** Building / MEP Codes  
**Category:** 2 - Code Compliance  
**Priority:** 4 - Response Time (4-5 yrs)  
**Correction:** Replace HVAC unit for Gymnasium (single station)  
**Qty:** 6,000.00  
**Unit of Measure:** S.F.  
**Estimate:** \$227,475.37  
**Assessor Name:** System  
**Date Created:** 01/22/2016

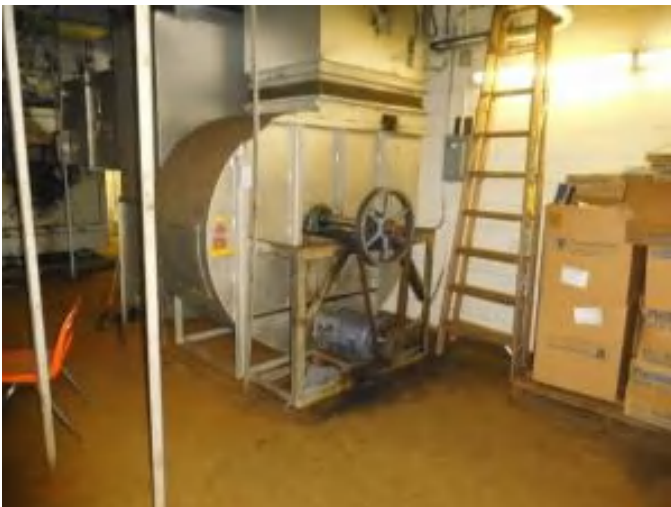
**Location:** nursing area  
**Distress:** Building / MEP Codes  
**Category:** 2 - Code Compliance  
**Priority:** 4 - Response Time (4-5 yrs)  
**Correction:** Replace indoor AHU, CV, DT (15T)  
**Qty:** 10.00  
**Unit of Measure:** TonAC  
**Estimate:** \$187,403.32  
**Assessor Name:** System  
**Date Created:** 01/22/2016

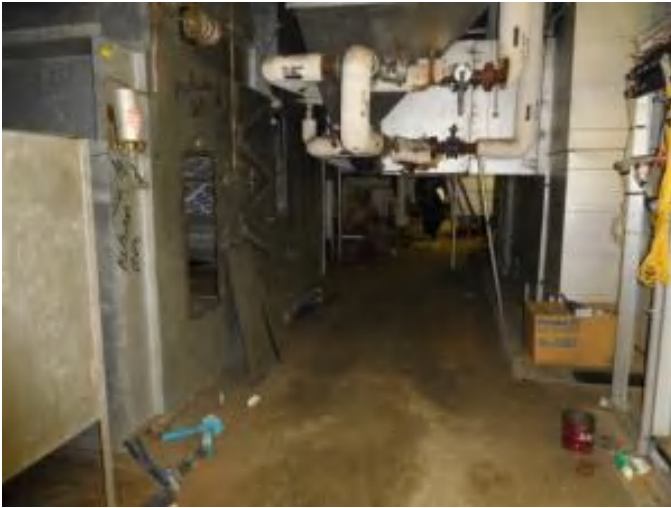
**Location:** music area  
**Distress:** Building / MEP Codes  
**Category:** 2 - Code Compliance  
**Priority:** 4 - Response Time (4-5 yrs)  
**Correction:** Replace indoor AHU, CV, DT (15T)  
**Qty:** 10.00  
**Unit of Measure:** TonAC  
**Estimate:** \$187,403.32  
**Assessor Name:** System  
**Date Created:** 01/22/2016

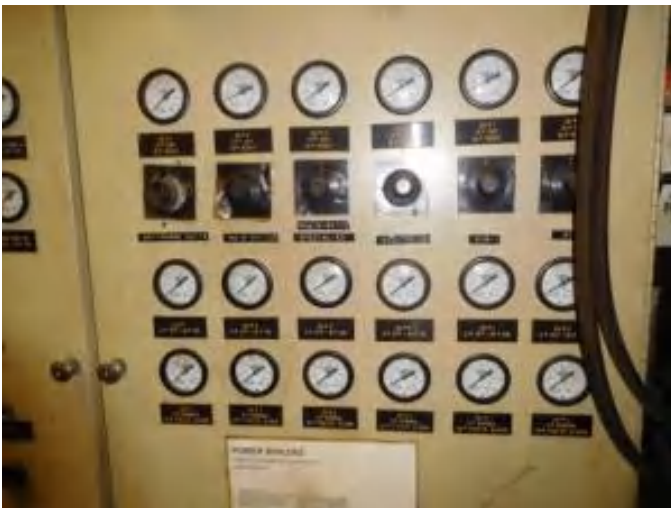
**Location:** entire building  
**Distress:** Inadequate  
**Category:** 4 - Capital Improvement  
**Priority:** 4 - Response Time (4-5 yrs)  
**Correction:** Replace pneumatic controls with DDC (350KSF)  
**Qty:** 370,000.00  
**Unit of Measure:** S.F.  
**Estimate:** \$6,816,675.20  
**Assessor Name:** System  
**Date Created:** 01/22/2016

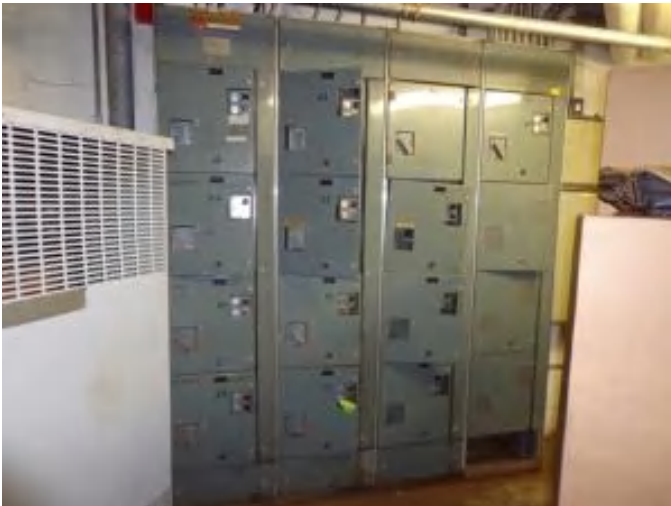
**Location:** Mechanical and Electrical Rooms  
**Distress:** Beyond Service Life  
**Category:** 3 - Operations / Maint.  
**Priority:** 4 - Response Time (4-5 yrs)  
**Correction:** Replace Electrical DIstribution System (U1)  
**Qty:** 1.00  
**Unit of Measure:** Ea.  
**Estimate:** \$1,948,524.99  
**Assessor Name:** System  
**Date Created:** 01/19/2016

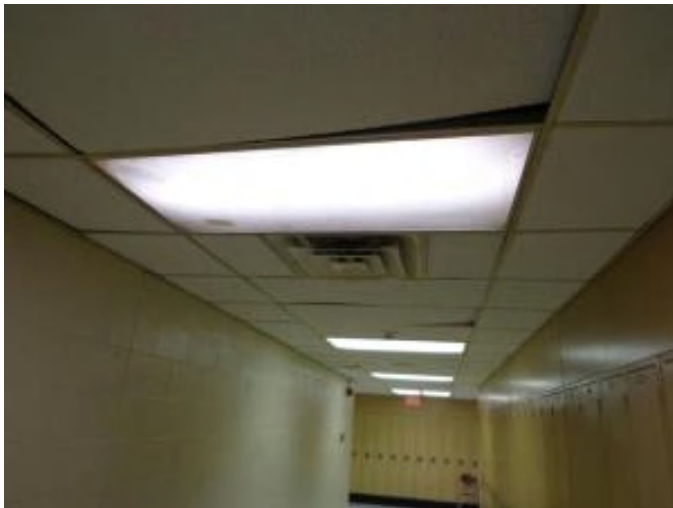
**Location:** Building wide  
**Distress:** Damaged  
**Category:** 3 - Operations / Maint.  
**Priority:** 4 - Response Time (4-5 yrs)  
**Correction:** Maintain Lighting Fixtures  
**Qty:** 150.00  
**Unit of Measure:** Ea.  
**Estimate:** \$20,925.82  
**Assessor Name:** System  
**Date Created:** 01/19/2016

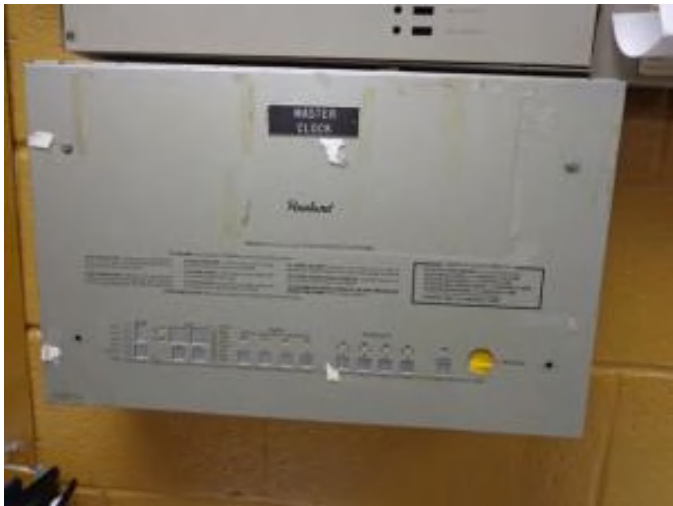
**Location:** Building wide  
**Distress:** Damaged  
**Category:** 3 - Operations / Maint.  
**Priority:** 4 - Response Time (4-5 yrs)  
**Correction:** Provide wireless GPS clock system  
**Qty:** 1.00  
**Unit of Measure:** LS  
**Estimate:** \$123,151.72  
**Assessor Name:** System  
**Date Created:** 01/19/2016

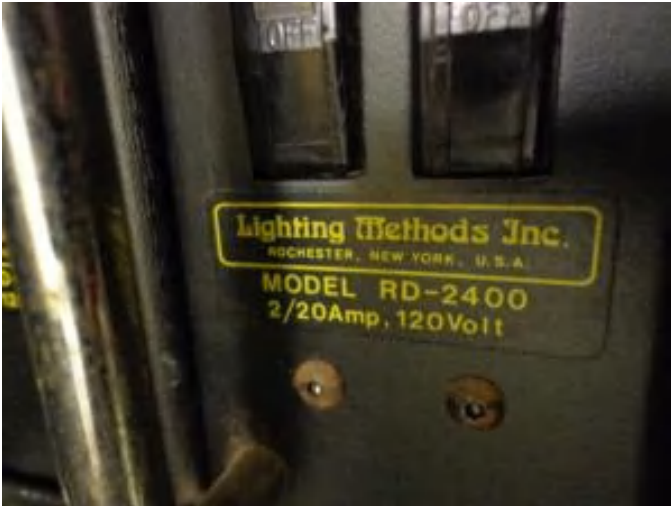
**Location:** Stage  
**Distress:** Beyond Service Life  
**Category:** 3 - Operations / Maint.  
**Priority:** 4 - Response Time (4-5 yrs)  
**Correction:** Replace stage dimmer control board  
**Qty:** 1.00  
**Unit of Measure:** Ea.  
**Estimate:** \$221,517.71  
**Assessor Name:** System  
**Date Created:** 01/19/2016

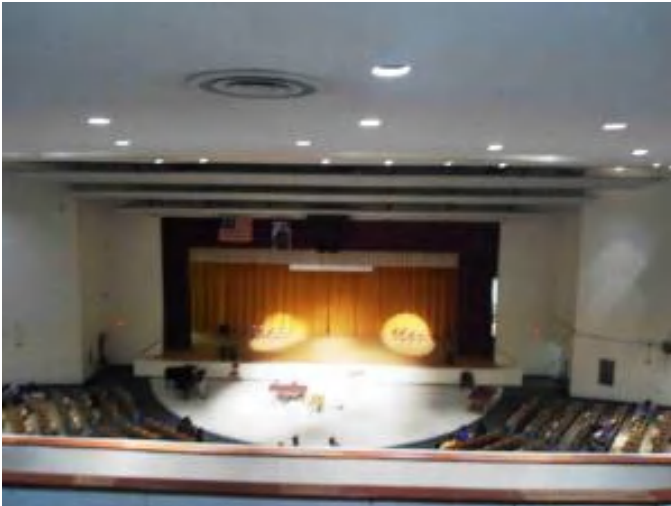
The school stage has a stage curtain assembly that appears to be from the original construction. Modern applications are typically fire-proof applications with adjustable tracks and electric support for operation. The curtains are torn in a few section and the track is not functioning properly, overall the system is in fair condition. It is recommended that the curtain and track system be upgraded to a new system. Special care should be considered in regards to modern fire proofing for the new installation.

**Location:** Stage  
**Distress:** Life Safety / NFPA / PFD  
**Category:** 1 - Health & Safety  
**Priority:** 4 - Response Time (4-5 yrs)  
**Correction:** Remove and replace stage curtain - insert the LF of track and SF of curtain  
**Qty:** 200.00  
**Unit of Measure:** Ea.  
**Estimate:** \$155,694.60  
**Assessor Name:** System  
**Date Created:** 10/29/2015

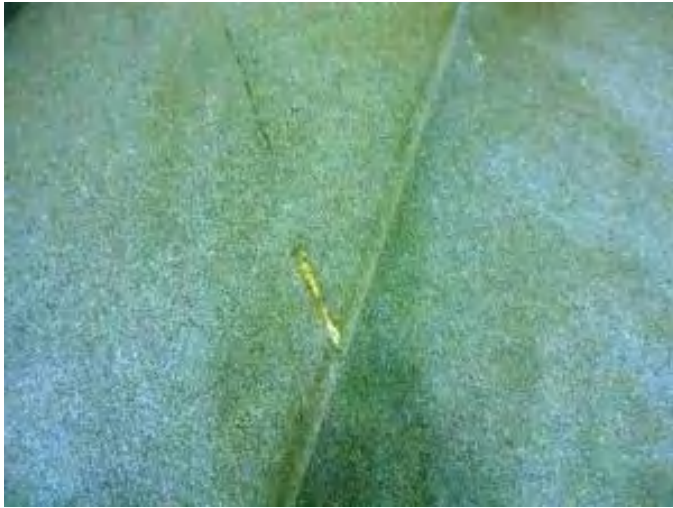
Typical carpeting in the un-renovated portion (Music Hall) of the building is in poor condition, and it can be expected to degrade over time. Generally, the carpet is located in offices, medical instruction classrooms, conference areas and the main auditorium. To anticipate these life cycle expenditures, schedule these floor finishes for low priority replacement with new commercial-grade, roll carpeting over the next ten-year period. Carpet upgrades are warranted within the next ten year as an overall effort and sooner in the Music Hall section of the school.

**Location:** Music Hall  
**Distress:** Damaged  
**Category:** 3 - Operations / Maint.  
**Priority:** 5 - Response Time (> 5 yrs)  
**Correction:** Remove and replace carpet  
**Qty:** 20,000.00  
**Unit of Measure:** S.F.  
**Estimate:** \$223,815.21  
**Assessor Name:** System  
**Date Created:** 10/29/2015

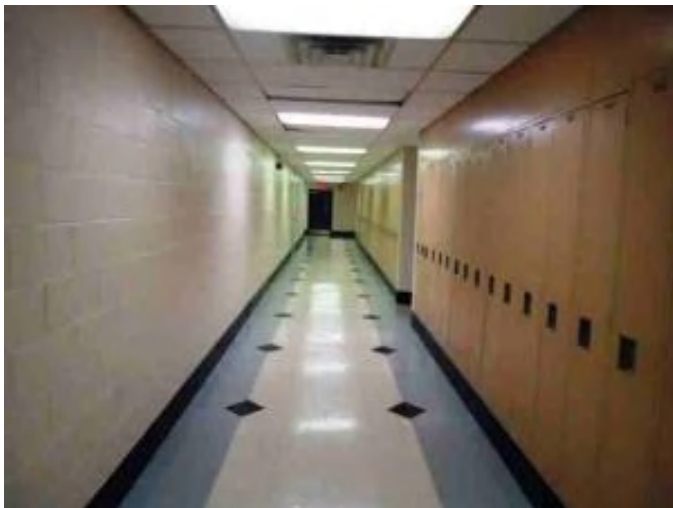
**Location:** Building Wide  
**Distress:** Damaged  
**Category:** 3 - Operations / Maint.  
**Priority:** 5 - Response Time (> 5 yrs)  
**Correction:** Remove and replace suspended acoustic ceilings - lighting not included  
**Qty:** 260,000.00  
**Unit of Measure:** S.F.  
**Estimate:** \$3,921,431.87  
**Assessor Name:** System  
**Date Created:** 10/29/2015
