Mann School

School District of Philadelphia

S434001;Mann

Site Assessment Report

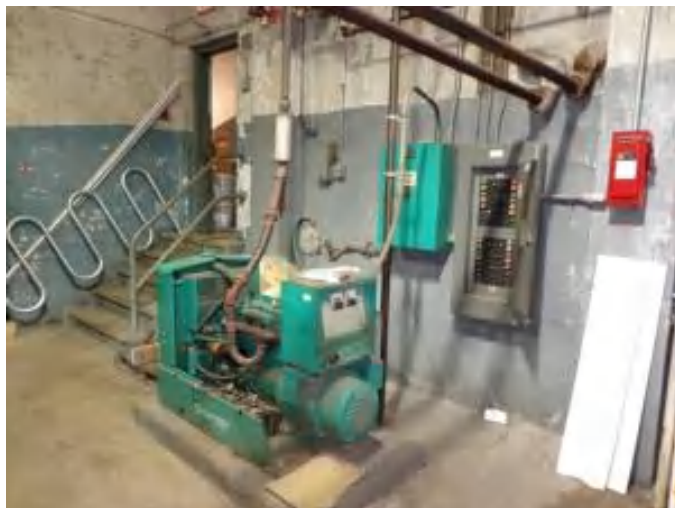
Location: Mechanical Room

System: D5090 - Other Electrical Systems

Distress: Life Safety / NFPA / PFD

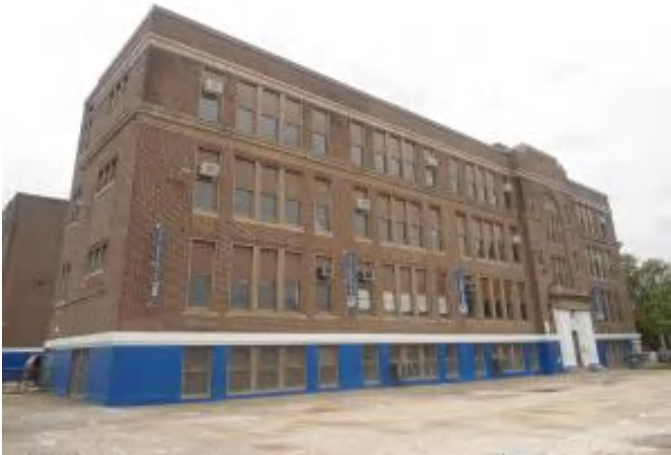
Location: Main Entrance

System: B2030 - Exterior Doors

Distress: Life Safety / NFPA / PFD

Notes: The main entrance is a double door system that has been upgraded from the original construction. This system is in good condition however as indicated in the photo the concrete step does not meet the length of the door thus allowing a trap hazard. Special consideration for a new door system is required and a modification to the exterior step removing the hazard. Remove and replace door and step.

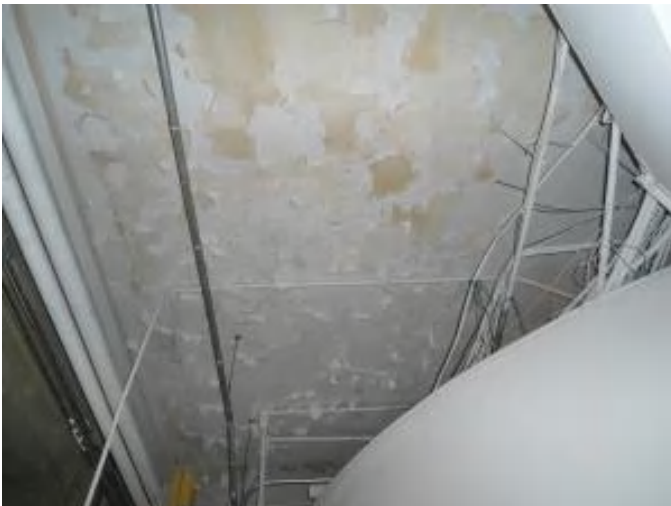
Location: Building Wide

System: C3010230 - Paint & Covering

Distress: Damaged

Notes: There are several minor areas of wall damage that ranges from serious to minor. Although the school is on a cyclical program of renewal and each painted surface is renewed at years end this system is at the point in which repairs are necessary. Remove damaged wall finishes and repair areas then apply primer and paint finish.

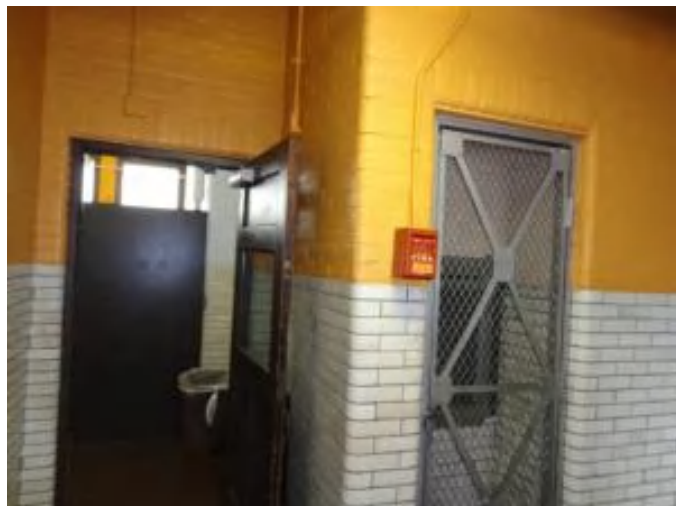
Location: Entire Building

System: D5030 - Communications and Security

Distress: Life Safety / NFPA / PFD

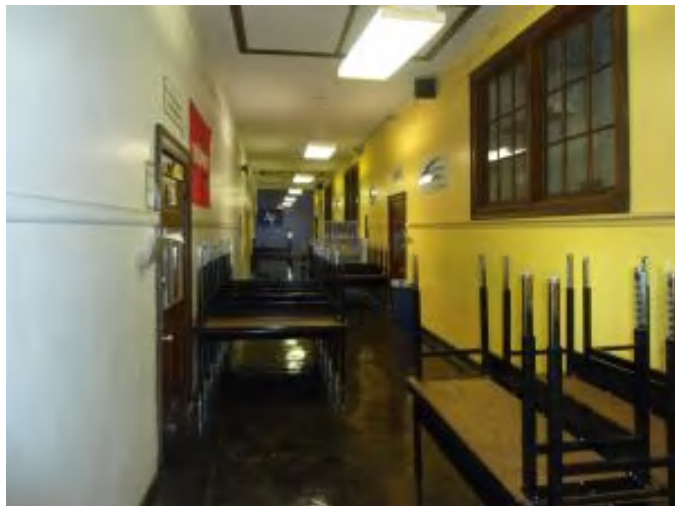
Location: Hallways

System: C1010 - Partitions

Distress: Building / MEP Codes

Notes: There are several transom lites and sidelights constructed into hallway wall systems. It is recommended that the lites and sidelights be removed and replaced with a fire rated wall construction. The deficiency provides a budgetary consideration to correct the hallway, transoms, lites and sidelights.

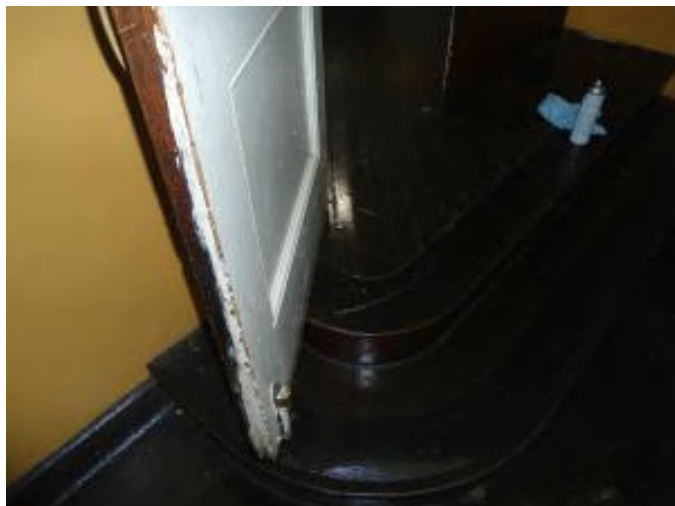
Location: Building Wide

System: C1020 - Interior Doors

Distress: Beyond Service Life

Notes: Interior doors are typically wood in wood frames with transom lites, sidelights, wired glass glazing. Other interior doors include wooden glass pane doors with original wooden pane frames, hollow metal in hollow metal frames at stairwells and exit ways. Doors are generally in good condition considering the age of the application. Doors swing in the direction of exit and do not obstruct hallways. . Universal upgrades are required for the interior door systems it is recommended that the interior doors system be removed and replaced with a new modern metal framed hollow metal door system with consideration for ADA compliance. Special Note: The double door systems leading to the auditorium are elevated on wooden stairs and the door swing exceeds the stair elevation creating a pinch hazard. The modification to the auditorium door systems are recommended to include stair modifications to correct this issue.

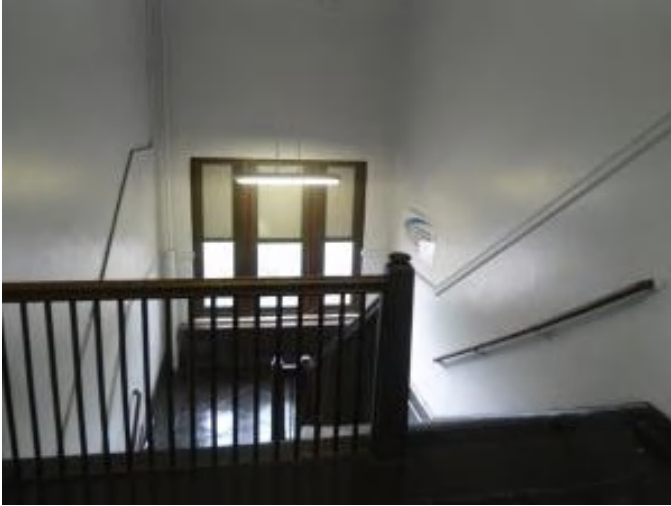
Location: Stairs

System: C2010 - Stair Construction

Distress: Building / MEP Codes

Notes: Current legislation regarding stairs require graspable handrails on both sides, that the rails have a specific end geometry, and that the handrails continue horizontally at the landings. In addition, guardrails must prevent the passage of a 4 inch diameter sphere (6 inches in the triangle formed by the lower rail and tread/riser angle). Although the stairs are compliant with the code enforced at the time of construction until a major renovation occurs, they are deficient in handrail and guardrail design relative to current standards.

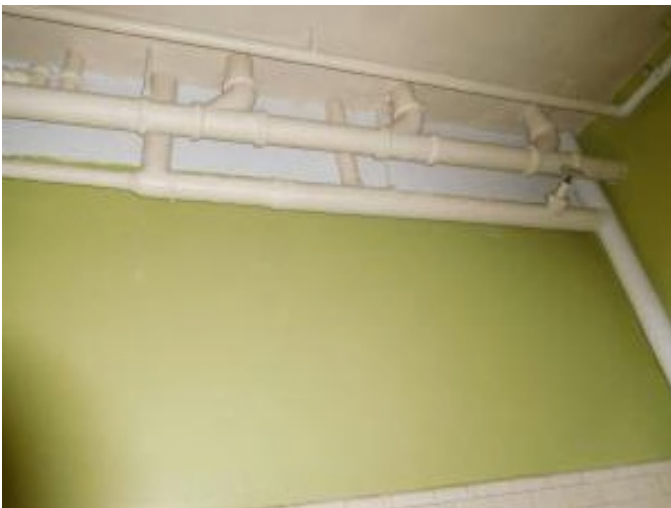
Location: entire building

System: D2030 - Sanitary Waste

Distress: Beyond Service Life

Notes: Inspect old cast iron sanitary piping including camera observation and replace damaged sections.

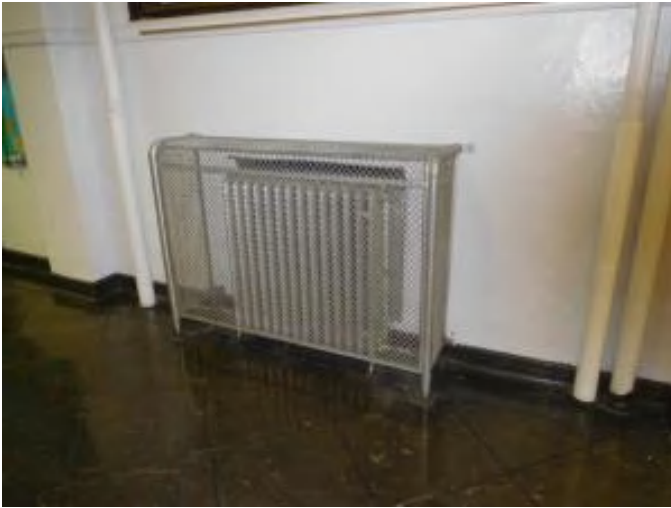
Location: entire building

System: D3040 - Distribution Systems

Distress: Building / MEP Codes

Notes: Provide a four pipe fan coil system with roof mounted outside air system ducted to each fan coil unit. Provide a fan coil unit for each classroom and separate area. Include new heat exchanger and pump for hot water, piping, control valves and controls to replace steam heating system.

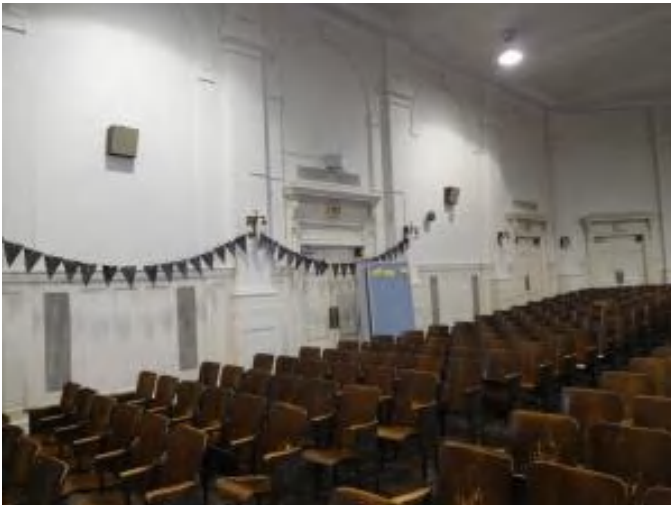
Location: auditorium

System: D3040 - Distribution Systems

Distress: Building / MEP Codes

Notes: Provide a new central station air handling unit for the auditorium with hot and chilled water coils, filters, outside and return air dampers, hydronic valves and controls, blower and motor. Connect to hot and chilled water systems.

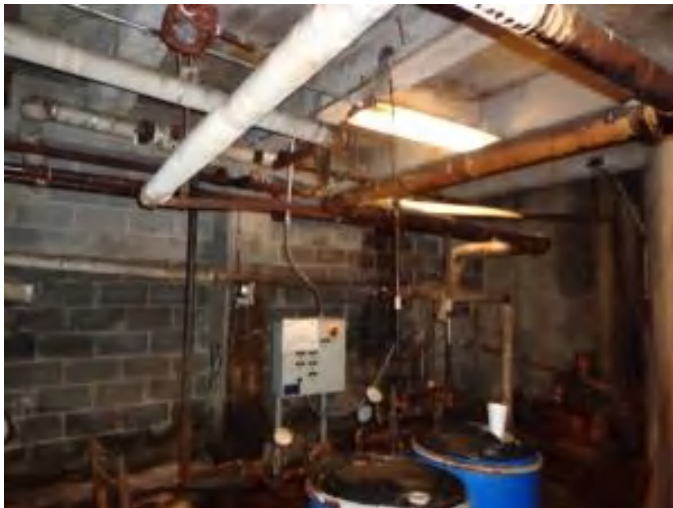
Location: Boiler Room , mechanical

System: D5020 - Lighting and Branch Wiring

Distress: Beyond Service Life

Notes: Replace lighting in Boiler Room and mechanical spaces in Basement. (Approximately 3,024 SF)

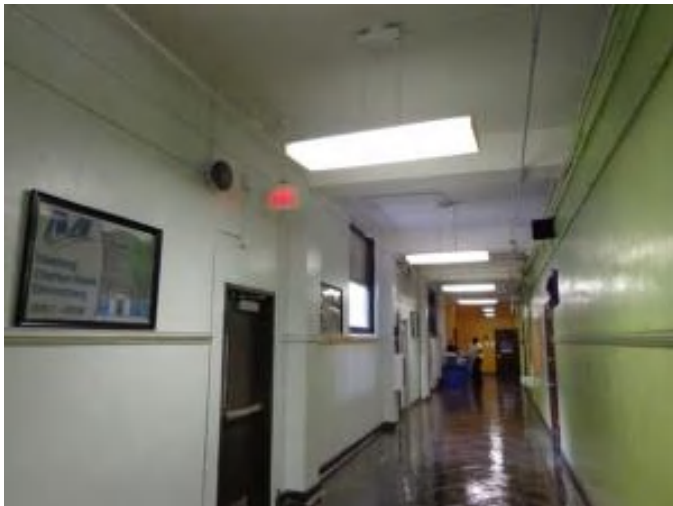
Location: Entire Building

System: D5030 - Communications and Security

Distress: Beyond Service Life

Notes: Replace clock and program system.

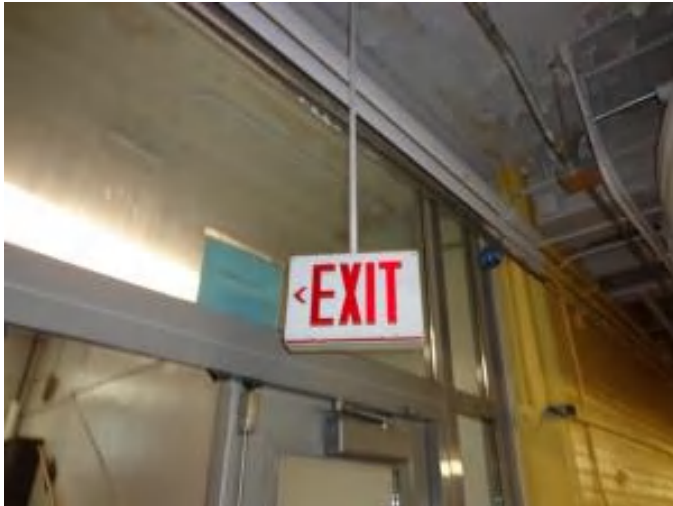
Location: Entire Building

System: D5090 - Other Electrical Systems

Distress: Beyond Service Life

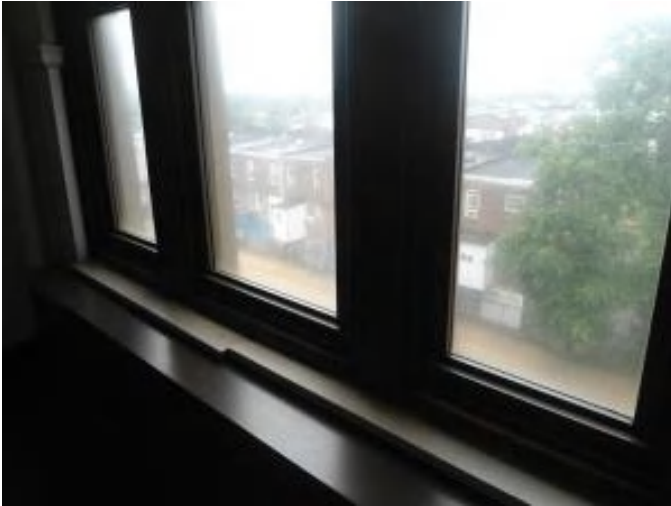
Location: Exterior Elevation

System: B2020 - Exterior Windows

Distress: Beyond Service Life

Notes: The wood and metal-framed, double hung windows with standard single pane glass have been replaced in the last twenty years. It is recommended that the exterior window systems be replaced with units that retain their dimensions and profiles, but that incorporate updated energy-efficient features.

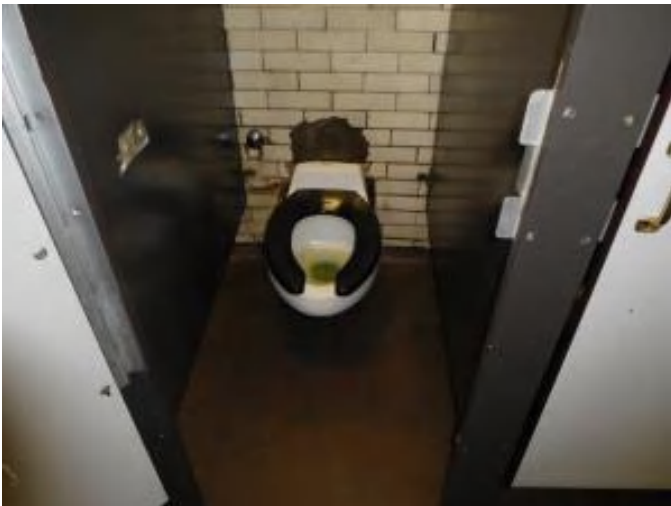
Location: toilet rooms

System: D2010 - Plumbing Fixtures

Distress: Beyond Service Life

Notes: Replace older plumbing fixtures, including water closets, lavatories, urinals, service sinks, and water coolers. Include fittings and trim.

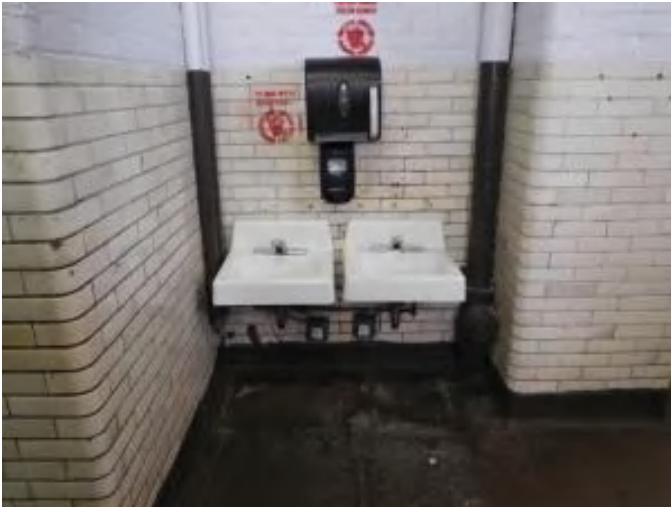
Location: toilet rooms

System: D2010 - Plumbing Fixtures

Distress: Beyond Service Life

Notes: Replace older plumbing fixtures, including water closets, lavatories, urinals, service sinks, and water coolers. Include fittings and trim.

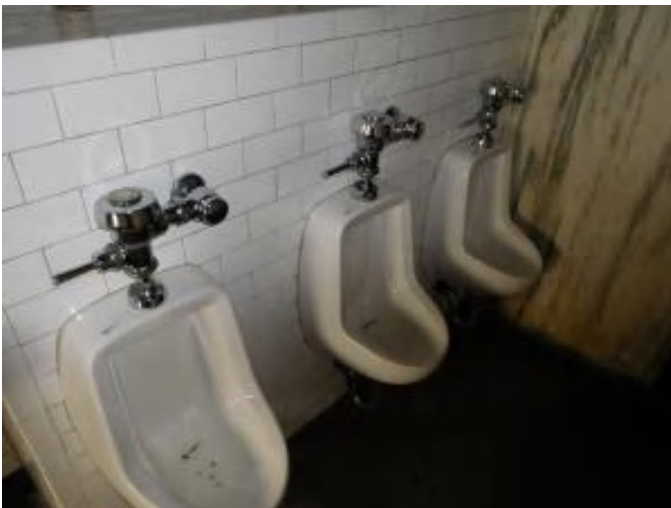
Location: toilet rooms

System: D2010 - Plumbing Fixtures

Distress: Beyond Service Life

Notes: Replace older plumbing fixtures, including water closets, lavatories, urinals, service sinks, and water coolers. Include fittings and trim.

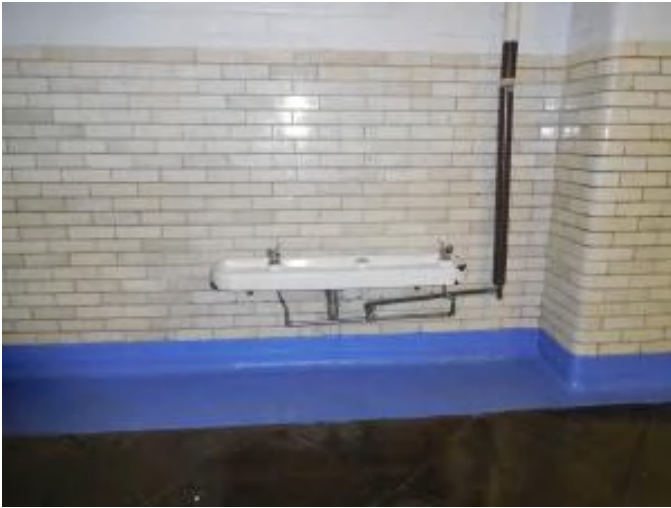
Location: corridors

System: D2010 - Plumbing Fixtures

Distress: Beyond Service Life

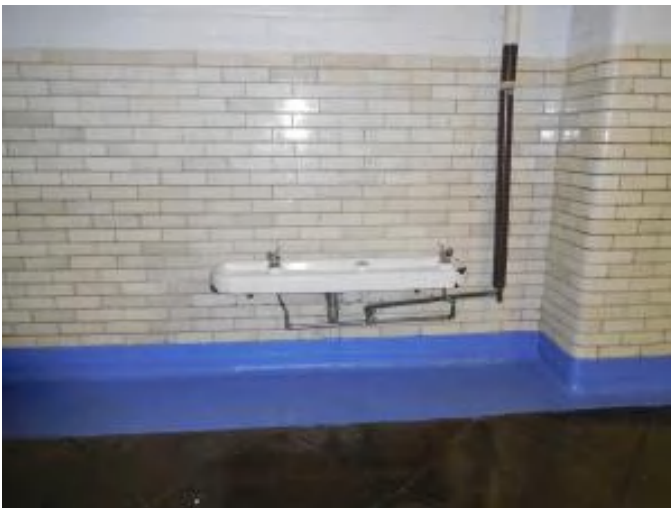
Location: entire building

System: D2020 - Domestic Water Distribution

Distress: Beyond Service Life

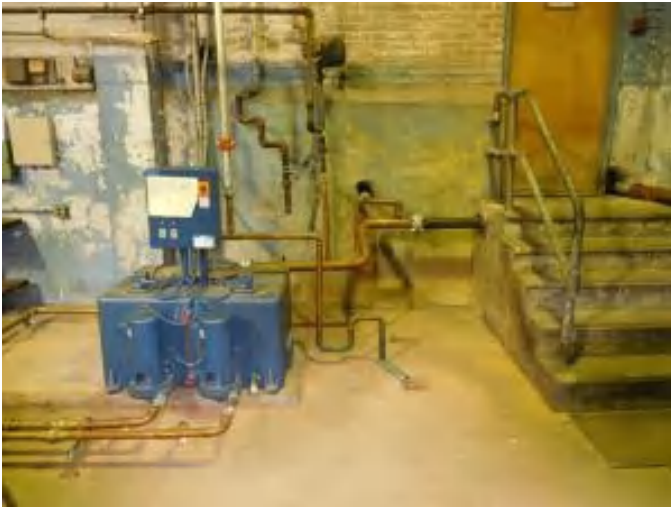
Location: roof, mechanical room

System: D3030 - Cooling Generating Systems

Distress: Inadequate

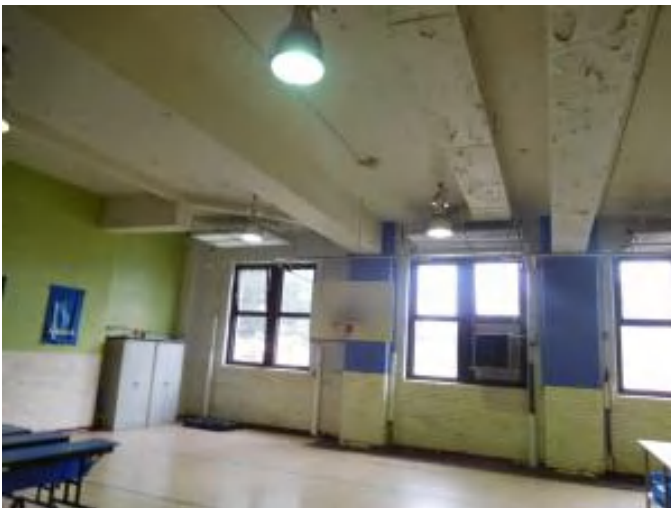
Location: cafeteria

System: D3040 - Distribution Systems

Distress: Building / MEP Codes

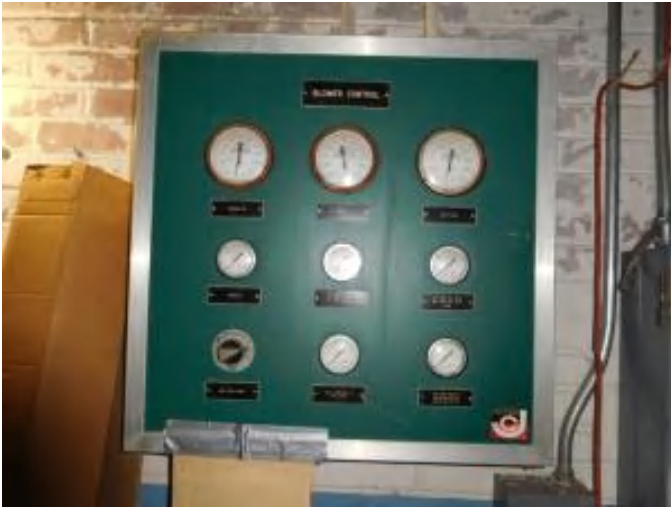
Location: entire building

System: D3060 - Controls & Instrumentation

Distress: Inadequate

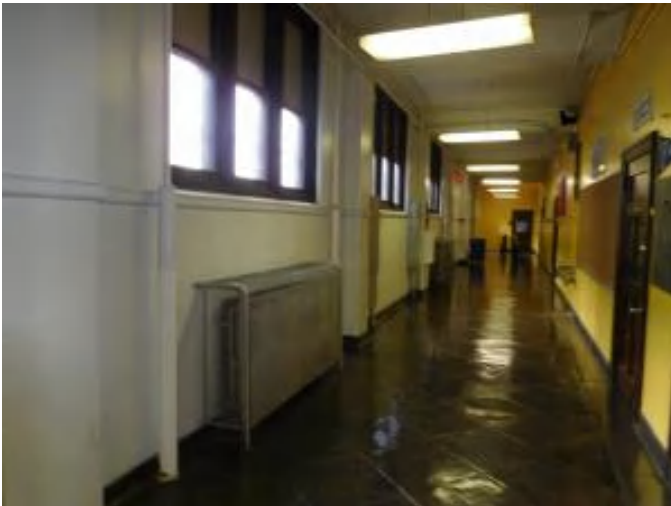
Location: entire building

System: D4010 - Sprinklers

Distress: Life Safety / NFPA / PFD

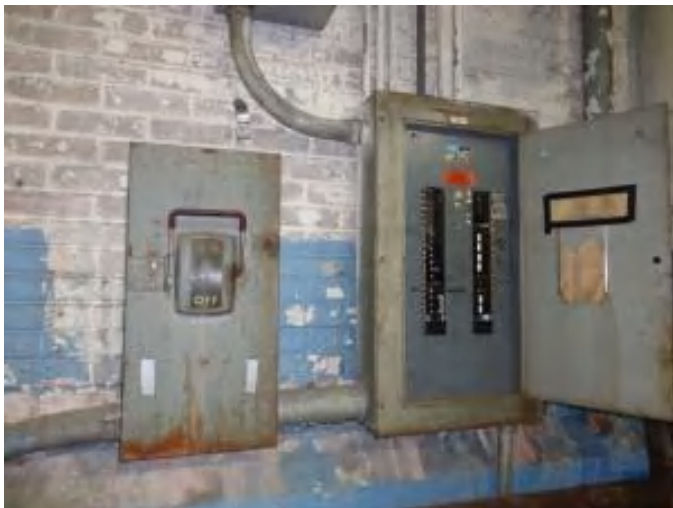
Location: Corridors -all floors

System: D5010 - Electrical Service/Distribution

Distress: Beyond Service Life

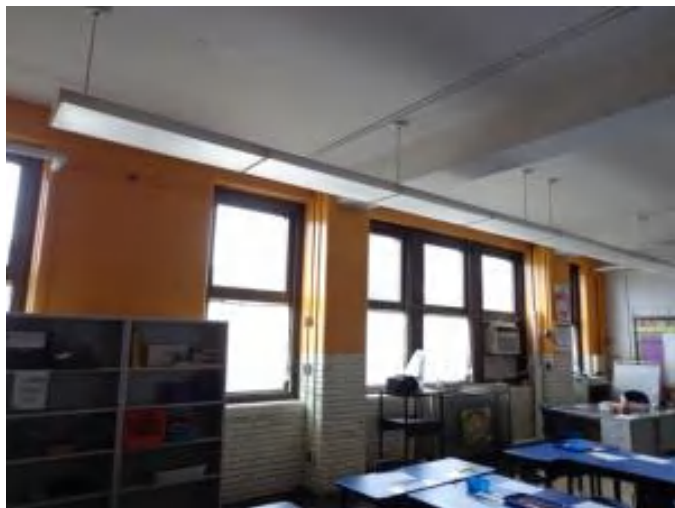
Location: Entire Building

System: D5020 - Lighting and Branch Wiring

Distress: Beyond Service Life

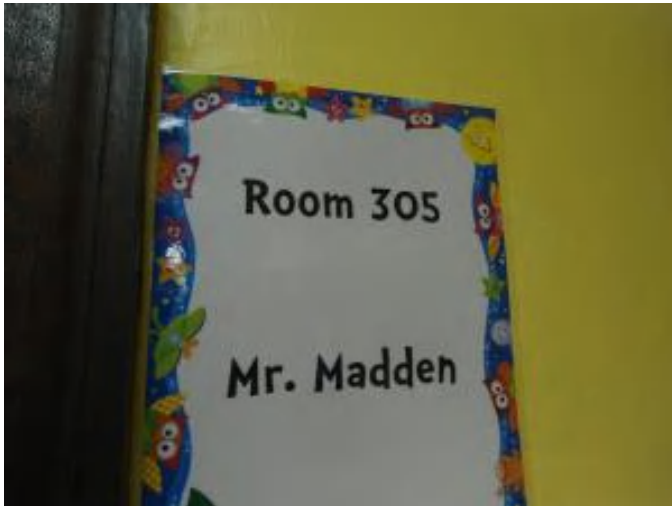
Location: Building Wide Signage

System: C1030 - Fittings

Distress: Accessibility

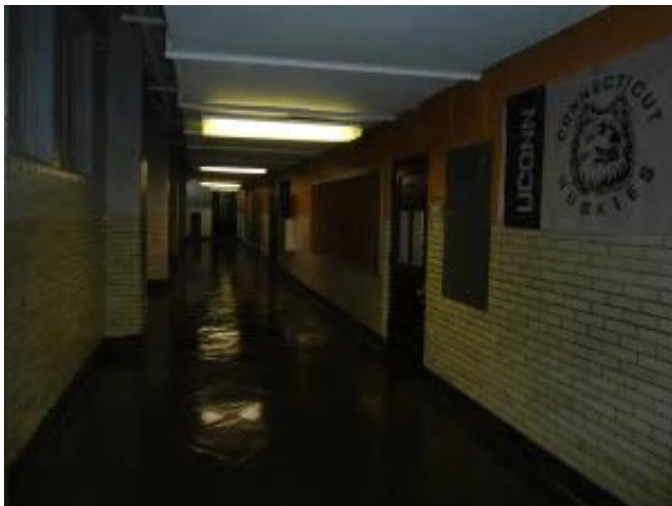
Location: Building Wide

System: C1030 - Fittings

Distress: Beyond Service Life

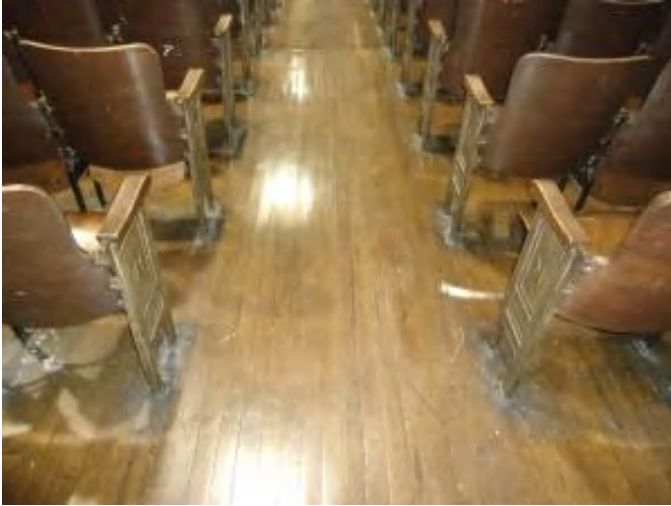
Location: Classrooms Auditorium

System: C3020414 - Wood Flooring

Distress: Beyond Service Life

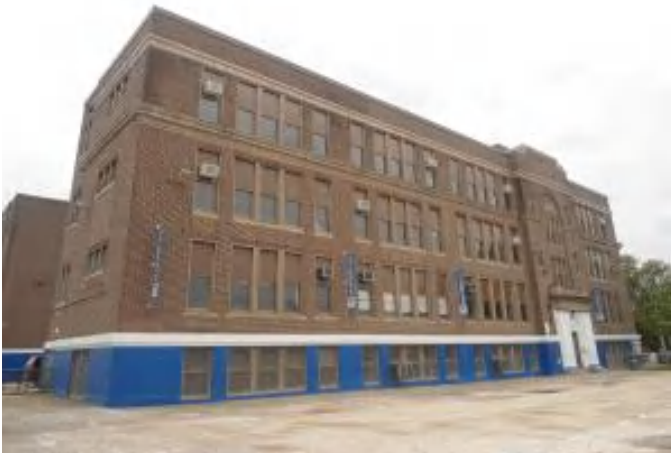
Location: New Elevator Intall

System: D1010 - Elevators and Lifts

Distress: Accessibility

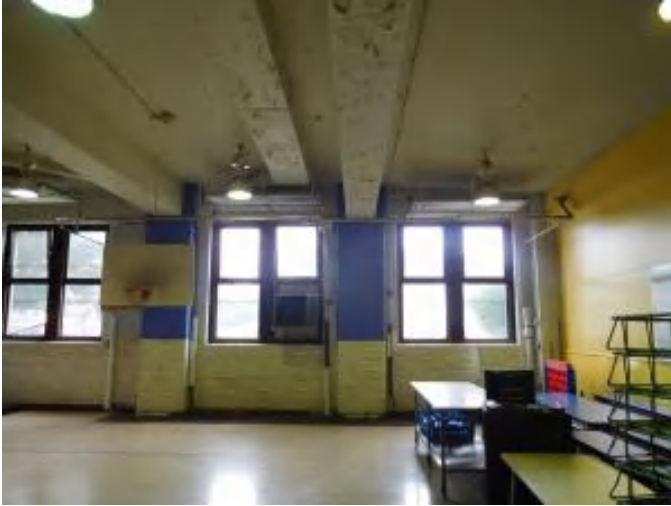
Location: gymnasium

System: D3040 - Distribution Systems

Distress: Building / MEP Codes

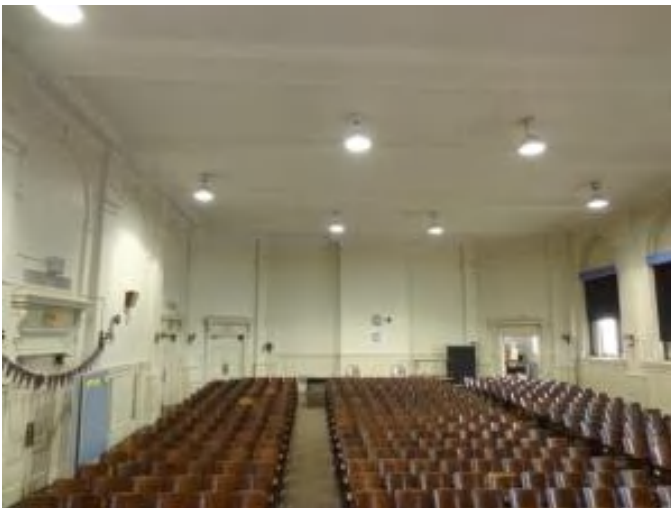
Location: Auditorium

System: D5020 - Lighting and Branch Wiring

Distress: Inadequate

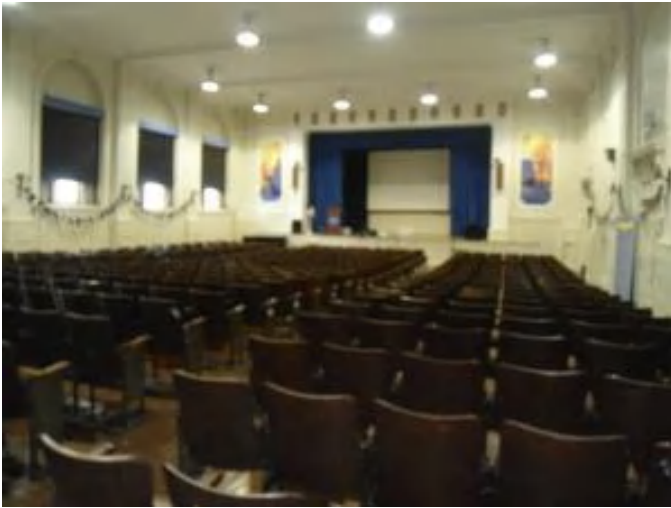
Location: Auditorium

System: E2010 - Fixed Furnishings

Distress: Beyond Service Life

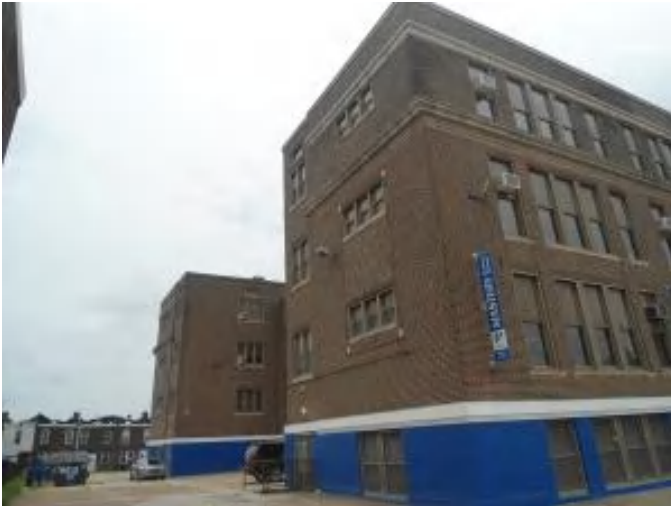
Location: Site

System: G2040 - Site Development

Distress: Health Hazard / Risk

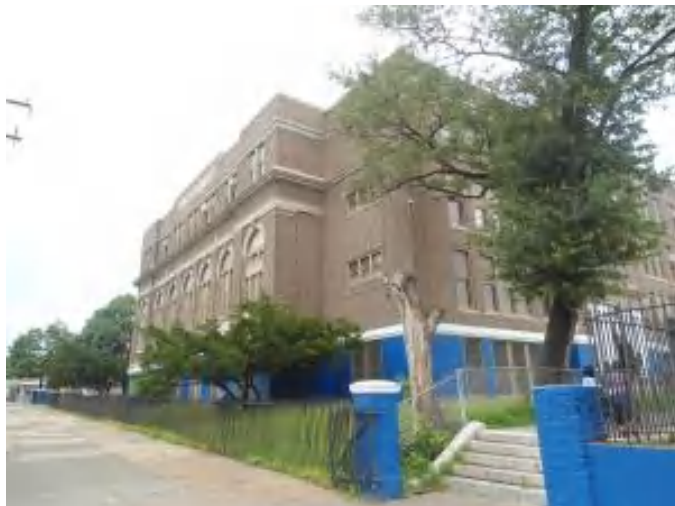
Location: Site

System: G2050 - Landscaping & Irrigation

Distress: Inadequate
