Facility Condition Assessment Summary Report

Marshall, J School

School District of Philadelphia
S736001;Marshall, J
Final
Site Assessment Report
January 31, 2017

Facility Condition Assessment
July 2015

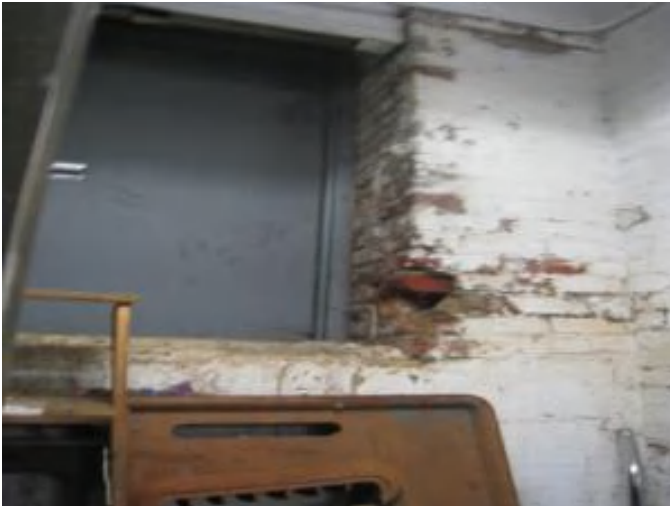
System: B2010 - Exterior Walls

Location: boiler room

Distress: Failing

Notes: Repair cracked brick foundation pier in basement

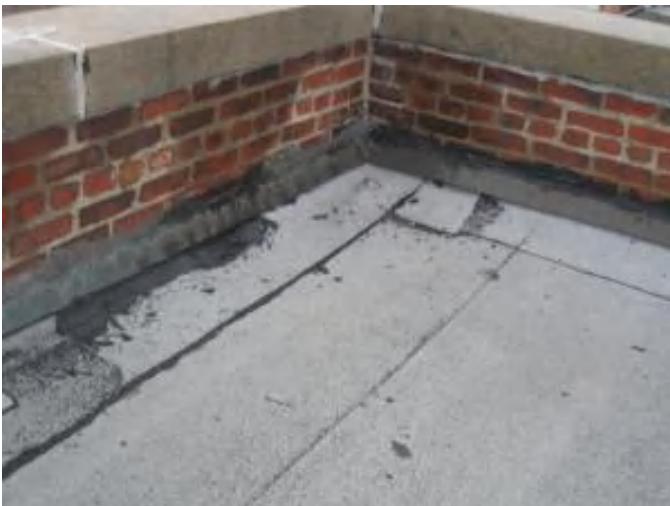
System: B3010105 - Built-Up

Location: roof

Distress: Failing

Notes: Replace flashing and counterflashing of roof

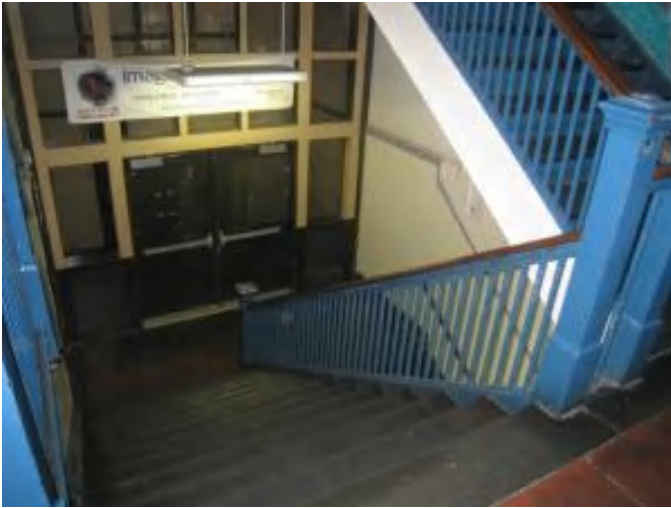
System: C2010 - Stair Construction

Location: all stairways

Distress: Building / MEP Codes

Notes: Remove and replace stairway handrails and guards with code compliant systems wall mounted handrails and center-mounted railings and balustrade

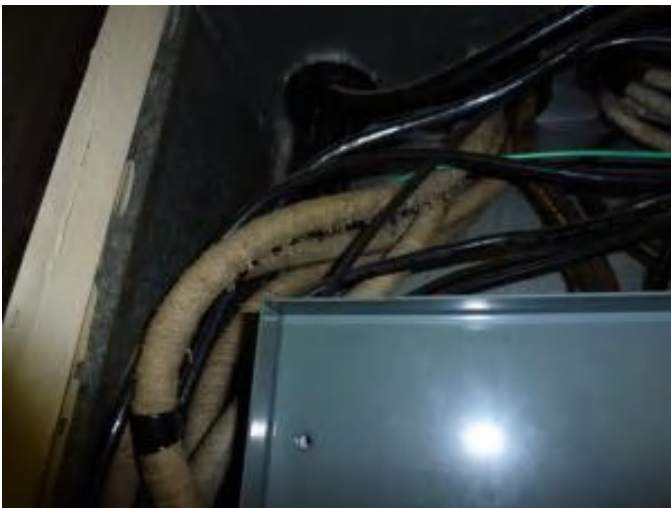
System: D5010 - Electrical Service/Distribution

Location: Entire Building

Distress: Beyond Service Life

Notes: Replace the entire distribution system with new panel boards and new feeders. Provide arc flash label on the all panel boards. Estimated, 1 main distribution and 15 lighting/receptacle panel boards.

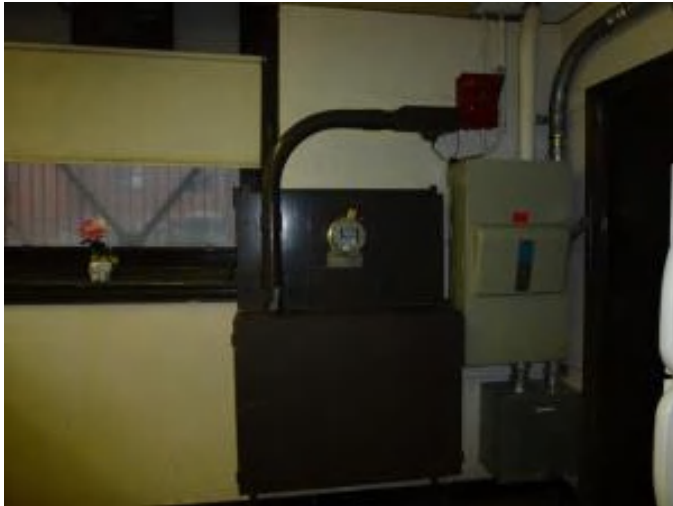
System: D5010 - Electrical Service/Distribution

Location: Teacher Lounge in the basement

Distress: Beyond Service Life

Notes: Upgrade the existing electrical service with a new service. Replace the existing switchboard with new 1600A, 208/120V switchboard.

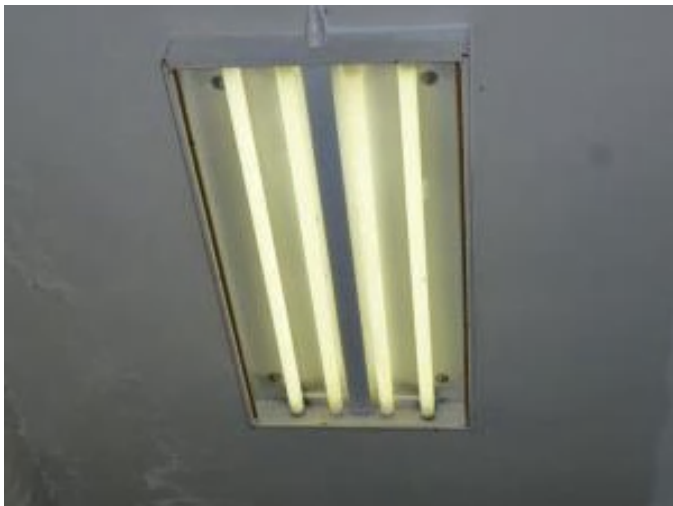
System: D5020 - Lighting and Branch Wiring

Location: Entire Building

Distress: Beyond Service Life

Notes: Replace all lighting fixtures with new fluorescent lighting fixtures with T-5 lamp.

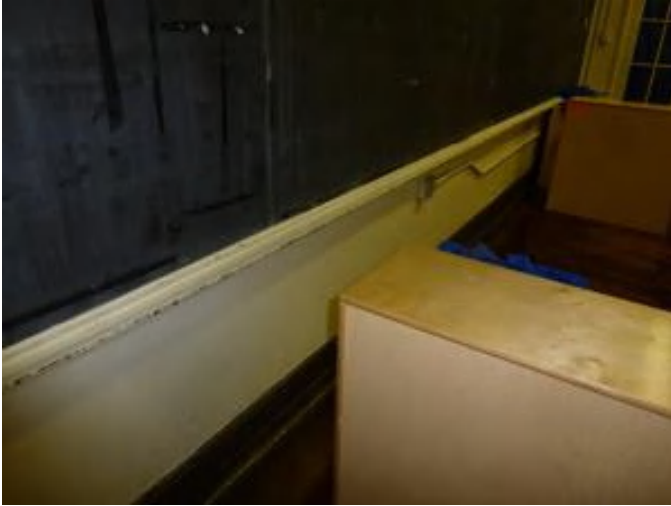
System: D5020 - Lighting and Branch Wiring

Location: Entire Building

Distress: Inadequate

Notes: Install minimum two receptacles in each wall of class rooms and sufficient number of receptacles in other areas per NEC. We recommend adding a two-compartment surface mounted raceway, for data power, for the computer lab room.

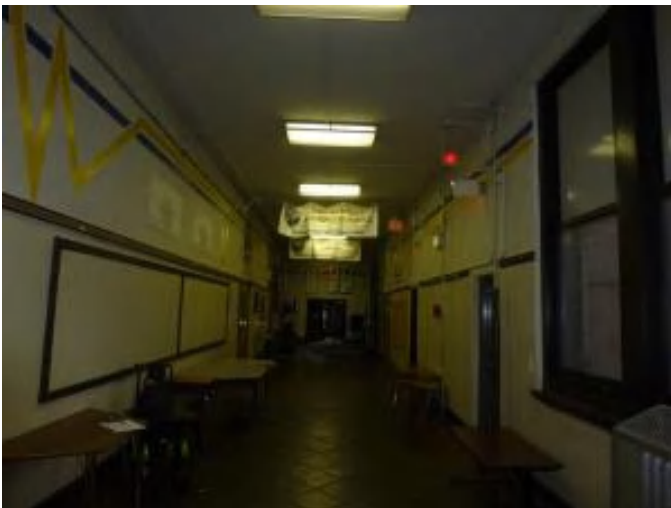
System: D5020 - Lighting and Branch Wiring

Location: Corridooes

Distress: Life Safety / NFPA / PFD

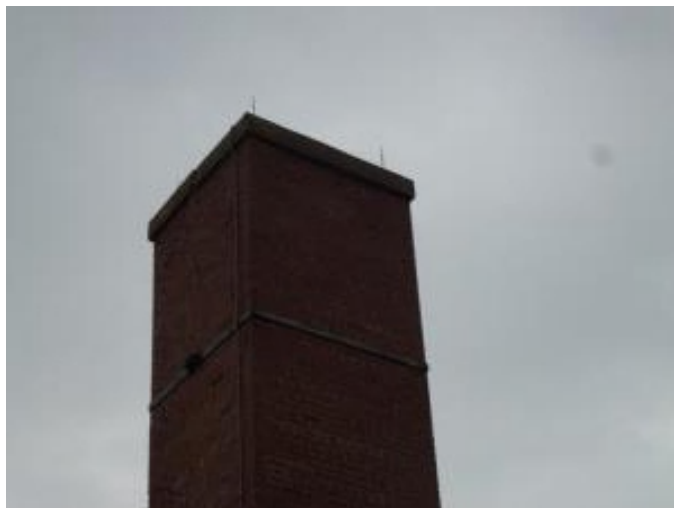
System: D5090 - Other Electrical Systems

Location: Roof

Distress: Health Hazard / Risk

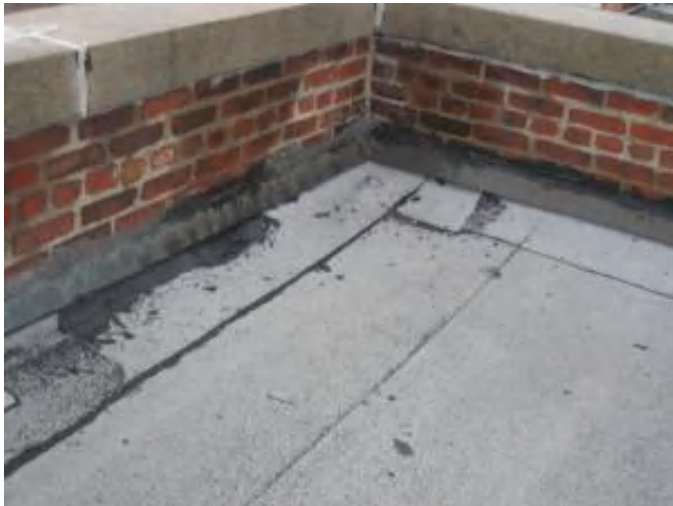
System: B2010 - Exterior Walls

Location: exterior walls

Distress: Failing

Notes: Repoint brick structures and parapets in area of roof

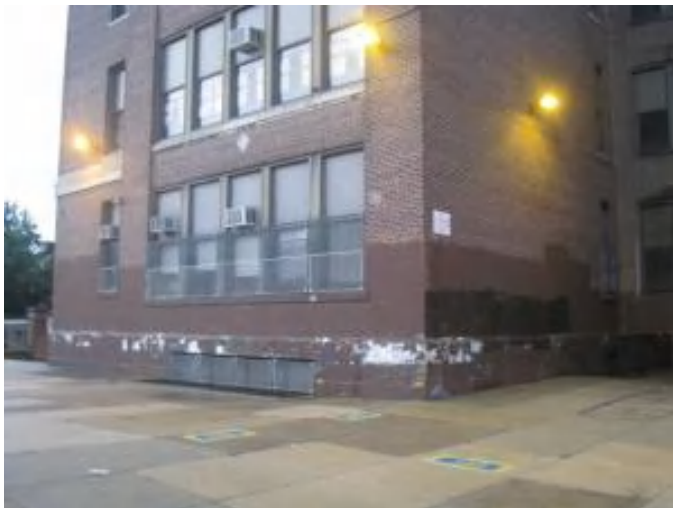
System: B2010 - Exterior Walls

Location: exterior walls

Distress: Appearance

Notes: Repaint exposed above-ground foundation facing playground/parking area

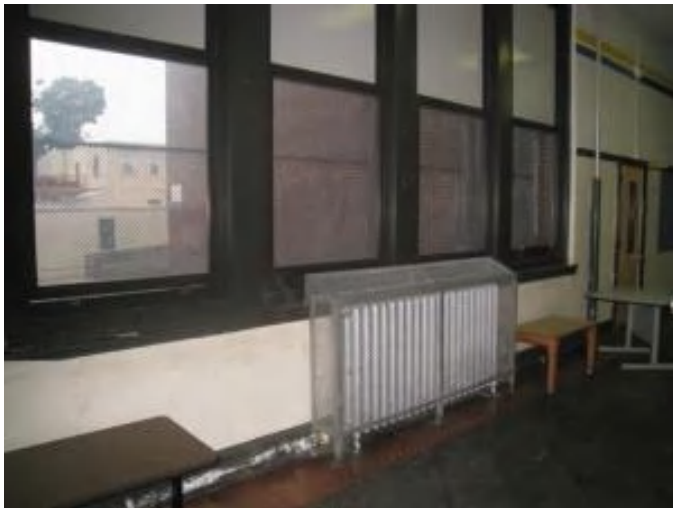
System: B2020 - Exterior Windows

Location: windows

Distress: Beyond Service Life

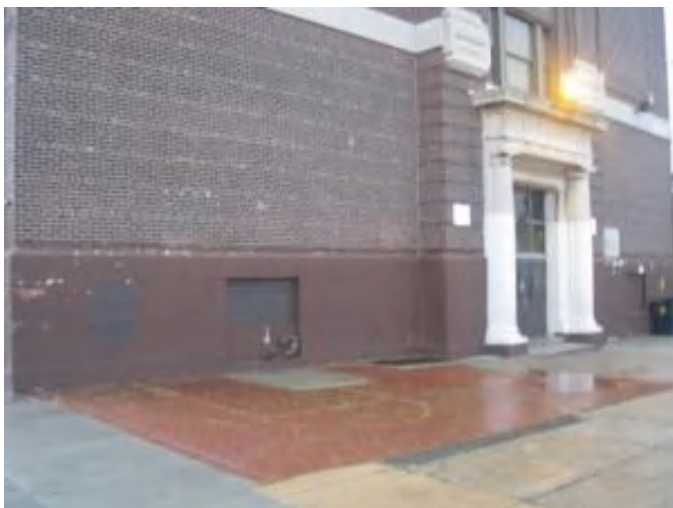
System: B2030 - Exterior Doors

Location: exterior doors

Distress: Damaged

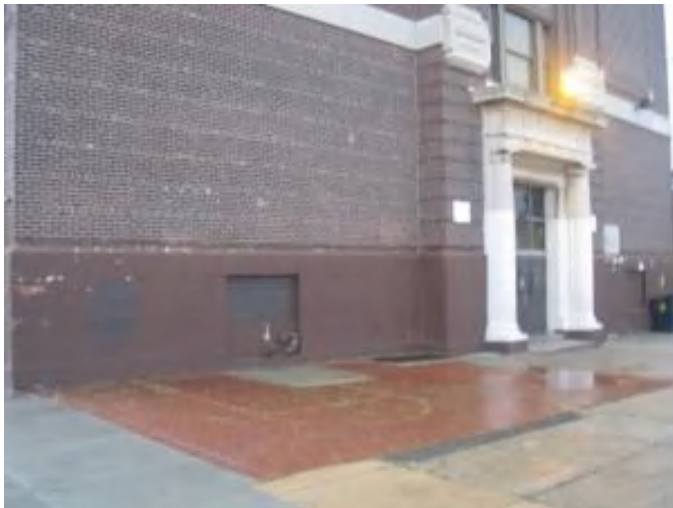
System: B2030 - Exterior Doors

Location: exterior doors

Distress: Failing

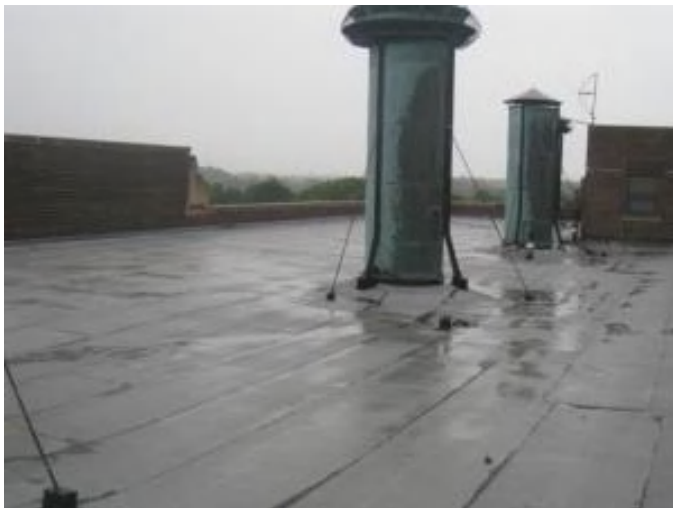
System: B3010105 - Built-Up

Location: roof

Distress: Failing

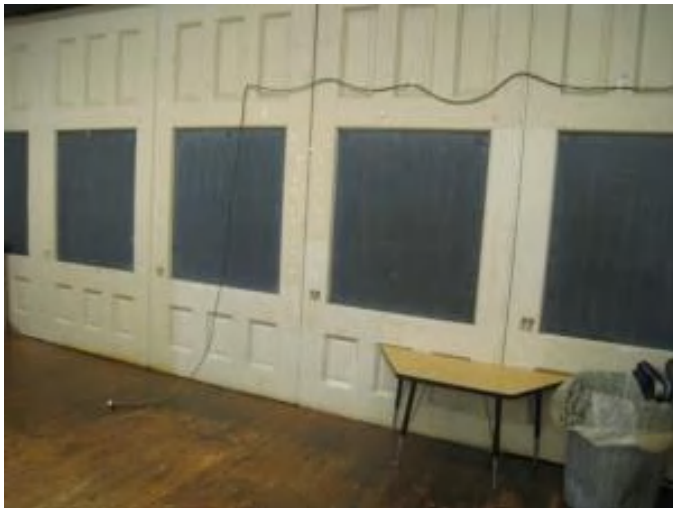
System: C1010 - Partitions

Location: classrooms

Distress: Damaged

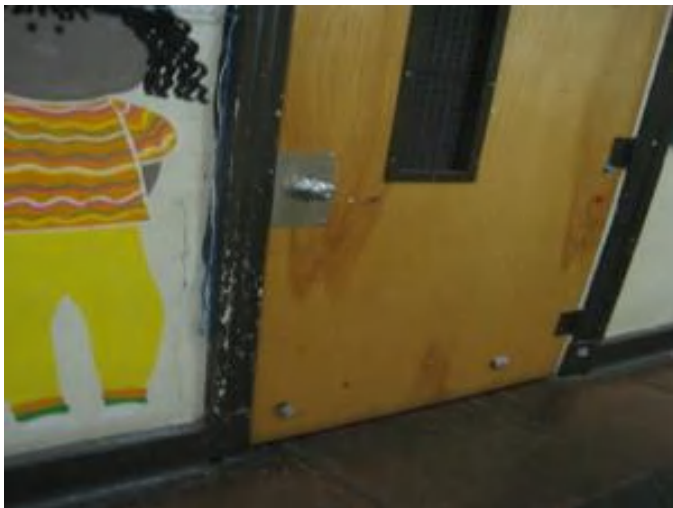
System: C1020 - Interior Doors

Location: classrooms, offices, closets

Distress: Failing

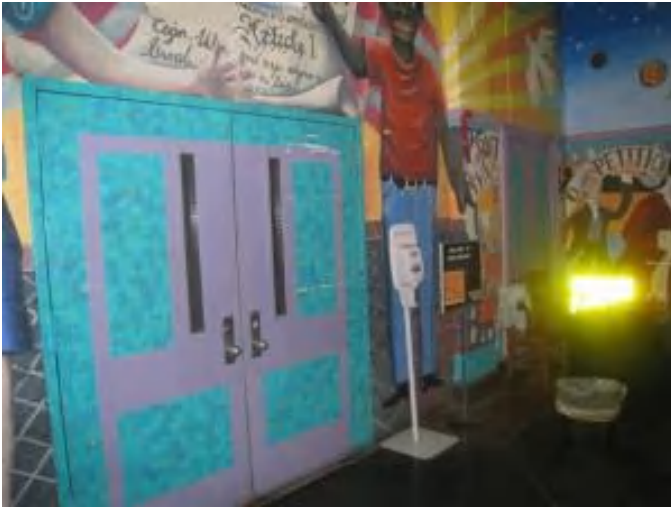
System: C1020 - Interior Doors

Location: mechanical rooms and stairways

Distress: Failing

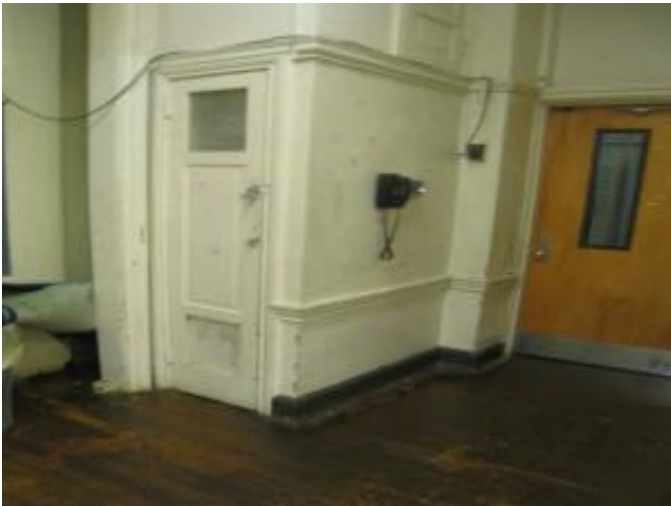
System: C1020 - Interior Doors

Location: classrooms and offices

Distress: Security Issue

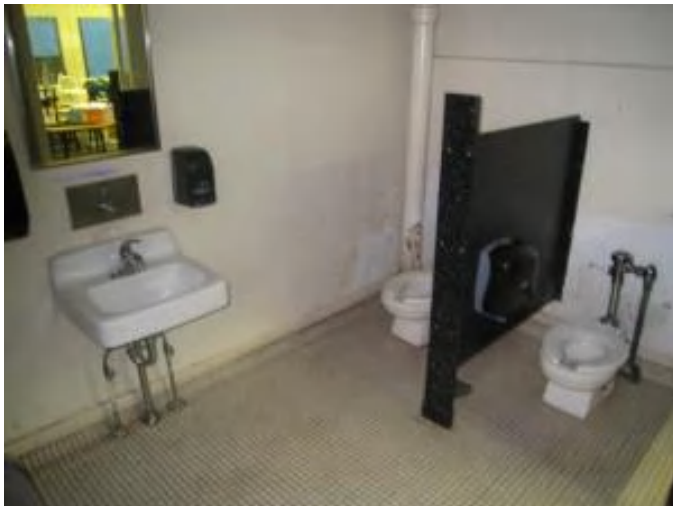
System: C1030 - Fittings

Location: toilet rooms

Distress: Damaged

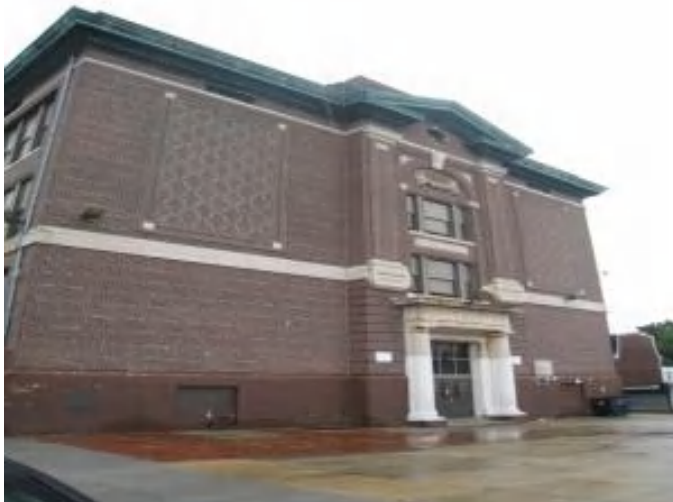
System: C2010 - Stair Construction

Location: exterior stairs

Distress: Failing

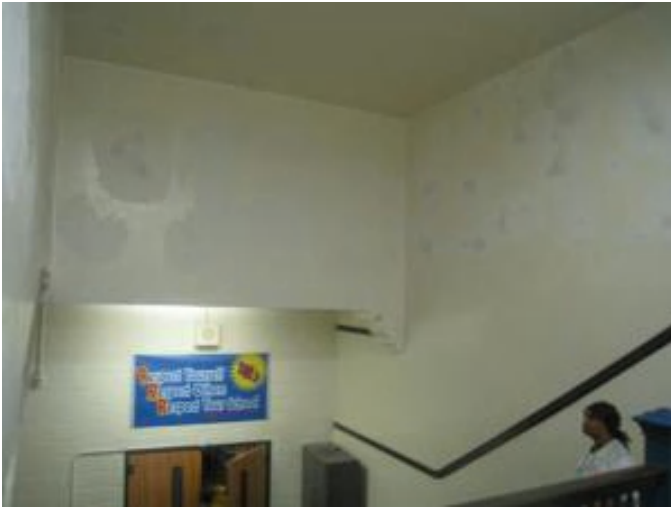
System: C3010230 - Paint & Covering

Location: entire building

Distress: Appearance

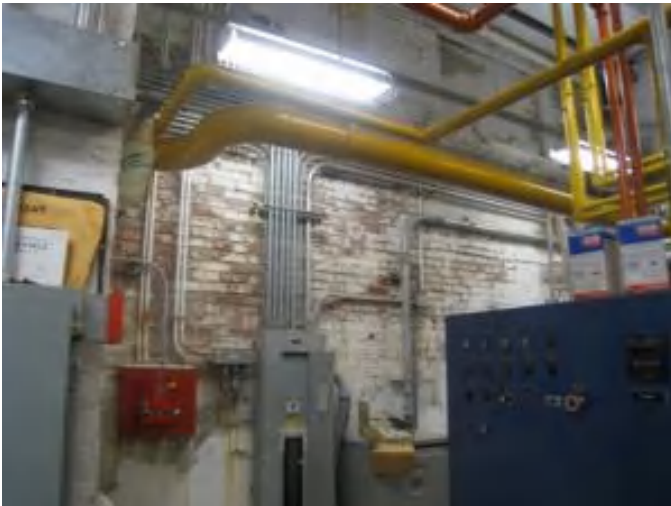
System: C3010230 - Paint & Covering

Location: mechanical rooms

Distress: Appearance

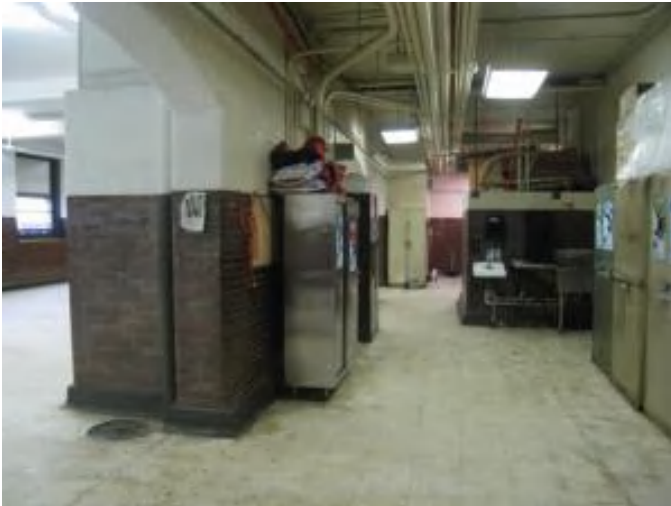
System: C3020413 - Vinyl Flooring

Location: classrooms and offices

Distress: Damaged

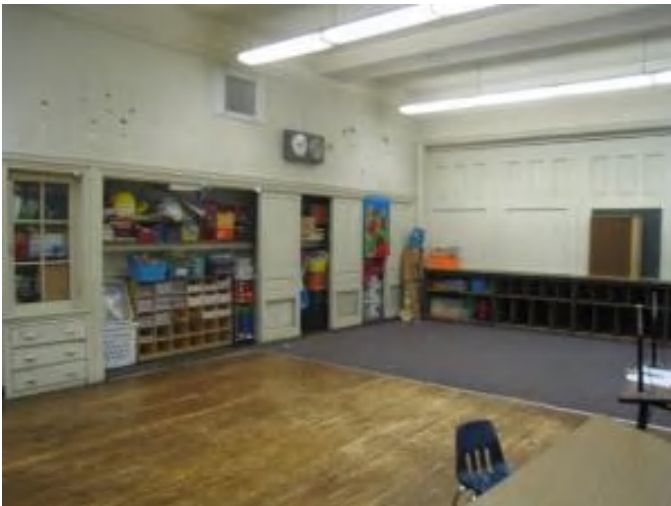
System: C3020414 - Wood Flooring

Location: classrooms and auditorium

Distress: Maintenance Required

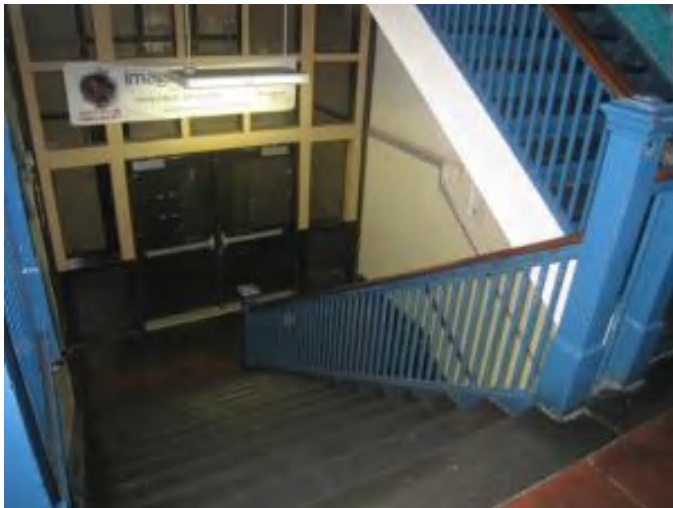
System: C3020415 - Concrete Floor Finishes

Location: mechanical rooms, basement and corridors

Notes: Strip and refinish concrete

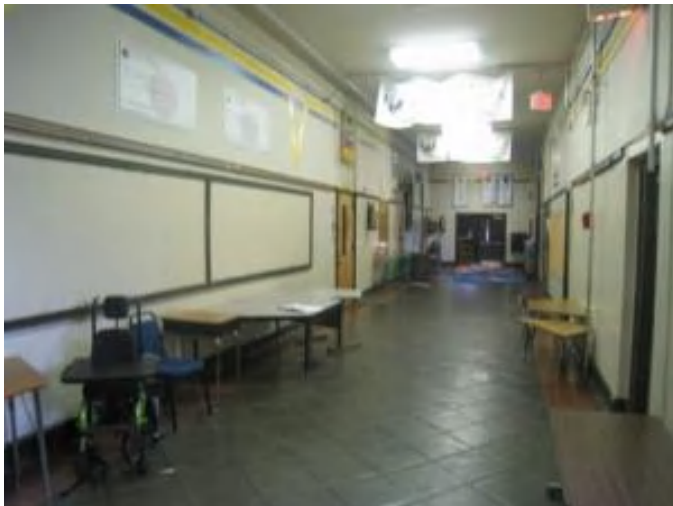
System: C3020415 - Concrete Floor Finishes

Location: corridors and stairways

Notes: Clean and reseal concrete floors in hallways and stairways

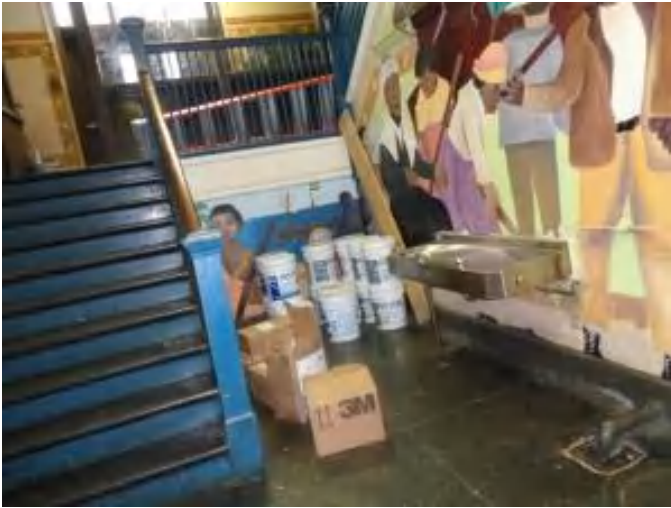
System: D2010 - Plumbing Fixtures

Location: corridors

Distress: Beyond Service Life

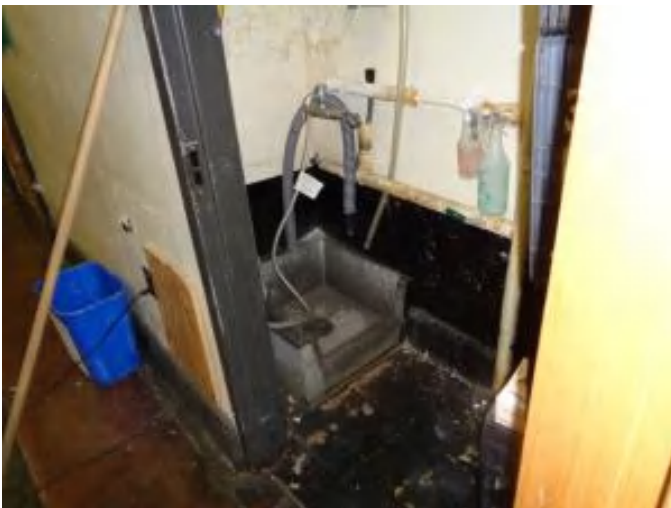
System: D2010 - Plumbing Fixtures

Location: janitor closets

Distress: Beyond Service Life

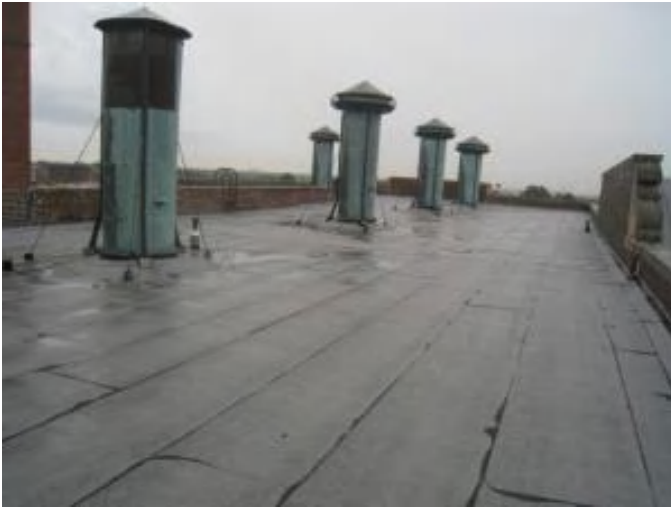
System: D2040 - Rain Water Drainage

Location: roof

Distress: Building / MEP Codes

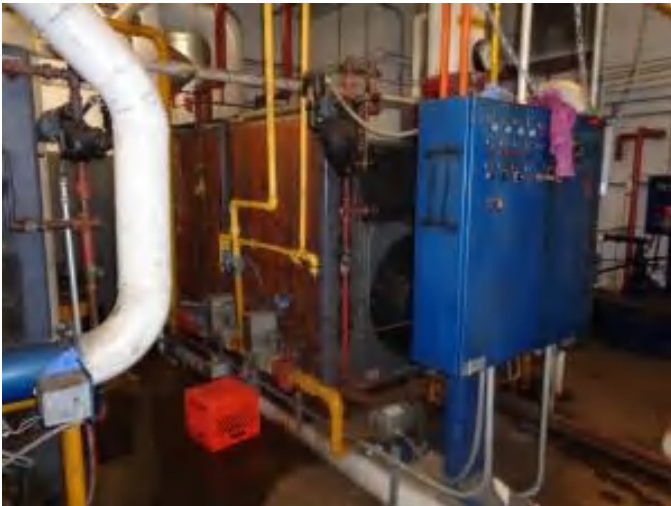
System: D3020 - Heat Generating Systems

Location: boiler room

Distress: Damaged

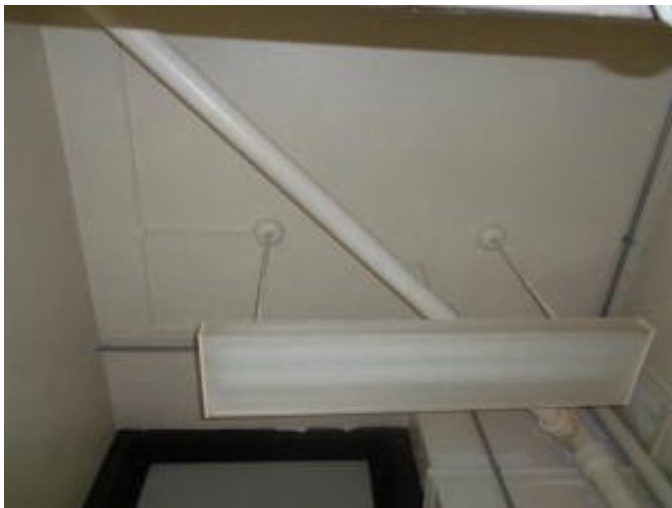
System: D3040 - Distribution Systems

Location: Throughout the building

Distress: Building / MEP Codes

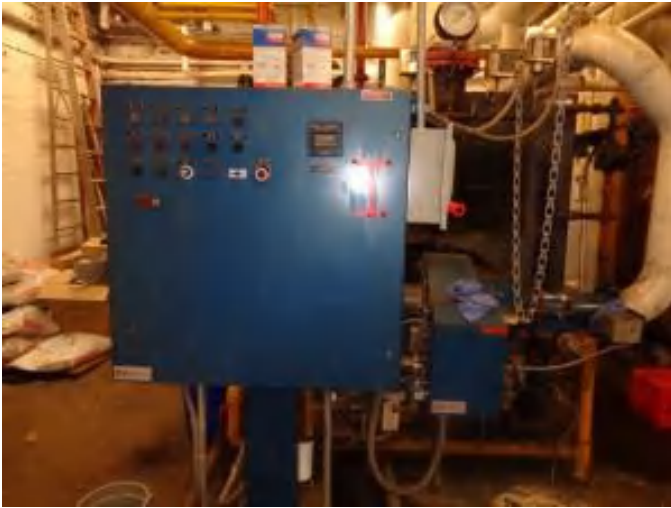
System: D3060 - Controls & Instrumentation

Location: entire building

Distress: Obsolete

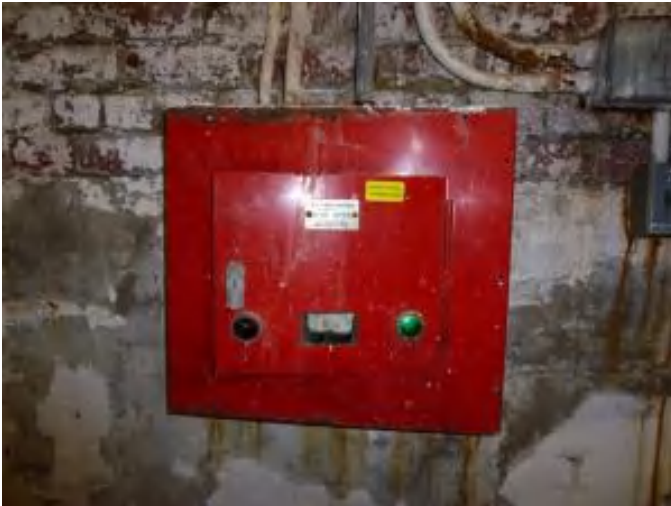
System: D5030 - Communications and Security

Location: Entire Building

Distress: Beyond Service Life

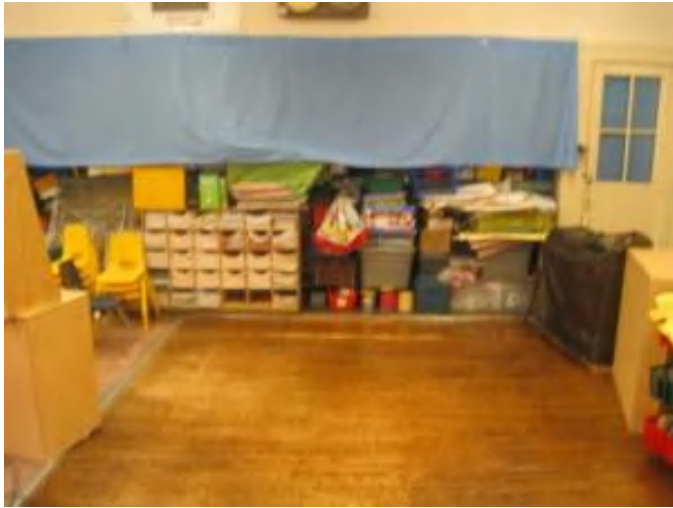
System: E2010 - Fixed Furnishings

Location: classrooms

Distress: Failing

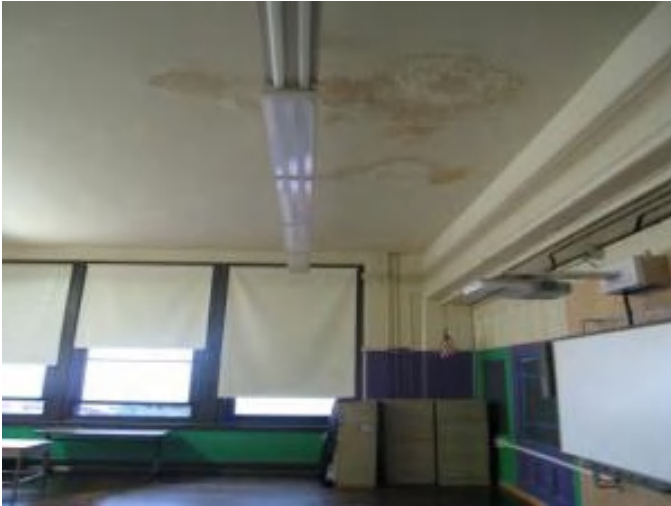
System: C3030 - Ceiling Finishes

Location: entire building

Distress: Appearance

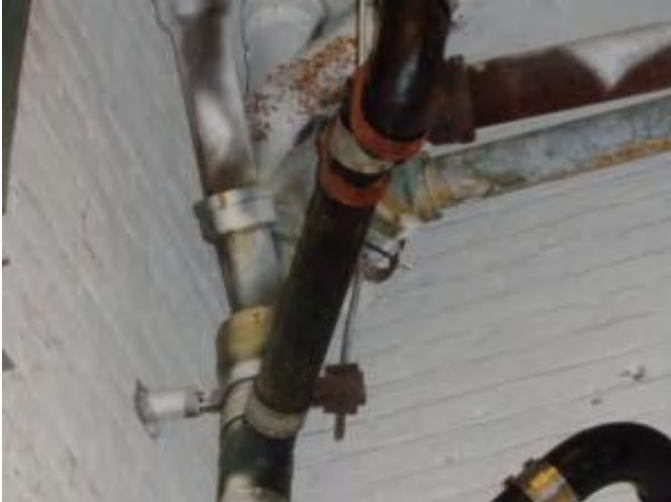
System: D2030 - Sanitary Waste

Location: entire building

Distress: Beyond Service Life

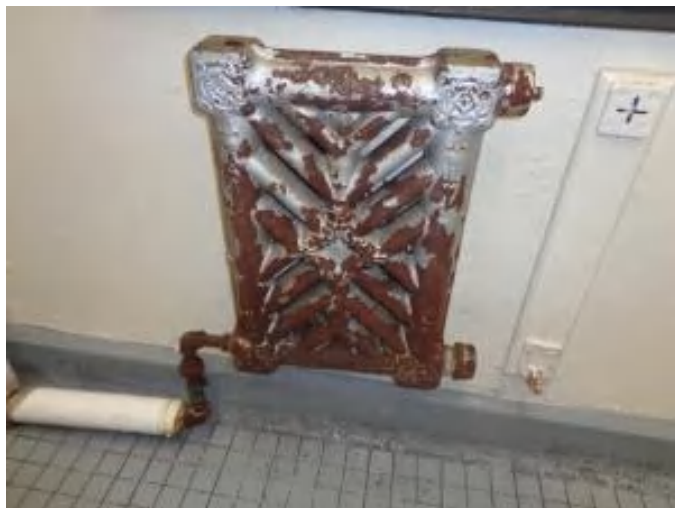
System: D3040 - Distribution Systems

Location: Throughout Building

Distress: Beyond Service Life

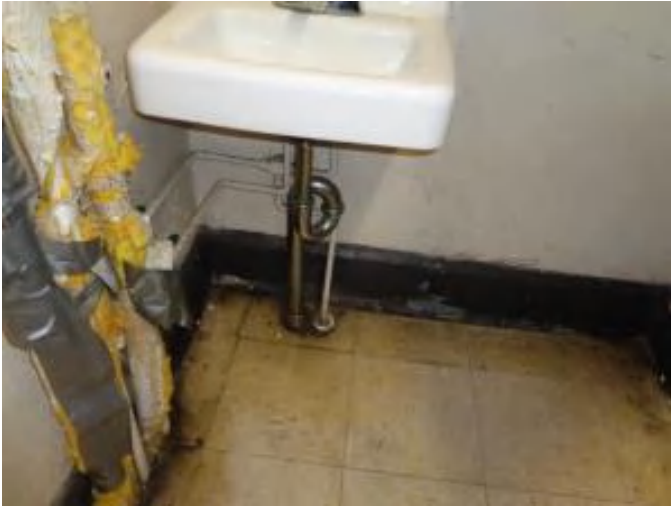
System: D2020 - Domestic Water Distribution

Location: entire building

Distress: Beyond Service Life

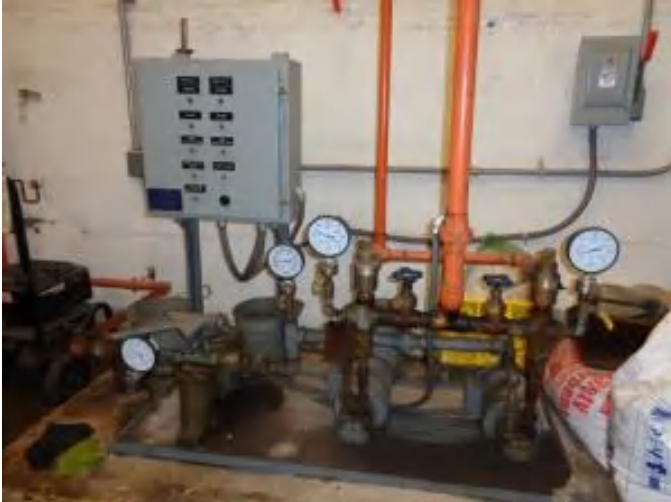
System: D3020 - Heat Generating Systems

Location: Boiler Room

Distress: Beyond Service Life

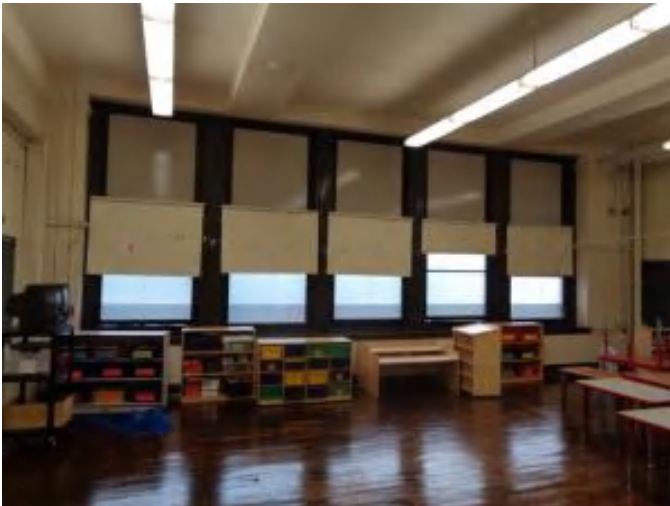
System: D3040 - Distribution Systems

Location: Classrooms

Distress: Inadequate

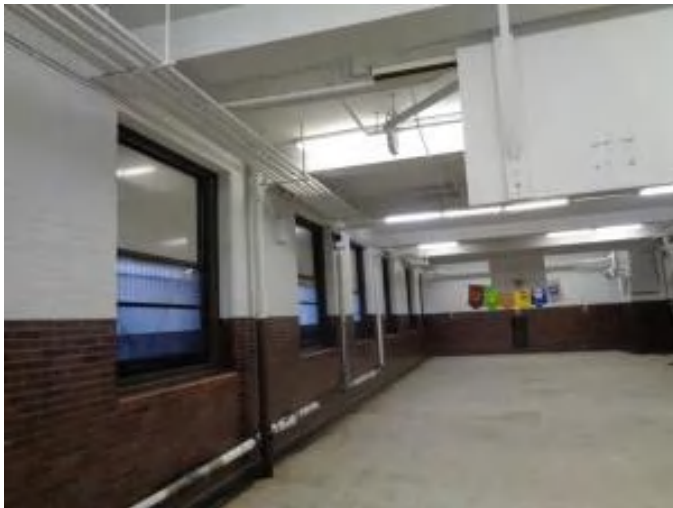
System: D3040 - Distribution Systems

Location: cafeteria

Distress: Beyond Service Life

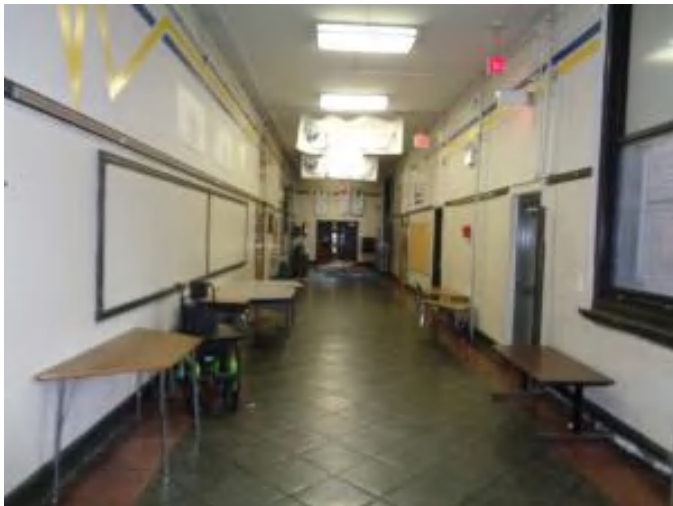
System: D4010 - Sprinklers

Location: entire building

Distress: Life Safety / NFPA / PFD

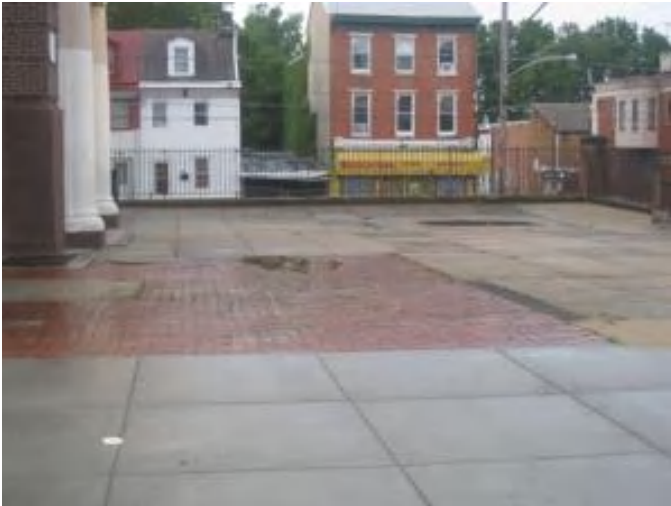
System: G2020 - Parking Lots

Location: play area

Distress: Accessibility

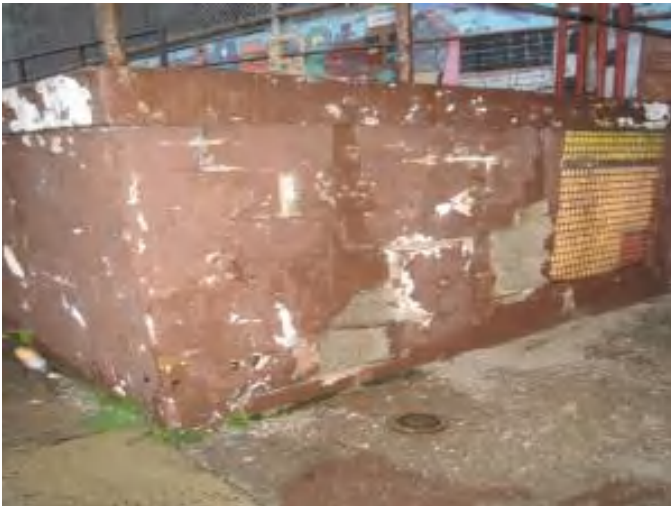
System: G2040 - Site Development

Location: site

Distress: Damaged

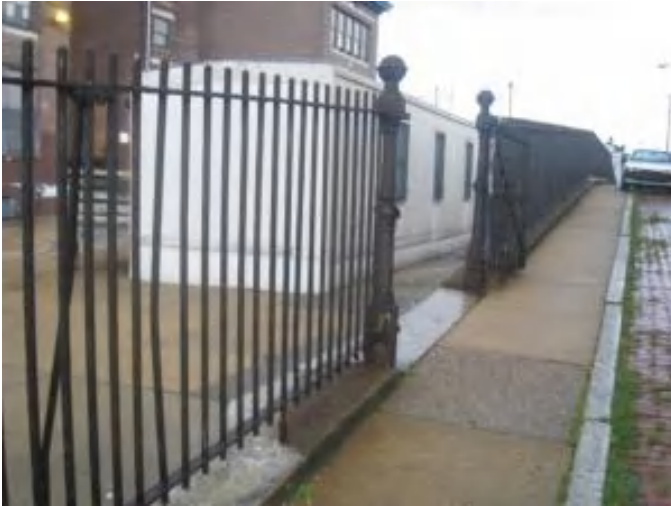
System: G2040 - Site Development

Location: site

Distress: Damaged

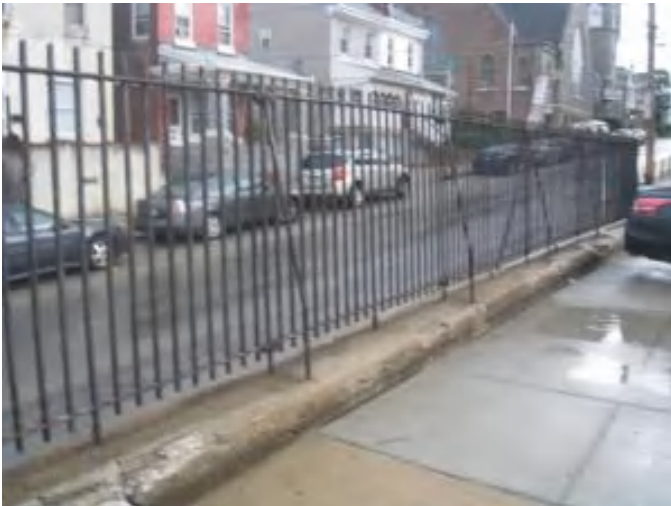
System: G2040 - Site Development

Location: site

Distress: Failing

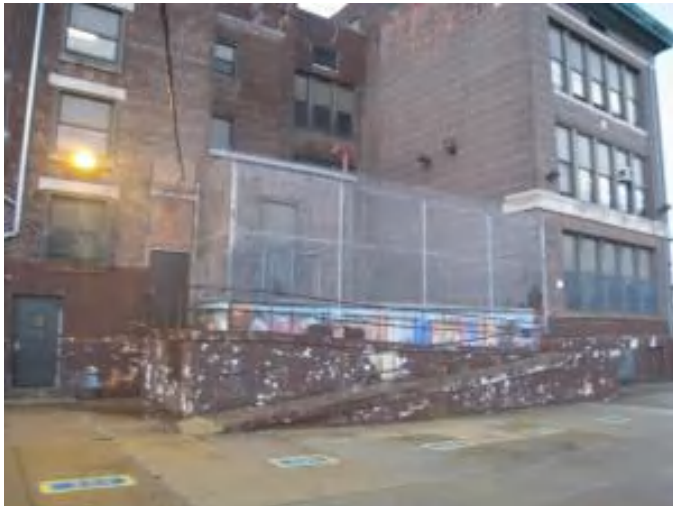
System: G2040 - Site Development

Location: outside play area

Distress: Appearance
