Facility Condition Assessment Summary Report

Marshall, T School

School District of Philadelphia
S550001; Marshall, T
Final
Site Assessment Report
January 31, 2017

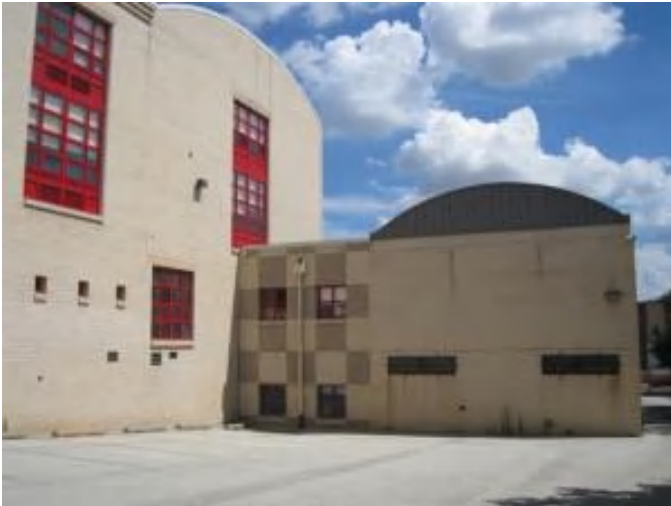
Location: exterior walls

System: B2010 - Exterior Walls

Distress: Failing

Notes: Repair caulk joint where beam flashing terminates above first floor in buff brick walls; repair caulk joints where leaks occur at aluminum tube frame glazing units set into brick (600lf)

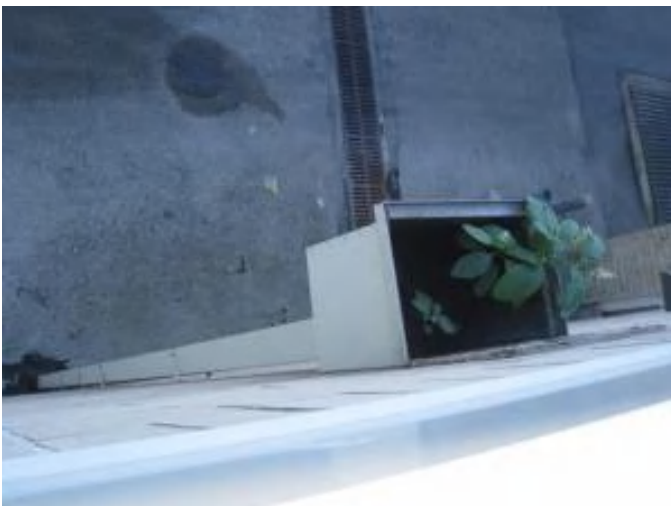
Location: roof

Roof coverings consist of a fully adhered rolled asphalt sheet system, with fine, dark granules embedded in the surface. The roofing membrane covering all flat roofs is almost 20 years old, but is failing in a number of locations. Bubble, cracks, wrinkles and failing asphalt is visible everywhere; some bubbles and wrinkles block drainage to scuppers or roof drains. Leaks are visible inside the building as stained ceiling tiles in a number of locations under each roof. Even though a typical asphalt roof should last for 20 years, this system has already failed even though it has

System: B3010105 - Built-Up

Distress: Failing

been patched in many locations. The asphalt roof should be replaced as soon as possible. Flashing along the perimeter, on skylight curbs, and rooftop equipment curbs consists of the same asphalt membrane material terminated under a clear anodized aluminum fascia or counterflashing. A small parapet is formed approximately 18" in average height. The highest roof over the 4 story element utilizes through-wall scuppers, collection boxes, and vertical leaders to drain roof water to lower roofs where water is collected down internal flat roof drains. The lowest flat roof and the curved roofs utilize through-wall scuppers, collection boxes and horizontal gutters, and vertical leaders down to pipes which connect to the underground storm water system. Except for the 3 clogged scupper boxes at the upper flat roof level (filled with debris and live plants), this system is working as designed, notwithstanding the numerous leaks in the failed membrane. There is a large, multi-panel, curved glass skylight over the lobby. One of the panels in the skylight is cracked and in need of replacement.

Notes: Remove and replace built-up roof, including gravel stop, expansion joint and curbs; clean out scuppers (34,200sf)

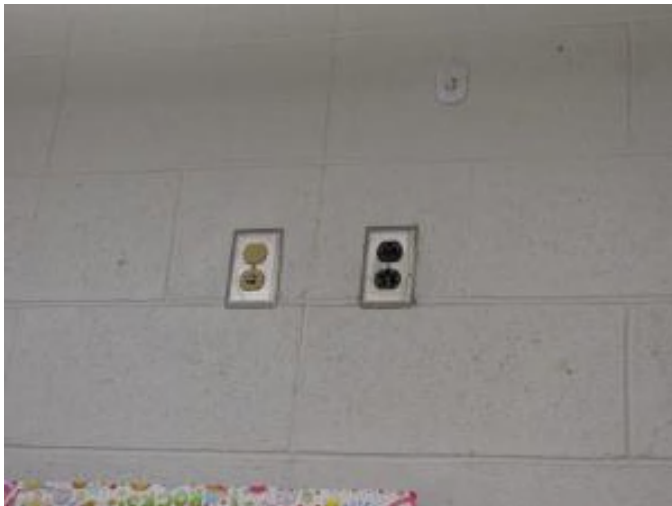
Location: Entire Building

System: D5020 - Lighting and Branch Wiring

Distress: Inadequate

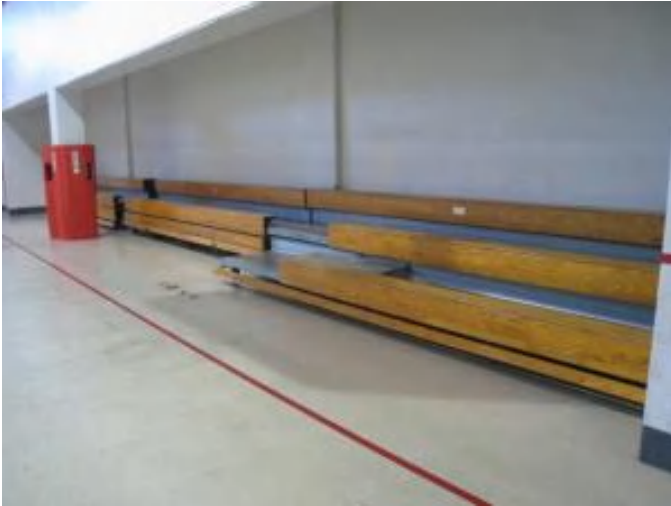
Location: gymnasium pier (soffit support)

Partitions in corridors, classrooms, offices, toilet rooms, gymnasium, auditorium, stairways, cafeteria, and kitchen are constructed of painted block (concrete masonry units), in good physical condition. The 4-story open atrium is separated from connecting corridors and spaces by a fire rated wall with labeled, fire rated doors. The gym has an alcove created for bleacher seating. The block wall above the alcove is supported by heavy steel lintels, bearing on a block pier, which has a horizontal crack in need of structural repair.

System: A2020 - Basement Walls

Distress: Failing

Notes: Repair structural pier supporting wall over alcove in gym. (50sf)

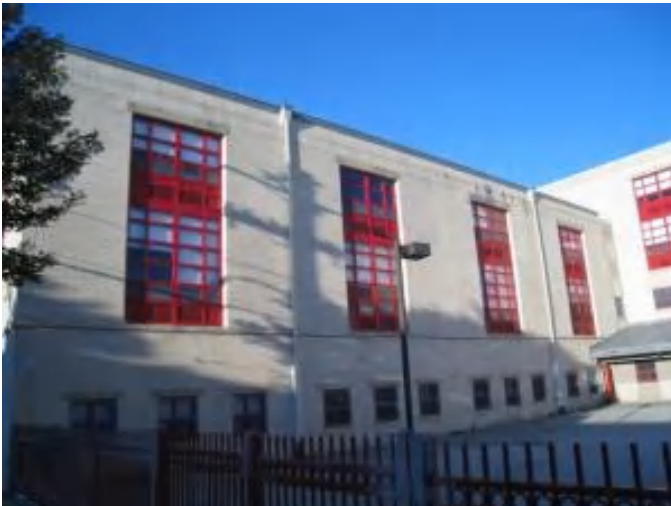
Location: exterior walls

System: B2010 - Exterior Walls

Distress: Appearance

Notes: Power wash brick behind and around scuppers and vertical leaders; wash other stained areas around louvers and under coping. (10,000sf)

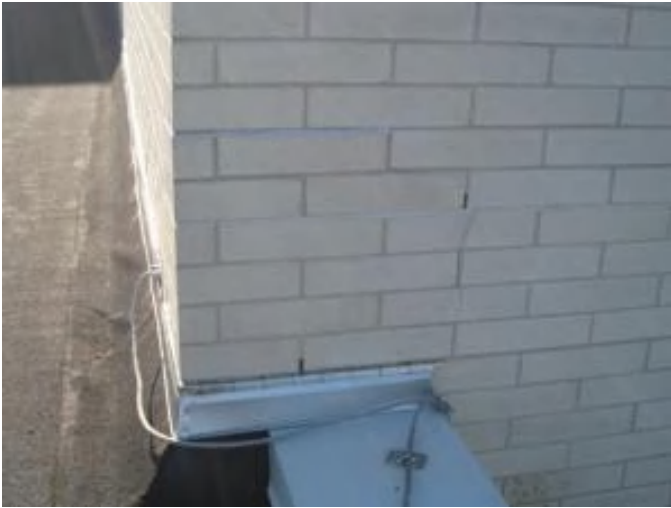
Location: exterior walls

System: B2010 - Exterior Walls

Distress: Failing

Notes: Repair cracked bricks (100sf)

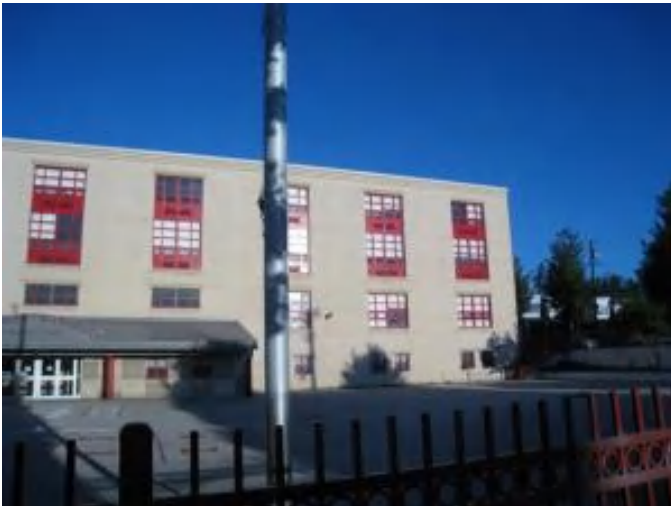
Location: entrance canopies - steel beams

System: B2010 - Exterior Walls

Distress: Failing

Notes: Repaint rusted steel beams supporting metal roof canopies over main and secondary entrances (300sf)

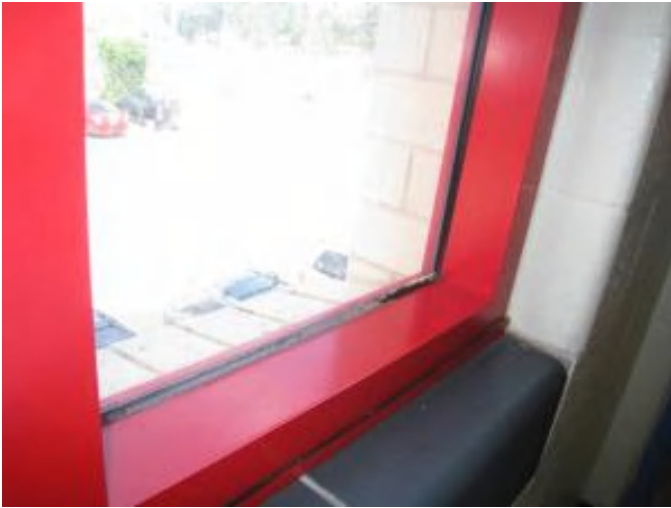
Location: exterior window system

System: B2020 - Exterior Windows

Distress: Building Envelope Integrity

Notes: Replace all faded single sheet plexiglass lites with insulated glass lites in modified-to-fit existing aluminum tube frame system (65 - 4'x4'; 70 - 4'x8' equivalent in 8 sections with one operable unit)

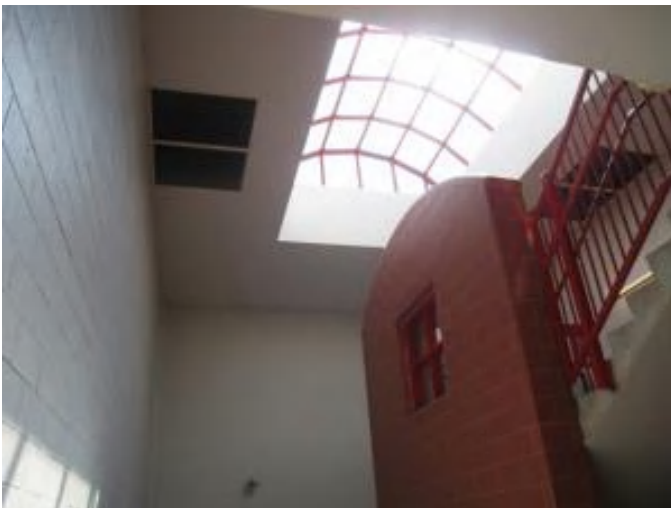
Location: lobby skylight

System: B2020 - Exterior Windows

Distress: Damaged

Notes: Repair broken glass in lobby skylight (10sf)

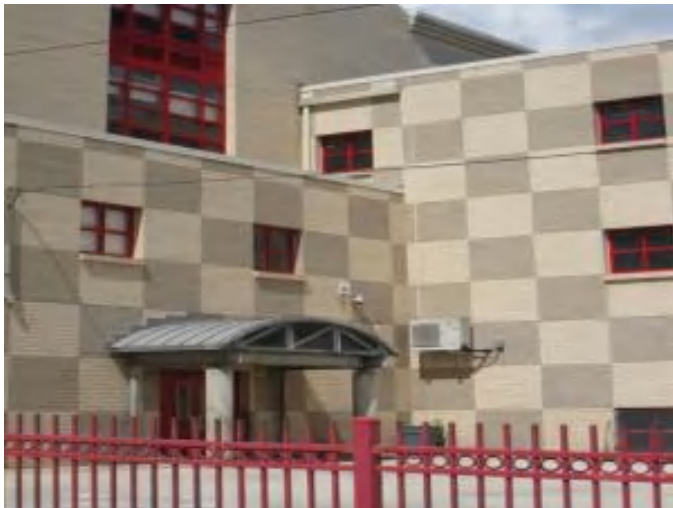
Location: exterior exit doors

Exterior doors are field painted hollow metal steel doors and frame units, some with narrow lite vision panels with security grating. The paint on most doors and frames is scratched, worn, and in poor condition with rust forming on some door frames and door panels. Doors and frames should be repainted to minimize further rusting and deterioration. Exit hardware and door closers are generally working but need adjustment to ensure good operation. Building entrance doors are tempered glass with clear anodized aluminum frames, in good condition.

System: B2030 - Exterior Doors

Distress: Appearance

Notes: Repaint all grade exit exterior doors and frames. (16 – 3'x7')

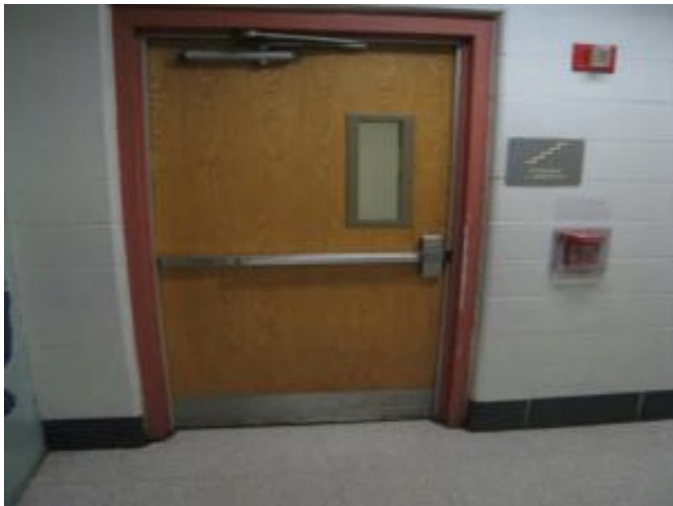
Location: interior wood doors

System: C1020 - Interior Doors

Distress: Appearance

Notes: Refinish all corridor and stair and toilet room solid core wood interior doors. Refinish/repaint steel frames. (60) 3'x7' doors

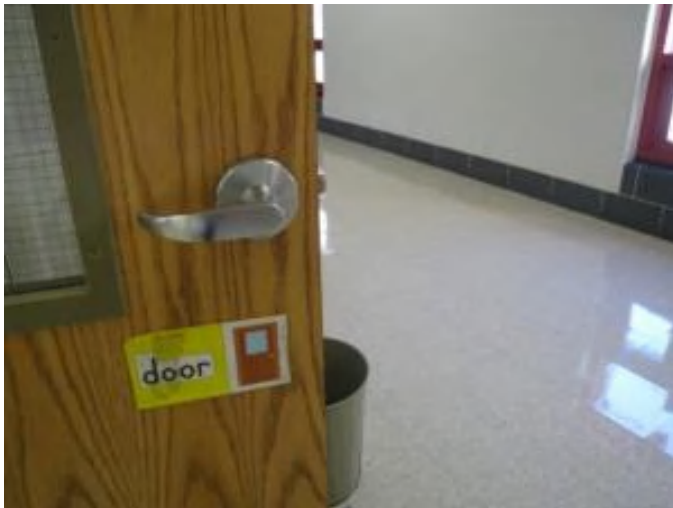
Location: classrooms, offices

System: C1020 - Interior Doors

Distress: Security Issue

Notes: Provide security hardware for classrooms and offices locking from inside of room (90 each)

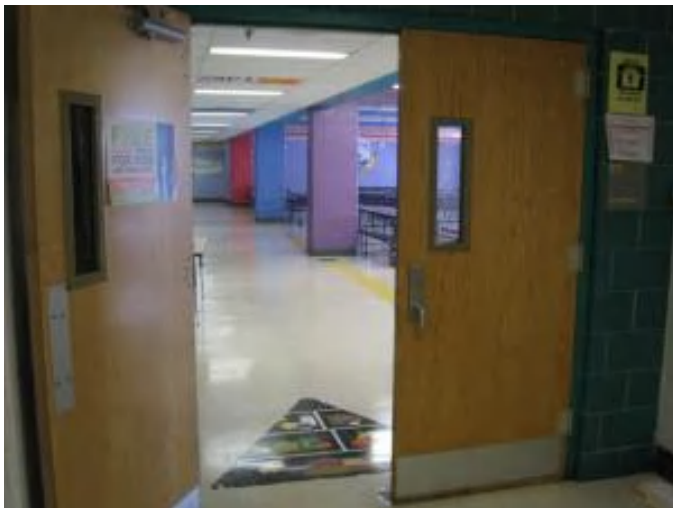
Location: interior door frames

System: C1020 - Interior Doors

Distress: Appearance

Notes: Refinish/repaint steel frames (for wood doors). (60) 3'x7' doors

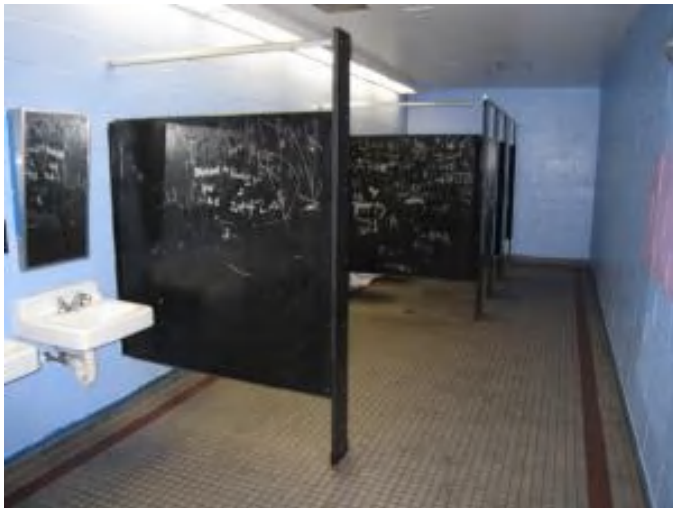
Location: toilet room

System: C1030 - Fittings

Distress: Damaged

Notes: Replace plastic toilet room stall partitions, damaged by vandalism (4 stalls)

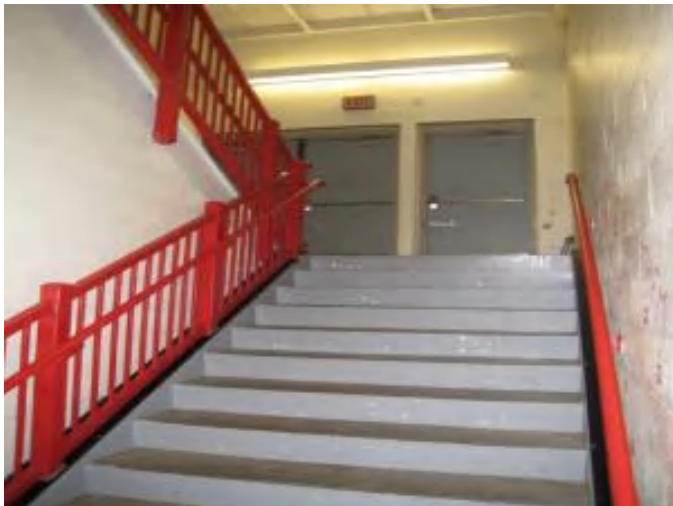
Location: stairways

System: C2010 - Stair Construction

Distress: Appearance

Notes: Repaint railings and balustrades in interior stairways (900sf)

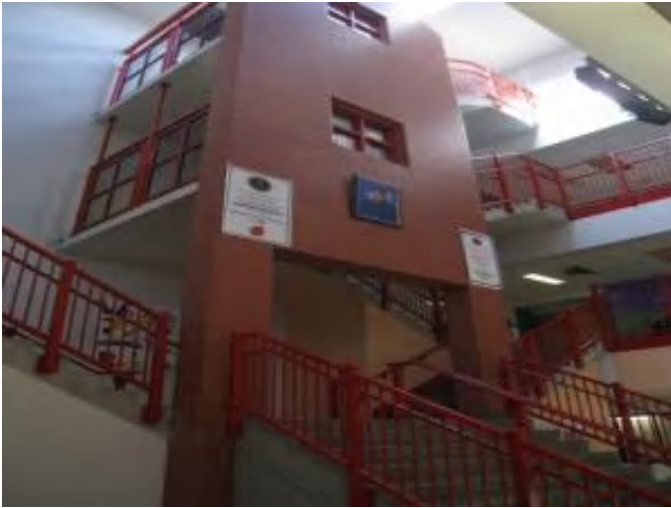
Location: stairways

System: C2010 - Stair Construction

Distress: Appearance

Notes: Repaint railings and balustrades in interior stairways (600 lf)

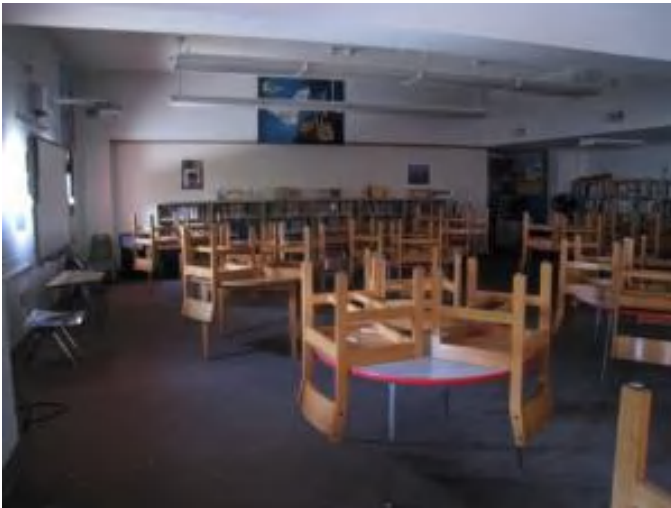
Location: classrooms, IMC, auditorium aisles

System: C3020411 - Carpet

Distress: Damaged

Notes: Replace carpet in classrooms, IMC, auditorium aisles (8,000 sf)

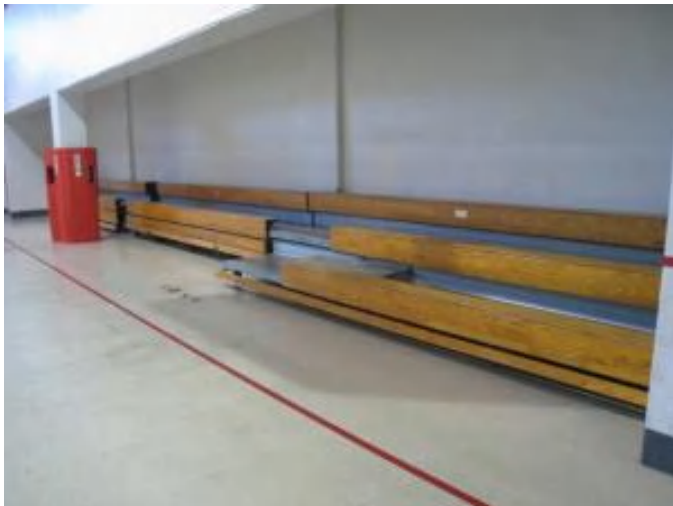
Location: gym floor

System: C3020415 - Concrete Floor Finishes

Distress: Failing

Notes: Replace gym floor – high build coating system (9,300 sf)

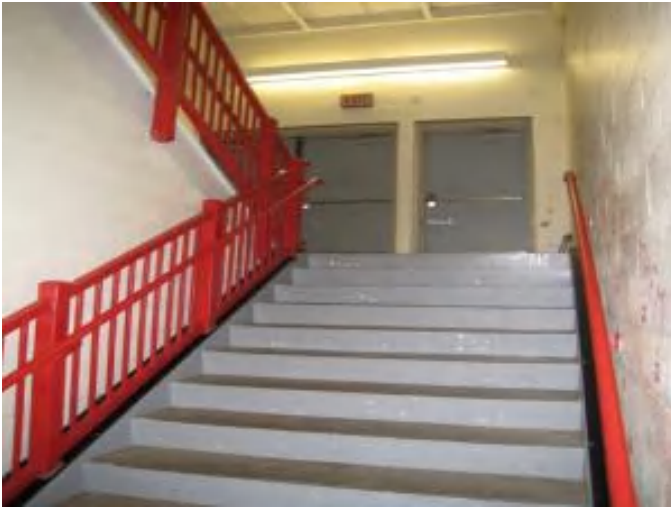
Location: stair treads

System: C3020415 - Concrete Floor Finishes

Distress: Appearance

Notes: Reseal/paint concrete stair treads and risers in building (3500sf treads and risers)

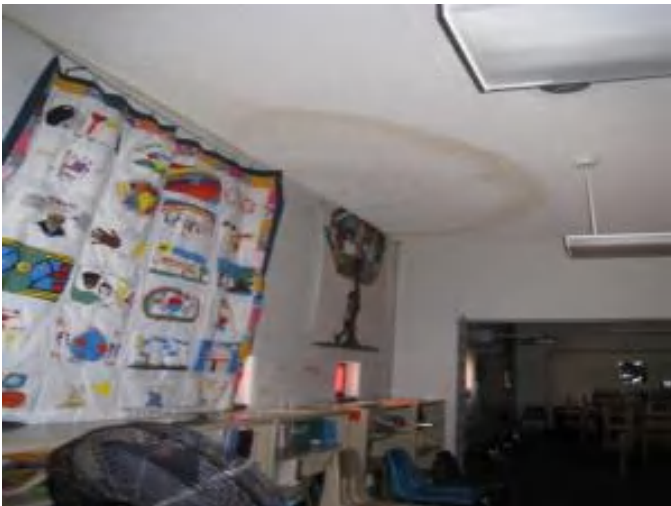
Location: ceilings

System: C3030 - Ceiling Finishes

Distress: Damaged

Notes: Replace damaged or stained acoustical tile ceilings in all corridors and some classrooms with new suspended acoustical tile ceiling system (5,000sf)

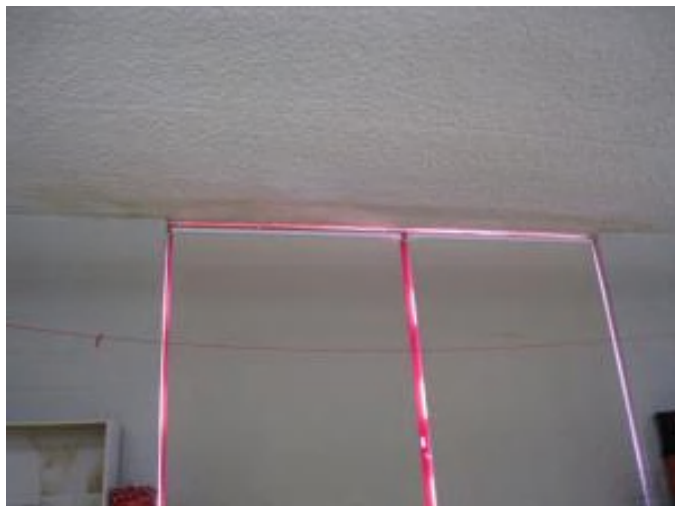
Location: ceilings

System: C3030 - Ceiling Finishes

Distress: Damaged

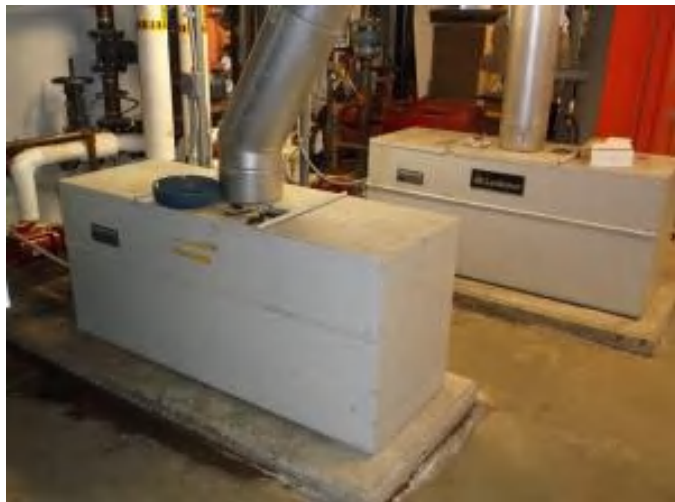
Location: Boiler mechanical equipment room

System: D2020 - Domestic Water Distribution

Distress: Beyond Service Life

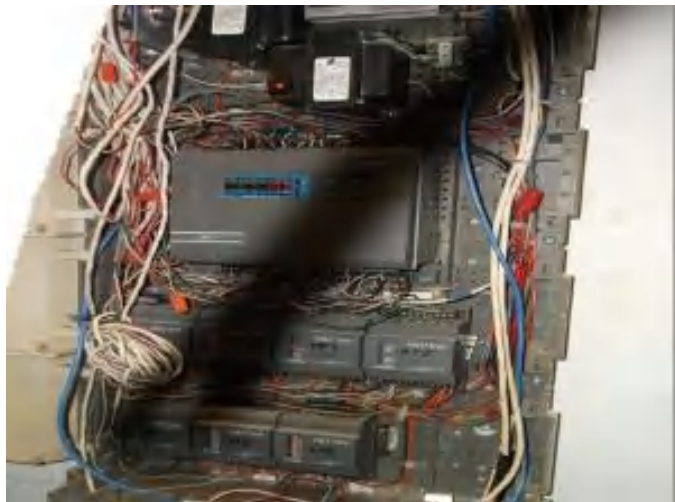
Location: Throughout the building

System: D3060 - Controls & Instrumentation

Distress: Energy Efficiency

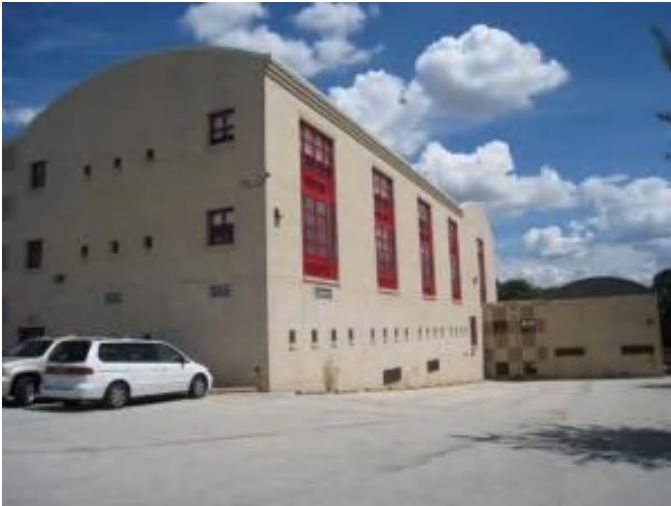
Location: faculty parking lot

System: G2020 - Parking Lots

Distress: Failing

Notes: Crack fill Faculty parking in rear of building (400 lf)

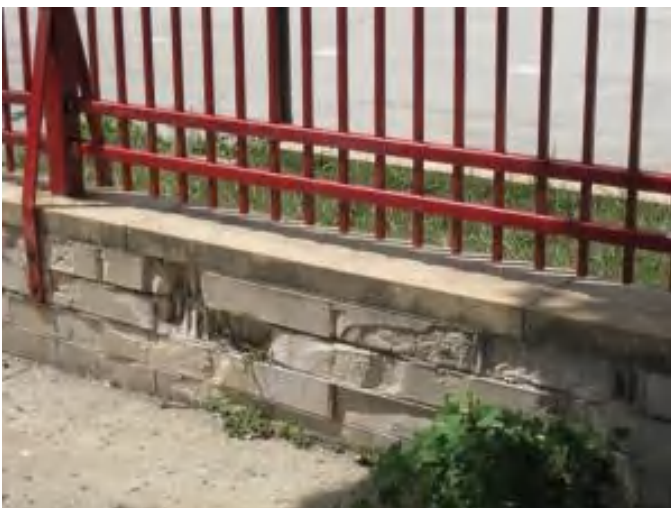
Location: site retaining wall

System: G2040 - Site Development

Distress: Damaged

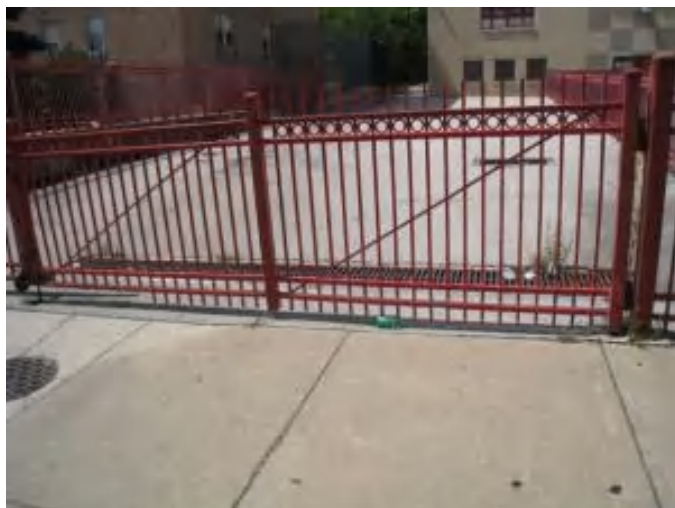
Location: site fence

System: G2040 - Site Development

Distress: Appearance
