Facility Condition Assessment Summary Report

Masterman School

Site Assessment Report

February 2, 2017

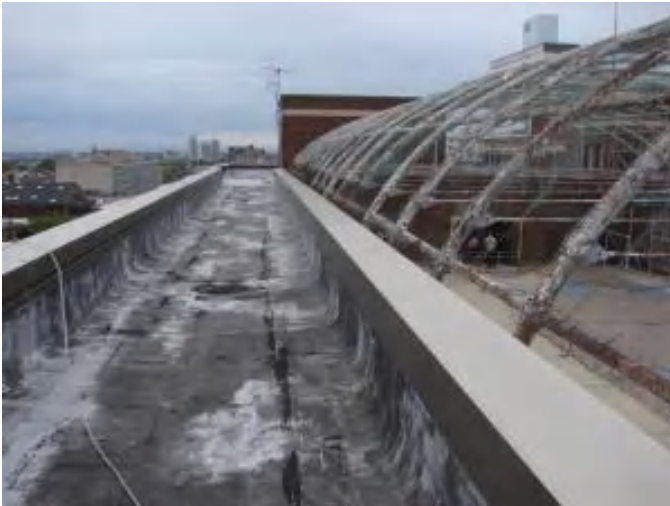
System: B3010105 - Built-Up

Location: Exterior

Distress: Building Envelope Integrity

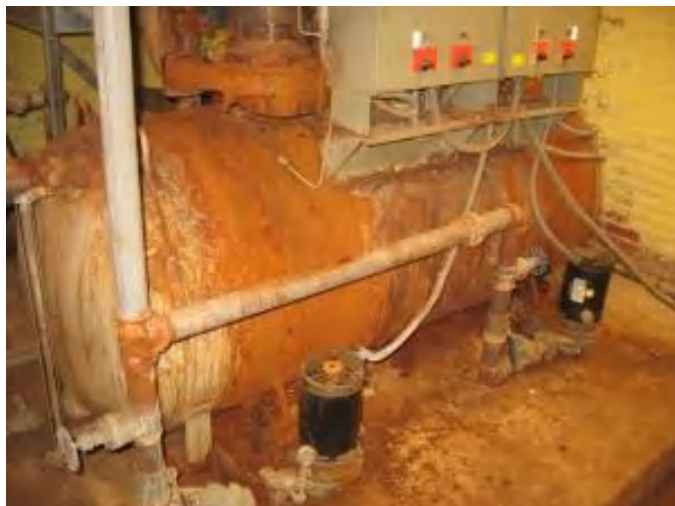
System: D3040 - Distribution Systems

Location: Basement mechanical room

Distress: Damaged

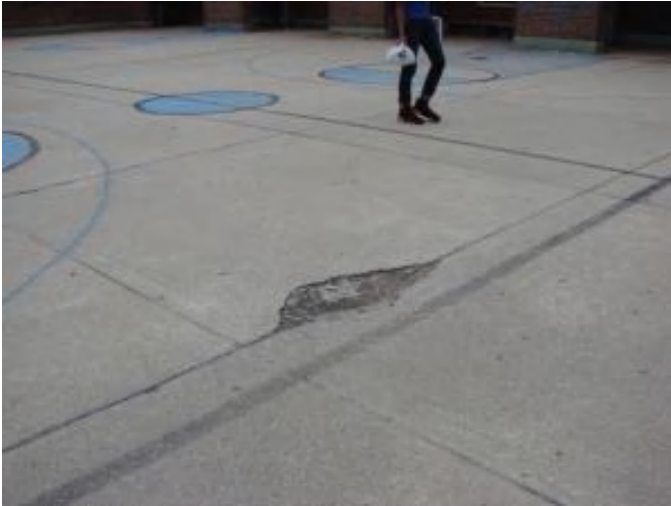
System: B3010120 - Single Ply Membrane

Location: Exterior

Distress: Building Envelope Integrity

Notes: Replace topping on outdoor gym floor, install new waterproofing membrane

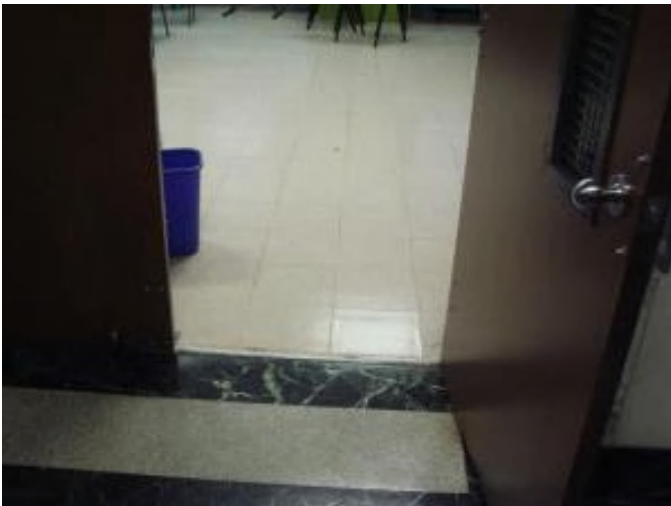
System: C3020413 - Vinyl Flooring

Location: Interior

Distress: Beyond Service Life

Notes: Replace damaged VCT

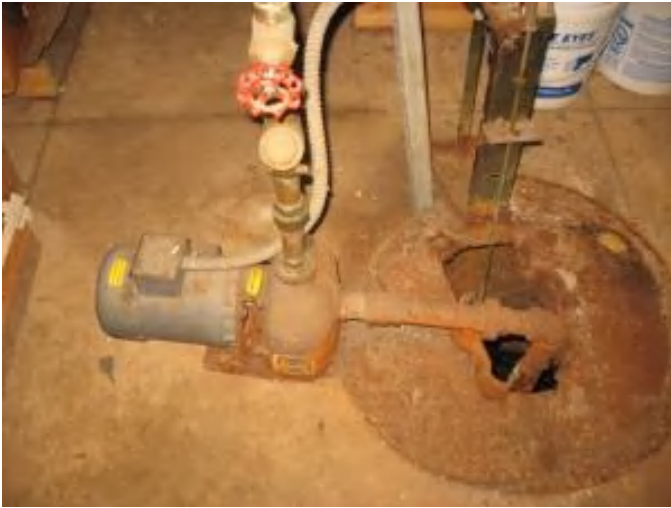
System: D2030 - Sanitary Waste

Location: Basement mechanical room

Distress: Health Hazard / Risk

Notes: Replace existing sewage ejector pump system and piping in the basement as it is beyond its service life and was not functional during the site visit.

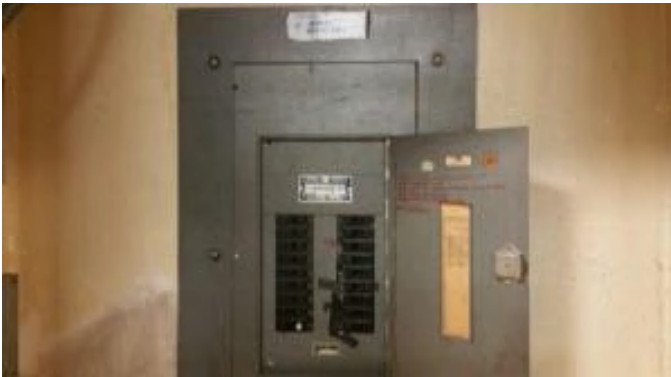
System: D5010 - Electrical Service/Distribution

Location: throughout the building

Distress: Beyond Service Life

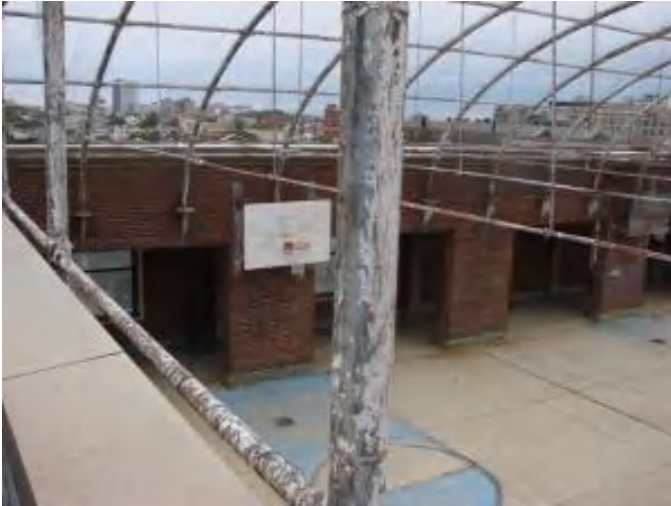
System: B1020 - Roof Construction

Location: Exterior

Distress: Maintenance Required

Notes: Refurbish wire mesh structure enclosing outdoor gym on 4th floor; clean and paint framing, install new wire mesh

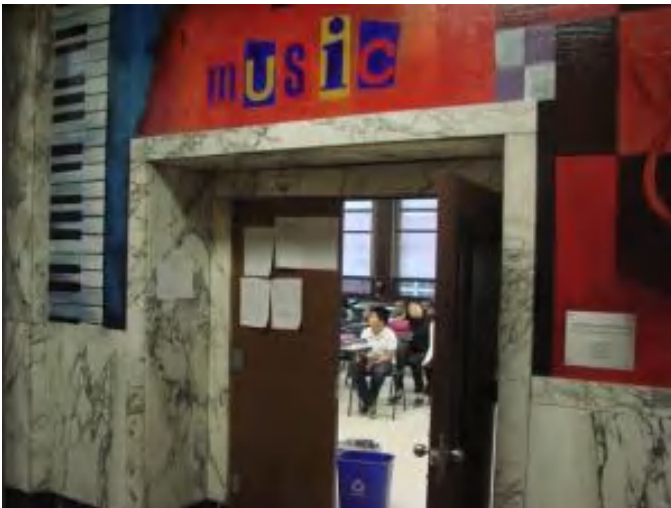
System: C1020 - Interior Doors

Location: Interior

Distress: Accessibility

Notes: Provide ADA compliant hardware on interior doors

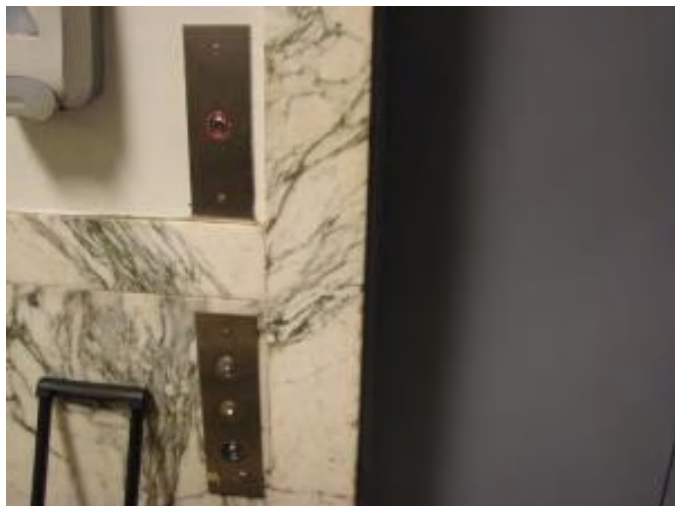
System: D1010 - Elevators and Lifts

Location: Interior

Distress: Beyond Service Life

Notes: Refurbish elevator cabins and provide new controls (2 elevators)

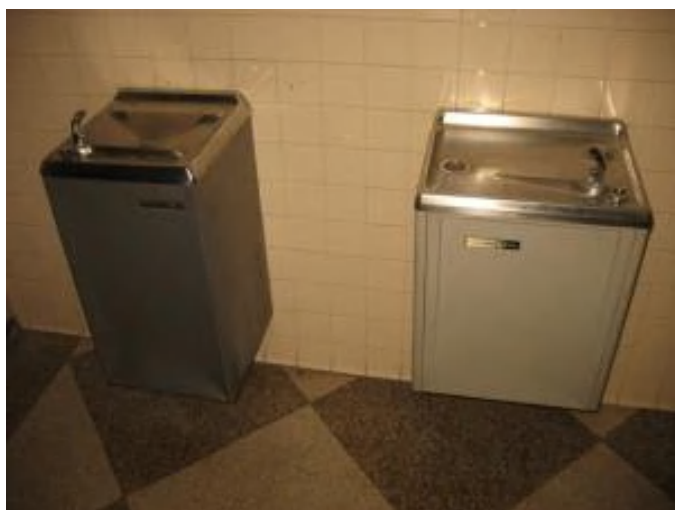
System: D2010 - Plumbing Fixtures

Location: Corridors

Distress: Beyond Service Life

Notes: Replace six (6) wall hung drinking fountains and integral refrigerated coolers in the corridors. These units are well beyond their service life and are NOT accessible type.

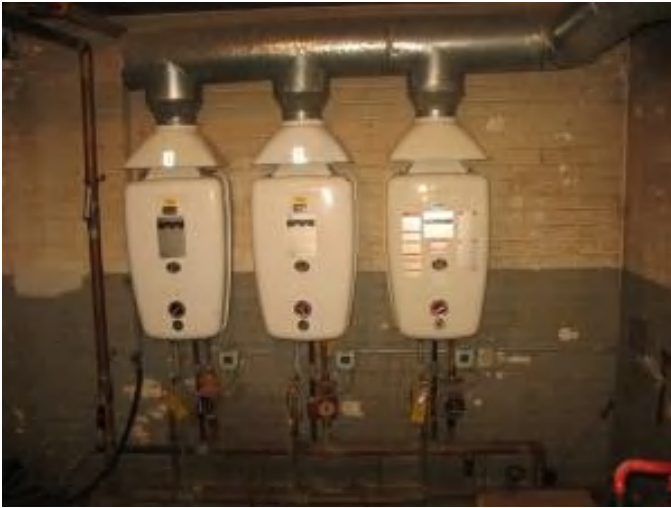
System: D2020 - Domestic Water Distribution

Location: Basement mechanical room

Distress: Beyond Service Life

Notes: Replace existing three (3) Paloma gas fired instant hot water heaters which are approaching the end of their service lives with new gas fired hot water heaters.

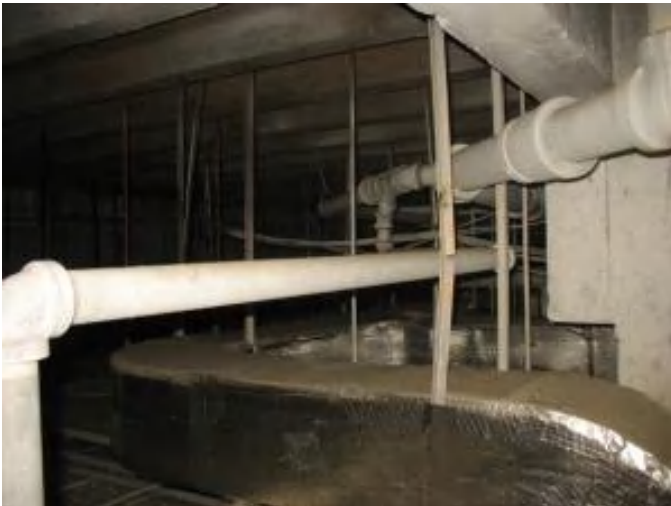
System: D2030 - Sanitary Waste

Location: Throughout building

Distress: Beyond Service Life

Notes: Hire a qualified contractor to perform a detailed examination of the sanitary waste piping using visual inspection and video cameras to locate and replace any damaged piping and to further quantify the extent of potential failures.

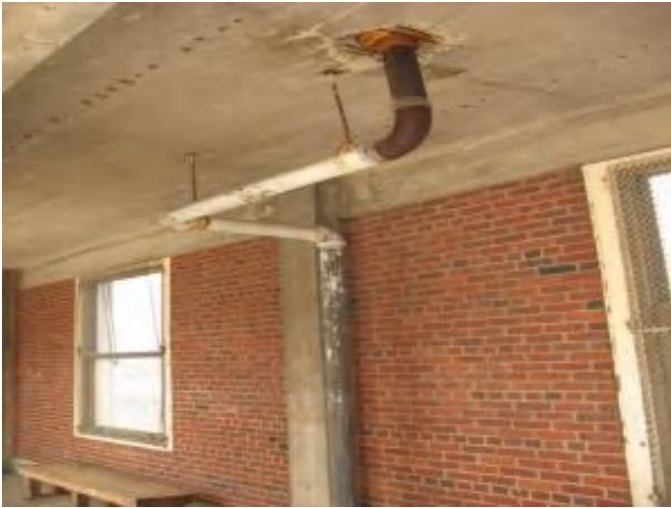
System: D2040 - Rain Water Drainage

Location: Throughout building

Distress: Beyond Service Life

Notes: Hire a qualified contractor to perform a detailed examination of the rain water drainage piping using visual inspection and video cameras to locate and replace any damaged piping and to further quantify the extent of potential failures.

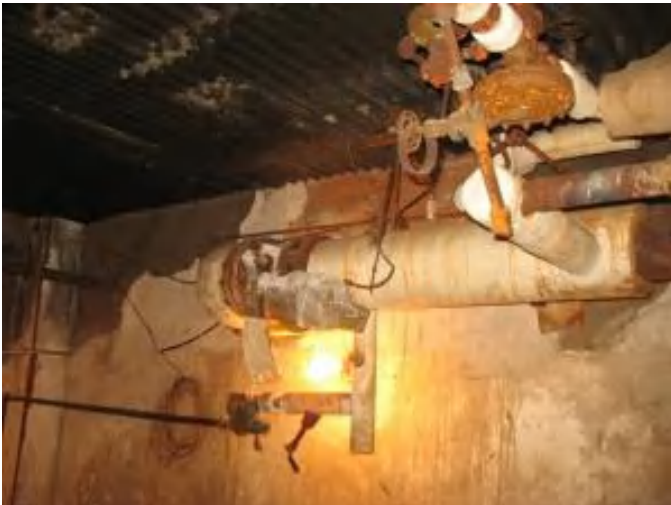
System: D3040 - Distribution Systems

Location: Throughout building

Distress: Beyond Service Life

Notes: Hire a qualified contractor to examine the steam piping, in service for nearly 80 years, and perform additional testing to locate and replace any damaged piping and to further quantify the extent of potential failures.

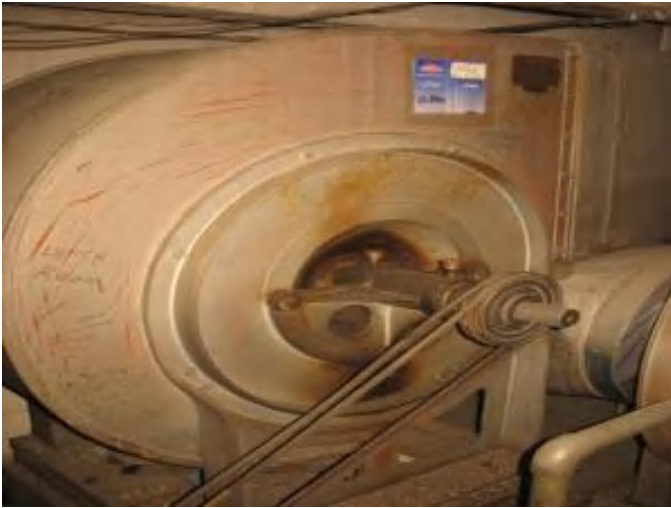
System: D3040 - Distribution Systems

Location: Penthouse

Distress: Beyond Service Life

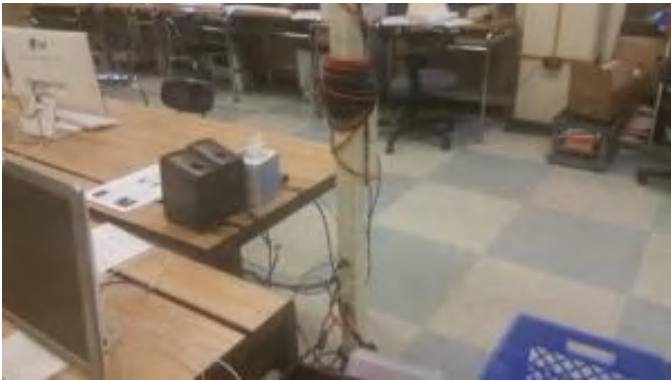
System: D5020 - Lighting and Branch Wiring

Location: throughout the building

Distress: Beyond Service Life

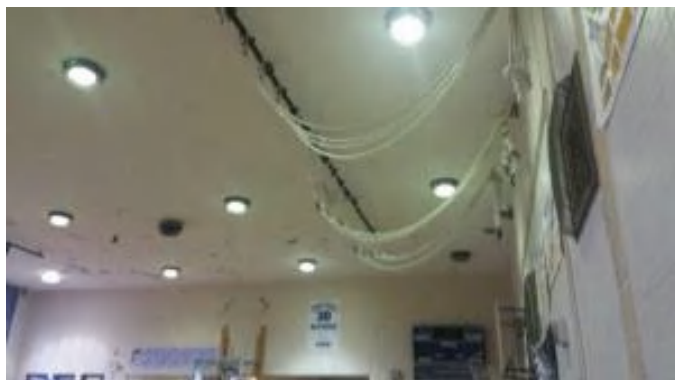
System: D5020 - Lighting and Branch Wiring

Location: throughout the building

Distress: Beyond Service Life

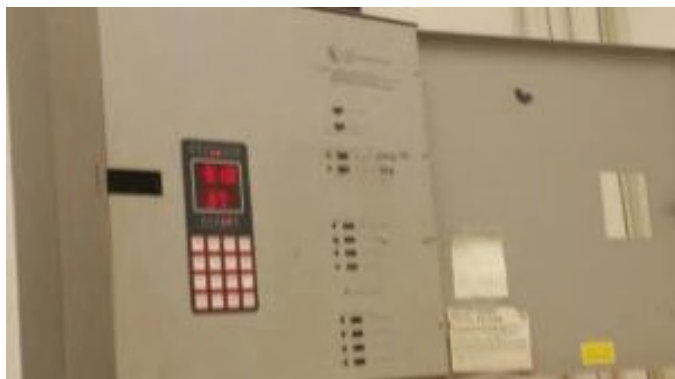
System: D5030 - Communications and Security

Location: throughout the building

Distress: Health Hazard / Risk

Notes: Install a new automated FA System

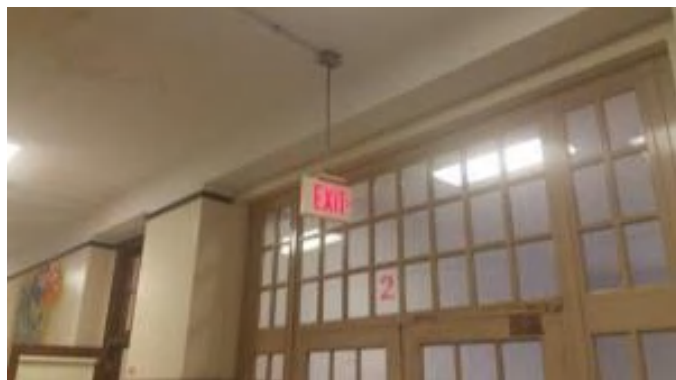
System: D5090 - Other Electrical Systems

Location: throughout the building

Distress: Beyond Service Life

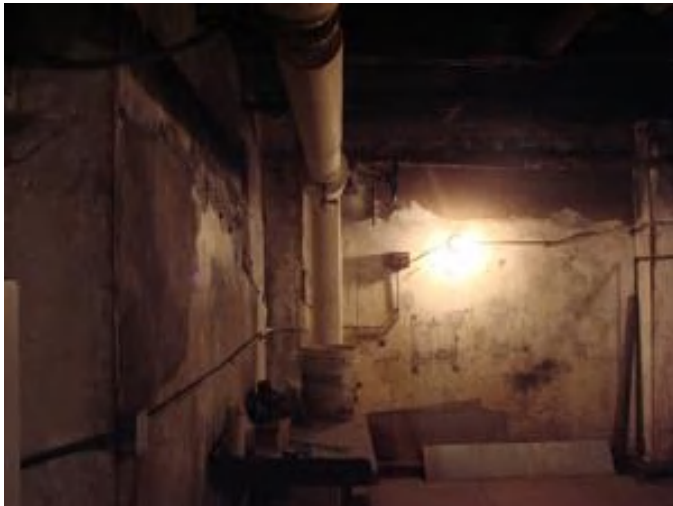
System: C3010230 - Paint & Covering

Location: Interior

Distress: Beyond Service Life

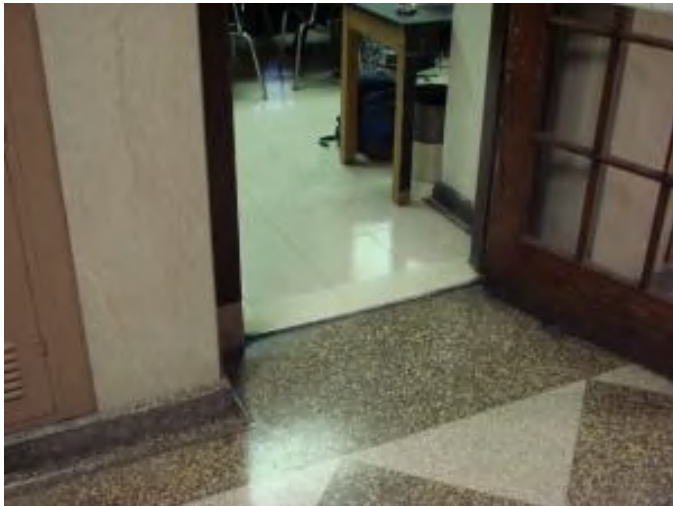
System: C3020413 - Vinyl Flooring

Location: Interior

Distress: Beyond Service Life

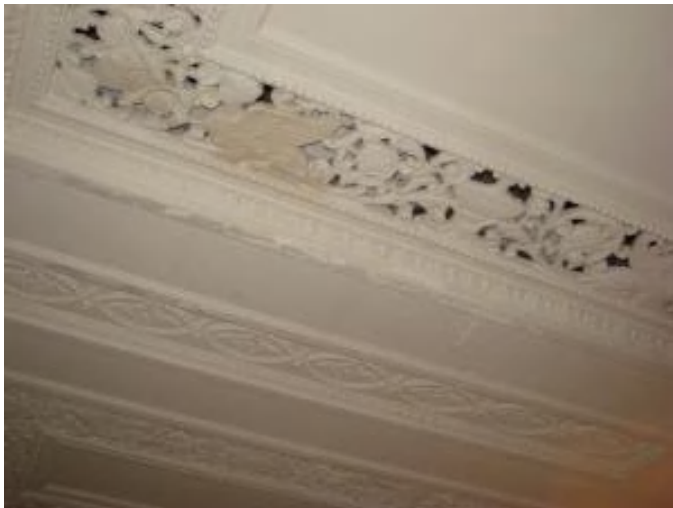
System: C3030 - Ceiling Finishes

Location: Interior

Distress: Beyond Service Life

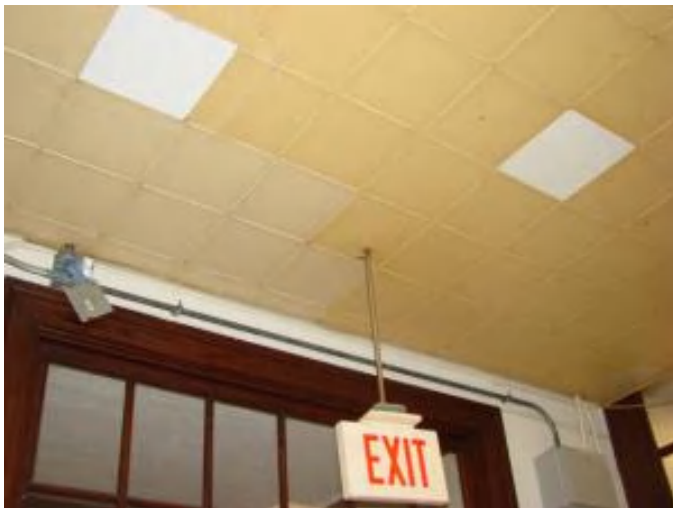
System: C3030 - Ceiling Finishes

Location: Interior

Distress: Beyond Service Life

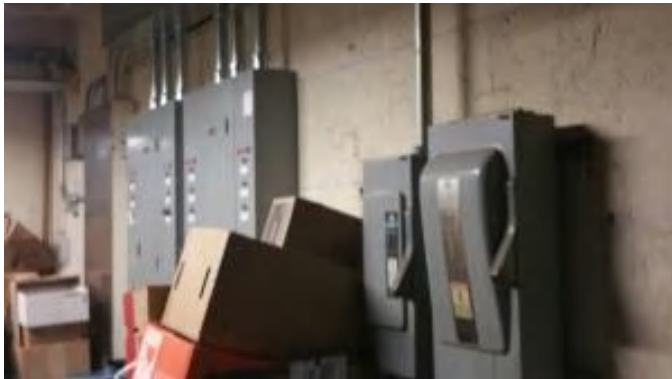
System: D5010 - Electrical Service/Distribution

Location: electrical room

Distress: Beyond Service Life

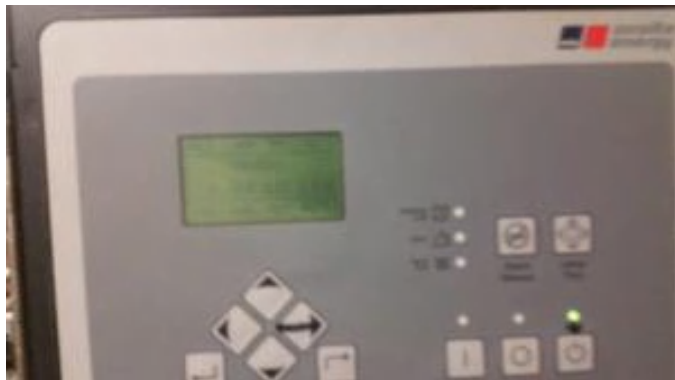
System: D5030 - Communications and Security

Location: Throughout the building

Distress: Beyond Service Life

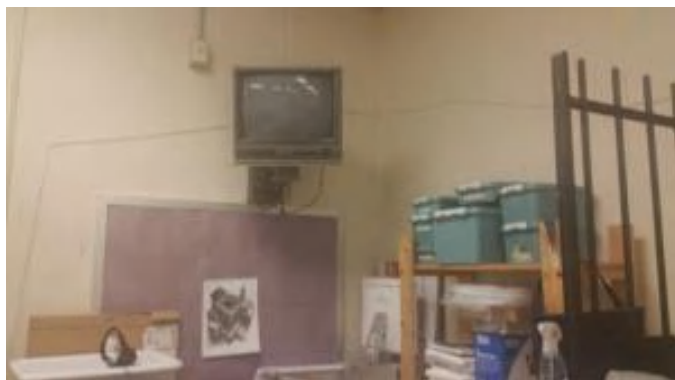
System: D5030 - Communications and Security

Location: B214001;Masterman

Distress: Inadequate

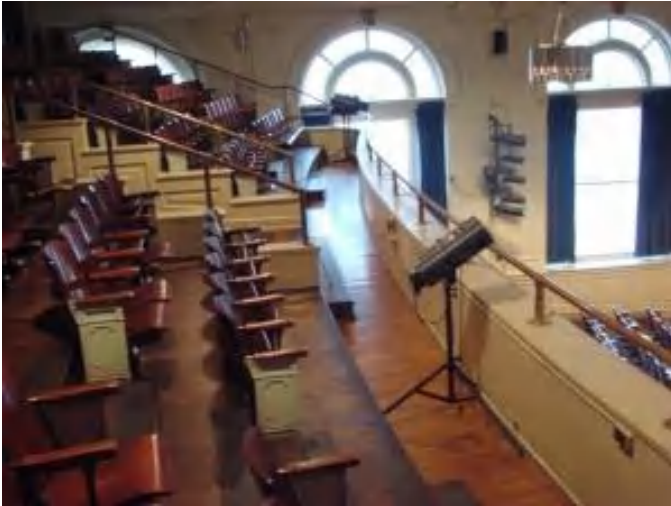
System: C3020414 - Wood Flooring

Location: Interior

Distress: Maintenance Required

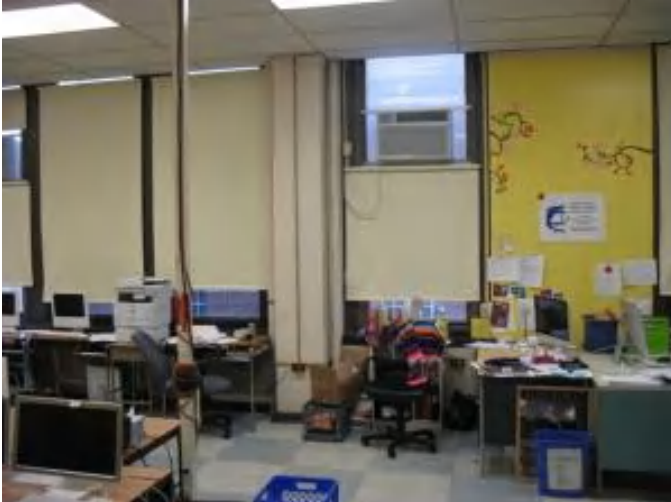
System: D3030 - Cooling Generating Systems

Location: Throughout building

Distress: Inadequate

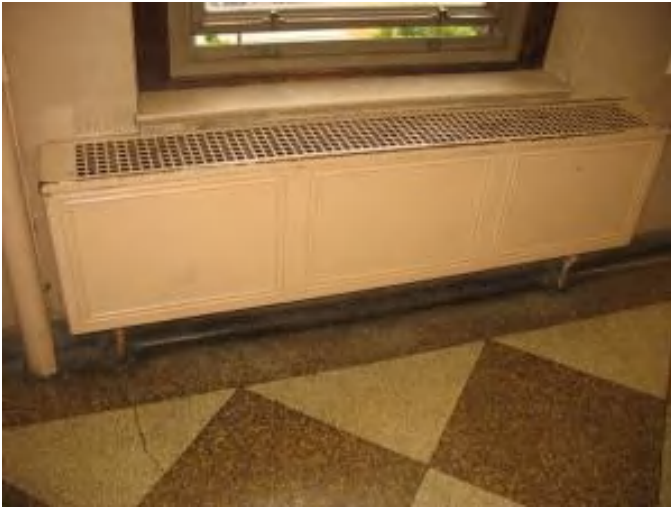
System: D3040 - Distribution Systems

Location: Classrooms

Distress: Building / MEP Codes

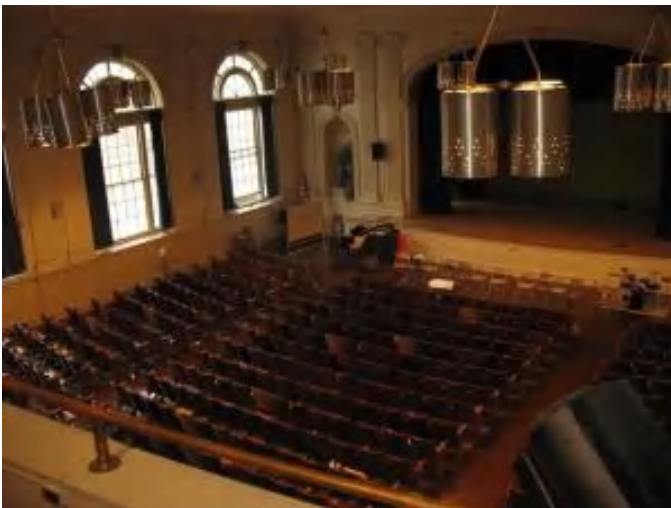
System: D3040 - Distribution Systems

Location: Auditorium

Distress: Building / MEP Codes

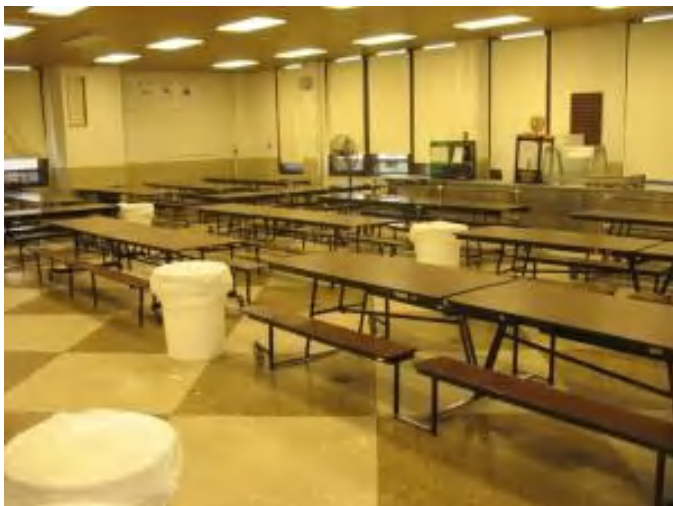
System: D3040 - Distribution Systems

Location: Cafeteria

Distress: Building / MEP Codes

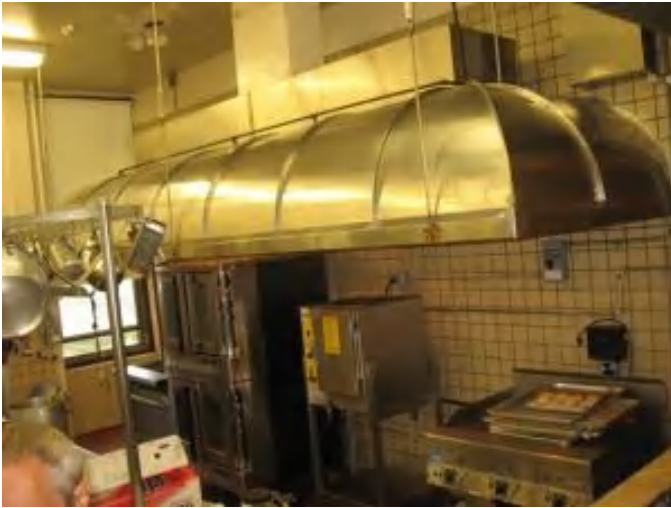
System: D3040 - Distribution Systems

Location: Kitchen

Distress: Building / MEP Codes

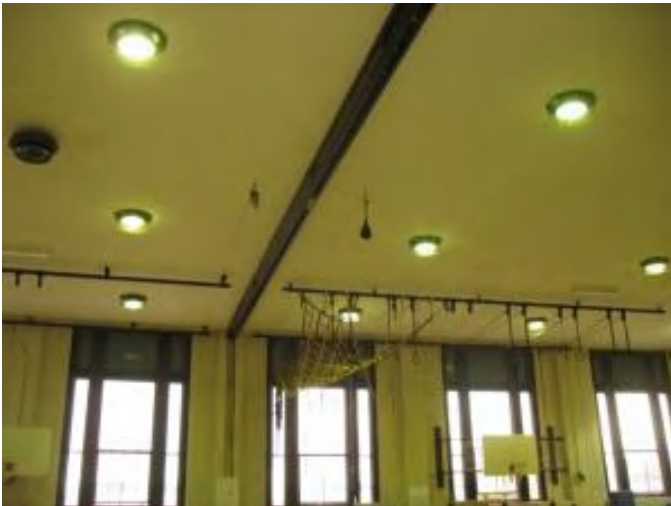
System: D3040 - Distribution Systems

Location: Gymnasium

Distress: Building / MEP Codes

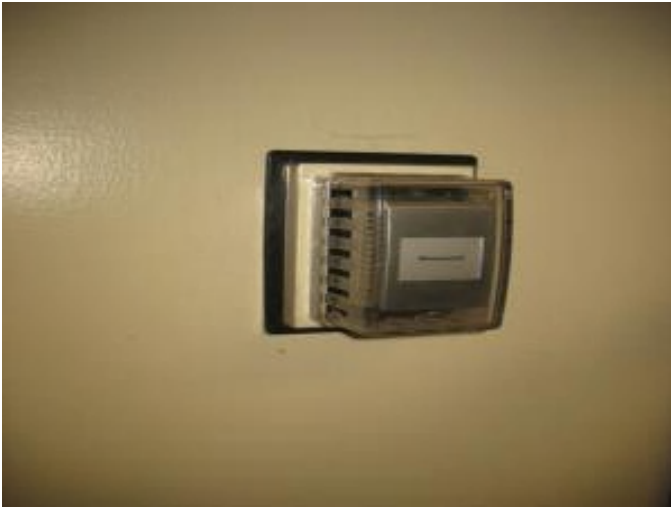
System: D3060 - Controls & Instrumentation

Location: Throughout building

Distress: Inadequate

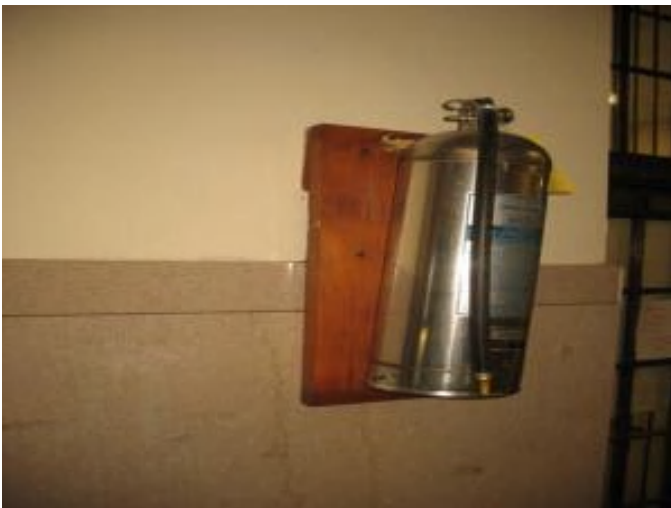
System: D4010 - Sprinklers

Location: Throughout building

Distress: Life Safety / NFPA / PFD

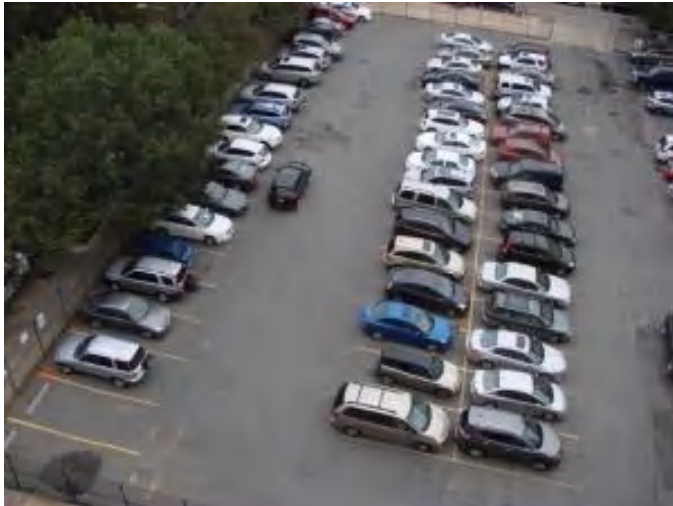
System: G4020 - Site Lighting

Location: Grounds

Distress: Security Issue

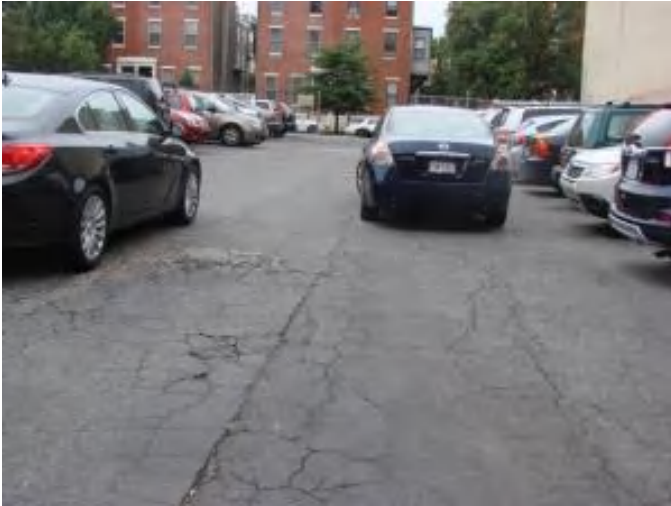
System: G2020 - Parking Lots

Location: Grounds

Distress: Beyond Service Life

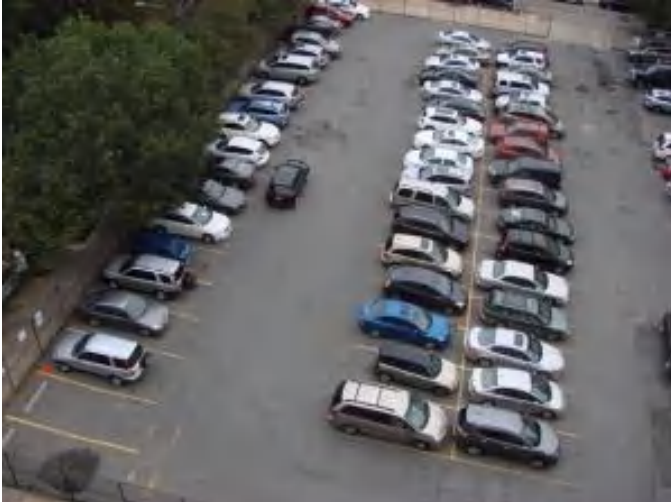
System: G2020 - Parking Lots

Location: Grounds

Distress: Beyond Service Life

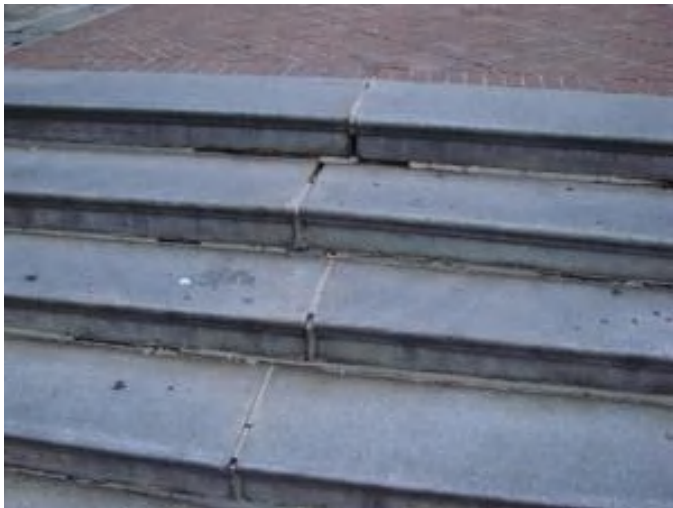
System: G2030 - Pedestrian Paving

Location: Grounds/ courtyard

Distress: Beyond Service Life

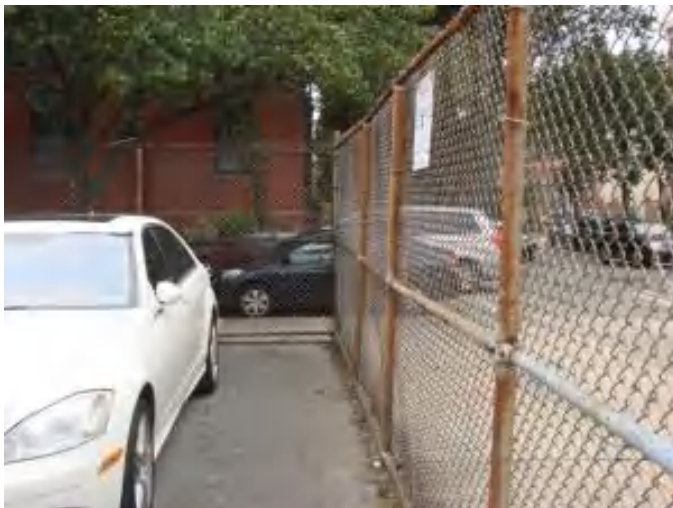
System: G2040 - Site Development

Location: Grounds

Distress: Beyond Service Life

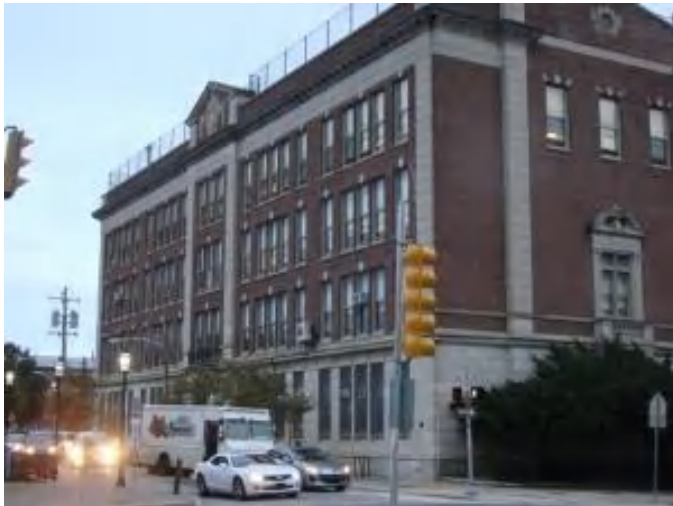
System: G4030 - Site Communications & Security

Location: Grounds

Distress: Inadequate
