Facility Condition Assessment Summary Report

McCall School

S234001;McCall

Site Assessment Report

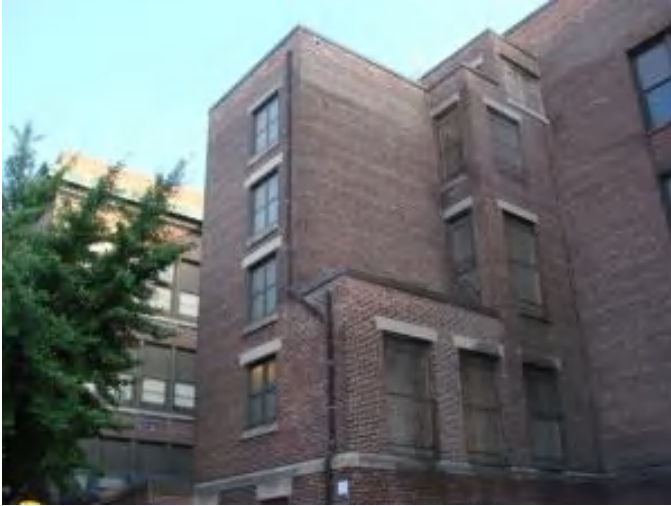
System: C2010 - Stair Construction

The load bearing masonry structure of the fire escape located in the middle of the South wall is unusable due to severe structural deterioration of walls and stair structure. It has been condemned by the City of Philadelphia in 2006.

Location: Exterior/ fire tower stair

Distress: Failing

Notes: Rebuild fire exit tower

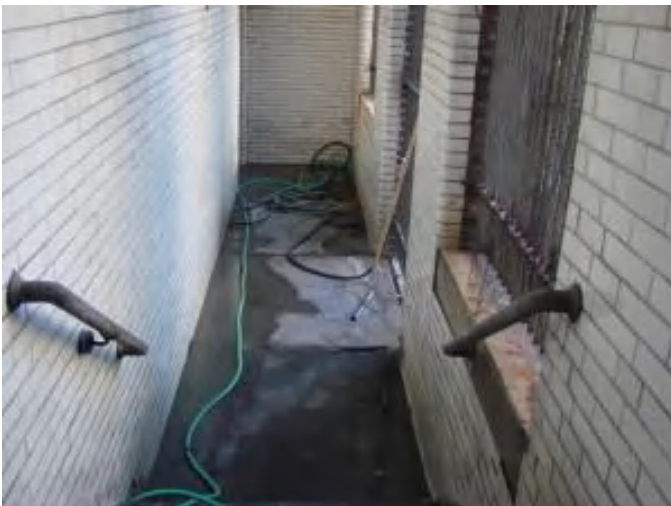
System: C2010 - Stair Construction

Location: Exterior/ fire tower stair

Distress: Failing

Notes: Install new stairs in fire exit tower

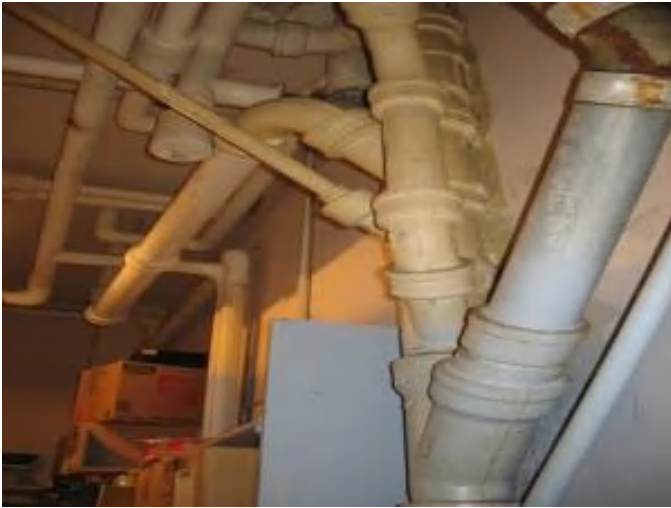
System: D2030 - Sanitary Waste

The maintenance staff reported mostly minor problems with the sanitary waste piping systems. However, the sewer piping has been in service for over 50 years and will require more frequent attention from the maintenance staff as time passes. The District should hire a qualified contractor to examine the sanitary waste piping using video cameras to locate and replace any damaged piping and to further quantify the extent of potential failures.

Location: Throughout building

Distress: Health Hazard / Risk

Notes: Hire a qualified contractor to perform a detailed examination of the sanitary waste piping using visual inspection and video cameras to locate and replace any damaged piping and to further quantify the extent of potential failures.

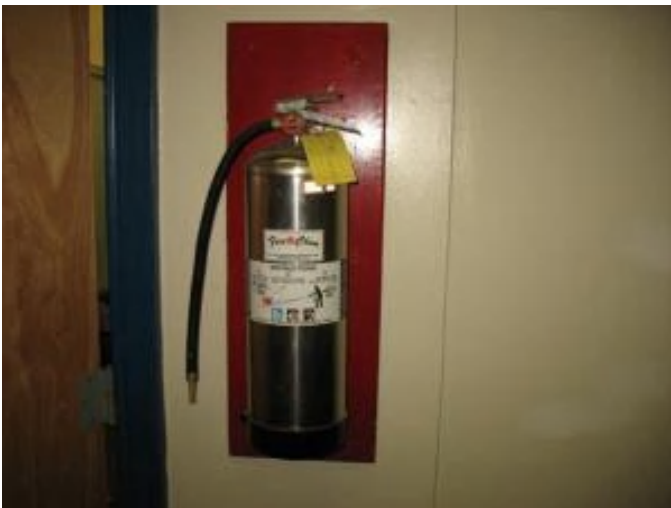
System: D4010 - Sprinklers

Location: Throughout building

Distress: Life Safety / NFPA / PFD

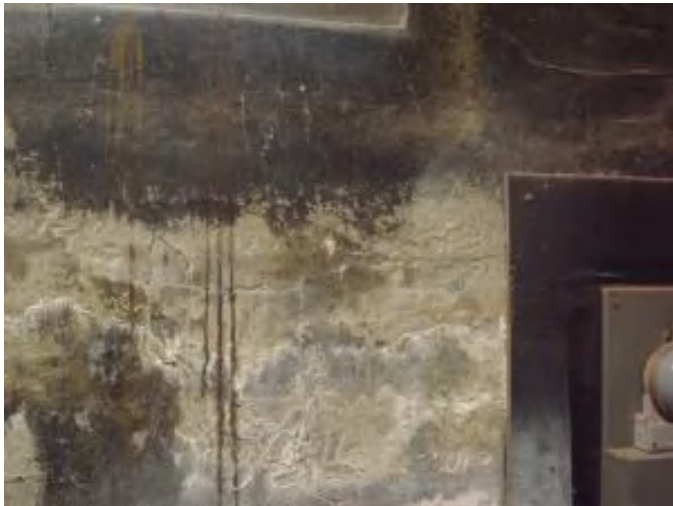
System: A2020 - Basement Walls

The building typically rests on concrete foundations and bearing walls that are not showing signs of settlement. Foundation walls do not show signs of deterioration with the exception of small cracks in electrical rooms in South West corner of the basement. The basement slab does not show signs of heaving or cracking. No signs of water penetration through walls have been observed or reported, however, some mildew was observed in basement electrical rooms.

Location: Interior/ basement

Distress: Health Hazard / Risk

Notes: Conduct mildew remediation in basement

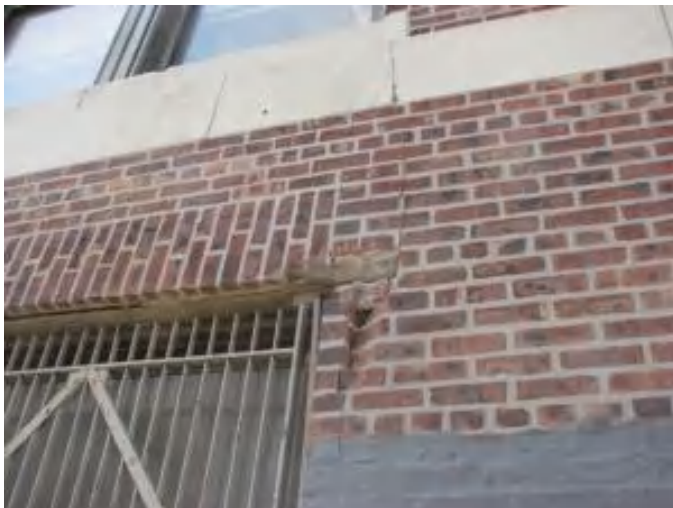
System: B2010 - Exterior Walls

The main structure consists typically of load bearing masonry walls, beams and concrete, ribbed slabs in the original building. Long roof spans in the Auditorium and Gymnasium are supported with steel truss joists resting on masonry bearing walls. Above ground floor slabs are generally in good condition, however, the masonry bearing wall on the North side and North West corner of the original building is cracked along the lintel level of the basement windows. The North West corner, previously stabilized with steel rods and anchor plates, shows masonry cracks and face brick buckling up to the third floor level. It is strongly recommended that a structural analysis is conducted to determine the exact cause of overstress cracking and develop remedial action.

Location: Exterior

Distress: Damaged

Notes: Repair and stabilize cracked exterior bearing walls

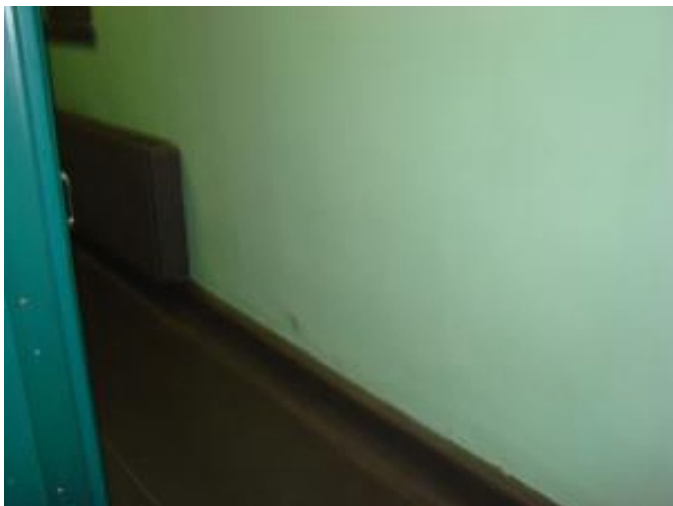
System: C3010230 - Paint & Covering

Location: Interior

Distress: Beyond Service Life

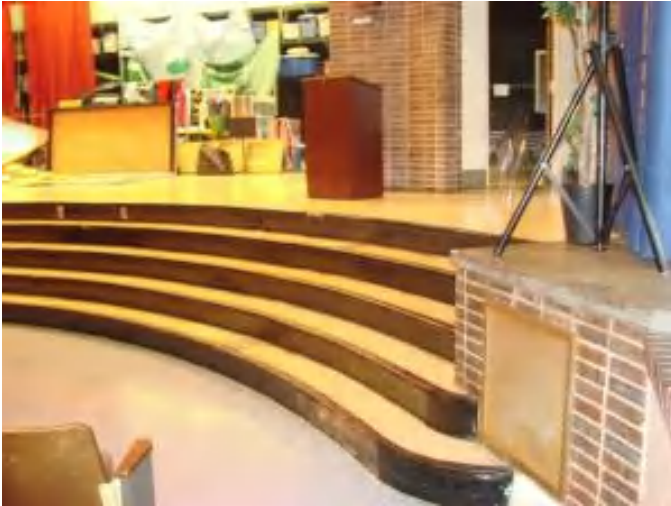
System: C3020413 - Vinyl Flooring

Location: interior

Distress: Health Hazard / Risk

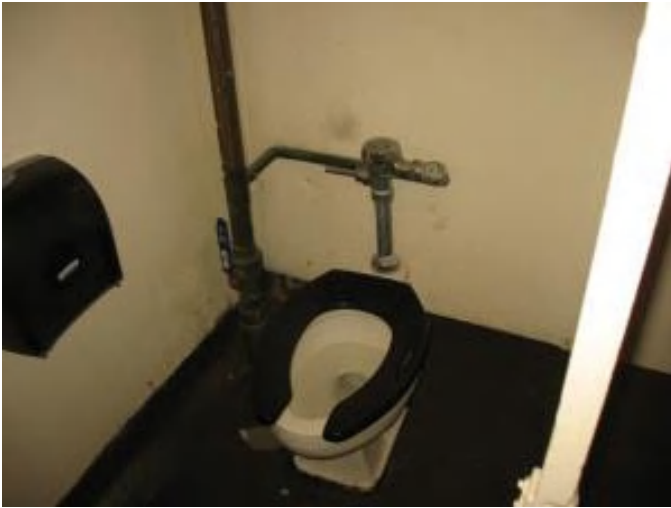
System: D2010 - Plumbing Fixtures

Plumbing Fixtures - Many of the original plumbing fixtures remain in service. Fixtures in the restrooms on each floor consist of floor and wall mounted flush valve water closets, wall hung urinals, and lavatories with wheel handle faucets. With proper maintenance these fixtures should provide reliable service for the next 5-10 years. However, the older units should be replaced as part of any renovation of the spaces.

Location: Restrooms

Distress: Beyond Service Life

Notes: Replace the water closets in the restrooms with new code compliant fixtures.

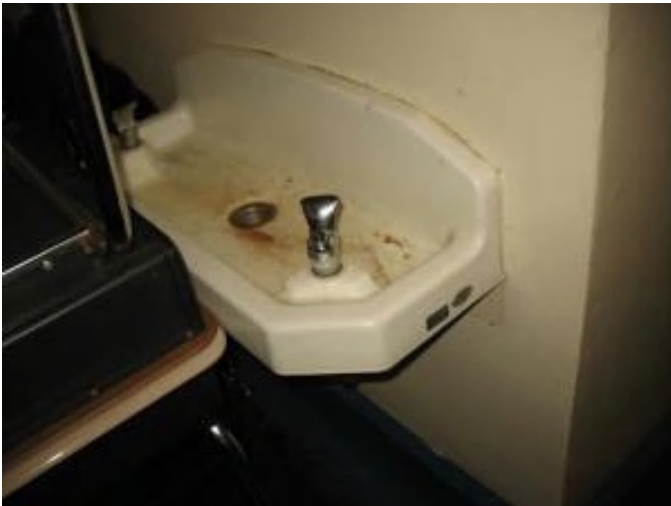
System: D2010 - Plumbing Fixtures

Drinking fountains in the corridors and at the restrooms are a mixture of wall hung with integral refrigerated coolers and wall hung porcelain fountains. The porcelain fountains are well beyond their service life and should be replaced; most are NOT accessible type.

Location: Corridors

Distress: Beyond Service Life

Notes: Replace the wall hung drinking fountains and integral refrigerated coolers in the corridors and at the restrooms. These units are well beyond their service life.

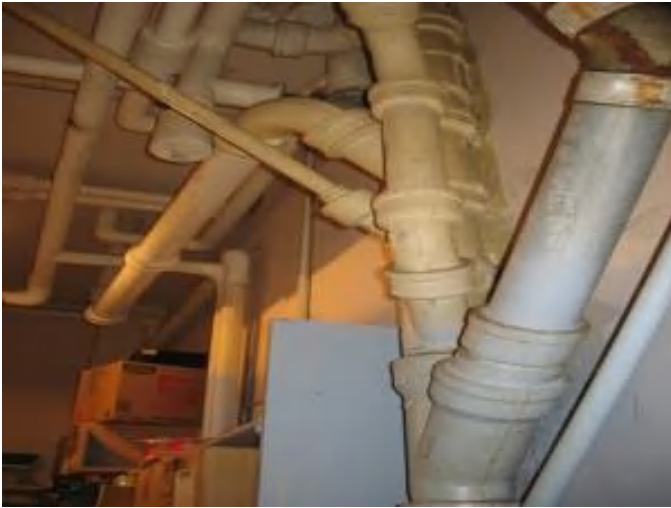
System: D2040 - Rain Water Drainage

Location: Throughout building

Distress: Beyond Service Life

Notes: Hire a qualified contractor to perform a detailed examination of the rain water drainage piping using visual inspection and video cameras to locate and replace any damaged piping and to further quantify the extent of potential failures.

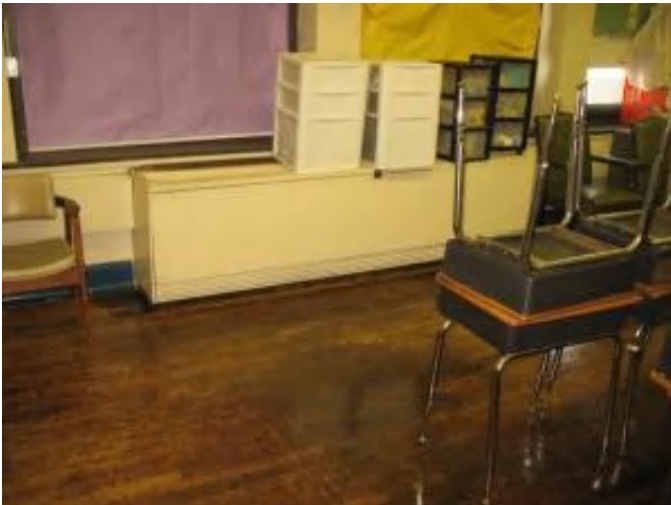
System: D3040 - Distribution Systems

Location: Throughout building

Distress: Beyond Service Life

Notes: Remove the existing unit ventilators and install units with hot and chilled water coils and integral heat exchangers to introduce outdoor air to the building.

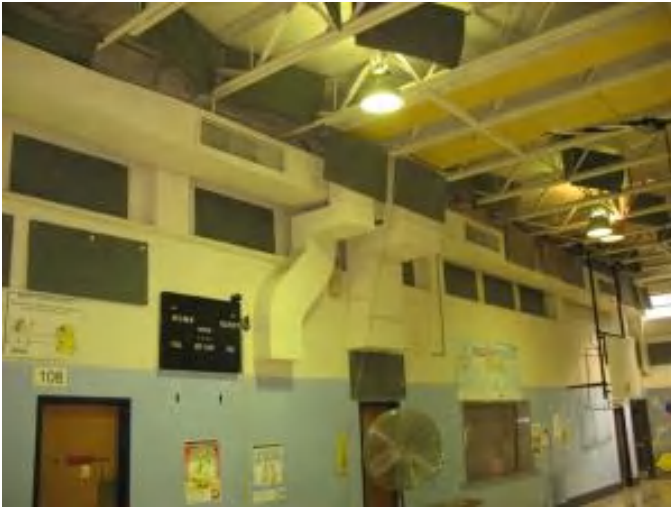
System: D3040 - Distribution Systems

Location: Auditorium Mechanical room

Distress: Beyond Service Life

Notes: Provide ventilation for the Gymnasium/Cafeteria by installing a fan coil air handling unit installed in the mechanical room behind the Auditorium stage and utilize the existing outdoor air intake.

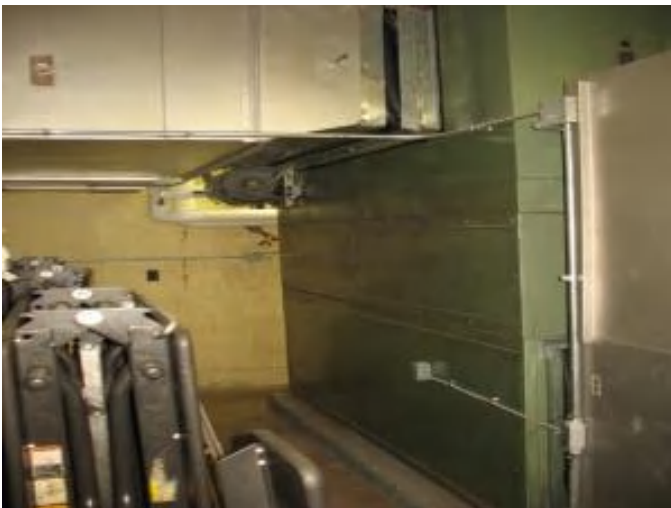
System: D3040 - Distribution Systems

Location: Auditorium Mechanical room

Distress: Beyond Service Life

Notes: Provide ventilation for the Auditorium by installing a fan coil air handling unit in the mechanical room behind the Auditorium stage and utilize the existing outdoor air intake.

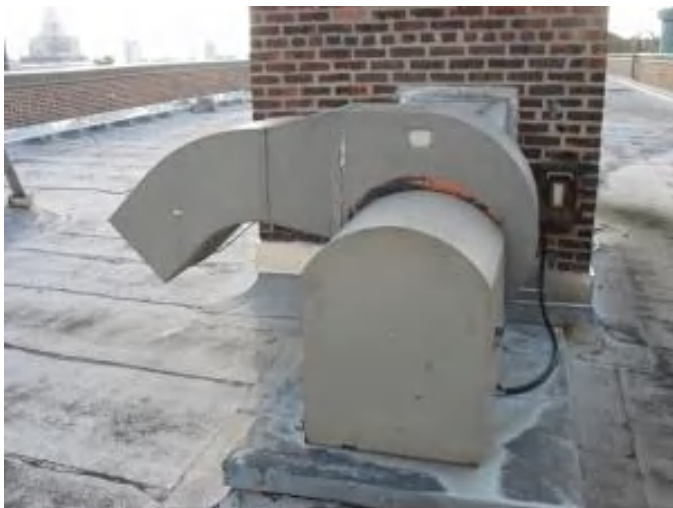
System: D3040 - Distribution Systems

Exhaust for the restrooms is provided by two roof mounted exhaust fans. One exhaust fan serves the girls restrooms, the other serves the boys. An exhaust fan mounted on the roof of the boiler room serves the boiler room. The existing roof mounted exhaust fans serving the restrooms are beyond their service life and should be replaced.

Location: Roof

Distress: Beyond Service Life

Notes: Replace existing exhaust fans on the roof serving the bathrooms and utilize the existing ductwork.

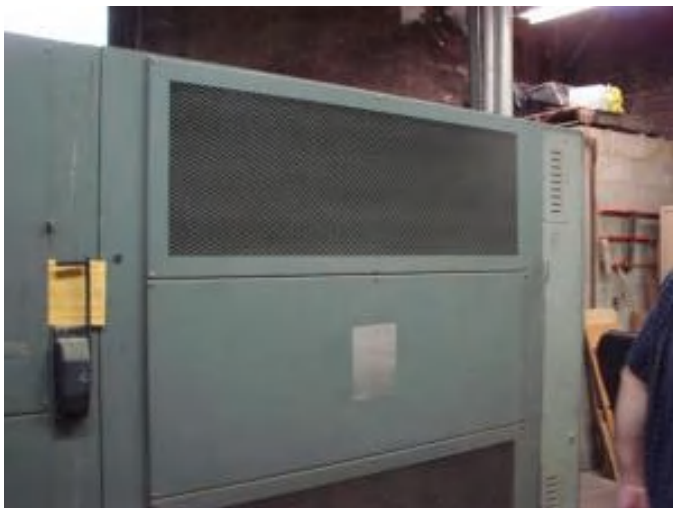
System: D5010 - Electrical Service/Distribution

Electrical Service- The electrical service is fed from an underground distribution system along S Seventh St. The service enters the building underground to a 500 kVA, 2400V:208/120V substation. The substation is equipped with a 600A load interrupter switch. After the medium voltage transformer, the substation contains a 208/120V 1600A distribution section. The substation is original to the building, and was manufactured by Westinghouse. The substation is not adequately sized for a building air conditioning system and elevator.

Location: Basement

Distress: Inadequate

Notes: Replace existing substation with new 480/277V sized to provide power for an elevator and air conditioning equipment.

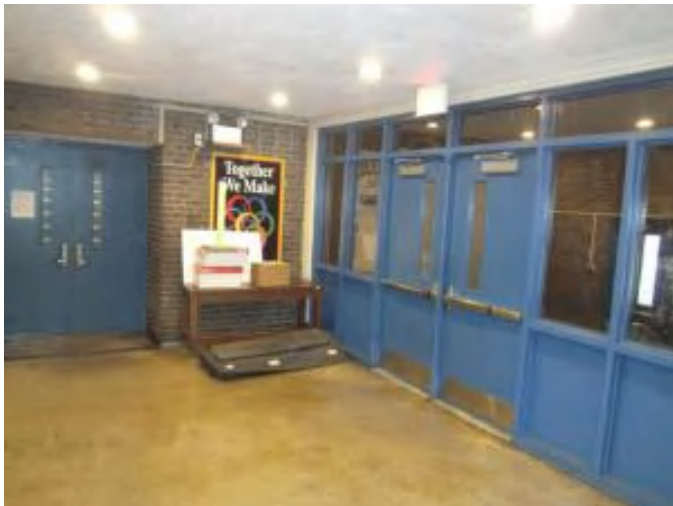
System: D5020 - Lighting and Branch Wiring

Location: Throughout Building

Distress: Inadequate

Notes: Replace existing T12 fixtures with T8 fixtures and incandescent fixtures with compact fluorescent.

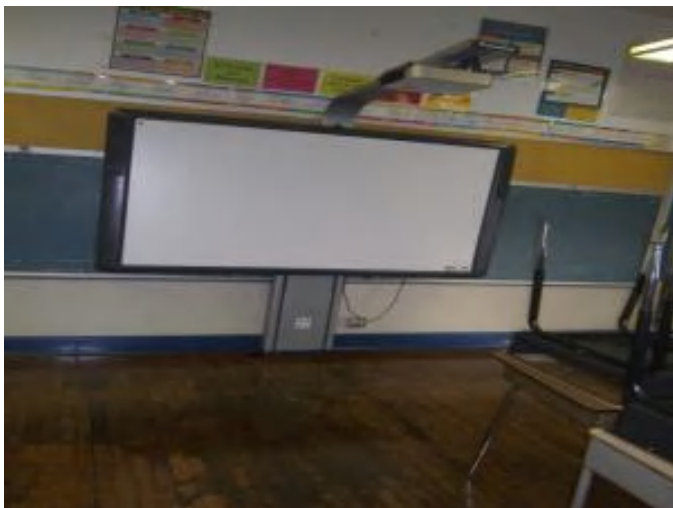
System: D5020 - Lighting and Branch Wiring

Location: Throughout Building

Distress: Inadequate

Notes: Install minimum 2 receptacles on each wall of classrooms and other purpose rooms.

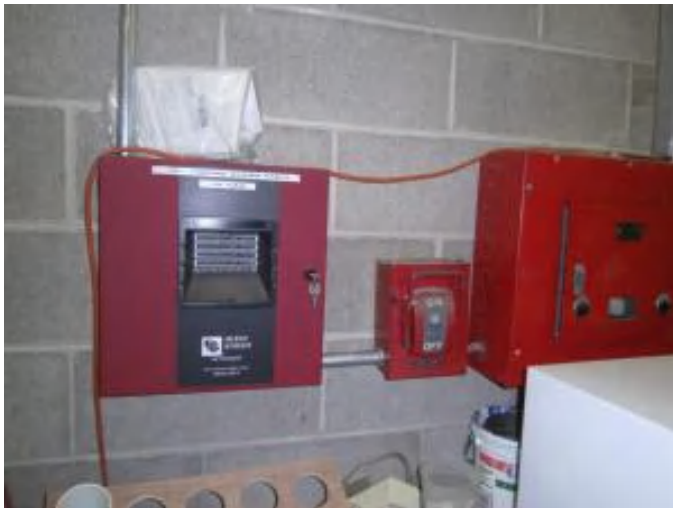
System: D5030 - Communications and Security

Location: Throughout Building

Distress: Life Safety / NFPA / PFD

Notes: Install a generator sized to operate the elevator and emergency lighting.

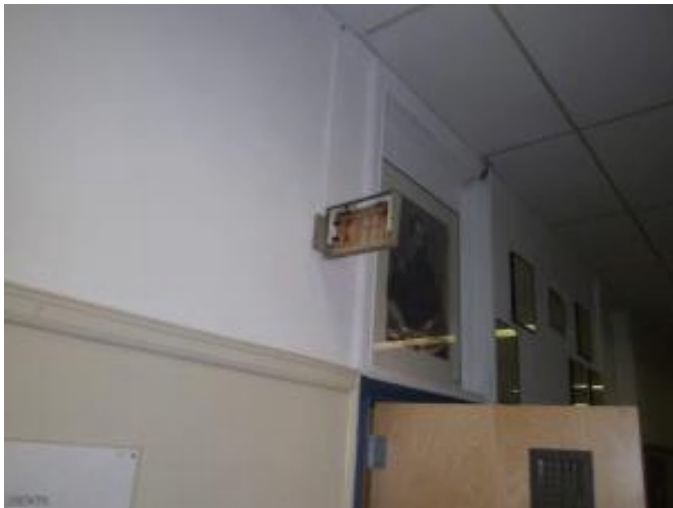
System: D5090 - Other Electrical Systems

Emergency Lighting System / Exit Lighting- The emergency lighting is provided by battery packs located in the corridors. Most of these battery packs were in inoperable condition. The exit lighting is are incandescent and are in poor condition.

Location: Throughout Building

Distress: Health Hazard / Risk

Notes: Replace existing EXIT fixtures with new LED type.

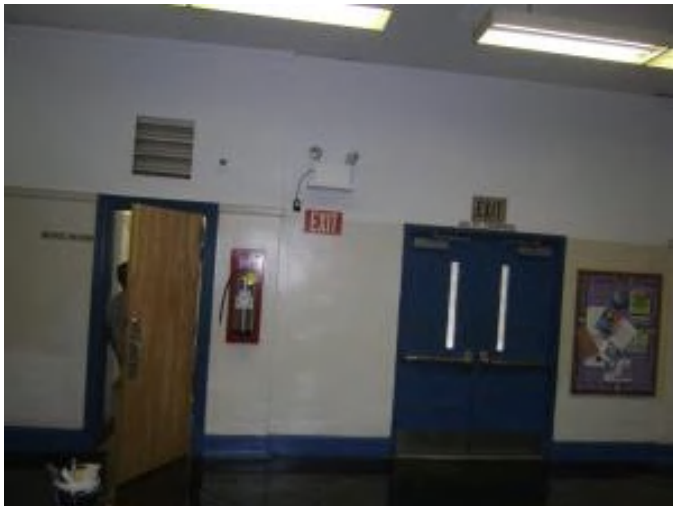
System: D5090 - Other Electrical Systems

Location: Throughout Building

Distress: Life Safety / NFPA / PFD

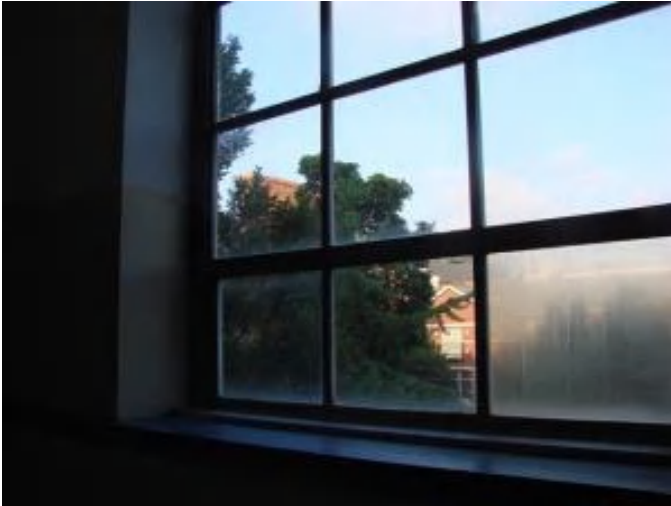
System: B2020 - Exterior Windows

The original windows were replaced in 1980's with extruded aluminum double hung windows, single acrylic glazed. Basement windows are fitted with security screens attached to adjacent masonry. All windows and screens are generally in poor condition and beyond their useful life.

Location: Exterior

Distress: Beyond Service Life

Notes: Replace all windows

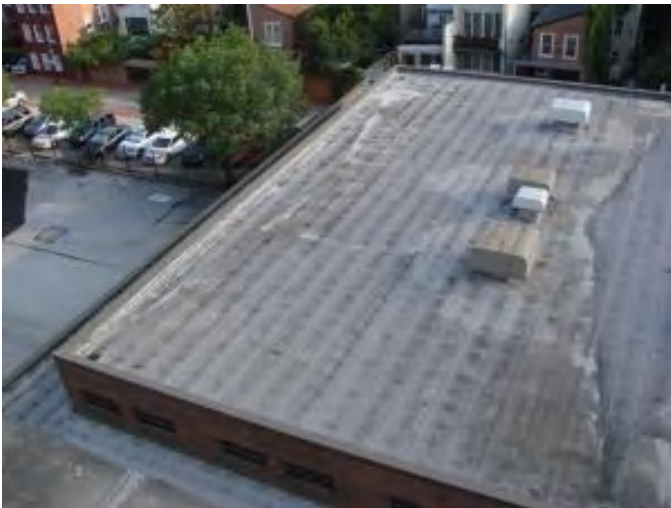
System: B3010105 - Built-Up

Roofing is typically built-up. All roofing and flashing is typically in poor condition with deterioration of the built-up system including water ponding and soft spots; several leaks have been reported.

Location: Exterior/ roof

Distress: Building Envelope Integrity

Notes: Install all new roofing system including insulation; tear-down existing roofing; install flashing, counter flashing and reglets

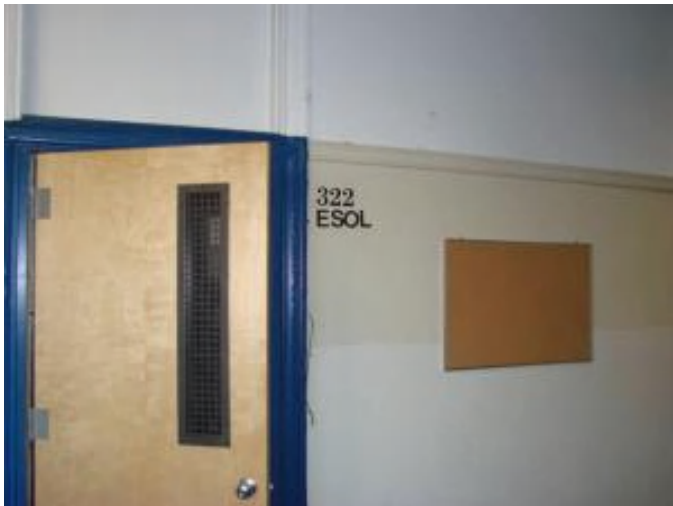
System: C1020 - Interior Doors

Interior doors are generally solid core wood, some glazed in original wood frames installed in late 1990's. Door finishes are typically in good condition. Most doors are fitted with door knobs and are not ADA compliant. The doors leading to exit stairways are hollow metal doors and frames in good condition.

Location: Interior

Distress: Accessibility

Notes: Provide ADA compliant hardware on interior doors

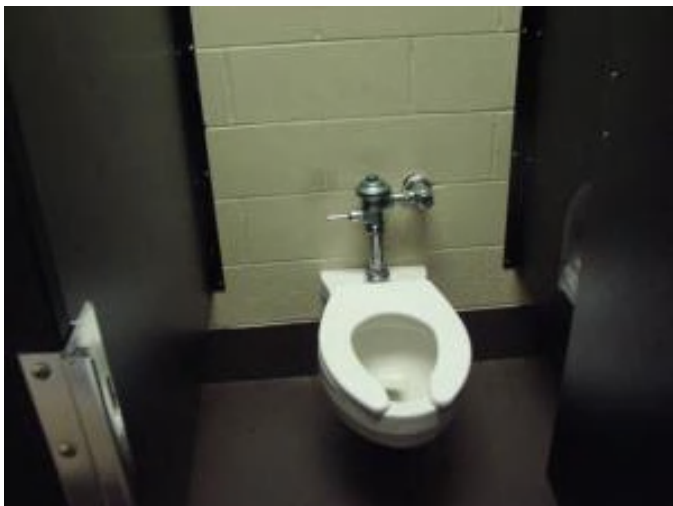
System: C1030 - Fittings

Location: Interior

Distress: Accessibility

Notes: Reconfigure toilets on each floor for accessibility, provide new toilet partitions

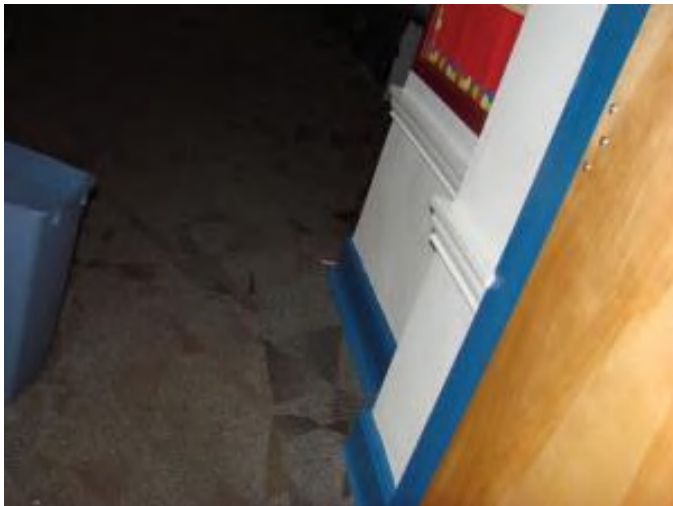
System: C3020411 - Carpet

Location: Interior

Notes: Replace carpet in library

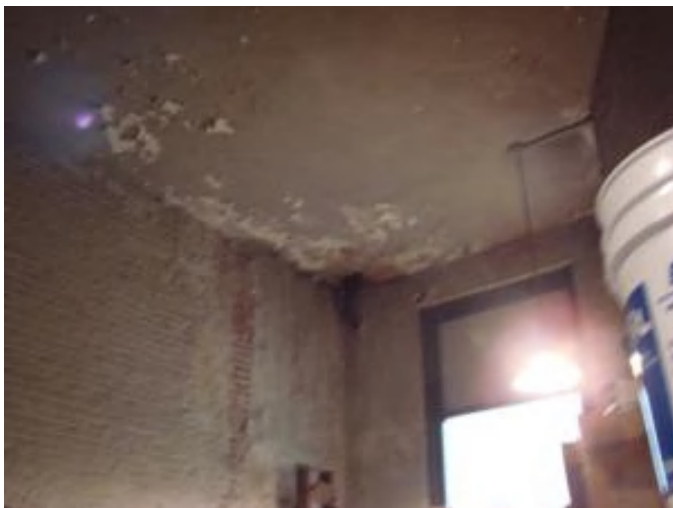
System: C3030 - Ceiling Finishes

Location: Interior

Notes: Repair and repaint exposed ceilings

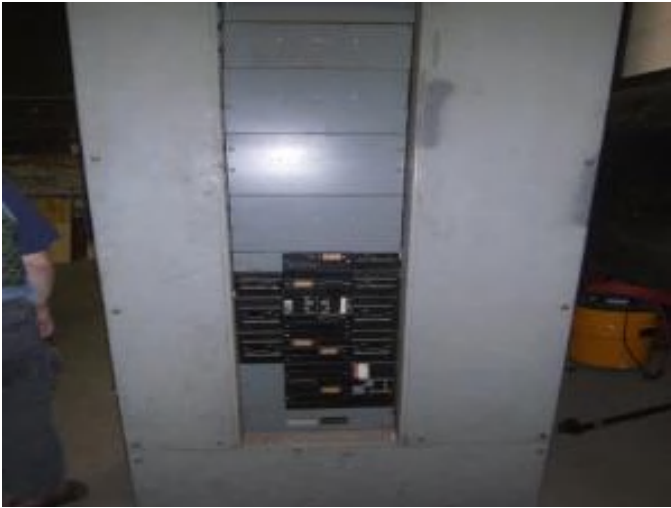
System: D5010 - Electrical Service/Distribution

Location: Electrical Room

Distress: Inadequate

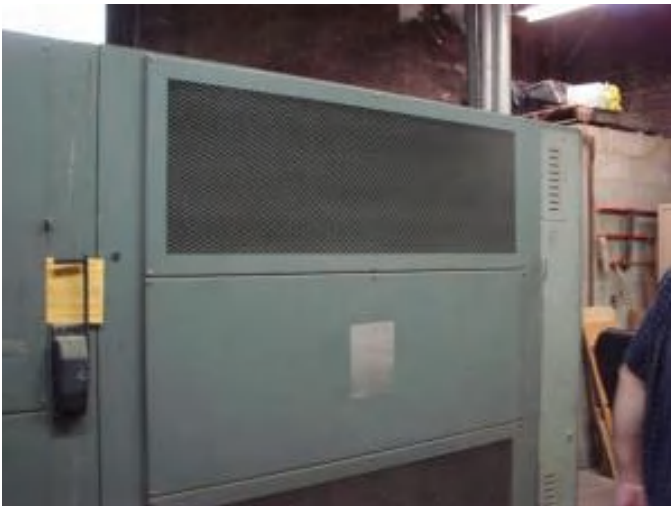
System: D5010 - Electrical Service/Distribution

Location: Electrical Room

Distress: Inadequate

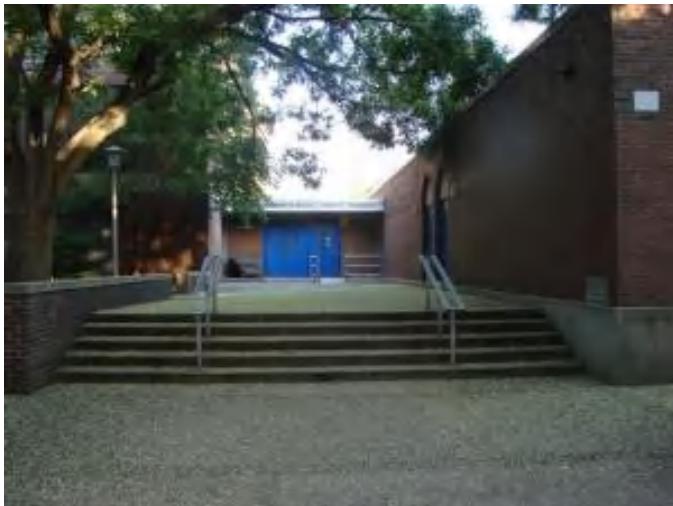
System: D5030 - Communications and Security

Location: interior/exterior and Main Entrance

Distress: Inadequate

Notes: Add video surveillance to interior, main entrance/courtyard.

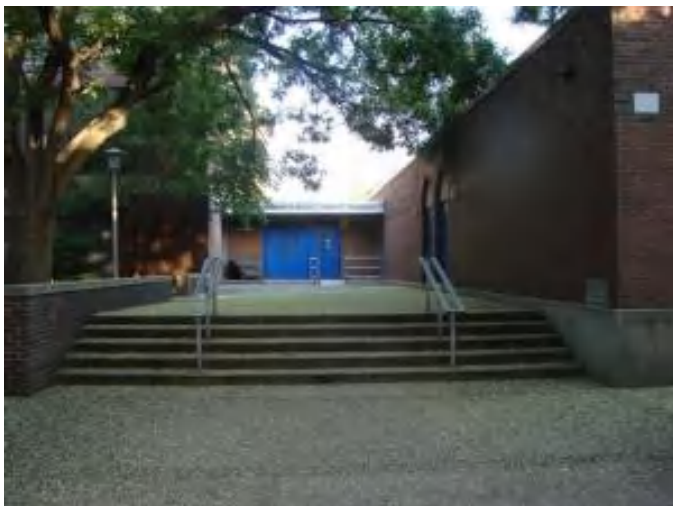
System: D5030 - Communications and Security

Location: Main Entrance/court yard

Distress: Inadequate

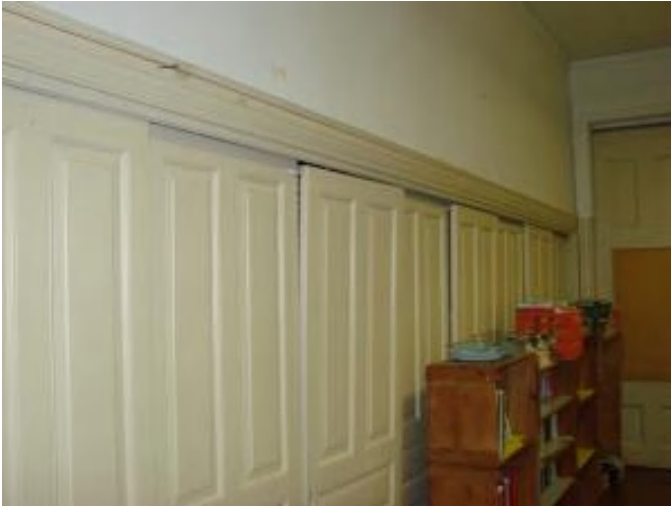
System: C1010 - Partitions

Location: Interior

Distress: Damaged

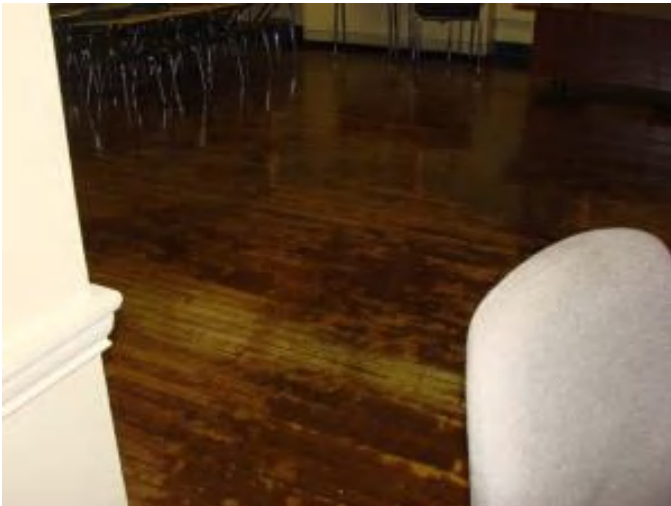
System: C3020414 - Wood Flooring

Location: Interior

Distress: Beyond Service Life

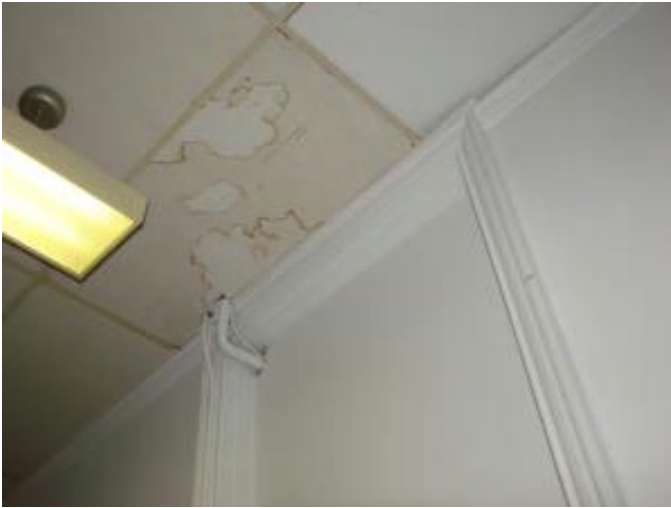
System: C3030 - Ceiling Finishes

Location: Interior

Distress: Beyond Service Life

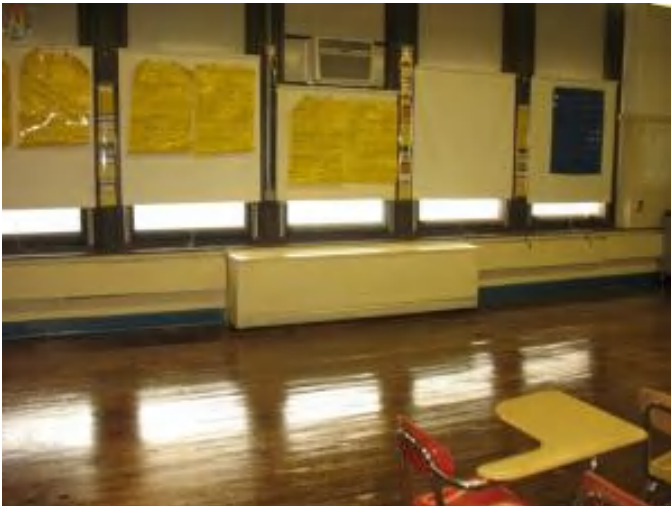
System: D3030 - Cooling Generating Systems

Location: Throughout building

Distress: Inadequate

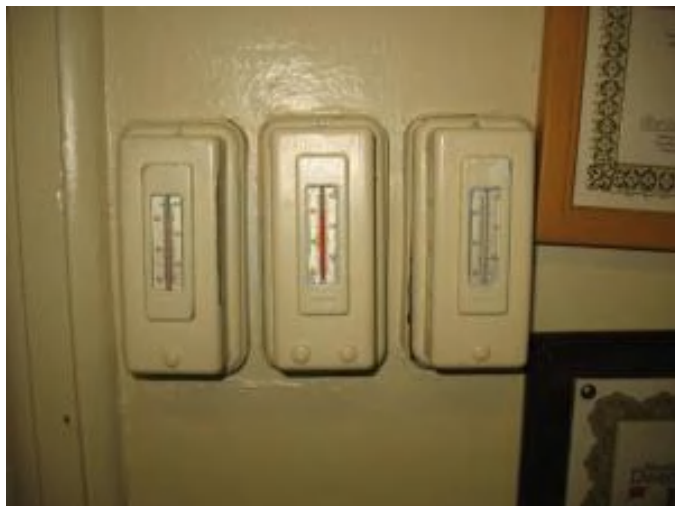
System: D3060 - Controls & Instrumentation

Controls & Instrumentation - The original pneumatic systems still provide basic control functions. Pneumatic room thermostats are intended to control the steam radiator control valves. In reality the radiator control valves are wide open and heating control is achieved via the boilers. Pneumatic control air is supplied from a duplex Quincy compressor and air drying system located in the boiler room. The original control valves and pneumatic actuators are beyond their service life and should be rebuilt or replaced. These controls should be converted to DDC.

Location: Throughout building

Distress: Inadequate

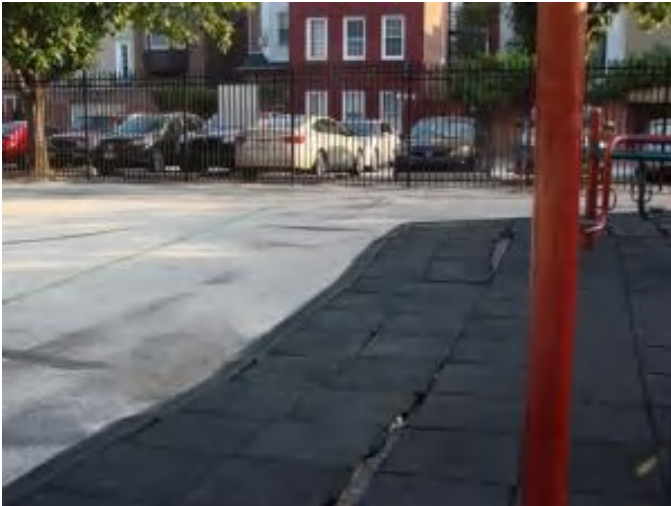
System: G2030 - Pedestrian Paving

Location: Grounds/ site

Distress: Beyond Service Life

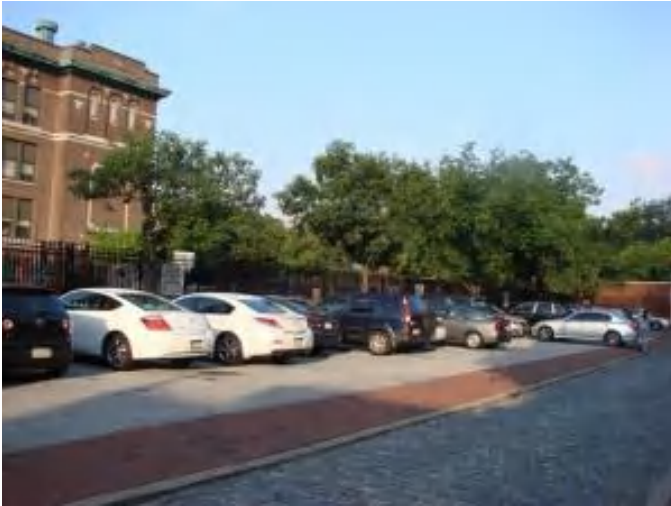
System: G2020 - Parking Lots

There is a parking lot at the North West corner of the site. It is partially fenced with 14 spaces inside and 19 spaces outside, directly accessible from Cypress St. The pavement is in good condition; however, the aisle striping is faded and missing in 80% of area.

Location: Grounds/ site

Distress: Beyond Service Life

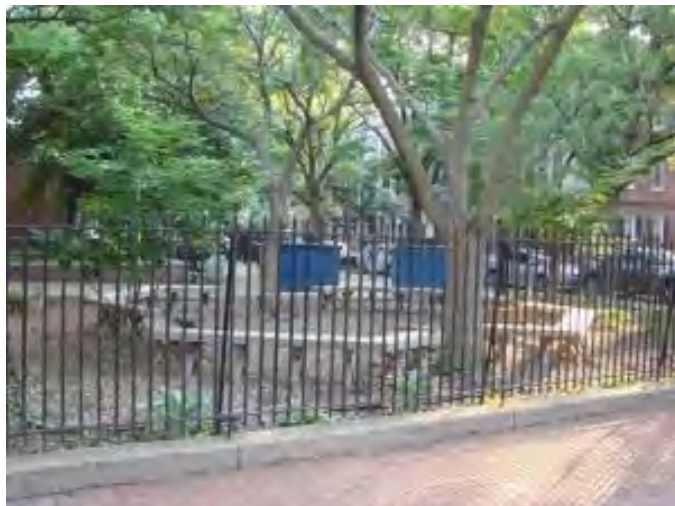
System: G2040 - Site Development

Location: Grounds/ site

Distress: Beyond Service Life
