Facility Condition Assessment Summary Report

McClure School

School District of Philadelphia
S738001; McClure
Final
Site Assessment Report

January 30, 2017

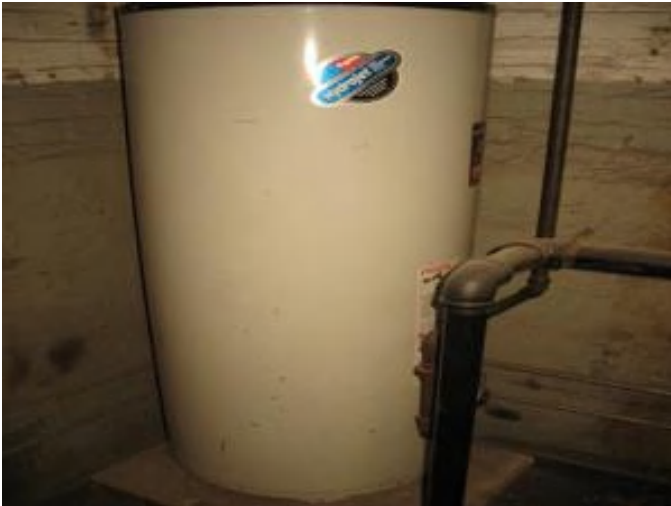
System: D2020 - Domestic Water Distribution

One Bradford White gas fired, 48 gallon, vertical hot water heater with circulating pump supplies hot water for domestic use. The unit is located in the boiler room on the basement level and has an installation date of 2000. The hot water heater is equipped with a T&P relief valve. The domestic hot water heater is beyond its service life and should be replaced in the next 1-2 years.

Location: Boiler room

Distress: Beyond Service Life

Notes: Replace the existing vertical gas fired, 48 gallon, domestic hot water heater which is beyond its service life with a new gas fired hot water heater.

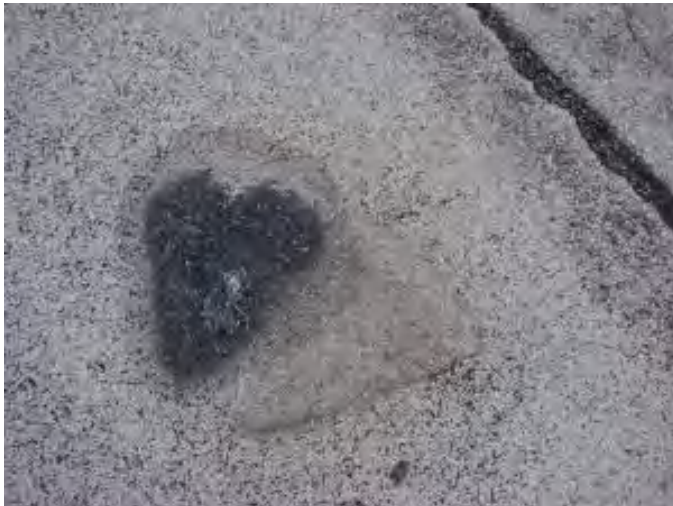
System: B3010105 - Built-Up

Roofing is typically built-up, over 25 years old. All roofing and flashing is typically in poor condition with severe deterioration of the built-up system including water ponding and soft spots; building engineer reported that several leaks have been repaired.

Location: Exterior

Distress: Beyond Service Life

Notes: Install all new roofing system including insulation within next 4 to 5 years; tear-down existing roofing; install flashing, counter flashing and reglets

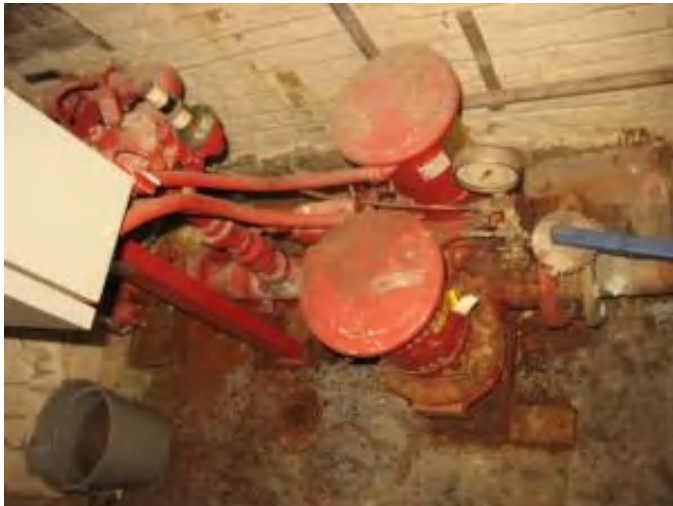
System: D2020 - Domestic Water Distribution

Location: Boiler room

Distress: Damaged

Notes: Replace the skid mounted duplex 5HP domestic water booster pumps and isolation valves on the incoming domestic water line which show signs of rust damage.

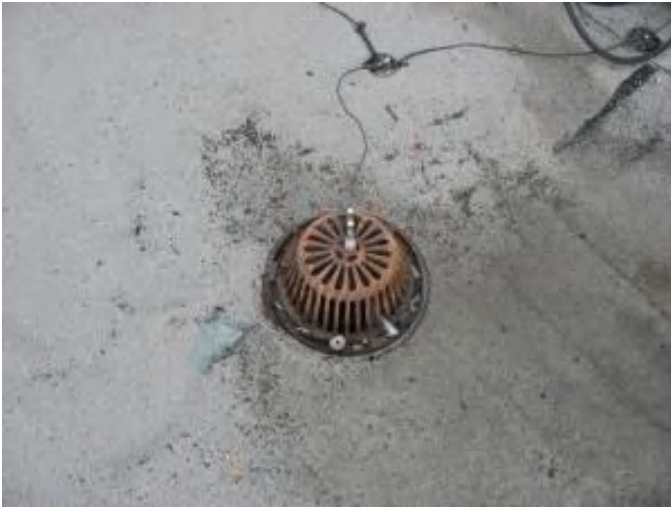
System: D2040 - Rain Water Drainage

Rain Water Drainage - Rain water drains from the roof are routed through mechanical chases in the building and appear to be original. Sections of the cast iron piping with hub and spigot fittings have been replaced with steel piping and no-hub fittings. The Building Engineer reported that rain leaders leak in several places within the building. The District should hire a qualified contractor to examine the rain water drainage piping using video cameras to locate and replace any damaged piping and to further quantify the extent of potential failures.

Location: Throughout building

Distress: Damaged

Notes: Hire a qualified contractor to perform a detailed examination of the rain water drainage piping using visual inspection and video cameras to locate and replace any damaged piping and to further quantify the extent of potential failures.

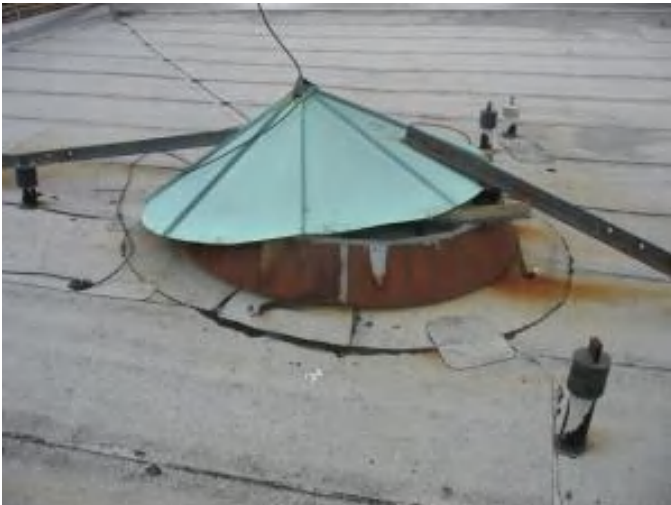
System: D3040 - Distribution Systems

Location: Roof

Distress: Damaged

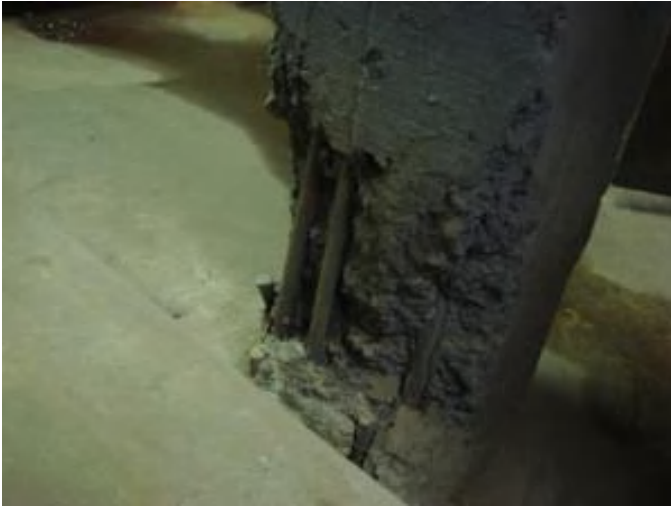
System: B1010 - Floor Construction

Location: Interior/ basement

Distress: Damaged

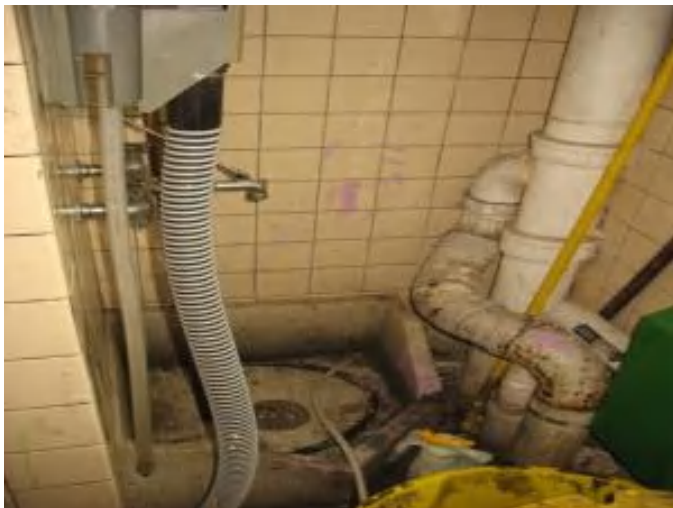
System: D2030 - Sanitary Waste

The maintenance staff reported mostly minor problems with the sanitary waste piping systems. The original sewer piping has been in service for over 100 years and will require more frequent attention from the maintenance staff as time passes. The District should hire a qualified contractor to examine the sanitary waste piping using video cameras to locate and replace any damaged piping and to further quantify the extent of potential failures.

Location: Throughout building
Distress: Beyond Service Life
Category: 3 - Operations / Maint.
Priority: 3 - Response Time (3-4 yrs)
Correction: Inspect sanitary waste piping and replace damaged sections. (+50KSF)
Qty: 57,500.00
Unit of Measure: S.F.
Estimate: \$282,080.52
Assessor Name: System
Date Created: 11/13/2015

Notes: Hire a qualified contractor to perform a detailed examination of the sanitary waste piping using visual inspection and video cameras to locate and replace any damaged piping and to further quantify the extent of potential failures.

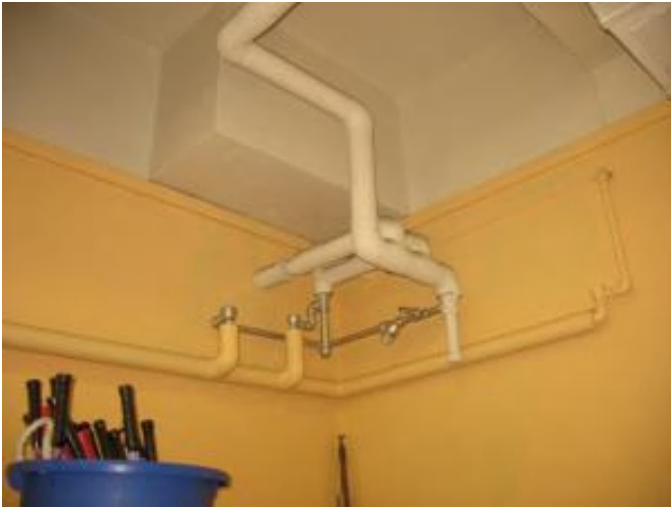
System: D3040 - Distribution Systems

Distribution Systems - Steam piping is black steel with welded fittings. The condensate piping is black steel with threaded fittings. Steam and condensate piping mains from the basement level run up through the building to the radiators on all three floors. The distribution piping has been in use well beyond its service life and will require more frequent attention from the maintenance staff to address pipe/valve failures as time passes. The District should hire a qualified contractor to examine the steam and condensate piping and perform additional testing to locate and replace any damaged piping and to further quantify the extent of potential failures. The District should budget for replacing this piping over the next 10 years.

Location: Throughout building

Distress: Beyond Service Life

Notes: Hire a qualified contractor to examine the steam piping, in service for over 100 years, and perform additional testing to locate and replace any damaged piping and to further quantify the extent of potential failures.

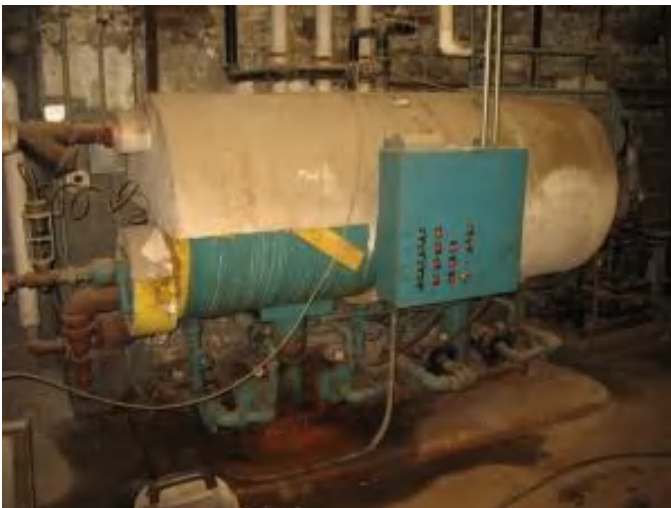
System: D3040 - Distribution Systems

The condensate receiver and boiler feed tank assembly and four (4) pumps are installed in the boiler room. The feed tank appears to be in good condition but the feed pumps are showing signs of rust damage, two of the pumps should be replaced. The Building Engineer reported that there is no steam in the boiler room when he runs the boilers.

Location: Boiler room

Distress: Damaged

Notes: Replace two (2) of the boiler feed water pumps which are damaged from rust.

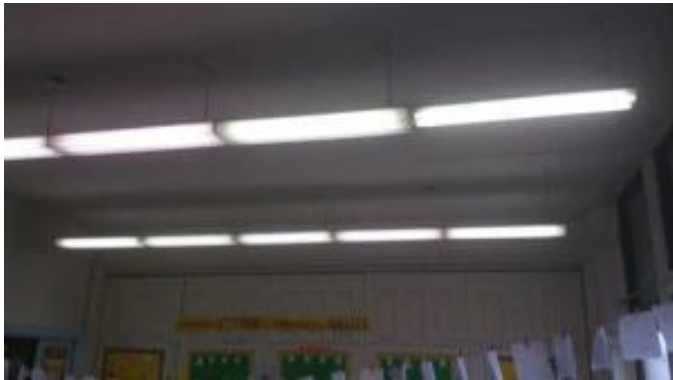
System: D5020 - Lighting and Branch Wiring

Lighting - Interior building is illuminated by various types of fixtures. They include fluorescent lighting (with T-12 & T-8 lamp) in majority of the areas, including; classrooms, corridor, offices, and the Kitchen. Surface or pendant mounted industrial fluorescent fixtures are used in mechanical and electrical rooms. The Gymnasium also has old HID fixtures. The majority of interior lighting fixtures is in a poor condition and has reached the end of their useful service.

Location: throughout the building

Distress: Beyond Service Life

Notes: Install new a lighting system for the entire building•

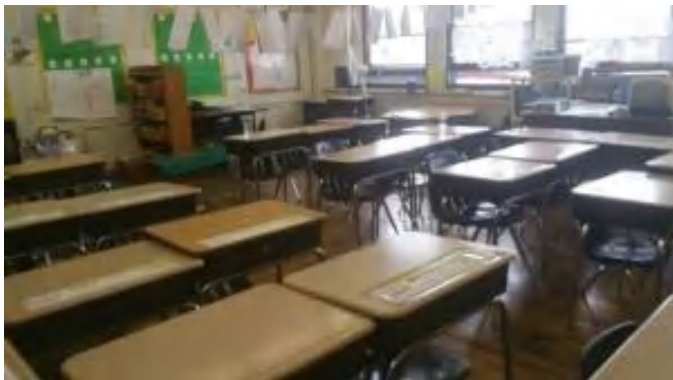
System: D5020 - Lighting and Branch Wiring

Location: throughout the building

Distress: Inadequate

Notes: Install new receptacles in all classrooms and other areas (minimum two receptacles on each wall).

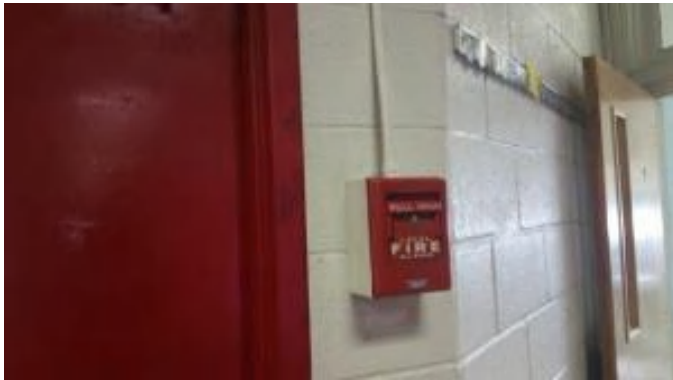
System: D5030 - Communications and Security

Location: throughout the building
Distress: Health Hazard / Risk
Category: 1 - Health & Safety
Priority: 3 - Response Time (3-4 yrs)
Correction: Replace fire alarm system
Qty: 1.00
Unit of Measure: S.F.
Estimate: \$489,008.76
Assessor Name: System
Date Created: 01/06/2016

Notes: Install a new automated FA System

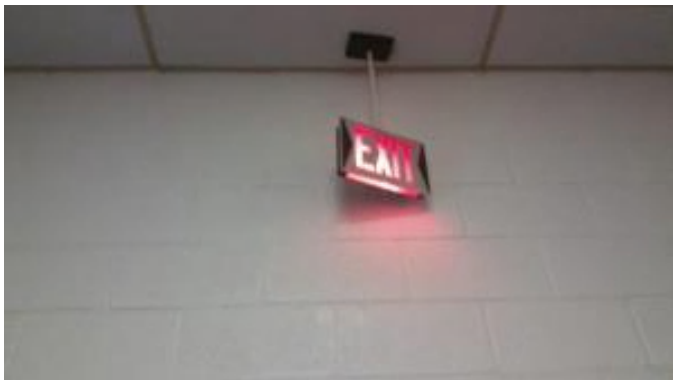
System: D5090 - Other Electrical Systems

Location: throughout the building
Distress: Beyond Service Life
Category: 3 - Operations / Maint.
Priority: 3 - Response Time (3-4 yrs)
Correction: Add Emergency/Exit Lighting
Qty: 1.00
Unit of Measure: Ea.
Estimate: \$331,983.88
Assessor Name: System
Date Created: 01/06/2016

Notes: Install new emergency exit signs emergency lights.

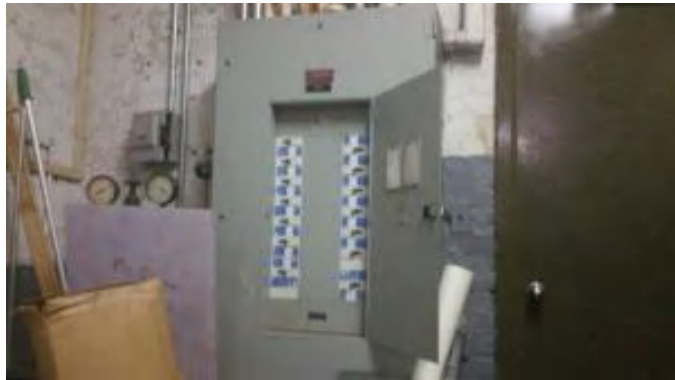
System: D5090 - Other Electrical Systems

Location: electrical room

Distress: Inadequate

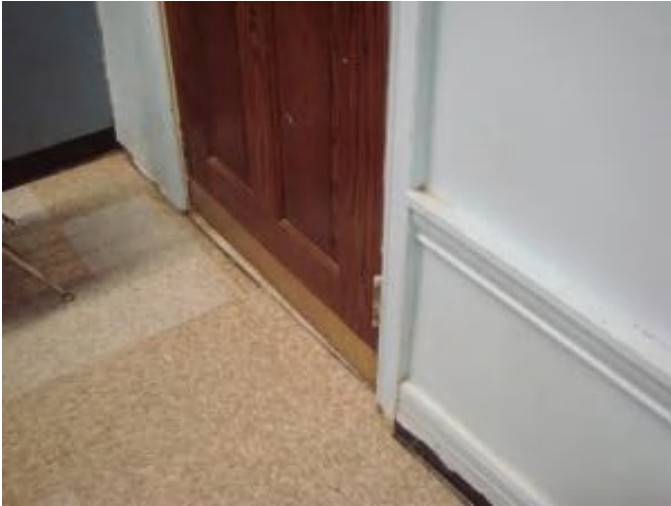
System: A1030 - Slab on Grade

Location: Interior/ basement

Distress: Failing

Notes: Repair deteriorated slab section in basement (room 006)

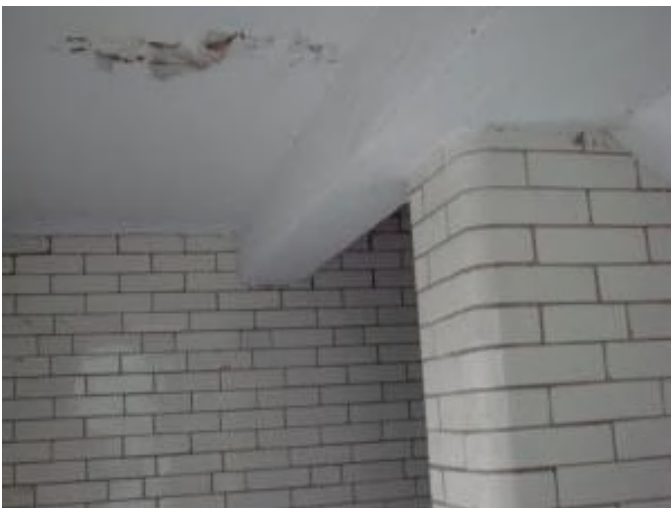
System: B1010 - Floor Construction

The main structure consists typically of cast-in-place concrete columns, beams and one-way concrete slabs. Above ground floor slabs are generally in good condition, however floor slabs in fire tower show minor structural deterioration including spalled concrete and exposed, and rusting reinforcement. One of the concrete columns in boiler room is damaged with exposed reinforcing.

Location: Exterior/ Interior

Distress: Damaged

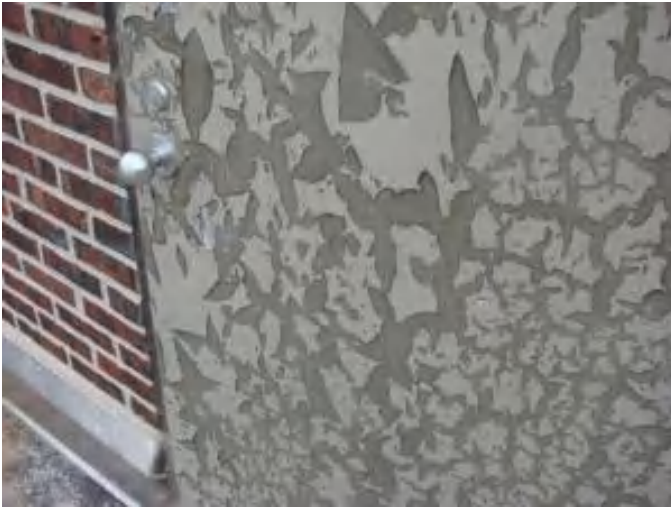
System: B2030 - Exterior Doors

Exterior doors are typically hollow metal in fair to poor condition; they are beyond their service life. Generally, the building is not accessible per ADA requirements due to first floor-grade separation and elevation difference between floors, with no ramps or lifts.

Location: Exterior

Distress: Beyond Service Life

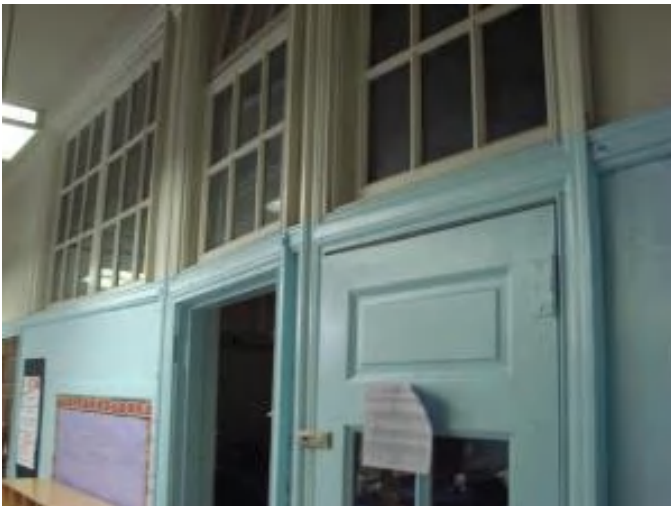
System: C1020 - Interior Doors

Location: Interior

Distress: Beyond Service Life

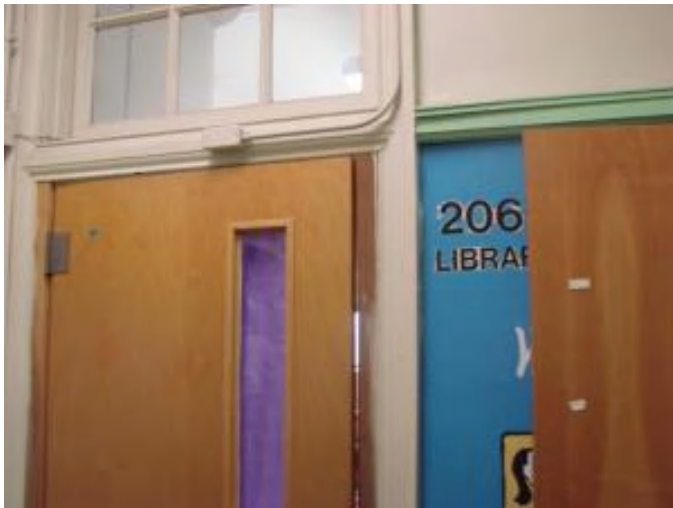
System: C1030 - Fittings

Location: Interior

Distress: Beyond Service Life

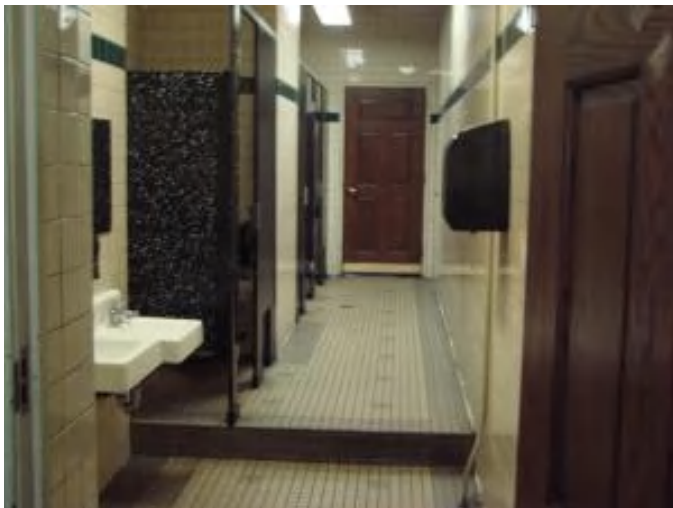
System: C1030 - Fittings

Location: Interior

Distress: Building / MEP Codes

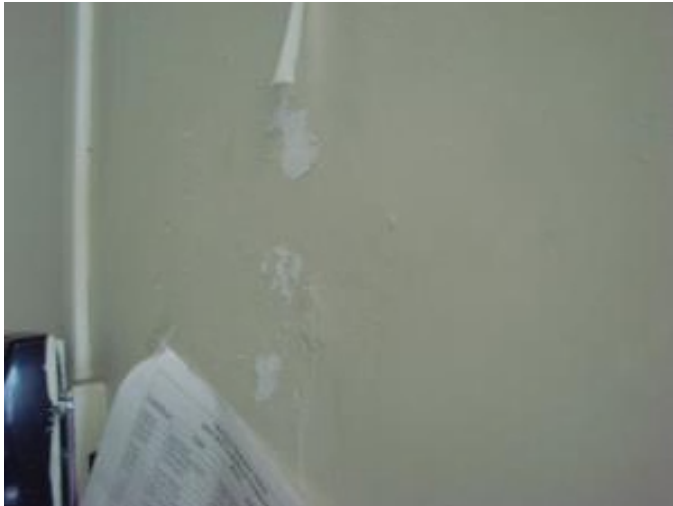
System: C3010230 - Paint & Covering

Location: Interior

Distress: Beyond Service Life

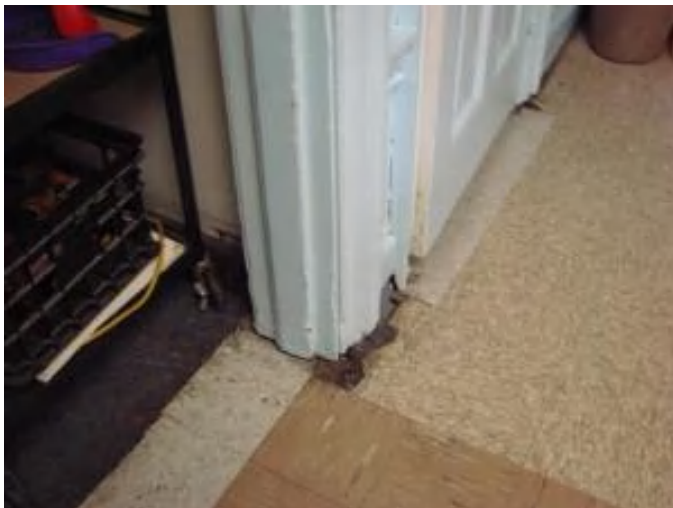
System: C3020413 - Vinyl Flooring

Location: Interior

Distress: Damaged

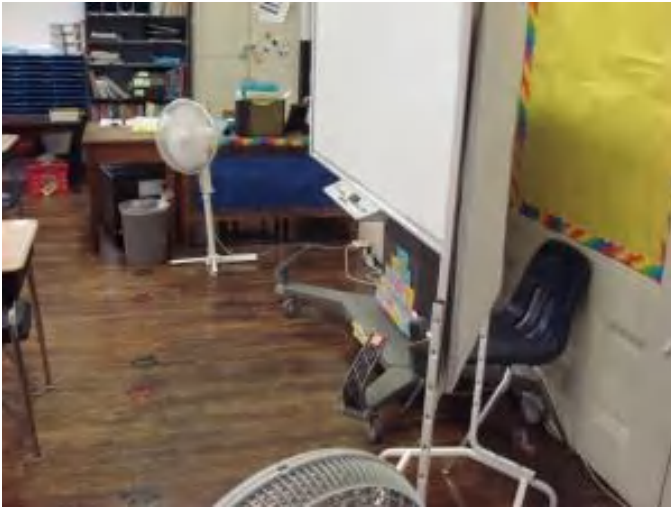
System: C3020414 - Wood Flooring

Flooring in classrooms is generally hardwood in fair to poor condition; and patterned concrete in most corridors in the original building. Some classrooms and gym have VCT installed in mid 2000's. Floor in toilets is typically ceramic tile installed in late 2000's.

Location: Interior

Distress: Beyond Service Life

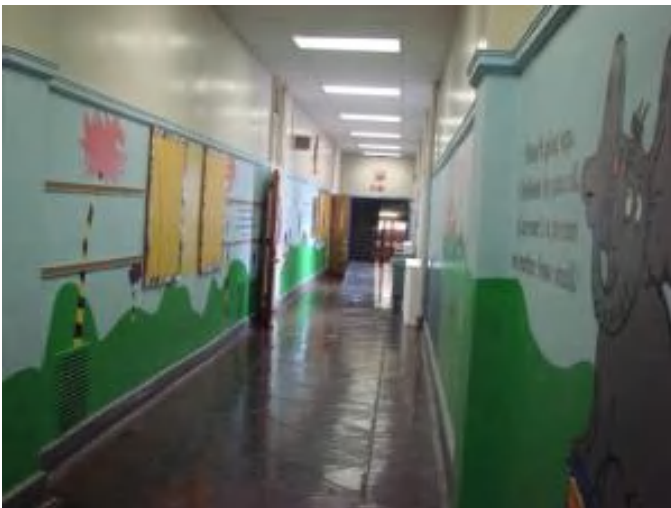
System: C3030 - Ceiling Finishes

Location: Interior

Distress: Beyond Service Life

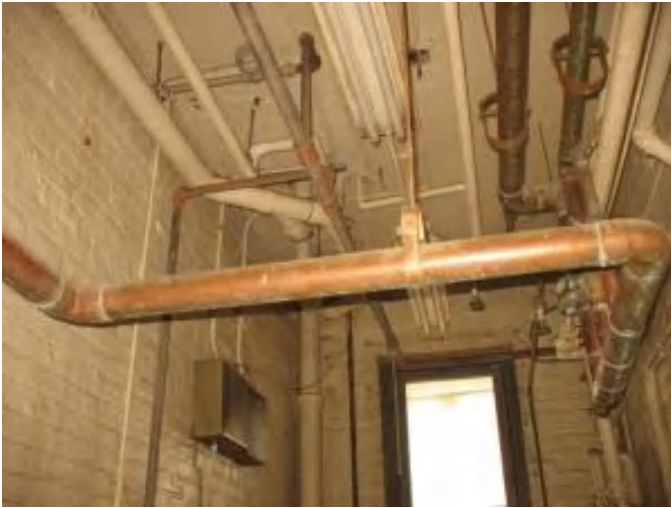
System: D2020 - Domestic Water Distribution

Location: Throughout building

Distress: Beyond Service Life

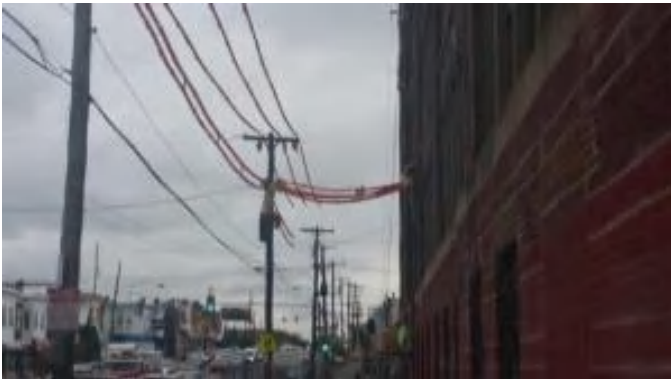
System: D5010 - Electrical Service/Distribution

Site electrical service - The primary power is at 13.2KV from the street power pole which goes underground and feeds a transformer (500 KVA, 13.2KV – 120V/208V, 3 Phase). The electrical service is old and has reached the end of its useful service. The main disconnect is rated at 1200A, 120V/208V, 3 phase, and is located in main electrical room. The PECO meter (PECO MU-16455) is also located inside the electrical room. The service entrance and the main building electrical distribution systems are old, in very poor condition. They provide power for lighting and receptacles of the building, and not the HVAC System.

Location: electrical room

Distress: Beyond Service Life

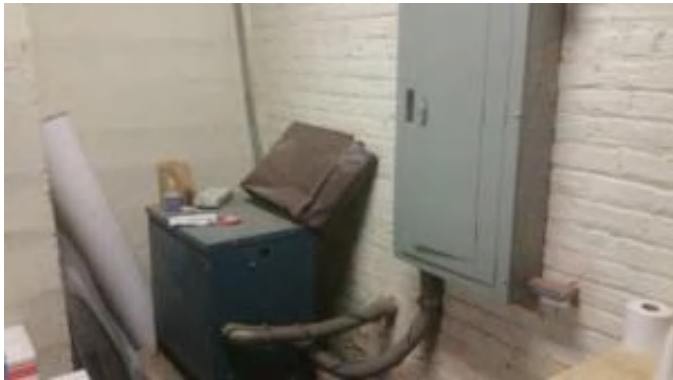
System: D5010 - Electrical Service/Distribution

Location: throughout the building

Distress: Beyond Service Life

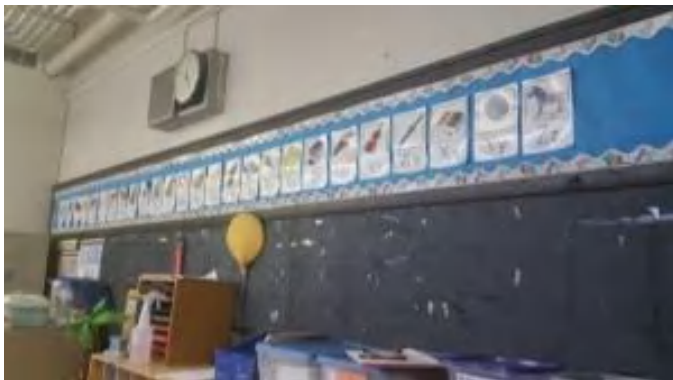
System: D5030 - Communications and Security

Location: throughout the building

Distress: Beyond Service Life

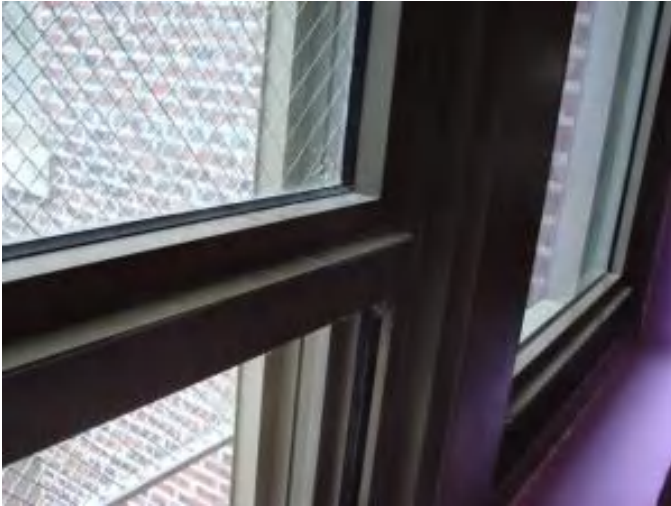
System: B2020 - Exterior Windows

The original windows were replaced in 1990's with extruded aluminum double hung windows, single, acrylic glazed. Basement windows are fitted with steel bar security screens, damaged and rusting. All windows are generally in good condition; however, they are not energy efficient.

Location: Exterior

Distress: Energy Efficiency

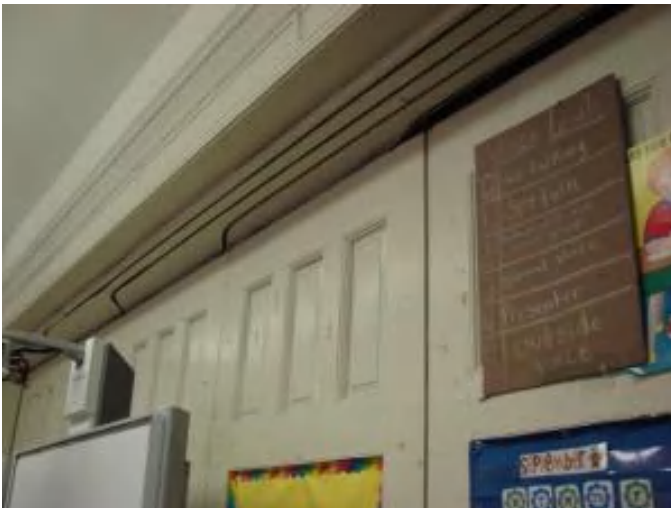
System: C1010 - Partitions

Location: Interior

Distress: Inadequate

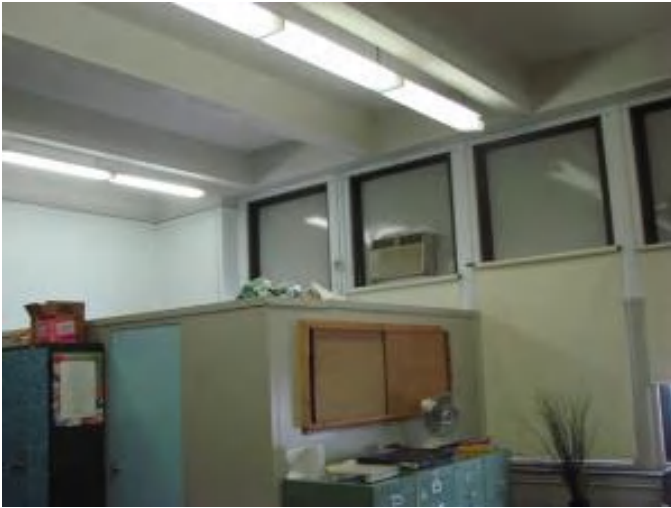
System: C3030 - Ceiling Finishes

Location: Interior

Distress: Beyond Service Life

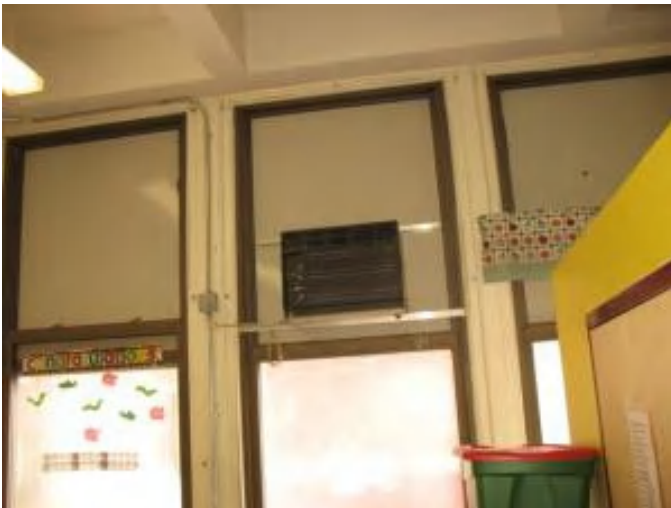
System: D3030 - Cooling Generating Systems

Terminal & Package Units - Several of the classrooms in the school building have window conditioning units that have an anticipated service life of only 10 years. Installing a 150 ton air-cooled chiller with pumps located in a mechanical room and chilled water distribution piping would supply more reliable air conditioning for the building with a much longer service life.

Location: Throughout building

Distress: Inadequate

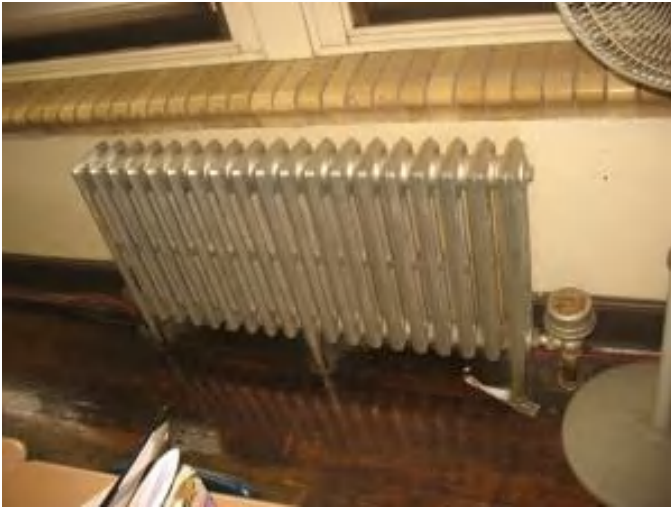
System: D3040 - Distribution Systems

Location: Classrooms

Distress: Building / MEP Codes

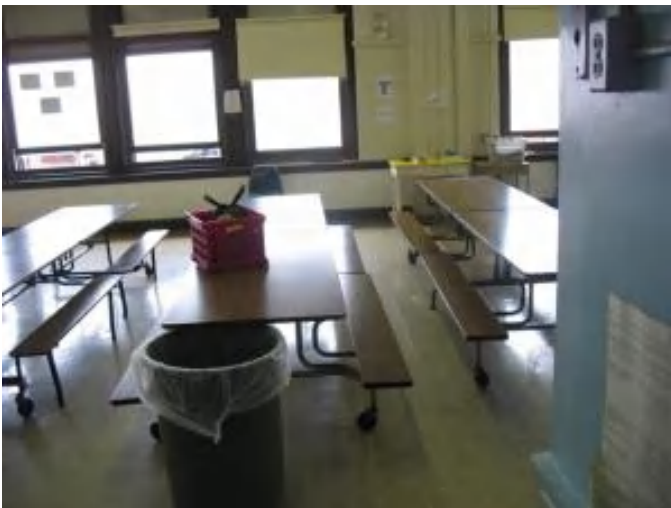
System: D3040 - Distribution Systems

Location: Cafeteria

Distress: Building / MEP Codes

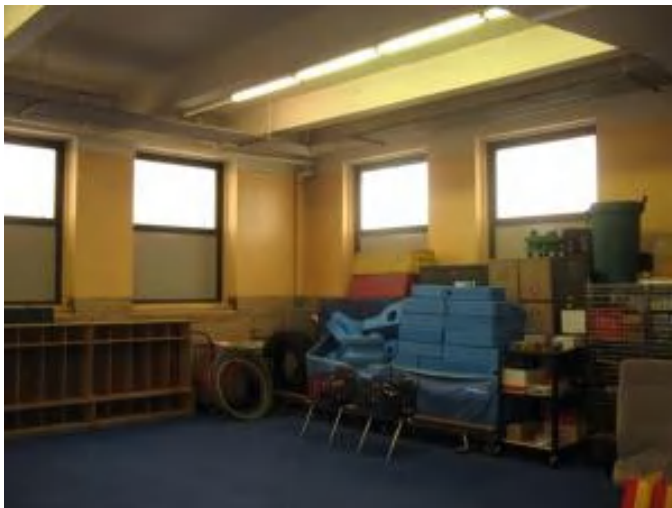
System: D3040 - Distribution Systems

Location: Gymnasium

Distress: Building / MEP Codes

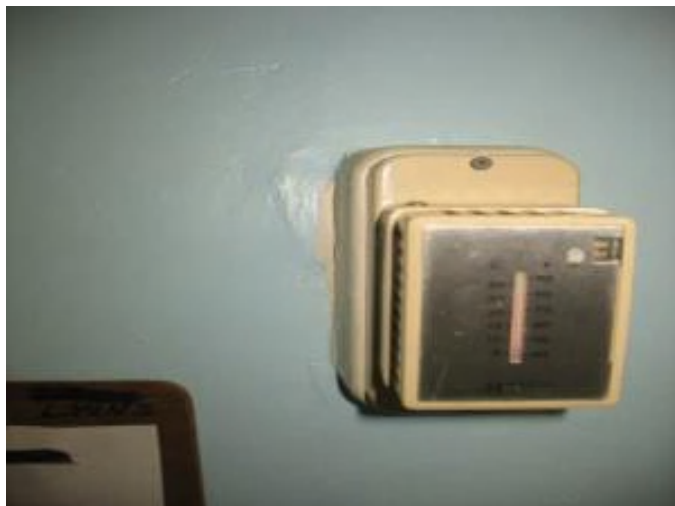
System: D3060 - Controls & Instrumentation

Controls & Instrumentation - The original pneumatic systems provide no control functions. Pneumatic room thermostats are intended to control the steam radiator control valves. In reality the radiator control valves are wide open and heating control is achieved via the boilers. Pneumatic control air is supplied from a Champion compressor and Champion air dryer. The pneumatic systems are beyond their service life and require too much attention from the maintenance staff. The original control valves and pneumatic actuators are beyond their service life and should be rebuilt or replaced. These controls should be converted to DDC.

Location: Throughout building

Distress: Energy Efficiency

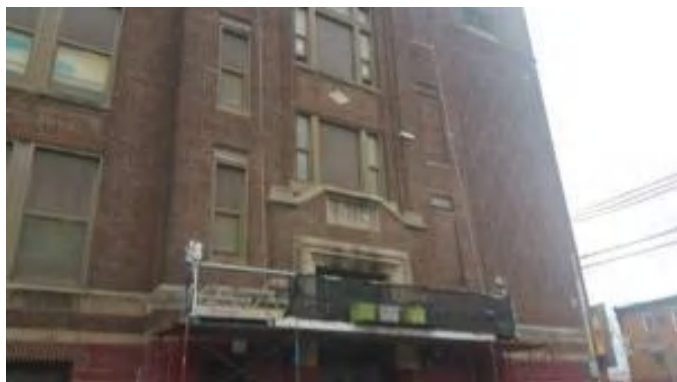
System: G4020 - Site Lighting

Location: Grounds

Distress: Inadequate

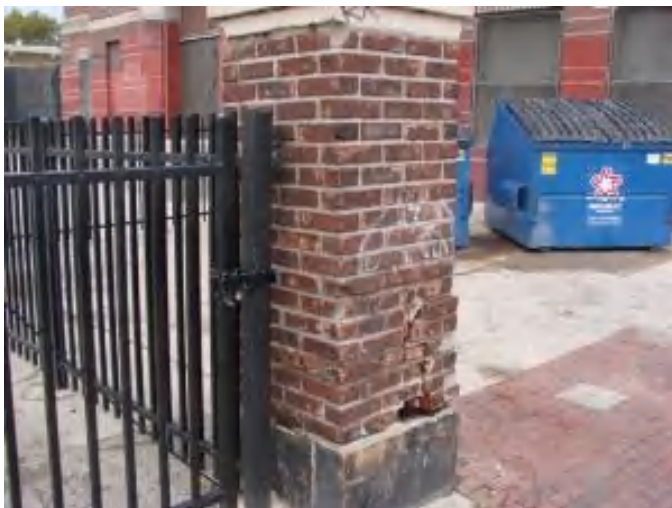
System: G2040 - Site Development

Location: Grounds

Distress: Damaged

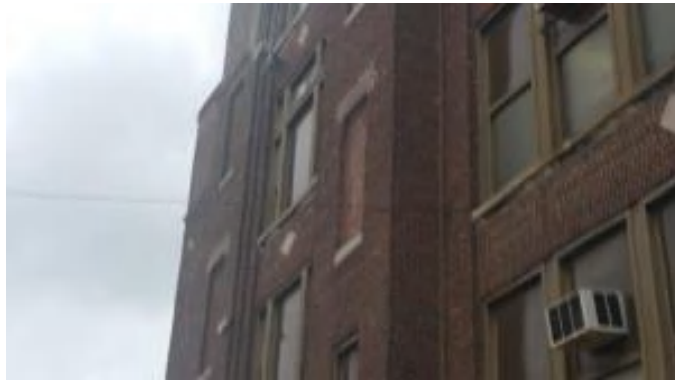
System: G4030 - Site Communications & Security

Location: Grounds

Distress: Inadequate

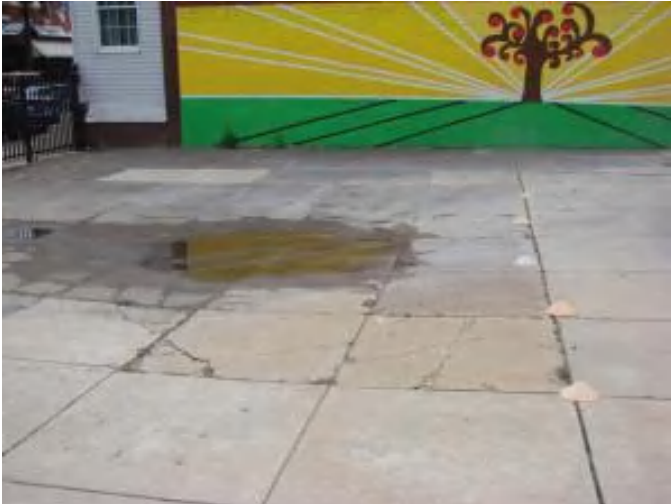
System: G2030 - Pedestrian Paving

Location: Grounds

Distress: Beyond Service Life

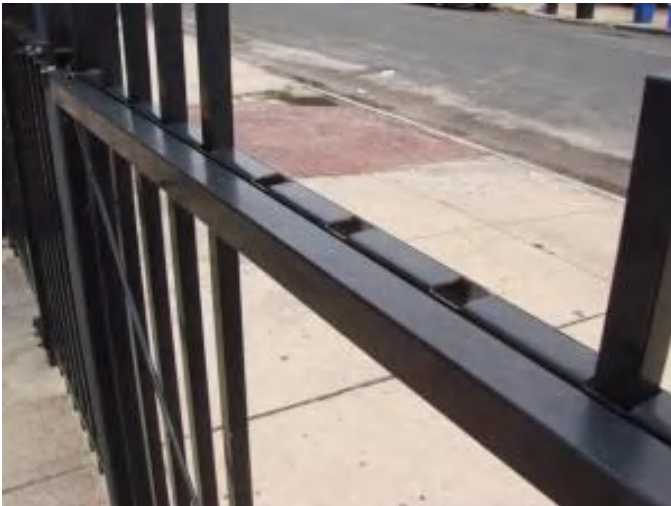
System: G2040 - Site Development

Location: Grounds

Distress: Damaged
