Facility Condition Assessment Summary Report

McDaniel School

McDaniel Annex (St Edmond) School

January 30, 2017

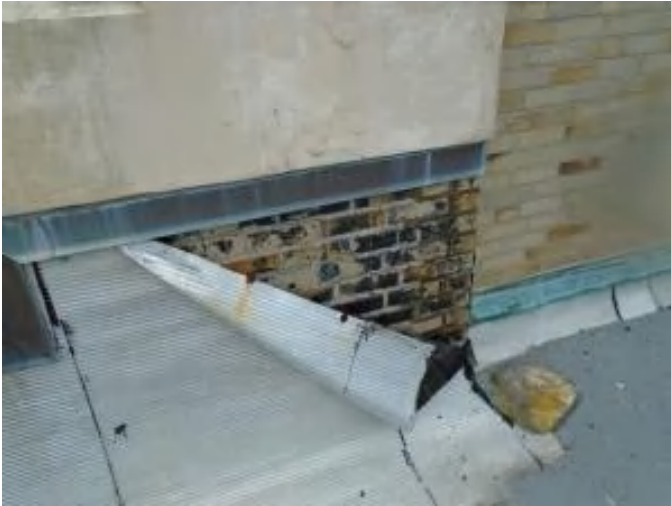
System: B3010105 - Built-Up

Location: Roof

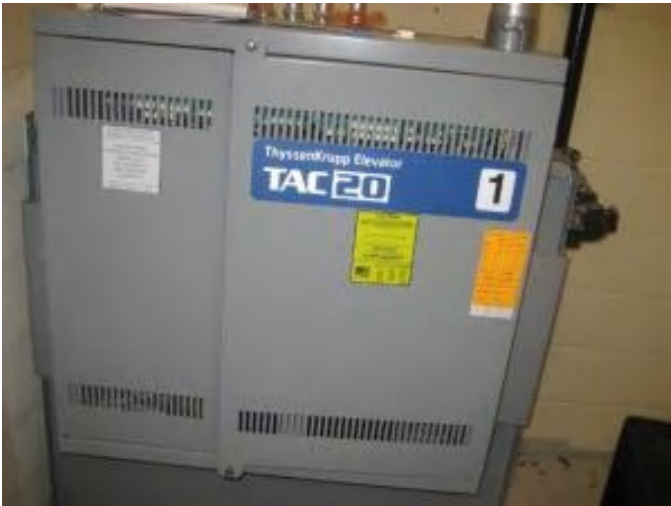
System: D1010 - Elevators and Lifts

Location: Elevator Machine room

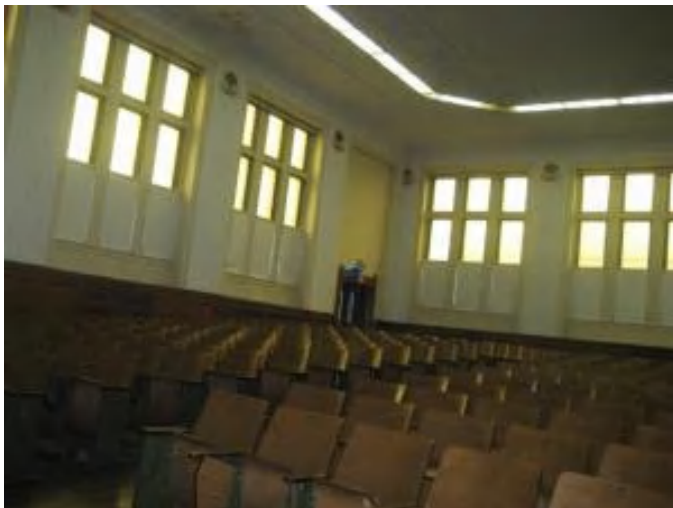
System: D5030 - Communications and Security

Location: Auditorium
Distress: Inadequate
Category: 4 - Capital Improvement
Priority: 2 - Response Time (2-3 yrs)
Correction: Add/Replace Sound System
Qty: 1.00
Unit of Measure: LS
Estimate: \$24,582.34
Assessor Name: Craig Anding
Date Created: 08/04/2015

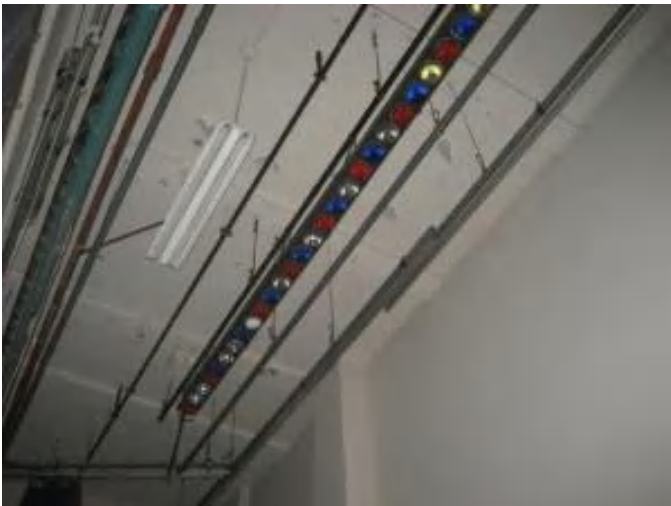
System: E1020 - Institutional Equipment

Location: Auditorium

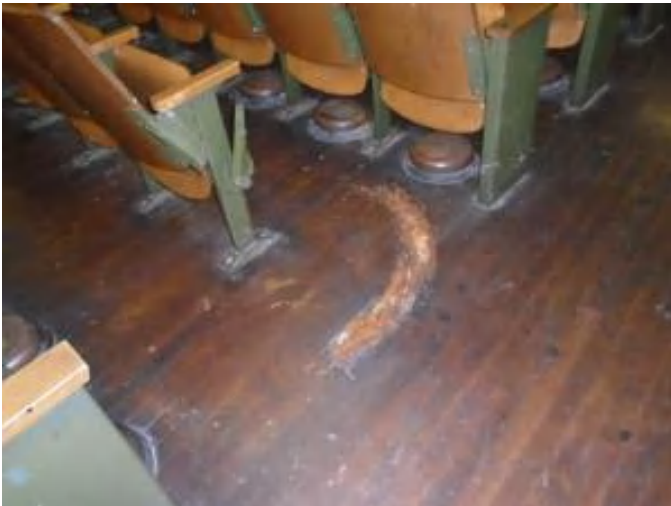
System: E2010 - Fixed Furnishings

Fixed furnishings include: fixed casework in classrooms, corridors and library, generally in good condition; window shades/blinds, generally in good condition; fixed auditorium seating is original, generally in fair condition with some damaged seats.

Location: Auditorium

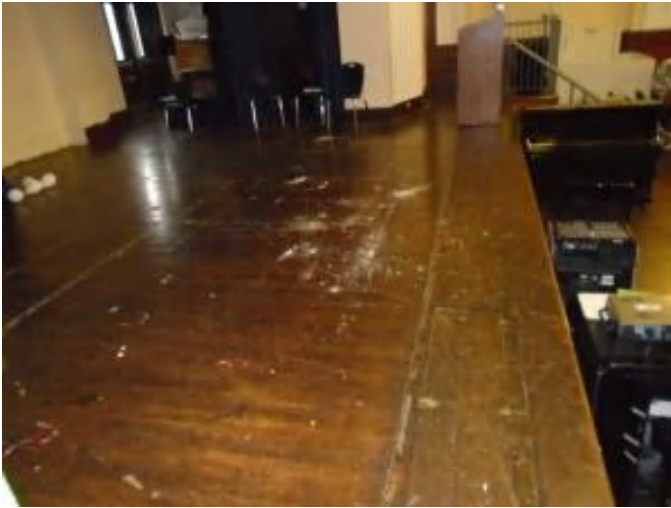
System: C3020414 - Wood Flooring

Location: Auditorium, stage
Distress: Appearance
Category: 3 - Operations / Maint.
Priority: 4 - Response Time (4-5 yrs)
Correction: Refinish wood floors
Qty: 4,200.00
Unit of Measure: S.F.
Estimate: \$45,221.15
Assessor Name: Craig Anding
Date Created: 08/07/2015

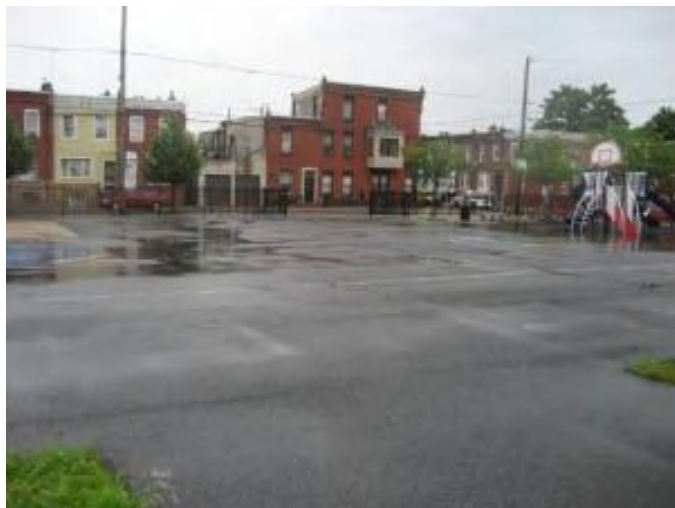
System: G4020 - Site Lighting

Location: Playground/parking

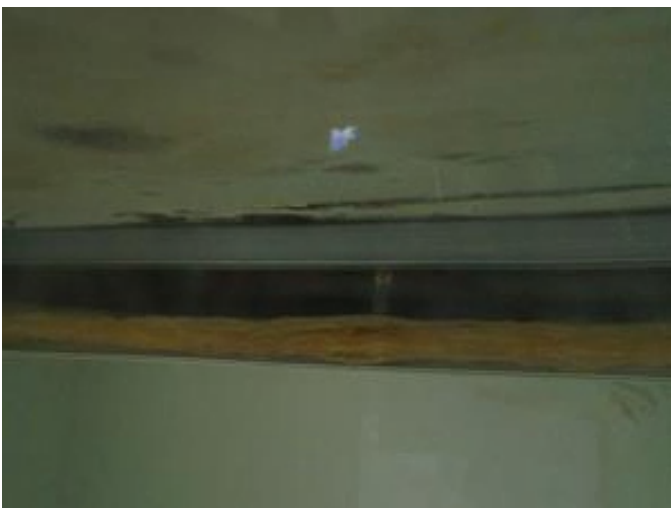
System: C3010230 - Paint & Covering

Location: Throughout

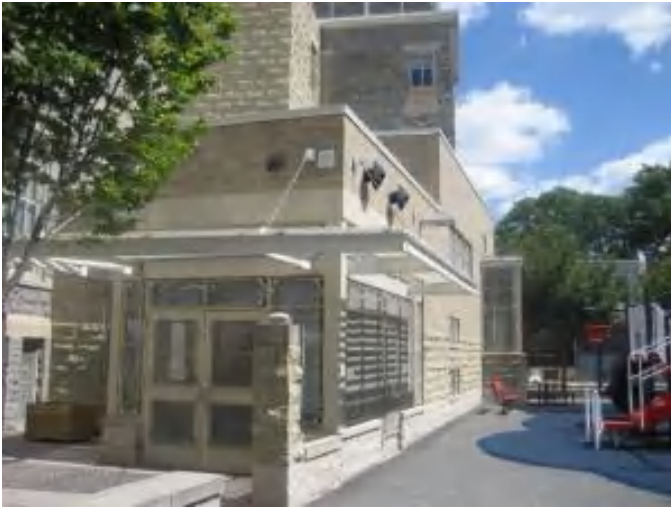
System: D5030 - Communications and Security

Location: Building Perimeter
Distress: Security Issue
Category: 1 - Health & Safety
Priority: 2 - Response Time (2-3 yrs)
Correction: Add/Replace Video Surveillance System
Qty: 12.00
Unit of Measure: Ea.
Estimate: \$142,988.74
Assessor Name: Ben Nixon
Date Created: 10/14/2015

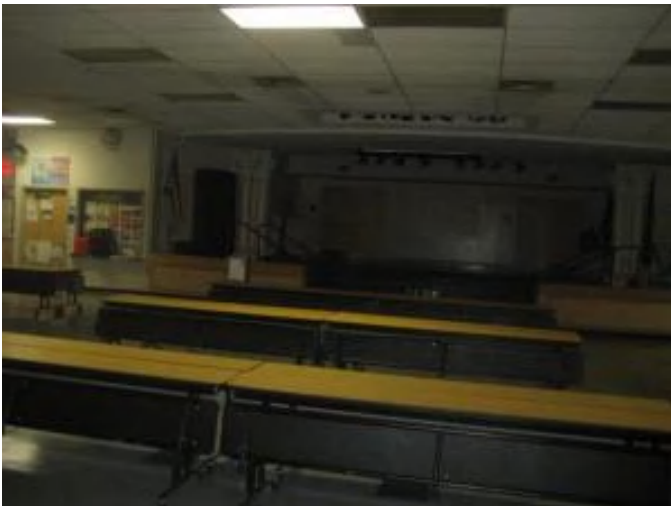
System: D5030 - Communications and Security

Location: Entire School
Distress: Failing
Category: 3 - Operations / Maint.
Priority: 2 - Response Time (2-3 yrs)
Correction: Add/Replace Clock System or Components
Qty: 45.00
Unit of Measure: Ea.
Estimate: \$10,876.26
Assessor Name: Ben Nixon
Date Created: 10/14/2015

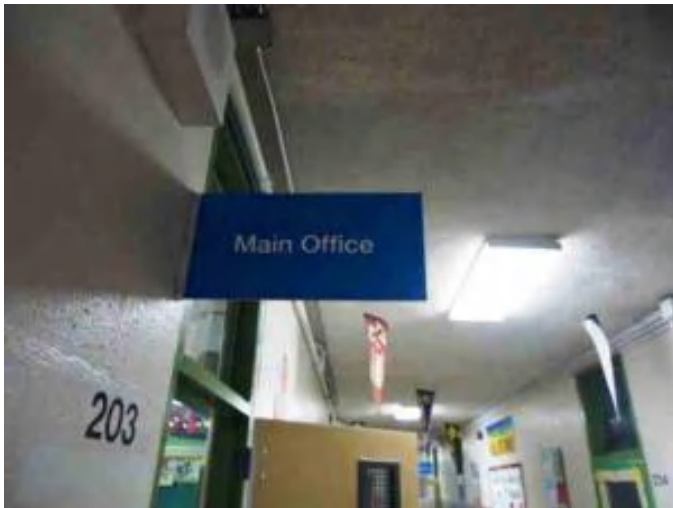
System: C1010 - Partitions

Location: Classrooms

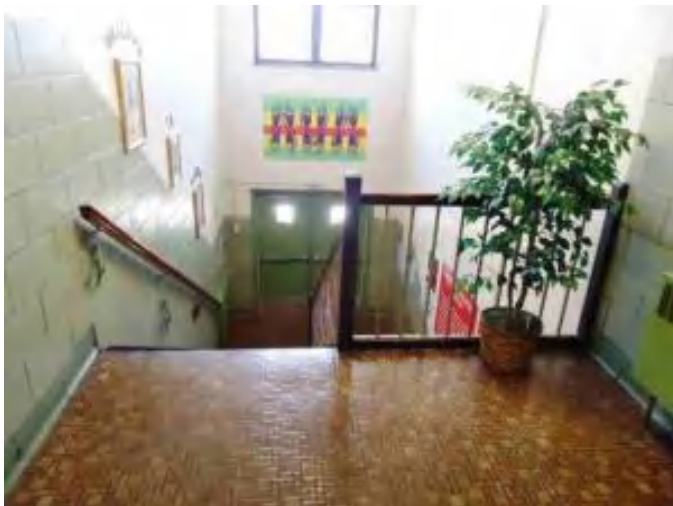
System: C2010 - Stair Construction

Location: Stairs

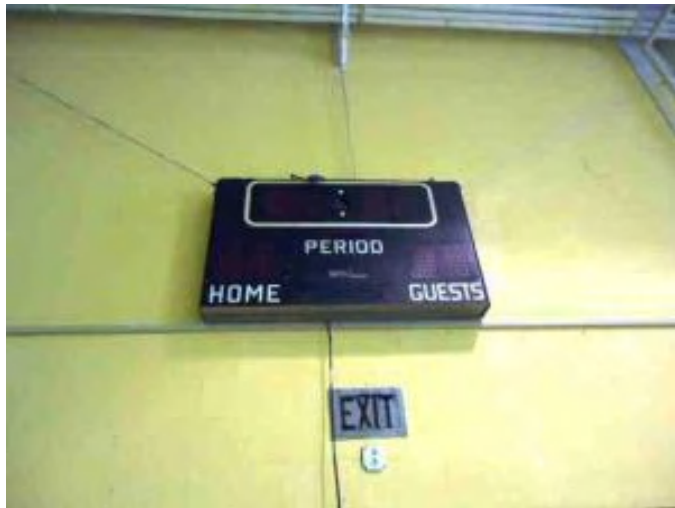
System: E1020 - Institutional Equipment

Location: Gym

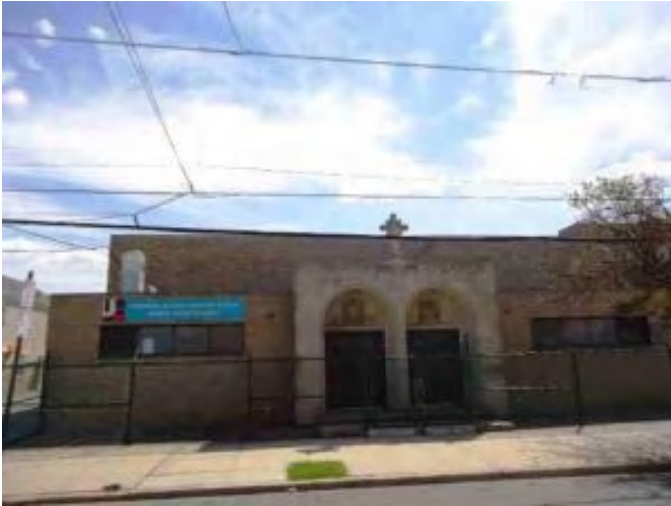
System: B2030 - Exterior Doors

Location: Exterior Elevation

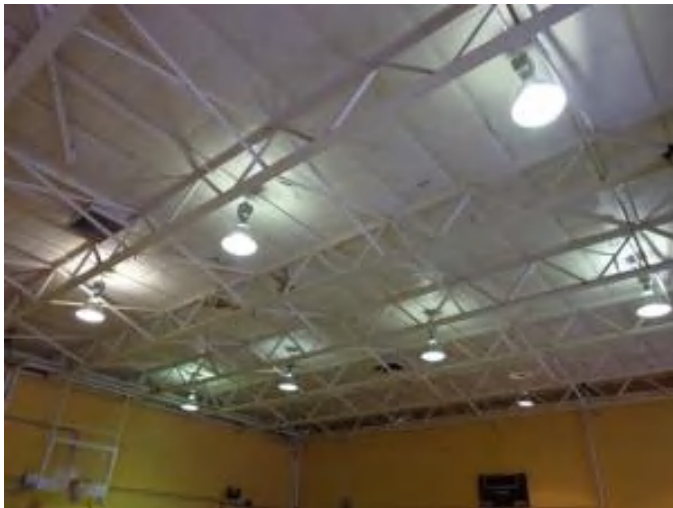
Location: Gym
Distress: Failing
Category: 3 - Operations / Maint.
Priority: 3 - Response Time (3-4 yrs)
Correction: Replace lighting fixtures
Qty: 16.00
Unit of Measure: Ea.
Estimate: \$53,605.73
Assessor Name: System
Date Created: 10/19/2015

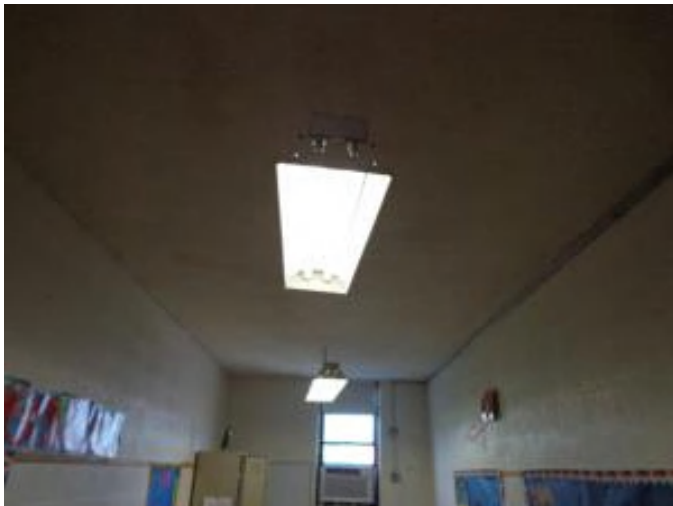
Location: Various rooms
Distress: Beyond Service Life
Category: 3 - Operations / Maint.
Priority: 3 - Response Time (3-4 yrs)
Correction: Replace lighting fixtures
Qty: 16.00
Unit of Measure: Ea.
Estimate: \$13,736.76
Assessor Name: System
Date Created: 10/19/2015

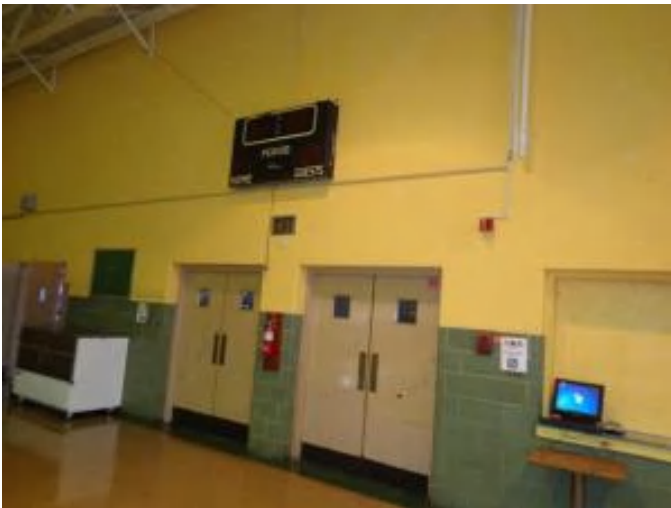
Location: Building wide
Distress: Life Safety / NFPA / PFD
Category: 1 - Health & Safety
Priority: 3 - Response Time (3-4 yrs)
Correction: Replace fire alarm system
Qty: 21,224.00
Unit of Measure: S.F.
Estimate: \$69,398.60
Assessor Name: System
Date Created: 10/19/2015

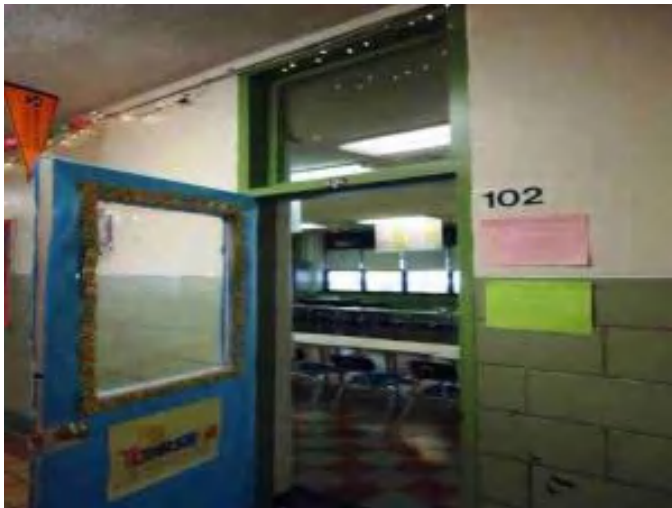
Location: Classroom
Distress: Damaged
Category: 3 - Operations / Maint.
Priority: 4 - Response Time (4-5 yrs)
Correction: Remove and replace interior doors - wood doors with hollow metal frames - per leaf
Qty: 80.00
Unit of Measure: Ea.
Estimate: \$381,646.97
Assessor Name: System
Date Created: 11/20/2015

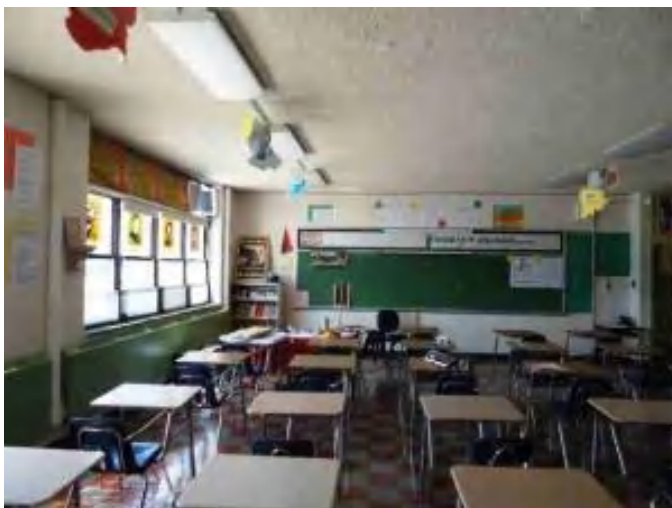
Location: Classrooms
Distress: Damaged
Category: 3 - Operations / Maint.
Priority: 4 - Response Time (4-5 yrs)
Correction: Replace blackboards with marker boards - pick the appropriate size and insert the quantities
Qty: 40.00
Unit of Measure: Ea.
Estimate: \$27,529.28
Assessor Name: System
Date Created: 11/20/2015

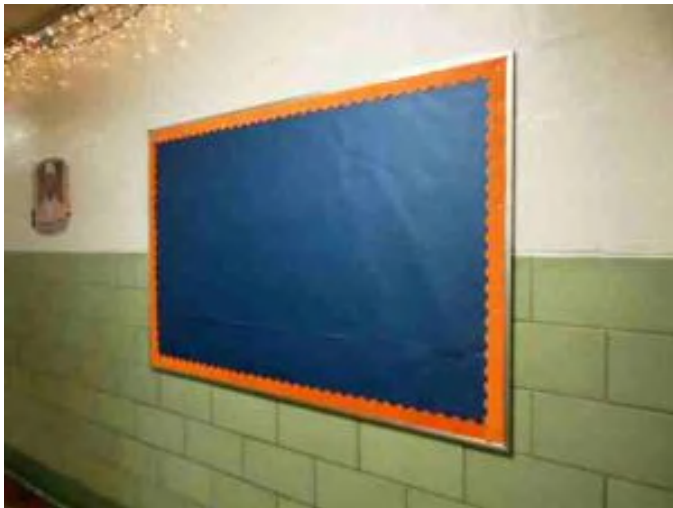
Location: Classrooms
Distress: Damaged
Category: 3 - Operations / Maint.
Priority: 4 - Response Time (4-5 yrs)
Correction: Remove and replace tackboards - select size
Qty: 6.00
Unit of Measure: Ea.
Estimate: \$4,756.35
Assessor Name: System
Date Created: 11/20/2015

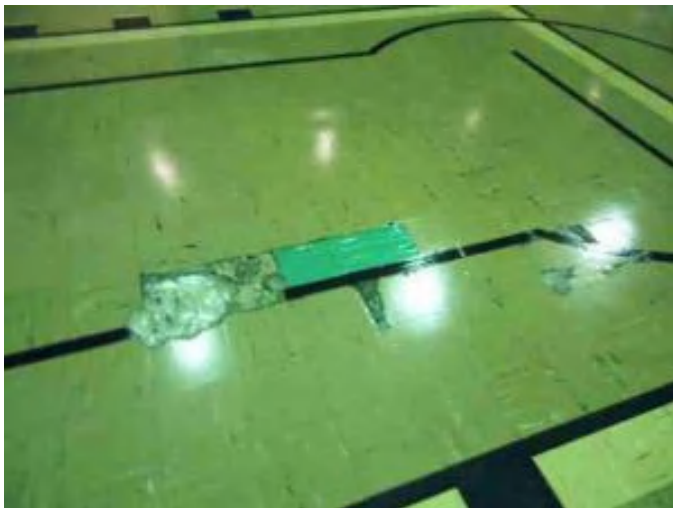
Location: Classrooms
Distress: Life Safety / NFPA / PFD
Category: 1 - Health & Safety
Priority: 4 - Response Time (4-5 yrs)
Correction: Remove VAT and replace with VCT - SF of area
Qty: 10,000.00
Unit of Measure: S.F.
Estimate: \$151,666.68
Assessor Name: System
Date Created: 11/20/2015

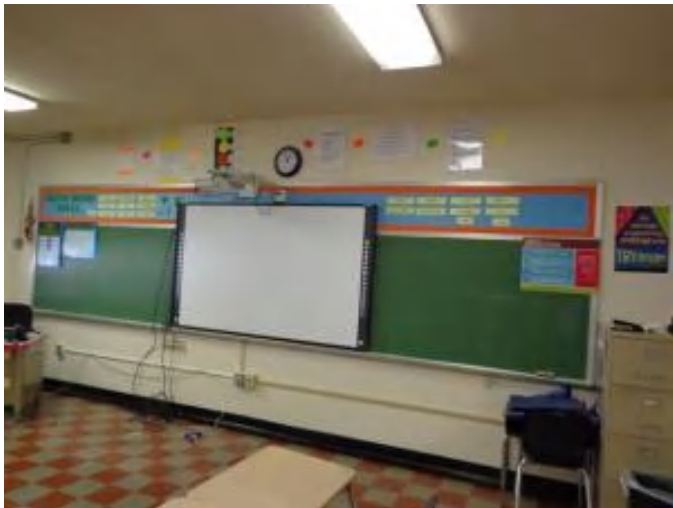
Location: Building wide
Distress: Inadequate
Category: 4 - Capital Improvement
Priority: 4 - Response Time (4-5 yrs)
Correction: Add/Replace Clock System or Components
Qty: 18.00
Unit of Measure: Ea.
Estimate: \$12,017.11
Assessor Name: System
Date Created: 10/19/2015

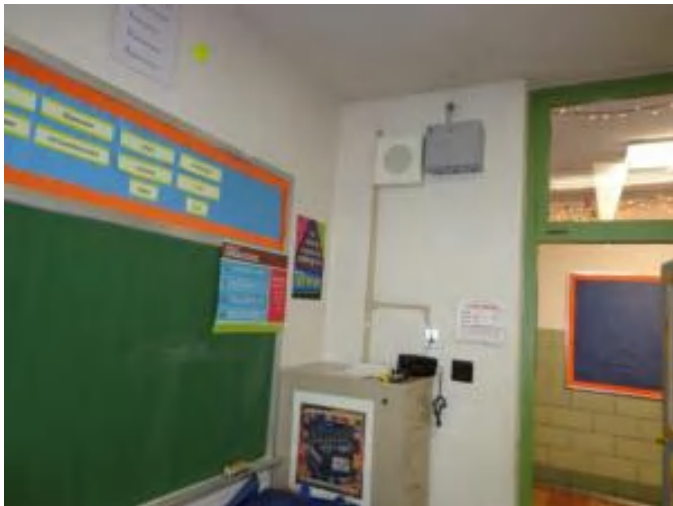
Location: Classrooms
Distress: Inadequate
Category: 4 - Capital Improvement
Priority: 4 - Response Time (4-5 yrs)
Correction: Add telephone outlets
Qty: 6.00
Unit of Measure: Ea.
Estimate: \$8,756.16
Assessor Name: System
Date Created: 10/19/2015

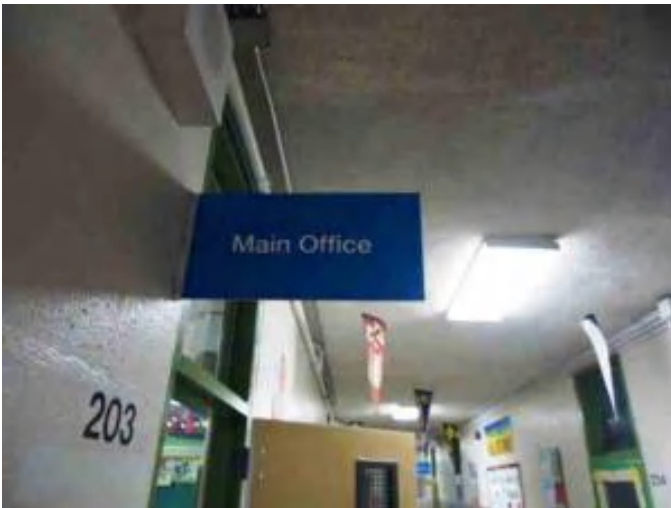
Location: Building Wide
Distress: Damaged
Category: 3 - Operations / Maint.
Priority: 5 - Response Time (> 5 yrs)
Correction: Replace missing or damaged signage - insert the number of rooms
Qty: 100.00
Unit of Measure: Ea.
Estimate: \$27,091.25
Assessor Name: System
Date Created: 11/20/2015

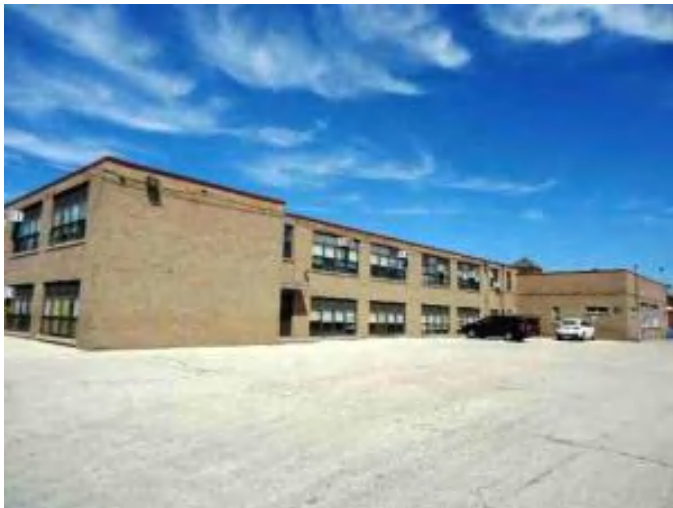
Location: Building Wide
Distress: Accessibility
Category: 2 - Code Compliance
Priority: 5 - Response Time (> 5 yrs)
Correction: Add interior hydraulic elevator - 2 floors - adjust the electrical run lengths to hook up the elevator
Qty: 1.00
Unit of Measure: Ea.
Estimate: \$387,153.48
Assessor Name: System
Date Created: 11/20/2015
