Facility Condition Assessment Summary Report

McKinley School

School District of Philadelphia
S535001;McKinley
Final
Site Assessment Report
January 31, 2017

Facility Assessment, July 2015

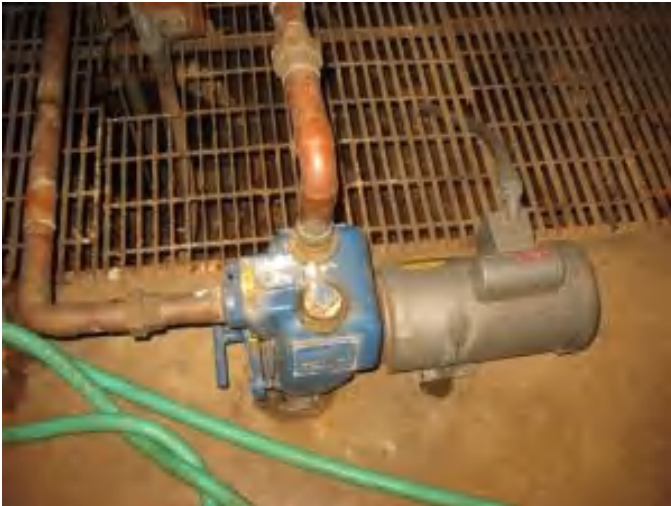
System: D2030 - Sanitary Waste

A sewage ejector pit located in basement boiler room receives water from the basement area. It has one pump, is beyond its useful service life, and needs to be replaced. The pit is not sealed.

Location: Boiler room

Distress: Health Hazard / Risk

Notes: Replace existing sewage ejector pump system and piping in the basement as it is beyond its useful service life.

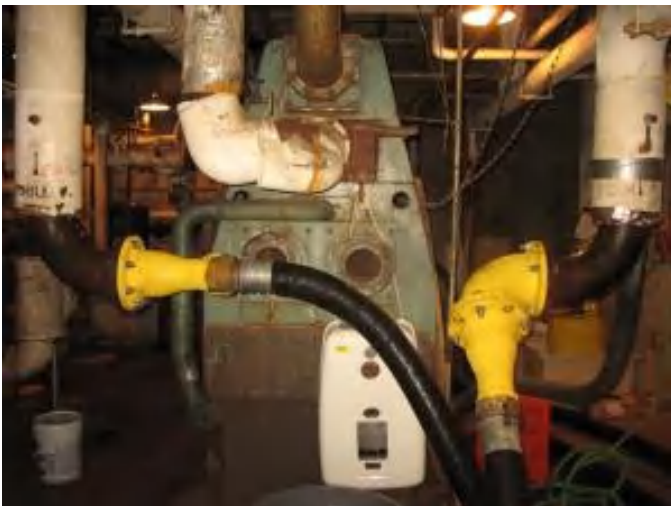
System: D3030 - Cooling Generating Systems

Cooling Generating Systems - Chilled water used to be generated by one York absorption chiller located in the boiler room with heat rejected by one galvanized B.A.C. cooling tower located on the roof. When the building is in cooling mode the chilled water is diverted to a shell and tube heat exchanger that cools the building water in the secondary water loop. The chiller has been defunct since 2013 and a temporary, portable chiller is located on the south side of the building. The cooling tower is well beyond its useful service life. The chiller and cooling tower should be replaced with a new packaged 190 ton air cooled chiller fitted with modern controls.

Location: Boiler room

Distress: Failing

Notes: Replace the existing defunct absorption chiller and cooling tower with a new 190 ton packaged air cooled chiller fitted with modern controls. All associated piping and pumping systems should also be replaced.

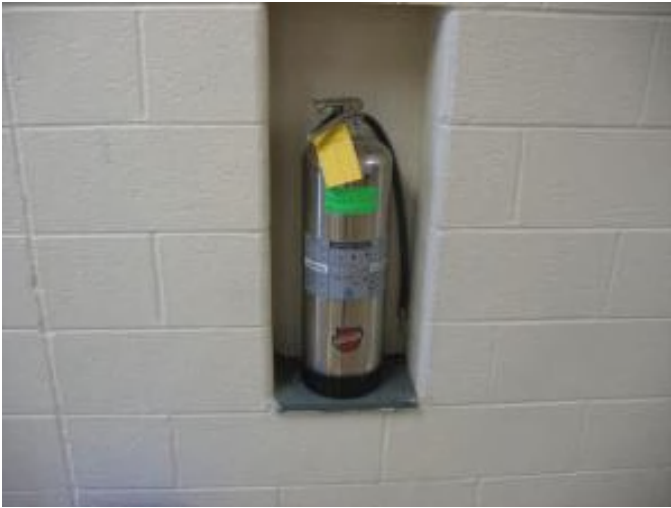
System: D4010 - Sprinklers

Location: Throughout building

Distress: Life Safety / NFPA / PFD

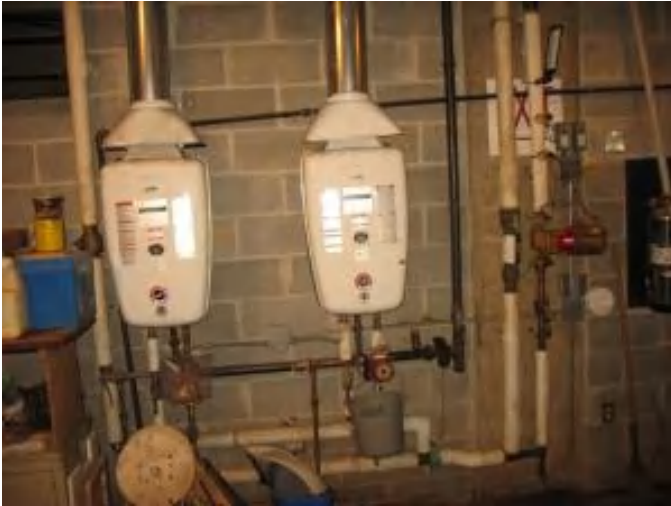
System: D2020 - Domestic Water Distribution

Two Paloma instant hot water heaters with circulating pump, installation dates unknown, supplies hot water for domestic use. The units are located in the basement boiler room. These units are beyond their service life and should be replaced in the next 2-3 years. A water softener located in the boiler room supplies conditioned water to the boilers.

Location: Boiler room

Distress: Beyond Service Life

Notes: Replace two existing Paloma gas fired instant hot water heaters with new gas fired instant hot water heaters.

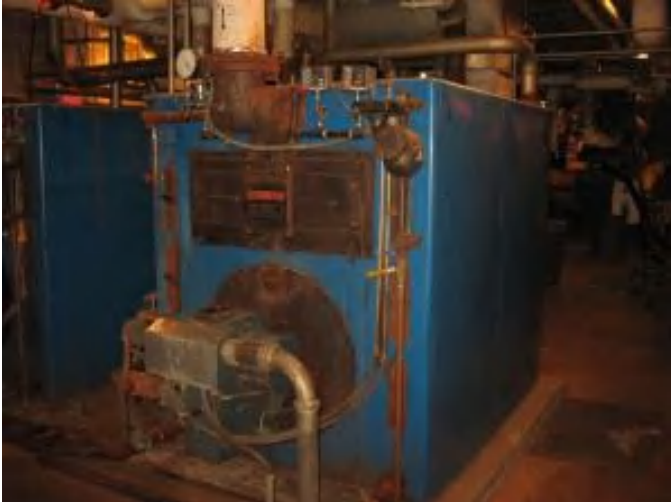
System: D3020 - Heat Generating Systems

Heat Generating Systems - Low pressure steam is generated at a maximum of 15 lbs/sq. in., typically 5-7 lbs/sq. in., by two 104HP Weil-McLain cast iron sectional boilers original to the building. Two boilers are required to handle the load on very cold days. Each boiler is equipped with a Power Flame burner designed to operate on natural gas. When the building is in heating mode the steam is diverted to a shell and tube heat exchanger that heats the building water in the secondary water loop. Combustion air makeup is supplied by louvers equipped with motorized dampers. Burner controls provide full modulation with electronic ignition and digital flame sensing. The gas train serving each boiler does not appear to have code required venting of the regulators and dual solenoid valves with venting of the chamber between. Cast iron sectional boilers have an anticipated service life of 35 years or more; as these units have been in service 45 years they need to be replaced.

Location: Boiler room

Distress: Beyond Service Life

Notes: Replace the two existing 3,480MBH cast iron boilers, including burners and exhaust ductwork, which are beyond their service life.

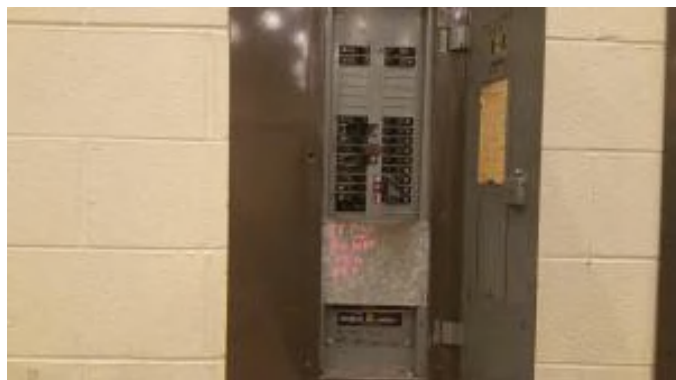
System: D5010 - Electrical Service/Distribution

Location: Throughout the building

Distress: Beyond Service Life

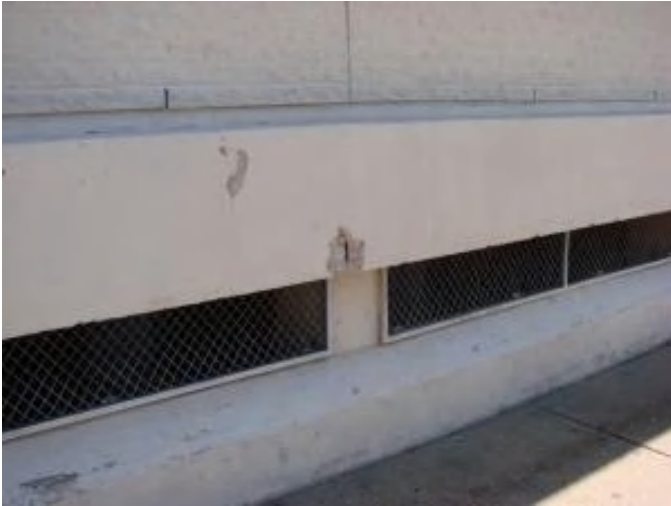
System: B2010 - Exterior Walls

Location: Exterior

Distress: Damaged

Notes: Repair cracked exterior columns and spalled concrete walls.

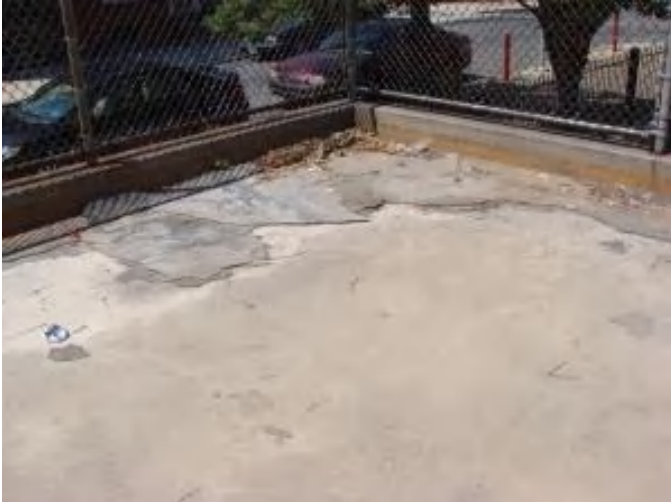
System: B3010120 - Single Ply Membrane

Roofing system is a built-up system installed approximately in 1990 and in fair condition; roofing over the classroom pods is asphalt shingles, installed in 2009 in hip configuration in good condition. All flat roofing and flashing is typically in fair condition with some deterioration of the built-up system and flashing sealant; leaks have not been reported. Exposed portion of the garage roof structure is covered with concrete topping, severely cracked and leaking.

Location: Exterior

Distress: Building Envelope Integrity

Notes: Install new topping over garage roof

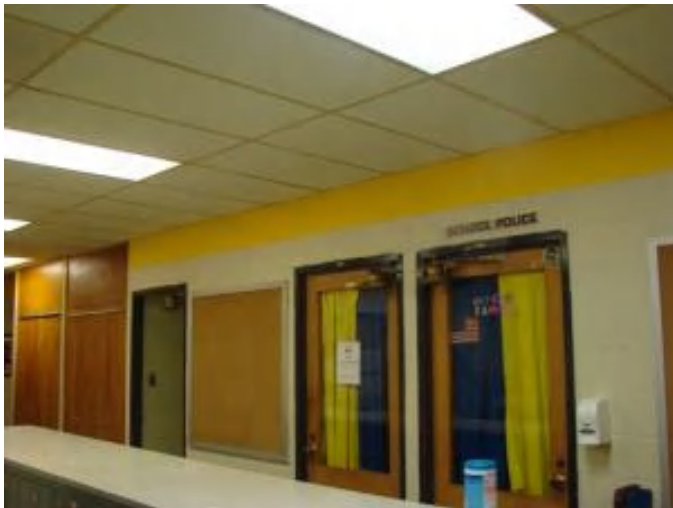
System: C1020 - Interior Doors

Location: Interior

Distress: Accessibility

Notes: Replace interior doors hardware for ADA accessibility

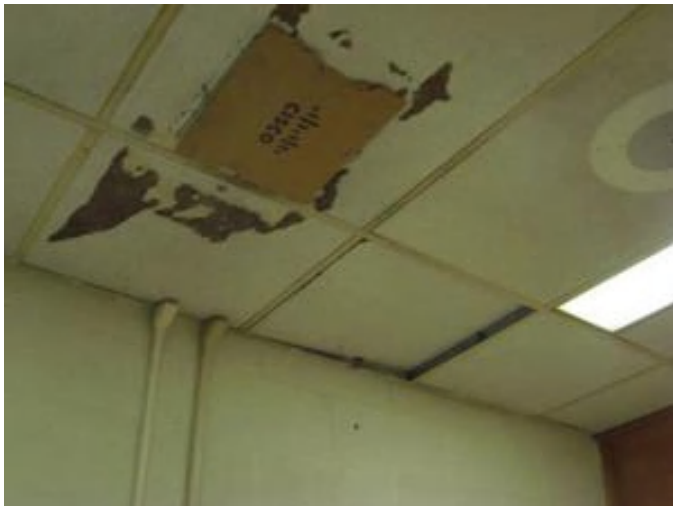
System: C3030 - Ceiling Finishes

Location: Interior

Distress: Beyond Service Life

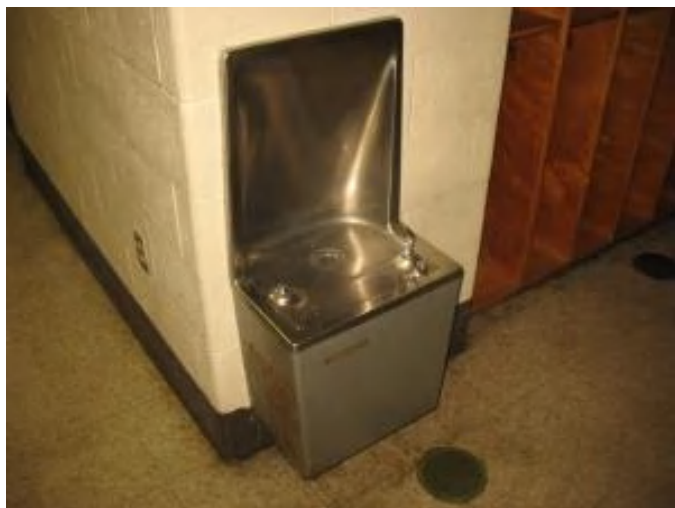
System: D2010 - Plumbing Fixtures

Drinking fountains in the corridors and at the restrooms consist of wall hung fixtures with integral refrigerated coolers and porcelain fixtures. They are beyond their service life and should be replaced; most are NOT accessible type.

Location: Corridors

Distress: Accessibility

Notes: Replace the wall hung drinking fountains and integral refrigerated coolers in the corridors and at the restrooms. These units are well beyond their service life and most are NOT accessible type.

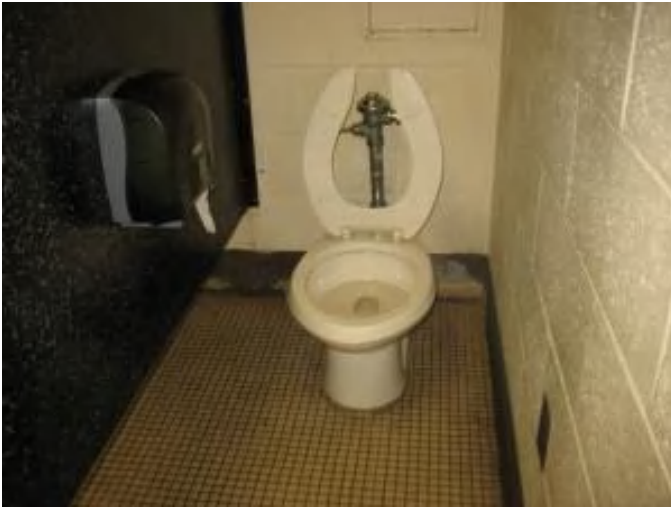
System: D2030 - Sanitary Waste

The maintenance staff reported mostly minor problems with the sanitary waste piping systems. However, the sewer piping has been in service for 45 years and will require more frequent attention from the maintenance staff as time passes. The District should hire a qualified contractor to examine the sanitary waste piping using video cameras to locate and replace any damaged piping and to further quantify the extent of potential failures.

Location: Throughout building

Distress: Beyond Service Life

Notes: Hire a qualified contractor to perform a detailed examination of the sanitary waste piping using visual inspection and video cameras to locate and replace any damaged piping and to further quantify the extent of potential failures.

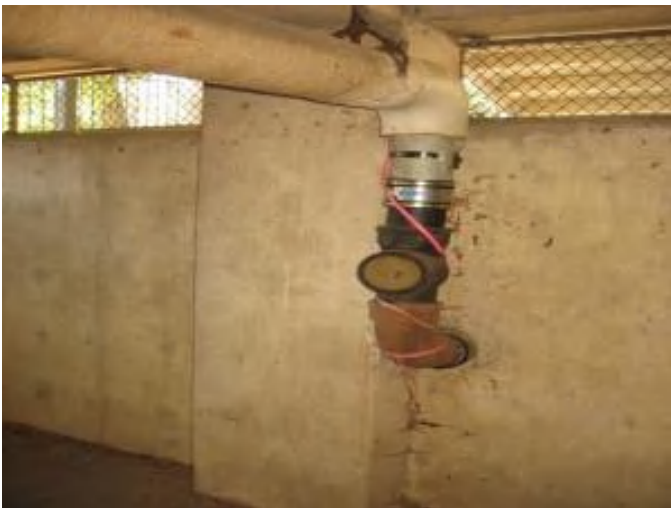
System: D2040 - Rain Water Drainage

The rain water drains from the roof are routed through mechanical chases in the building and appear to be original. Drains that run through the parking garage have heat tracing, but the heat trace system does not work. The drain piping should be inspected by a qualified contractor and repaired as necessary.

Location: Throughout building

Distress: Beyond Service Life

Notes: Hire a qualified contractor to perform a detailed examination of the rain water drainage piping using visual inspection and video cameras to locate and replace any damaged piping and to further quantify the extent of potential failures.

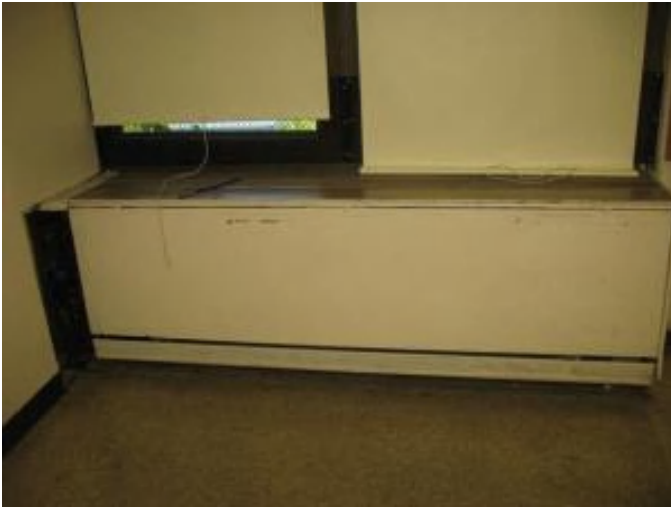
System: D3040 - Distribution Systems

Location: Throughout building

Distress: Beyond Service Life

Notes: Replace the existing unit ventilators with two pipe units that have integral heat exchangers to introduce outdoor air to the building.

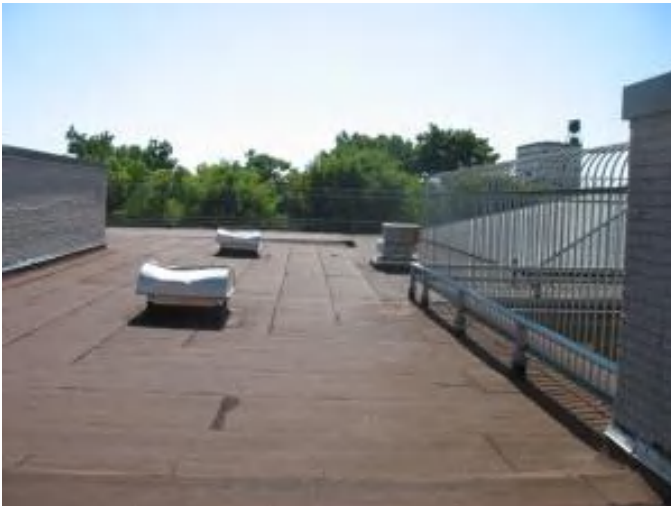
System: D3040 - Distribution Systems

Terminal & Package Units - The building is exhausted by eighteen (18) fans located on the roof. There are nine (9) fans on the main roof and nine (9) fans on the upper roof. All of the exhaust fans are original to the building, beyond their service life, and need to be replaced.

Location: Roof

Distress: Beyond Service Life

Notes: Replace eighteen (18) exhaust fans serving the building.

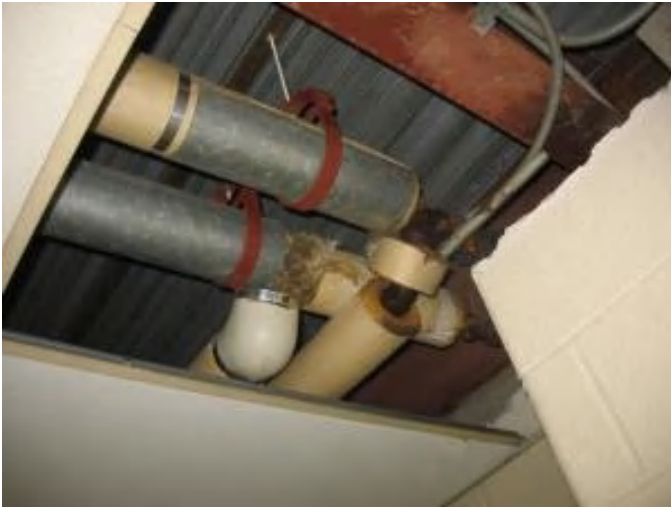
System: D3040 - Distribution Systems

Distribution Systems - Building water distribution piping is black steel with threaded fittings. The distribution piping has been damaged by rust from condensation. The piping is beyond its service life and will require more frequent attention from the maintenance staff to address pipe/valve failures as time passes. The District should hire a qualified contractor to examine the distribution piping and perform additional testing to locate and replace any damaged piping and to further quantify the extent of potential failures. The District should budget for replacing this piping over the next 5 years.

Location: Throughout buliding

Distress: Beyond Service Life

Notes: Hire a qualified contractor to examine the distribution piping, in service for 45 years and damaged, and perform additional testing to locate and replace any damaged piping and to further quantify the extent of potential failures.

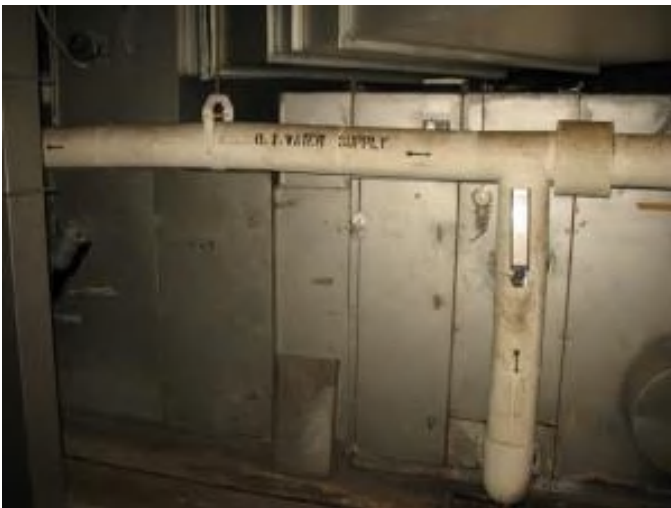
System: D3040 - Distribution Systems

Location: IMC Mech Room

Distress: Beyond Service Life

Notes: Replace AH-3, located above the IMC, which serves the IMC, Cafeteria, and hallway.

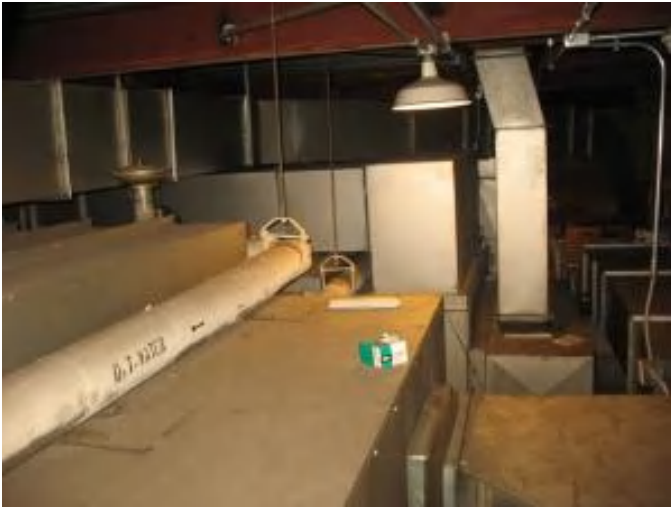
System: D3040 - Distribution Systems

Location: IMC Mech Room

Distress: Beyond Service Life

Notes: Replace AH-2, located above the IMC, which serves the IMC, Cafeteria, and hallway.

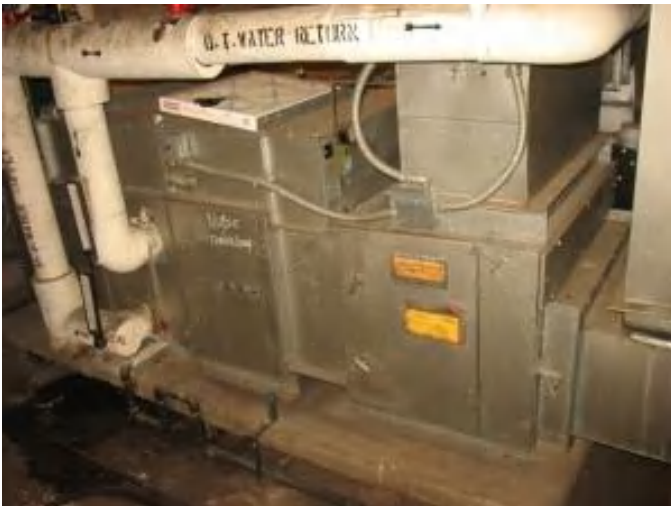
System: D3040 - Distribution Systems

Location: IMC Mech Room

Distress: Beyond Service Life

Notes: Replace AH-1, located above the IMC, which serves the nurses office and teachers' lounge.

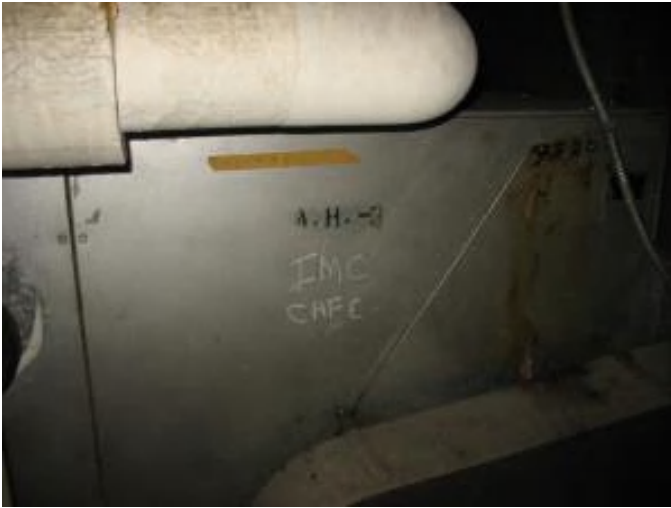
System: D3040 - Distribution Systems

Location: IMC Mech Room

Distress: Beyond Service Life

Notes: Replace AH-4, located above the IMC, which serves the main office, two music rooms, and accommodation room.

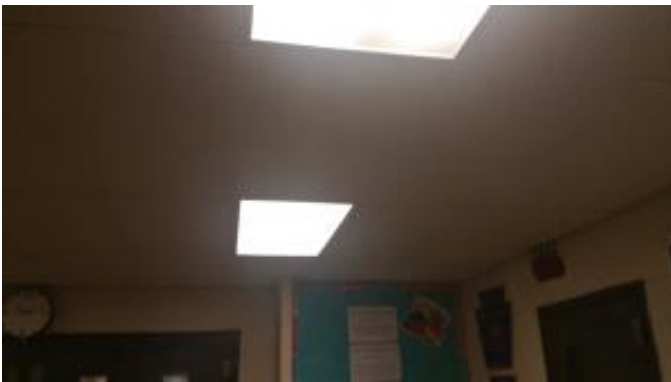
System: D5020 - Lighting and Branch Wiring

Location: Thrpughout the building

Distress: Beyond Service Life

Notes: Install new lighting fixtures for all the class rooms, and other rooms. New fluorescent lighting (T-5) will be adequate, however, using the state-of-the-art LED lighting will improve the energy usage.

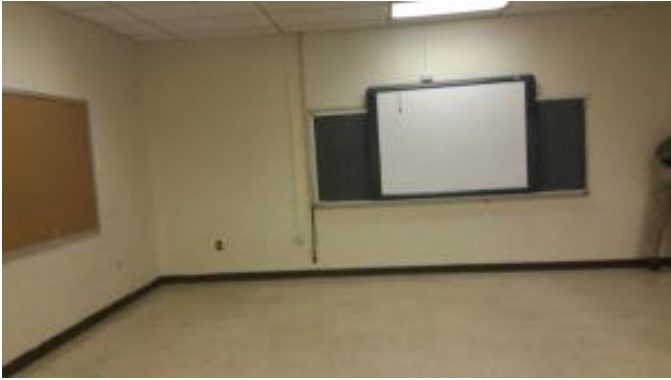
System: D5020 - Lighting and Branch Wiring

Receptacles - There is inadequate receptacles in classrooms, multi-purpose room, computer room, etc. We recommend two receptacles in each wall of class rooms and other purpose rooms. Also, we recommend adding a wire-mold system with receptacles on every 3' for the computer room.

Location: Throughout the building

Distress: Building / MEP Codes

Notes: Install two receptacles in all of class rooms and other purpose rooms. Add a wire-mold system with receptacles on every 3' for the computer room.

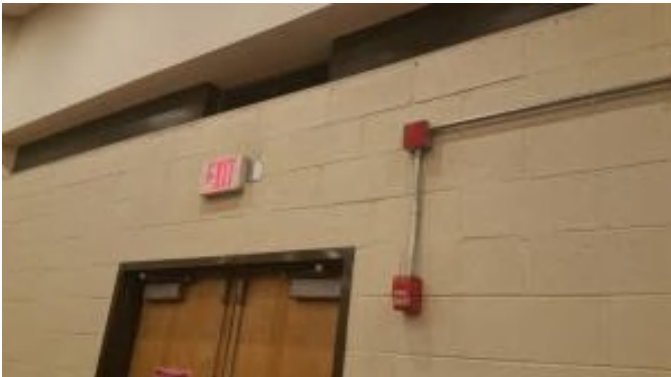
System: D5030 - Communications and Security

Fire Alarm System – The present Fire Alarm system is inadequate and is not addressable. A new Automated Fire Alarm System is needed.

Location: throughout the building

Distress: Building / MEP Codes

Notes: Install a new Automated Fire Alarm System to be located in the new Electrical Room.

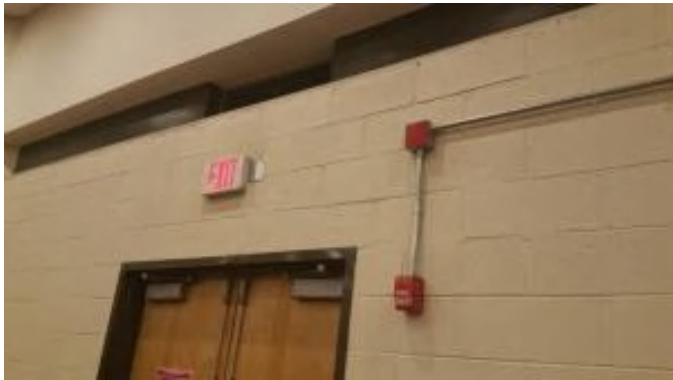
System: D5090 - Other Electrical Systems

Emergency Lighting System / Exit Lighting- The emergency lighting and exit lighting is inadequate throughout each floor and stairways.

Location: throughout the building

Distress: Life Safety / NFPA / PFD

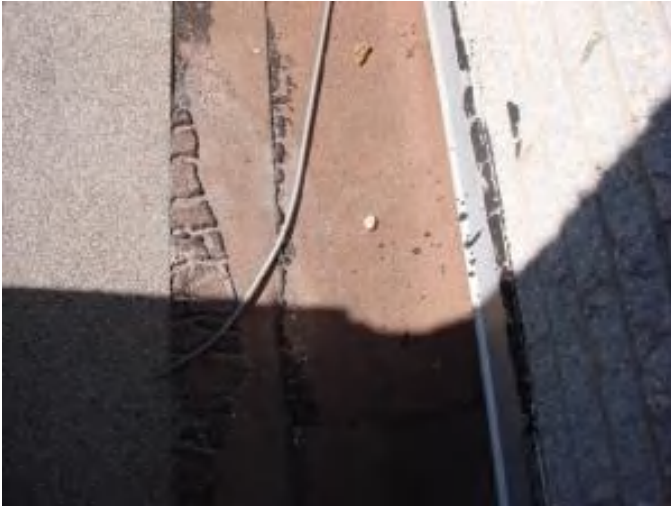
System: B3010105 - Built-Up

Location: Exterior

Distress: Beyond Service Life

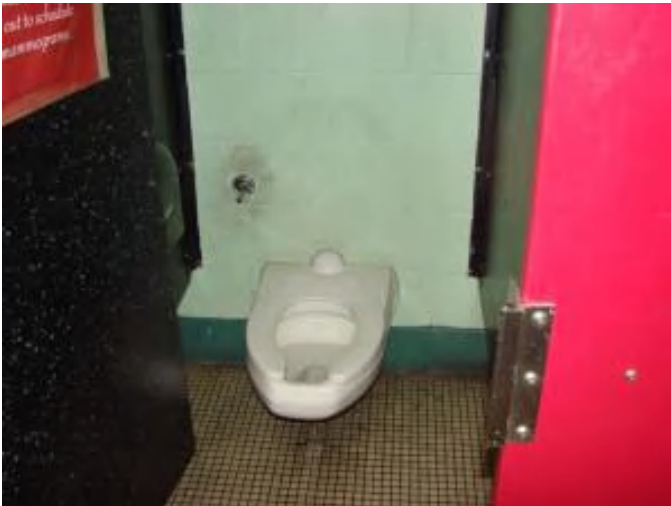
System: C1030 - Fittings

Location: Interior

Distress: Accessibility

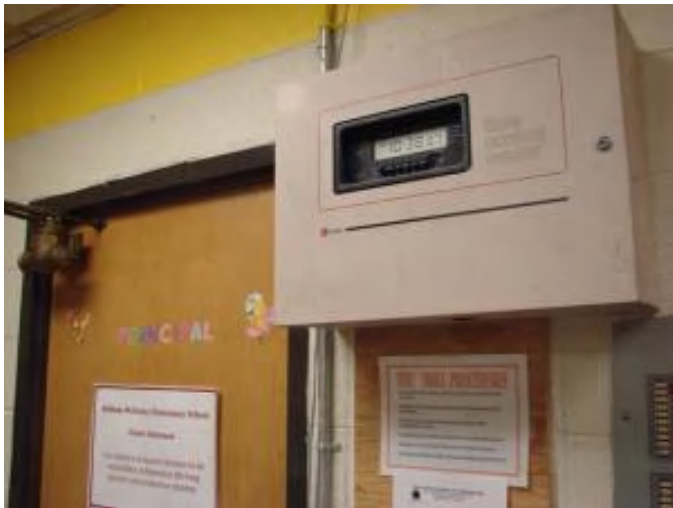
System: C1030 - Fittings

Location: Interior

Distress: Inadequate

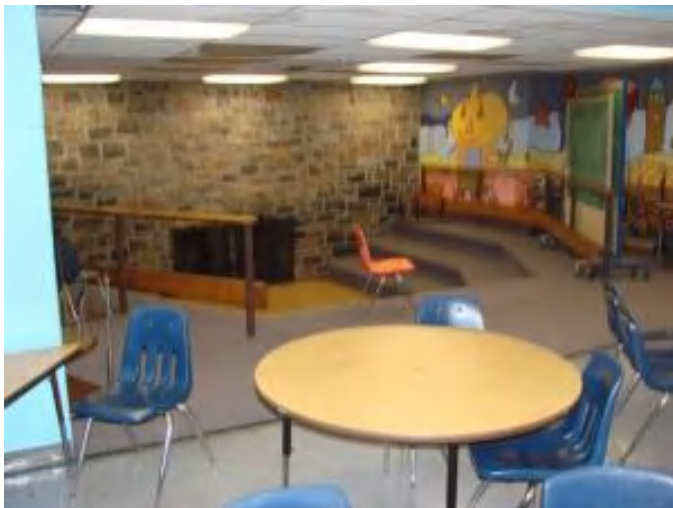
System: C3020411 - Carpet

Flooring in classrooms, corridors, gym and portion of cafeteria is VCT; and ceramic tile in toilets. Flooring in the kitchen is quarry tile in good condition. Approximately 50% of VCT flooring was replaced in 2014. Most flooring is in fair to good condition. Auditorium has carpet in poor condition.

Location: Interior

Distress: Beyond Service Life

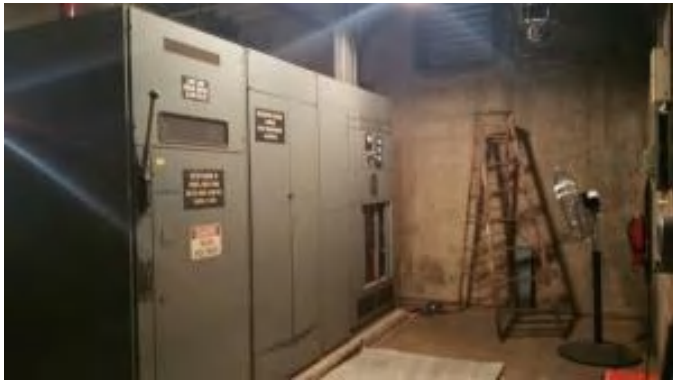
System: D5010 - Electrical Service/Distribution

Location: electrical room in the basement

Distress: Beyond Service Life

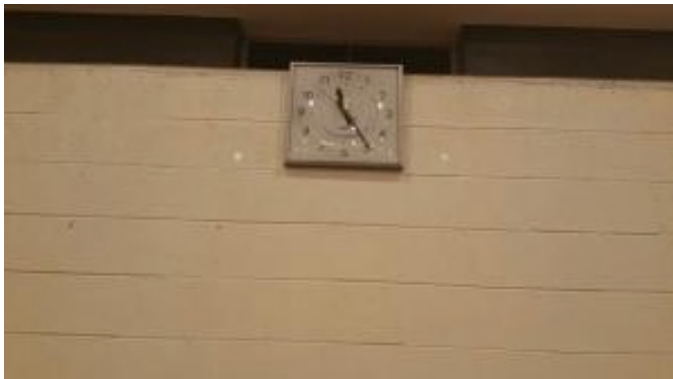
System: D5030 - Communications and Security

Location: Throughout the building

Distress: Beyond Service Life

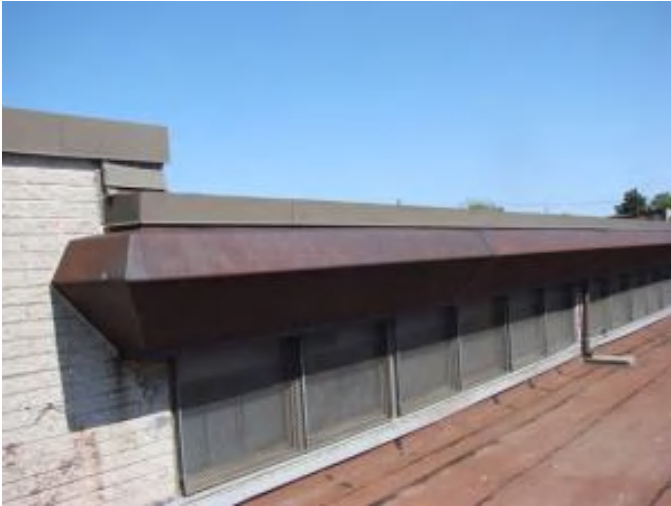
System: B2020 - Exterior Windows

Location: Exterior

Distress: Beyond Service Life

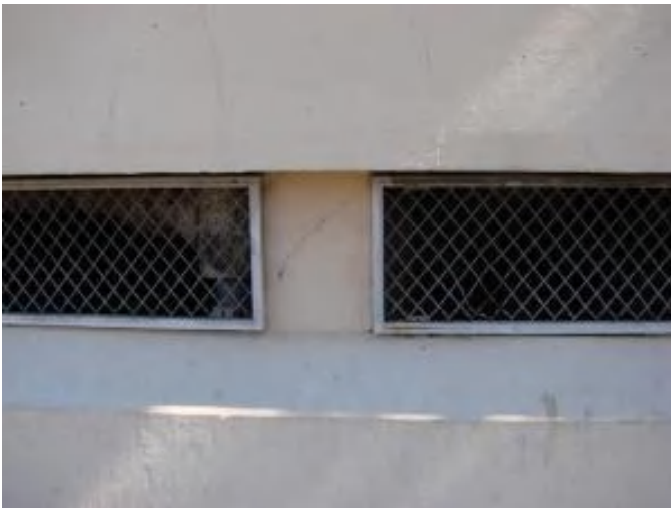
System: B2020 - Exterior Windows

Location: Exterior

Distress: Beyond Service Life

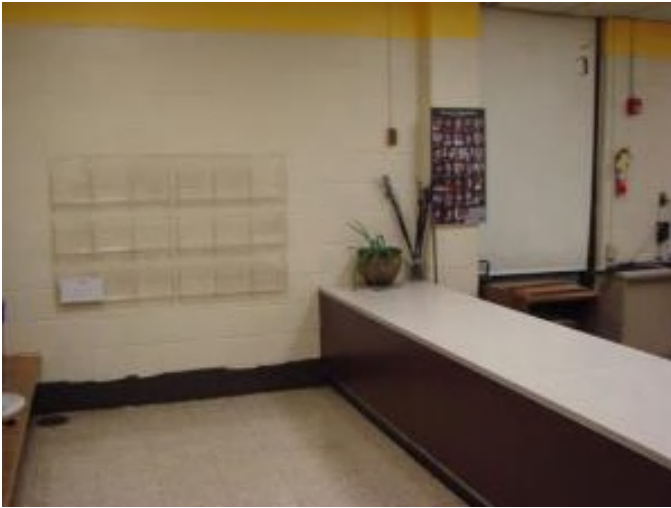
System: C3010230 - Paint & Covering

The interior wall finishes in the building are generally painted CMU or drywall. Generally, paint is in fair to good condition throughout the building; however it is reaching the end of the useful life.

Location: Interior

Distress: Beyond Service Life

Notes: Repaint all walls

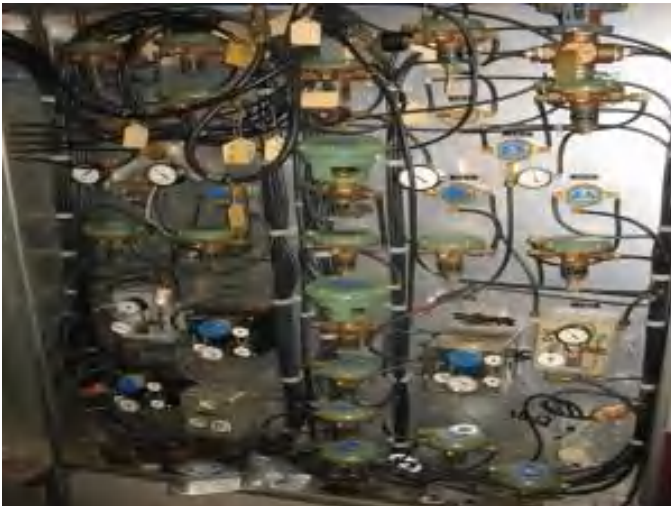
System: D3060 - Controls & Instrumentation

Location: Throughout building

Distress: Inadequate

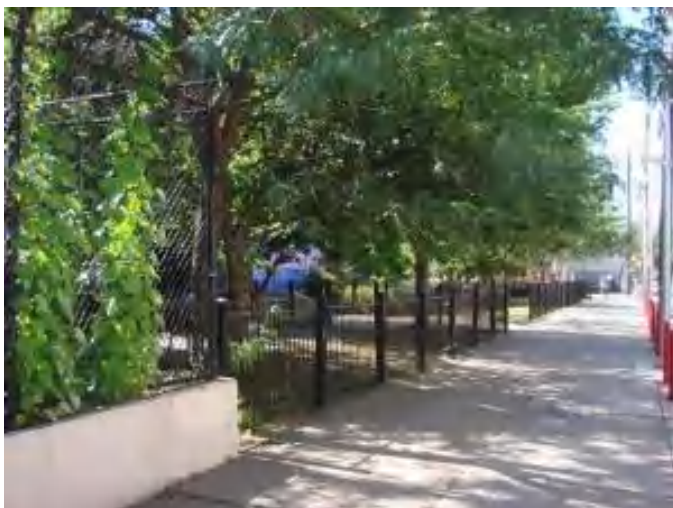
System: G4020 - Site Lighting

Location: Grounds/ site

Distress: Security Issue

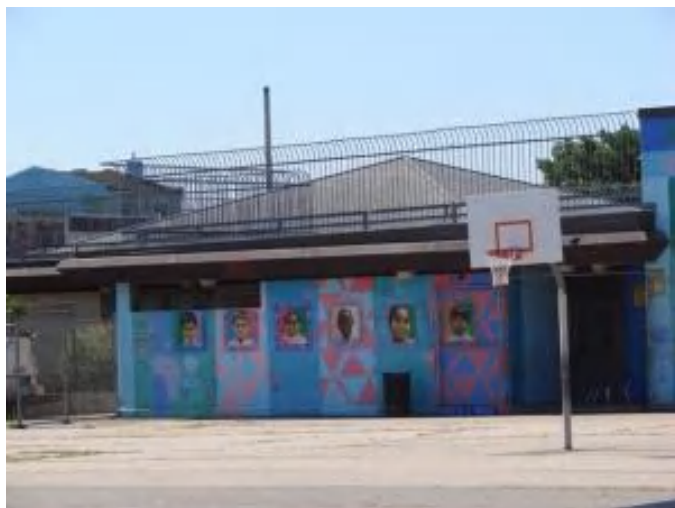
System: G4030 - Site Communications & Security

Location: Grounds/ site

Distress: Security Issue

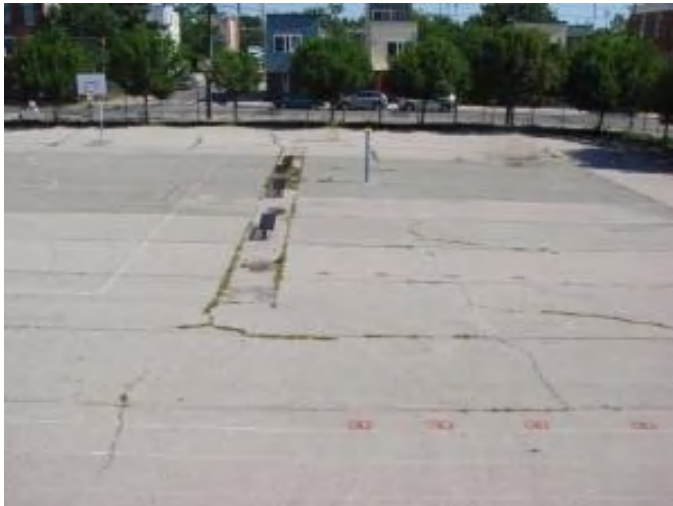
System: G2030 - Pedestrian Paving

There is no parking lot at the site; parking garage is located in the building's basement. There are no stall markings. Playground pavement adjacent to the building is in poor condition, paving is cracked and deteriorated; playground equipment is in good condition. Perimeter picket fence and chain link fence separating the playground from the street is generally in good condition. There is landscaping along East and West sides of the building, generally in good condition; installed 2005.

Location: Grounds/ site

Distress: Beyond Service Life
