Facility Condition Assessment Summary Report

McMichael School

School District of Philadelphia
S136001;McMichael
Final
Site Assessment Report
February 1, 2017

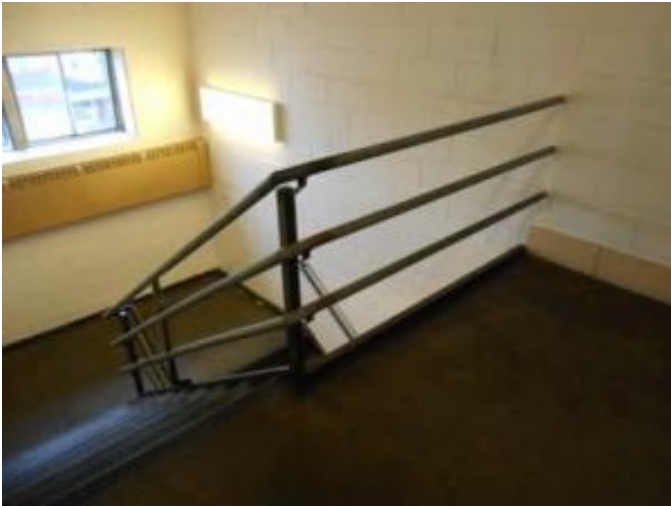
System: C2010 - Stair Construction

Location: Exit stairwells

Distress: Building / MEP Codes

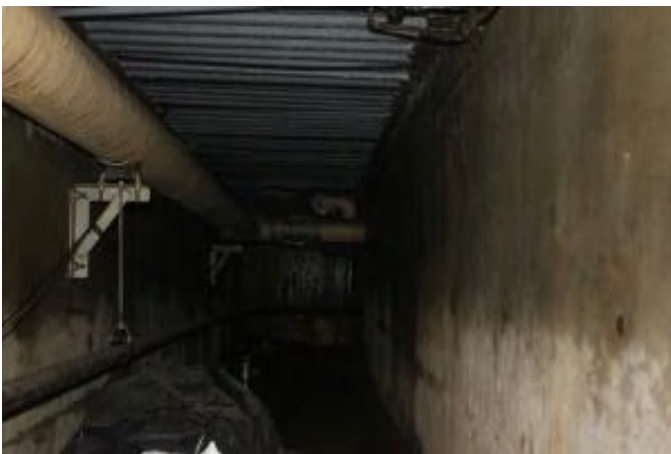
System: D3040 - Distribution Systems

Location: Entire building

Distress: Failing

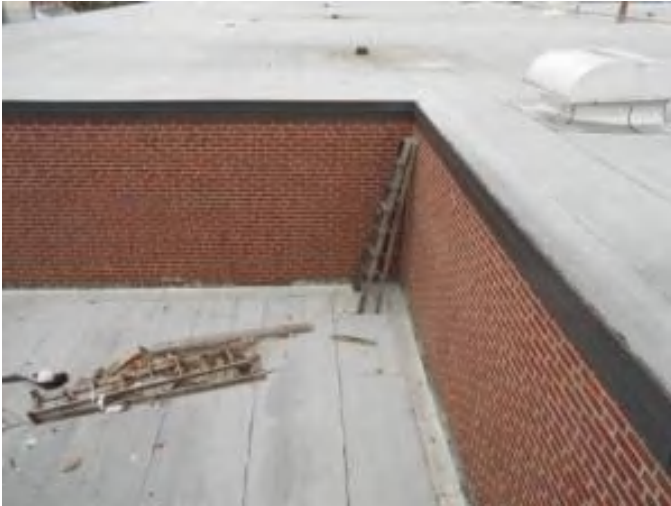
System: B2010 - Exterior Walls

Location: Roofs to low roofs

Distress: OSHA

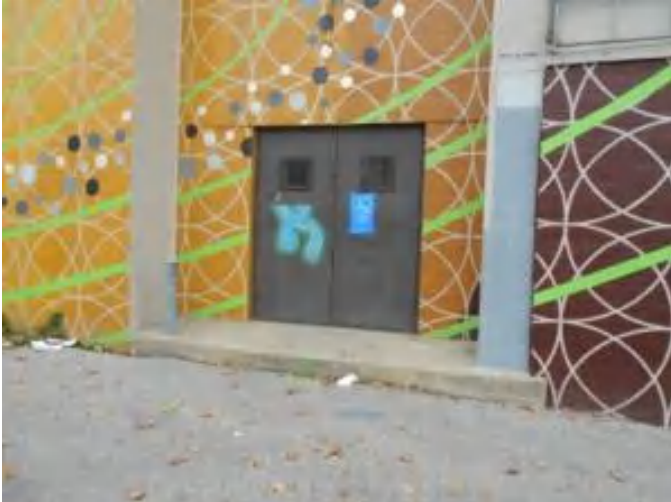
System: B2030 - Exterior Doors

Location: Exterior doors

Distress: Beyond Service Life

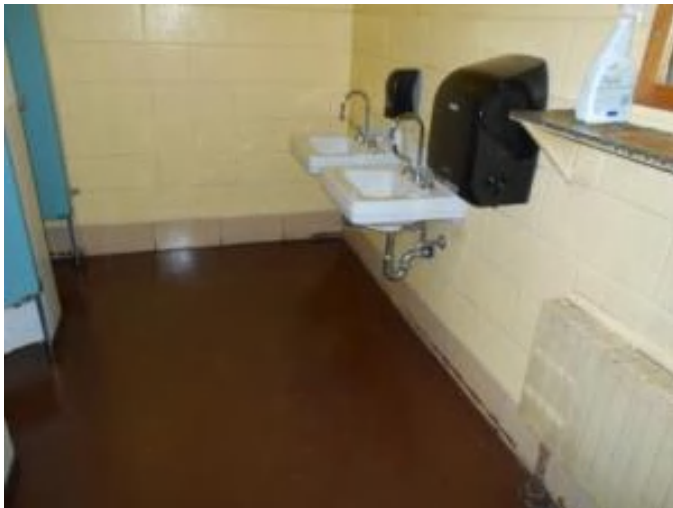
System: C1010 - Partitions

Location: TBD and nurse office

Distress: Accessibility

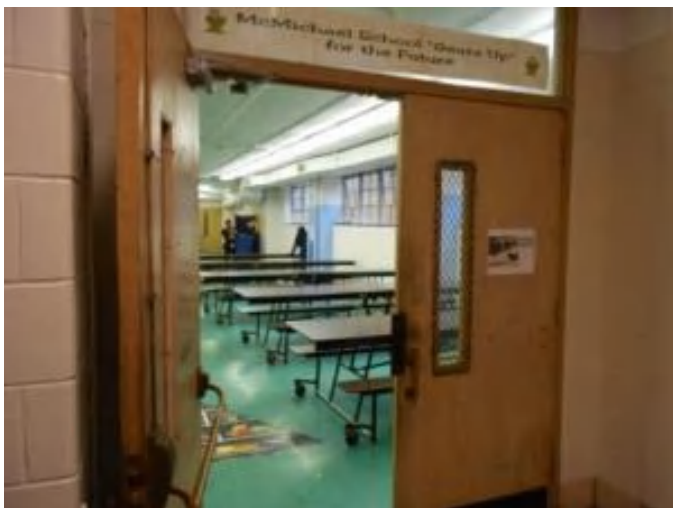
System: C1020 - Interior Doors

Location: Throughout the building

Distress: Beyond Service Life

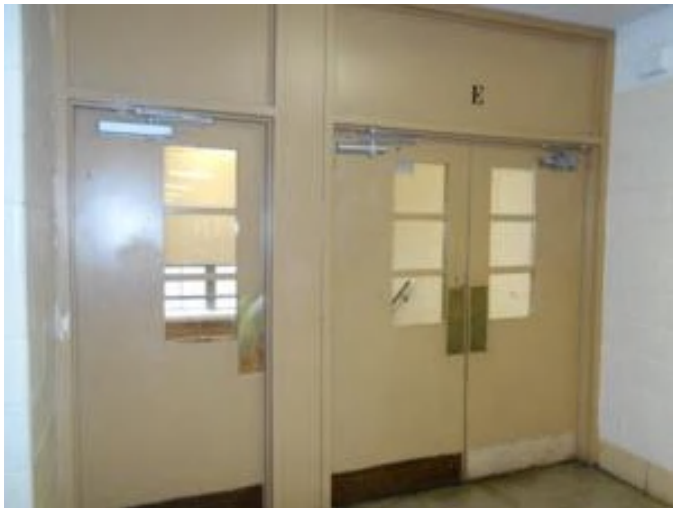
System: C1020 - Interior Doors

Location: Exit stairwells

Distress: Beyond Service Life

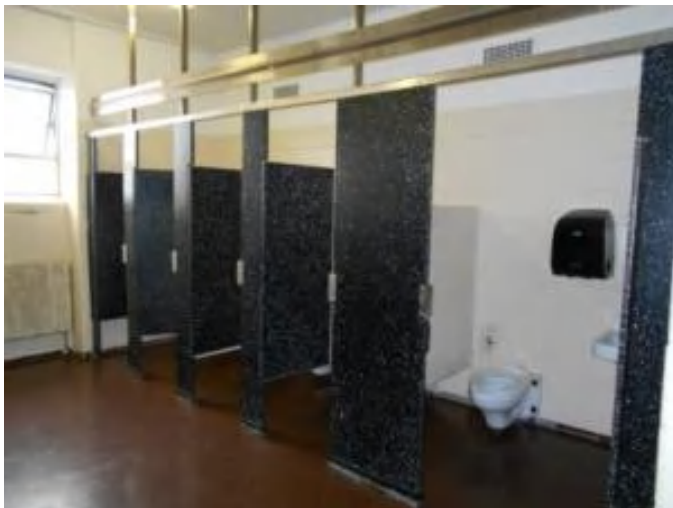
System: C1030 - Fittings

Location: Student toilet rooms

Distress: Beyond Service Life

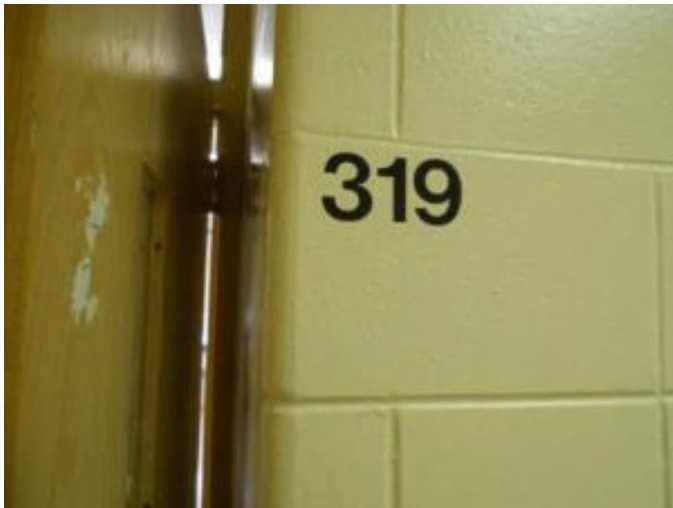
System: C1030 - Fittings

Location: Throughout the building

Distress: Building / MEP Codes

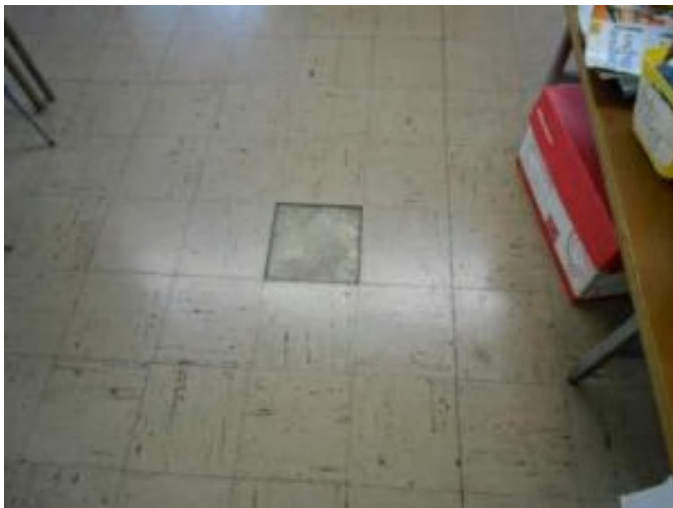
System: C3020413 - Vinyl Flooring

Location: Throughout the building

Distress: Health Hazard / Risk

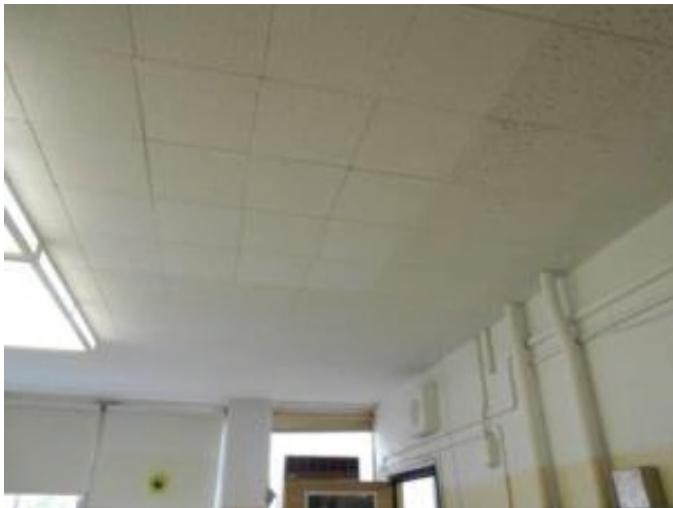
System: C3030 - Ceiling Finishes

Location: Auditorium, office, cafeteria, lobby

Distress: Beyond Service Life

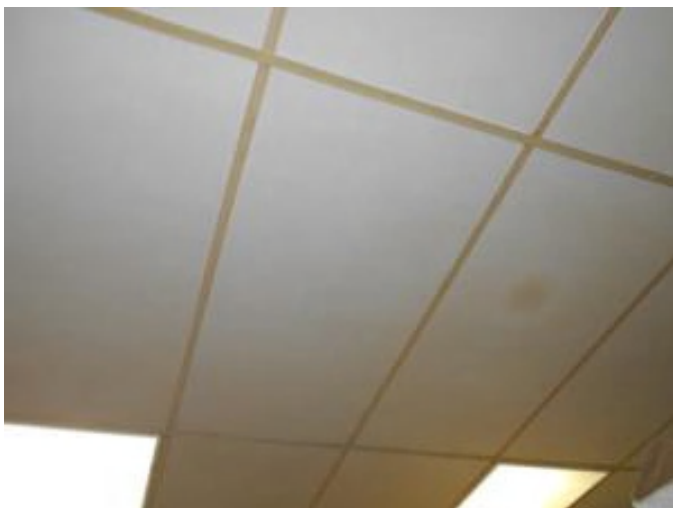
System: C3030 - Ceiling Finishes

Location: Kitchen

Distress: Beyond Service Life

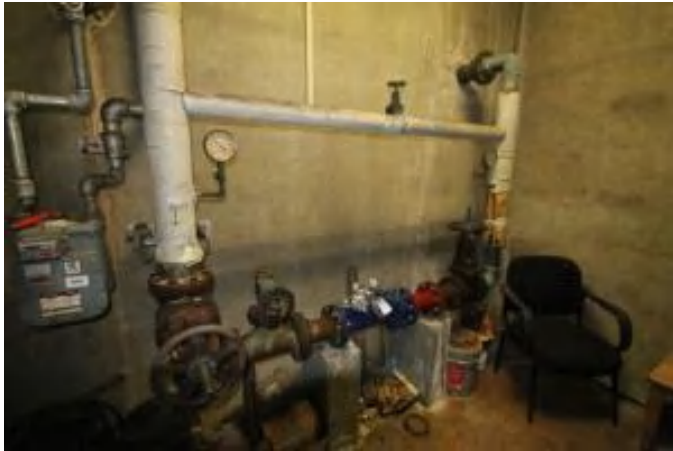
System: D2020 - Domestic Water Distribution

Location: Basement
Distress: Building / MEP Codes
Category: 2 - Code Compliance
Priority: 2 - Response Time (2-3 yrs)
Correction: Provide 4" reduced pressure back flow preventer
Qty: 1.00
Unit of Measure: Ea.
Estimate: \$19,182.58
Assessor Name: System
Date Created: 02/09/2016

Notes: Install 4 inch backflow preventer.

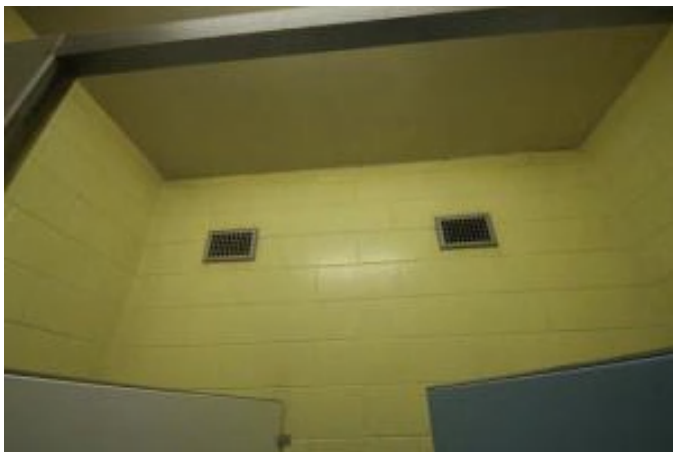
System: D3040 - Distribution Systems

Location: Rooftop
Distress: Not Reliable
Category: 3 - Operations / Maint.
Priority: 2 - Response Time (2-3 yrs)
Correction: Replace power roof ventilator (36" dia.)
Qty: 4.00
Unit of Measure: Ea.
Estimate: \$224,781.48
Assessor Name: System
Date Created: 02/09/2016

Notes: Replace roof top exhaust fans due to toilet room odors, 4

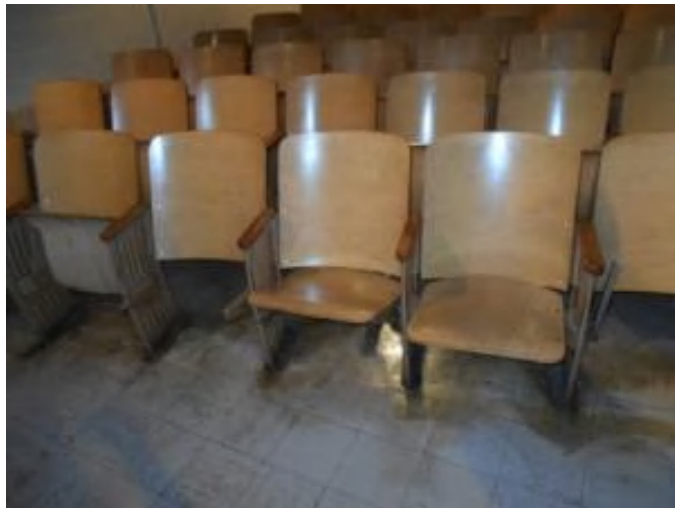
System: E2010 - Fixed Furnishings

Location: Auditorium

Distress: Beyond Service Life

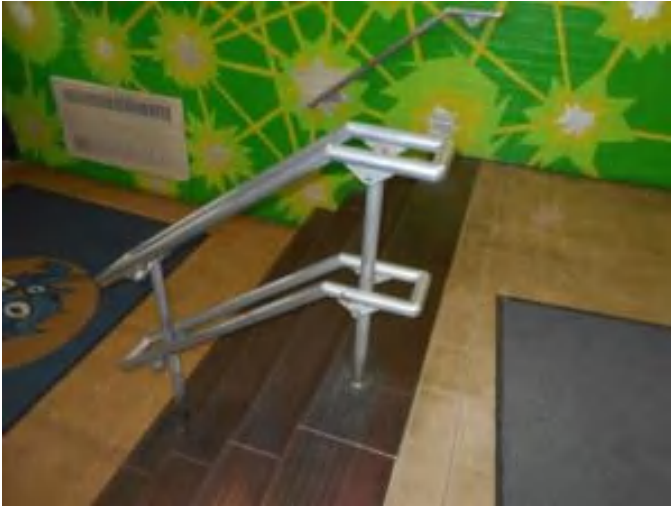
System: A1030 - Slab on Grade

Location: Front entry

Distress: Accessibility

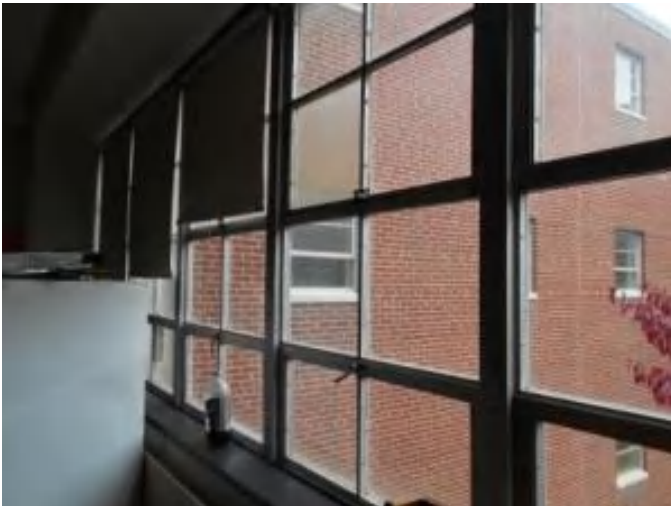
System: B2020 - Exterior Windows

Location: Exterior windows

Distress: Beyond Service Life

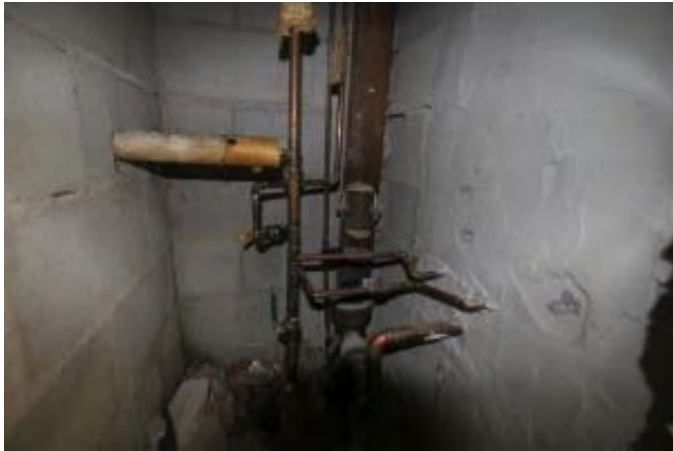
System: D2030 - Sanitary Waste

Location: Entire building

Distress: Failing

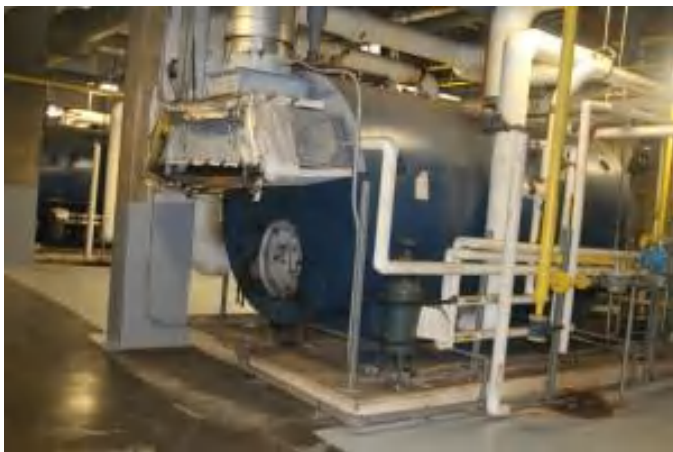
System: D3020 - Heat Generating Systems

Location: Boiler room

Distress: Failing

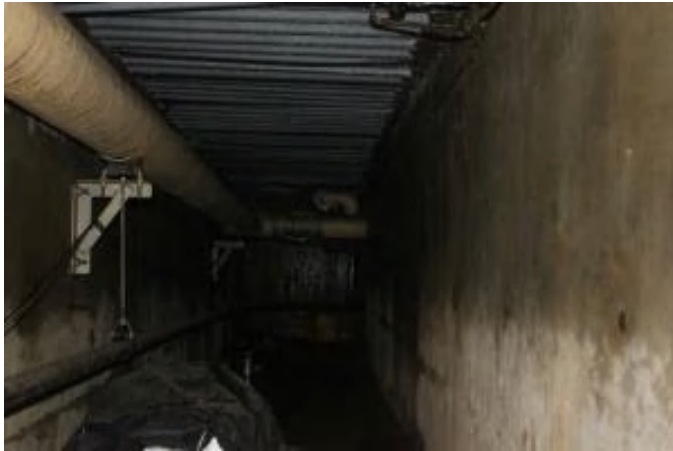
System: D3040 - Distribution Systems

Location: Entire building

Distress: Beyond Service Life

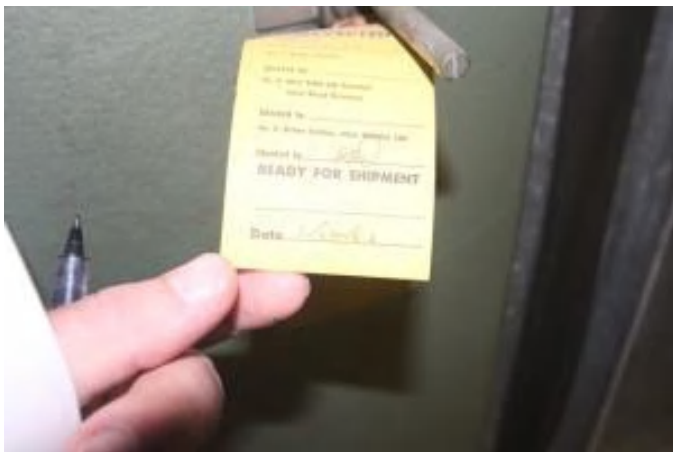
System: D3040 - Distribution Systems

Location: Gym

Distress: Beyond Service Life

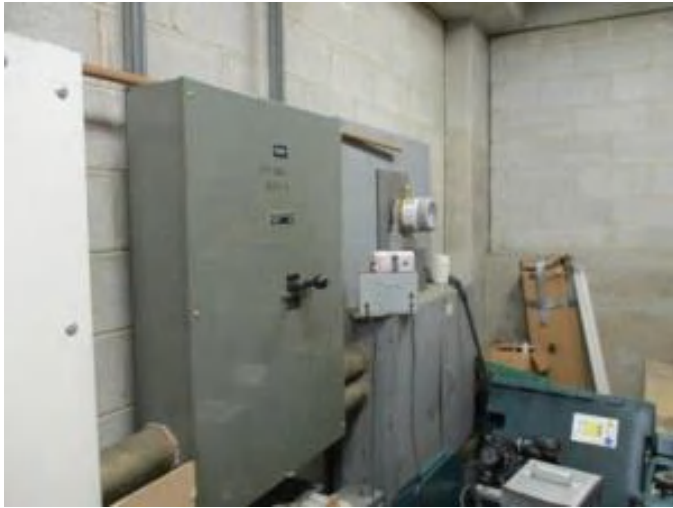
System: D5010 - Electrical Service/Distribution

Location: Basement
Distress: Beyond Service Life
Category: 3 - Operations / Maint.
Priority: 3 - Response Time (3-4 yrs)
Correction: Replace Switchboard
Qty: 1.00
Unit of Measure: Ea.
Estimate: \$526,691.26
Assessor Name: System
Date Created: 01/20/2016

Notes: Provide a new electrical service 480V/277V, 3 phase power, approximate 1600 Amperes.

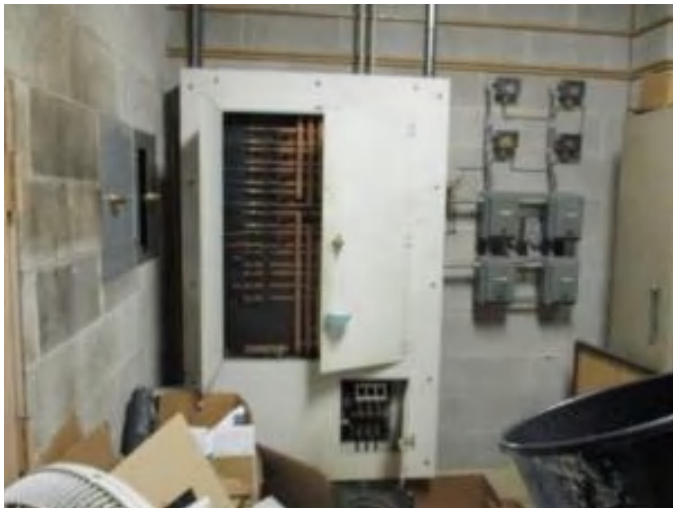
System: D5010 - Electrical Service/Distribution

Location: Entire Building
Distress: Beyond Service Life
Category: 3 - Operations / Maint.
Priority: 3 - Response Time (3-4 yrs)
Correction: Replace Electrical Distribution System (U)
Qty: 1.00
Unit of Measure: Ea.
Estimate: \$406,423.91
Assessor Name: System
Date Created: 01/20/2016

Notes: Replace original surface mounted panelboards and their associated wiring/conduits. Approximate (15) 208/120V panel boards.

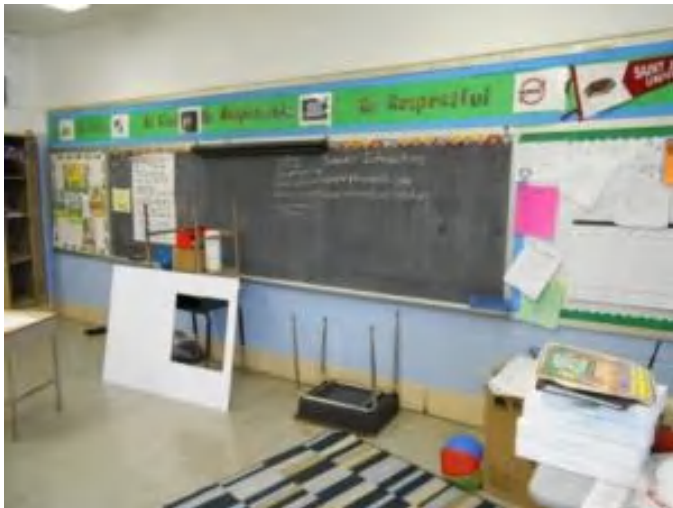
System: D5020 - Lighting and Branch Wiring

Location: Entire Building
Distress: Inadequate
Category: 4 - Capital Improvement
Priority: 3 - Response Time (3-4 yrs)

Correction: Add wiring device
Qty: 346.00

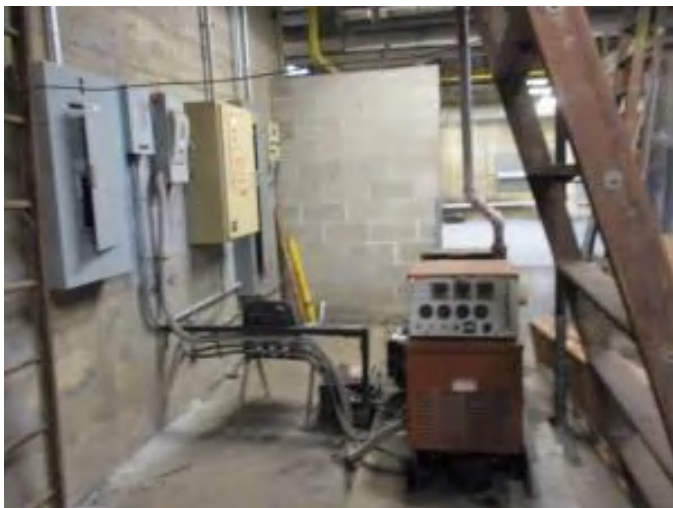
System: D5090 - Other Electrical Systems

Location: Outdoor
Distress: Inadequate
Category: 4 - Capital Improvement
Priority: 3 - Response Time (3-4 yrs)

Correction: Add Standby Generator System
Qty: 1.00

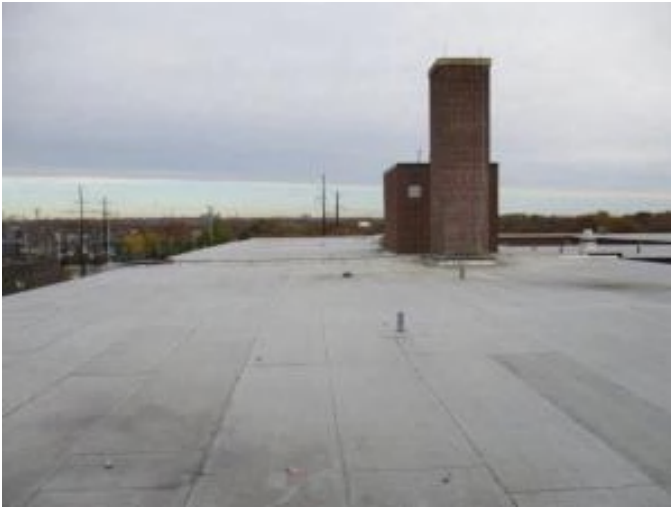
System: D5090 - Other Electrical Systems

Location: Roof
Distress: Building / MEP Codes
Category: 2 - Code Compliance
Priority: 3 - Response Time (3-4 yrs)
Correction: Repair Lightning Protection System
Qty: 1.00
Unit of Measure: Job
Estimate: \$24,249.82
Assessor Name: System
Date Created: 01/20/2016

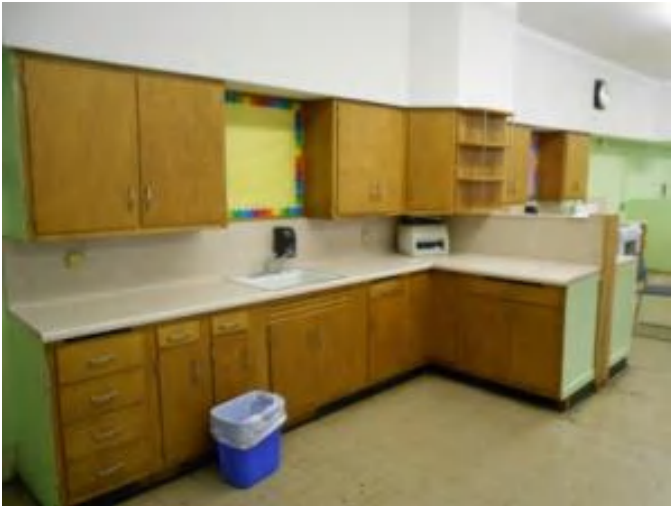
System: E2010 - Fixed Furnishings

Location: Classrooms
Distress: Beyond Service Life
Category: 3 - Operations / Maint.
Priority: 3 - Response Time (3-4 yrs)
Correction: Remove and replace casework - per LF - insert quantities for cabinets in the estimate
Qty: 200.00
Unit of Measure: L.F.
Estimate: \$201,181.44
Assessor Name: System
Date Created: 02/25/2016

Notes: Replace classroom cabinetry.

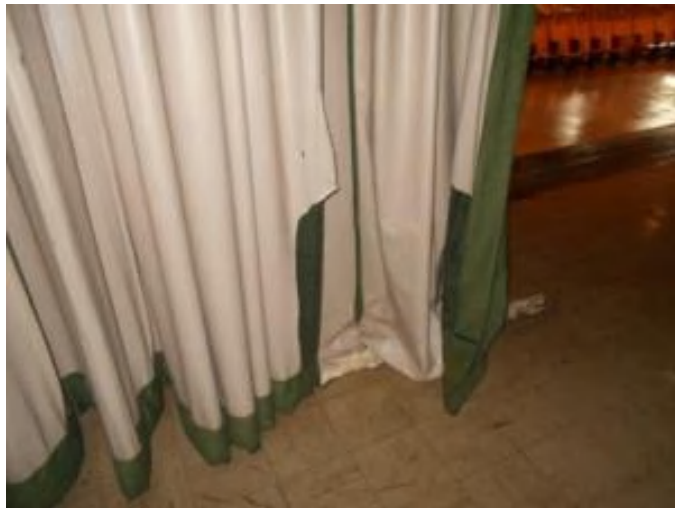
System: E2010 - Fixed Furnishings

Location: Stage

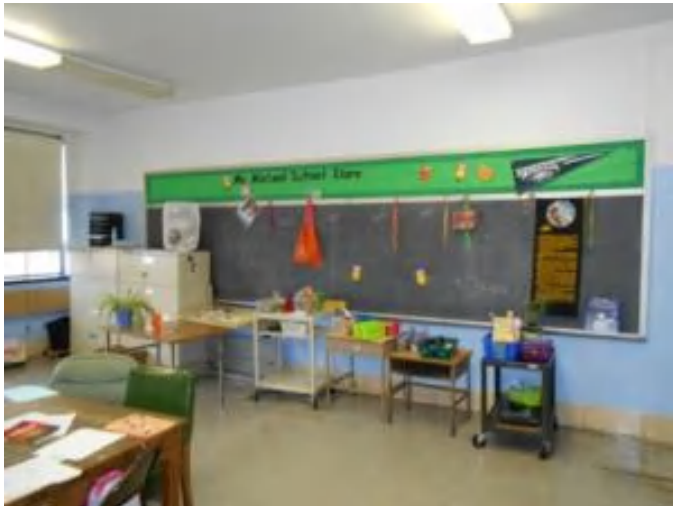
System: C1030 - Fittings

Location: Classrooms

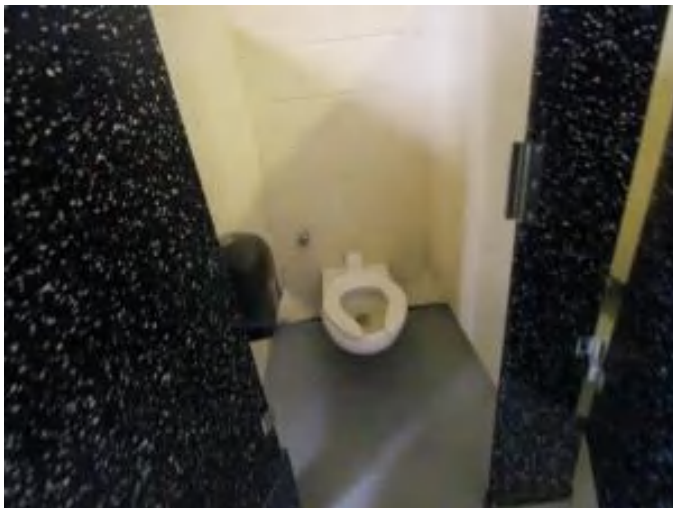
System: D2010 - Plumbing Fixtures

Location: Toilet rooms

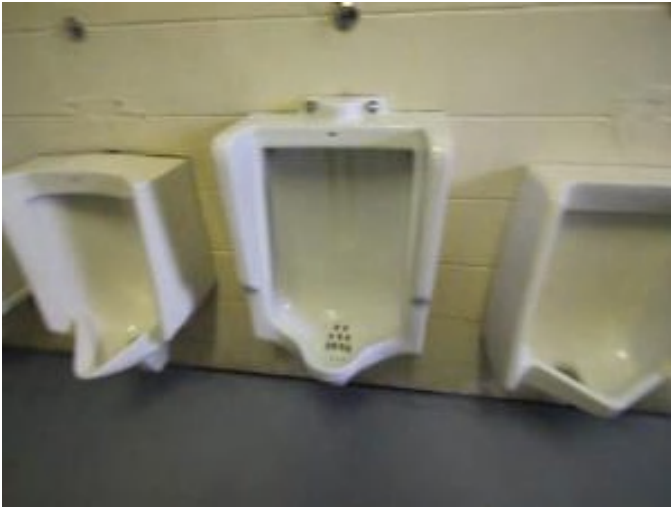
System: D2010 - Plumbing Fixtures

Location: Toilet rooms

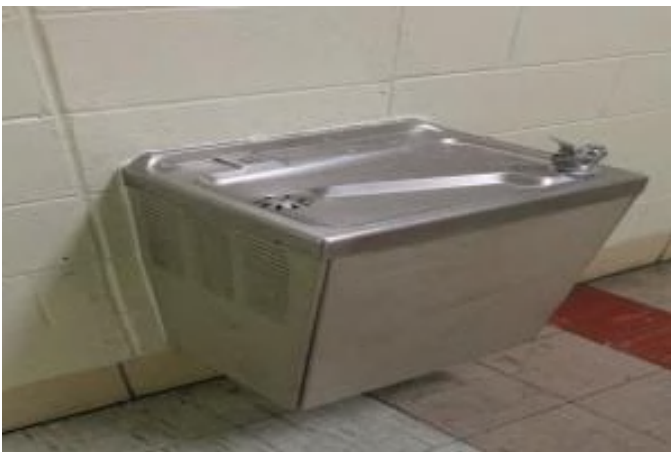
System: D2010 - Plumbing Fixtures

Location: Corridors

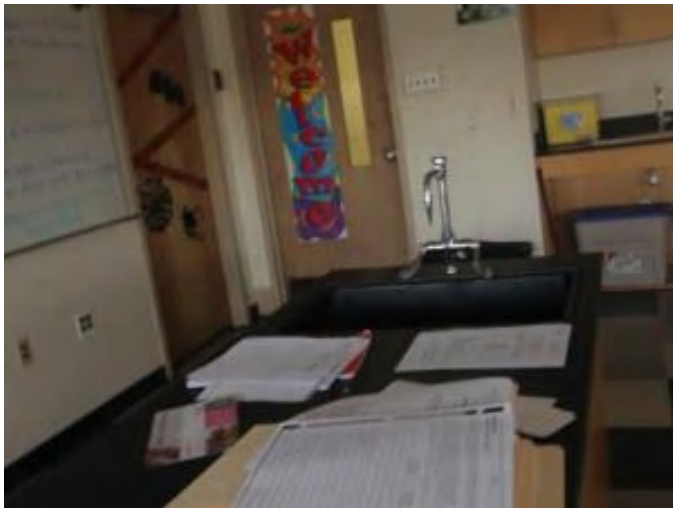
System: D2010 - Plumbing Fixtures

Location: Toilet rooms, et al.
Distress: Failing
Category: 3 - Operations / Maint.
Priority: 4 - Response Time (4-5 yrs)
Correction: Replace lavatory faucet
Qty: 10.00

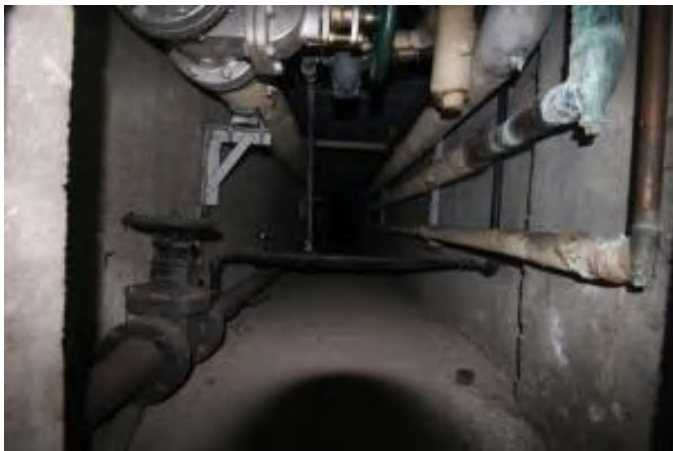
System: D2020 - Domestic Water Distribution

Location: Entire building
Distress: Beyond Service Life
Category: 3 - Operations / Maint.
Priority: 4 - Response Time (4-5 yrs)
Correction: Replace domestic water piping (75 KSF)
Qty: 50,000.00

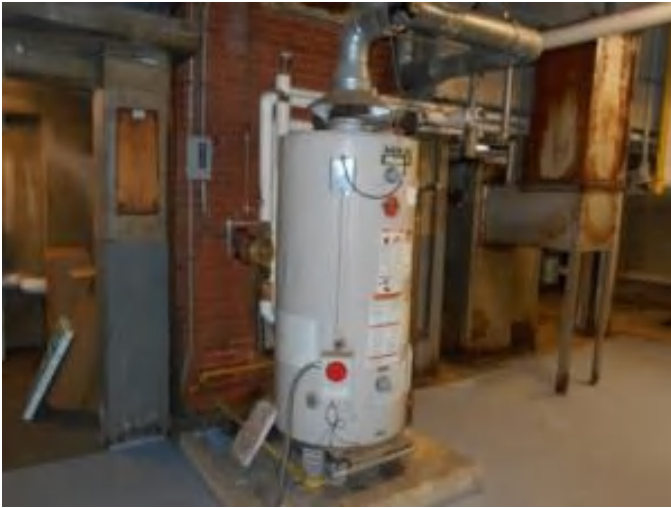
System: D2020 - Domestic Water Distribution

Location: Boiler room
Distress: Beyond Service Life
Category: 3 - Operations / Maint.
Priority: 4 - Response Time (4-5 yrs)
Correction: Replace vertical tank type gas-fired water heater (75 gal)
Qty: 1.00
Unit of Measure: Ea.
Estimate: \$43,408.89
Assessor Name: System
Date Created: 02/09/2016

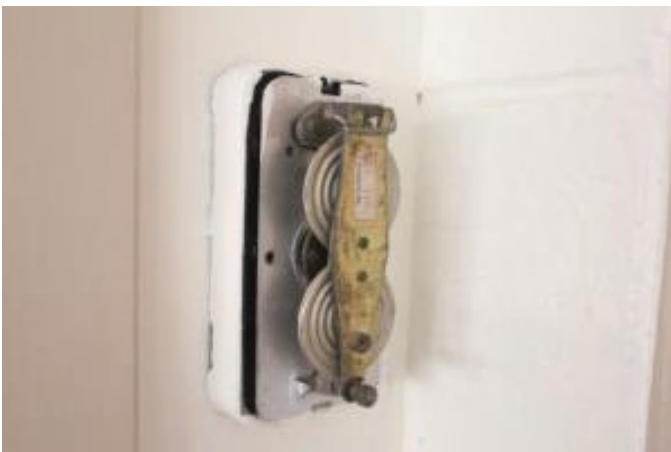
System: D3060 - Controls & Instrumentation

Location: Entire building
Distress: Failing
Category: 3 - Operations / Maint.
Priority: 4 - Response Time (4-5 yrs)
Correction: Replace pneumatic controls with DDC (150KSF)
Qty: 100,000.00
Unit of Measure: S.F.
Estimate: \$1,791,140.52
Assessor Name: System
Date Created: 02/09/2016

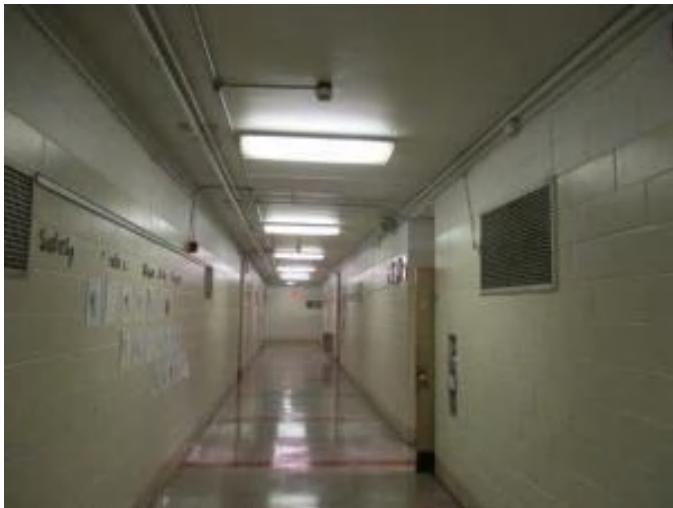
System: D5020 - Lighting and Branch Wiring

Location: Entire Building
Distress: Obsolete
Category: 3 - Operations / Maint.
Priority: 4 - Response Time (4-5 yrs)
Correction: Add Lighting Fixtures
Qty: 500.00
Unit of Measure: Ea.
Estimate: \$430,919.66
Assessor Name: System
Date Created: 01/20/2016

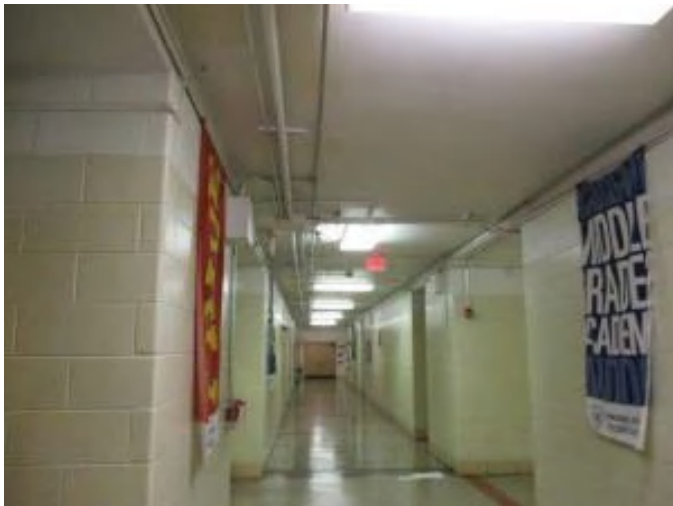
System: D5030 - Communications and Security

Location: Entire Building
Distress: Security Issue
Category: 1 - Health & Safety
Priority: 4 - Response Time (4-5 yrs)
Correction: Add/Replace Video Surveillance System
Qty: 1.00
Unit of Measure: Ea.
Estimate: \$64,172.26
Assessor Name: System
Date Created: 01/20/2016

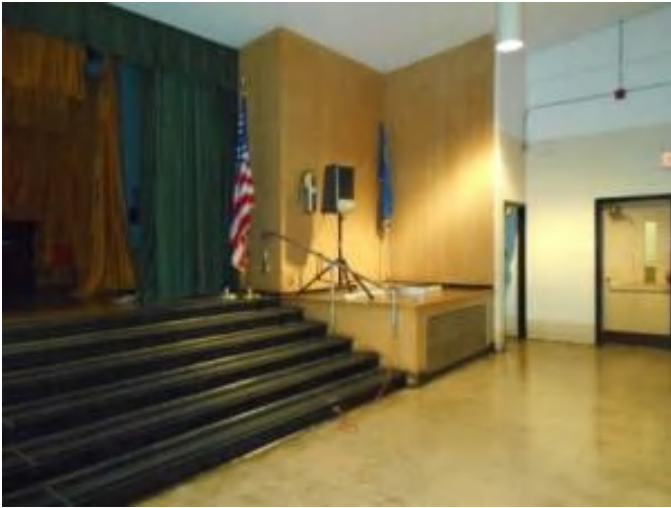
System: D5030 - Communications and Security

Location: Auditorium
Distress: Inadequate
Category: 4 - Capital Improvement
Priority: 4 - Response Time (4-5 yrs)
Correction: Add/Replace Sound System
Qty: 1.00
Unit of Measure: LS
Estimate: \$26,144.90
Assessor Name: System
Date Created: 01/20/2016

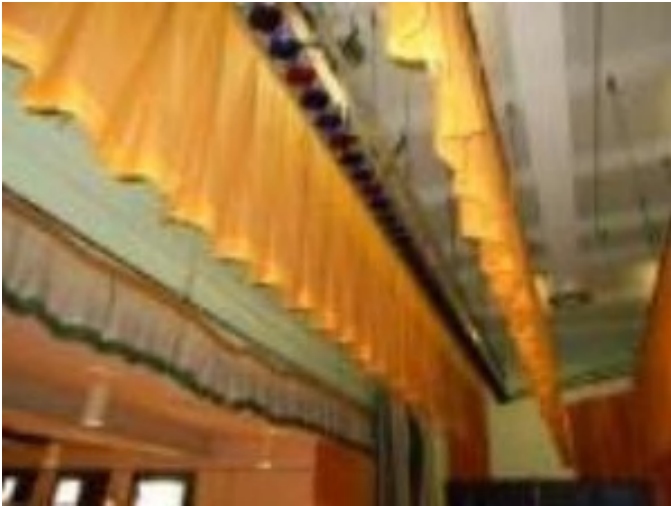
System: E1020 - Institutional Equipment

Location: Auditorium
Distress: Obsolete
Category: 3 - Operations / Maint.
Priority: 4 - Response Time (4-5 yrs)
Correction: Add/Replace Stage Theatrical Lighting System
Qty: 1.00
Unit of Measure: Ea.
Estimate: \$293,594.70
Assessor Name: System
Date Created: 01/20/2016

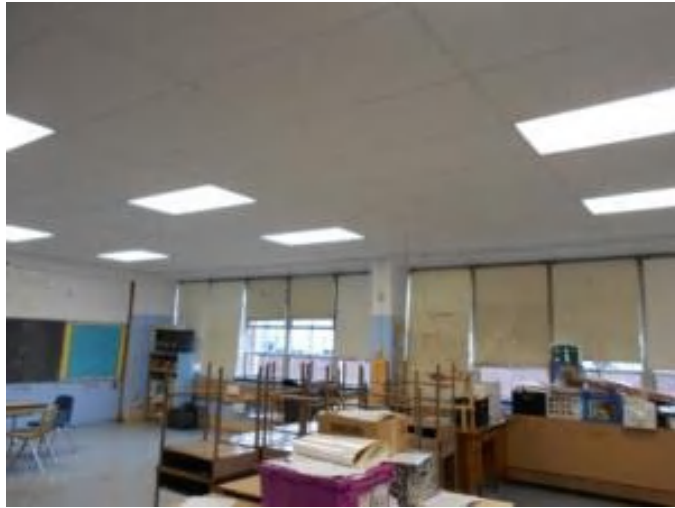
System: E2010 - Fixed Furnishings

Location: Exterior windows

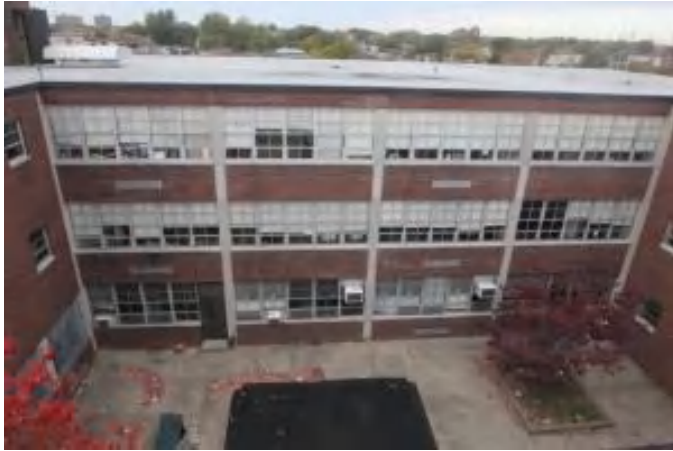
System: D3030 - Cooling Generating Systems

Location: Entire building

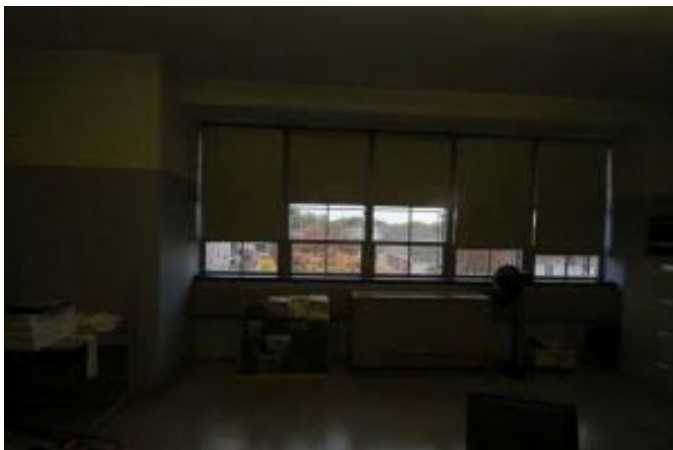
System: D3040 - Distribution Systems

Location: Classrooms

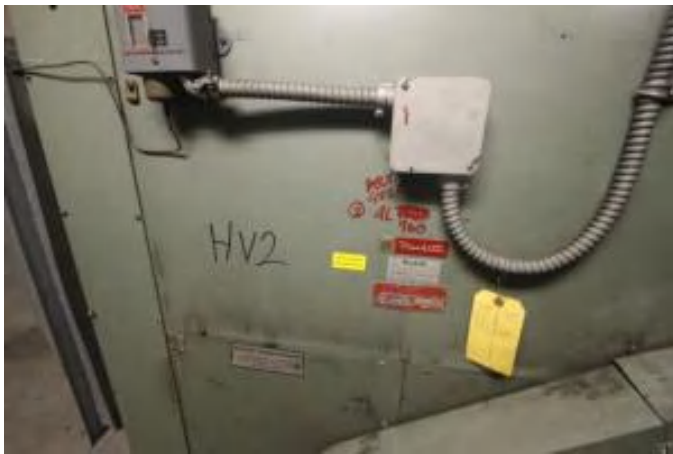
System: D3040 - Distribution Systems

Location: Auditorium

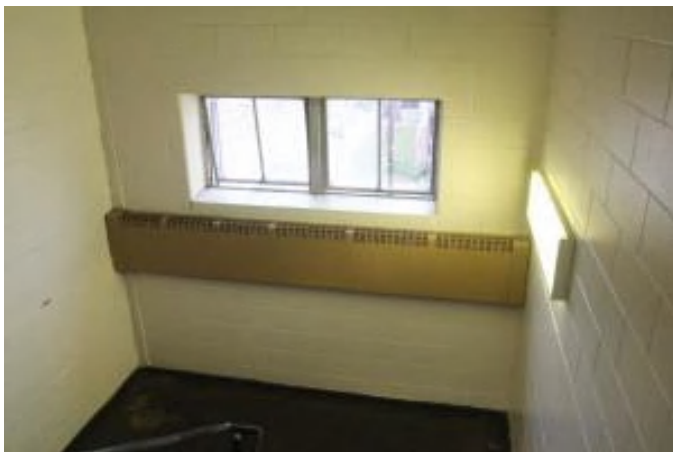
System: D3040 - Distribution Systems

Location: Entire building

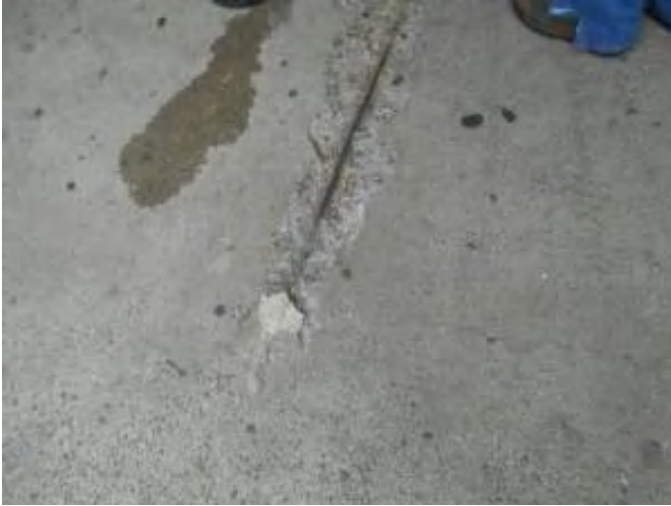
System: G2030 - Pedestrian Paving

Location: Front entry

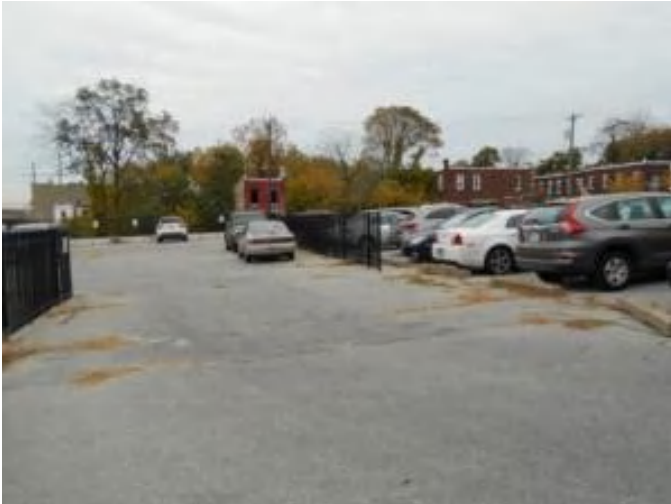
System: G2020 - Parking Lots

Location: Parking lot

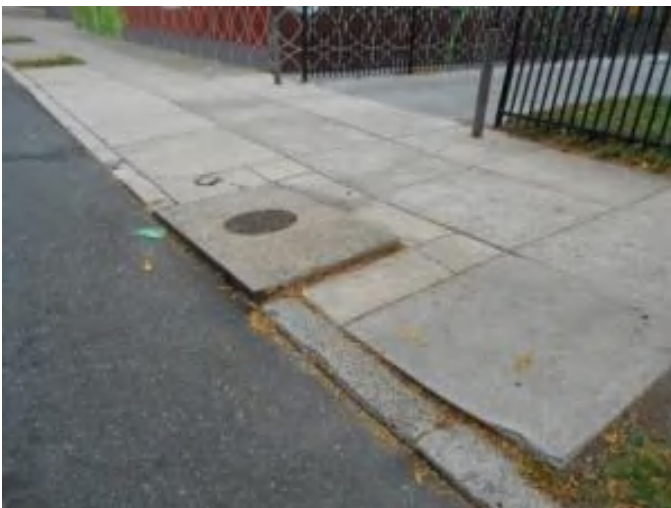
System: G2030 - Pedestrian Paving

Location: Fairmount Avenue

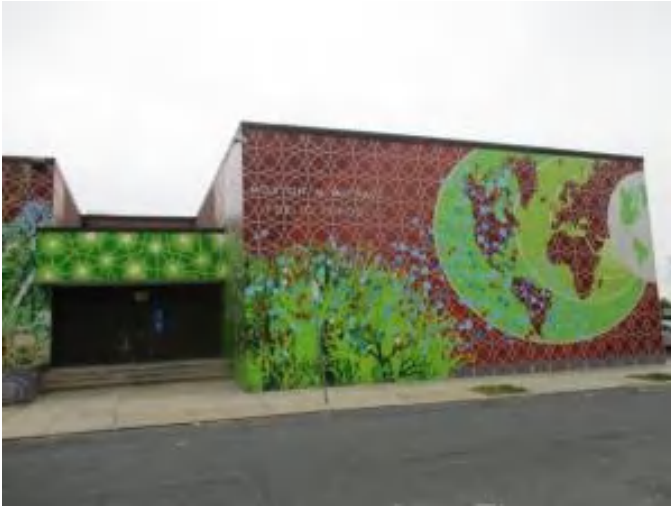
System: G4030 - Site Communications & Security

Location: Building Perimeter
