Facility Condition Assessment Summary Report

Meade School

School District of Philadelphia
S457001;Meade
Final
Site Assessment Report
January 31, 2017

Site Assessment Report

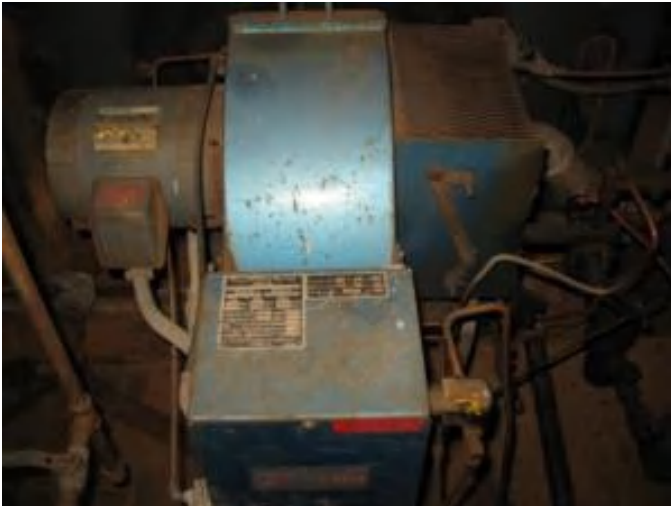
System: D3020 - Heat Generating Systems

Location: Boiler room

Distress: Beyond Service Life

Notes: Replace the two (2) existing 5,600MBH natural gas/oil burners on the boilers, which are nearing the end of their service life, with more efficient new burners.

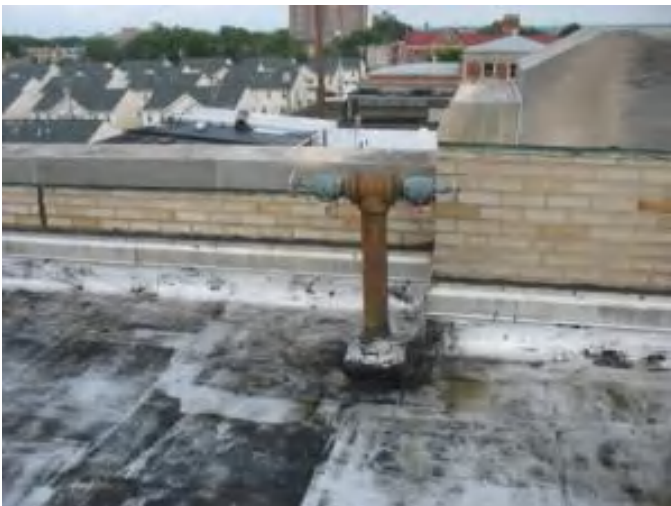
System: D4010 - Sprinklers

Location: Throughout building

Distress: Life Safety / NFPA / PFD

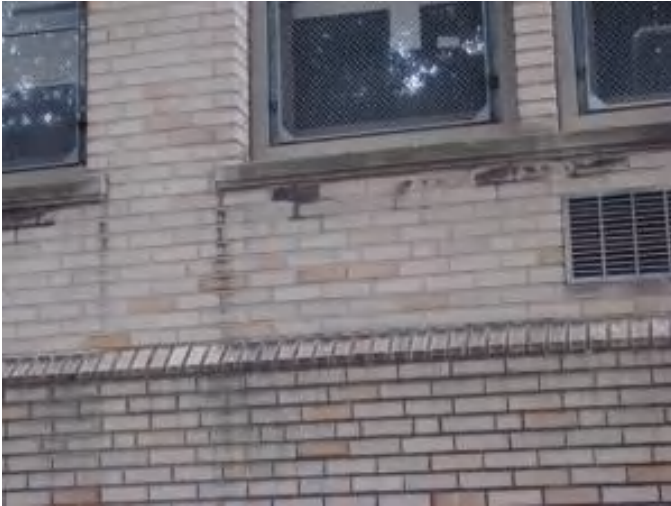
System: B2010 - Exterior Walls

The building envelope is typically masonry with face brick. In general, masonry is in very poor condition with cracks and missing mortar. Many leaks have been reported. The expansion joints on east and west wall are failing. Parapets above the roof show severe cracking and missing mortar from stone coping joints.

Location: Exterior

Distress: Building Envelope Integrity

Notes: Repair cracks in masonry, replace missing mortar – all exterior walls; replace expansion joint on east and west wall

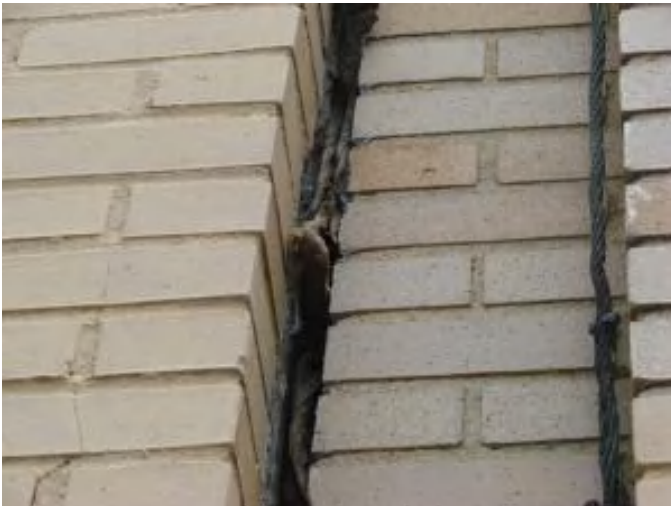
System: B2010 - Exterior Walls

Location: Exterior

Distress: Failing

Notes: Replace expansion joint on east and west wall

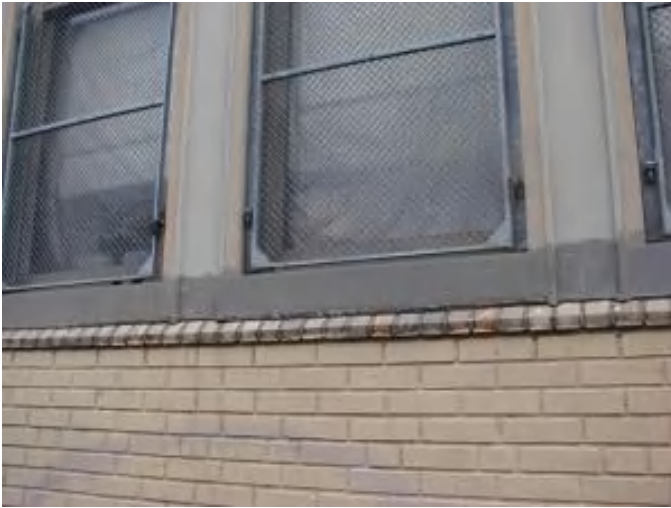
System: B2020 - Exterior Windows

The original windows in original building were retrofitted in mid 1990's with extruded aluminum double hung windows single glazed with acrylic glazing. The old window frames were left in place and are rotting causing major leaks around windows perimeters Addition has original rolled steel windows also single glazed. All windows are generally in very poor condition with some of the windows inoperable; first floor windows have security screens in fair to poor condition; they are unsafe to operate due to possible balancing mechanism failure. The windows are generally not energy efficient.

Location: Exterior

Distress: Building Envelope Integrity

Notes: Replace all windows

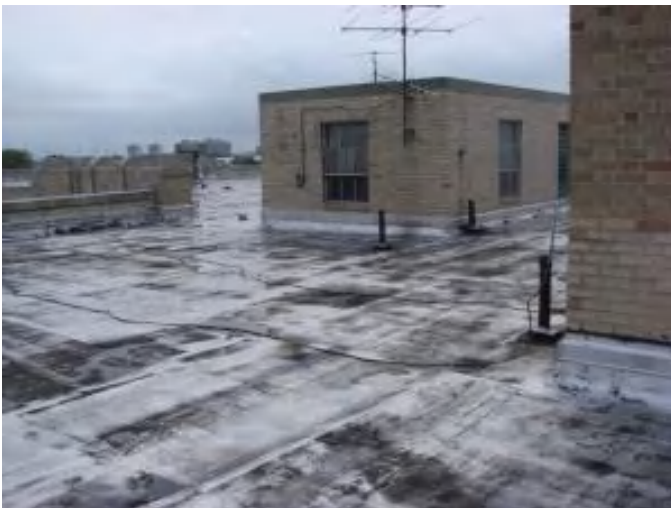
System: B3010105 - Built-Up

Roofing is built-up in very poor condition with. All flashing is typically in poor condition allowing for water penetration into the building; major leaks have been reported and observed. Exterior doors are typically hollow metal in poor condition with rust and peeling paint showing. Generally, the building is not accessible per ADA requirements due to first floor- grade separation with no ramps or lifts.

Location: Exterior/ Roof

Distress: Building Envelope Integrity

Notes: Install all new roofing system including insulation; tear-down existing roofing; install flashing, counter flashing and reglets

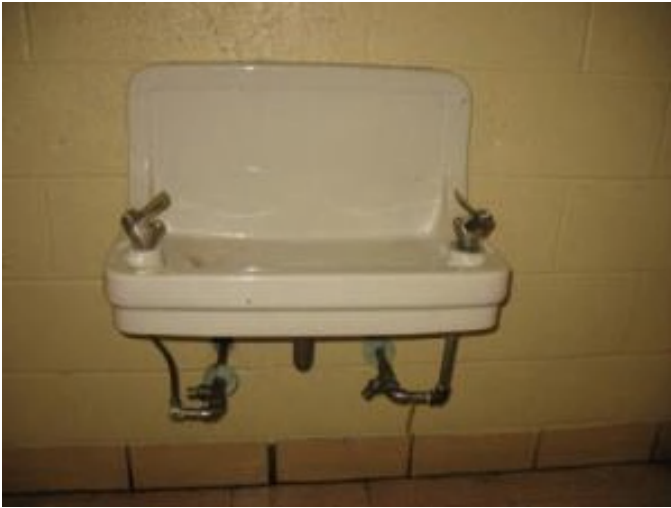
System: D2010 - Plumbing Fixtures

Drinking fountains in the corridors and at the restrooms are a mixture of wall hung with integral refrigerated coolers and wall hung porcelain fountains. The porcelain fountains are well beyond their service life and should be replaced; most are NOT accessible type.

Location: Throughout building

Distress: Beyond Service Life

Notes: Replace the wall hung drinking fountains and integral refrigerated coolers in the corridors and at the restrooms. These units are well beyond their service life and most are NOT accessible type.

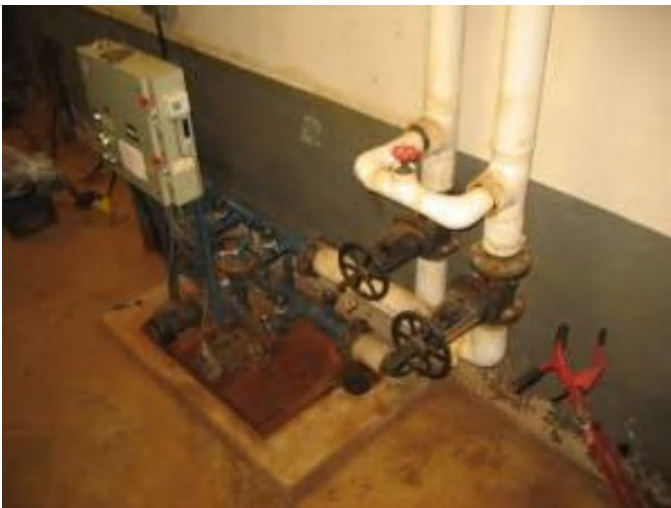
System: D2020 - Domestic Water Distribution

Location: Basement Mechanical room

Distress: Beyond Service Life

Notes: Replace domestic water booster pumps.

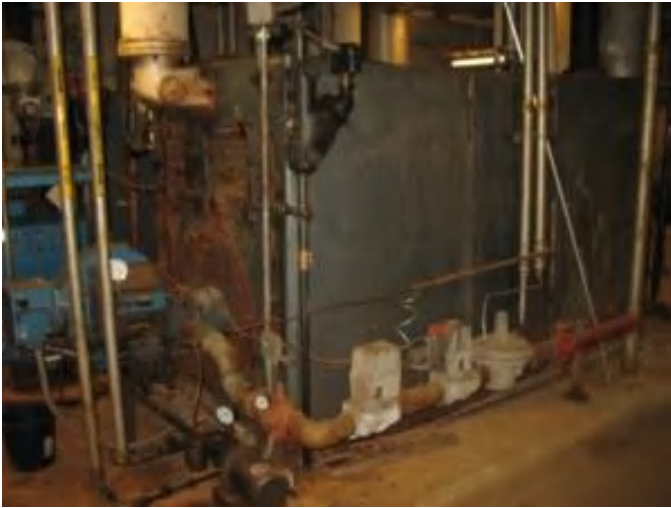
System: D3020 - Heat Generating Systems

Low pressure steam is generated at a maximum of 15 lbs/sq. in., typically 5-8 lbs/sq. in., by two 120 HP Weil-McLain H-1994 cast iron sectional boilers. The building engineer did not know when the boilers were installed but estimated they are over 40 years old. One boiler can handle the load in normal winter weather conditions; two units are required on very cold days. Each boiler is equipped with a Power Flame burner designed to operate on natural gas or fuel oil. The burners should be replaced as they are nearing the end of their service life and newer, more efficient technologies are available. Burner controls provide full modulation with electronic ignition, digital flame sensing and pressure atomization on oil. Burner oil pumps are loose and not driven by the fan motor. Combustion air makeup is supplied by louvers equipped with motorized dampers. Induced draft fans with positive draft control are installed on the rear of each boiler. The gas train serving the boilers does appear to have code required venting of the regulators and dual solenoid valves with venting of the chamber between. The Building Engineer reports the system loses a significant amount of condensate due to failed traps, which is made up with chemically treated city water. Cast iron sectional boilers have an anticipated service life of 35 years or more; as these units have been in service for an unknown amount of time they should be inspected on a regular basis.

Location: Boiler room

Distress: Beyond Service Life

Notes: Replace the two (2) existing 5,230MBH cast iron boilers, which are beyond their service life.

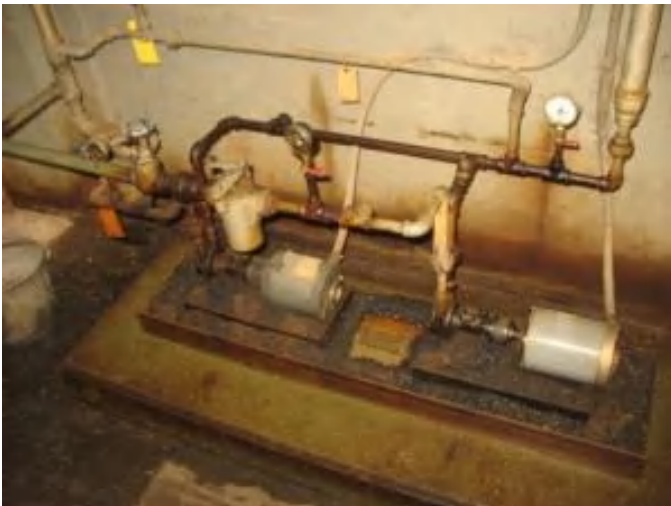
System: D3020 - Heat Generating Systems

Location: Basement

Distress: Beyond Service Life

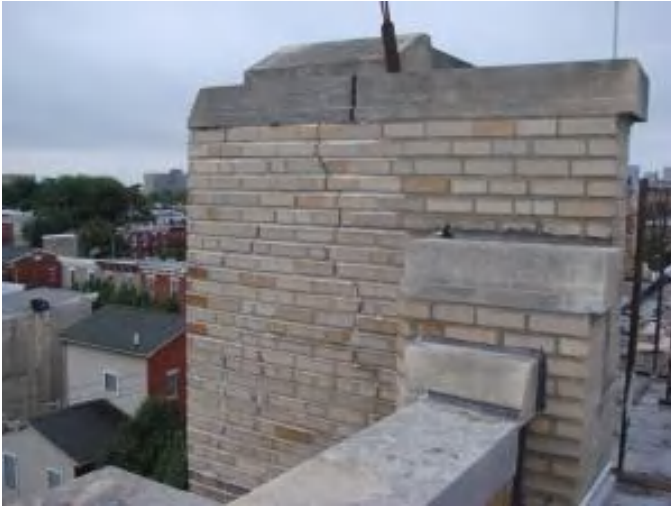
System: B2010 - Exterior Walls

Location: Exterior/ Roof level

Distress: Failing

Notes: Rebuild brick parapets at original building roof perimeter; re-set stone coping

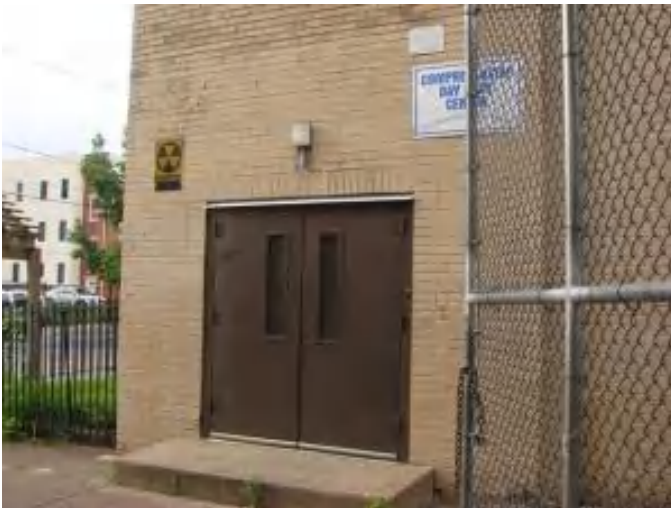
System: B2030 - Exterior Doors

Location: Exterior

Distress: Beyond Service Life

Notes: Replace all exterior doors

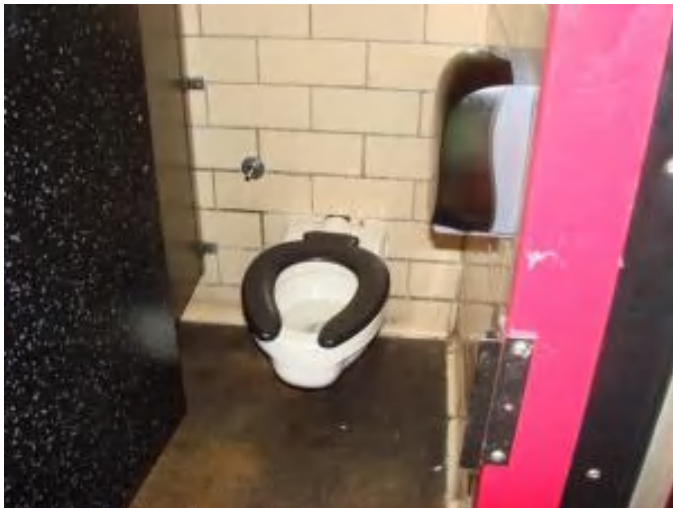
System: C1030 - Fittings

Location: Interiors

Distress: Accessibility

Notes: Reconfigure toilets on each floor for accessibility, provide new toilet partitions and toilet accessories including grab bars

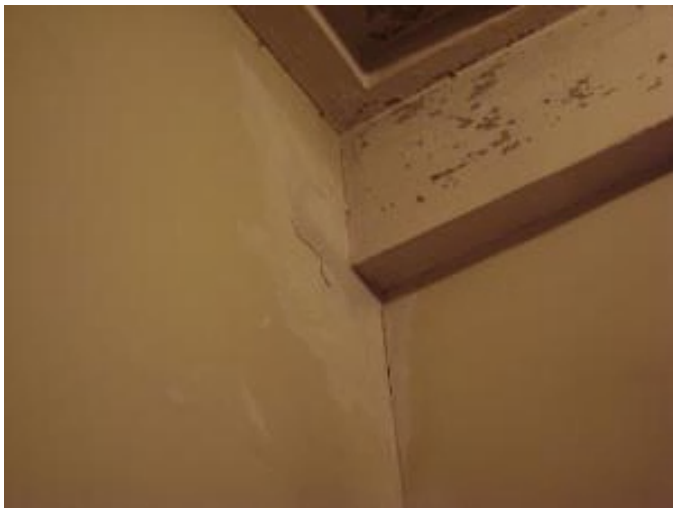
System: C3010230 - Paint & Covering

Location: Interiors

Distress: Damaged

Notes: Repair and repaint damaged interior walls

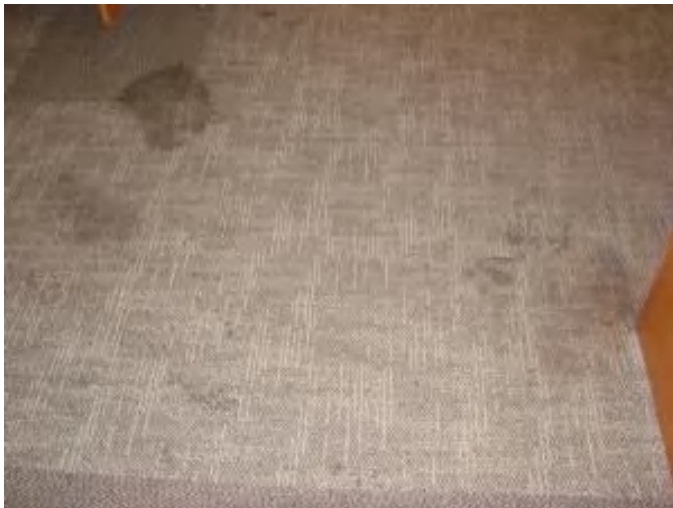
System: C3020411 - Carpet

Location: Interiors/ Library

Distress: Beyond Service Life

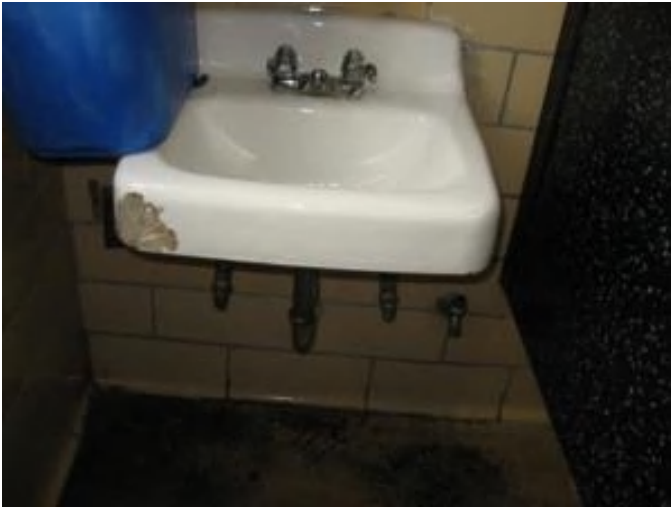
System: D2010 - Plumbing Fixtures

Location: Restrooms

Distress: Accessibility

Notes: Replace the wheel lavatories in the restrooms with new code compliant fixtures.

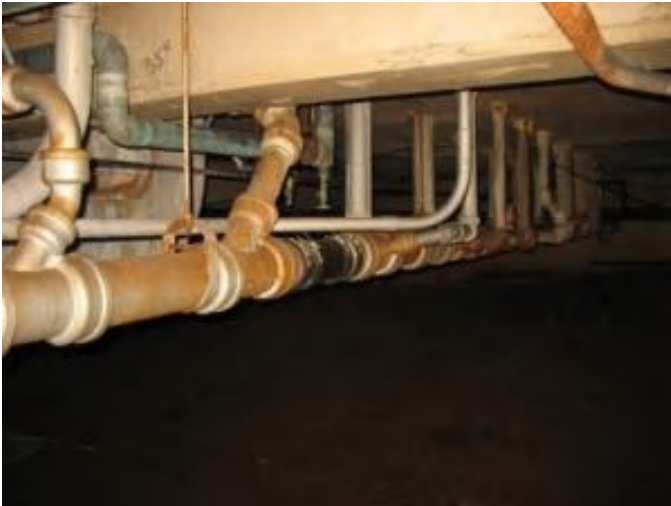
System: D2030 - Sanitary Waste

The maintenance staff reported mostly minor problems with the sanitary waste piping systems. However, the sewer piping has been in service for nearly 70 years and will require more frequent attention from the maintenance staff as time passes. The District should hire a qualified contractor to examine the sanitary waste piping using video cameras to locate and replace any damaged piping and to further quantify the extent of potential failures.

Location: Throughout building

Distress: Beyond Service Life

Notes: Hire a qualified contractor to perform a detailed examination of the sanitary waste piping using visual inspection and video cameras to locate and replace any damaged piping and to further quantify the extent of potential failures.

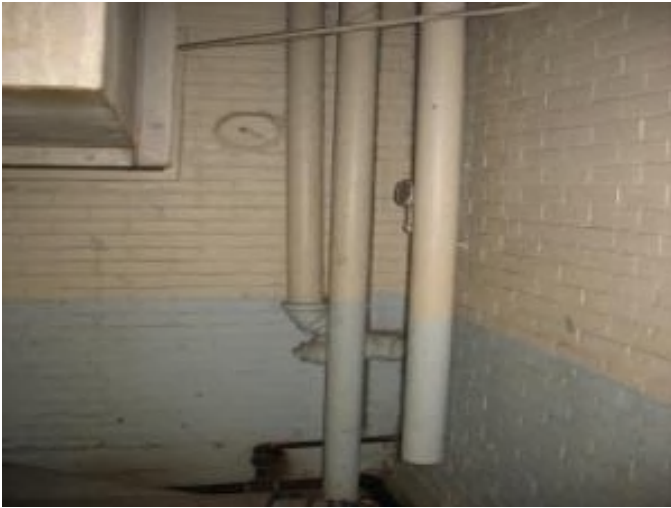
System: D2040 - Rain Water Drainage

Location: Throughout building

Distress: Beyond Service Life

Notes: Hire a qualified contractor to perform a detailed examination of the rain water drainage piping using visual inspection and video cameras to locate and replace any damaged piping and to further quantify the extent of potential failures.

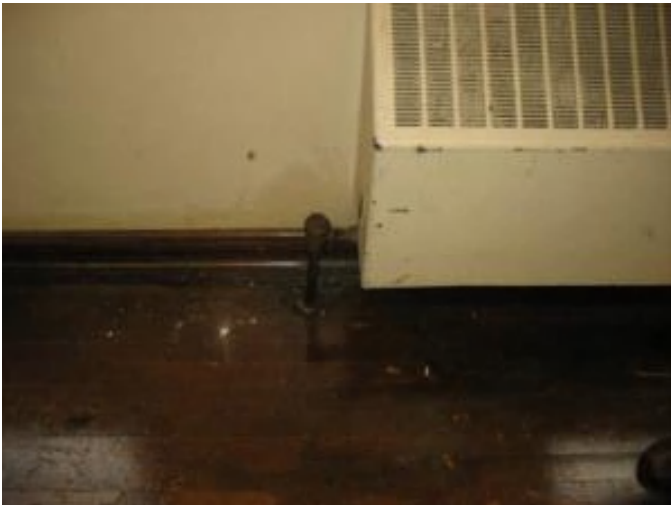
System: D3040 - Distribution Systems

Location: Throughout building

Distress: Beyond Service Life

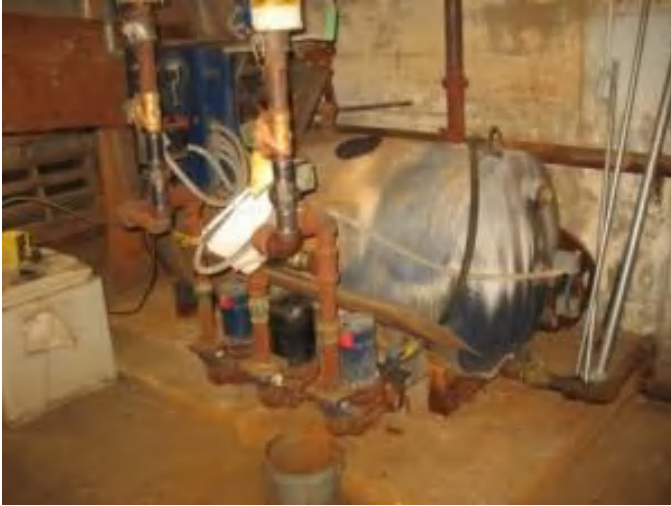
System: D3040 - Distribution Systems

Two boiler feed tanks are installed in the basement; one in the boiler room and one in the crawl space under element two of the building. A serious problem was reported with failed steam traps. Live steam passes into the condensate piping system from the failed traps and then vents from the condensate handling equipment. The District has not conducted a steam trap survey for this building and traps are not serviced on a regular schedule.

Location: Throughout building

Distress: Maintenance Required

Notes: Conduct a steam trap survey to identify and replace failed traps passing live steam into the condensate piping system.

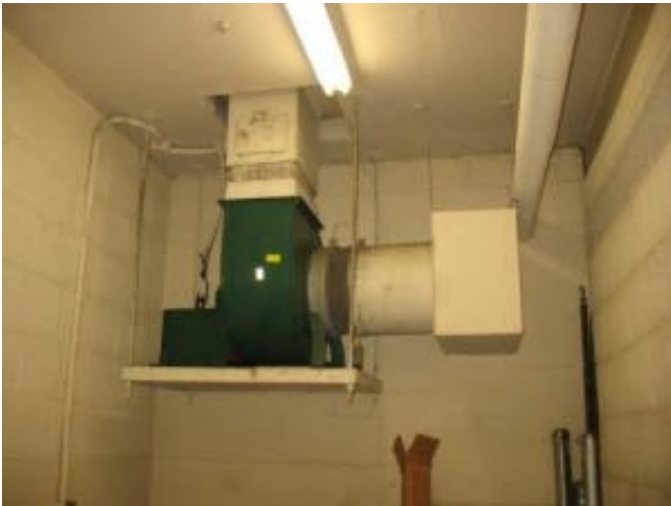
System: D3040 - Distribution Systems

Location: Roof

Distress: Building / MEP Codes

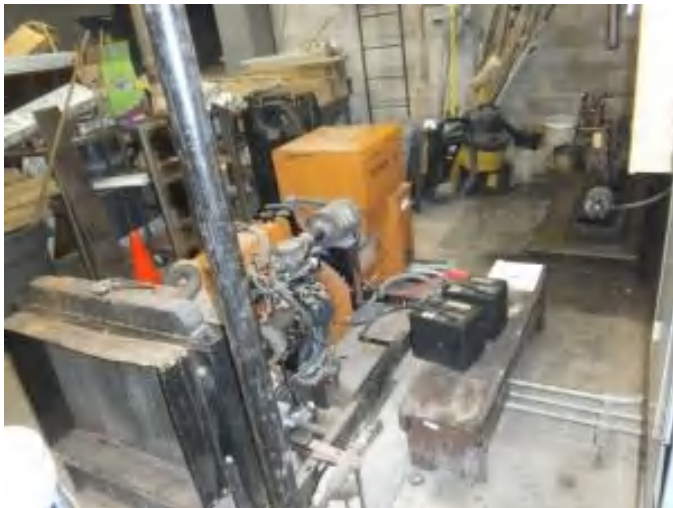
System: D5090 - Other Electrical Systems

Location: Basement

Distress: Inadequate

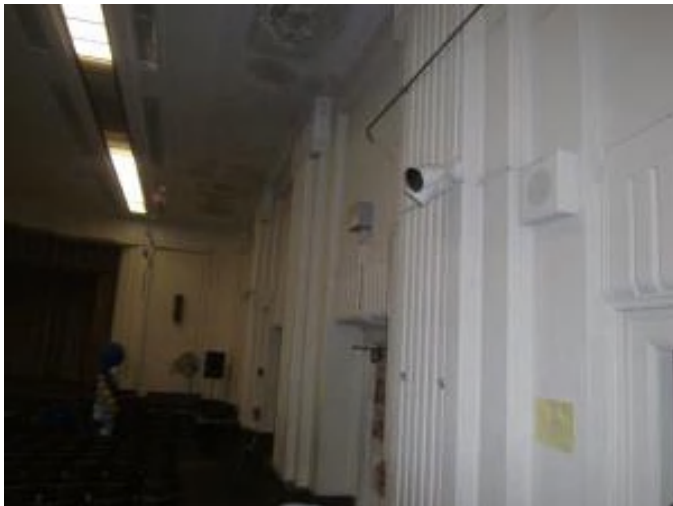
System: D5090 - Other Electrical Systems

Location: Throughout Building

Distress: Life Safety / NFPA / PFD

Notes: Provide new emergency fixtures for emergency egress.

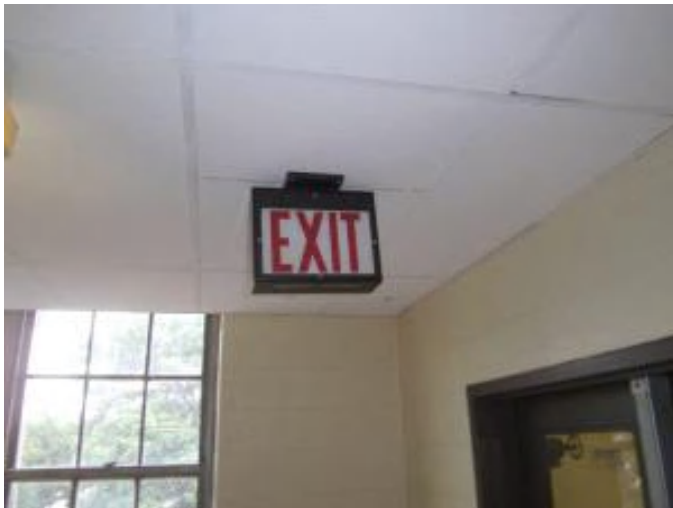
System: D5090 - Other Electrical Systems

Location: Throughout Building

Notes: Replace exit lights with LED style fixtures

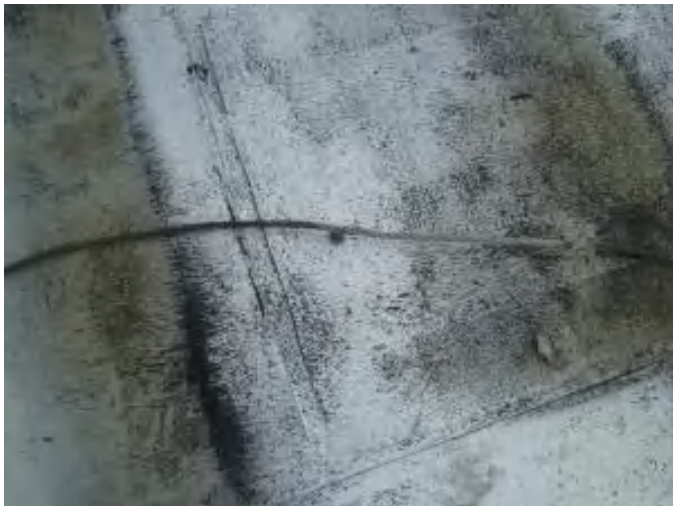
System: D5090 - Other Electrical Systems

Location: Roof

Notes: Repair lightning protection system.

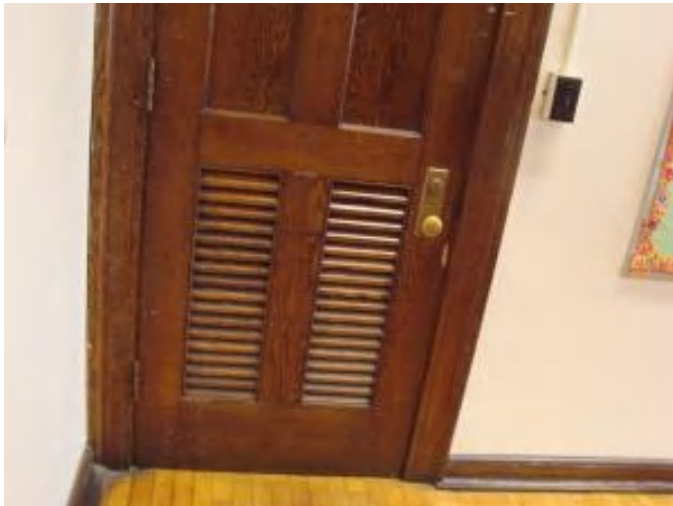
System: C1020 - Interior Doors

Location: Interiors

Distress: Beyond Service Life

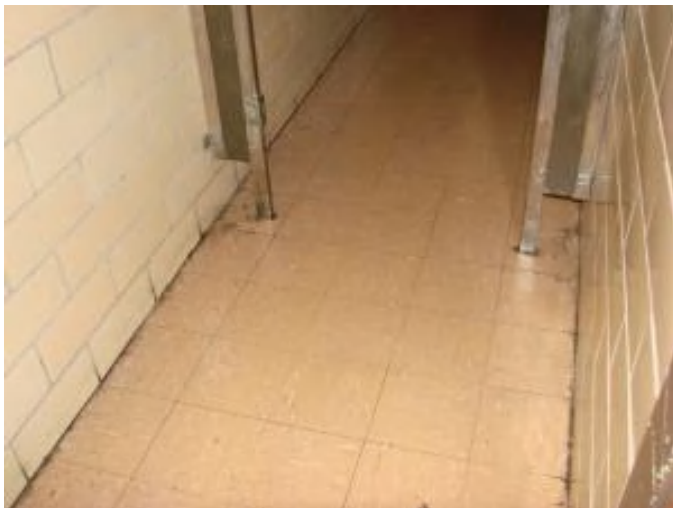
System: C3020413 - Vinyl Flooring

Location: Interiors

Distress: Beyond Service Life

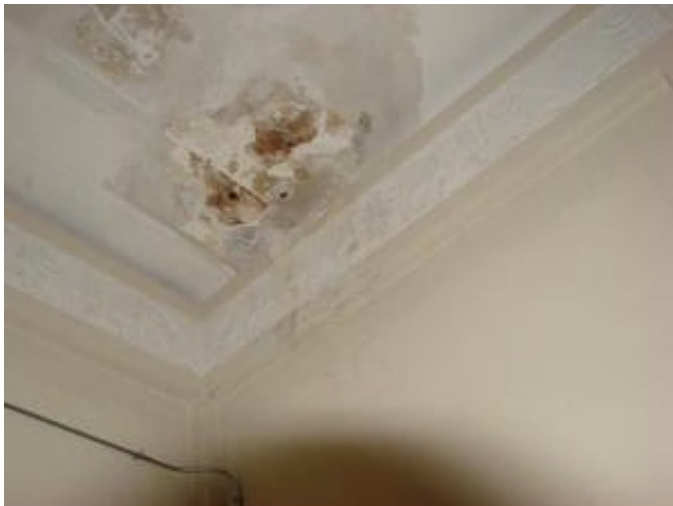
System: C3030 - Ceiling Finishes

Location: Interiors

Distress: Damaged

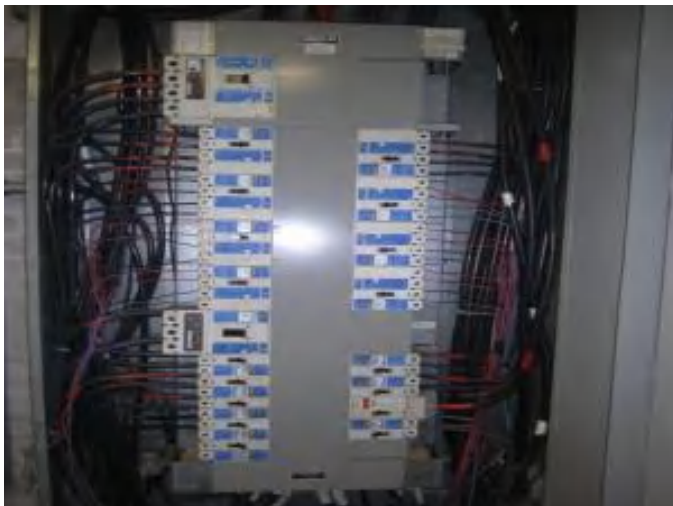
System: D5010 - Electrical Service/Distribution

Location: Throughout Building

Distress: Inadequate

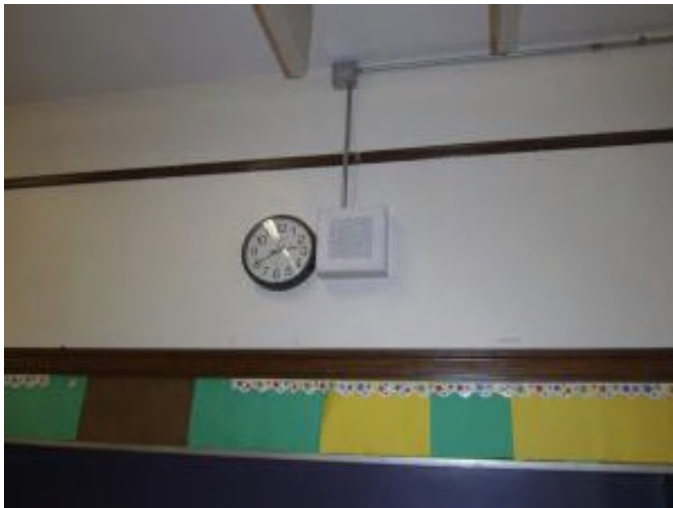
System: D5030 - Communications and Security

Location: Throughout Building

Distress: Inadequate

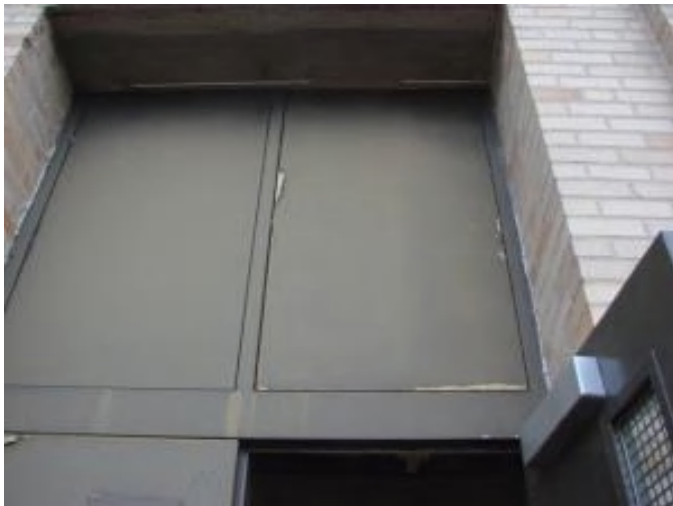
System: D5030 - Communications and Security

Location: 1st Floor

Distress: Security Issue

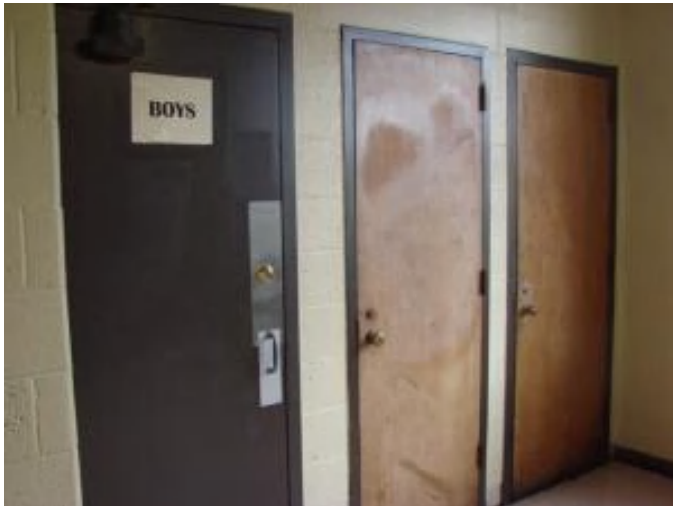
System: C1030 - Fittings

Location: Interiors

Distress: Beyond Service Life

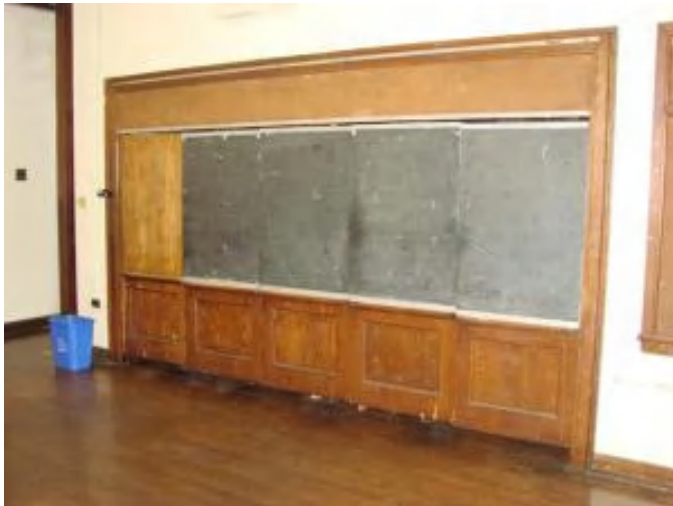
System: C1030 - Fittings

Location: Interiors

Distress: Beyond Service Life

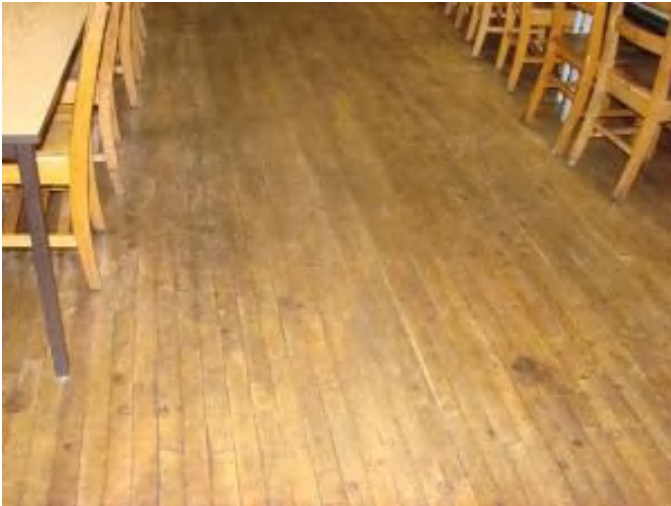
System: C3020414 - Wood Flooring

Location: Interiors

Distress: Beyond Service Life

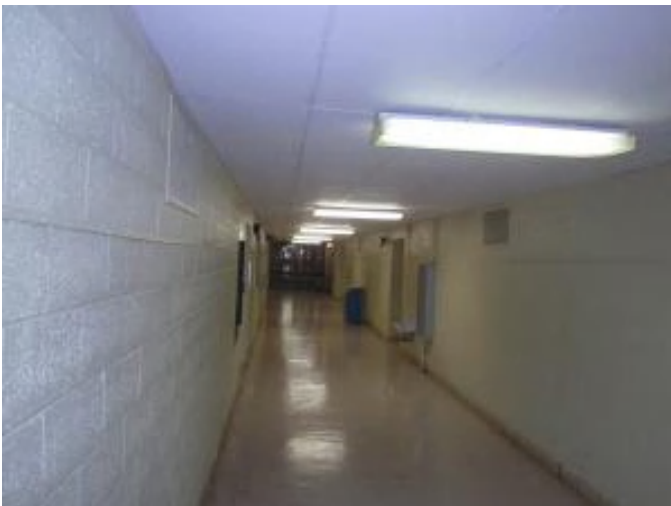
System: C3030 - Ceiling Finishes

Location: Interiors

Distress: Inadequate

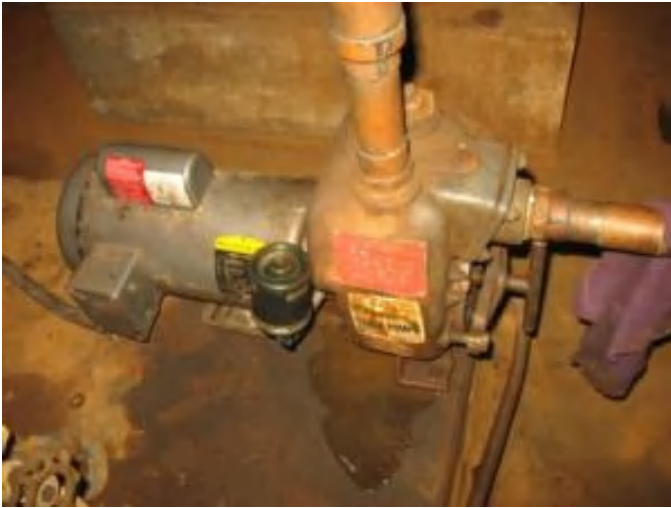
System: D2030 - Sanitary Waste

A small sewage ejector pit located in basement receives water from the basement area. It has a single pump that is beyond its service life, it should be replaced to prevent flooding of the basement. The pit is not sealed, but should be.

Location: Basement

Distress: Beyond Service Life

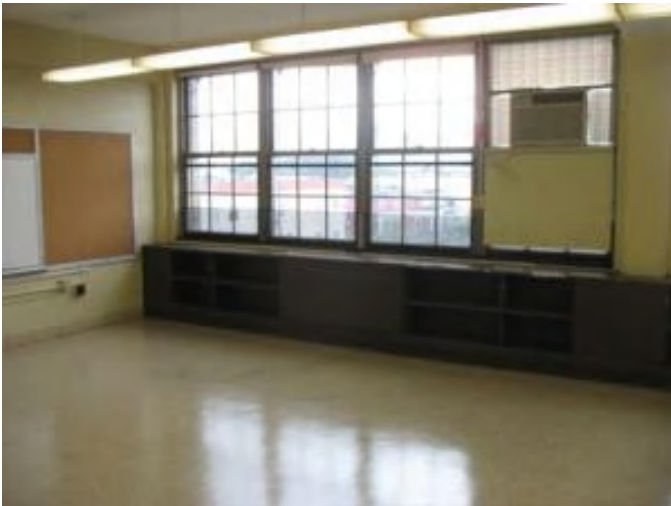
System: D3030 - Cooling Generating Systems

Location: Roof

Distress: Inadequate

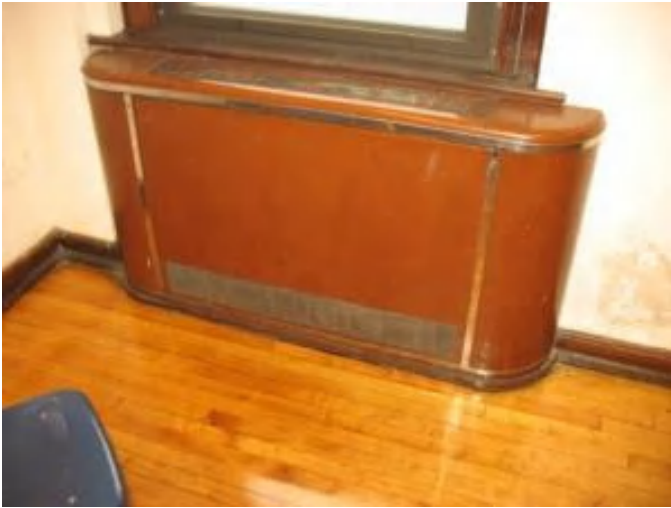
System: D3040 - Distribution Systems

Location: Throughout building

Distress: Building / MEP Codes

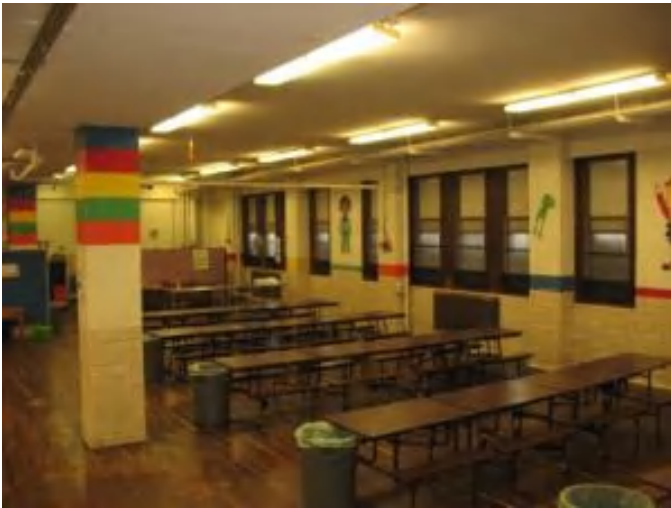
System: D3040 - Distribution Systems

Location: Lunch room/gymnasium

Distress: Building / MEP Codes

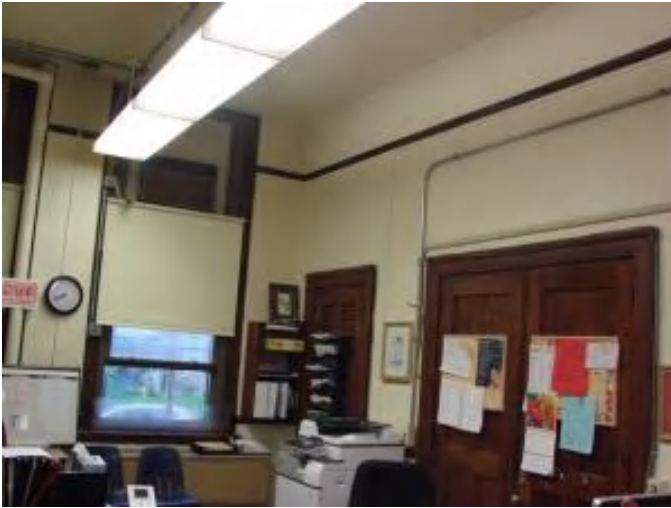
System: D3040 - Distribution Systems

Location: Administration

Distress: Building / MEP Codes

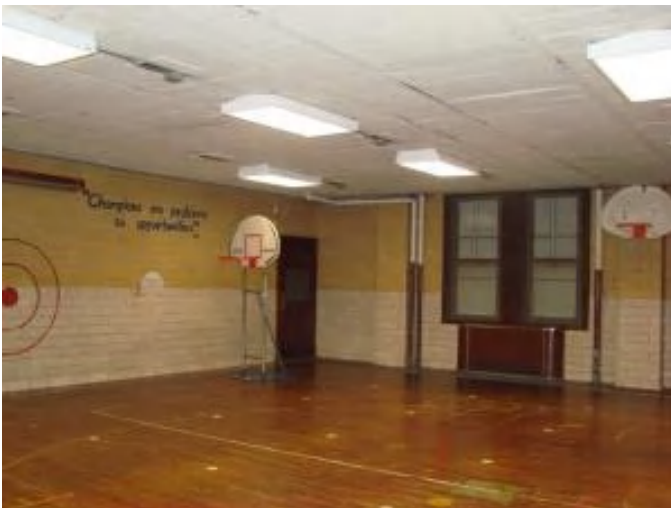
System: D3040 - Distribution Systems

Location: Small gymnasium

Distress: Building / MEP Codes

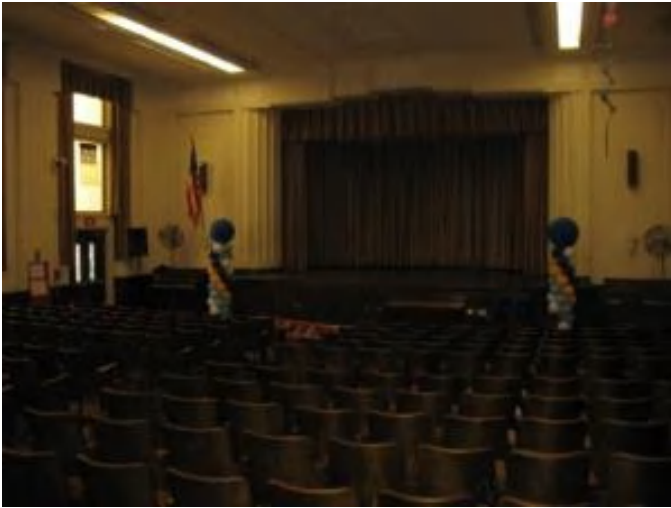
System: D3040 - Distribution Systems

Location: Auditorium

Distress: Building / MEP Codes

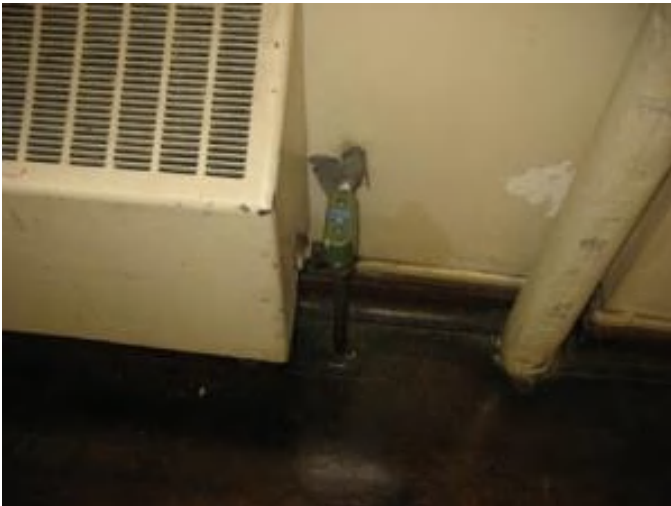
System: D3060 - Controls & Instrumentation

The original pneumatic systems still provide basic control functions. Pneumatic room thermostats are intended to control the steam radiator control valves. In reality the radiator control valves are wide open and heating control is achieved via the boilers. Pneumatic control air is supplied from a duplex Quincy compressor and dryer located in the boiler room. The maintenance staff reports no problems with oil, moisture or dirt in the pneumatic copper tubing. The pneumatic systems are beyond their service life and require too much attention from the maintenance staff. The original control valves and pneumatic actuators are beyond their service life and should be rebuilt or replaced. These controls should be converted to DDC.

Location: Throughout building

Distress: Inadequate

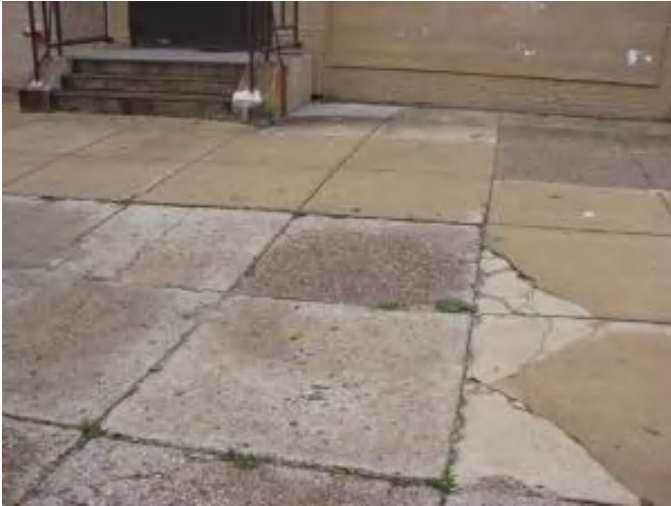
System: G2030 - Pedestrian Paving

Location: Grounds/ Site

Distress: Beyond Service Life

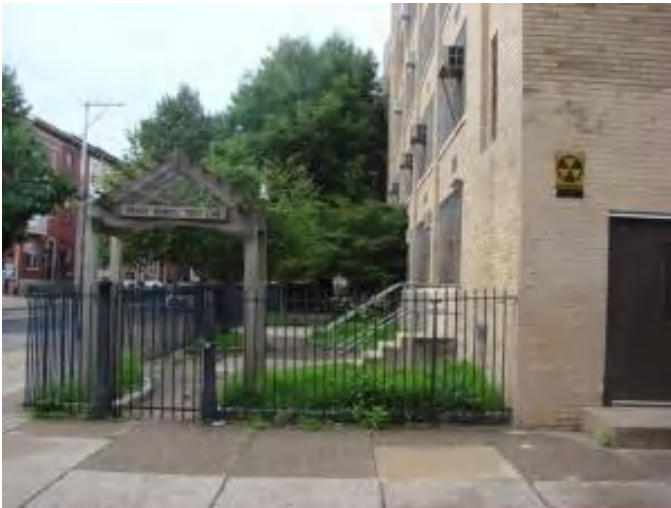
System: G2050 - Landscaping & Irrigation

Location: Grounds/ Site

Distress: Failing
