Facility Condition Assessment Summary Report

Meehan Middle School

S801001;Lincoln, Meehan, and Field

Site Assessment Report

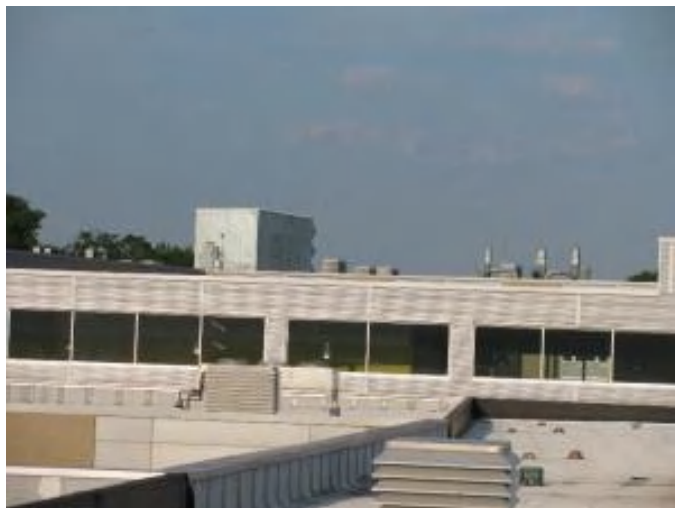
Location: Lincoln - Main Building - Roof

System: D5090 - Other Electrical Systems

Distress: Life Safety / NFPA / PFD

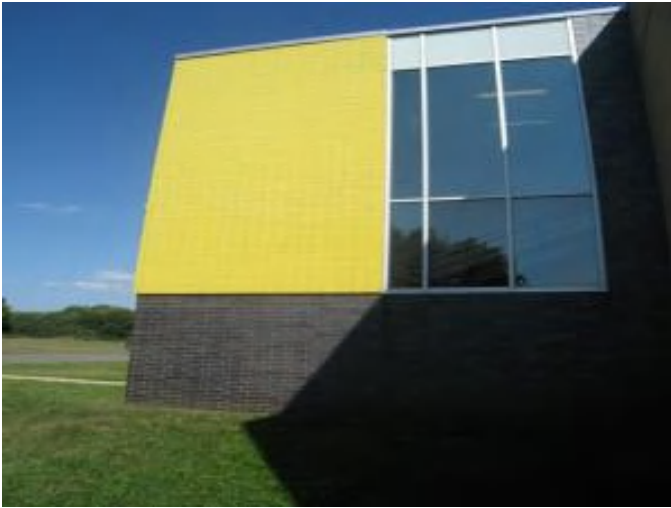
Location: Lincoln - Main Building - stair 1 window

have full height glass without screens. The outside pane of one of the glazing units in Stairway 1 was observed to be broken; the inside pane still seemed to be intact. Also, in Stairway 4, one of the inside covers of the aluminum tube system frames was missing. Gaskets in all units appeared to be intact and windows appeared to be in good condition. Building entrances are all constructed of full height clear glass letting in copious amounts of light into the atrium corridors inside. The main entrance vestibule is a tall element that terminates into the 2nd floor roof, calling attention to the main entrance. There is a glass greenhouse the size of a double classroom in the front of the building on the left side; it is actively utilized by students for project work. The corridor across from the cafeteria has full height windows facing the courtyard. Aluminum tube frame corners do not seal properly, at the tops of the entrance vestibules where those elements meet the roof coping; there are gaps and openings where rain and snow can enter the wall cavity below. These areas need to

System: B2020 - Exterior Windows

Distress: Damaged

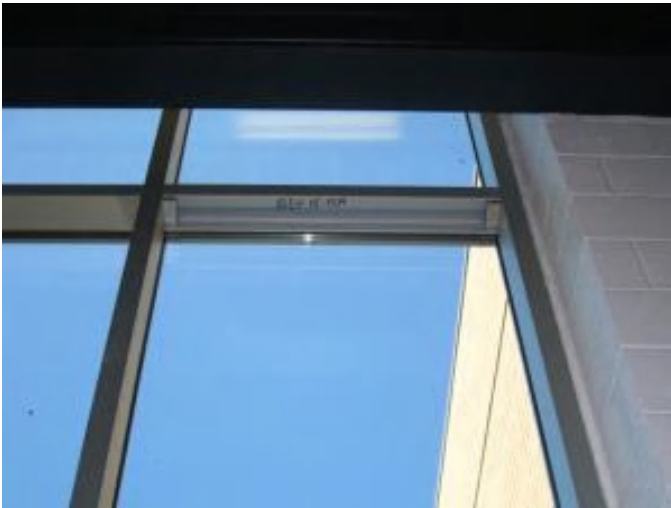
Location: Lincoln - Main Building - stair 4 mullion

System: B2020 - Exterior Windows

Distress: Damaged

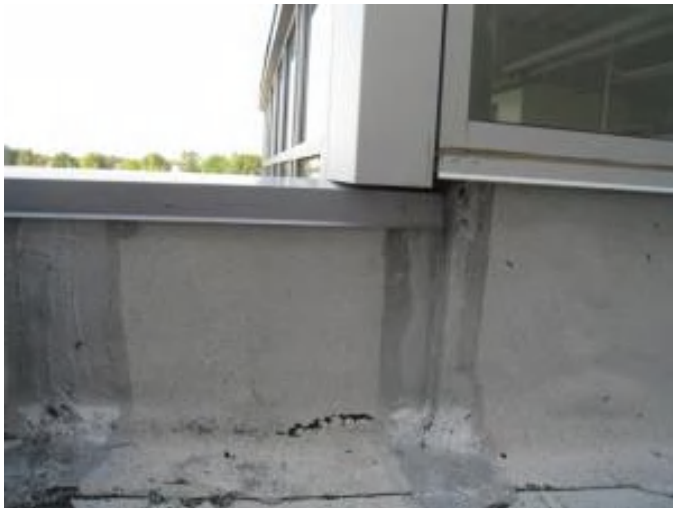
Location: Lincoln - Main Building - mullions @ roof coping

System: B3010120 - Single Ply Membrane

Distress: Failing

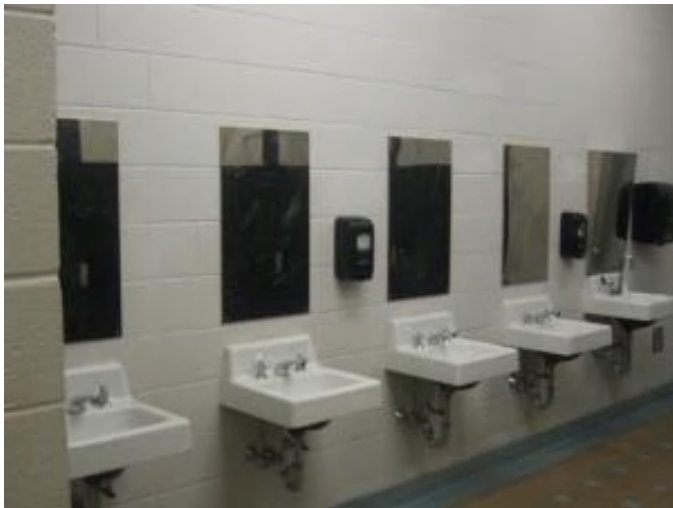
Location: Lincoln - Main Building - toilet rooms

System: C1030 - Fittings

Distress: Damaged

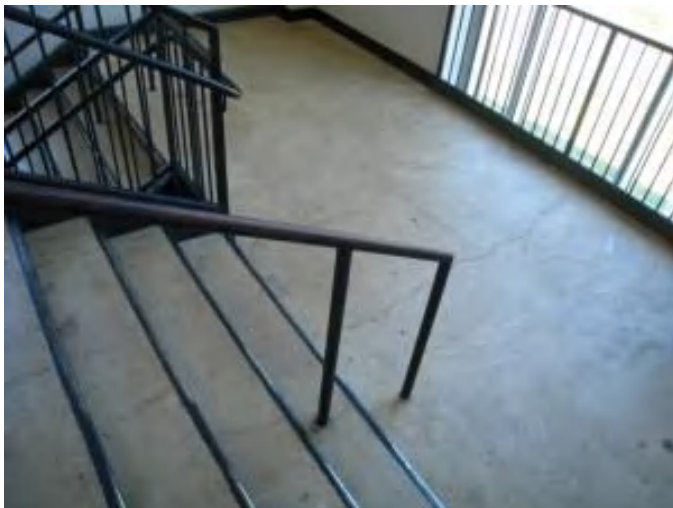
Location: Lincoln - Main Building - stair railings

System: C2010 - Stair Construction

Distress: Appearance

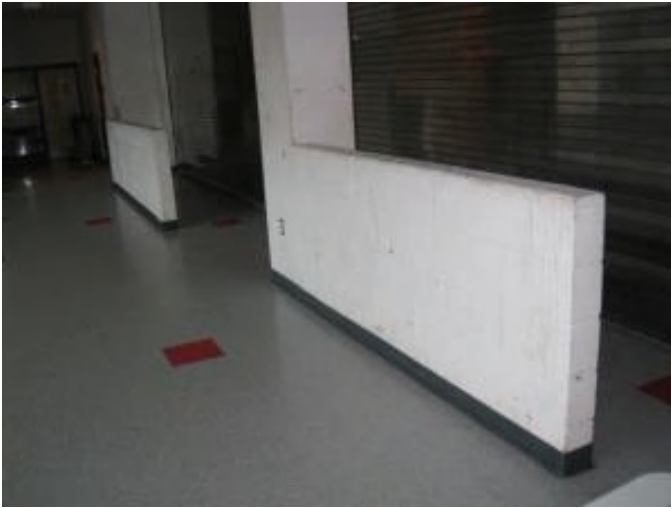
Location: Lincoln - Main Building - walls

Wall finishes consist of painted block or gypsum board. Concrete block walls are generally in good condition. Classrooms have a combination of block and gypsum board partitions. Where desks are adjacent to gypsum board, there is surface damage which should be spackled and repainted.

System: C3010230 - Paint & Covering

Distress: Damaged

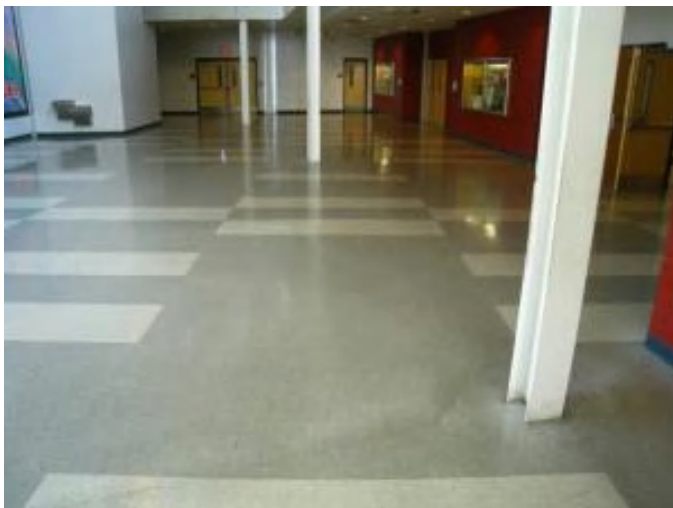
Location: Lincoln - Main Building - corridors

Floors consist mostly of 12"x12" vinyl composition tile (VCT) in classrooms, offices, corridors, the auditorium, and the cafeteria. There are a number of cracks in VCT surfaces on ground floor corridors along column control joints that cross the corridors. In removing these tiles for repair, the slab should be studied to ascertain if there is a settlement problem. The library, and some offices have glued-down carpet. The auditorium has VCT under seating and carpet in the aisles; carpeting is in fair condition and should be cleaned as part of maintenance. The stage in the auditorium has an oak floor as does the TV/media rooms near the auditorium. Toilet rooms have ceramic mosaic tile floors, all in good condition and in need of a thorough cleaning. Art and Horticulture rooms have sealed concrete floor finishes, which are very dirty from the materials ground into the floor in normal use. The slabs in these two rooms should be stripped, cleaned and refinished with a more cleanable industrial epoxy or urethane floor system. The gymnasium floor is an oak plank floor in good condition. The kitchen has quarry tile, which is highly durable and in good condition. The cafeteria and the two atria leading from the two building entrances are VCT. The main surfaces are in good condition, however there are cracks at almost every column control joint and column isolation joint due to minor slab settlement; similar cracking and settling was observed in other corridors around the building. Tiles in cracked areas should be removed, the slab flashpatched to level the surface, then refinished with new VCT. Building entrances used by students and guests have recessed traffic mats. They are all beginning to show signs of wear and detachment from the slab below; they should be removed and re-secured or replaced with new traffic mats.

System: C3020413 - Vinyl Flooring

Distress: Damaged

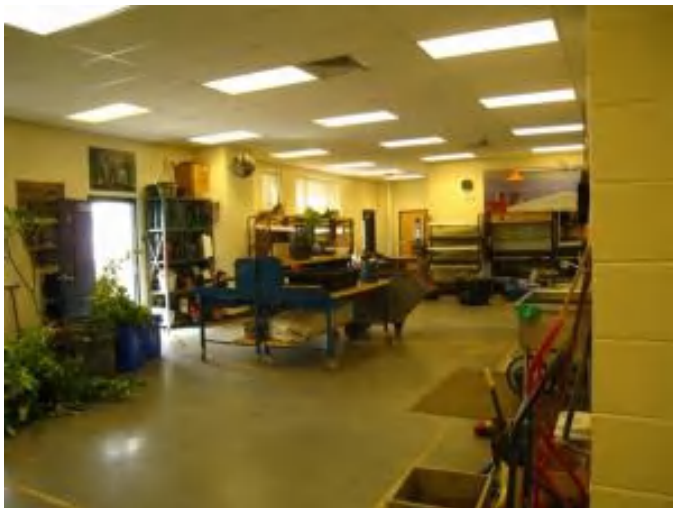
Location: Lincoln - Main Building - conc floors

System: C3020415 - Concrete Floor Finishes

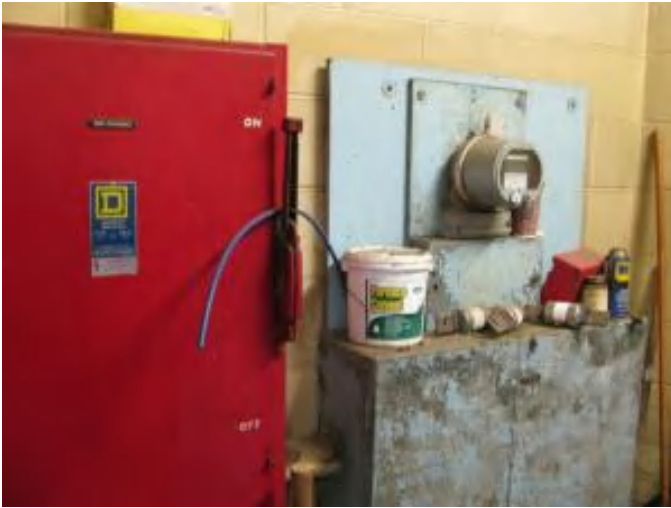
Location: Basement

System: D5010 - Electrical Service/Distribution

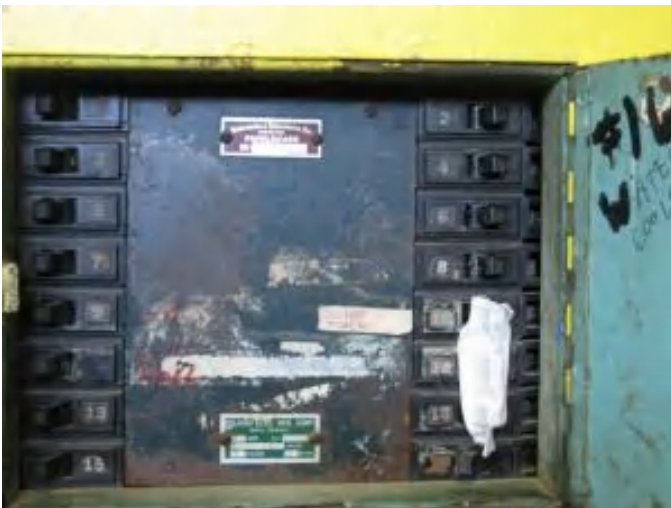
Location: Entire Building

System: D5010 - Electrical Service/Distribution

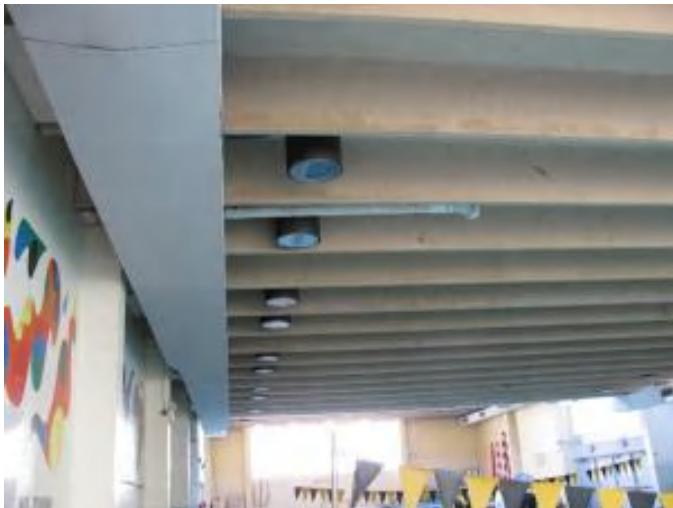
Location: Entire Building

System: D5020 - Lighting and Branch Wiring

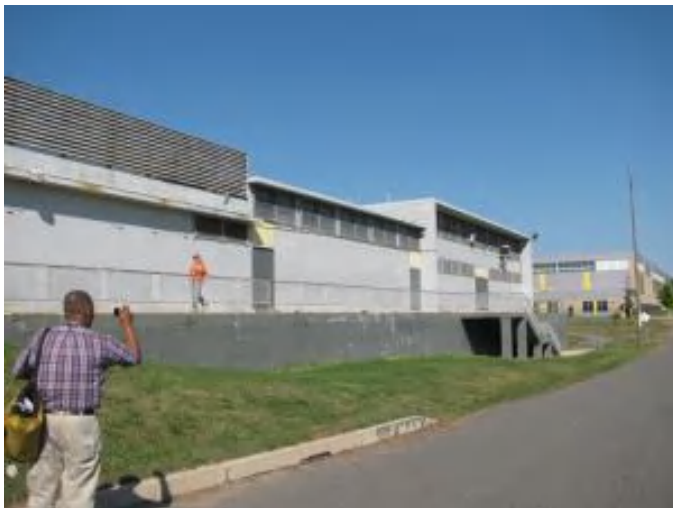
Location: Exterior Building

System: D5020 - Lighting and Branch Wiring

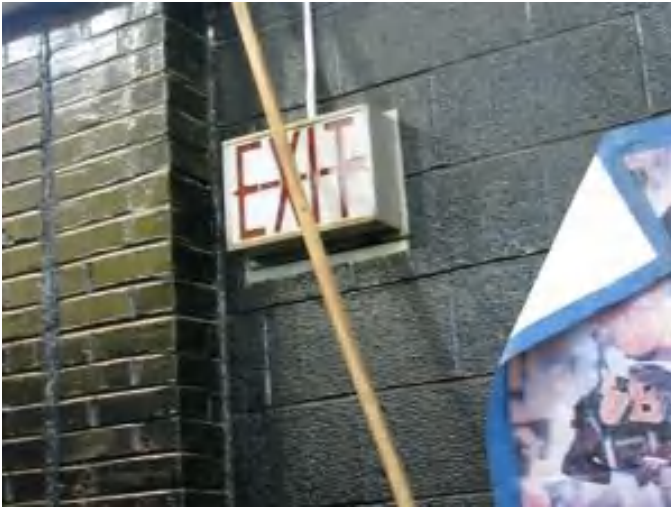
Location: Entire Building

System: D5020 - Lighting and Branch Wiring

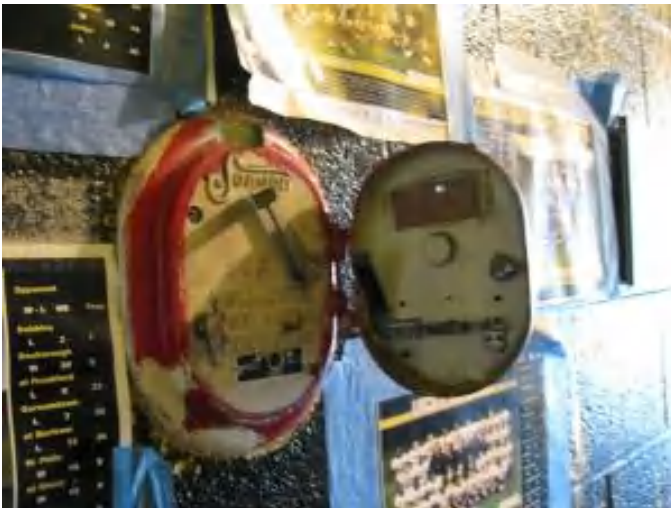
Location: Entire Building

System: D5030 - Communications and Security

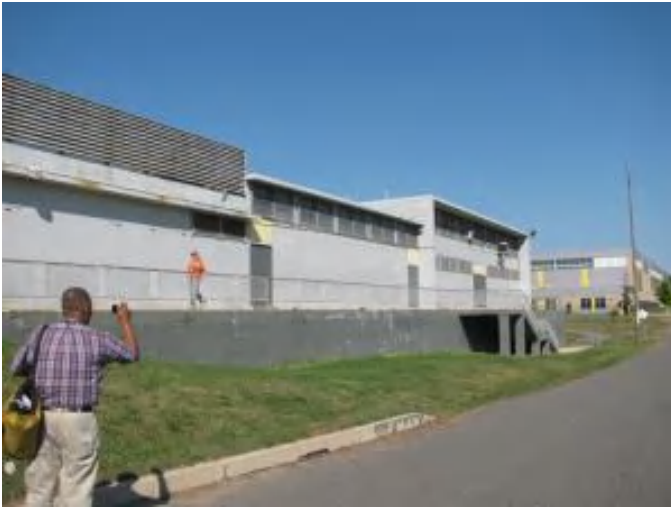
Location: Exterior Building

System: D5030 - Communications and Security

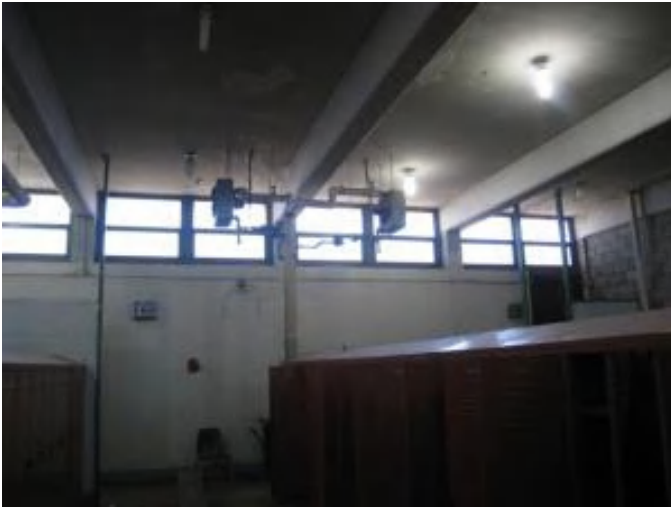
Location: Lincoln - Locker Facility - windows

System: B2020 - Exterior Windows

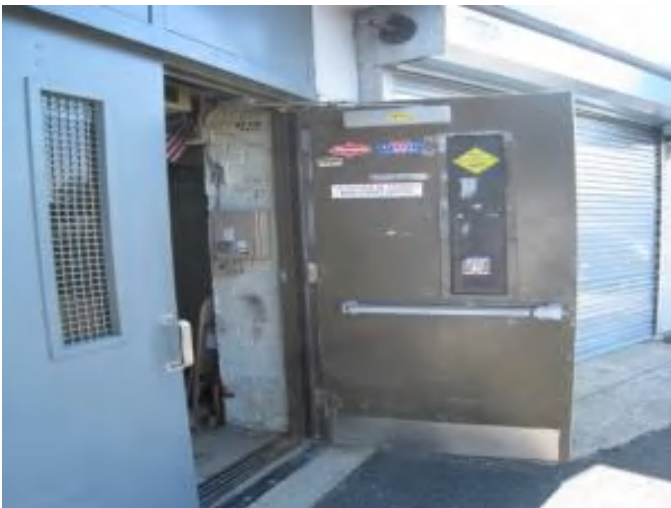
Location: Lincoln - Locker Facility - exterior doors

System: B2030 - Exterior Doors

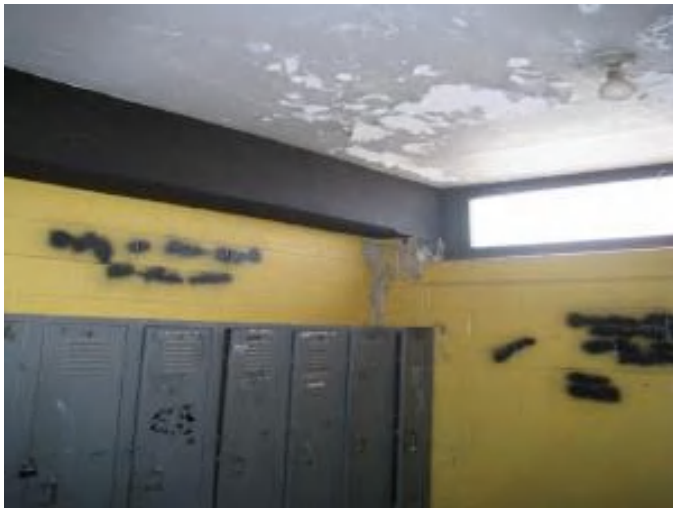
Location: Lincoln - Locker Facility - locker room

System: C1030 - Fittings

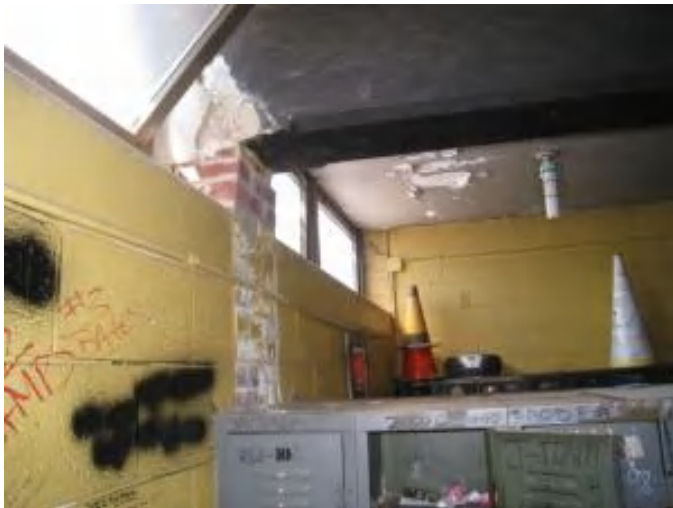
Location: Lincoln - Locker Facility - interiors

System: C3010230 - Paint & Covering

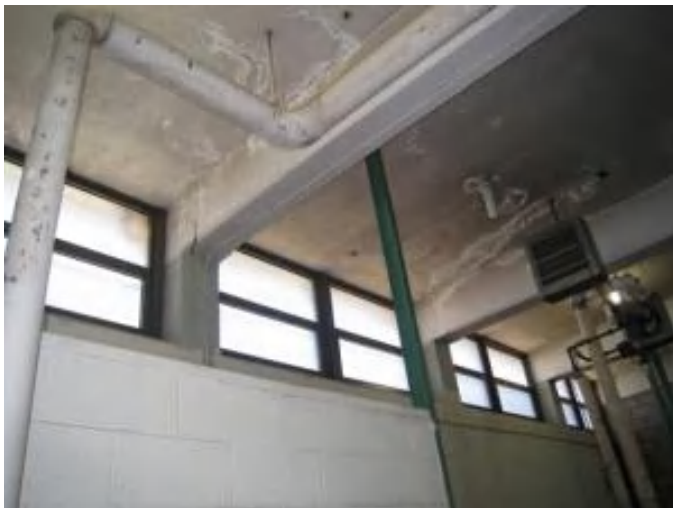
Location: Lincoln - Locker Facility - ceilings

System: C3010230 - Paint & Covering

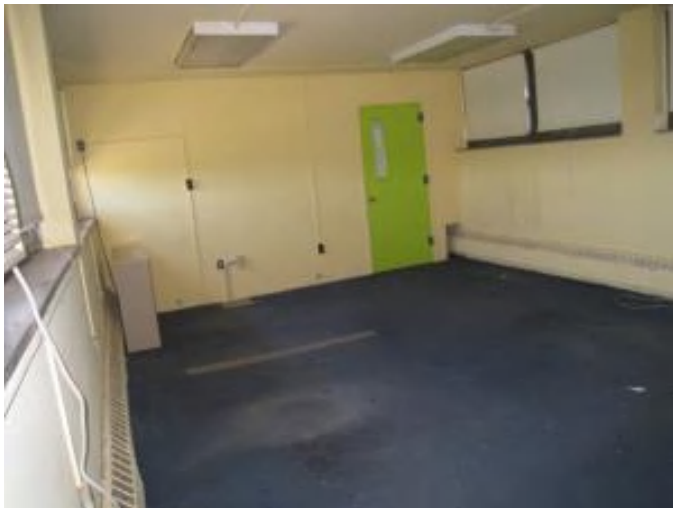
Location: Lincoln - Locker Facility - apartment

System: C3020411 - Carpet

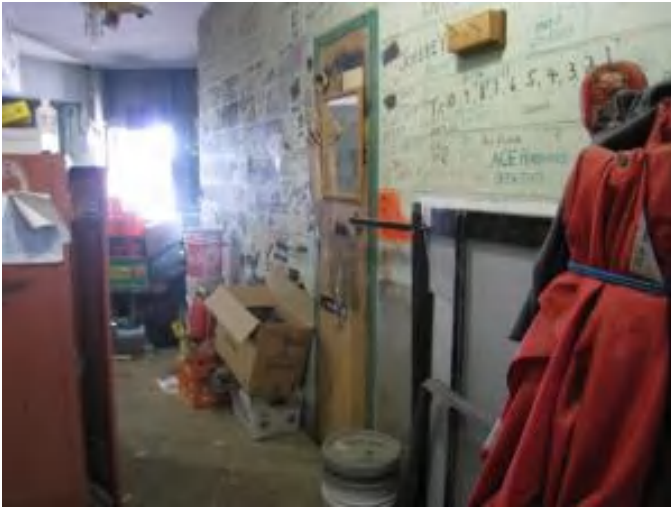
Location: Lincoln - Locker Facility - conc floors

System: C3020415 - Concrete Floor Finishes

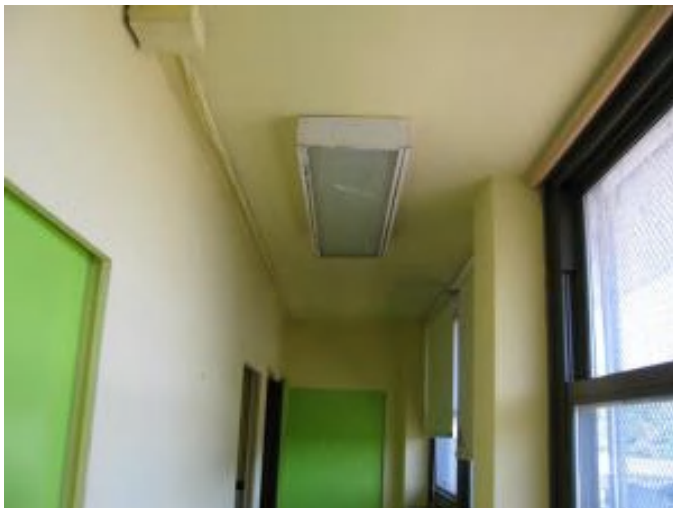
Location: Entire Building

System: D5020 - Lighting and Branch Wiring

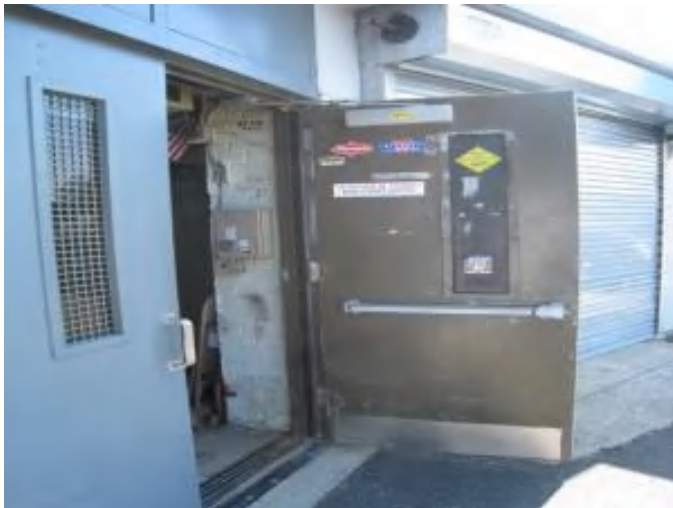
Location: Lincoln - Pool House - exterior doors

System: B2030 - Exterior Doors

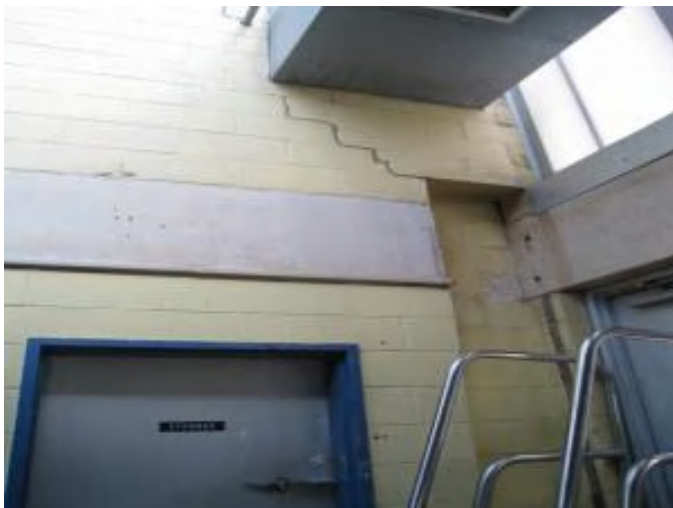
Location: Lincoln - Pool House - interior doors

System: C1020 - Interior Doors

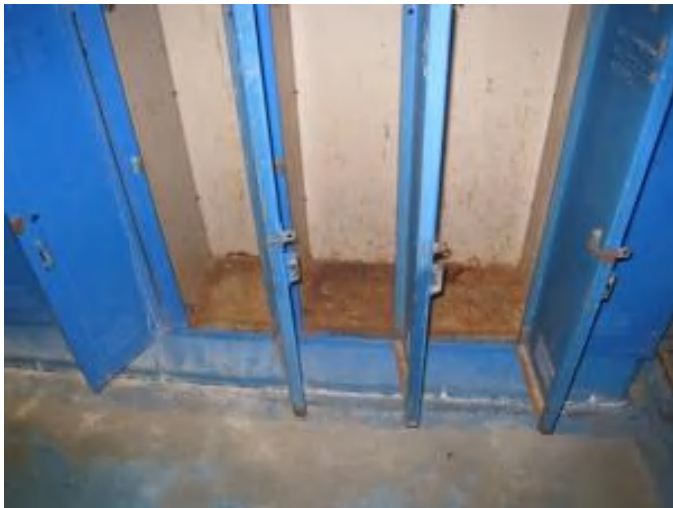
Location: Lincoln - Pool House - lockers

System: C1030 - Fittings

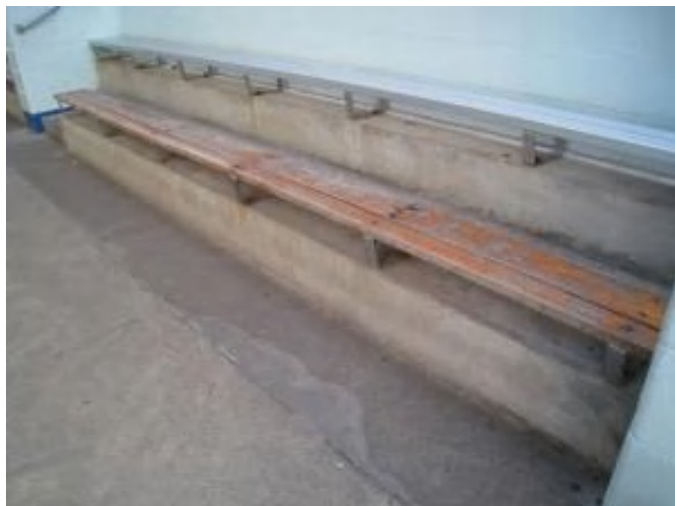
Location: Lincoln - Pool House - pool

System: E2010 - Fixed Furnishings

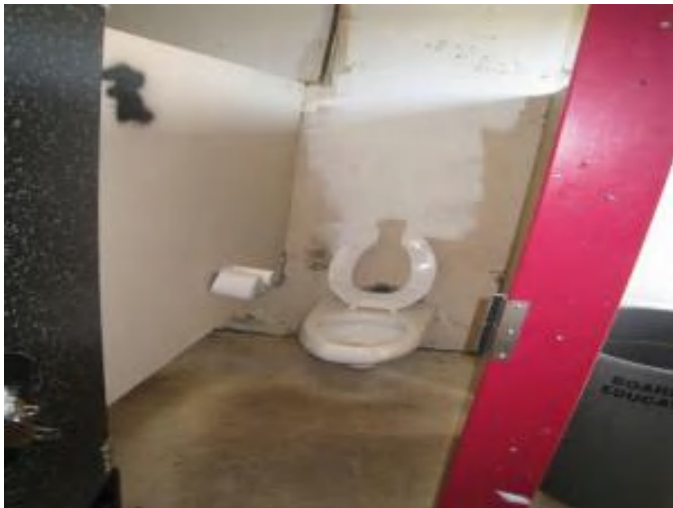
Location: Lincoln - Stands and Toilet Facilities

System: C3010230 - Paint & Covering

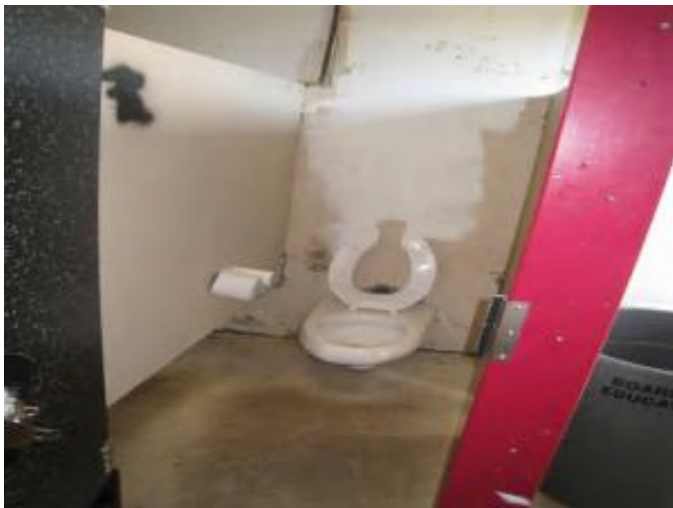
Location: Lincoln - Stands and Toilet Facilities

System: C3020415 - Concrete Floor Finishes

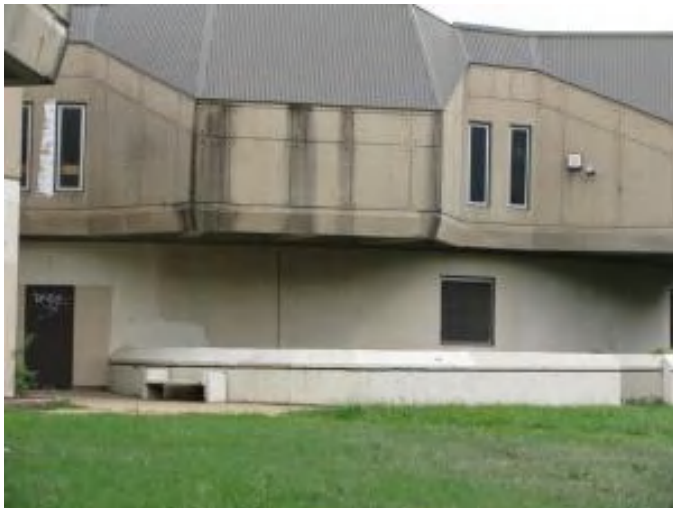
Location: Meehan- Exterior Building

System: D5020 - Lighting and Branch Wiring

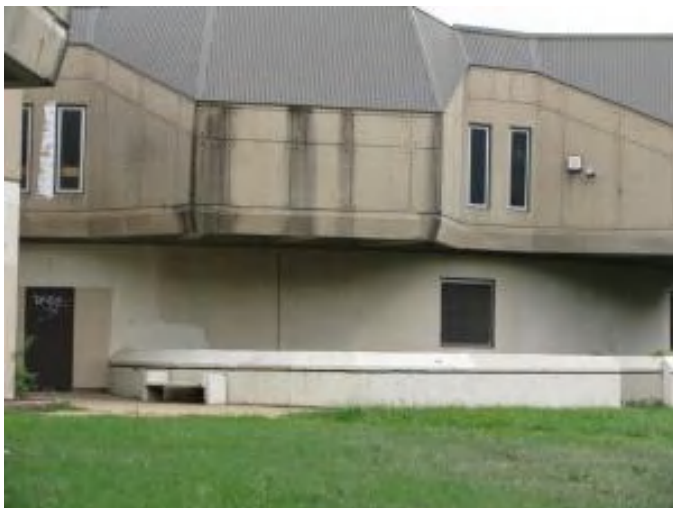
Location: Meehan- Exterior Building

System: D5030 - Communications and Security

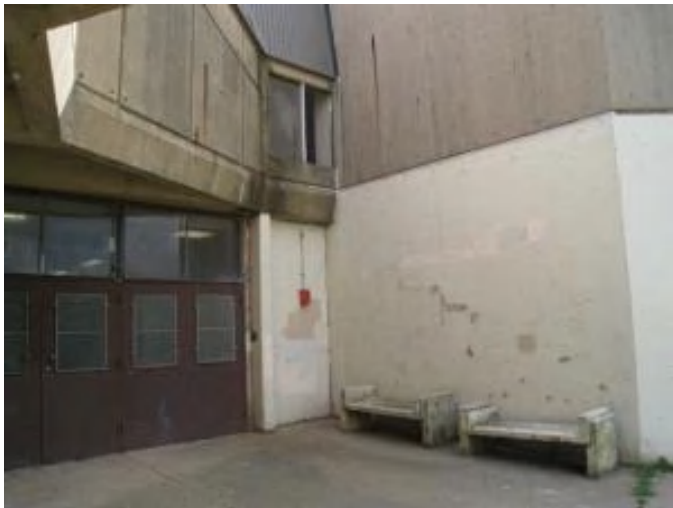
Location: Meehan - exterior doors

System: B2030 - Exterior Doors

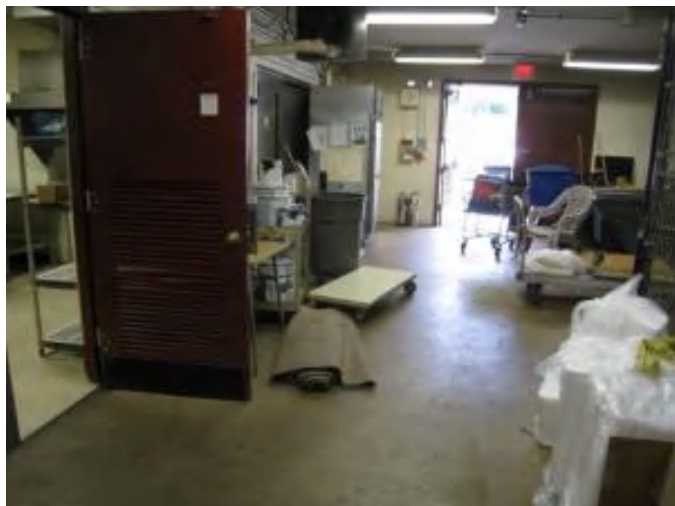
Location: Meehan - mechanical area and ground level doors

System: C1020 - Interior Doors

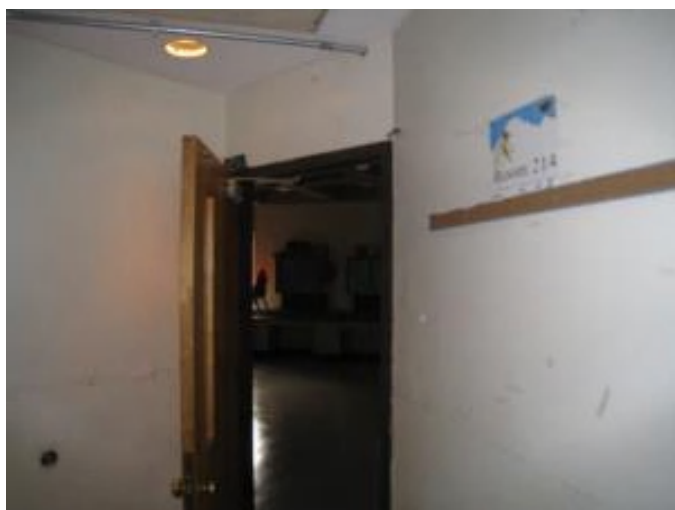
Location: Meehan - interior doors

System: C1020 - Interior Doors

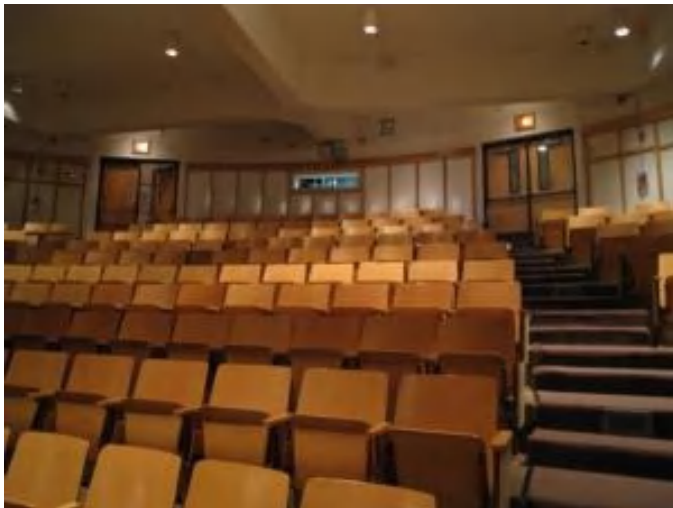
Location: Meehan - library and auditorium

System: C3020411 - Carpet

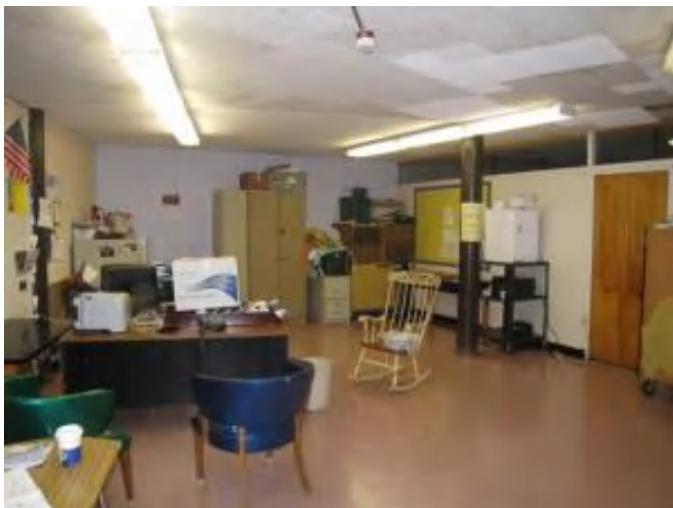
Location: Meehan - acoustical ceilings

System: C3030 - Ceiling Finishes

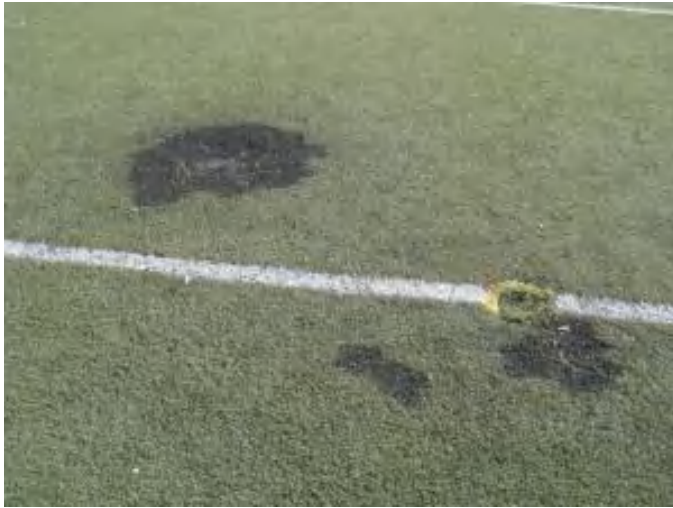
Location: Lincoln - football field

System: G2050 - Landscaping & Irrigation
