Facility Condition Assessment Summary Report

Memphis Street Academy (Jones) School

School District of Philadelphia
S510001; Jones
Final
Site Assessment Report

February 1, 2017

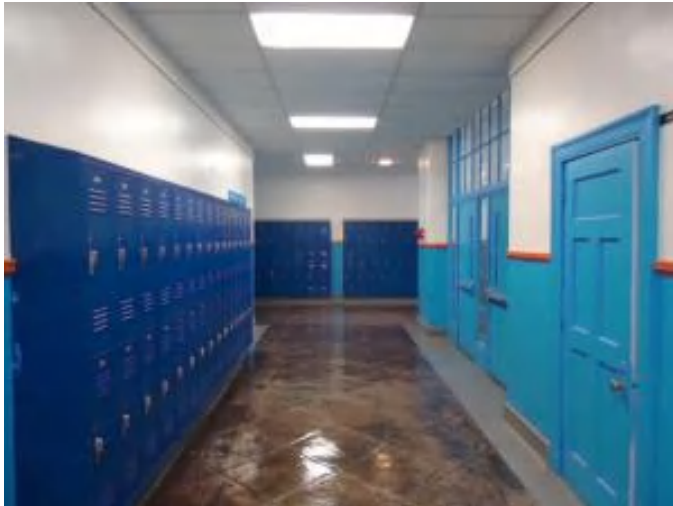
System: C1020 - Interior Doors

The interior door system is original to the buildings construction. Interior doors are typically wood in wood frames with glass glazing. Several doors are damaged and replacement glass panes have been installed to replace damaged doors panes. Complaint during the time of the construction of this school the interior doors no longer compliant with today's standards. Doors are generally in fair condition considering the age of the application. Universal upgrades are required for the interior door systems, it is recommended that the interior doors system be removed and replaced with a new modern metal framed wooden door system with consideration for ADA compliance.

Distress: Damaged

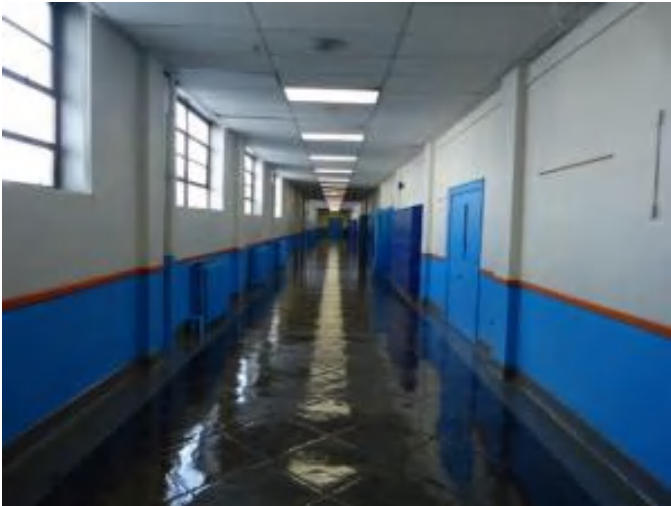
System: D1010 - Elevators and Lifts

There is no elevator that services this school. Goods, services, and amenities offered in public buildings are generally required to be available to all persons. To assist those that may be physically challenged and to meet current accessibility legislation to provide wheelchair access to the upper floors of this facility, the installation of a new hydraulic elevator has been recommended on the southern elevation of the building or at another suitable location. The new installation should blend as much as possible with the overall appearance of this historic structure and include all required ADA features, such as audible jewels and gongs, an accessible control panel, etc.

Distress: Accessibility

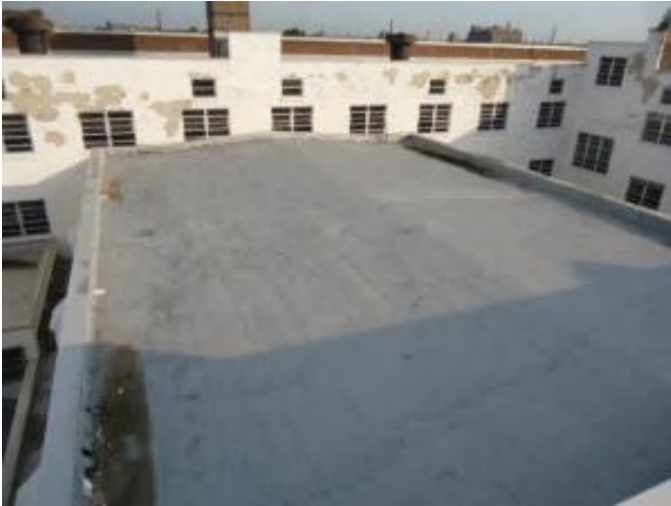
System: B2010 - Exterior Walls

The exterior brick surfaces are generally in fair to good condition for their age. As indicated in the photos major areas of the exterior brick finish has been painted. In some locations, bricks have cracked or spalled and should be replaced. The repointing of deteriorated mortar joints is also recommended, using mortar of a similar color and consistency as the original. Following the detailed examination of the brick and repair of mortar construction joints, the entire building should be pressure washed to remove stains and embedded pollutants. During this effort the exterior painted surfaces are expected to be clean of previous painted materials. If moisture is found to be penetrating the masonry facade, the application of a spray sealant to the suspected exterior masonry surface is recommended.

Distress: Damaged

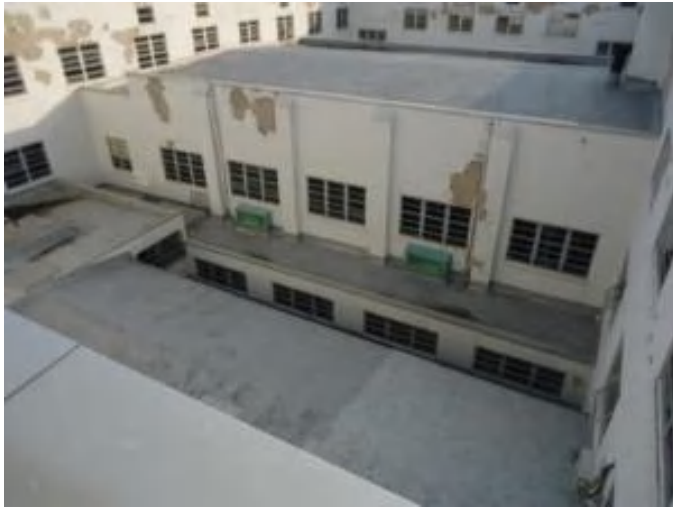
System: B2020 - Exterior Windows

Most of the exterior windows have been upgraded from the original applications. As indicated in the photos several of the windows appear to be original. A majority of the window system is estimated to have been installed in the 1990's. Several of the windows no longer work and will require attention prior to an overall effort. Overall, the windows are in fair condition based on the year of installation or last renovation. The entire exterior window system is recommended to be replaced with units that retain their dimensions and profiles, but that incorporate updated energy-efficient features.

Distress: Damaged

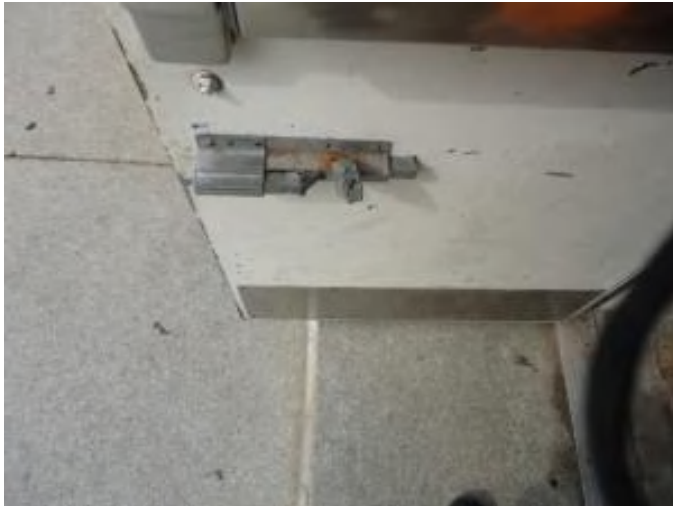
System: B2030 - Exterior Doors

The exterior doors are metal applications with metal frames. The exterior door system for this school is a very high traffic system. The doors are in fair condition but are aging at a faster rate than expected based on traffic and condition. The exterior door system, store front and service doors are recommended for upgrade. Also, there are several double door systems that have been upgraded from the original construction. As indicated in the photo the concrete step does not meet the length of the door thus allowing a trap hazard. Special consideration for a new door system is required and a modification to the exterior step removing the hazard.

Distress: Damaged

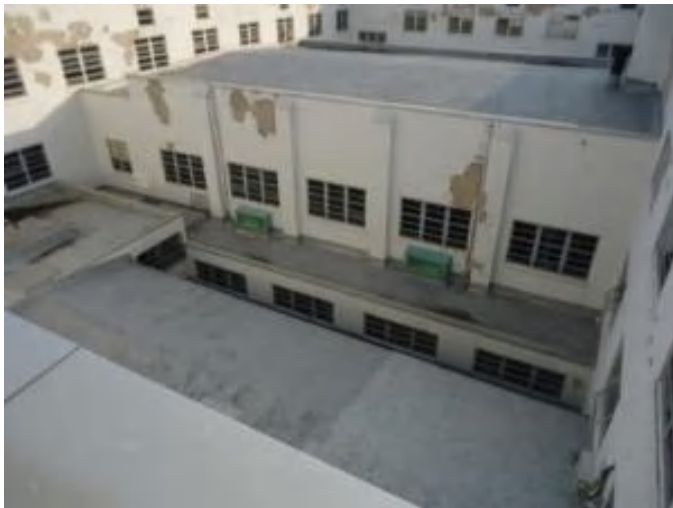
System: B3010105 - Built-Up

There are a number of roof sections and different roof elevations ranging from the main roof to the mechanical roof. Parapet heights, coping materials, and the height of the flashing also varies in different sections. The main roof is a built up application that was installed in the early 1990'S. The other built up roofs have not conclusive installation dates and have been seal coated several times to extend the life cycle of the application. Considering the age and condition of the roofing systems, universal upgrades are recommended. Remove and replace all roof sections.

Distress: Beyond Service Life

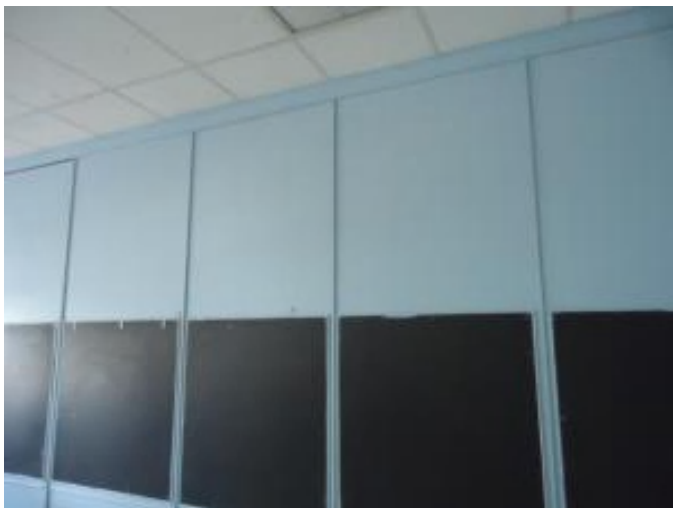
System: C1010 - Partitions

Distress: Inadequate

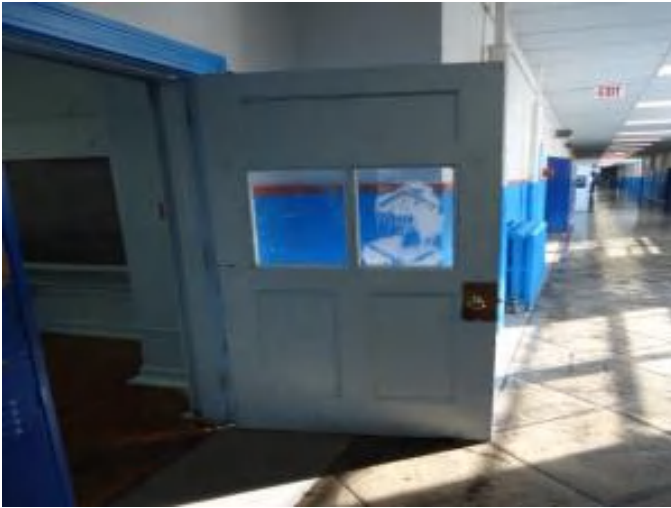
System: C1020 - Interior Doors

Location: Classrooms
Distress: Damaged
Category: 3 - Operations / Maint.
Priority: 3 - Response Time (3-4 yrs)
Correction: Remove and replace interior doors - wood doors with hollow metal frames - per leaf
Qty: 250.00
Unit of Measure: Ea.
Estimate: \$1,192,646.78
Assessor Name: System
Date Created: 10/15/2015

Notes: The interior door system is original to the buildings construction. Interior doors are typically wood in wood frames with glass glazing. Several doors are damaged and replacement glass panes have been installed to replace damaged doors panes. Complaint during the time of the construction of this school the interior doors no longer compliant with today's standards. Doors are generally in fair condition considering the age of the application. Universal upgrades are required for the interior door systems, it is recommended that the interior doors system be removed and replaced with a new modern metal framed wooden door system with consideration for ADA compliance.

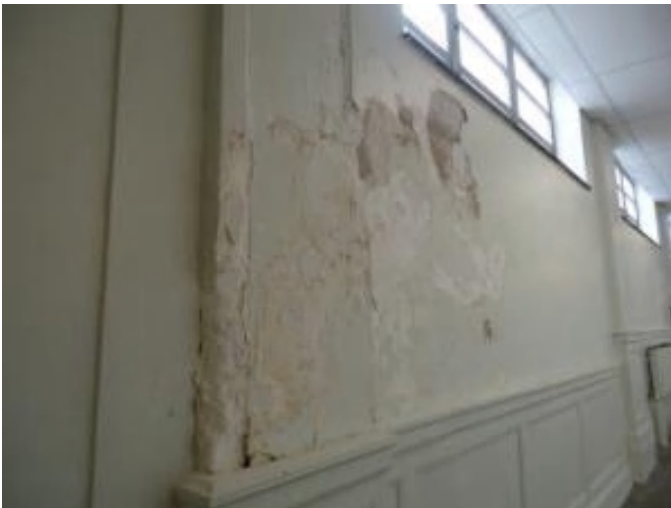
System: C3010230 - Paint & Covering

There are several minor areas of wall damage that ranges from serious to minor. As indicated in the photos the exterior walls appear to be the main source of the damage. The auditorium exterior hallway wall and walls that face the exterior will require immediate attention. Although the school is on a cyclical program of renewal and each painted surface is renewed at years end this system is at the point in which repairs are necessary. Remove damaged wall finishes and repair areas then apply primer and paint finish.

Location: Building Wide
Distress: Damaged
Category: 3 - Operations / Maint.
Priority: 3 - Response Time (3-4 yrs)
Correction: Repair and repaint all interior walls - SF of wall surface
Qty: 10,000.00
Unit of Measure: S.F.
Estimate: \$67,738.77
Assessor Name: System
Date Created: 10/15/2015

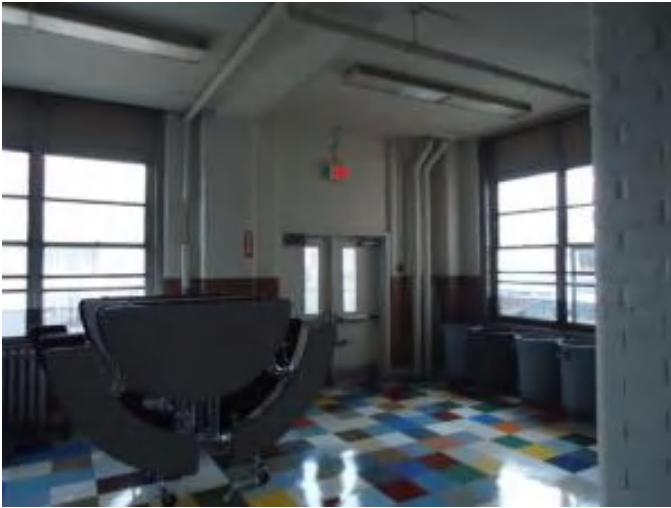
System: C3030 - Ceiling Finishes

The ceiling finish is a mix of 12 x 12 ceiling grid, painted and 2 x 4 Acoustical tile finish. The ceilings are damaged from leaks and

abuse, several repairs have been completed in specific areas and are in good condition considering the age of the application and the current condition of the school. This deficiency provides a budgetary consideration for removal and replacement of the current ceiling finish in damaged areas and also to add a new acoustical tile finish. Considering the recommended mechanical and electrical upgrades this effort should be completed as part of an overall renewal program for the school. No work should be considered until after the recommended exterior efforts are complete.

Location: Building Wide
Distress: Damaged
Category: 3 - Operations / Maint.
Priority: 3 - Response Time (3-4 yrs)
Correction: Remove and replace suspended acoustic ceilings - lighting not included
Qty: 5,000.00
Unit of Measure: S.F.
Estimate: \$75,412.15
Assessor Name: System
Date Created: 10/15/2015

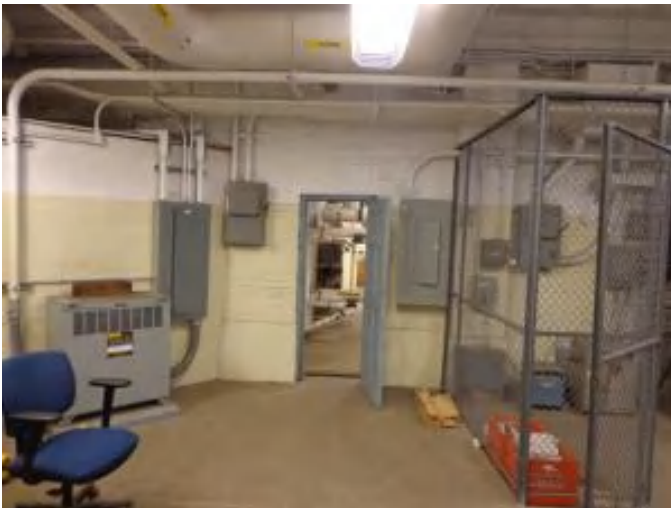
System: D5010 - Electrical Service/Distribution

Location: Main Electrical Room
Distress: Obsolete
Category: 3 - Operations / Maint.
Priority: 3 - Response Time (3-4 yrs)
Correction: Replace Switchboard
Qty: 1.00
Unit of Measure: Ea.
Estimate: \$851,415.84
Assessor Name: System
Date Created: 10/22/2015

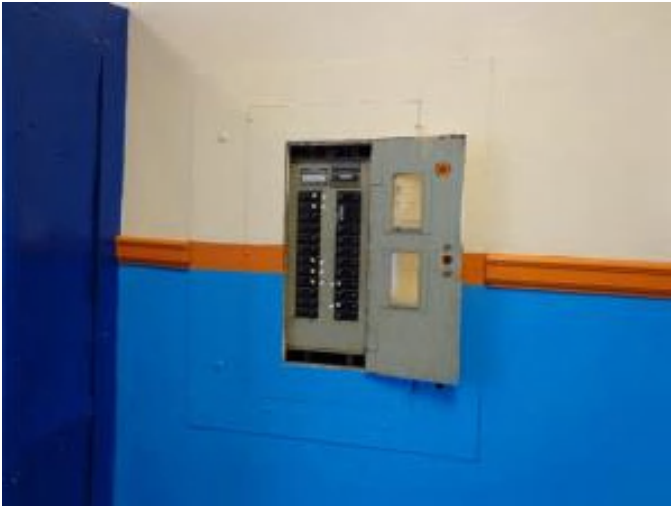
System: D5010 - Electrical Service/Distribution

Distress: Beyond Service Life

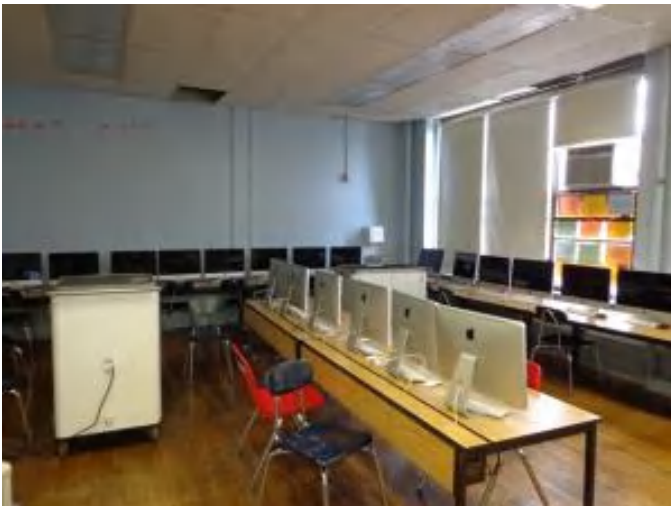
System: D5020 - Lighting and Branch Wiring

Distress: Beyond Service Life

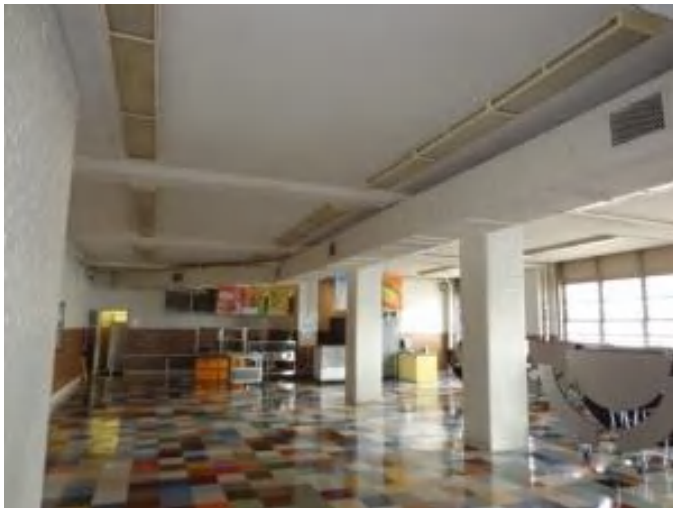
System: D5020 - Lighting and Branch Wiring

A lighting system upgrade is recommended for all rooms having fixtures with T12 lamps.

Distress: Beyond Service Life

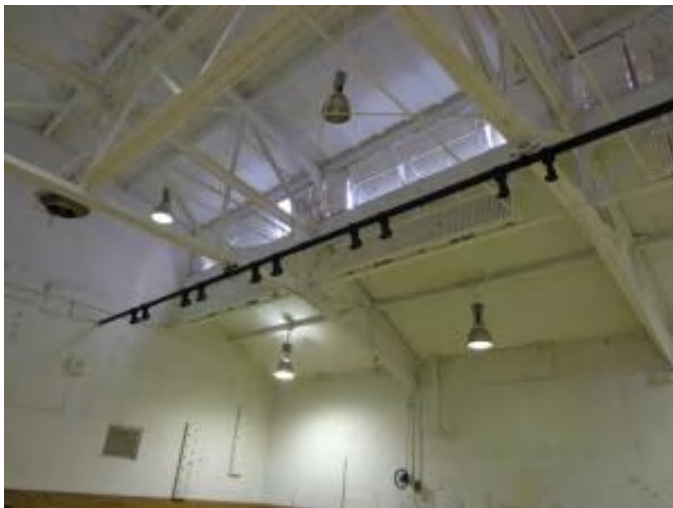
System: D5020 - Lighting and Branch Wiring

Location: Gymnasiums

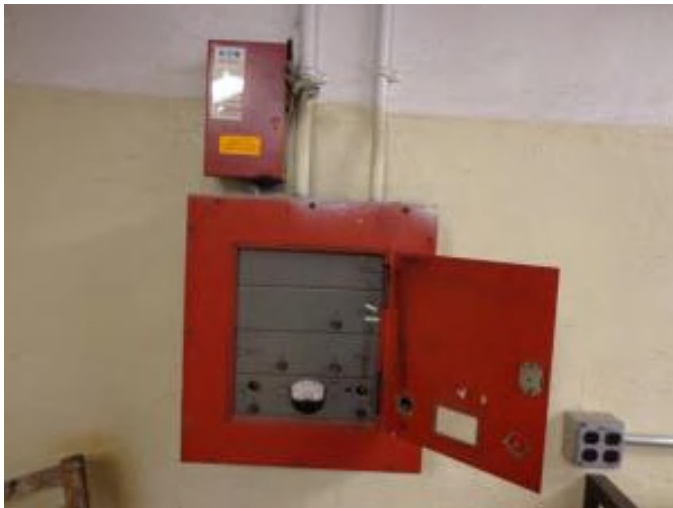
System: D5030 - Communications and Security

Location: Building wide
Distress: Beyond Service Life
Category: 3 - Operations / Maint.
Priority: 3 - Response Time (3-4 yrs)
Correction: Replace fire alarm system
Qty: 118,000.00
Unit of Measure: S.F.
Estimate: \$456,403.09
Assessor Name: System
Date Created: 10/22/2015

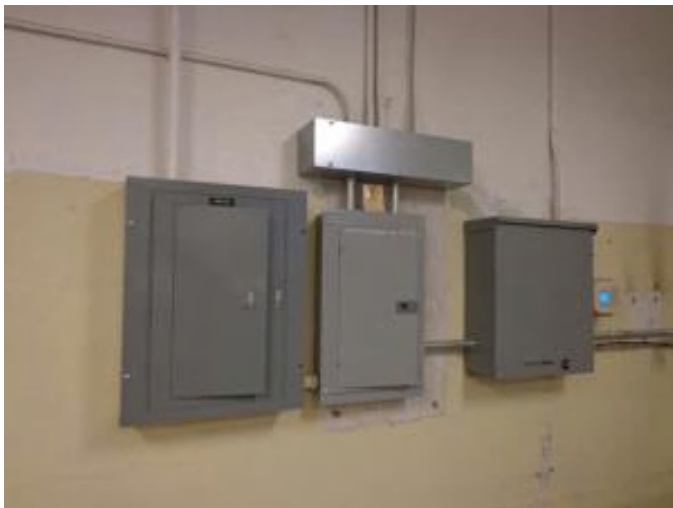
System: D5090 - Other Electrical Systems

Location: Basement Electrical Room
Distress: Inadequate
Category: 4 - Capital Improvement
Priority: 3 - Response Time (3-4 yrs)
Correction: Replace standby generator system
Qty: 1.00
Unit of Measure: Ea.
Estimate: \$430,015.72
Assessor Name: System
Date Created: 10/22/2015

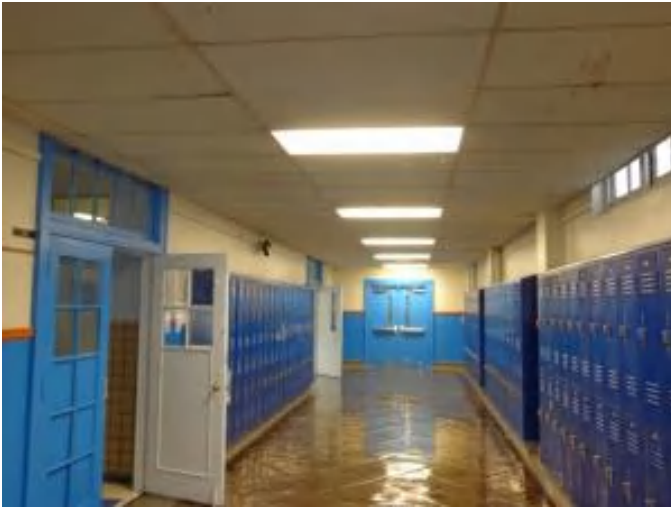
System: D5090 - Other Electrical Systems

Location: Building wide
Distress: Damaged
Category: 3 - Operations / Maint.
Priority: 3 - Response Time (3-4 yrs)
Correction: Replace Emergency/Exit Lighting
Qty: 10.00
Unit of Measure: Ea.
Estimate: \$11,857.19
Assessor Name: System
Date Created: 10/22/2015

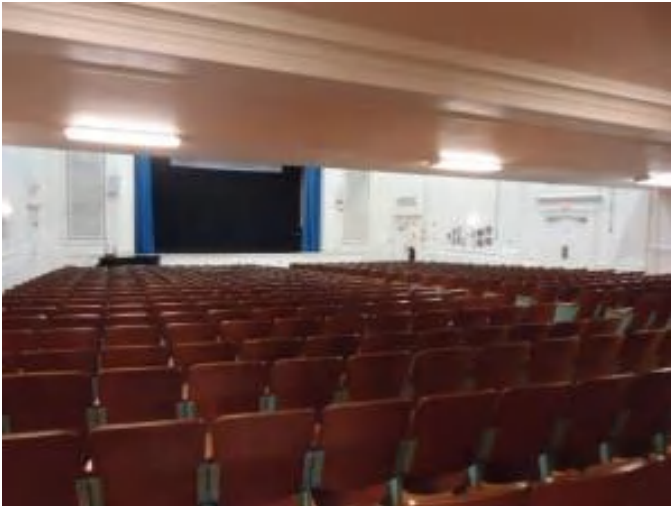
System: E2010 - Fixed Furnishings

Location: Stage
Distress: Life Safety / NFPA / PFD
Category: 1 - Health & Safety
Priority: 3 - Response Time (3-4 yrs)
Correction: Remove and replace stage curtain - insert the LF of track and SF of curtain
Qty: 1.00
Unit of Measure: Ea.
Estimate: \$12,381.21
Assessor Name: System
Date Created: 10/15/2015

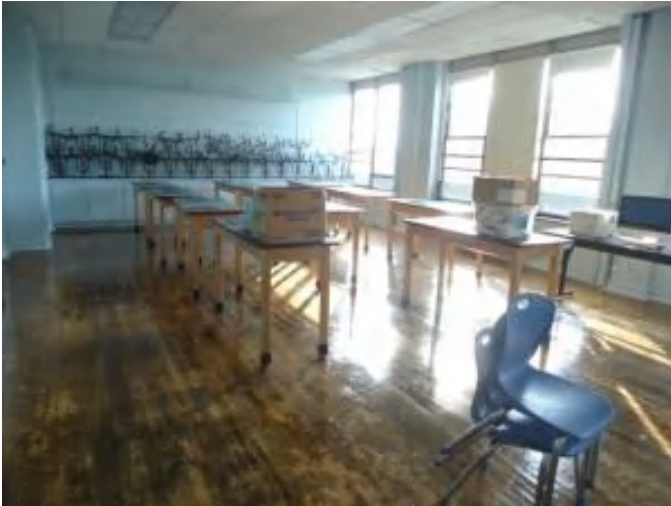
System: C1010 - Partitions

The lab casework and working desk with countertop have been upgraded from the original construction however the installation date is unknown. The system is in fair condition but showing signs of age and high usage. This deficiency provides a budgetary consideration for new casework and countertops for the lab spaces. Remove and replace casework.

Location: Science Labs

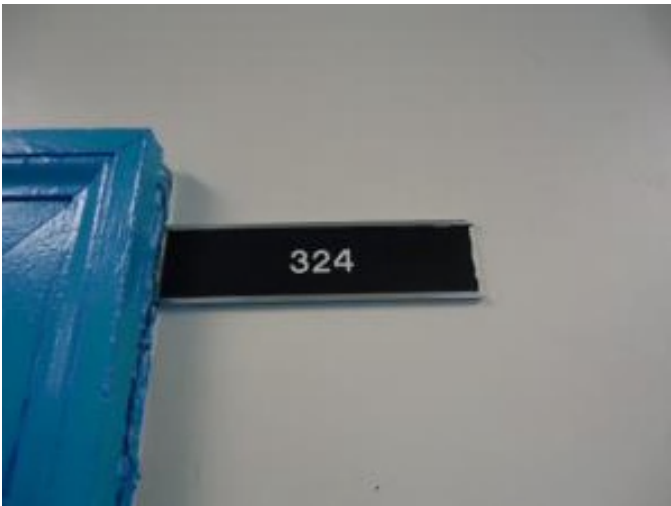
System: C1030 - Fittings

Location: Building Wide

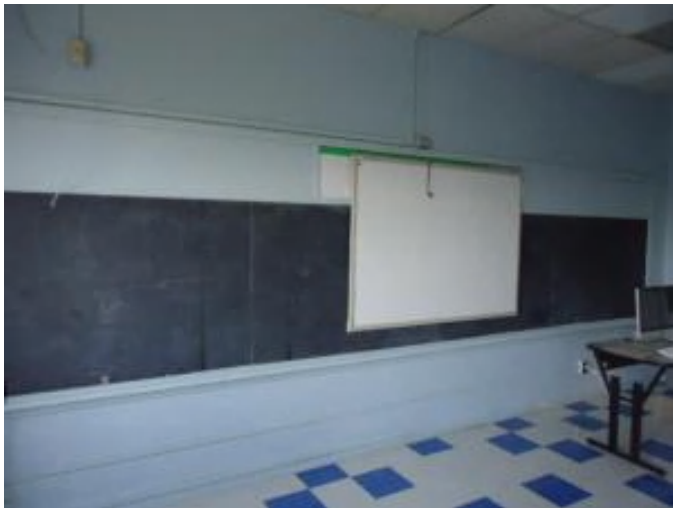
System: C1030 - Fittings

The classroom chalk boards are original to the buildings construction. This system is damaged and beyond its expected life, universal upgrades are warranted. Remove and upgrade chalkboards to new marker board systems.

Location: Classrooms
Distress: Damaged
Category: 3 - Operations / Maint.
Priority: 4 - Response Time (4-5 yrs)
Correction: Replace blackboards with marker boards - pick the appropriate size and insert the quantities
Qty: 100.00
Unit of Measure: Ea.
Estimate: \$68,823.21
Assessor Name: System
Date Created: 10/15/2015

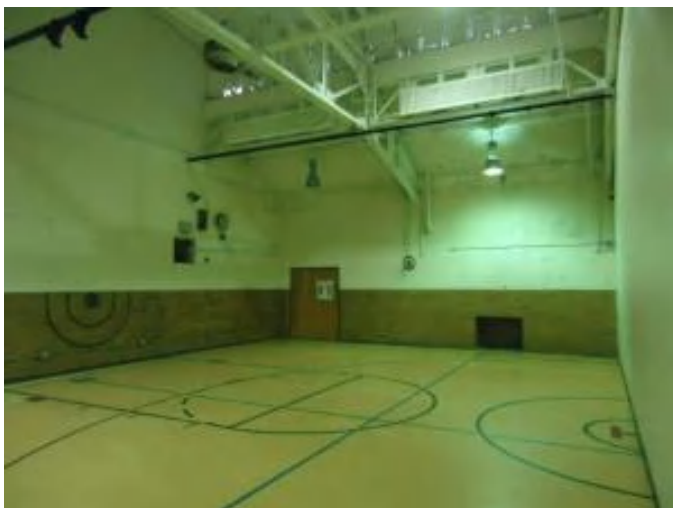
System: C3020413 - Vinyl Flooring

Location: Gym
Distress: Health Hazard / Risk
Category: 1 - Health & Safety
Priority: 4 - Response Time (4-5 yrs)
Correction: Remove and replace vinyl sheet flooring
Qty: 10,000.00
Unit of Measure: S.F.
Estimate: \$183,111.57
Assessor Name: System
Date Created: 10/15/2015

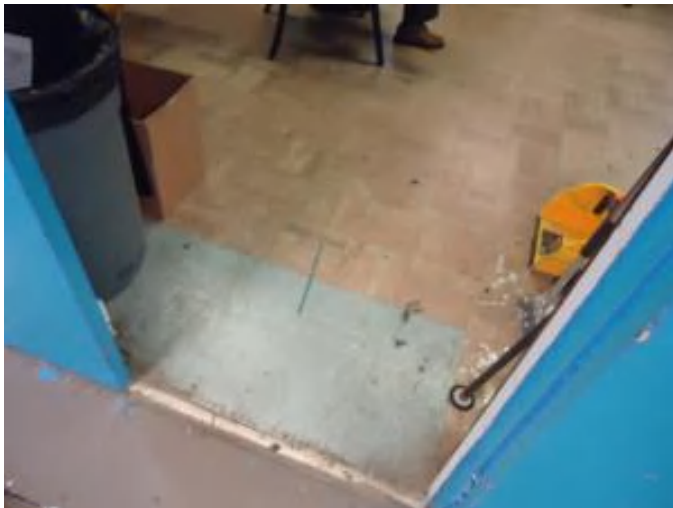
System: C3020413 - Vinyl Flooring

Location: Room 109
Distress: Health Hazard / Risk
Category: 1 - Health & Safety
Priority: 4 - Response Time (4-5 yrs)
Correction: Remove VAT and replace with VCT - SF of area
Qty: 1,200.00
Unit of Measure: S.F.
Estimate: \$18,200.00
Assessor Name: System
Date Created: 10/15/2015

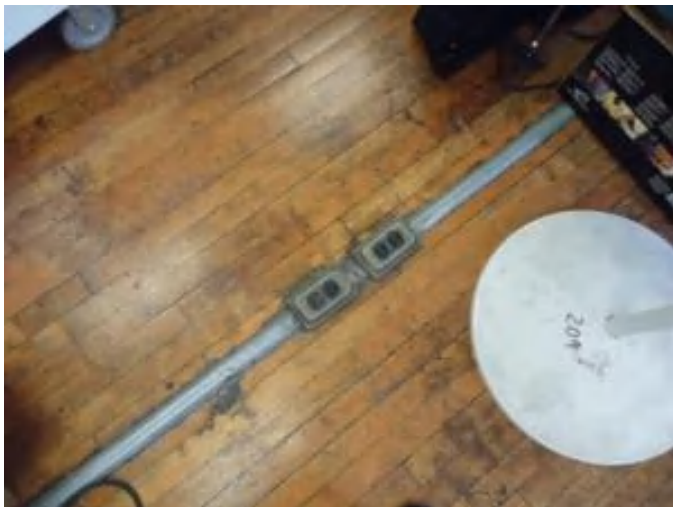
System: C3020414 - Wood Flooring

The classrooms and auditorium in this school have a wooden floor finish. Most of the classrooms appear to be from original construction. However, the auditorium is in like new condition. The classroom system is showing signs of age such as the effects of sanding and refinishing with yearly cleaning and waxing with some repairs. The floor finish is in fair condition however, the finish is beyond its expected life cycle. It is recommended that the wooden floor finish be removed and replaced with an in kind finish.

Location: Classrooms
Distress: Damaged
Category: 3 - Operations / Maint.
Priority: 4 - Response Time (4-5 yrs)
Correction: Remove and replace wood flooring
Qty: 30,000.00
Unit of Measure: S.F.
Estimate: \$874,562.13
Assessor Name: System
Date Created: 10/15/2015

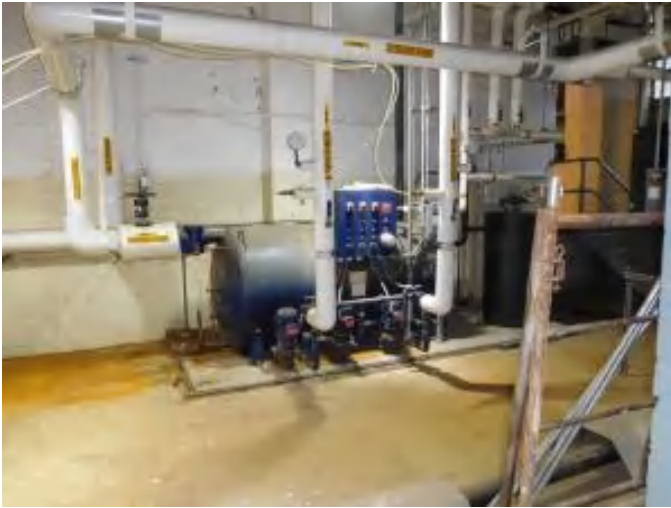
System: D2020 - Domestic Water Distribution

Water piping has been replaced since the original installation with copper. Sanitary, waste, vent and rainwater piping is original installation hub and spigot cast iron. Water service is a six inch line and three inch meter from E. Ann St. with a backflow preventer. This equipment is in the mechanical room. Rainwater and sanitary main lines connect at Memphis St. and Tulip St. The six inch gas service is from E. Ann St., and the meter assembly is in a closet in office 110A with a flexible partition separation.

Location: entire building
Distress: Beyond Service Life
Category: 3 - Operations / Maint.
Priority: 4 - Response Time (4-5 yrs)
Correction: Replace domestic water piping (150 KSF)
Qty: 118,000.00
Unit of Measure: S.F.
Estimate: \$489,354.25
Assessor Name: System
Date Created: 10/22/2015

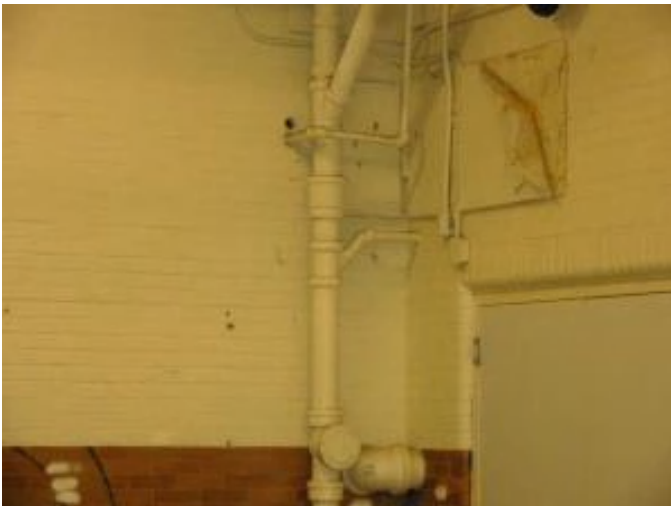
System: D2030 - Sanitary Waste

Plumbing fixtures in toilet rooms were replaced in 2005 and should be serviceable twenty five more years. The water heaters should be serviceable for twenty or more years. The cast iron piping has exceeded the anticipated service life. Rainwater and vent piping should continue functioning, but the sanitary and waste piping should be inspected to determine condition and replace damaged portions. The domestic water piping may have lead solder based on age, and has periodic leaks where copper piping is in contact with galvanized trapeze hangers. This piping should be replaced.

Location: entire building
Distress: Beyond Service Life
Category: 3 - Operations / Maint.
Priority: 4 - Response Time (4-5 yrs)
Correction: Inspect sanitary waste piping and replace damaged sections. (+100KSF)
Qty: 118,000.00
Unit of Measure: S.F.
Estimate: \$501,099.58
Assessor Name: System
Date Created: 10/22/2015

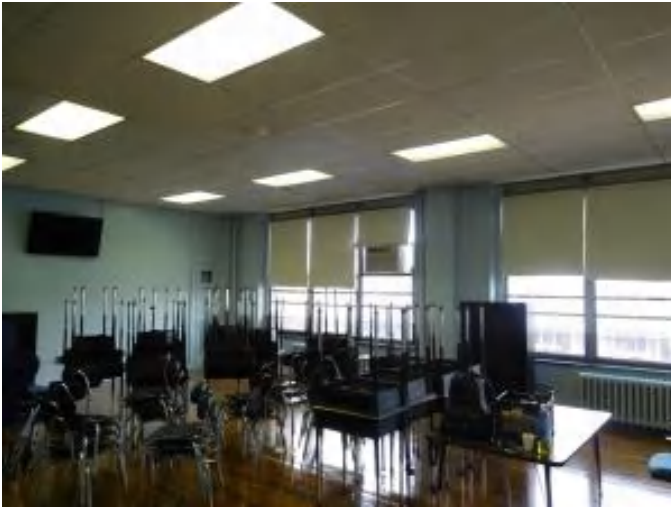
System: D3040 - Distribution Systems

Location: entire building

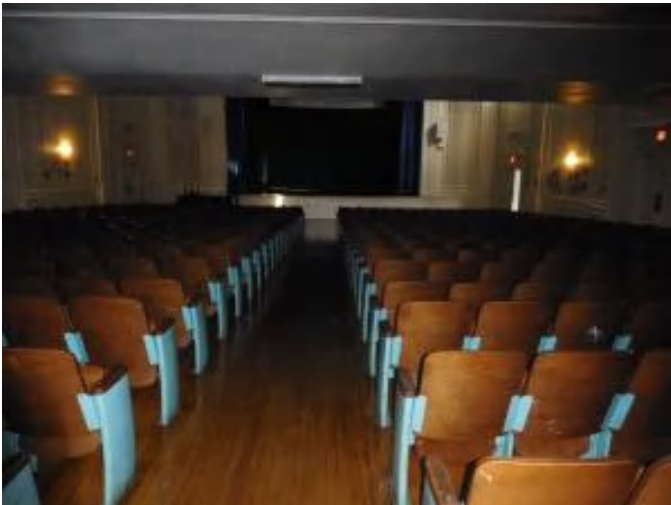
System: D3040 - Distribution Systems

Location: auditorium

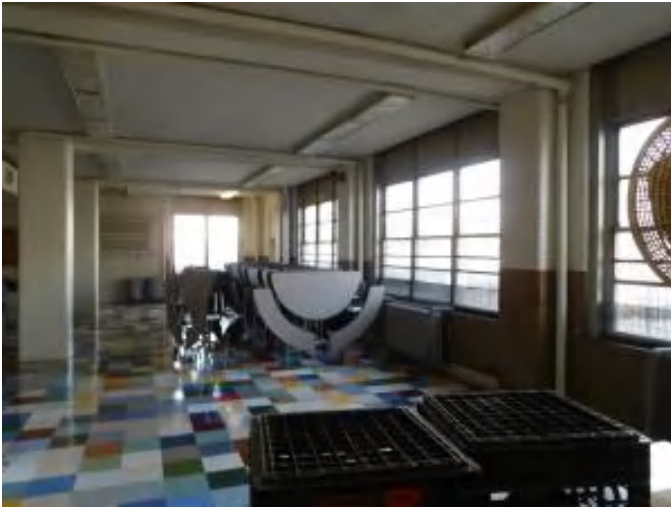
System: D3040 - Distribution Systems

Location: cafeterias a,b

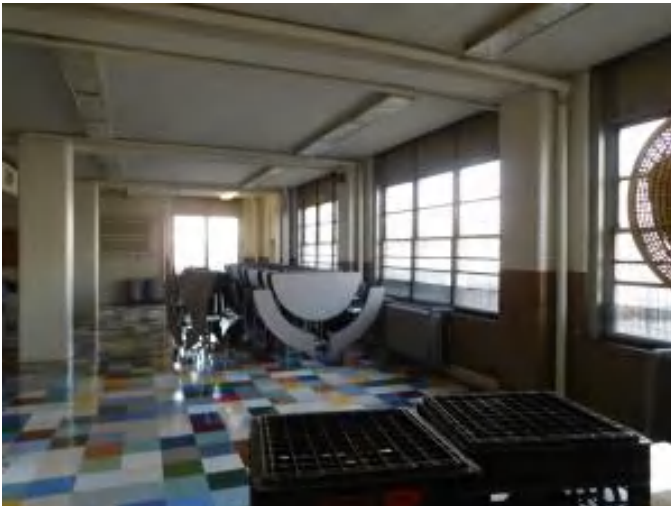
System: D3040 - Distribution Systems

Location: cafeterias a,b

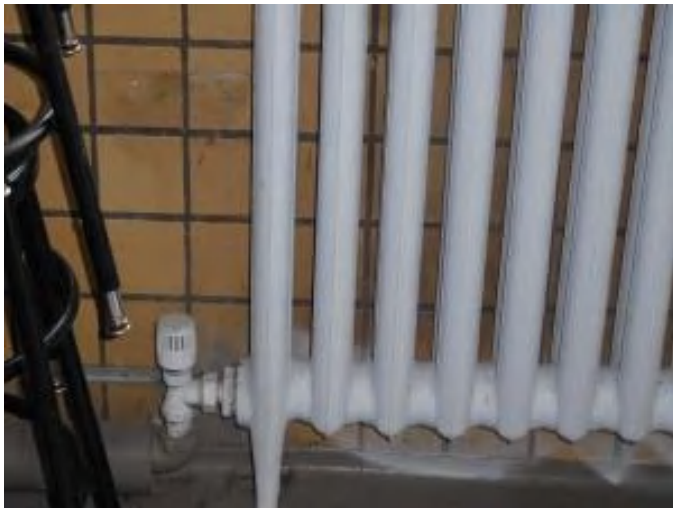
System: D3060 - Controls & Instrumentation

Location: entire building
Distress: Inadequate
Category: 4 - Capital Improvement
Priority: 4 - Response Time (4-5 yrs)
Correction: Replace pneumatic controls with DDC (150KSF)
Qty: 118,000.00
Unit of Measure: S.F.
Estimate: \$2,113,545.75
Assessor Name: System
Date Created: 10/22/2015

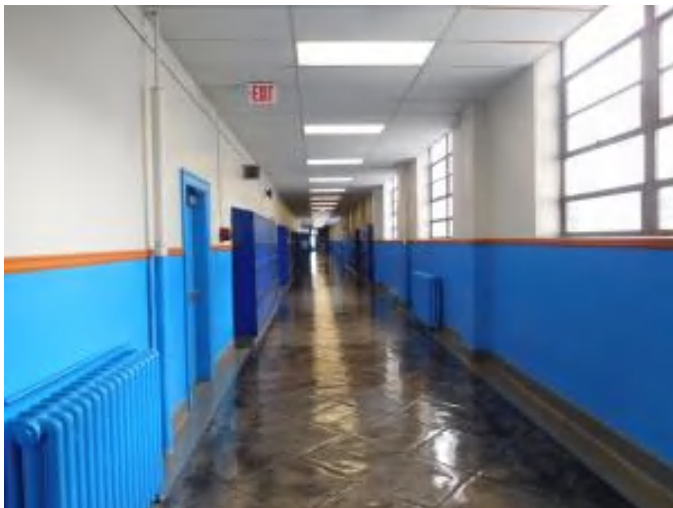
System: D4010 - Sprinklers

Location: entire building
Distress: Life Safety / NFPA / PFD
Category: 1 - Health & Safety
Priority: 4 - Response Time (4-5 yrs)
Correction: Install a fire protection sprinkler system
Qty: 118,000.00
Unit of Measure: S.F.
Estimate: \$1,688,044.11
Assessor Name: System
Date Created: 10/22/2015

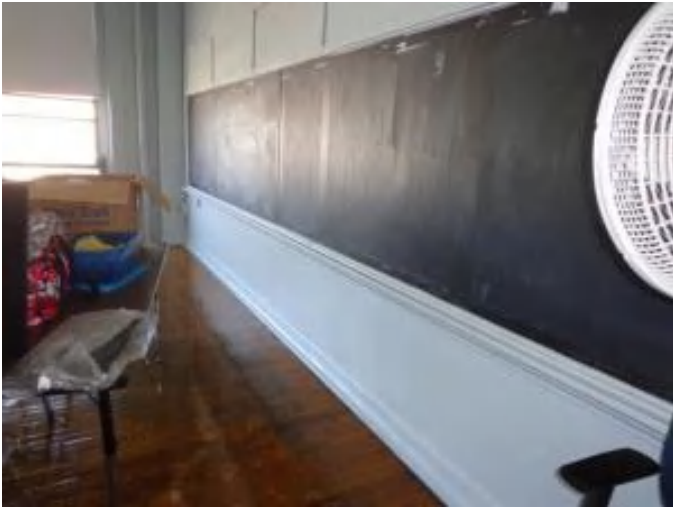
System: D5020 - Lighting and Branch Wiring

Location: Classrooms
Distress: Inadequate
Category: 4 - Capital Improvement
Priority: 4 - Response Time (4-5 yrs)
Correction: Provide surface raceway system and wiring devices
Qty: 1,500.00
Unit of Measure: L.F.
Estimate: \$189,687.05
Assessor Name: System
Date Created: 10/22/2015

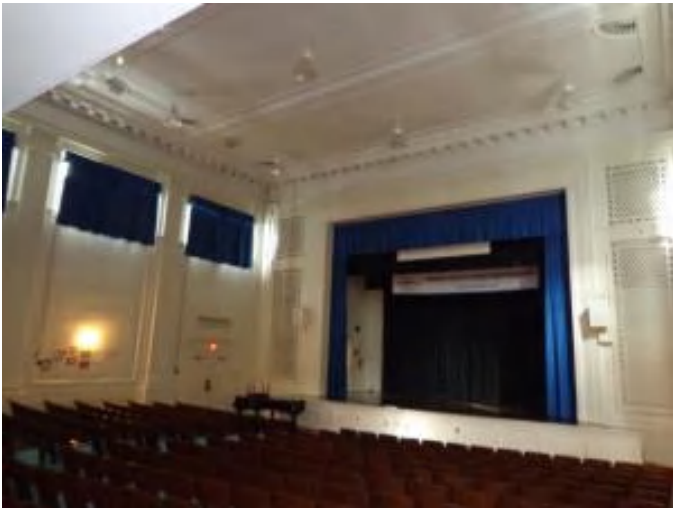
System: D5020 - Lighting and Branch Wiring

Location: Auditorium
Distress: Appearance
Category: 3 - Operations / Maint.
Priority: 4 - Response Time (4-5 yrs)
Correction: Replace Lighting Fixtures (SF)
Qty: 5,837.00
Unit of Measure: S.F.
Estimate: \$80,256.91
Assessor Name: System
Date Created: 10/22/2015

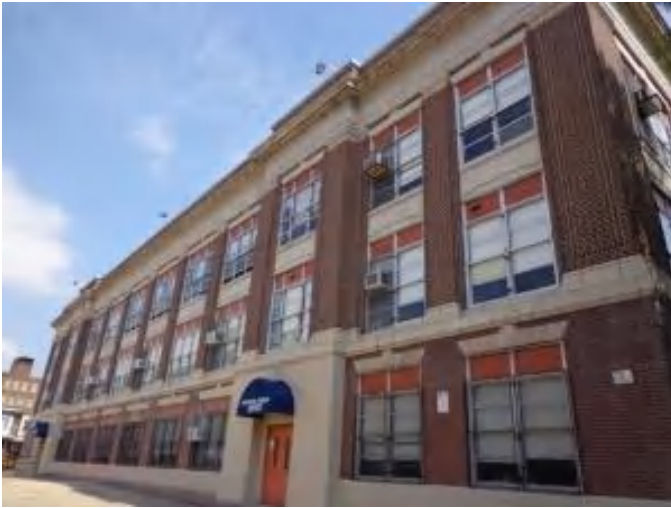
System: D5030 - Communications and Security

Location: Building exterior

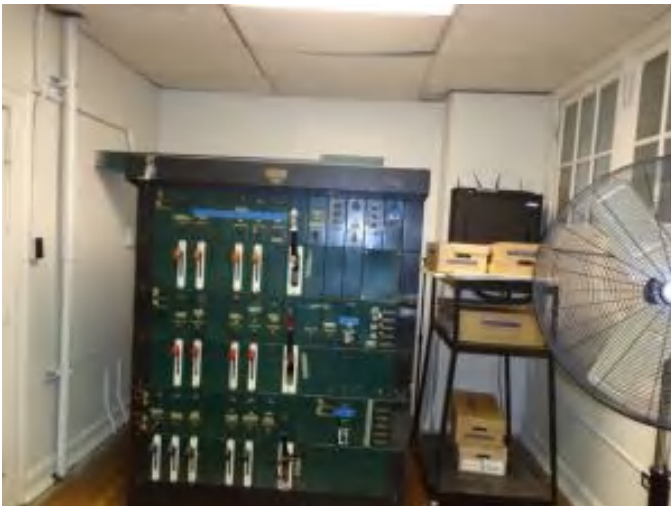
System: E1020 - Institutional Equipment

The library equipment, theater and stage equipment and audio-visual equipment are from the original construction or latest renovation efforts of the school. The systems are in use and in fair condition however, the systems are beyond the expected life for this application and upgrades are warranted.

Location: Stage Dimmer Board

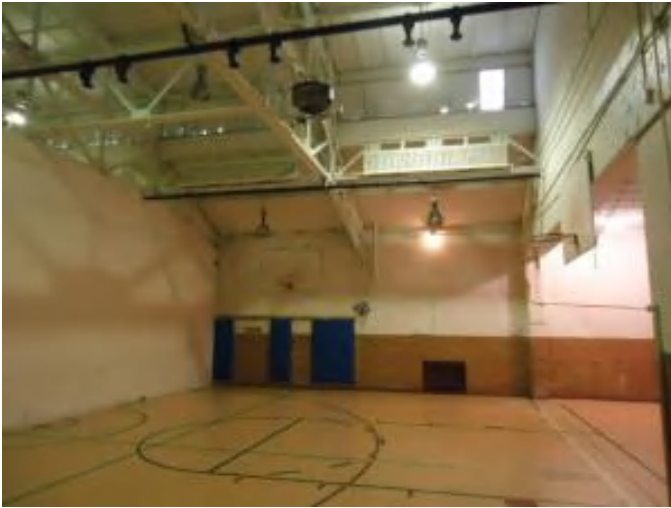
System: E1020 - Institutional Equipment

The boys and girls Gyms are the main areas as this schools indoor activities. The old Gyms are still used as either a student common area or practice court. The interior backboards and support equipment is beyond its service life. Damaged boards are recommended for removal and replacement.

Location: Gyms

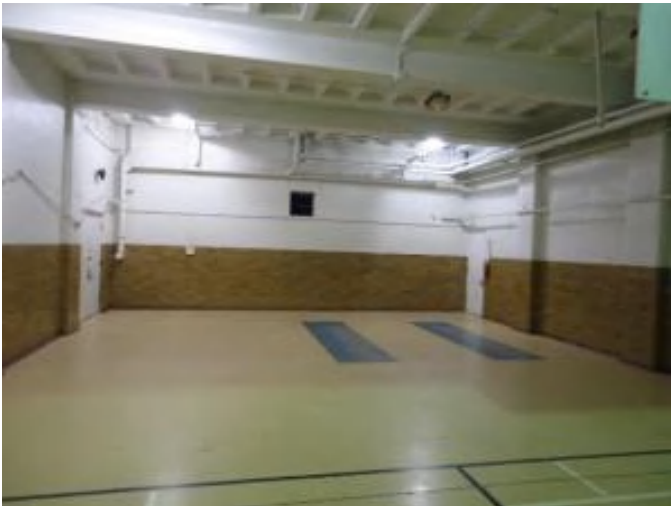
System: E1020 - Institutional Equipment

The practice Gyms or Boy's and Girl's Gyms each have a single scoreboard that appears to be from the early 1950's and no longer functions. This deficiency provides a budgetary consideration for the removal and replacement of each scoreboard.

Location: Gyms

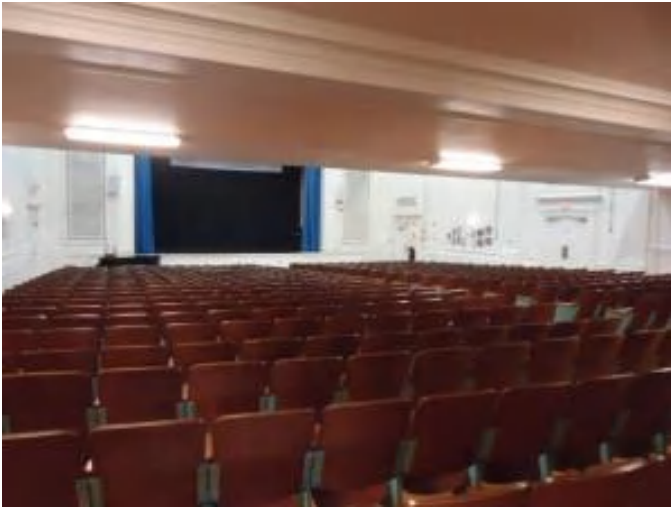
System: E2010 - Fixed Furnishings

The fixed seating for this school is from the original construction. The systems are in fair condition considering the age and usage. This project provides a budgetary consideration for universal upgrades for the fixed seating and furnishing of this school. Ensure that ADA requirements are followed with the new seating layout.

Location: Auditorium

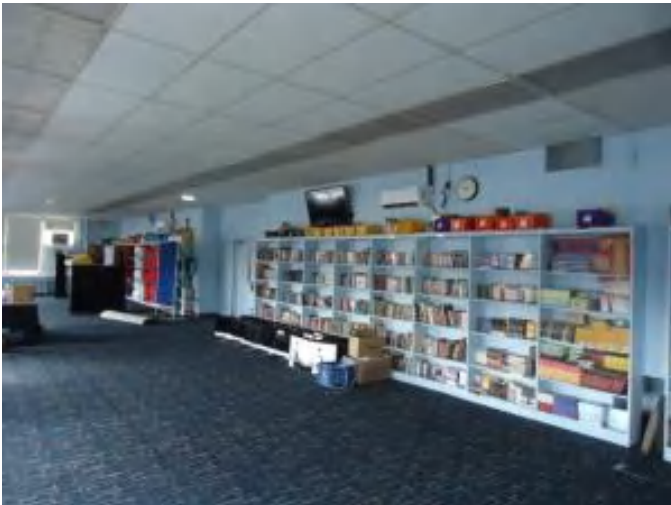
System: E2010 - Fixed Furnishings

Location: Library

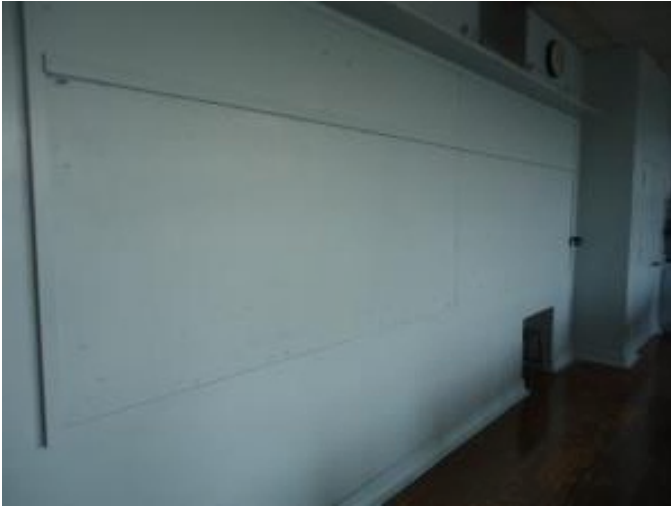
System: C1030 - Fittings

There are several tack boards in the hallways for student displays. The systems are damaged and beyond the expected service life for this application. Remove and replace tack boards is recommended.

Location: Hallways

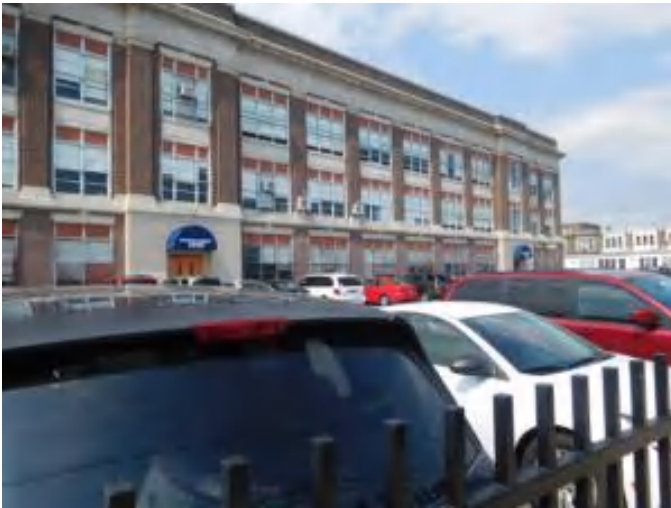
System: D3030 - Cooling Generating Systems

Location: roof, mechanical room

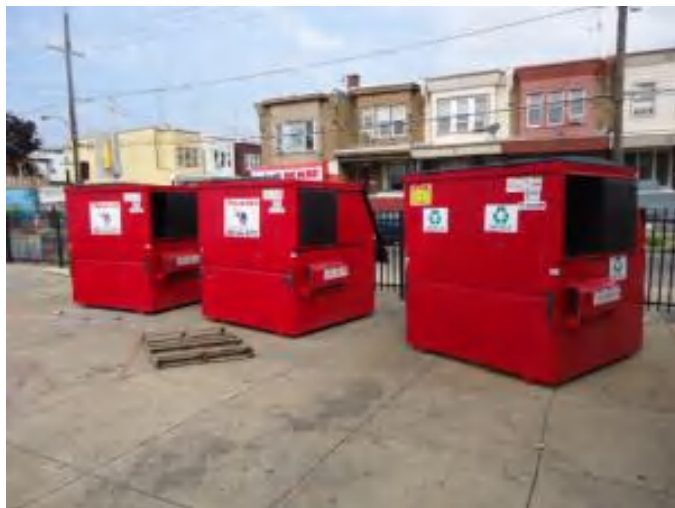
System: G2040 - Site Development

Location: Site

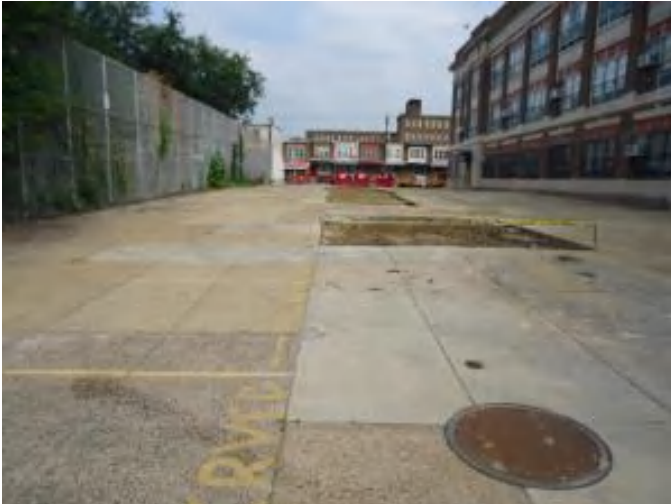
System: G2030 - Pedestrian Paving

Location: Site

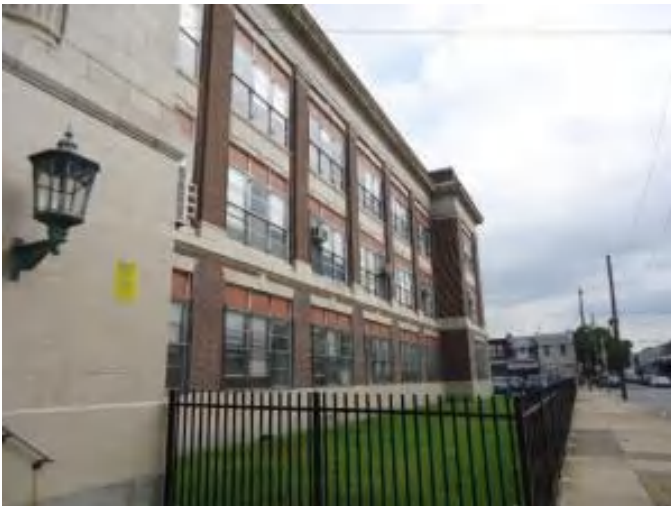
System: G2050 - Landscaping & Irrigation

Location: Site
