Facility Condition Assessment Summary Report

Meredith School

School District of Philadelphia
S238001;Meredith
Final
Site Assessment Report
January 31, 2017

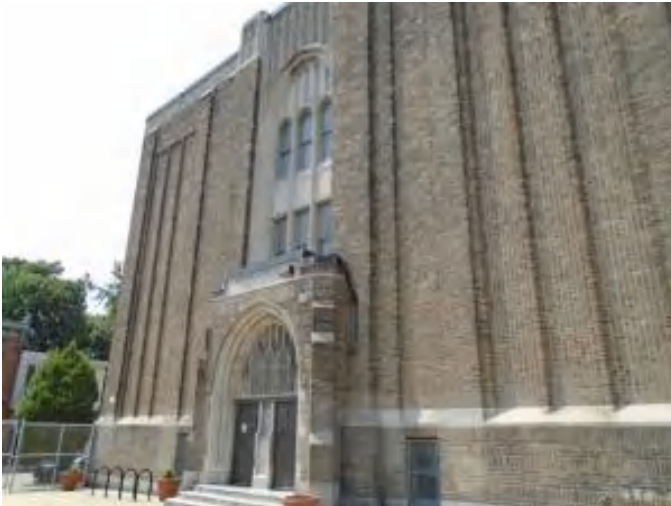
System: B2030 - Exterior Doors

Location: Exterior doors

Distress: Beyond Service Life

Notes: Replace exterior doors – beyond service life and failing

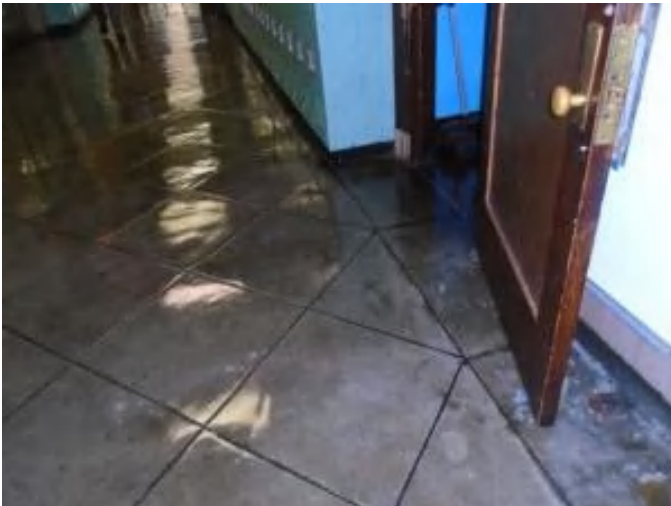
System: C1020 - Interior Doors

Location: Throughout

Distress: Accessibility

Notes: Replace interior door handles with lever type handles and latch sets

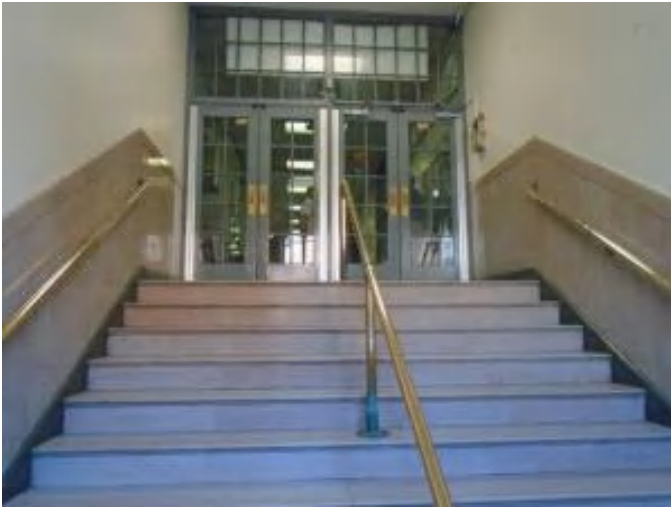
System: D1010 - Elevators and Lifts

Location: TBD

Distress: Accessibility

Notes: Install elevator for accessibility

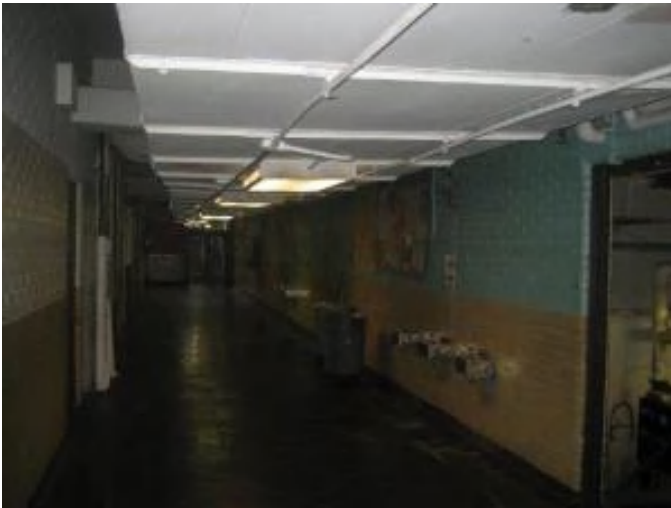
System: D2010 - Plumbing Fixtures

Hallways have stainless steel wall mounted fountains without coolers. They should all be upgraded to accessible fountains with integrated coolers.

Location: Hallways

Distress: Accessibility

Notes: Replace drinking fountains with refrigerated, accessible fountains.

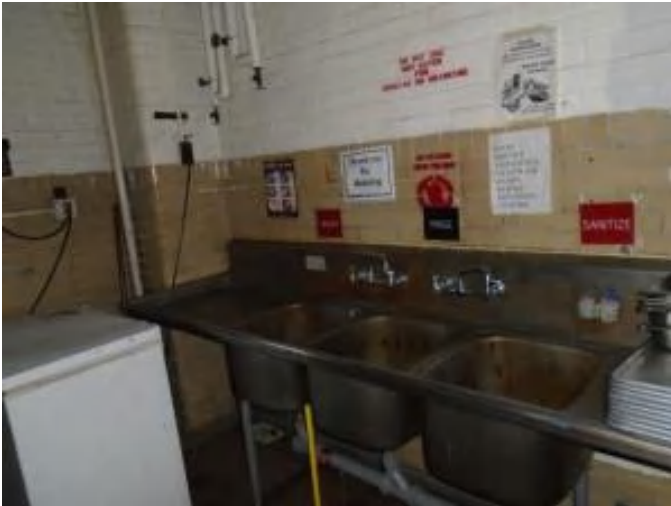
System: D2010 - Plumbing Fixtures

The basement cafeteria kitchen has a stainless steel, three basin, floor standing, commercial, dish washing sink with two faucets and without chemical sanitization injection system. The cafeteria sink does not have a grease trap. The sink is in poor condition and should be replaced. There is a porcelain lavatory in fair condition which can be expected to last more than 5 years.

Location: Cafeteria kitchen

Distress: Beyond Service Life

Notes: Replace 3 basin kitchen sink.

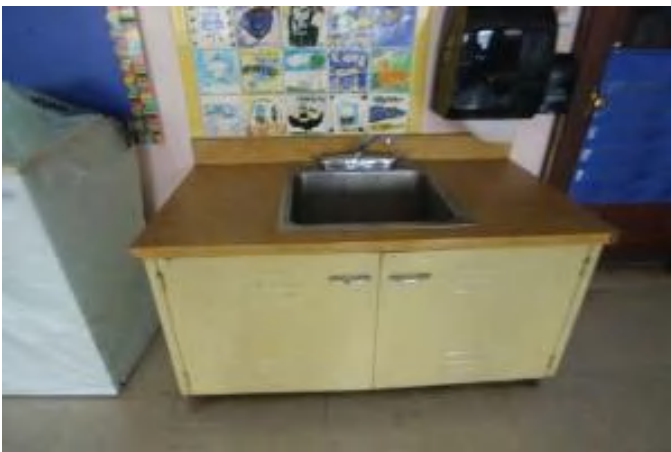
System: D2010 - Plumbing Fixtures

Location: Kindergarten rooms

Distress: Beyond Service Life

Notes: Replace kindergarten classroom sinks.

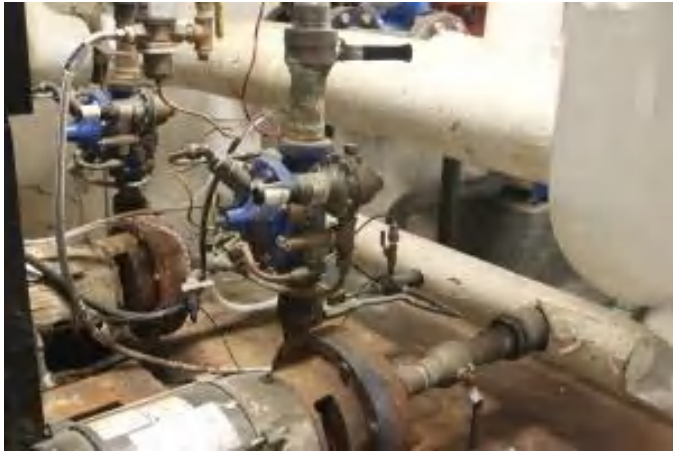
System: D2020 - Domestic Water Distribution

in good condition, but the circulation pump does not work and the first floor teacher's lounge required the water to run for a minute before it got warm. The hot water circulation pump should be repaired.

Location: Boiler room
Distress: Failing
Category: 3 - Operations / Maint.
Priority: 2 - Response Time (2-3 yrs)
Correction: Replace duplex domestic booster pump set (5 HP)
Qty: 1.00
Unit of Measure: Ea.
Estimate: \$17,276.41
Assessor Name: System
Date Created: 10/19/2015

Notes: Repair domestic hot water circulation pump and install pneumatic storage tank.

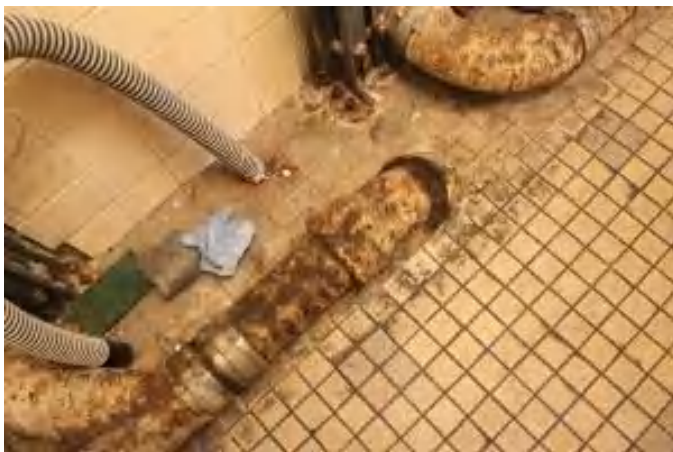
System: D2030 - Sanitary Waste

Sanitary waste and roof drain piping is threaded galvanized steel pipe and hub and spigot cast iron with hubless banded cast iron and PVC repairs. Lavatories and sinks have copper traps. Due to age, material, and history of recent failure of both systems described by the building engineer and principal, the sanitary and rainwater drain pipe systems should be replaced. There is a ground water sump at the west end of the basement hallway with two pumps, and they both run.

Location: Entire building
Distress: Failing
Category: 3 - Operations / Maint.
Priority: 2 - Response Time (2-3 yrs)
Correction: Inspect sanitary waste piping and replace damaged sections. (+50KSF)
Qty: 55,437.00
Unit of Measure: S.F.
Estimate: \$271,960.12
Assessor Name: System
Date Created: 10/19/2015

Notes: Replace sanitary drain piping due to age, severe rust, and failure.

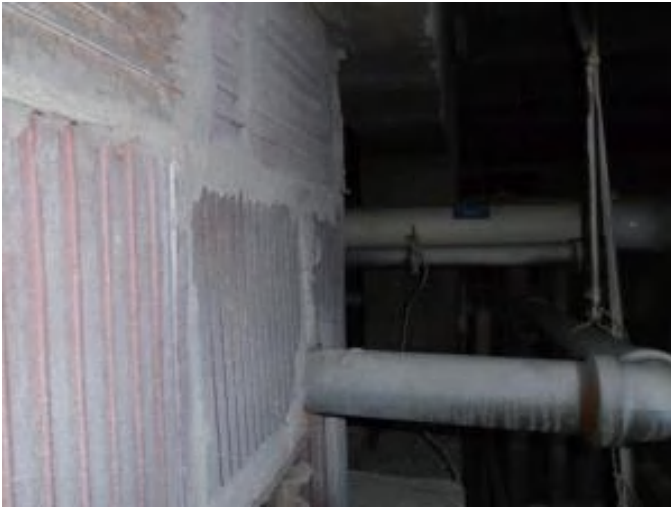
System: D2040 - Rain Water Drainage

Location: Entire building

Distress: Failing

Notes: Replace roof drain piping due to age and prior failure.

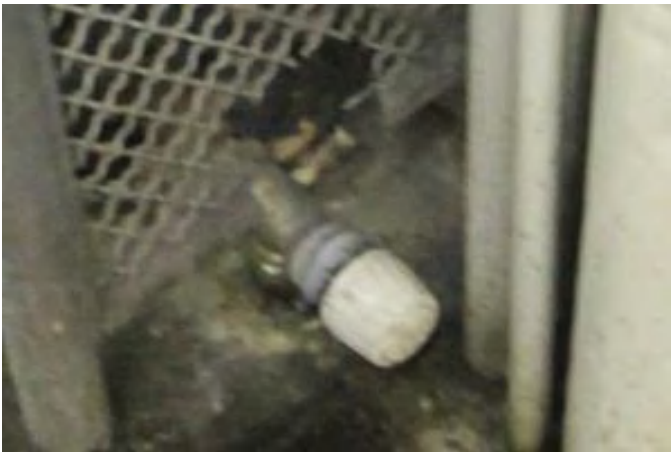
System: D3060 - Controls & Instrumentation

Classroom and stairway radiators have manual thermostat steam flow control valves. The control system is obsolete and should be completely replaced with a modern digital control system when other HVAC upgrades are implemented.

Location: Entire building

Distress: Obsolete

Notes: Upgrade control system to digital.

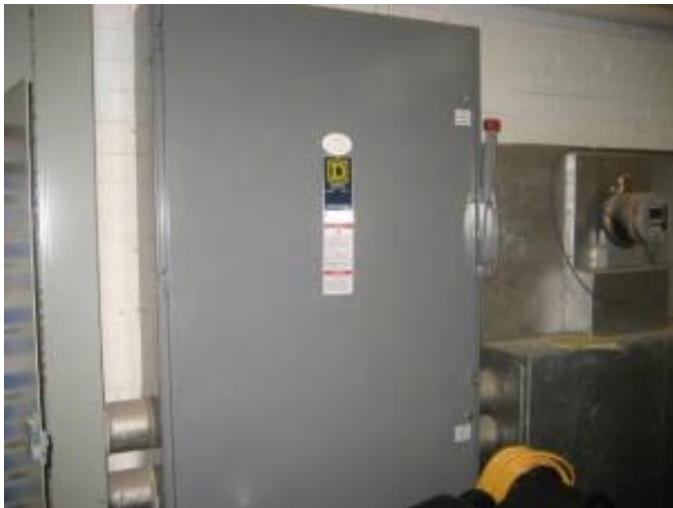
System: D5010 - Electrical Service/Distribution

Location: Basement
Distress: Inadequate
Category: 4 - Capital Improvement
Priority: 2 - Response Time (2-3 yrs)
Correction: Replace Switchboard
Qty: 1.00
Unit of Measure: Ea.
Estimate: \$323,421.35
Assessor Name: System
Date Created: 10/19/2015

Notes: Provide a new electrical service 480V/277V, 3 phase power, approximate 800 Amperes and will be located in the vicinity of the existing electrical service.

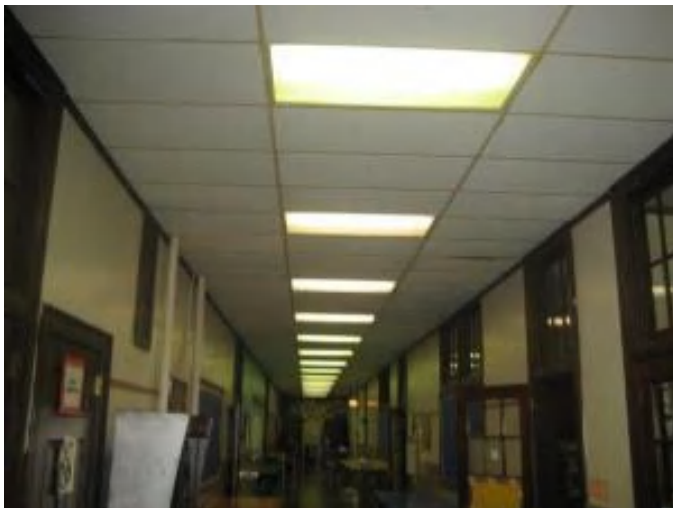
System: D5020 - Lighting and Branch Wiring

Classrooms, corridors are illuminated with recessed mounted fluorescent fixtures, with T-12 lamps. The auditorium is illuminated with pendant mounted architectural fixture with 330w mogul based incandescent lamps. The Gymnasium and cafeteria are illuminated with surface mounted fixtures with T-12 lamps. Approximately 90% of the fixtures need to be replaced

Location: Entire Building
Distress: Energy Efficiency
Category: 4 - Capital Improvement
Priority: 2 - Response Time (2-3 yrs)
Correction: Add Lighting Fixtures
Qty: 660.00
Unit of Measure: Ea.
Estimate: \$568,813.95
Assessor Name: System
Date Created: 10/19/2015

Notes: Replace 90% of the existing lighting fixtures with up/down, recessed fluorescent fixtures with T8 lamps in classroom/offices and corridors. Approximate 660 fixtures

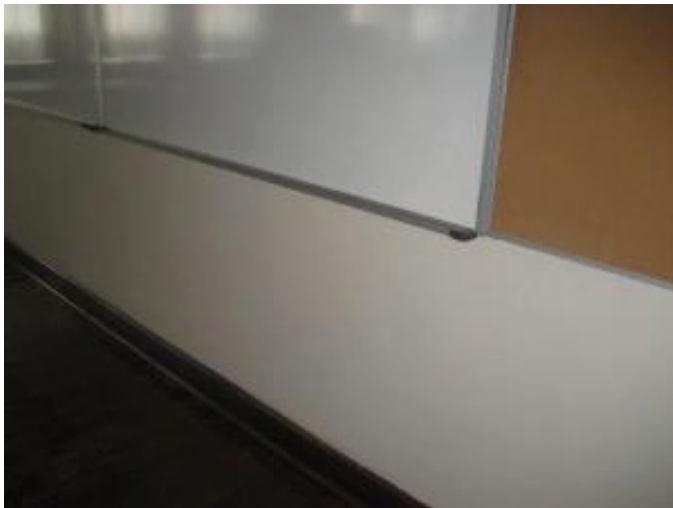
System: D5020 - Lighting and Branch Wiring

There number of receptacles in classrooms are inadequate. The teacher's whiteboard wall and the opposite of it need to be provided with double compartment surface raceways, the other two walls with minimum two-duplex outlets each, when feasible.

Location: Classrooms
Distress: Inadequate
Category: 4 - Capital Improvement
Priority: 2 - Response Time (2-3 yrs)
Correction: Add wiring device
Qty: 480.00
Unit of Measure: Ea.
Estimate: \$176,338.08
Assessor Name: System
Date Created: 10/19/2015

Notes: Provide (2)25FT of surface raceways with 24" receptacles on center and two-duplex wall mount receptacles. Approximate 480

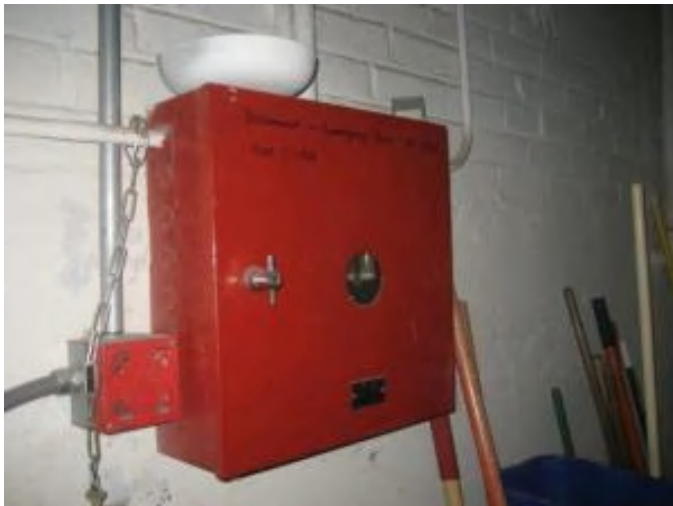
System: D5030 - Communications and Security

Location: Entire School
Distress: Building / MEP Codes
Category: 2 - Code Compliance
Priority: 2 - Response Time (2-3 yrs)
Correction: Replace fire alarm system
Qty: 74.00
Unit of Measure: S.F.
Estimate: \$197,449.18
Assessor Name: System
Date Created: 10/19/2015

Notes: Replace old fire alarm system with addressable type with audio/visual devices at corridors and classrooms. Approximate 74 devices

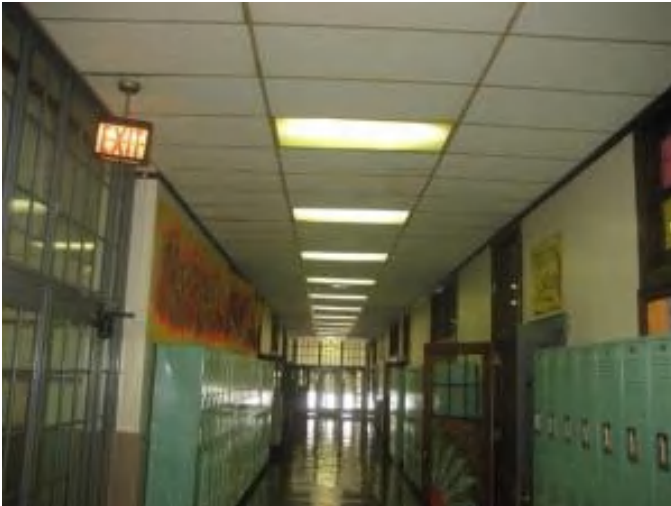
System: D5030 - Communications and Security

Location: Entire School

Distress: Security Issue

Notes: Add CCTV cameras to provide a full coverage of the building interior. Approximate 22 CCTV cameras

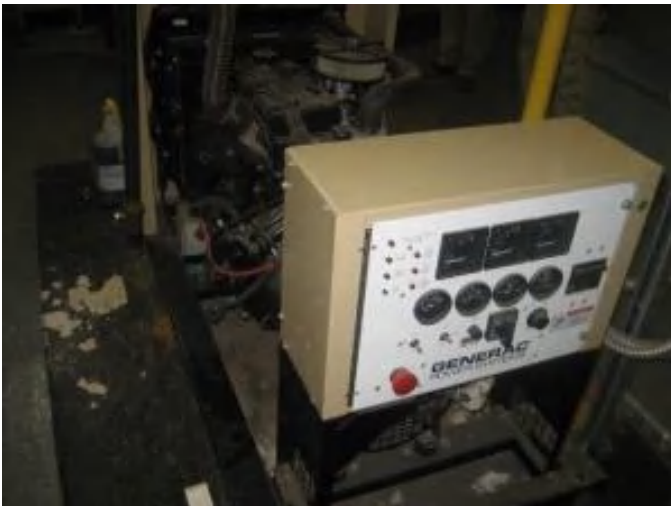
System: D5090 - Other Electrical Systems

Location: Outdoor

Distress: Beyond Service Life

Notes: Provide 50KW, outdoor, diesel powered generator.

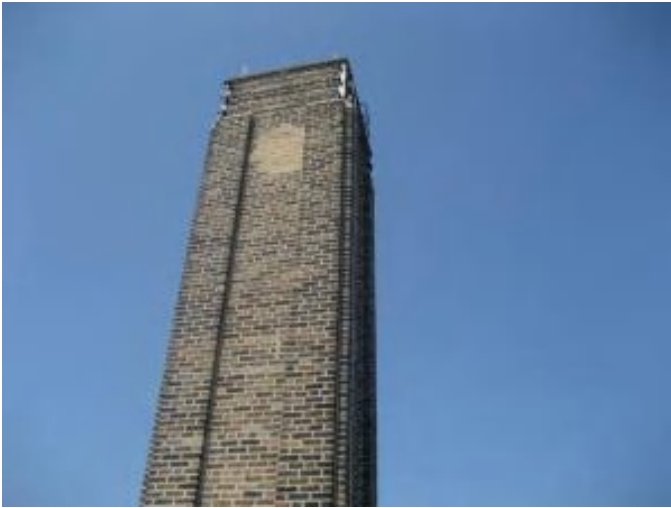
System: D5090 - Other Electrical Systems

Location: Roof
Distress: Building / MEP Codes
Category: 2 - Code Compliance
Priority: 2 - Response Time (2-3 yrs)
Correction: Provide Lightning Protection System
Qty: 1.00
Unit of Measure: LS
Estimate: \$21,472.30
Assessor Name: System
Date Created: 10/19/2015

Notes: Prepare a study to determine if the existing lightning system provide the proper protection to the school building.

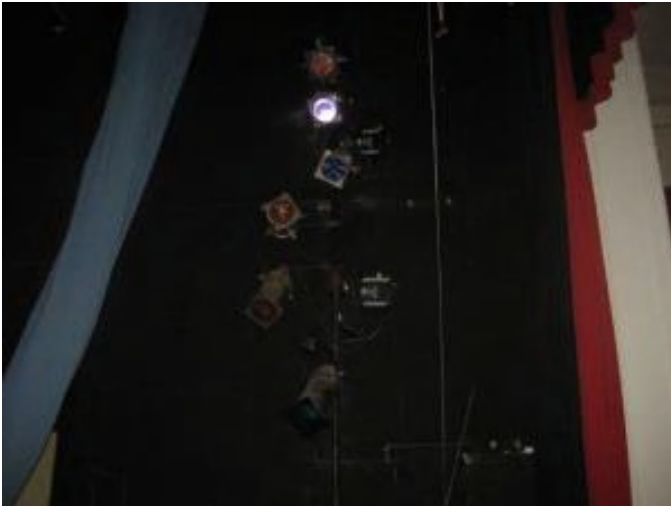
System: E1020 - Institutional Equipment

Location: Auditorium
Distress: Inadequate
Category: 4 - Capital Improvement
Priority: 2 - Response Time (2-3 yrs)
Correction: Add/Replace Stage Theatrical Lighting System
Qty: 1.00
Unit of Measure: Ea.
Estimate: \$323,055.06
Assessor Name: System
Date Created: 10/19/2015

Notes: Provide a dimming system and additional theatrical lighting.

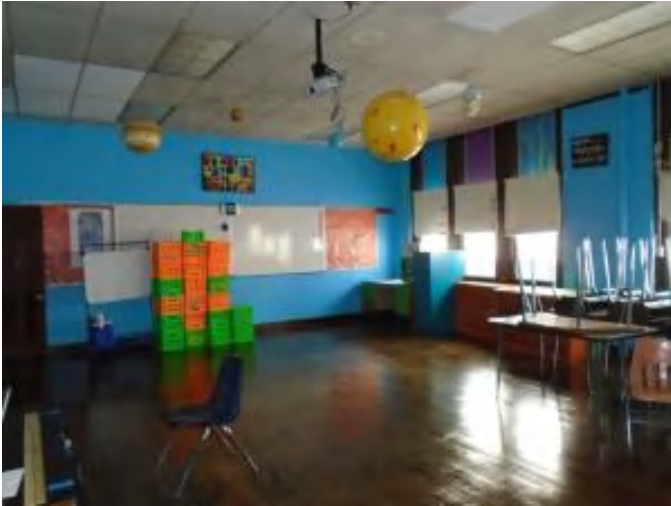
System: C3030 - Ceiling Finishes

Location: Throughout

Distress: Beyond Service Life

Notes: Replace suspended acoustic tile ceiling system – beyond service life (50% of suspended ceiling)

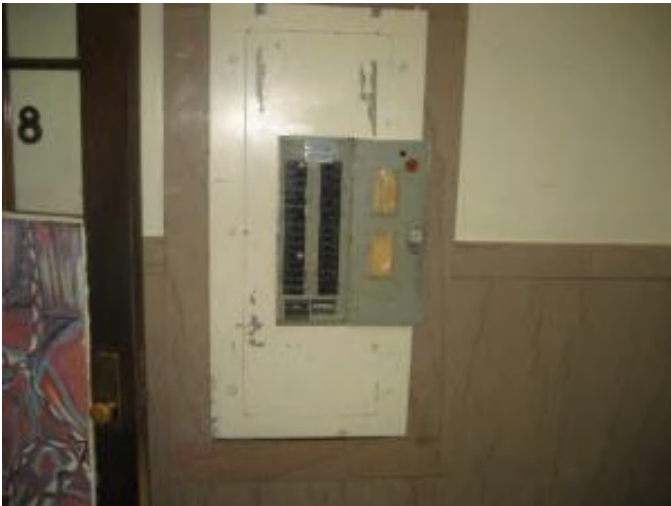
System: D5010 - Electrical Service/Distribution

In each floor, there are original 120/240V panel-boards for lighting and receptacles and new ones for window type air conditioning units. The original panel-boards and associated wiring have exceeded the end of their useful life and the new panel-boards are not sized to absorb additional HVAC loads. They need to be replaced. There are (1) 75KVA and (1) 50KVA phase converters from 240V to 120/208V which normally feeds newest mechanical equipment. Panel-board's doors at corridors are not locked and represent a potential hazard for students. As a safety issue all panel-boards at corridor or in areas where students are present must be provided with lockable devices.

Location: Entire Building

Distress: Inadequate

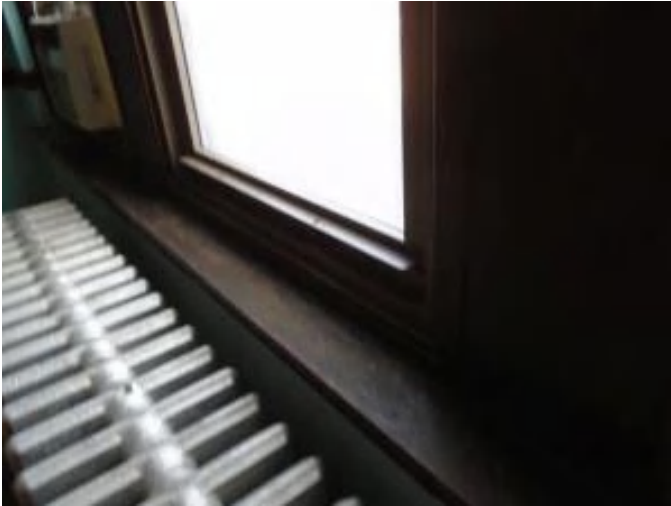
System: B2020 - Exterior Windows

Location: Windows

Distress: Energy Efficiency

Notes: Replace Plexiglas window – hazed

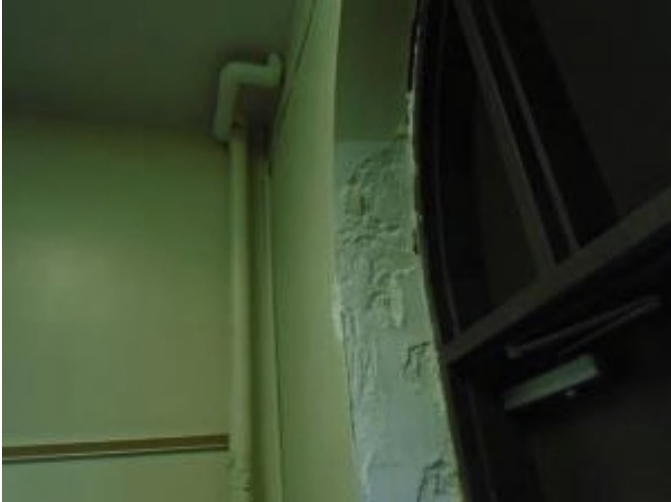
System: C3010230 - Paint & Covering

Location: Auditorium

Distress: Damaged

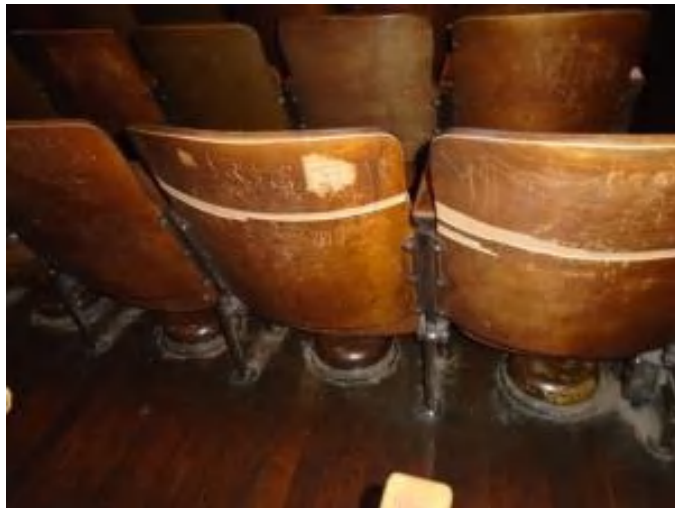
System: E2010 - Fixed Furnishings

Fixed furnishings include: fixed casework in classrooms, corridors and library, generally in fair to good condition; and fixed auditorium seating for 231 generally in fair condition with some damaged seats.

Location: Auditorium

Distress: Damaged

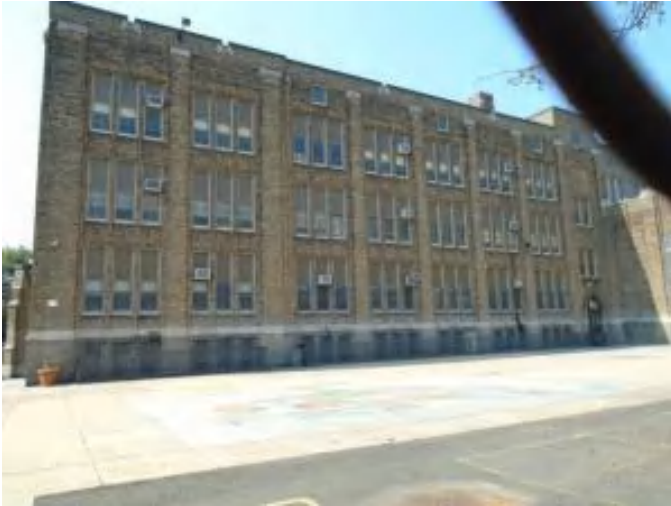
System: D3030 - Cooling Generating Systems

There is no central cooling generating system. Classrooms and offices are equipped with a total of 32 window unit air-conditioners. There are two split unit air conditioners for computer network equipment rooms. Total cooling capacity is estimated at 65 tons. These units are insufficient, so a central cooling system with 150 ton capacity should be installed to replace them.

Location: Entire building

Distress: Inadequate

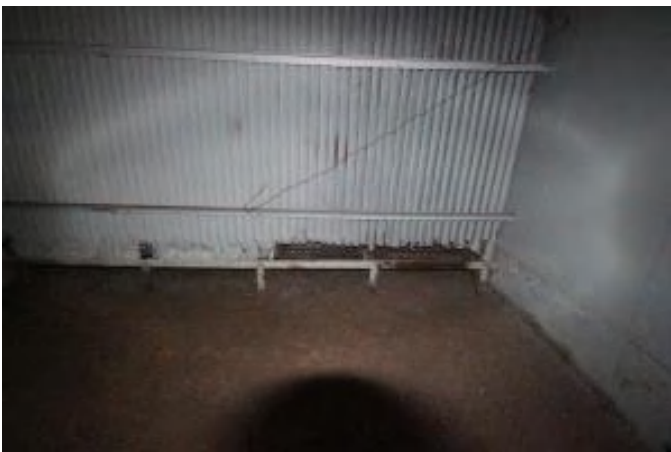
System: D3040 - Distribution Systems

There is one air handling unit located built into the basement mechanical room. It is original to the building and includes intake filter, 15 HP fan, and steam heating coils. The filter section is 6 feet wide and 8 feet tall and is heavily coated with dust. The entire air supply comes from outside through a pneumatically controlled dampers on the west side of the building; there is no recirculation of building air. The air handler is obsolete and should be replaced with a new unit including cooling coils, humidification, and dehumidification sections and also new insulated ductwork throughout the basement. Room exhaust air discharges through clay block vertical ducts to the attic plenum and exits the building through gravity vents in the roof. Toilet rooms have new exhaust ducts. The cafeteria does not have any fuel burning appliances, and there is no fume hood.

Location: Basement

Distress: Beyond Service Life

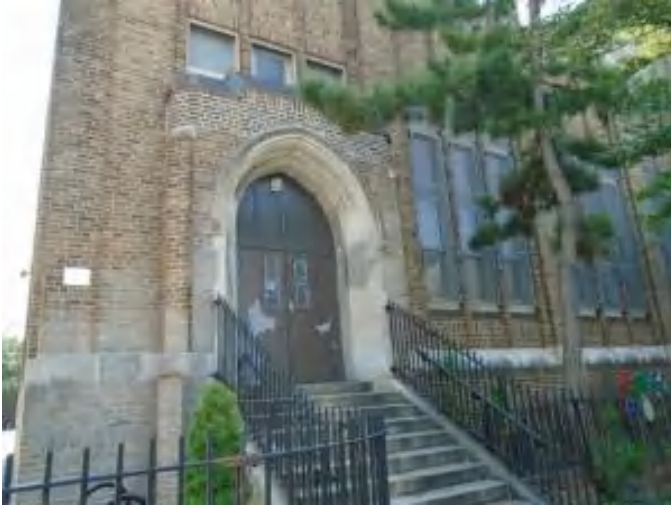
System: G2030 - Pedestrian Paving

Location: Entrance

Distress: Accessibility

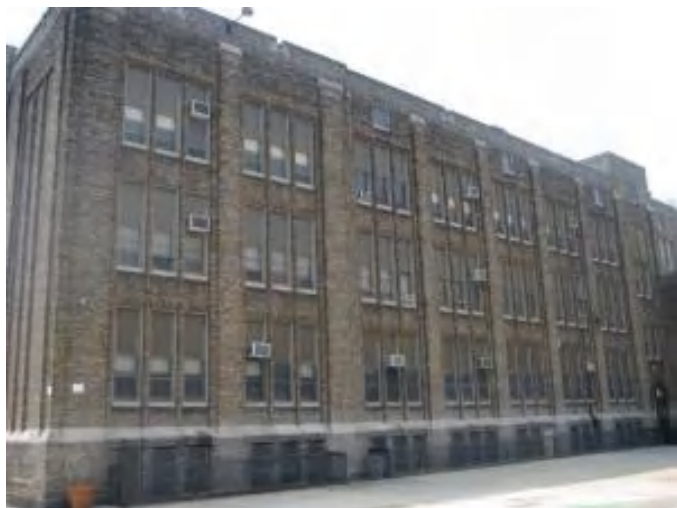
System: G4030 - Site Communications & Security

Location: Outdoor

Distress: Security Issue
