## Facility Condition Assessment Summary Report

### Mifflin School

School District of Philadelphia  
**S632001;Mifflin**  
Final  
**Site Assessment Report**  
January 31, 2017

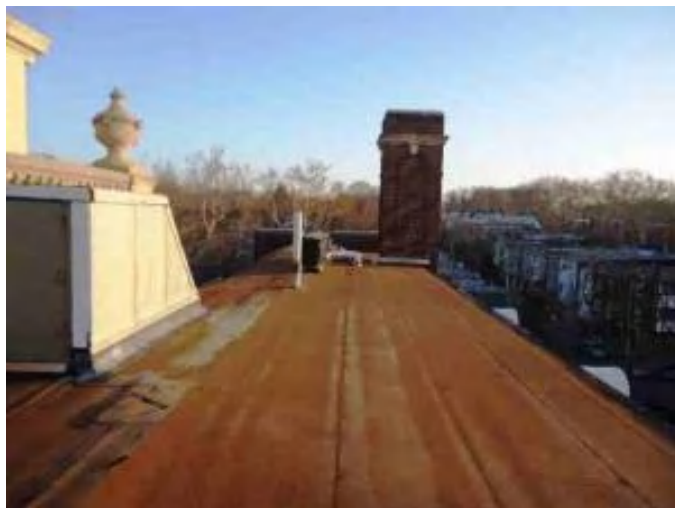
#### System: B3010105 - Built-Up

**Location:** Roof

**Distress:** Damaged

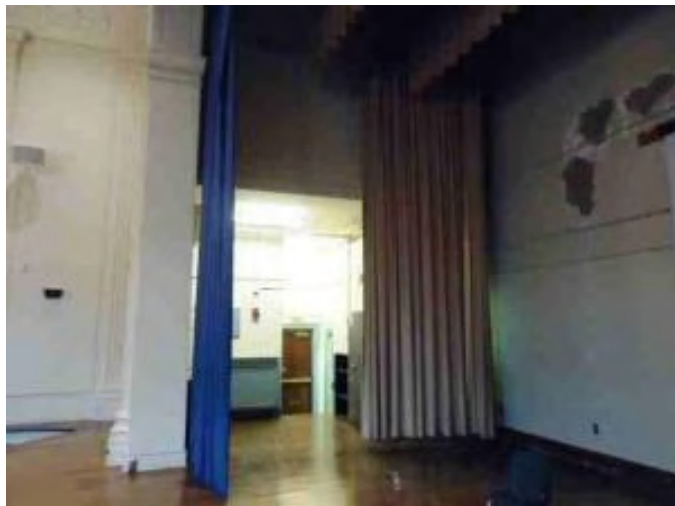
**System: E2010 - Fixed Furnishings**

The school stage has a stage curtain assembly that appears to be from the original construction. Modern applications are typically fire-proof applications with adjustable tracks and electric support for operation. The curtains are torn in a few sections and the track is not functioning properly, overall the system is in poor condition. It is recommended that the curtain and track system be upgraded to a new system. Special care should be considered in regards to modern fire proofing for the new installation.

**Location:** Stage

**Distress:** Life Safety / NFPA / PFD

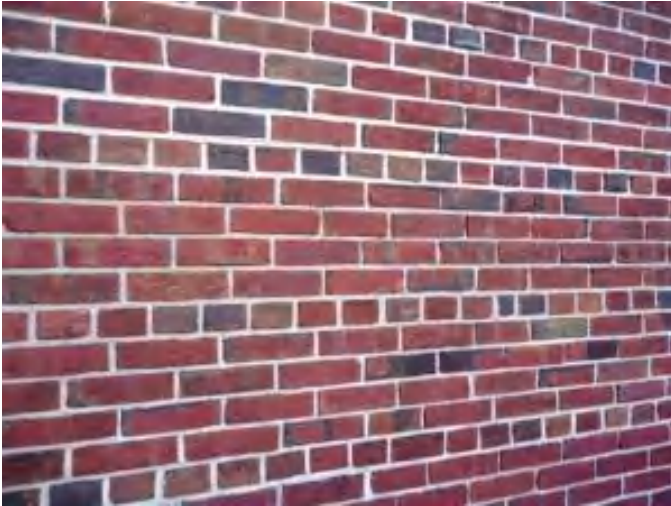
**System: B2010 - Exterior Walls**

The exterior brick surfaces are generally in fair to good condition for their age. In some locations, bricks have cracked or spalled and should be replaced. The repointing of deteriorated mortar joints is also recommended, using mortar of a similar color and consistency as the original. Following the detailed examination of the brick and repair of mortar construction joints, the entire building should be pressure washed to remove stains and embedded pollutants. If moisture is found to be penetrating the masonry facade, the application of a spray sealant to the suspected exterior masonry surface is recommended.

**Location:** Exterior Elevation

**Distress:** Damaged

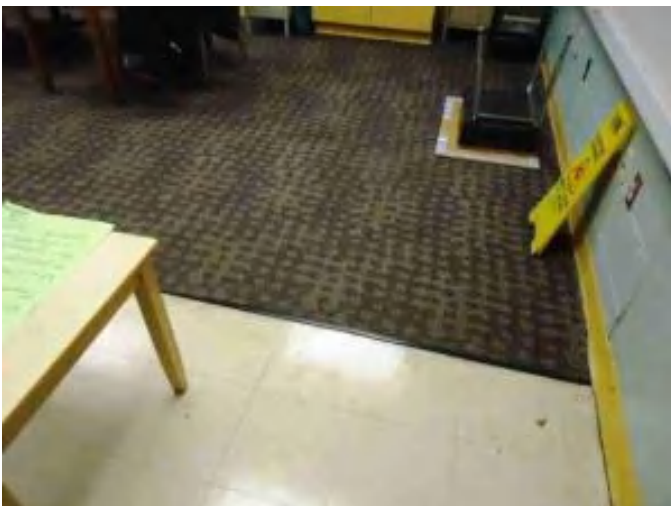
**System: C3020411 - Carpet**

**Location:** Administrative Office

**Distress:** Damaged

**Notes:** The hallways and stair landings consist of marble or terrazzo finish and mechanical spaces have a sealed concrete finish. The interior carpet finish was installed approximately in 2000 and is in fair condition considering the age and high traffic conditions. This finish will exceed its expected life within the next five years and is recommended for removal and replacement.

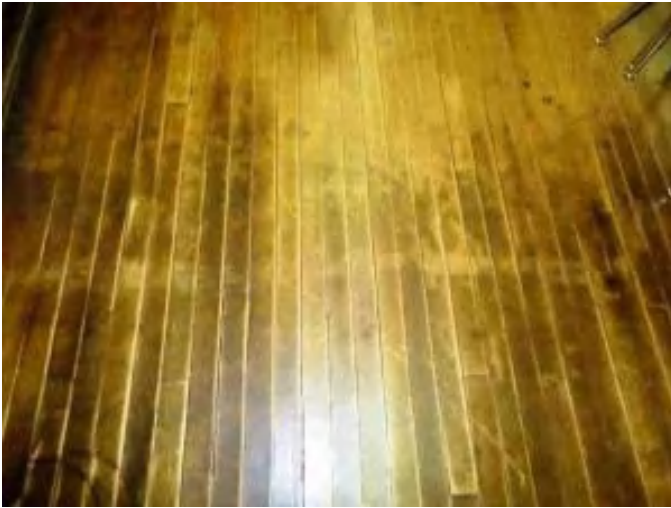
**System: C3020414 - Wood Flooring**

The wooden floor finish in the classrooms has served this school from the first day of school. The systems maintenance has been a priority each year as part of a cyclical program to either, sand, clean and resurface or wax as needed. Considering the age and current condition of the classroom wooden floor finish, removal and replacement is recommended.

**Location:** Classrooms

**Distress:** Damaged

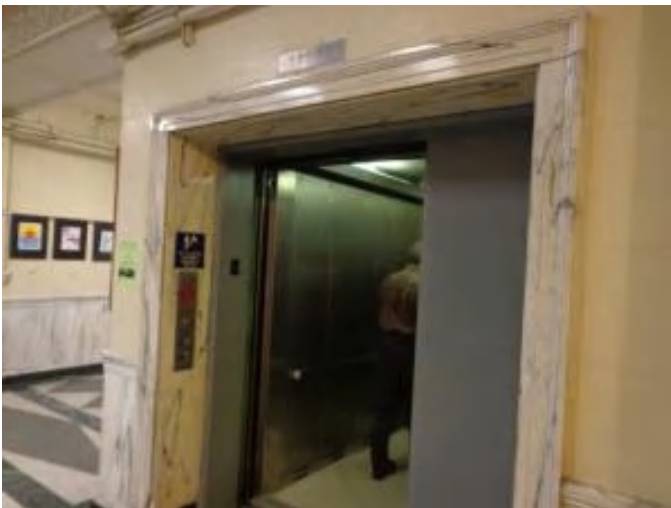
**System: D1010 - Elevators and Lifts**

**Location:** Elevator machine room

**Distress:** Beyond Service Life

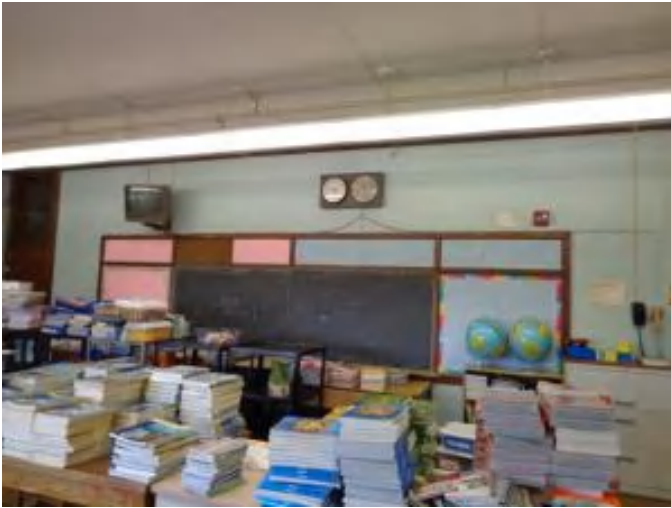
**System: D5020 - Lighting and Branch Wiring**

The areas that still have fluorescent lighting fixtures with obsolete T12 lamps include stairwells, most restrooms, and eight (8) classrooms on the Second Floor. These areas are included for fixture replacement in this report. Classroom lighting is controlled by two all switches.

**Location:** Stairwells, restrooms, classrooms

**Distress:** Beyond Service Life

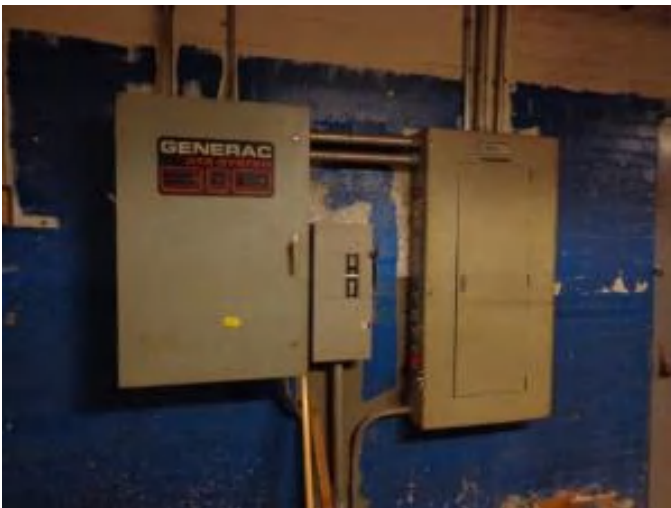
**System: D5090 - Other Electrical Systems**

**Location:** Boiler Room 008

**Distress:** Beyond Service Life

**Notes:** Replace standby power system, including generator, automatic transfer switch, and emergency lighting Panelboard EL. Generator size should be increased to supply the electric traction elevator with standby power (estimate 60 kW generator).

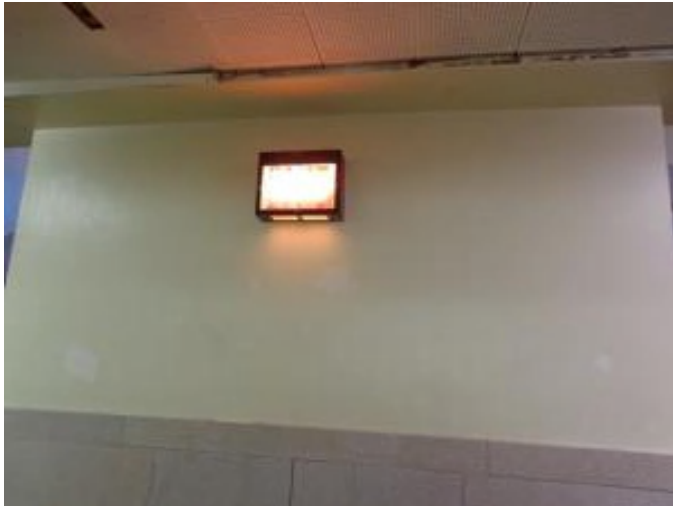
**System: D5090 - Other Electrical Systems**

**Location:** Building wide

**Distress:** Beyond Service Life

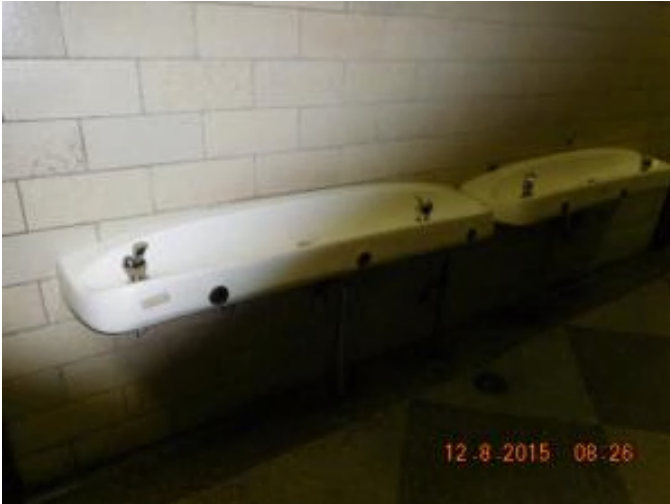
**System: D2010 - Plumbing Fixtures**

**Location:** corridors

**Distress:** Beyond Service Life

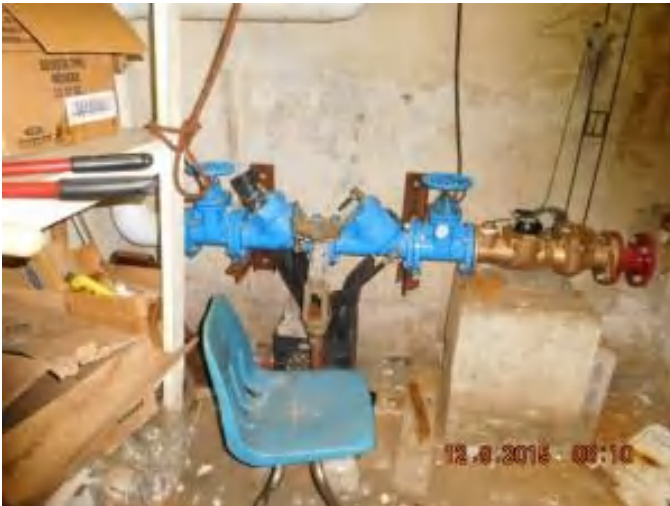
**System: D2020 - Domestic Water Distribution**

**Location:** entire building

**Distress:** Beyond Service Life

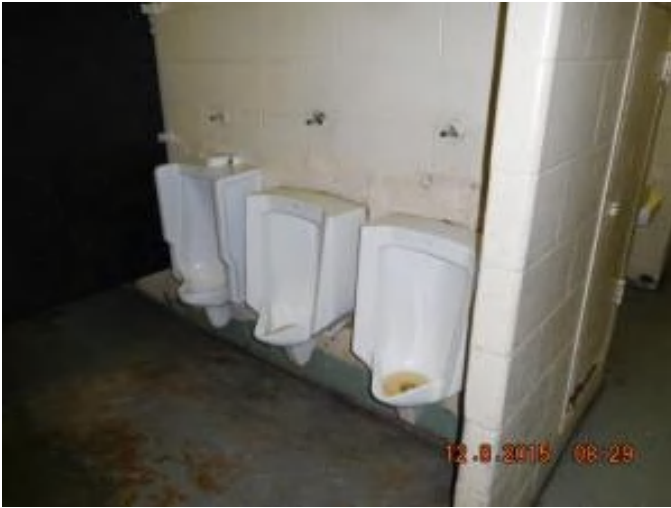
**System: D2030 - Sanitary Waste**

**Location:** entire building

**Distress:** Beyond Service Life

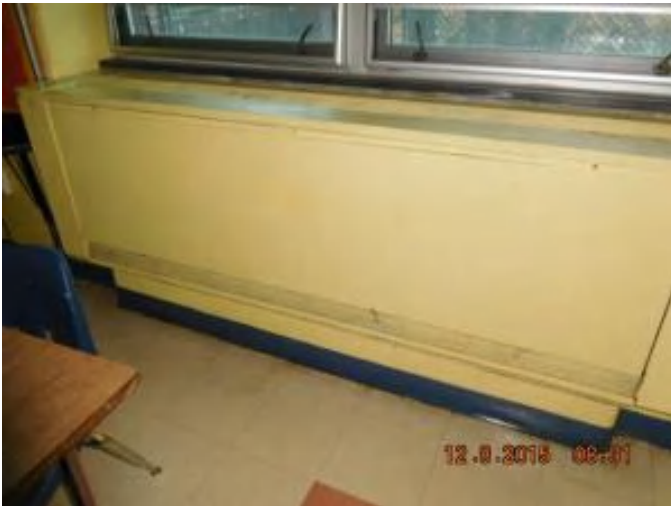
**System: D3040 - Distribution Systems**

**Location:** classrooms

**Distress:** Building / MEP Codes

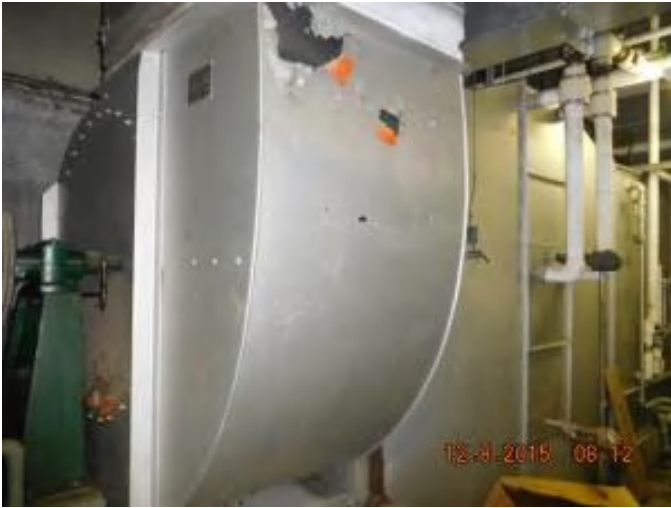
**System: D3040 - Distribution Systems**

**Location:** auditorium

**Distress:** Building / MEP Codes

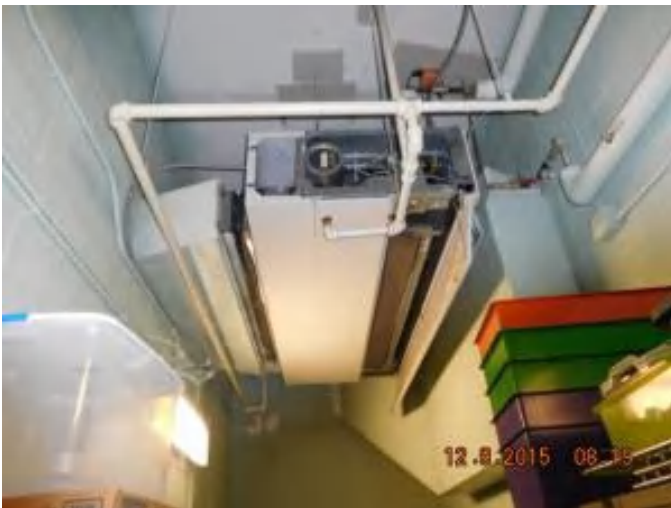
**System: D3040 - Distribution Systems**

**Location:** cafeteria

**Distress:** Building / MEP Codes

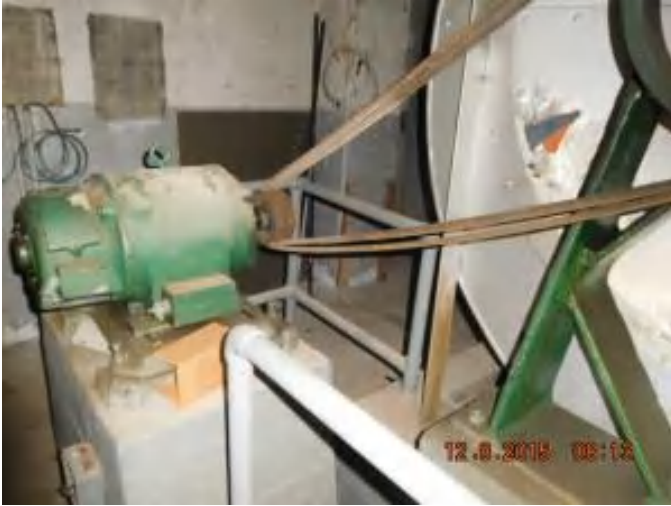
**System: D3040 - Distribution Systems**

**Location:** gymnasium

**Distress:** Building / MEP Codes

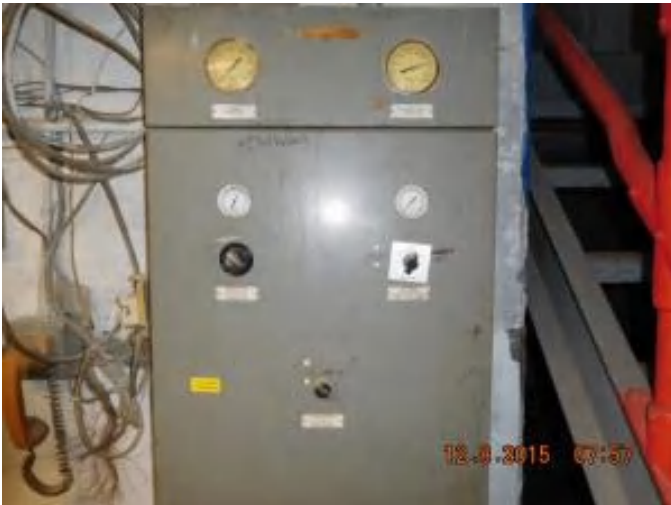
**System: D3060 - Controls & Instrumentation**

**Location:** entire building

**Distress:** Inadequate

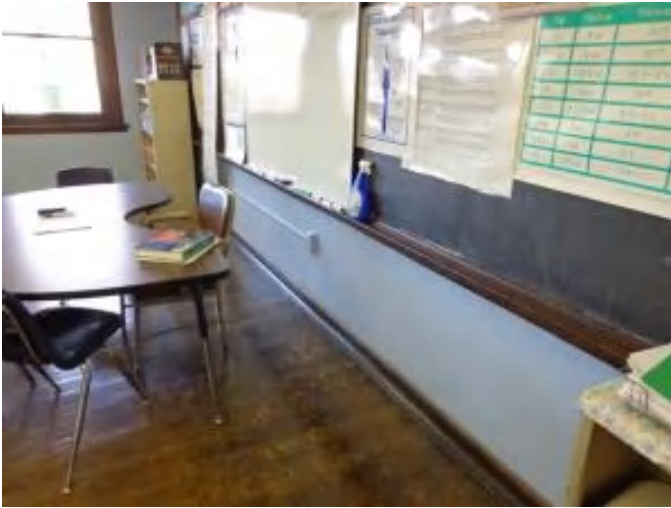
**System: D5020 - Lighting and Branch Wiring**

**Location:** Classrooms

**Distress:** Inadequate

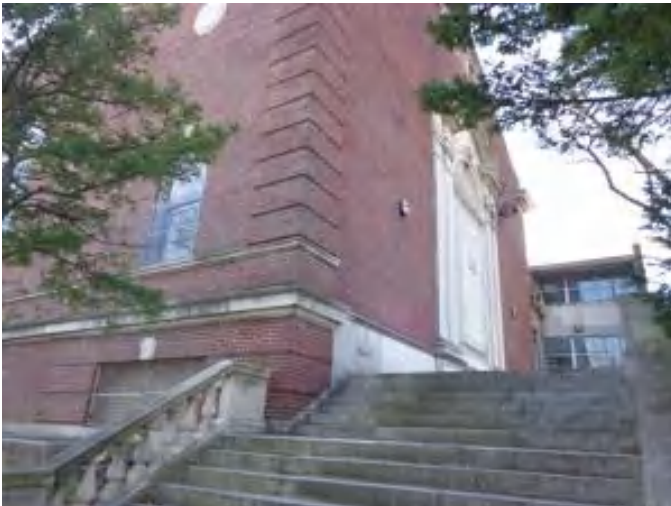
**System: D5020 - Lighting and Branch Wiring**

Wall mounted exterior lighting consists of wall packs, decorative vandal-resistant round fixtures with compact fluorescent lamps and HID floodlighting fixtures. Fixtures are located at each exit discharge and to illuminate the play areas. Exterior lighting is in good condition with a remaining useful life that extends beyond this report. For safety considerations, an additional floodlighting fixture is recommended to illuminate the exterior stairs at the northwest corner of the building.

**Location:** Building exterior

**Distress:** Life Safety / NFPA / PFD

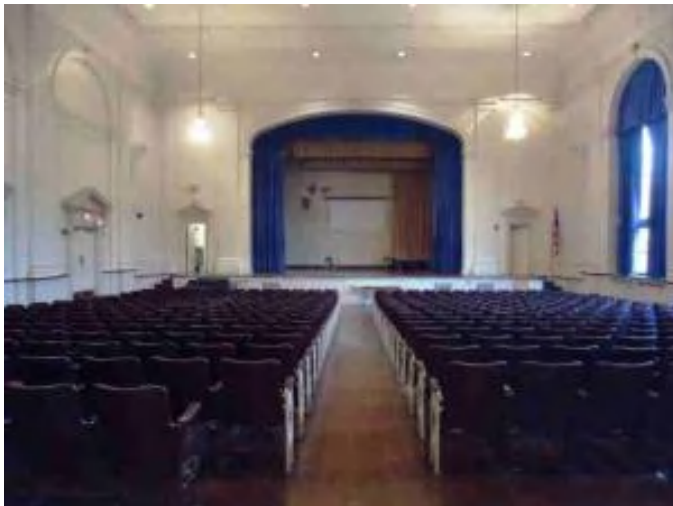
**System: E2010 - Fixed Furnishings**

The fixed seating for this school is from the original construction. The systems are in fair condition considering the age and usage. This project provides a budgetary consideration for universal upgrades for the fixed seating and furnishing of this school. Ensure that ADA requirements are followed with the new seating layout.

**Location:** Auditorium

**Distress:** Damaged

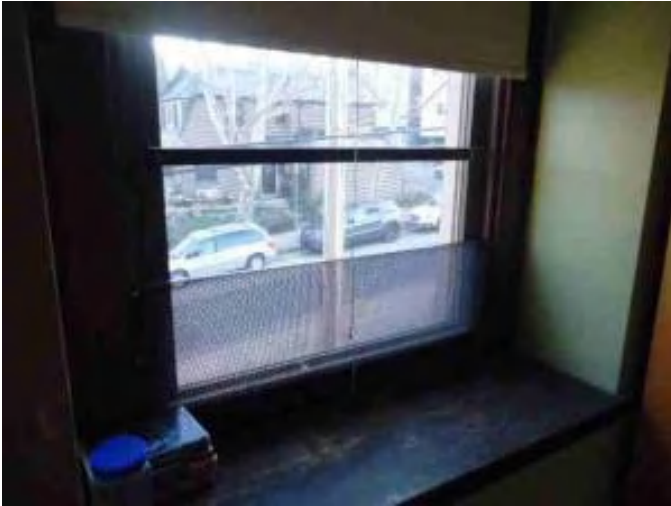
**System: B2020 - Exterior Windows**

This schools historic presentation to the community reflects upon the exterior window system that was reported to have been upgraded in the late 1980s. Several of the windows no longer work and will require attention prior to an overall effort. Overall, the windows are in fair condition based on the year of installation or last renovation. The entire exterior window system is recommended to be replaced with units that retain their dimensions and profiles, but that incorporate updated energy-efficient features.

**Location:** Exterior Elevation

**Distress:** Damaged

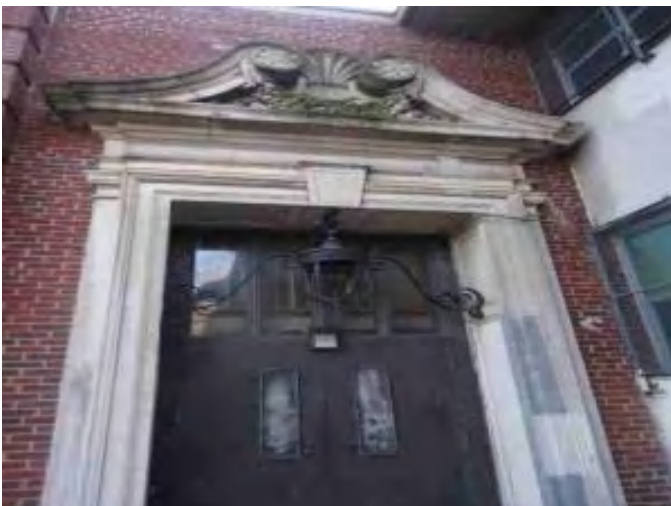
**System: B2030 - Exterior Doors**

**Location:** Exterior Elevation

**Distress:** Damaged

**Notes:** The exterior doors are metal applications with metal frames. The exterior door system for this school is a very high traffic system. Most of the doors are in fair condition but are aging at a faster rate than expected based on traffic and condition. The service doors on the roof have expired and failed compromising access to elevator rooms and tower rooms. The exterior door system, store front and service doors are recommended for upgrade.

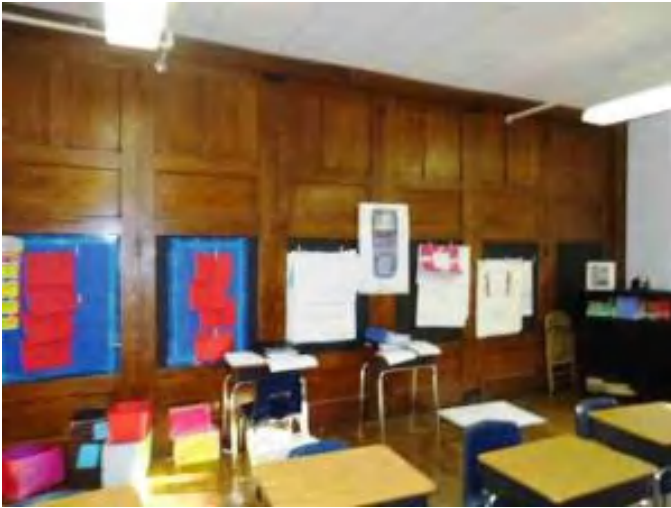
**System: C1010 - Partitions**

There are several movable partitions that remain in classrooms. These wall systems are no longer used and in most cases cannot be used due to damage or wall modifications to support classroom needs. This deficiency provides a budgetary consideration to remove and replace the wall systems with universal removal of the existing movable partitions and upgrades to a permeate wall systems.

**Location:** Classrooms

**Distress:** Damaged

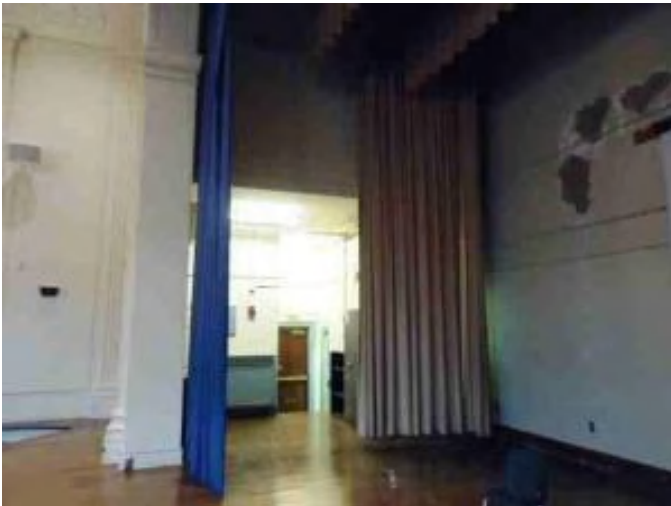
**System: C3010230 - Paint & Covering**

**Location:** Building Wide

**Distress:** Damaged

**Notes:** There are painted walls, trim, and some painted ceilings in this building. The interior finishes are in good to fair condition depending on the location of the finish. For example due to recent roof leaks over the auditorium several areas will require repair and repainting. This school will require an almost continuous program of renewal of the applied finishes to maintain an acceptable appearance. Cyclical painting should be considered for a standard approach to maintaining the quality of the interior finishes. It is recommended that all previously painted surfaces be repainted according to established cycles for this occupancy and use type. Minor repairs should be completed before work begins. This effort is expected to be coordinated with other mechanical electrical efforts in order to prevent overlapping efforts.

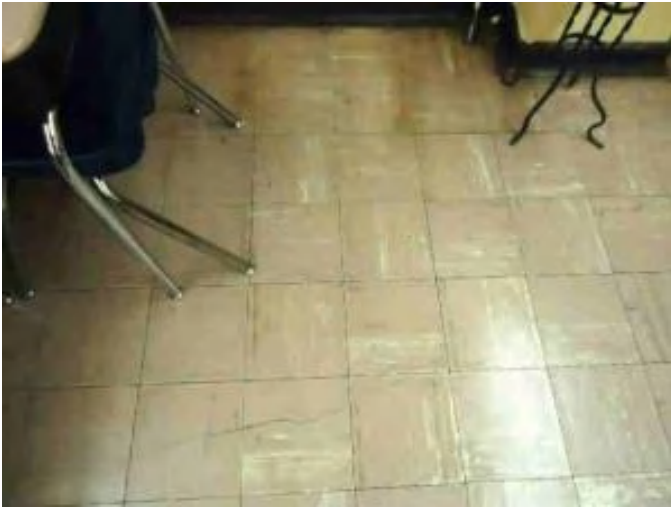
**System: C3020413 - Vinyl Flooring**

The vinyl tile finish is a 9 x 9 application and is suspect to contain asbestos. This finish is recommended for upgrade to a new 12 x 12 vinyl tile application. Suspected asbestos containing materials (ACM) are believed to be limited to the original vinyl floor tile and mastic. While currently sound and manageable in place, future renovation efforts should include provision to test and abate any and all ACM.

**Location:** Building Wide

**Distress:** Damaged

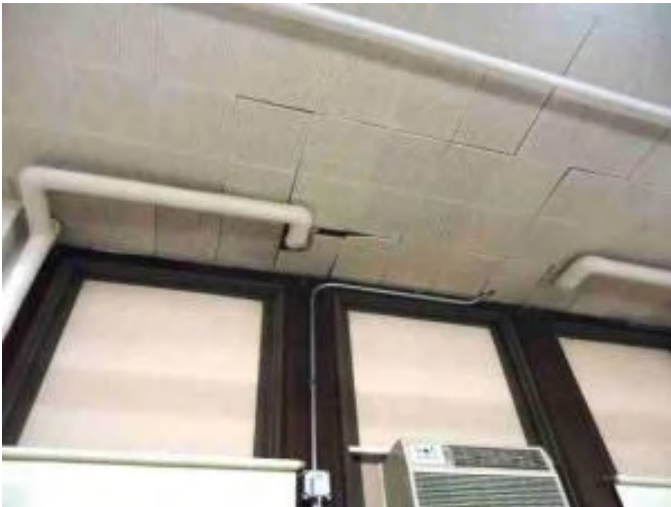
**System: C3030 - Ceiling Finishes**

**Location:** Building Wide

**Distress:** Damaged

**Notes:** The ceiling finish is a mix of 12 x 12 ceiling grid, painted and 2 x 4 Acoustical tile finish. Ceilings have been repaired in several areas and is in good condition considering the age of the application and the current condition of the school. The ceiling finish is expected to require upgrades to support the recommended mechanical electrical efforts in this report. This deficiency provides a budgetary consideration for removal and replacement of the current ceiling finish to a new acoustical tile finish. Considering the recommended mechanical and electrical upgrades this effort should be completed as part of an overall renewal program for the school. No work should be considered until after the recommended exterior efforts are complete.

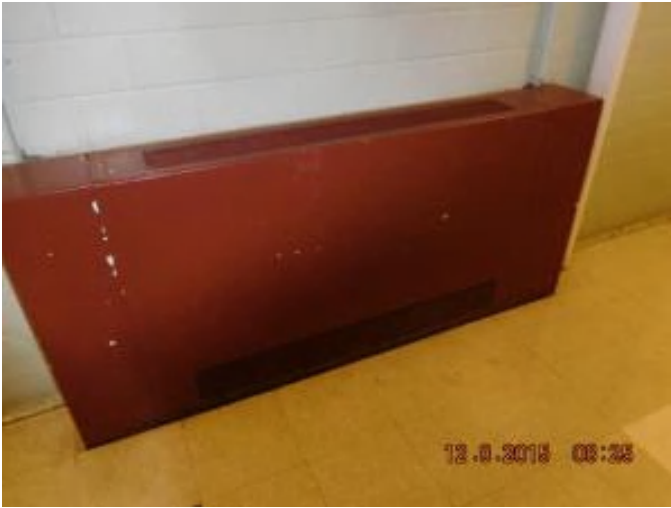
**System: D3030 - Cooling Generating Systems**

**Location:** roof, mechanical room

**Distress:** Inadequate

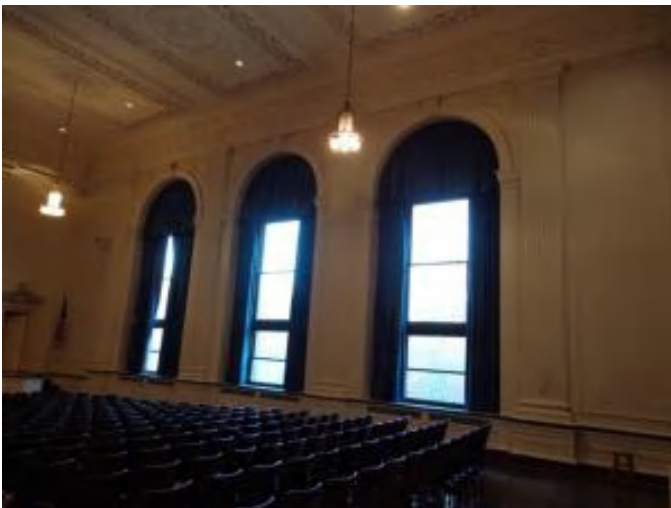
**System: D5020 - Lighting and Branch Wiring**

**Location:** Auditorium

**Distress:** Damaged

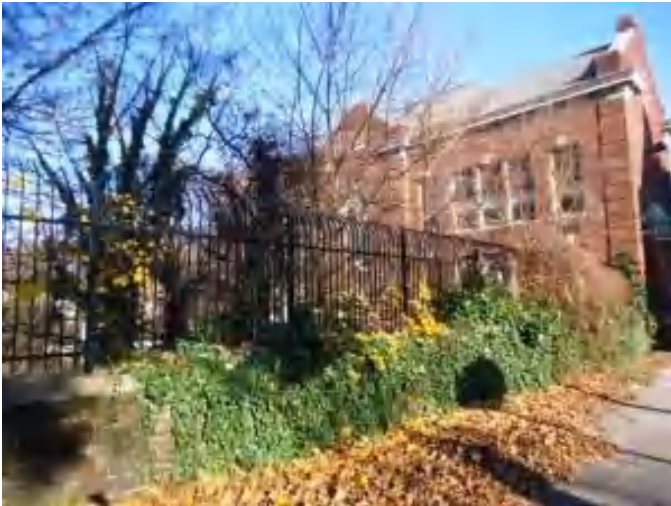
#### System: G2040 - Site Development

**Location:** Site

**Distress:** Damaged

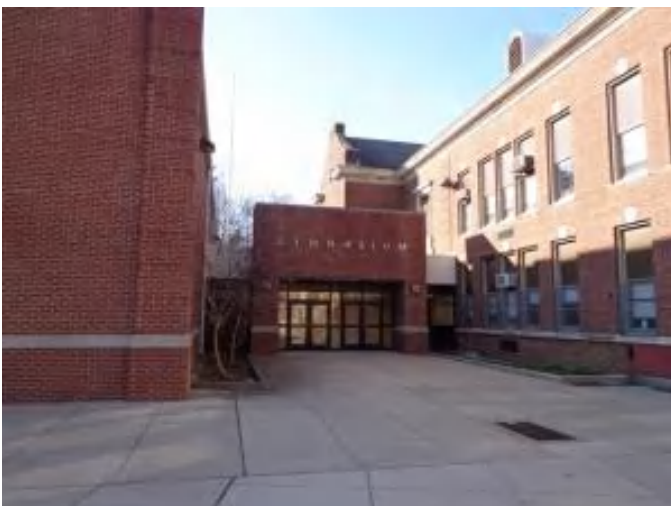
#### System: G4030 - Site Communications & Security

**Location:** Site

**Distress:** Security Issue

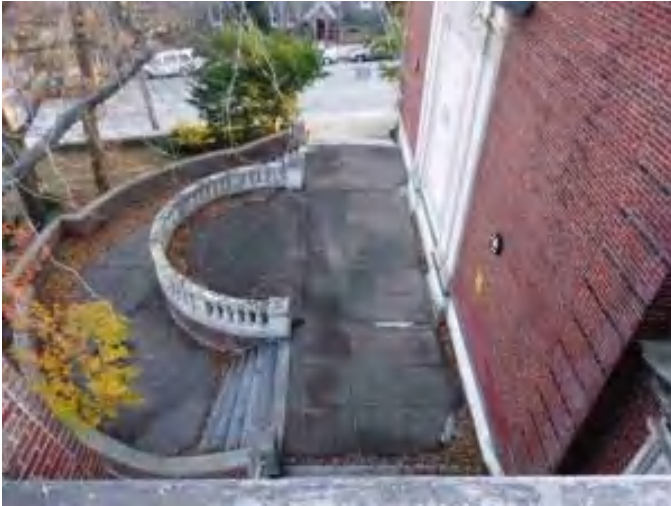
**System: G2030 - Pedestrian Paving**

**Location:** Site

**Distress:** Damaged

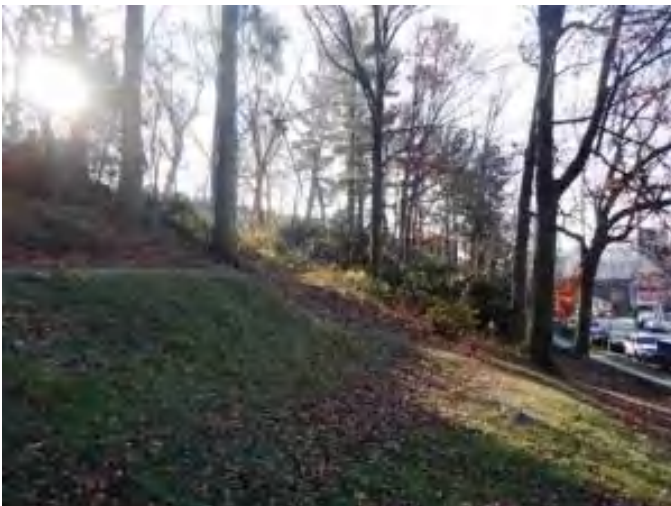
**System: G2040 - Site Development**

**Location:** Site

**Distress:** Damaged
