Facility Condition Assessment Summary Report

Mitchell School

School District of Philadelphia
S137001; Mitchell
Final
Site Assessment Report

February 1, 2017

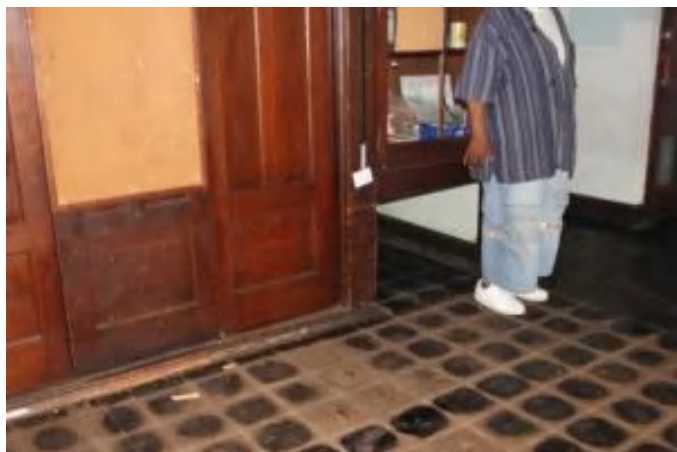
System: C3020413 - Vinyl Flooring

Location: Classroom

Distress: Damaged

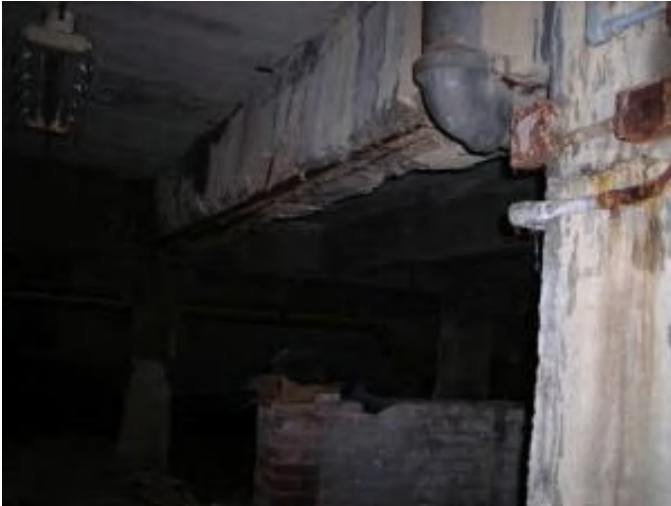
System: A2020 - Basement Walls

Location: Basement

Distress: Damaged

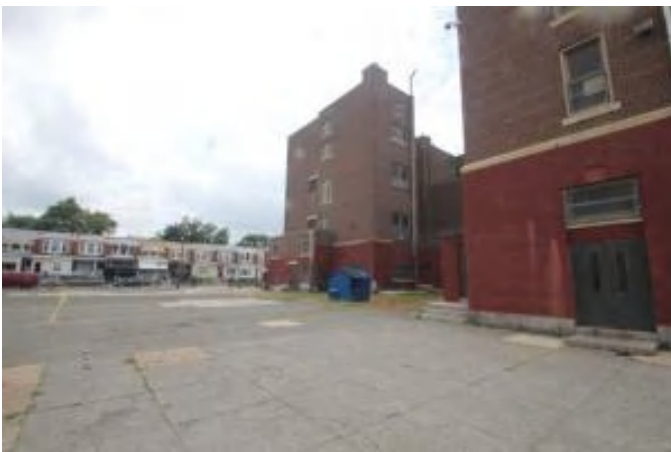
System: B2030 - Exterior Doors

Location: Entrances

Distress: Failing

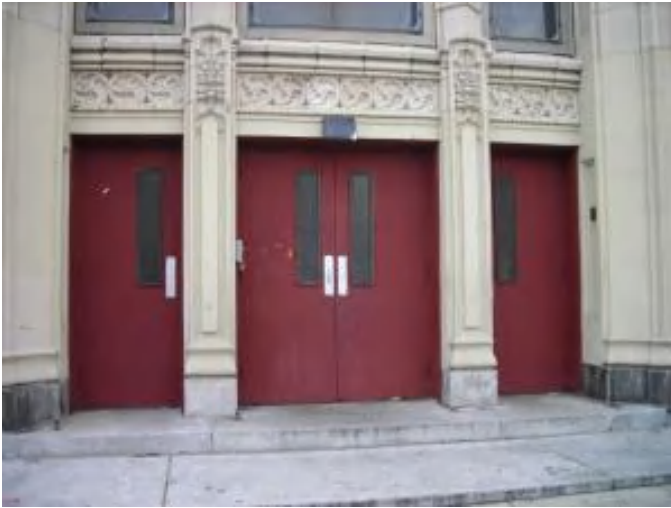
System: B2030 - Exterior Doors

Location: TBD

Distress: Accessibility

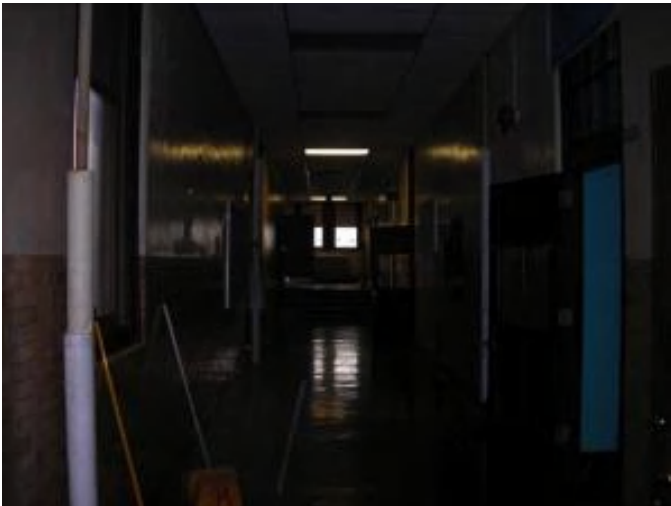
System: C1020 - Interior Doors

Location: Throughout

Distress: Accessibility

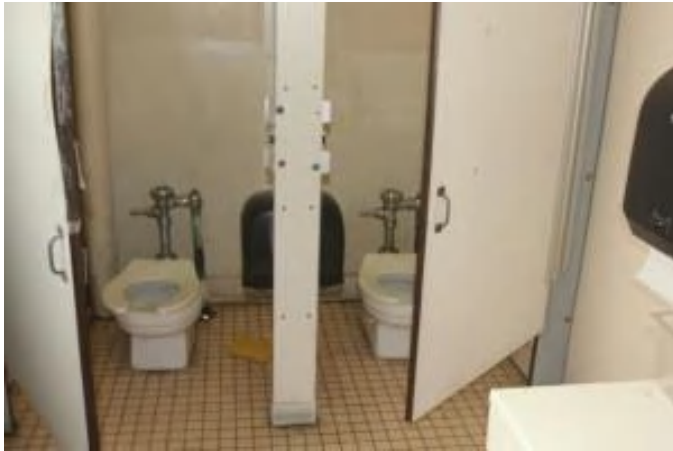
System: C1030 - Fittings

Location: Toilets
Distress: Accessibility
Category: 2 - Code Compliance
Priority: 2 - Response Time (2-3 yrs)
Correction: Remove and replace damaged toilet partitions - handicap units
Qty: 10.00
Unit of Measure: Ea.
Estimate: \$9,778.55
Assessor Name: System
Date Created: 08/11/2015

Notes: Provide new toilet partitions and toilet accessories including grab bars for accessibility

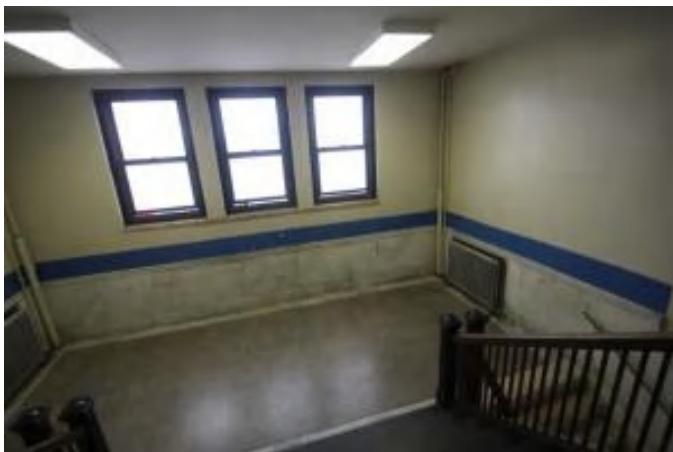
System: C2010 - Stair Construction

Location: Stairways
Distress: Building / MEP Codes
Category: 2 - Code Compliance
Priority: 2 - Response Time (2-3 yrs)
Correction: Replace inadequate or install proper stair railing - select appropriate material
Qty: 400.00
Unit of Measure: L.F.
Estimate: \$67,545.12
Assessor Name: System
Date Created: 08/04/2015

Notes: Replace railing in stairways with code compliant

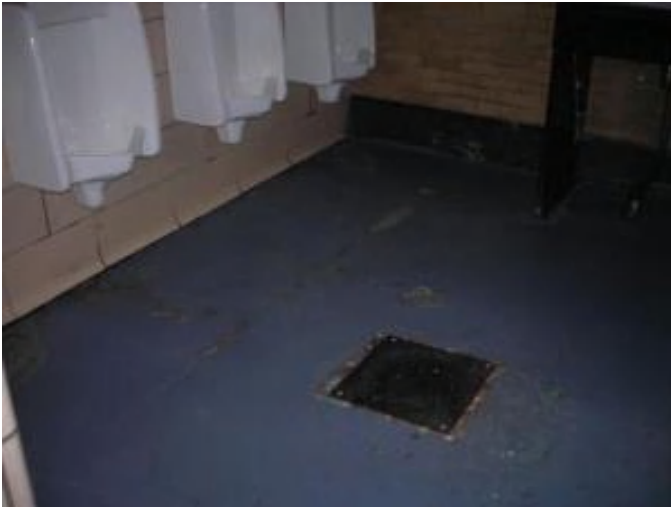
System: C3020415 - Concrete Floor Finishes

Location: Toilet rooms

Distress: Health Hazard / Risk

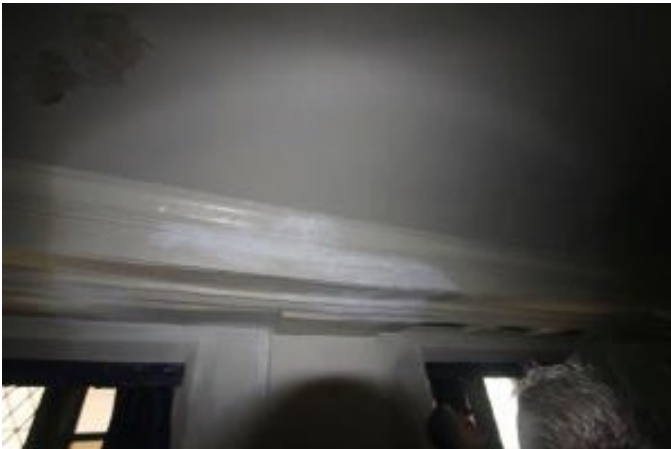
System: C3030 - Ceiling Finishes

Location: Balcony

Distress: Damaged

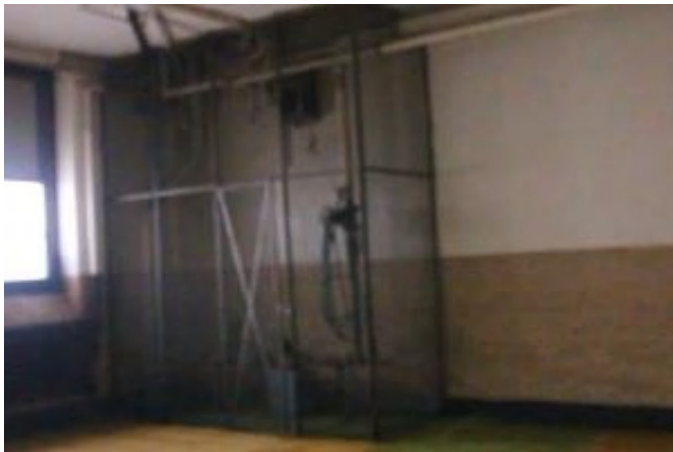
System: D2020 - Domestic Water Distribution

Location: Dining room

Distress: Building / MEP Codes

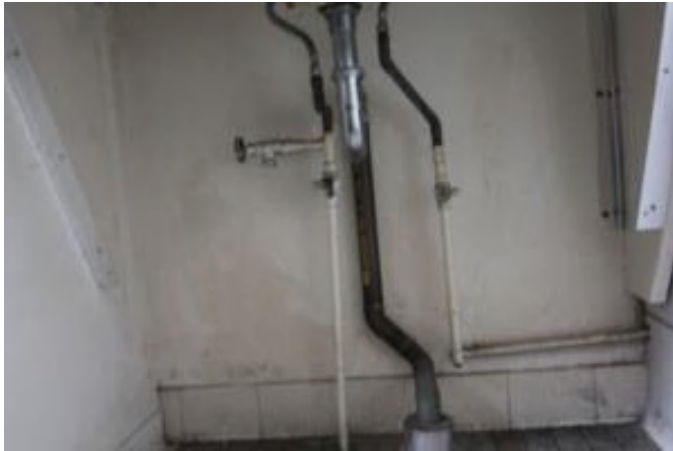
System: D2030 - Sanitary Waste

Location: Toilet rooms

Distress: Health Hazard / Risk

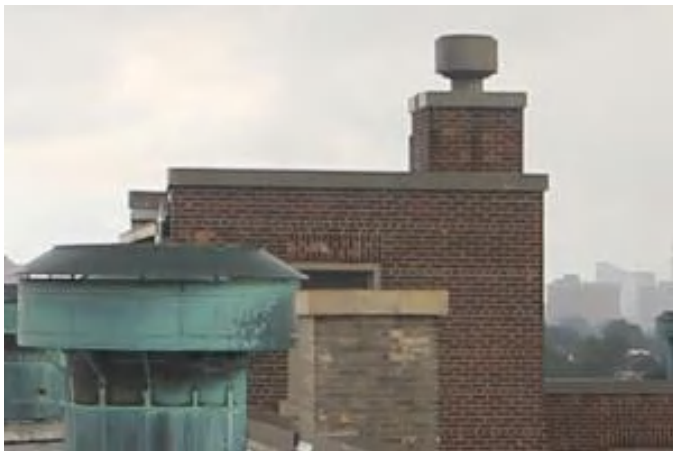
System: D3040 - Distribution Systems

Location: Toilet rooms

Distress: Inadequate

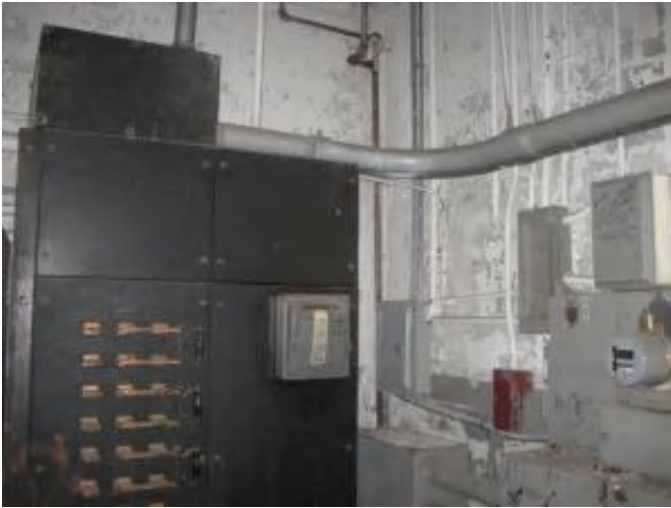
System: D5010 - Electrical Service/Distribution

Location: Basement fan room
Distress: Beyond Service Life
Category: 3 - Operations / Maint.
Priority: 2 - Response Time (2-3 yrs)
Correction: Replace Switchboard
Qty: 1.00
Unit of Measure: Ea.
Estimate: \$433,333.72
Assessor Name: System
Date Created: 07/30/2015

Notes: Provide new service, 480/277V, 3 phase power, approximate 1600Amperes and will occupy the same space of the existing fusible service entrance switchboard.

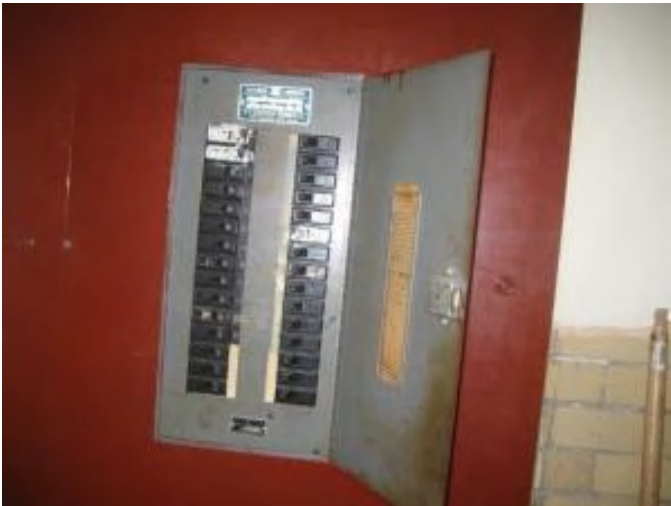
System: D5010 - Electrical Service/Distribution

Location: Entire Building
Distress: Beyond Service Life
Category: 3 - Operations / Maint.
Priority: 2 - Response Time (2-3 yrs)
Correction: Replace Electrical Distribution System (U)
Qty: 12.00
Unit of Measure: Ea.
Estimate: \$345,134.38
Assessor Name: System
Date Created: 07/30/2015

Notes: Replace the entire distribution system with new panels and new wiring/conduits. Approximate (12) 208/120V.

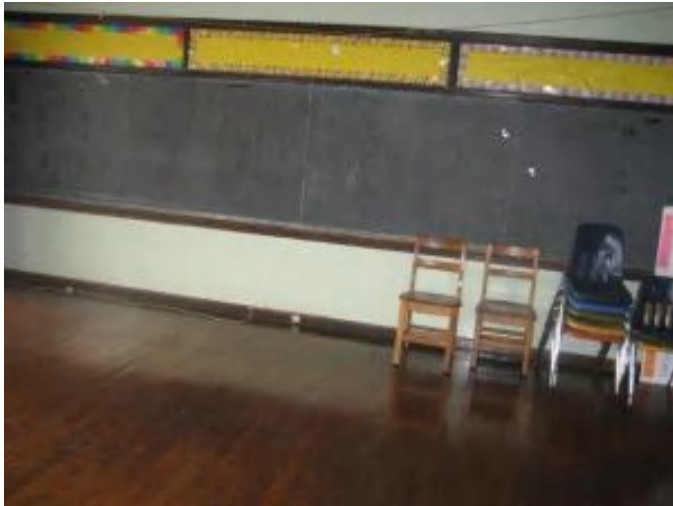
System: D5020 - Lighting and Branch Wiring

Location: Classrooms
Distress: Inadequate
Category: 4 - Capital Improvement
Priority: 2 - Response Time (2-3 yrs)
Correction: Add wiring device
Qty: 512.00
Unit of Measure: Ea.
Estimate: \$188,093.95
Assessor Name: System
Date Created: 07/30/2015

Notes: Provide to the teacher's whiteboard wall and the opposite of it with double compartment surface raceways and the other two walls with duplex outlets. Approximate 512 receptacles.

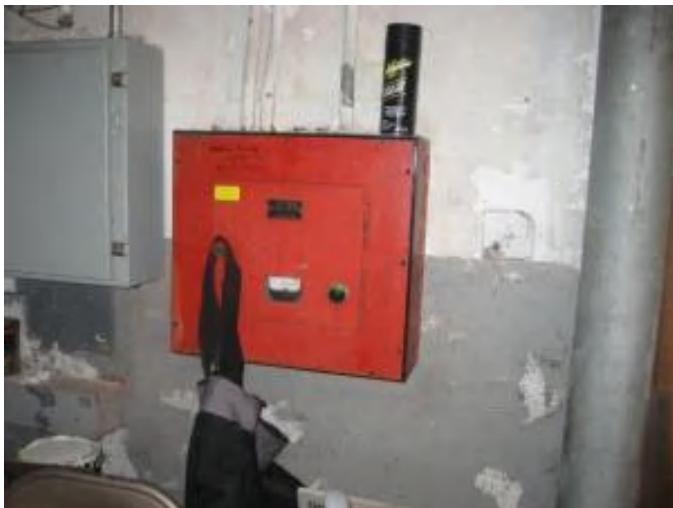
System: D5030 - Communications and Security

Location: Entire Building
Distress: Obsolete
Category: 3 - Operations / Maint.
Priority: 2 - Response Time (2-3 yrs)
Correction: Replace fire alarm system
Qty: 1.00
Unit of Measure: S.F.
Estimate: \$222,554.22
Assessor Name: System
Date Created: 07/30/2015

Notes: Provide a new addressable fire alarm system.

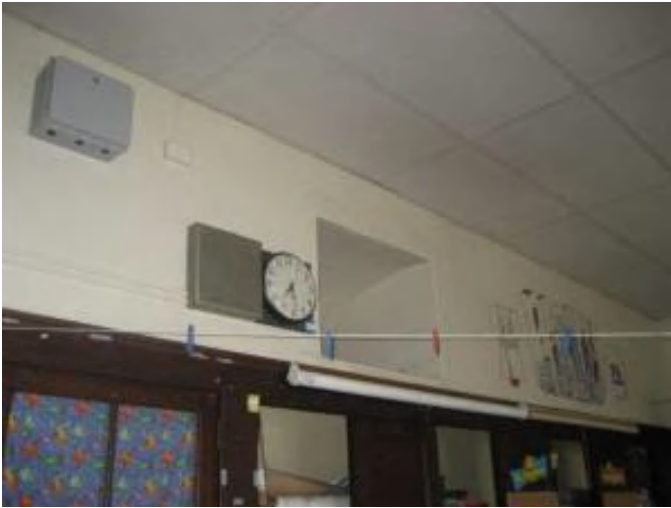
System: D5030 - Communications and Security

Location: Entire Building

Distress: Obsolete

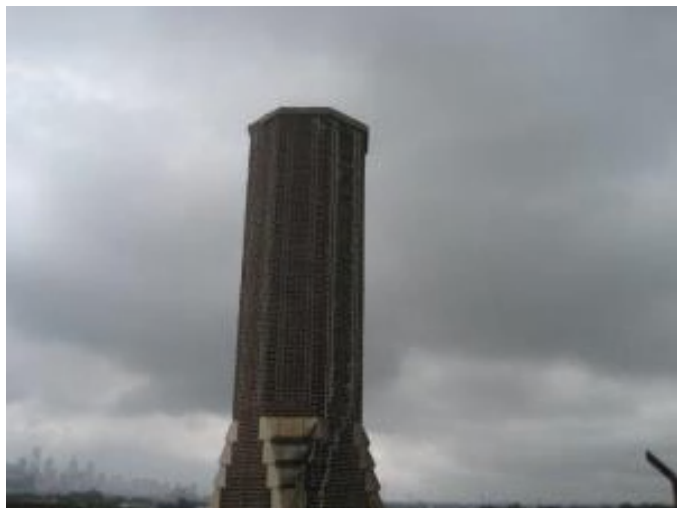
System: D5090 - Other Electrical Systems

Location: Roof

Distress: Building / MEP Codes

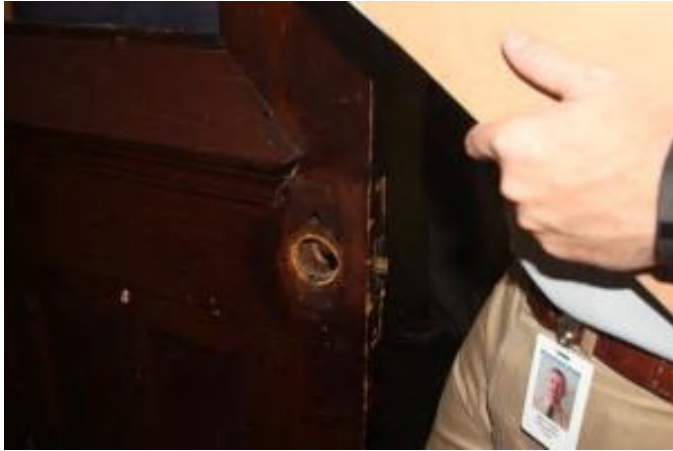
System: C1020 - Interior Doors

Location: Throughout
Distress: Beyond Service Life
Category: 3 - Operations / Maint.
Priority: 3 - Response Time (3-4 yrs)
Correction: Remove and replace interior doors - wood doors with wood frame - per leaf
Qty: 80.00
Unit of Measure: Ea.
Estimate: \$372,347.12
Assessor Name: System
Date Created: 08/11/2015

Notes: Repair or replace rusted, dented, scratched doors and frames

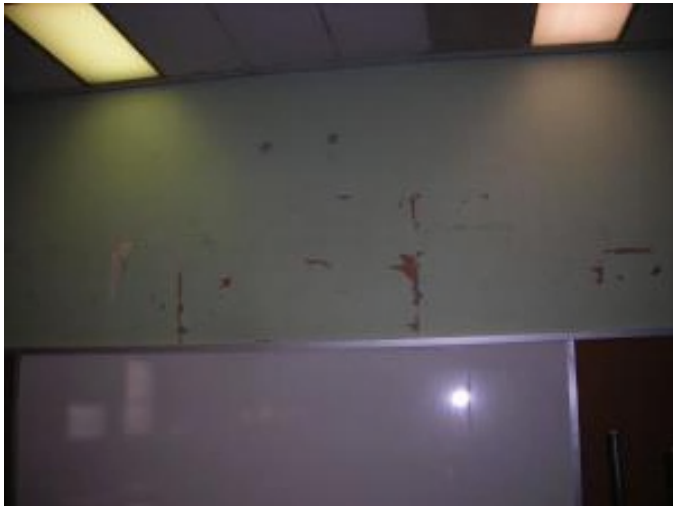
System: C3010230 - Paint & Covering

Location: Throughout
Distress: Damaged
Category: 3 - Operations / Maint.
Priority: 3 - Response Time (3-4 yrs)
Correction: Repair substrate and repaint interior walls - SF of wall surface
Qty: 160,000.00
Unit of Measure: S.F.
Estimate: \$1,130,962.48
Assessor Name: System
Date Created: 08/05/2015

Notes: Patch paint plaster walls – damaged (50% of plaster wall surface)

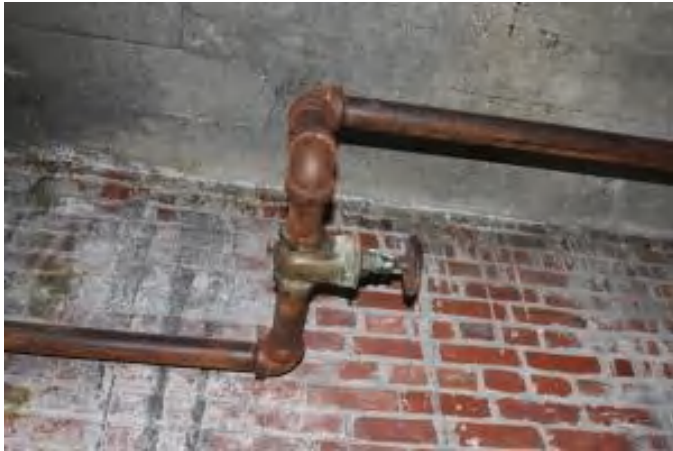
System: D3040 - Distribution Systems

Location: Entire building
Distress: Beyond Service Life
Category: 3 - Operations / Maint.
Priority: 3 - Response Time (3-4 yrs)
Correction: Perform testing to identify and replace damaged steam and condensate piping.
Qty: 90,000.00
Unit of Measure: S.F.
Estimate: \$851,433.52
Assessor Name: System
Date Created: 08/10/2015

Notes: Replace the existing steam and condensate distribution piping due to age and corrosion.

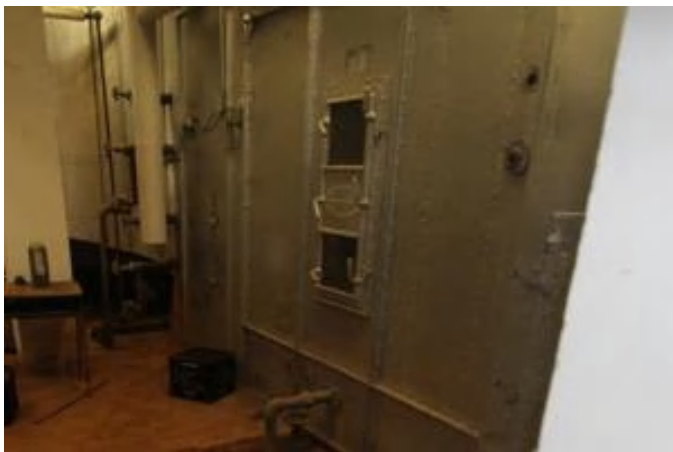
System: D3040 - Distribution Systems

Location: Basement
Distress: Damaged
Category: 3 - Operations / Maint.
Priority: 3 - Response Time (3-4 yrs)
Correction: Install / replace HVAC unit for Auditorium (800 seat).
Qty: 800.00
Unit of Measure: Seat
Estimate: \$447,414.96
Assessor Name: System
Date Created: 08/10/2015

Notes: Replace the original air handler serving the auditorium.

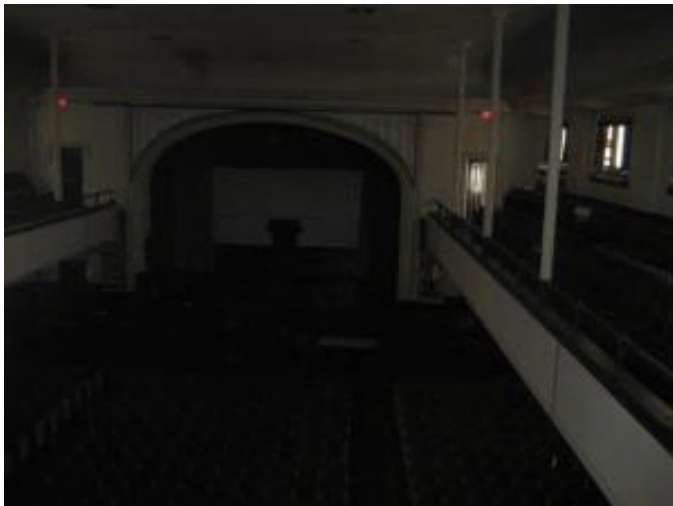
System: E1020 - Institutional Equipment

Location: Auditorium

Distress: Obsolete

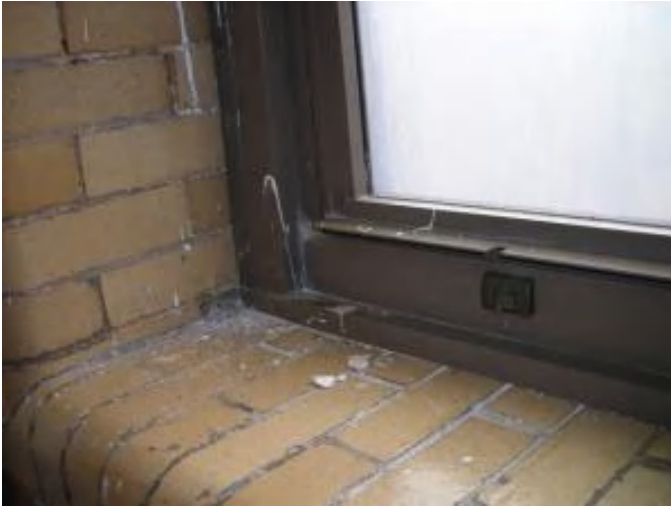
System: B2020 - Exterior Windows

Location: Throughout

Distress: Damaged

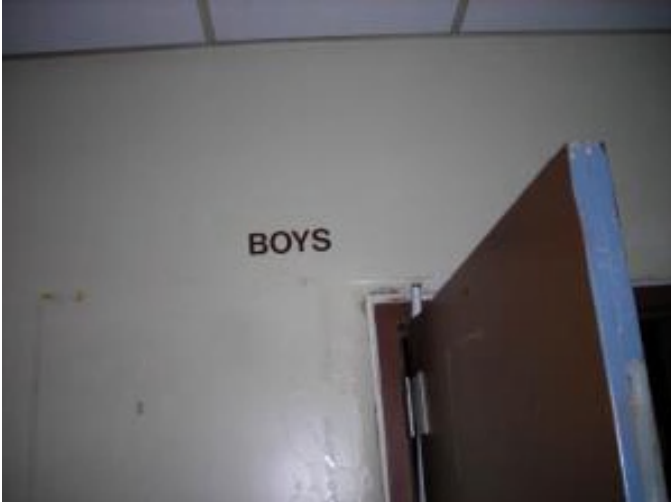
System: C1030 - Fittings

Location: Throughout

Distress: Inadequate

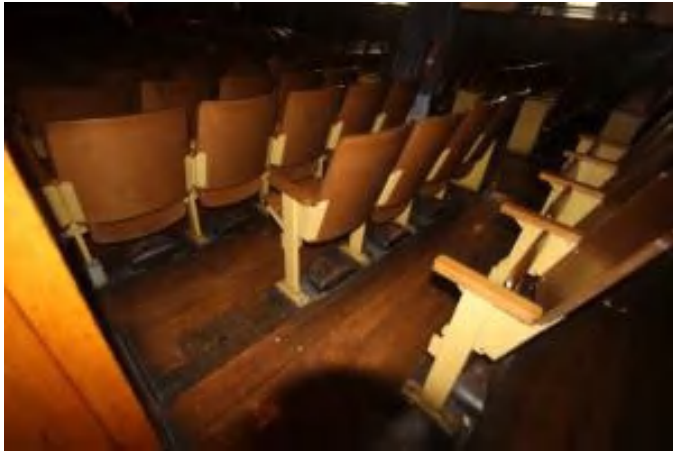
System: C3020414 - Wood Flooring

Location: Auditorium, balcony, classrooms

Distress: Appearance

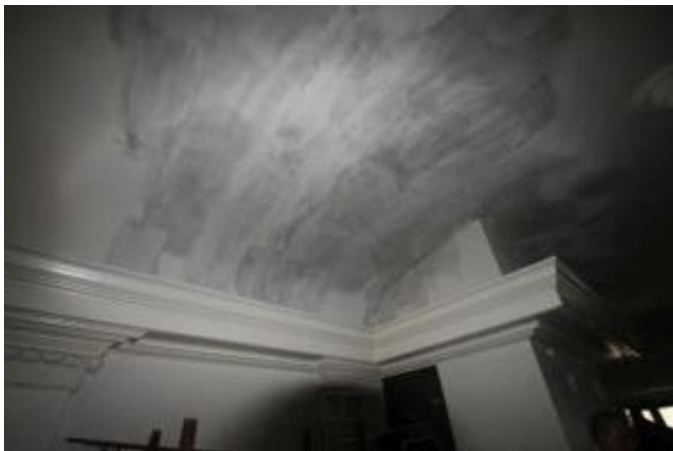
System: C3030 - Ceiling Finishes

Location: Throughout

Distress: Appearance

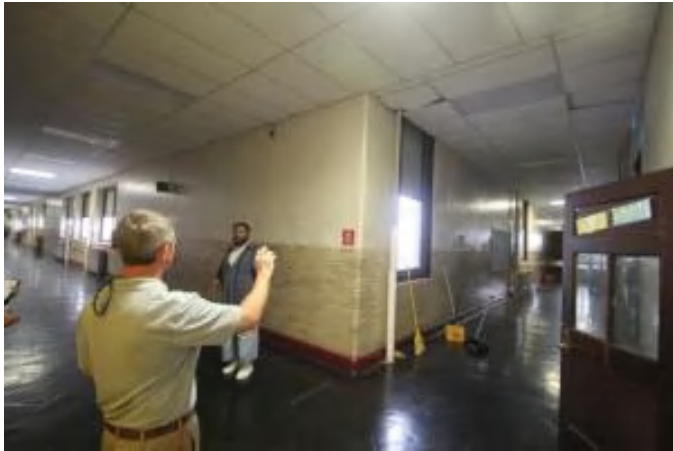
System: C3030 - Ceiling Finishes

Location: Throughout

Distress: Damaged

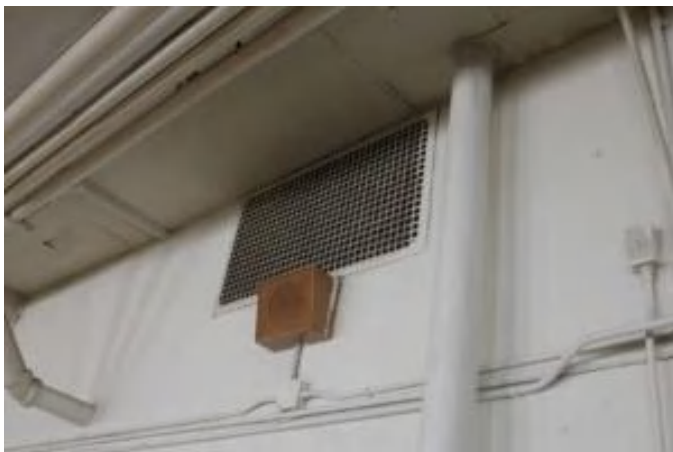
System: C3030 - Ceiling Finishes

Location: Cafeteria

Distress: Failing

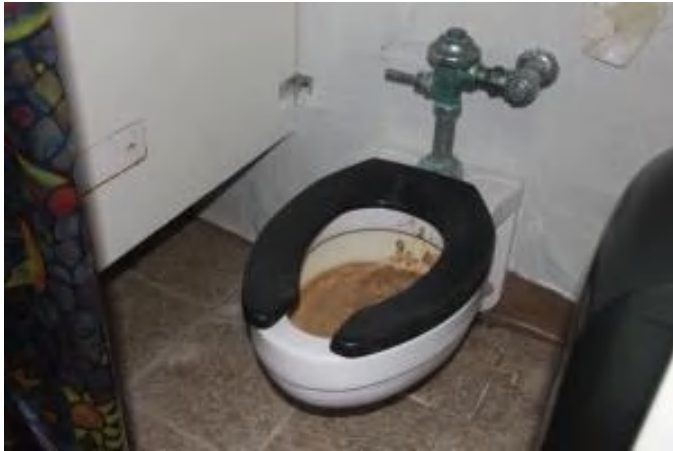
System: D2010 - Plumbing Fixtures

Location: Annex
Distress: Beyond Service Life
Category: 3 - Operations / Maint.
Priority: 4 - Response Time (4-5 yrs)
Correction: Remove and replace or replace water closet - quantify additional units
Qty: 2.00
Unit of Measure: Ea.
Estimate: \$14,924.30
Assessor Name: System
Date Created: 08/10/2015

Notes: Replace two water closets and one lavatory in annex building as part of complete remodel.

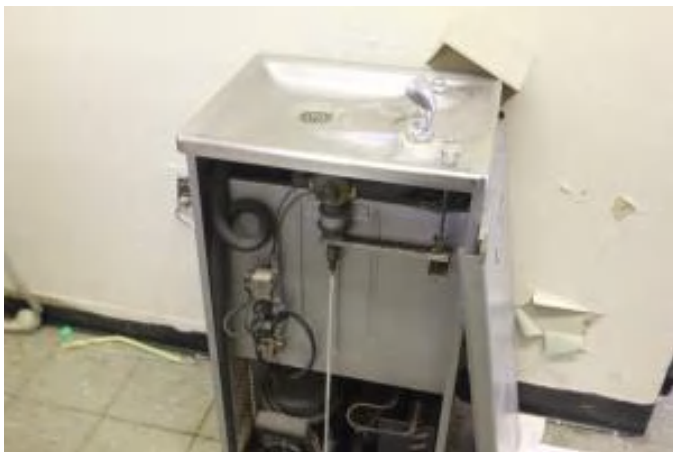
System: D2010 - Plumbing Fixtures

Location: Annex
Distress: Accessibility
Category: 2 - Code Compliance
Priority: 4 - Response Time (4-5 yrs)
Correction: Remove and Replace Water Fountains - without ADA new recessed alcove
Qty: 1.00
Unit of Measure: Ea.
Estimate: \$7,579.19
Assessor Name: System
Date Created: 08/10/2015

Notes: Replace drinking water fountain with accessible unit in annex building as part of complete remodel.

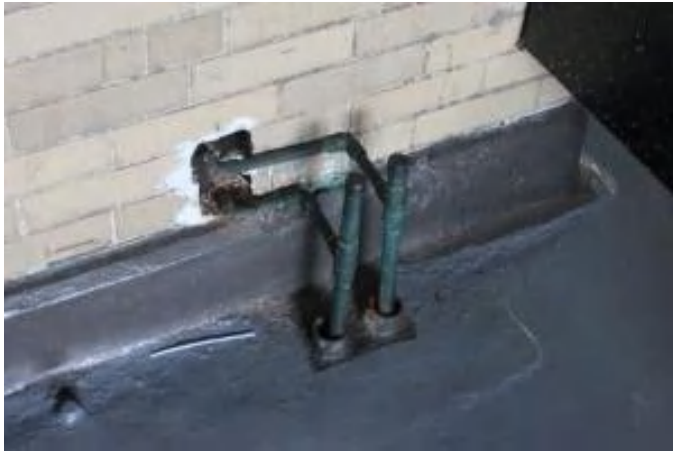
System: D2020 - Domestic Water Distribution

Location: Entire building

Distress: Beyond Service Life

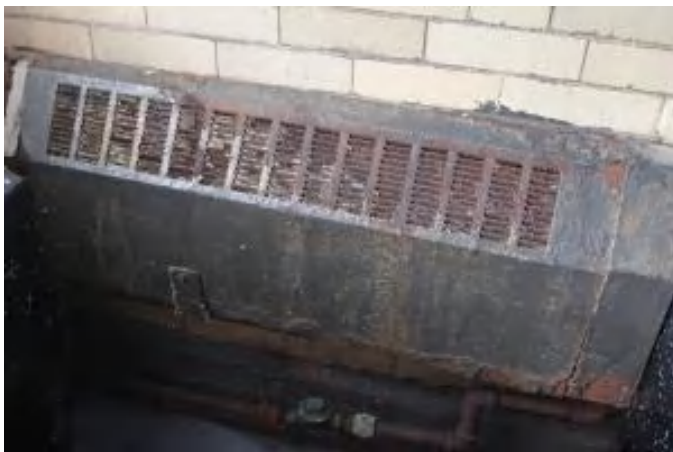
System: D3040 - Distribution Systems

Location: classrooms

Distress: Damaged

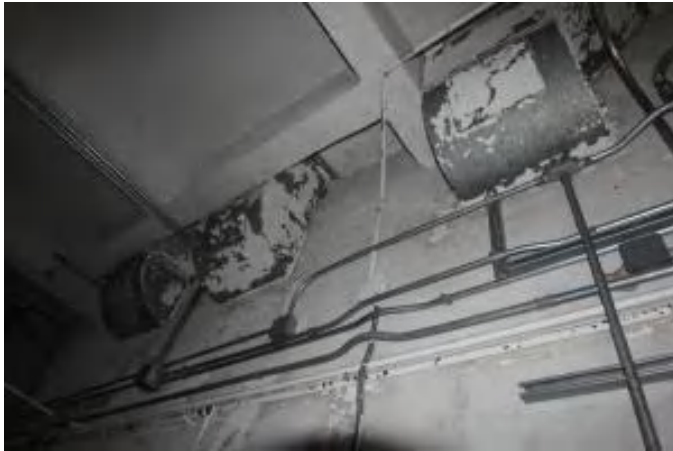
System: D3040 - Distribution Systems

Location: Basement

Distress: Energy Efficiency

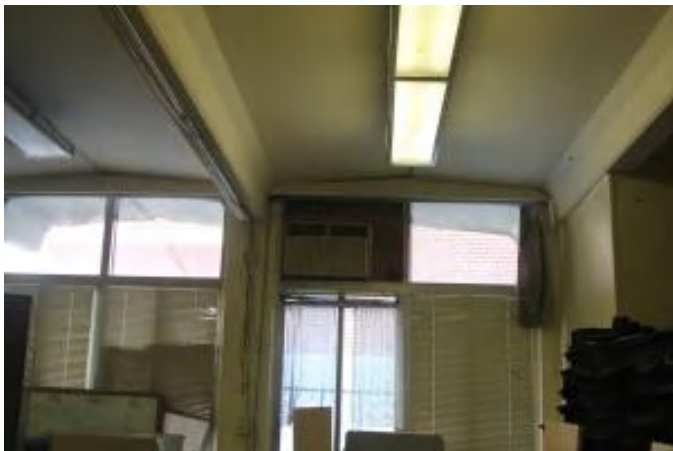
System: D3050 - Terminal & Package Units

Location: Annex

Distress: Inadequate

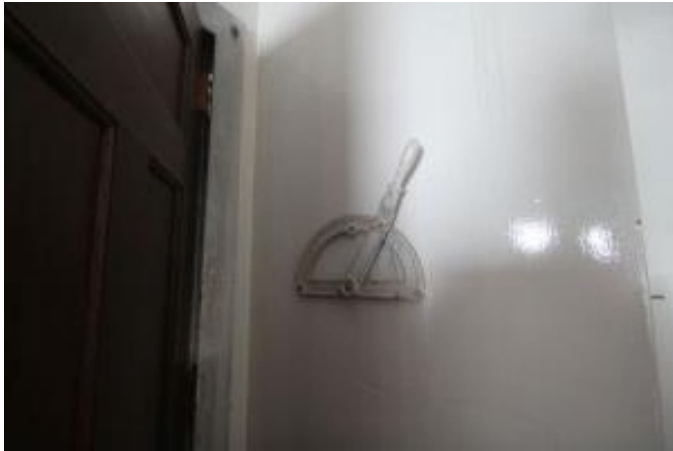
System: D3060 - Controls & Instrumentation

Location: Entire building

Distress: Energy Efficiency

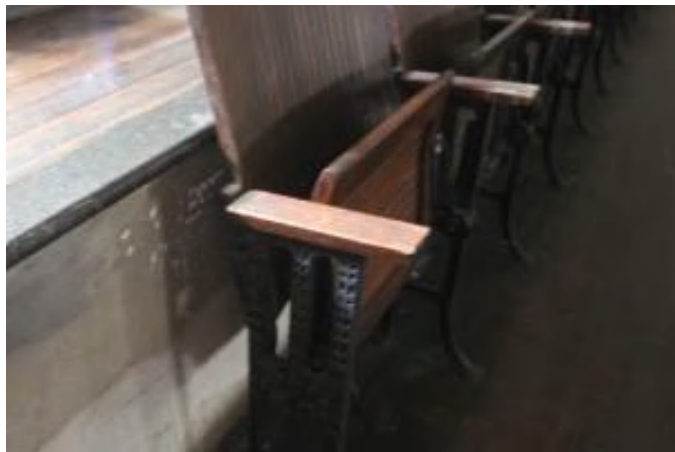
System: E2010 - Fixed Furnishings

Location: Auditorium

Distress: Failing

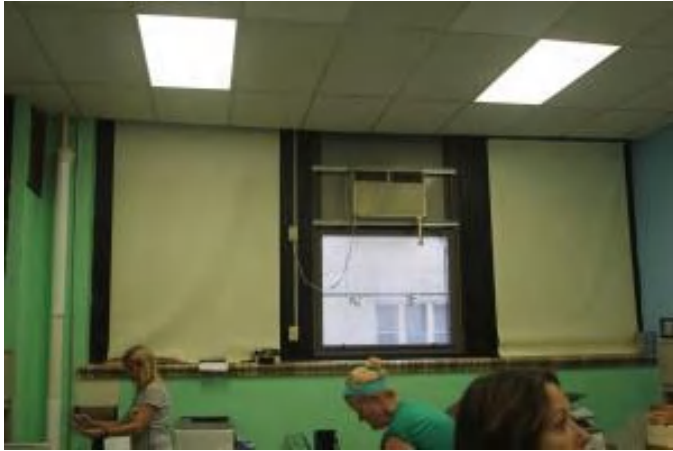
System: D3030 - Cooling Generating Systems

Location: Roof tops

Distress: Inadequate

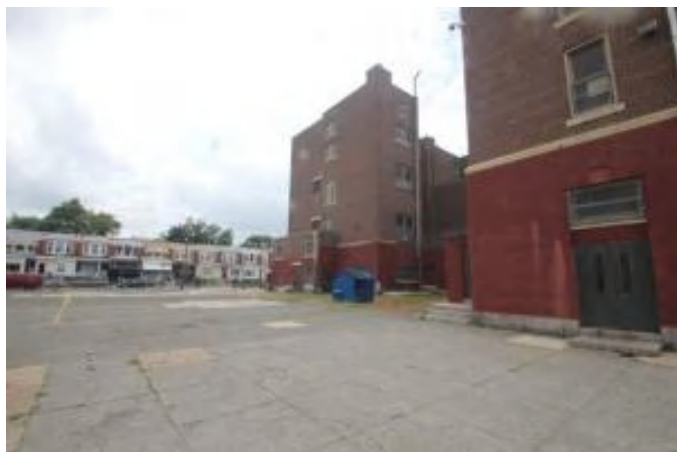
System: G2030 - Pedestrian Paving

Location: Entrance

Distress: Building / MEP Codes

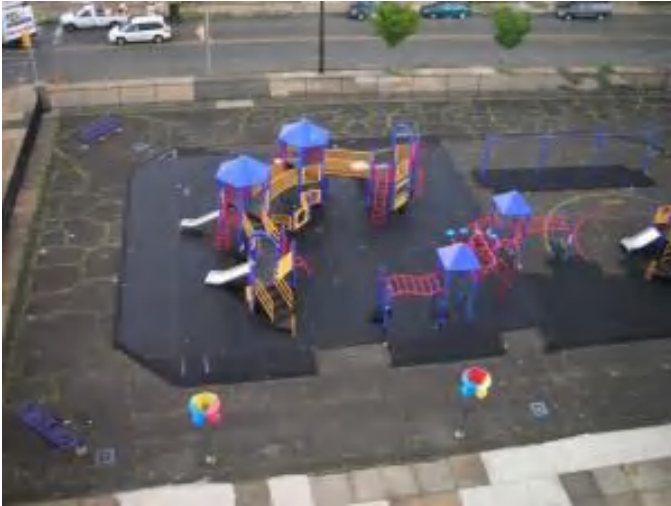
System: G2030 - Pedestrian Paving

Location: Play yard

Distress: Damaged

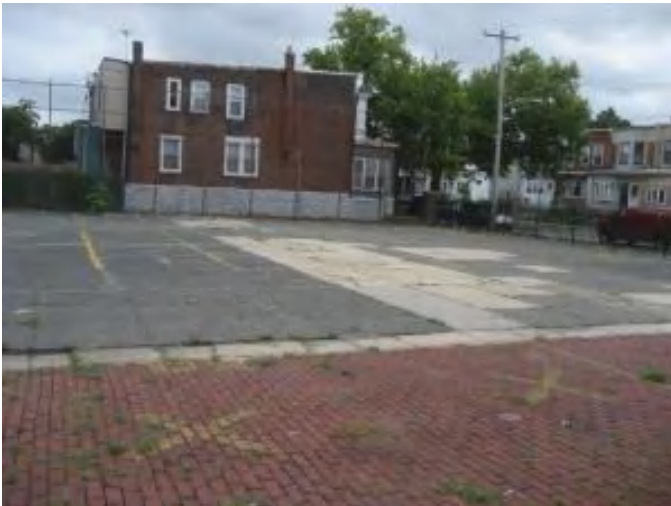
System: G4020 - Site Lighting

Location: Parking Lot

Distress: Security Issue
