Facility Condition Assessment Summary Report

Moffet School

School District of Philadelphia
S537001;Moffet
Final
Site Assessment Report

January 31, 2017

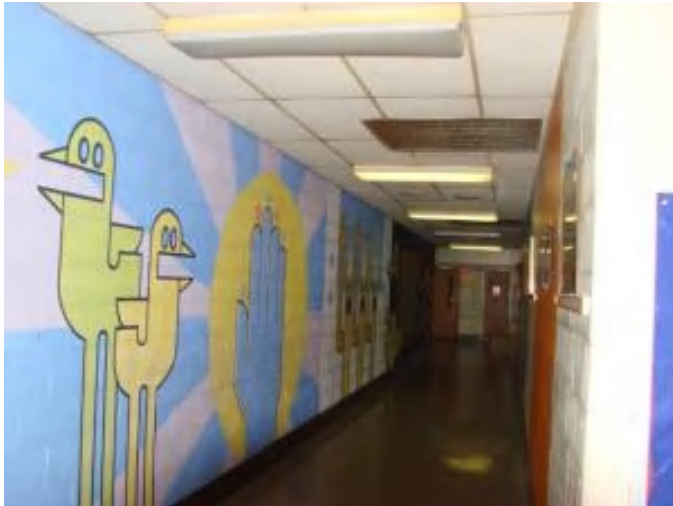
System: D4010 - Sprinklers

Location: Throughout buliding

Distress: Life Safety / NFPA / PFD

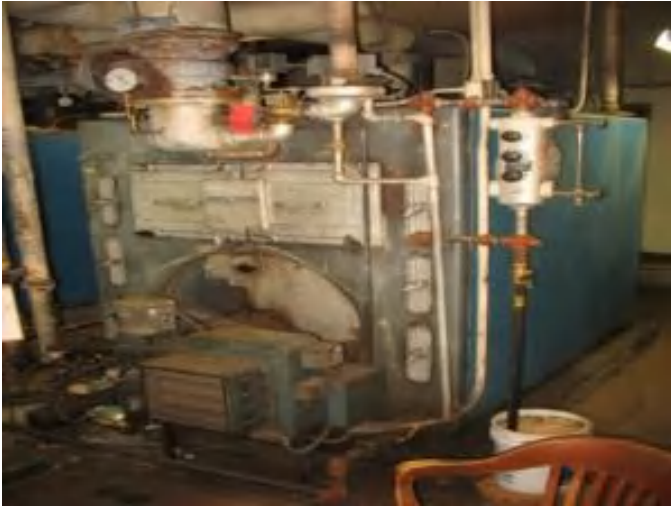
System: D3020 - Heat Generating Systems

Heat Generating Systems - Low pressure steam is generated by two Weil-McLain cast iron sectional boilers original to the building, located in the penthouse boiler room. Each boiler is equipped with what looks like the original burner, designed to operate on natural gas or fuel oil. Combustion air makeup is supplied by louvers equipped with motorized dampers. Burner oil pumps are connected and driven by the fan motor, which is not allowed by current code. The gas train serving the building does not appear to have code required venting of the regulators and dual solenoid valves with venting of the chamber between. The Building Engineer reports the system loses a significant amount of condensate due to failed traps, which is made up with chemically treated city water. Cast iron sectional boilers have an anticipated service life of 35 years or more; these units have been in service approximately 45 years. The boilers appear to have been poorly maintained. The District should replace these boilers within the next 1-3 years.

Location: Boiler Room

Distress: Beyond Service Life

Notes: Replace the two existing cast iron sectional boilers and burners with new cast iron sectional boilers of similar size, burners, and power ventilators.

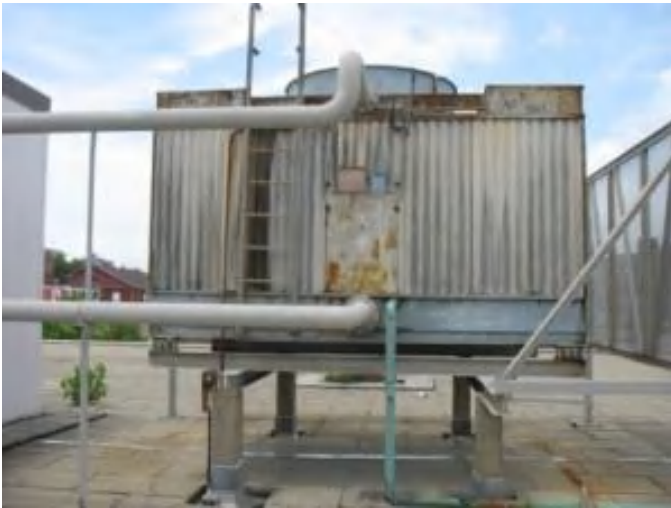
System: D3030 - Cooling Generating Systems

Absorption chillers have an anticipated service life of 30 years; this unit has been in service approximately 45 years and needs to be replaced. The building engineer reported an air leak in the chiller which requires the continuous running of a vacuum pump to keep the chiller operational. Galvanized cooling tower have an anticipated service life of 18 years; this unit has been in service approximately 45 years. The existing absorption chiller and cooling tower are beyond their service life and should be replaced with a new packaged roof top mounted air cooled chiller fitted with modern controls.

Location: Boiler room

Distress: Beyond Service Life

Notes: Replace the existing absorption chiller and cooling tower with a new water cooled chiller and cooling tower fitted with modern controls. All associated piping and pumping systems should also be replaced.

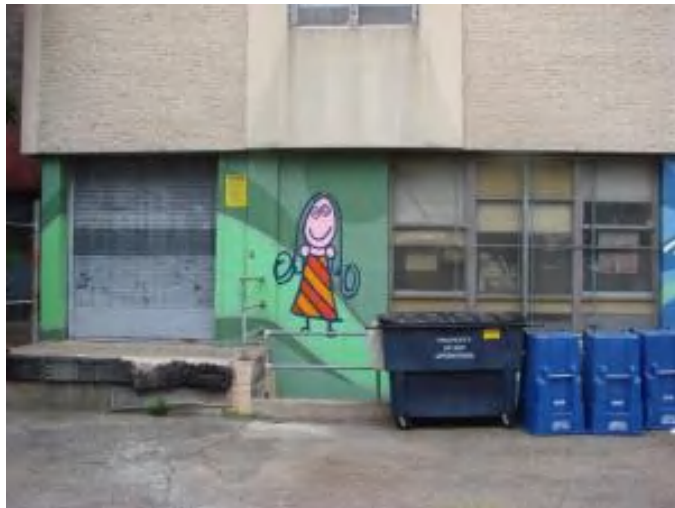
System: E1090 - Other Equipment

Institutional and Commercial equipment includes stage equipment, generally in good condition; A/V equipment in very good condition; gym equipment – basketball backstops, scoreboards, etc.; generally in fair condition. Other equipment includes kitchen equipment, generally in good condition. Vehicular equipment includes loading dock bumpers, severely damaged.

Location: Exterior

Distress: Damaged

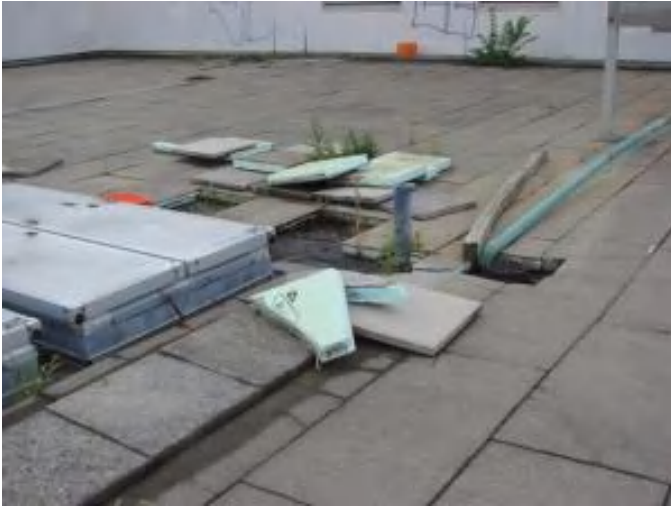
System: B3010105 - Built-Up

Roofing system is a built-up system approximately 15 to 20 years old and in fair condition with external insulating panels above it (outsulation); all roofing and flashing is typically in fair condition with some deterioration of the built-up system and insulation panels; leaks have not been reported.

Location: Exterior/ Roof

Distress: Beyond Service Life

Notes: Install all new roofing system including insulation within next 5 to 10 years; tear-down existing roofing; install flashing, and counter flashing

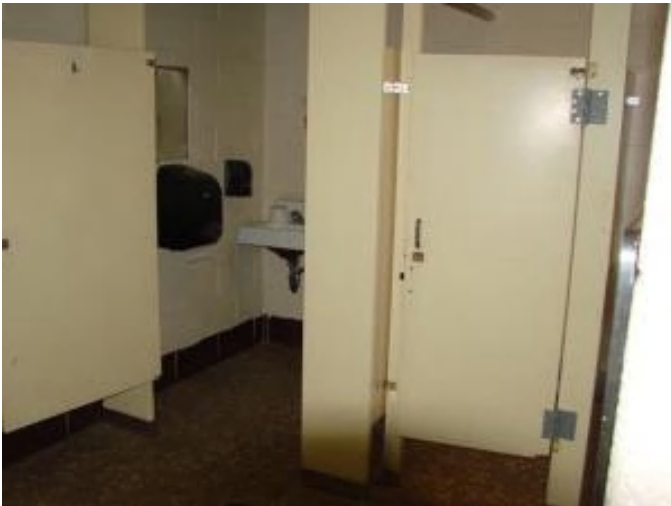
System: C1030 - Fittings

Fittings include toilet accessories and toilet partitions, generally in fair condition, no accessible compartments; chalkboards, in good condition. Handrails are generally in good condition. Built-in cabinets are steel, in good condition. Interior identifying signage is typically directly painted on wall or door surfaces generally in good condition.

Location: Interiors

Distress: Accessibility

Notes: Reconfigure toilets for accessibility, provide new toilet partitions

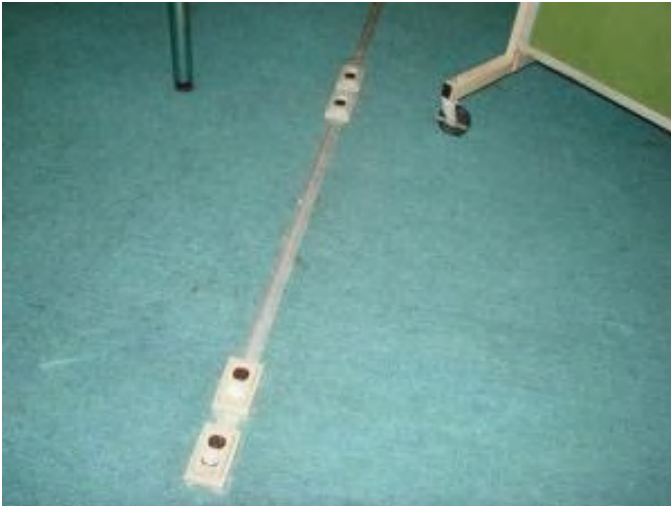
System: C3020411 - Carpet

Location: Interiors
Distress: Beyond Service Life
Category: 3 - Operations / Maint.
Priority: 3 - Response Time (3-4 yrs)
Correction: Remove and replace carpet
Qty: 2,000.00

Notes: Replace existing carpet

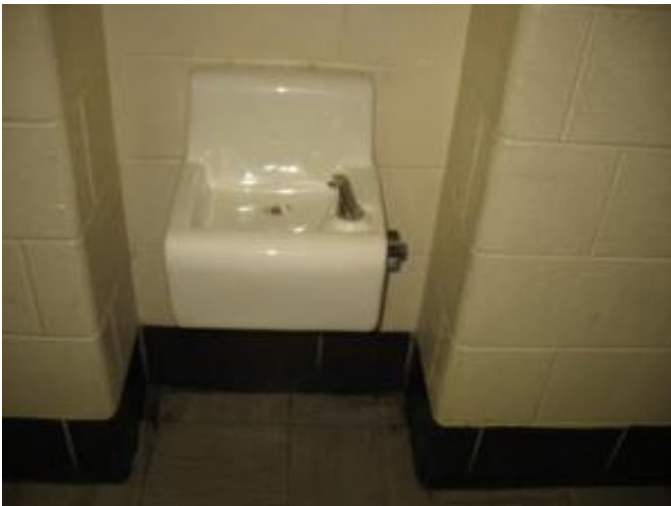
System: D2010 - Plumbing Fixtures

Drinking fountains in the corridors and at the restrooms consist of wall hung fixtures with integral refrigerated coolers or wall hung porcelain fixtures. Both types are well beyond their service life and should be replaced; most are NOT accessible type.

Location: Corridors
Distress: Beyond Service Life
Category: 3 - Operations / Maint.
Priority: 3 - Response Time (3-4 yrs)
Correction: Remove and Replace Water Fountains - without ADA new recessed alcove
Qty: 8.00

Notes: Replace the wall hung drinking fountains and integral refrigerated coolers in the corridors and at the restrooms. These units are well beyond their service life and most are NOT accessible type.

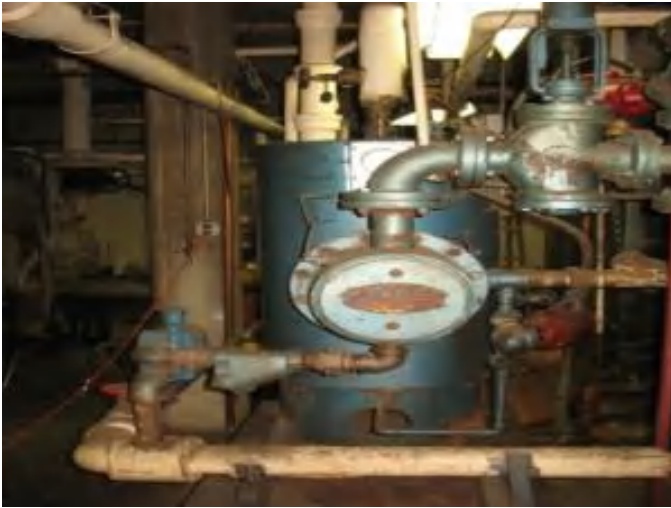
System: D2020 - Domestic Water Distribution

Domestic hot water is produced via a steam to water heat exchanger in a vertical hot water storage tank. This system requires at least one boiler to be running for the building to have hot water. The tank and heat exchanger are most likely original to the building and beyond their service life. This system is inefficient, requiring the boilers to be run in the summer when they could be shut down. A new gas fired domestic hot water system with circulating pump should be installed to eliminate dependence on the boiler. A water softener located in the boiler room supplies conditioned water to the boilers.

Location: Boiler Room
Distress: Beyond Service Life
Category: 3 - Operations / Maint.
Priority: 3 - Response Time (3-4 yrs)
Correction: Replace instantaneous water heater
Qty: 3.00
Unit of Measure: Ea.
Estimate: \$73,420.64
Assessor Name: System
Date Created: 08/03/2015

Notes: Install three new gas fired instant hot water heaters with circulating pump.

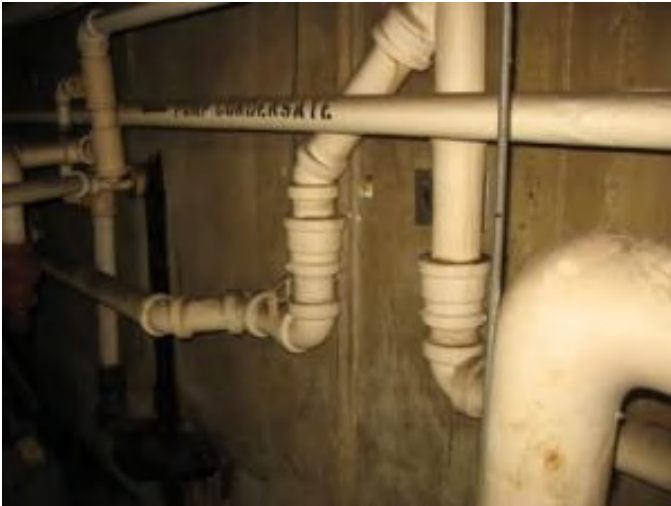
System: D2030 - Sanitary Waste

The maintenance staff reported mostly minor problems with the sanitary waste piping systems. However, the sewer piping has been in service for nearly 45 years and will require more frequent attention from the maintenance staff as time passes. The District should hire a qualified contractor to examine the sanitary waste piping using video cameras to locate and replace any damaged piping and to further quantify the extent of potential failures.

Location: Throughout building
Distress: Health Hazard / Risk
Category: 1 - Health & Safety
Priority: 3 - Response Time (3-4 yrs)
Correction: Inspect sanitary waste piping and replace damaged sections. (+50KSF)
Qty: 40,000.00
Unit of Measure: S.F.
Estimate: \$196,229.92
Assessor Name: System
Date Created: 08/03/2015

Notes: Hire a qualified contractor to perform a detailed examination of the sanitary waste piping using visual inspection and video cameras to locate and replace any damaged piping and to further quantify the extent of potential failures.

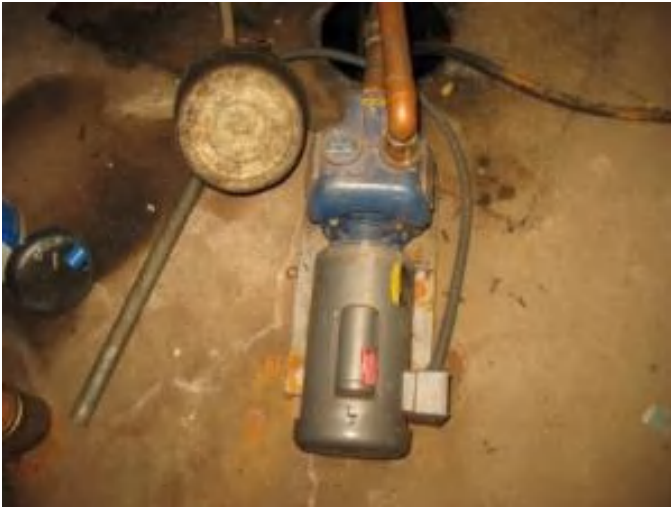
System: D2030 - Sanitary Waste

Location: Elevator machine room

Distress: Beyond Service Life

Notes: Replace existing sewage ejector pump system and piping in the sub-basement as it is approaching the end of its useful service life.

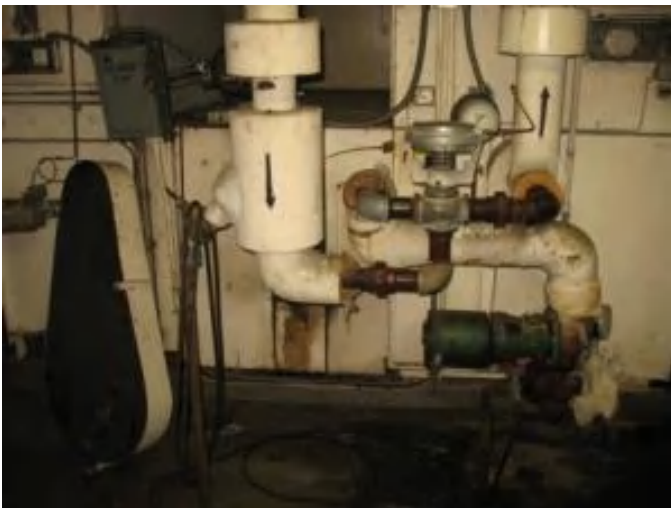
System: D3040 - Distribution Systems

Two Trane Climate Changer air handling units located in the boiler room and original to the building provide conditioned air to the Auditorium and Gymnasium. The Auditorium AHU provides heating and cooling. The Gymnasium AHU only provides heating. These AHUs are beyond their service life and should be replaced with more efficient modern units. Fraying asbestos insulation covers the piping for the units and should be abated immediately.

Location: Boiler room

Distress: Beyond Service Life

Notes: Replace the Trane Climate Changer air handling unit serving the Auditorium by installing a new air handling unit with outdoor air ducted to the unit from louvers in the boiler room.

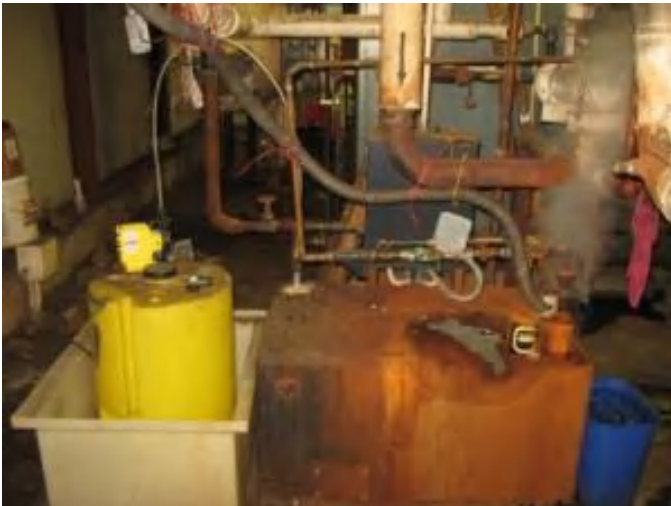
System: D3040 - Distribution Systems

Distribution Systems - Steam piping is black steel (ASTM A53) with welded fittings. The condensate piping is Schedule 80 black steel with threaded fittings. Steam and condensate piping mains are located in the penthouse boiler room. The steam distribution piping is all located in the boiler room and has been in use beyond its service life and will require more frequent attention from the maintenance staff to address pipe/valve failures as time passes. The District should hire a qualified contractor to examine the steam and condensate piping and perform additional testing to locate and replace any damaged piping and to further quantify the extent of potential failures. The District should budget for replacing this piping over the next 10 years.

Location: Boiler Room

Distress: Beyond Service Life

Notes: Hire a qualified contractor to examine the steam and condensate piping, in service for nearly 45 years, and perform additional testing to locate and replace any damaged piping and to further quantify the extent of potential failures.

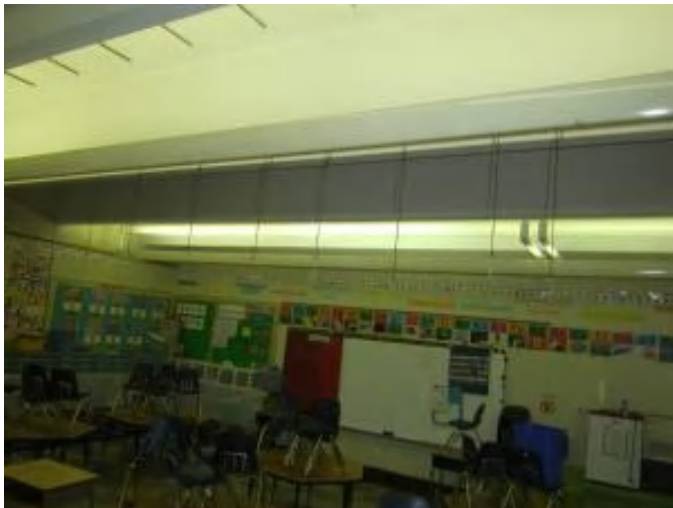
System: D5020 - Lighting and Branch Wiring

Location: Throughout Building
Distress: Energy Efficiency
Category: 4 - Capital Improvement
Priority: 3 - Response Time (3-4 yrs)
Correction: Replace Lighting Fixtures (SF)
Qty: 40,000.00
Unit of Measure: S.F.
Estimate: \$515,883.60
Assessor Name: System
Date Created: 08/05/2015

Notes: Replace existing T12 fixtures with T8 fixtures

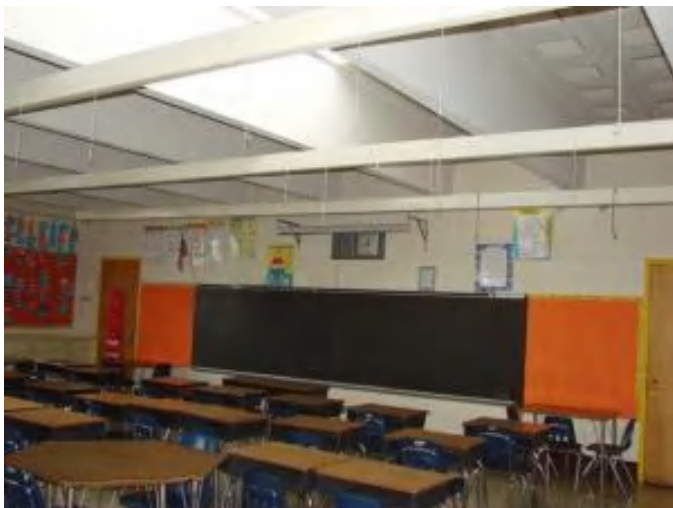
System: D5020 - Lighting and Branch Wiring

Location: Throughout Building
Distress: Inadequate
Category: 4 - Capital Improvement
Priority: 3 - Response Time (3-4 yrs)
Correction: Add wiring device
Qty: 1.00
Unit of Measure: Ea.
Estimate: \$52,046.92
Assessor Name: System
Date Created: 08/05/2015

Notes: Install minimum one receptacle on each wall of classrooms and other purpose rooms.

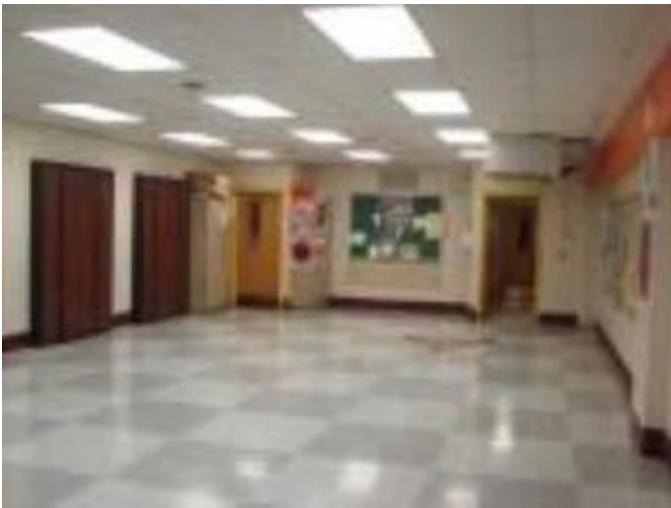
System: D5030 - Communications and Security

Fire Alarm System – The school has a Simplex 4005 fire alarm system. The system consists of pull stations and bells with strobes located in the corridors only. There are no devices in classrooms, gymnasium, or auditorium. Administrative area contains an audible device. It is recommended to upgrade the fire alarm system to provide adequate visual coverage throughout the school.

Location: Throughout Building
Distress: Life Safety / NFPA / PFD
Category: 1 - Health & Safety
Priority: 3 - Response Time (3-4 yrs)
Correction: Replace fire alarm system
Qty: 1.00
Unit of Measure: S.F.
Estimate: \$49,966.64
Assessor Name: System
Date Created: 08/05/2015

Notes: Install a new addressable fire alarm system and provide audible and/or visual devices in all areas.

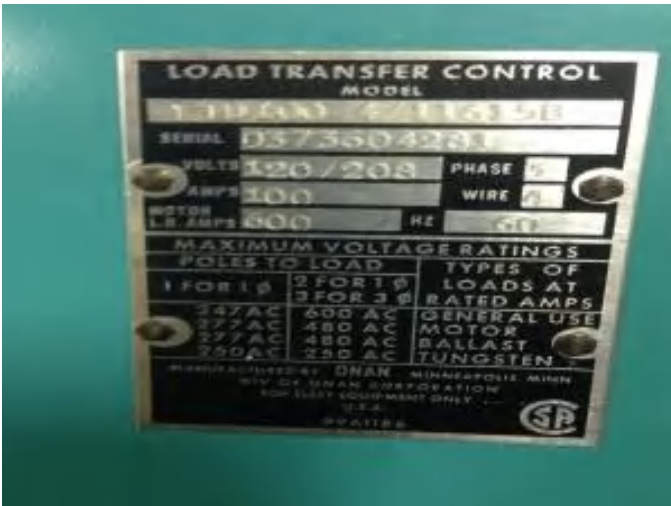
System: D5090 - Other Electrical Systems

Location: Penthouse
Distress: Inadequate
Category: 4 - Capital Improvement
Priority: 3 - Response Time (3-4 yrs)
Correction: Replace standby generator system
Qty: 1.00
Unit of Measure: Ea.
Estimate: \$120,018.54
Assessor Name: System
Date Created: 08/05/2015

Notes: Replace existing generator with larger generator sized to operate the elevator.

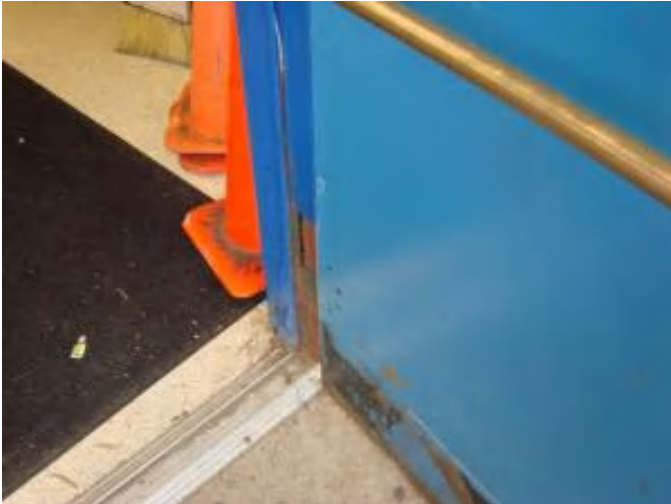
System: B2030 - Exterior Doors

The exterior doors are typically hollow metal doors and frames, painted. The doors are generally in fair condition; no weather-stripping is installed. The loading dock is equipped with overhead roll-up, manually operated doors in fair condition.

Location: Exterior

Distress: Building / MEP Codes

Notes: Install ADA compliant hardware and weather-stripping on all exterior doors

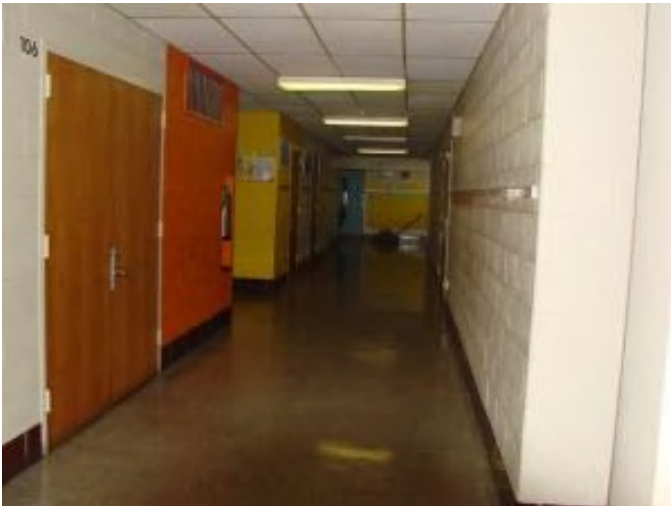
System: C1020 - Interior Doors

Location: Interiors

Distress: Accessibility

Notes: • Replace interior doors hardware for ADA accessibility

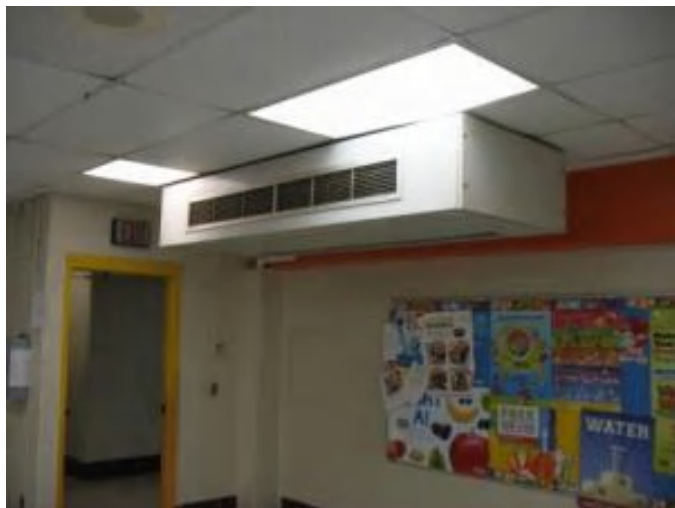
System: D3040 - Distribution Systems

A two pipe distribution system supplies building heating or cooling water to the unit ventilators and two air handling units (AHU). There are two primary loop water pumps which can serve either the boilers or the chiller depending on valve configuration. There are two secondary loop water pumps which serve the hot/cold water distribution network. Two condenser water pumps serve the cooling tower and absorption chiller. All pumps appear to be original to the building, are beyond the anticipated service life of 25 years, and should be replaced.

Location: Throughout building

Distress: Beyond Service Life

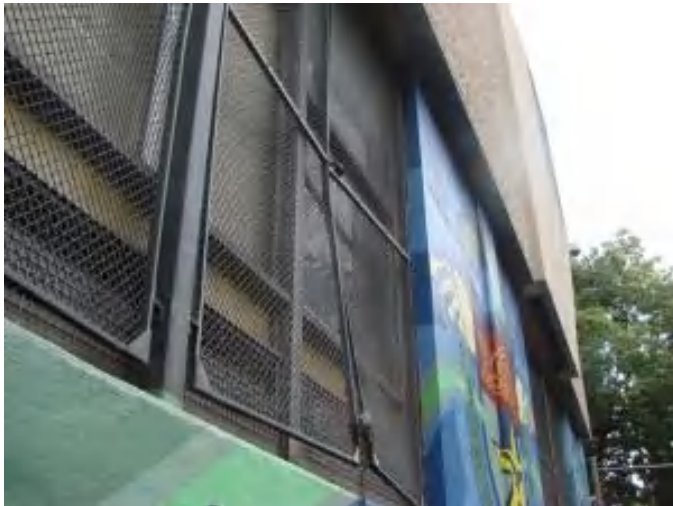
System: B2020 - Exterior Windows

Location: Exterior

Distress: Beyond Service Life

Notes: Replace all windows within next 5 to 10 years including security screens

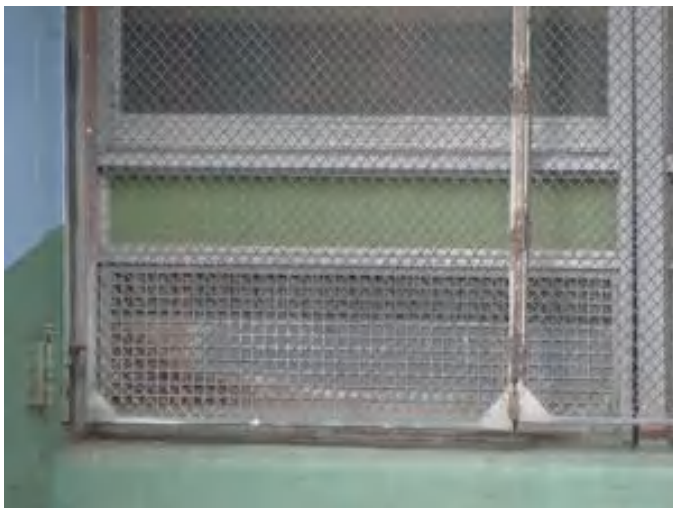
System: B2020 - Exterior Windows

The windows are original extruded aluminum double hung windows double glazed insulated glass and security screens. All windows are generally in good condition with some security screens damaged.

Location: Exterior

Distress: Damaged

Notes: Replace all windows within next 5 to 10 years including security screens

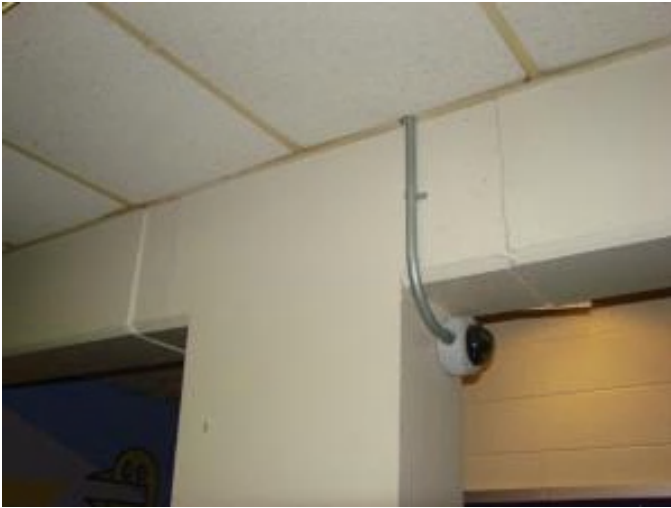
System: C3030 - Ceiling Finishes

Most ceilings in the original building are 2x4 suspended acoustical panels in fair condition. The suspension system and tiles are approaching the end of their useful life. Auditorium is equipped with suspended acoustical baffles in good condition.

Location: Interiors

Distress: Beyond Service Life

Notes: Replace all suspended acoustical ceilings

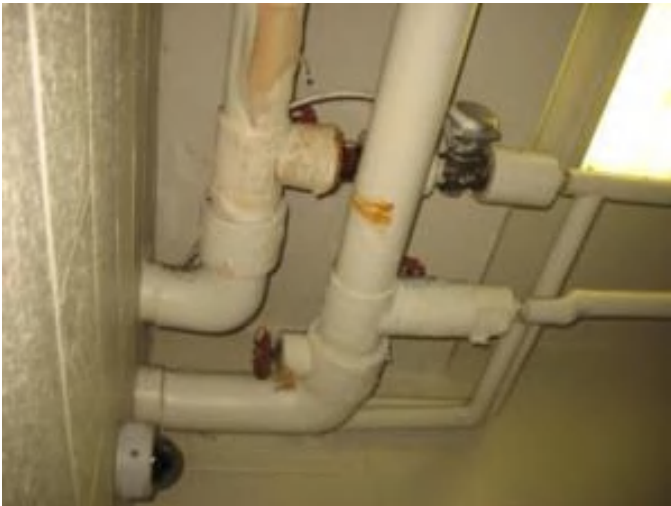
System: D3060 - Controls & Instrumentation

Location: Throughout building

Distress: Inadequate

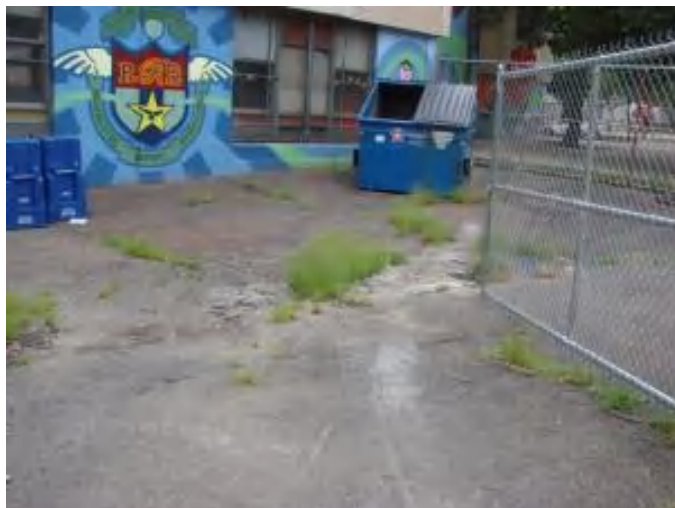
System: G2020 - Parking Lots

Location: Grounds/ Site

Distress: Beyond Service Life

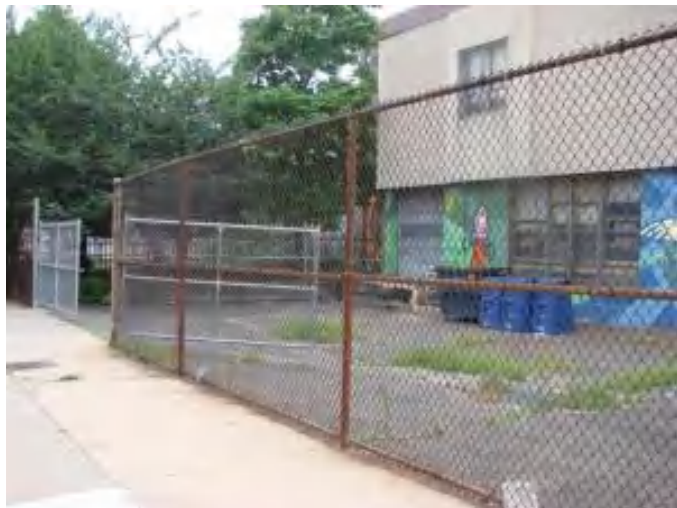
System: G2040 - Site Development

Location: Grounds/ Site

Distress: Beyond Service Life

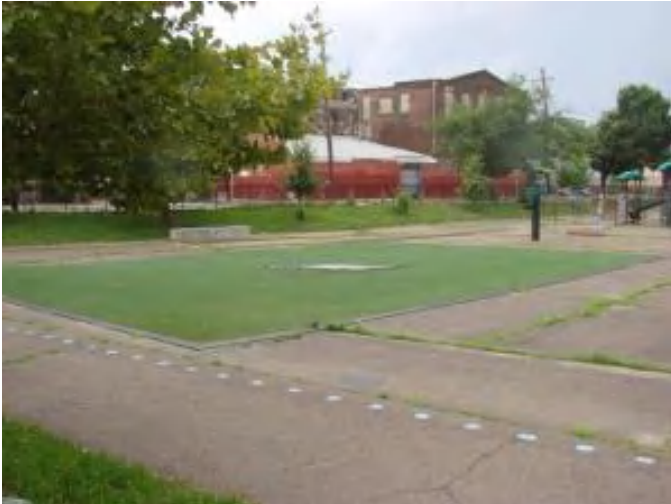
System: G2030 - Pedestrian Paving

Location: Grounds/ Site

Distress: Beyond Service Life

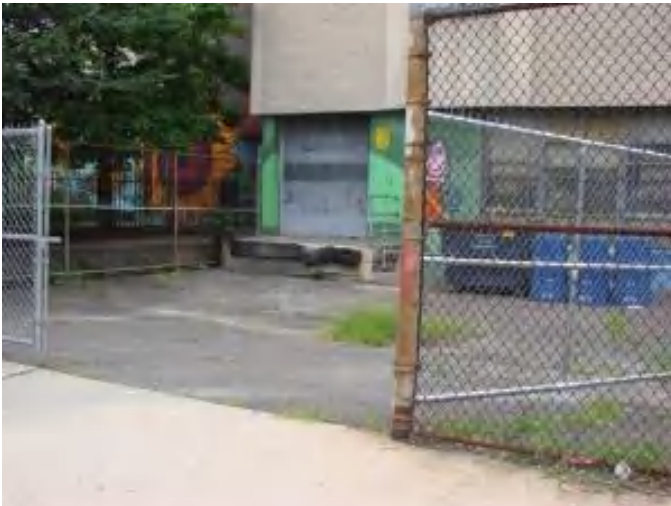
System: G2040 - Site Development

Location: Grounds/ Site

Distress: Security Issue
