### Moore School

School District of Philadelphia  
**S831001;Moore**  
Final  
**Site Assessment Report**  
January 31, 2017

Facility Assessment  
October 2015

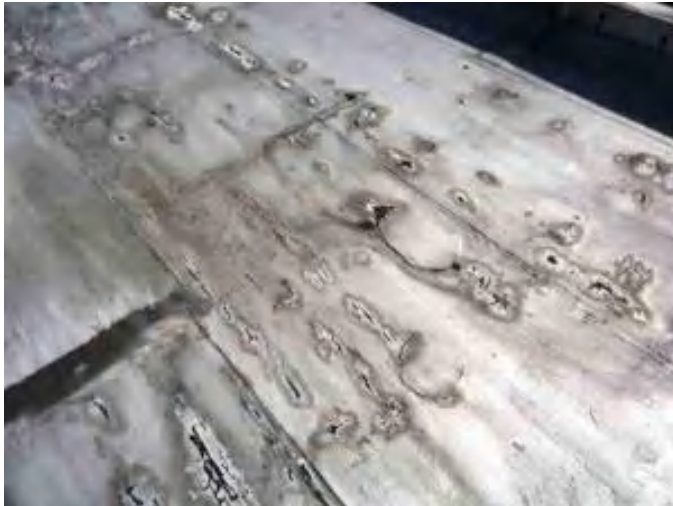
#### **System: B3010105 - Built-Up**

The existing built up roofing system has clear signs of ponding and there reportedly has been an increase of roofing maintenance on this single ply roofing system. During the time of the inspection several major issues were noted such as open holes in the roof, ripped membrane and open tears exposing the insulation to the elements. It is recommended that a new built-up roofing system be installed as this roof has clearly failed.

**Location:** Roof

**Distress:** Failing

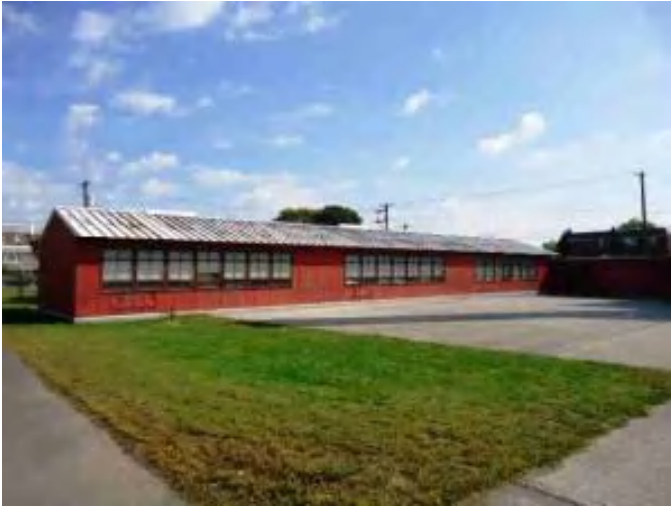
**System: B3010130 - Preformed Metal Roofing**

The existing metal roofing system over the temporary addition has clear signs of damage and reportedly has been an increase of roofing maintenance. During the time of the inspection several major issues were noted such as water leaking into the interior classrooms and damaging the finishes. It is recommended that a new metal roofing system be installed.

**Location:** Roof

**Distress:** Damaged

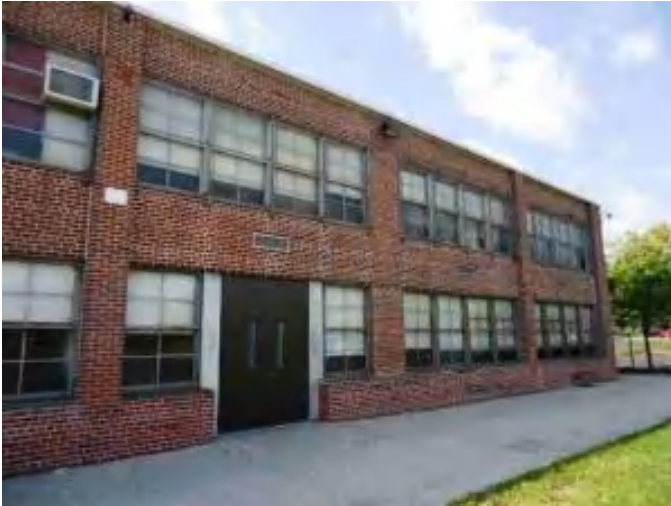
**System: B2020 - Exterior Windows**

As indicated in the photos the single pane steel or aluminum framed windows appear to be original. Several of the windows no longer work and will require attention prior to an overall effort. Overall, the windows are in fair condition based on the year of installation or last renovation. The entire exterior window system is recommended to be replaced with units that retain their dimensions and profiles, but that incorporate updated energy-efficient features.

**Location:** Exterior Elevation

**Distress:** Damaged

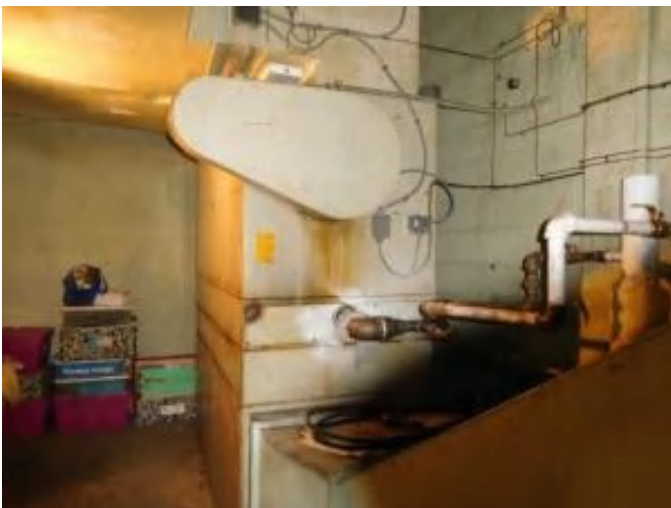
**System: D3040 - Distribution Systems**

**Location:** auditorium

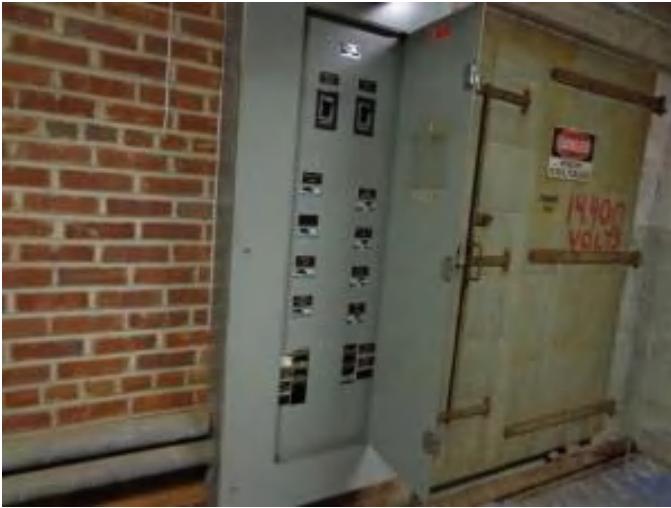
**System: D5010 - Electrical Service/Distribution**

**Location:** Mechanical Room 005

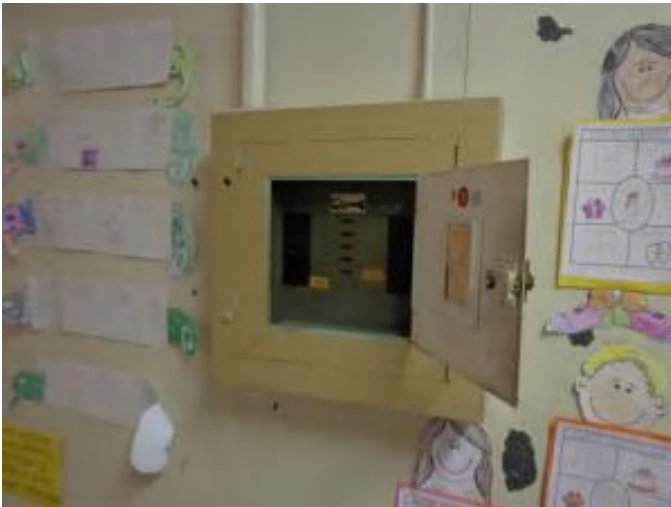
**System: D5010 - Electrical Service/Distribution**

**Location:** Building wide

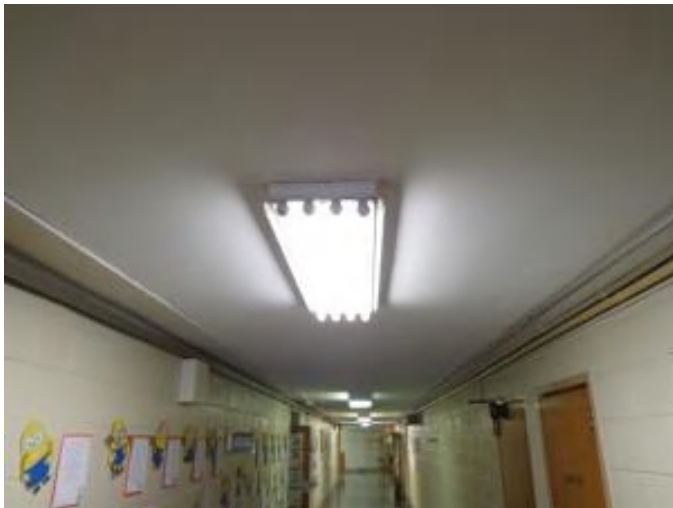
**System: D5020 - Lighting and Branch Wiring**

**Location:** Building wide

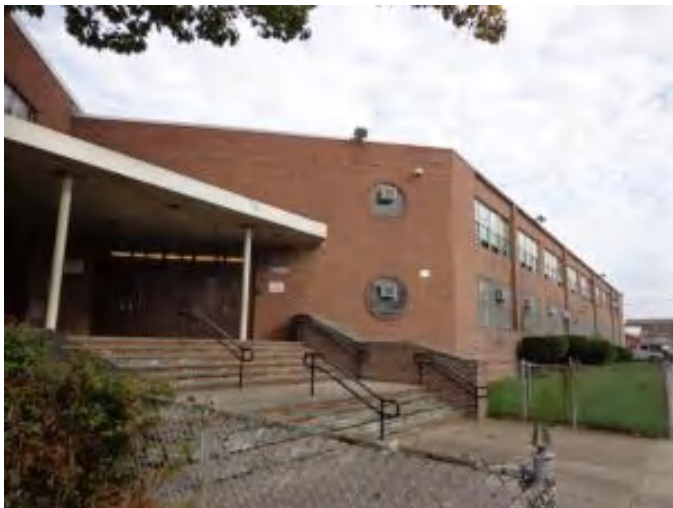
**System: D5020 - Lighting and Branch Wiring**

**Location:** Exit discharges

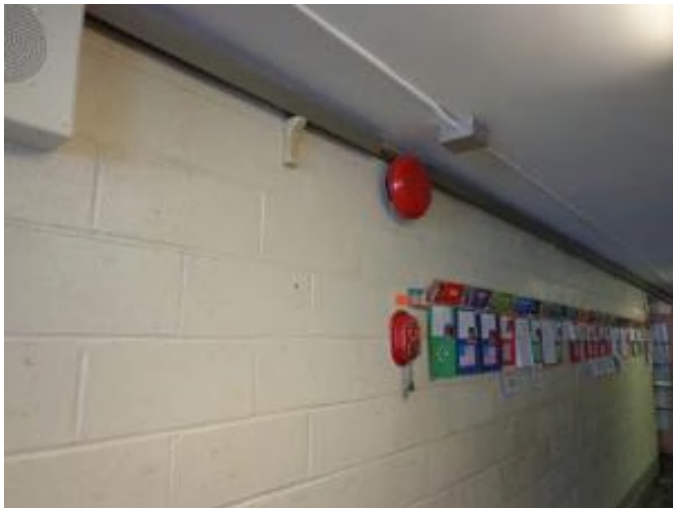
**System: D5030 - Communications and Security**

**Location:** Building wide  
**Distress:** Life Safety / NFPA / PFD  
**Category:** 1 - Health & Safety  
**Priority:** 3 - Response Time (3-4 yrs)  
**Correction:** Replace fire alarm system  
**Qty:** 67,701.00  
**Unit of Measure:** S.F.  
**Estimate:** \$456,557.35  
**Assessor Name:** System  
**Date Created:** 12/19/2015

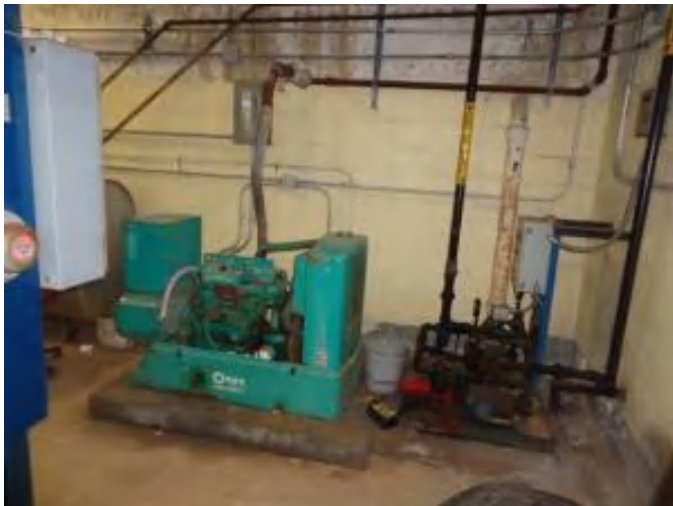
**System: D5090 - Other Electrical Systems**

**Location:** Boiler Room 002  
**Distress:** Beyond Service Life  
**Category:** 3 - Operations / Maint.  
**Priority:** 3 - Response Time (3-4 yrs)  
**Correction:** Replace standby generator system  
**Qty:** 1.00  
**Unit of Measure:** Ea.  
**Estimate:** \$234,650.74  
**Assessor Name:** System  
**Date Created:** 12/19/2015

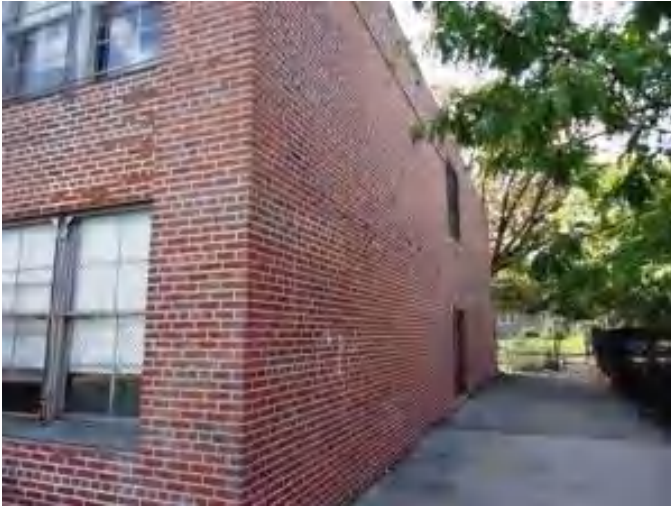
**System: B2010 - Exterior Walls**

The exterior brick surfaces are generally in fair to good condition for their age. In some locations, bricks have cracked or spalled and should be replaced. The repointing of deteriorated mortar joints is also recommended, using mortar of a similar color and consistency as the original. Following the detailed examination of the brick and repair of mortar construction joints, the entire building should be pressure washed to remove stains and embedded pollutants. If moisture is found to be penetrating the masonry facade, the application of a spray sealant to the suspected exterior masonry surface is recommended.

**Location:** Exterior Elevation

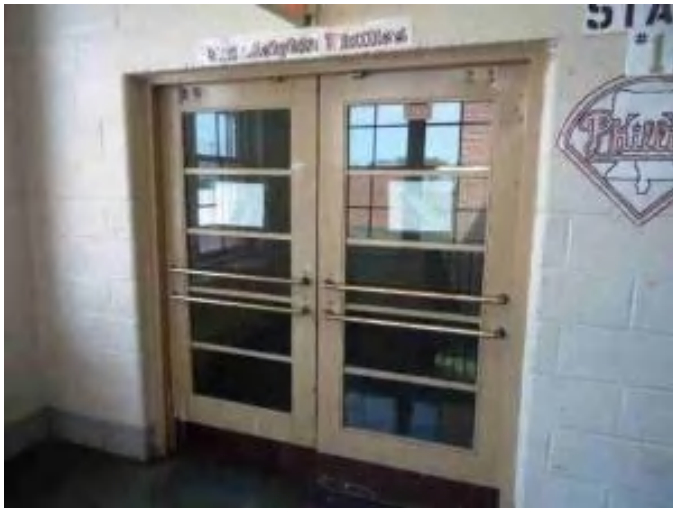
**System: C1010 - Partitions**

Interior partitions include CMU and glazed block. A large portion of the interior corridor, exit stair doors are not code compliant. Several doors are typically metal in metal frames with transom lites or sidelights, glass glazing. The older doors are generally in good condition considering the age of the application. To restore the door finishes, universal upgrades are required for the older door applications. Remove and replace original door systems with new code compliant fire rated door system.

**Location:** Corridor Doors  
**Distress:** Life Safety / NFPA / PFD  
**Category:** 1 - Health & Safety  
**Priority:** 4 - Response Time (4-5 yrs)  
**Correction:** Install fire rated walls and door where required  
- insert number of doors  
**Qty:** 10.00  
**Unit of Measure:** S.F.  
**Estimate:** \$89,183.57  
**Assessor Name:** System  
**Date Created:** 10/30/2015

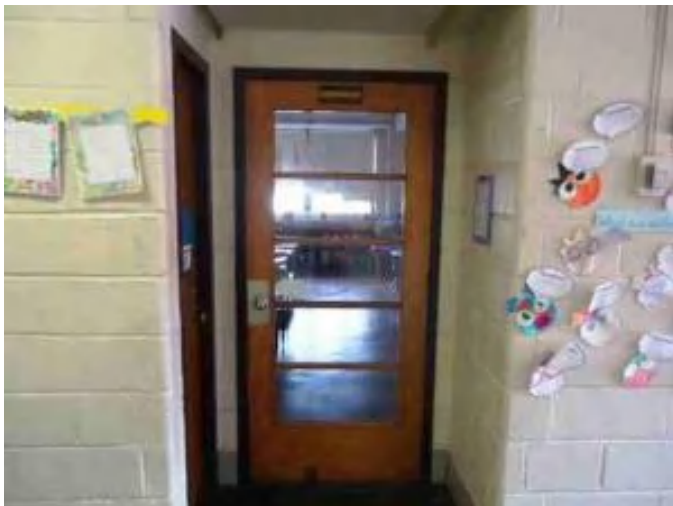
**System: C1020 - Interior Doors**

Interior doors are typically wood in wood frames with glass glazing. Other interior doors include wooden glass pane doors with original wooden pane frames, hollow metal in hollow metal frames. Doors are generally in good condition considering the age of the application. Universal upgrades are required for the interior door systems, it is recommended that the interior doors system be removed and replaced with a new modern metal framed wooden door system with consideration for ADA compliance.

**Location:** Classroom Doors  
**Distress:** Damaged  
**Category:** 3 - Operations / Maint.  
**Priority:** 4 - Response Time (4-5 yrs)  
**Correction:** Remove and replace interior doors - wood doors with hollow metal frames - per leaf  
**Qty:** 80.00  
**Unit of Measure:** Ea.  
**Estimate:** \$381,646.97  
**Assessor Name:** System  
**Date Created:** 10/30/2015

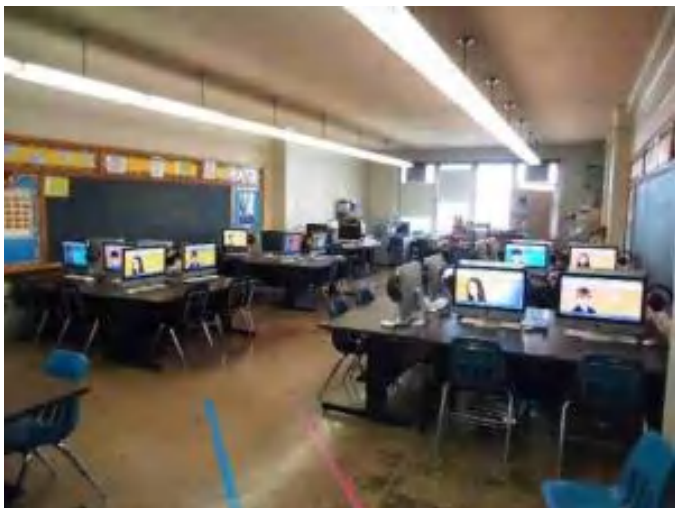
**System: C1030 - Fittings**

The classroom chalk boards are original to the buildings construction. This system is damaged and beyond its expected life, universal upgrades are warranted. Remove and upgrade chalk boards to new marker board systems.

**Location:** Classrooms  
**Distress:** Damaged  
**Category:** 3 - Operations / Maint.  
**Priority:** 4 - Response Time (4-5 yrs)  
**Correction:** Replace blackboards with marker boards - pick the appropriate size and insert the quantities  
**Qty:** 80.00  
**Unit of Measure:** Ea.  
**Estimate:** \$55,058.57  
**Assessor Name:** System  
**Date Created:** 10/30/2015

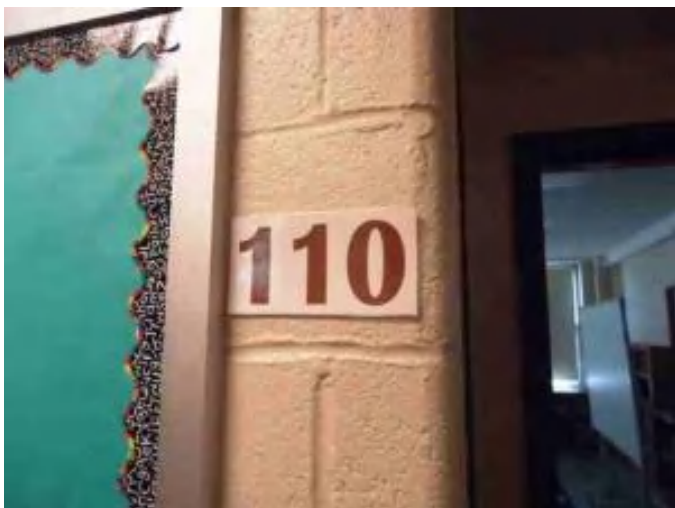
**System: C1030 - Fittings**

There is no directional signage and room signage is a custom design in places and scarce or painted with no consistency in others. Accessibility signage criteria have been established for the physically challenged. These include mounting heights, contrast and finish, raised and Braille characters and pictograms, and character proportions and heights. It is recommended that compliant signage be installed throughout the building.

**Location:** Building Wide  
**Distress:** Damaged  
**Category:** 3 - Operations / Maint.  
**Priority:** 4 - Response Time (4-5 yrs)  
**Correction:** Replace missing or damaged signage - insert the number of rooms  
**Qty:** 120.00  
**Unit of Measure:** Ea.  
**Estimate:** \$32,509.50  
**Assessor Name:** System  
**Date Created:** 10/30/2015

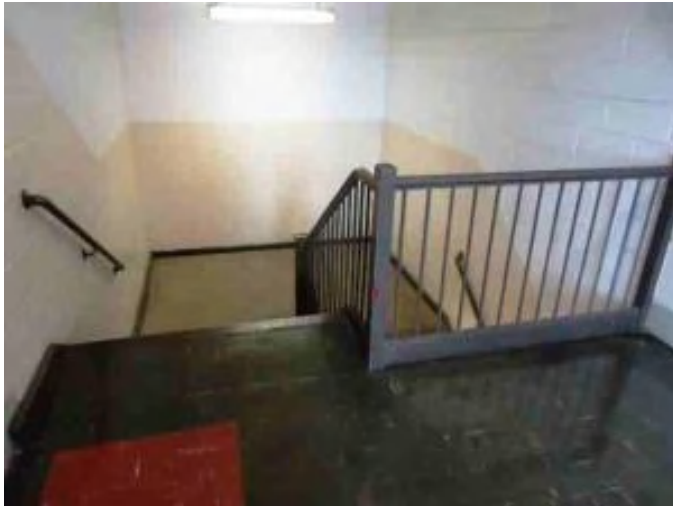
**System: C2010 - Stair Construction**

Stair construction is a concrete design. Stair treads and landings are finished with concrete and metal nosings and are good condition. Current requirements for stairs indicate that they have graspable handrails on both sides, that the rails have a specific end geometry,

and that the handrails continue horizontally at the landings. In addition, guardrails must prevent the passage of a 4 inch diameter sphere (6 inches in the triangle formed by the lower rail and tread/riser angle). Although the stairs are compliant with the code enforced at the time of construction until a major renovation occurs, they are deficient in handrail and guardrail design relative to current standards. Future efforts should include comprehensive stair railing removal and replacement upgrades.

**Location:** Stairs

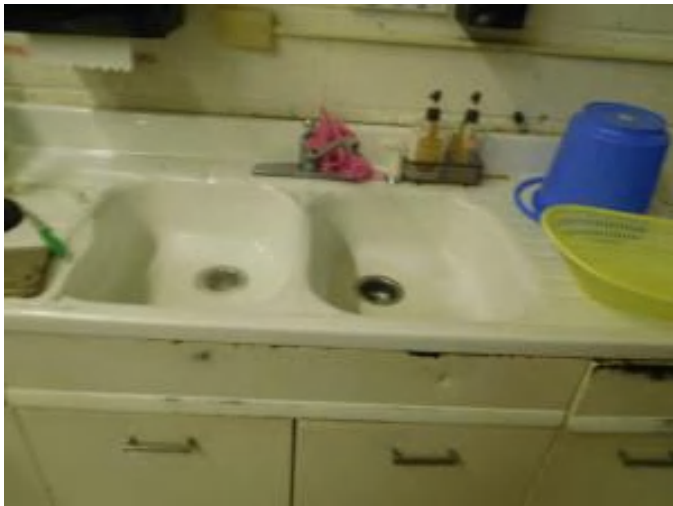
**System: D2010 - Plumbing Fixtures**

**Location:** kitchen

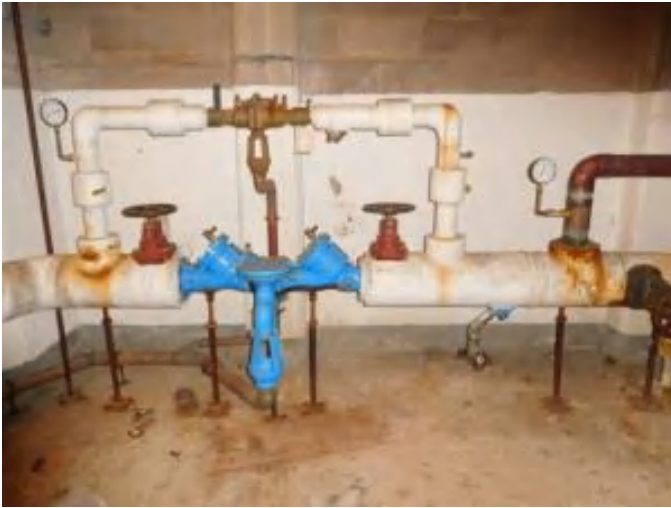
**System: D2020 - Domestic Water Distribution**

**Location:** entire building

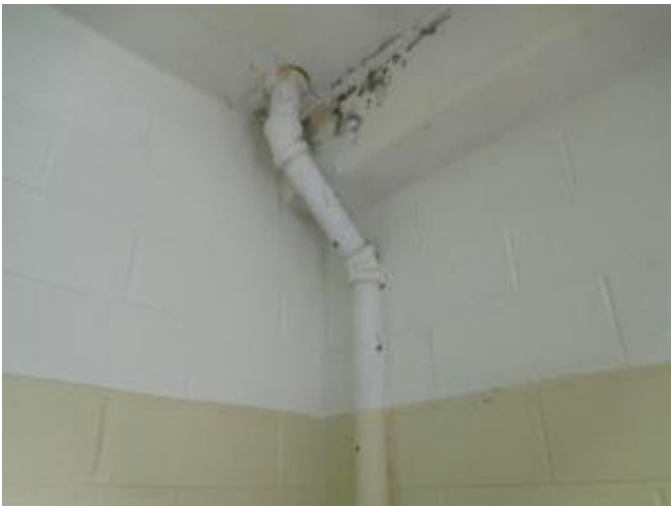
**System: D2030 - Sanitary Waste**

**Location:** entire building

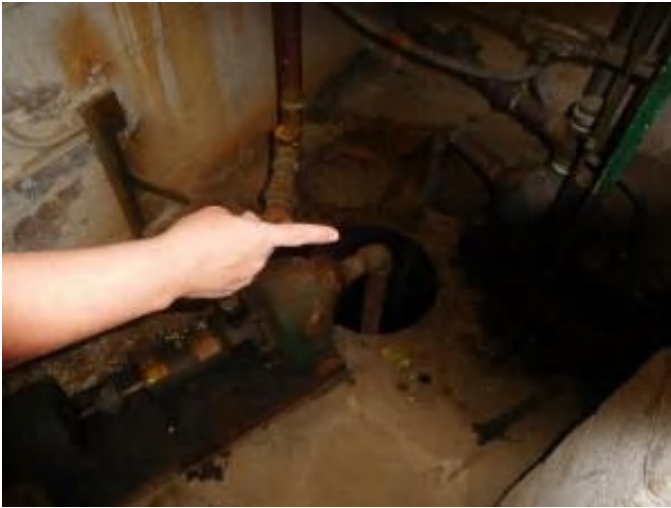
**System: D2030 - Sanitary Waste**

**Location:** mechanical room

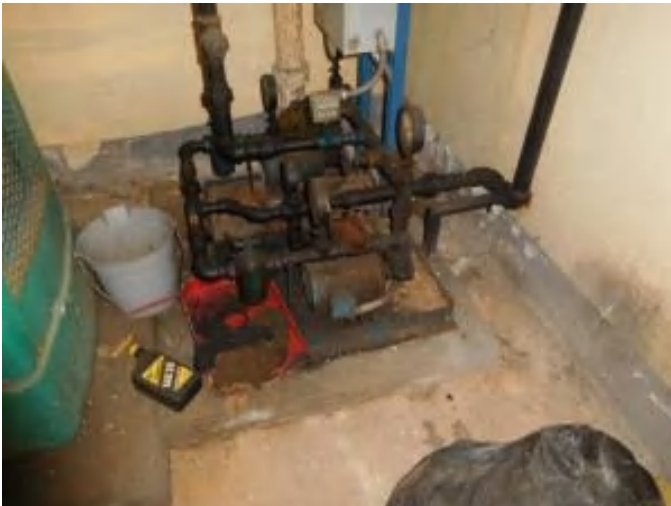
**System: D3020 - Heat Generating Systems**

**Location:** mechanical room

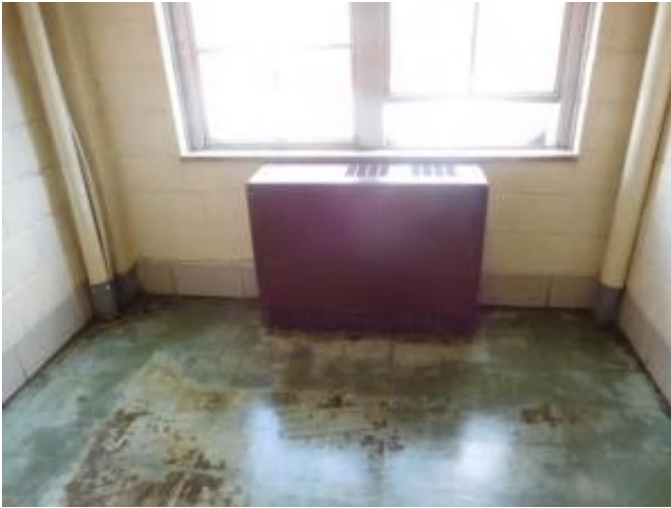
**System: D3040 - Distribution Systems**

**Location:** entire building

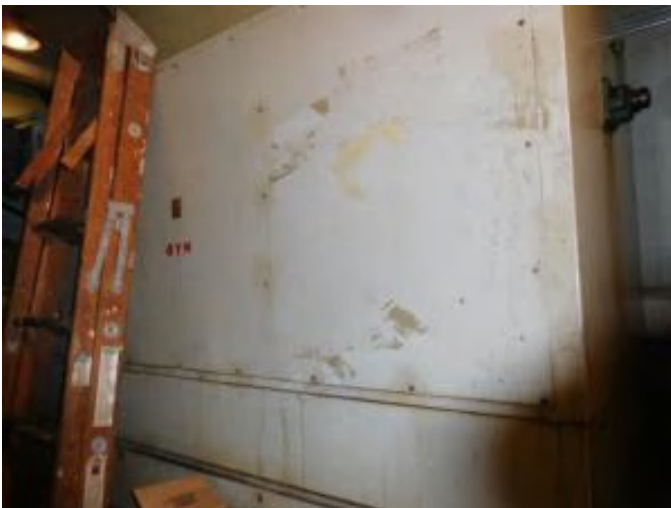
**System: D3040 - Distribution Systems**

**Location:** cafeteria/gymnasium

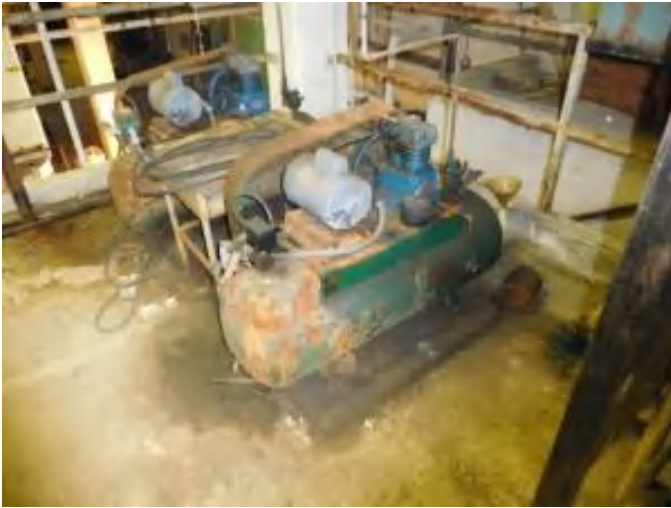
**System: D3060 - Controls & Instrumentation**

**Location:** entire building  
**Distress:** Inadequate  
**Category:** 4 - Capital Improvement  
**Priority:** 4 - Response Time (4-5 yrs)  
**Correction:** Replace pneumatic controls with DDC (75KSF)  
**Qty:** 67,701.00  
**Unit of Measure:** S.F.  
**Estimate:** \$1,452,328.64  
**Assessor Name:** System  
**Date Created:** 01/15/2016

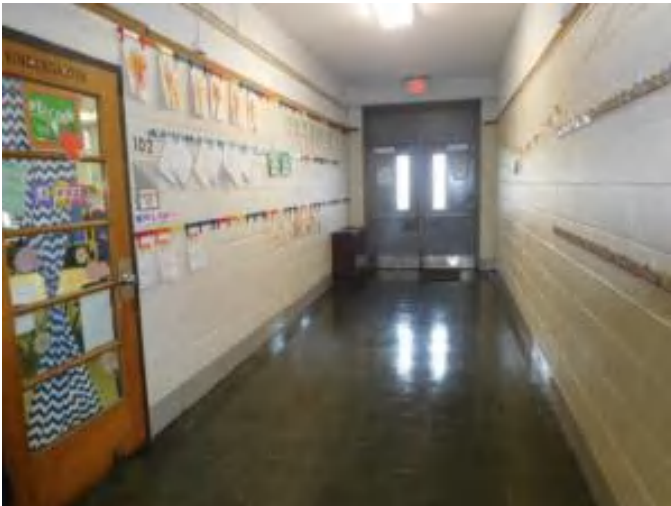
**System: D4010 - Sprinklers**

**Location:** entire building  
**Distress:** Life Safety / NFPA / PFD  
**Category:** 1 - Health & Safety  
**Priority:** 4 - Response Time (4-5 yrs)  
**Correction:** Install a fire protection sprinkler system  
**Qty:** 67,701.00  
**Unit of Measure:** S.F.  
**Estimate:** \$968,495.16  
**Assessor Name:** System  
**Date Created:** 01/15/2016

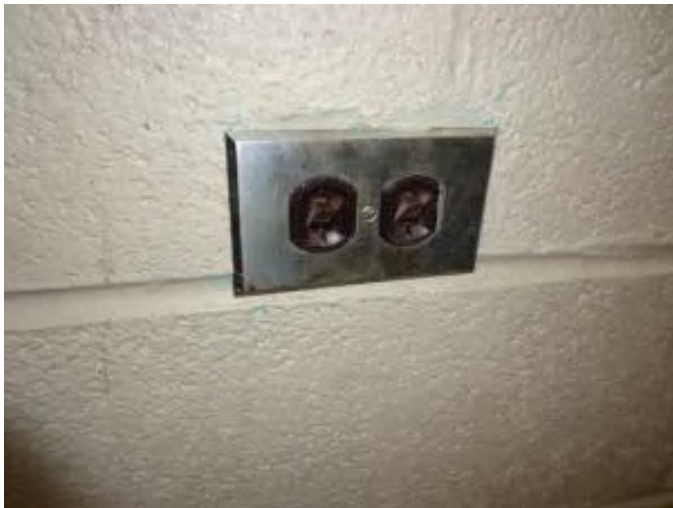
**System: D5020 - Lighting and Branch Wiring**

**Location:** Classrooms

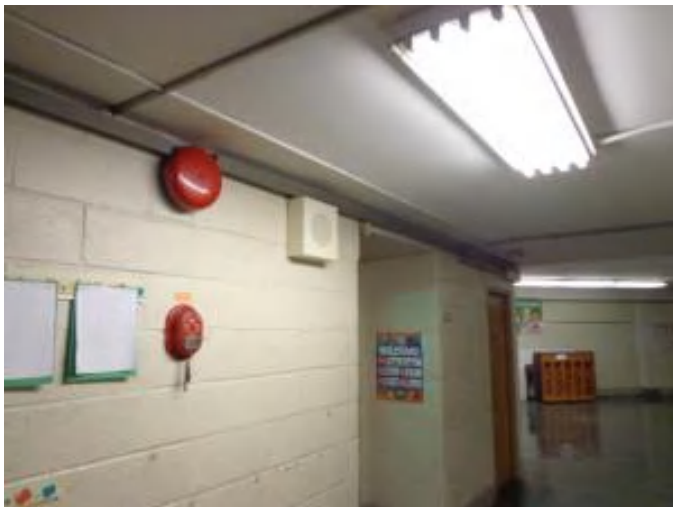
**System: D5030 - Communications and Security**

**Location:** Building wide

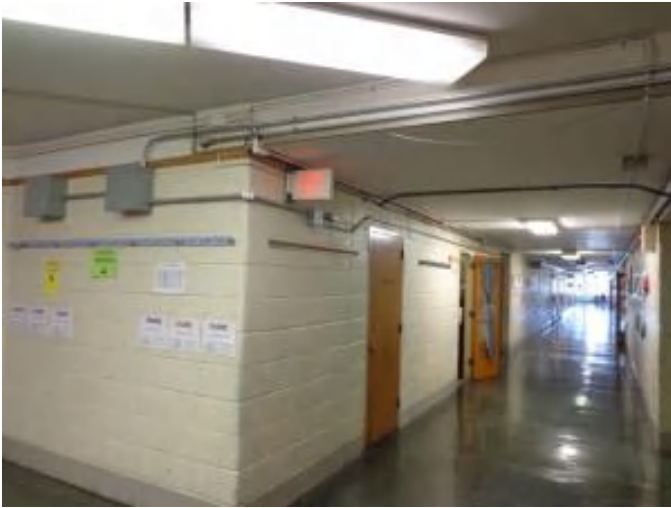
**System: D5030 - Communications and Security**

**Location:** Building wide

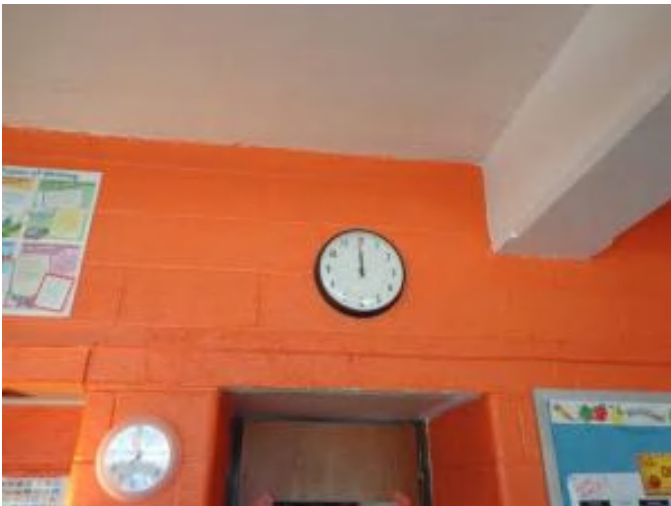
**System: D5030 - Communications and Security**

**Location:** Building wide

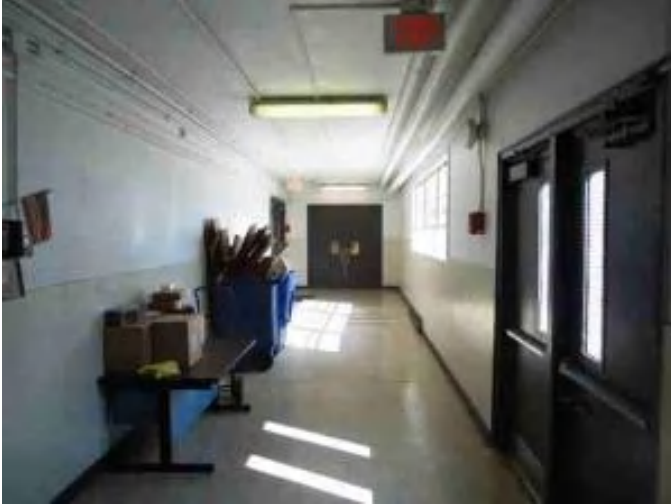
**System: B2030 - Exterior Doors**

The exterior doors are metal applications with metal frames. The exterior door system for this school is a very high traffic system. The doors are in fair condition but are aging at a faster rate than expected based on traffic and condition. The exterior door system, store front and service doors are recommended for upgrade.

**Location:** Exterior Elevation

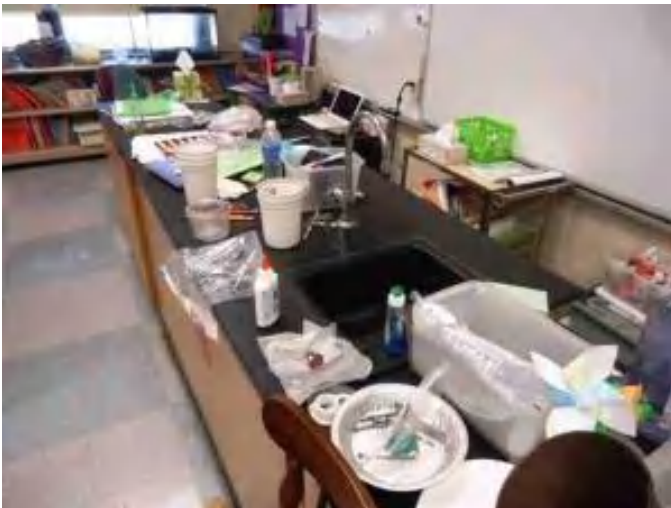
**System: C1010 - Partitions**

This school's science labs have been upgraded from the original construction. The installation consist of an instruction demonstration desk with sink. Wall mounted storage cabinets and cabinets with sinks for student use. The system is showing signs of age and lack of maintenance such as broken sink fixtures missing cabinet doors and damaged shelves. This deficiency provides a budgetary consideration for the universal upgrade of the science teaching labs to include new counter tops, sink, cabinets, shelves and fixtures required to support a conducive level of education.

**Location:** Science Classrooms

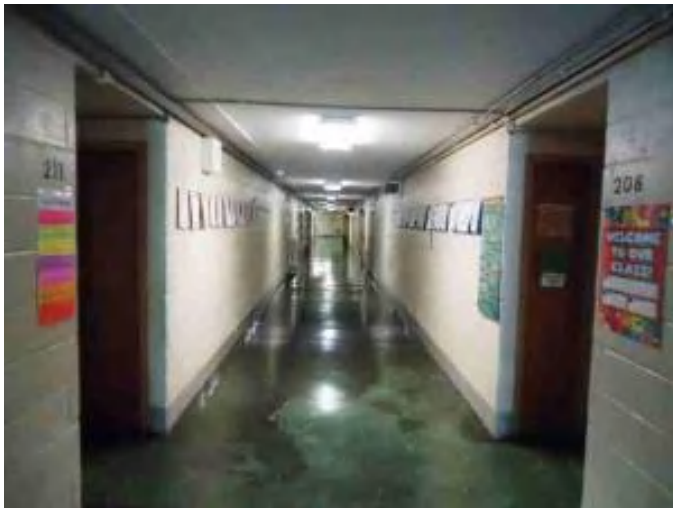
**System: C3020413 - Vinyl Flooring**

**Location:** Building Wide  
**Distress:** Damaged  
**Category:** 3 - Operations / Maint.  
**Priority:** 5 - Response Time (> 5 yrs)  
**Correction:** Remove VAT and replace with VCT - SF of area  
**Qty:** 40,000.00  
**Unit of Measure:** S.F.  
**Estimate:** \$606,666.72  
**Assessor Name:** System  
**Date Created:** 10/30/2015

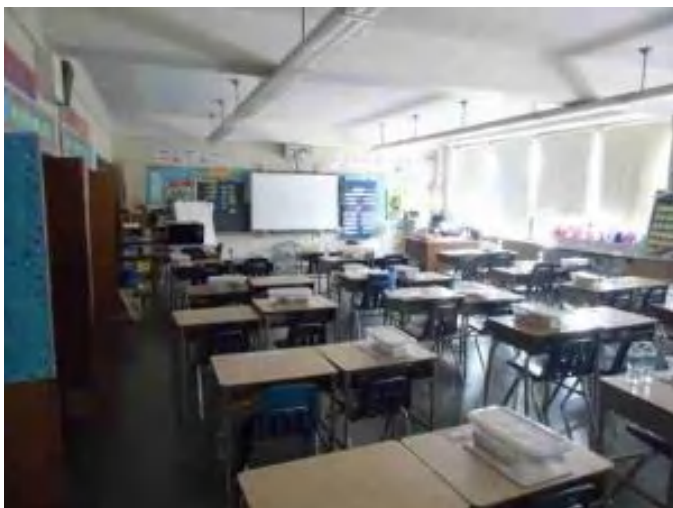
**System: C3030 - Ceiling Finishes**

The ceiling finish is a mix of 12 x 12 ceiling grid, painted and 2 x 4 Acoustical tile finish. Ceilings have been repaired in several areas and are in good condition considering the age of the application and the current condition of the school. The ceiling finish is expected to require upgrades to support the recommended efforts in this report prior to re-opening. This deficiency provides a budgetary consideration for removal and replacement of the current ceiling finish to a new acoustical tile finish. Considering the recommended mechanical and electrical upgrades this effort should be completed as part of an overall renewal program for the school. No work should be considered until after the recommended exterior efforts are complete.

**Location:** Building Wide  
**Distress:** Damaged  
**Category:** 3 - Operations / Maint.  
**Priority:** 5 - Response Time (> 5 yrs)  
**Correction:** Remove and replace suspended acoustic ceilings - lighting not included  
**Qty:** 50,000.00  
**Unit of Measure:** S.F.  
**Estimate:** \$754,121.51  
**Assessor Name:** System  
**Date Created:** 10/30/2015

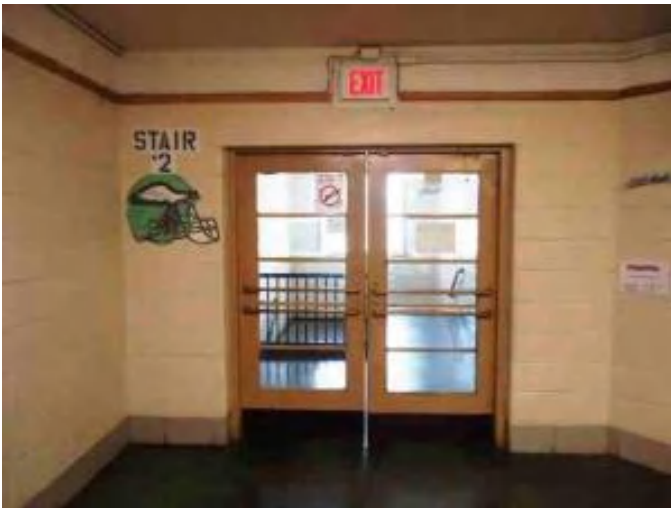
**System: D1010 - Elevators and Lifts**

There is no elevator that services this school. Goods, services, and amenities offered in public buildings are generally required to be available to all persons. To assist those that may be physically challenged and to meet current accessibility legislation to provide wheelchair access to the upper floors of this facility, the installation of a new hydraulic elevator has been recommended on the southern elevation of the building or at another suitable location. The new installation should blend as much as possible with the overall appearance of this structure and include all required ADA features, such as audible jewels and gongs, an accessible control panel, etc.

**Location:** Building Wide  
**Distress:** Accessibility  
**Category:** 2 - Code Compliance  
**Priority:** 5 - Response Time (> 5 yrs)  
**Correction:** Add interior hydraulic elevator - 2 floors - adjust the electrical run lengths to hook up the elevator  
**Qty:** 1.00  
**Unit of Measure:** Ea.  
**Estimate:** \$387,153.48  
**Assessor Name:** System  
**Date Created:** 10/30/2015

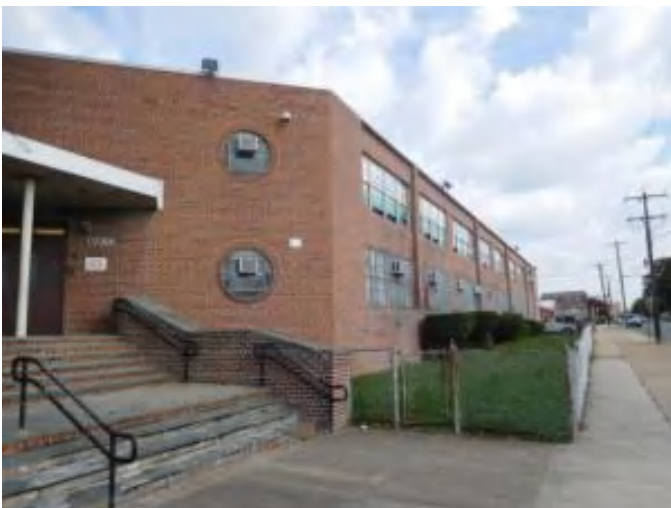
**System: D3030 - Cooling Generating Systems**

There is no central air conditioning. The building has some window air conditioners in the old building, but none in the annex. A ductless split system with an exterior wall mounted condensing unit cools the IT room.

**Location:** roof, mechanical room  
**Distress:** Inadequate  
**Category:** 4 - Capital Improvement  
**Priority:** 5 - Response Time (> 5 yrs)  
**Correction:** Install chilled water system with distribution piping and pumps. (+75KSF)  
**Qty:** 67,701.00  
**Unit of Measure:** S.F.  
**Estimate:** \$1,087,247.07  
**Assessor Name:** System  
**Date Created:** 01/15/2016

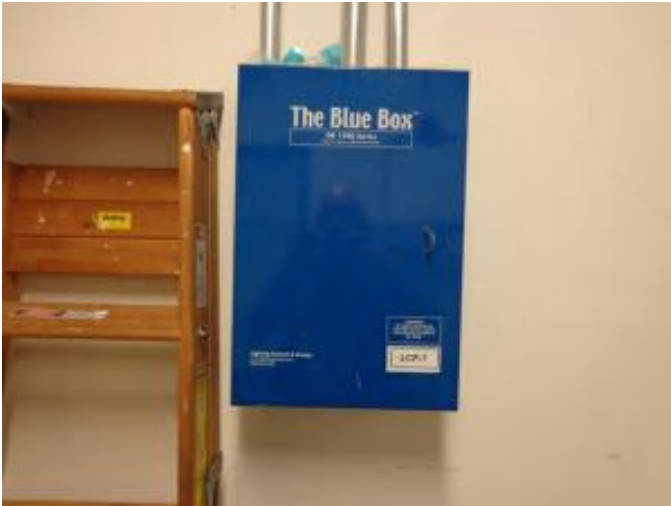
#### System: D5020 - Lighting and Branch Wiring

**Location:** Classrooms

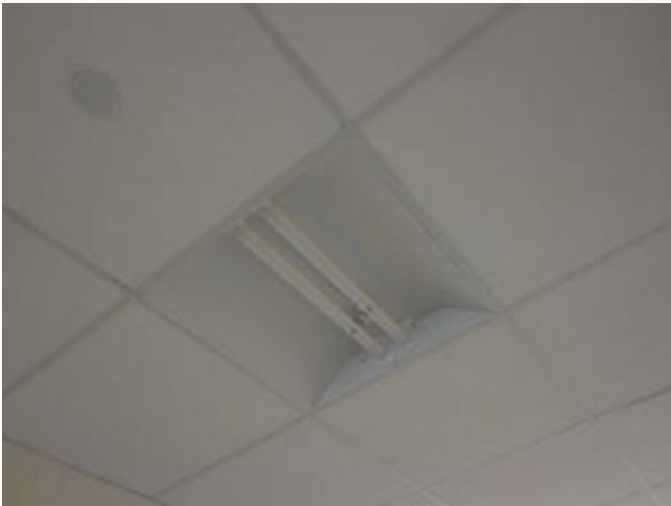
#### System: D5020 - Lighting and Branch Wiring

**Location:** Corridor

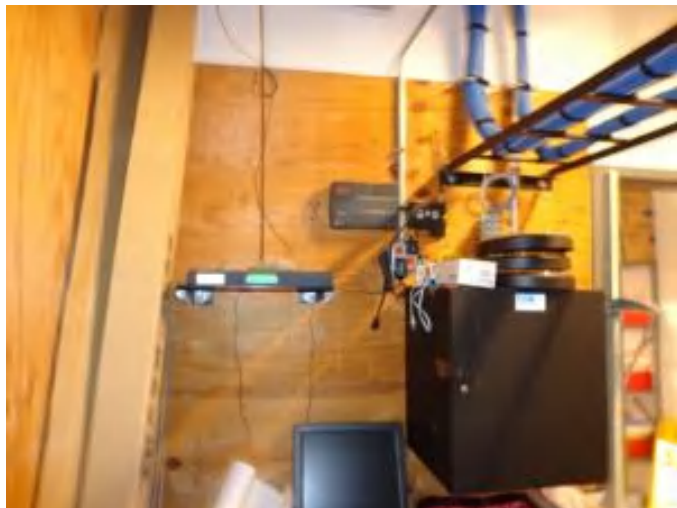
**System: D5030 - Communications and Security**

**Location:** MDF Room P109A

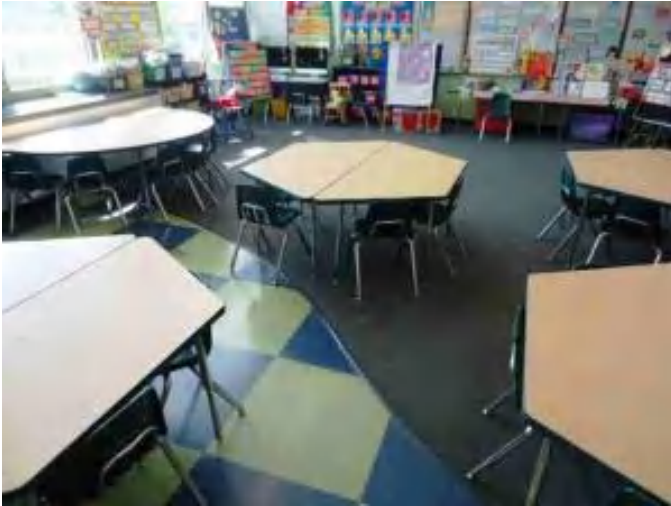
**System: C3020411 - Carpet**

**Location:** Classrooms

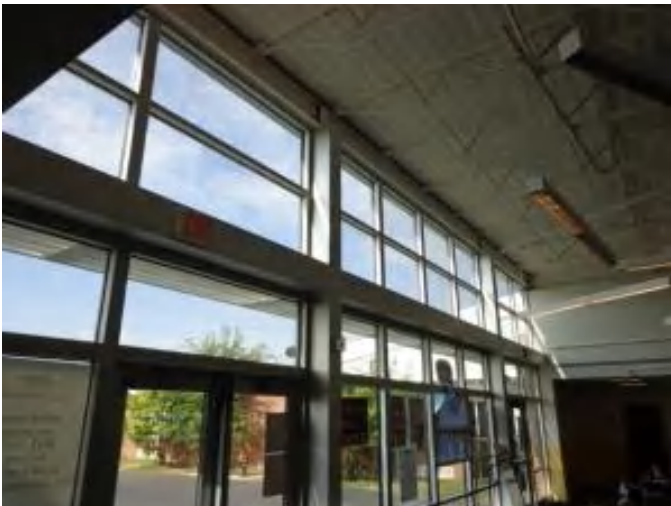
**System: D5020 - Lighting and Branch Wiring**

**Location:** Cafetorium

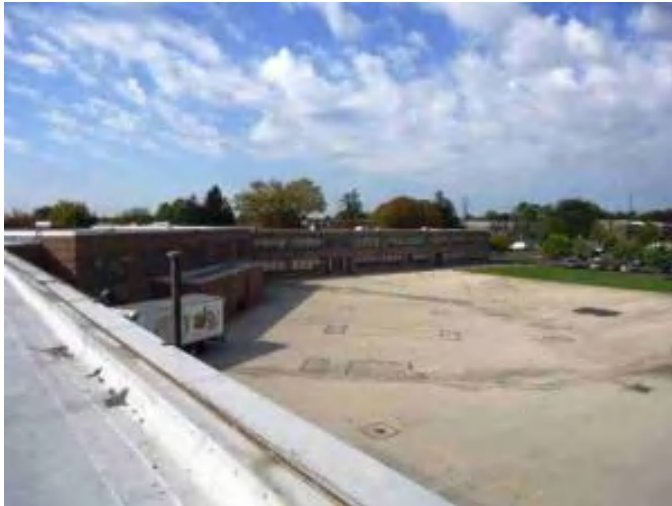
#### **System: G2020 - Parking Lots**

**Location:** Playground

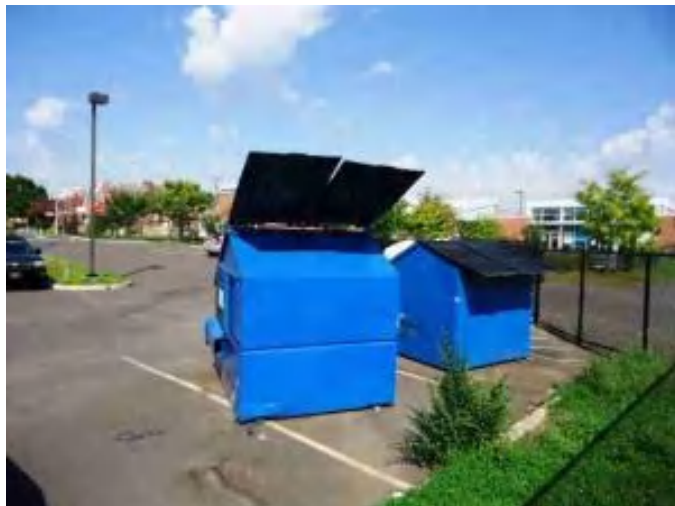
**System: G2040 - Site Development**

**Location:** Site
