## Facility Condition Assessment Summary Report

### Morris School

**Site Assessment Report**

**January 31, 2017**

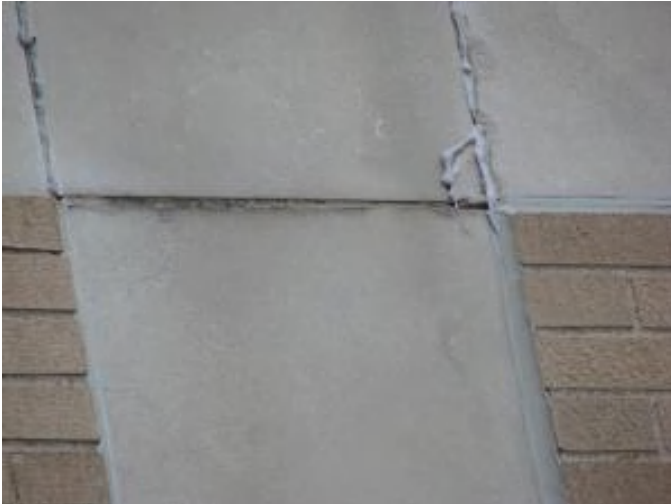
**System: B2010 - Exterior Walls**

The building envelope is typically face brick masonry with CMU backup. It was renovated in 2005. In general, masonry is in fair to good condition with some missing mortar. The columns and girders are clad with cementitious panels to accentuate the structural grid. These panels are sealed to adjacent brick with sealant where mortar was missing; joints at panels' perimeter show substantial deterioration. Water penetration through walls has been reported.

**Location:** Exterior

**Distress:** Building Envelope Integrity

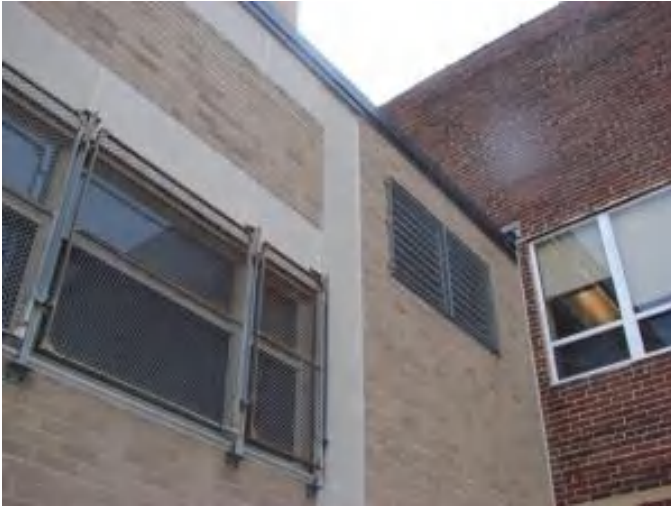
**System: B2020 - Exterior Windows**

The original building windows were replaced in 2000 with extruded aluminum double hung windows double glazed insulated glass. All windows are generally in poor condition with some of the windows inoperable; first floor windows have security screens in fair condition. The leaks around the windows perimeters have been reported and are evident.

**Location:** Exterior

**Distress:** Building Envelope Integrity

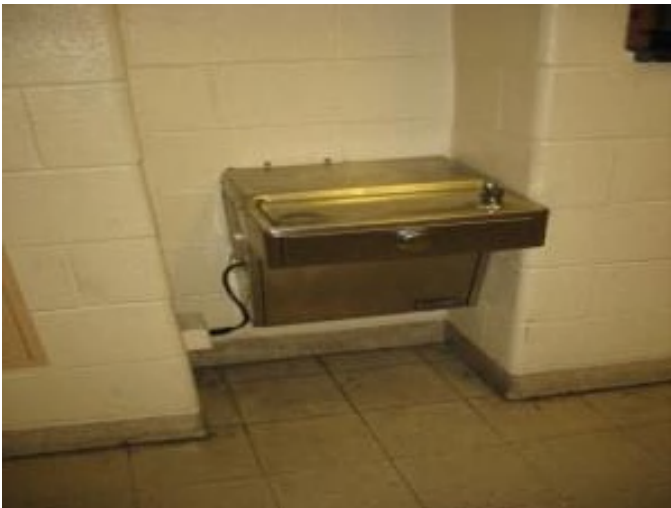
**System: D2010 - Plumbing Fixtures**

**Location:** Throughout building

**Distress:** Beyond Service Life

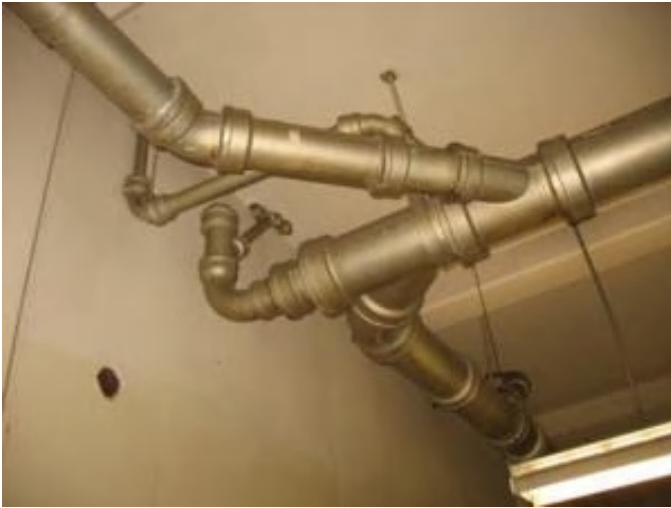
**System: D2030 - Sanitary Waste**

The maintenance staff reported mostly minor problems with the sanitary waste piping systems. However, the sewer piping has been in service for nearly 50 years and will require more frequent attention from the maintenance staff as time passes. The District should hire a qualified contractor to examine the sanitary waste piping using video cameras to locate and replace any damaged piping and to further quantify the extent of potential failures.

**Location:** Throughout buliding

**Distress:** Beyond Service Life

- Hire a qualified contractor to perform a detailed examination of the sanitary waste piping using visual inspection and video cameras to locate and replace any damaged piping and to further quantify the extent of potential failures.

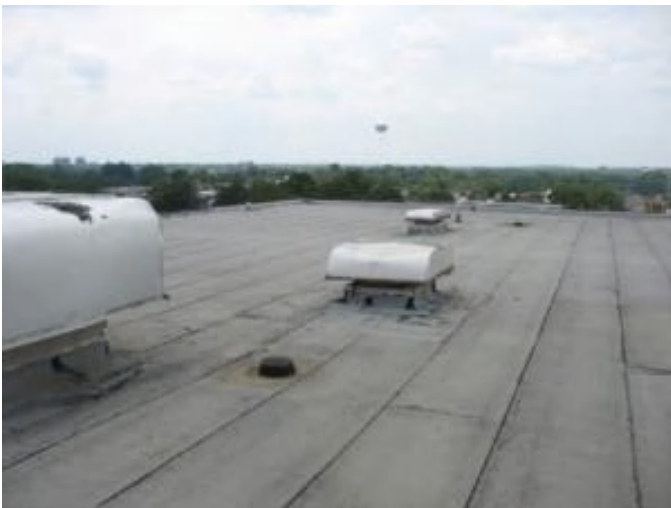
**System: D3040 - Distribution Systems**

Exhaust for the restrooms is provided by two roof mounted exhaust fans. The existing roof mounted exhaust fans are beyond their service life and should be replaced.

**Location:** Roof

**Distress:** Beyond Service Life

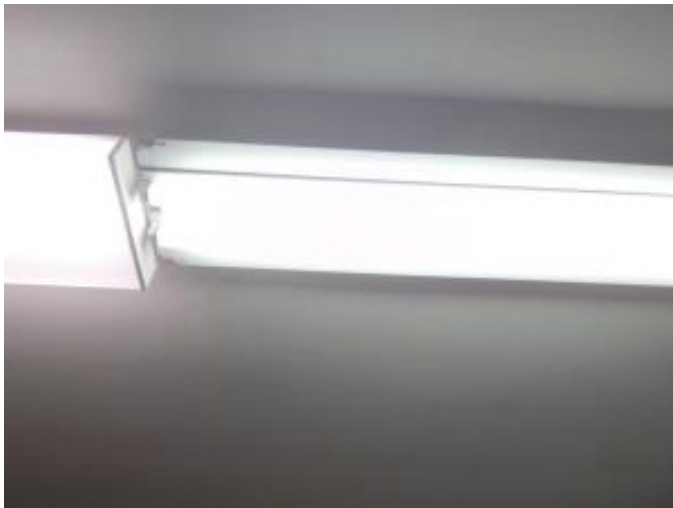
**System: D5020 - Lighting and Branch Wiring**

**Location:** Throughout Building

**Distress:** Inadequate

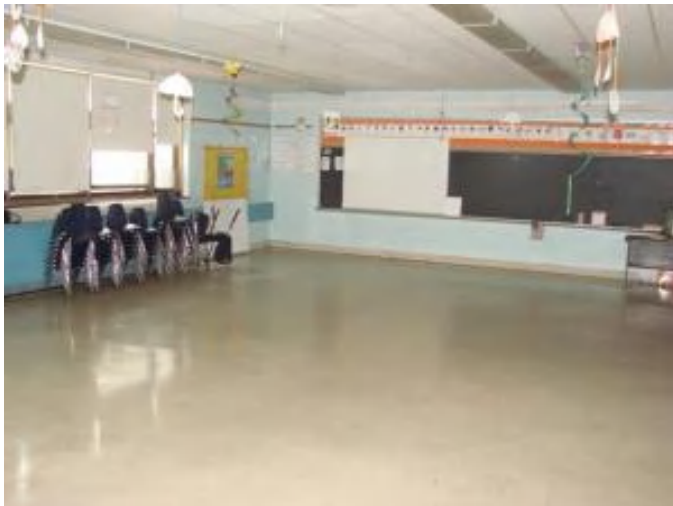
**System: D5020 - Lighting and Branch Wiring**

**Location:** Throughout Building

**Distress:** Inadequate

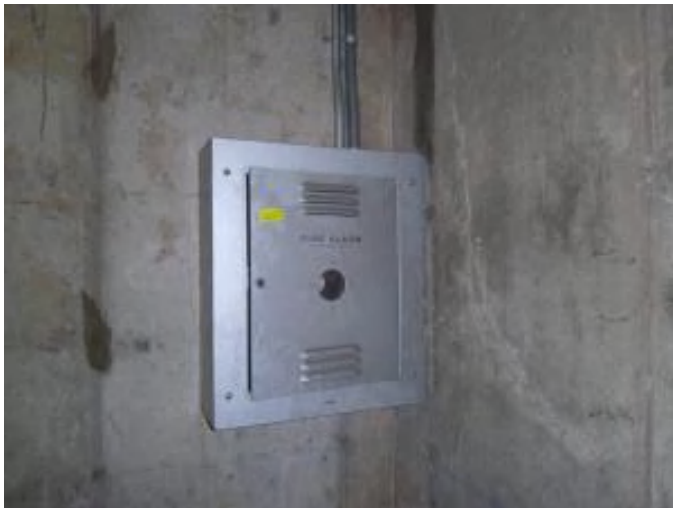
**System: D5030 - Communications and Security**

**Location:** Throughout Building

**Distress:** Life Safety / NFPA / PFD

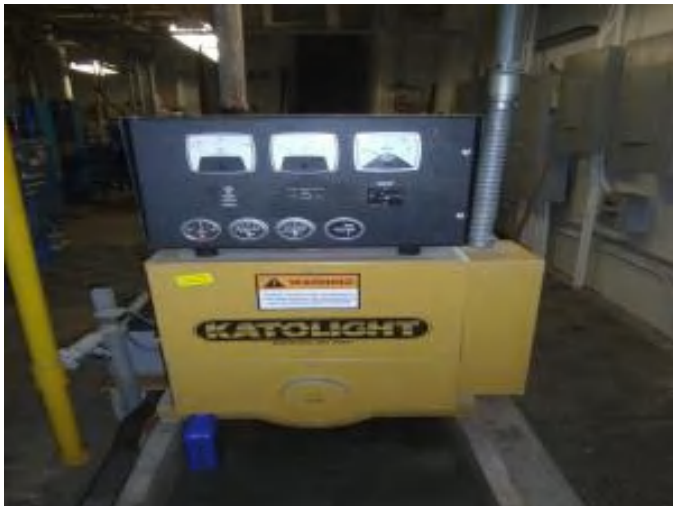
**System: D5090 - Other Electrical Systems**

**Location:** Basement

**Distress:** Inadequate

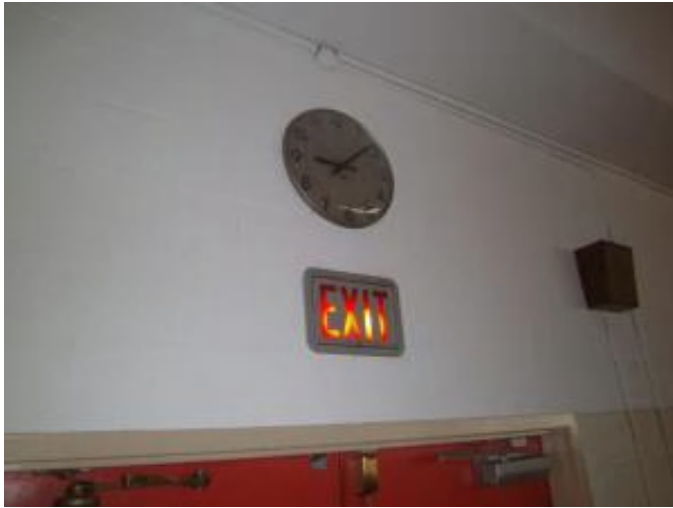
**System: D5090 - Other Electrical Systems**

**Location:** Throughout Building

**Distress:** Inadequate

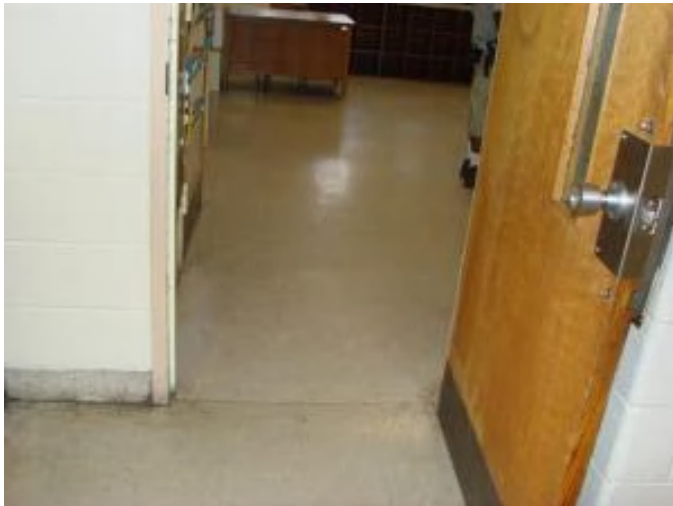
**System: C1020 - Interior Doors**

**Location:** Interior

**Distress:** Accessibility

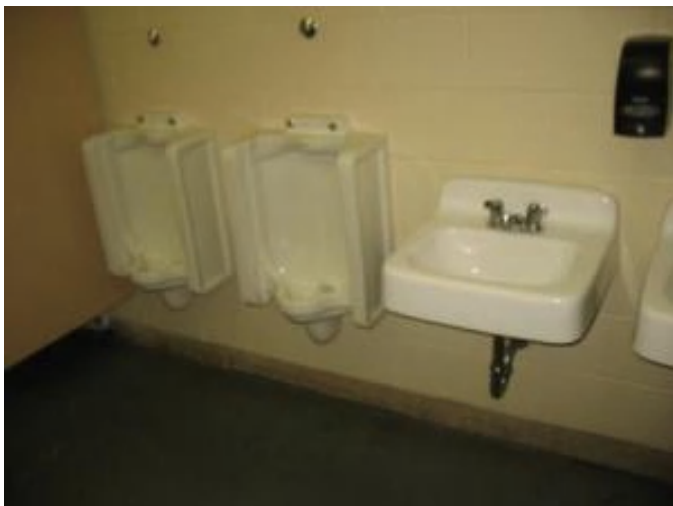
**System: D2010 - Plumbing Fixtures**

**Location:** Restrooms

**Distress:** Accessibility

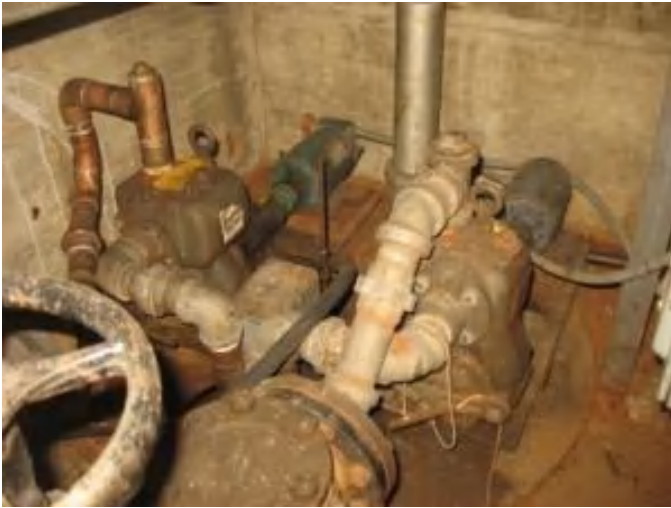
**System: D2030 - Sanitary Waste**

A sewage ejector pit located in basement boiler room receives water from the basement area. It has two pumps that are beyond their service life. According to the Building Engineer one of the pumps was rebuilt in 2014. Both pumps and motors should be replaced. The pit is not sealed, but should be.

**Location:** Boiler Room

**Distress:** Beyond Service Life

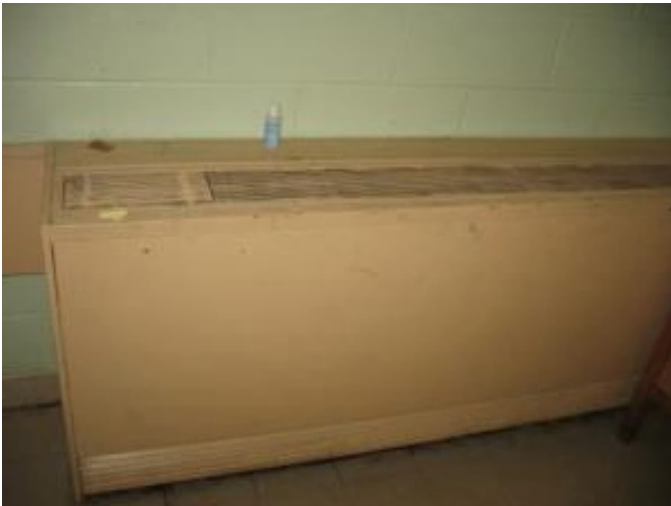
**System: D3040 - Distribution Systems**

**Location:** Throughout building

**Distress:** Beyond Service Life

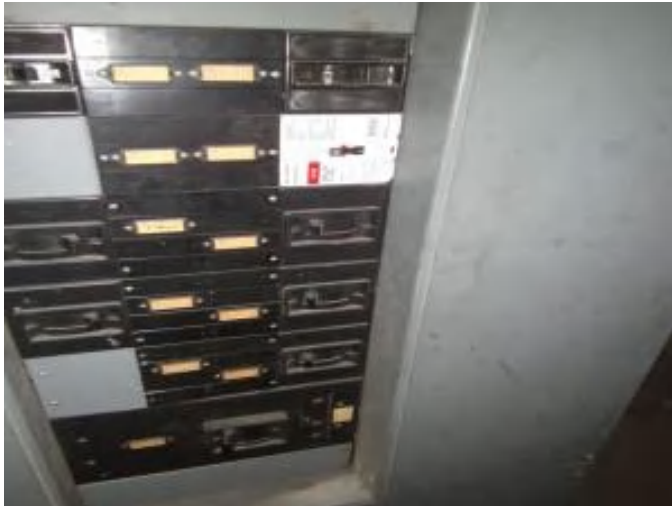
**System: D5010 - Electrical Service/Distribution**

With the addition of air conditioning to the school, the 500 kVA station transformer will not be large enough to carry the new load. A second substation will need to be installed to provide power for the air conditioning. It is recommended that a second feeder from the load side of the medium voltage service disconnect switch be installed to serve a new 2400V:480/277V substation.

**Location:** Basement

**Distress:** Inadequate

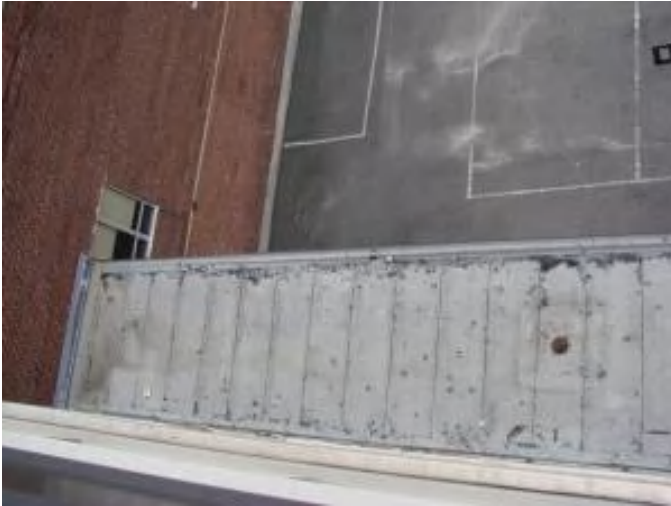
**System: B3010105 - Built-Up**

Roofing system is a built-up system approximately 15 to 20 years old and in fair condition; all roofing and flashing is typically in fair condition with some deterioration of the built-up system; leaks have not been reported.

**Location:** Exterior

**Distress:** Building Envelope Integrity

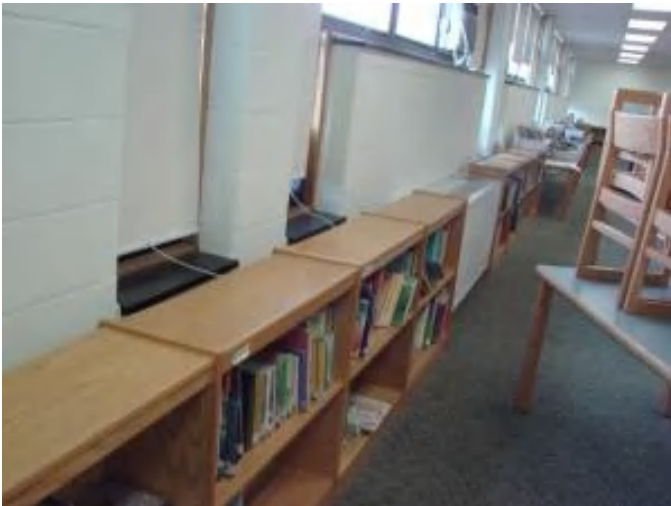
**System: C3020411 - Carpet**

**Location:** Interior

**Distress:** Beyond Service Life

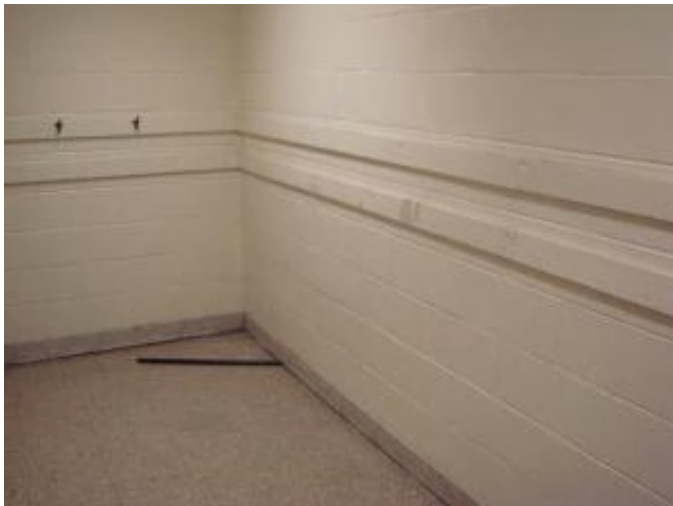
**System: C3020413 - Vinyl Flooring**

**Location:** Interior

**Distress:** Beyond Service Life

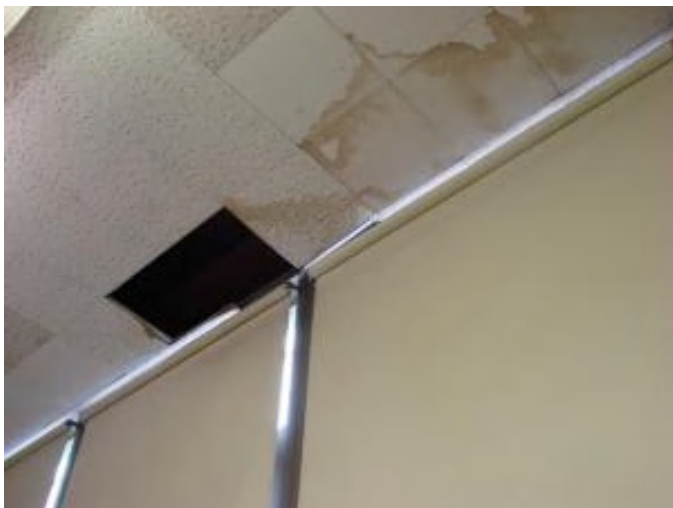
**System: C3030 - Ceiling Finishes**

**Location:** Interior

**Distress:** Beyond Service Life

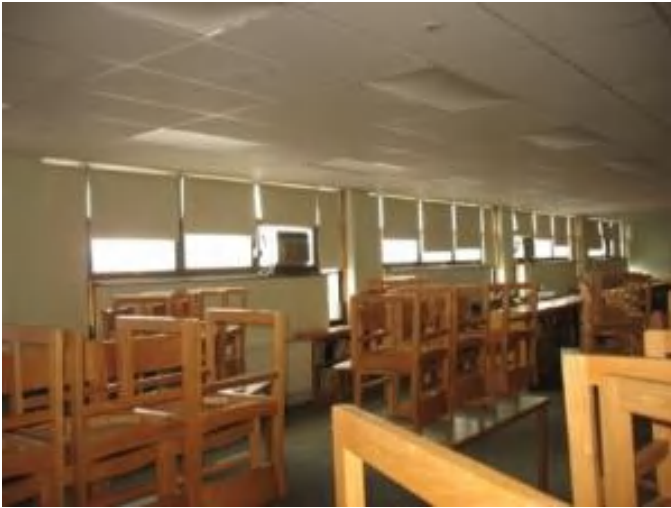
**System: D3030 - Cooling Generating Systems**

Several of the classrooms in the school building have window air conditioning units that have an anticipated service life of only 10 years. Installing a 200 ton air-cooled chiller on the roof, with pumps located in the mechanical room, and chilled water distribution piping would supply more reliable air conditioning for the building with a much longer service life.

**Location:** Roof

**Distress:** Inadequate

- Remove the window air conditioning units and install a 200 ton air-cooled chiller on the roof with chilled water distribution piping and pumps located in the mechanical room to supply more reliable air conditioning for the building with a much longer service life.

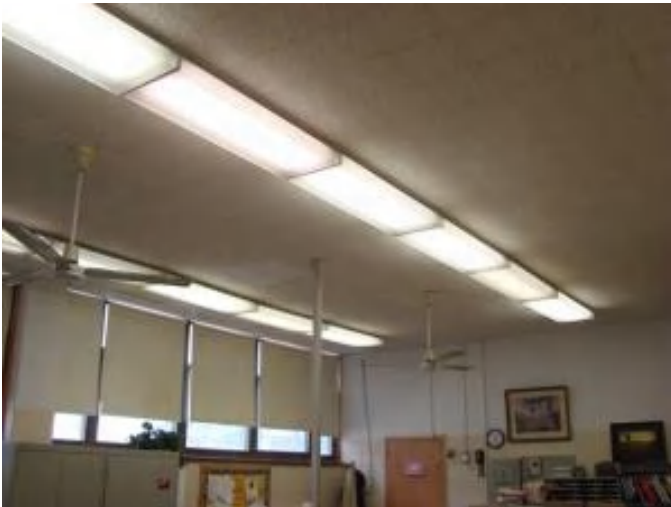
**System: D3040 - Distribution Systems**

**Location:** Administration

**Distress:** Building / MEP Codes

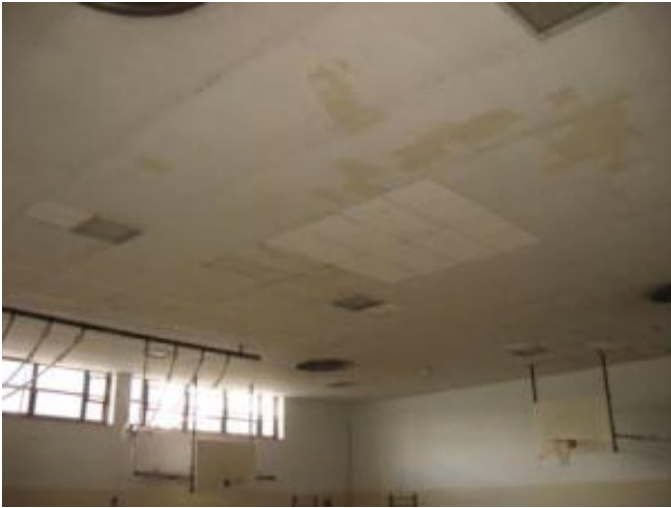
**System: D3040 - Distribution Systems**

**Location:** Gymnasium

**Distress:** Building / MEP Codes

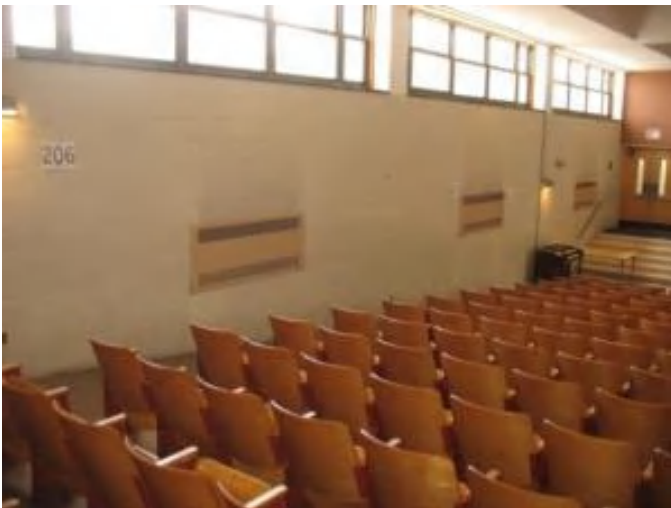
**System: D3040 - Distribution Systems**

**Location:** Auditorium

**Distress:** Building / MEP Codes

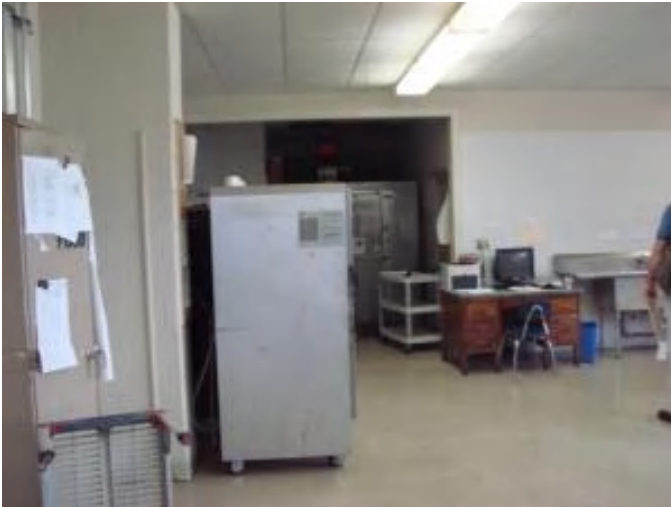
**System: D3040 - Distribution Systems**

**Location:** Cafeteria

**Distress:** Building / MEP Codes

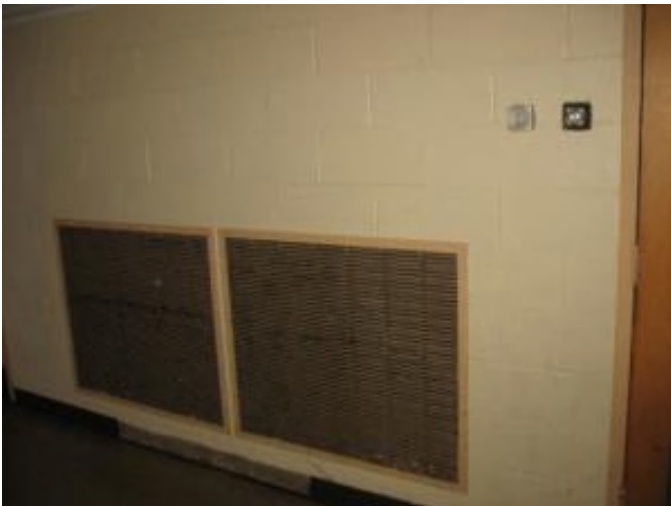
**System: D3060 - Controls & Instrumentation**

The original pneumatic systems still provide basic control functions. Pneumatic room thermostats are intended to control the steam radiator control valves. In reality the radiator control valves are wide open and heating control is achieved via the boilers. Pneumatic control air is supplied from two Quincy compressors located in the boiler room. The maintenance staff reports no problems with oil, moisture or dirt in the pneumatic copper tubing. The pneumatic systems are beyond their service life and require too much attention from the maintenance staff. The original control valves and pneumatic actuators are beyond their service life and should be rebuilt or replaced. These controls should be converted to DDC.

**Location:** Throughout building

**Distress:** Energy Efficiency

- Replace the pneumatic controls for the HVAC systems with modern DDC modules, valves and actuators to improve reliability and energy efficiency. Provide a new building automation system (BAS) with communication interface to the preferred system in use throughout the District.

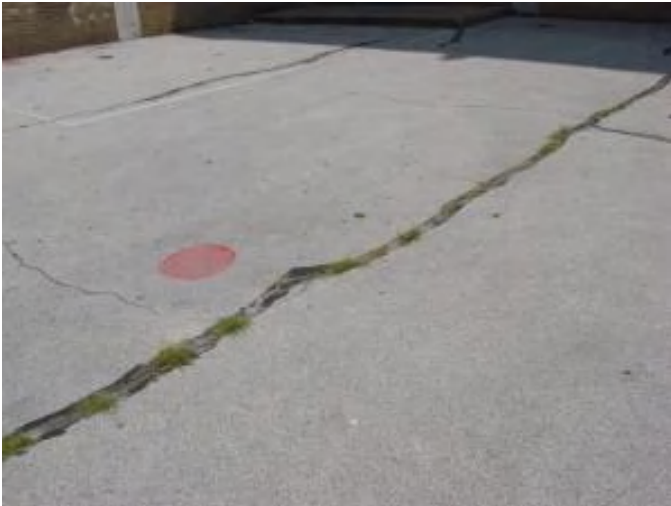
#### **System: G2030 - Pedestrian Paving**

**Location:** Grounds

**Distress:** Damaged

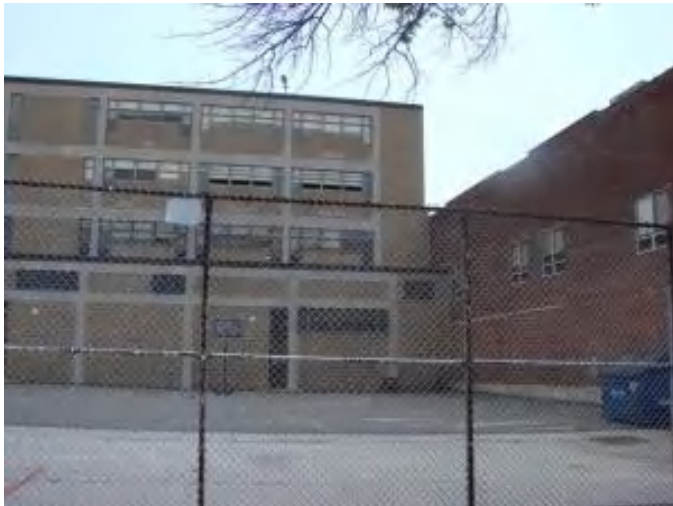
**System: G2040 - Site Development**

**Location:** Grounds

**Distress:** Security Issue

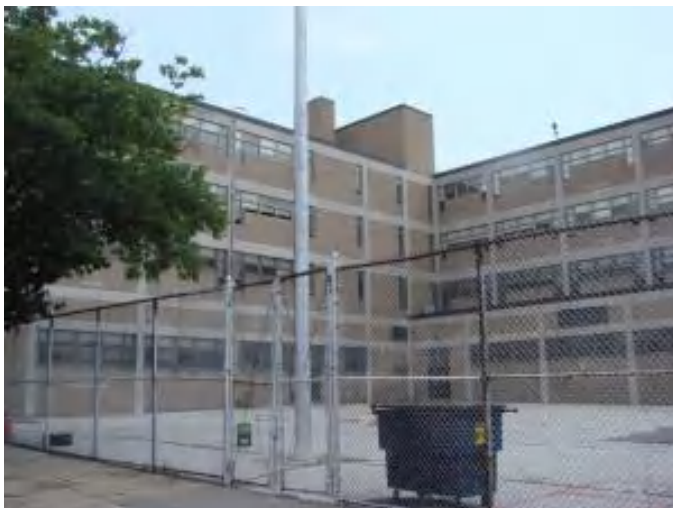
**System: G2040 - Site Development**

**Location:** Grounds

**Distress:** Beyond Service Life
