Facility Condition Assessment Summary Report

Morrison School

School District of Philadelphia
S739001;Morrison
Final
Site Assessment Report
January 31, 2017

Facility Condition Assessment
July 2015

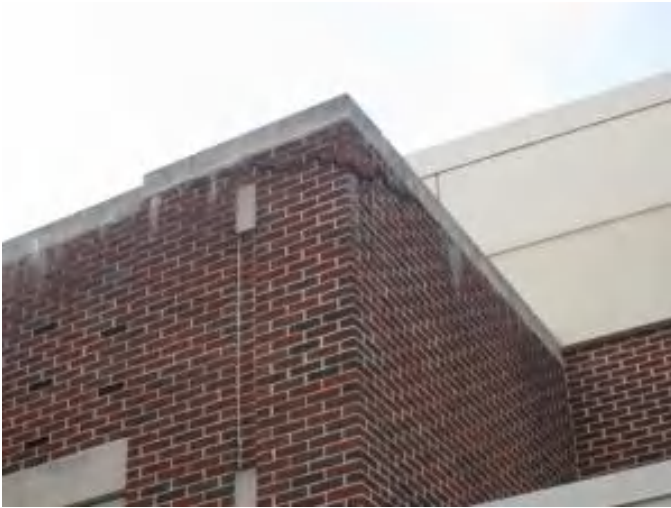
Location: exterior brick wall - addition

System: B2010 - Exterior Walls

Distress: Failing

Notes: Reconstruct top of wall at top over entrance to southwest addition

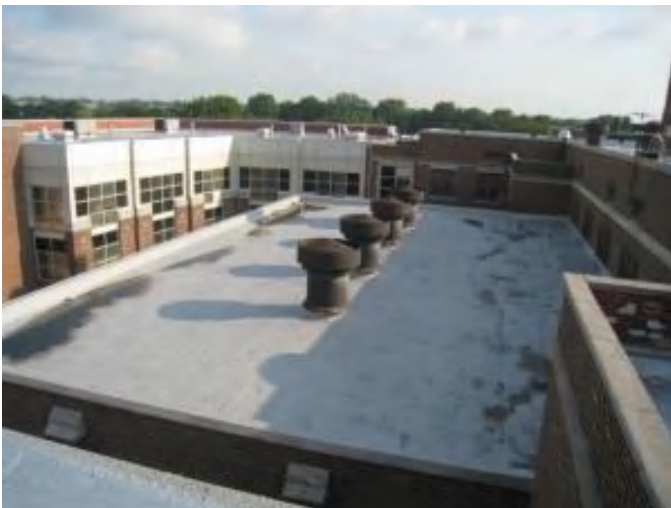
Location: roofs

System: B3010105 - Built-Up

Distress: Failing

Notes: Repair flashing and counterflashing on all roofs with brick parapets

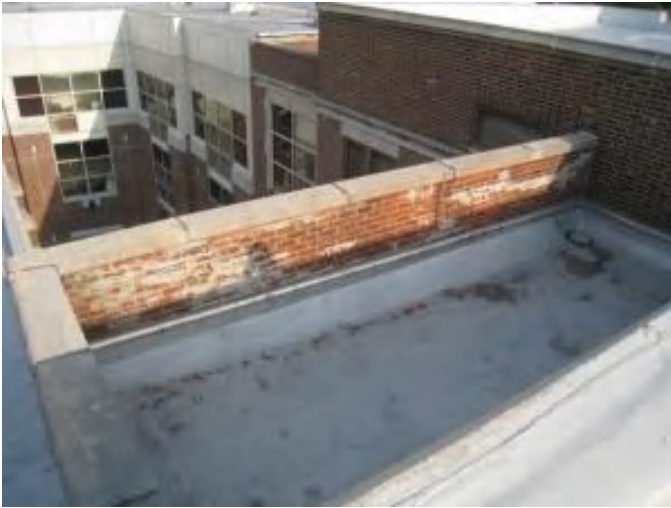
Location: roof parapets

System: B3010105 - Built-Up

Distress: Failing

Notes: Repair flashing and counterflashing on all roofs with brick parapets

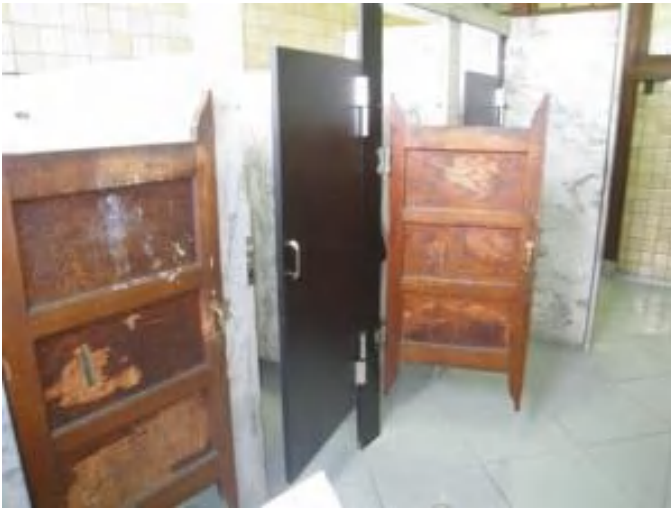
Location: toilet rooms

System: C1030 - Fittings

Distress: Damaged

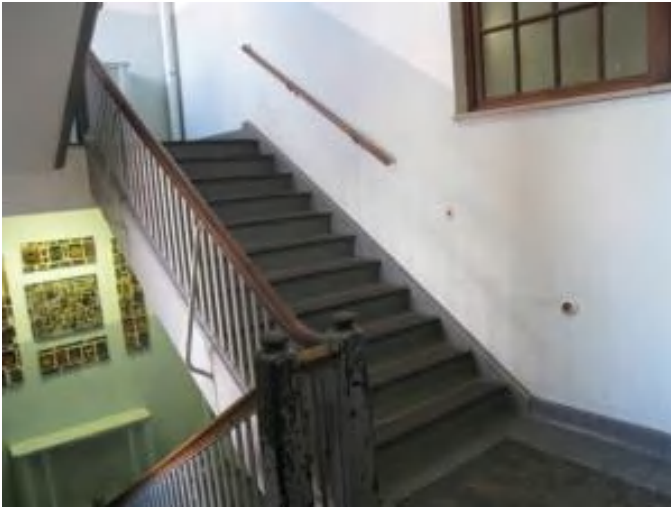
Location: stairways - old building

System: C2010 - Stair Construction

Distress: Building / MEP Codes

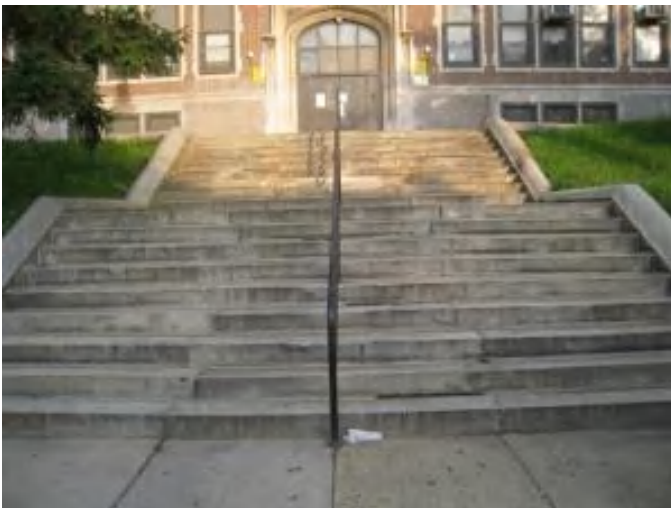
Location: exterior entrance stairs

System: C2010 - Stair Construction

Distress: Failing

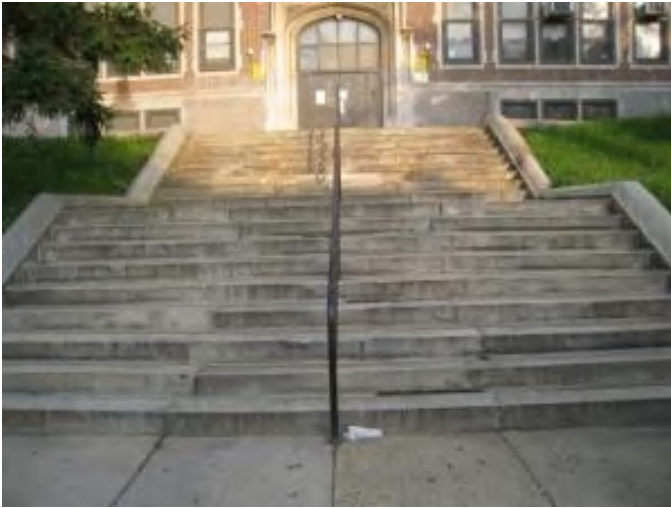
Location: exterior entrance stairway

System: C2010 - Stair Construction

Distress: Building / MEP Codes

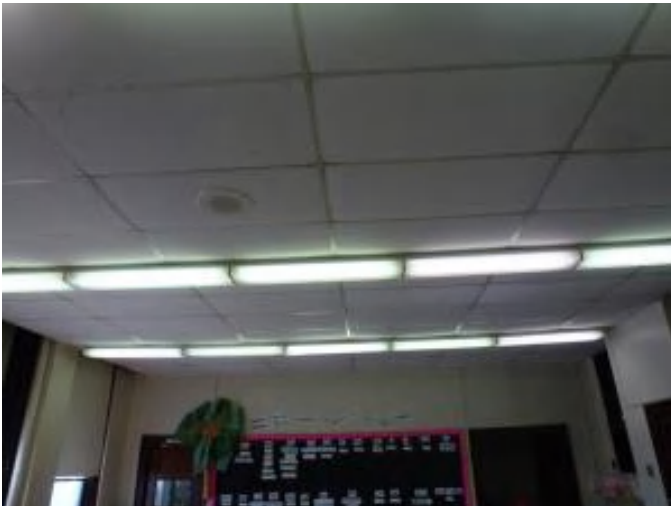
Location: Entire Building

System: D5020 - Lighting and Branch Wiring

Distress: Beyond Service Life

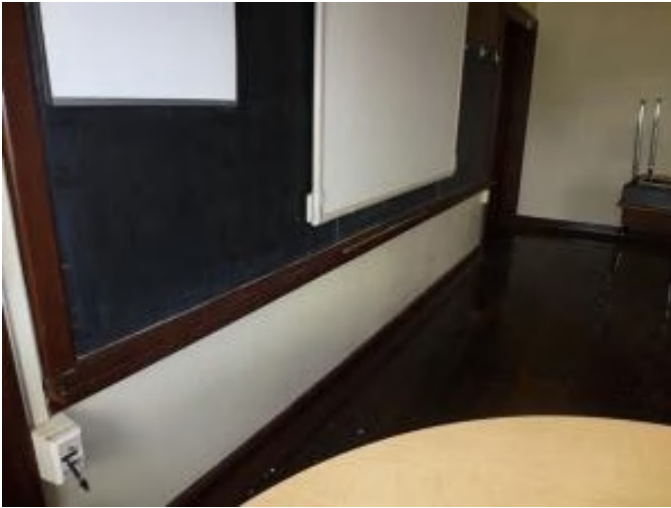
Location: Entire building

System: D5020 - Lighting and Branch Wiring

Distress: Inadequate

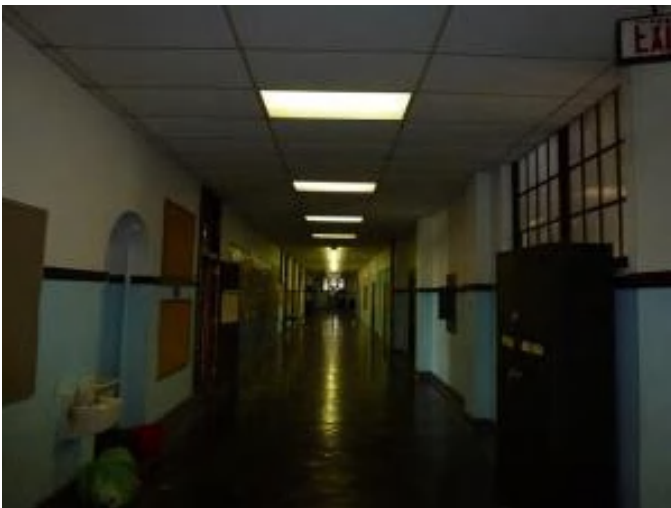
Location: Entire Building

System: D5020 - Lighting and Branch Wiring

Distress: Life Safety / NFPA / PFD

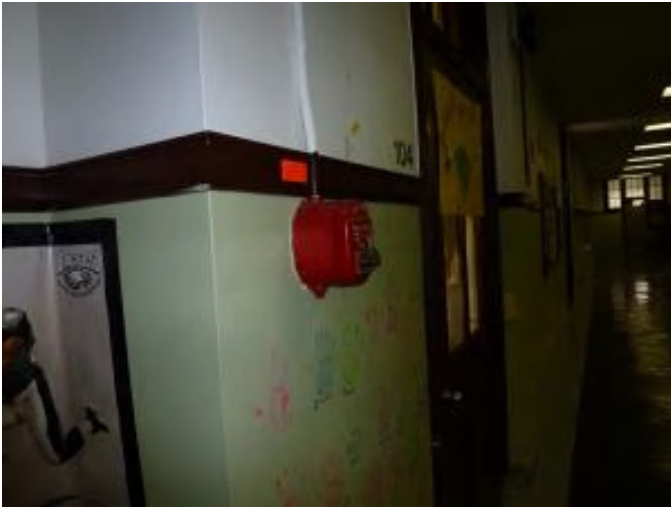
Location: Entire Building

System: D5030 - Communications and Security

Distress: Beyond Service Life

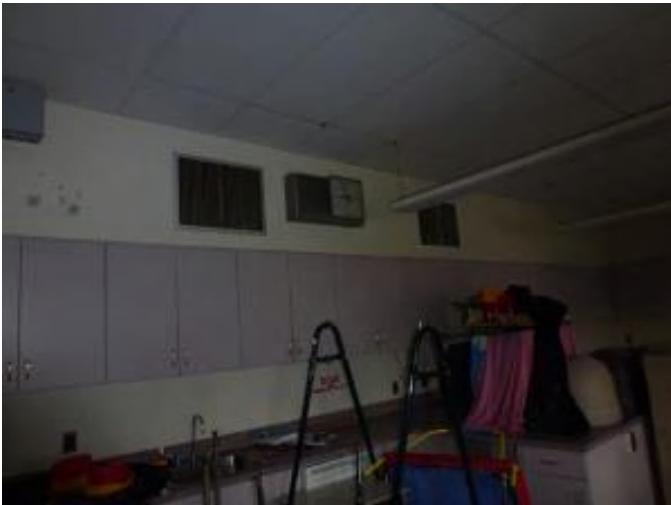
Location: Entire Building

System: D5030 - Communications and Security

Distress: Damaged

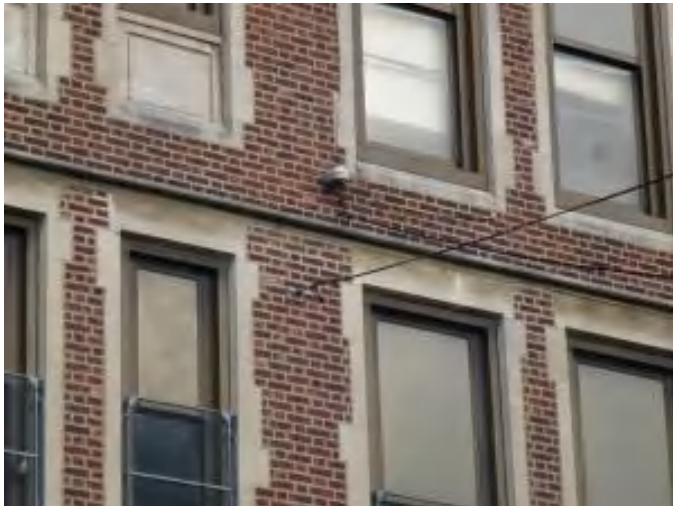
Location: exterior

System: D5030 - Communications and Security

Distress: Security Issue

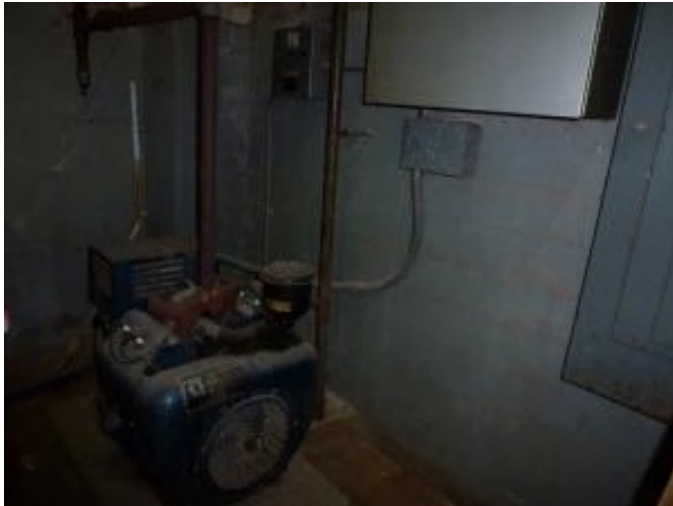
Location: Boiler Room in the basement

System: D5090 - Other Electrical Systems

Distress: Life Safety / NFPA / PFD

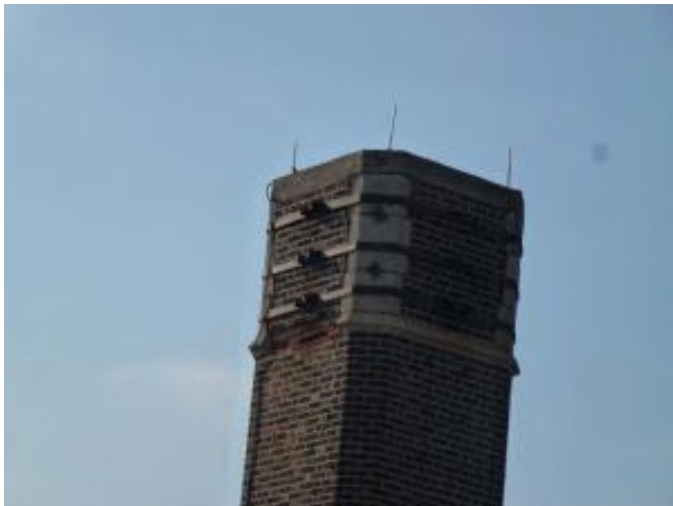
Location: roof and chimney

System: D5090 - Other Electrical Systems

Distress: Life Safety / NFPA / PFD

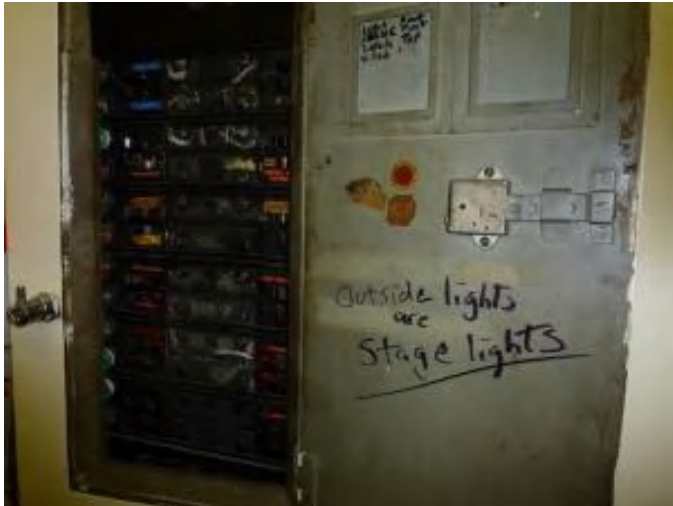
Location: Auditorium

System: E1020 - Institutional Equipment

Distress: Beyond Service Life

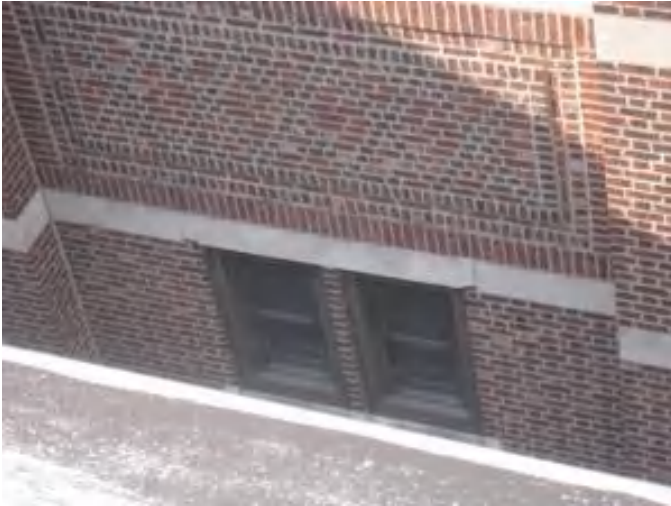
Location: exterior limestone panels - old building

System: B2010 - Exterior Walls

Distress: Damaged

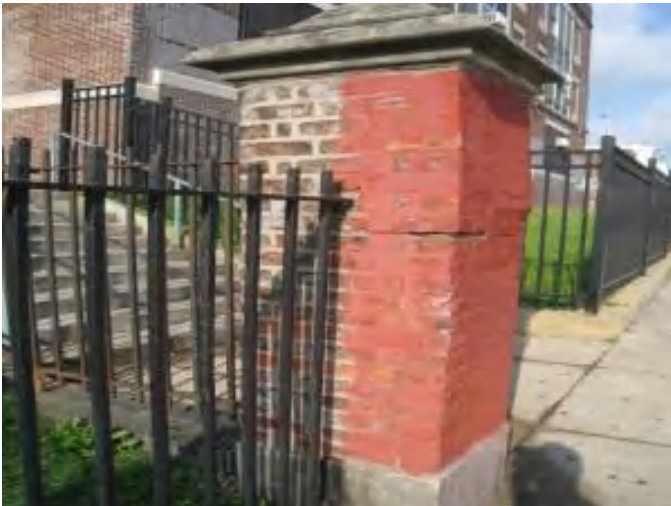
Location: exterior brick structures along street

System: B2010 - Exterior Walls

Distress: Damaged

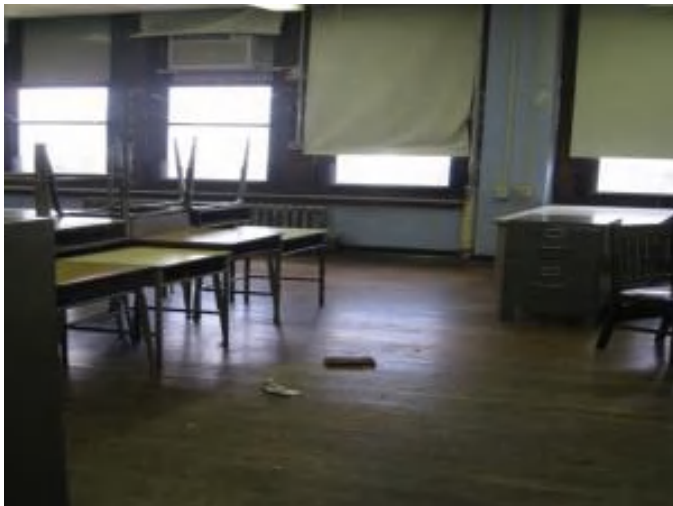
Location: windows

System: B2020 - Exterior Windows

Distress: Beyond Service Life

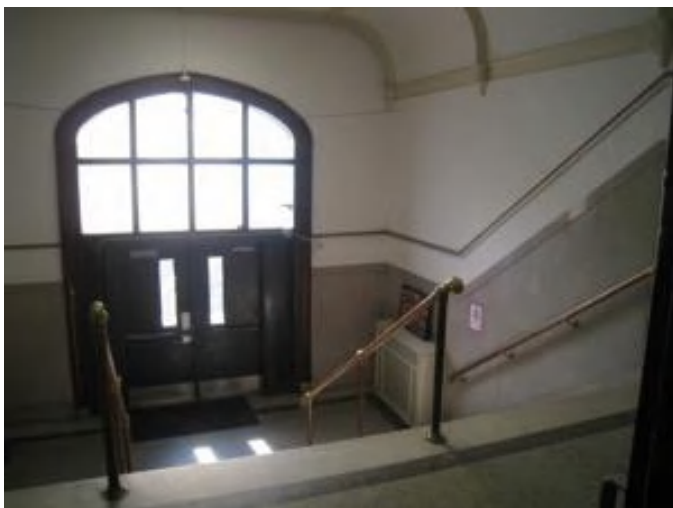
Location: exterior doors

System: B2030 - Exterior Doors

Distress: Appearance

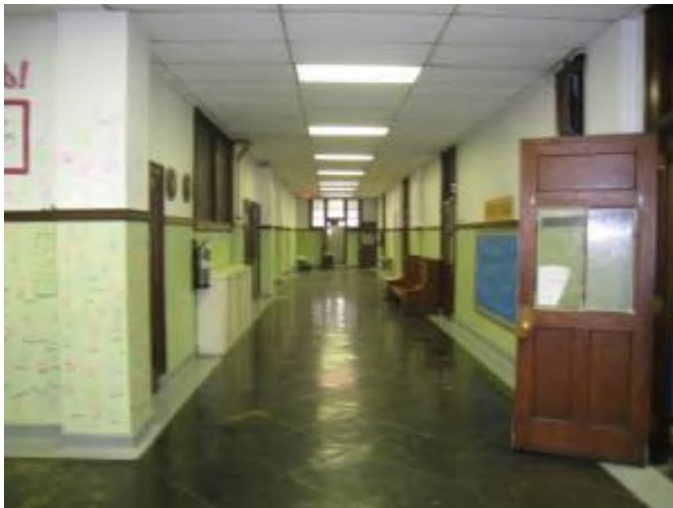
Location: corridors - old building

System: C1010 - Partitions

Distress: Building / MEP Codes

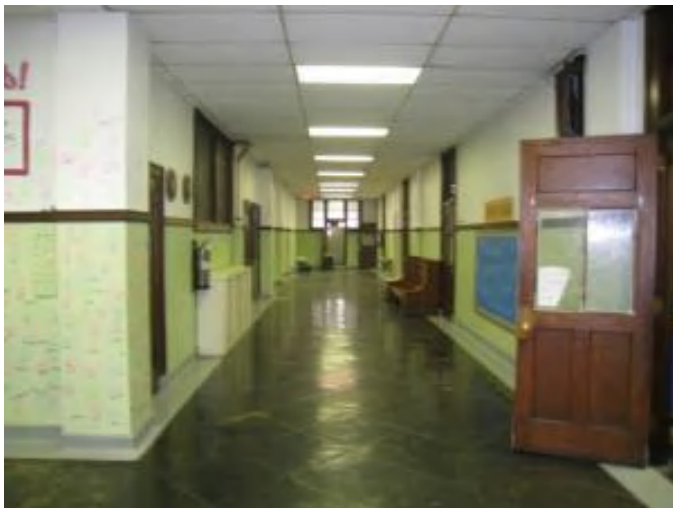
Location: interior doors in old building

System: C1020 - Interior Doors

Distress: Damaged

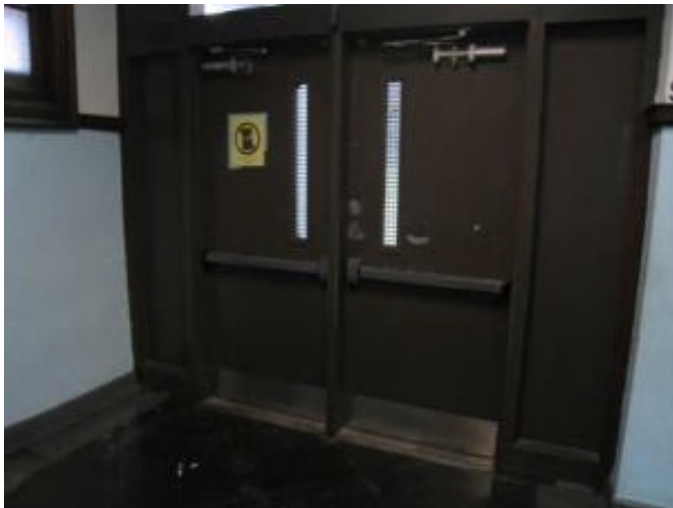
Location: interior doors

System: C1020 - Interior Doors

Distress: Appearance

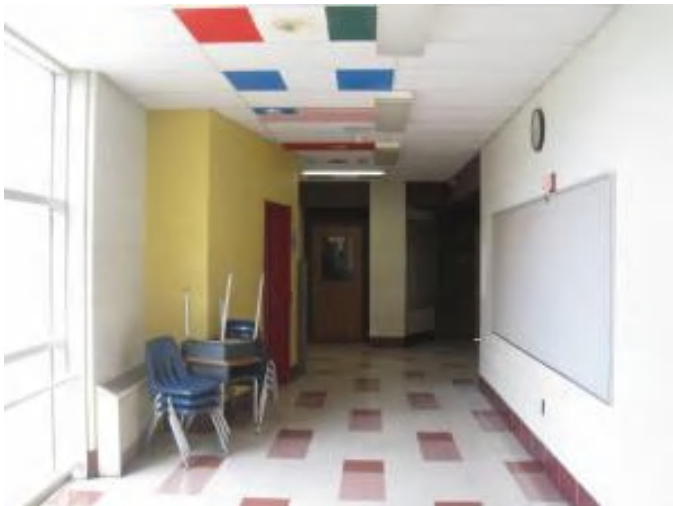
Location: interior doors in addition

System: C1020 - Interior Doors

Distress: Appearance

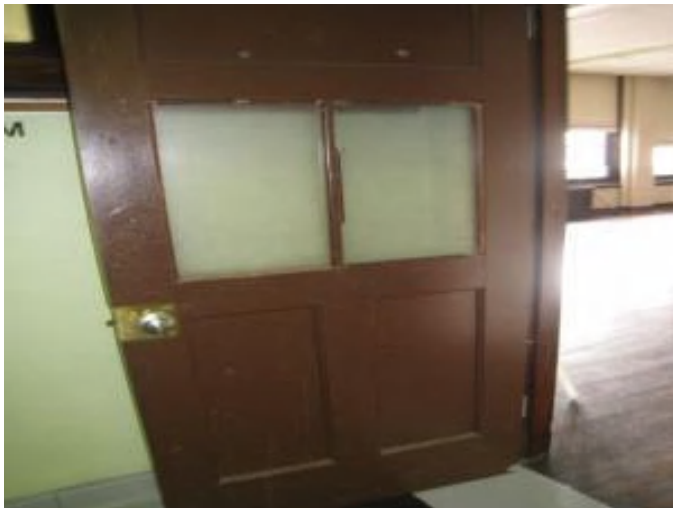
Location: classroom and office doors

System: C1020 - Interior Doors

Distress: Security Issue

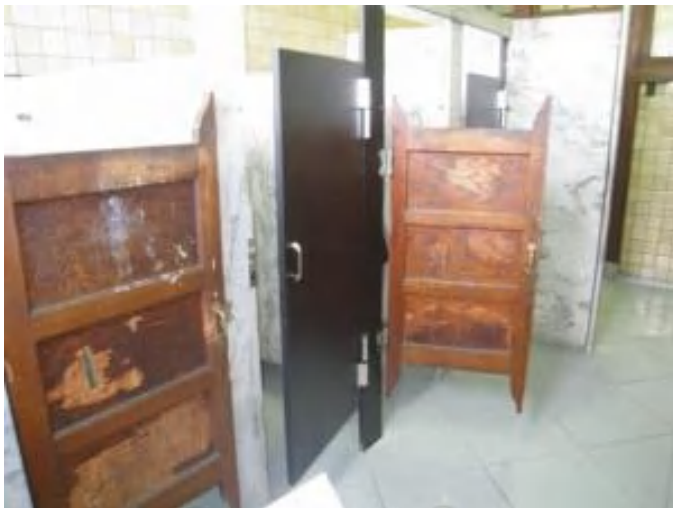
Location: toilet rooms - old building

System: C1030 - Fittings

Distress: Damaged

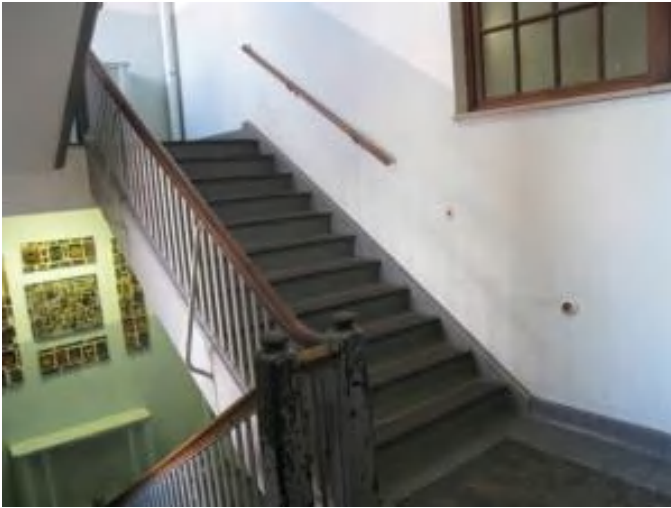
Location: walls - old building

System: C3010230 - Paint & Covering

Distress: Appearance

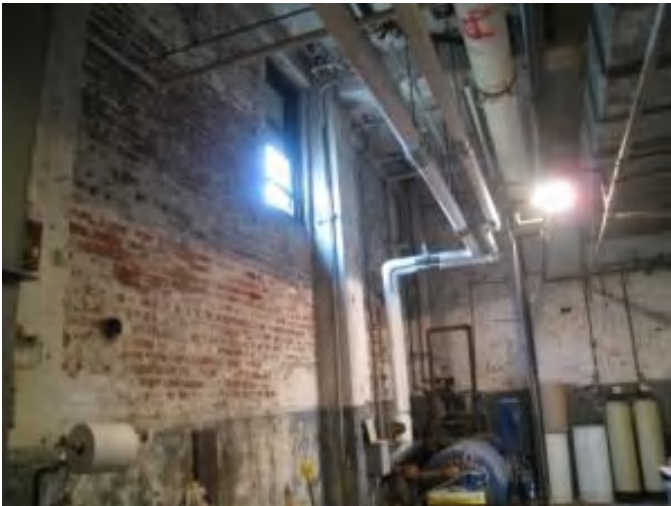
Location: mechanical room

System: C3010230 - Paint & Covering

Distress: Failing

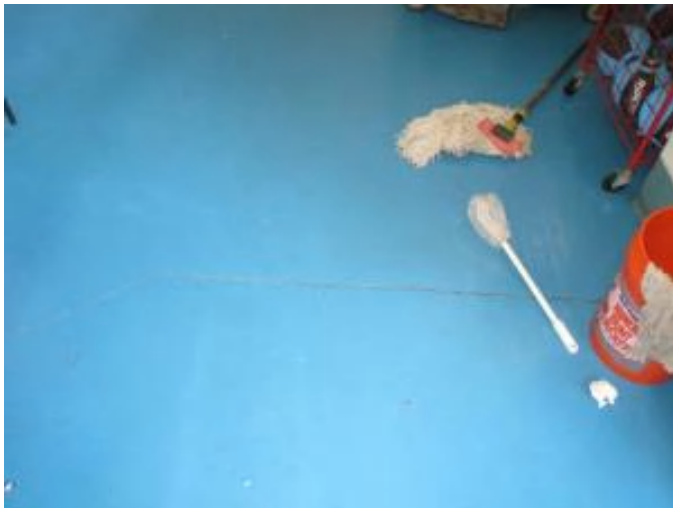
Location: old building and gymnasium

System: C3020413 - Vinyl Flooring

Distress: Beyond Service Life

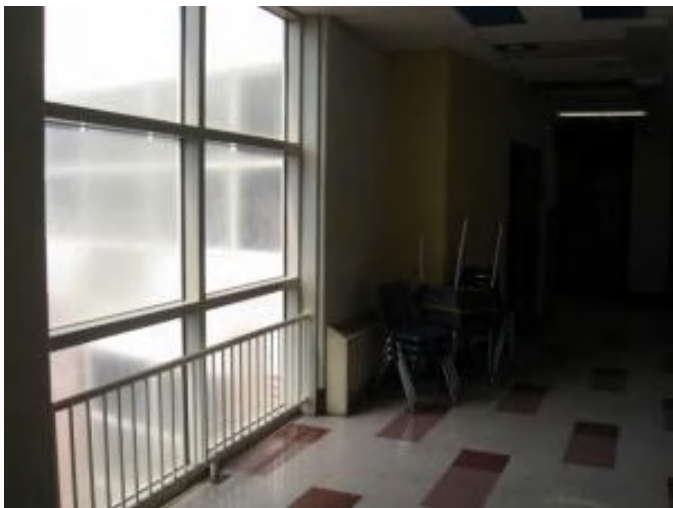
Location: floors - addition

System: C3020413 - Vinyl Flooring

Distress: Appearance

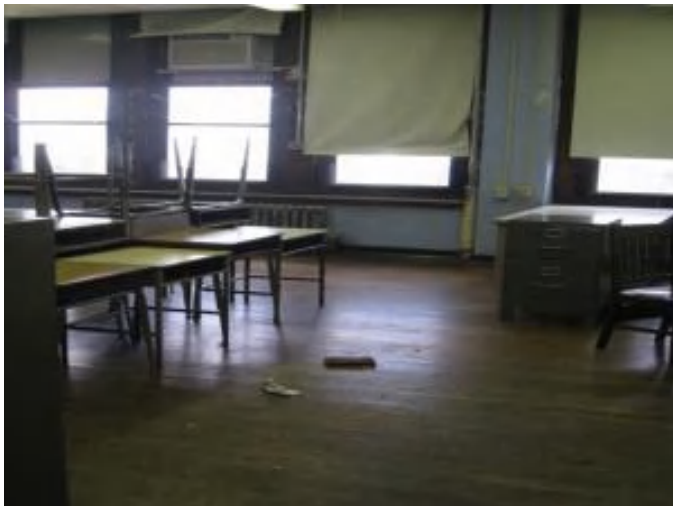
Location: classrooms - old building

System: C3020414 - Wood Flooring

Distress: Appearance

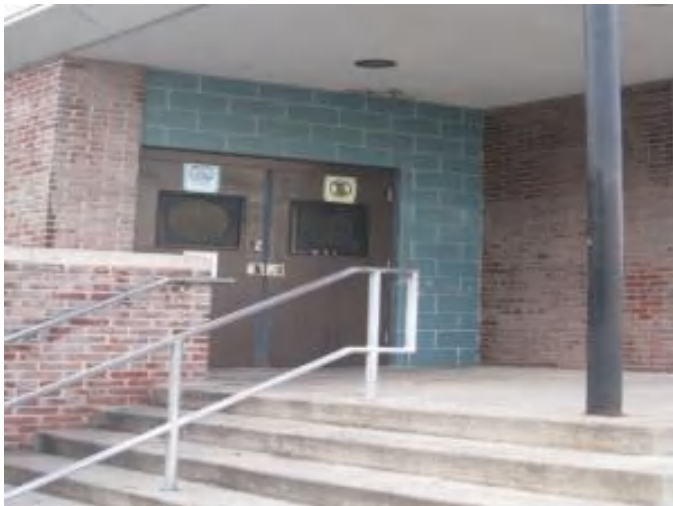
Location: soffit - addition entrance

System: C3030 - Ceiling Finishes

Distress: Damaged

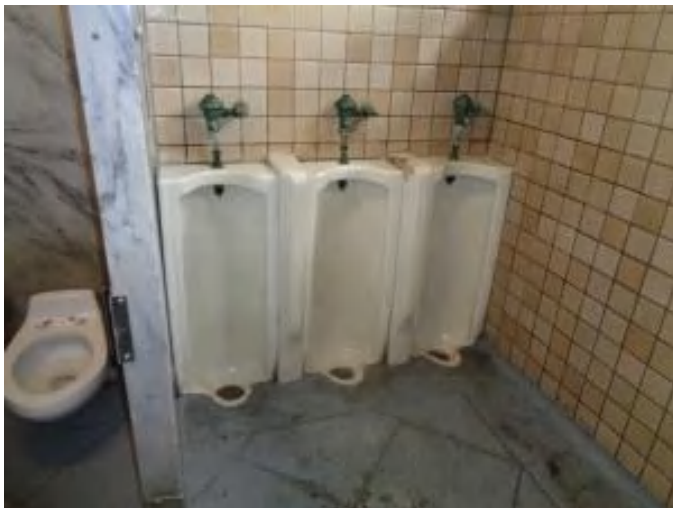
Location: Throughout the building

System: D2010 - Plumbing Fixtures

Distress: Beyond Service Life

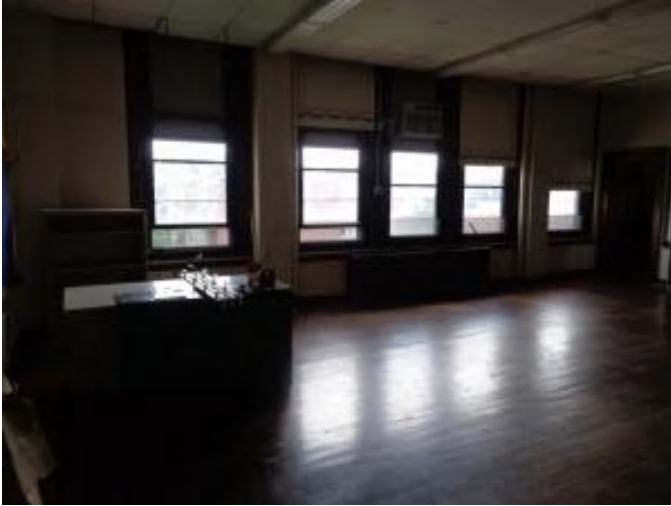
Location: Throughout the building

System: D3040 - Distribution Systems

Distress: Health Hazard / Risk

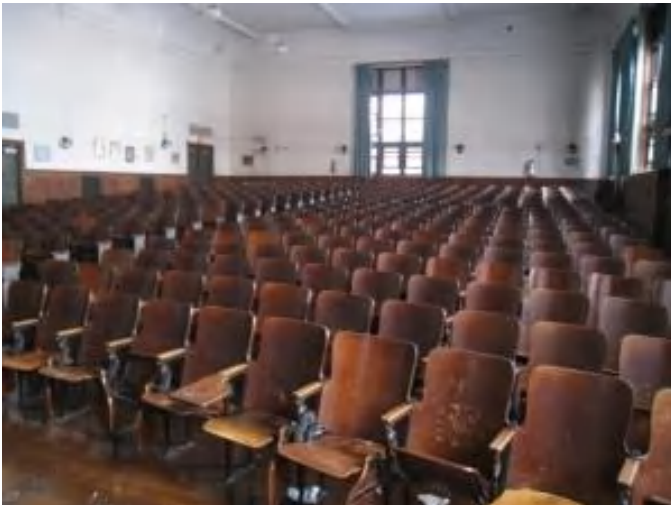
Location: auditorium

System: E2010 - Fixed Furnishings

Distress: Failing

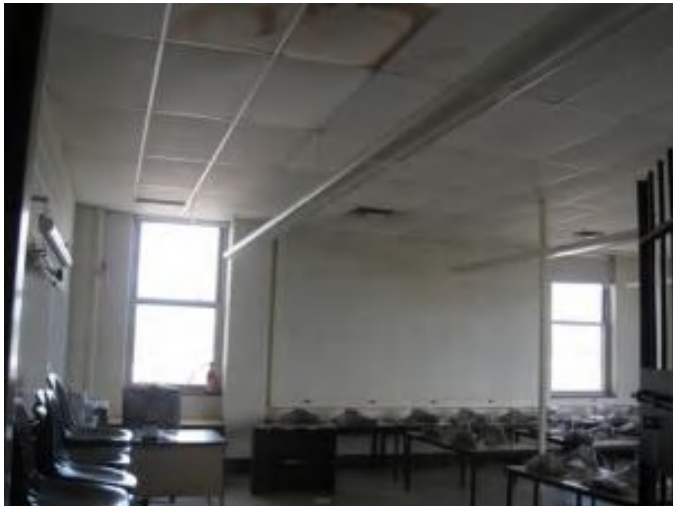
Location: ceilings

System: C3030 - Ceiling Finishes

Distress: Appearance

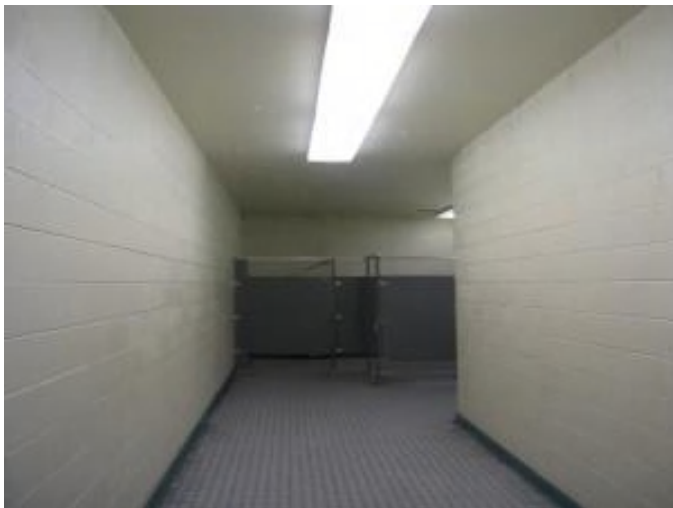
Location: ceilings in mechanical rooms and toilet rooms

System: C3030 - Ceiling Finishes

Distress: Appearance

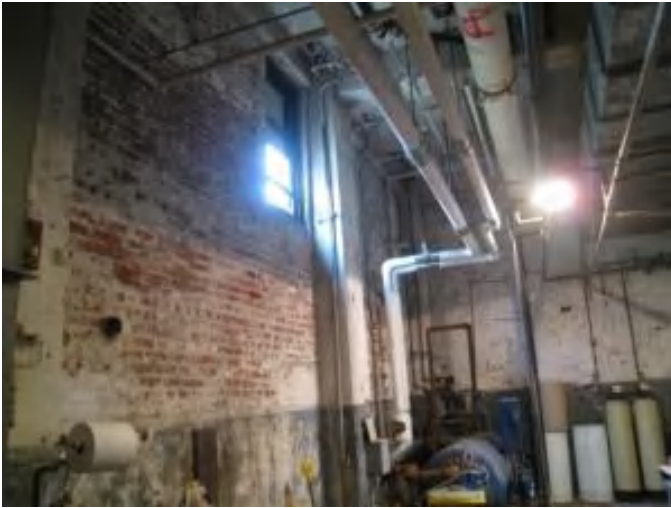
Location: Throughout the building

System: D3040 - Distribution Systems

Distress: Beyond Service Life

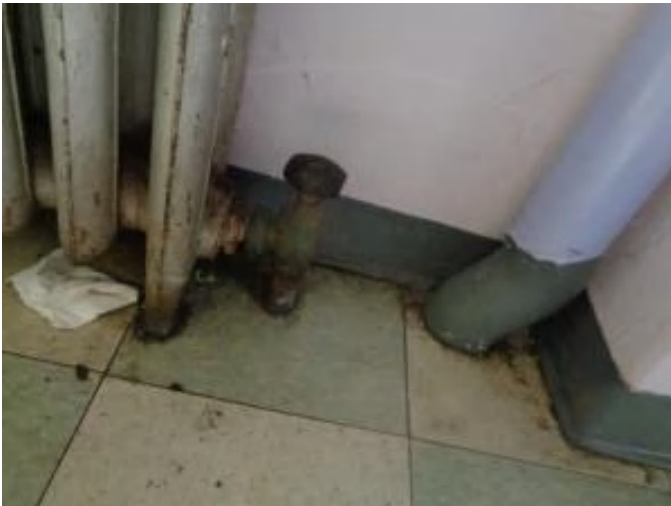
Location: Throughout the building

System: D3060 - Controls & Instrumentation

Distress: Failing

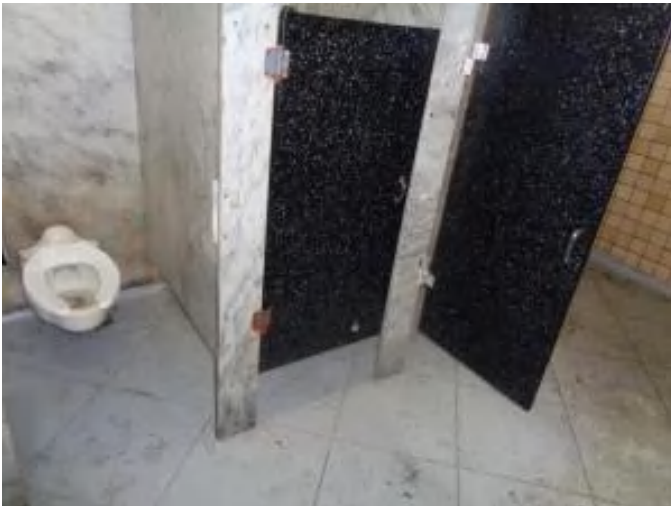
Location: Throughout the building

System: D2010 - Plumbing Fixtures

Distress: Beyond Service Life

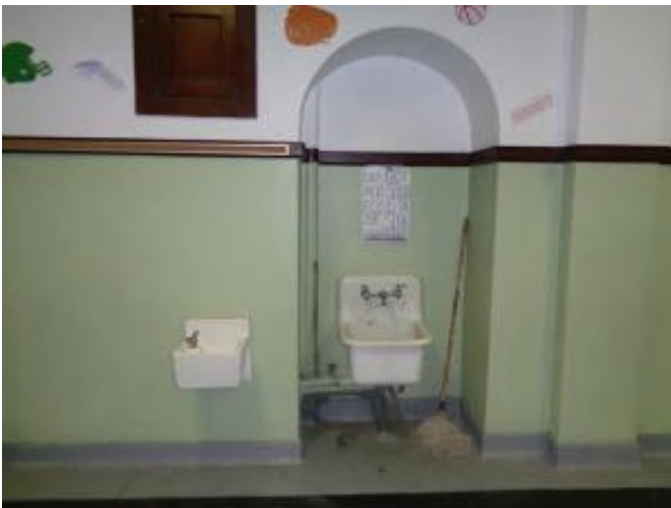
Location: Throughout the building

System: D2010 - Plumbing Fixtures

Distress: Beyond Service Life

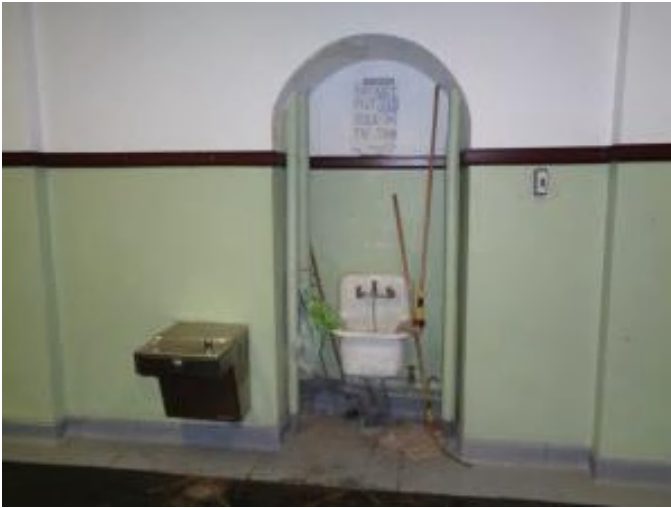
Location: Throughout the building

System: D2010 - Plumbing Fixtures

Distress: Beyond Service Life

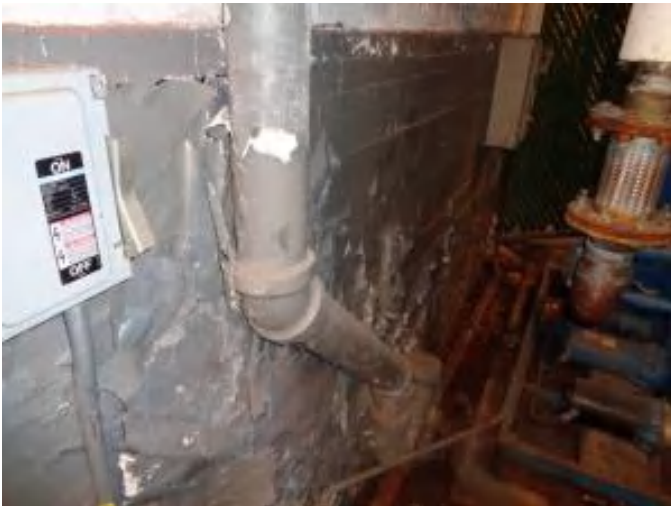
Location: Throughout the building

System: D2030 - Sanitary Waste

Distress: Beyond Service Life

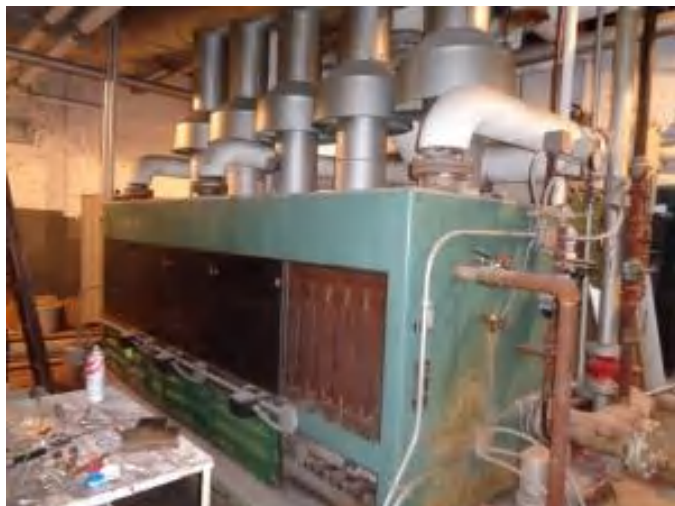
Location: Boiler Mechanical Equipment Room

Heat Generating Systems - Steam is generated in the basement of the original building by two Weil McLain K-26 natural gas fired boilers. The boilers sit on 6" high concrete pads and each have a capacity of 4200 lb/hr steam. The boilers appear to be nearing the end of their serviceable life and should be replaced within the next 5-10 years.

System: D3020 - Heat Generating Systems

Distress: Beyond Service Life

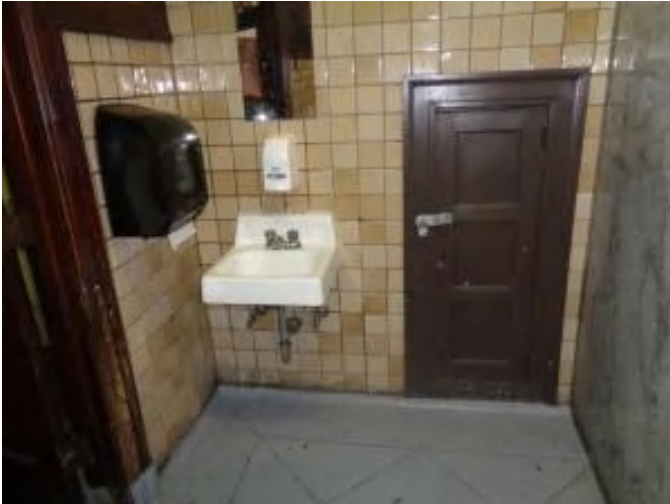
Location: Throughout the building

System: D2010 - Plumbing Fixtures

Distress: Beyond Service Life

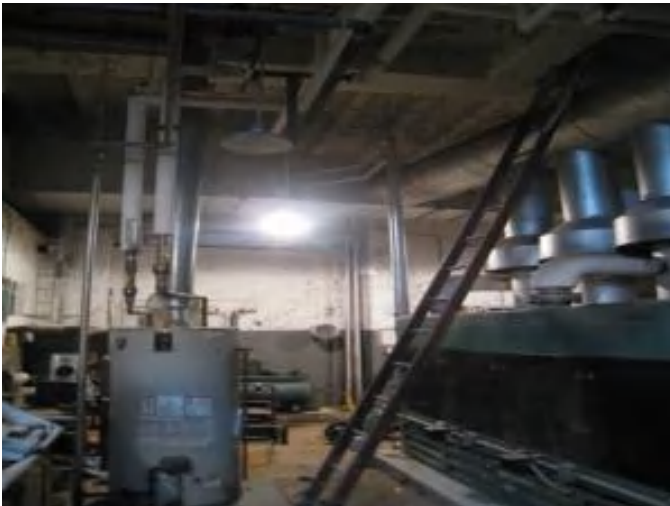
Location: Throughout the building

System: D2020 - Domestic Water Distribution

Distress: Beyond Service Life

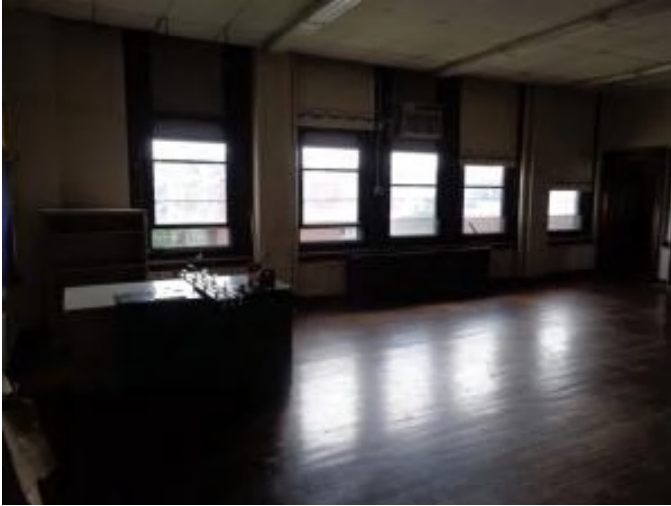
Location: Throughout the building

System: D3030 - Cooling Generating Systems

Distress: Inadequate

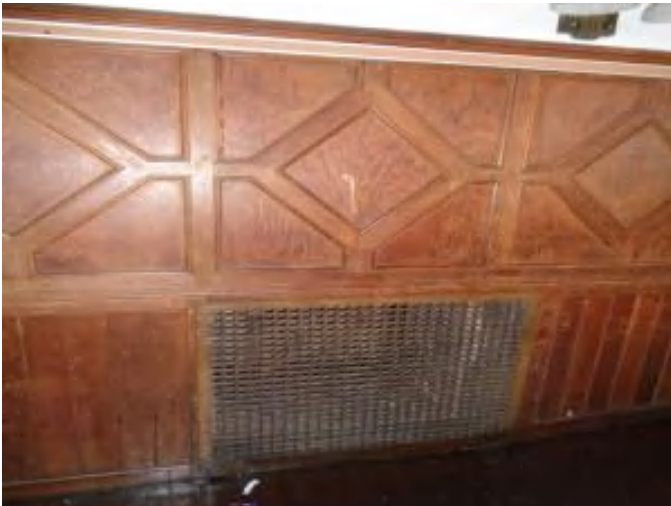
Location: Auditorium

System: D3040 - Distribution Systems

Distress: Beyond Service Life

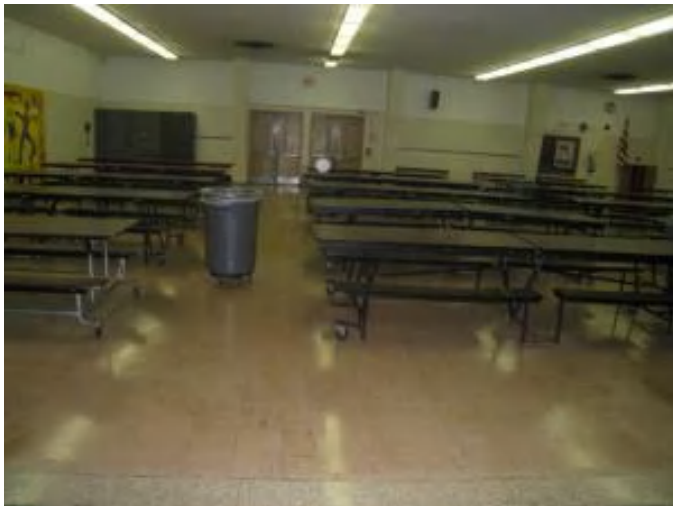
Location: Cafeteria

System: D3040 - Distribution Systems

Notes: Install AHUs to condition the cafeteria

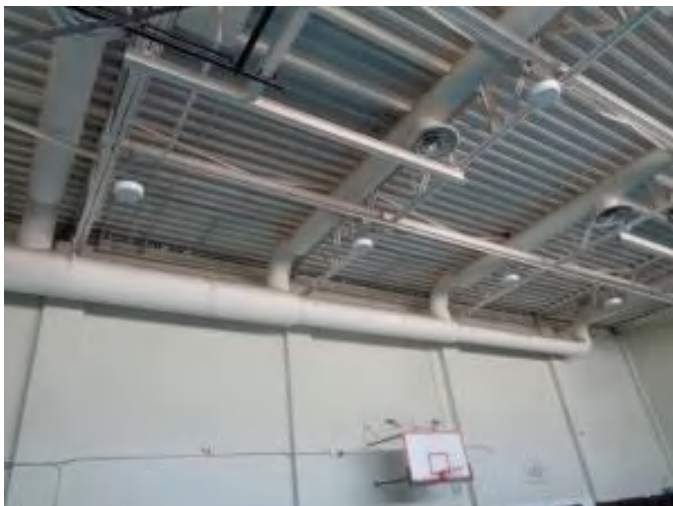
Location: Gymnasium

System: D3040 - Distribution Systems

Notes: Install AHUs to condition the gymnasium

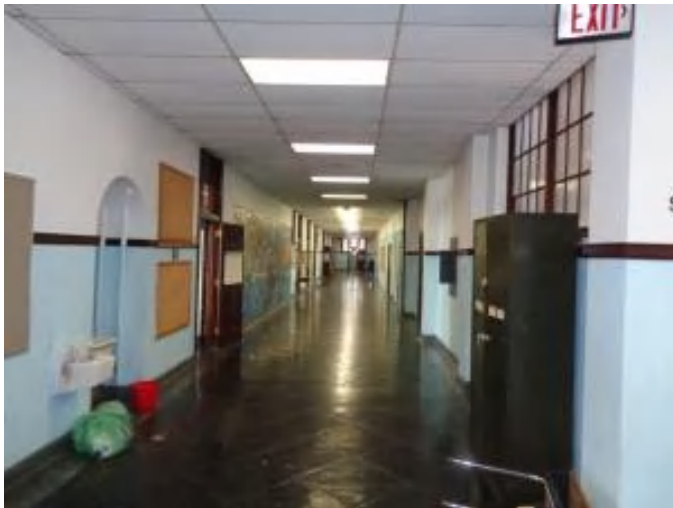
Location: Throughout the building

System: D4010 - Sprinklers

Distress: Life Safety / NFPA / PFD

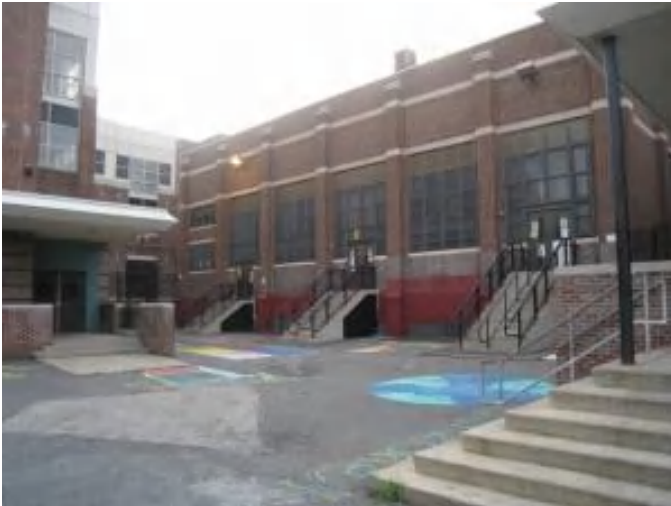
Location: parking lot entrance

System: G2020 - Parking Lots

Distress: Failing

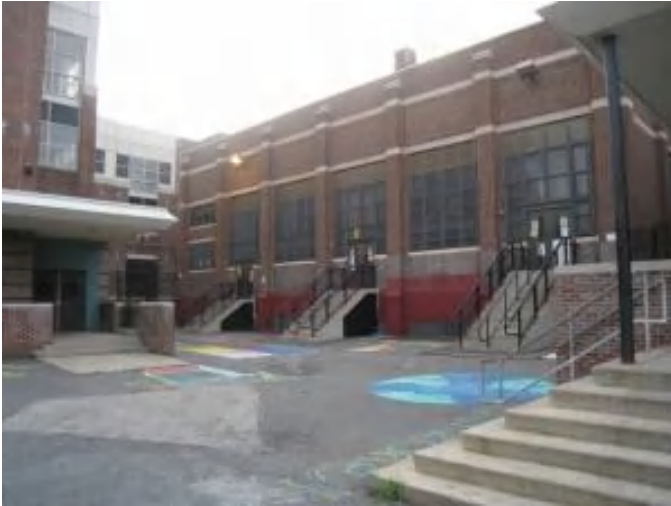
Location: parking lot / play area

System: G2020 - Parking Lots

Distress: Damaged

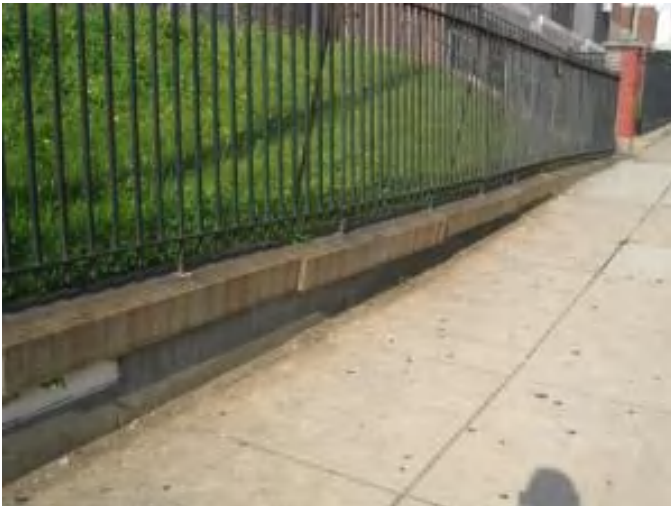
Location: site fence

System: G2040 - Site Development

Distress: Failing

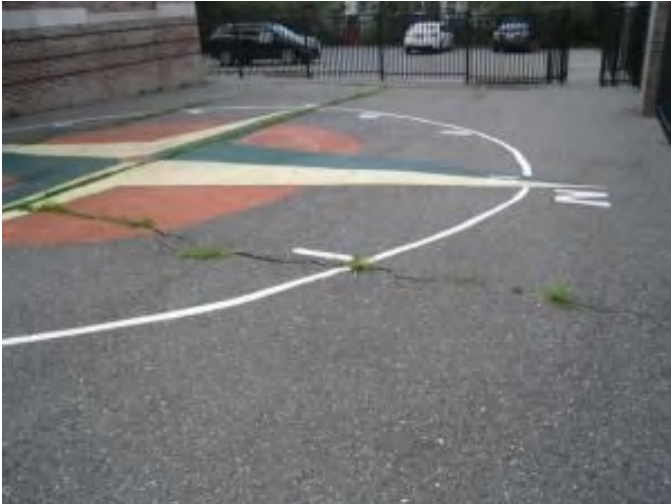
Location: parking lot

System: G2020 - Parking Lots

Distress: Damaged
