Facility Condition Assessment Summary Report

Morton School

Morton Annex (Our Lady of Loreto) School

January 30, 2017

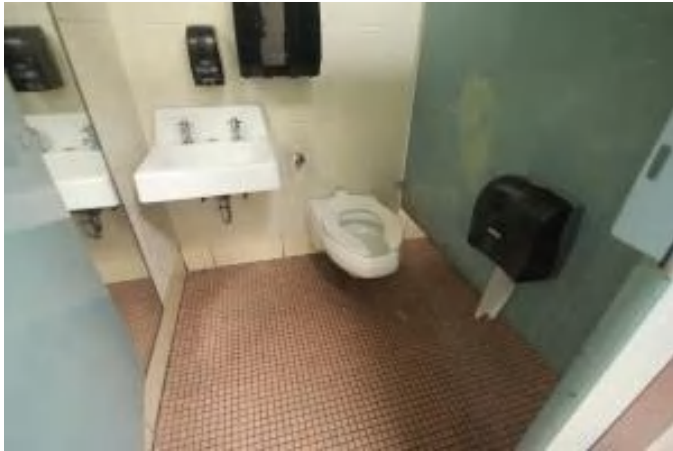
System: C1030 - Fittings

Location: Throughout

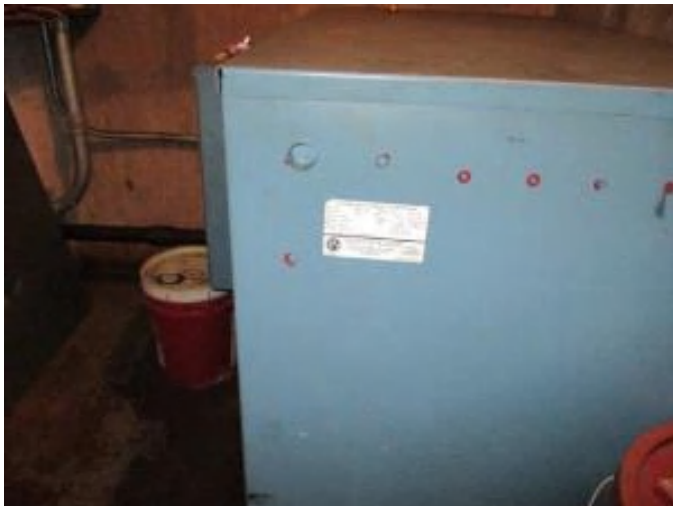
System: D1010 - Elevators and Lifts

Location: Basement Elevator Machine Room

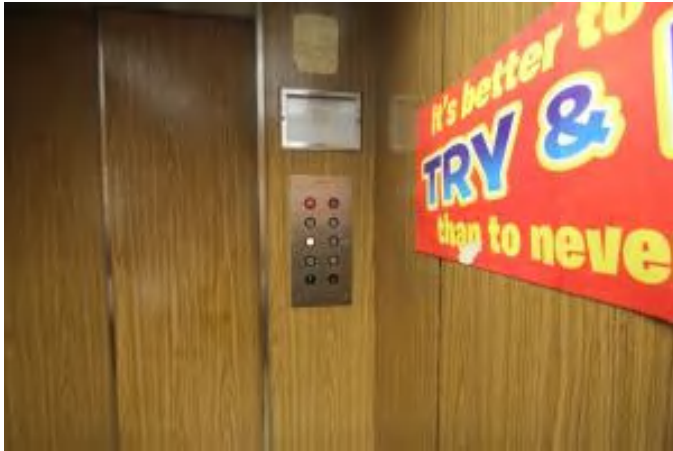
System: D1010 - Elevators and Lifts

The school has a hydraulic elevator rated 25HP at 480V. Building Engineer indicated that sometimes the elevator does not work. Elevator is approximately 30 years old and has reached its useful service life. Replace hydraulic elevator.

Location: Elevator

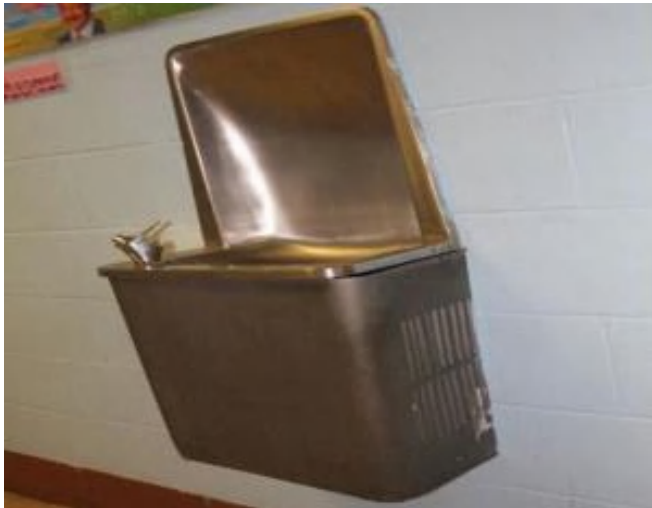
System: D2010 - Plumbing Fixtures

Location: Corridors
Distress: Accessibility
Category: 2 - Code Compliance
Priority: 2 - Response Time (2-3 yrs)
Correction: Remove and replace or replace lavatory - quantify accessible if required
Qty: 25.00
Unit of Measure: Ea.
Estimate: \$93,805.51
Assessor Name: James Sullivan
Date Created: 01/04/2016

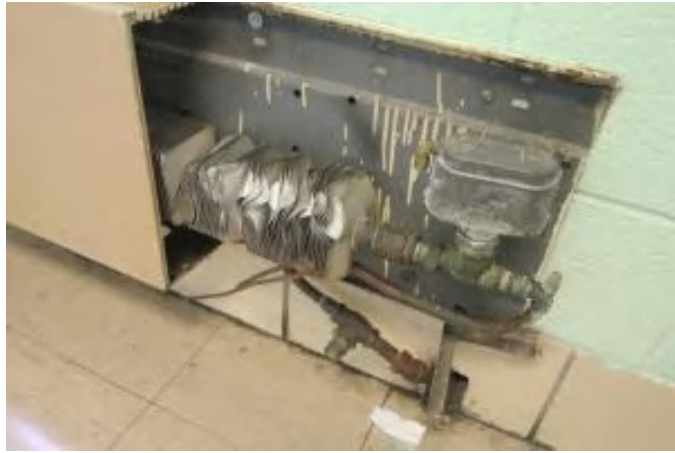
System: D3060 - Controls & Instrumentation

HVAC controls are Barber-Coleman brand pneumatic with mechanical timers. Many air lines are no longer connected to control elements. Controls are obsolete and should be replaced with modern digital control. A duplex air compressor including tank and refrigerated filter-dryer is located in the boiler room. The pressure vessel certificate in the building engineer's office shows the air tank was installed in 1990. One air pump does not operate, but one would be sufficient for utility use after controls are converted.

Location: Entire building

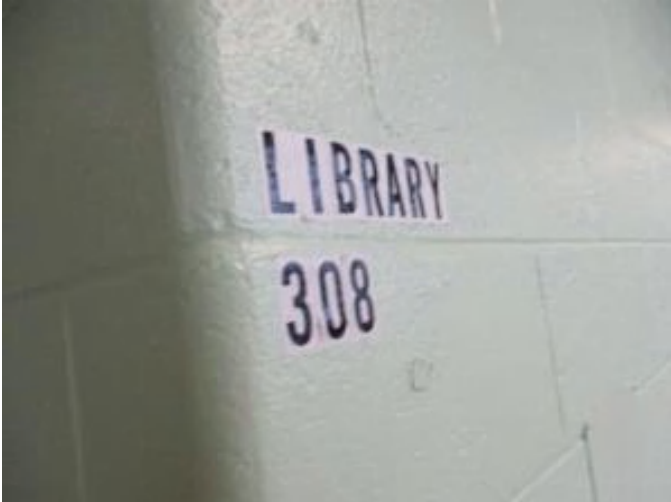
System: C1030 - Fittings

Location: Throughout

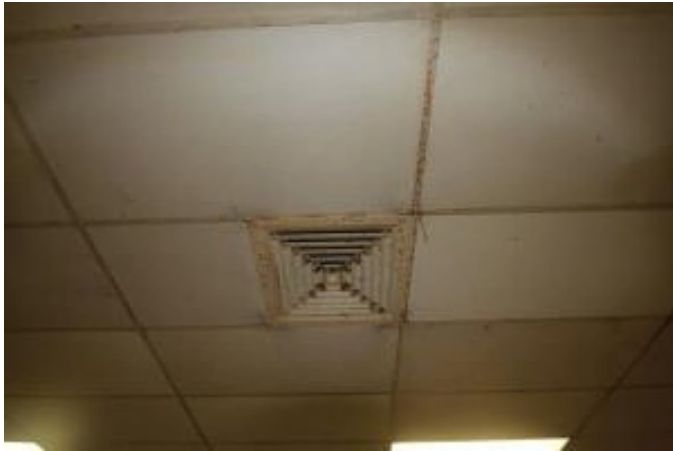
System: C3030 - Ceiling Finishes

Location: Various

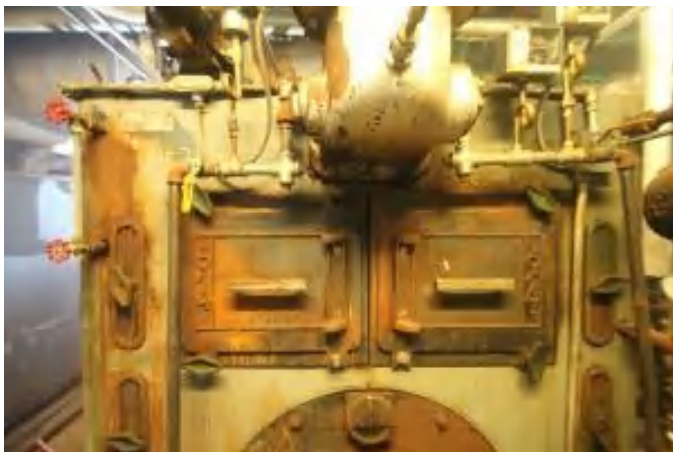
System: D3020 - Heat Generating Systems

Two Weil-McLain brand, model 94, 14 section, 2,927 MBH (87 HP) capacity boilers provide steam for the building. They were installed in 1972 and have exceeded their expected life by 13 years, so they should be replaced due to age. Boilers are equipped with Weil-McLain gas burners. Gas service enters the building along Dickens St. in a 6 inch line. Boiler feed water is supplied by two pumps from the condensate collection tank in the mechanical room through separate feed lines. The water softener and chemical injection system for the boiler is located next to the tank. The hydronic hot water pumps are located in the mechanical room and were being replaced at the time of the inspection. There are three entirely new Bell & Gossett hydronic hot water pumps: two 10 HP, 70 ft. head, 400 gpm pumps and one 3 HP, 45 ft. head, 175 gpm pump. The steam to water heat exchanger and hydronic expansion tank are located above the pumps along the ceiling.

Location: Boiler room

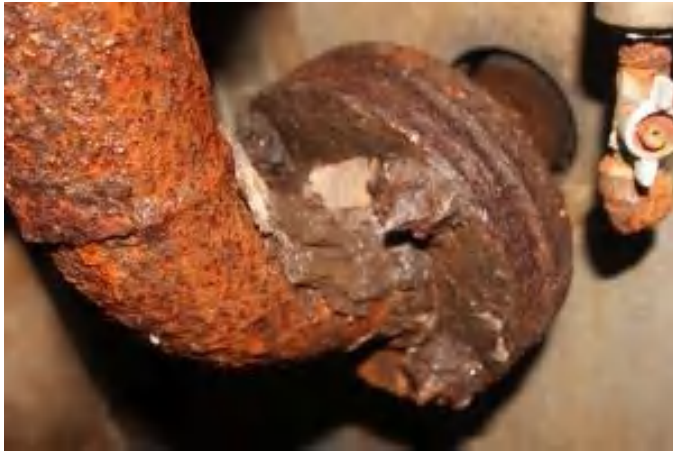
System: D3040 - Distribution Systems

Location: Entire building

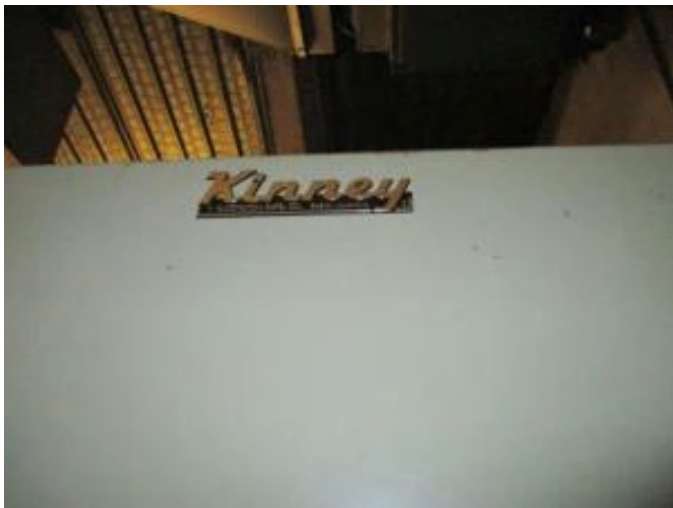
System: D5010 - Electrical Service/Distribution

A 500KVA, 13.2KV- 277/480V Unit Substation, located in the school basement serves this facility. The unit substation is manufactured by Kinney Electrical MFG Co. and is original installation and has already exceeded its 40 years of useful service life and has no extra capacity for expansion or new Heating, Ventilation, Air Conditioning (HVAC) system. An estimated 1000KVA, 13.2KV-480/277V Unit substation is required. The new unit substation will feed a 480V Motor Control Center (MCC) and HVAC (Heating, Ventilation and Air Conditioning) equipment, and a 480V 3 phase to 120V/208V 3 phase 225 KVA step-down transformer to feed receptacles, lighting and other smaller loads.

Location: Basement

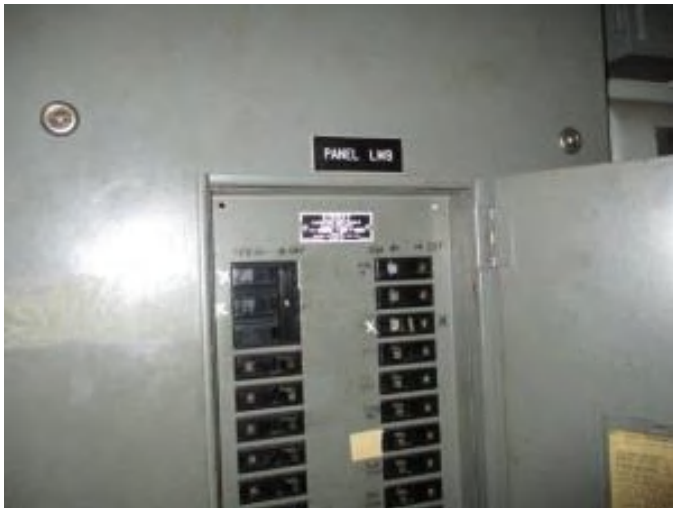
System: D5010 - Electrical Service/Distribution

There are panel-boards in each floor for lighting and receptacles. These panel-boards and associated wiring have exceeded the end of their 40 years of useful service life. They need to be replaced.

Location: Entire Building
Distress: Obsolete
Category: 3 - Operations / Maint.
Priority: 3 - Response Time (3-4 yrs)
Correction: Replace Electrical Distribution System (U)
Qty: 1.00
Unit of Measure: Ea.
Estimate: \$493,933.91
Assessor Name: James Sullivan
Date Created: 12/18/2015

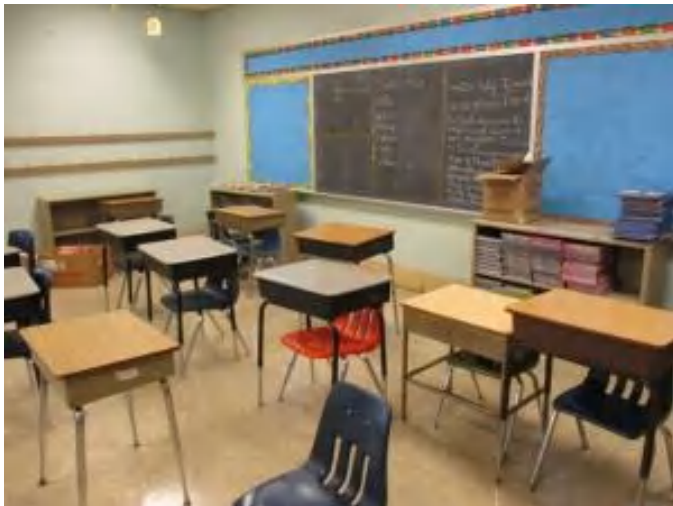
System: D5020 - Lighting and Branch Wiring

The number of receptacles in 40% of the classrooms are inadequate. The teacher's whiteboard wall and the opposite of it need to be provided with double compartment surface raceways, the other two walls with minimum two duplex outlets each, when feasible.

Location: Entire Building
Distress: Inadequate
Category: 4 - Capital Improvement
Priority: 3 - Response Time (3-4 yrs)
Correction: Add wiring device
Qty: 190.00
Unit of Measure: Ea.
Estimate: \$70,535.23
Assessor Name: James Sullivan
Date Created: 12/18/2015

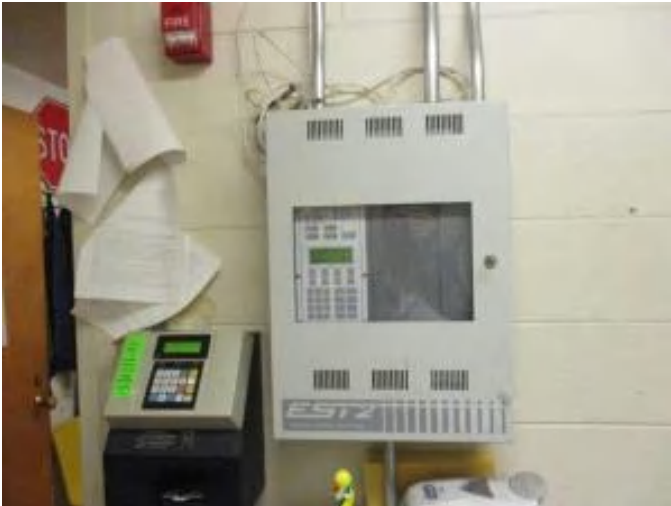
System: D5030 - Communications and Security

Location: Entire Building
Distress: Life Safety / NFPA / PFD
Category: 1 - Health & Safety
Priority: 3 - Response Time (3-4 yrs)
Correction: Replace fire alarm system
Qty: 1.00
Unit of Measure: S.F.
Estimate: \$244,122.97
Assessor Name: James Sullivan
Date Created: 12/18/2015

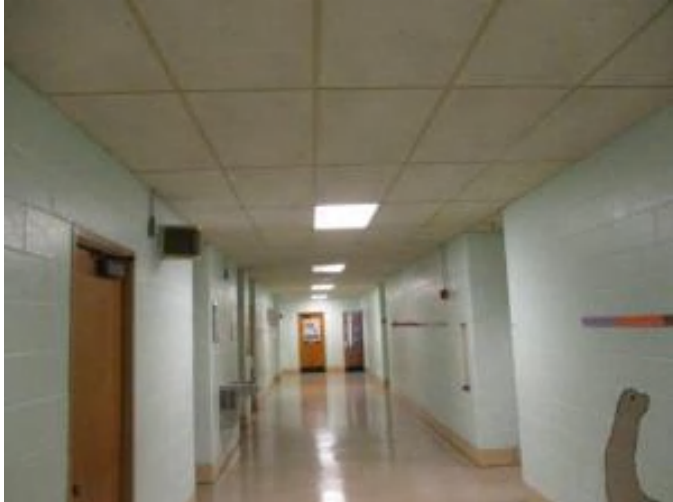
System: D5030 - Communications and Security

Location: Entire Building

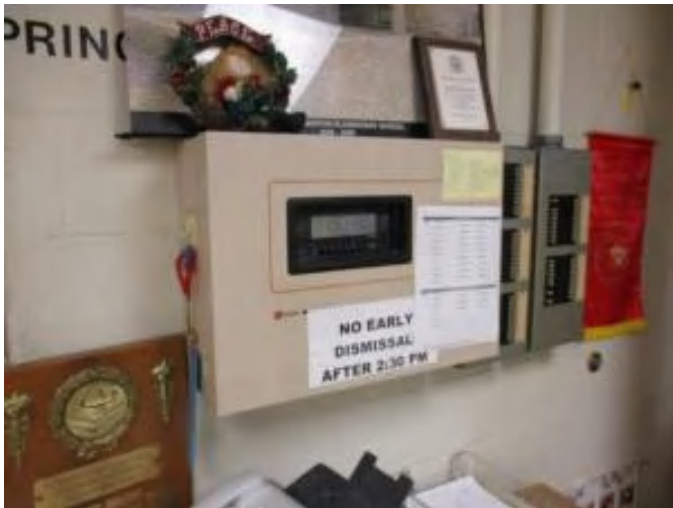
System: D5030 - Communications and Security

The present clock control system is manufactured by Simplex Time Control Center. The system is old and difficult to find parts and repair. Replace clock system with wireless, synchronized, battery operated system.

Location: Entire Building
Distress: Obsolete
Category: 3 - Operations / Maint.
Priority: 4 - Response Time (4-5 yrs)
Correction: Add/Replace Clock System or Components
Qty: 50.00
Unit of Measure: Ea.
Estimate: \$112,560.22
Assessor Name: James Sullivan
Date Created: 12/18/2015

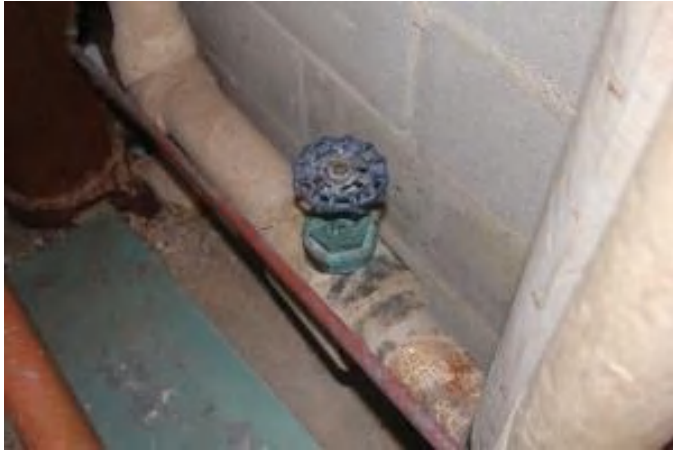
System: D2020 - Domestic Water Distribution

Location: Entire building

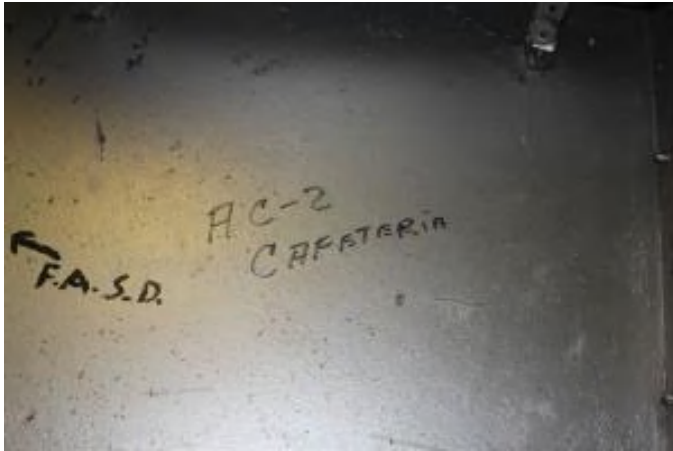
System: D3040 - Distribution Systems

Location: Air handler room

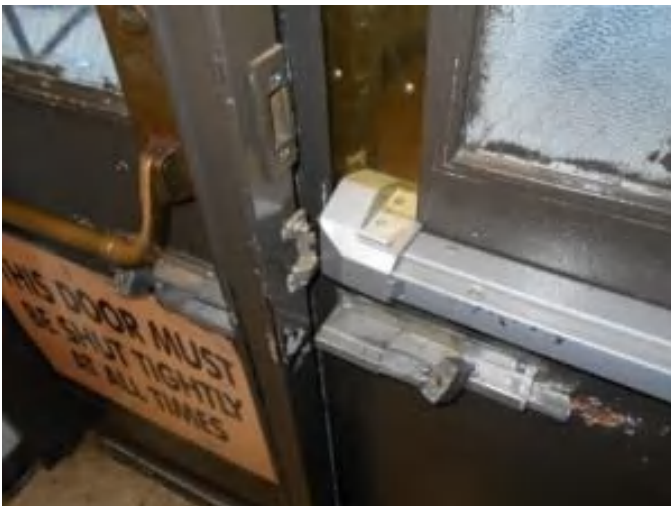
System: B2030 - Exterior Doors

Location: Exterior doors

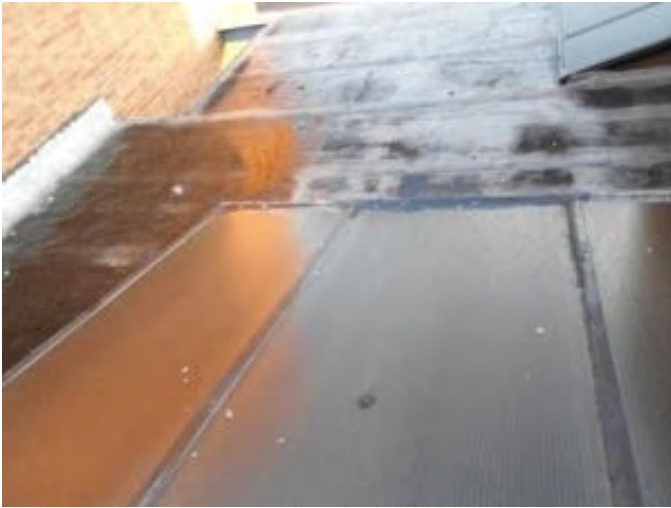
System: B3010105 - Built-Up

Location: Roofs
Distress: Building Envelope Integrity
Category: 3 - Operations / Maint.
Priority: 1 - Response Time (< 2 yr)
Correction: Remove and Replace Built Up Roof

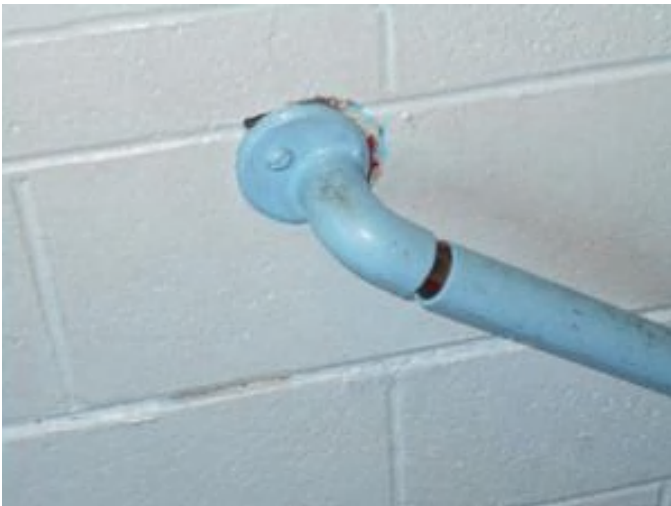
System: C2010 - Stair Construction

Location: Interior stairs
Distress: Building / MEP Codes
Category: 2 - Code Compliance
Priority: 1 - Response Time (< 2 yr)
Correction: Replace inadequate or install proper stair railing - select appropriate material

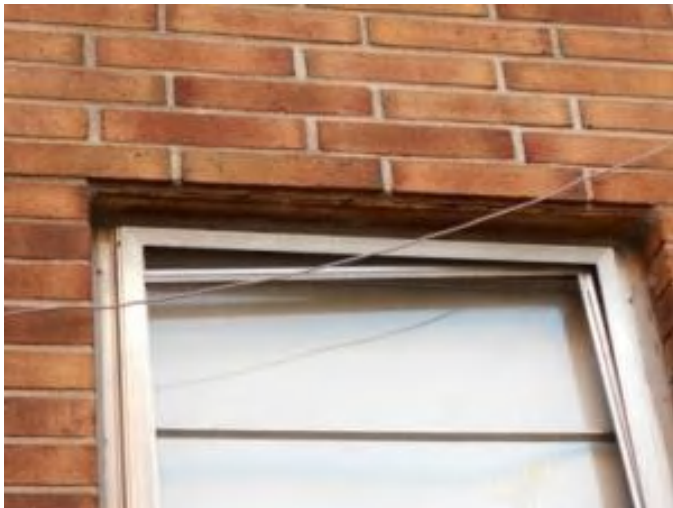
Location: Office wing windows and door
Distress: Building Envelope Integrity
Category: 3 - Operations / Maint.
Priority: 2 - Response Time (2-3 yrs)
Correction: Remove and replacing failing steel lintels in brick wall construction
Qty: 40.00
Unit of Measure: L.F.
Estimate: \$22,172.93
Assessor Name: System
Date Created: 02/04/2016

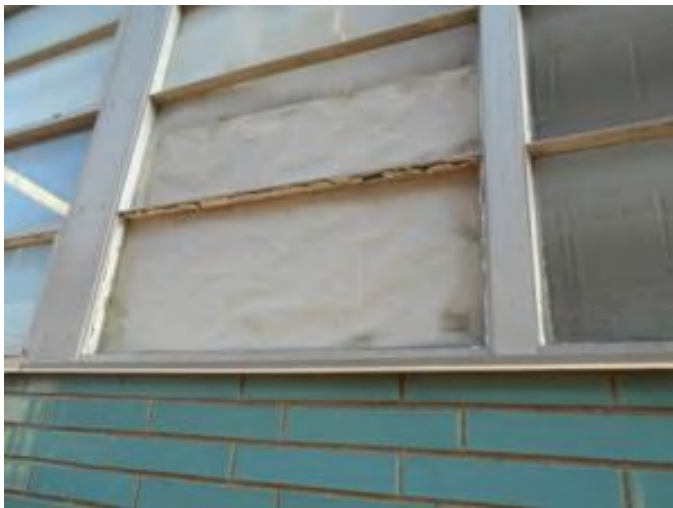
Location: Exterior
Distress: Building Envelope Integrity
Category: 3 - Operations / Maint.
Priority: 2 - Response Time (2-3 yrs)
Correction: Remove and replace aluminum windows - pick the appropriate size and style and insert the number of units
Qty: 138.00
Unit of Measure: Ea.
Estimate: \$817,560.56
Assessor Name: System
Date Created: 02/04/2016

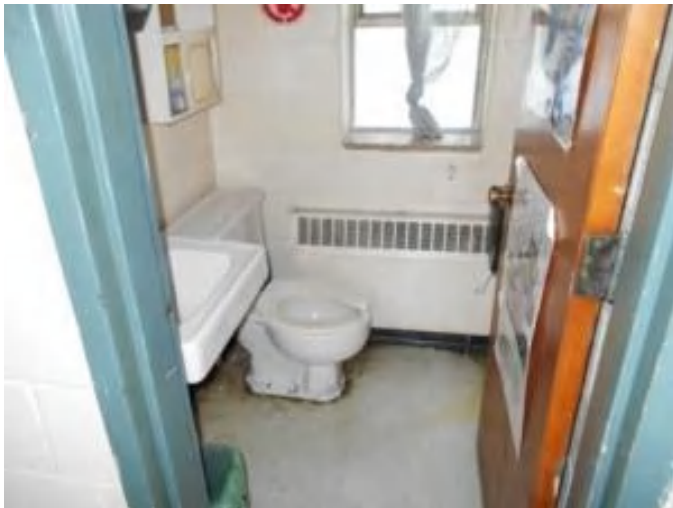
Location: TBD
Distress: Accessibility
Category: 2 - Code Compliance
Priority: 2 - Response Time (2-3 yrs)
Correction: Build new single restroom to meet code requirements
Qty: 2.00
Unit of Measure: Ea.
Estimate: \$140,651.95
Assessor Name: System
Date Created: 02/04/2016

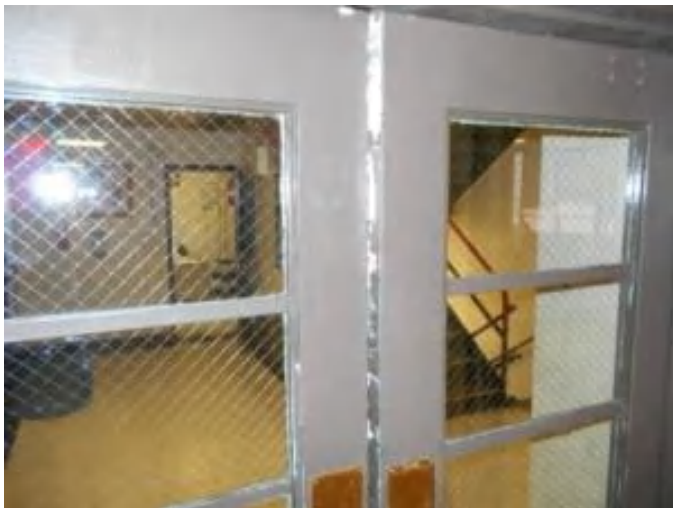
Location: Interior doors
Distress: Beyond Service Life
Category: 3 - Operations / Maint.
Priority: 2 - Response Time (2-3 yrs)
Correction: Remove and replace interior doors - wood doors with hollow metal frames - per leaf
Qty: 50.00
Unit of Measure: Ea.
Estimate: \$180,051.35
Assessor Name: System
Date Created: 02/04/2016

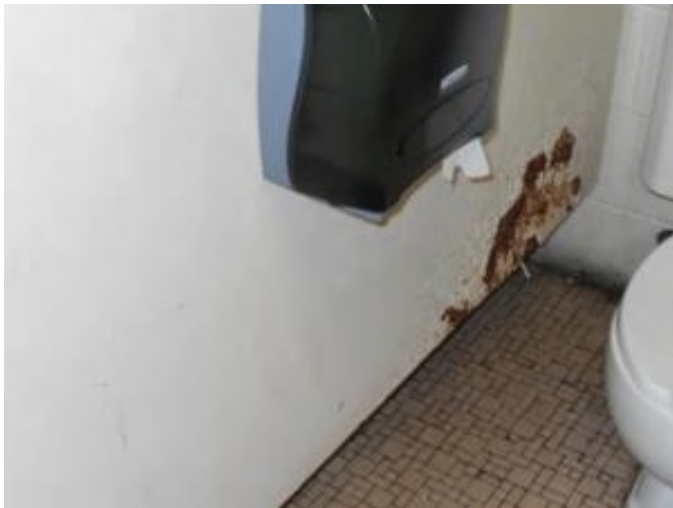
Location: Student restrooms
Distress: Accessibility
Category: 2 - Code Compliance
Priority: 2 - Response Time (2-3 yrs)
Correction: Remove and replace damaged toilet partitions - handicap units
Qty: 13.00
Unit of Measure: Ea.
Estimate: \$37,697.94
Assessor Name: System
Date Created: 02/04/2016

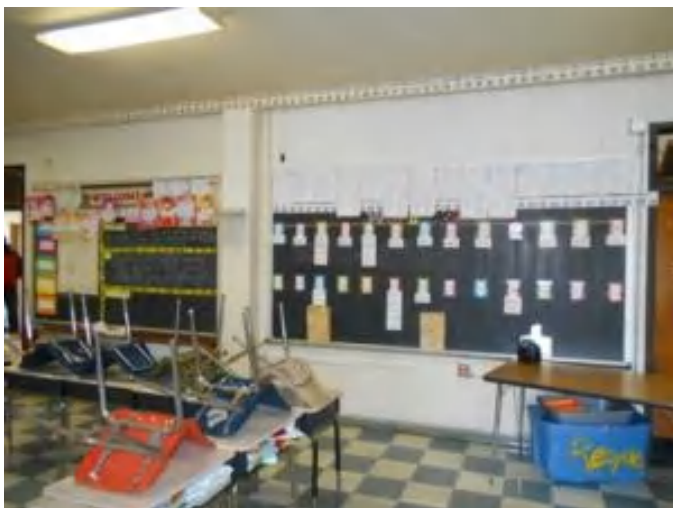
Location: Classrooms
Distress: Obsolete
Category: 3 - Operations / Maint.
Priority: 2 - Response Time (2-3 yrs)
Correction: Replace blackboards with marker boards - pick the appropriate size and insert the quantities
Qty: 16.00
Unit of Measure: Ea.
Estimate: \$25,346.46
Assessor Name: System
Date Created: 02/04/2016

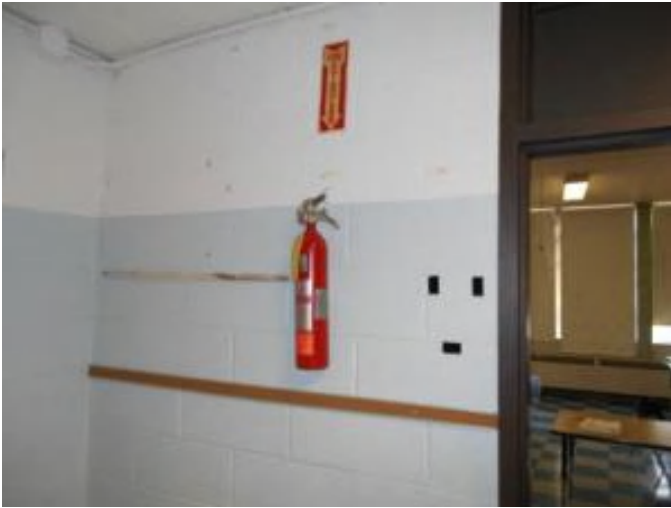
Location: Interiors
Distress: Building / MEP Codes
Category: 2 - Code Compliance
Priority: 2 - Response Time (2-3 yrs)
Correction: Replace missing or damaged signage - insert the number of rooms
Qty: 30.00
Unit of Measure: Ea.
Estimate: \$8,127.37
Assessor Name: System
Date Created: 02/04/2016

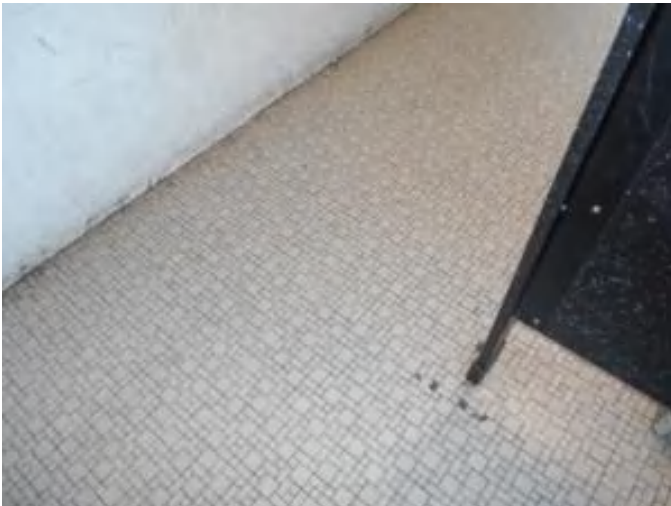
Location: Restrooms
Distress: Beyond Service Life
Category: 3 - Operations / Maint.
Priority: 2 - Response Time (2-3 yrs)
Correction: Remove and replace terrazzo or tile flooring - pick the appropriate material
Qty: 1,050.00
Unit of Measure: S.F.
Estimate: \$39,750.50
Assessor Name: System
Date Created: 02/04/2016

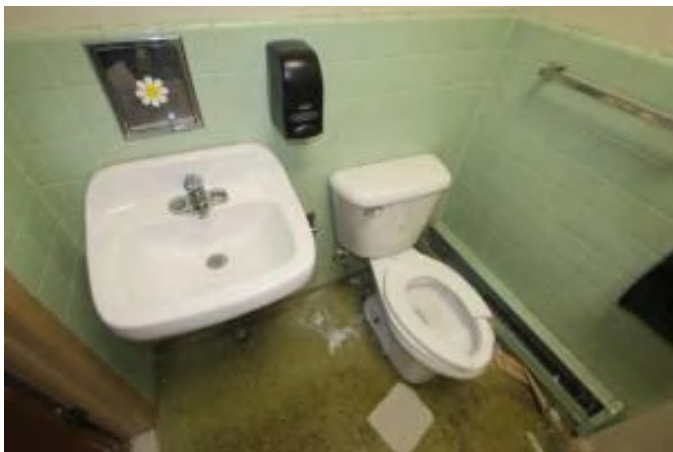
Location: Convent bathrooms
Distress: Appearance
Category: 3 - Operations / Maint.
Priority: 2 - Response Time (2-3 yrs)
Correction: Remove and replace or replace water closet - quantify additional units
Qty: 4.00
Unit of Measure: Ea.
Estimate: \$5,251.48
Assessor Name: System
Date Created: 02/18/2016

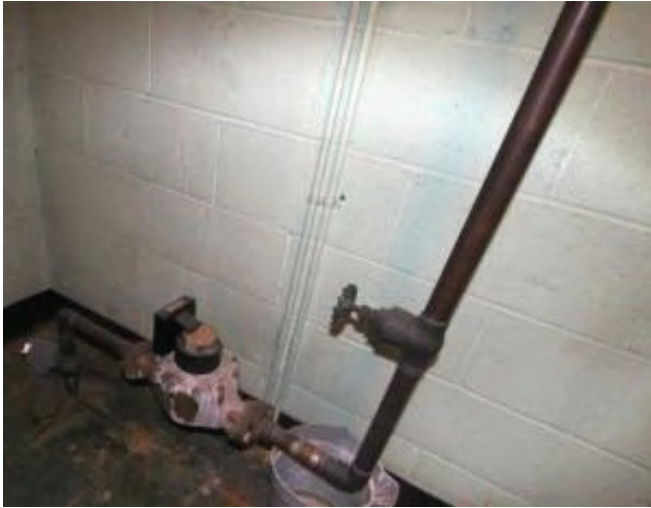
Location: Basement
Distress: Building / MEP Codes
Category: 2 - Code Compliance
Priority: 2 - Response Time (2-3 yrs)
Correction: Provide 3" reduced pressure back flow preventer
Qty: 1.00
Unit of Measure: Ea.
Estimate: \$3,253.01
Assessor Name: System
Date Created: 02/18/2016

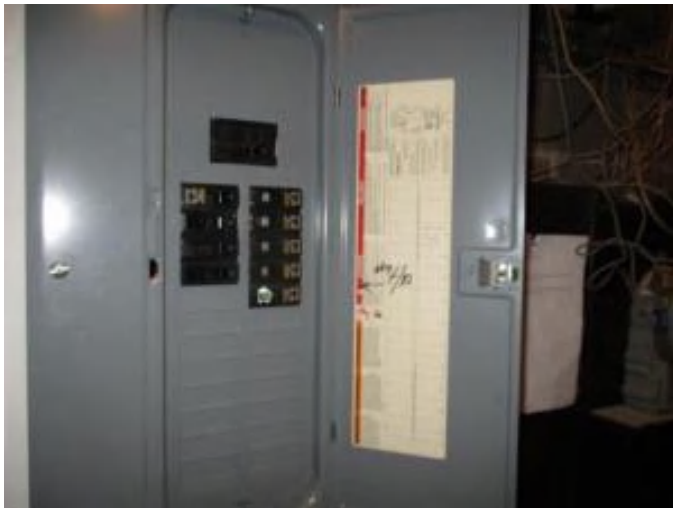
Location: Entire Building
Distress: Inadequate
Category: 4 - Capital Improvement
Priority: 3 - Response Time (3-4 yrs)
Correction: Replace Panelboard
Qty: 2.00
Unit of Measure: Ea.
Estimate: \$28,823.76
Assessor Name: System
Date Created: 02/09/2016

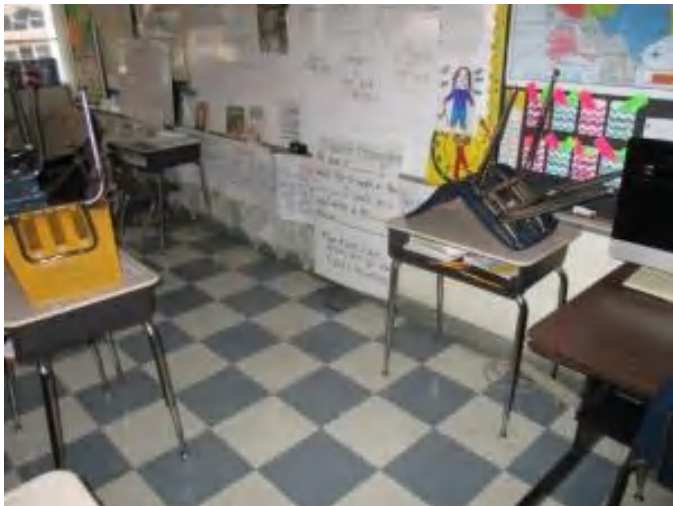
Location: Entire Building
Distress: Inadequate
Category: 4 - Capital Improvement
Priority: 3 - Response Time (3-4 yrs)
Correction: Add wiring device
Qty: 50.00
Unit of Measure: Ea.
Estimate: \$32,529.33
Assessor Name: System
Date Created: 02/09/2016

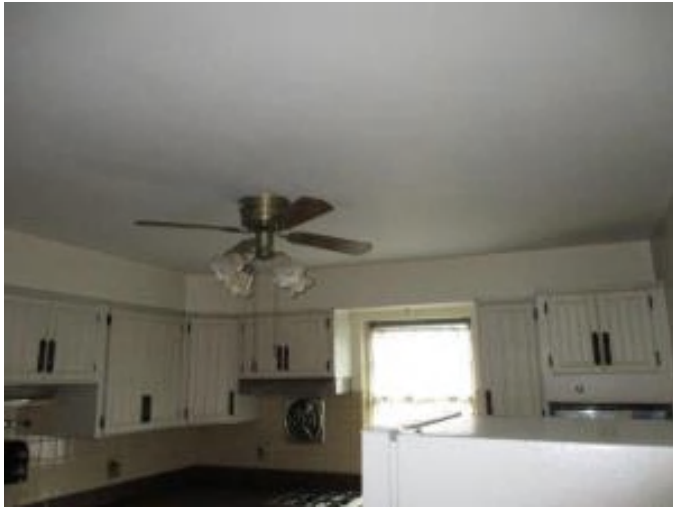
Location: Building South Side
Distress: Obsolete
Category: 3 - Operations / Maint.
Priority: 4 - Response Time (4-5 yrs)
Correction: Add Lighting Fixtures
Qty: 10.00
Unit of Measure: Ea.
Estimate: \$11,762.11
Assessor Name: System
Date Created: 02/10/2016

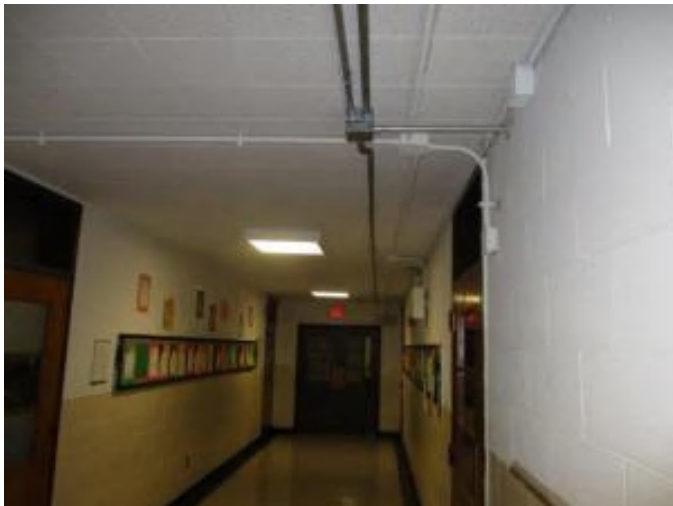
Location: Entire Building
Distress: Security Issue
Category: 1 - Health & Safety
Priority: 4 - Response Time (4-5 yrs)
Correction: Add/Replace Video Surveillance System
Qty: 8.00
Unit of Measure: Ea.
Estimate: \$29,821.15
Assessor Name: System
Date Created: 02/10/2016

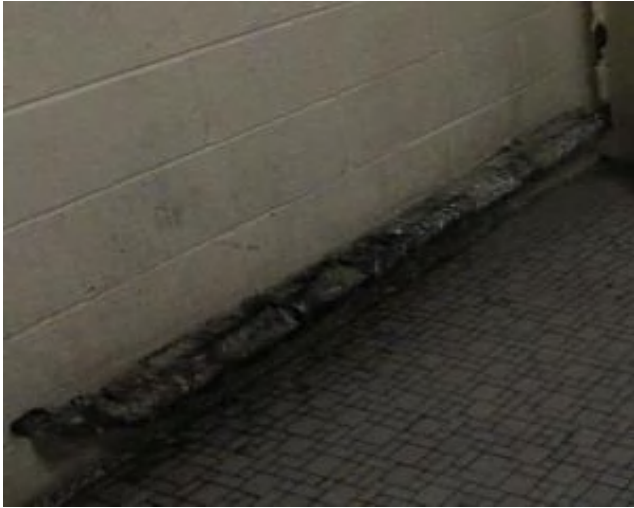
Location: Entire building
Distress: Beyond Service Life
Category: 3 - Operations / Maint.
Priority: 5 - Response Time (> 5 yrs)
Correction: Replace finned tube radiation terminals (per 100 LF)
Qty: 400.00
Unit of Measure: L.F.
Estimate: \$161,416.57
Assessor Name: System
Date Created: 02/19/2016
