Facility Condition Assessment Summary Report

Munoz-Marin School

School District of Philadelphia
S568001; Munoz Marin
Final
Site Assessment Report
February 1, 2017

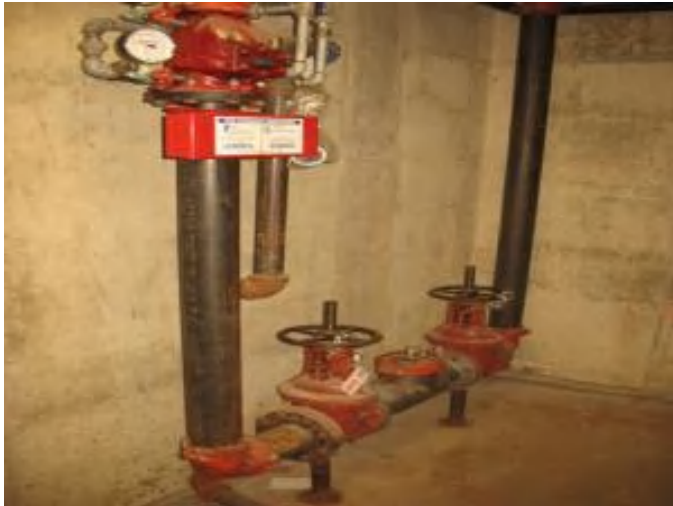
System: D4010 - Sprinklers

Sprinklers - The building is equipped with a wet type sprinkler system only within the two story lobby in the center of the building. A 4" fire water line enters the building in the basement mechanical room along the same wall as the domestic water. The fire suppression system is the originally installed equipment and should not need replacement within the next 10 years. Installing a sprinkler system with quick response type heads throughout the building should reduce insurance costs by providing protection for the property investment. A fire pump may be required depending on the available city water pressure. The building does not have any standpipes.

Location: Throughout building

Distress: Life Safety / NFPA / PFD

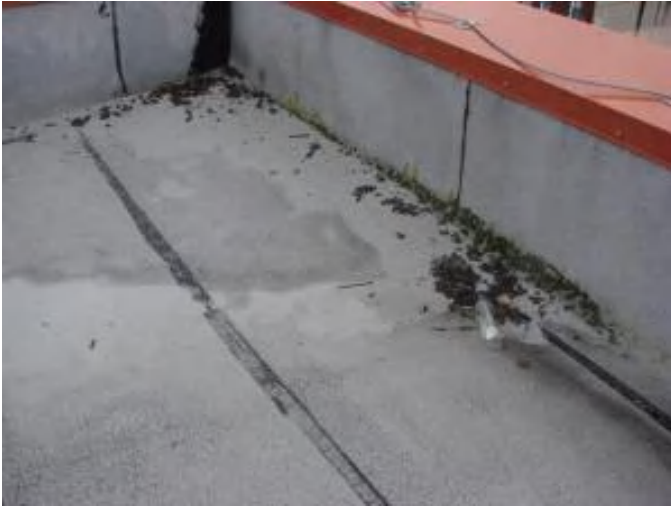
System: B3010105 - Built-Up

Roofing is typically built-up system over rigid insulation; several large soft spot areas have been observed, leaks over second floor roof have been reported.

Location: Exterior

Distress: Building Envelope Integrity

Notes: Install all new roofing system including insulation; tear-down existing roofing; install flashing, counter flashing and reglets

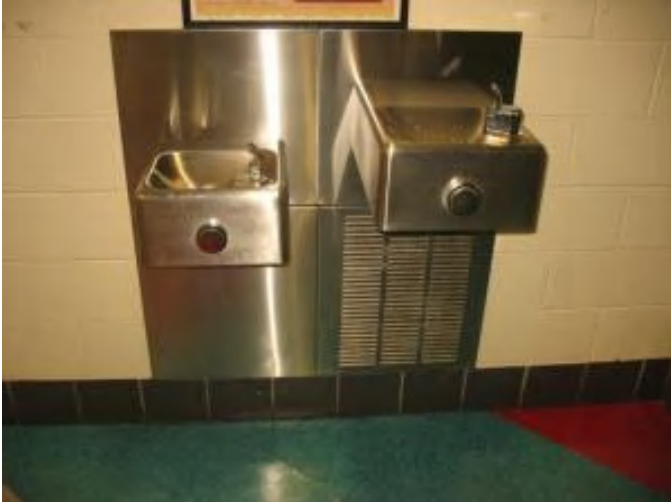
System: D2010 - Plumbing Fixtures

Drinking fountains in the corridors and at the restrooms consist of wall hung fixtures with integral refrigerated coolers; they are accessible type. The principal reported that many of the drinking fountains do not work. The drinking fountains in the corridors should be replaced as many of the units have failed.

Location: Corridors

Distress: Failing

Notes: Replace ten (10) wall hung drinking fountains and integral refrigerated coolers in the corridors; many of these units were not working during the site visit.

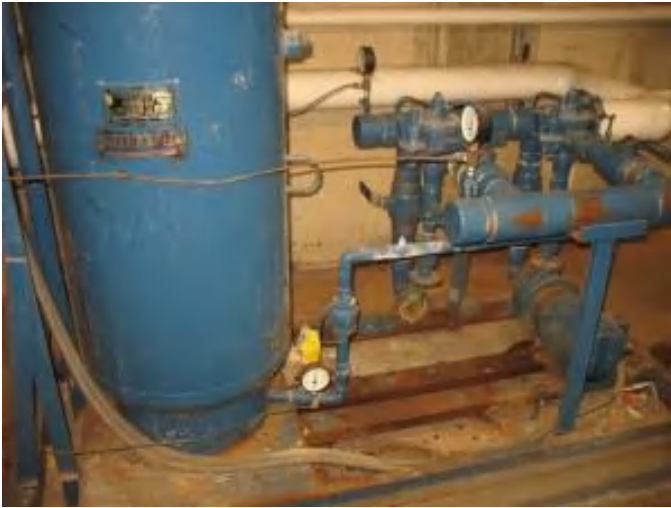
System: D2020 - Domestic Water Distribution

Location: Basement mechanical room
Distress: Failing
Category: 3 - Operations / Maint.
Priority: 2 - Response Time (2-3 yrs)
Correction: Replace duplex domestic booster pump set (5 HP)
Qty: 1.00
Unit of Measure: Ea.
Estimate: \$52,907.04
Assessor Name: Craig Anding
Date Created: 11/17/2015

Notes: Replace the duplex 7.5HP domestic water booster pumps, expansion tank, and isolation valves on incoming domestic water line with a new skid mounted pressure booster system.

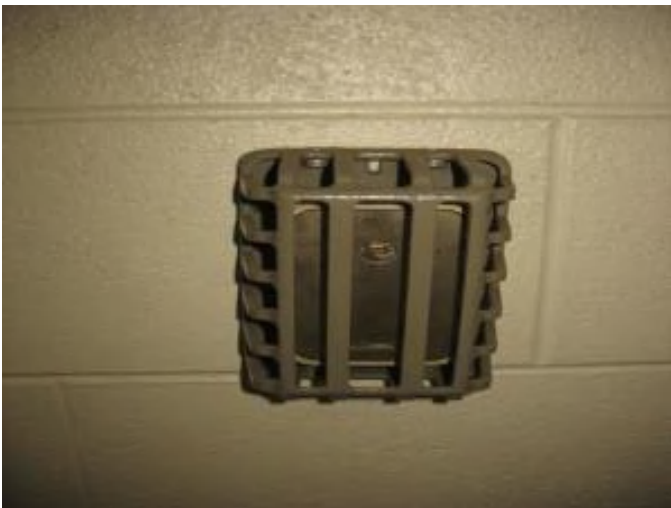
System: D3060 - Controls & Instrumentation

Location: Throughout building
Distress: Failing
Category: 3 - Operations / Maint.
Priority: 2 - Response Time (2-3 yrs)
Correction: Replace pneumatic controls with DDC (150KSF)
Qty: 119,250.00
Unit of Measure: S.F.
Estimate: \$2,135,934.71
Assessor Name: Craig Anding
Date Created: 11/17/2015

Notes: Install a new control system for the HVAC systems with modern DDC modules, valves and actuators to improve reliability and energy efficiency. Provide a new building automation system (BAS) with communication interface to the preferred system in use throughout the District.

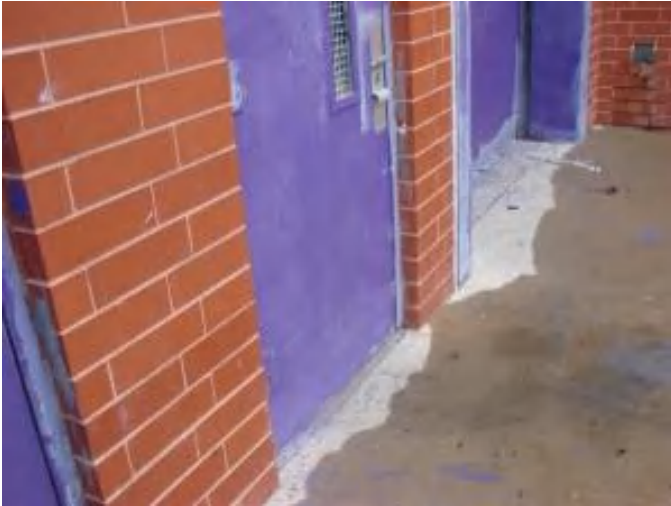
System: B2030 - Exterior Doors

Exterior doors are typically hollow metal, glazed; service doors are typically hollow metal in hollow metal frames, in poor condition. Loading dock and storage room have insulated roll-up doors in poor condition.

Location: Exterior

Distress: Beyond Service Life

Notes: Replace all exterior doors

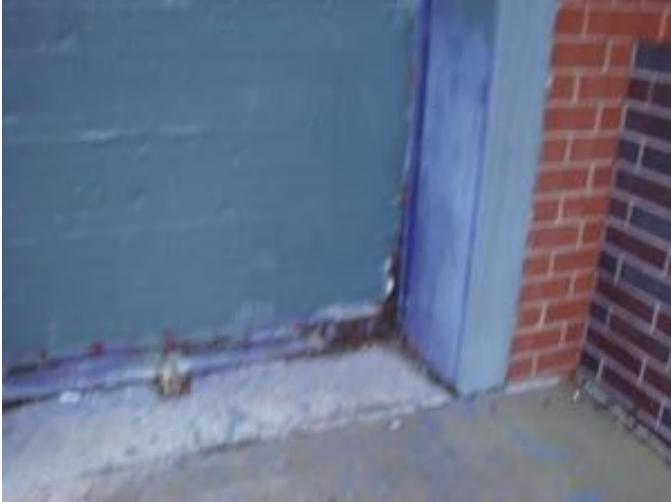
System: B2030 - Exterior Doors

Location: Exterior

Distress: Beyond Service Life

Notes: Replace overhead roll-up doors

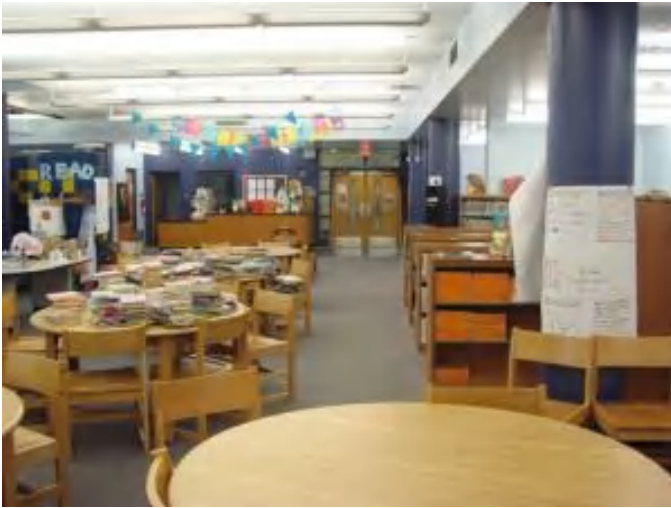
System: C3020411 - Carpet

Flooring in most areas is generally vinyl composition tile, in very good condition. Flooring in library and principal's office is carpet in very poor condition. Gym has resilient sheet flooring in very good condition. Flooring in toilets and kitchen area is typically ceramic tiles and quarry tiles, respectively; in good condition.

Location: Interior
Distress: Beyond Service Life
Category: 3 - Operations / Maint.
Priority: 3 - Response Time (3-4 yrs)
Correction: Remove and replace carpet
Qty: 4,400.00
Unit of Measure: S.F.
Estimate: \$49,239.35
Assessor Name: Craig Anding
Date Created: 01/12/2016

Notes: Replace carpet in library and office spaces

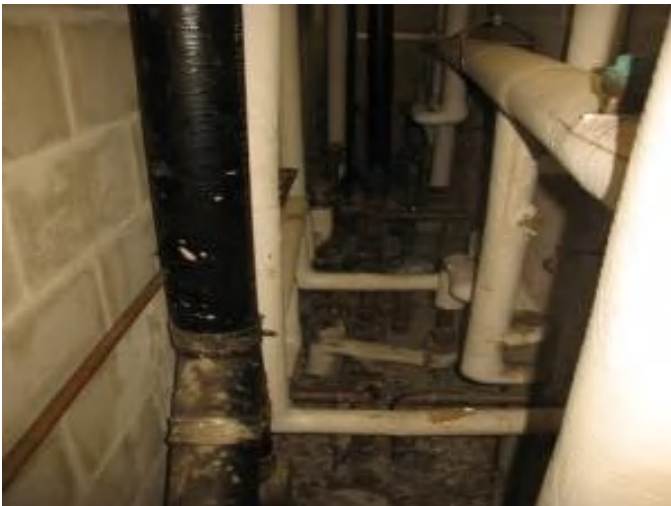
System: D2030 - Sanitary Waste

Location: Throughout building
Distress: Maintenance Required
Category: 3 - Operations / Maint.
Priority: 3 - Response Time (3-4 yrs)
Correction: Inspect sanitary waste piping and replace damaged sections. (+100KSF)
Qty: 119,250.00
Unit of Measure: S.F.
Estimate: \$506,407.80
Assessor Name: Craig Anding
Date Created: 11/17/2015

Notes: Hire a qualified contractor to perform a detailed examination of the sanitary waste piping using visual inspection and video cameras to locate and replace any damaged piping and to further quantify the extent of potential failures.

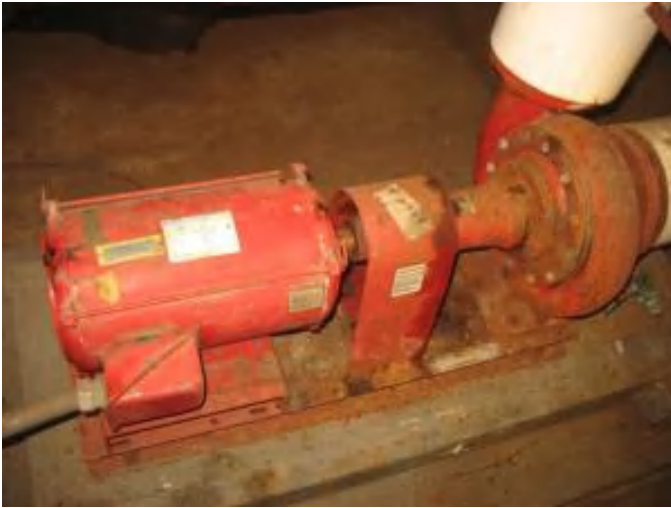
System: D3020 - Heat Generating Systems

All pumps are original to the building, appear to be in good condition with the exception of the hot water supply pumps P-1 and P-1, and are within the anticipated service life of 25 years. All main piping is black steel, covered with insulation, and appears to be in decent condition. Smaller branch piping is copper and covered in insulation. There were a few fittings that are covered in rust, so the distribution piping should be inspected and repaired as necessary.

Location: Basement mechanical room

Distress: Damaged

Notes: Replace two (2) 15HP end-suction heating water supply pumps, P-1 and P-2, in the basement which are damaged from rust.

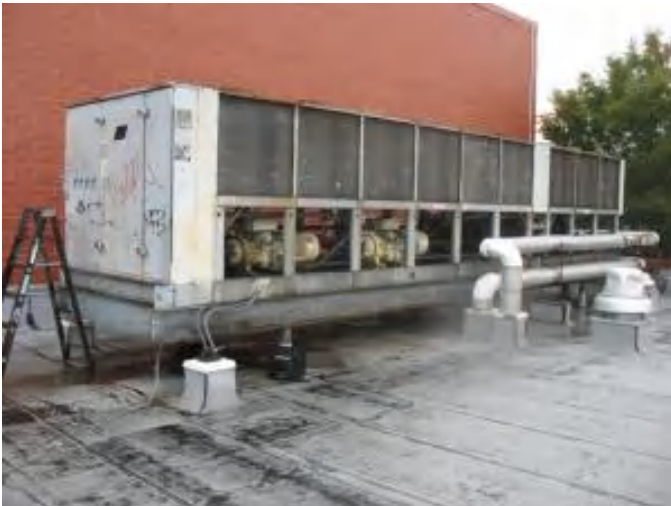
System: D3030 - Cooling Generating Systems

Cooling Generating Systems - Chilled glycol is generated by one (1) Dunham-Bush air-cooled screw chiller located on the roof at the South end of the building. The chiller is a nominal 190 tons, has three (3) compressors, and utilizes R22 refrigerant which is being phased out of use in the United States. The chiller is original to the building, installed in 1997, according to the Building Engineer. Screw chillers have an anticipated service life of 20 years; this unit has been in service 18 years and is approaching the end of its service life. This chiller should be replaced within the next 1-3 years to ensure continuous operation of the chilled water system.

Location: Roof

Distress: Beyond Service Life

Notes: Replace the existing nominal 190 ton roof mounted air cooled chiller with a unit of similar capacity.

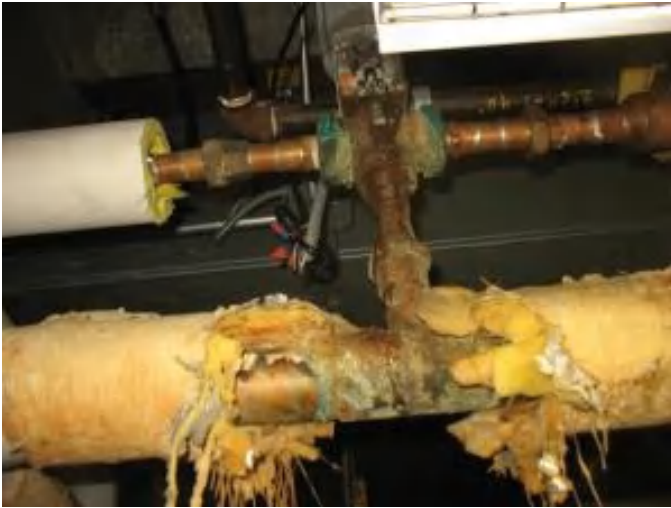
System: D3040 - Distribution Systems

Location: Throughout building

Distress: Damaged

Notes: Hire a qualified contractor to examine the chilled water, hot water and dual temperature distribution piping which is showing signs of rust damage, and perform additional testing to locate and replace any damaged piping and to further quantify the extent of potential failures.

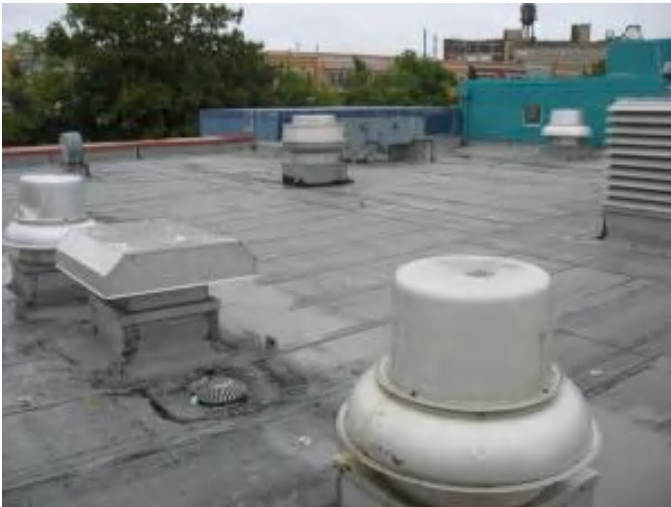
System: D3040 - Distribution Systems

Location: Roof

Distress: Maintenance Required

Notes: Replace nine (9) roof mounted power ventilators which are approaching the end of their service life.

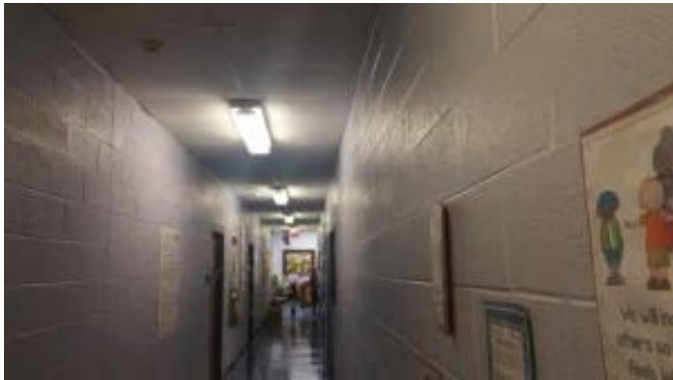
System: D5020 - Lighting and Branch Wiring

Lighting - Interior building is illuminated by various types of fixtures. They include fluorescent lighting, mostly T-8 lamps in majority of the areas, including; classrooms, corridor, offices and Kitchen. Surface or pendent mounted industrial fluorescent used in mechanical and electrical rooms. Gymnasium is illuminated by metal halide enclosed glass fixture. The majority of interior lighting fixtures are in a poor condition and have reached their useful life.

Location: throughout the building

Distress: Beyond Service Life

Notes: Install new lighting system for the entire building. The existing lighting is inadequate.

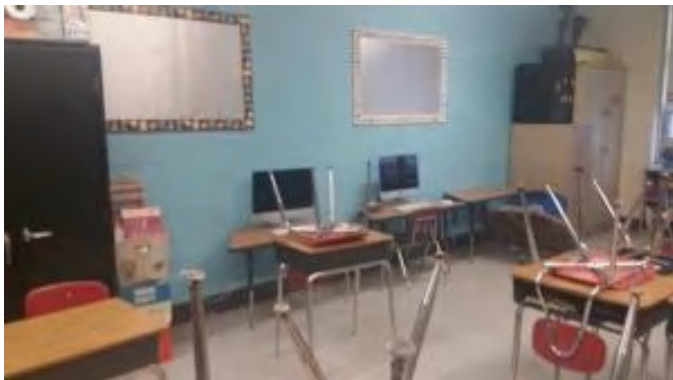
System: D5020 - Lighting and Branch Wiring

Location: throughout the building

Distress: Inadequate

Notes: Install minimum two receptacles on each wall of the classrooms and other areas within the building using surface-mounted receptacles.

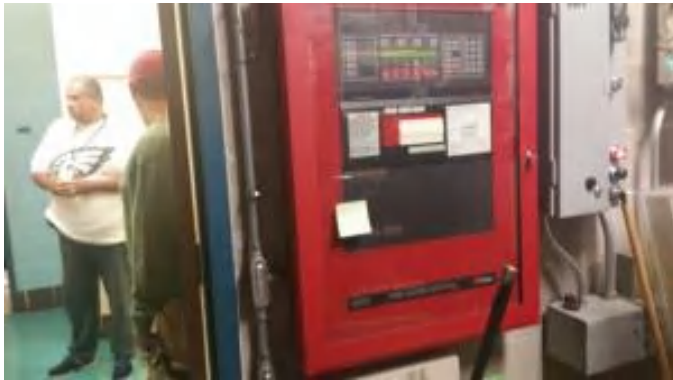
System: D5030 - Communications and Security

Location: throughout the building

Distress: Life Safety / NFPA / PFD

Notes: Install new automated and addressable FA system to meet the life safety codes.

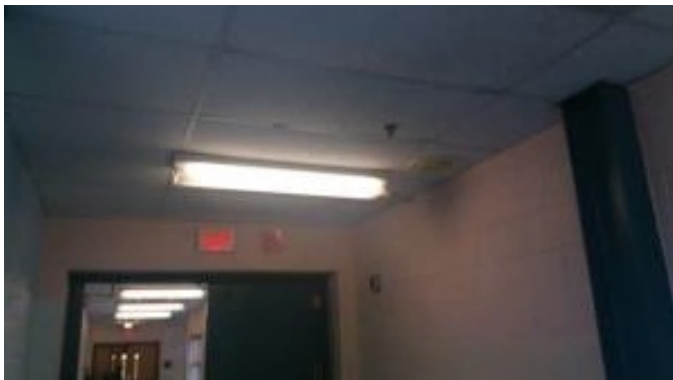
System: D5090 - Other Electrical Systems

Location: throughout the building

Distress: Beyond Service Life

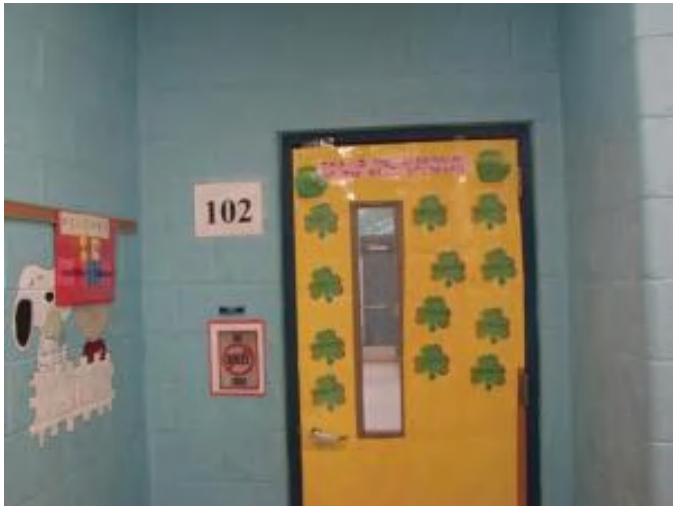
System: C1030 - Fittings

Toilet partitions are mostly phenolic resin panels, ADA compliant, in very good condition, Accessories are in very good condition. Modular signage is generally in good condition, however, several signs have been painted over.

Location: Interior

Distress: Damaged

Notes: Replace damaged signage

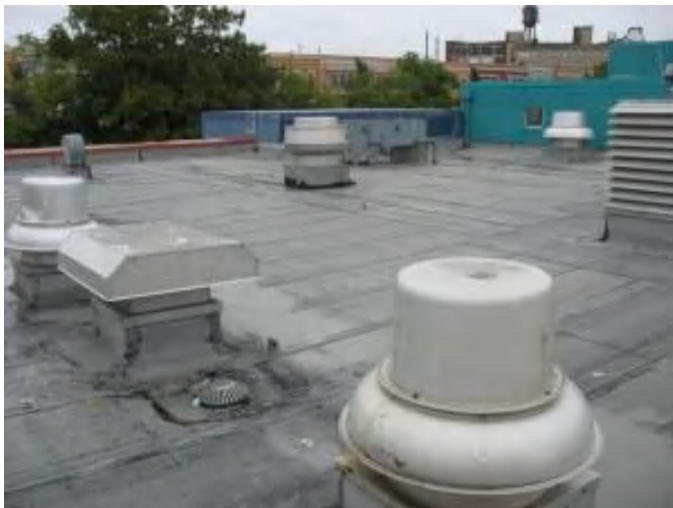
System: D3040 - Distribution Systems

Location: Roof

Distress: Maintenance Required

Notes: Replace thirteen (13) roof mounted exhaust fans which are approaching the end of their service life.

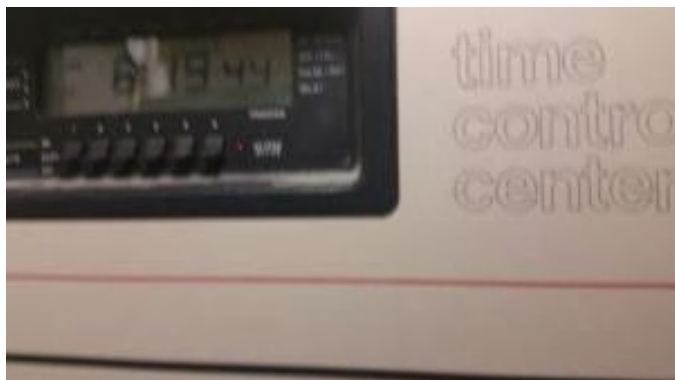
System: D5030 - Communications and Security

Location: throughout the building

Distress: Beyond Service Life

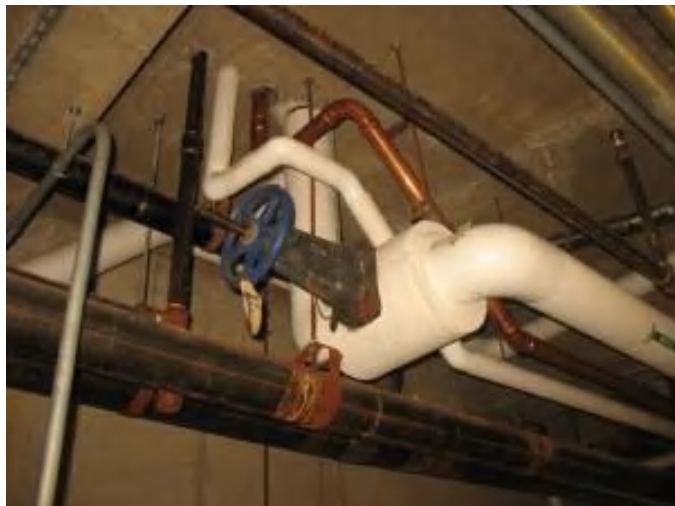
System: D2020 - Domestic Water Distribution

Location: Throughout building

Distress: Maintenance Required

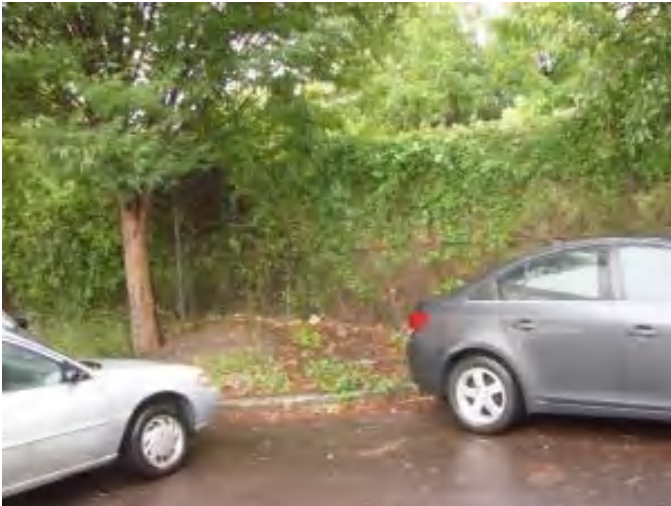
System: G2040 - Site Development

Location: Grounds

Distress: Beyond Service Life

Notes: Replace chain link fence along west property line

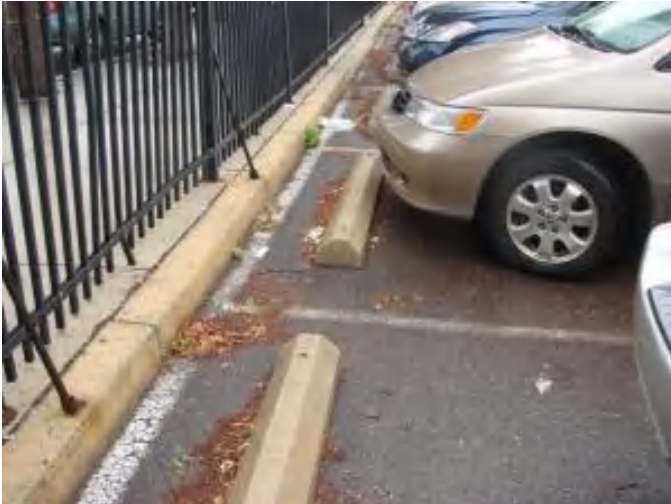
System: G2020 - Parking Lots

There is a staff parking lot at the site, in good condition. Parking for 34 vehicles has 2 spaces designated as accessible. Striping is faded. Compliant accessible signage is in good condition.

Location: Grounds

Distress: Beyond Service Life

Notes: Restripe parking lot

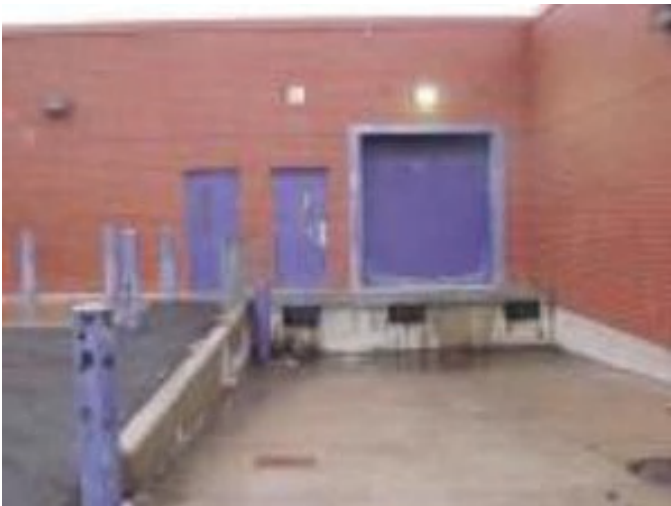
System: G4030 - Site Communications & Security

Location: Grounds

Distress: Inadequate
