## Facility Condition Assessment Summary Report

### Nebinger School

School District of Philadelphia  
**S259001;Nebinger**  
Final  
**Site Assessment Report**  
January 31, 2017

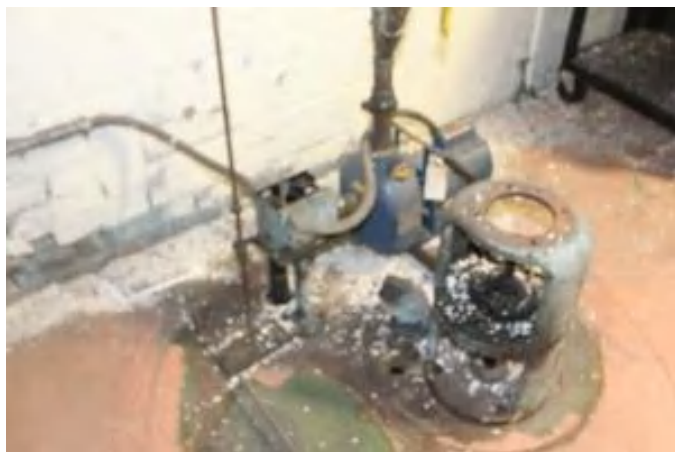
#### System: A2020 - Basement Walls

**Location:** Basement

**Distress:** Failing

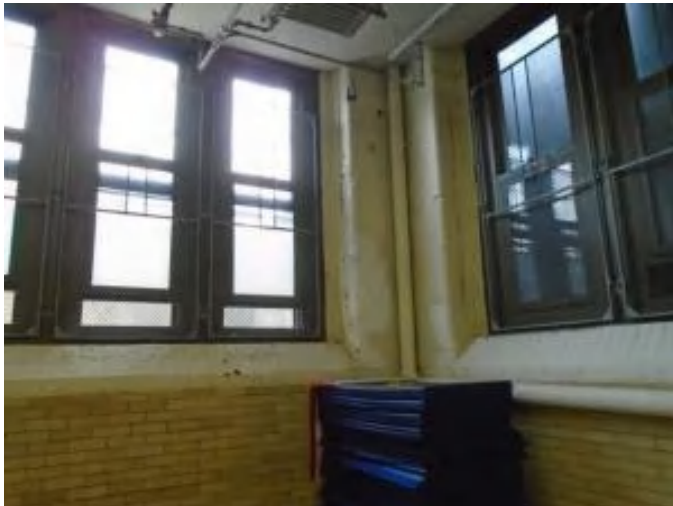
**System: A2020 - Basement Walls**

**Location:** Gym

**Distress:** Damaged

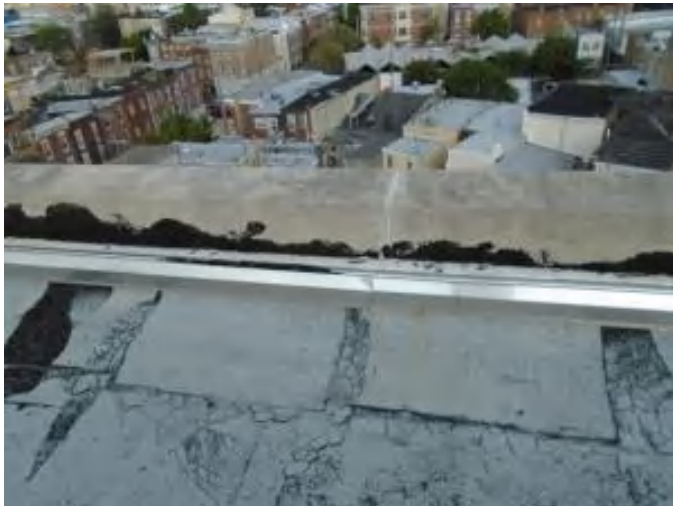
**System: B2010 - Exterior Walls**

**Location:** Parapet wall

**Distress:** Failing

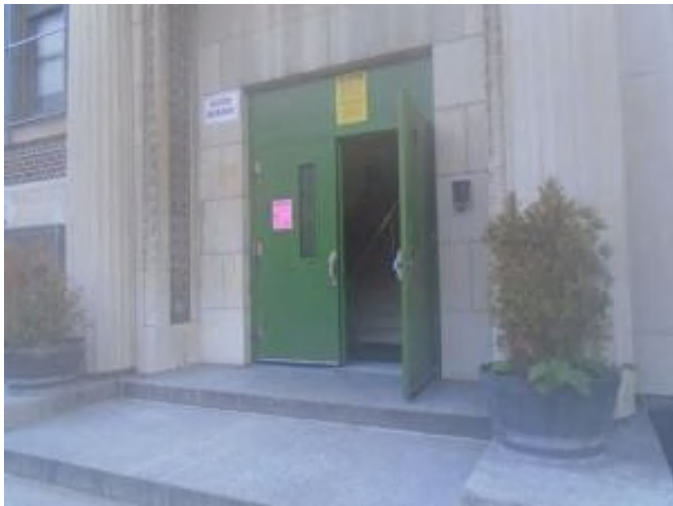
**System: B2030 - Exterior Doors**

**Location:** Entrance

**Distress:** Accessibility

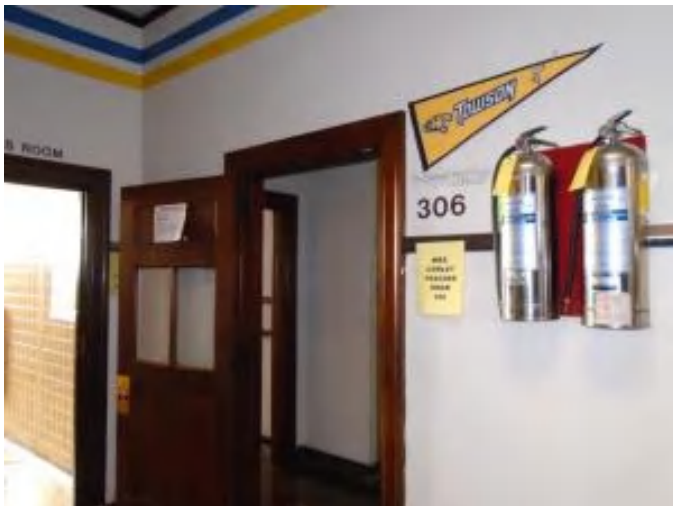
**System: C1020 - Interior Doors**

**Location:** Various

**Distress:** Accessibility

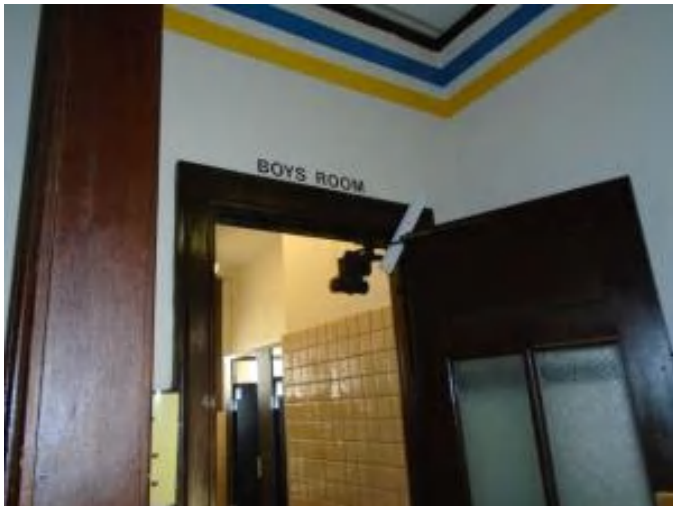
**System: C1030 - Fittings**

**Location:** Various

**Distress:** Inadequate

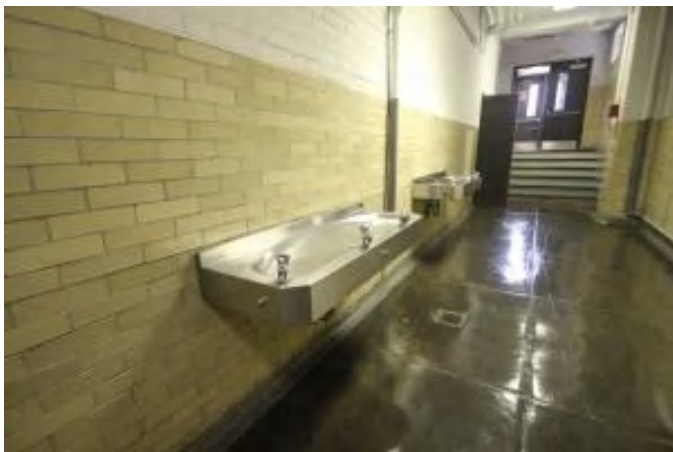
**System: D2010 - Plumbing Fixtures**

**Location:** Hallways

**Distress:** Accessibility

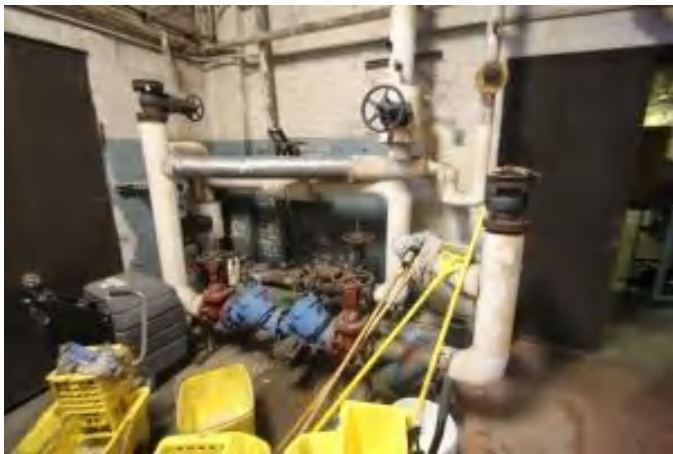
**System: D2020 - Domestic Water Distribution**

**Location:** Boiler room

**Distress:** Building / MEP Codes

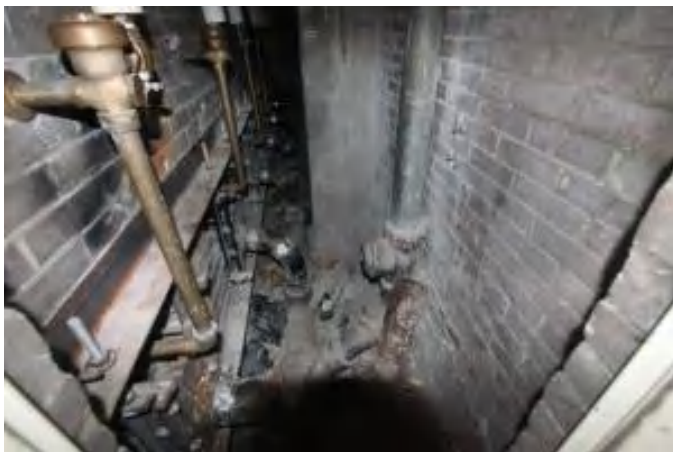
**System: D2020 - Domestic Water Distribution**

**Location:** Toilet rooms

**Distress:** Failing

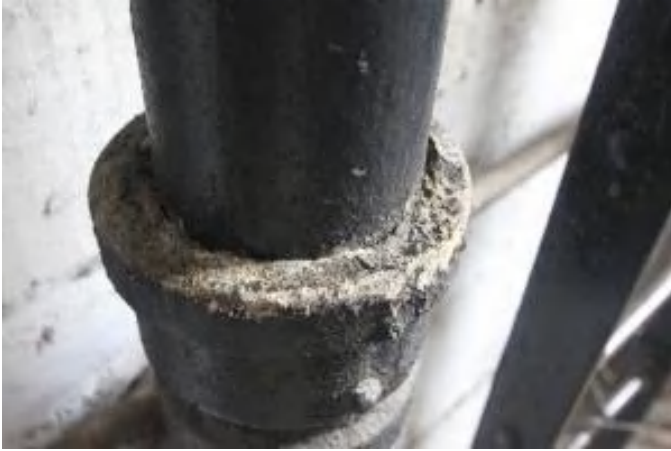
**System: D2040 - Rain Water Drainage**

**Location:** Entire building

**Distress:** Failing

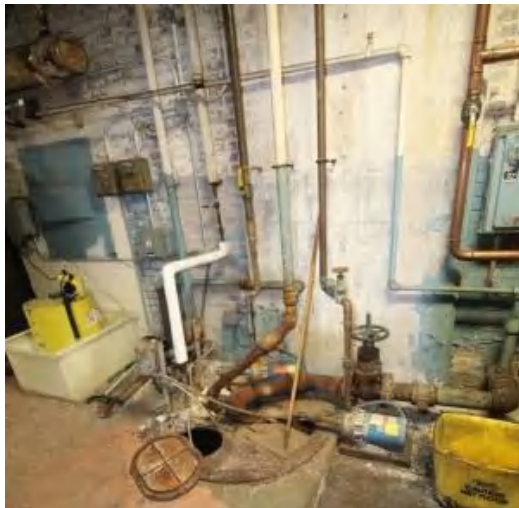
**System: D3020 - Heat Generating Systems**

**Location:** Boiler Room

**Distress:** Beyond Service Life

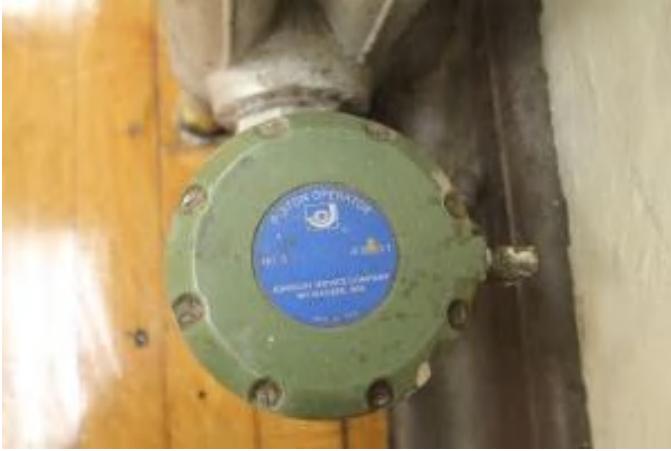
**System: D3060 - Controls & Instrumentation**

**Location:** Entire building

**Distress:** Failing

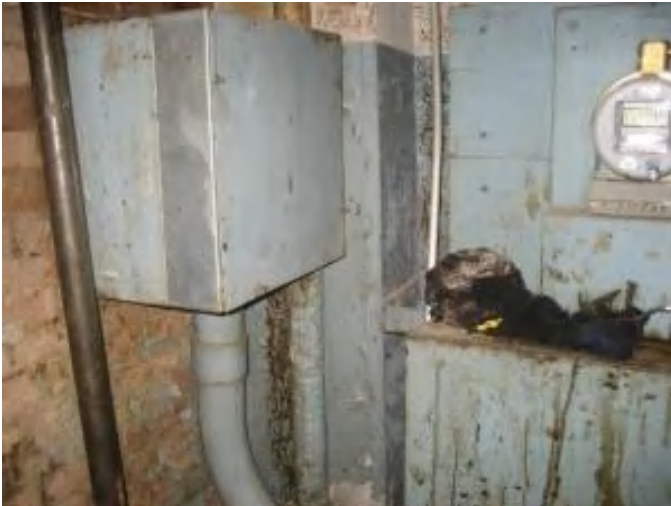
**System: D5010 - Electrical Service/Distribution**

**Location:** Basement

**Distress:** Inadequate

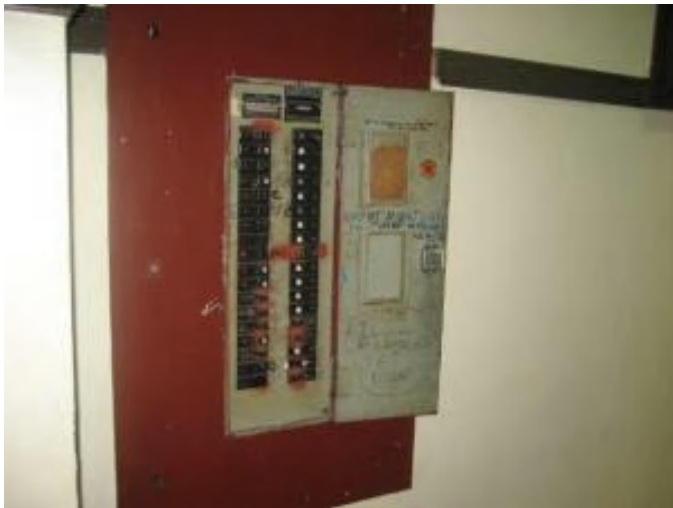
**System: D5010 - Electrical Service/Distribution**

**Location:** Entire Building

**Distress:** Inadequate

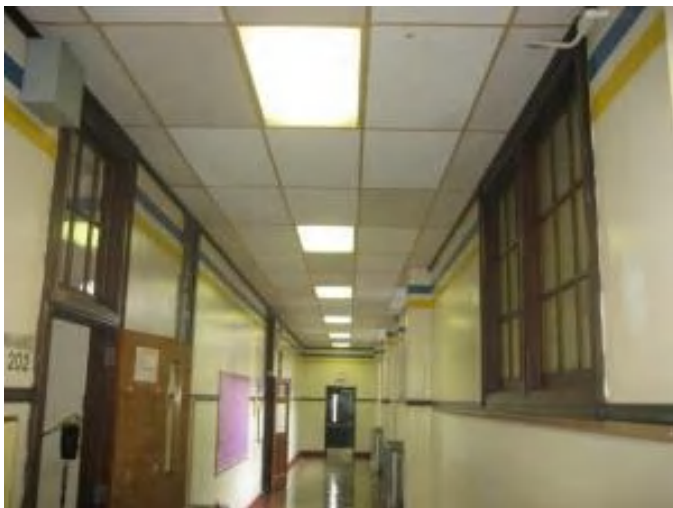
**System: D5020 - Lighting and Branch Wiring**

**Location:** Entire Building

**Distress:** Energy Efficiency

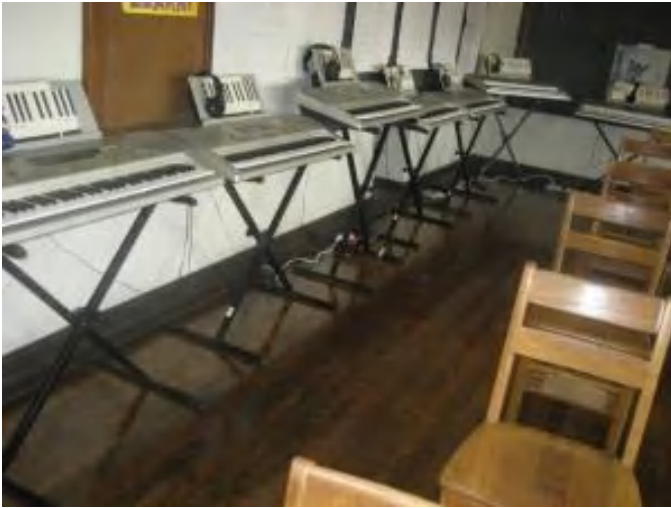
**System: D5020 - Lighting and Branch Wiring**

**Location:** Classrooms

**Distress:** Inadequate

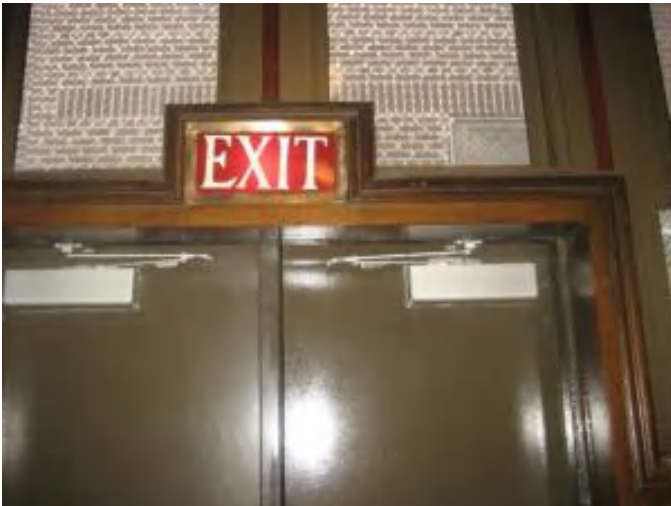
**System: D5020 - Lighting and Branch Wiring**

**Location:** Exit doors and corridors

**Distress:** Building / MEP Codes

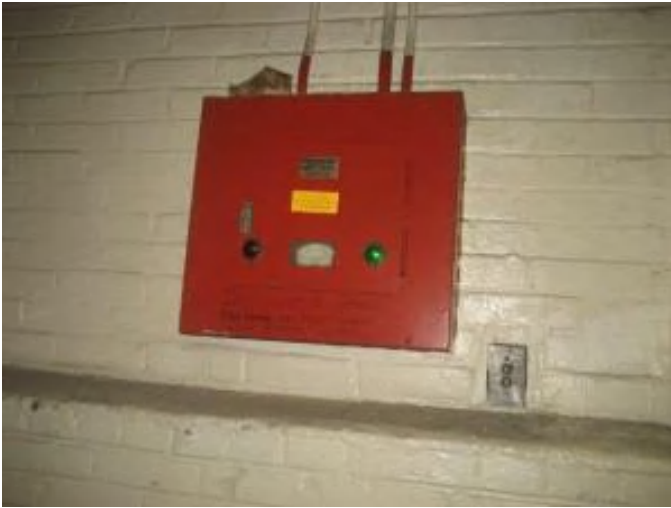
**System: D5030 - Communications and Security**

**Location:** Entire Building  
**Distress:** Building / MEP Codes  
**Category:** 2 - Code Compliance  
**Priority:** 2 - Response Time (2-3 yrs)  
**Correction:** Replace fire alarm system  
**Qty:** 79.00  
**Unit of Measure:** S.F.  
**Estimate:** \$156,765.43  
**Assessor Name:** Craig Anding  
**Date Created:** 10/21/2015

**Notes:** Replace old fire alarm system with addressable type with audio/visual devices at corridors and classrooms. Approximate 79 devices

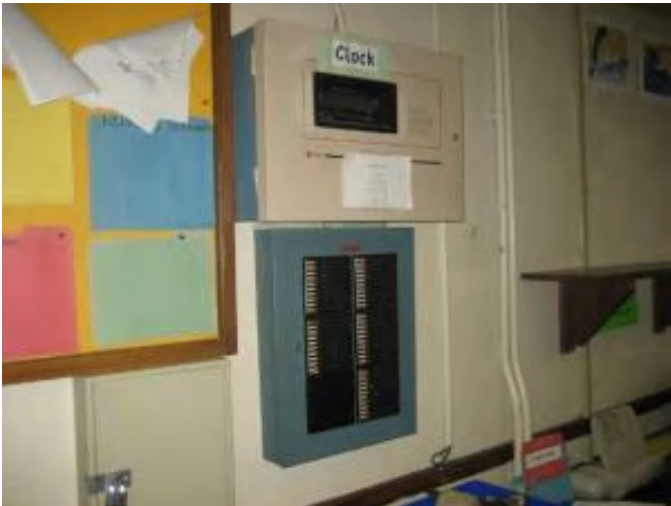
**System: D5030 - Communications and Security**

**Location:** Entire Building  
**Distress:** Obsolete  
**Category:** 3 - Operations / Maint.  
**Priority:** 2 - Response Time (2-3 yrs)  
**Correction:** Add/Replace Clock System or Components  
**Qty:** 60.00  
**Unit of Measure:** Ea.  
**Estimate:** \$112,560.22  
**Assessor Name:** Craig Anding  
**Date Created:** 10/21/2015

**Notes:** Replace clock and bell system with wireless, battery operated, clock system. Approximate 60 clocks.

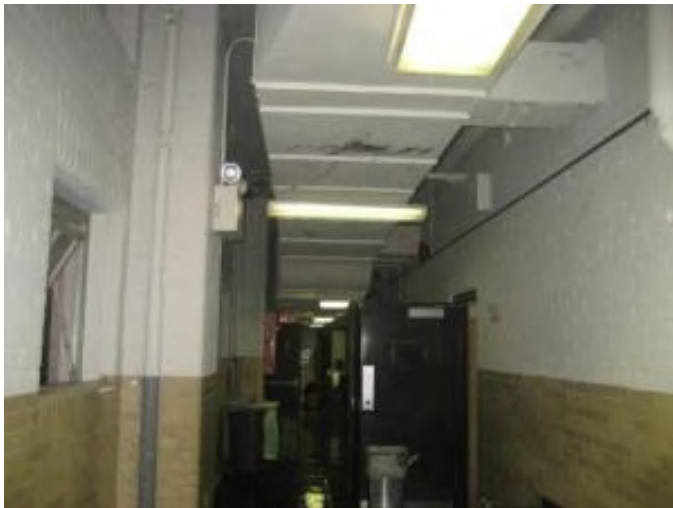
**System: D5090 - Other Electrical Systems**

**Location:** Outdoor

**Distress:** Inadequate

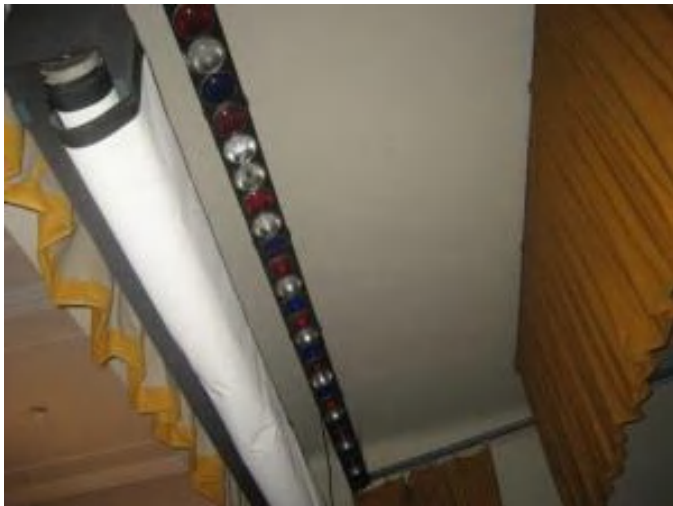
**System: E1020 - Institutional Equipment**

**Location:** Auditorium

**Distress:** Inadequate

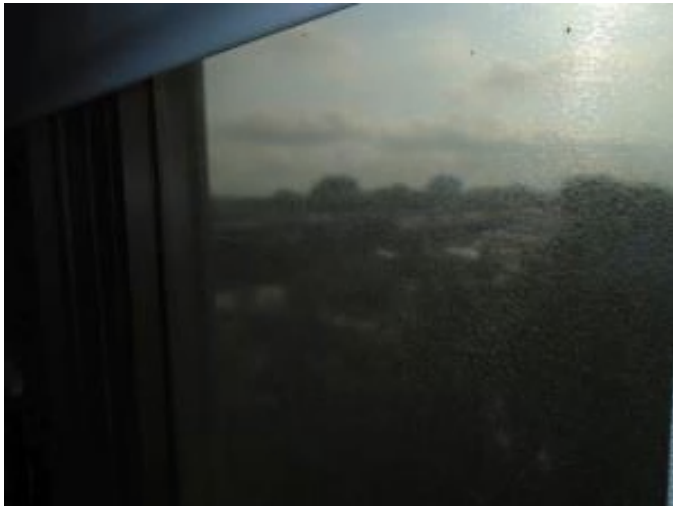
**System: B2020 - Exterior Windows**

**Location:** Windows

**Distress:** Energy Efficiency

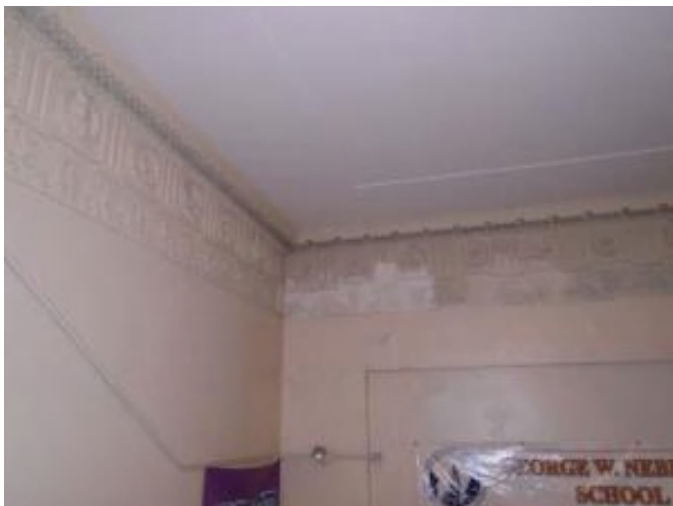
**System: C3010230 - Paint & Covering**

**Location:** Various

**Distress:** Damaged

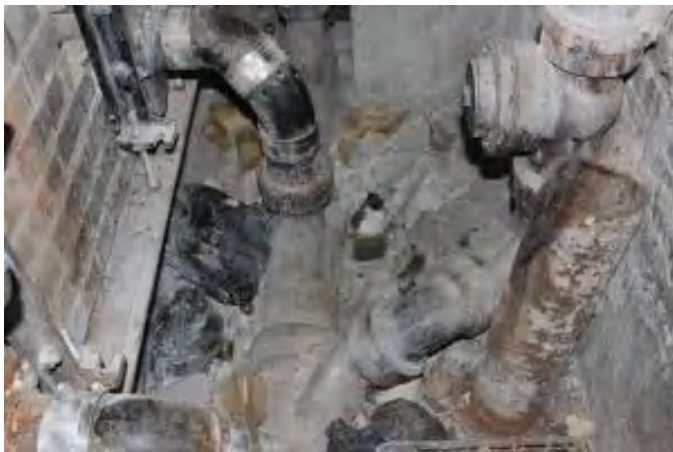
**System: D2030 - Sanitary Waste**

**Location:** Entire building

**Distress:** Failing

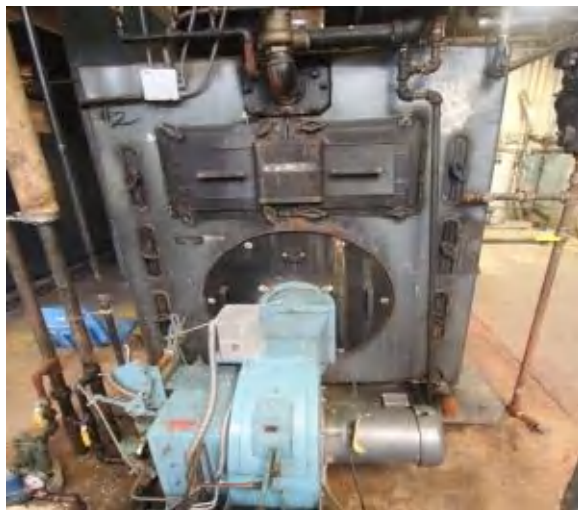
**System: D3020 - Heat Generating Systems**

**Location:** Boiler Room

**Distress:** Beyond Service Life

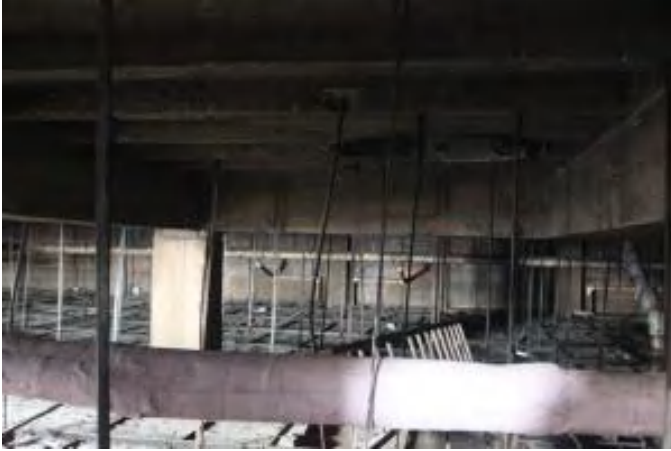
**System: D3040 - Distribution Systems**

**Location:** Entire building

**Distress:** Beyond Service Life

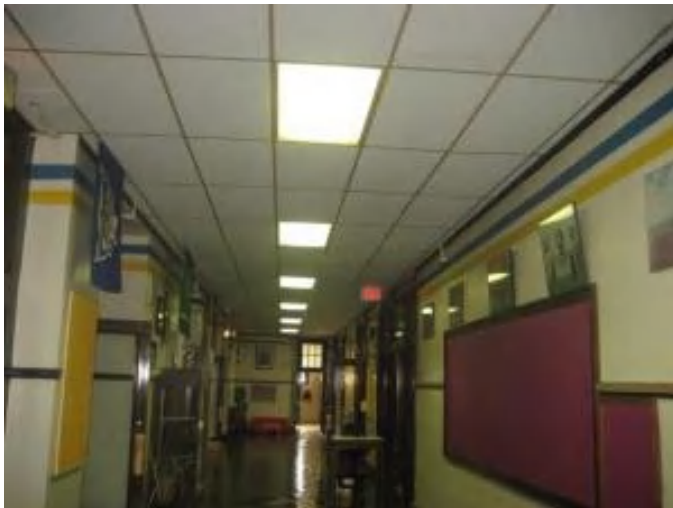
**System: D5030 - Communications and Security**

**Location:** Entire Building

**Distress:** Security Issue

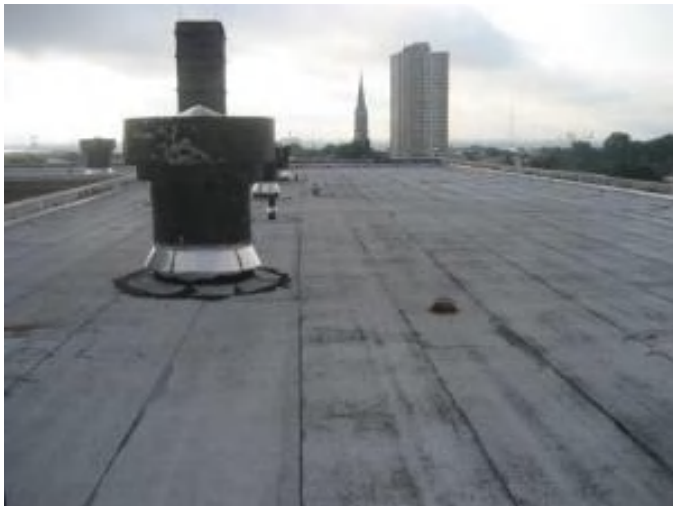
**System: D5090 - Other Electrical Systems**

**Location:** Roof

**Distress:** Building / MEP Codes

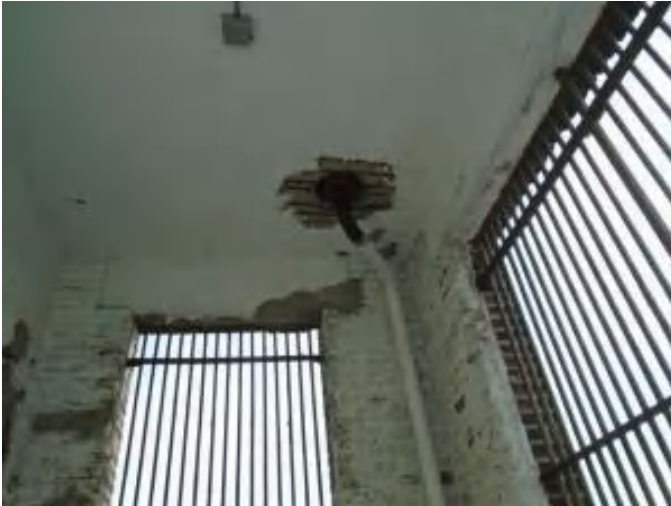
**System: B2010 - Exterior Walls**

**Location:** Fire Towers

**Distress:** Damaged

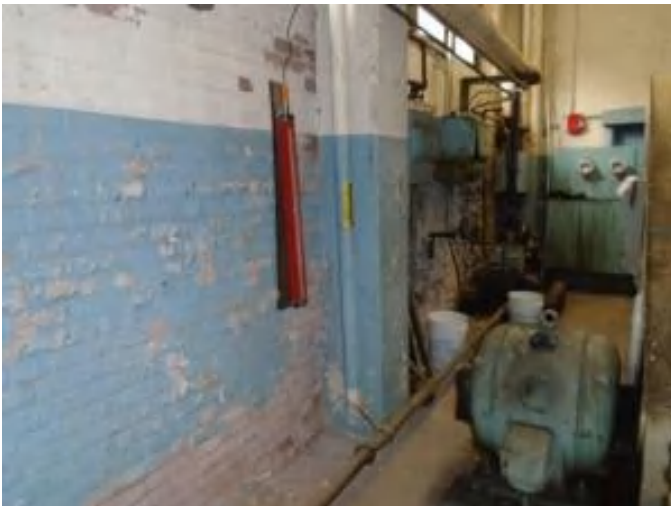
**System: C3010230 - Paint & Covering**

**Location:** Fire tower, boiler

**Distress:** Appearance

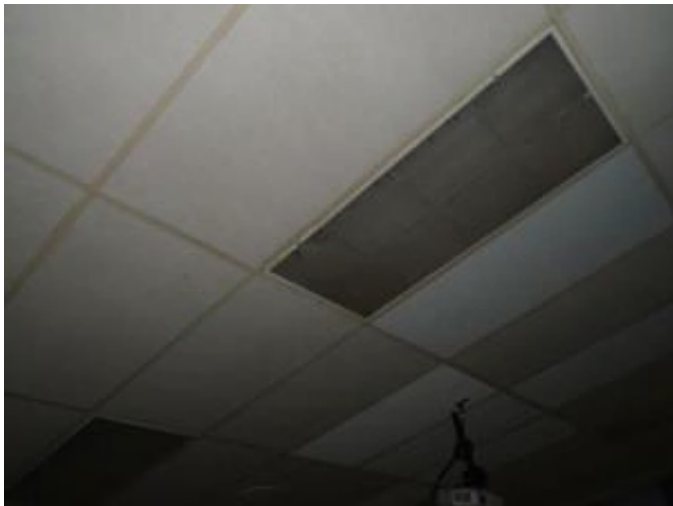
**System: C3030 - Ceiling Finishes**

**Location:** Various

**Distress:** Beyond Service Life

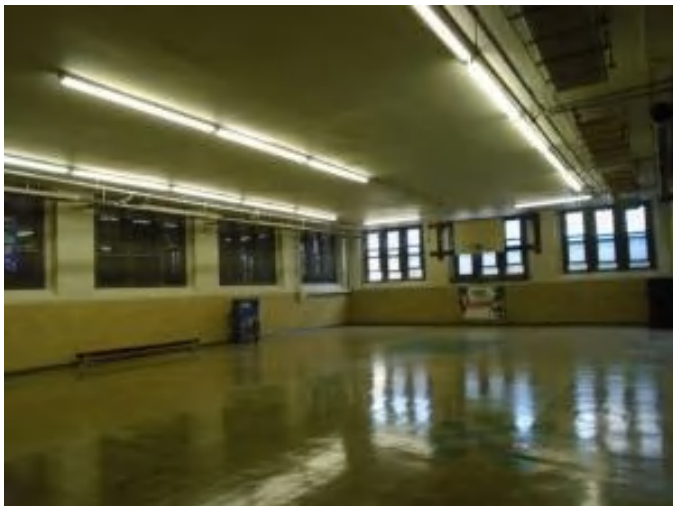
**System: C3030 - Ceiling Finishes**

**Location:** Gym

**Distress:** Inadequate

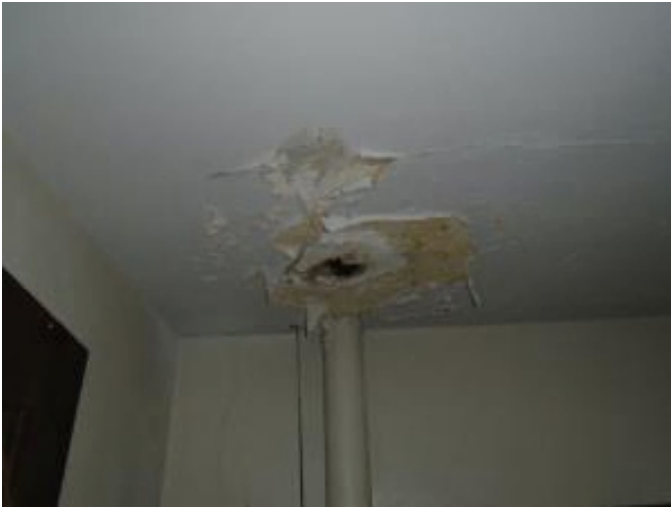
**System: C3030 - Ceiling Finishes**

**Location:** Auditorium

**Distress:** Damaged

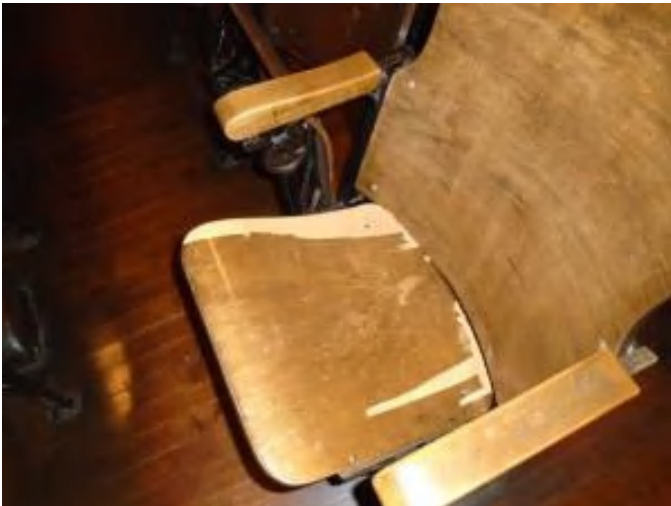
**System: E2010 - Fixed Furnishings**

**Location:** Auditorium

**Distress:** Damaged

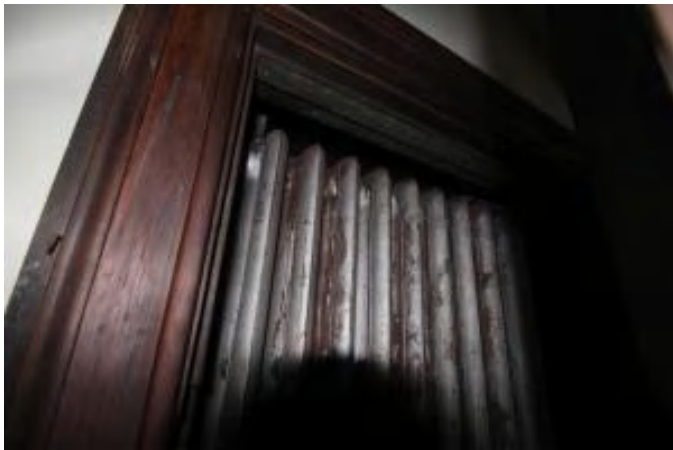
**System: D3040 - Distribution Systems**

**Location:** Classrooms

**Distress:** Health Hazard / Risk

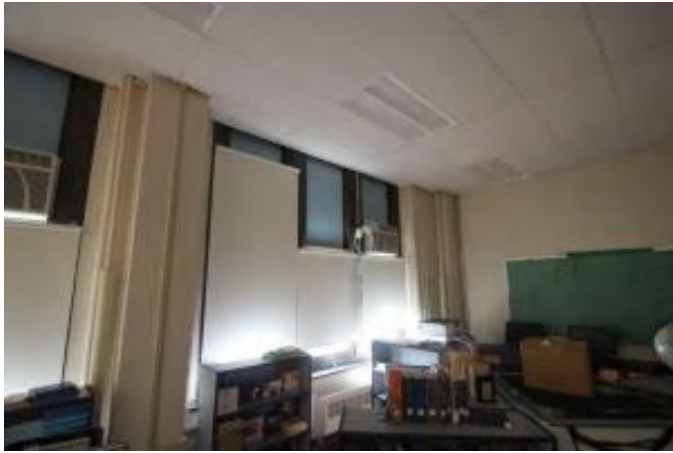
**System: D4010 - Sprinklers**

**Location:** Entire building

**Distress:** Life Safety / NFPA / PFD

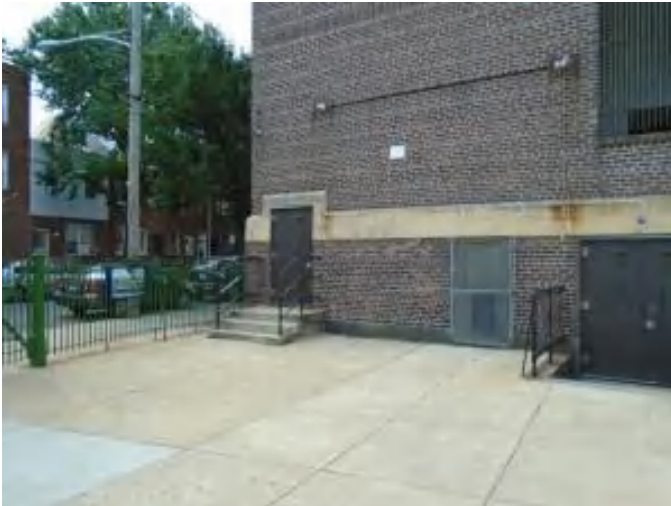
#### System: G2030 - Pedestrian Paving

**Location:** Entrance

**Distress:** Accessibility

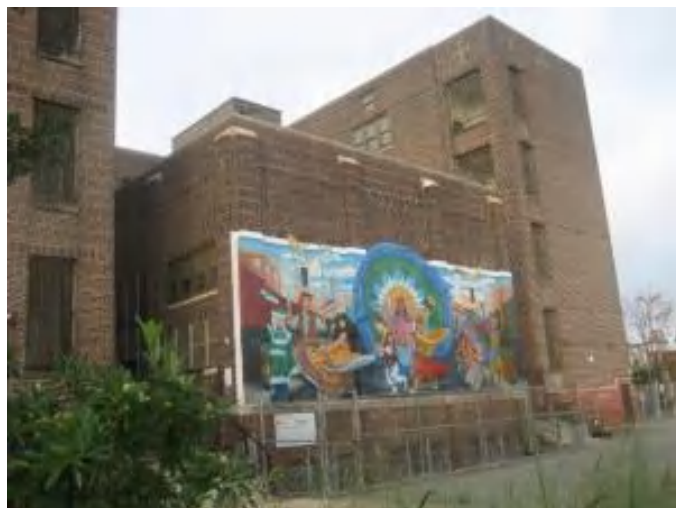
**System: G4030 - Site Communications & Security**

**Location:** Outdoor

**Distress:** Security Issue

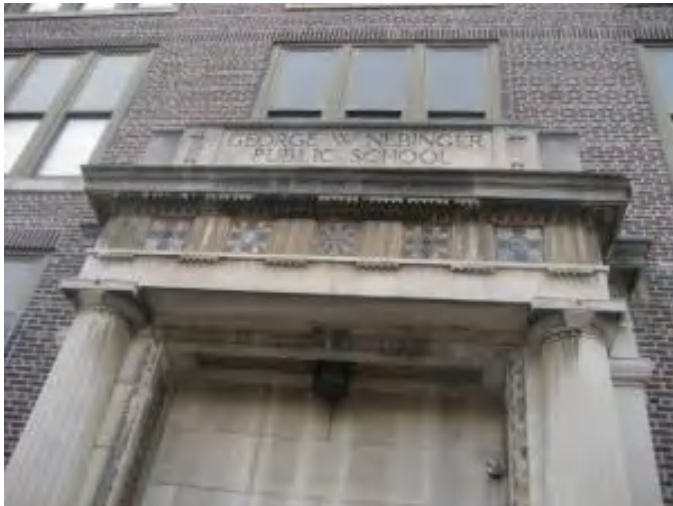
**System: G4020 - Site Lighting**

**Location:** Exit doors

**Distress:** Security Issue

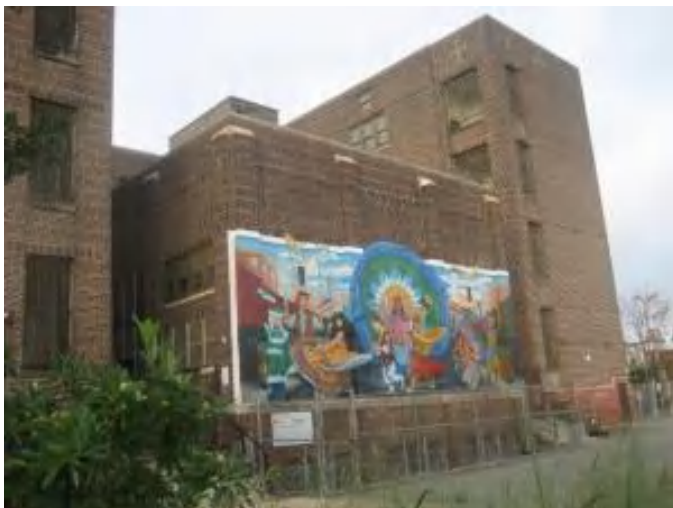
**System: G4030 - Site Communications & Security**

**Location:** Playground/parking

**Distress:** Inadequate
