Northeast High School

School District of Philadelphia

S802001; Northeast HS and Field

Site Assessment Report

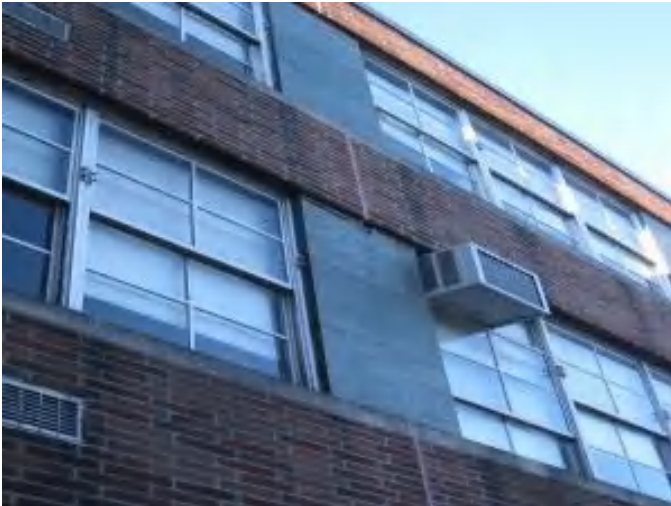
System: B2010 - Exterior Walls

Location: exterior wall - granite panels

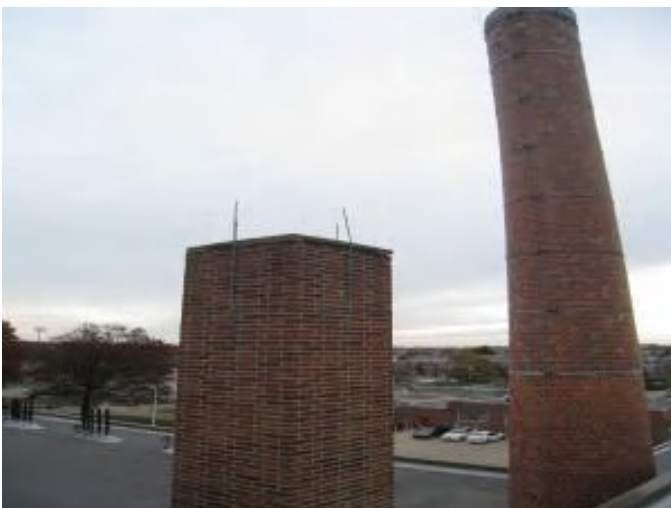
System: B2010 - Exterior Walls

Location: chimney cap

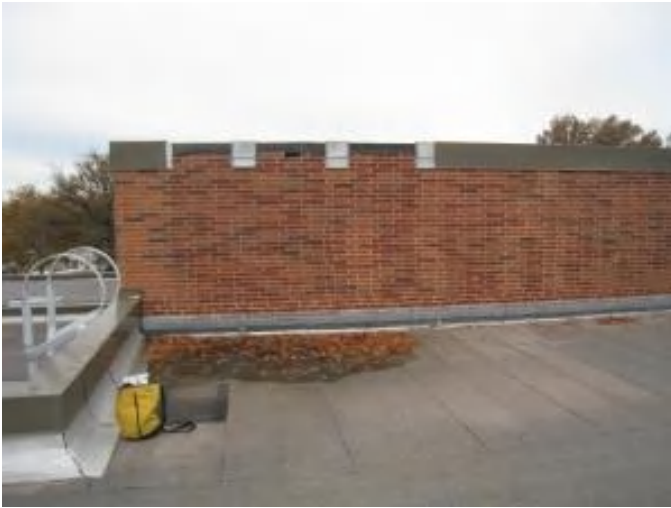
System: B3010105 - Built-Up

Location: coping above auditorium wall

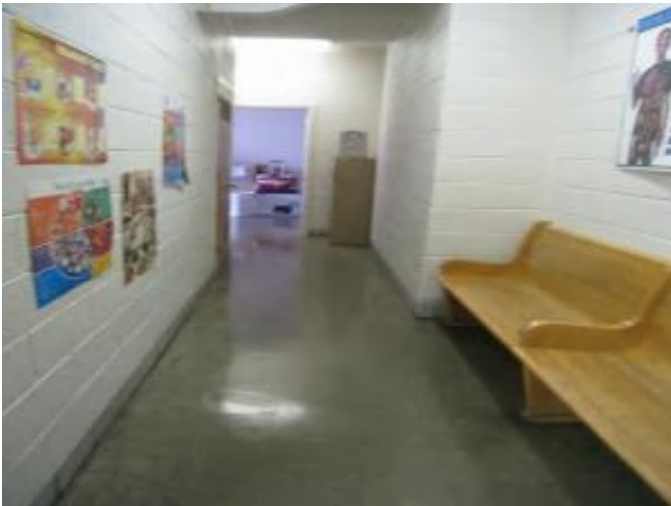
System: C1010 - Partitions

Location: dead end corridor

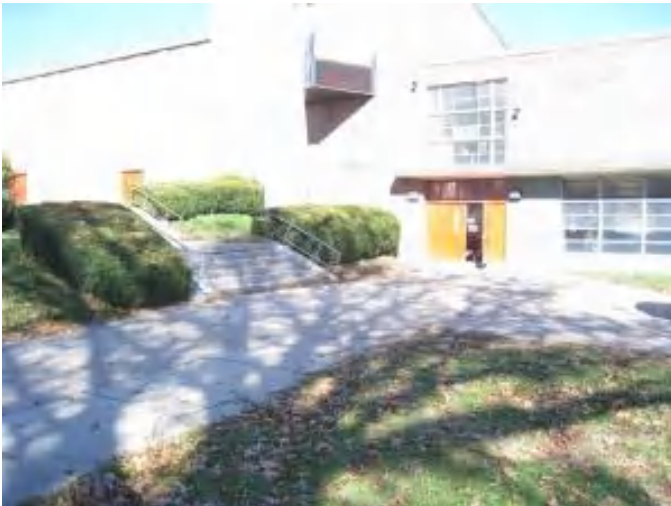
System: C2010 - Stair Construction

Location: exterior handrails

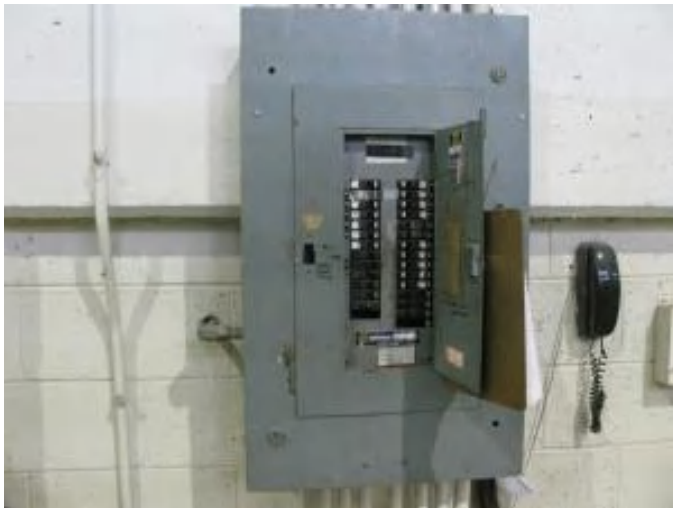
System: D5010 - Electrical Service/Distribution

Location: Entire Building
Distress: Beyond Service Life
Category: 3 - Operations / Maint.
Priority: 1 - Response Time (< 2 yr)
Correction: Replace Electrical Distribution System (U)
Qty: 1.00
Unit of Measure: Ea.
Estimate: \$1,732,276.67
Assessor Name: Craig Anding
Date Created: 11/25/2015

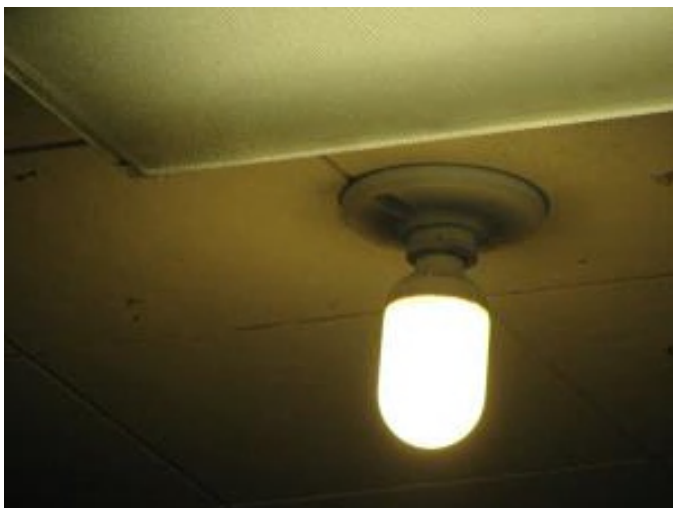
System: D5020 - Lighting and Branch Wiring

Location: Entire Building
Distress: Beyond Service Life
Category: 3 - Operations / Maint.
Priority: 1 - Response Time (< 2 yr)
Correction: Replace Lighting Fixtures (SF)
Qty: 0.00
Unit of Measure: S.F.
Estimate: \$3,015,218.13
Assessor Name: Craig Anding
Date Created: 11/25/2015

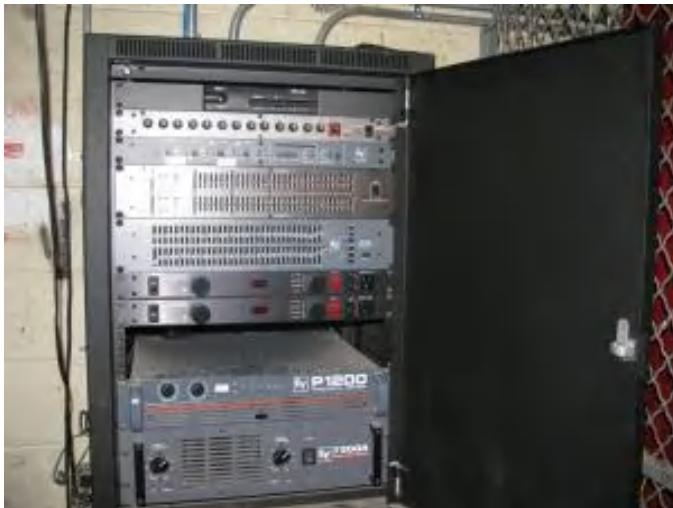
System: D5030 - Communications and Security

Location: Auditorium
Distress: Beyond Service Life
Category: 3 - Operations / Maint.
Priority: 1 - Response Time (< 2 yr)
Correction: Add/Replace Sound System
Qty: 1.00
Unit of Measure: LS
Estimate: \$52,318.79
Assessor Name: Craig Anding
Date Created: 11/25/2015

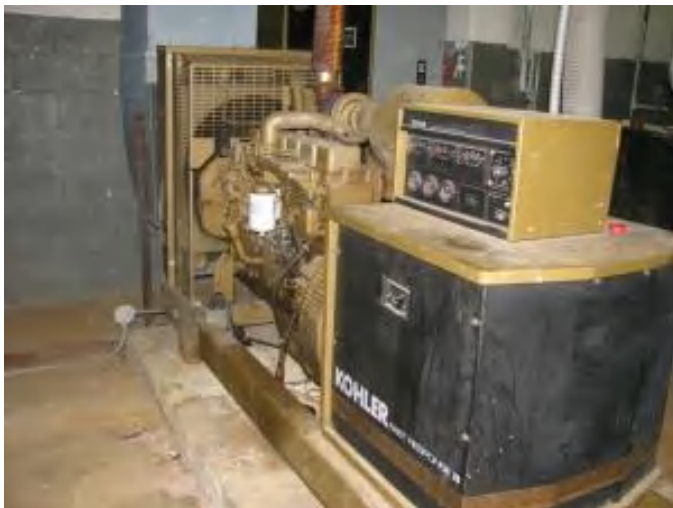
System: D5090 - Other Electrical Systems

Location: Boiler Room
Distress: Beyond Service Life
Category: 3 - Operations / Maint.
Priority: 1 - Response Time (< 2 yr)
Correction: Replace standby generator system
Qty: 1.00
Unit of Measure: Ea.
Estimate: \$250,154.96
Assessor Name: Craig Anding
Date Created: 11/25/2015

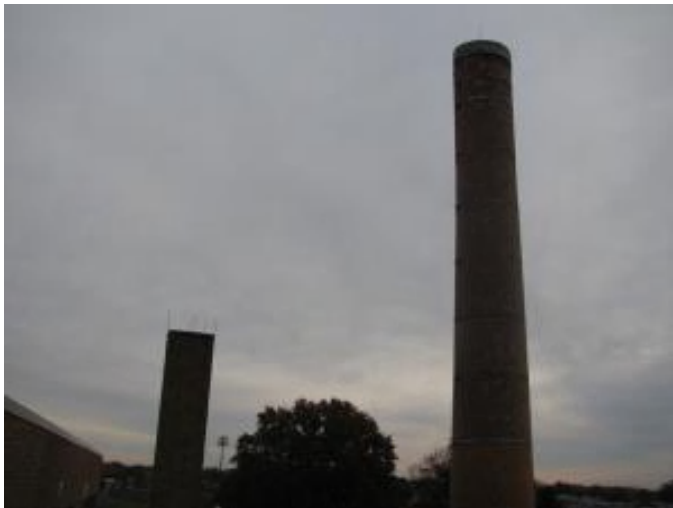
System: D5090 - Other Electrical Systems

Location: Roof
Distress: Life Safety / NFPA / PFD
Category: 1 - Health & Safety
Priority: 1 - Response Time (< 2 yr)
Correction: Repair Lightning Protection System
Qty: 1.00
Unit of Measure: Job
Estimate: \$28,234.94
Assessor Name: Craig Anding
Date Created: 11/25/2015

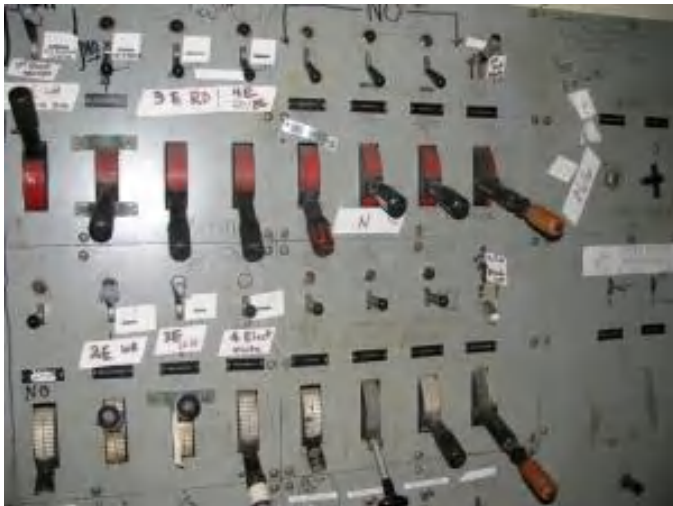
System: E1020 - Institutional Equipment

Location: Auditorium
Distress: Beyond Service Life
Category: 3 - Operations / Maint.
Priority: 1 - Response Time (< 2 yr)
Correction: Add/Replace Stage Theatrical Lighting System
Qty: 1.00
Unit of Measure: Ea.
Estimate: \$298,881.35
Assessor Name: Craig Anding
Date Created: 11/25/2015

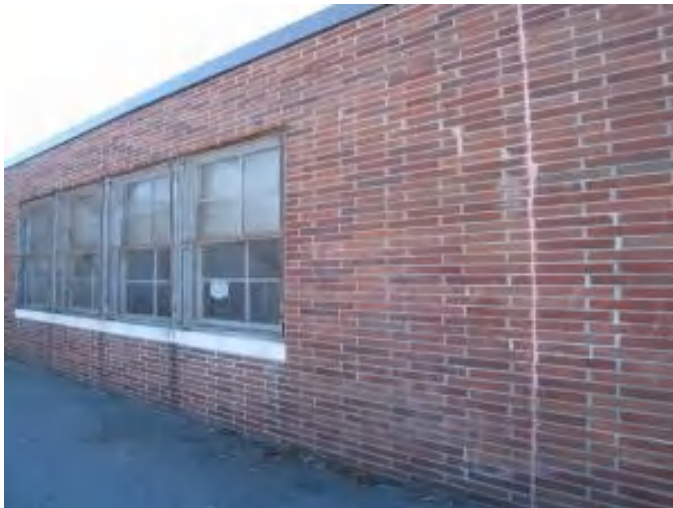
System: B2010 - Exterior Walls

Location: exterior brick walls
Distress: Failing
Category: 3 - Operations / Maint.
Priority: 2 - Response Time (2-3 yrs)
Correction: Repair cracks in masonry - replace missing mortar and repoint - SF of wall area
Qty: 500.00
Unit of Measure: S.F.
Estimate: \$16,144.74
Assessor Name: Craig Anding
Date Created: 01/23/2016

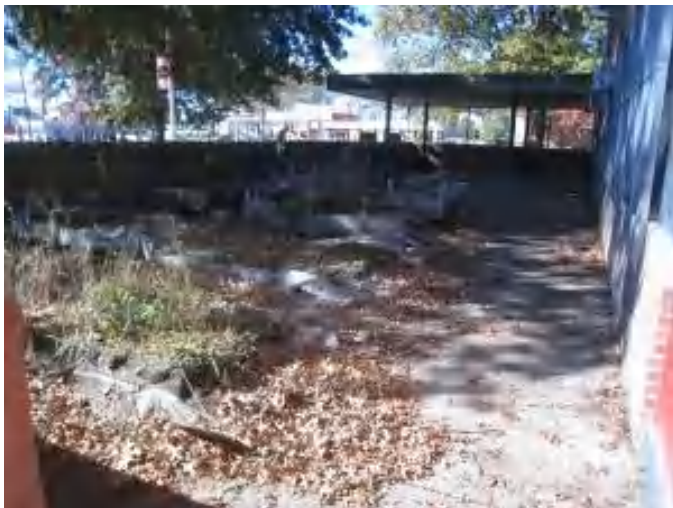
System: B2010 - Exterior Walls

Location: exterior wall - seating area
Distress: Damaged
Category: 3 - Operations / Maint.
Priority: 2 - Response Time (2-3 yrs)
Correction: Repair cracks in masonry - replace missing mortar and repoint - SF of wall area
Qty: 60.00
Unit of Measure: S.F.
Estimate: \$1,937.37
Assessor Name: Craig Anding
Date Created: 01/25/2016

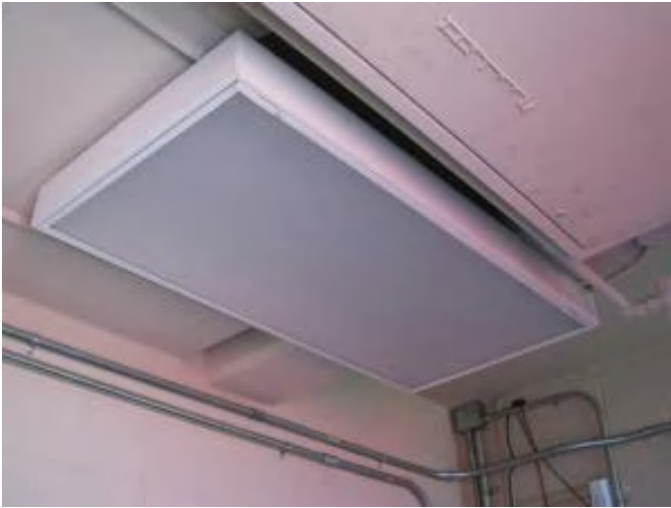
System: D5020 - Lighting and Branch Wiring

Location: Entire Building
Distress: Beyond Service Life
Category: 4 - Capital Improvement
Priority: 1 - Response Time (< 2 yr)
Correction: Replace Lighting Fixtures (SF)
Qty: 0.00
Unit of Measure: S.F.
Estimate: \$142,940.81
Assessor Name: Craig Anding
Date Created: 12/28/2015

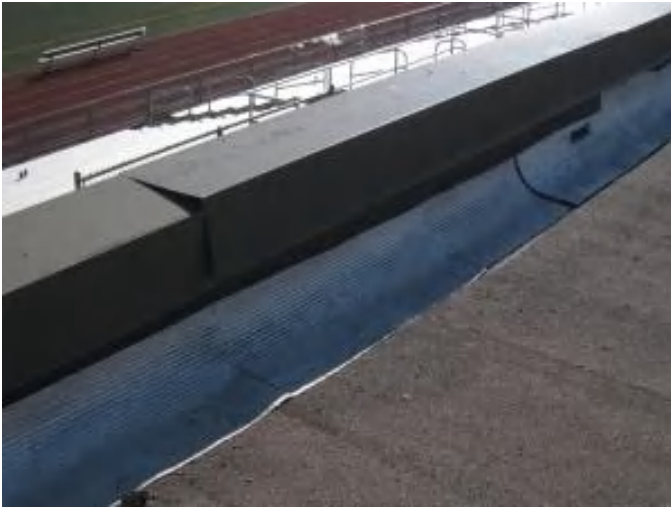
System: B3010105 - Built-Up

Location: coping
Distress: Damaged
Category: 3 - Operations / Maint.
Priority: 2 - Response Time (2-3 yrs)
Correction: Remove and replace or replace parapet caps - BUR
Qty: 20.00
Unit of Measure: L.F.
Estimate: \$1,711.83
Assessor Name: Craig Anding
Date Created: 01/26/2016

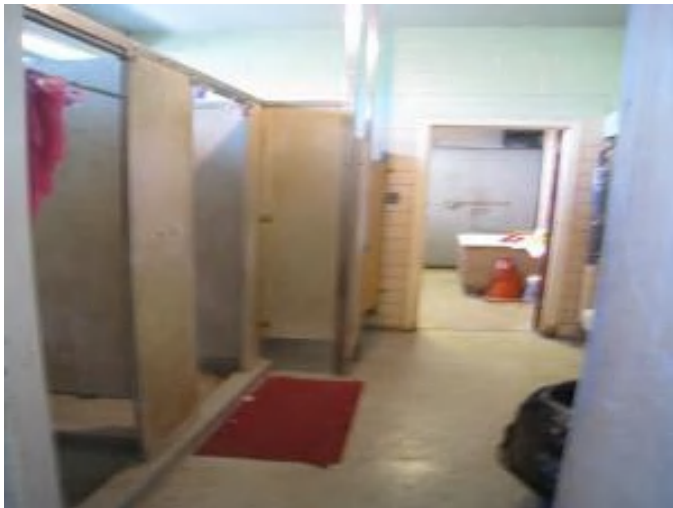
System: C1030 - Fittings

Location: toilet rooms
Distress: Health Hazard / Risk
Category: 3 - Operations / Maint.
Priority: 2 - Response Time (2-3 yrs)
Correction: Remove and replace damaged toilet partitions - handicap units
Qty: 29.00
Unit of Measure: Ea.
Estimate: \$28,357.80
Assessor Name: Craig Anding
Date Created: 01/26/2016

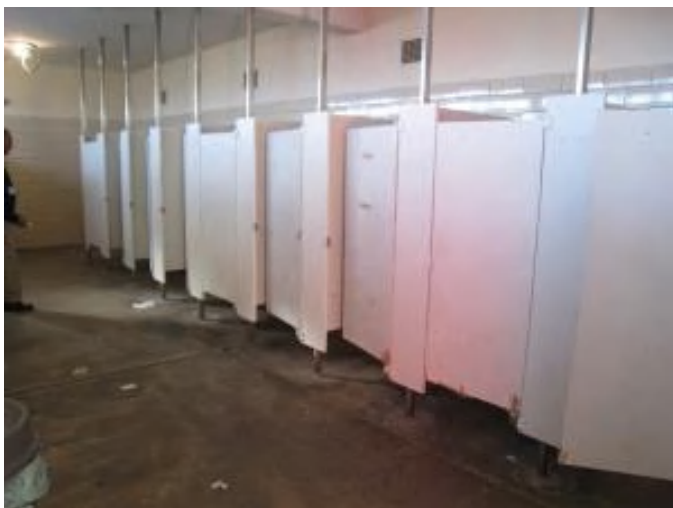
System: C1030 - Fittings

Location: toilet rooms
Distress: Failing
Category: 3 - Operations / Maint.
Priority: 2 - Response Time (2-3 yrs)
Correction: Replace toilet accessories - select accessories and quantity
Qty: 29.00
Unit of Measure: Ea.
Estimate: \$21,937.18
Assessor Name: Craig Anding
Date Created: 01/26/2016

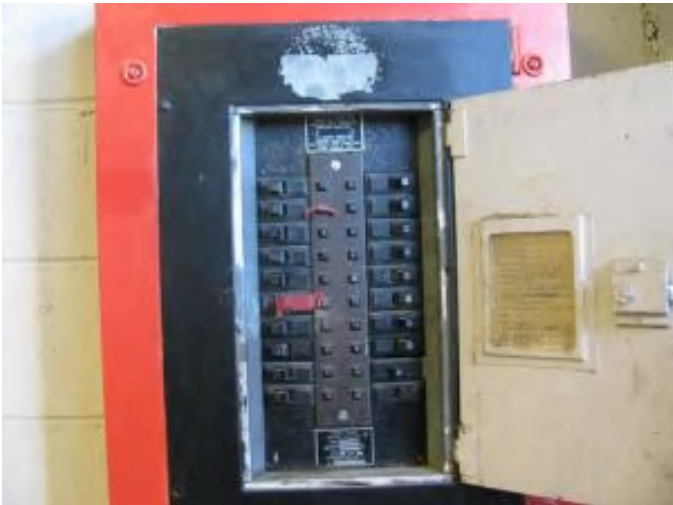
System: D5010 - Electrical Service/Distribution

Location: Entire Building
Distress: Inadequate
Category: 3 - Operations / Maint.
Priority: 3 - Response Time (3-4 yrs)
Correction: Replace Panelboard
Qty: 1.00
Unit of Measure: Ea.
Estimate: \$86,160.04
Assessor Name: Craig Anding
Date Created: 12/28/2015

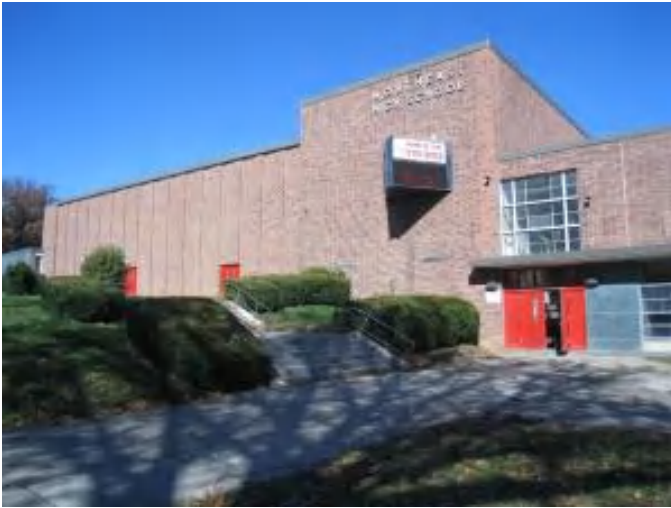
System: G2030 - Pedestrian Paving

Location: sidewalks
Distress: Damaged
Category: 3 - Operations / Maint.
Priority: 2 - Response Time (2-3 yrs)
Correction: Remove and replace concrete sidewalk or concrete paving - 4" concrete thickness
Qty: 1,000.00
Unit of Measure: S.F.
Estimate: \$14,382.85
Assessor Name: Steven Litman
Date Created: 01/25/2016
