### Overbrook Ed Center School

### Overbrook Ed Center Annex School

## Site Assessment Report

February 2, 2017

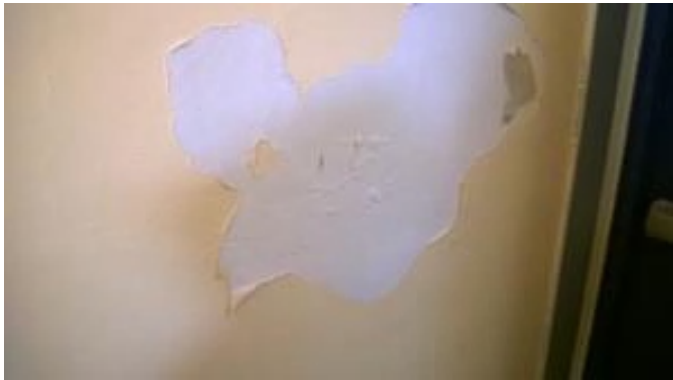
#### System: C3010230 - Paint & Covering

**Location:** Building wide

**Distress:** Maintenance Required

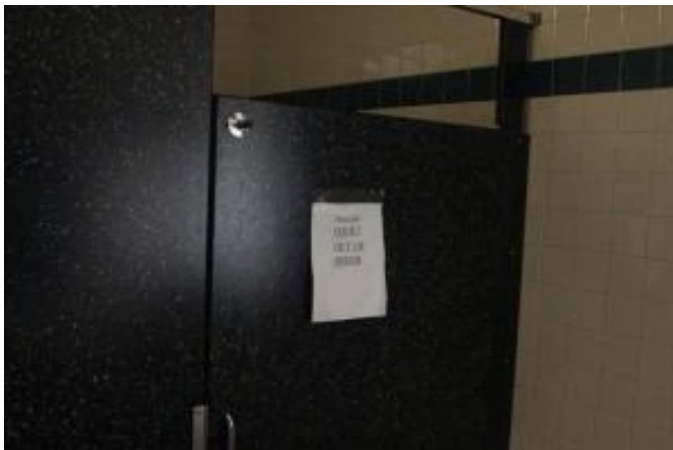
#### System: D2010 - Plumbing Fixtures

**Location:** Toilet rooms

**Distress:** Failing

**Notes:** Repair or replace out of order water closet

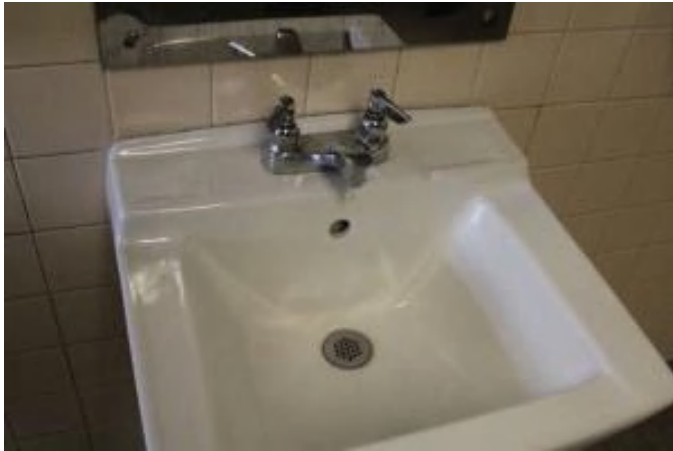
**System: D2010 - Plumbing Fixtures**

**Location:** Toilet rooms  
**Distress:** Failing  
**Category:** 3 - Operations / Maint.  
**Priority:** 2 - Response Time (2-3 yrs)  
**Correction:** Replace lavatory faucet  
**Qty:** 2.00

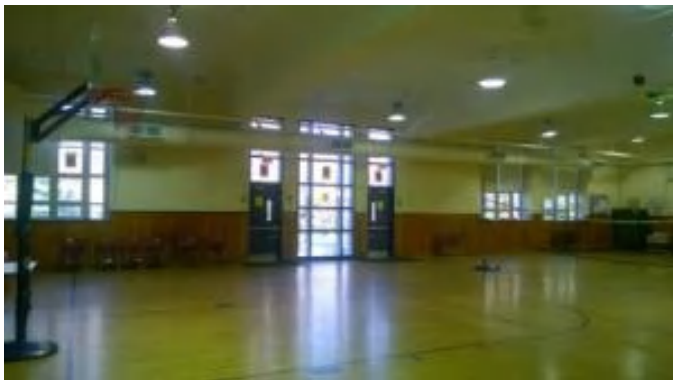
**System: E2010 - Fixed Furnishings**

**Location:** Computer lab and gym  
**Distress:** Inadequate  
**Category:** 3 - Operations / Maint.  
**Priority:** 2 - Response Time (2-3 yrs)  
**Correction:** Replace or add roller shades  
**Qty:** 200.00

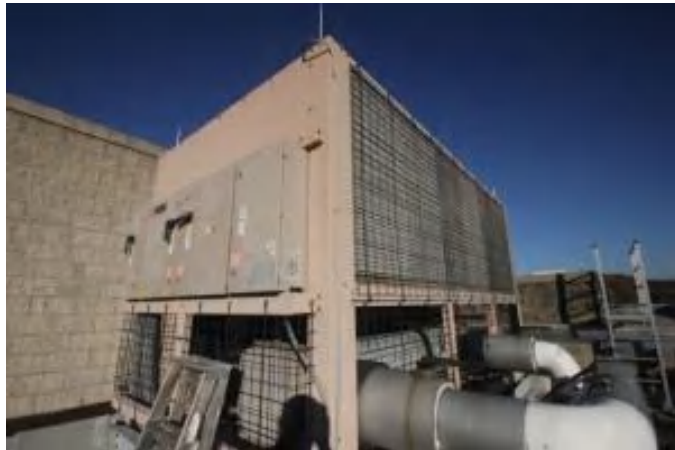
**System: D3030 - Cooling Generating Systems**

**Location:** Roof

**Distress:** Failing

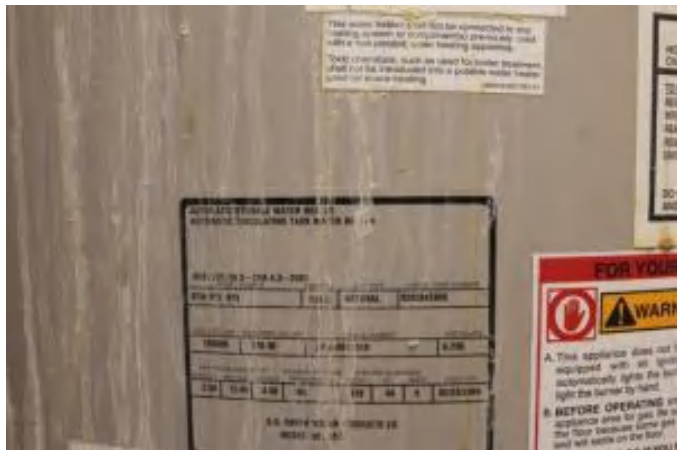
**System: D2020 - Domestic Water Distribution**

**Location:** Janitor closet

**Distress:** Beyond Service Life

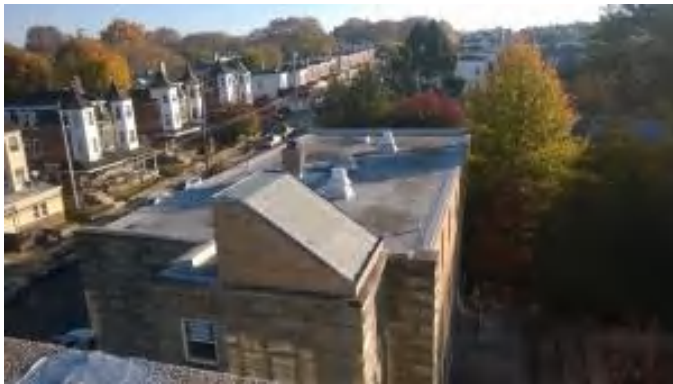
#### System: B3010105 - Built-Up

**Location:** Roof

**Distress:** Building Envelope Integrity

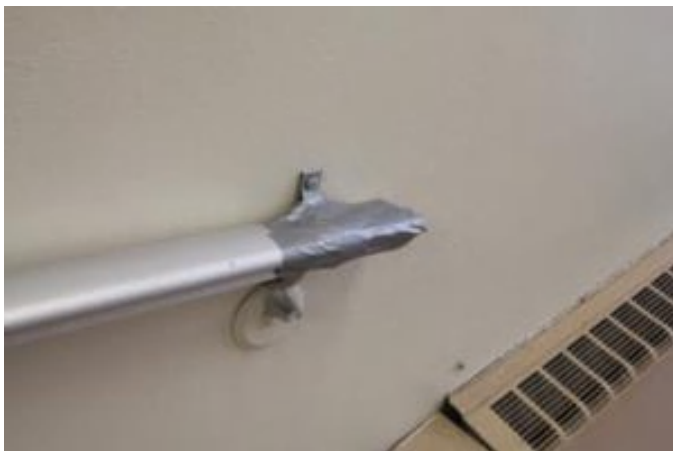
#### System: C2010 - Stair Construction

**Location:** Exit stairwells

**Distress:** Building / MEP Codes

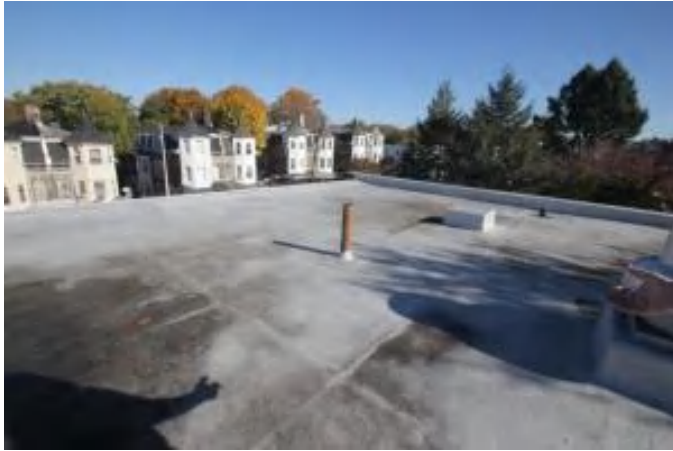
**System: B2010 - Exterior Walls**

**Location:** East end high roof

**Distress:** OSHA

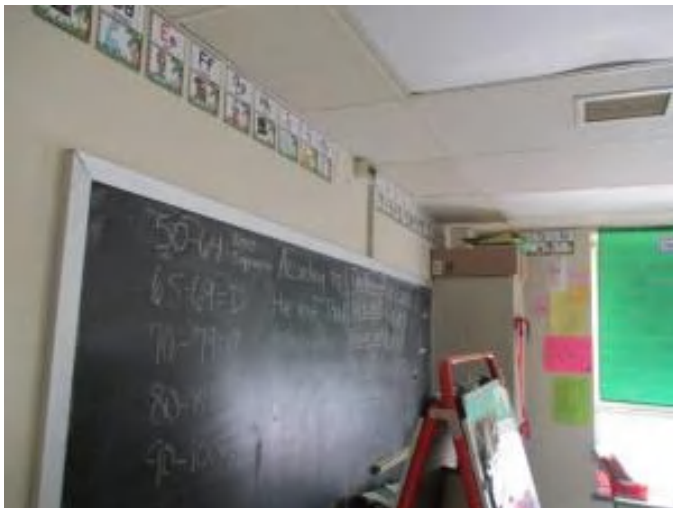
**System: C1030 - Fittings**

**Location:** Classrooms

**Distress:** Obsolete

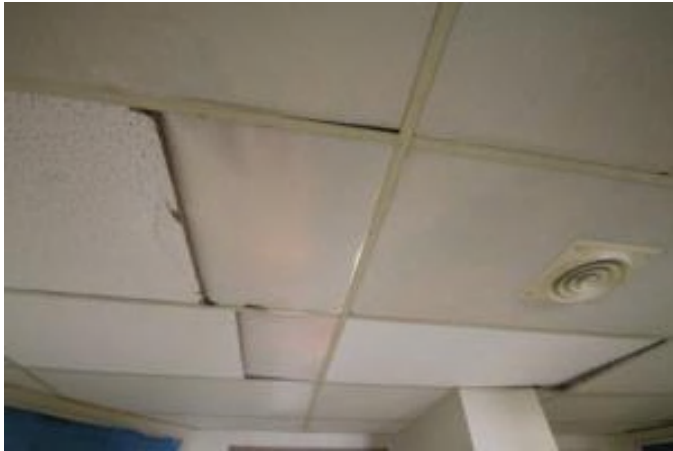
**System: C3030 - Ceiling Finishes**

**Location:** Boys toilet room and under skylight

**Distress:** Maintenance Required

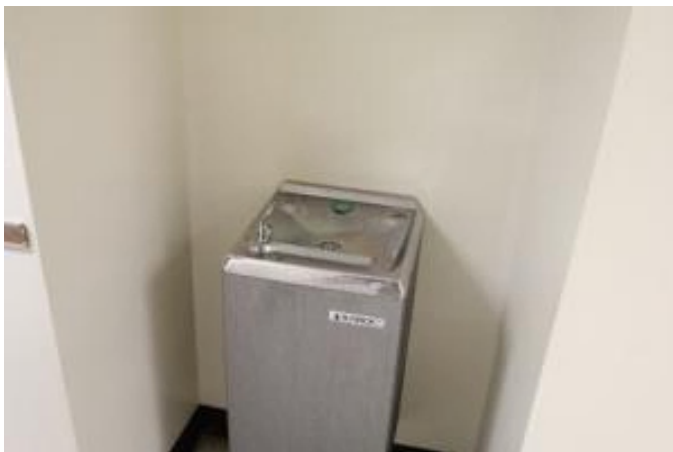
**System: D2010 - Plumbing Fixtures**

**Location:** Corridors

**Distress:** Accessibility

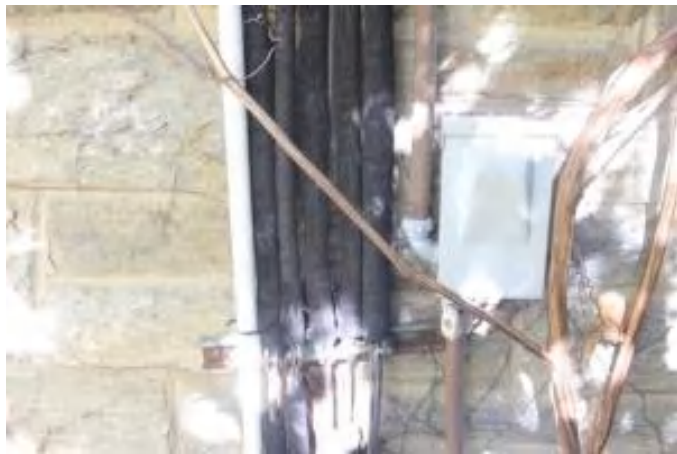
**System: D3040 - Distribution Systems**

**Location:** Outside

**Distress:** Failing

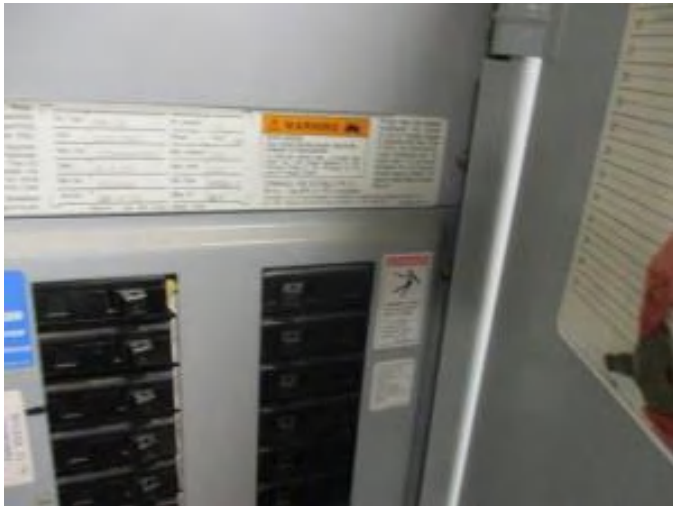
**System: D5010 - Electrical Service/Distribution**

**Location:** Entire Building

**Distress:** Inadequate

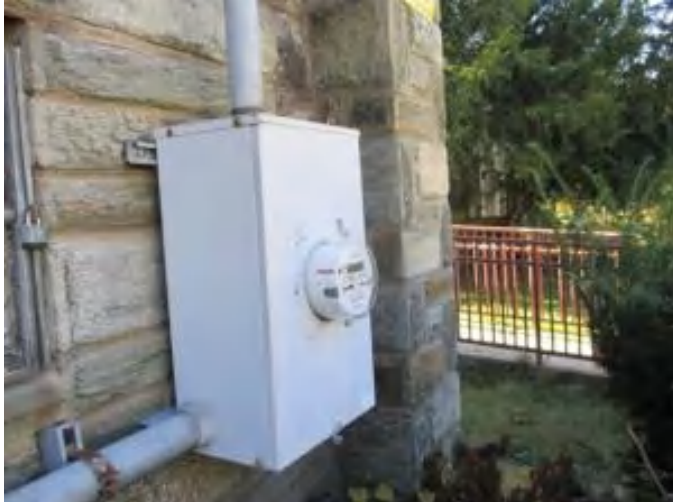
**System: D5010 - Electrical Service/Distribution**

**Location:** Ground level

**Distress:** Inadequate

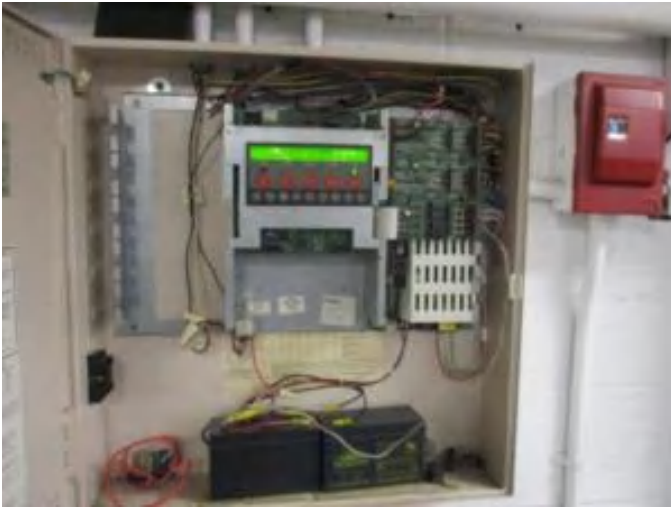
**System: D5030 - Communications and Security**

**Location:** Entire Building

**Distress:** Life Safety / NFPA / PFD

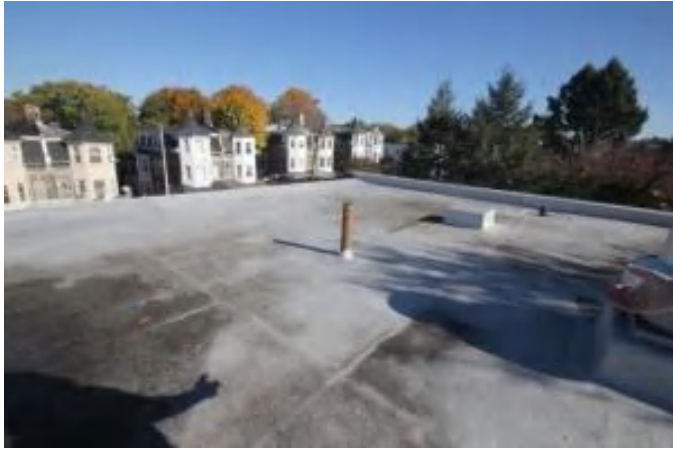
**System: D5090 - Other Electrical Systems**

**Location:** Roof  
**Distress:** Building / MEP Codes  
**Category:** 2 - Code Compliance  
**Priority:** 3 - Response Time (3-4 yrs)  
**Correction:** Repair Lightning Protection System  
**Qty:** 1.00  
**Unit of Measure:** Job  
**Estimate:** \$24,249.82  
**Assessor Name:** Craig Anding  
**Date Created:** 01/20/2016

**Notes:** Prepare a study to determine if the school requires lightning protection system.

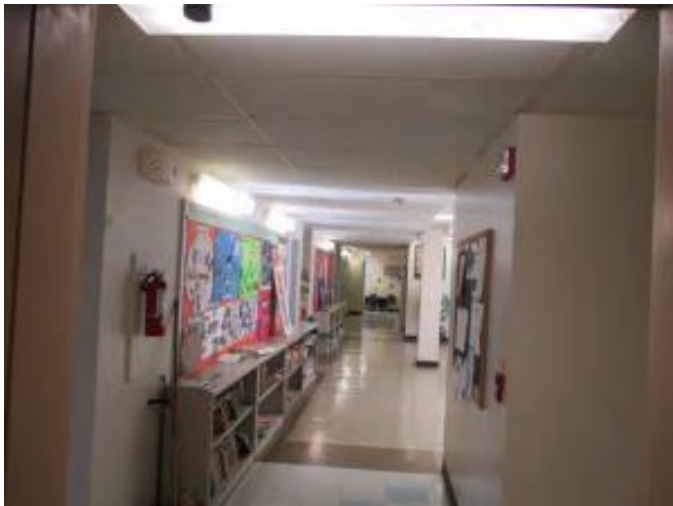
**System: D5090 - Other Electrical Systems**

**Location:** Entire Building  
**Distress:** Life Safety / NFPA / PFD  
**Category:** 1 - Health & Safety  
**Priority:** 3 - Response Time (3-4 yrs)  
**Correction:** Replace Emergency/Exit Lighting  
**Qty:** 5.00  
**Unit of Measure:** Ea.  
**Estimate:** \$16,970.23  
**Assessor Name:** Craig Anding  
**Date Created:** 01/20/2016

**Notes:** Provide emergency lighting fixtures with battery backup. Approximate 5

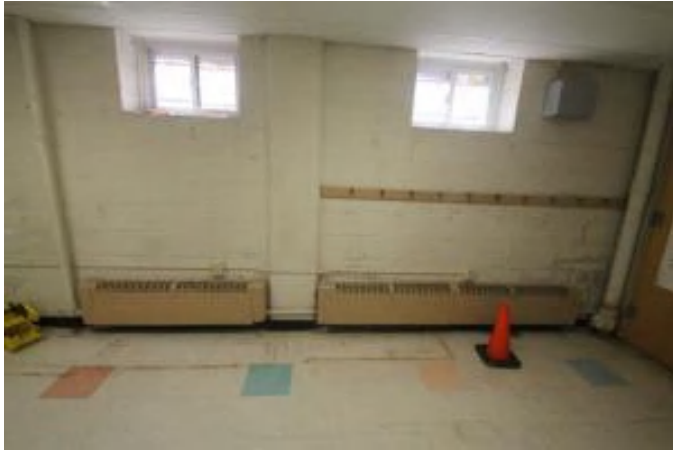
**System: D2030 - Sanitary Waste**

**Location:** Entire building

**Distress:** Beyond Service Life

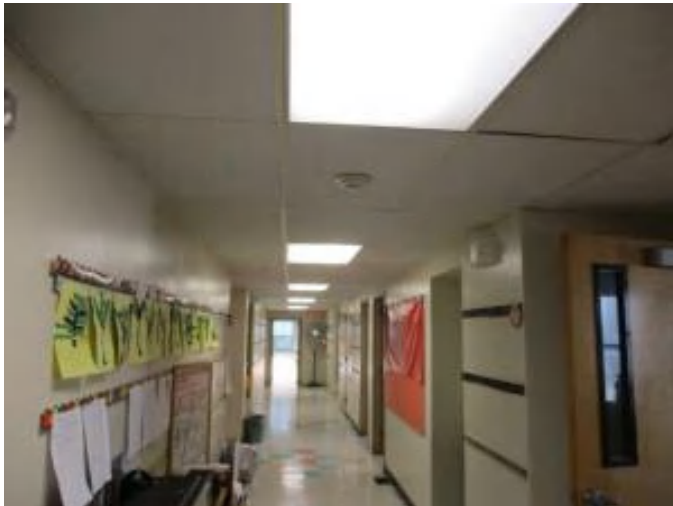
**System: D5030 - Communications and Security**

**Location:** Entire Building

**Distress:** Security Issue

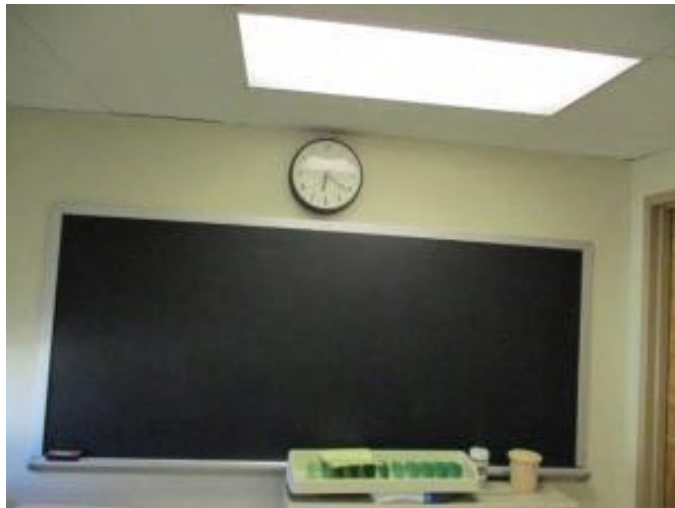
**System: D5030 - Communications and Security**

**Location:** Entire Building

**Distress:** Inadequate

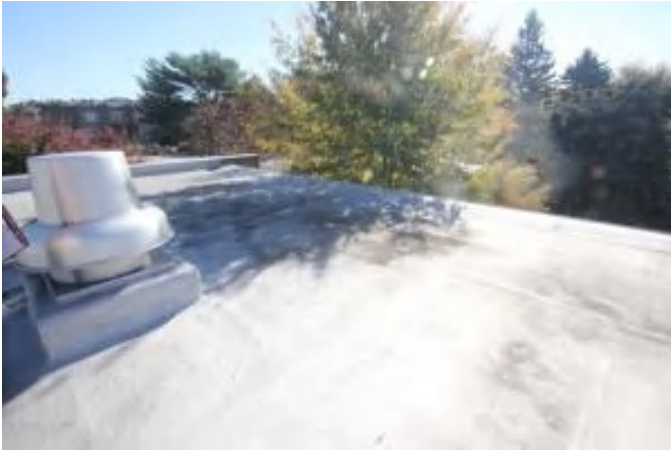
**System: D3040 - Distribution Systems**

**Location:** Entire building

**Distress:** Inadequate

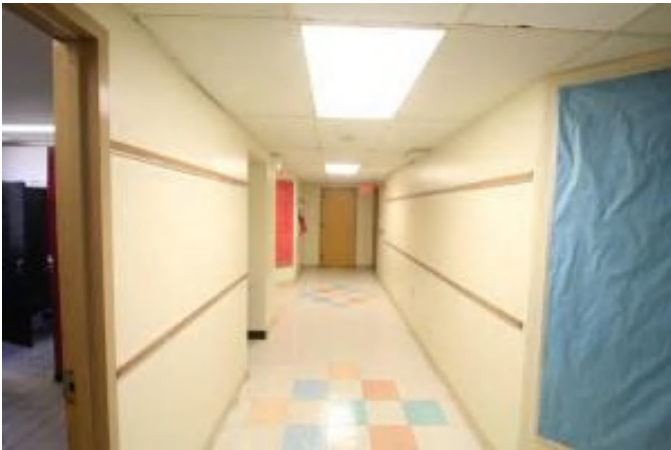
**System: D4010 - Sprinklers**

**Location:** Entire building

**Distress:** Life Safety / NFPA / PFD

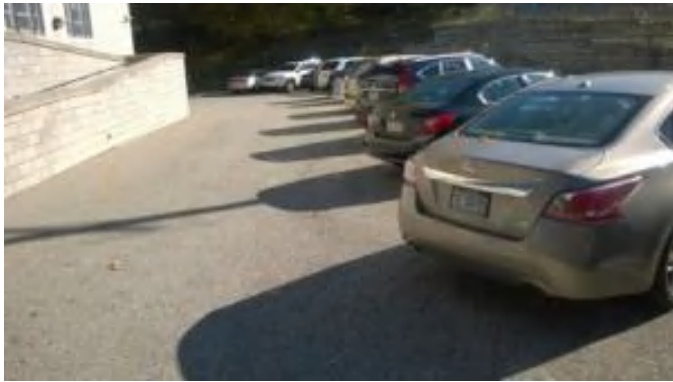
#### System: G2020 - Parking Lots

**Location:** Parking lot

**Distress:** Health Hazard / Risk

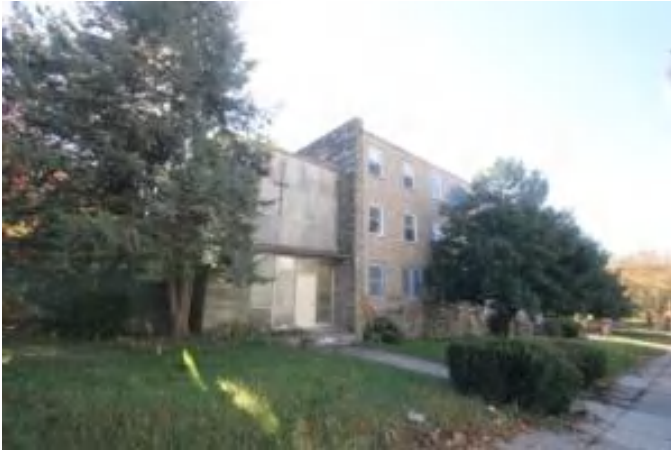
**System: G2050 - Landscaping & Irrigation**

**Location:** North end of site

**Distress:** Beyond Service Life

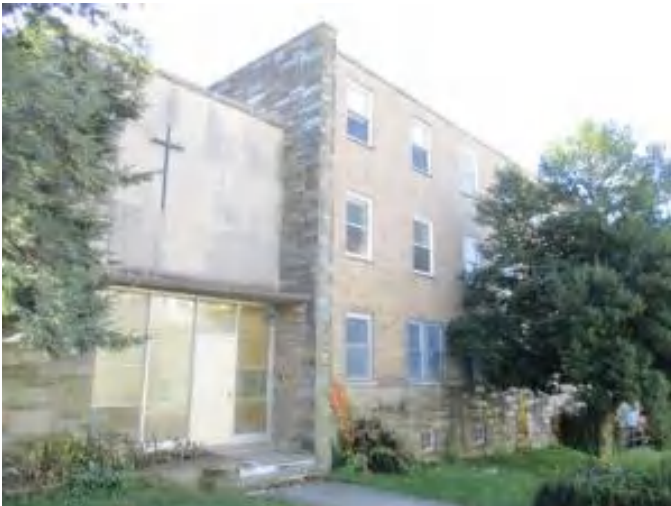
**System: G4030 - Site Communications & Security**

**Location:** Bldg Perimeter- Annex

**Distress:** Security Issue

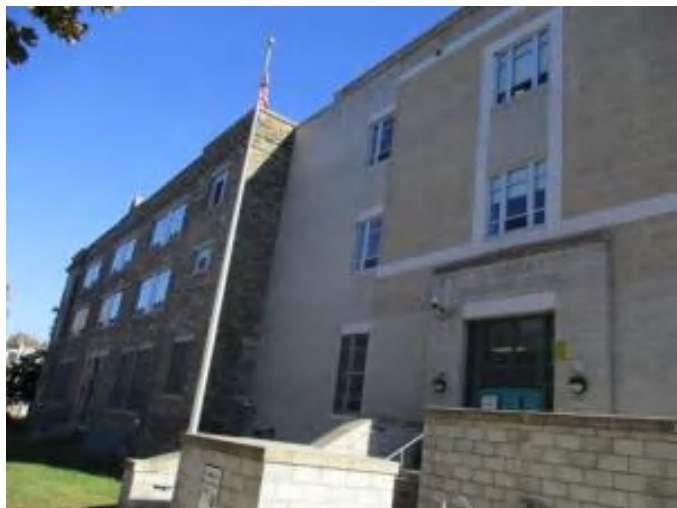
**System: G4030 - Site Communications & Security**

**Location:** Bldg. Perimeter- Overbrook Ed Center

**Distress:** Security Issue

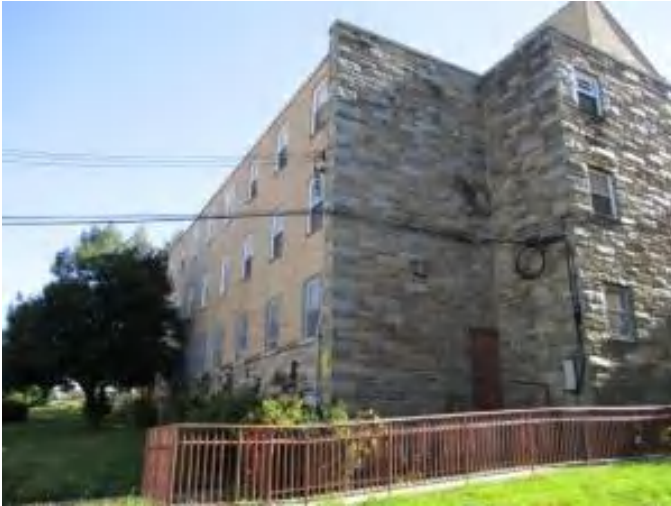
**System: G4020 - Site Lighting**

**Location:** Bldg perimeter- Annex

**Distress:** Security Issue
