Facility Condition Assessment Summary Report

Olney Elementary School

School District of Philadelphia
S740001;Olney ES
Final
Site Assessment Report
January 31, 2017

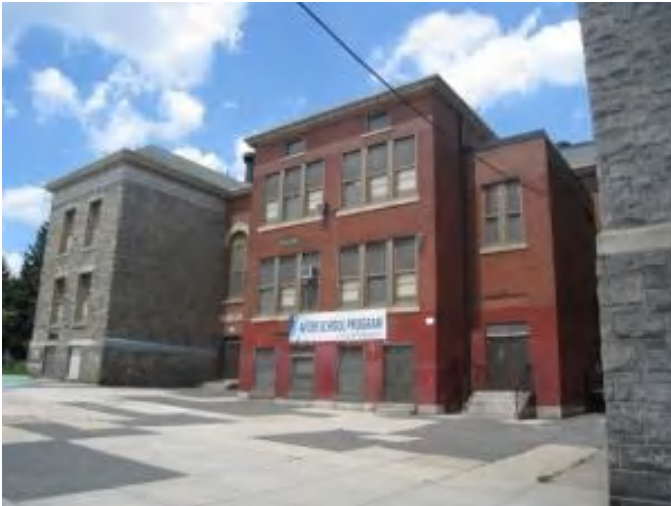
System: B2010 - Exterior Walls

Location: exterior - rear play area

Distress: Appearance

Notes: Clean graffiti from foundations

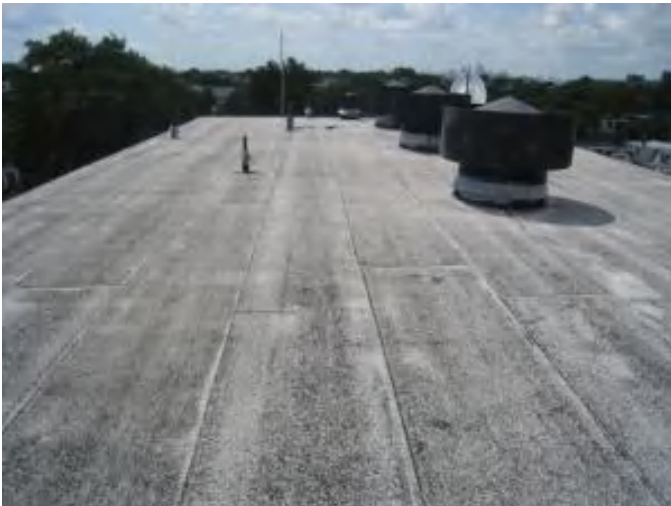
System: B3010105 - Built-Up

Location: roof

Distress: Beyond Service Life

Notes: Remove and replace existing flat roof and insulation; 2 levels

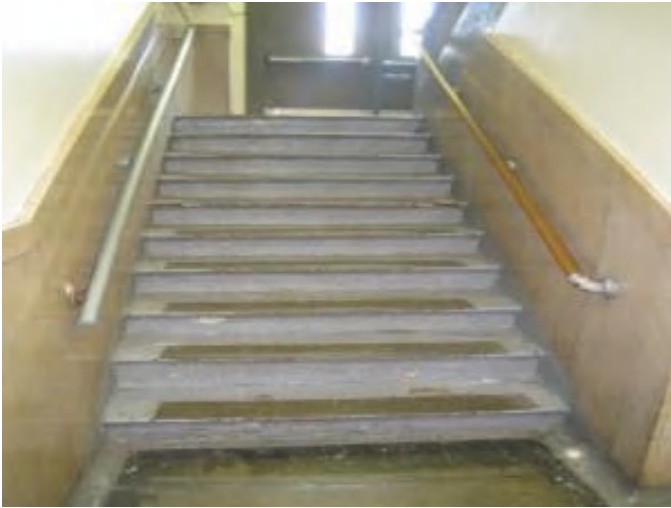
System: C2010 - Stair Construction

Location: stairways

Distress: Building / MEP Codes

Notes: Remove and replace stairway handrails and guards with code compliant systems (3) 3 story; wall mounted handrails, center mounted railings and balustrade

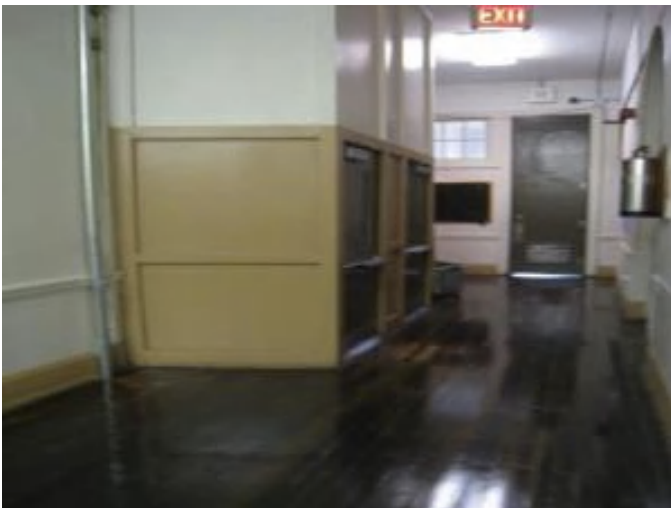
System: C2010 - Stair Construction

Location: stairway

Distress: Building / MEP Codes

Notes: Provide new 3-story stairway with code compliant platform and landing clearances.

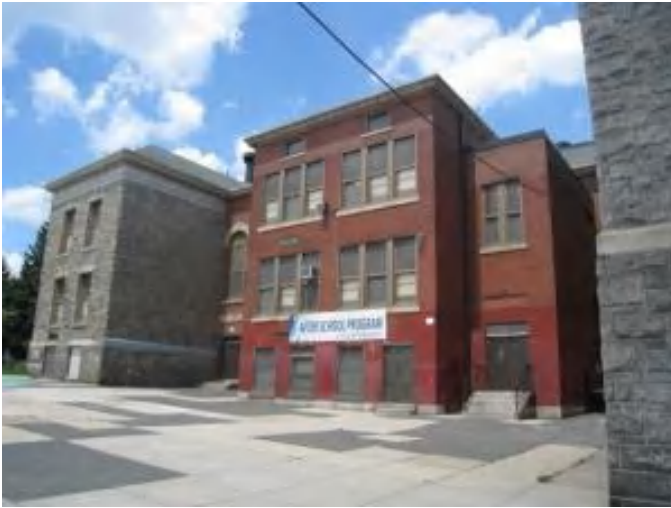
System: C2010 - Stair Construction

Location: exterior stairs

Distress: Building / MEP Codes

Notes: New handrails and guardrails on exterior stairs

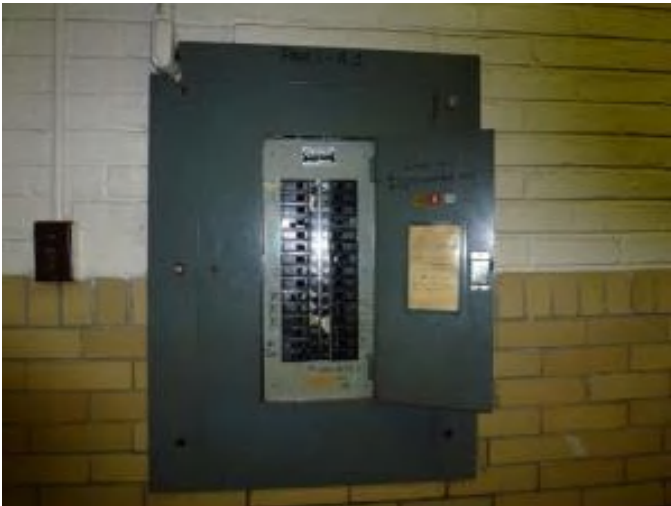
System: D5010 - Electrical Service/Distribution

Location: entire building

Distress: Beyond Service Life

Notes: Replace the entire distribution system with new panels and new wiring/conduits. Our recommendation is to replace existing conduits and wiring to new Junction boxes, receptacles, and lighting. Provide arc flash label on the electrical equipment. Estimated 15 panel boards.

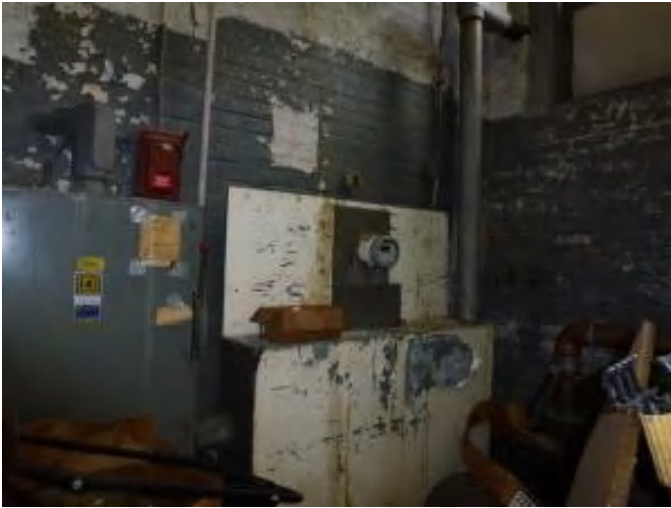
System: D5010 - Electrical Service/Distribution

Location: Boiler Room in the basement

Distress: Beyond Service Life

Notes: Upgrade the existing electrical service with a new service. Replace the existing switchboard with new 1600A, 208/120, 3PH, 4 wire switchboard.

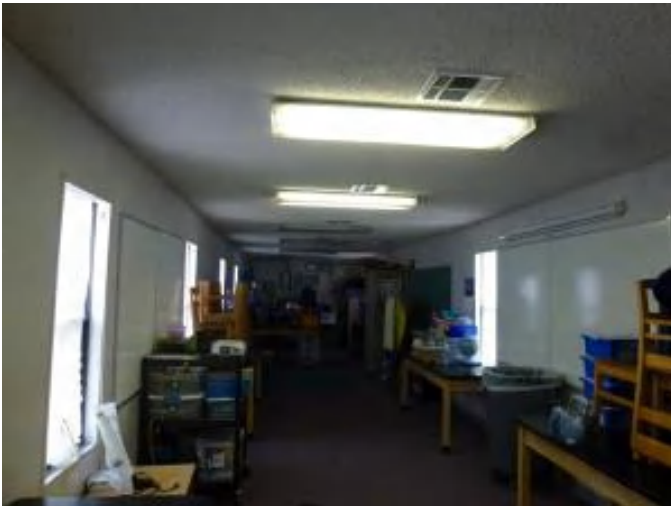
System: D5020 - Lighting and Branch Wiring

Location: Entire Building

Distress: Beyond Service Life

Notes: Replace all lighting fixtures with new fluorescent lighting fixtures with T-5 lamp throughout all buildings.

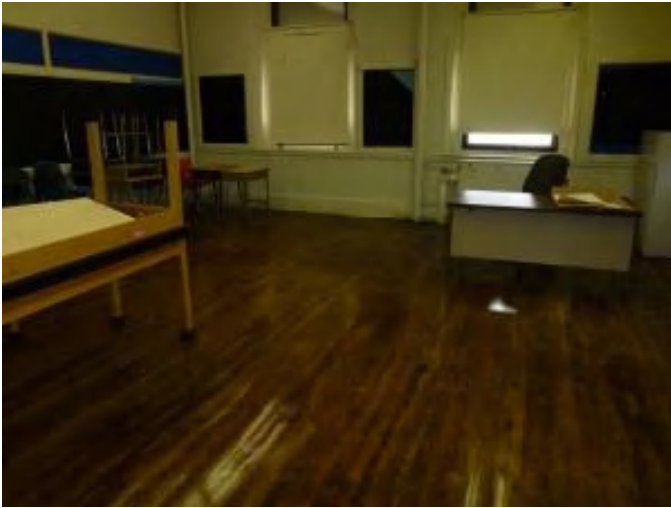
System: D5020 - Lighting and Branch Wiring

Location: entire building

Distress: Inadequate

Notes: Install minimum two receptacles in each wall of class rooms and sufficient number of receptacles in other areas per NEC. We recommend adding a two-compartment surface mounted raceway, for data power, for the computer lab room. Estimated 300 receptacles.

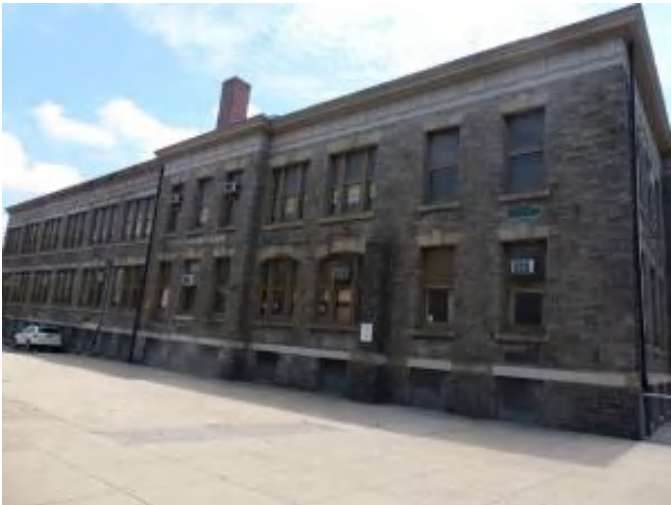
System: D5020 - Lighting and Branch Wiring

Location: Exterior Building

Distress: Life Safety / NFPA / PFD

Notes: Provide lighting fixtures on exterior walls. Estimated 15each

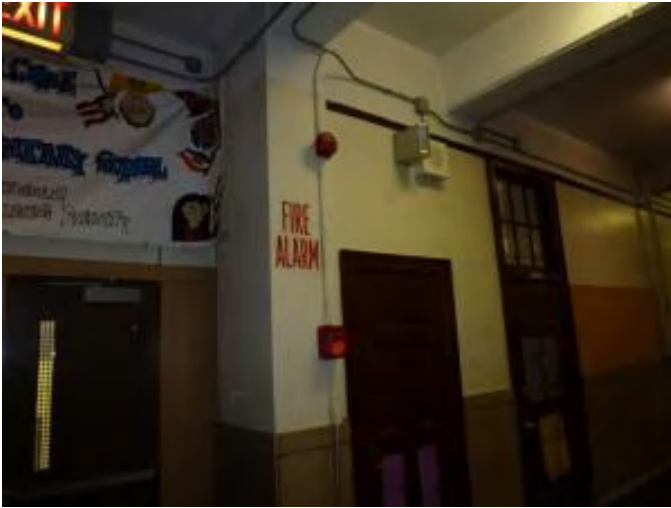
System: D5030 - Communications and Security

Location: Entire Building

Distress: Beyond Service Life

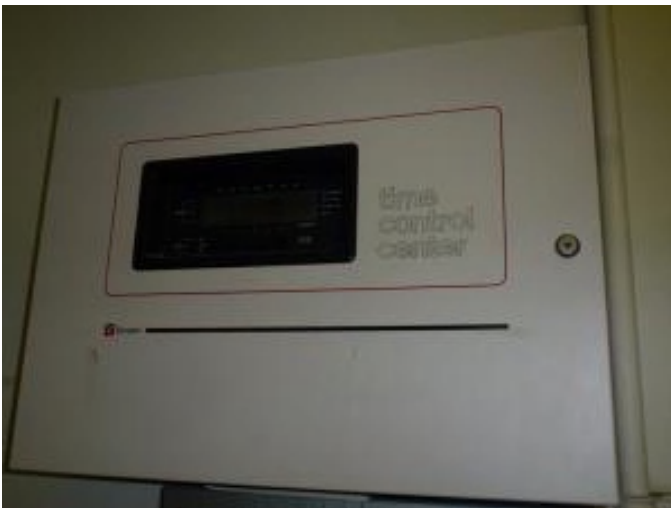
System: D5030 - Communications and Security

Location: entire building

Distress: Damaged

Notes: Replace existing master clock controller.

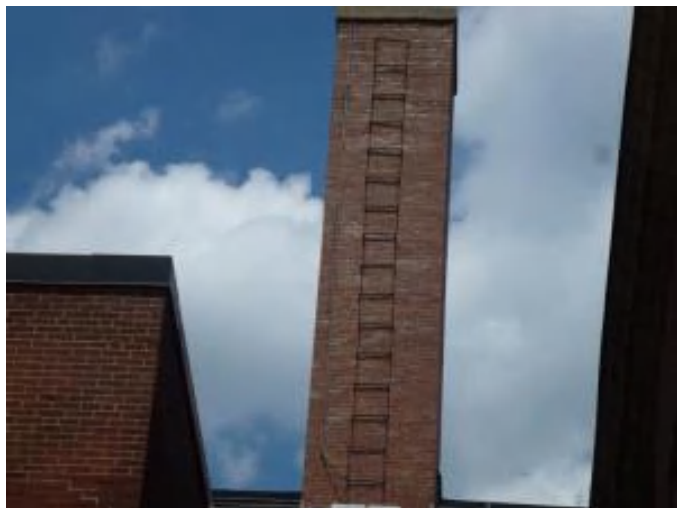
System: D5090 - Other Electrical Systems

Location: Roof

Distress: Life Safety / NFPA / PFD

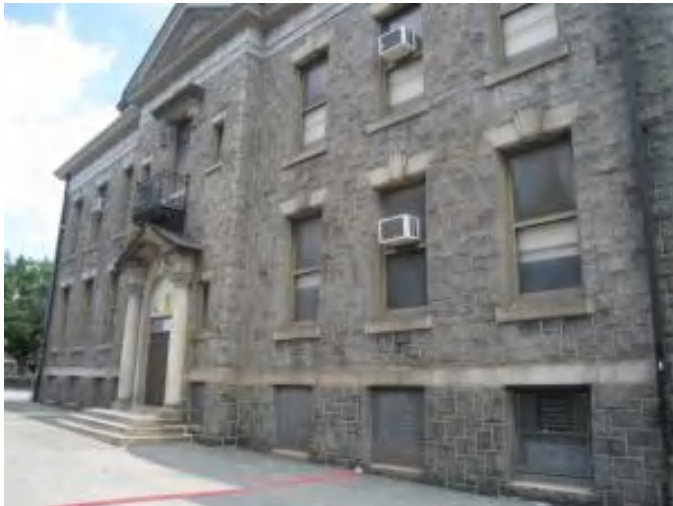
System: B2010 - Exterior Walls

Location: exterior walls

Distress: Appearance

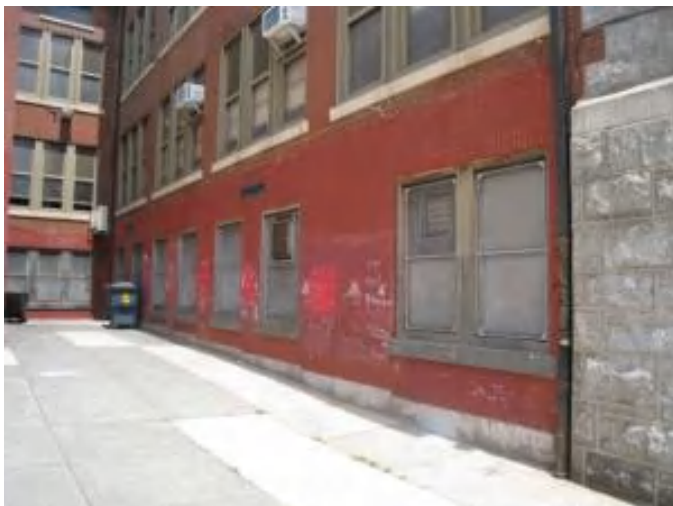
System: B2010 - Exterior Walls

Location: exterior - rear play area

Distress: Appearance

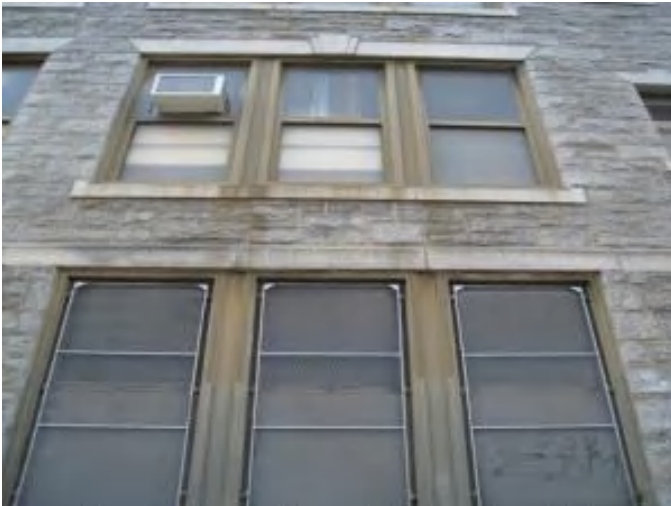
System: B2020 - Exterior Windows

Exterior windows were replaced in the 1980's with bronze anodized aluminum frame operable single hung units with single thickness clear plexiglass acrylic vision panel glazing. Windows are in poor condition with oxidized frames and severely scratched single-pane plexiglass vision panels. Operable units are difficult to operate up and down or do not stay open due to broken internal counterbalance weights. Single pane plexiglas units do not meet today's energy code requirements and are large sources of heat loss. Basement level windows have galvanized steel security screens attached to the windows.

Location: windows

Distress: Failing

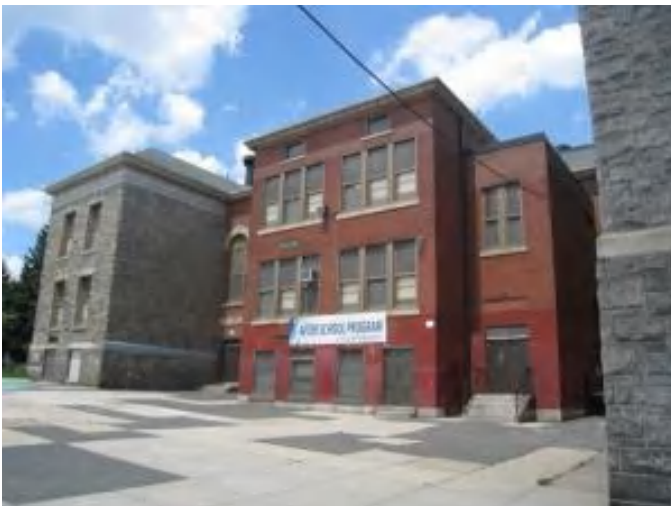
System: B2030 - Exterior Doors

Exterior doors are painted steel framed flush hollow metal units with steel frames. The main entrance and secondary main entrance on N. Water and Tabor Streets have classical-style limestone columns and pediments over door openings. They should be cleaned to highlight their style. Some doors have small glazing vision panels. Doors are in generally poor condition, have broken or non-functioning panic hardware, rusted dented panels and frames, and are not ADA compliant. There are no handicap entrances, no accessible ramps and no elevators. All exterior steel doors, frames, and hardware systems need to be replaced.

Location: exterior doors

Distress: Appearance

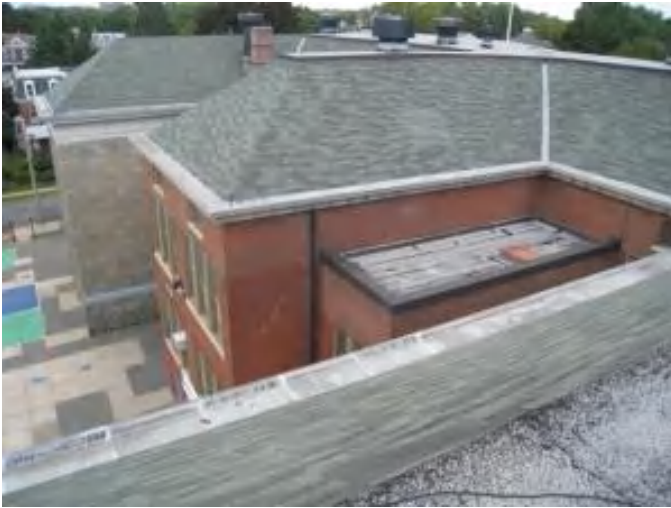
System: B3010140 - Shingle & Tile

Location: roof

Distress: Failing

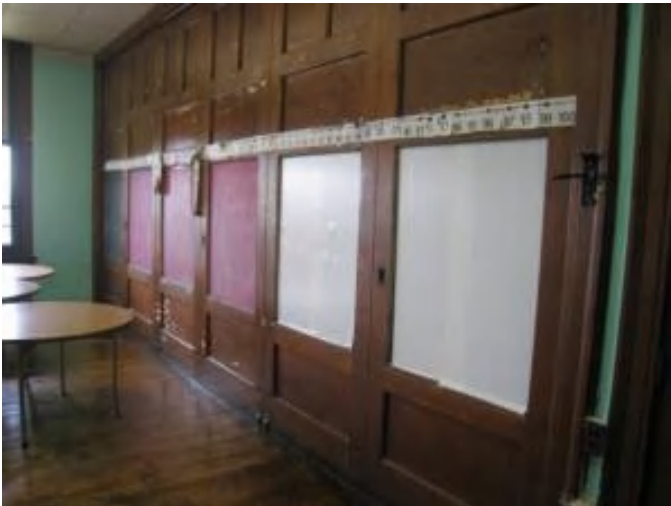
System: C1010 - Partitions

Location: classrooms

Distress: Damaged

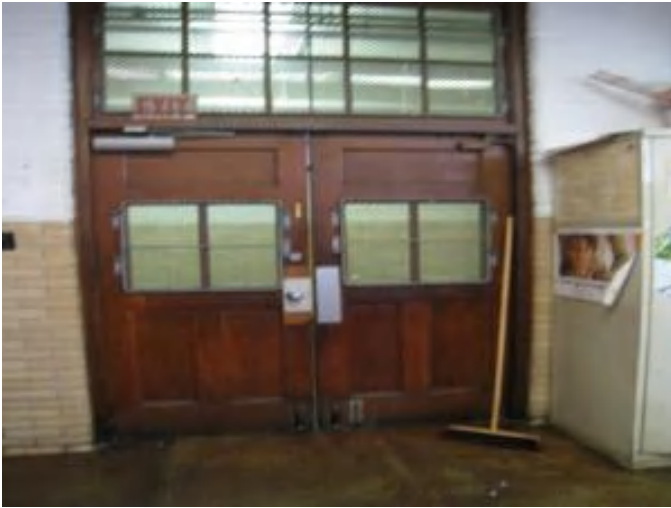
System: C1010 - Partitions

Location: corridors

Distress: Building / MEP Codes

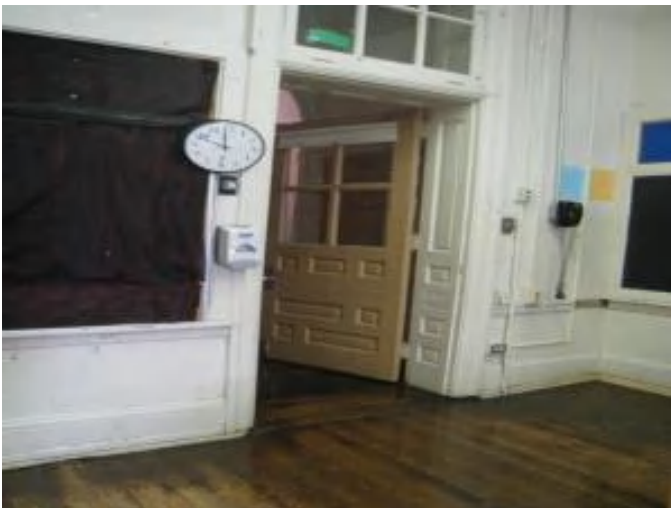
System: C1020 - Interior Doors

Location: interior doors

Distress: Damaged

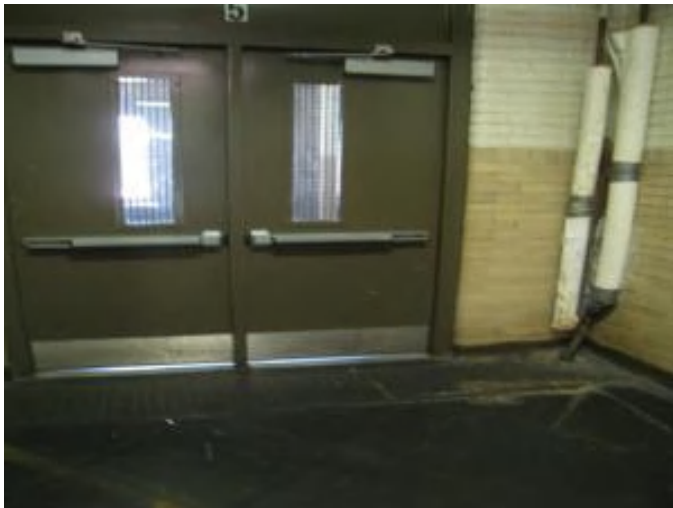
System: C1020 - Interior Doors

Location: basement and mechanical room

Distress: Damaged

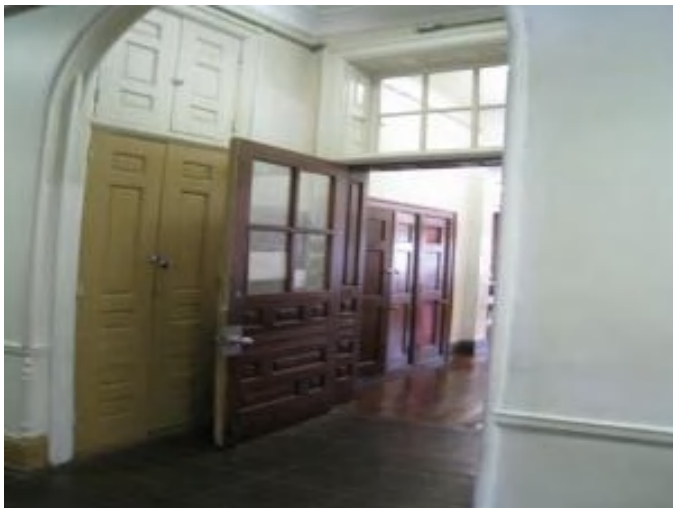
System: C1020 - Interior Doors

Location: classrooms, offices

Distress: Security Issue

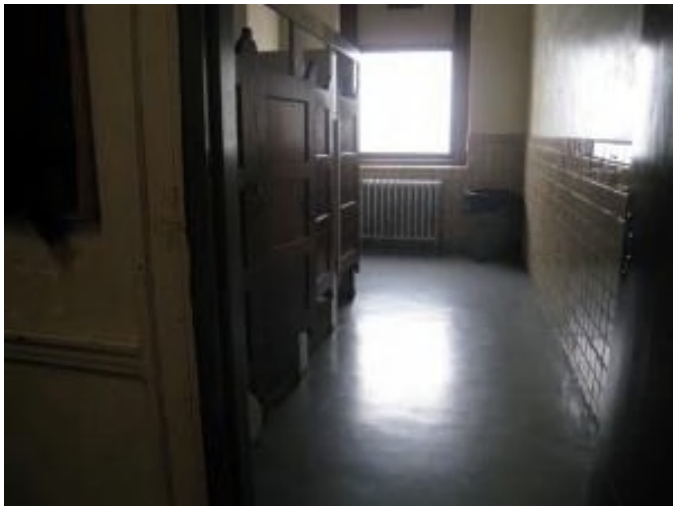
System: C1030 - Fittings

Location: toilet rooms

Distress: Damaged

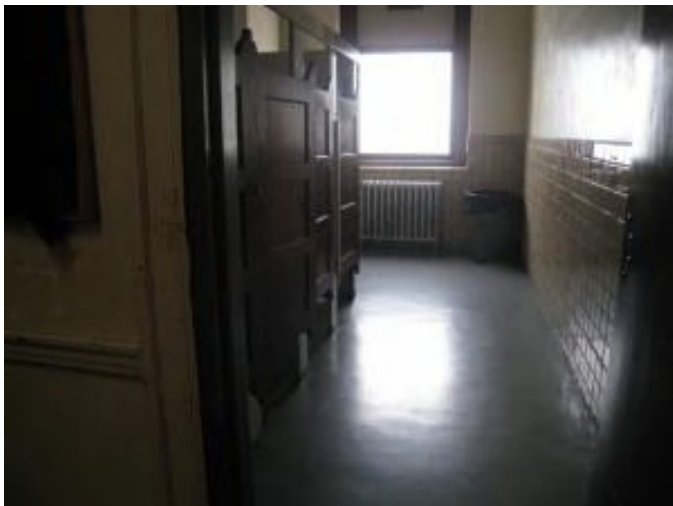
System: C1030 - Fittings

Location: toilet rooms

Distress: Damaged

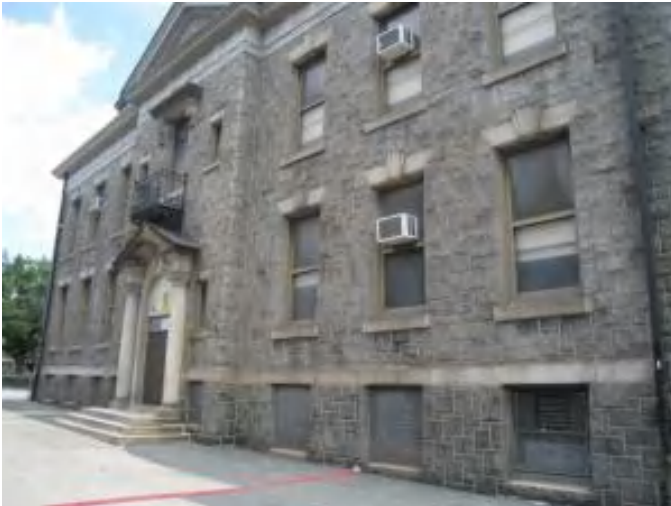
System: C2010 - Stair Construction

Location: exterior stairs

Distress: Damaged

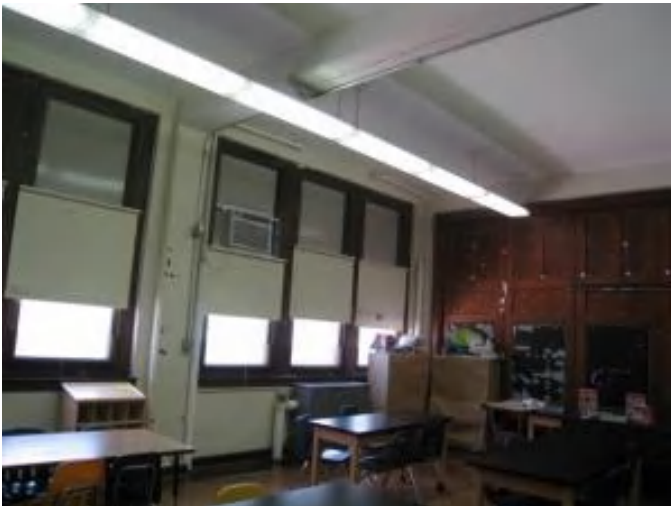
System: C3010230 - Paint & Covering

Location: interior walls

Distress: Damaged

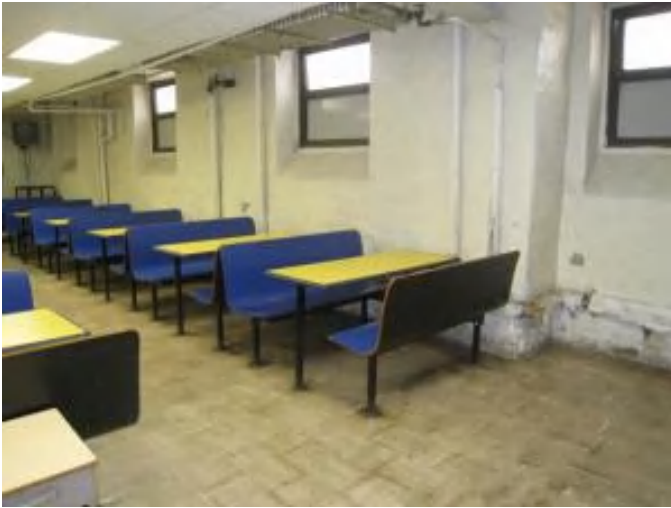
System: C3010230 - Paint & Covering

Location: mechanical room, lunch room

Distress: Appearance

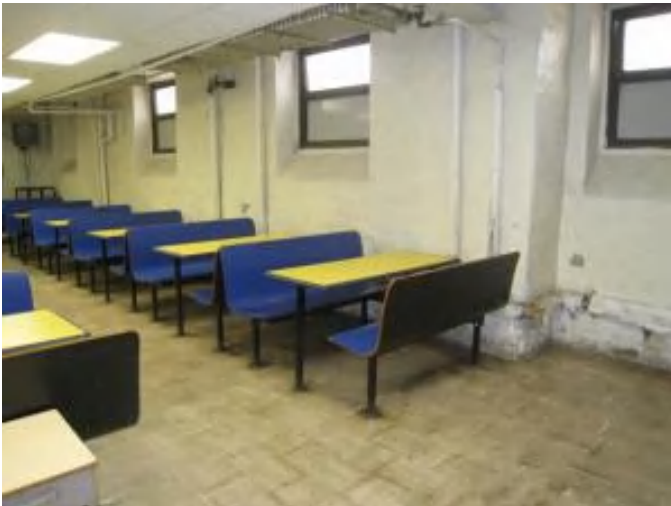
System: C3020413 - Vinyl Flooring

Location: cafeteria, basement

Distress: Health Hazard / Risk

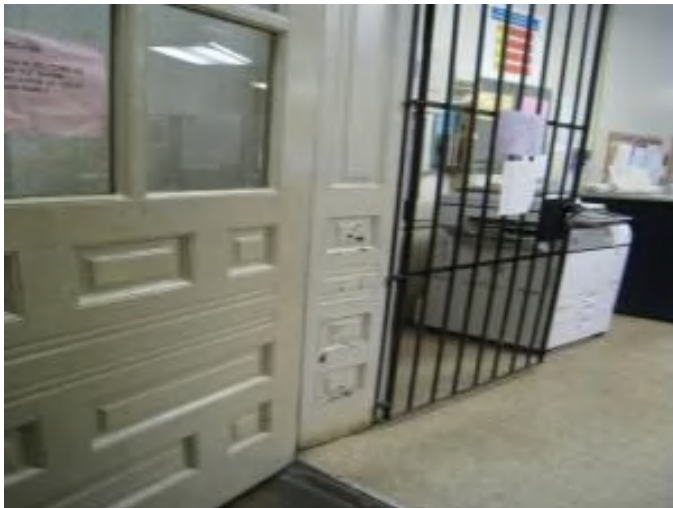
System: C3020413 - Vinyl Flooring

Location: school offices

Distress: Beyond Service Life

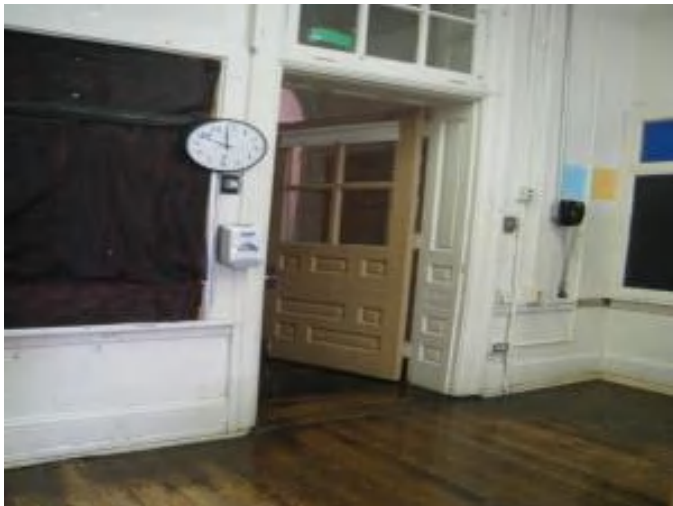
System: C3020414 - Wood Flooring

Location: corridors and classrooms

Distress: Damaged

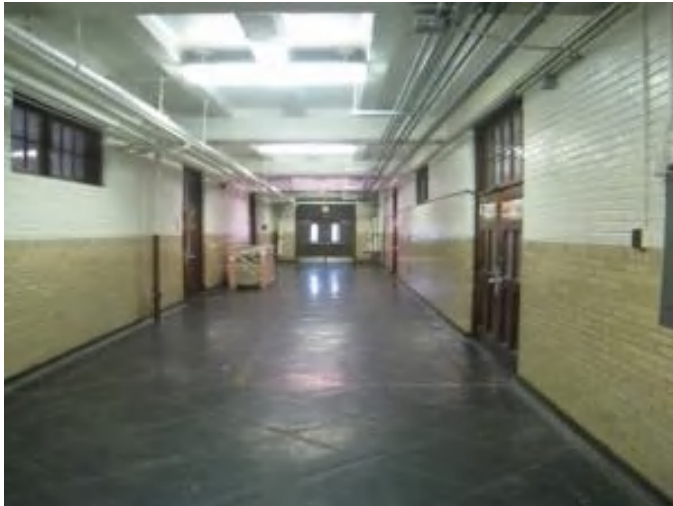
System: C3020415 - Concrete Floor Finishes

Location: basement, corridors, toilet rooms, stairways

Distress: Appearance

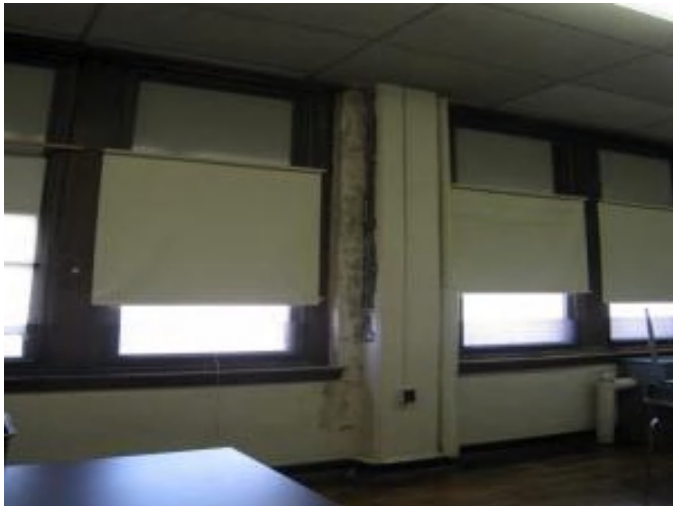
System: C3030 - Ceiling Finishes

Location: classrooms

Distress: Damaged

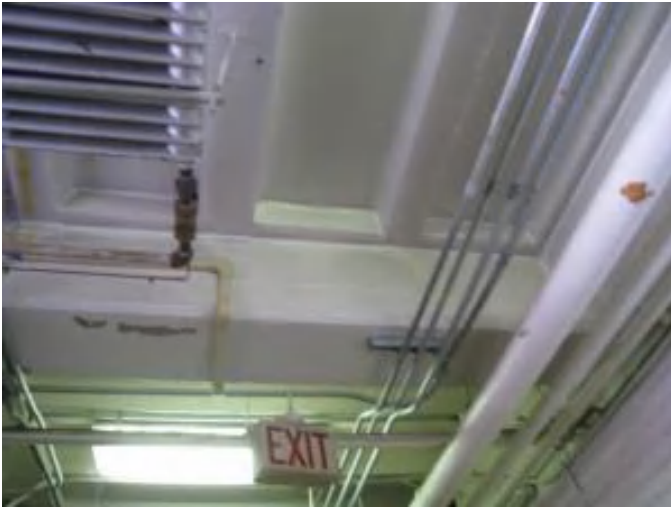
System: C3030 - Ceiling Finishes

Location: stair and 1st floor ceilings

Distress: Damaged

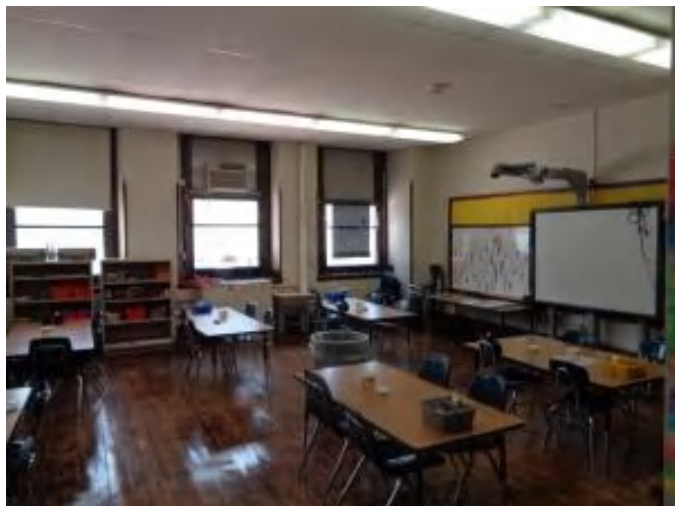
System: D3040 - Distribution Systems

Location: classrooms

Distress: Obsolete

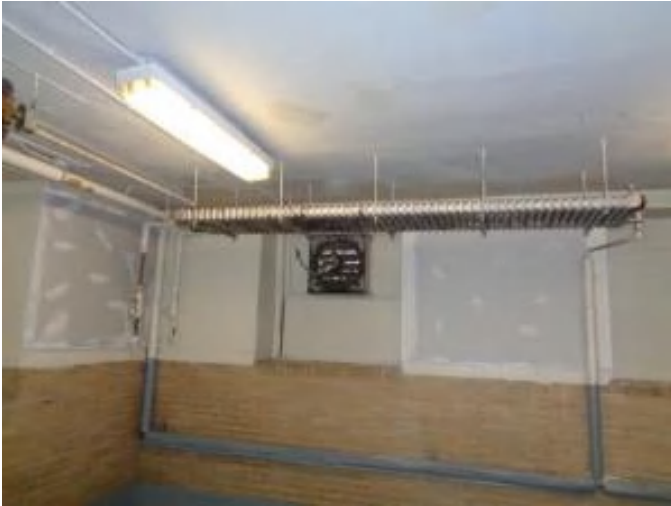
System: D3040 - Distribution Systems

Location: Throughout the building

Distress: Beyond Service Life

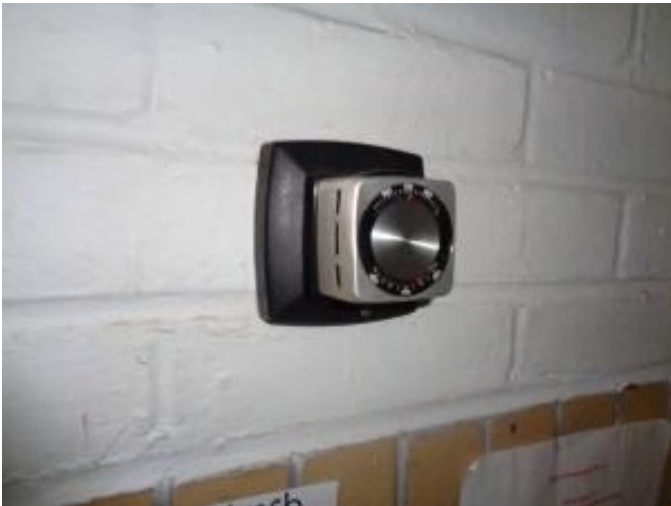
System: D3060 - Controls & Instrumentation

Controls & Instrumentation - There are some pneumatic thermostats on the walls that are not in service. The pneumatic control valves on the radiators in the original building are not in service. Most of the heating radiators are flowing 100% flow when the steam is on. This results in an "on-off" control for the whole building, i.e. when the boilers are on, the whole building has heat and when the boilers are off, the whole building is without heat. This system is not working properly and ultimately is not functional. Remove all existing controls and replace with new DDC system.

Location: entire building

Distress: Beyond Service Life

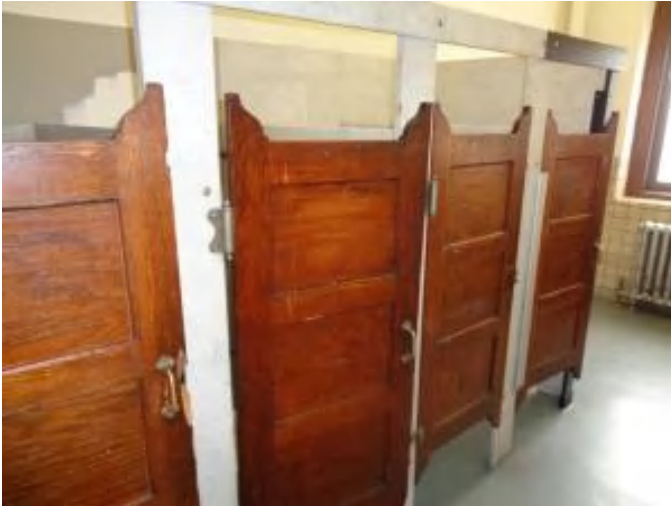
System: D2010 - Plumbing Fixtures

Location: toilet rooms

Distress: Beyond Service Life

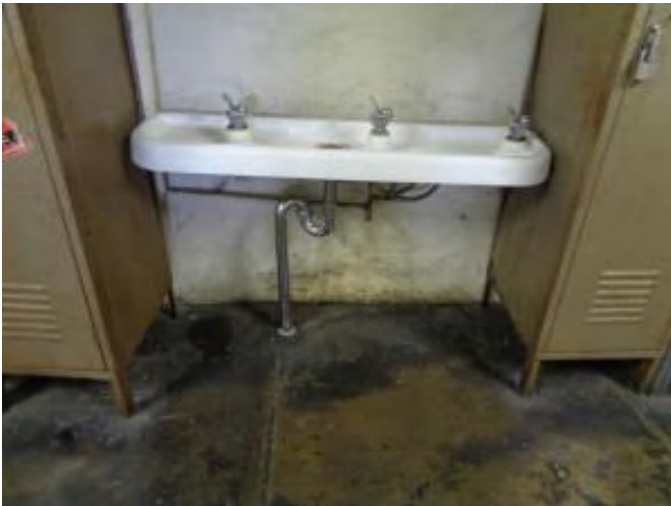
System: D2010 - Plumbing Fixtures

Location: corridors

Distress: Beyond Service Life

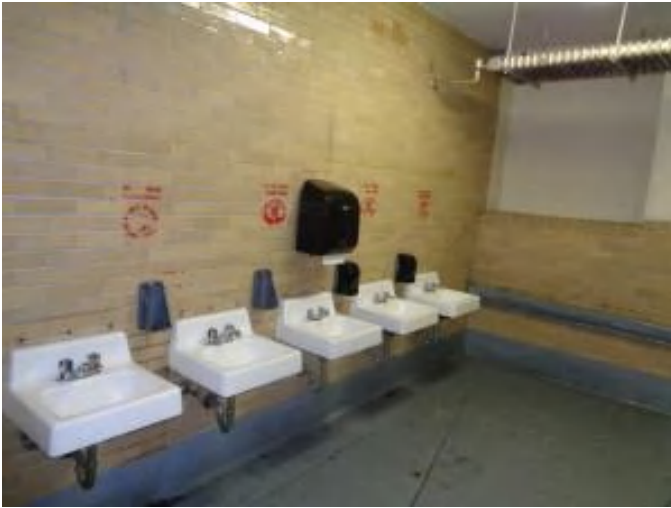
System: D2010 - Plumbing Fixtures

Location: toilet rooms

Distress: Beyond Service Life

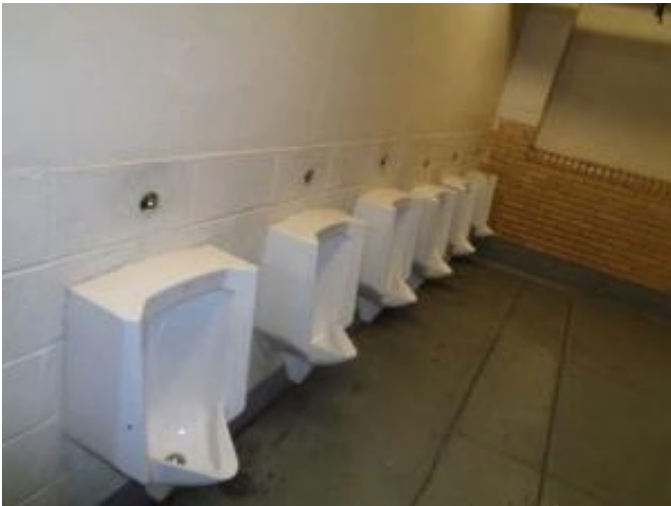
System: D2010 - Plumbing Fixtures

Location: toilet rooms

Distress: Beyond Service Life

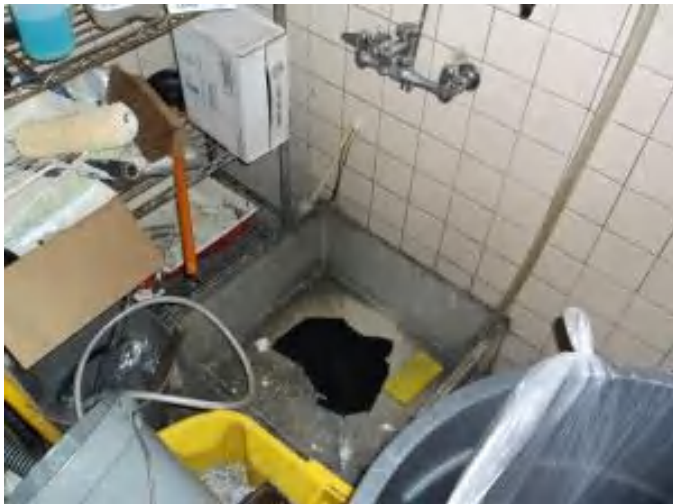
System: D2010 - Plumbing Fixtures

Location: janitor closets

Distress: Beyond Service Life

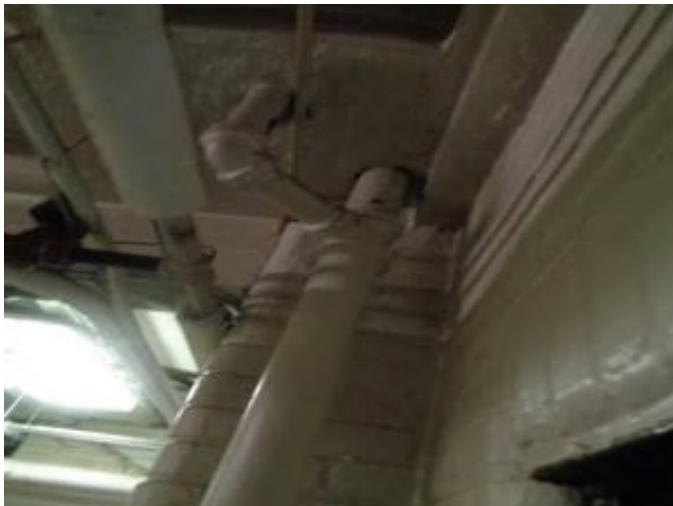
System: D2030 - Sanitary Waste

Sanitary Waste - The sanitary waste piping systems are hub and spigot cast iron pipe and appear to be the original equipment. An inspection of the complete sanitary system is recommended due to the age of the equipment.

Location: entire building

Distress: Beyond Service Life

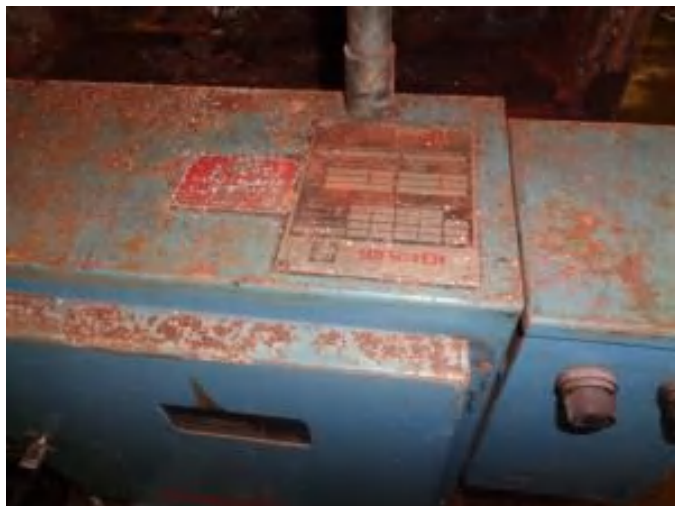
System: D3020 - Heat Generating Systems

Heat Generating Systems - Steam is generated in the basement of the by three Burnham model EL 80 boilers with dual fuel Webster burners. The boilers sit on 6" concrete pads and each have a gross output of 2,821 MBH each. The boilers appear to be nearing the end of their serviceable life and should be replaced within the next 5-10 years.

Location: boiler room

Distress: Beyond Service Life

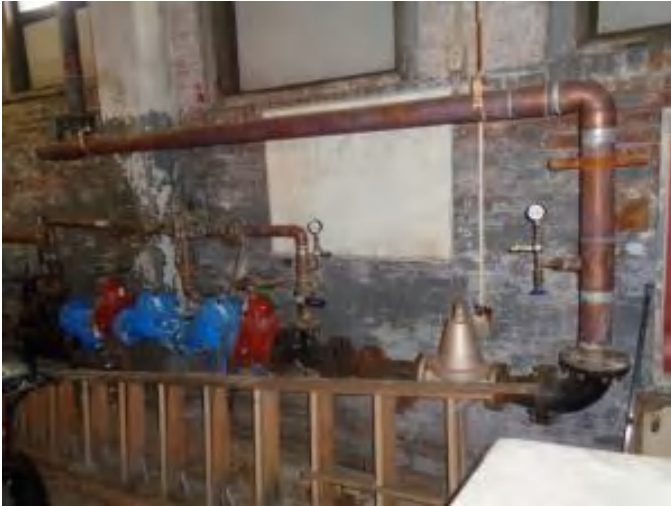
System: D2020 - Domestic Water Distribution

Location: entire building

Distress: Beyond Service Life

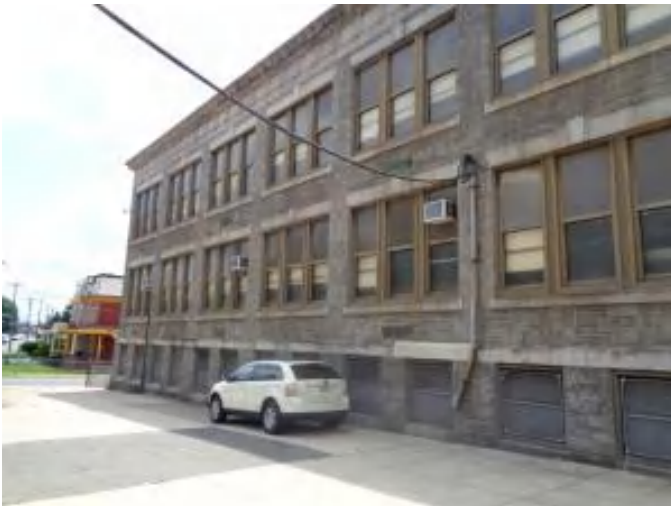
System: D3030 - Cooling Generating Systems

Location: entire building

Distress: Inadequate

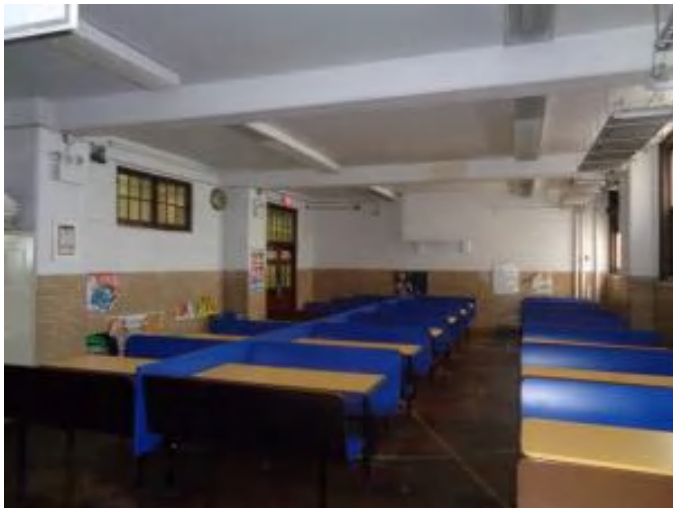
System: D3040 - Distribution Systems

Location: cafeteria

Distress: Beyond Service Life

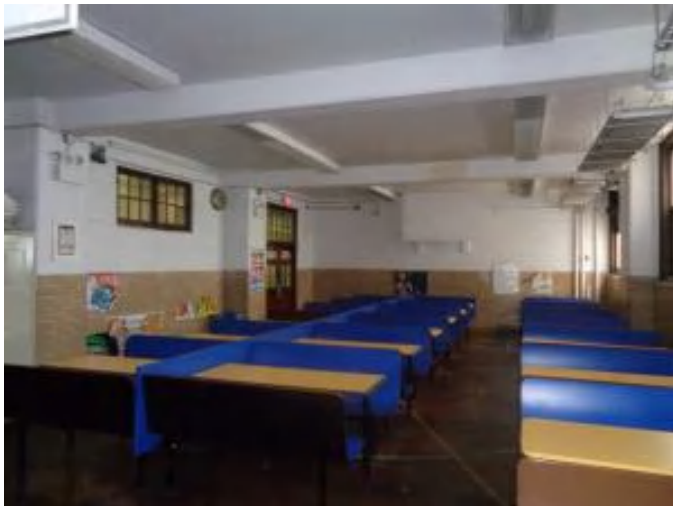
System: D4010 - Sprinklers

Location: entire building

Distress: Life Safety / NFPA / PFD

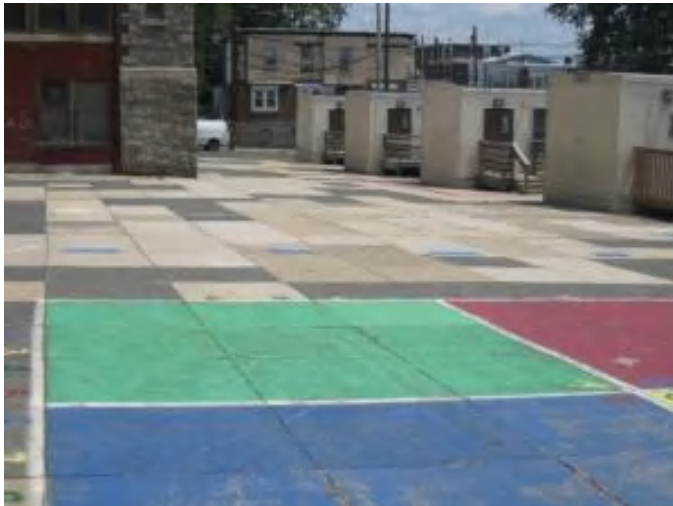
System: G2030 - Pedestrian Paving

Location: parking/play area

Distress: Damaged

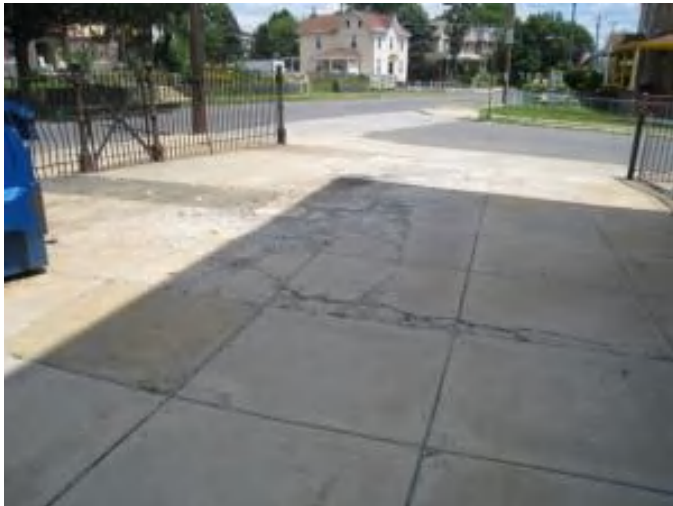
System: G2040 - Site Development

Location: site

Distress: Beyond Service Life
