Facility Condition Assessment Summary Report

Olney High School

School District of Philadelphia
S705001;Olney HS
Final
Site Assessment Report
February 1, 2017

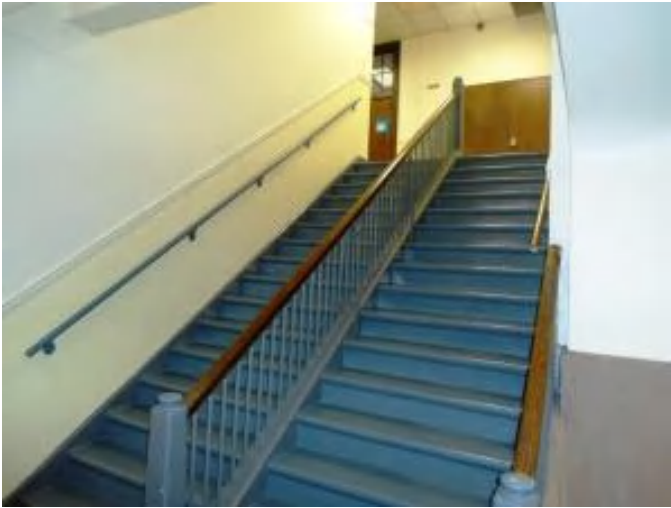
Location: Stairs

System: C2010 - Stair Construction

Distress: Life Safety / NFPA / PFD

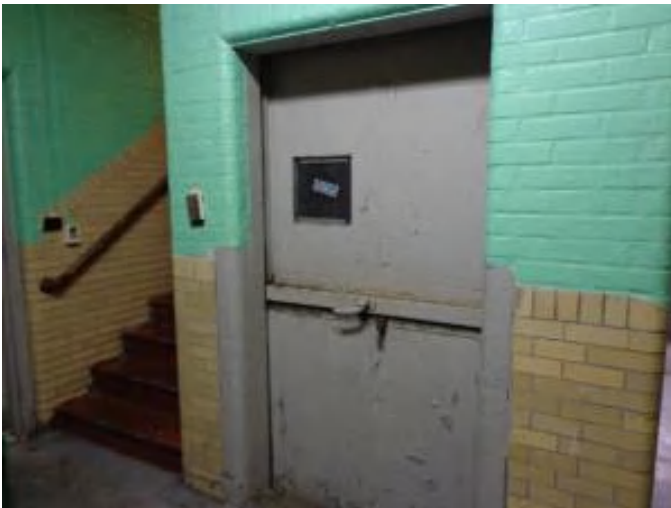
Location: Loading Dock to Kitchen

System: D1010 - Elevators and Lifts

Distress: Damaged

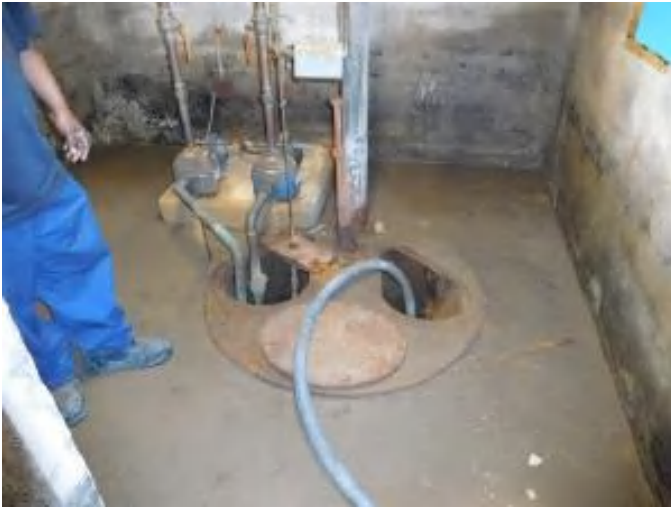
Location: mechanical room

System: D2030 - Sanitary Waste

Distress: Beyond Service Life

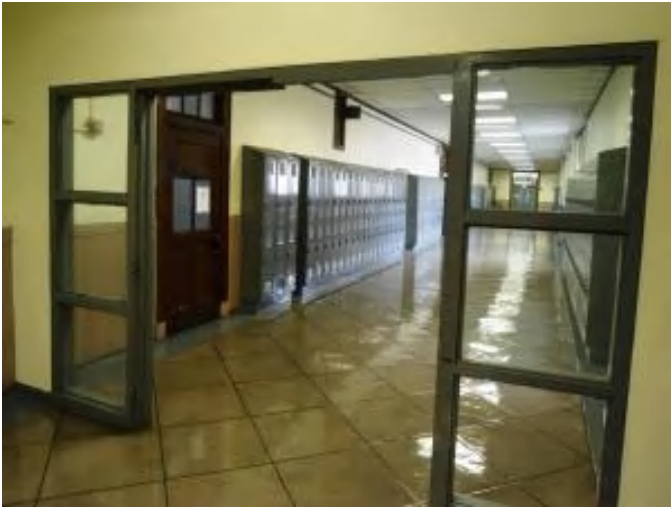
Location: Corridor Doors

System: C1010 - Partitions

Distress: Life Safety / NFPA / PFD

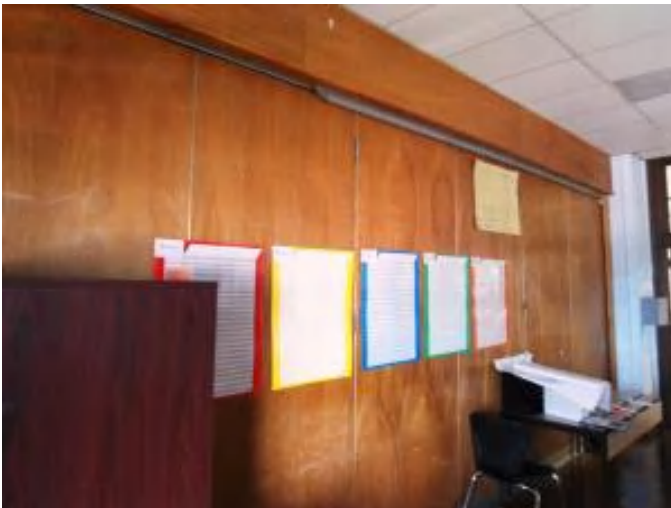
Location: Classrooms

System: C1010 - Partitions

Distress: Life Safety / NFPA / PFD

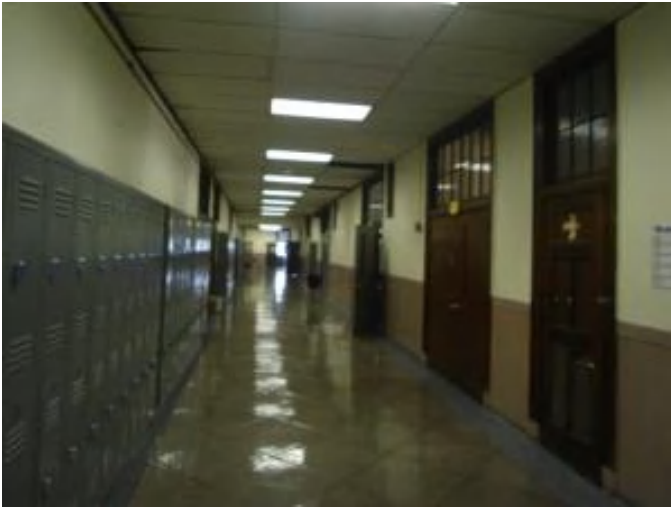
Location: Classroom Doors

System: C1010 - Partitions

Distress: Damaged

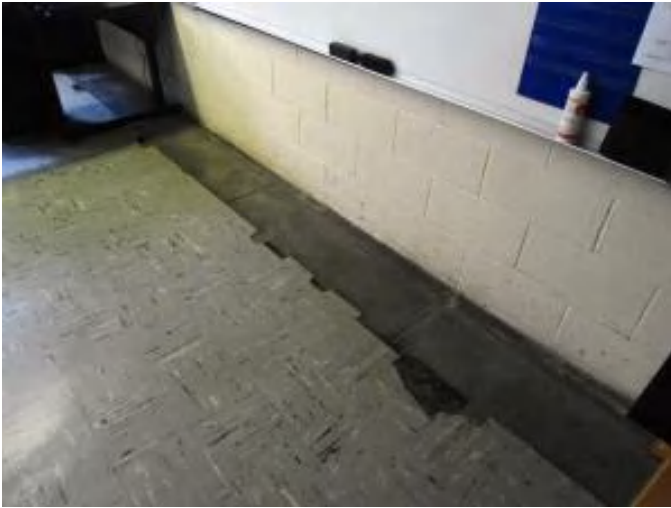
Location: Classrooms

System: C3020413 - Vinyl Flooring

Distress: Health Hazard / Risk

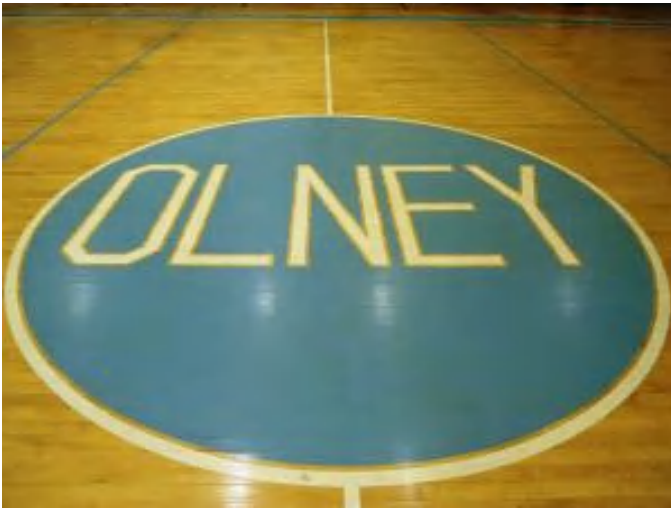
Location: Main Gym

The main GYM floor finish is beyond its expected life cycle for this application. Recent repairs have eliminated the trip hazards however, there are areas that remain that warrant replacement. The floor is recommended for universal upgrade.

System: C3020414 - Wood Flooring

Distress: Damaged

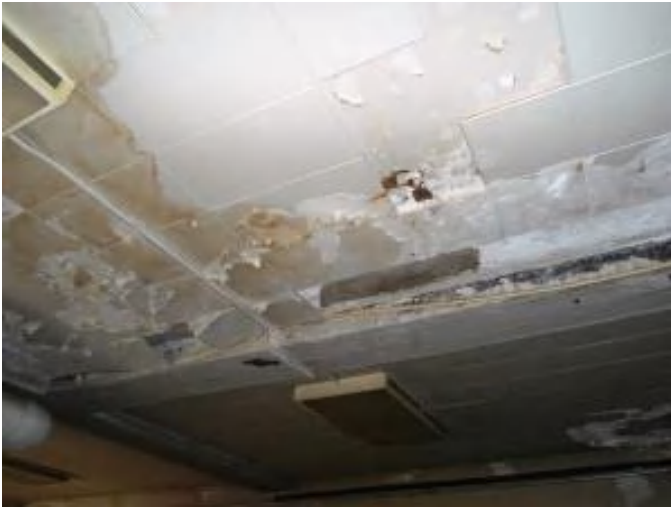
Location: Building Wide

System: C3030 - Ceiling Finishes

Distress: Damaged

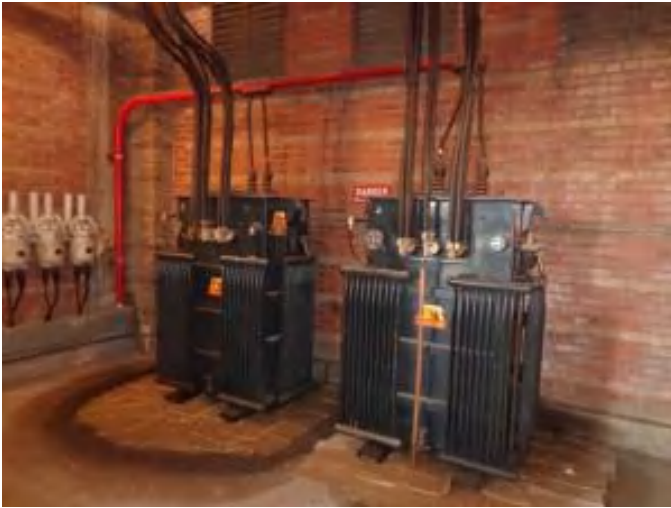
Location: Transformer Vault and Main Electrical Room

System: D5010 - Electrical Service/Distribution

Distress: Beyond Service Life

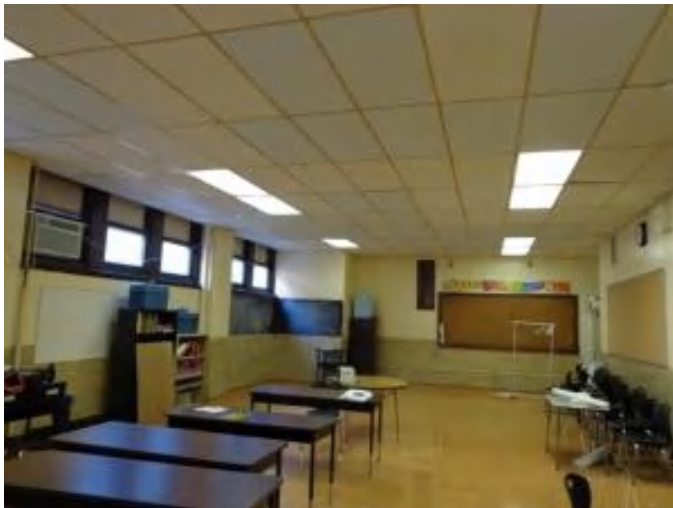
Location: Classrooms

System: D5020 - Lighting and Branch Wiring

Distress: Beyond Service Life

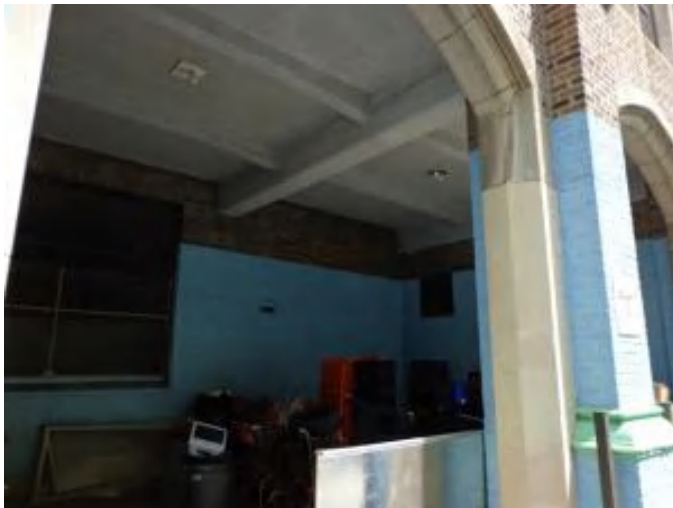
Location: Loading dock

System: D5020 - Lighting and Branch Wiring

Distress: Energy Efficiency

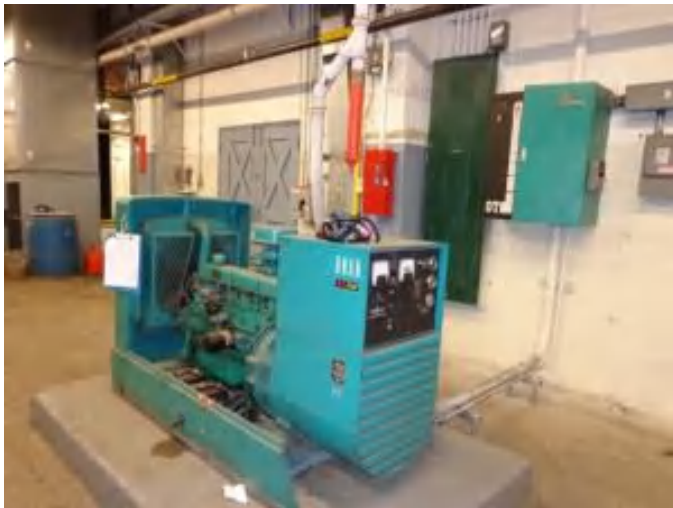
Location: Sub-Basement Boiler Room

System: D5090 - Other Electrical Systems

Distress: Inadequate

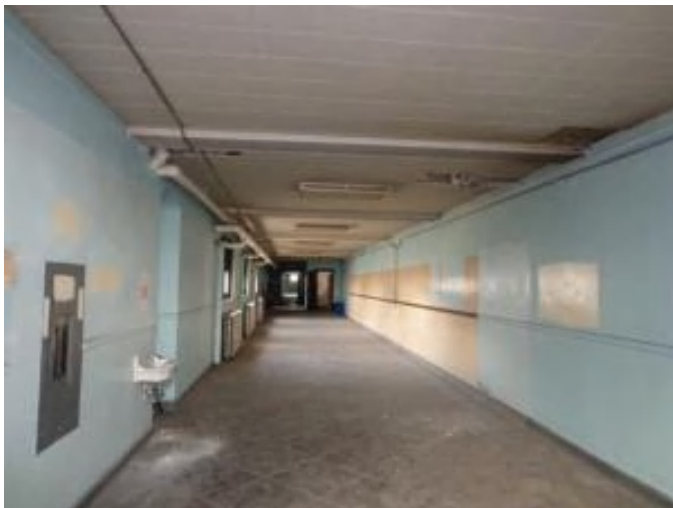
Location: Building wide

System: D5090 - Other Electrical Systems

Distress: Life Safety / NFPA / PFD

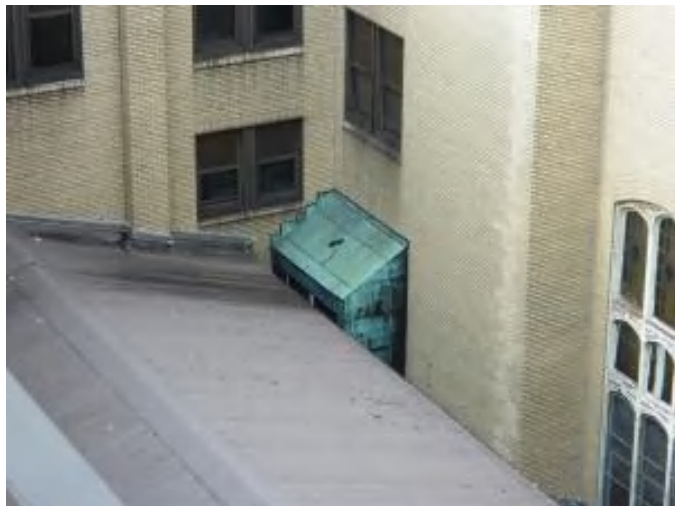
Location: Exterior Elevation

System: B2010 - Exterior Walls

Distress: Damaged

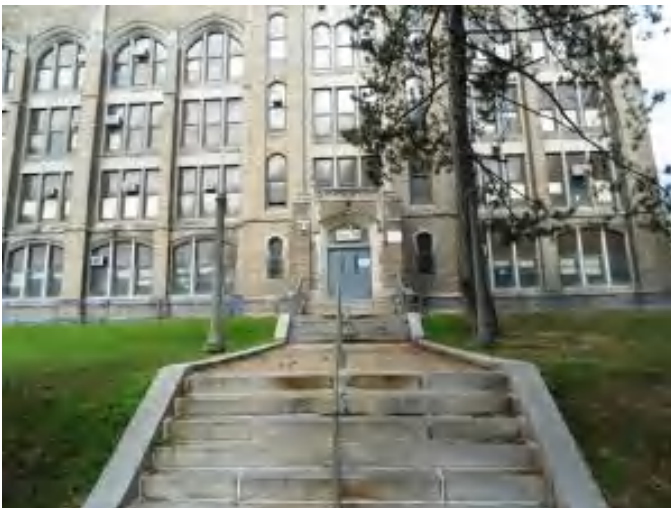
Location: Exterior Elevation

System: B2030 - Exterior Doors

Distress: Damaged

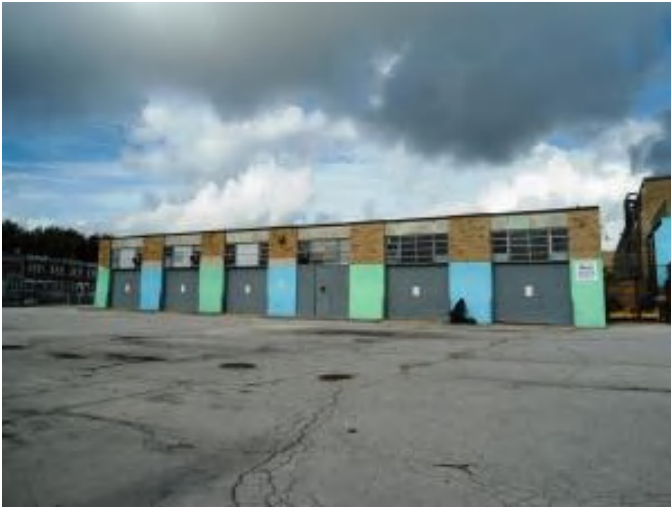
Location: Exterior Elevation

System: B2030 - Exterior Doors

Distress: Damaged

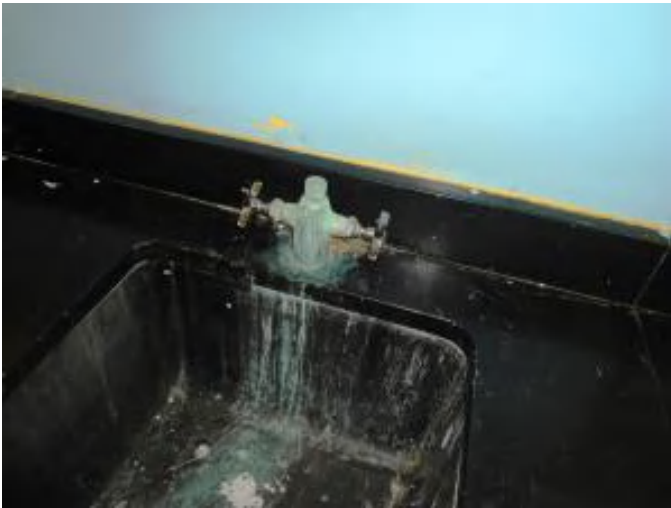
Location: Science Labs

System: C1010 - Partitions

Distress: Damaged

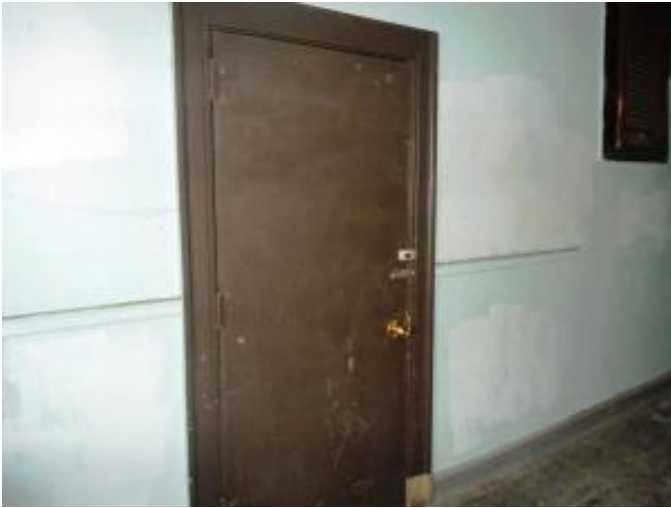
Location: Classroom Doors

System: C1020 - Interior Doors

Distress: Damaged

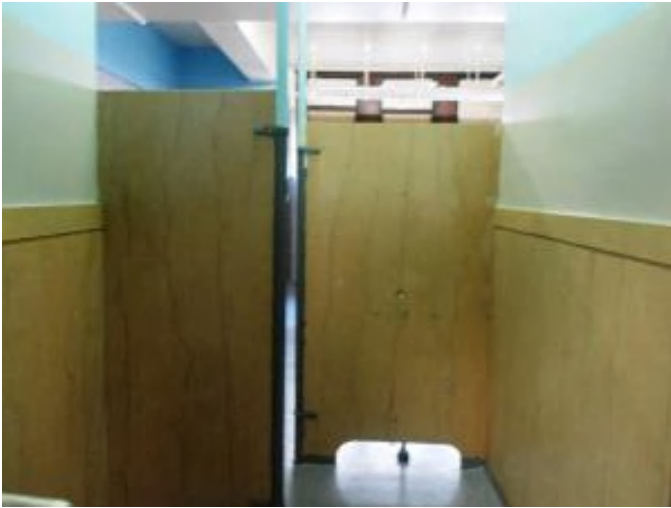
Location: Restroom

System: C1030 - Fittings

Distress: Damaged

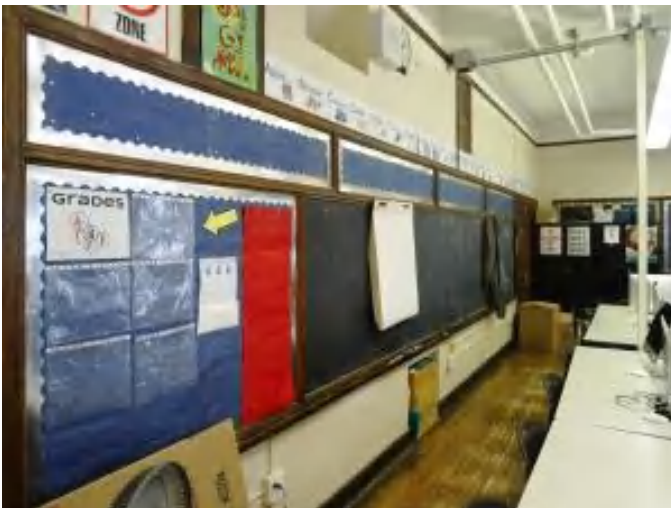
Location: Building Wide

System: C3020414 - Wood Flooring

Distress: Damaged

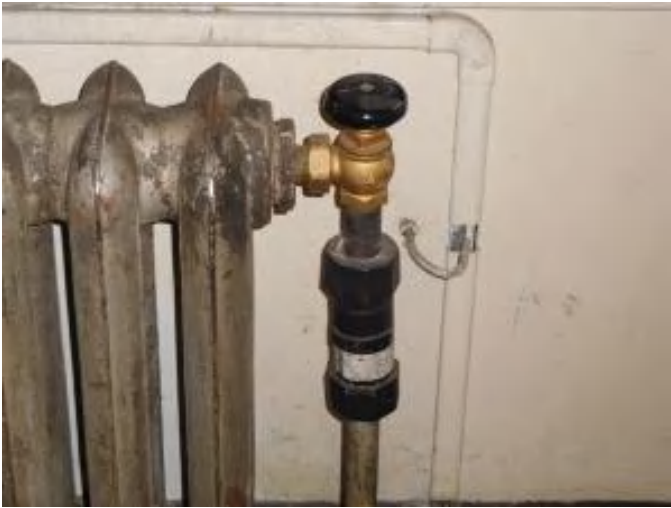
Location: entire building

System: D3040 - Distribution Systems

Distress: Building / MEP Codes

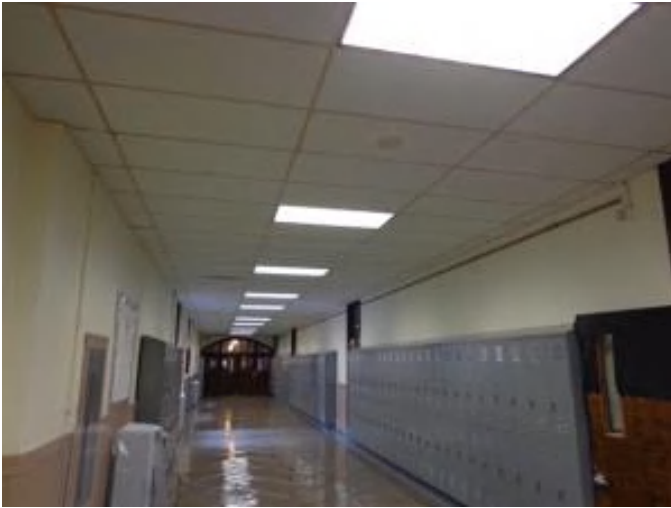
Location: Basement and Floor 1 corridors

System: D5020 - Lighting and Branch Wiring

Distress: Damaged

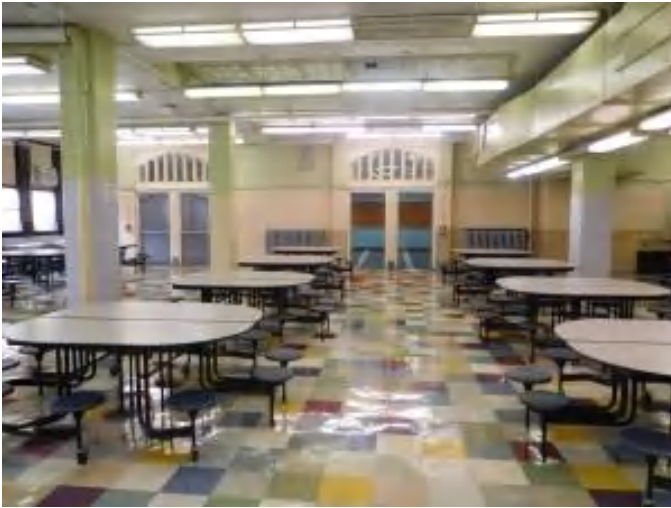
Location: cafeteria

System: D3040 - Distribution Systems

Distress: Building / MEP Codes

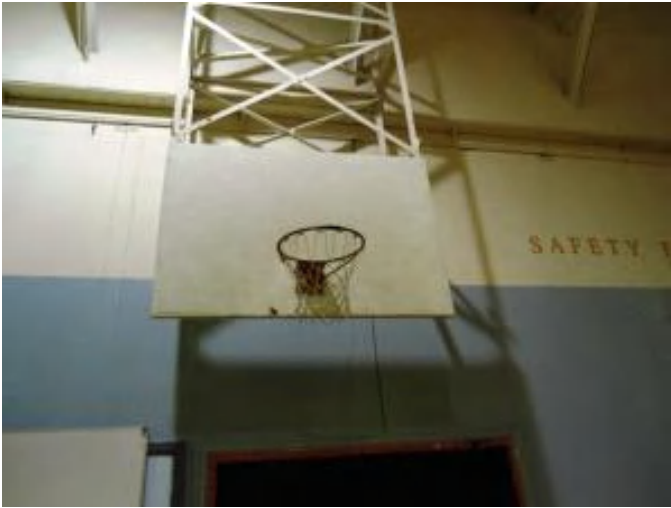
Location: Gym

System: E1020 - Institutional Equipment

Distress: Damaged

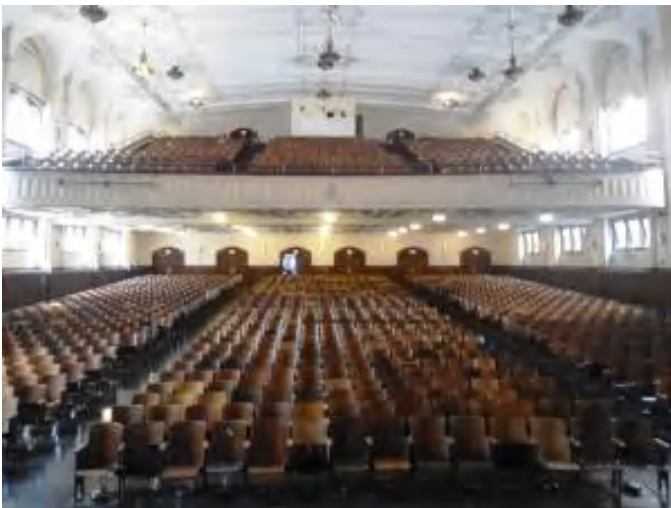
Location: Auditorium

System: E2010 - Fixed Furnishings

Distress: Damaged

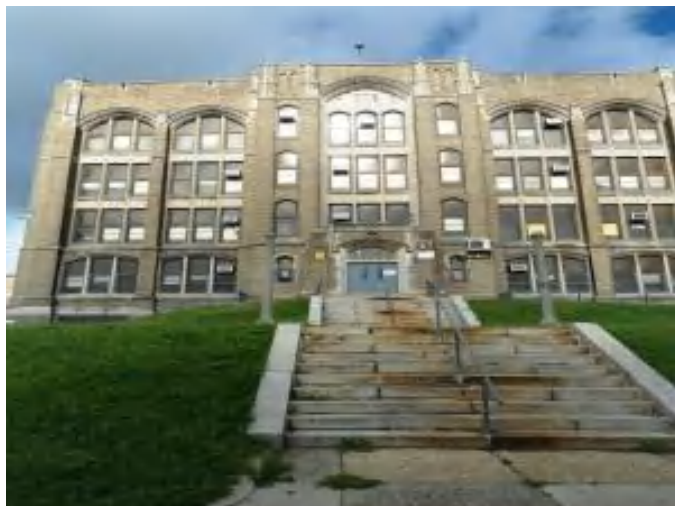
Location: Stairs Site

System: G2040 - Site Development

Distress: Damaged

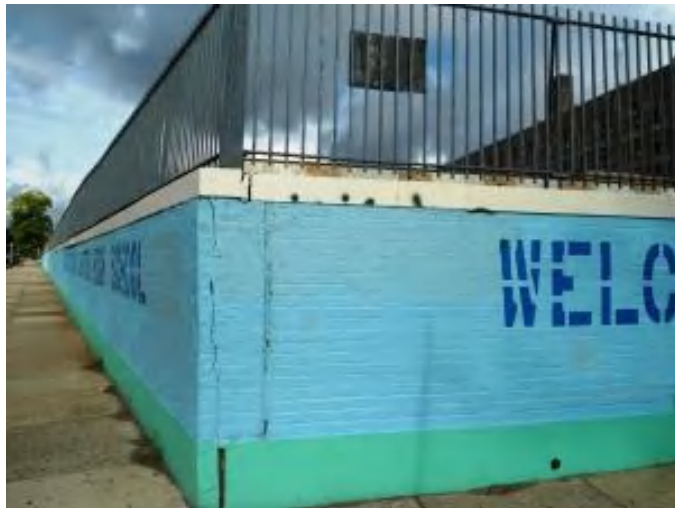
Location: Site

System: G2040 - Site Development

Distress: Damaged

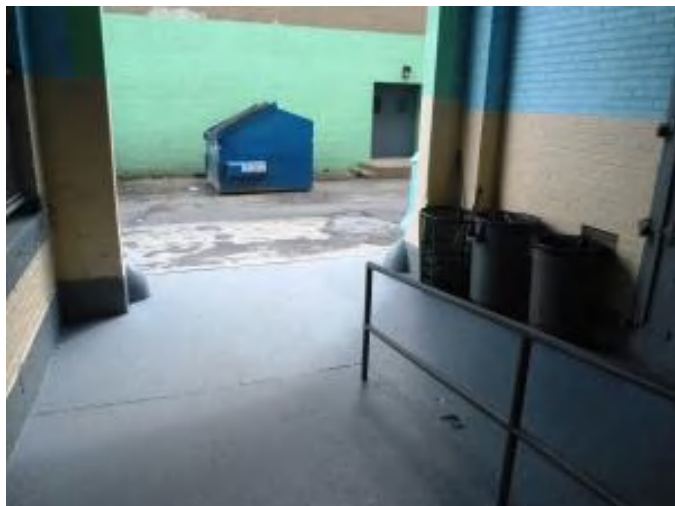
Location: Site

System: G2040 - Site Development

Distress: Health Hazard / Risk

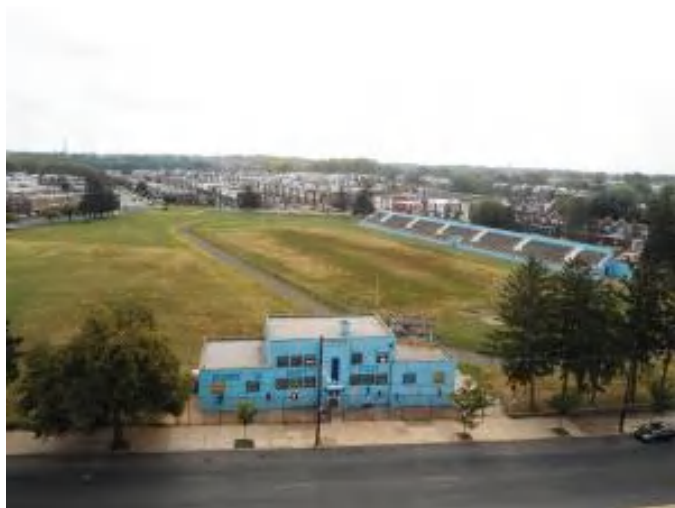
Location: Roof

System: B3010105 - Built-Up

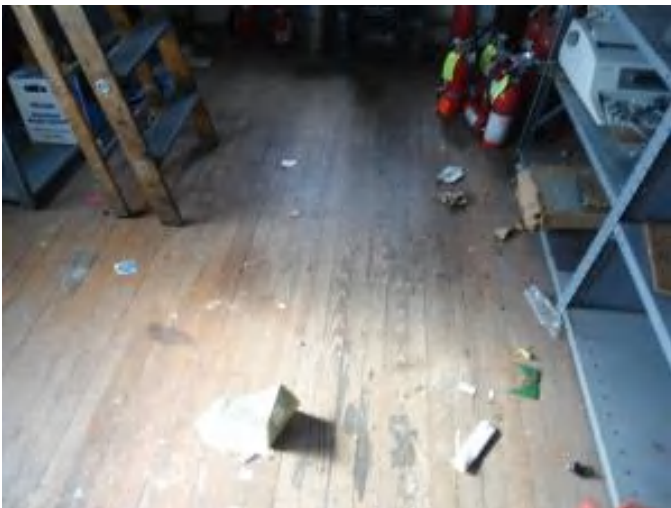
Location: Building Wide

System: C3020414 - Wood Flooring

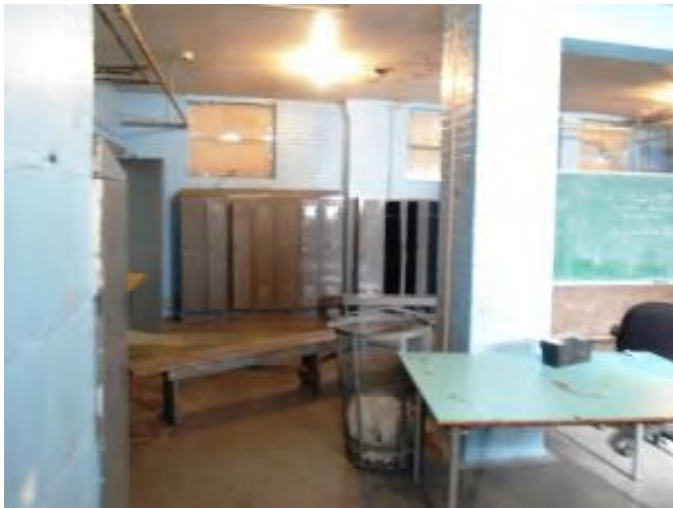
Location: Building Wide

System: C3030 - Ceiling Finishes

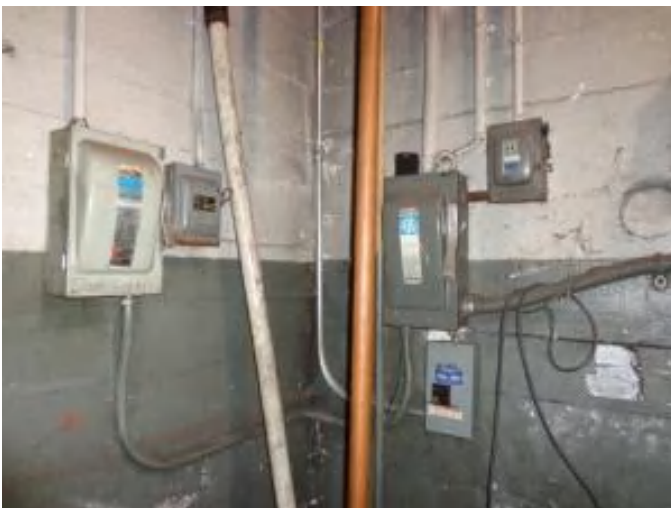
Location: Basement

System: D5010 - Electrical Service/Distribution

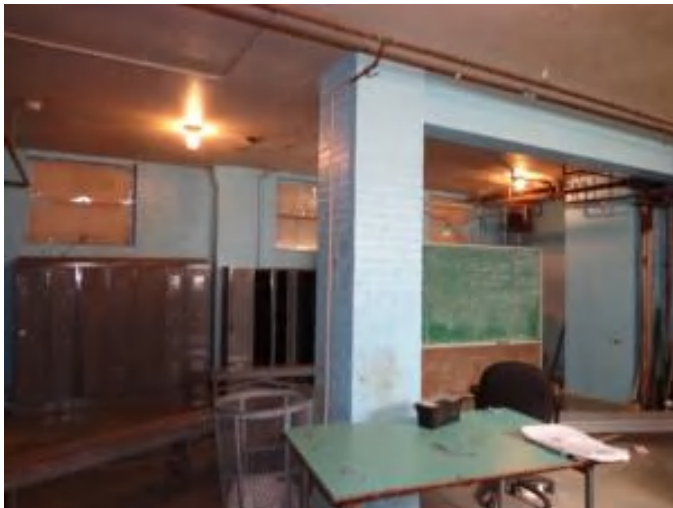
Location: Building wide

System: D5020 - Lighting and Branch Wiring

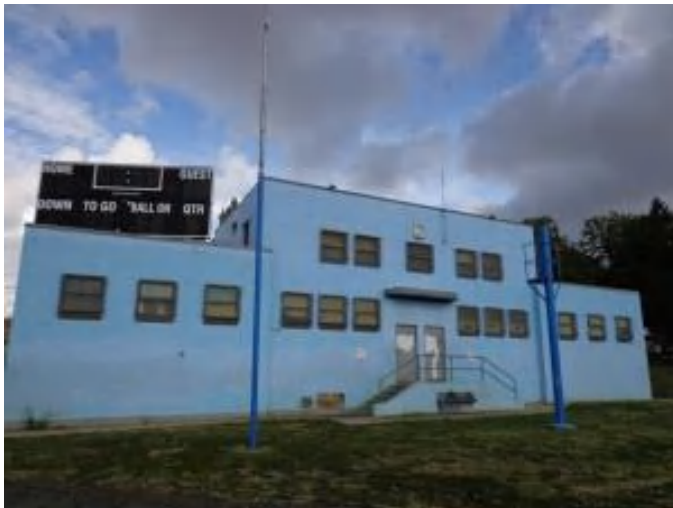
Location: Exterior Building

System: D5020 - Lighting and Branch Wiring

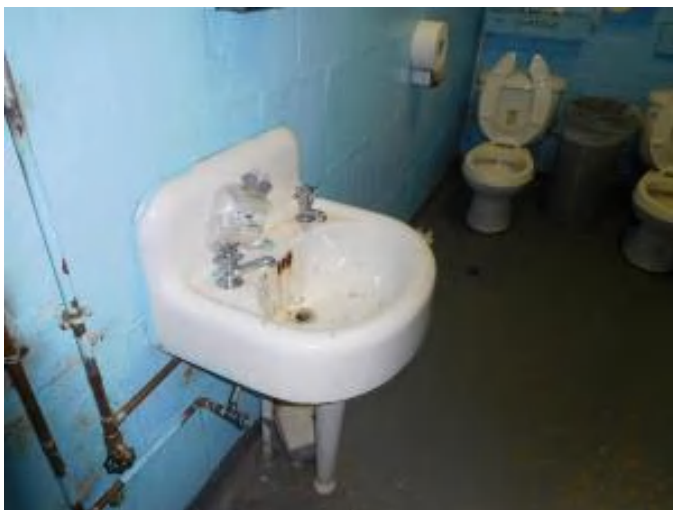
Location: toilet rooms

System: D2010 - Plumbing Fixtures

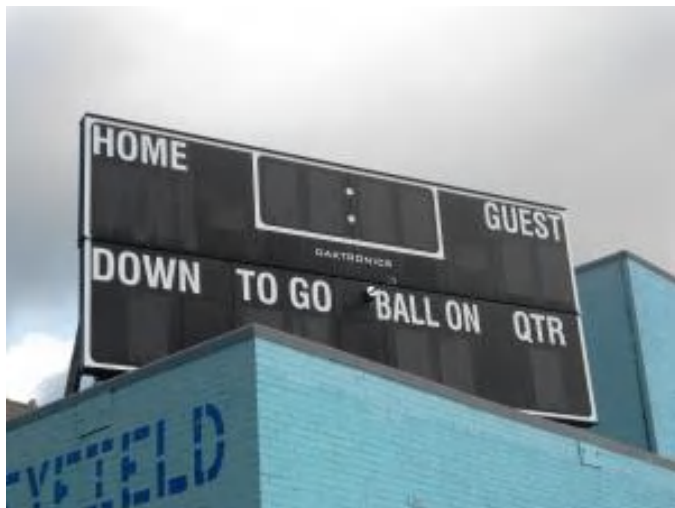
Location: Roof

System: E1020 - Institutional Equipment

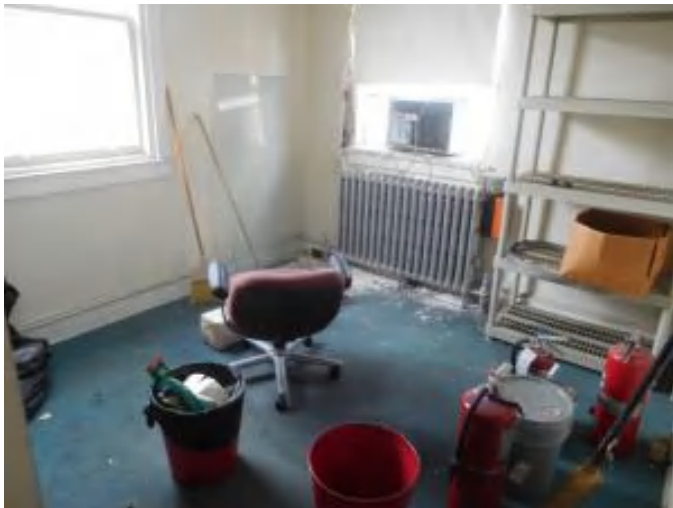
Location: entire building

System: D3060 - Controls & Instrumentation
