Facility Condition Assessment Summary Report

One Bright Ray (Bartram Business) School

S852001;Bartram Business

Site Assessment Report

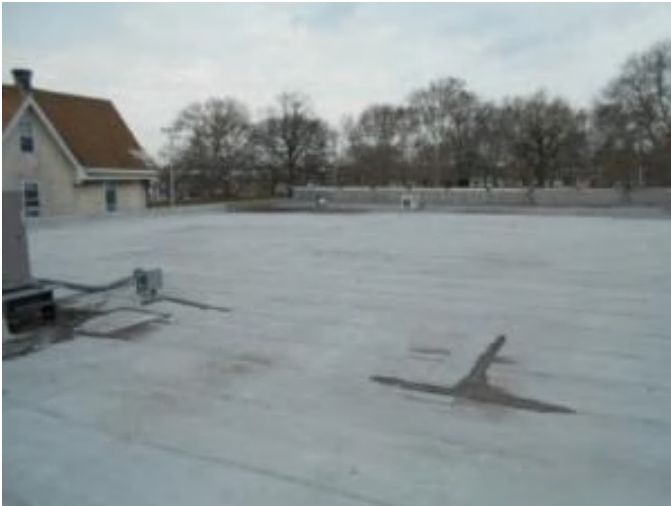
System: B3010105 - Built-Up

Location: Roofs

Distress: Failing

Notes: Replace leaking roof.

Correction: Remove and Replace Built Up Roof

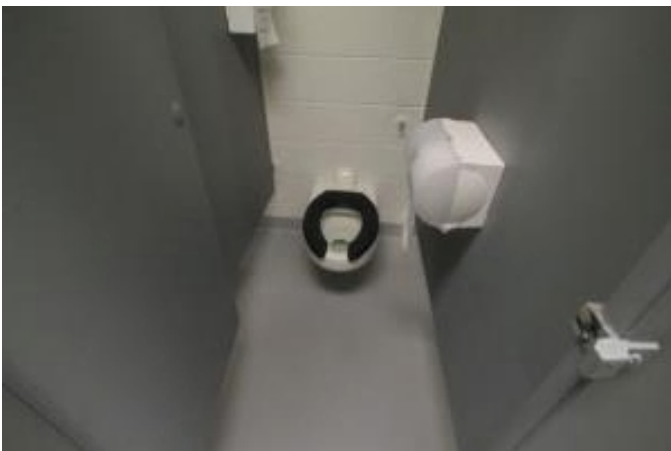
System: D2010 - Plumbing Fixtures

Toilet room fixtures are a mixture of original and replacements including 6 lavatories, 9 water closets, and 4 urinals. Flush valves are exposed, and 3 water closets at the front of the building are tank type. Two flush valves work poorly and should be replaced. The kitchen has a 3 basin commercial sink without disposal, chemical injector, or grease trap, and a lavatory. A cast iron with stainless steel rim service sink is located in the janitor closet at the back of the building with a vacuum breaker wall mounted faucet. Drinking fountains are wall hung stainless steel accessible units. Generally plumbing fixtures are in good condition and will not need replacement for 15 years.

Location: Toilet rooms

Distress: Failing

Correction: Replace flush valves (enter qty of WC or Urinals in estimate)

Notes: Replace failing flush valves

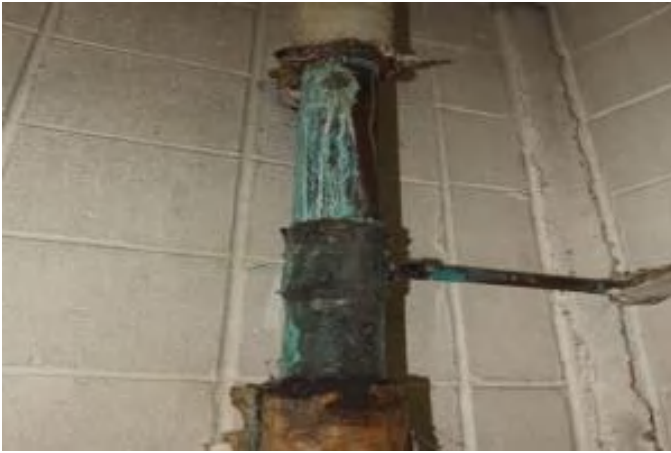
System: D2020 - Domestic Water Distribution

entry. There was wetness on the pipes in the meter room, likely due to failing solder joints. School faculty members were advised to report the leakage to the district immediately. Other areas of the domestic water piping have been repaired in the past. The entire domestic water distribution pipe system should be inspected and repaired (if the district has not done so already). Water is heated by a Bradford White 40 gallon natural gas water heater manufactured in 2014. It has a Taco model 007-SF5 1/25 HP circulation pump, but no thermal expansion tank. There is no domestic water pressure booster.

Location: Entire building

Distress: Failing

Correction: Replace domestic water piping (75 KSF)

Notes: Inspect and repair domestic water distribution pipes due to severe corrosion and leaks

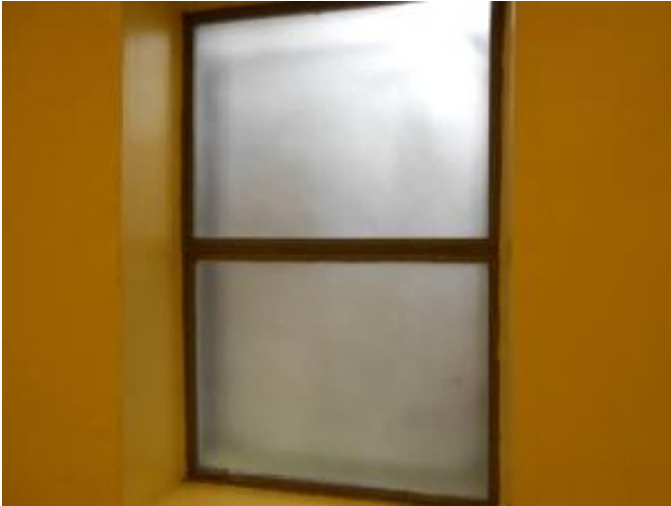
System: B2020 - Exterior Windows

Location: Southwest wall

Distress: Beyond Service Life

Correction: Remove and replace aluminum windows - pick the appropriate size and style and insert the number of units

Notes: Replace expired windows.

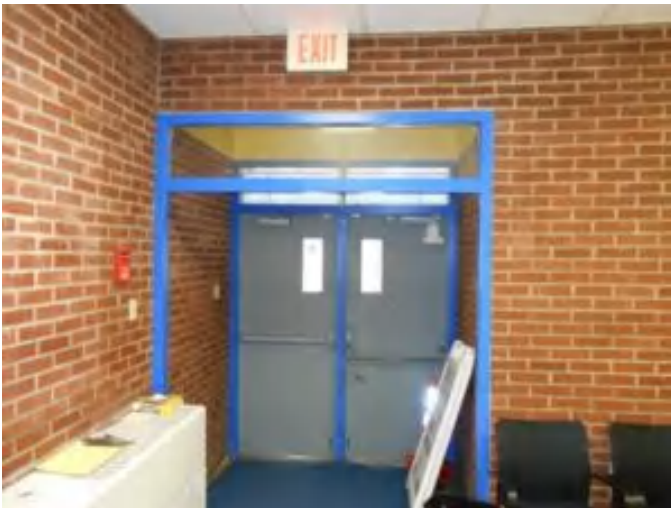
System: B2030 - Exterior Doors

Location: Exterior entrance

Distress: Accessibility

Correction: Replace hardware with compliant hardware, paint and weatherstrip - per leaf

Notes: Provide a handicap door operator at one exterior door on the main level.

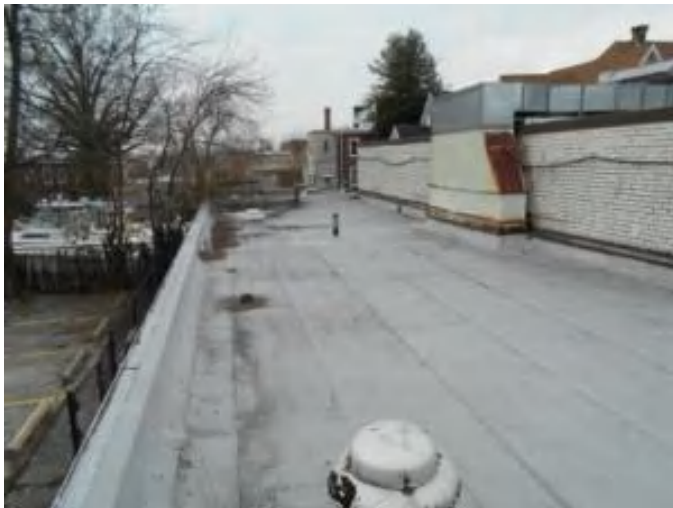
System: B3020 - Roof Openings

Location: TBD

Distress: OSHA

Correction: Replace roof hatch - pick the closest size

Notes: Install a roof hatch with fixed ladder to facilitate safe access to roof for maintenance of roof and roof mounted mechanical equipment.

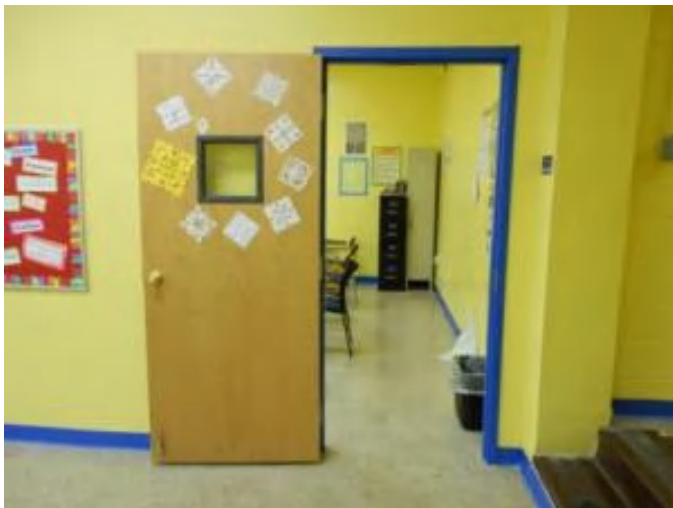
System: C1020 - Interior Doors

Location: Interior doors

Distress: Accessibility

Notes: Provide lever locksets at interior doors.

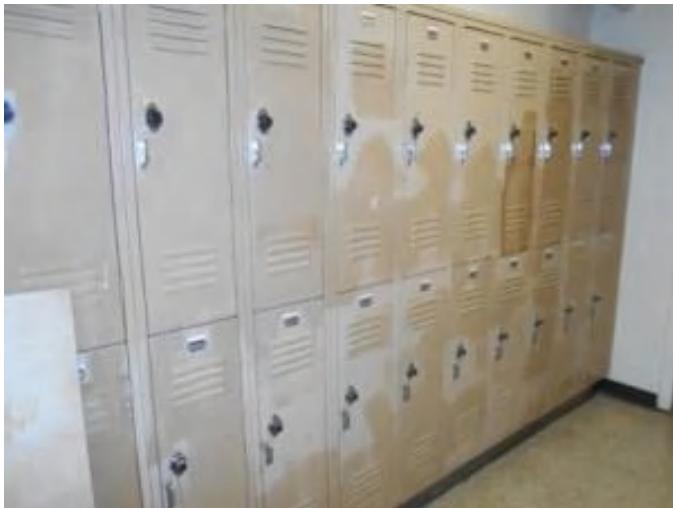
System: C1030 - Fittings

Location: Storage

Distress: Beyond Service Life

Notes: Replace student lockers that are rusted, dented, and have broken hardware.

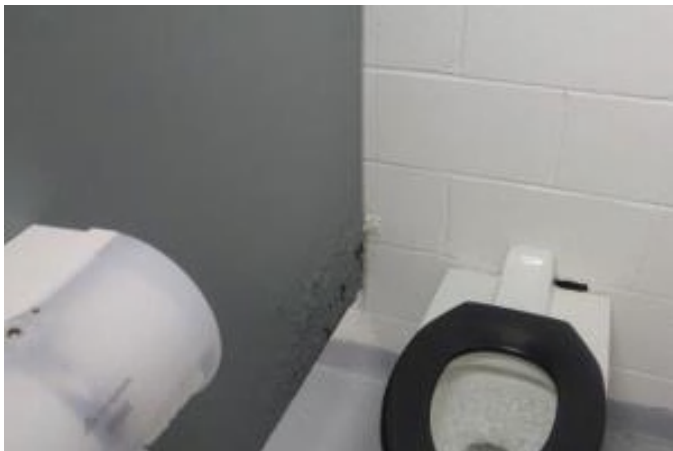
System: C1030 - Fittings

Location: Toilet rooms

Distress: Beyond Service Life

Notes: Replace rusty refurbished toilet partitions. Provide accessible partitions at at least one toilet room per sex.

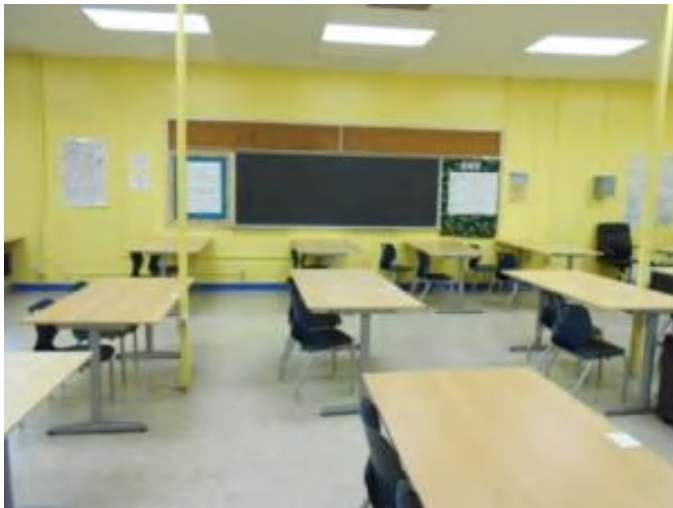
System: C1030 - Fittings

Location: Classrooms

Distress: Obsolete

Notes: Provide whiteboards in classrooms.

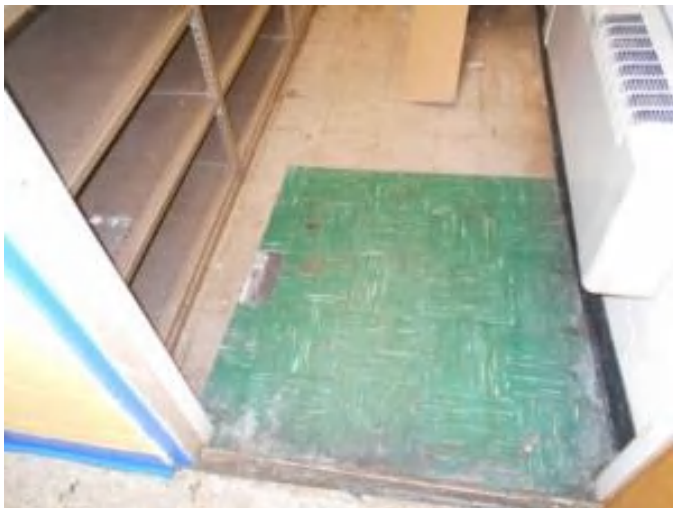
System: C3020413 - Vinyl Flooring

Location: Electric, storage, and mechanical rooms

Distress: Health Hazard / Risk

Notes: Remove 9" VAT and replace with 12" VCT

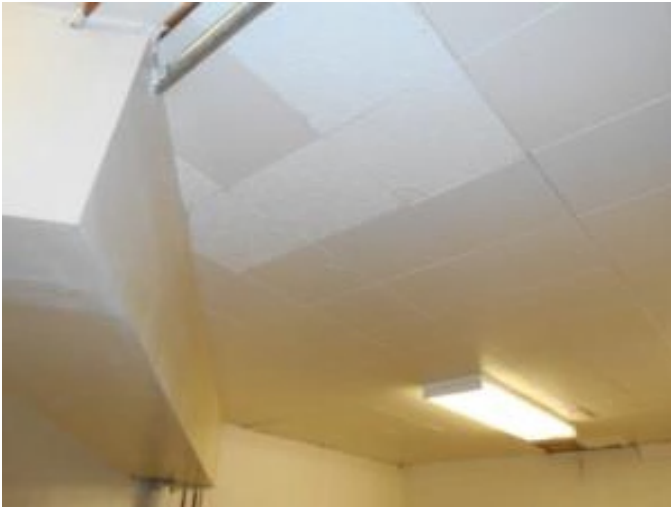
System: C3030 - Ceiling Finishes

Location: Kitchen, back of house areas

Distress: Beyond Service Life

Notes: Replace original 12" glued on acoustic ceiling tile.

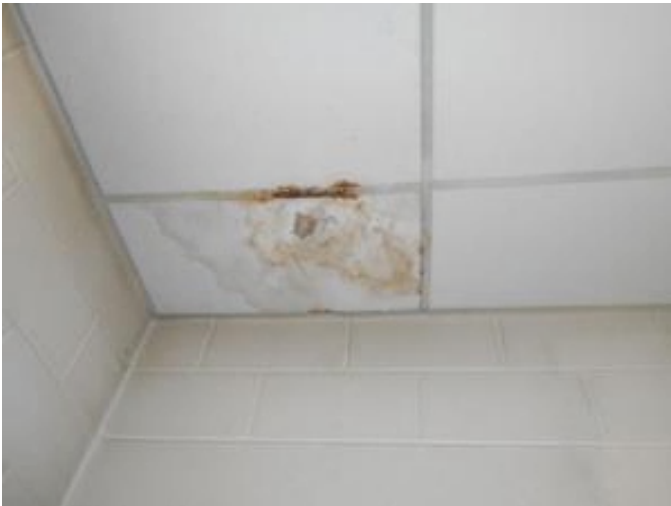
System: C3030 - Ceiling Finishes

Location: Various locations around the building

Distress: Damaged

Notes: Replace damaged/missing/stained ceiling tile. Repair grid as needed.

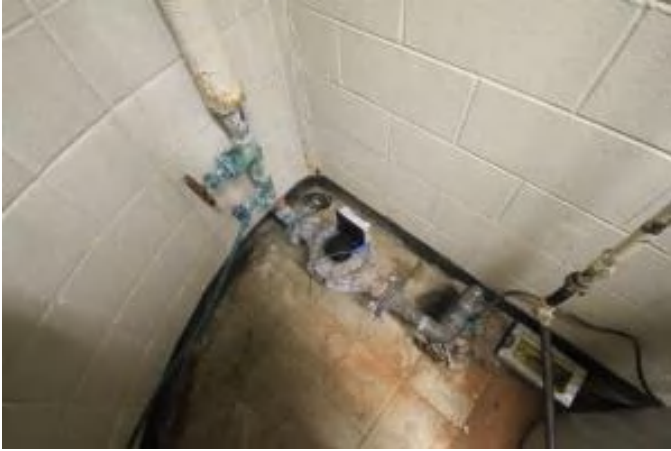
System: D2020 - Domestic Water Distribution

Water enters the building in a store room at the front of the building through a 2 inch connection. There is a water meter but no backflow preventer. A backflow preventer should be installed. Water distribution pipe is copper, and it is badly corroded at the

Location: Storage room

Distress: Building / MEP Codes

Notes: Install backflow preventer, 2"

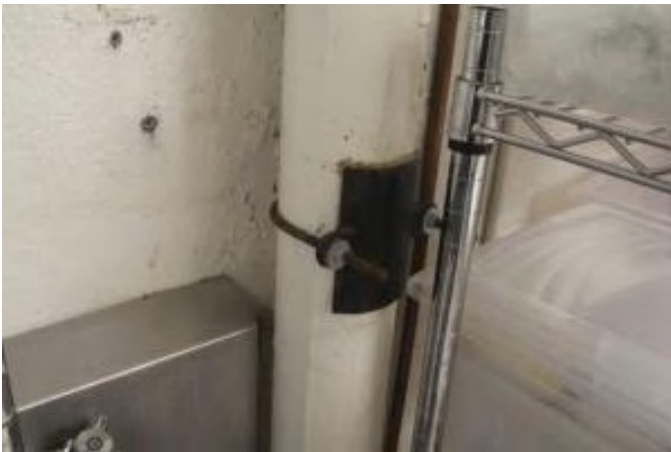
System: D2030 - Sanitary Waste

Sanitary drain pipes are both threaded galvanized steel and hub and spigot cast iron. They are likely original to the building and have been repaired previously in multiple areas. There is a patch on the kitchen vent stack pipe, yet it leaks elsewhere. The sanitary drain pipes should be inspected in detail and repaired as needed. There is no sewage ejector.

Location: Entire building

Distress: Failing

Notes: Inspect and repair sanitary drain pipes due to age and existing patches and leaks

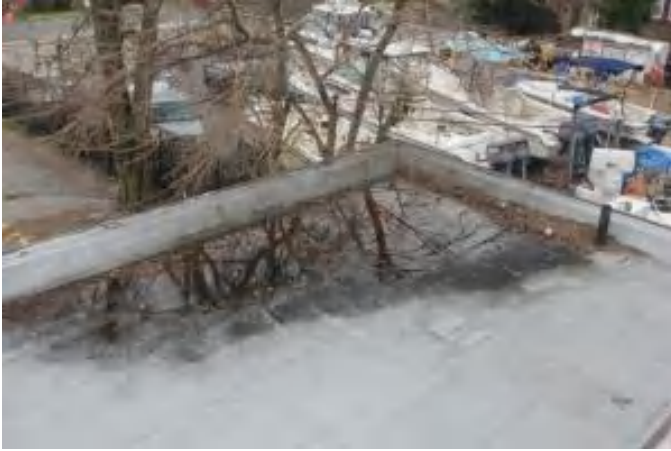
System: D2040 - Rain Water Drainage

Rooftop rain water drains have cast iron strainers. There are no overflow drains. There was standing water on the roof at the southwest corner of the building due to a clogged drain, likely due to a buildup of leaves and dirt. Cast iron hub and spigot drain pipes run inside the building. Based on age of the building (and condition of other pipe systems), rain water drain pipes should be inspected and repaired or replaced as needed. There no ground water sumps.

Location: Entire building

Distress: Failing

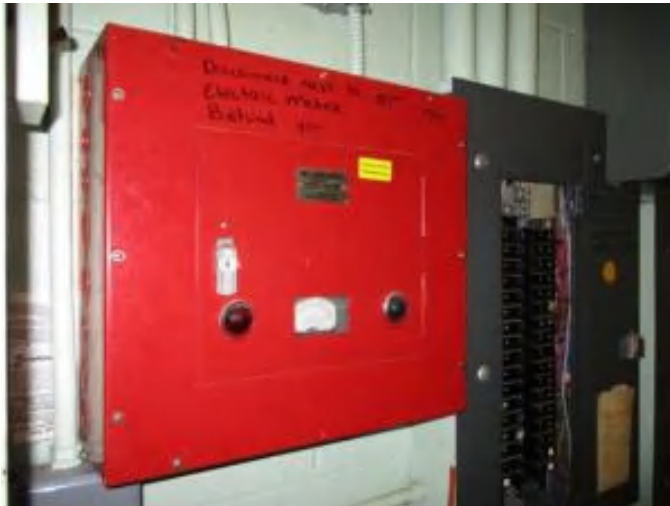
System: D5030 - Communications and Security

Location: Entire Building

Distress: Life Safety / NFPA / PFD

Correction: Replace fire alarm system

Notes: Replace old fire alarm system with addressable type with audio/visual devices at corridors and classrooms. Approximate 20 devices

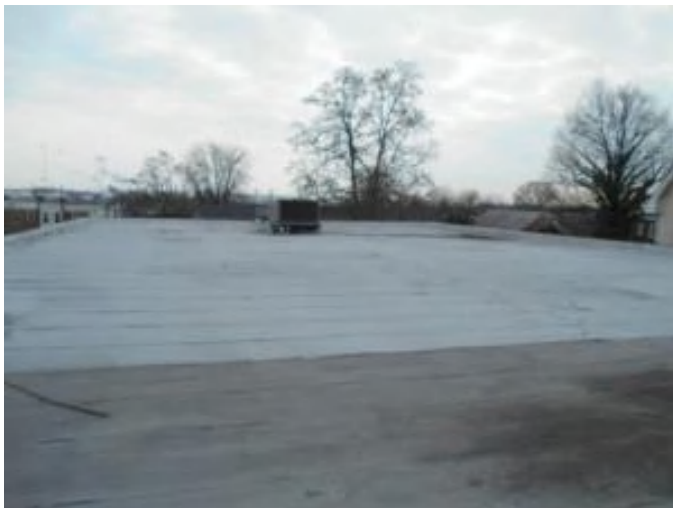
System: D5090 - Other Electrical Systems

Location: Roof

Distress: Building / MEP Codes

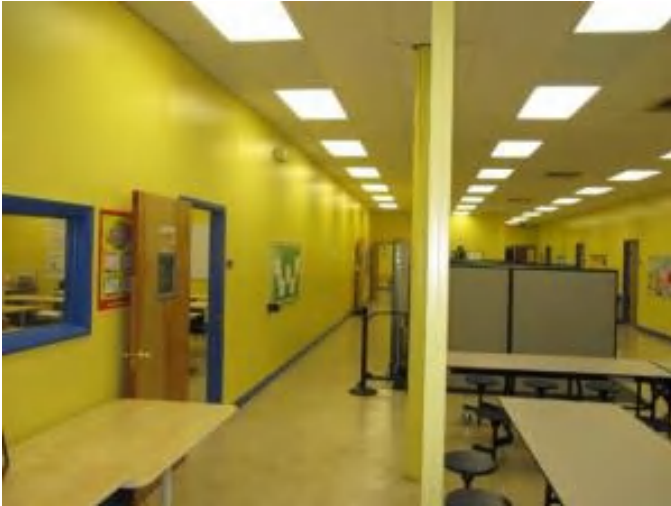
System: D5030 - Communications and Security

Location: Entire Building

Distress: Security Issue

Notes: Provide indoor surveillance CCTV cameras for complete coverage of the school building interior. Approximate 6

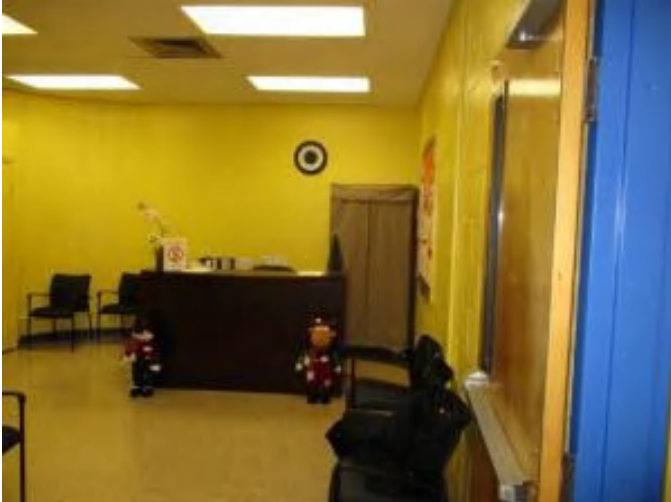
System: D5030 - Communications and Security

Location: Entire Building

Distress: Inadequate

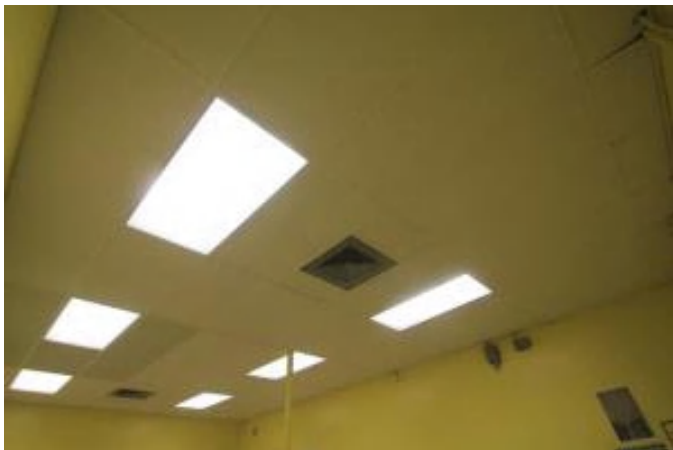
System: D4010 - Sprinklers

Location: Entire building

Distress: Life Safety / NFPA / PFD

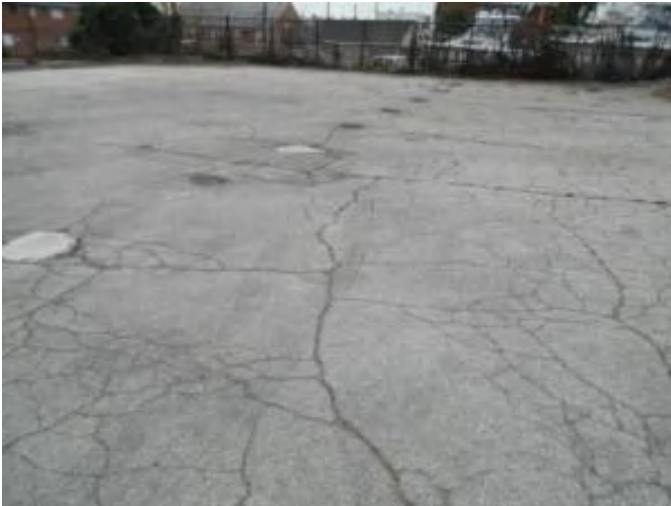
System: G2020 - Parking Lots

The parking lot is asphalt in fair condition with some cracking with vegetation in the cracks. The parking lot is striped and parking bumper curbs are installed. There is no signage and no designated accessible spaces with an accessible route to the building. Pedestrian pavement is concrete at the public street and at the service entrance between the building and the parking lot. It is in fair condition and is maintained to minimize trip hazards with several replacement slabs noted. Fencing surrounding the parking lot adjacent to residential properties is chain link in good condition. There is a low chain link fence dividing the parking lot and the rear building entrance, and a low fence with a gate at the vehicular entrance, all in good condition. A retaining wall is located at the far end of the parking lot with a significant drop to Dickens Avenue. A chain link fence provides fall protection for people, but is not sufficient to stop a vehicle from going over the edge. Landscaping consists of one new shrub at the northwest corner of the building and one mature tree in the parking lot. A small strip of volunteer vegetation occurs at the bottom of the retaining wall parallel to Dickens Ave.

Location: South end of site and entry drive

Distress: Maintenance Required

Notes: Crack seal and resurface the parking lot.

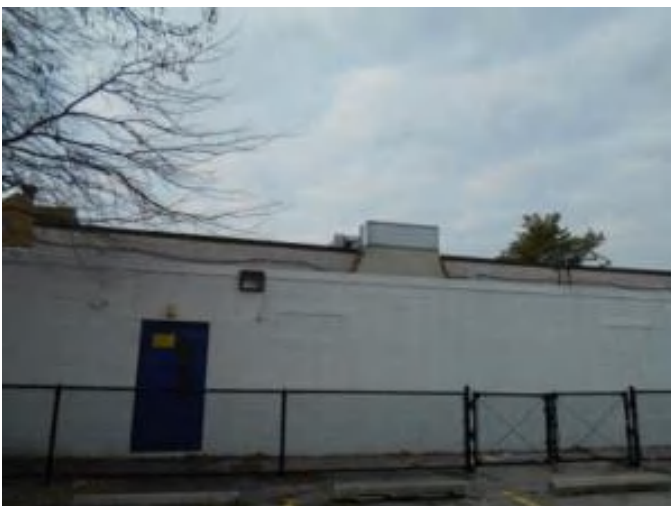
System: G2030 - Pedestrian Paving

Location: Rear service door

Distress: Building / MEP Codes

Notes: Provide an exterior landing at the rear service door.

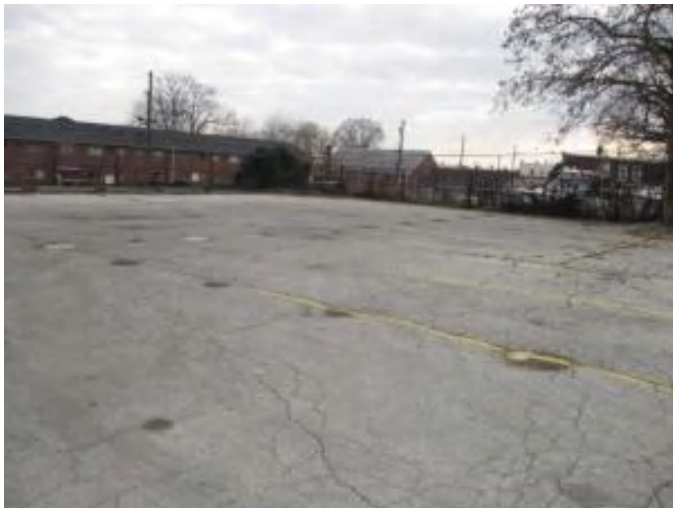
System: G4020 - Site Lighting

Location: Parking Lot

Distress: Security Issue

Notes: Provide pole mounted lighting fixtures to illuminate the parking lot. Approximate 2

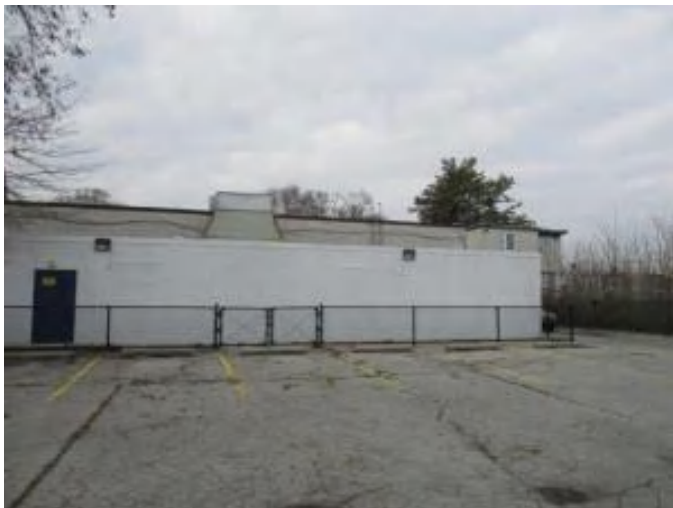
System: G4030 - Site Communications & Security

Location: Building Perimeter

Distress: Security Issue
