## Facility Condition Assessment Summary Report

### PLA North at Hunting Park (Alt Ed Center) School

School District of Philadelphia  
**S503001;Alt Ed Center**  
Final  
**Site Assessment Report**  
February 1, 2017

Facility Assessment  
November 2015

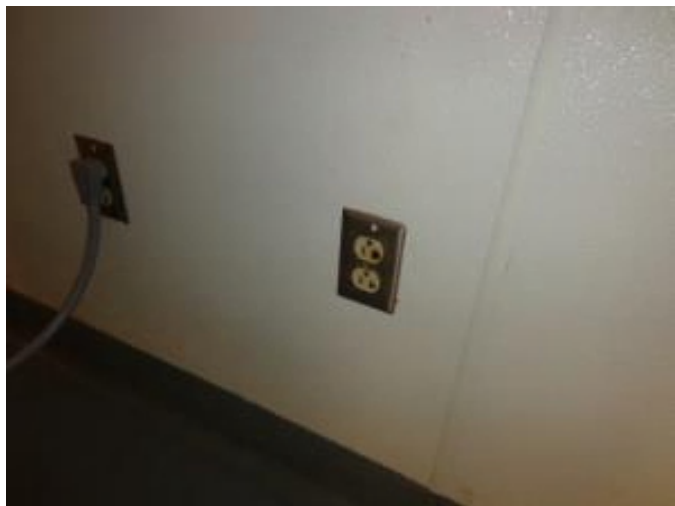
**Location:** Food Services

#### **System: D5020 - Lighting and Branch Wiring**

**Distress:** Life Safety / NFPA / PFD

**Notes:** Replace five (5) duplex receptacles in Food Services with ground-fault circuit-interrupting (GFCI) type receptacles to comply with NFPA 70, National Electrical Code (NEC) Article 210.8.

- Replace five (5) duplex receptacles in Food Services with ground-fault circuit-interrupting (GFCI) type receptacles to comply with NFPA 70, National Electrical Code (NEC) Article 210.8.

**Correction:** Replace Wiring Device

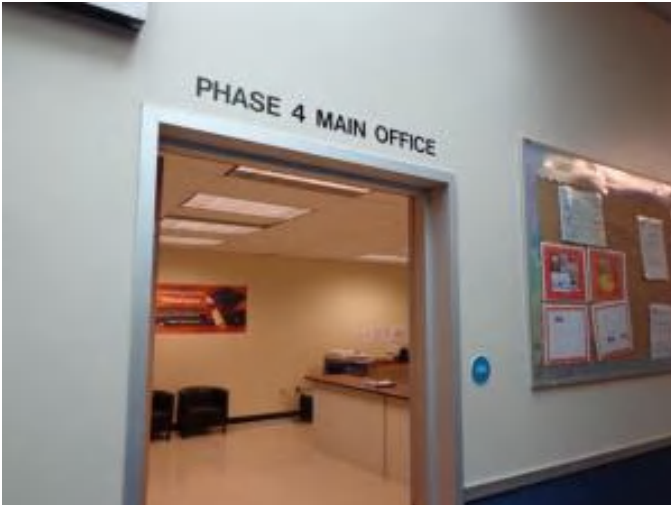
**Location:** Main Offices 186 and 123 and the Central Maintenance Warehouse area

**System: D5030 - Communications and Security**

**Distress:** Life Safety / NFPA / PFD

**Notes:** Provide allowance for adding six (6) fire alarm notification appliances in multiple occupancy areas that are missing devices to comply with requirements. Main Offices 186 and 123 and the Central Maintenance Warehouse area are missing devices.

- Provide allowance for adding six (6) fire alarm notification appliances in multiple occupancy areas that are missing devices to comply with ADA requirements. Main Offices 186 and 123 and the Central Maintenance Warehouse area are missing devices.

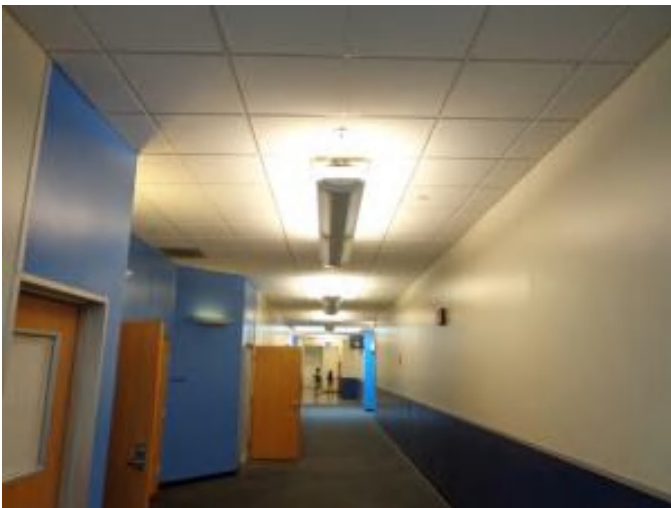
**Location:** Corridor south of Classroom Pods J, K, L and M

**System: D5090 - Other Electrical Systems**

**Distress:** Life Safety / NFPA / PFD

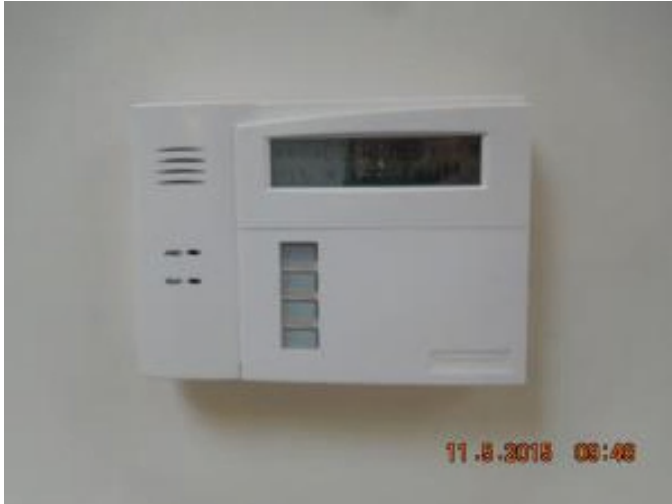
**Location:** entire building

**System: D3060 - Controls & Instrumentation**

**Distress:** Inadequate

**Correction:** Replace pneumatic controls with DDC (150KSF)

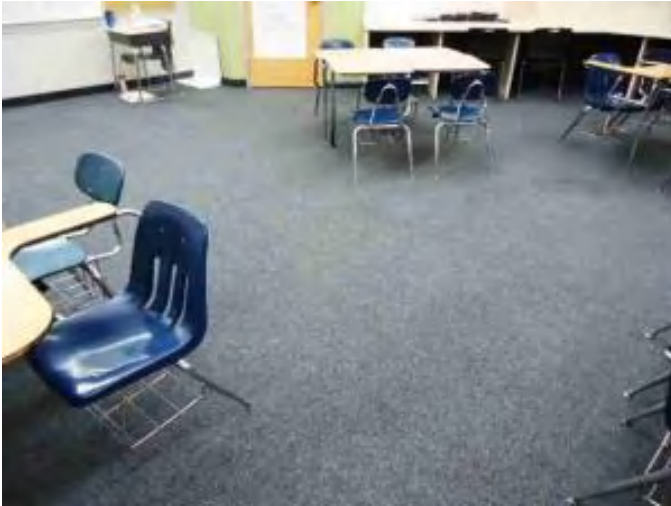
**Location:** Select Classrooms

**System: C3020411 - Carpet**

**Distress:** Damaged

**Notes:** The interior carpet finish was installed approximately in 2005 and is in fair condition considering the age and high traffic conditions. This finish will exceed its expected life within the next five years and is recommended for removal and replacement.

**Correction:** Remove and replace carpet

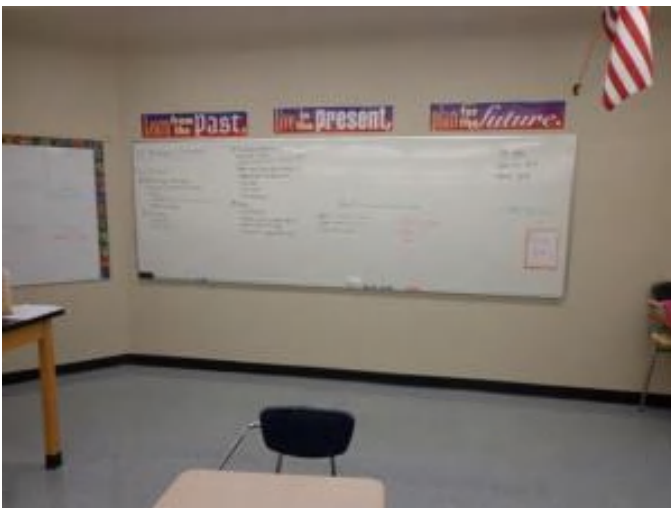
**Location:** Classrooms

Receptacles-- Except for classrooms, receptacle quantities are adequate in all other locations. In classrooms, there is typically only one duplex receptacle on the two walls where the instructor's desk is located. It is recommended that additional duplex receptacles be provided on each of these two walls using a metal surface raceway system. Except for the kitchen, ground-fault circuit-interrupting (GFCI) type receptacles were observed within 6 feet of all wet locations, as required by code. Replace five (5) duplex receptacles in the kitchen with GFCI receptacles to comply with NFPA 70, National Electrical Code (NEC) Article 210.8.

**System: D5020 - Lighting and Branch Wiring**

**Distress:** Inadequate
