## Facility Condition Assessment Summary Report

### Palumbo School

School District of Philadelphia  
**S262001;Palumbo**  
Final  
**Site Assessment Report**  
February 2, 2017

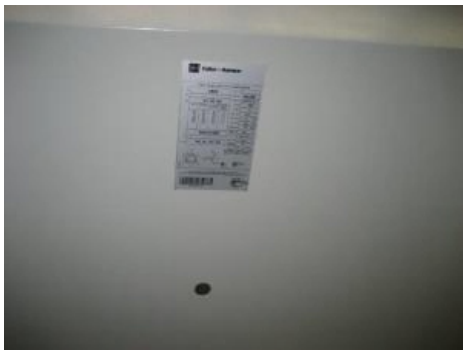
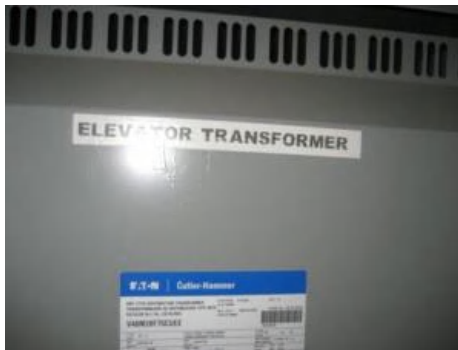
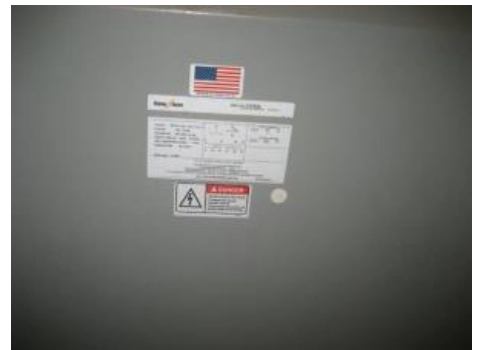
**System:** D5010 - Electrical Service/Distribution

**Note:** There are three dry type transformers:

1. 500KVA 480V-120/208V for lighting and receptacle loads
2. 150KVA 208V-240V to reefed existing 240V loads
3. 75KVA 480-208V for the elevators.

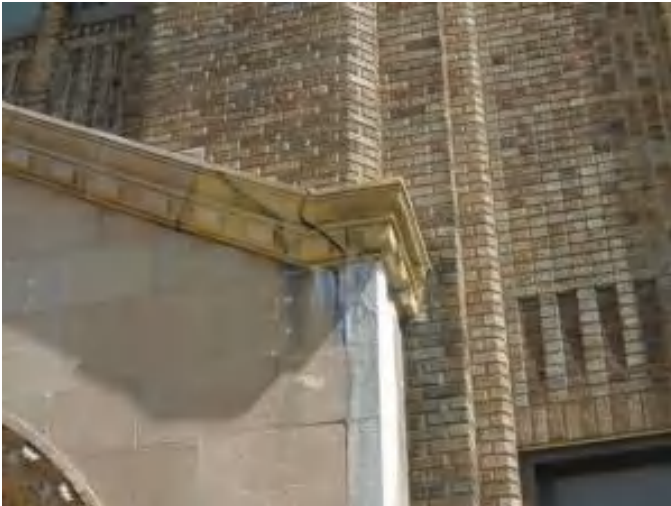
#### System: B2010 - Exterior Walls

**Location:** Entrances

**Distress:** Damaged

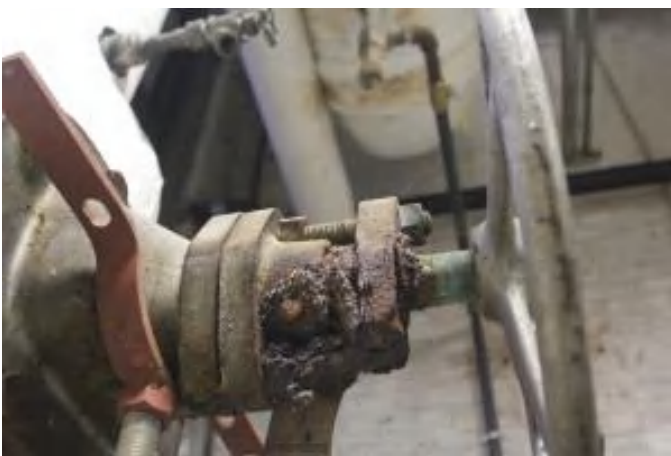
#### System: D2020 - Domestic Water Distribution

**Location:** Basement mechanical room

**Distress:** Failing

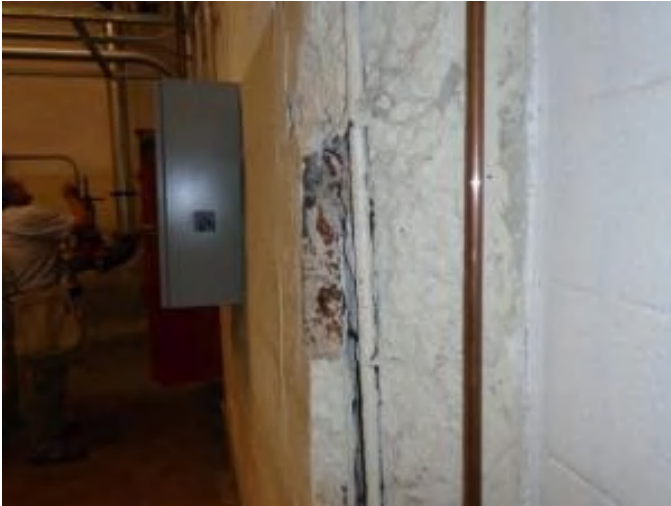
**System: A2020 - Basement Walls**

**Location:** Basement

**Distress:** Building Envelope Integrity

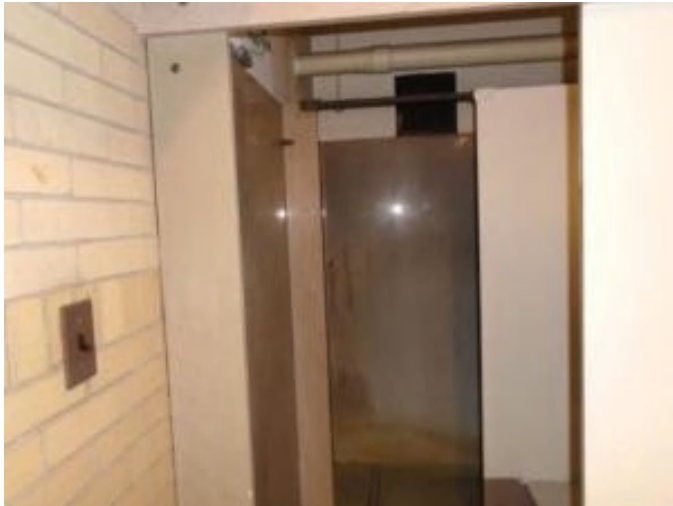
**System: C1010 - Partitions**

**Location:** Locker rooms

**Distress:** Obsolete

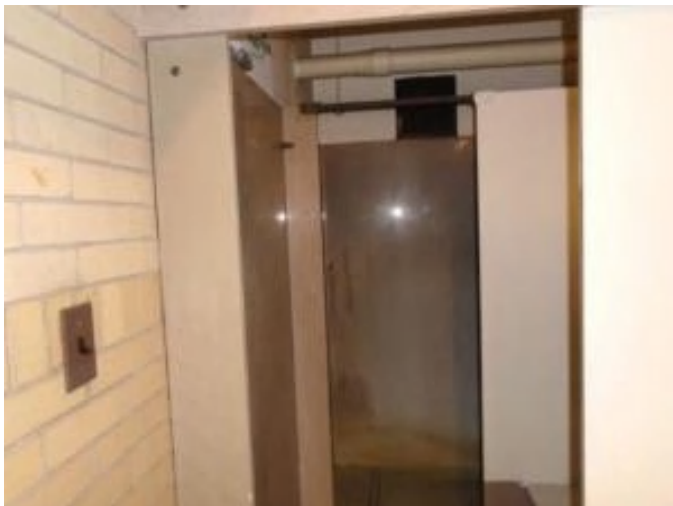
**System: C1010 - Partitions**

**Location:** Boys locker room

**Distress:** Building / MEP Codes

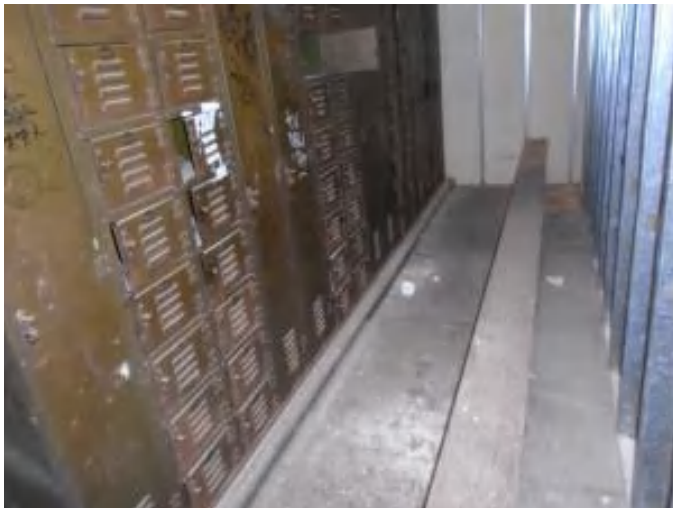
**System: C1030 - Fittings**

**Location:** Locker rooms

**Distress:** Failing

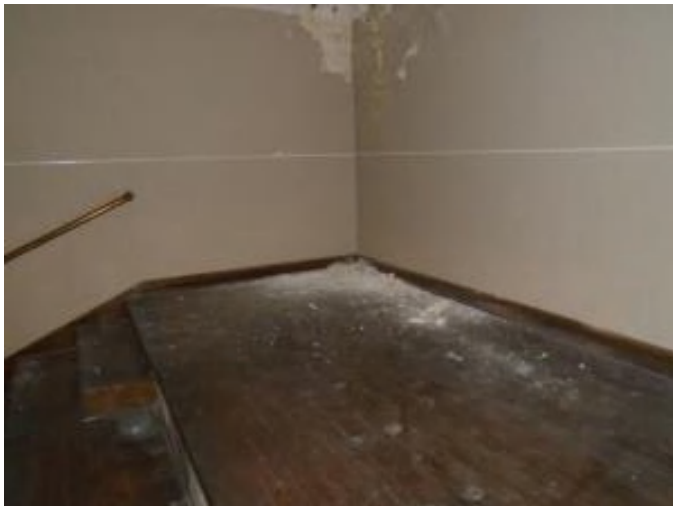
**System: C3010230 - Paint & Covering**

**Location:** Throughout

**Distress:** Damaged

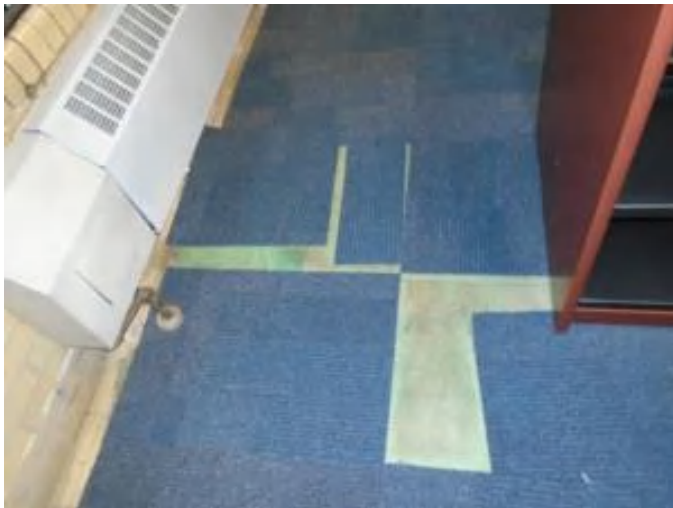
**System: C3020411 - Carpet**

**Location:** Various

**Distress:** Failing

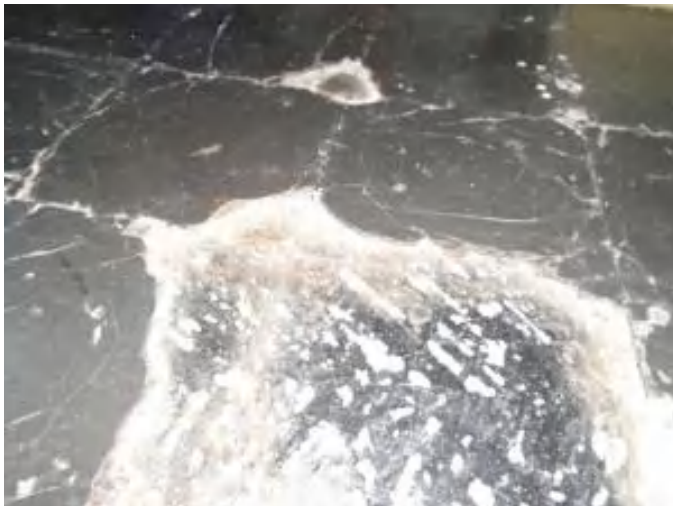
**System: C3020413 - Vinyl Flooring**

**Location:** Various

**Distress:** Damaged

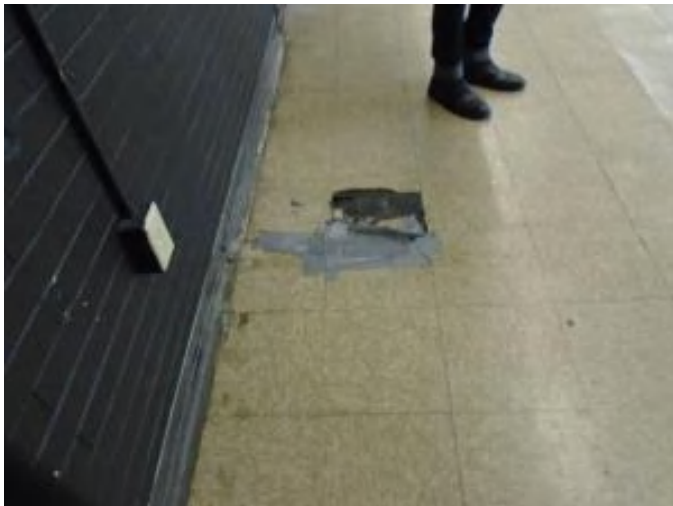
**System: C3020413 - Vinyl Flooring**

**Location:** Various

**Distress:** Damaged

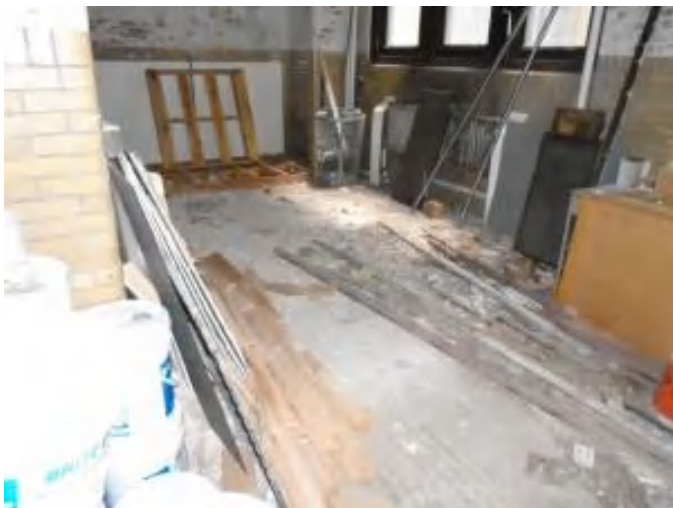
**System: C3020414 - Wood Flooring**

**Location:** Various

**Distress:** Damaged

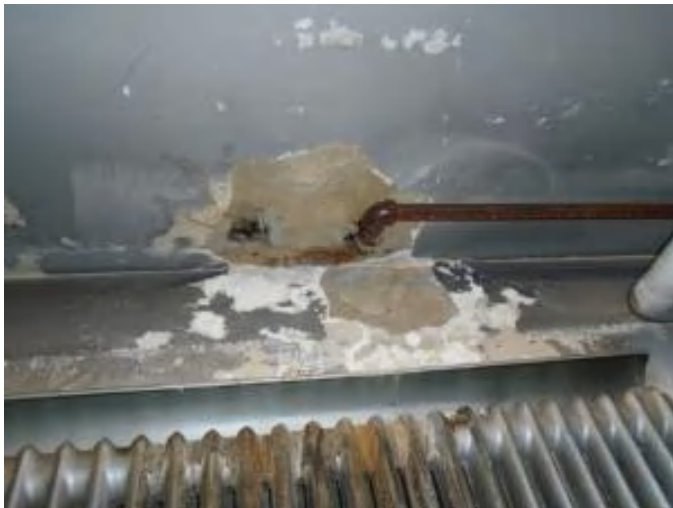
**System: C3030 - Ceiling Finishes**

**Location:** Various

**Distress:** Damaged

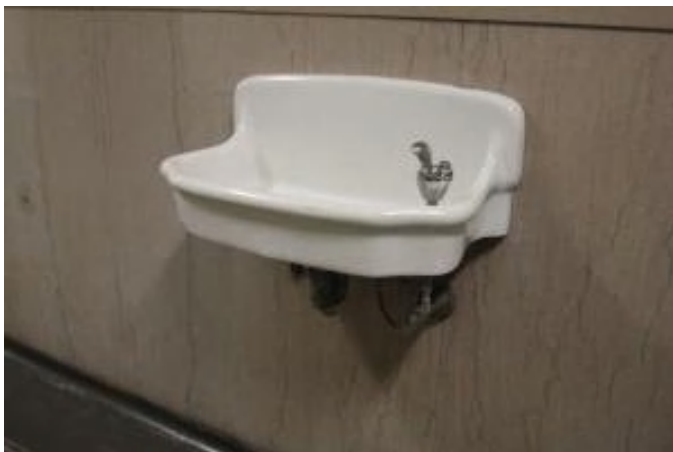
**System: D2010 - Plumbing Fixtures**

**Location:** Hallways

**Distress:** Accessibility

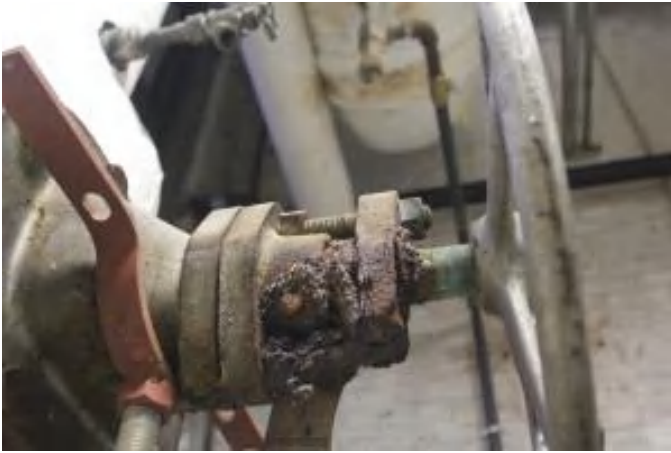
**System: D2020 - Domestic Water Distribution**

**Location:** Entire building

**Distress:** Failing

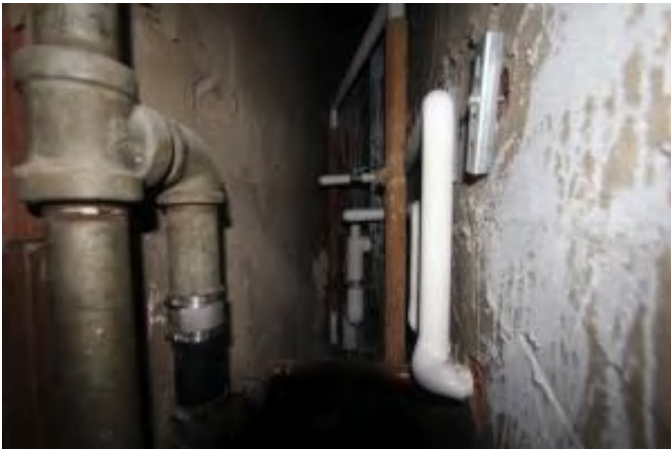
**System: D2030 - Sanitary Waste**

**Location:** Entire building

**Distress:** Failing

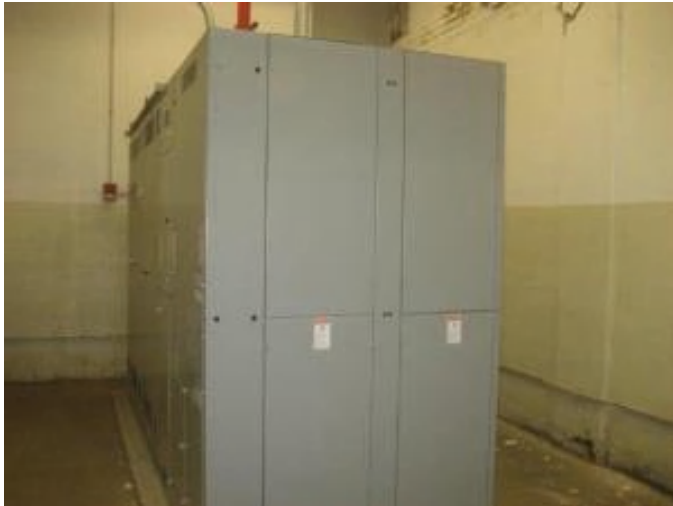
**System: D5010 - Electrical Service/Distribution**

**Location:** Basement

**Distress:** Inadequate

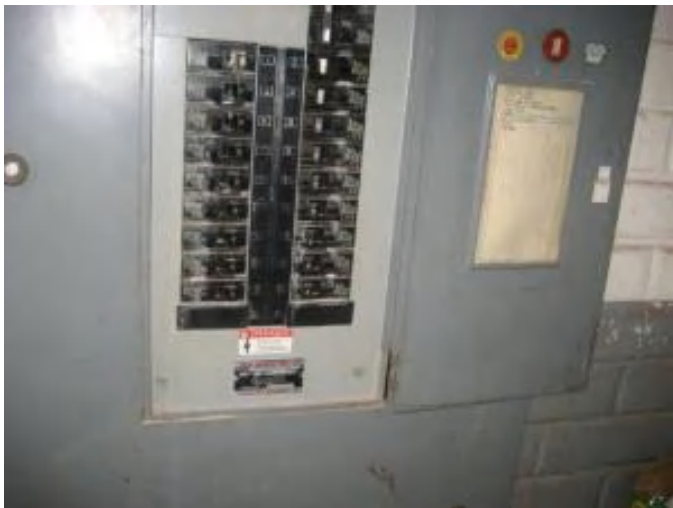
**System: D5010 - Electrical Service/Distribution**

**Location:** Entire school

**Distress:** Beyond Service Life

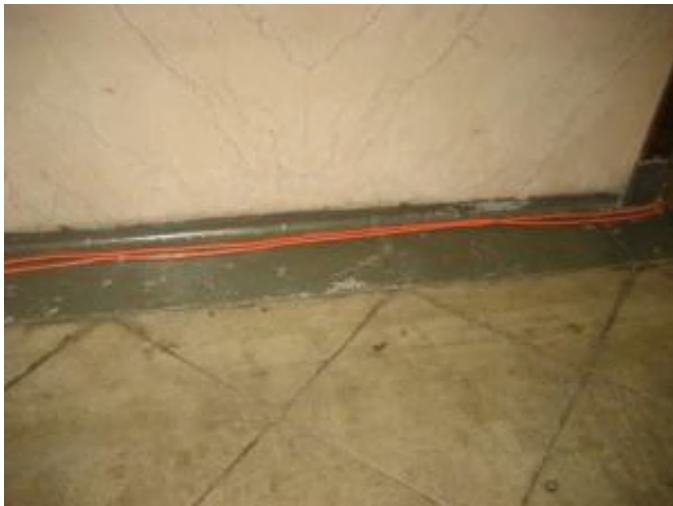
**System: D5020 - Lighting and Branch Wiring**

**Location:** classrooms

**Distress:** Inadequate

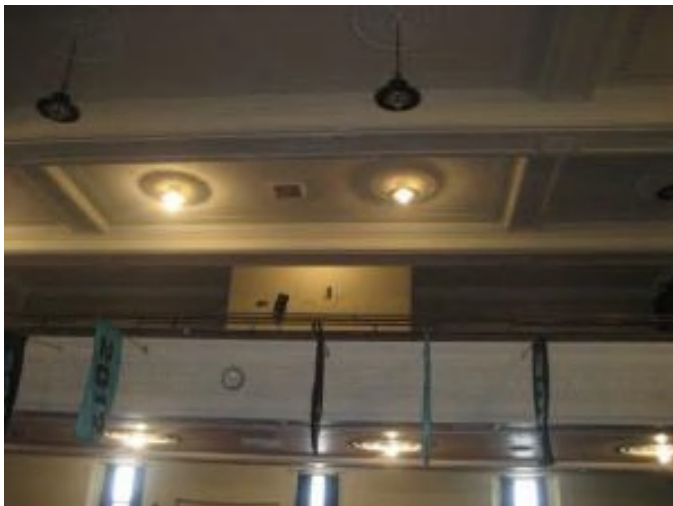
**System: D5020 - Lighting and Branch Wiring**

**Location:** Auditorium

**Distress:** Inadequate

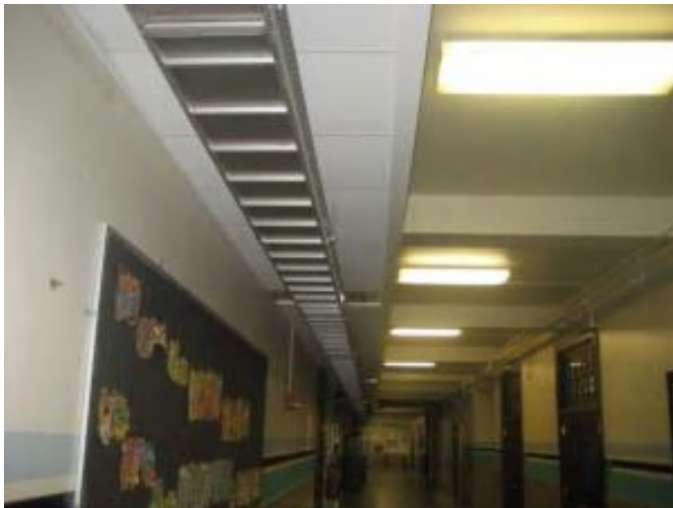
**System: D5030 - Communications and Security**

**Location:** Corridors, stairways

**Distress:** Security Issue

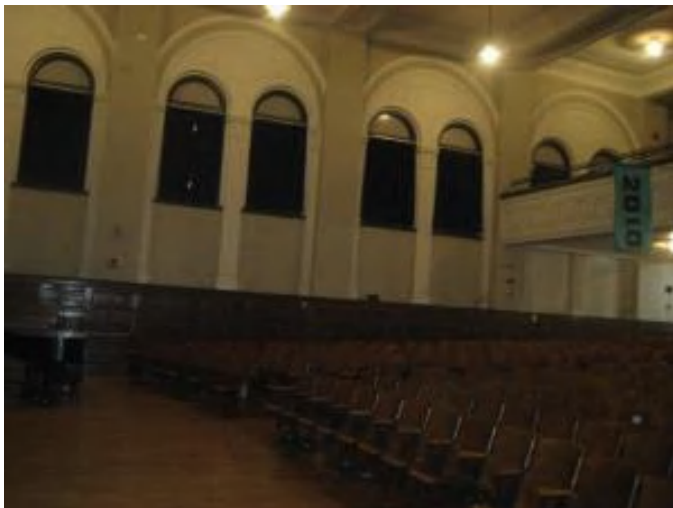
**System: D5030 - Communications and Security**

**Location:** Auditorium

**Distress:** Inadequate

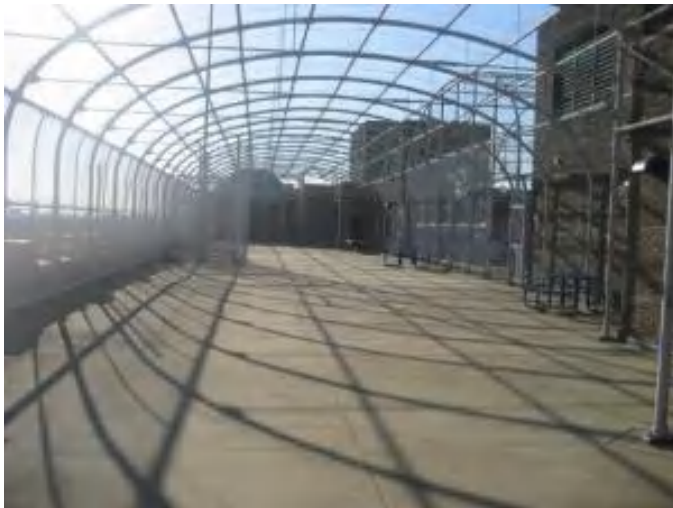
**System: D5090 - Other Electrical Systems**

**Location:** Roof

**Distress:** Building / MEP Codes

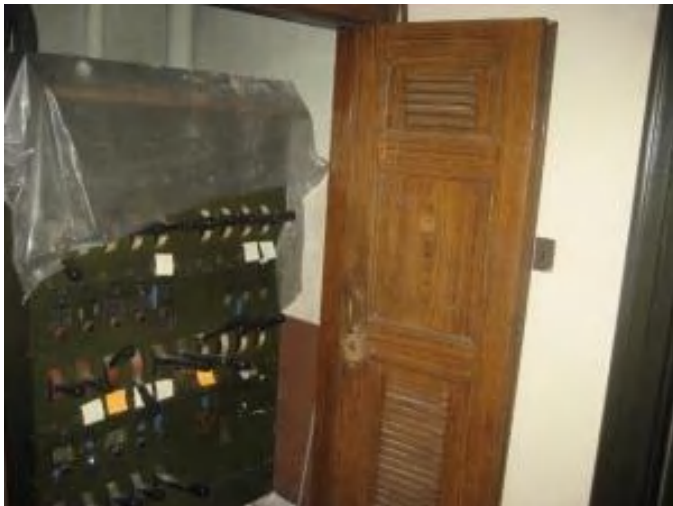
**System: E1020 - Institutional Equipment**

**Location:** Auditorium

**Distress:** Obsolete

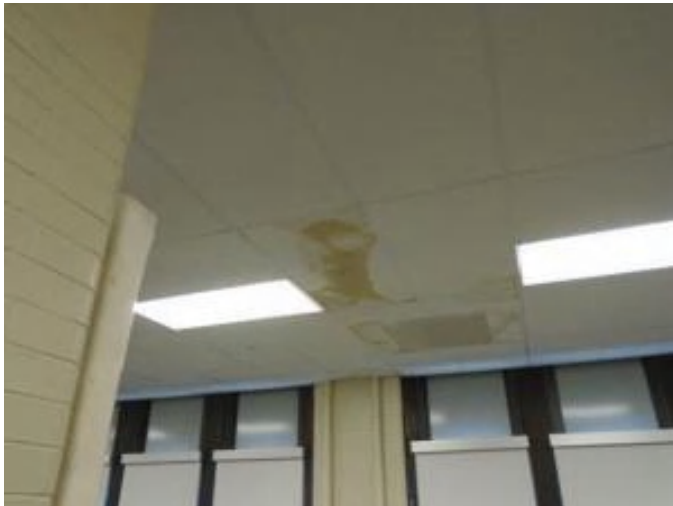
**System: C3030 - Ceiling Finishes**

**Location:** Various

**Distress:** Damaged

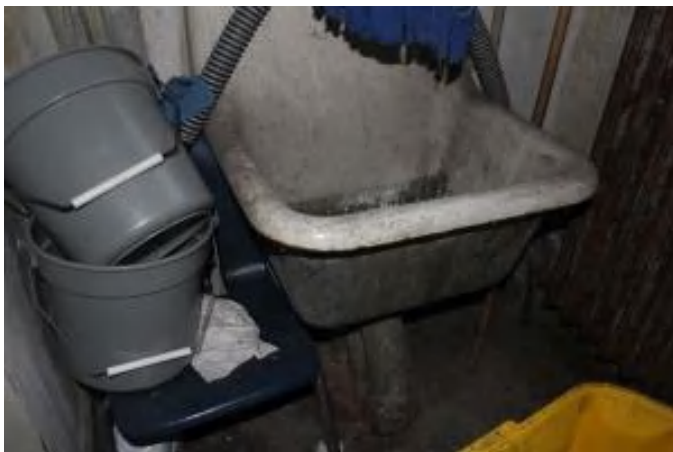
**System: D2010 - Plumbing Fixtures**

**Location:** Service closets

**Distress:** Beyond Service Life

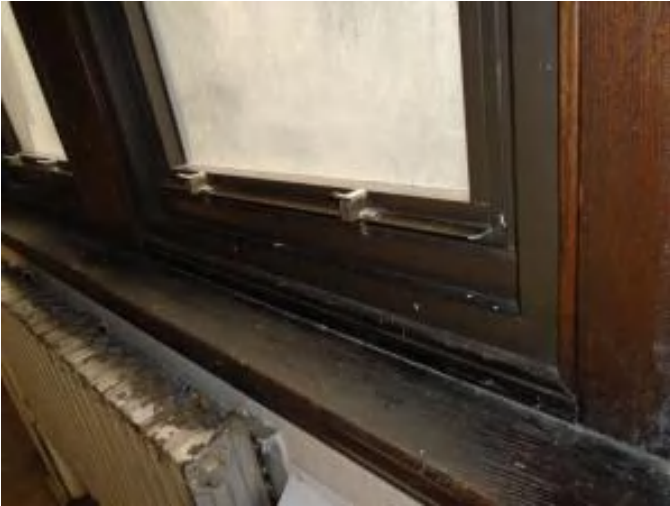
**System: B2020 - Exterior Windows**

**Location:** Throughout

**Distress:** Energy Efficiency

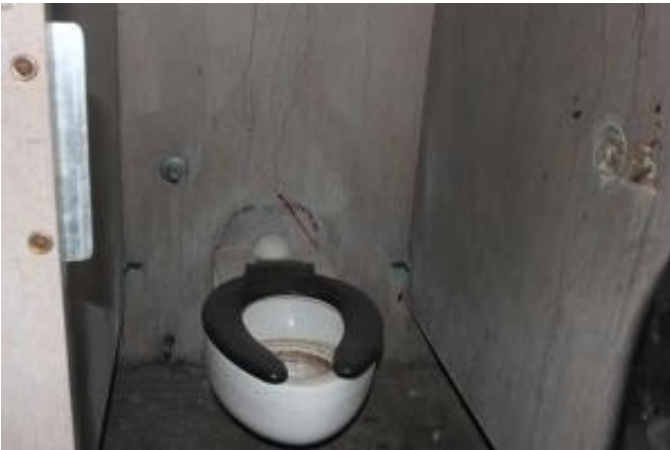
**System: D2010 - Plumbing Fixtures**

**Location:** Bathrooms

**Distress:** Beyond Service Life

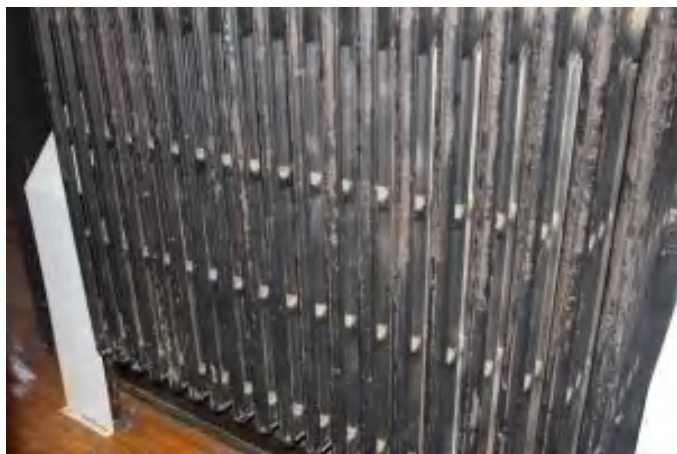
**System: D3040 - Distribution Systems**

**Location:** Entire building

**Distress:** Beyond Service Life

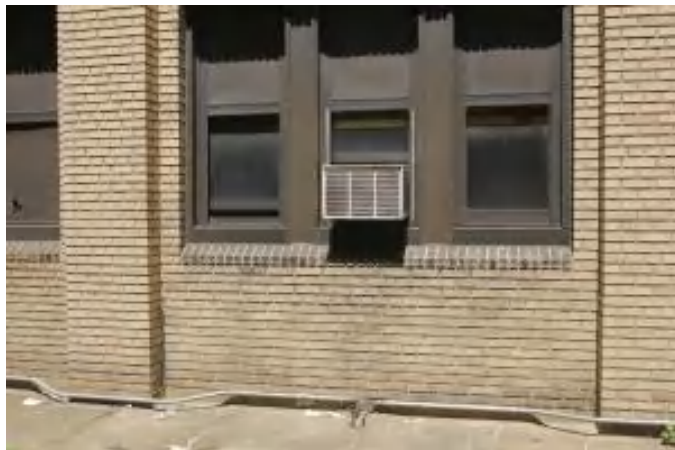
**System: D3030 - Cooling Generating Systems**

**Location:** Entire building

**Distress:** Inadequate

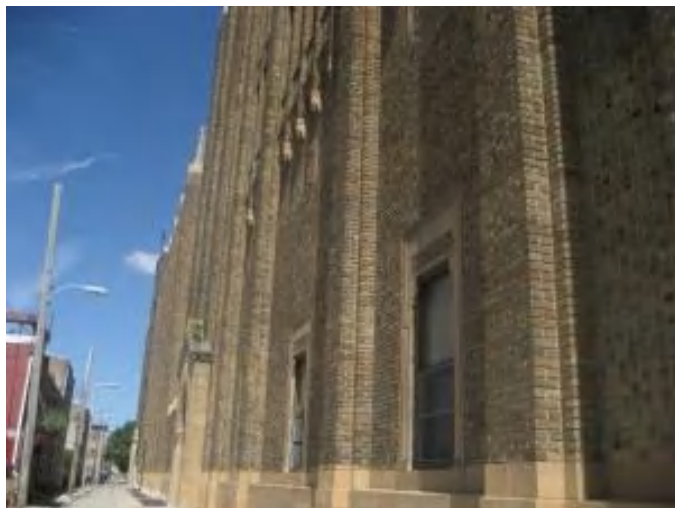
#### System: G4030 - Site Communications & Security

**Location:** Building perimeter

**Distress:** Health Hazard / Risk
