Facility Condition Assessment Summary Report

Parkway Northwest (Hill-Freedman) School

S646001;Hill / Freedman and Lewis

Site Assessment Report

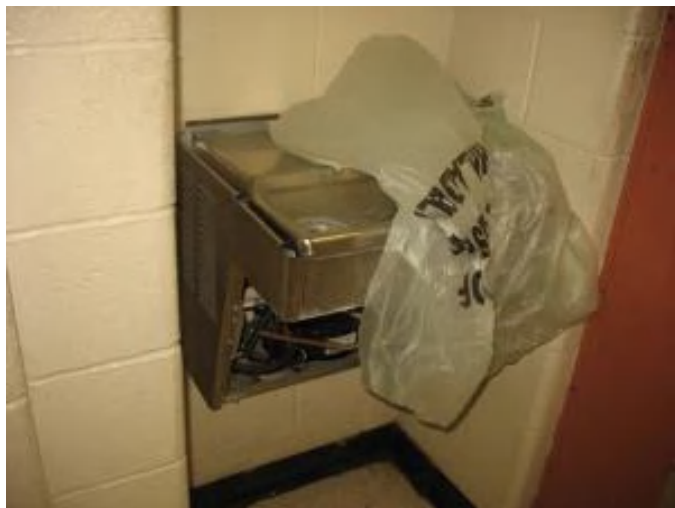
Location: Corridors

Drinking fountains consist of stainless steel wall hung fixtures with integral refrigerated coolers. Several fixtures were damaged and inoperable at the time of the site visit. The three (3) damaged fixtures should be replaced; most are accessible type.

System: D2010 - Plumbing Fixtures

Distress: Damaged

- Replace eight (8) lavatories, in use beyond their service life, with new code compliant fixtures.
- Replace three (3) wall hung drinking fountains and integral refrigerated coolers in the corridors. These units were damaged at the time of the site visit and were not operable.

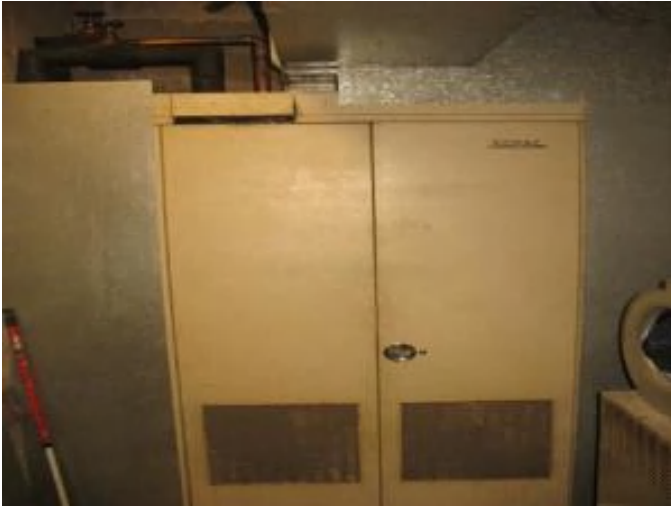
Location: Suite 110

System: D3040 - Distribution Systems

Distress: Beyond Service Life

Notes: Replace the Edpac AHU and associated fluid cooler serving suite 110 which are beyond their service lives.

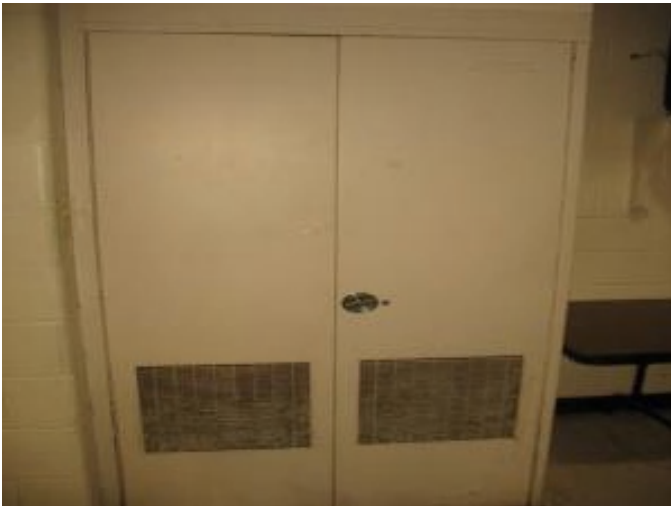
Location: Cafeteria/Auditorium

System: D3040 - Distribution Systems

Distress: Beyond Service Life

Notes: Replace the two (2) Edpac AHUs and associated fluid coolers serving the Cafeteria/Auditorium which are beyond their service lives.

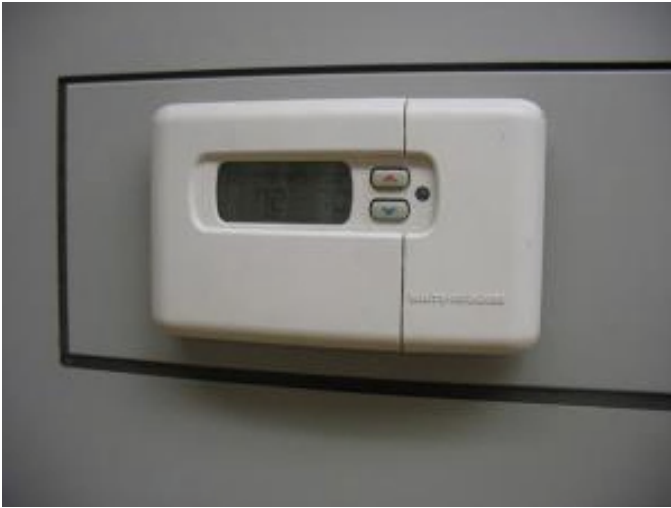
Location: Throughout building

System: D3060 - Controls & Instrumentation

Distress: Inadequate

Notes: Replace the existing controls for the HVAC systems with modern DDC modules to improve reliability and energy efficiency. Provide a new building automation system (BAS) with communication interface to the preferred system in use throughout the District.

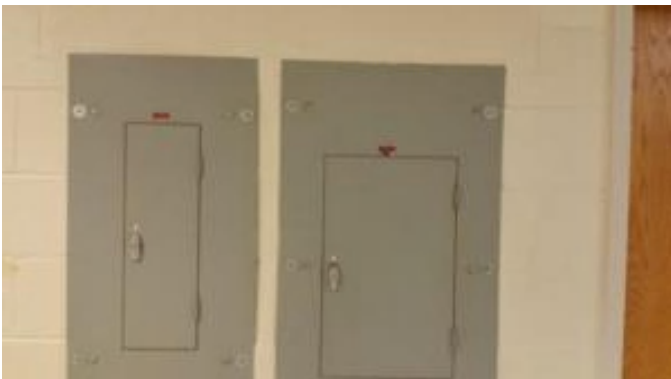
Location: throughout

System: D5010 - Electrical Service/Distribution

Distress: Beyond Service Life

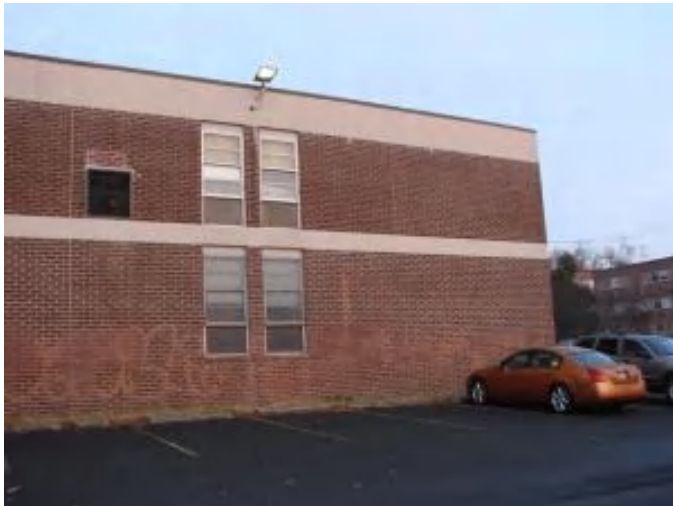
Location: Exterior

System: B2010 - Exterior Walls

Distress: Appearance

Notes: Clean exterior brick

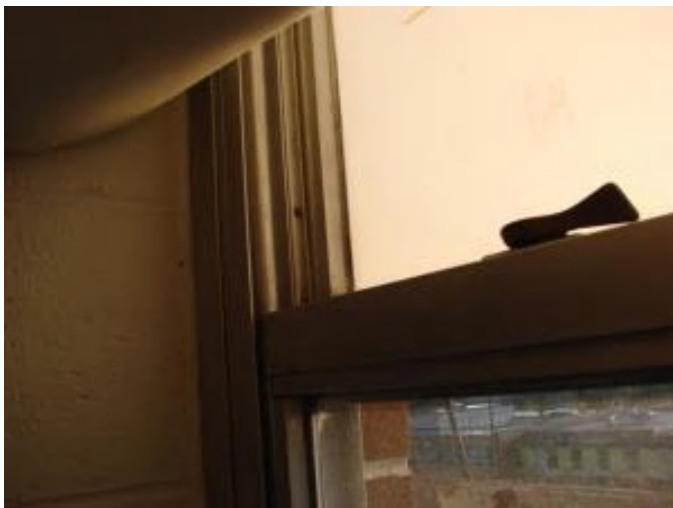
Location: Throughout

System: B2020 - Exterior Windows

Distress: Beyond Service Life

Notes: Replace exterior windows – beyond service life

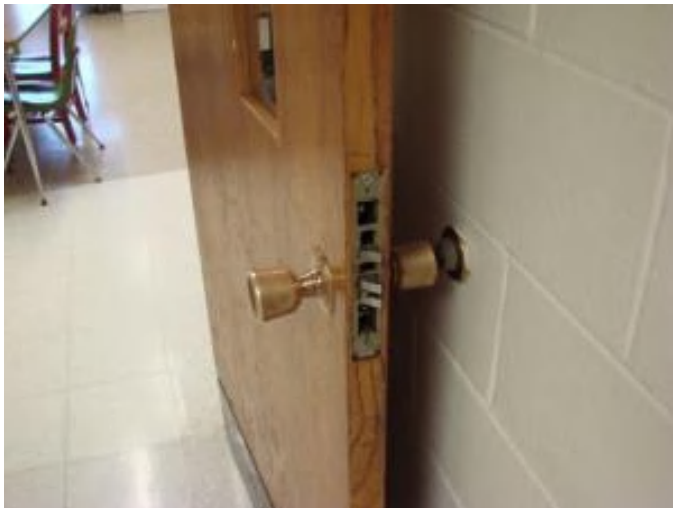
Location: Throughout

System: C1020 - Interior Doors

Distress: Beyond Service Life

Notes: Replace interior doors and hardware – beyond service life

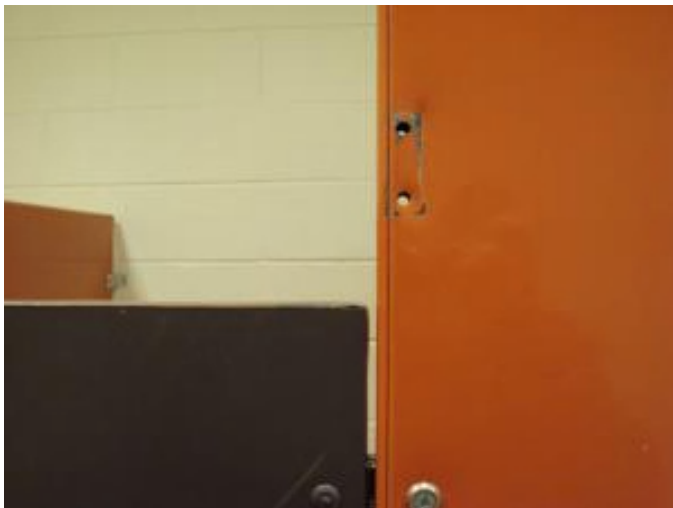
Location: Toilets

System: C1030 - Fittings

Distress: Failing

Notes: Replace toilet partitions - failing

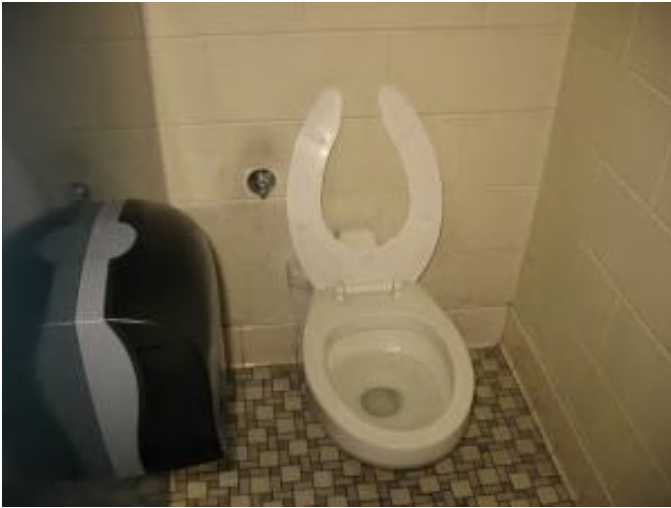
Location: Restrooms

System: D2010 - Plumbing Fixtures

Distress: Beyond Service Life

Notes: Replace eighteen (18) water closets, in use beyond their service life, with new code compliant fixtures.

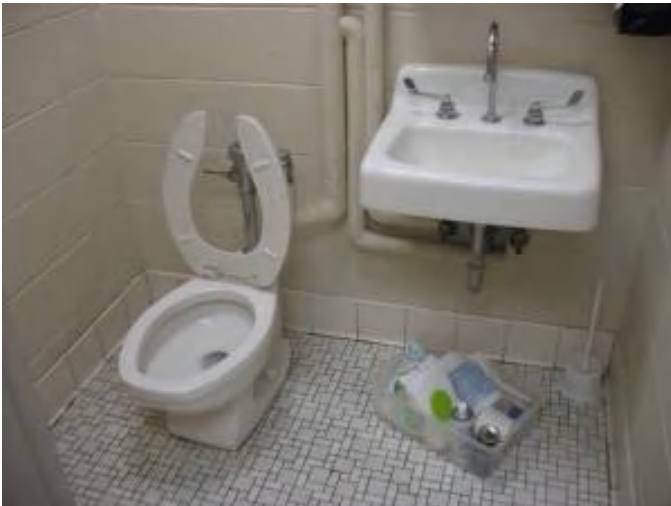
Location: Restrooms

System: D2010 - Plumbing Fixtures

Distress: Beyond Service Life

Notes: Replace eight (8) lavatories, in use beyond their service life, with new code compliant fixtures.

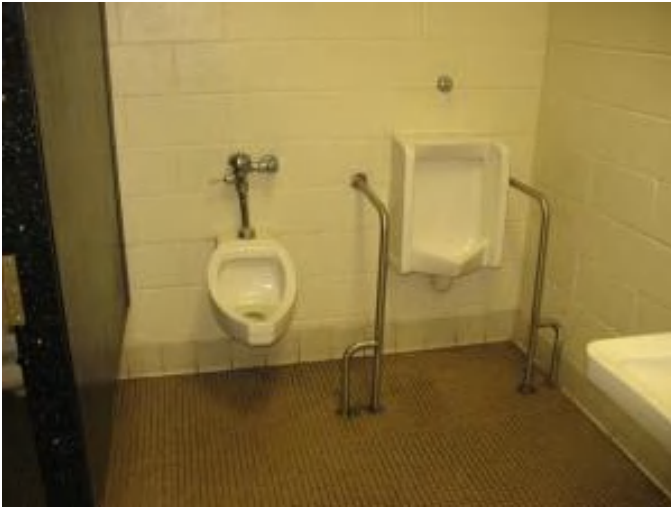
Location: Restrooms

System: D2010 - Plumbing Fixtures

Distress: Beyond Service Life

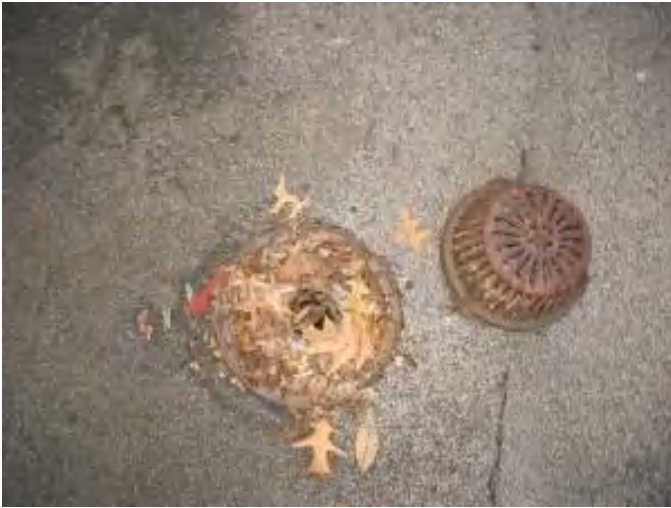
Location: Throughout building

The rain water drains from the roof are routed through classrooms and mechanical chases in the building and appear to be original. The piping is cast iron with hub and spigot fittings and is at the end of its service life. The drain piping should be inspected by a qualified contractor and repaired as necessary.

System: D2040 - Rain Water Drainage

Distress: Beyond Service Life

Notes: Hire a qualified contractor to perform a detailed examination of the rain water drainage piping using visual inspection and video cameras to locate and replace any damaged piping and to further quantify the extent of potential failures.

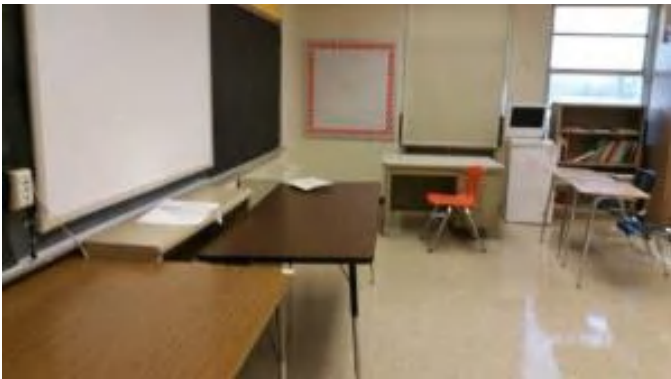
Location: throughout the building

System: D5020 - Lighting and Branch Wiring

Distress: Inadequate

Notes: Install new receptacles for 80% of the building
 $46,959 \text{ SF} \times 80\% = 37,569 \text{ SF}$

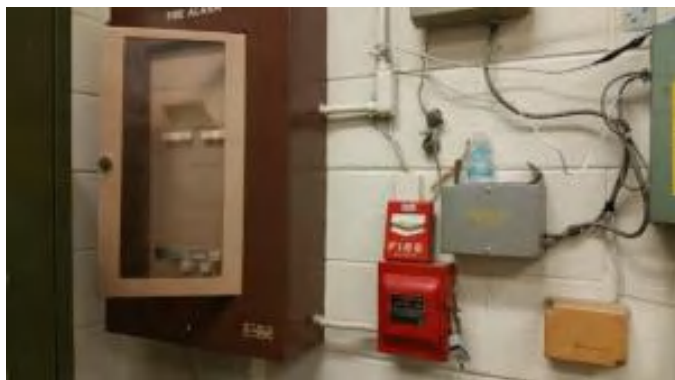
Location: throughout the building

System: D5030 - Communications and Security

Distress: Health Hazard / Risk

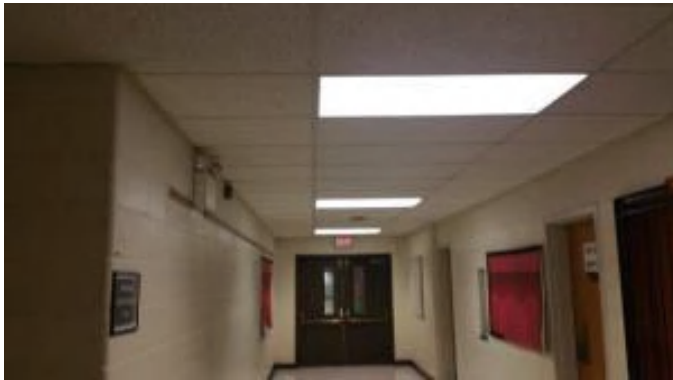
Location: throughout the building

System: D5090 - Other Electrical Systems

Distress: Inadequate

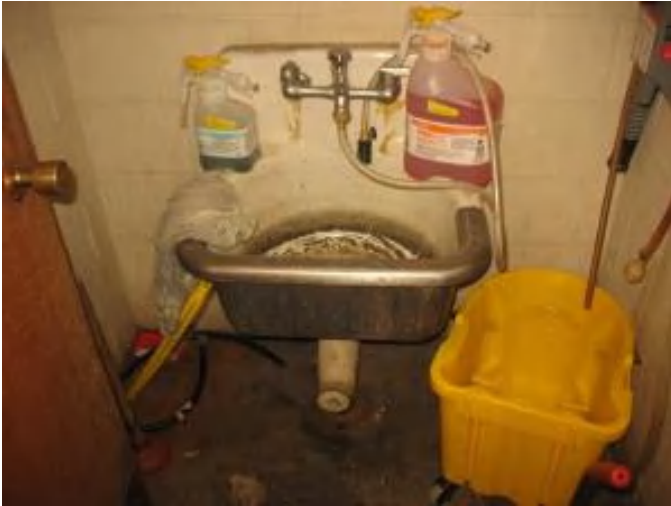
Location: Corridors

A service sink is available in a janitor closet in the corridor on each floor for use by the janitorial staff. The sinks are original to the building, in poor condition, and should be replaced.

System: D2010 - Plumbing Fixtures

Distress: Beyond Service Life

Notes: Replace three (3) service sinks, located in closets off the corridors of each floor, which are beyond their service lives.

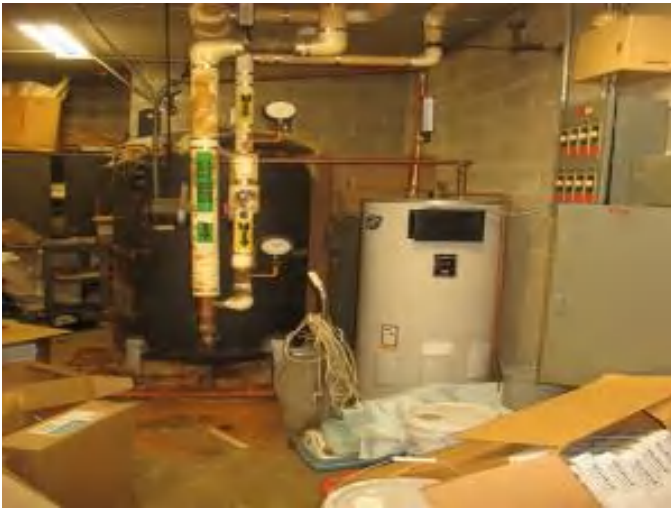
Location: Throughout building

System: D2020 - Domestic Water Distribution

Distress: Beyond Service Life

Notes: Hire a qualified contractor to perform a detailed inspection of the domestic water piping, in use for over 35 years, and replace any damaged piping.

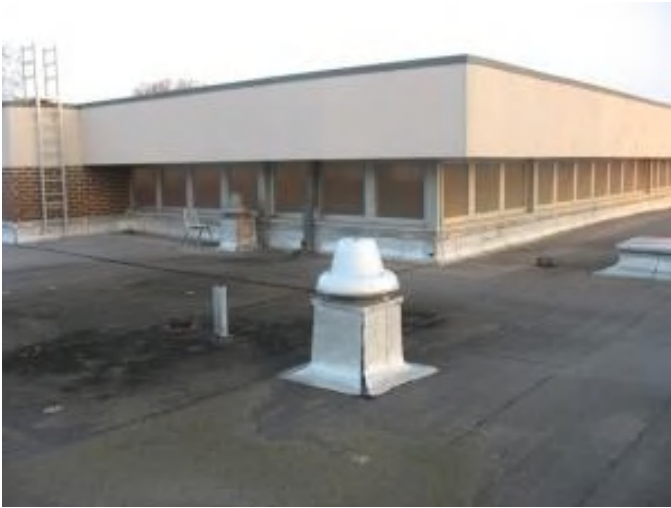
Location: Roof

System: D3040 - Distribution Systems

Distress: Beyond Service Life

Notes: Replace the ten (10) existing roof mounted exhaust fans that are estimated to be approaching the end of their useful service lives.

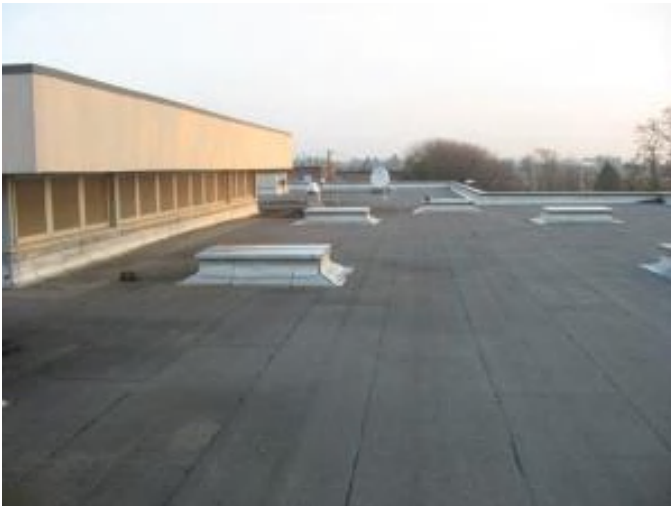
Location: Roof

System: D3040 - Distribution Systems

Distress: Beyond Service Life

Notes: Replace the five(5) existing roof mounted gravity ventilators that are estimated to be approaching the end of their useful service lives.

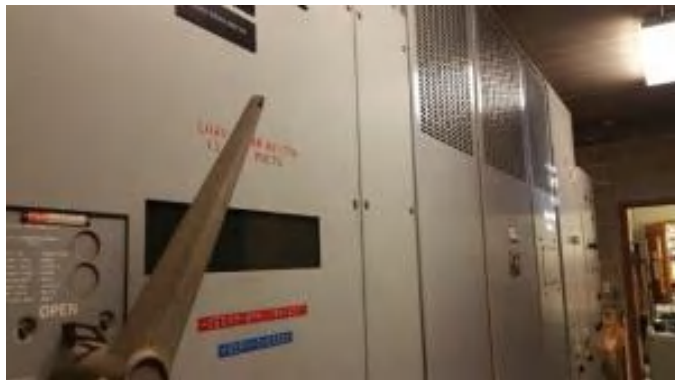
Location: electrical room

System: D5010 - Electrical Service/Distribution

Distress: Beyond Service Life

Notes: Install a new electrical service to replace the old electrical distribution system built in 1980.

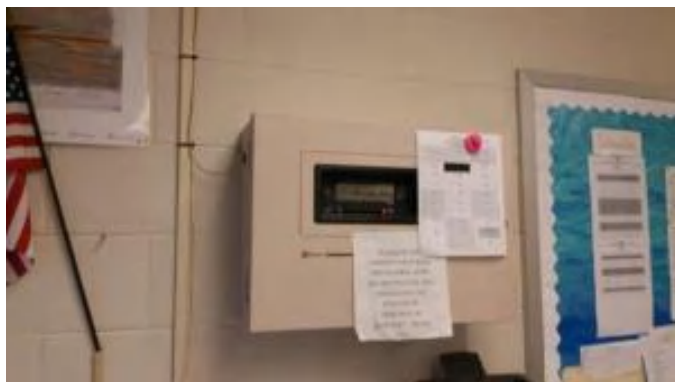
Location: throughout the building

System: D5030 - Communications and Security

Distress: Beyond Service Life

Notes: Install new clock system

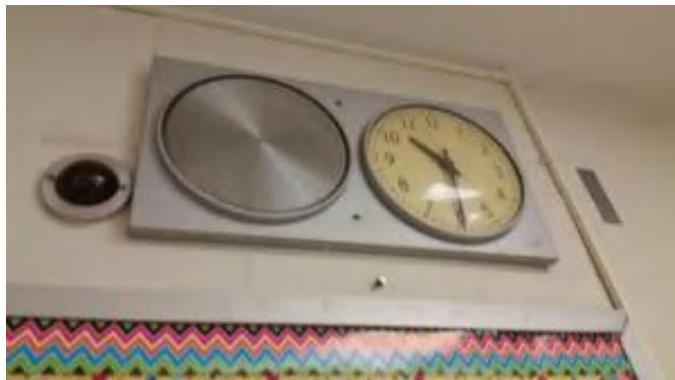
Location: throughout the building

System: D5030 - Communications and Security

Distress: Inadequate

Notes: Install additional video surveillance system for indoor and outdoor.

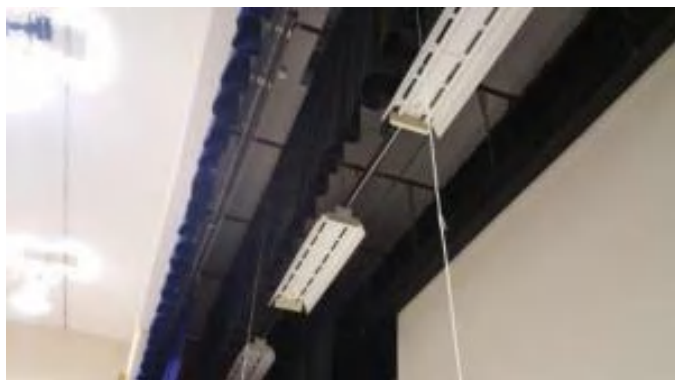
Location: Auditorium

System: E1020 - Institutional Equipment

Distress: Beyond Service Life

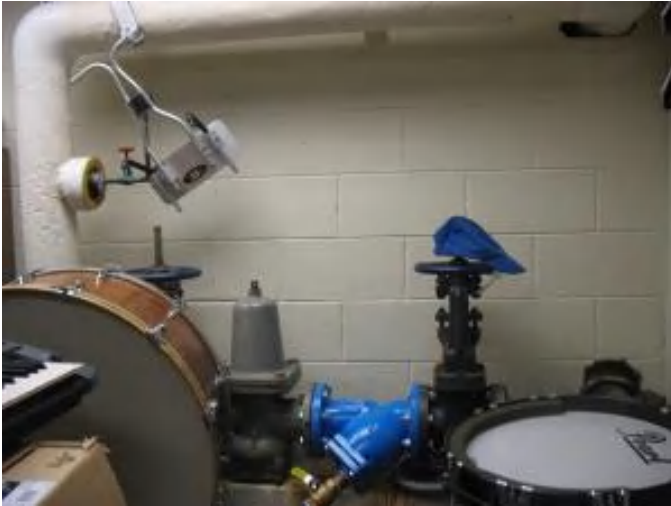
Location: Storage room

A 4" city water service enters the building in a storage room adjacent to the stage in the Cafeteria/Auditorium; the 4" meter and valves are located in the same room. A pressure regulating valve is installed but a backflow preventer is not. The maintenance staff reports no significant problems with scale build up in the domestic piping and the supply is adequate to the fixtures, but the piping in the building is over 35 years old and should be inspected and replaced by a qualified contractor.

System: D2020 - Domestic Water Distribution

Distress: Inadequate

Notes: Install a reduced pressure backflow preventer on the incoming 4" domestic water line.

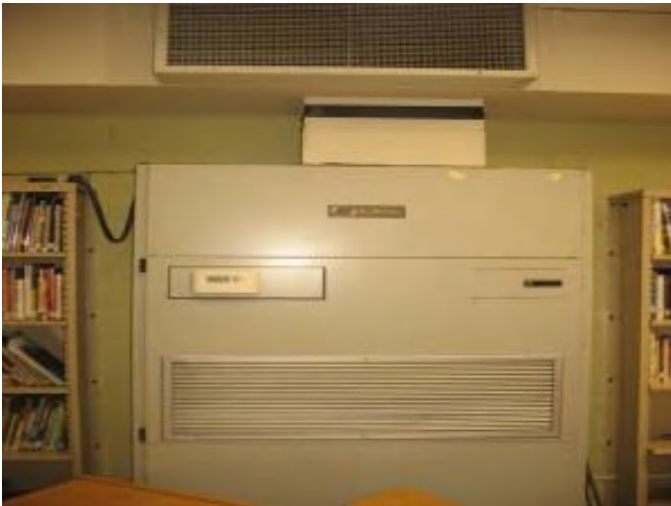
Location: Classrooms

Conditioned air is provided to the classrooms by Bard QTec self-contained packaged air-air heat pumps located in each classroom. Additionally, two (2) Bard QTec units are installed in the Cafeteria/Auditorium and two (2) units in the Gymnasium. The units are located on exterior walls of each space to allow for outdoor air ventilation. Each unit is equipped with electric heating coils for supplemental heating during very cold weather. According to the Building Engineer the units were installed in 2000. The Building Engineer did not report any issues with the heat pumps. Commercial air-air heat pumps have an anticipated service life of 15 years; these units have been in service 16 years and should be replaced within the next 2-4 years.

System: D3040 - Distribution Systems

Distress: Beyond Service Life

- Replace twenty-eight (28) Bard QTEC air-air heat exchangers in each classroom, four (4) of the units are located in other spaces, which are at the end of their service lives.

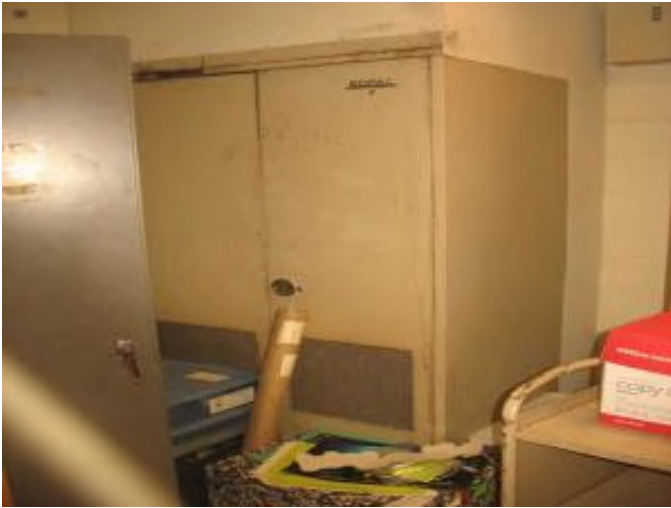
Location: Atrium

System: D3040 - Distribution Systems

Distress: Beyond Service Life

Notes: Replace the Edpac AHU and associated fluid cooler serving the Atrium which are beyond their service lives.

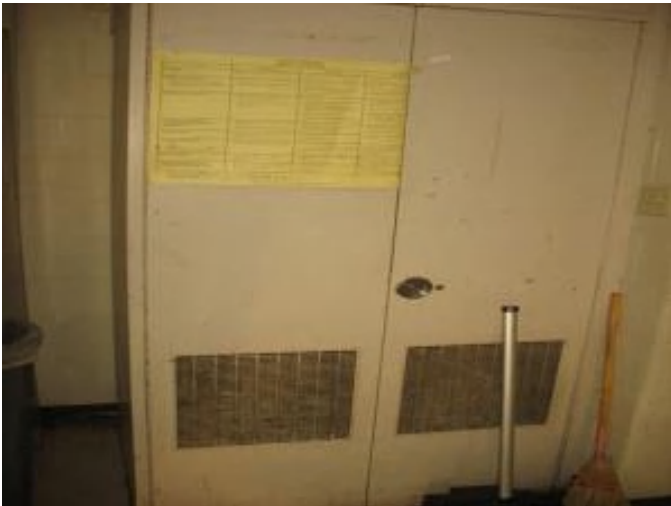
Location: Gymnasium

System: D3040 - Distribution Systems

Distress: Beyond Service Life

- Replace the Edpac AHU and associated fluid cooler serving the Gymnasium which are beyond their service lives.
- Replace the Edpac AHU and associated fluid cooler serving the Atrium which are beyond their service lives.

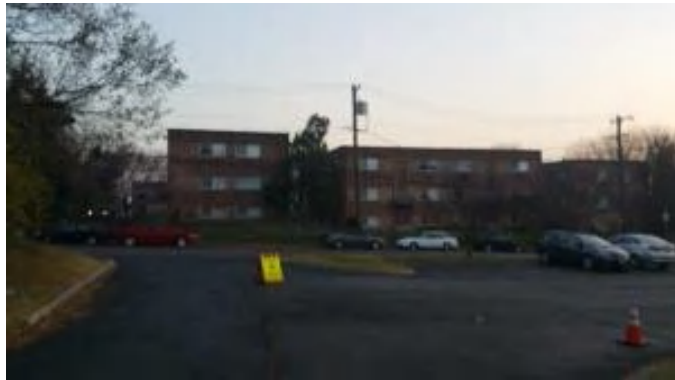
Location: grounds

System: G4020 - Site Lighting

Distress: Security Issue

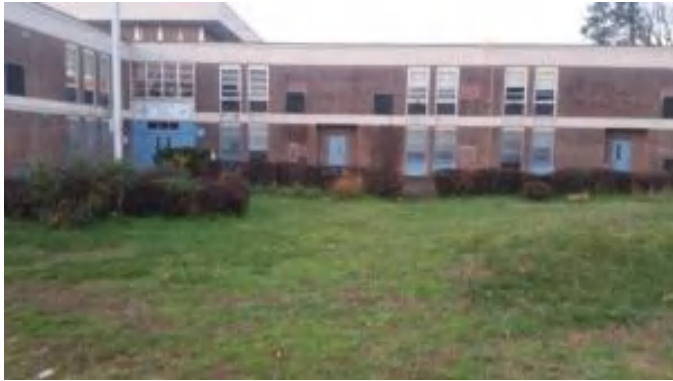
Location: grounds

System: G4030 - Site Communications & Security

Distress: Inadequate
