### Parkway West High (Sulzberger) School

# **S112001;Sulzberger**

## **Site Assessment Report**

February 2, 2017

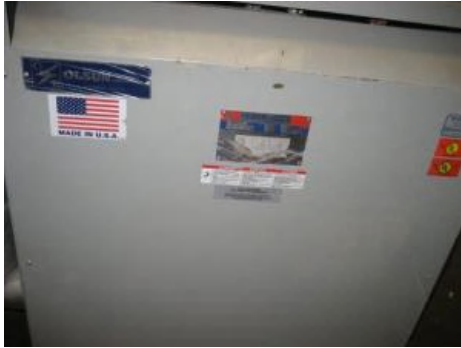
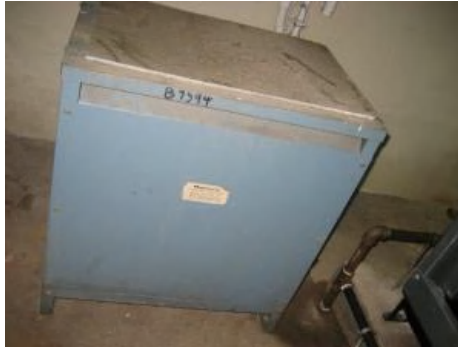
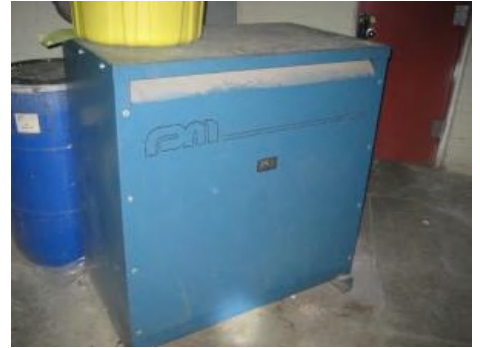
**System:** D5010 - Electrical Service/Distribution

**Note:** There are (3) phase converters from 240V single phase to 120/208V three phase system. The KVA rating of the phase converters are: (1)MAGNETRAN 75KVA, PMI(1)150KVA and (1) OLSUN 150KVA

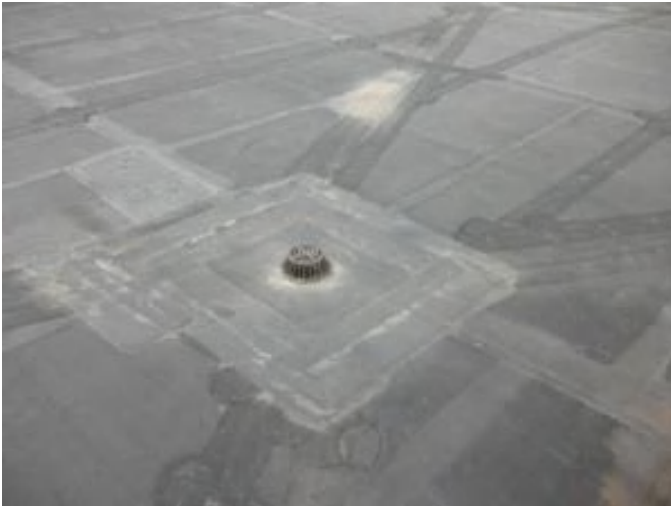
#### System: B3010105 - Built-Up

**Location:** All roofs

**Distress:** Failing

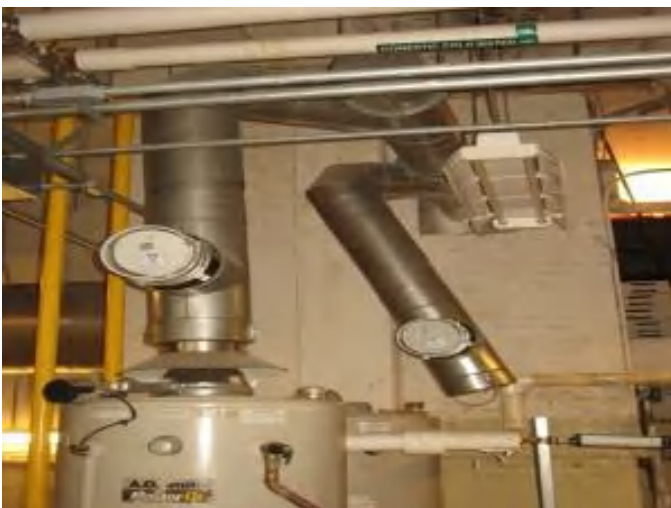
#### System: D2020 - Domestic Water Distribution

**Location:** Basement

**Distress:** Building / MEP Codes

**Notes:** Repair water heater exhaust.

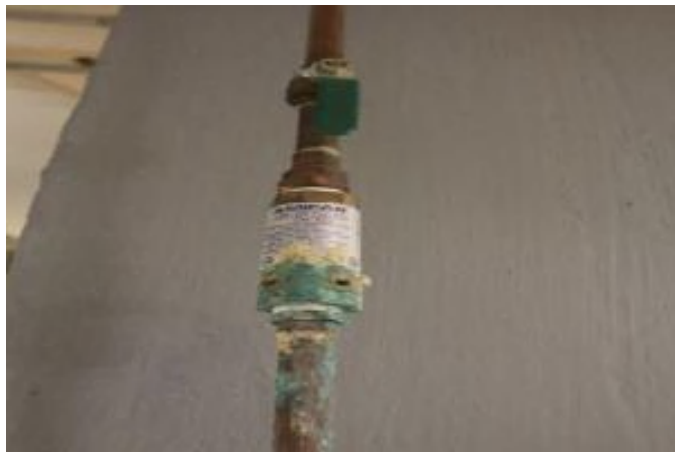
**System: D3060 - Controls & Instrumentation**

**Location:** Basement

**Distress:** Failing

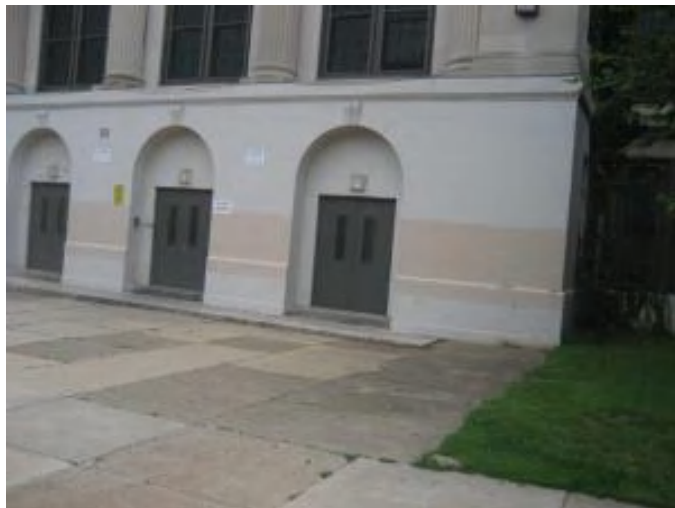
**System: D5030 - Communications and Security**

**Location:** Entrance

**Distress:** Security Issue

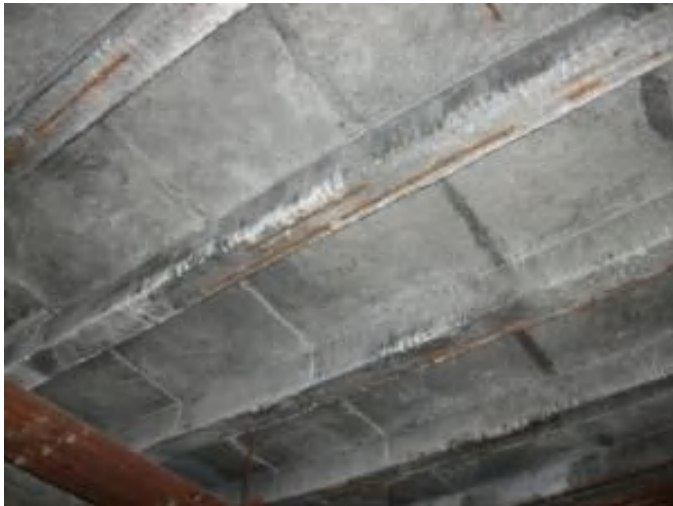
**System: B1010 - Floor Construction**

**Location:** Roof accesses, basement

**Distress:** Damaged

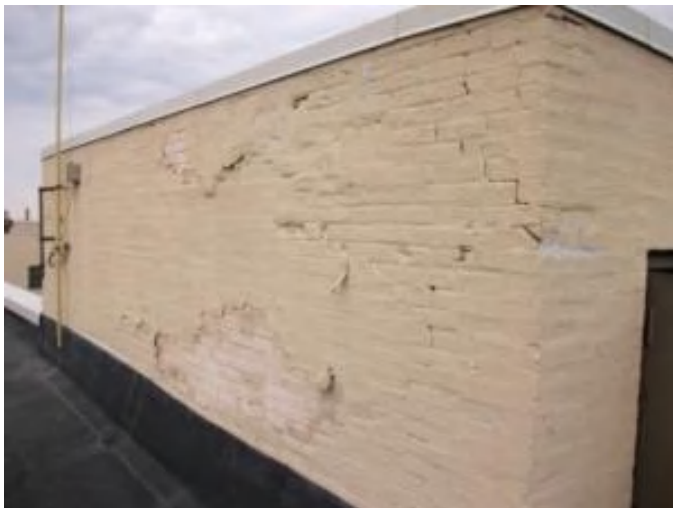
**System: B2010 - Exterior Walls**

**Location:** Lightcourts and walls at roofs.

**Distress:** Failing

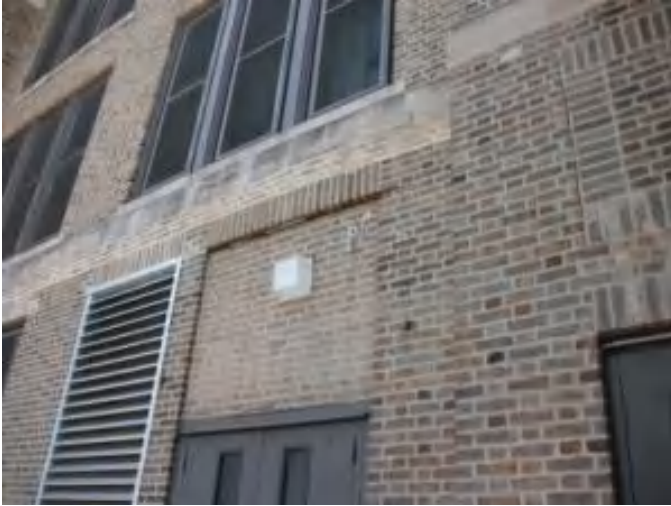
**System: B2010 - Exterior Walls**

**Location:** East wall, south end 2nd floor. West wall

**Distress:** Damaged

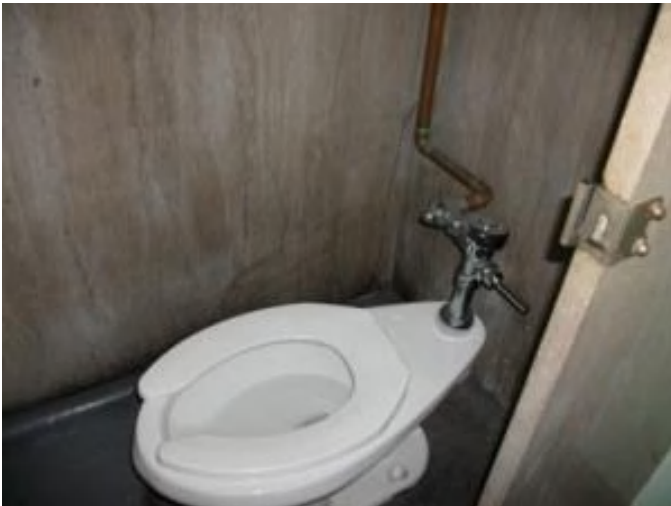
**System: C1010 - Partitions**

**Location:** Faculty/staff toilet rooms

**Distress:** Accessibility

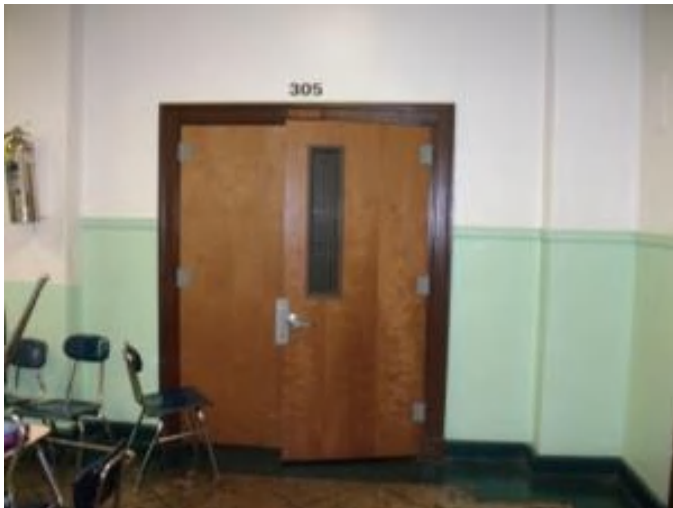
**System: C1020 - Interior Doors**

**Location:** Classrooms

**Distress:** Security Issue

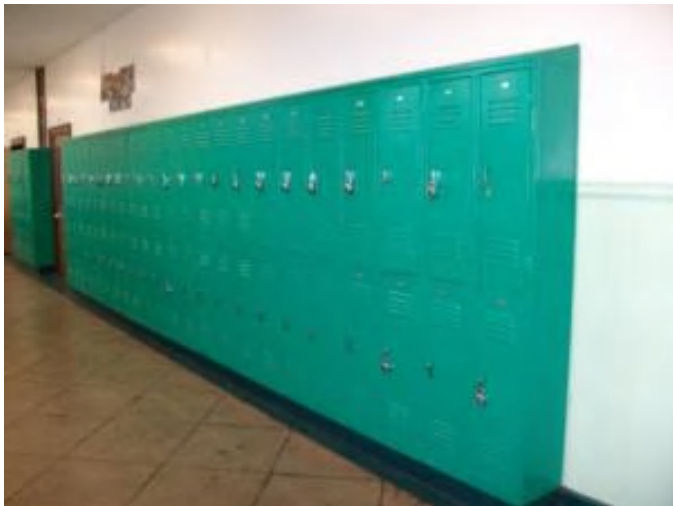
**System: C1030 - Fittings**

**Location:** Corridors, locker rooms

**Distress:** Beyond Service Life

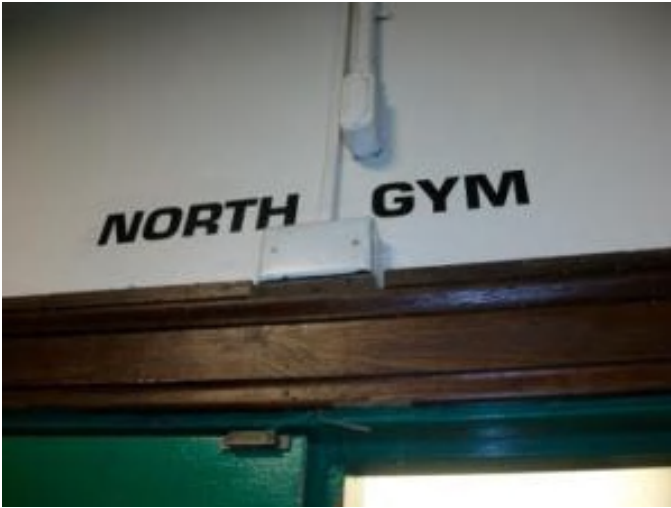
**System: C1030 - Fittings**

**Location:** Building wide

**Distress:** Inadequate

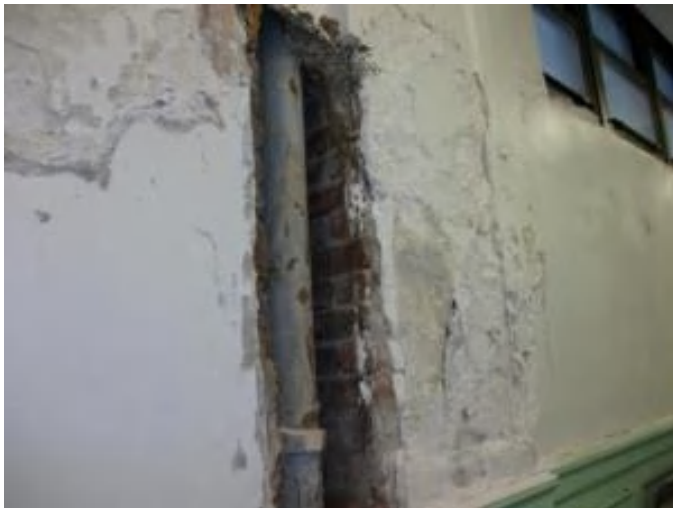
**System: C3010230 - Paint & Covering**

**Location:** Galleries, 3rd floor rooms

**Distress:** Damaged

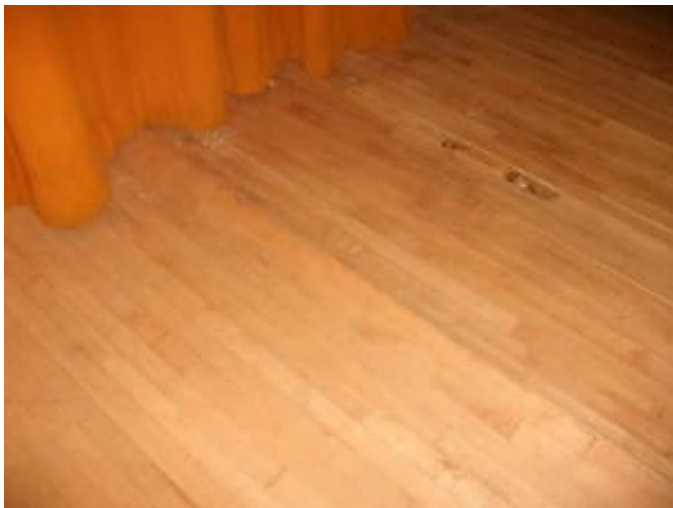
**System: C3020414 - Wood Flooring**

**Location:** B112001;Sulzberger

**Distress:** Damaged

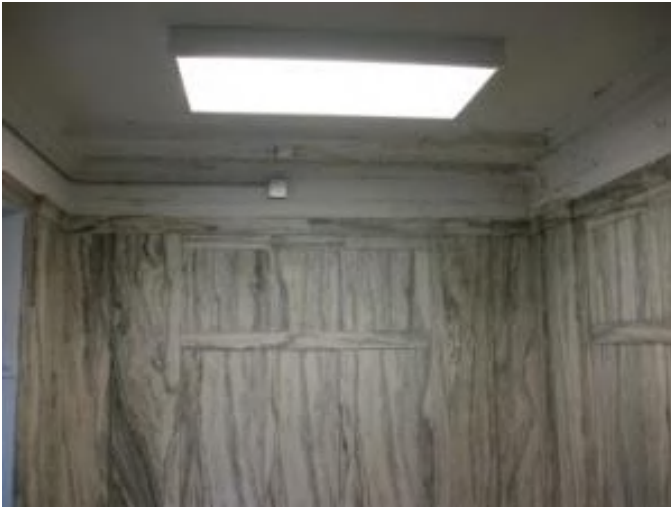
**System: C3030 - Ceiling Finishes**

**Location:** Main entry, auditorium, 3rd floor soffits

**Distress:** Damaged

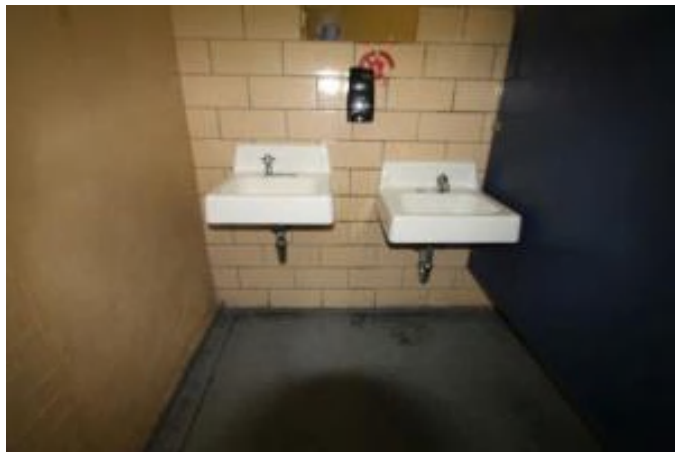
**System: D2020 - Domestic Water Distribution**

**Location:** Basement

**Distress:** Inadequate

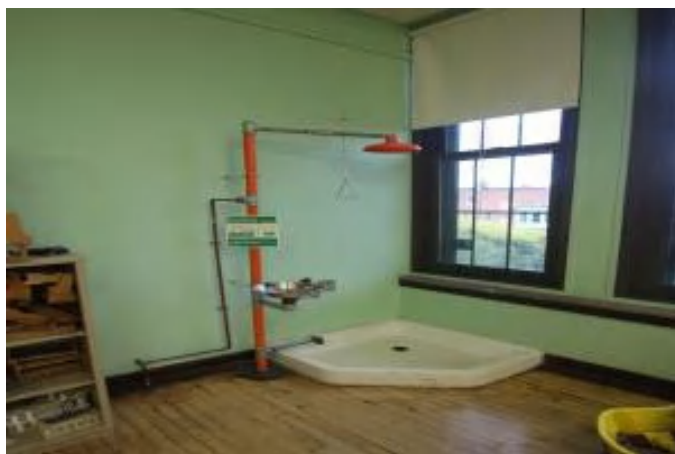
**System: D2020 - Domestic Water Distribution**

**Location:** Science classroom

**Distress:** Life Safety / NFPA / PFD

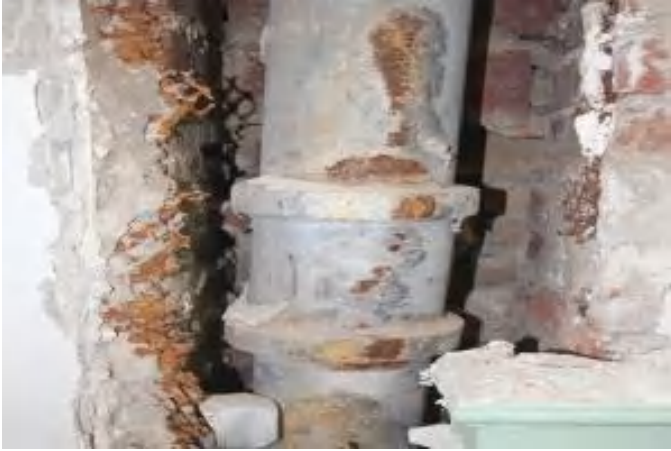
**System: D2040 - Rain Water Drainage**

**Location:** B112001;Sulzberger

**Distress:** Failing

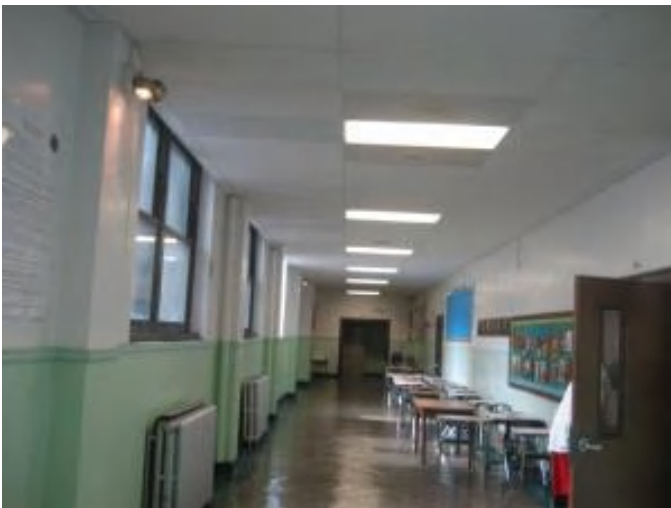
**System: D5030 - Communications and Security**

**Location:** Entire Building

**Distress:** Security Issue

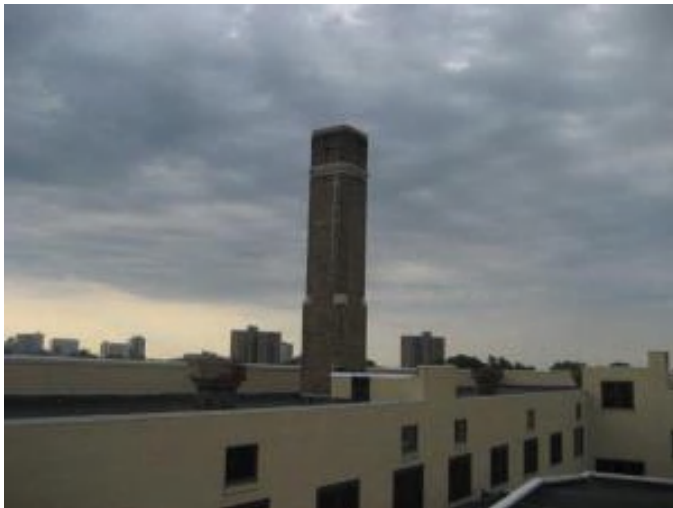
**System: D5090 - Other Electrical Systems**

**Location:** Roof

**Distress:** Building / MEP Codes

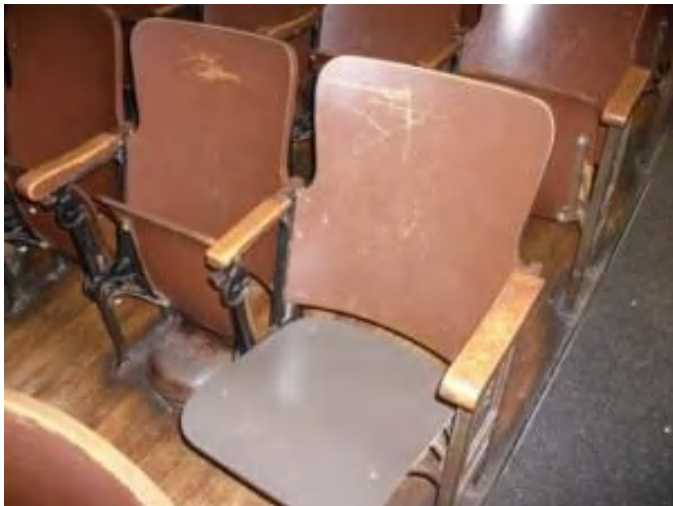
**System: E2010 - Fixed Furnishings**

**Location:** Auditorium, including balcony

**Distress:** Beyond Service Life

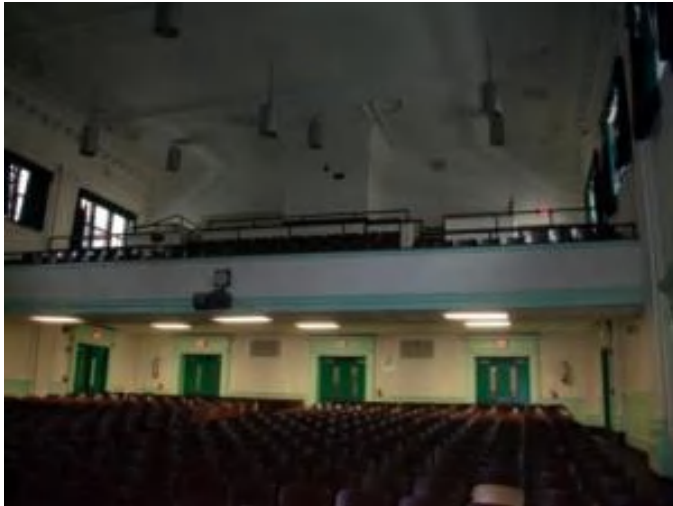
**System: E2010 - Fixed Furnishings**

**Location:** Auditorium

**Distress:** Failing

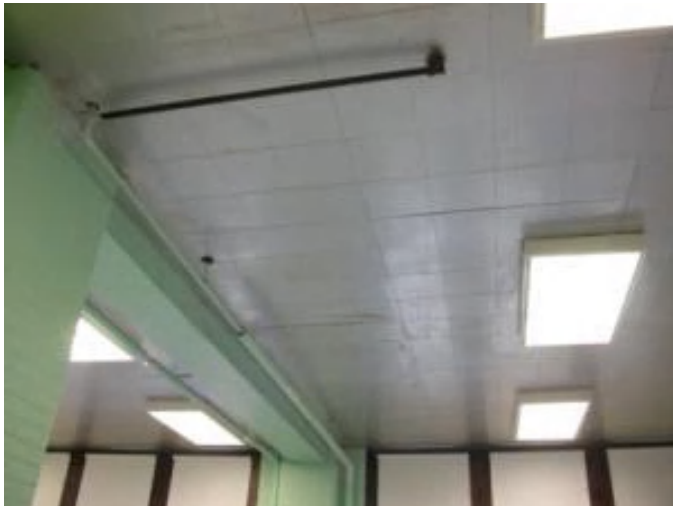
**System: C3030 - Ceiling Finishes**

**Location:** Cafeterias, gyms

**Distress:** Beyond Service Life

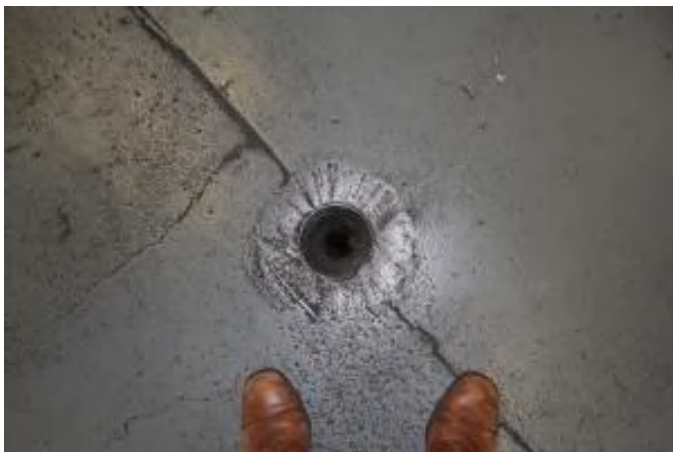
**System: D2030 - Sanitary Waste**

**Location:** B112001;Sulzberger

**Distress:** Beyond Service Life

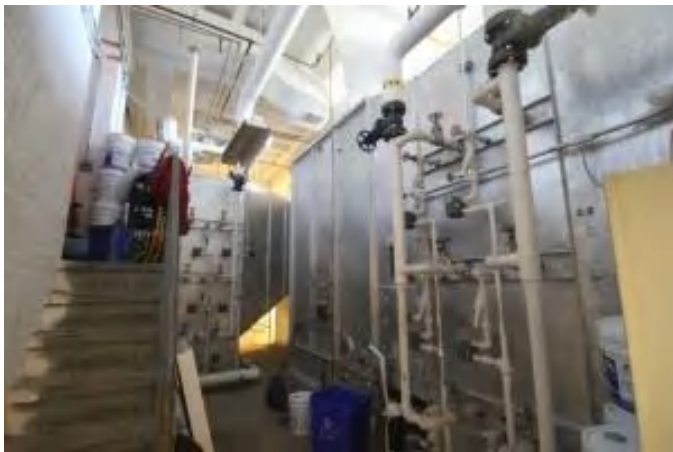
**System: D3040 - Distribution Systems**

**Location:** Basement fan rooms

**Distress:** Beyond Service Life

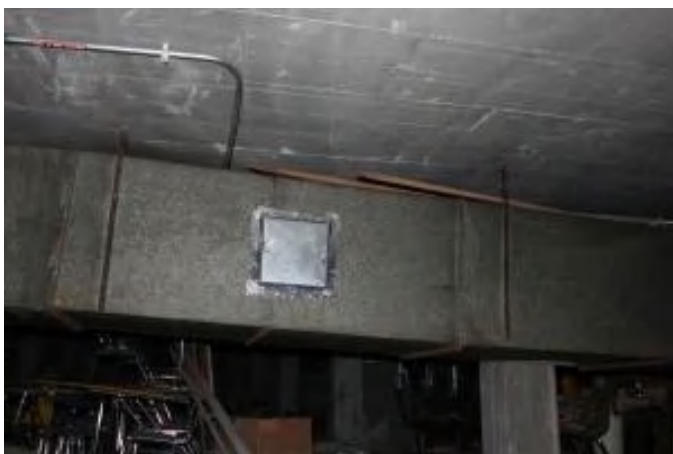
**System: D3040 - Distribution Systems**

**Location:** B112001;Sulzberger

**Distress:** Beyond Service Life

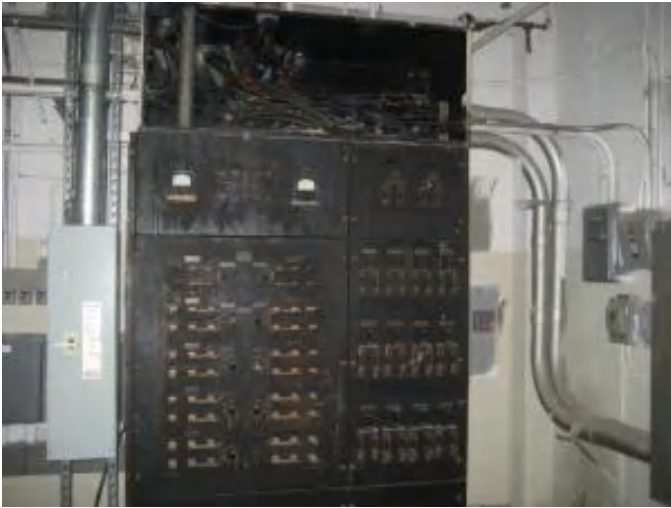
**System: D5010 - Electrical Service/Distribution**

**Location:** Basement-boiler room

**Distress:** Beyond Service Life

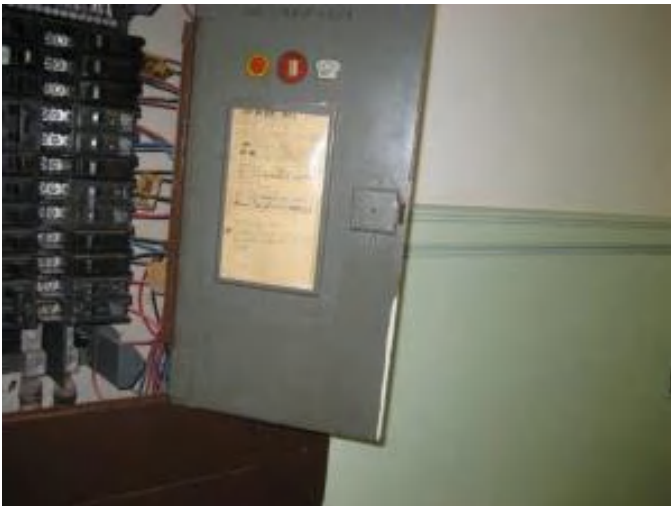
**System: D5010 - Electrical Service/Distribution**

**Location:** Entire building

**Distress:** Beyond Service Life

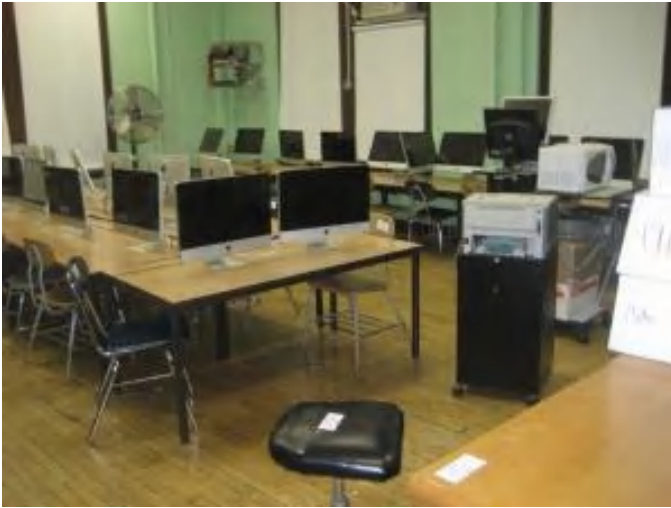
**System: D5020 - Lighting and Branch Wiring**

**Location:** Entire Building

**Distress:** Inadequate

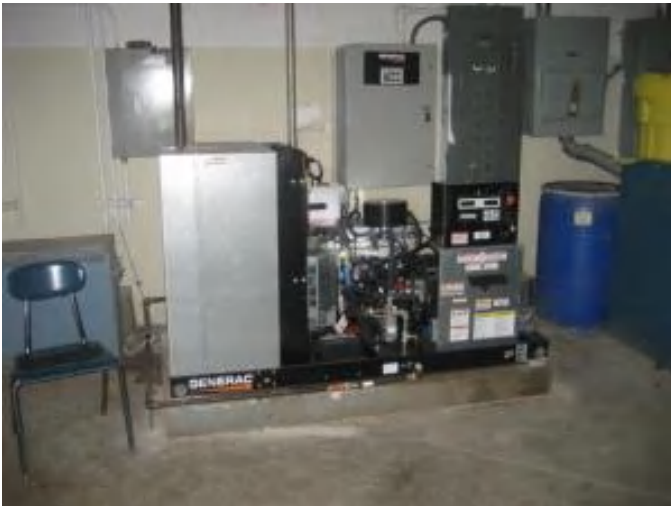
**System: D5090 - Other Electrical Systems**

**Location:** Outdoor

**Distress:** Inadequate

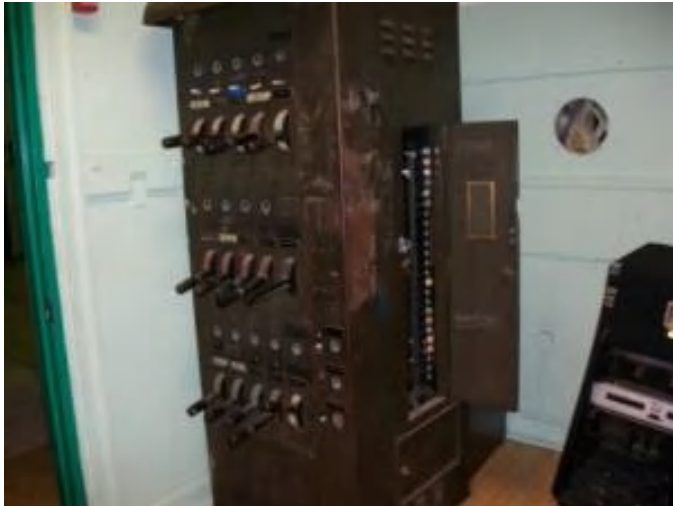
**System: E1020 - Institutional Equipment**

**Location:** Stage

**Distress:** Inadequate

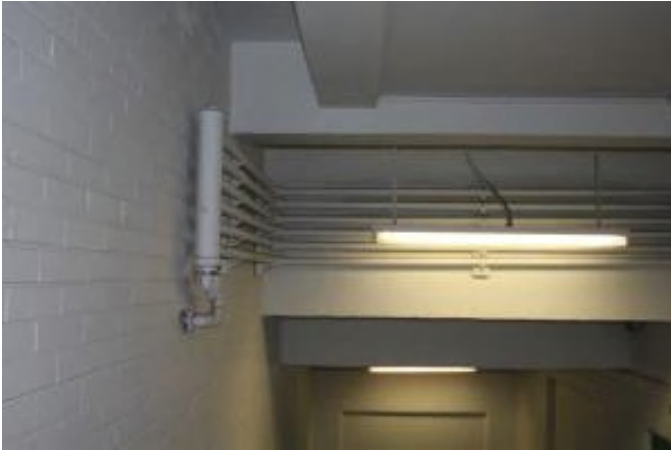
**System: D3040 - Distribution Systems**

**Location:** B112001;Sulzberger

**Distress:** Beyond Service Life

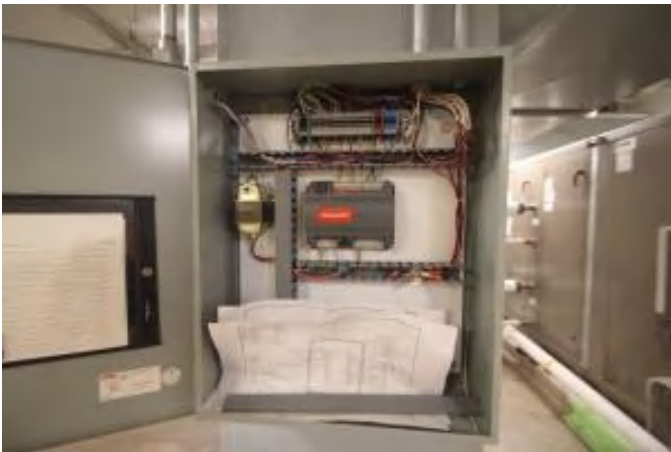
**System: D3060 - Controls & Instrumentation**

**Location:** Entire building

**Distress:** Obsolete

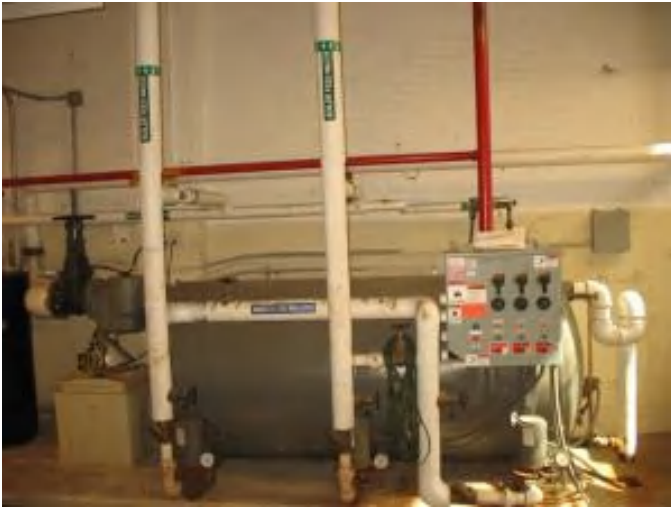
**System: D3060 - Controls & Instrumentation**

**Location:** Basement

**Distress:** Damaged

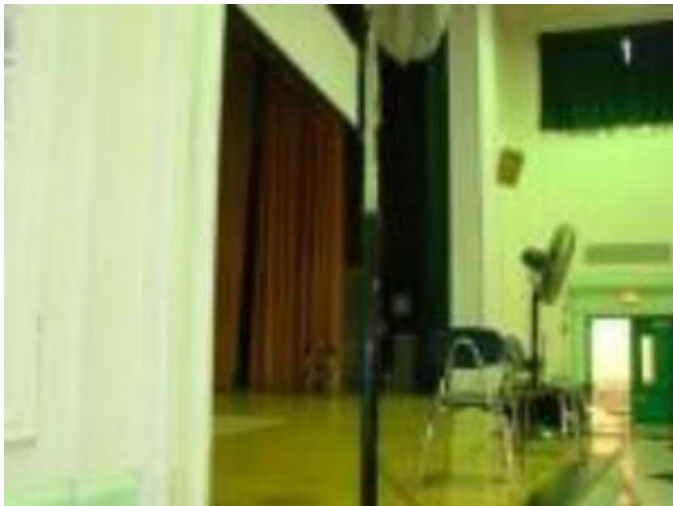
**System: D5030 - Communications and Security**

**Location:** Auditorium

**Distress:** Inadequate

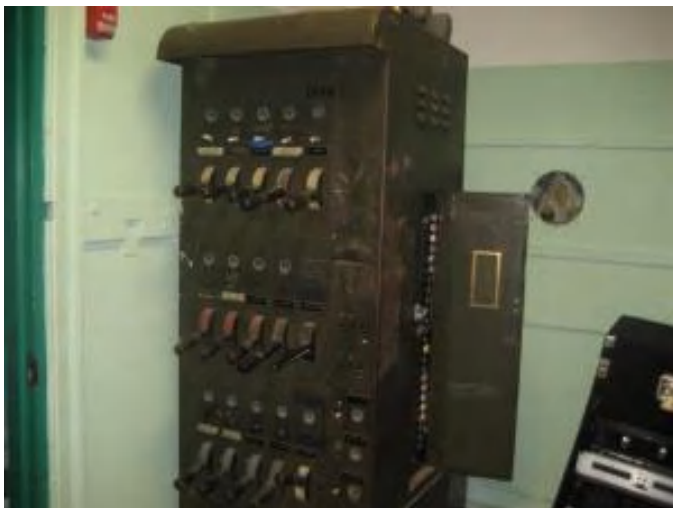
**System: E1020 - Institutional Equipment**

**Location:** Auditorium

**Distress:** Inadequate

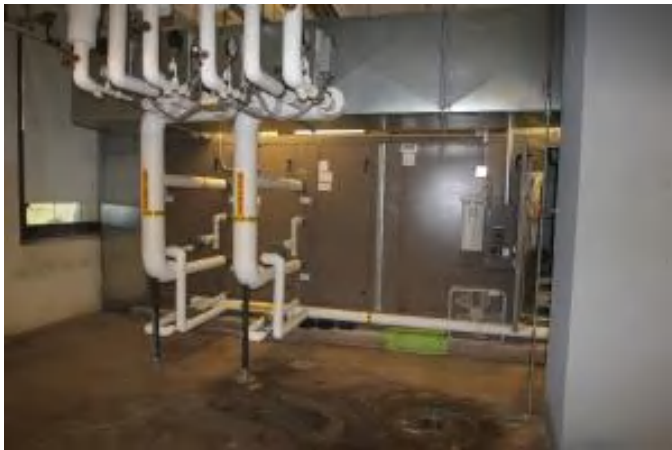
**System: D3060 - Controls & Instrumentation**

**Location:** Basement

**Distress:** Maintenance Required

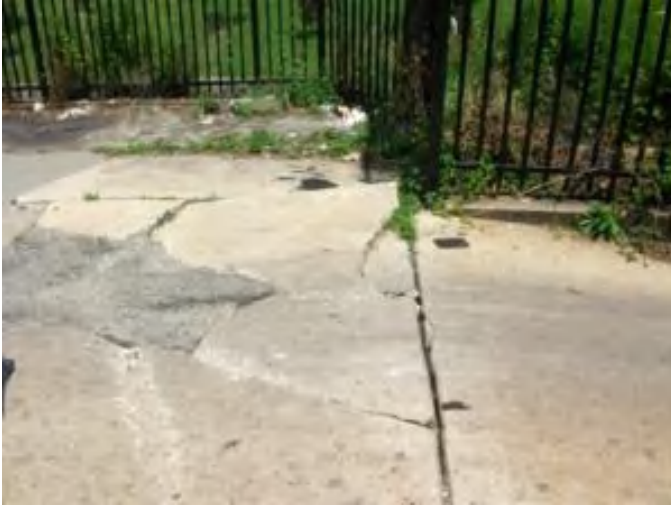
#### System: G2020 - Parking Lots

**Location:** East parking lot and ramp

**Distress:** Failing

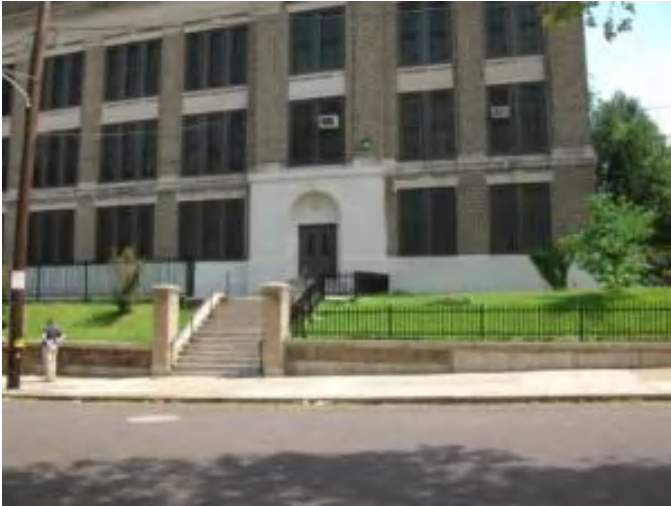
#### System: G2030 - Pedestrian Paving

**Location:** Exterior entrances

**Distress:** Accessibility

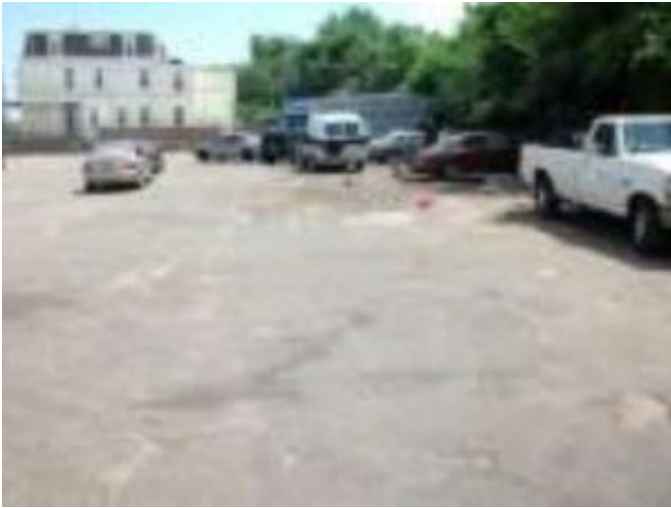
**System: G4020 - Site Lighting**

**Location:** Parking Lot

**Distress:** Security Issue

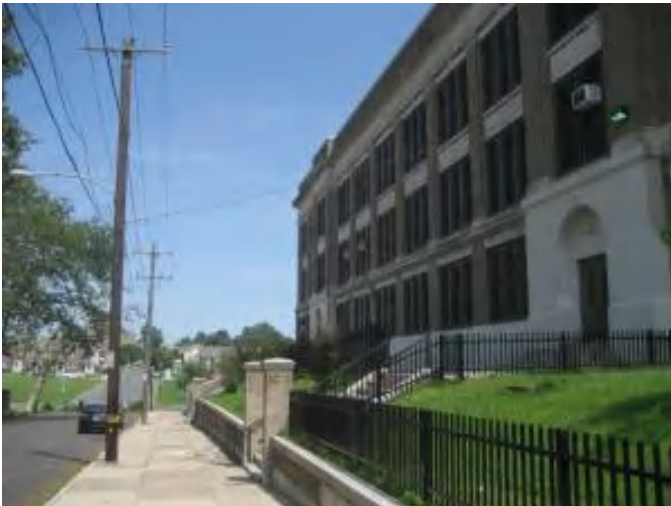
**System: G4030 - Site Communications & Security**

**Location:** Building Exterior

**Distress:** Security Issue

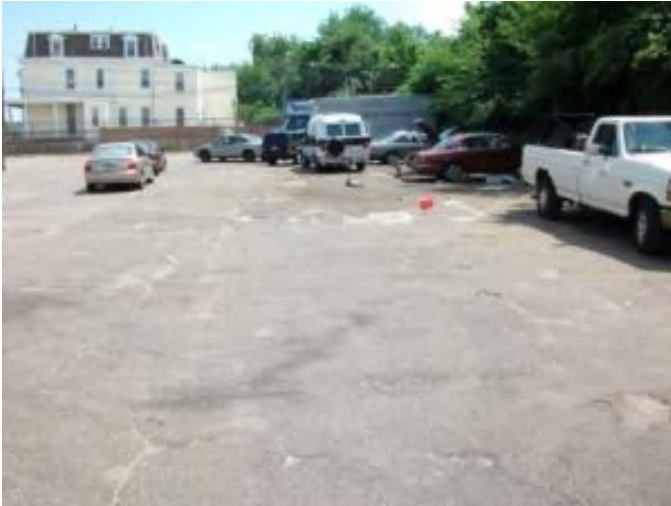
**System: G2020 - Parking Lots**

**Location:** Remote parking lot

**Distress:** Failing

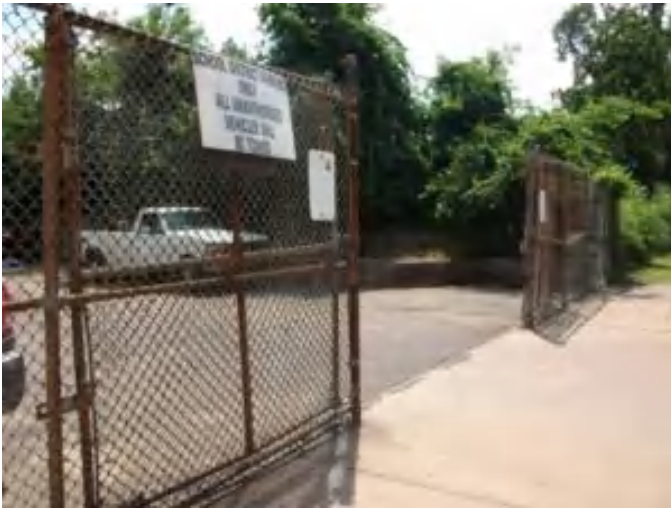
**System: G2040 - Site Development**

**Location:** Remote parking lot

**Distress:** Beyond Service Life

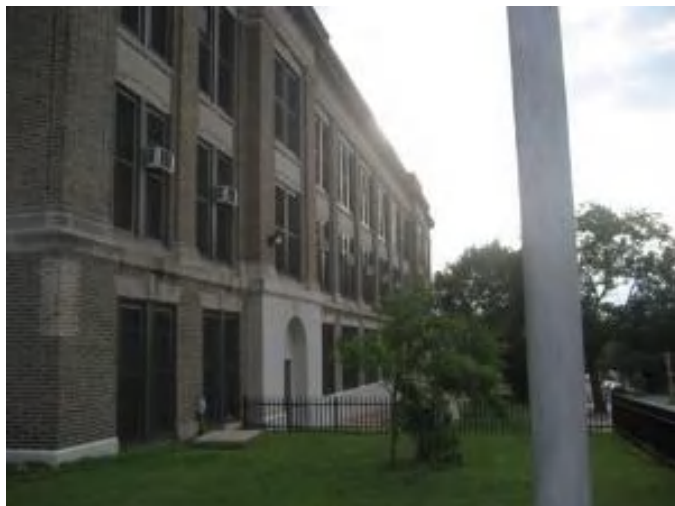
**System: G4030 - Site Communications & Security**

**Location:** Building Perimeter

**Distress:** Security Issue

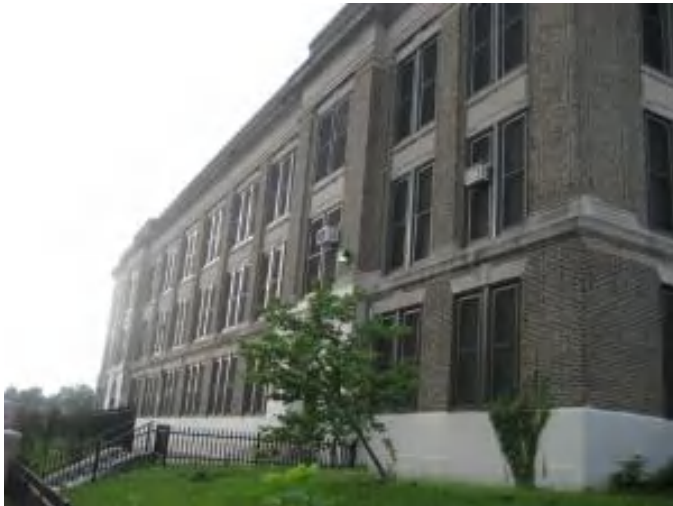
**System: G4020 - Site Lighting**

**Location:** Building Perimeter

**Distress:** Security Issue
