Facility Condition Assessment Summary Report

Pastorius School

School District of Philadelphia
S633001;Pastorius
Final
Site Assessment Report
February 1, 2017

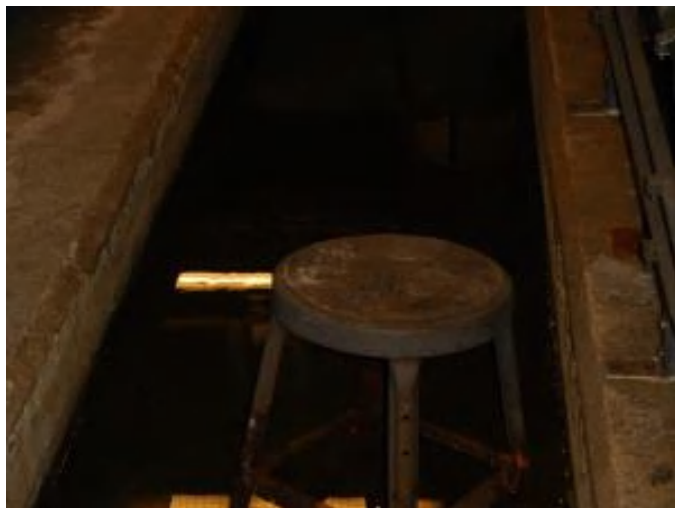
System: D2030 - Sanitary Waste

Location: mechanical room

Distress: Inadequate

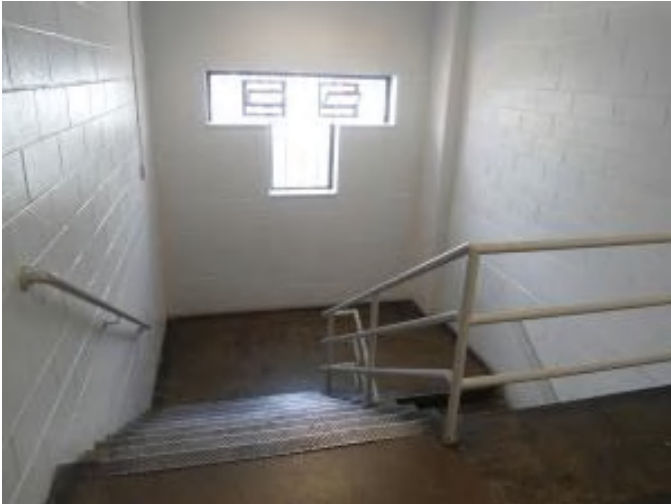
System: C2010 - Stair Construction

Location: Stair

Distress: Life Safety / NFPA / PFD

Notes: Current legislation regarding building accessibility by the handicapped requires that stairs have graspable handrails on both sides, that the rails have a specific end geometry, and that the handrails continue horizontally at the landings. In addition, guardrails must prevent the passage of a 4 inch diameter sphere (6 inches in the triangle formed by the lower rail and tread/riser angle). Although the stairs are compliant with the code enforced at the time of construction until a major renovation occurs, they are deficient in handrail and guardrail design relative to current standards. Future renovation efforts should include comprehensive stair railing upgrades.

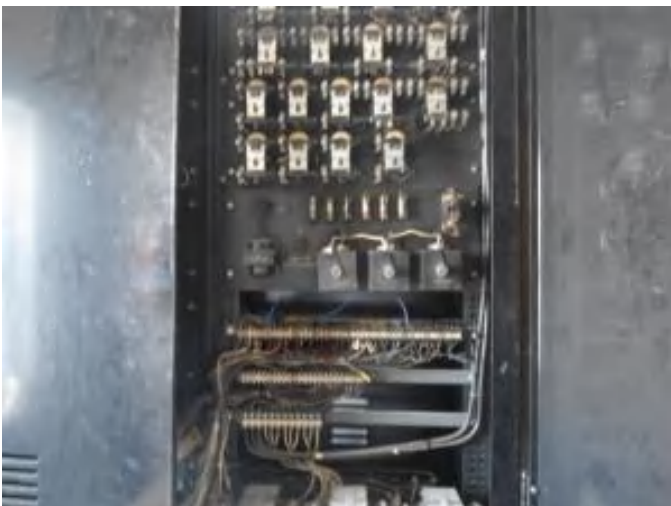
System: D1010 - Elevators and Lifts

Location: Elevator

Distress: Beyond Service Life

Notes: Upgrade and modernize elevator hoist system, machine room and cab.

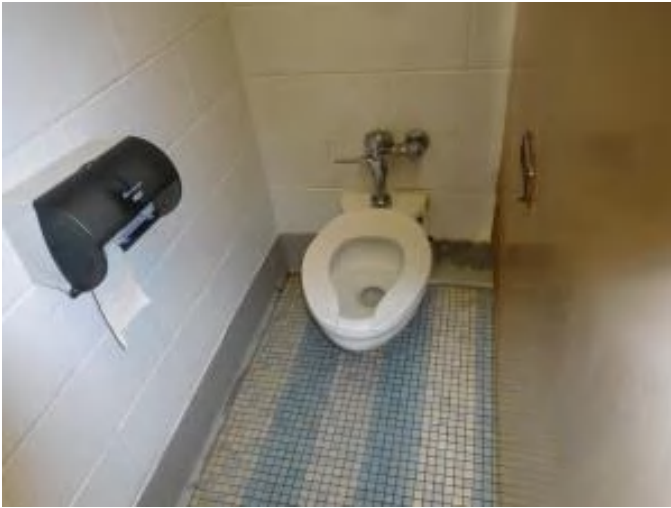
System: D2030 - Sanitary Waste

Location: entire building

Distress: Beyond Service Life

Notes: Inspect existing sanitary piping and replace damaged sections.

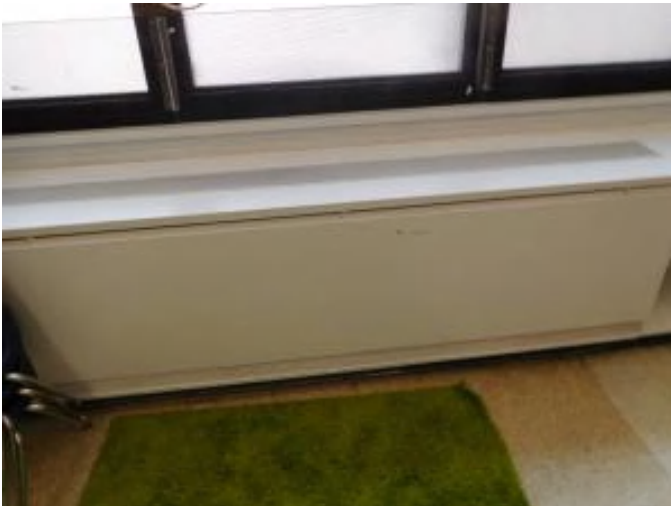
System: D3040 - Distribution Systems

Location: entire building

Distress: Building / MEP Codes

Notes: Replace the existing unit ventilators with new units designed for quiet operation and equipped with hot water and chilled water coils, hydronic control valves with digital controls and integral heat exchangers to provide code required fresh air quantities. Connect to new chilled and hot water piping systems and building automation control system.

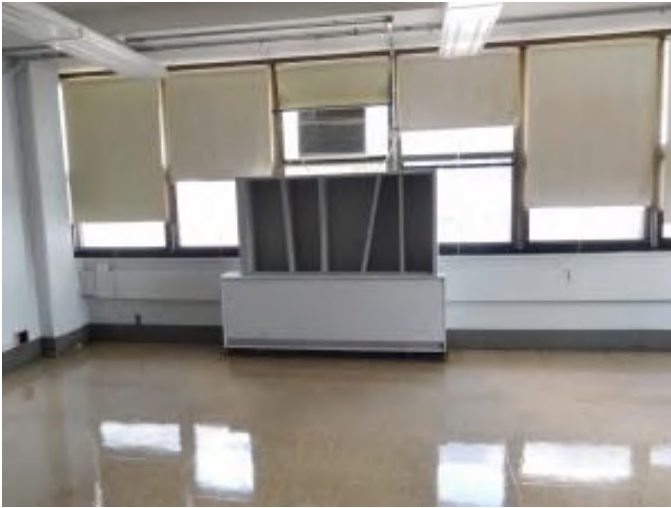
System: D3040 - Distribution Systems

Location: office

Distress: Building / MEP Codes

Notes: Provide a new central station air handling unit for the office with hot and chilled water coils, filters, outside and return air dampers, hydronic valves and controls, blower and motor. Connect to hot and chilled water systems.

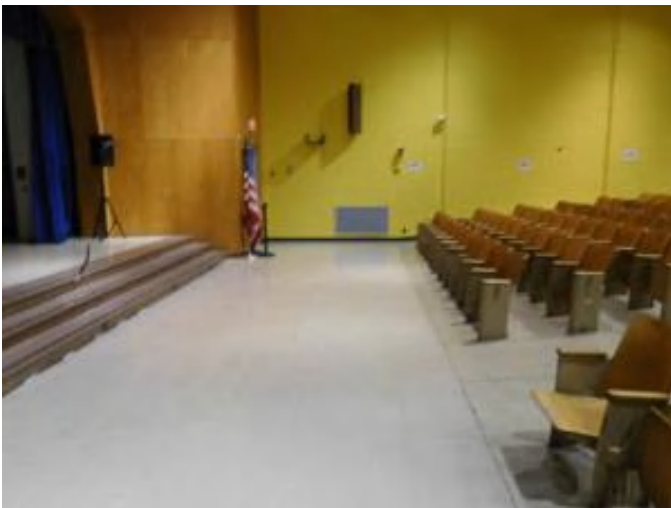
System: D3040 - Distribution Systems

Location: auditorium

Distress: Building / MEP Codes

Notes: • Install new single zone horizontal central station air handling unit in auditorium mechanical room to serve cafeteria. Connect to existing ductwork. Provide adequate outside air louver and ductwork to furnish code required fresh air. Unit to have hot and chilled water coils, filters, blower and motor. Include hydronic control valves with digital controls. Connect to building automation control system and hot and chilled water piping systems.

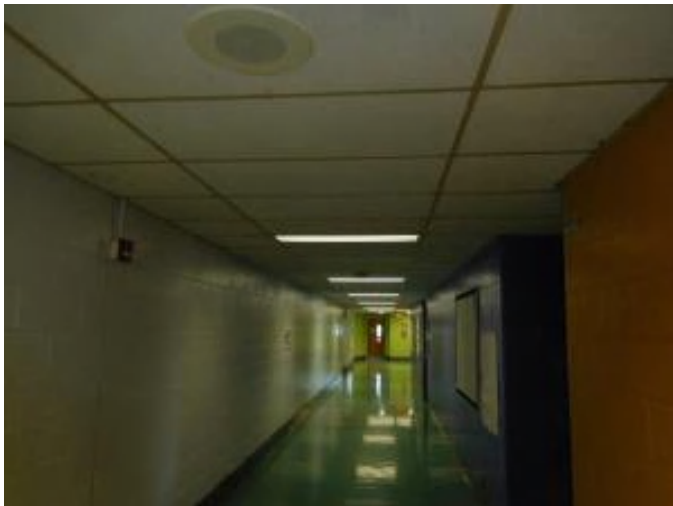
System: D4010 - Sprinklers

Location: entire building

Distress: Life Safety / NFPA / PFD

Notes: Install complete NFPA wet pipe automatic sprinkler system and standpipes. If required provide fire pump and jockey pump with controller.

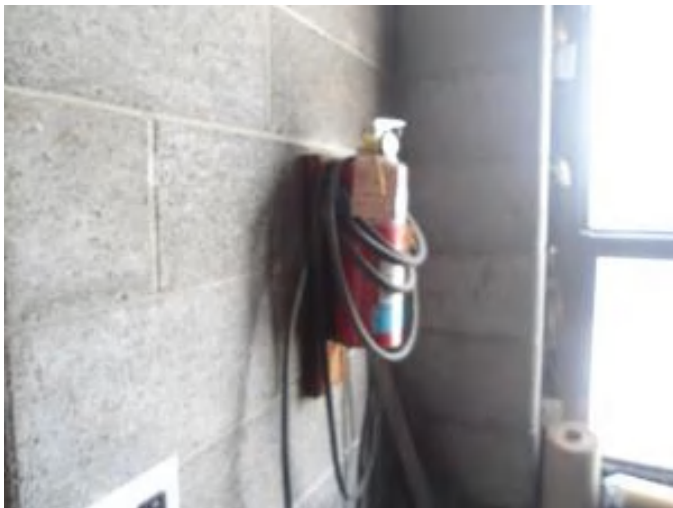
System: D5030 - Communications and Security

Location: Elevator Machine Room

Distress: Life Safety / NFPA / PFD

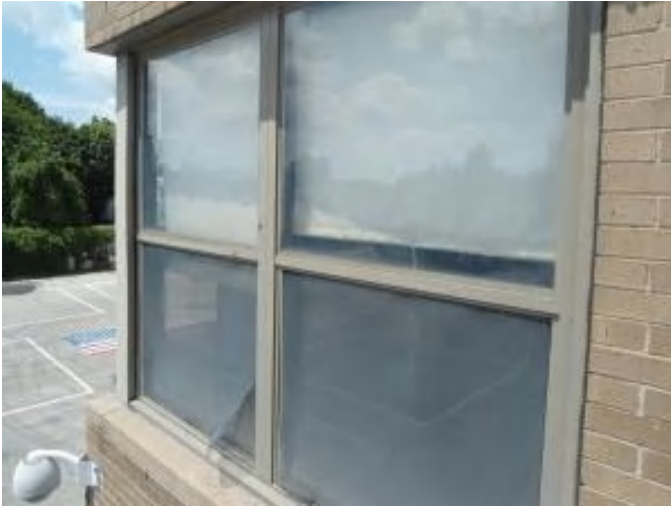
System: B2020 - Exterior Windows

Location: Exterior Elevation

Distress: Beyond Service Life

Notes: Exterior windows have been upgraded from the original applications. The current system is estimated to have been installed in the early 2000's. Several windows no longer work and will require attention prior to an overall effort. Windows are in fair condition based on the year of installation or last renovation. The exterior window system is recommended to be replaced with units that retain their dimensions and profiles, but that incorporate updated energy-efficient features.

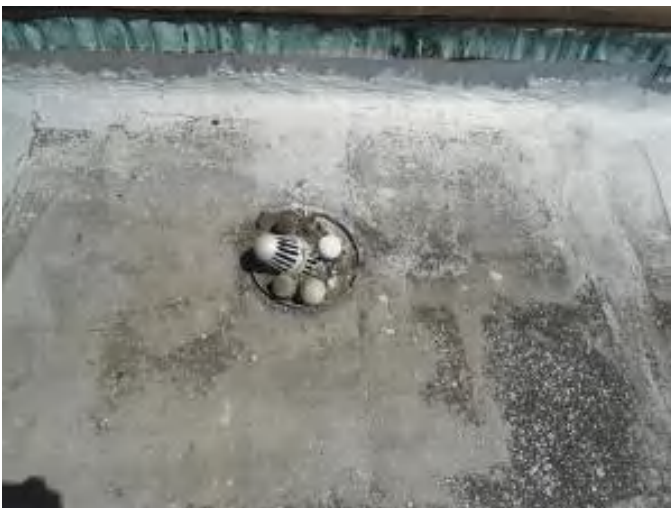
System: B3010105 - Built-Up

Location: Roof

Distress: Beyond Service Life

Notes: There are a number of roof sections and different roof elevations ranging from the main roof, cafeteria roof to the mechanical roof sections. The built up application that was installed in the early 1990'S is the primary application. Seal coat has been used several times to extend the life cycle of the application. However, considering the age and condition of the roofing systems, universal upgrades are recommended. Remove and replace all roof sections.

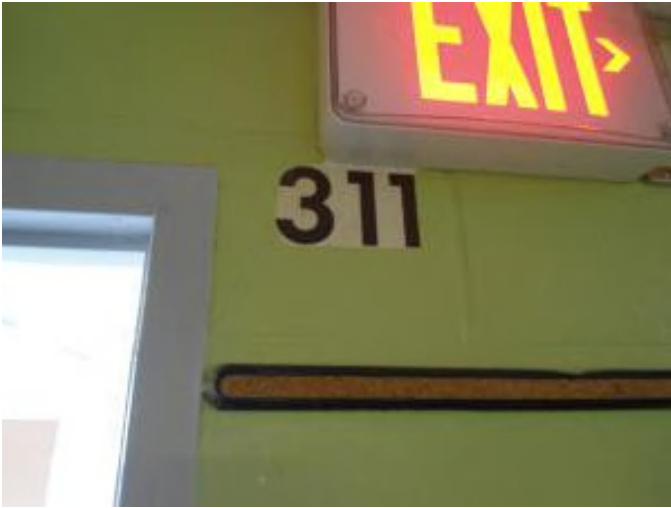
System: C1030 - Fittings

Location: Building Wide Signage

Distress: Accessibility

Notes: There is no directional signage and room signage is scarce or painted with no consistency. Accessibility signage criteria have been established for the physically challenged. These include mounting heights, contrast and finish, raised and Braille characters and pictograms, and character proportions and heights. It is recommended that compliant signage be installed throughout the building.

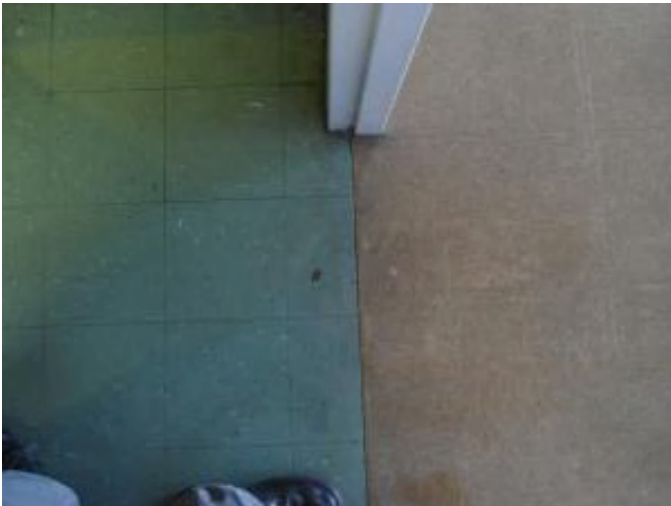
System: C3020413 - Vinyl Flooring

Location: Building Wide

Distress: Beyond Service Life

Notes: The vinyl floor finish in most of this school is in very good condition and appears to have part of an isolated upgrade reported to have taken place in the early 2000's. Some of the original flooring that was not a part of that effort consist of a 9x9 finish. This finish is suspect to contain asbestos and is recommended for upgrade. Remove and replace with a 12x12 vinyl tile application.

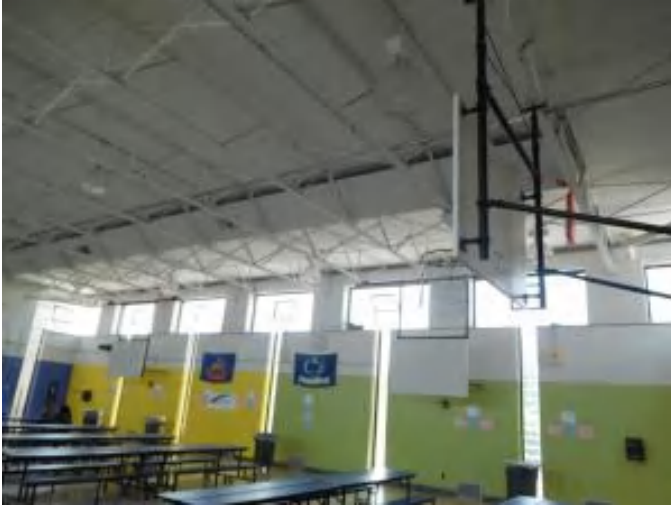
System: D3040 - Distribution Systems

Location: cafeteria

Distress: Building / MEP Codes

Notes: Provide a new central station air handling unit for the cafeteria with hot and chilled water coils, filters, outside and return air dampers, hydronic valves and controls, blower and motor. Connect to hot and chilled water systems.

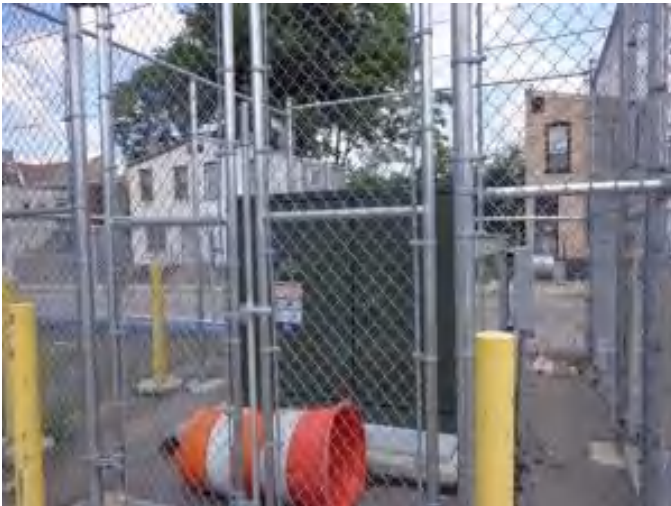
System: D5010 - Electrical Service/Distribution

Location: Main Electrical Room

Distress: Inadequate

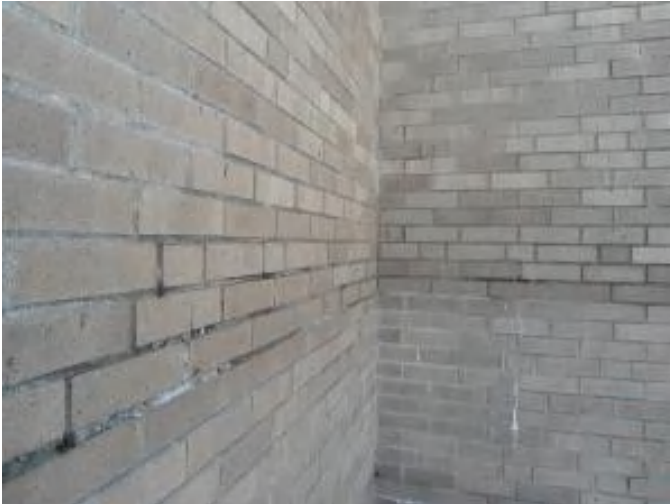
System: B2010 - Exterior Walls

Location: Exterior Elevation

Distress: Damaged

Notes: The exterior brick surfaces are generally in fair to good condition for their age. In some locations, bricks have cracked or spalled and should be replaced. The repointing of deteriorated mortar joints is also recommended, using mortar of a similar color and consistency as the original. Following the detailed examination of the brick and repair of mortar construction joints, the entire building should be pressure washed to remove stains and embedded pollutants. If moisture is found to be penetrating the masonry facade, the application of a spray sealant to the suspected exterior masonry surface is recommended.

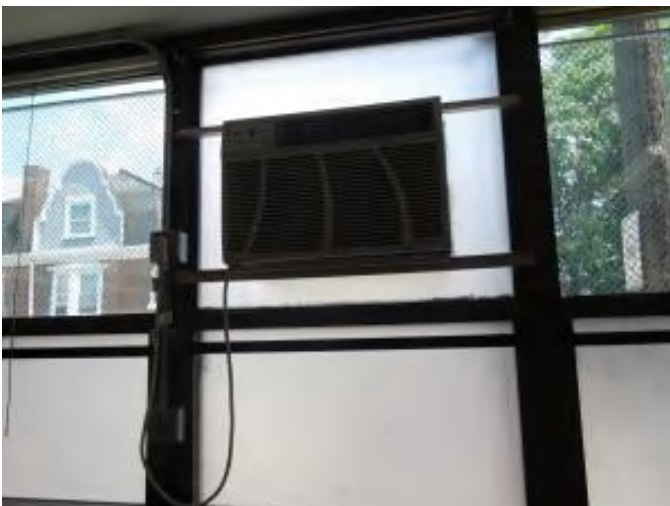
System: D3030 - Cooling Generating Systems

Location: roof, mechanical room

Distress: Inadequate

Notes: Remove the existing window air conditioning units and install a one hundred ninety ton air-cooled chiller on the roof with chilled water distribution piping, two pumps, chemical treatment and controls located in a mechanical room on the basement level.

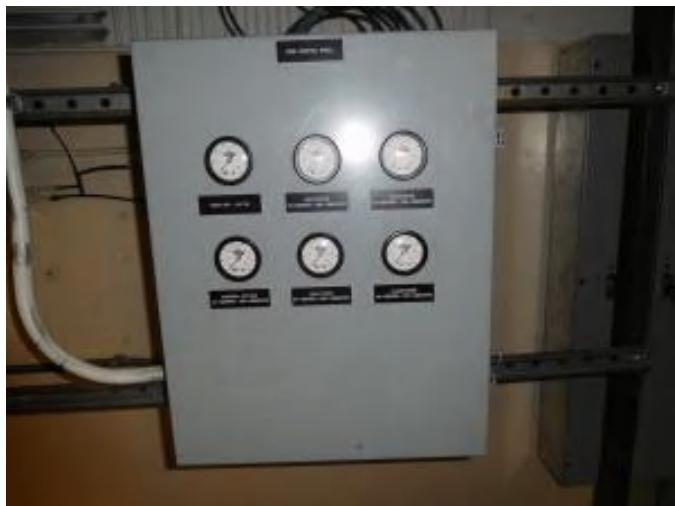
System: D3060 - Controls & Instrumentation

Location: entire building

Distress: Inadequate

Notes: Install new direct digital control system and building automation system with remote computer control capability and graphics package.

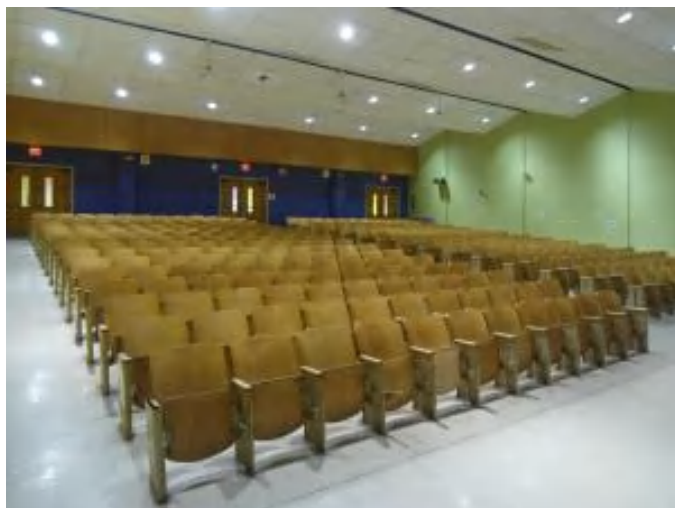
System: E2010 - Fixed Furnishings

Location: Auditorium

Distress: Beyond Service Life

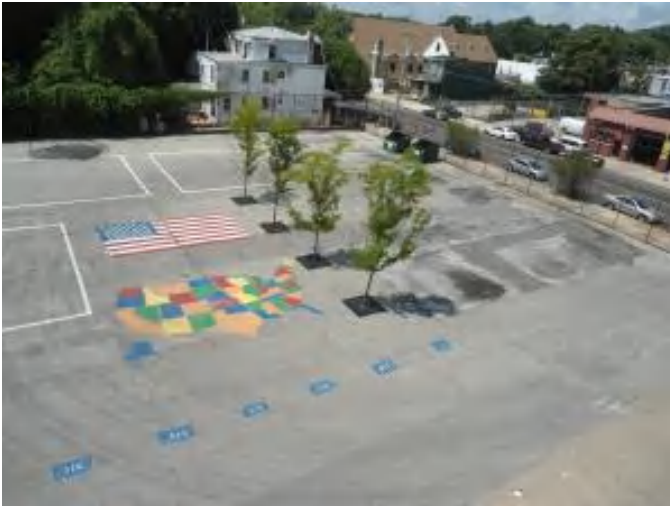
System: G2020 - Parking Lots

Location: Southern Site

Distress: Beyond Service Life

Notes: The asphalt play area is developing cracks that may turn into tripping hazards. It is recommended that the cracks be filled and the play area be resealed with proper area markers to support the sports activities of the schools physical education requirements.

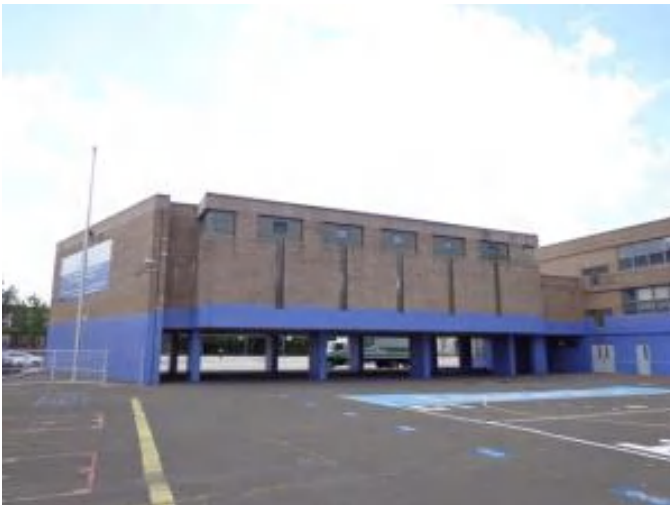
System: G4020 - Site Lighting

Location: Underside of gymnasium

Distress: Inadequate

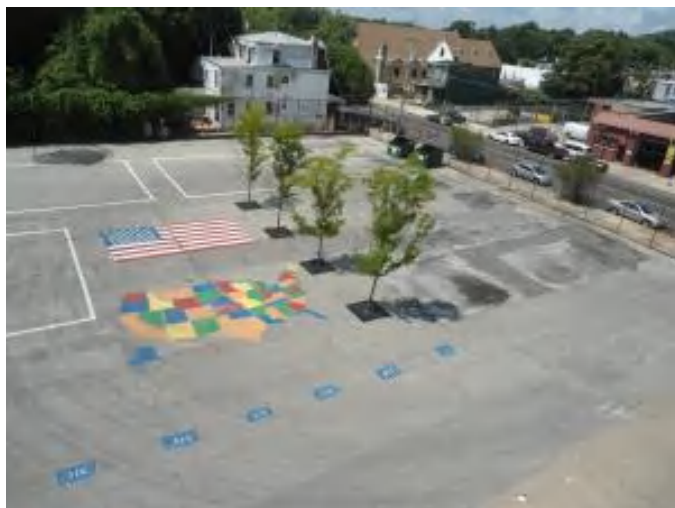
System: G2040 - Site Development

Location: Site

Distress: Beyond Service Life

Notes: This school has a perimeter fence surrounding the parking / playground area. The fence has several areas of repairs and the mounting post are damaged in several areas, overall the fence is in fair condition. This fence system is recommended to be removed and replaced with a new system within the next five to ten years.

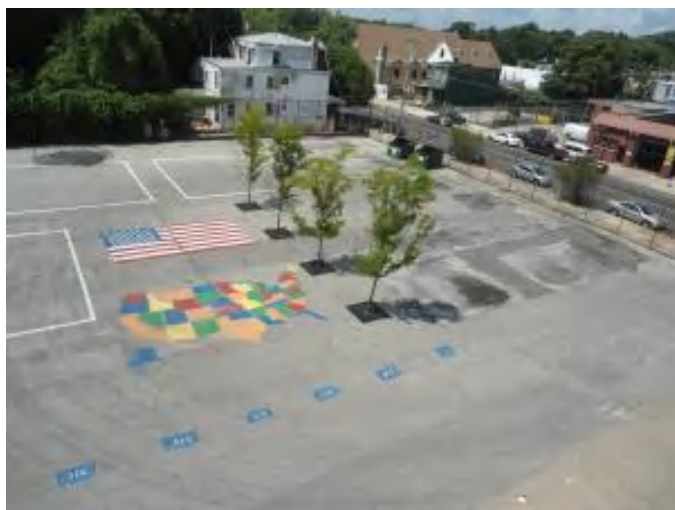
System: G2040 - Site Development

Location: Site

Distress: Health Hazard / Risk
