Facility Condition Assessment Summary Report

Peirce, TM School

S438001;Peirce, T M

Site Assessment Report

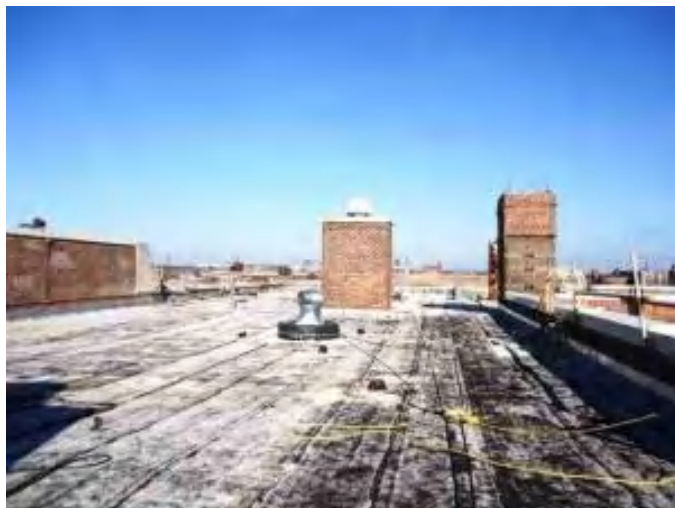
Location: Roof

There are a number of roof sections and different roof elevations ranging from the main roof to the mechanical roof. The built up application was reported to have been installed in the early 1990'S. Considering the age and condition of the roofing systems, universal upgrades are recommended.

Distress: Damaged

Notes: There are a number of roof sections and different roof elevations ranging from the main roof to the mechanical roof. The built up application was reported to have been installed in the early 1990'S. Considering the age and condition of the roofing systems, universal upgrades are recommended.

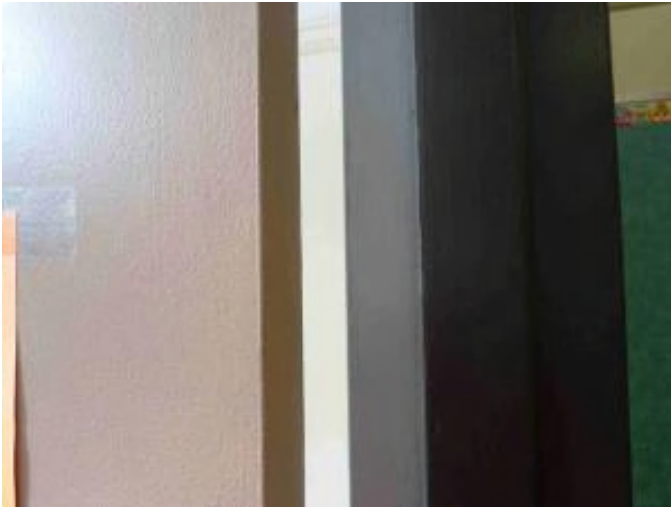
Location: Corridor doors

The stair and corridor doors were compliant during the time of the construction of the school in 1908. However a large portion of the interior corridor exit stair doors are not code compliant. Several doors are typically metal in metal frames with transom lites or sidelights, glass glazing. The older doors are generally in poor condition considering the age of the application. To restore the door finishes, universal upgrades are required for the older door applications. Remove and replace original corridor door systems with new code compliant fire rated door system.

Distress: Life Safety / NFPA / PFD

Notes: The stair and corridor doors were compliant during the time of the construction of the school in 1908. However a large portion of the interior corridor, exit stair doors are not code compliant. Several doors are typically metal in metal frames with transom lites or sidelights, glass glazing. The older doors are generally in poor condition considering the age of the application. To restore the door finishes, universal upgrades are required for the older door applications. Remove and replace original corridor door systems with new code compliant fire rated door system.

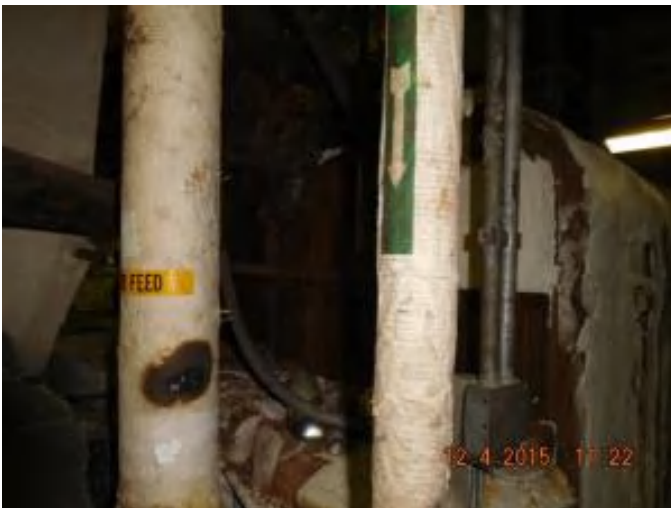
Location: mechanical room

Distress: Damaged

Notes: Replace inoperable damaged boiler with new similar unit.

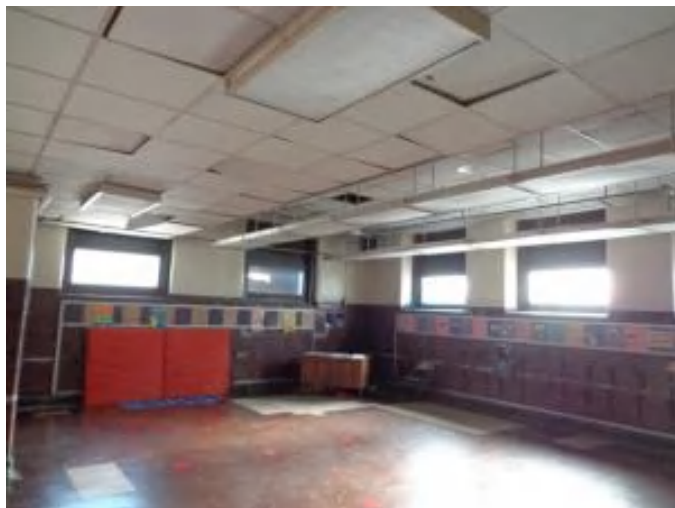
Location: Building wide

Distress: Life Safety / NFPA / PFD

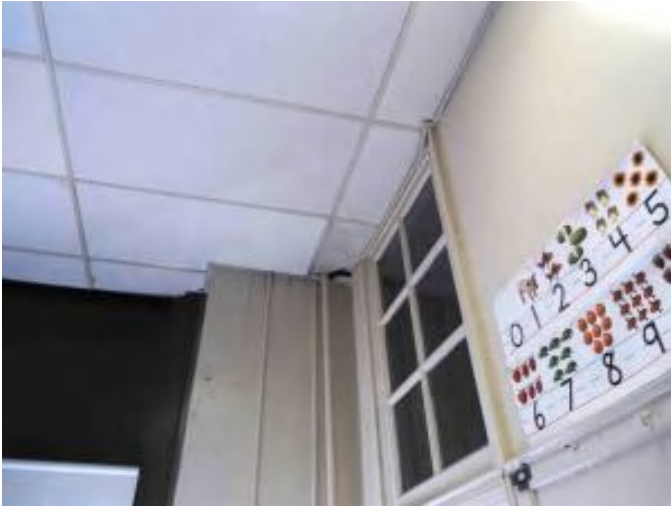
Location: Hallway

There are several transom lites and sidelights constructed into hallway wall systems. It is recommended that the lites and sidelights be removed and replaced with a fire rated wall construction. The deficiency provides a budgetary consideration to correct the hallway, transoms, lites and sidelights.

Distress: Life Safety / NFPA / PFD

Notes: There are several transom lites and sidelights constructed into hallway wall systems. It is recommended that the lites and sidelights be removed and replaced with a fire rated wall construction. The deficiency provides a budgetary consideration to correct the hallway, transoms, lites and sidelights.

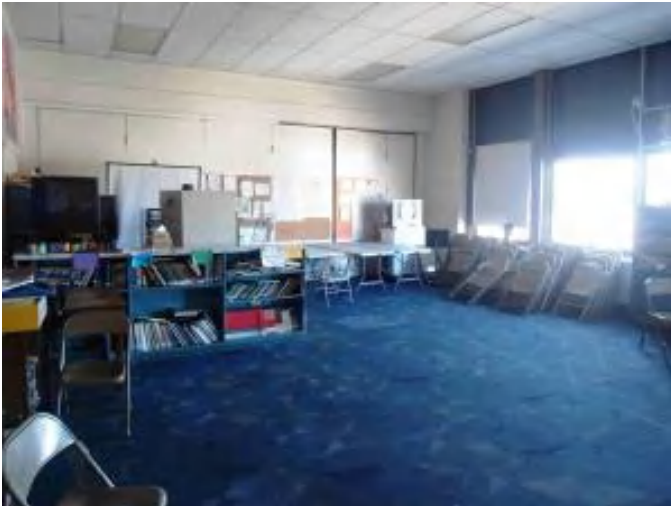
Location: Classroom

There are several movable partitions that remain in classrooms. These wall systems are no longer used and in most cases cannot be used due to damage or wall modifications to support classroom needs. This deficiency provides a budgetary consideration to remove and replace the wall systems with universal removal of the existing movable partitions and upgrades to a permeate wall systems.

Distress: Damaged

Notes: There are several movable partitions that remain in classrooms. These wall systems are no longer used and in most cases cannot be used due to damage or wall modifications to support classroom needs. This deficiency provides a budgetary consideration to remove and replace the wall systems with universal removal of the existing movable partitions and upgrades to a permeate wall systems.

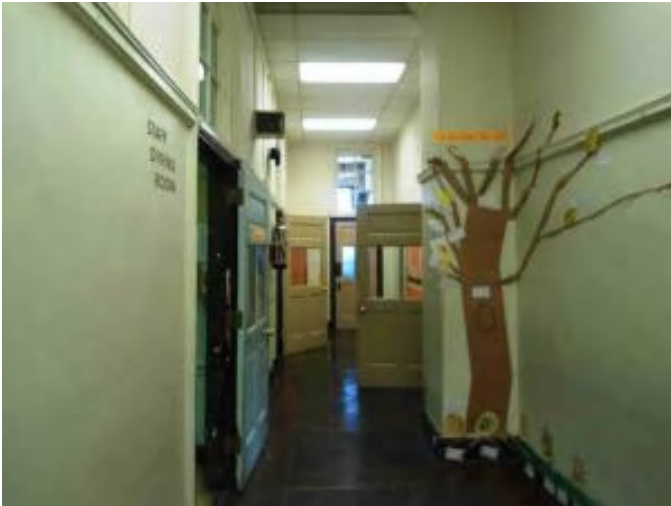
Location: Building Wide

Interior doors are typically wood in wood frames with transom lites, sidelights, wired glass glazing. Other interior doors include wooden glass pane doors with original wooden pane frames, hollow metal in hollow metal frames at stairwells and exit ways. Doors are generally in poor condition considering the age of the application. Universal upgrades are required for the interior door systems it is recommended that the interior doors system be removed and replaced with a new modern metal framed hollow metal door system with consideration for ADA compliance.

Distress: Damaged

Notes: Interior doors are typically wood in wood frames with transom lites, sidelights, wired glass glazing. Other interior doors include wooden glass pane doors with original wooden pane frames, hollow metal in hollow metal frames at stairwells and exit ways. Doors are generally in poor condition considering the age of the application. Universal upgrades are required for the interior door systems it is recommended that the interior doors system be removed and replaced with a new modern metal framed hollow metal door system with consideration for ADA compliance.

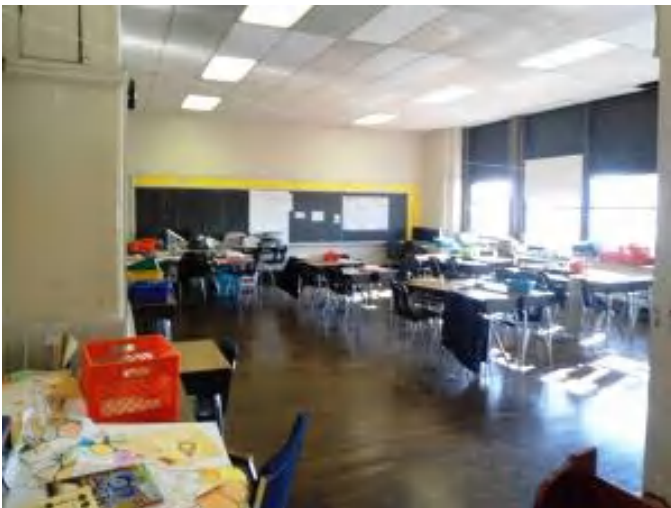
Location: Building Wide

Some of the classroom chalk boards are original to the buildings construction. This system is damaged and beyond its expected life, universal upgrades are warranted. Remove and upgrade damaged chalk boards to new marker board systems.

Distress: Damaged

Notes: Some of the classroom chalk boards are original to the buildings construction. This system is damaged and beyond its expected life, universal upgrades are warranted. Remove and upgrade damaged chalk boards to new marker board systems.

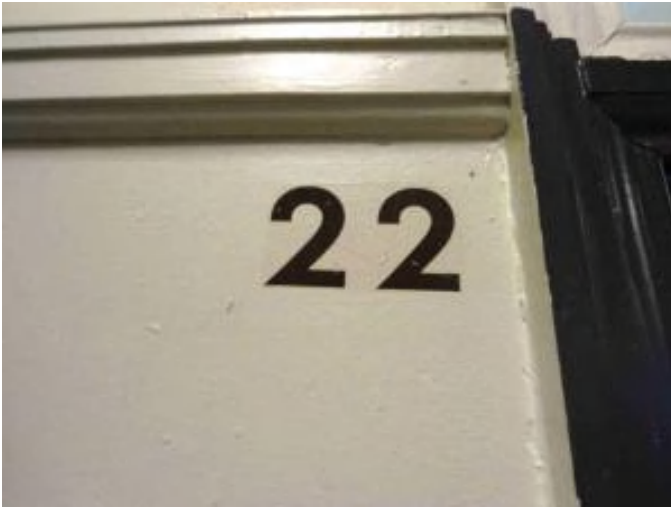
Location: Building Wide

There is no directional signage and room signage is a custom design in places and scarce or painted with no consistency in others. Accessibility signage criteria have been established for the physically challenged. These include mounting heights, contrast and finish, raised and Braille characters and pictograms, and character proportions and heights. It is recommended that compliant signage be installed throughout the building.

Distress: Damaged

Notes: There is no directional signage and room signage is a custom design in places and scarce or painted with no consistency in others. Accessibility signage criteria have been established for the physically challenged. These include mounting heights, contrast and finish, raised and Braille characters and pictograms, and character proportions and heights. It is recommended that compliant signage be installed throughout the building.

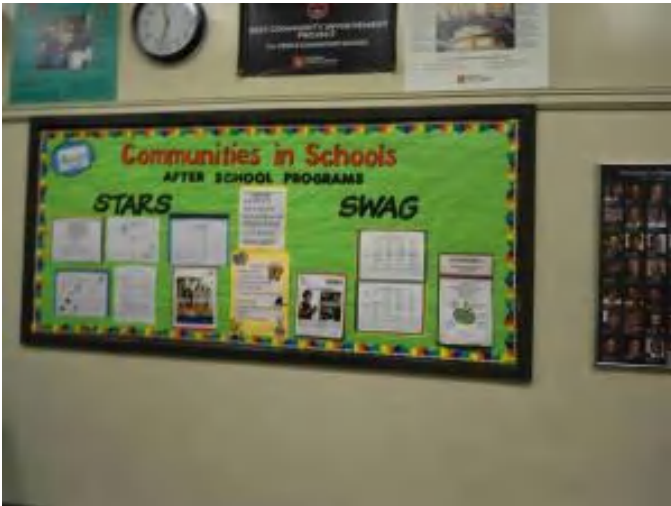
Location: Building Wide

There are several tack boards in the hallways for student displays. The systems are damaged and beyond the expected service life for this application. Remove and replace tack boards is recommended.

Distress: Damaged

Notes: There are several tack boards in the hallways for student displays. The systems are damaged and beyond the expected service life for this application. Remove and replace tack boards is recommended.

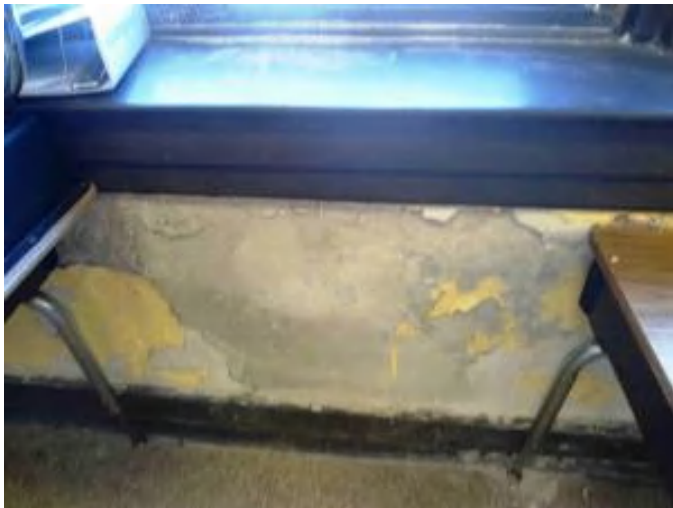
Location: Building Wide

There are painted walls, trim, brick and some painted ceilings in this building. Sections of the building, some textured concrete surfaces have been painted while in the new section they are not. The interior finishes are in fair to poor condition and will require an almost continuous program of renewal of the applied finishes to maintain an acceptable appearance. Cyclical painting should be considered for a standard approach to maintaining the quality of the interior finishes. It is recommended that all previously painted surfaces be repainted according to established cycles for this occupancy and use type. Repairs should be completed before work begins. This effort is expected to be coordinated with other mechanical electrical efforts in order to prevent overlapping efforts.

Distress: Damaged

Notes: There are painted walls, trim, brick and some painted ceilings in this building. Sections of the building, some textured concrete surfaces have been painted, while in the new section they are not. The interior finishes are in fair to poor condition and will require an almost continuous program of renewal of the applied finishes to maintain an acceptable appearance. Cyclical painting should be considered for a standard approach to maintaining the quality of the interior finishes. It is recommended that all previously painted surfaces be repainted according to established cycles for this occupancy and use type. Repairs should be completed before work begins. This effort is expected to be coordinated with other mechanical electrical efforts in order to prevent overlapping efforts.

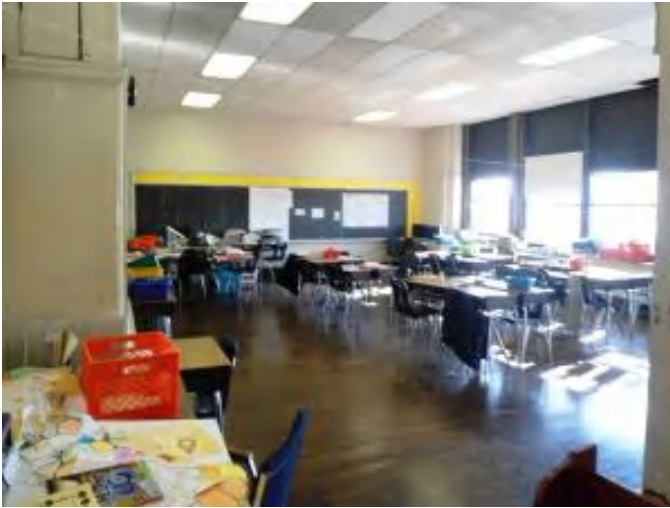
Location: Building Wide

The ceiling finish is a mix of 12 x 12 ceiling grid, painted and 2 x 4 Acoustical tile finish. Ceilings have been repaired in several areas and are in good condition considering the age of the application and the current condition of the school. The ceiling finish is expected to require upgrades to support the recommended efforts in this report prior to re-opening. This deficiency provides a budgetary consideration for removal and replacement of the current ceiling finish to a new acoustical tile finish. Considering the recommended mechanical and electrical upgrades this effort should be completed as part of an overall renewal program for the school. No work should be considered until after the recommended exterior efforts are complete.

Distress: Damaged

Notes: The ceiling finish is a mix of 12 x 12 ceiling grid, painted and 2 x 4 Acoustical tile finish. Ceilings have been repaired in several areas and is in good condition considering the age of the application and the current condition of the school. The ceiling finish is expected to require upgrades to support the recommended efforts in this report prior to re-opening. This deficiency provides a budgetary consideration for removal and replacement of the current ceiling finish to a new acoustical tile finish. Considering the recommended mechanical and electrical upgrades this effort should be completed as part of an overall renewal program for the school. No work should be considered until after the recommended exterior efforts are complete.

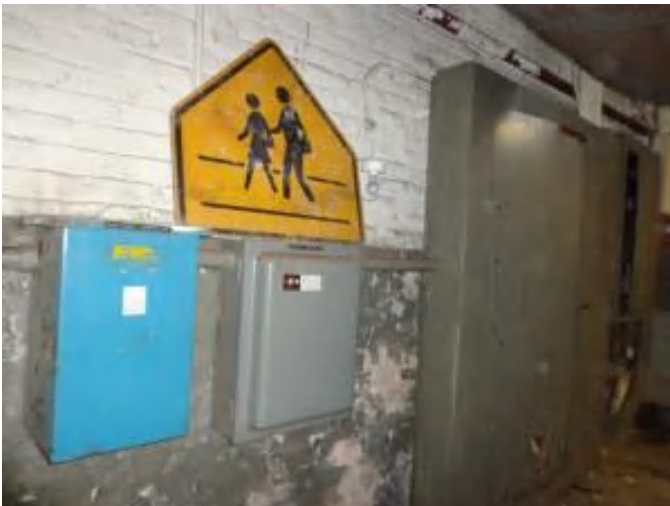
Location: Mechanical Room B11

Distress: Beyond Service Life

Notes: Remove the 400A, 120/240V, 2 phase, 5 wire service disconnecting means, metering cabinet, 400A main panelboard, and 75 kVA and 50 kVA phase change transformers and provide a 750 kVA load center unit substation with 2500A, 208/120V, 3 phase, 4 wire main switchboard with main circuit breaker and feeder circuit breakers to serve the existing building loads, and capacity to serve central air conditioning equipment, an elevator addition, and a fire pump (if required).

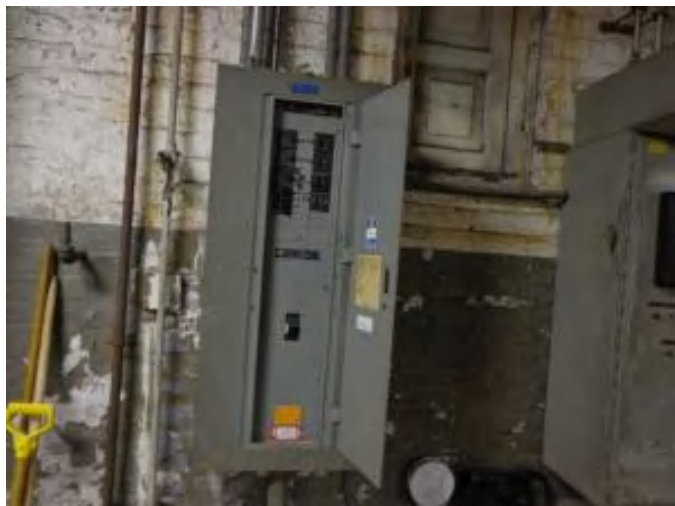
Location: Building wide

Distress: Beyond Service Life

Notes: Replace 225A Panelboard BR in Boiler Room B14 and (15) 120/240V panelboards in the building, including their feeder conductors. Panelboards are to be rated 208/120V, 3 phase, 4 wire and sized with adequate branch circuit breakers for additional receptacle circuits for classrooms.

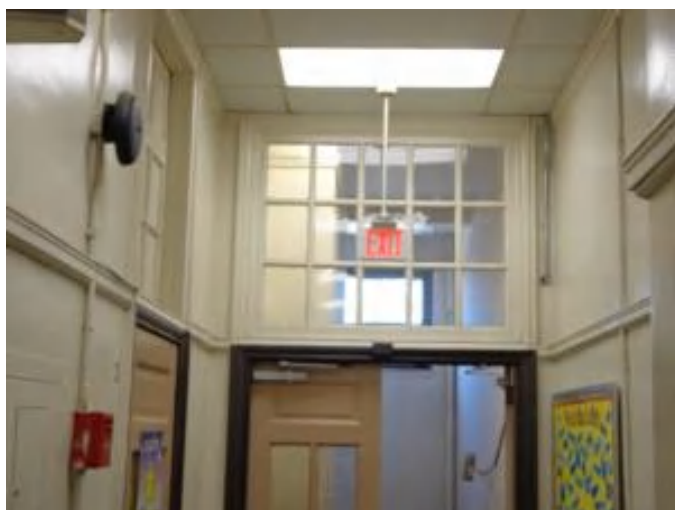
Location: Building wide

Distress: Life Safety / NFPA / PFD

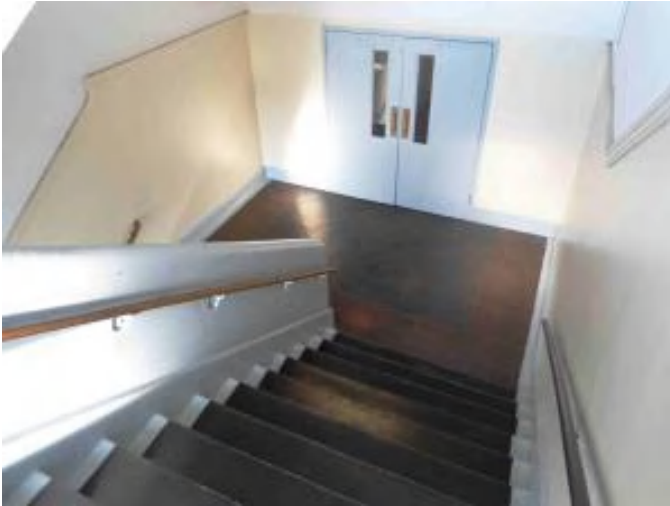
Location: Stairs

Stair construction is concrete. Stair treads and landings are finished with concrete. Current requirements for stairs indicate that they have graspable handrails on both sides, that the rails have a specific end geometry, and that the handrails continue horizontally at the landings. In addition, guardrails must prevent the passage of a 4 inch diameter sphere (6 inches in the triangle formed by the lower rail and tread/riser angle). Although the stairs are compliant with the code enforced at the time of construction until a major renovation occurs, they are deficient in handrail and guardrail design relative to current standards. Future efforts should include comprehensive stair railing removal and replacement upgrades.

Distress: Life Safety / NFPA / PFD

Notes: Current requirements for stairs indicate that they have graspable handrails on both sides, that the rails have a specific end geometry, and that the handrails continue horizontally at the landings. In addition, guardrails must prevent the passage of a 4 inch diameter sphere (6 inches in the triangle formed by the lower rail and tread/riser angle). Although the stairs are compliant with the code enforced at the time of construction until a major renovation occurs, they are deficient in handrail and guardrail design relative to current standards. Future efforts should include comprehensive stair railing removal and replacement upgrades.

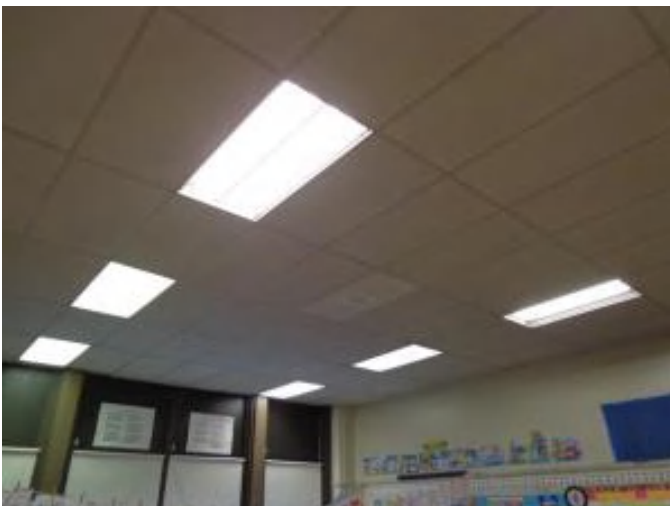
Location: Building wide

Distress: Beyond Service Life

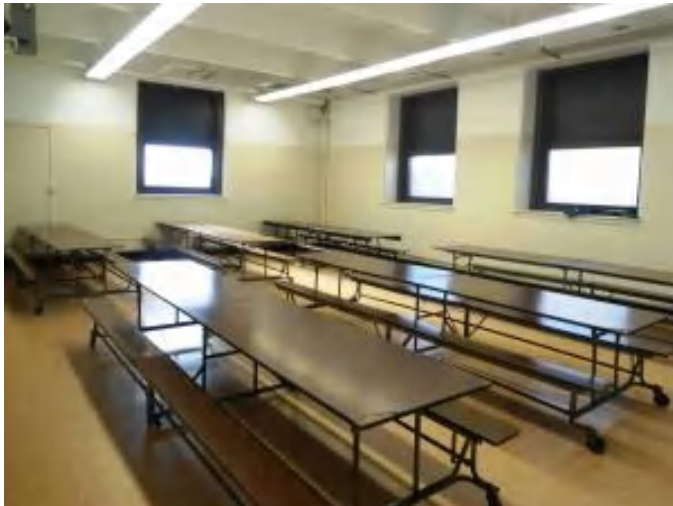
Location: Exterior Elevation

Exterior windows are a mix of single pane industrial grade metal and aluminum framed single pane windows. Windows are in good to poor condition based on the year of installation or last renovation. The single pane metal-framed, double hung windows have been replaced in the last twenty years. The original steel-framed, multi-light windows are original have exceeded their useful service life. The exterior window system is recommended to be replaced with units that retain their dimensions and profiles, but that incorporate updated energy-efficient features. This universal upgrade is expected to be completed as part of an overall renovation effort to eliminate dual efforts.

Distress: Damaged

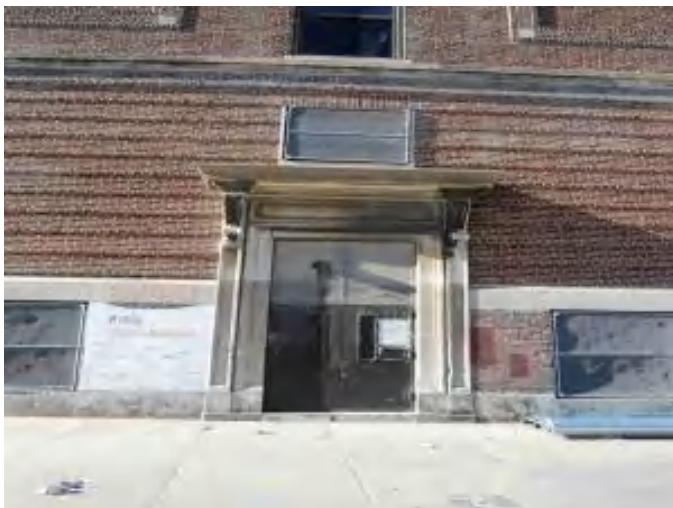
Location: Exterior Elevation

The exterior doors are metal applications with metal frames. The exterior door system for this school is a very high traffic system. The doors are in fair condition but are aging at a faster rate than expected based on traffic and condition. The exterior door system and service doors are recommended for upgrade. The new doors are expected to retain their dimensions and profiles, but that incorporate updated energy-efficient features.

Distress: Damaged

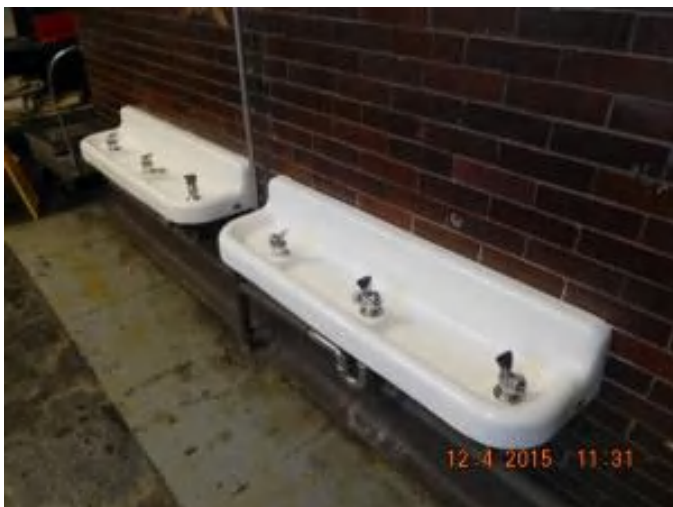
Location: corridors

Distress: Beyond Service Life

Notes: Replace older china drinking fountains in corridors.

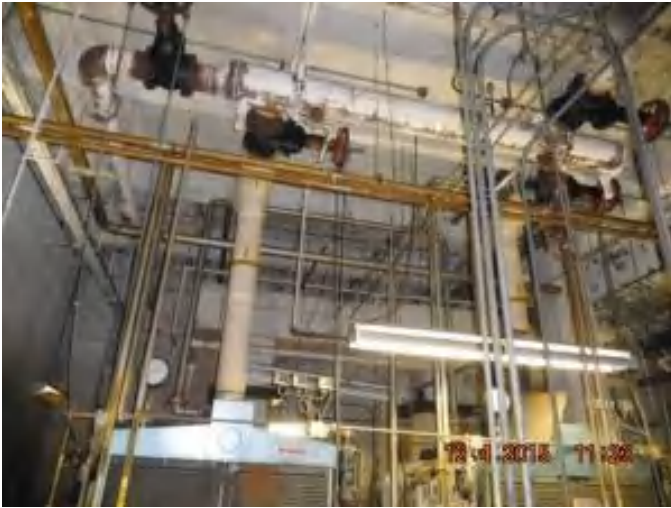
Location: entire building

Distress: Beyond Service Life

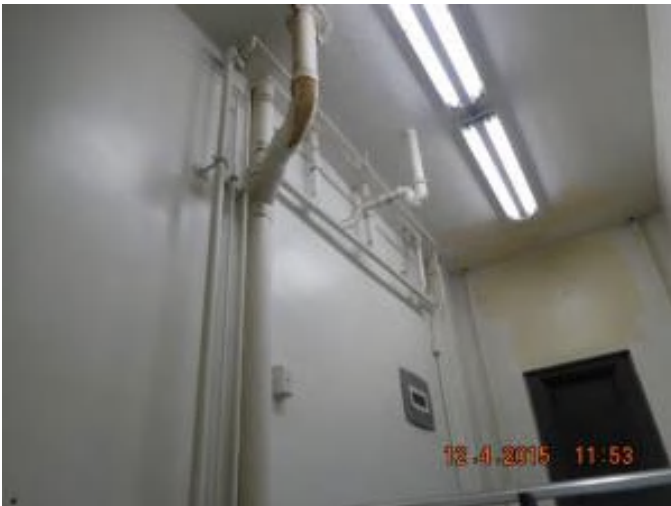
Location: entire building

Distress: Beyond Service Life

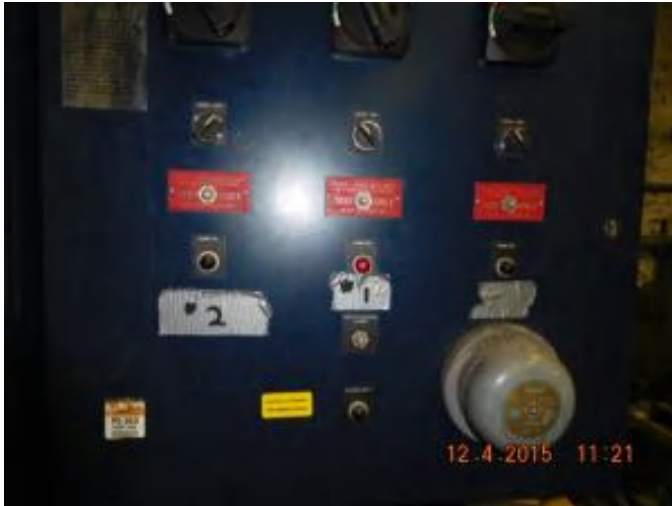
Location: mechanical room

Distress: Beyond Service Life

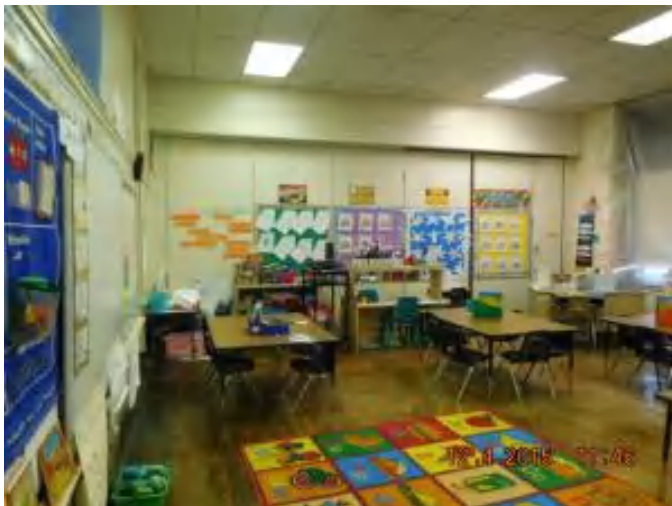
Location: entire building

Distress: Building / MEP Codes

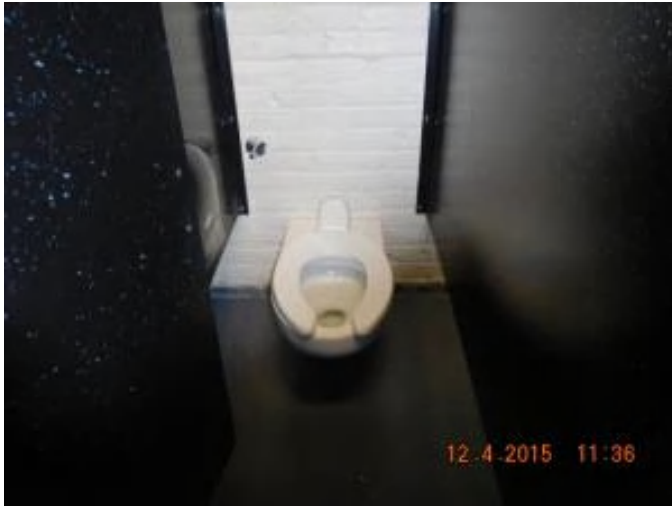
Location: toilet rooms

Distress: Building / MEP Codes

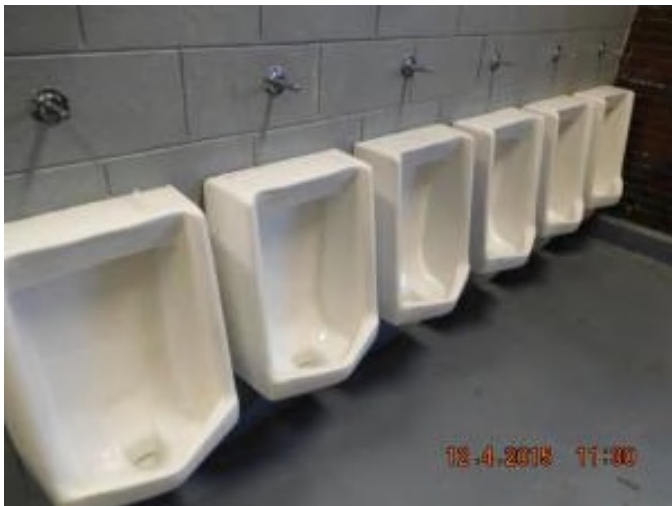
Location: toilet rooms

Distress: Building / MEP Codes

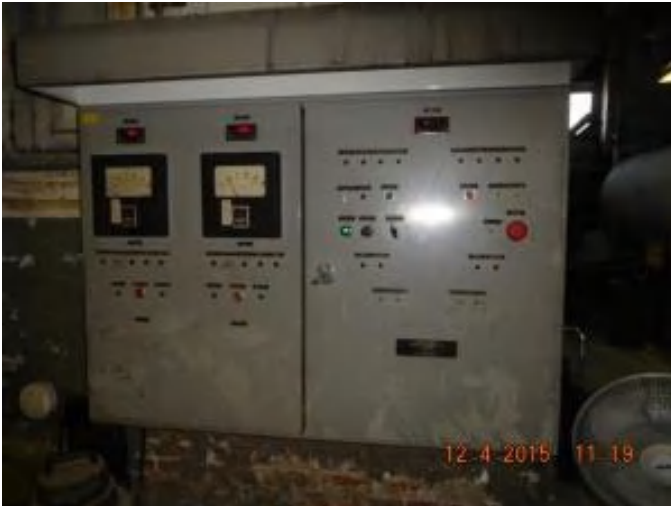
Location: entire building

Distress: Inadequate

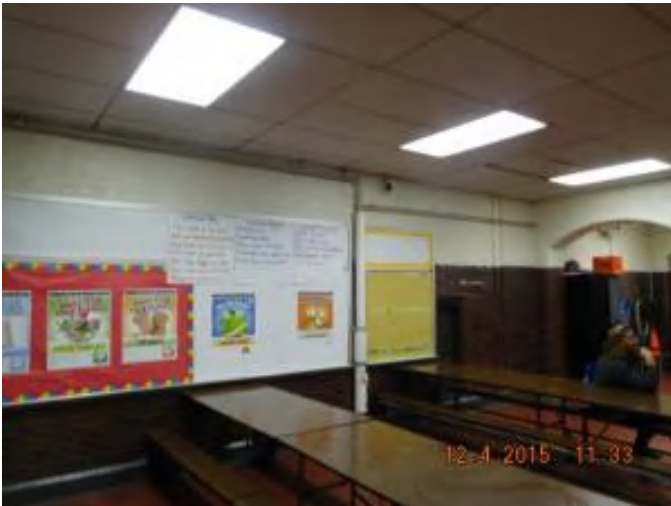
Location: entire building

Distress: Life Safety / NFPA / PFD

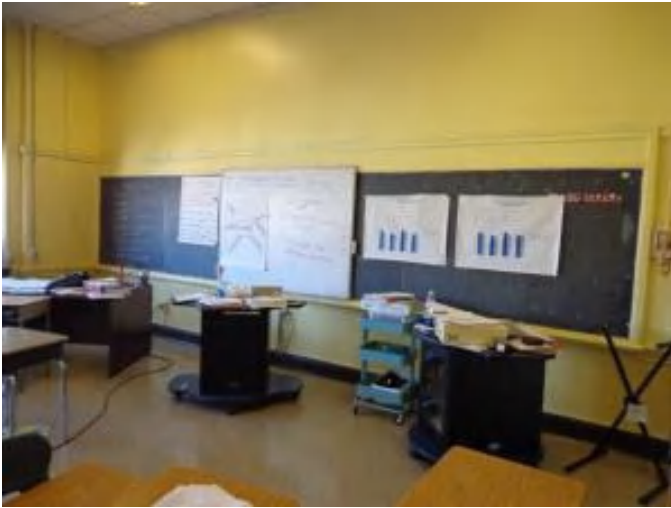
Location: Classrooms

Receptacles-- Most of the classrooms are provided with only a few duplex receptacles, which is not adequate for today's classroom. An additional 6 to 8 duplex receptacles should be provided in each of the 35 classrooms using a surface metal raceway system. Replacement of all duplex receptacles in the building is included in this report due to their age and condition (estimate 124 duplex receptacles to be replaced).

Distress: Inadequate

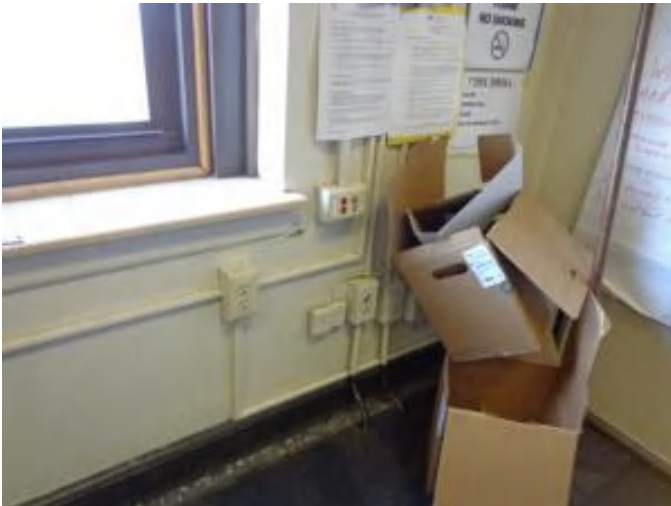
Location: Building wide

Distress: Beyond Service Life

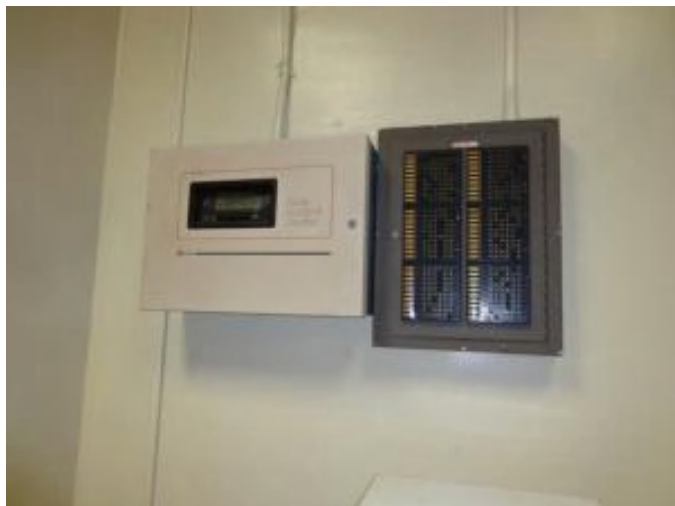
Location: Building wide

Distress: Failing

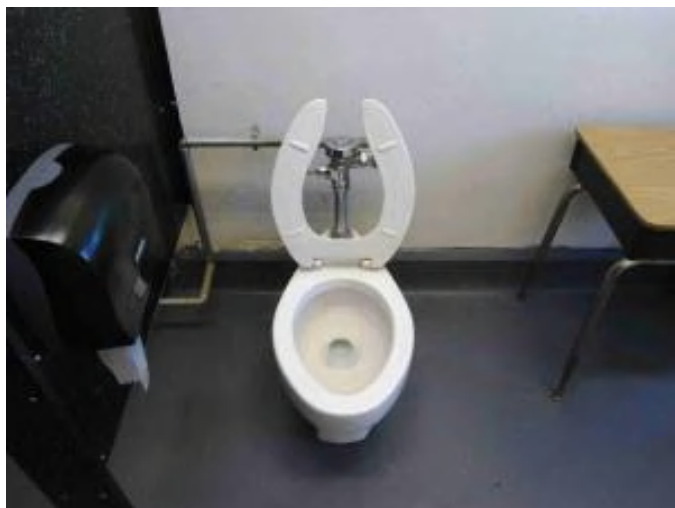
Location: Restrooms

Distress: Damaged

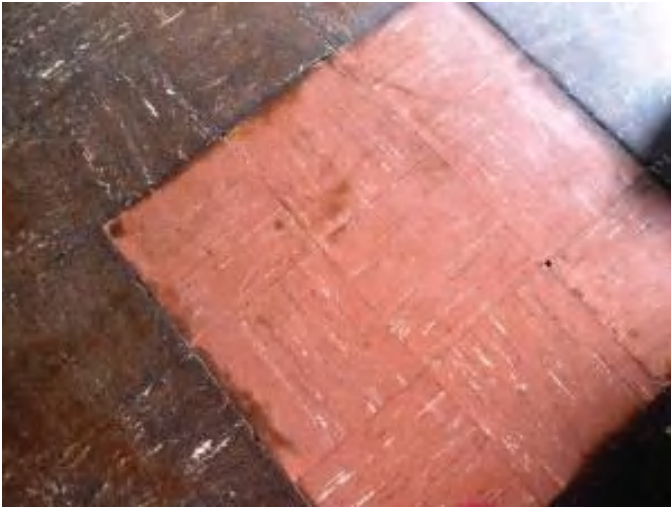
Location: Classrooms

The floor finish for this school is a combination of newly installed carpet in the IMC and administrative area, tile in the kitchen and service line areas, wooden classrooms with concrete hallways and vinyl stairs finishes and a 12x12 and 9x9 vinyl tile finish. The vinyl tile finish is a 9 x 9 application and is suspect to contain asbestos. The 9x9 vinyl finish is recommended for upgrade to a new 12 x 12

Distress: Health Hazard / Risk

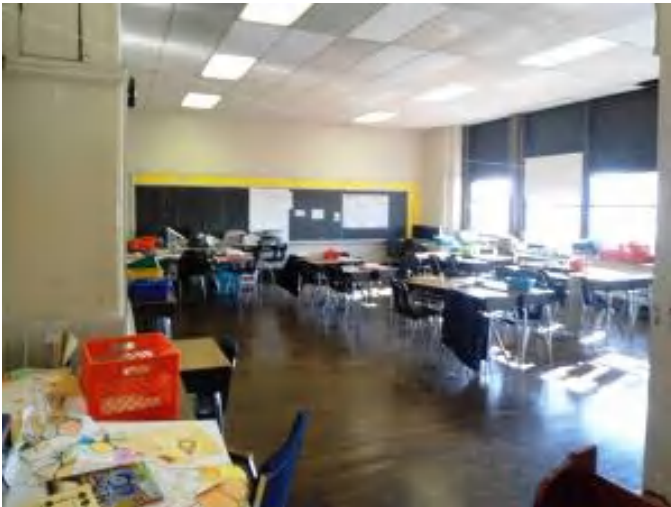
Location: Building Wide

The classrooms and auditorium in this school have a wooden floor finish that appears to be from original construction. The system is showing signs of age such as the effects of sanding and refinishing with yearly cleaning and waxing with some repairs. The floor finish is in fair condition however, the finish is beyond its expected life cycle. It is recommended that the damaged wood floor finish be removed and replaced with an in kind finish.

Distress: Damaged

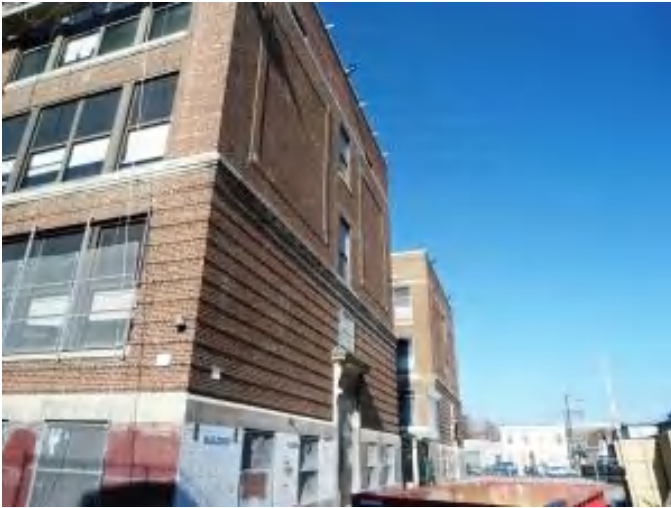
Location: Building Wide

There is no elevator that services this school. Goods, services, and amenities offered in public buildings are generally required to be available to all persons. To assist those that may be physically challenged and to meet current accessibility legislation to provide wheelchair access to the upper floors of this facility, the installation of a new hydraulic elevator has been recommended on the exterior elevation of the building or at another suitable location. The new installation should blend as much as possible with the overall appearance of this historic structure and include all required ADA features, such as audible jewels and gongs, an accessible control panel, etc.

Distress: Inadequate
