## Facility Condition Assessment Summary Report

### Penn Alexander School

School District of Philadelphia  
**S128001; Penn Alexander**  
Final  
**Site Assessment Report**  
January 30, 2017

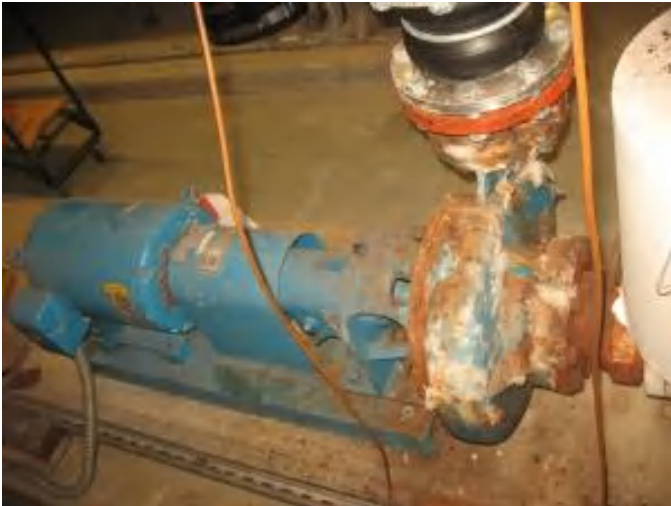
#### System: D3030 - Cooling Generating Systems

**Location:** Basement mechanical room

**Distress:** Damaged

**Notes:** Replace the 20HP chilled water return pump, P-12, which is damaged from water leaking from the chilled water piping, including the associated leaking piping.

**Correction:** Replace base mounted, end suction CHW pump (6" size, 25 HP, to 1550 GPM)

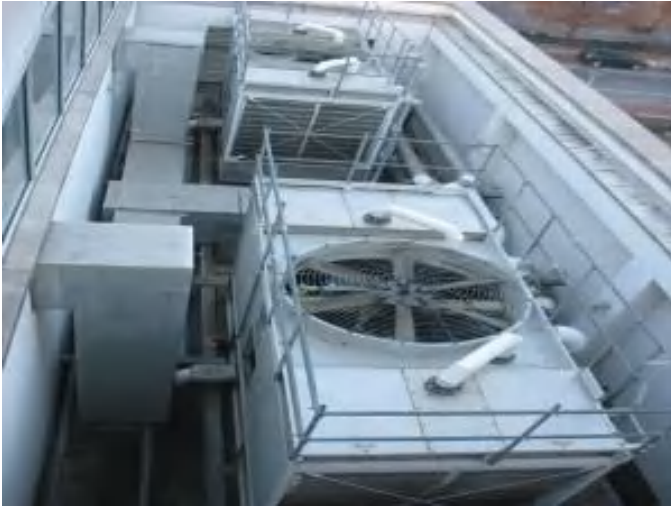
**System: D3030 - Cooling Generating Systems**

**Location:** Roof

**Distress:** Beyond Service Life

**Correction:** Replace cooling tower, ID, galv. (250 tons)

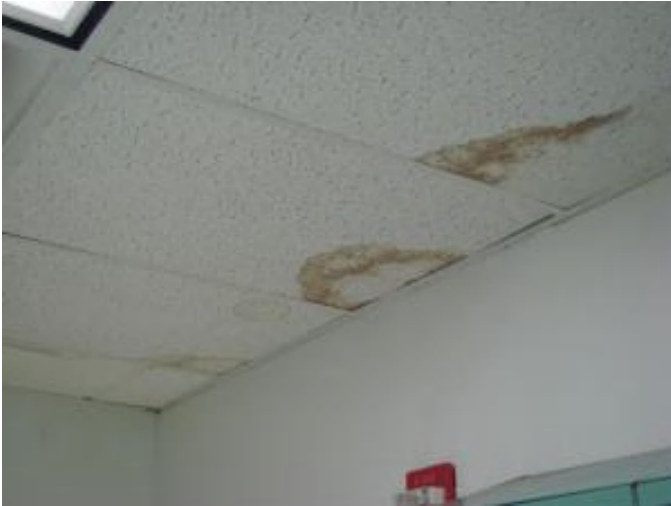
**System: C3030 - Ceiling Finishes**

**Location:** Various

**Distress:** Damaged

**Correction:** Remove and replace ceiling tiles only in suspended ceiling - pick the proper material

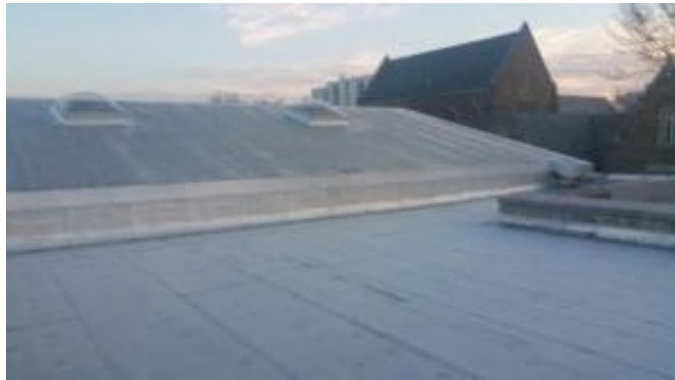
**System: D5090 - Other Electrical Systems**

**Location:** roof

**Distress:** Inadequate

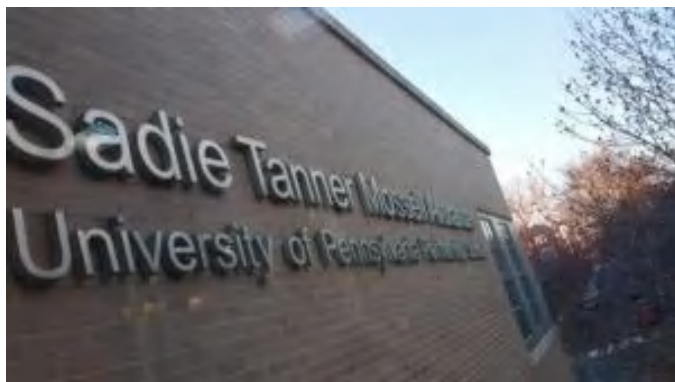
#### **System: G4020 - Site Lighting**

**Location:** grounds

**Distress:** Security Issue

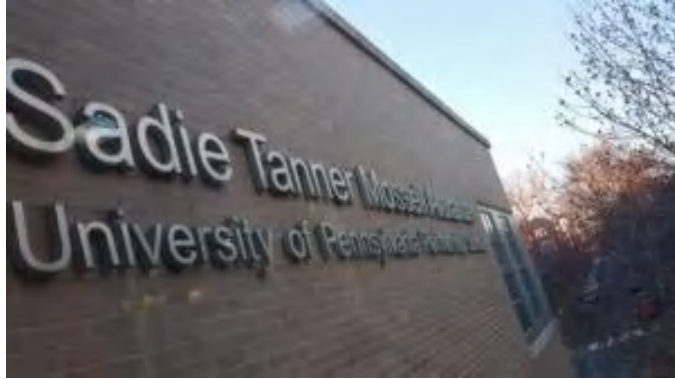
**System: G4030 - Site Communications & Security**

**Location:** grounds

**Distress:** Inadequate

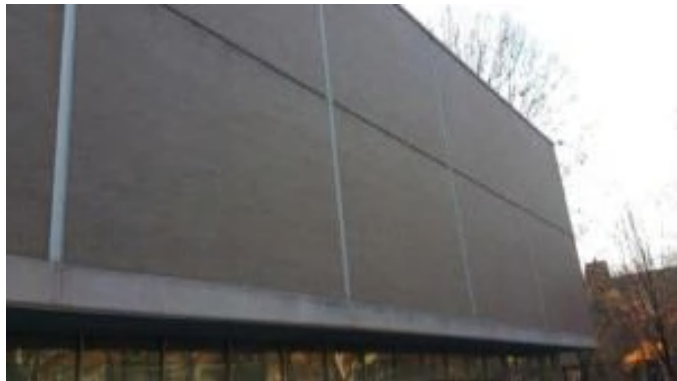
**System: G4030 - Site Communications & Security**

**Location:** grounds

**Distress:** Inadequate
