Facility Condition Assessment Summary Report

Penn Treaty School

Site Assessment Report

January 31, 2017

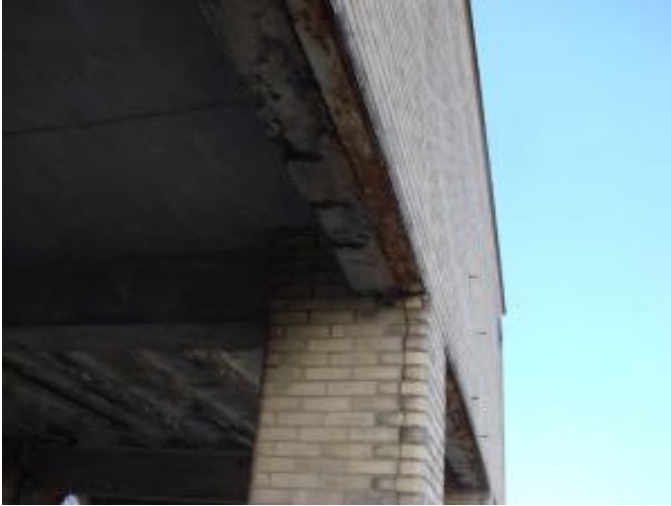
System: B1010 - Floor Construction

The main structure consists typically of cast-in-place concrete columns, beams and one-way concrete slabs. Long slab spans are supported with steel truss girders. Above ground floor slabs are generally in good condition, however, the penthouse floor slab, partially exposed to weather, shows substantial structural deterioration including spalled concrete and exposed, rusting reinforcement.

Location: Penthouse

Distress: Failing

Notes: Repair deteriorated structural roof slabs above open penthouses

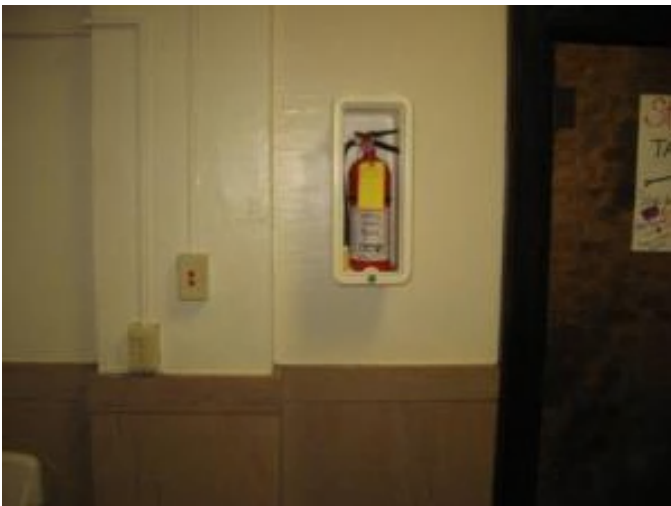
System: D4010 - Sprinklers

Location: Throughout bulding

Distress: Life Safety / NFPA / PFD

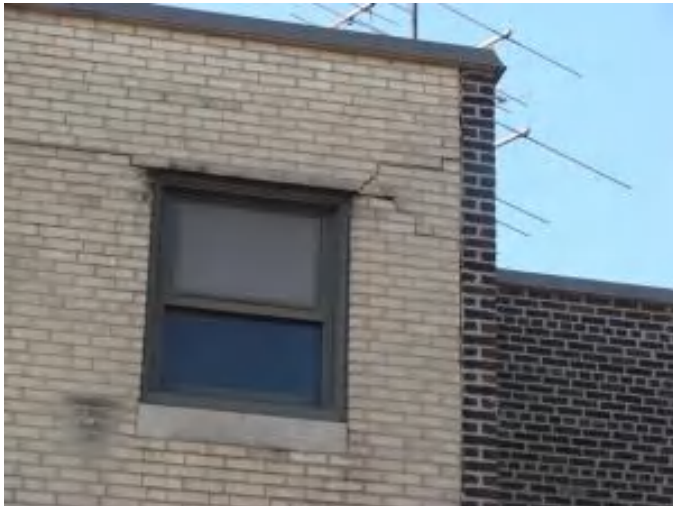
System: B2010 - Exterior Walls

The building envelope is typically masonry with face brick with decorative stone water table and window sills. In general, masonry is in fair to poor condition with deteriorated and missing mortar from joints (approximately 40%); the penthouses' walls show substantial cracks and wythes separation.

Location: Exterior

Distress: Building Envelope Integrity

Notes: Repair cracks in penthouses' masonry, tuck-point all walls

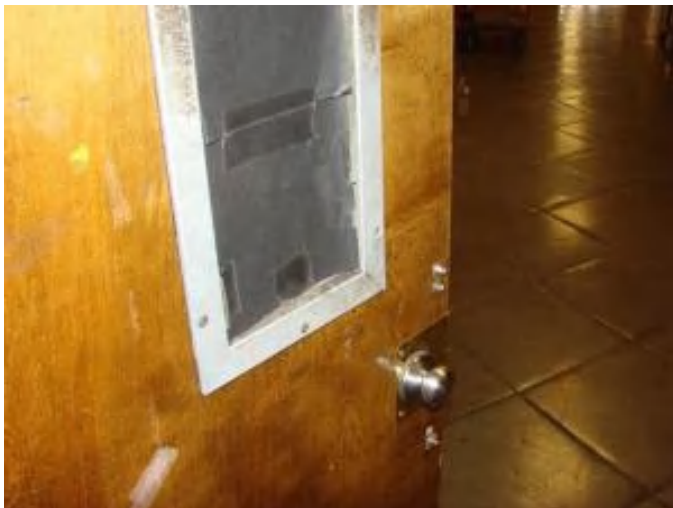
System: C1020 - Interior Doors

Location: Interiors

Distress: Accessibility

Notes: Provide ADA compliant hardware on interior doors

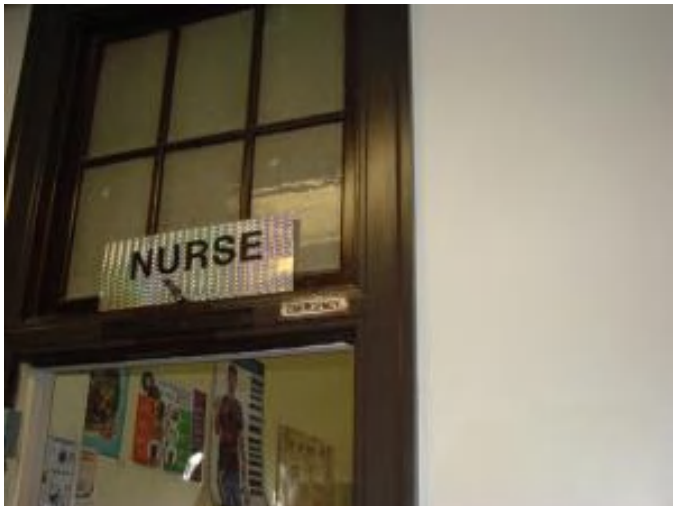
System: C1030 - Fittings

Location: Interiors

Distress: Accessibility

Notes: Install new signage throughout the building to meet ADA and accessibility requirements

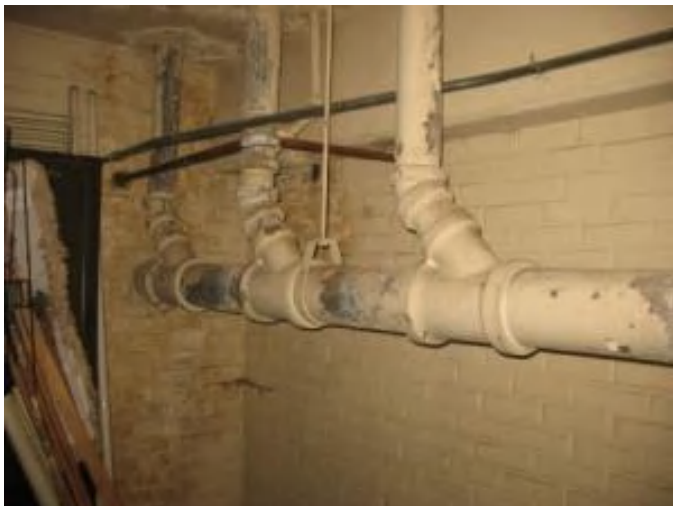
System: D2030 - Sanitary Waste

The maintenance staff reported no problems with the sanitary waste piping systems. However, the sewer piping has been in service for nearly 40 years and will require more frequent attention from the maintenance staff as time passes. The District should hire a qualified contractor to examine the sanitary waste piping using video cameras to locate and replace any damaged piping and to further quantify the extent of potential failures.

Location: Throughout building

Distress: Health Hazard / Risk

Notes: Hire a qualified contractor to perform a detailed examination of the sanitary waste piping using visual inspection and video cameras to locate and replace any damaged piping and to further quantify the extent of potential failures.

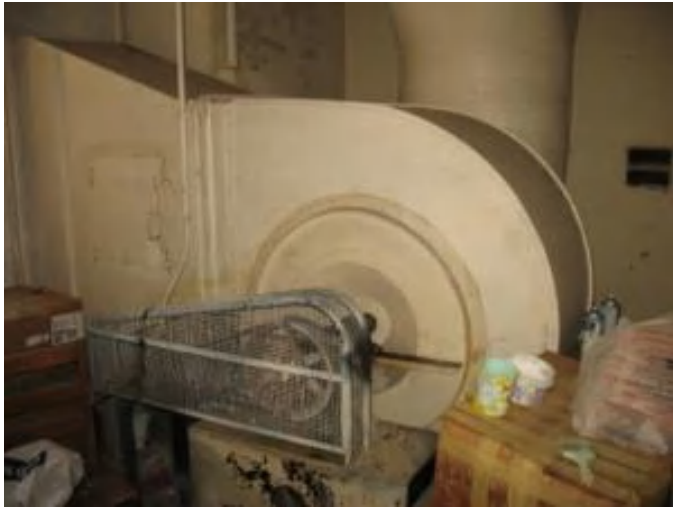
System: D3040 - Distribution Systems

Location: Throughout building

Distress: Building / MEP Codes

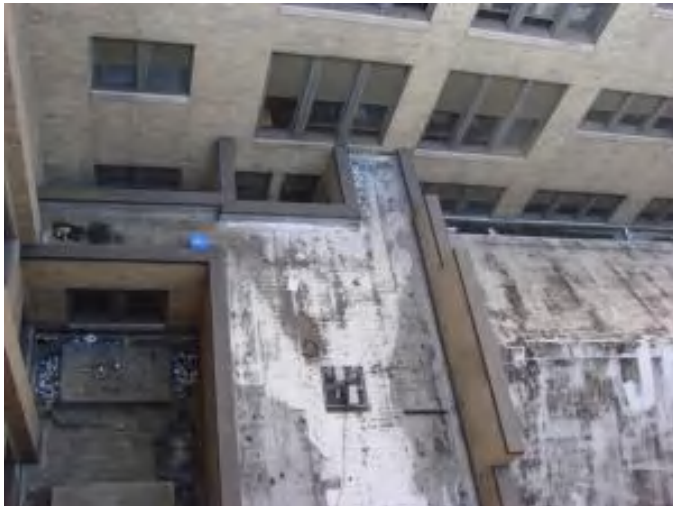
System: B3010105 - Built-Up

Roofing is typically built-up. All roofing and flashing is typically in poor condition with deterioration of the built-up system including water ponding and soft spots; several leaks have been reported.

Location: Exterior/ Roof

Distress: Failing

Notes: Install all new roofing system including insulation; tear-down existing roofing; install flashing, counter flashing and reglets

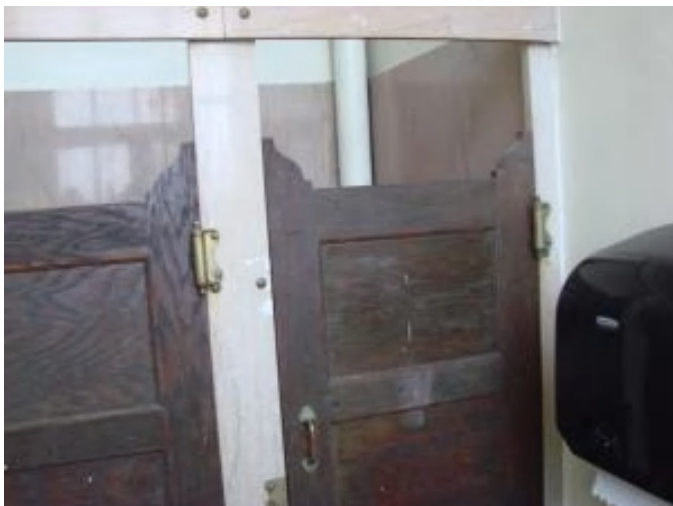
System: C1030 - Fittings

Location: Interiors

Distress: Accessibility

Notes: Reconfigure toilets on each floor for accessibility, provide new toilet partitions

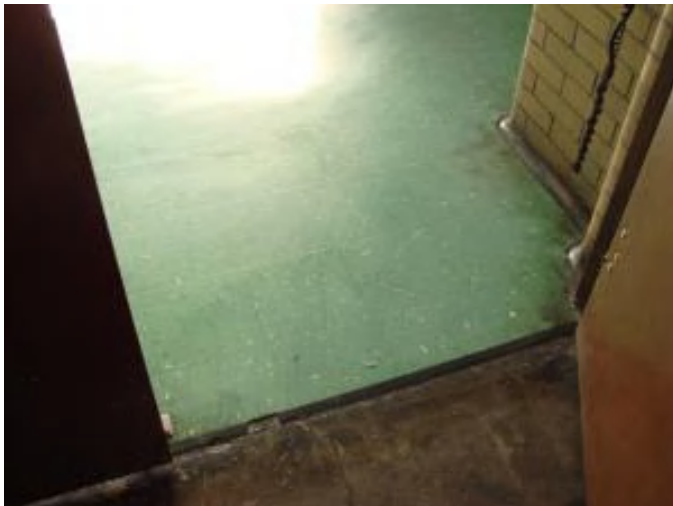
System: C3020413 - Vinyl Flooring

Location: Interiors

Distress: Beyond Service Life

Notes: Replace all VAT floor tiles

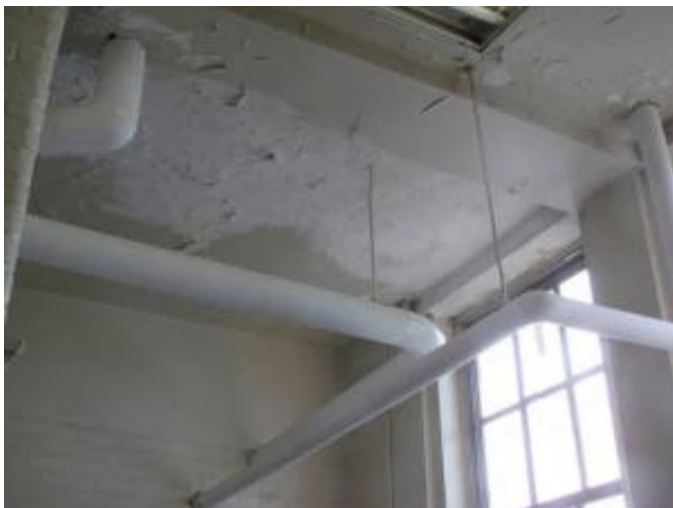
System: C3030 - Ceiling Finishes

Location: Interiors

Distress: Appearance

Notes: Repair and repaint exposed ceilings

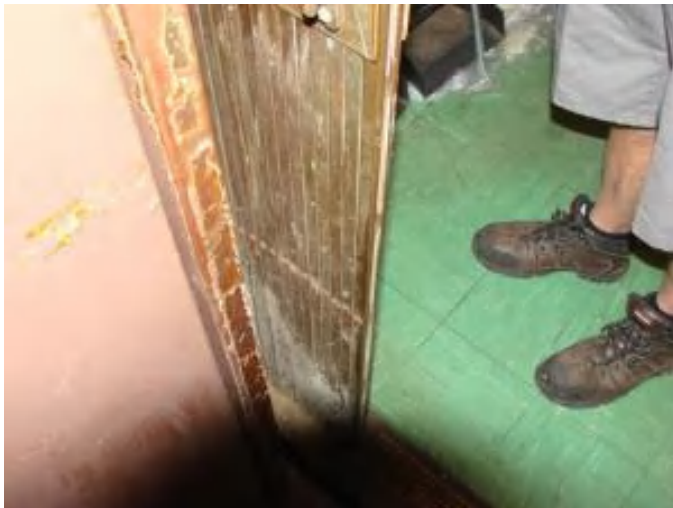
System: D1010 - Elevators and Lifts

Conveying systems - The building has 3 original elevators, manually operated, in very poor condition. One elevator is not operational

Location: Interiors

Distress: Beyond Service Life

Notes: Replace 3 original elevators serving all floors and basement

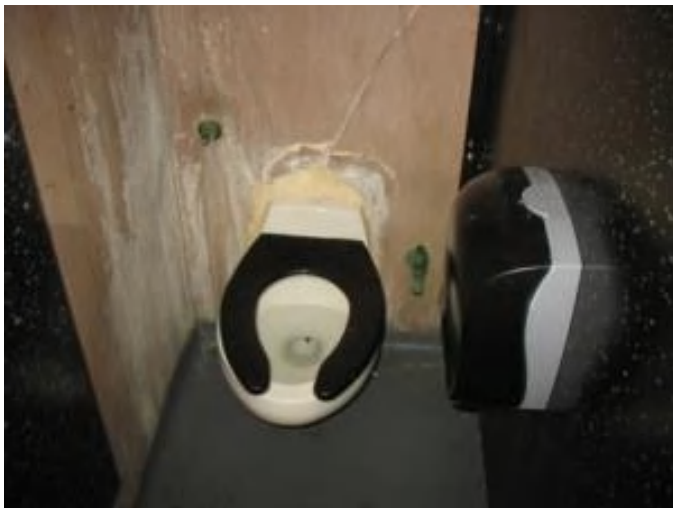
System: D2010 - Plumbing Fixtures

Location: Restrooms

Distress: Beyond Service Life

Notes: Replace the lavatories in the restrooms with new code compliant fixtures.

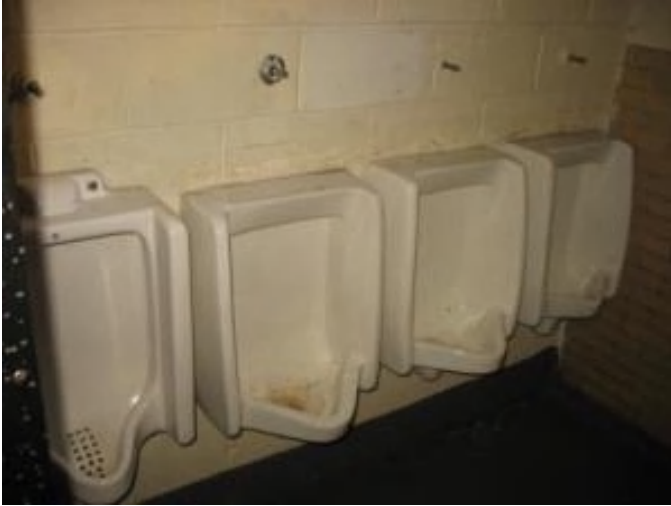
System: D2010 - Plumbing Fixtures

Location: B511001;Penn Treaty

Distress: Beyond Service Life

Notes: Replace the lavatories in the restrooms with new code compliant fixtures.

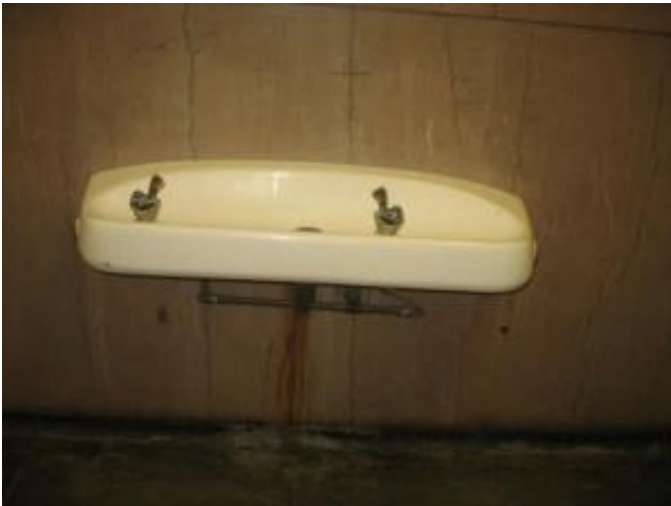
System: D2010 - Plumbing Fixtures

Drinking fountains in the corridors and at the restrooms are a mixture of wall hung with integral refrigerated coolers and porcelain fixtures. Most are not accessible type, are beyond their service life, and should be replaced.

Location: Throughout building

Distress: Beyond Service Life

Notes: Replace the wall hung drinking fountains and integral refrigerated coolers in the corridors and at the restrooms. These units are well beyond their service life and most are NOT accessible type.

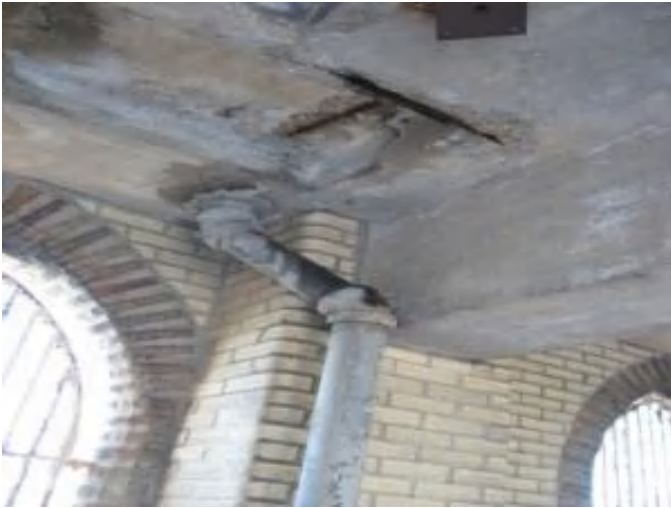
System: D2040 - Rain Water Drainage

Rain Water Drainage - The rain water drains from the roof are routed through mechanical chases in the building and appear to be original. The drain piping should be inspected and repaired as necessary.

Location: Roof

Distress: Beyond Service Life

Notes: The drain piping should be inspected and repaired as necessary.

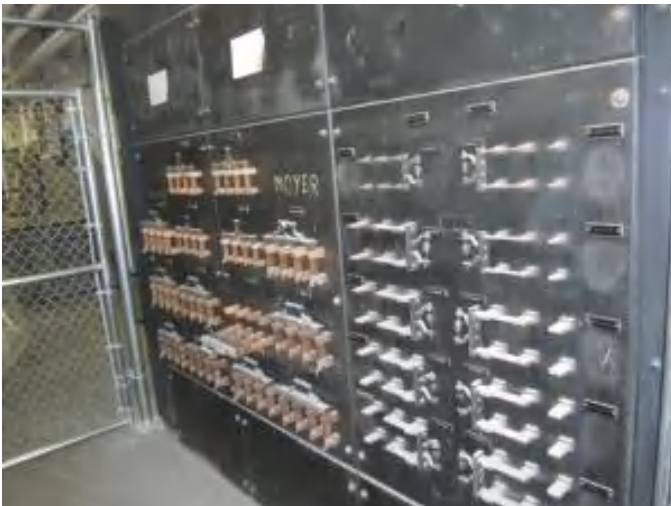
System: D5010 - Electrical Service/Distribution

Distribution System and Raceway System- The facility has an old antiquated open blade, open bus switchgear that is original to the building. This switchgear then distributes the power to various panels located throughout the school. Each floor contains panels to provide branch circuit power to receptacles and lights on that floor. The switchgear has surpassed its useful life, and due to its open bus configuration, is a safety issue. Most of the panels throughout the building have exceeded their useful life as well and should be replaced due to the availability of parts. Some of the panels are open bus as well, and pose a safety issue. There are some 2 phase

Location: Basement

Distress: Beyond Service Life

Notes: Replace existing service with new 480/277V three phase service.

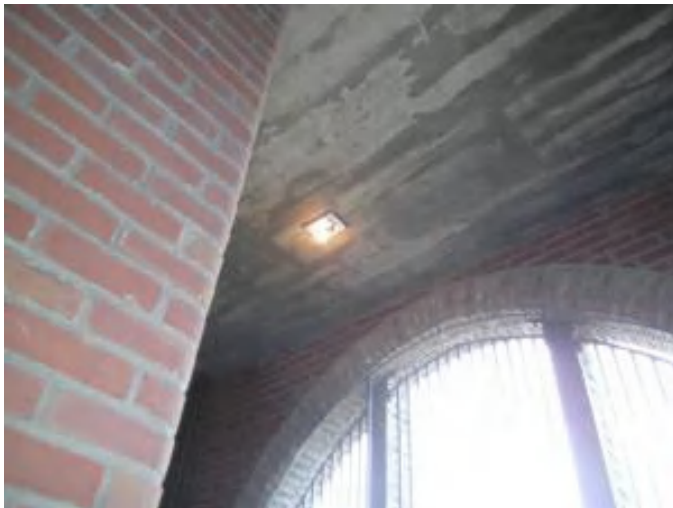
System: D5020 - Lighting and Branch Wiring

Lighting- The facility has a mix of both T12 lamps and T8 lamps in its fluorescent fixtures, with T12 being the norm. Corridors typically have 4 lamp lay in grid type 2X4 fixtures. Typical classrooms contain 1X4, 2 lamp pendant mounted fixtures and are controlled by a single switch. Cafeteria lighting is by 2X4 surface mounted fixtures. Lighting levels were found to be around 30 fc in classrooms that have the T12 lamps. In areas with updated T8 lamps (computer rooms, admin areas) lighting levels were above the 50 fc mark. The gymnasium has 10 metal halide high bay type fixtures providing 20 fc. The auditorium uses circular surface mounted decorative fixtures with screw in type compact fluorescent lamps. Fire towers are incandescent in general with some screw in fluorescent type. The lighting upgrade should be completed throughout the school. The lighting in the basement mechanical areas was updated during the mechanical upgrades.

Location: Throughout Building

Distress: Inadequate

Notes: Upgrade lighting system to T8 fluorescent fixtures.

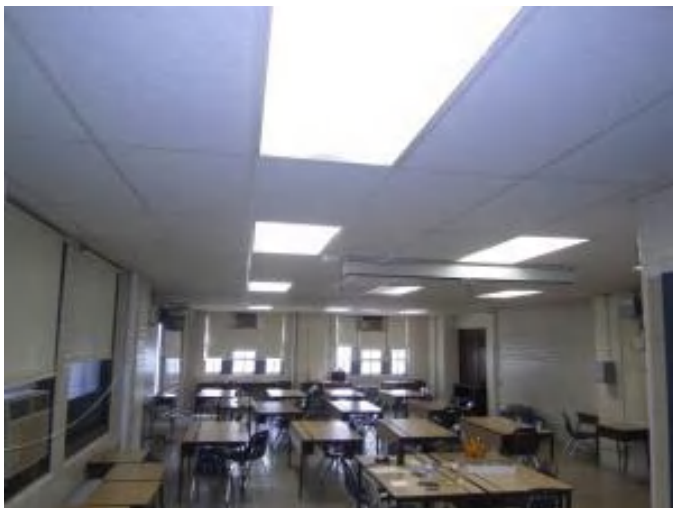
System: D5020 - Lighting and Branch Wiring

Receptacles- Classrooms are typically supplied with 3 to 4 duplex receptacles. A minimum of 2 receptacles per wall should be added to each classroom. The receptacles located in the food prep area are not GFI protected. All receptacles in this area should be replaced with GFI protected receptacles. One of the computer rooms had power poles to provide power and data to the middle of the classroom. Another computer classroom had computers spread along the perimeter of the room, and used extension cords and power strips. Surface mounted raceway is recommended for this room.

Location: Throughout Building

Distress: Inadequate

Notes: Provide minimum 2 receptacles per wall in classrooms.

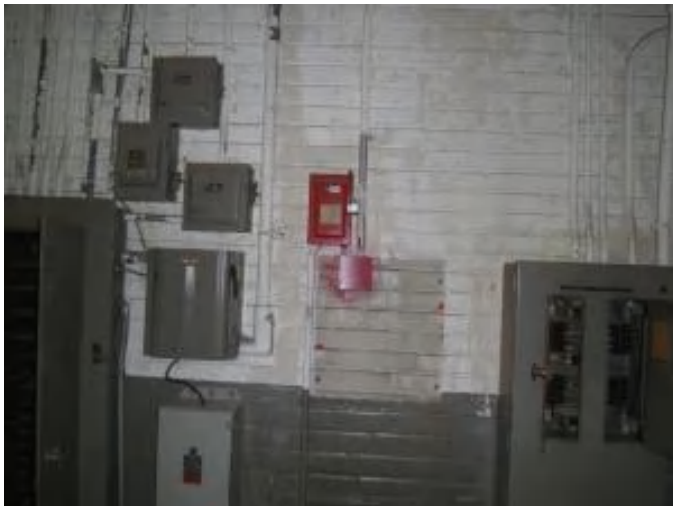
System: D5030 - Communications and Security

Fire Alarm System – The fire alarm system is an antiquated 120V system with pull stations and bells located in the corridors only. It is recommended that a new addressable fire alarm system be installed with full audio or visual annunciating devices.

Location: Throughout Building

Distress: Life Safety / NFPA / PFD

Notes: Replace 120V fire alarms system with low voltage addressable system.

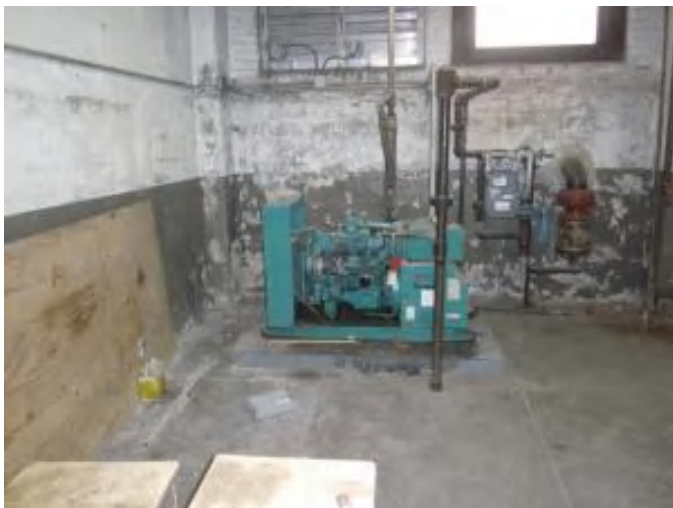
System: D5090 - Other Electrical Systems

Location: Basement

Distress: Building / MEP Codes

Notes: Replace existing emergency generator with one of sufficient size to support an elevator and emergency lighting.

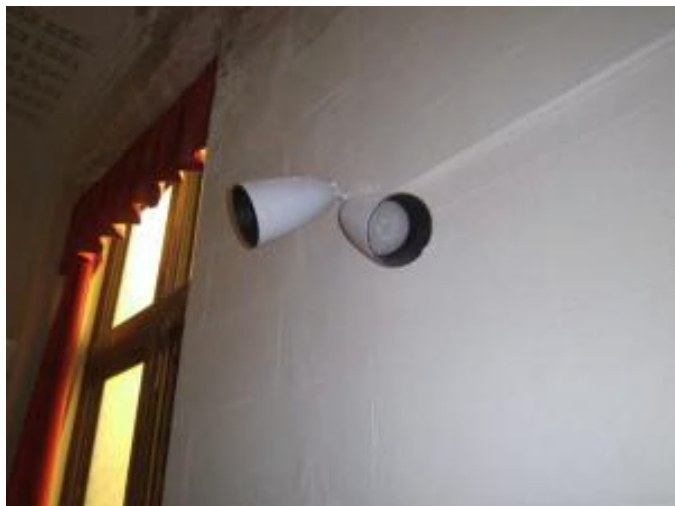
System: D5090 - Other Electrical Systems

Location: Throughout Building

Distress: Inadequate

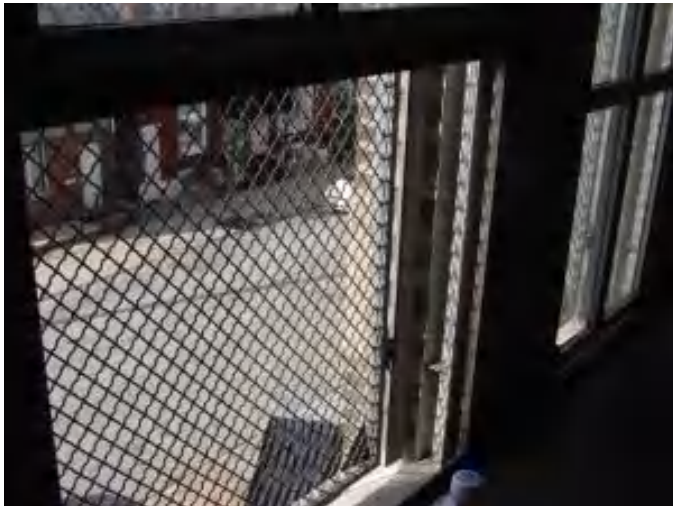
System: B2020 - Exterior Windows

The original windows were replaced in late 1970's with extruded aluminum double hung windows, single glazed. Basement and first floor windows are fitted with security screens attached to adjacent masonry. All windows and screens are generally in poor condition and beyond their useful life.

Location: Exterior

Distress: Beyond Service Life

Notes: Replace all windows

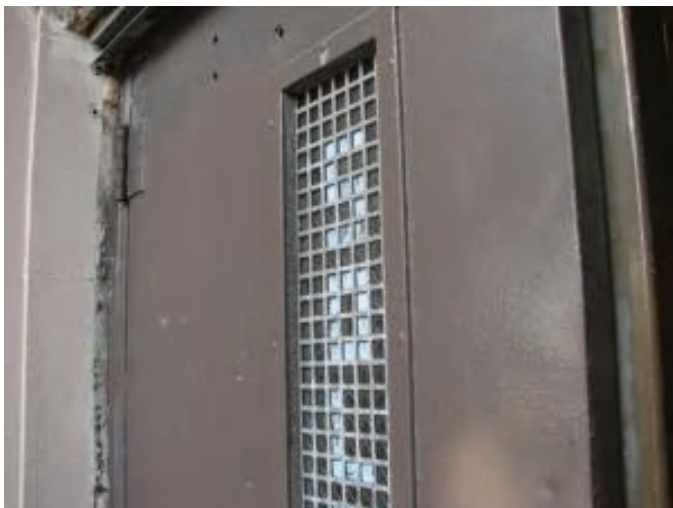
System: B2030 - Exterior Doors

Exterior doors and frames are typically hollow metal in fair to good condition; most of the service doors are in poor condition, some rusting and missing hardware.

Location: Exterior

Distress: Beyond Service Life

Notes: Replace exterior service doors, including penthouses; provide weather-stripping

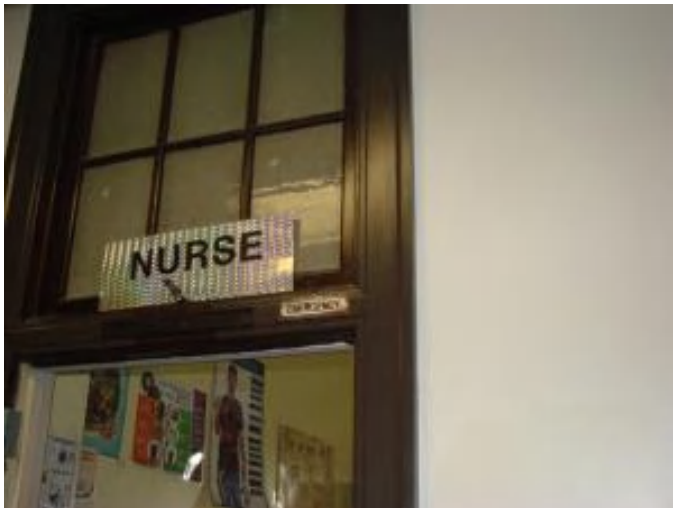
System: C1020 - Interior Doors

Location: Interior

Distress: Damaged

Notes: Repair and refinish all original interior doors

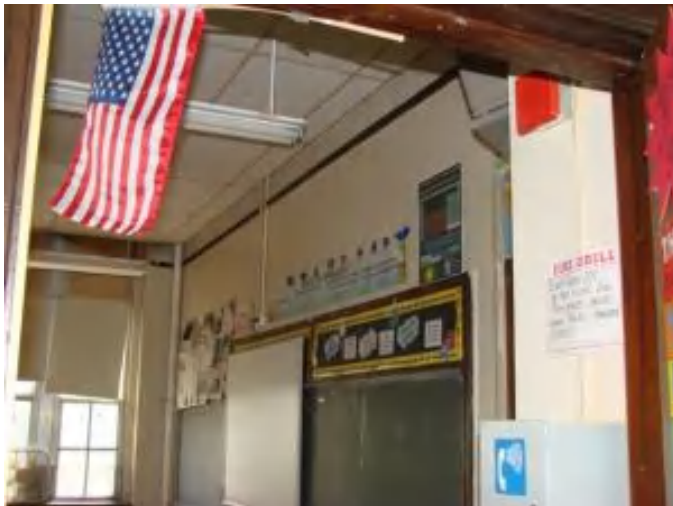
System: C1030 - Fittings

Location: Interiors

Distress: Beyond Service Life

Notes: Replace original chalk boards

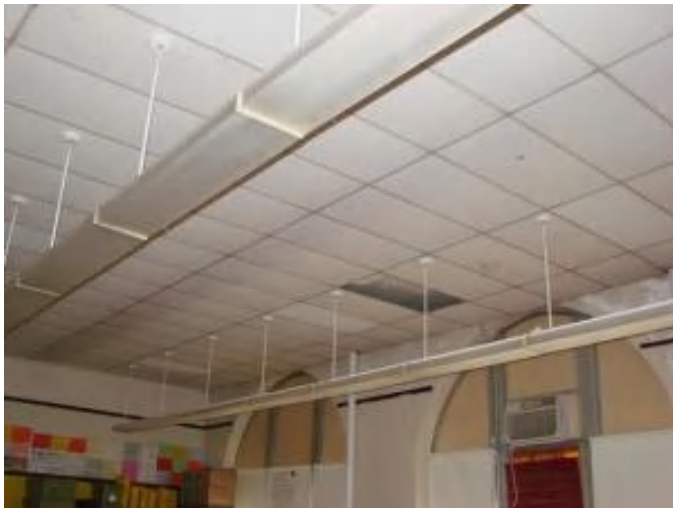
System: C3030 - Ceiling Finishes

Location: Interiors

Distress: Beyond Service Life

Notes: Replace all suspended acoustical ceilings

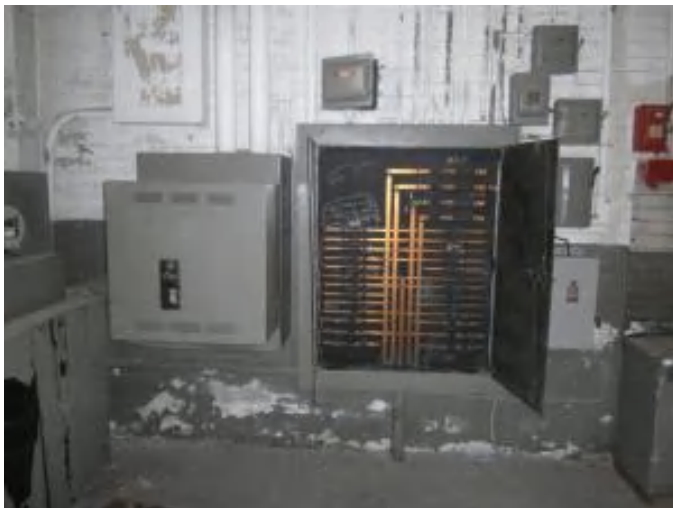
System: D5010 - Electrical Service/Distribution

Location: Throughout Building

Distress: Beyond Service Life

Notes: Provide a new distribution system to replace old panels.

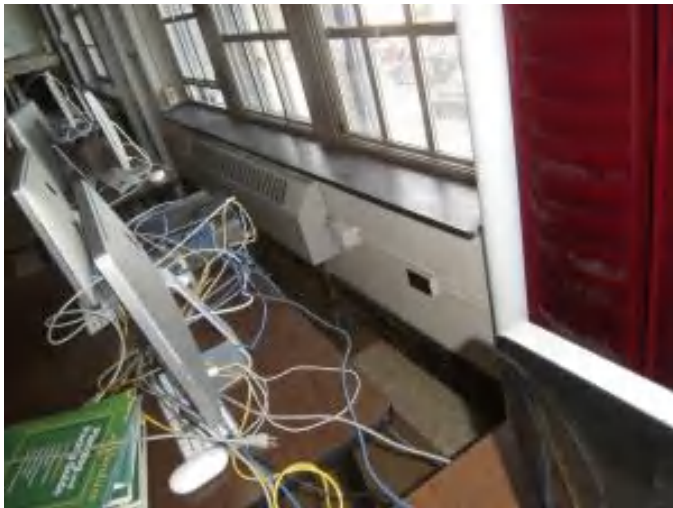
System: D5020 - Lighting and Branch Wiring

Location: Computer Classroom

Distress: Inadequate

Notes: Provide surface mounted raceway in computer classroom.

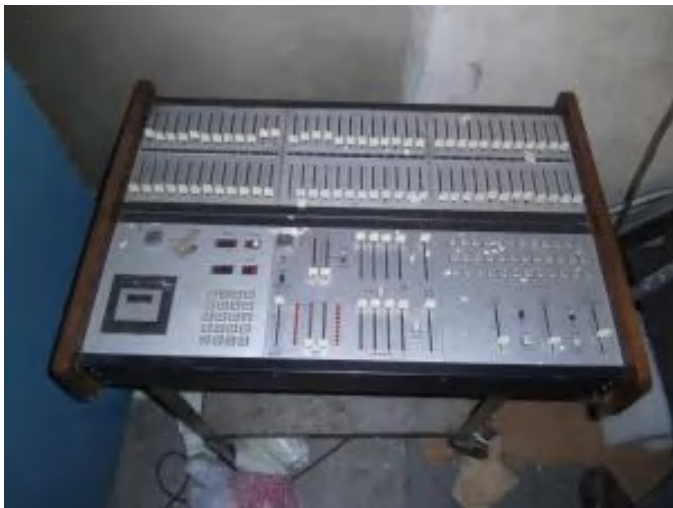
System: D5030 - Communications and Security

Location: Throughout building

Distress: Beyond Service Life

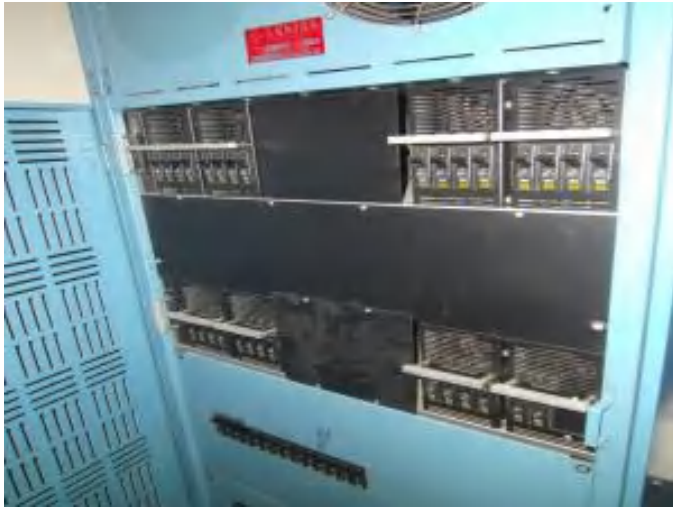
System: E1020 - Institutional Equipment

Theatrical lighting and sound – The existing theatrical lighting and sound system have exceeded their useful life. Both the light dimming panel and the sound board are antiquated and should be replaced.

Location: Auditorium

Distress: Beyond Service Life

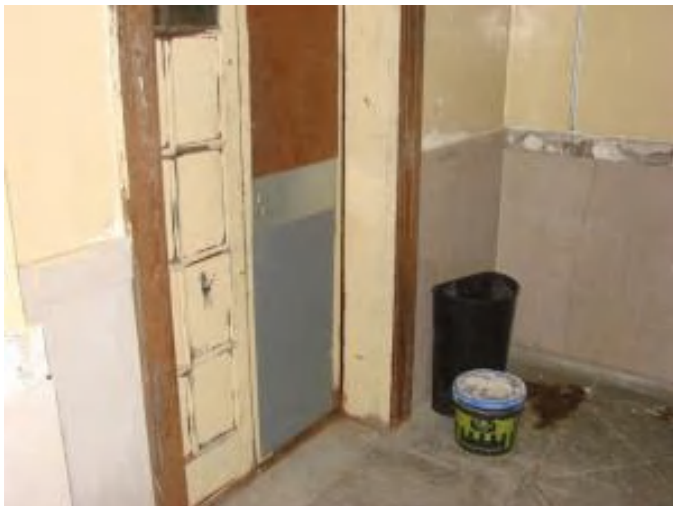
System: C3010230 - Paint & Covering

Location: Interiors

Distress: Appearance

Notes: Repair and repaint interior walls (50% area)

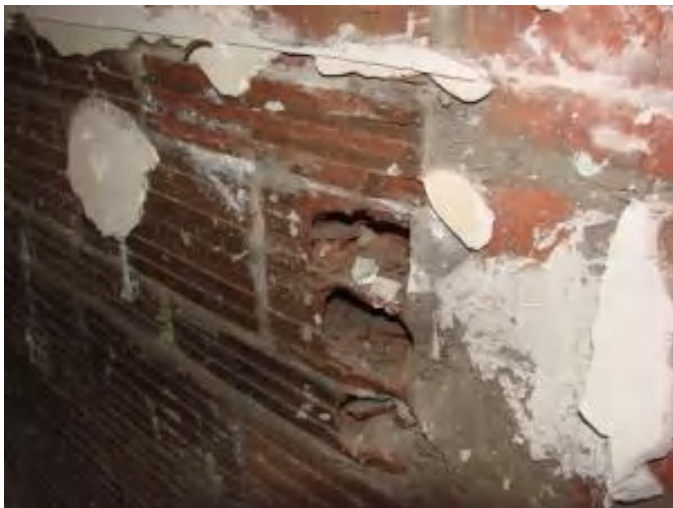
System: C3010232 - Wall Tile

Location: Interiors

Distress: Damaged

Notes: Replace stone wainscot

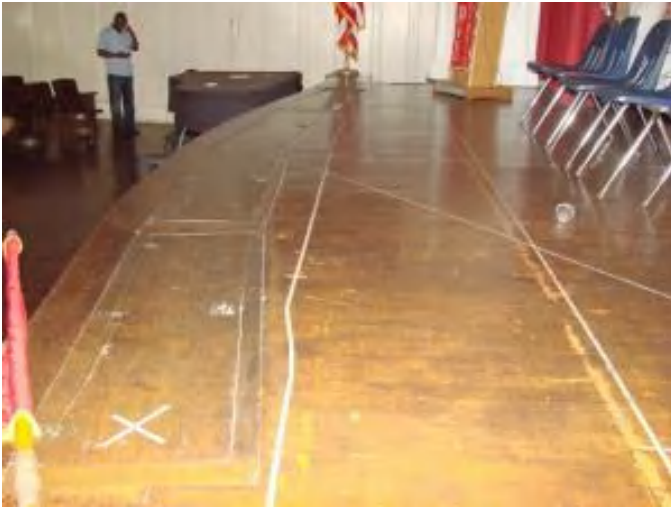
System: C3020414 - Wood Flooring

Location: Interiors

Distress: Appearance

Notes: Repair refinish hardwood flooring

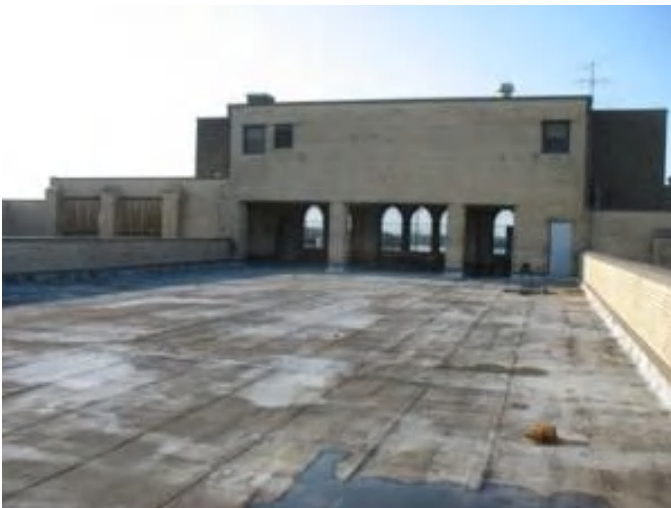
System: D3030 - Cooling Generating Systems

Terminal & Package Units - Several of the classrooms in the school building have window air conditioning units that have an anticipated service life of only 10 years. Installing a 375 ton air-cooled chiller on the roof with pumps located in a mechanical room and chilled water distribution piping could supply more reliable air conditioning for the building with a much longer service life.

Location: Roof

Distress: Inadequate

Notes: Remove the window air conditioning units and install a 375 ton air-cooled chiller on the roof with chilled water distribution piping and pumps located in a mechanical room to supply more reliable air conditioning for the building with a much longer service life.

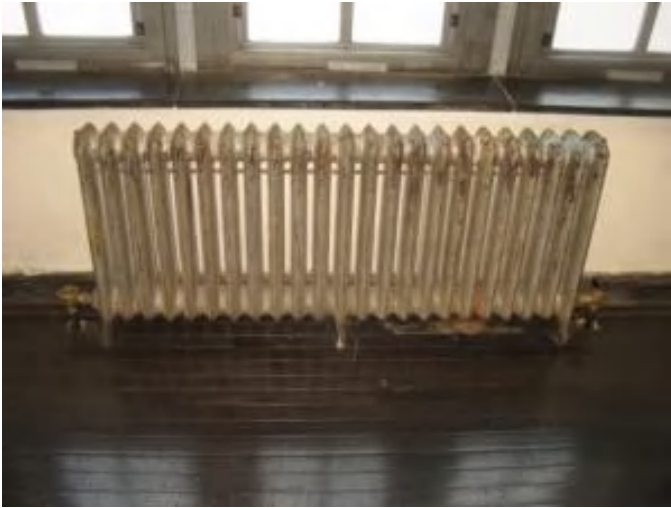
System: D3040 - Distribution Systems

Location: Throughout building

Distress: Building / MEP Codes

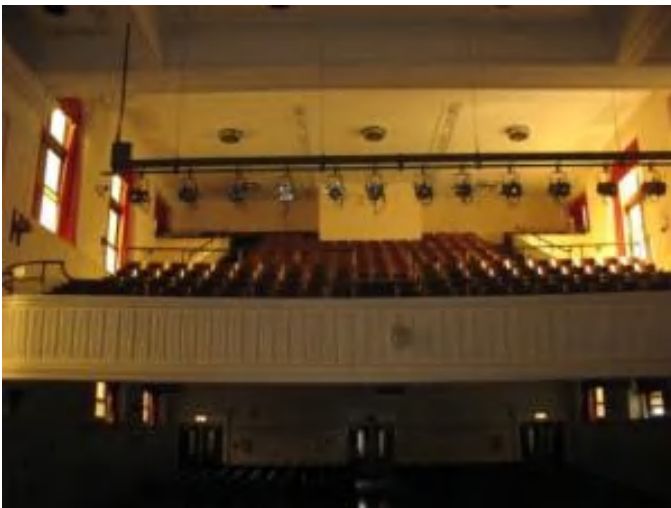
System: D3040 - Distribution Systems

Location: Auditorium

Distress: Building / MEP Codes

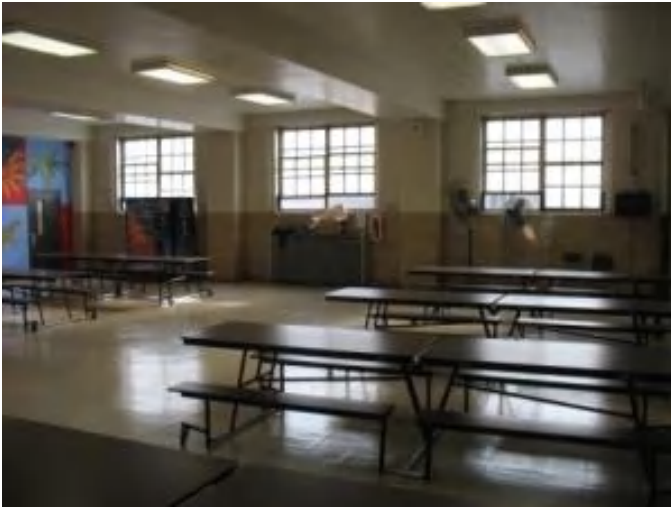
System: D3040 - Distribution Systems

Location: Cafeteria

Distress: Building / MEP Codes

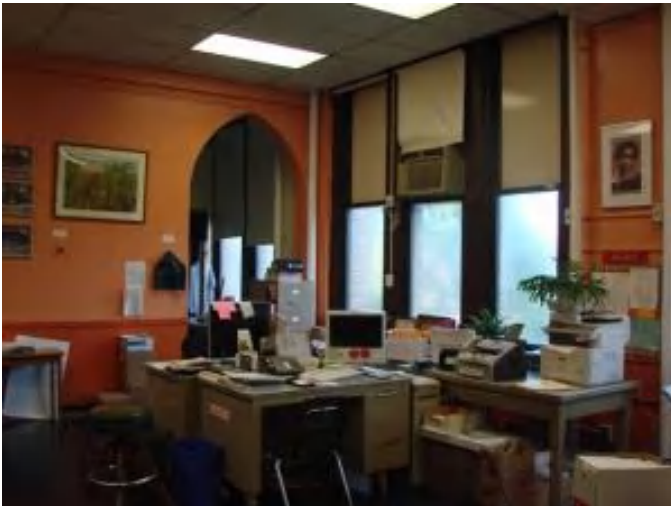
System: D3040 - Distribution Systems

Location: Administration

Distress: Building / MEP Codes

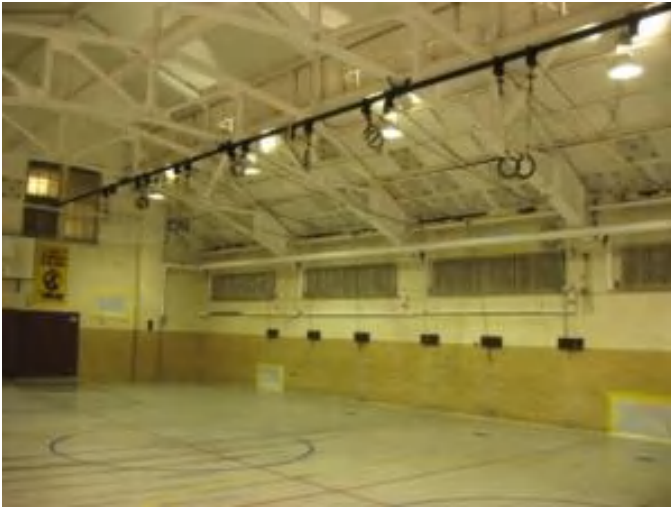
System: D3040 - Distribution Systems

Location: Gymnasium

Distress: Building / MEP Codes

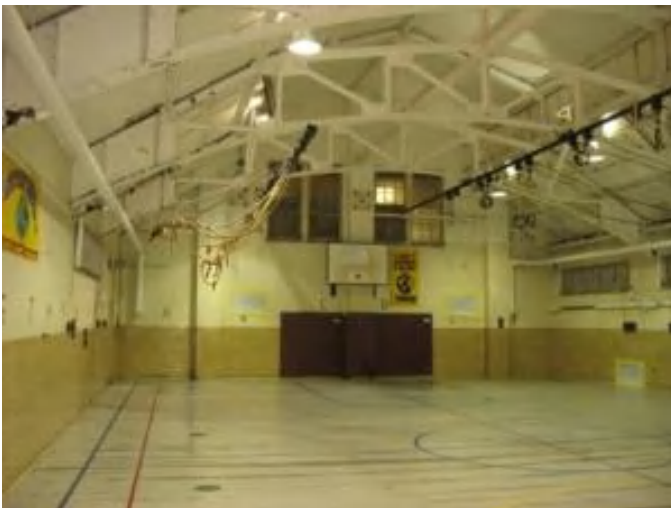
System: D3040 - Distribution Systems

Location: Gymnasium

Distress: Building / MEP Codes

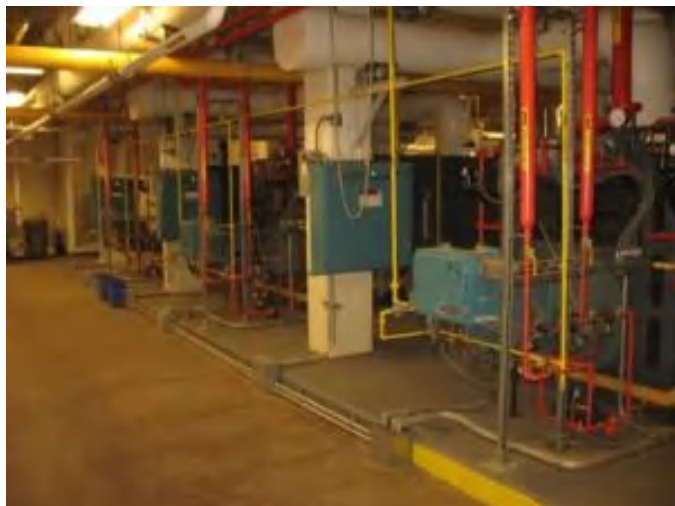
System: D3060 - Controls & Instrumentation

Location: Throughout building

Distress: Energy Efficiency

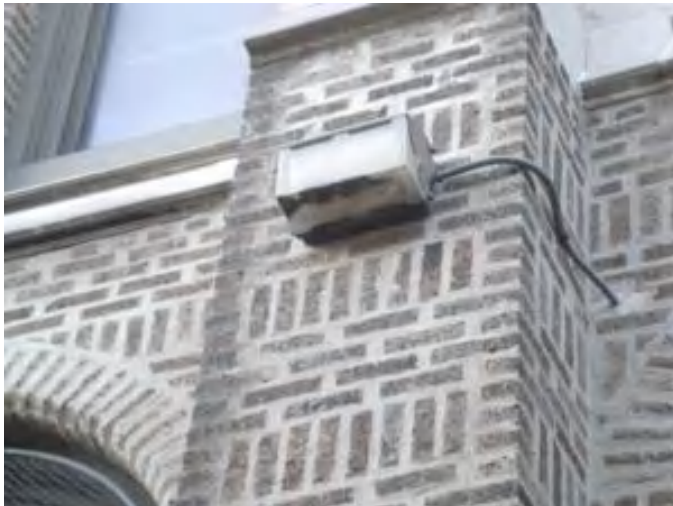
System: G4020 - Site Lighting

Location: Exterior

Distress: Beyond Service Life

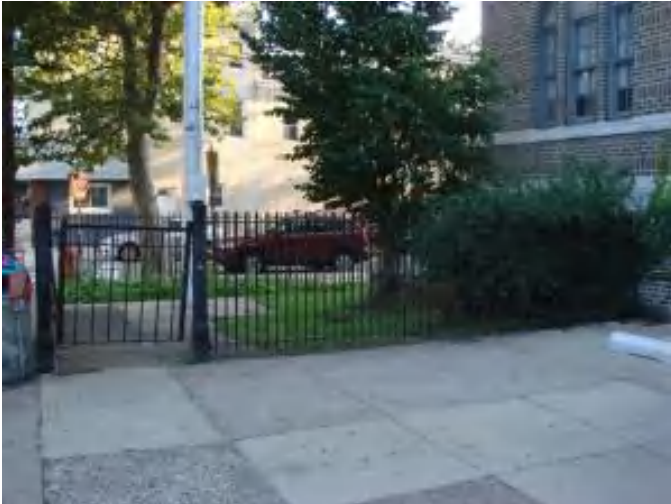
System: G2040 - Site Development

Location: Grounds/ Site

Distress: Beyond Service Life
